Final
2018 Annual Land Use Control Monitoring Report,
RVAAP-01 Ramsdell Quarry Landfill,
RVAAP-05 Winklepeck Burning Grounds,
RVAAP-08 through RVAAP-11 (Load Lines 1 through 4), and
RVAAP-12 (Load Line 12)

Camp James A. Garfield Joint Military Training Center
Former Ravenna Army Ammunition Plant
Portage and Trumbull Counties, Ohio

May 24, 2019

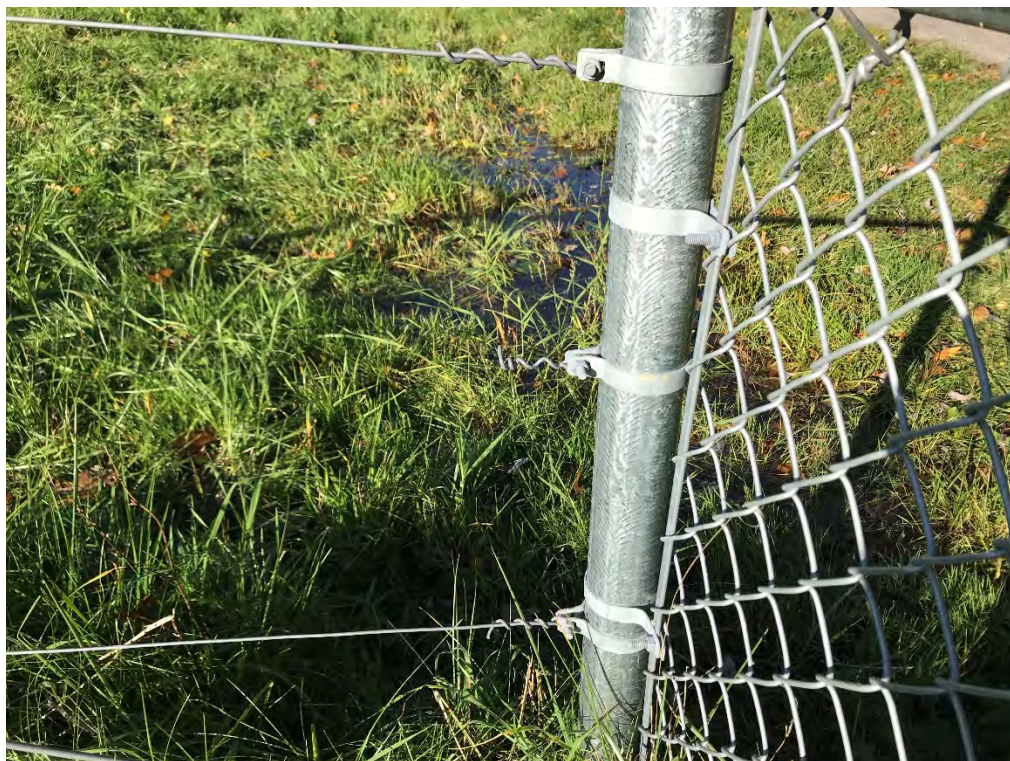
One strand of the 5-wire tensile fence surrounding the LUC area was broken at the northwest corner fence post. The Army and Ohio Army National Guard were notified of the wire break by email on November 7, 2018. The wire break was repaired on December 3, 2018.

Broken wire of 5-wire tensile fence, northwest corner.

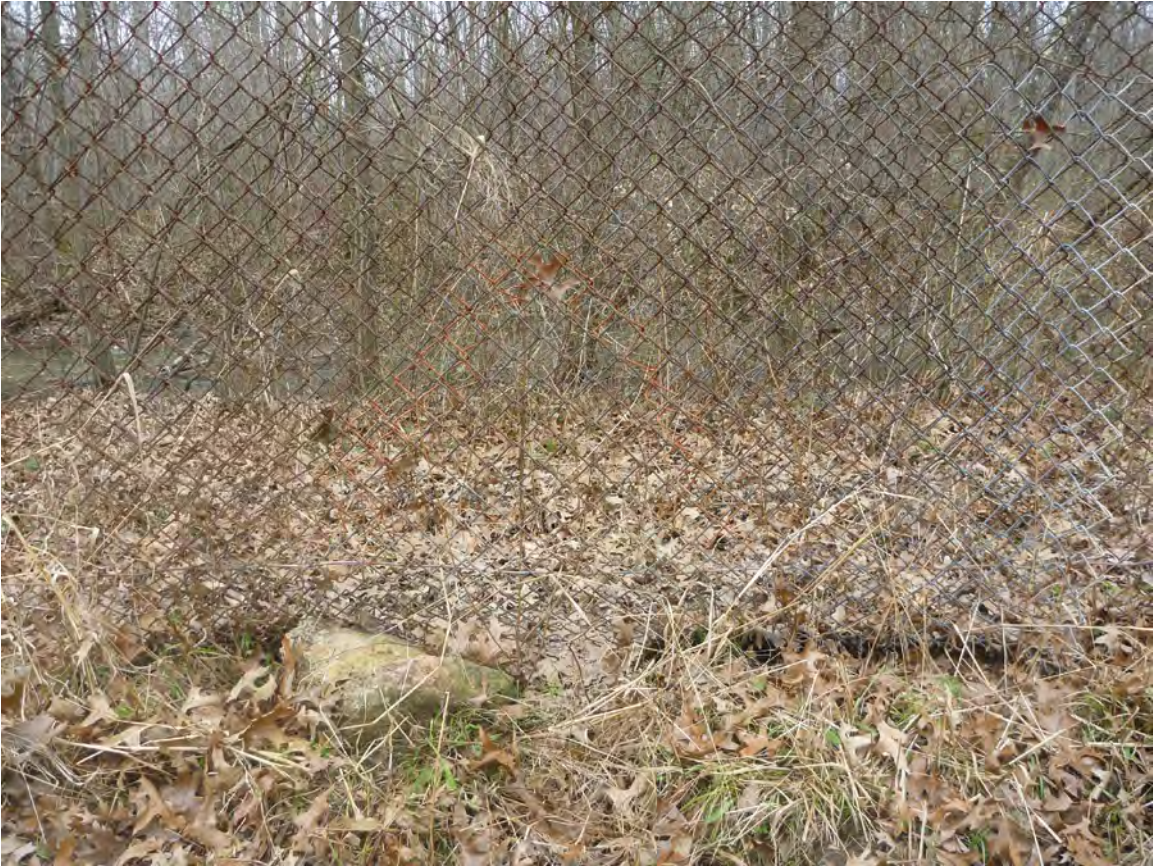
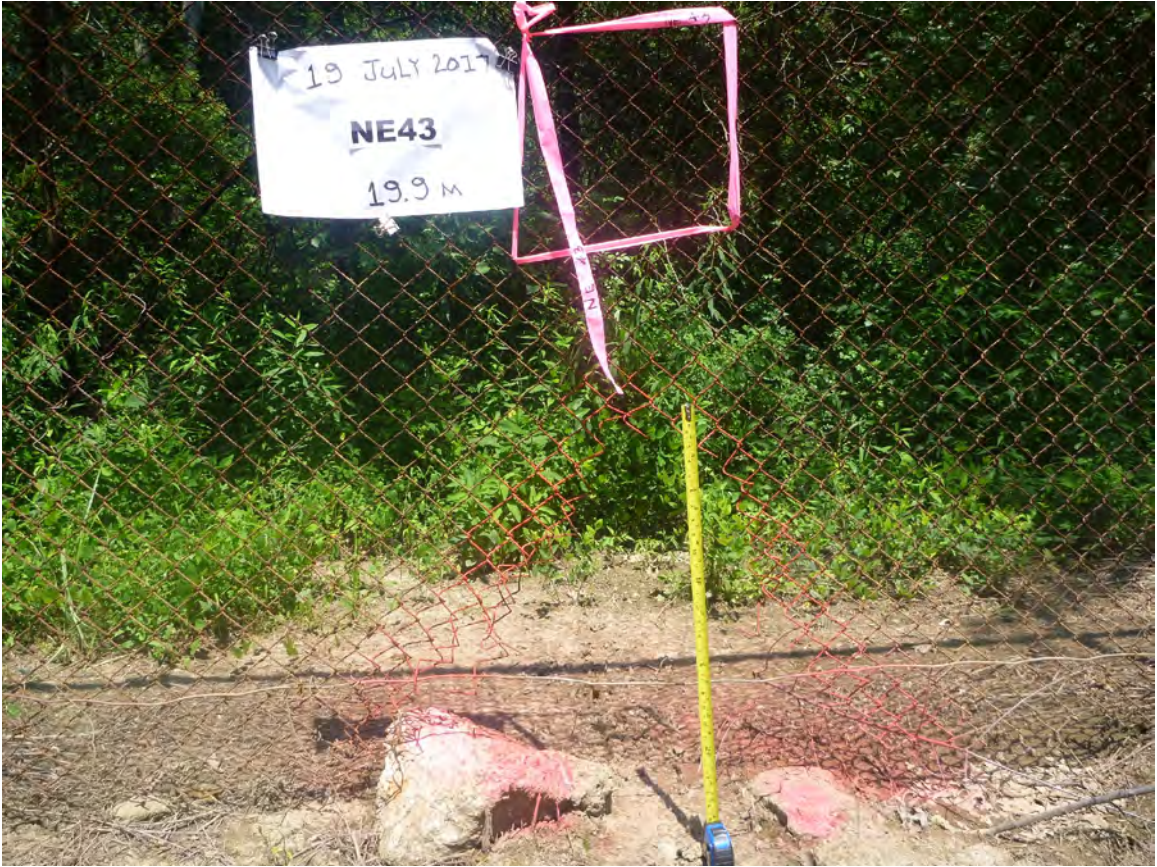
PHOTO NE43 discovered 7/19/2017

Repair photo NE43 dated 12/27/2018

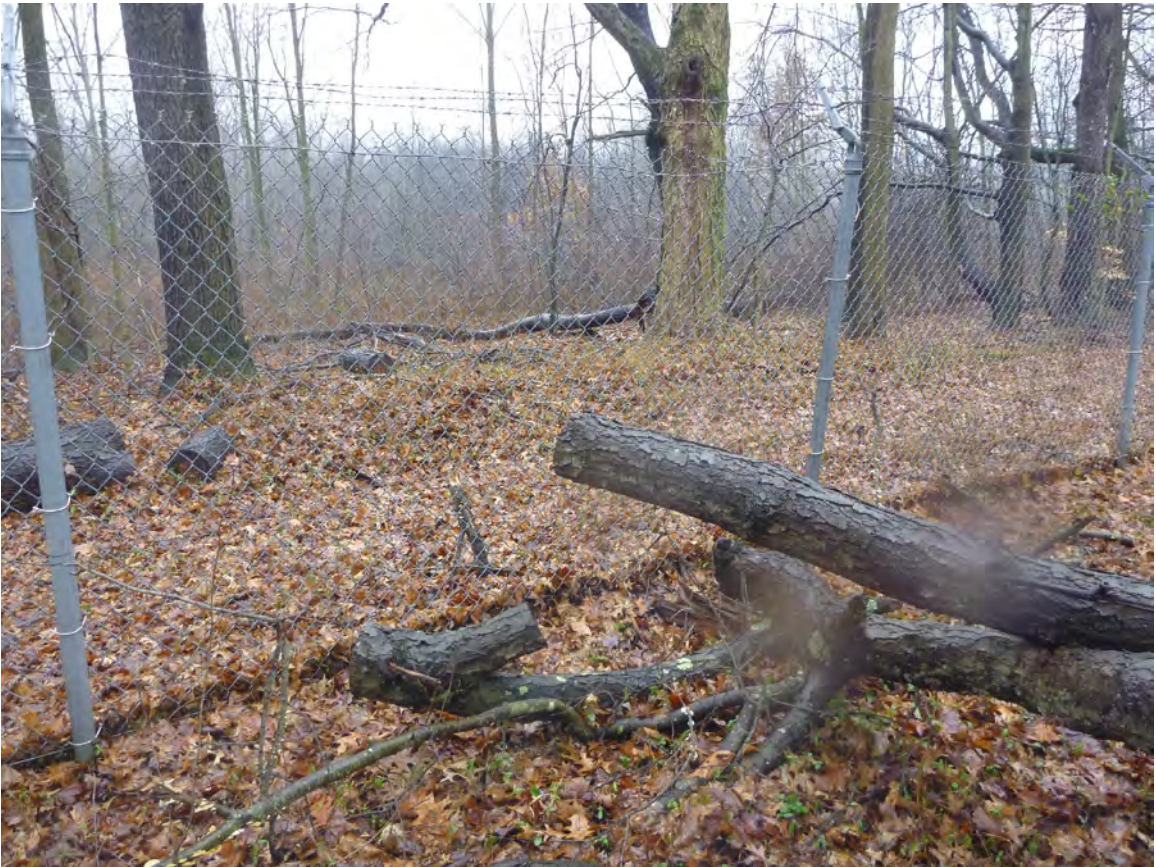
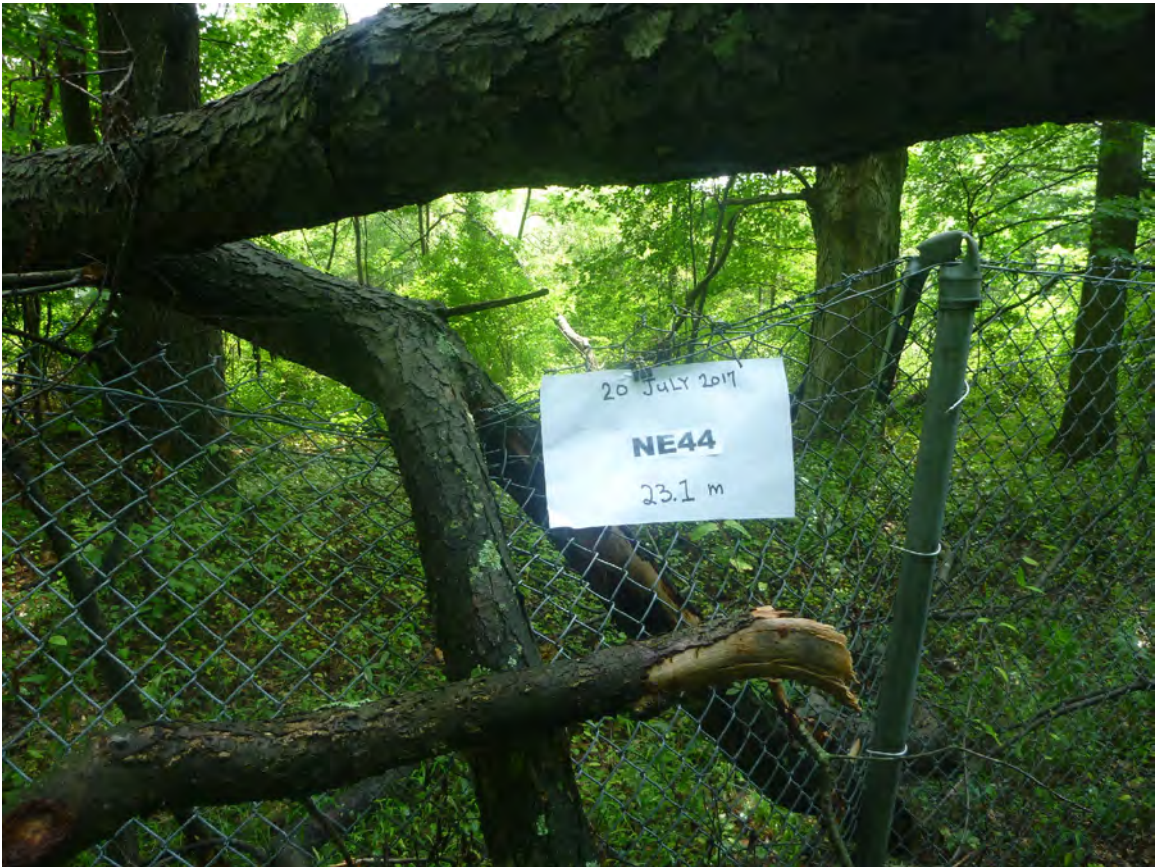
PHOTO NE44 discovered 7/20/2017

Repair photo NE44 dated 12/28/2018

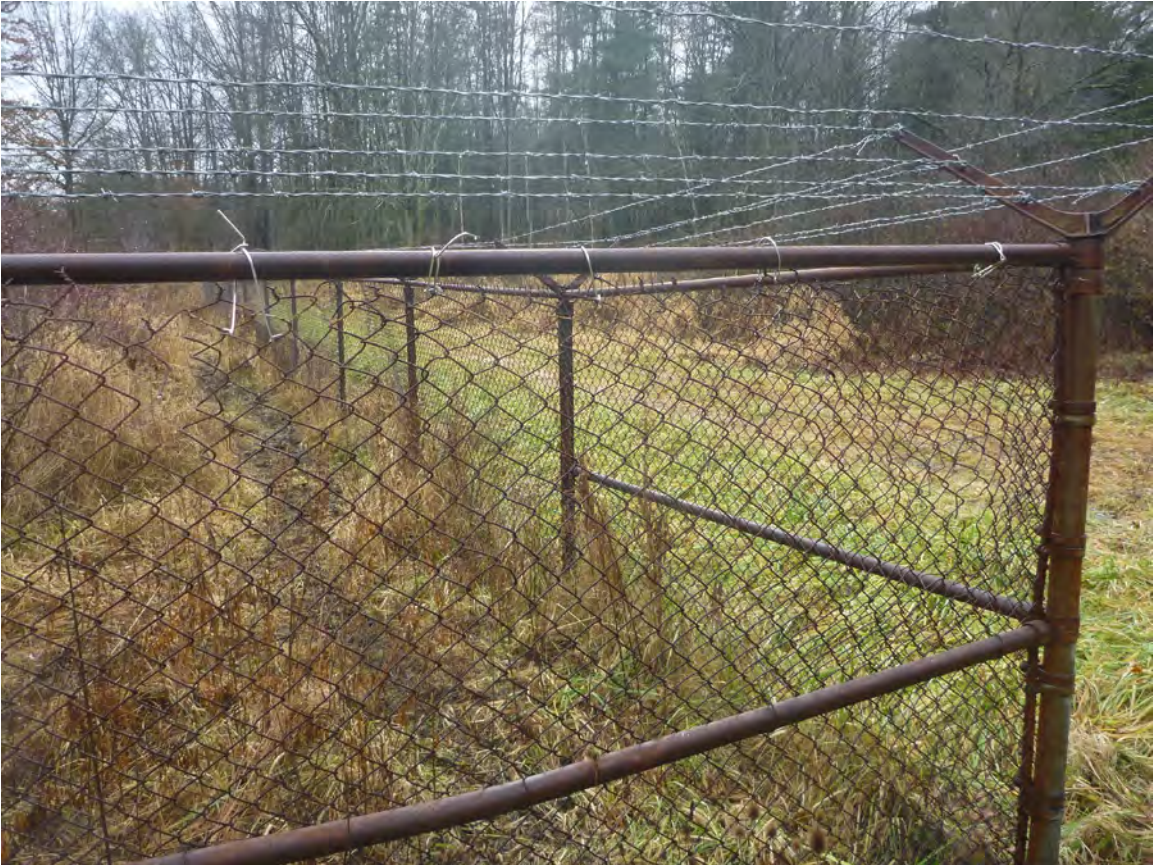
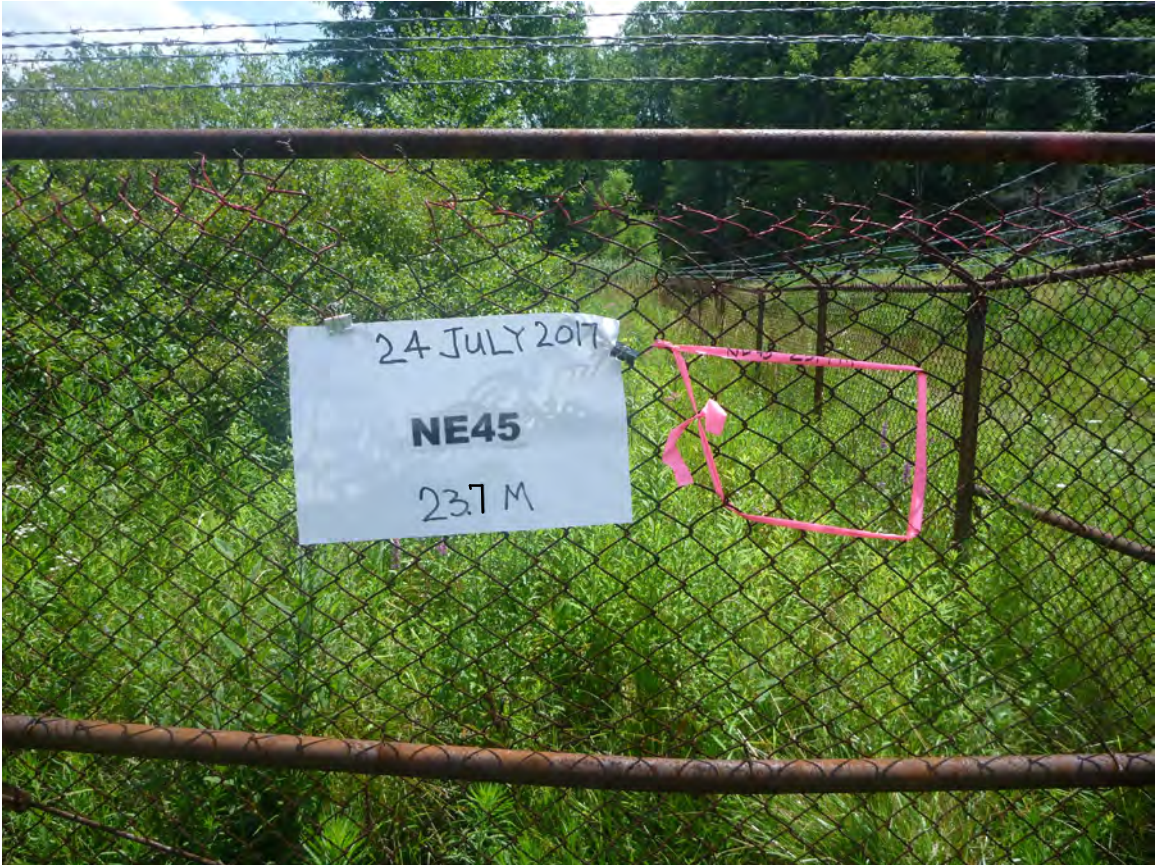
PHOTO NE45 discovered 7/24/2017

Repair photo NE45 dated 12/28/2018

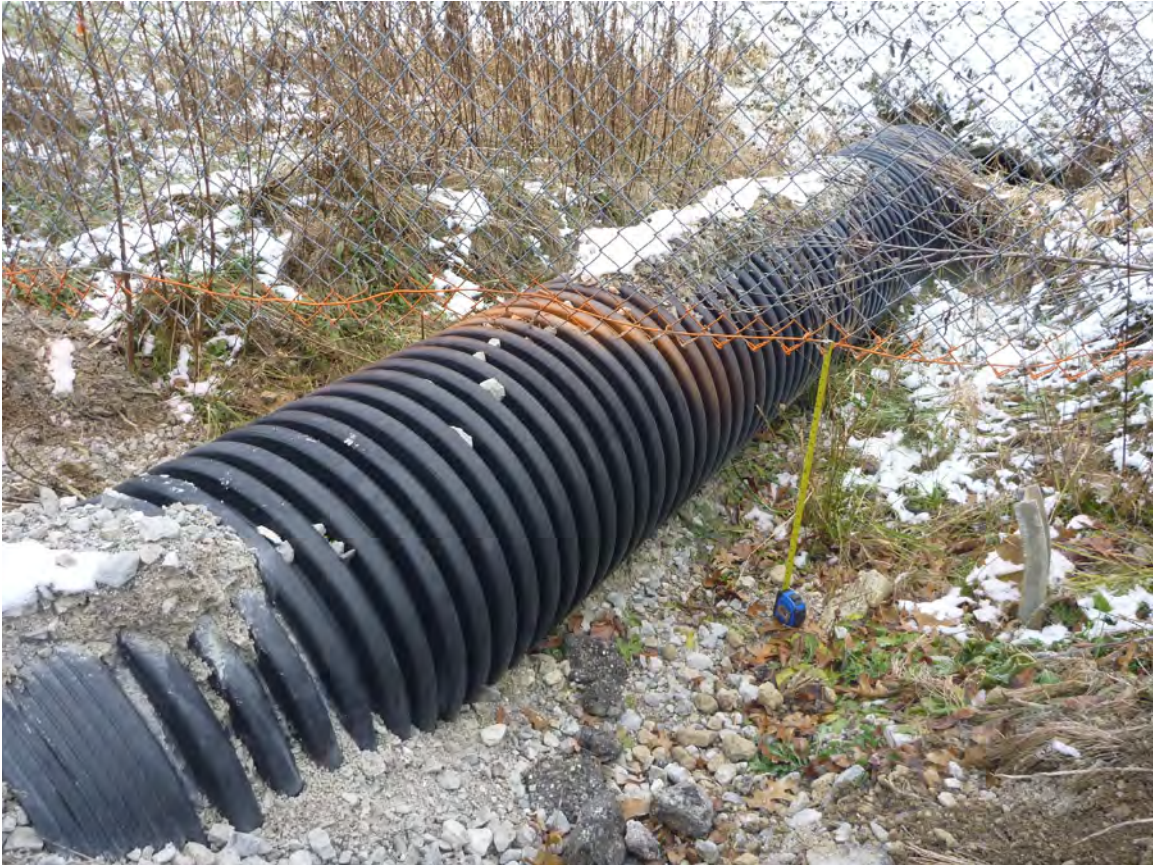
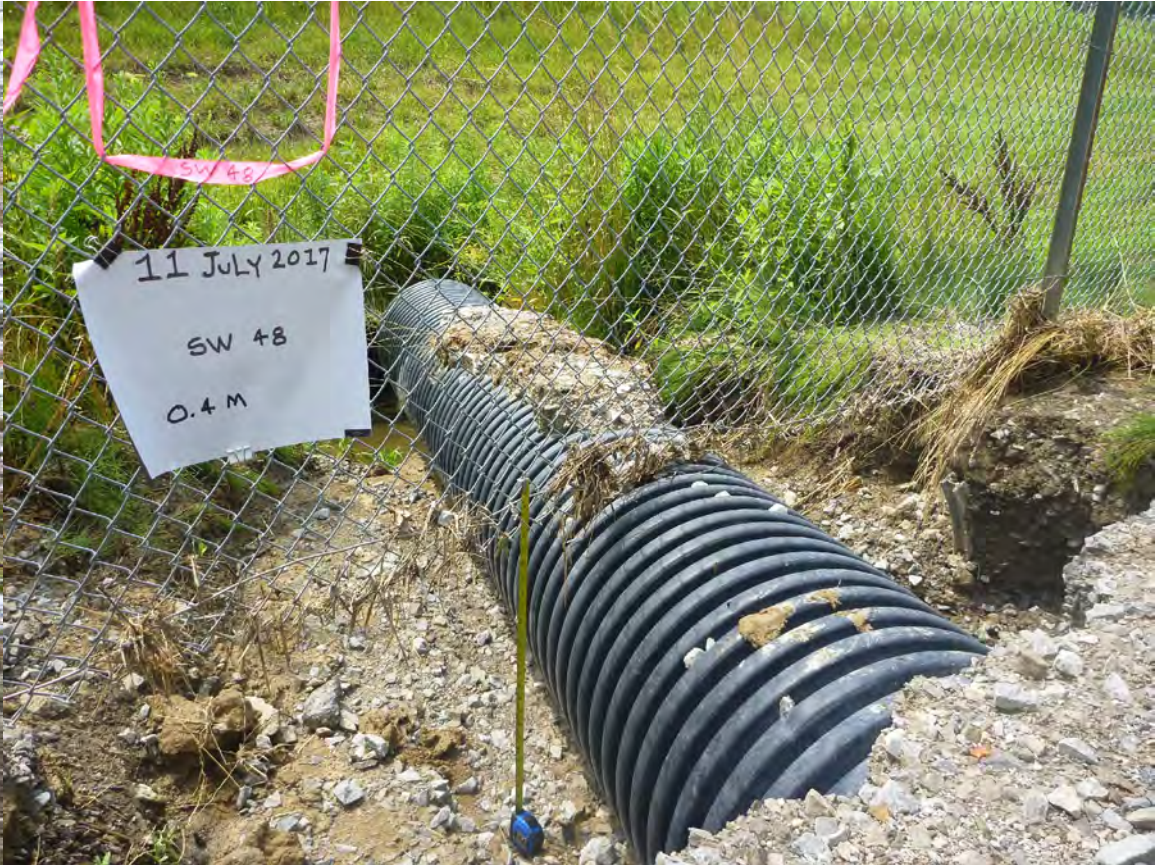
PHOTO SW48 discovered 7/11/2017

All of the perimeter fence defects called out during the 2018 inspection have been repaired as of January 3, 2019, with the exception of SW48 and SE07. SW48 and SE07 are culvert washouts, and the repairs are under contract and are underway as of mid-April 2019.

UPDATED PHOTO SW48 12/10/2018

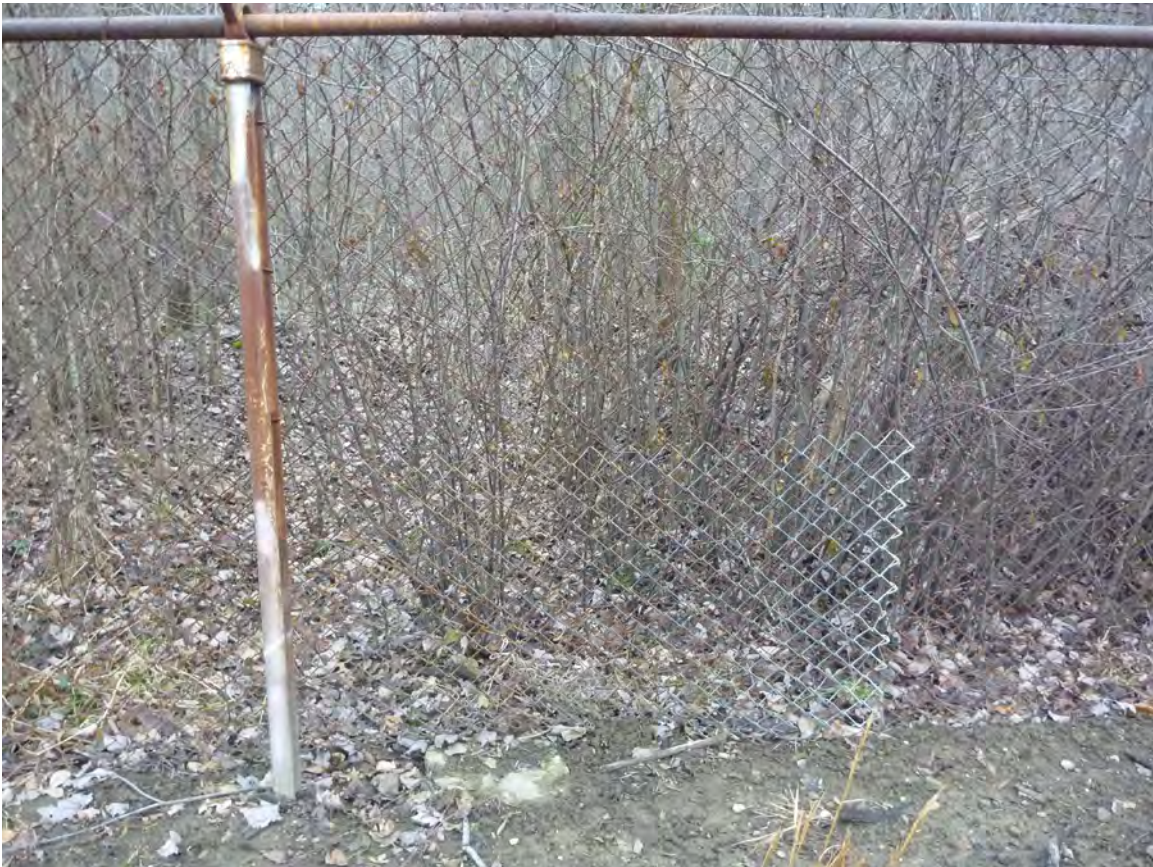
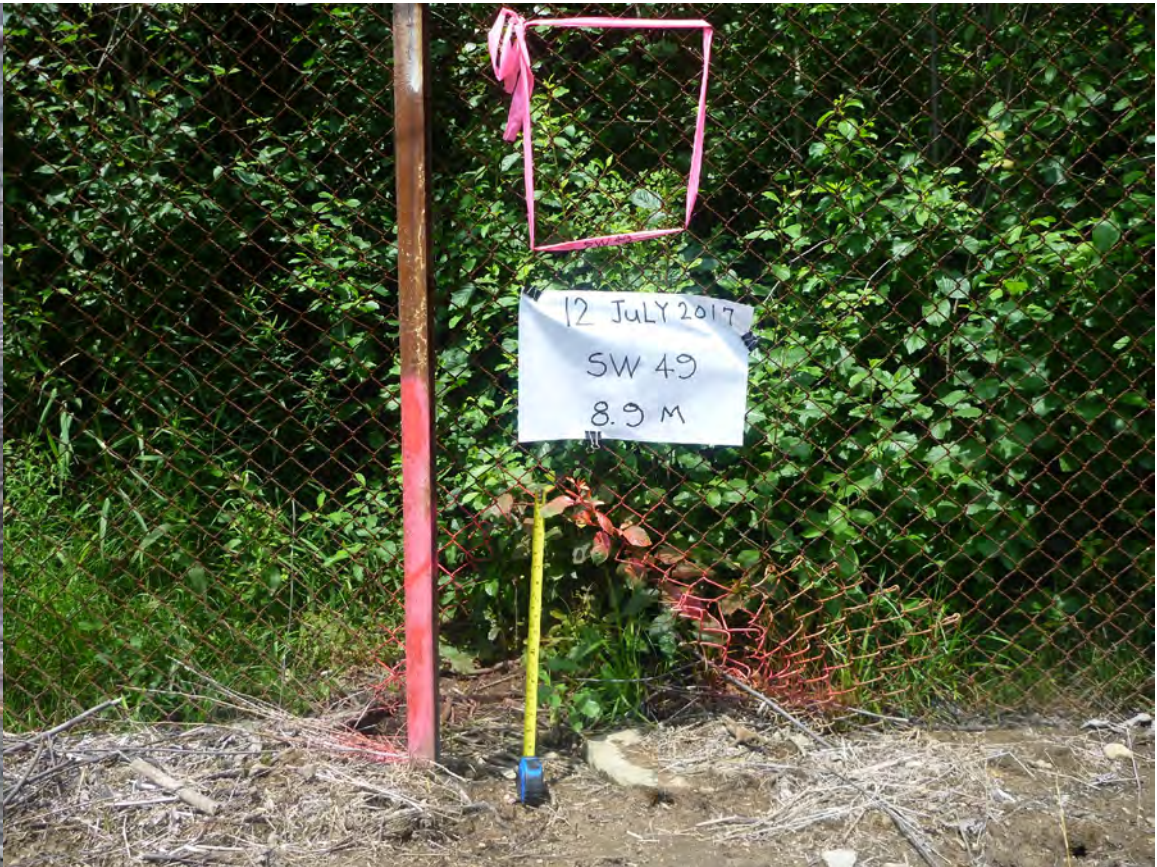
PHOTO SW49 discovered 07/12/2017

Repair photo SW49 dated 12/17/2018
