**DEPARTMENT OF THE ARMY
BALTIMORE DISTRICT, CORPS OF ENGINEERS
2 HOPKINS PLACE
BALTIMORE, MD 21201**

MEMORANDUM FOR RECORD

SUBJECT: Summary of Findings, Magnetometer-Assisted Survey of Sand Creek conducted on 8-12 January 2024, as related to the Time Critical Removal Action for Open Demolition Area #2 (ODA2) at Camp James A. Garfield Joint Military Training Center (CJAG), Ravenna, OH

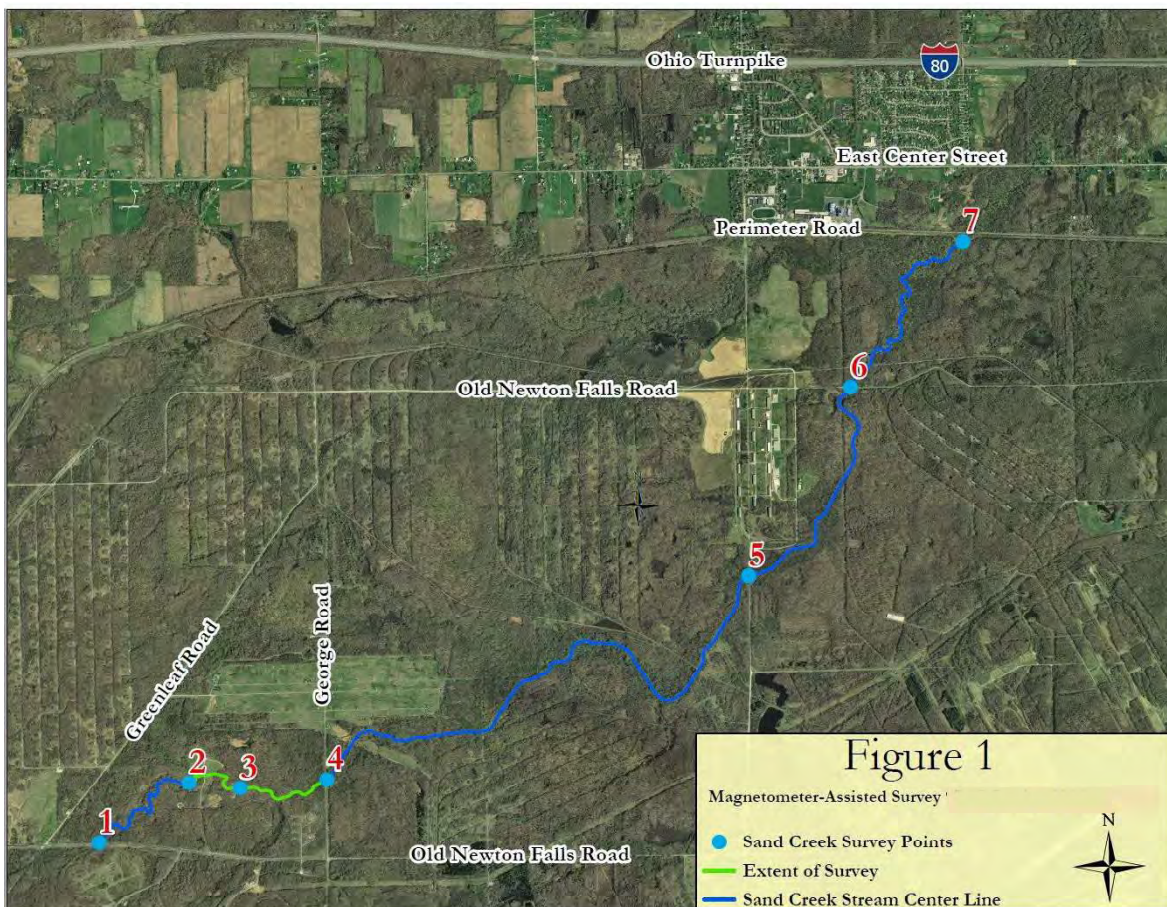
- a) *Dates and Extent of Survey.* The Sand Creek survey was conducted on 8-12 January 2024.
- b) *Personnel.* The survey was conducted by OESS Personnel (Mr. John Day and Mr. Daniel Dorrell).
- c) *Areas Surveyed.* Seven (7) way-points were established and evaluated during the initial survey (**Figure 1**) completed on 12-16 October 2016. These waypoints were used as markers/reference for the sweep conducted on 8-12 January 2024. For this event, approximately 1.5 line-miles were surveyed in and around the creek line between the ODA2 MRS western boundary (Waypoint 2) to George Road (Waypoint 4), as illustrated on **Figure 1**. The survey did not extend beyond Waypoint 4 based on field observations based on the absence of magnetic anomalies in the creek.

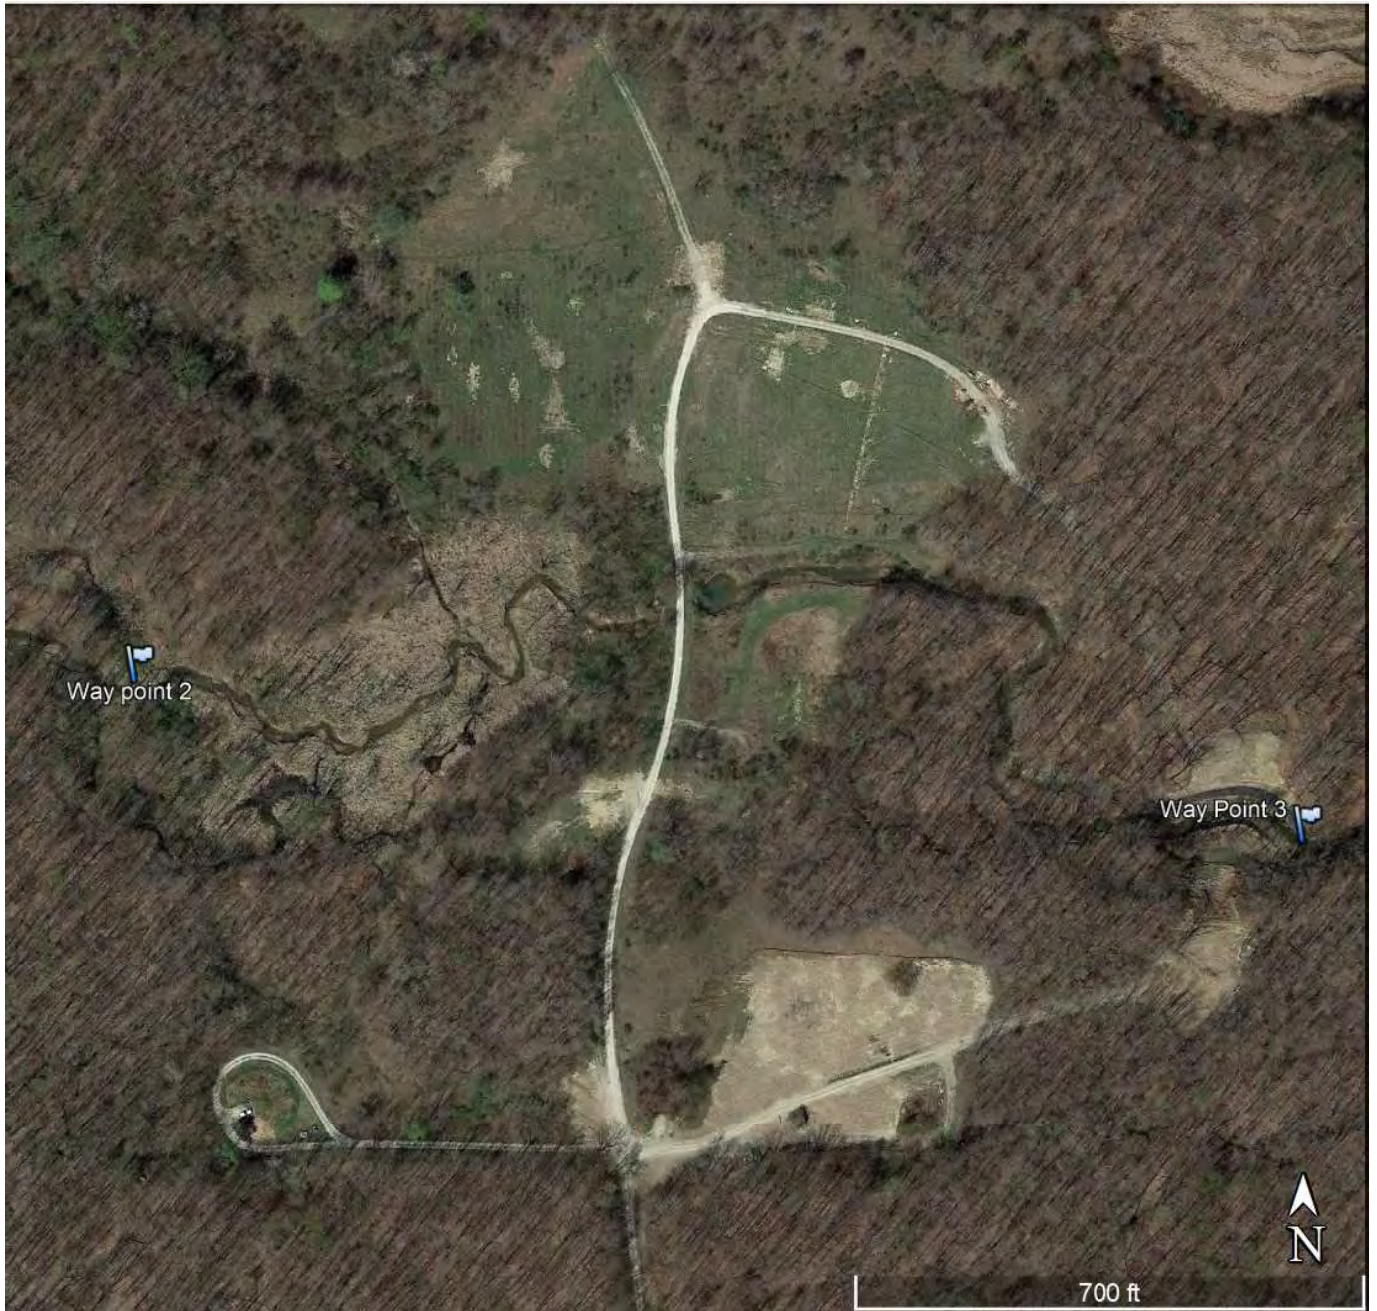
Map of Waypoints 2 and 3

- a) **Waypoints 2 to 3 observations:** MPPEH/Munitions debris (MD) was recovered between Waypoint 2 to Waypoint 3. Significant erosion was observed in the bends in Sand Creek (**Attachment A**). Ongoing erosion of the creek banks in these areas continues to release MPPEH/MD into the creek. This material appears to be accumulating in the creek bends located near the culvert in ODA2. Approximately forty (40) lbs of MPPEH/MD was recovered between Waypoints 2 to 3. All items were inspected and determined to be (Material Documented As Safe) MDAS.

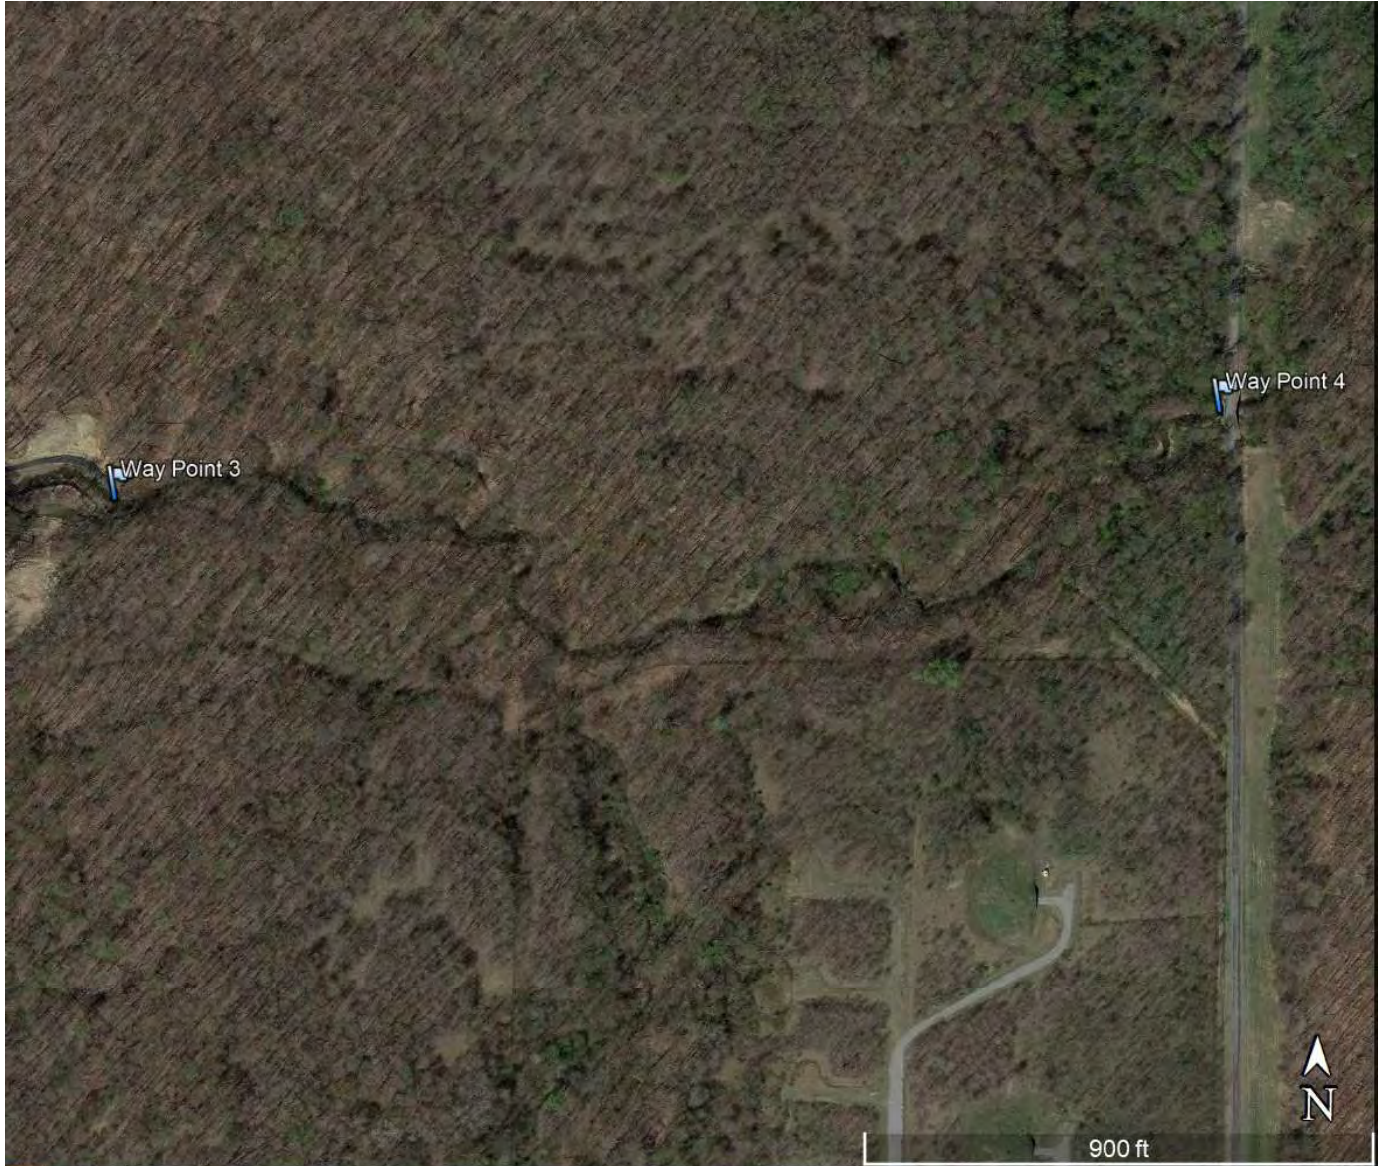
Map of Waypoints 3 and 4

- b) **Waypoints 3 to 4:** Many small MPPEH/MD items were found and appear to have eroded out of the banks and the cliffs to the north and south of Sand Creek between the culvert and Waypoint 4. It is believed this material was eroded, transported, and deposited in this area during a high-energy storm event. Approximately five (5) lbs of MPPEH/MD was recovered between Waypoints 3 and 4 during the 8-12 January 2024 survey. All items were inspected and determined to be MDAS.
- c) No MEC was encountered during this survey. All recovered MPPEH/MD items were inspected and determined to be MDAS. All MDAS was transported to the earth covered magazine (Bldg 1501) at ODA2 and stored pending final disposition (recycling) at a future date.

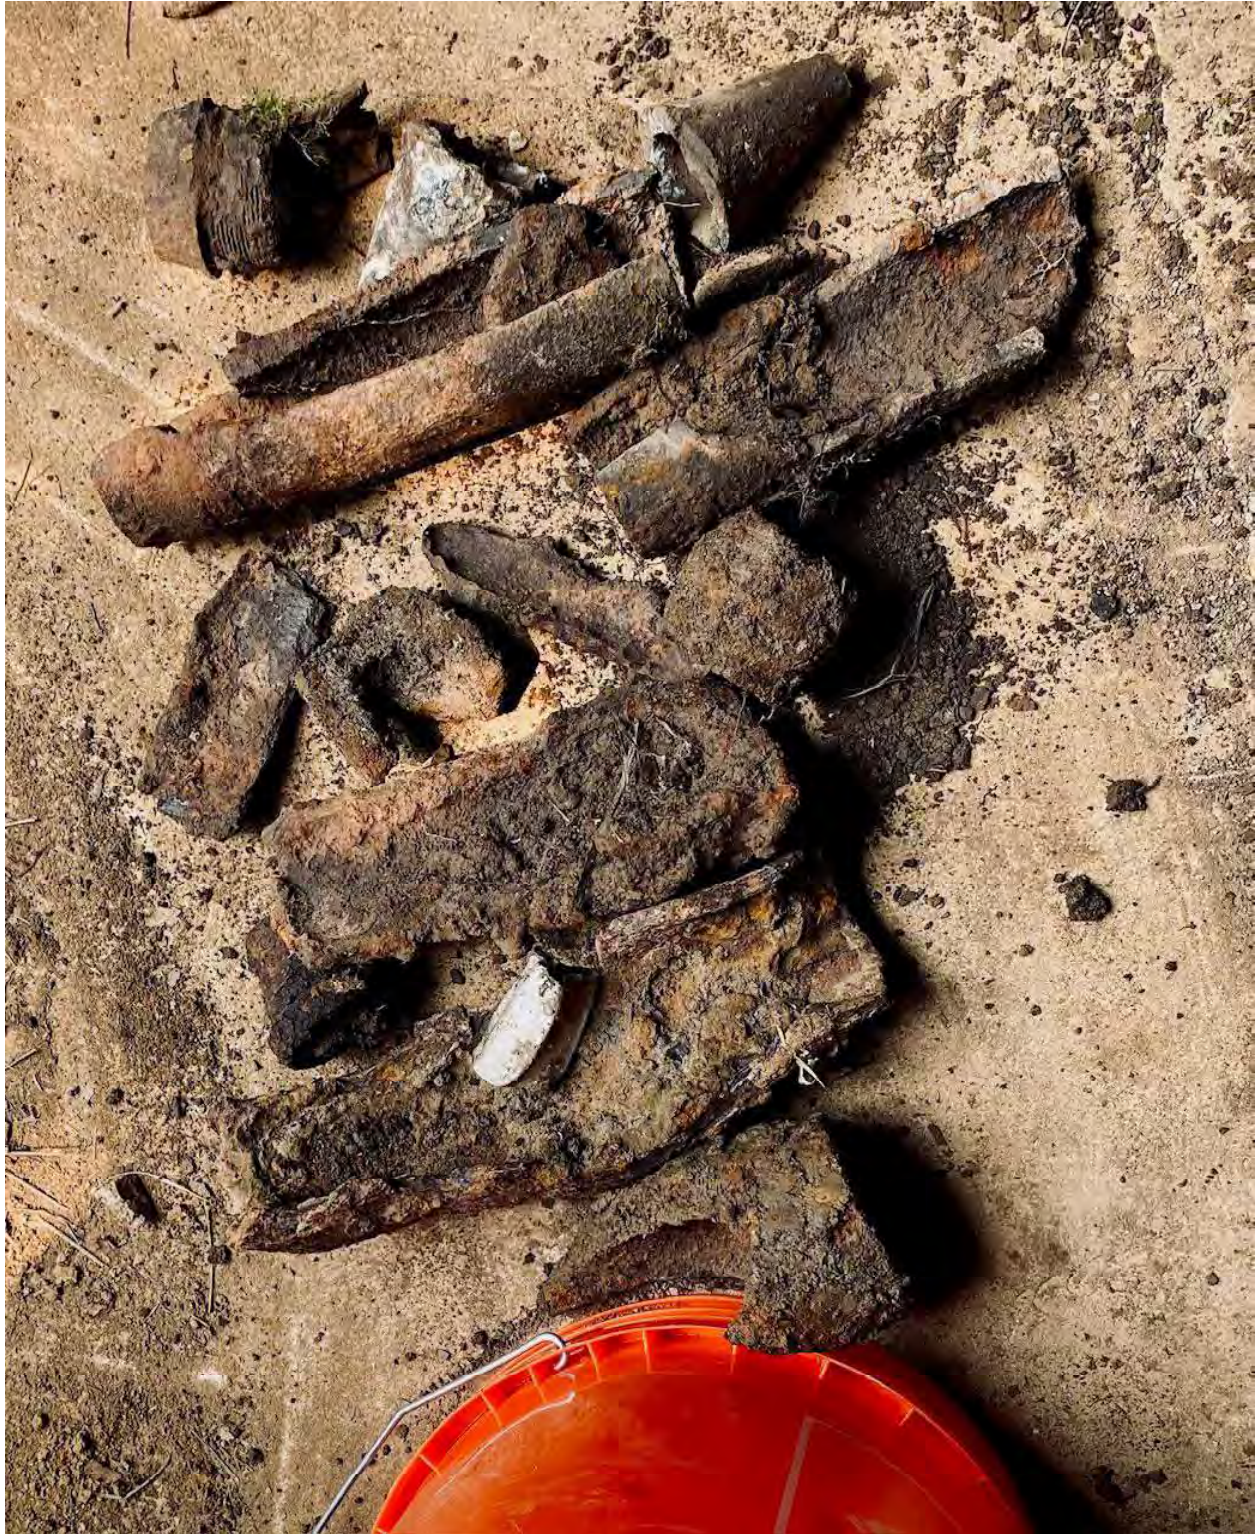
- a) Approximately forty-five (45) lbs of MDAS was recovered. Forty (40) lbs of MDAS was recovered from the creek between Waypoint 2 and Waypoint 3. This material does not appear to be migrating downstream, rather this material appears to be collecting near the culvert located near the center of the ODA2 MRS. Five (5) lbs of MDAS was recovered from the creek between Waypoint 3 and Waypoint 4. Based on these observations, it is concluded that the river banks are continuing to erode during high-energy storm events. Future surveys of this area are recommended.

Recovered Munitions Debris

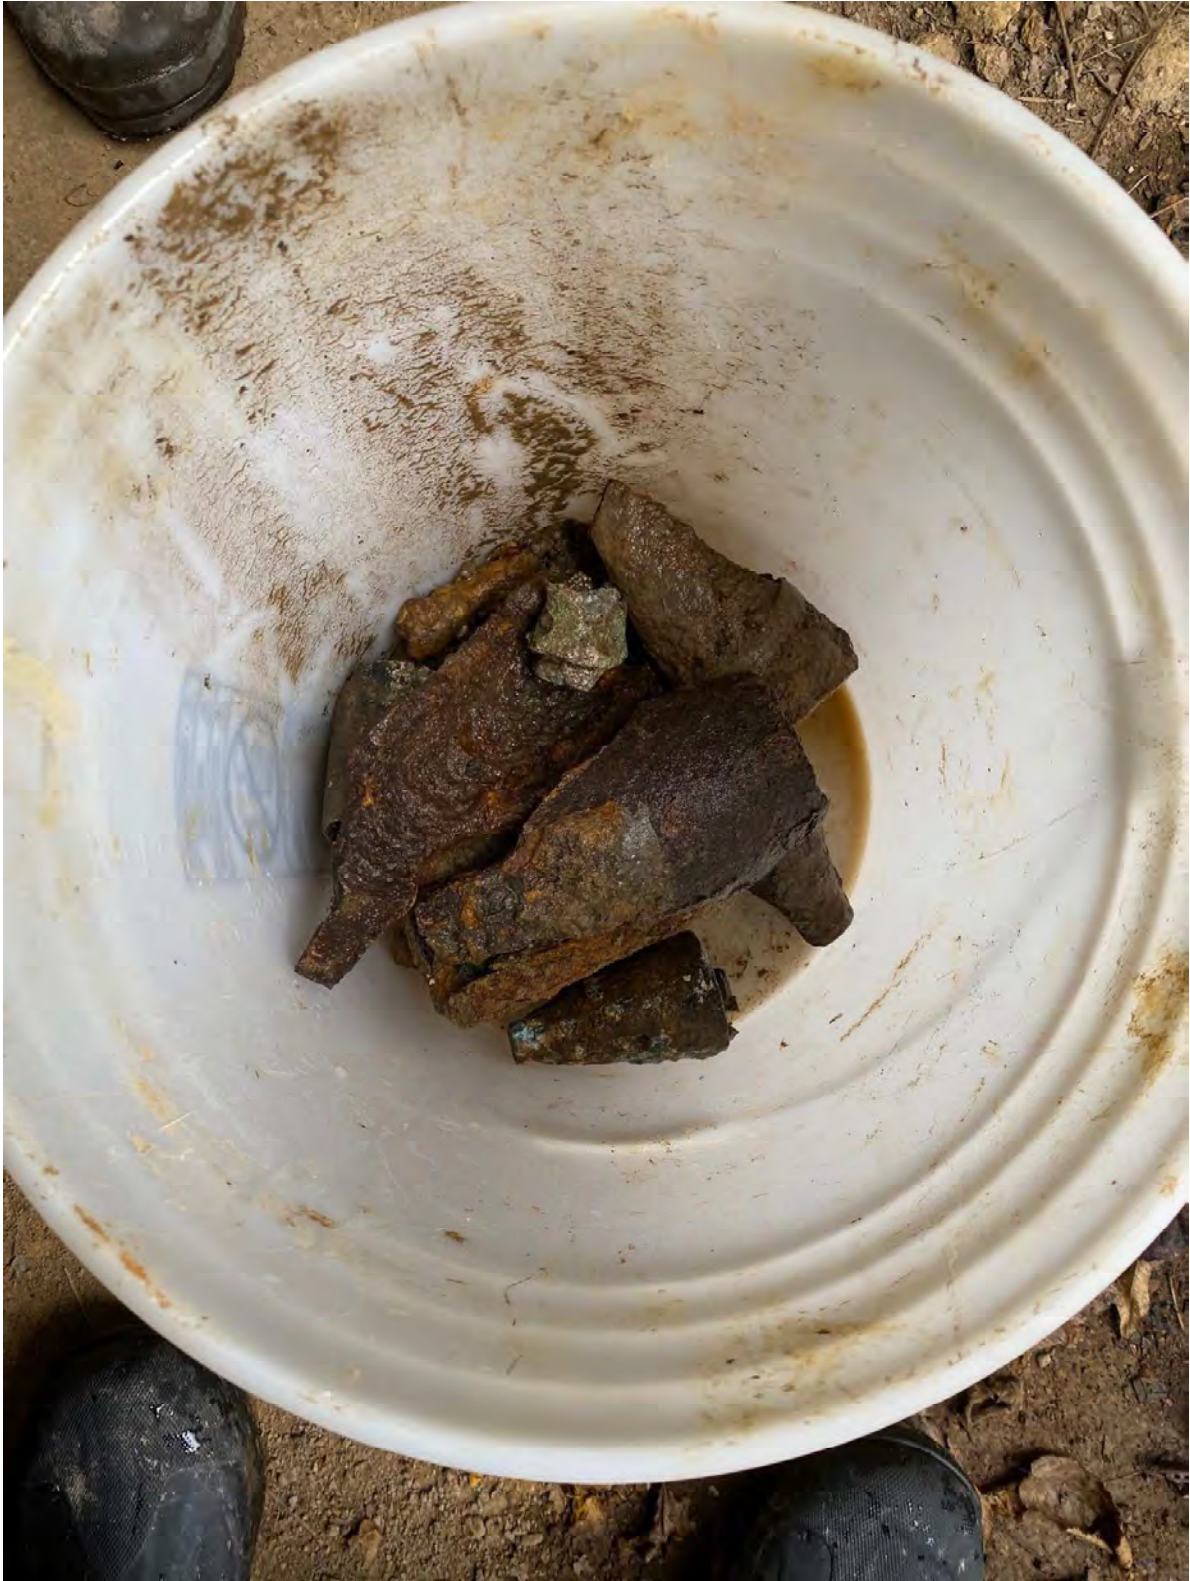
Recovered Munitions Debris

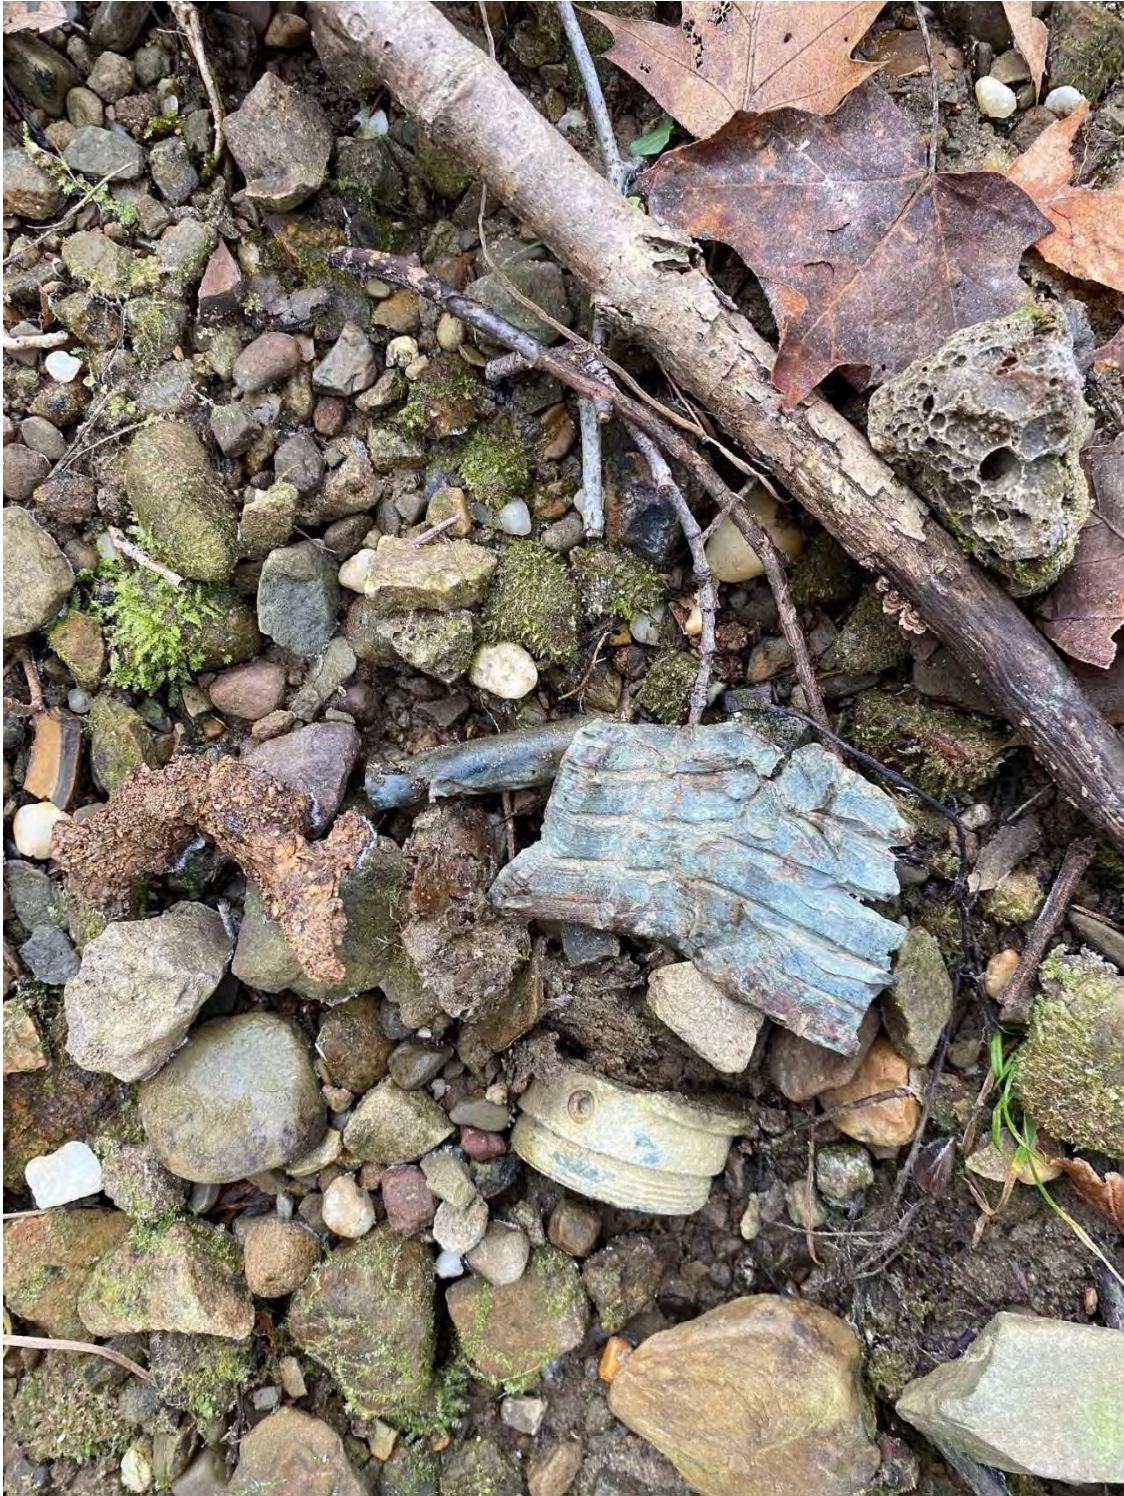
MPPEH – Smaller Items Recovered Near Creek Bank

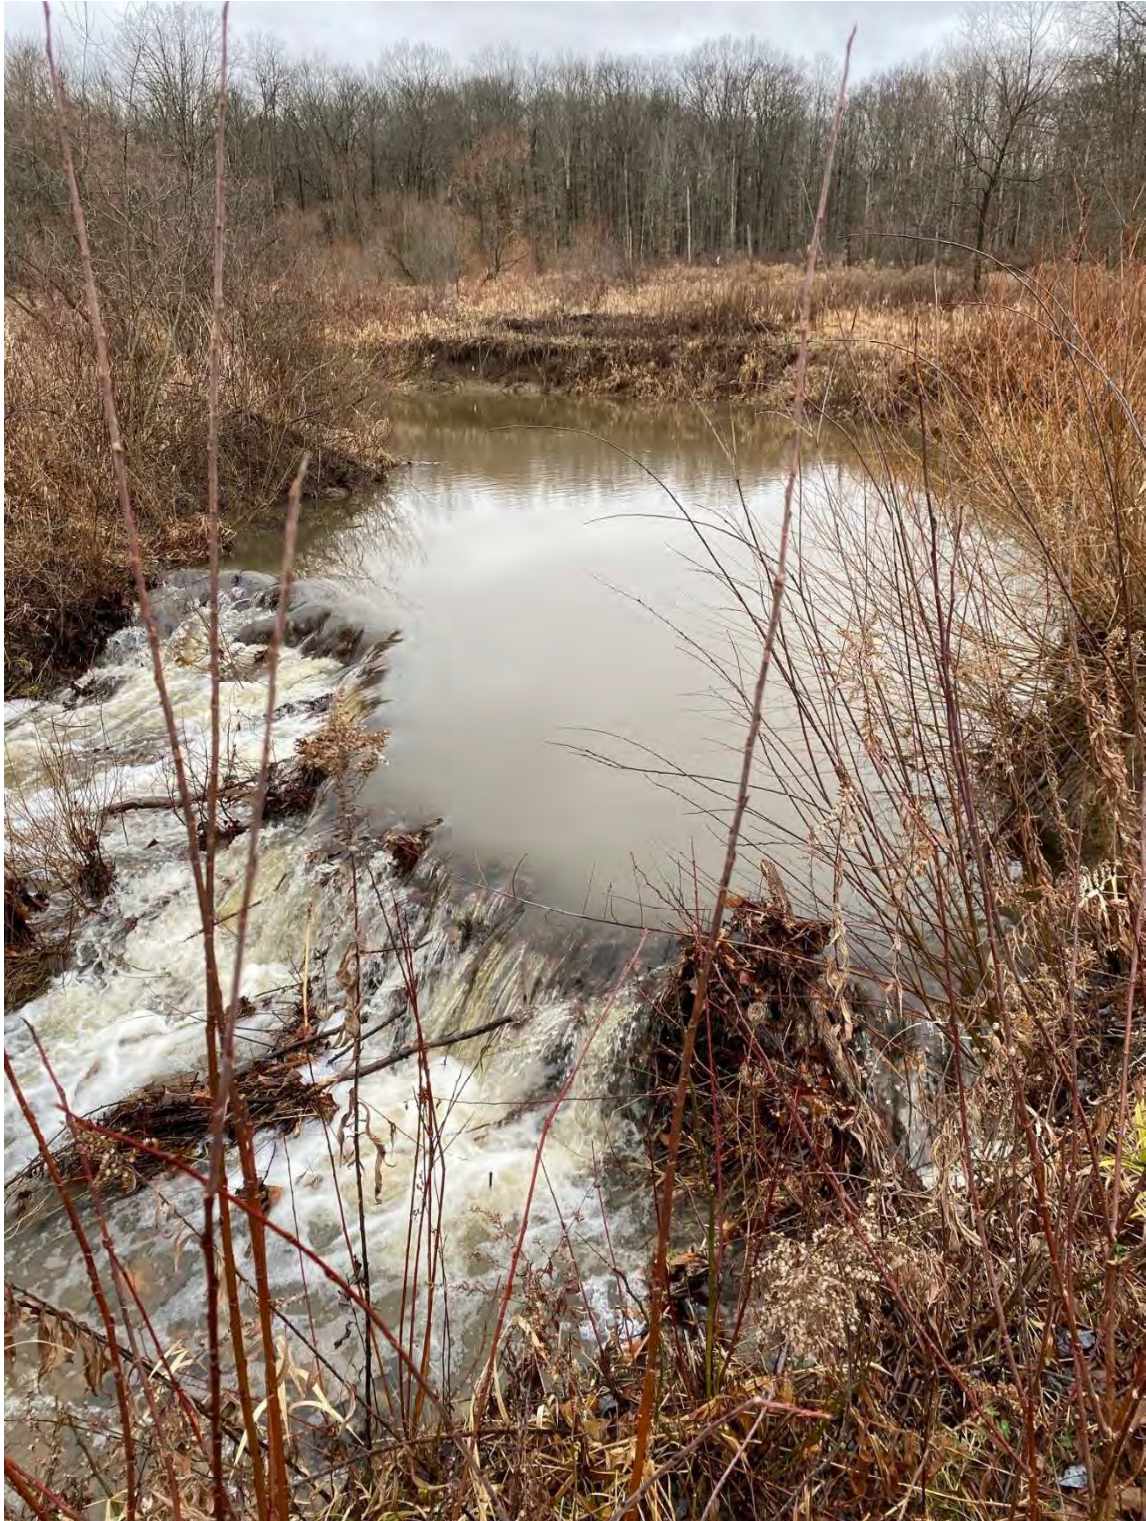
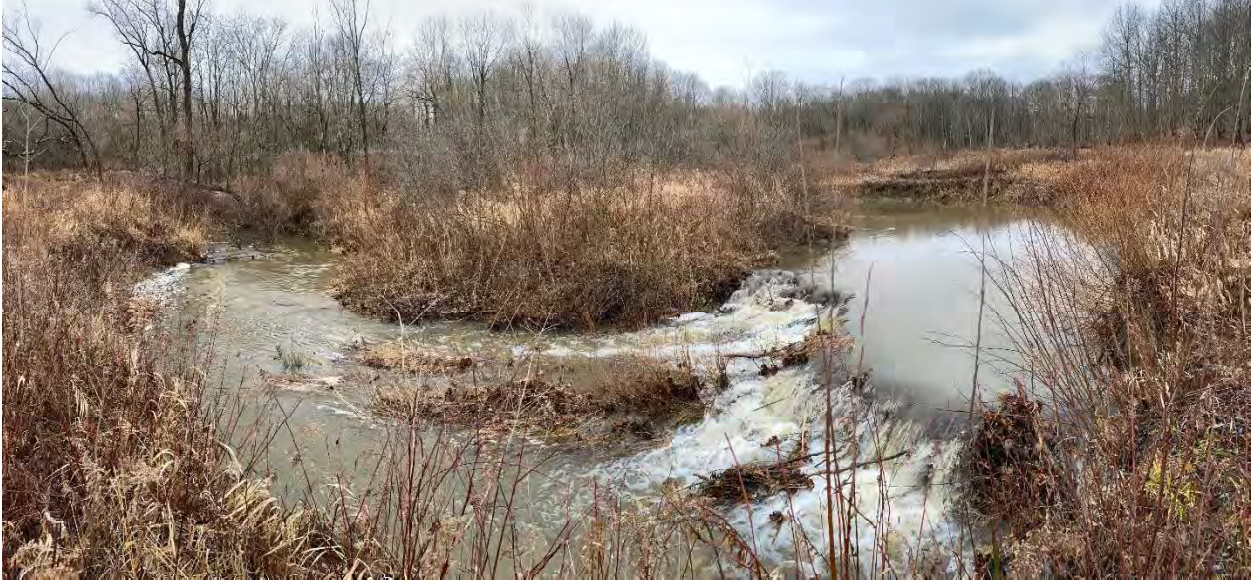
In addition, a beaver dam was observed during the survey. The dam is blocking the creek to the west of the culvert (**Attachment B**). Water is ponding in this area and is too deep to safely survey with hand-held magnetometers. The deeper water area was not evaluated during this evaluation.

Beavers have constructed a large dam in the creek west of the culvert (**Attachment B**). The water level in this area was too deep and unsafe for evaluation with hand-held magnetometers. The deep water area of the creek was not evaluated during this evaluation.

Beaver Dam

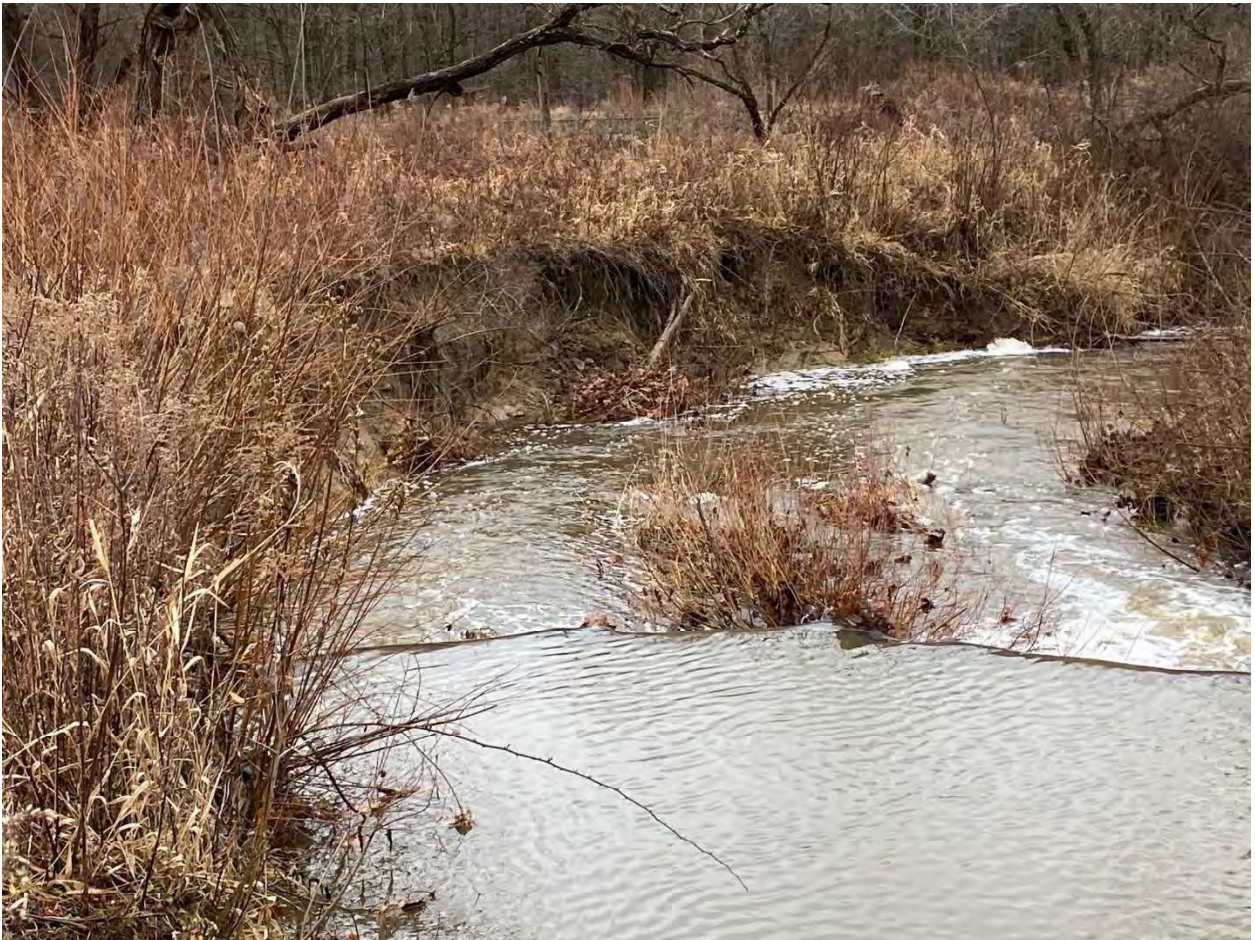
- b) Significant erosion of the creek banks continues between Waypoint 2 and Waypoint 4. The major bends in the creek, along with the cliffs to the north and south of sand creek are most likely the source area for the MPPEH/MD items recovered during this survey.
- c) There was no evidence that MEC, MPPEH, or MD is migrating beyond the ODA2 MRS boundary.

Area of Erosion Down Stream of Beaver Dam

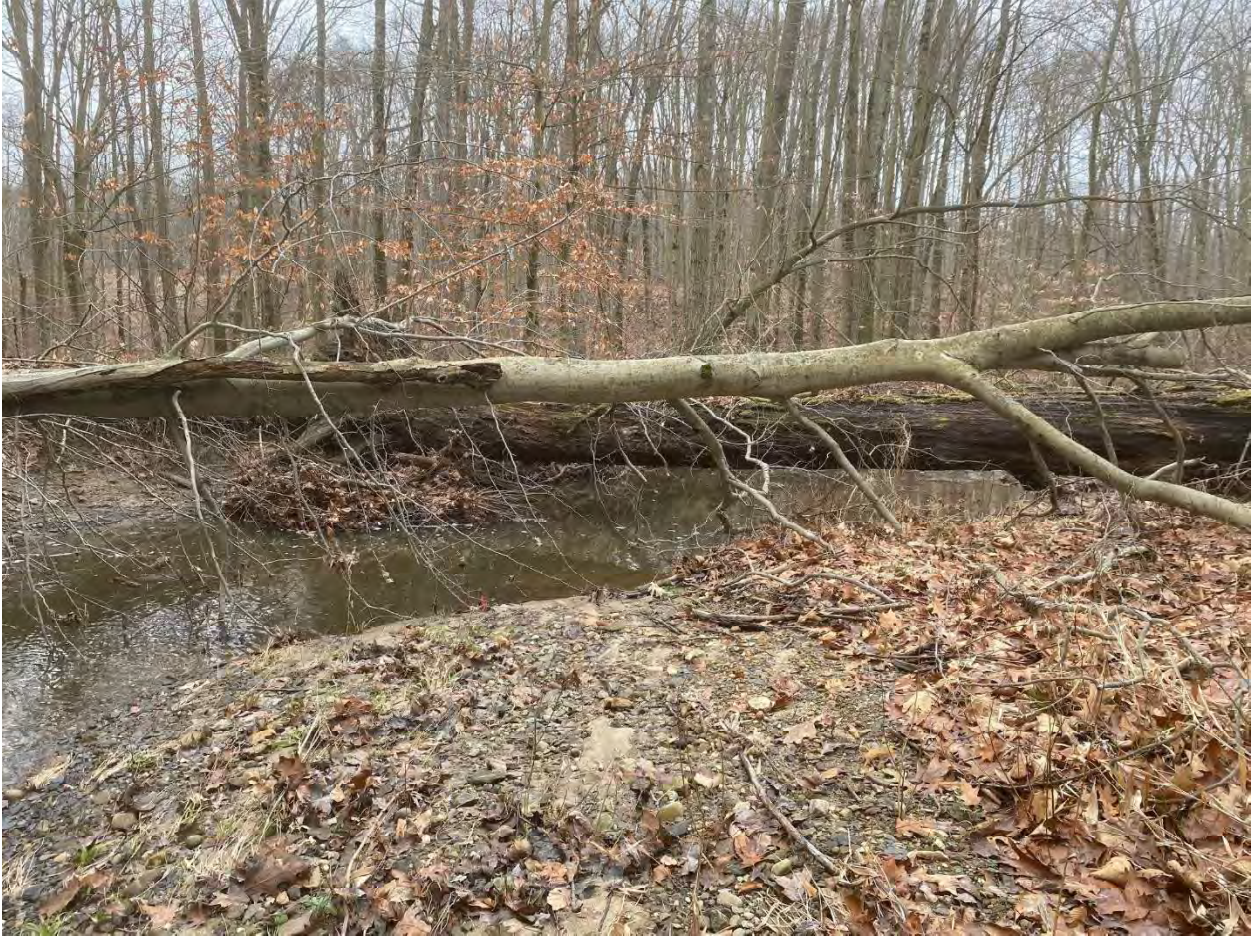
Trees Fallen Across Creek Due to Erosion.
