Building Inspection Form

Property Owner:	Department of the Army BRAC Technical Support Office Rock Island Arsenal, Rock Island, IL	Site	Load Line 6
		Building Number	2F-7
Facility Address:	Ravenna Army Ammunition Plant 8451 St. Route 5 Ravenna, OH 44266	Function	Powder Pelleting
		Date of Inspection:	07/08/05

ENGINEERING SURVEY REPORT #3

BUILDING 2F-1 THROUGH 2F-4, 2F-6 THROUGH 2F-10, 2F-12,
2F-13, 2F-15, 2F-18 THROUGH 2F-20, 2F-31, 6-51,

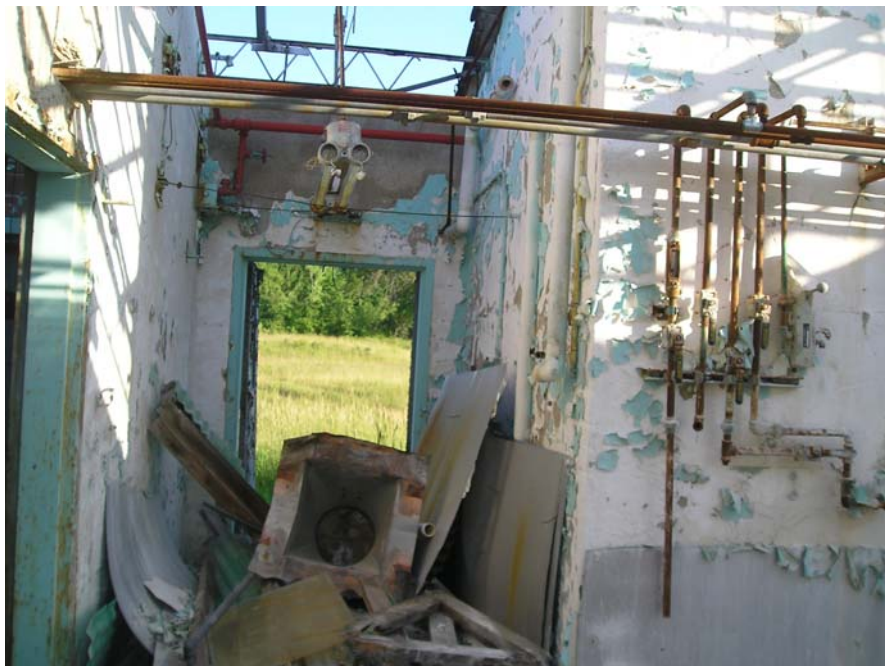
Wall Inspection Information

Are Surfaces Painted : ☒ Yes ☐ No If Yes, Was Peeling of Paint Observed: ☒ Yes ☐ No

Are Cracks, Crevices, Openings bigger than a hairline: ☒ Yes ☐ No

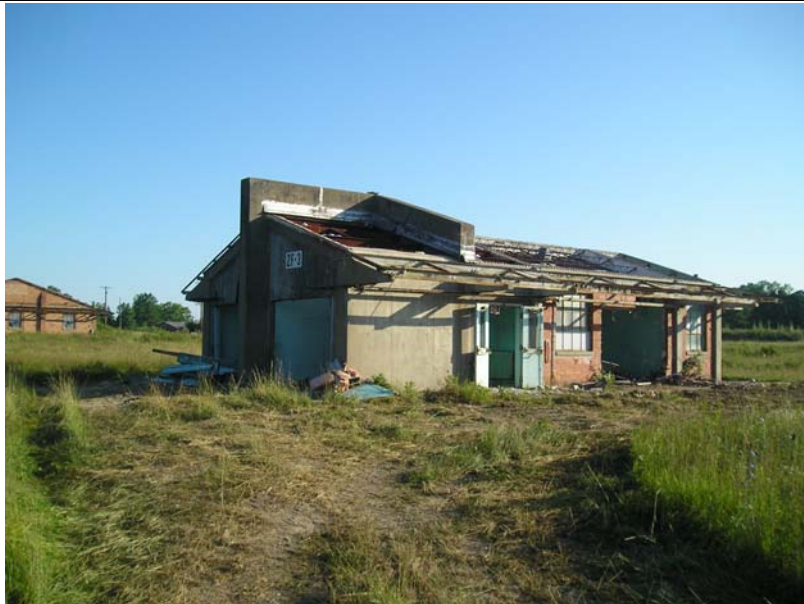
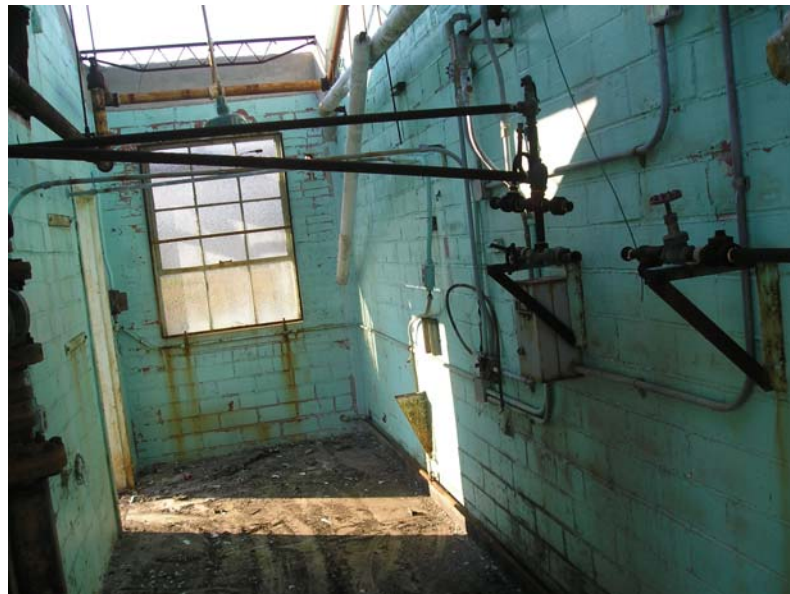
Roof Inspection Information

Roof Type	<input checked="" type="checkbox"/> Transite Panels	<input type="checkbox"/> Shingled	<input type="checkbox"/> Tar	<input type="checkbox"/> Concrete	<input checked="" type="checkbox"/> Removed
Roof Frame	<input type="checkbox"/> Wood	<input checked="" type="checkbox"/> Steel			
Roof Condition :	<input type="checkbox"/> Intact	<input type="checkbox"/> Holes or Openings Observed	<input type="checkbox"/> Collapsed and Unsafe	<input checked="" type="checkbox"/> Removed	
Visible Explosives Present on interior roof framing or ceiling:	<input type="checkbox"/> Yes	<input checked="" type="checkbox"/> No	If Yes, identify location below.		
Location: NA					
Suspect surfaces present that are not accessible for Visual Inspection: <input type="checkbox"/> Yes <input checked="" type="checkbox"/> No

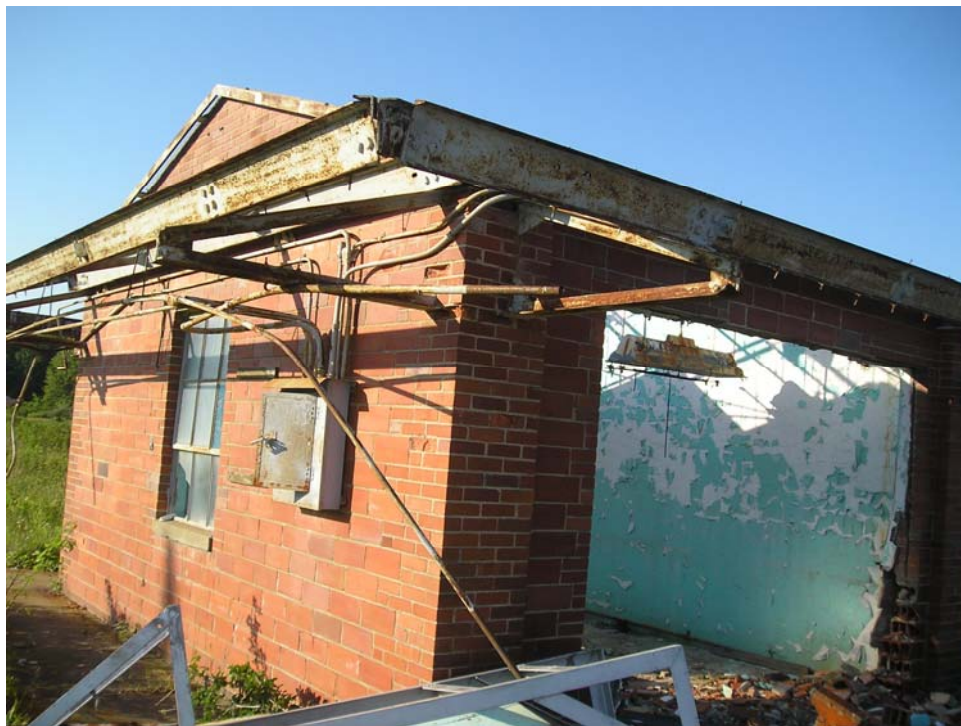
**Wall Inspection Information**

Are Cracks, Crevices, Openings bigger than a hairline: <input checked="" type="checkbox"/> Yes <input type="checkbox"/> No						
Entrapment of Explosive Residues in Cracks, Crevices, or Openings observed: <input type="checkbox"/> Yes <input checked="" type="checkbox"/> No						
Other suspect surfaces present that are not accessible for Visual Inspection: <input type="checkbox"/> Yes <input checked="" type="checkbox"/> No						
For hollow wall construction (i.e. tile), is internal examination needed at wall penetrations or suspect areas? <input type="checkbox"/> Yes <input checked="" type="checkbox"/> No <input type="checkbox"/> NA						
If yes, identify location and report findings below:						
Observations/Notes: None

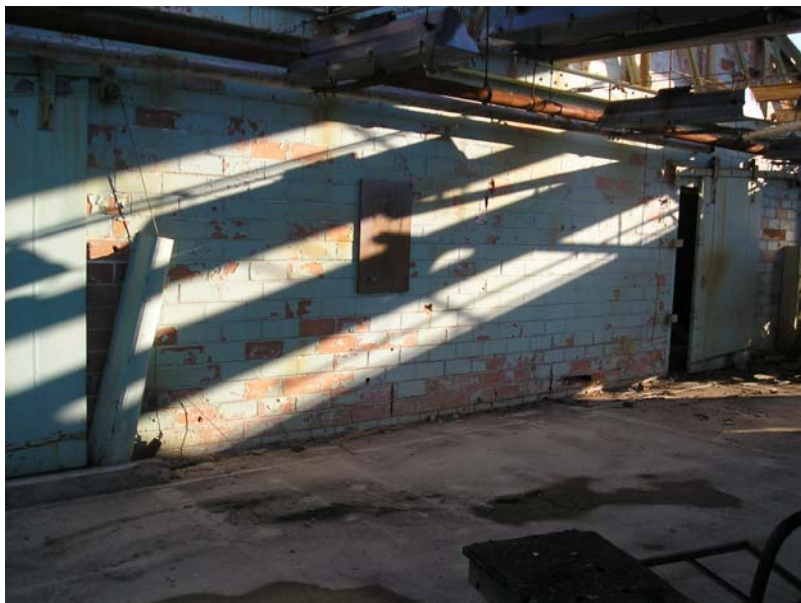
Wall Inspection Information

Are Cracks, Crevices, Openings bigger than a hairline: <input checked="" type="checkbox"/> Yes <input type="checkbox"/> No						
Entrapment of Explosive Residues in Cracks, Crevices, or Openings observed: <input type="checkbox"/> Yes <input checked="" type="checkbox"/> No						
Other suspect surfaces present that are not accessible for Visual Inspection: <input type="checkbox"/> Yes <input checked="" type="checkbox"/> No						
For hollow wall construction (i.e. tile), is internal examination needed at wall penetrations or suspect areas? <input type="checkbox"/> Yes <input checked="" type="checkbox"/> No <input type="checkbox"/> NA						
If yes, identify location and report findings below:						
Observations/Notes: None

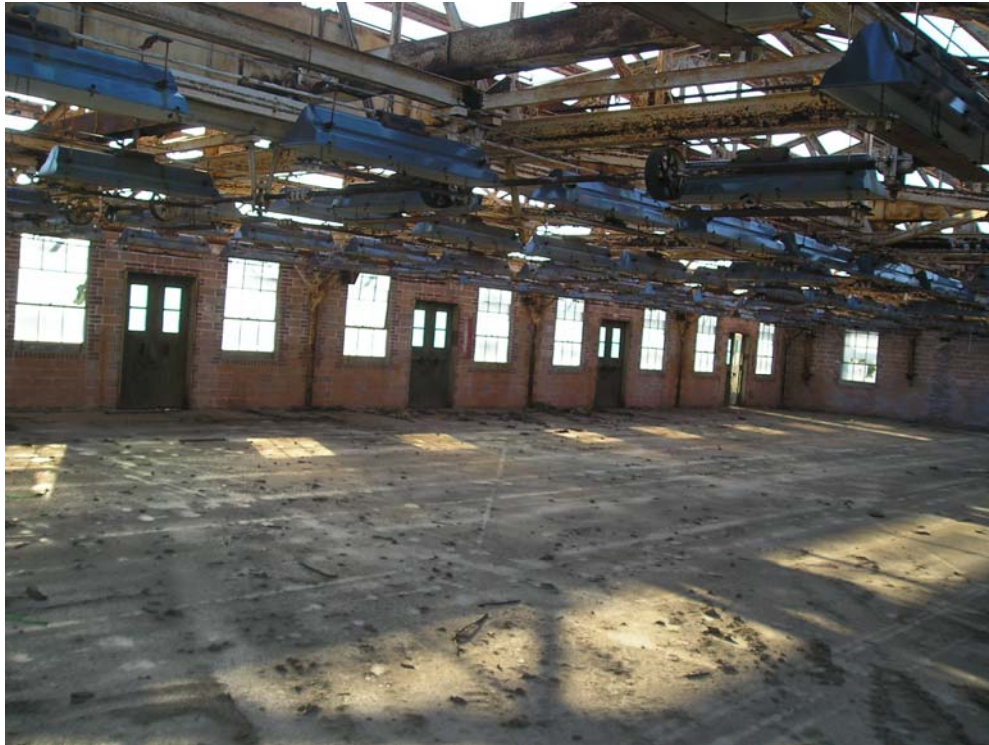
Roof Inspection Information

Roof Type	<input checked="" type="checkbox"/> Transite Panels	<input type="checkbox"/> Shingled	<input type="checkbox"/> Tar	<input type="checkbox"/> Concrete	<input checked="" type="checkbox"/> Removed
Roof Frame	<input type="checkbox"/> Wood	<input checked="" type="checkbox"/> Steel			
Roof Condition :	<input type="checkbox"/> Intact	<input type="checkbox"/> Holes or Openings Observed	<input type="checkbox"/> Collapsed and Unsafe	<input checked="" type="checkbox"/> Removed	
Visible Explosives Present on interior roof framing or ceiling: <input type="checkbox"/> Yes <input checked="" type="checkbox"/> No If Yes, identify location below.					
Location: NA					
Suspect surfaces present that are not accessible for Visual Inspection: <input type="checkbox"/> Yes <input checked="" type="checkbox"/> No

Other Observations/Notes: None
