Final
FY 2014 Annual Report for the
Quarterly Land Use Control Inspections,
RVAAP-05 Winklepeck Burning Grounds

Camp Ravenna Joint Military Training Center
Former Ravenna Army Ammunition Plant
Portage and Trumbull Counties, Ohio

January 8, 2015

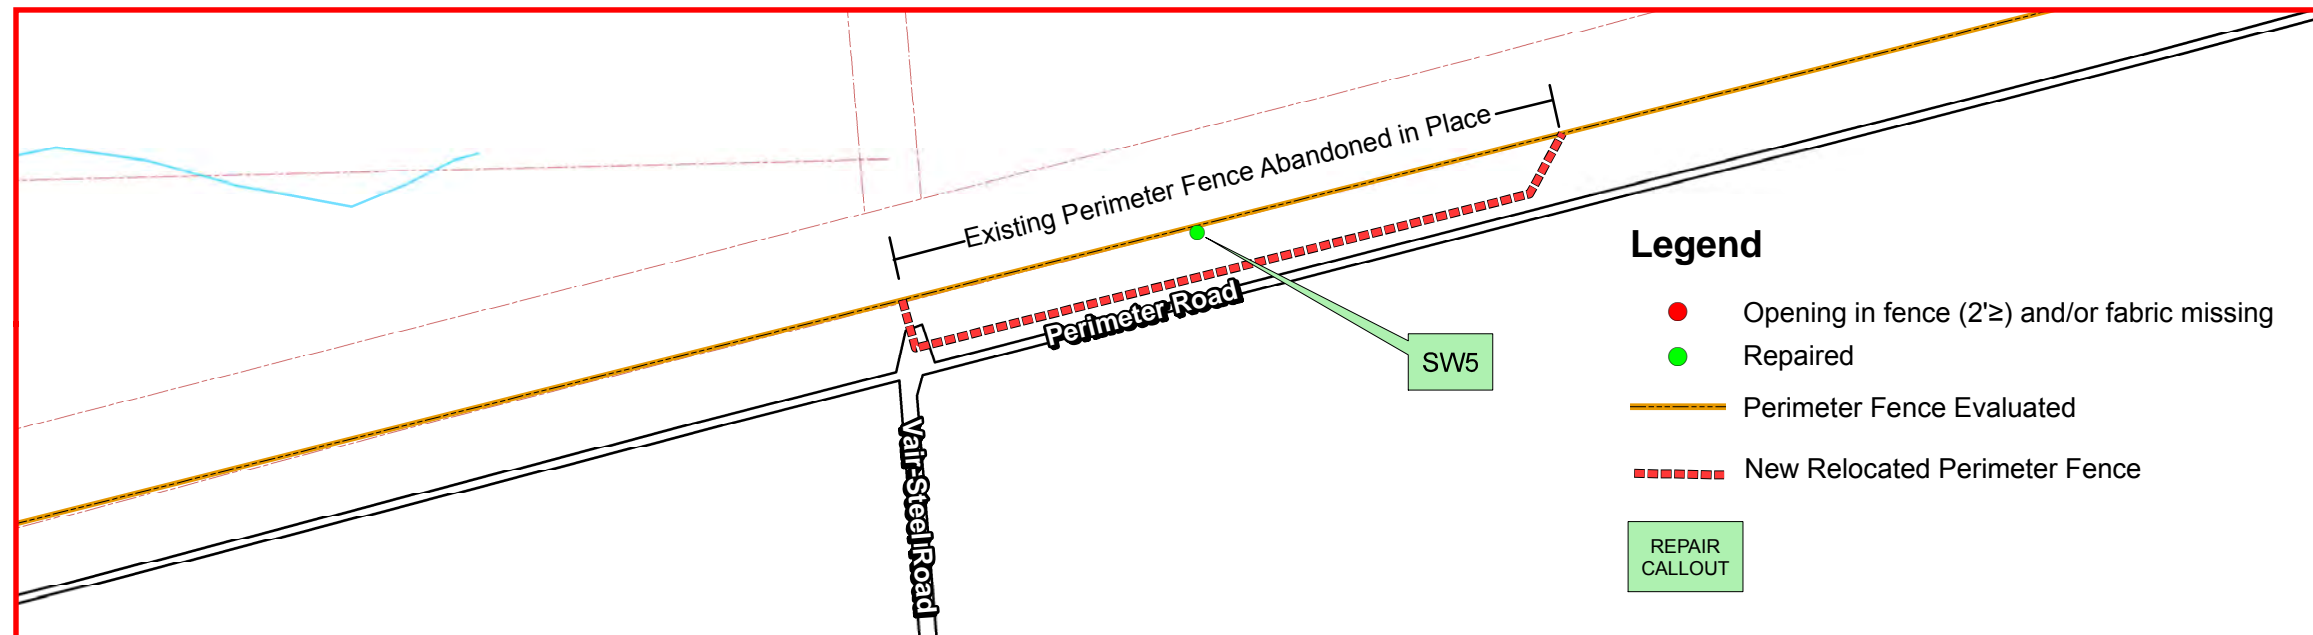
DETAIL SHEET FOR SW5

PHOTO SW5 discovered 02/12/2013

REPAIR PHOTO SW5 DEPICTING NEW RELOCATED FENCE
photo dated 11/19/2013

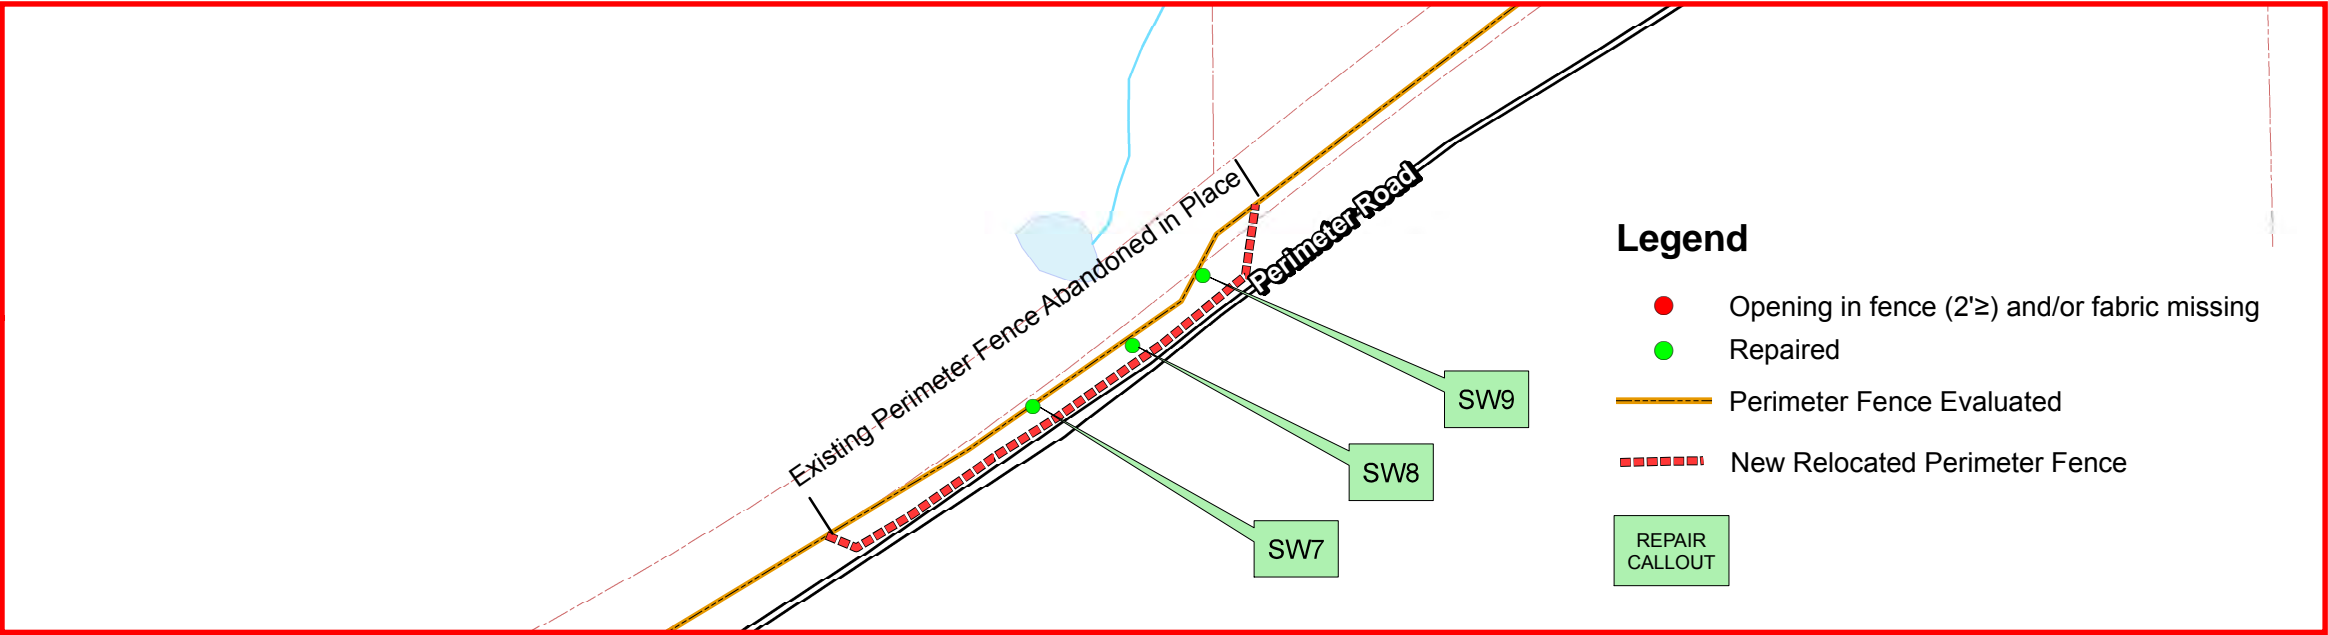
DETAIL SHEET FOR SW7, SW8 and SW9

PHOTO SW7 discovered 02/12/2013

REPAIR PHOTO SW7 DEPICTING NEW RELOCATED FENCE
photo taken 11/19/2013

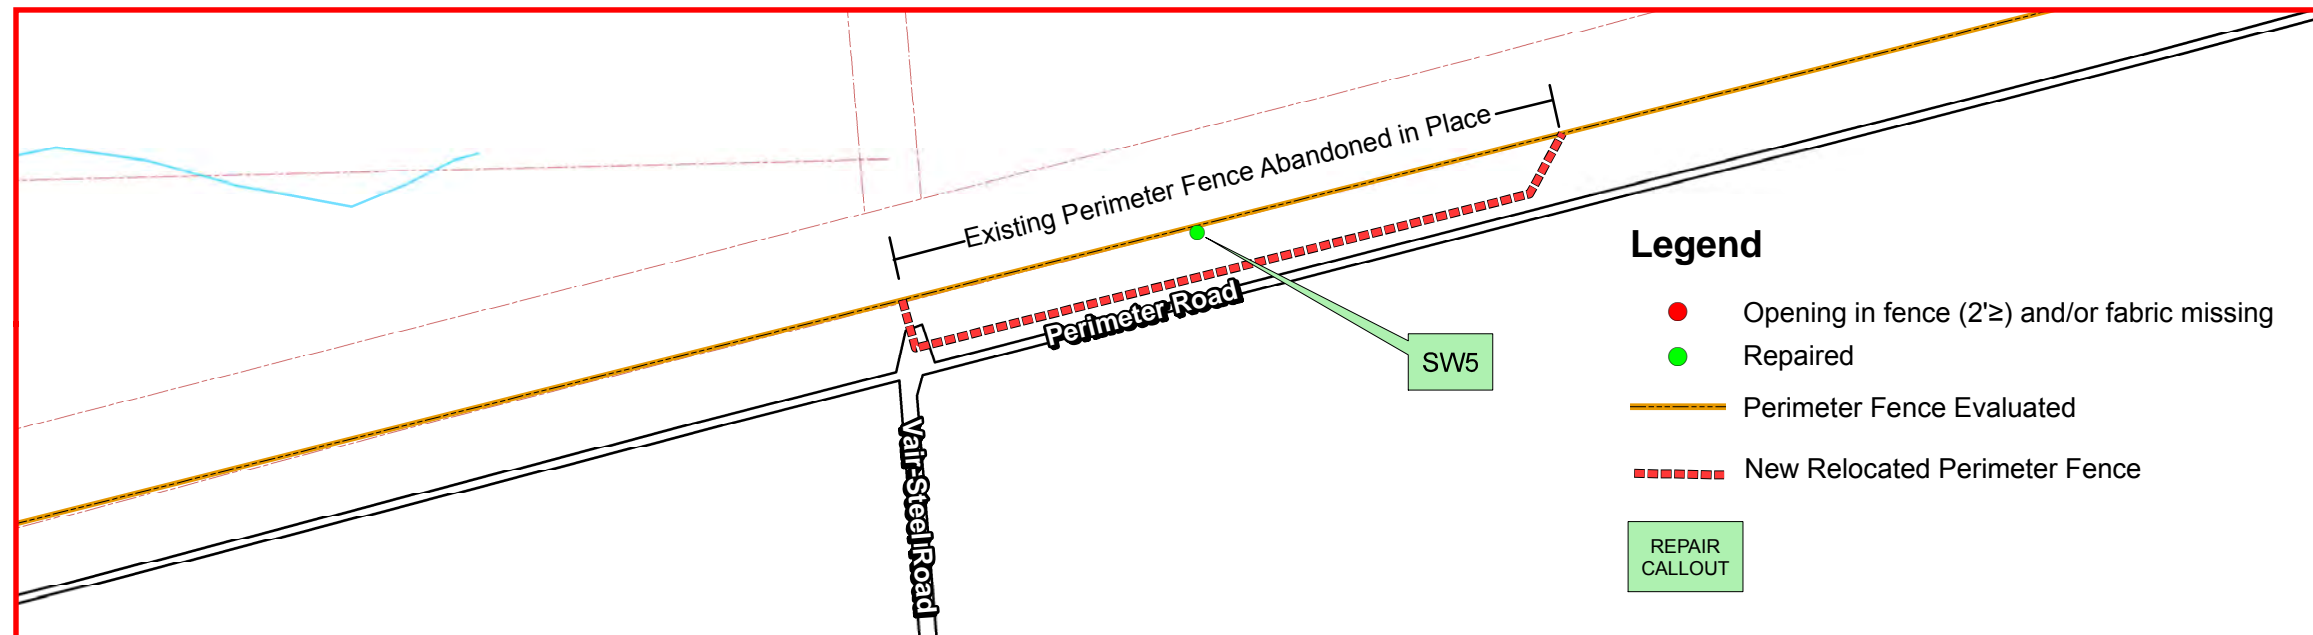
DETAIL SHEET FOR SW5

PHOTO SW5 discovered 02/12/2013

REPAIR PHOTO SW5 DEPICTING NEW RELOCATED FENCE
dated 11/19/2013

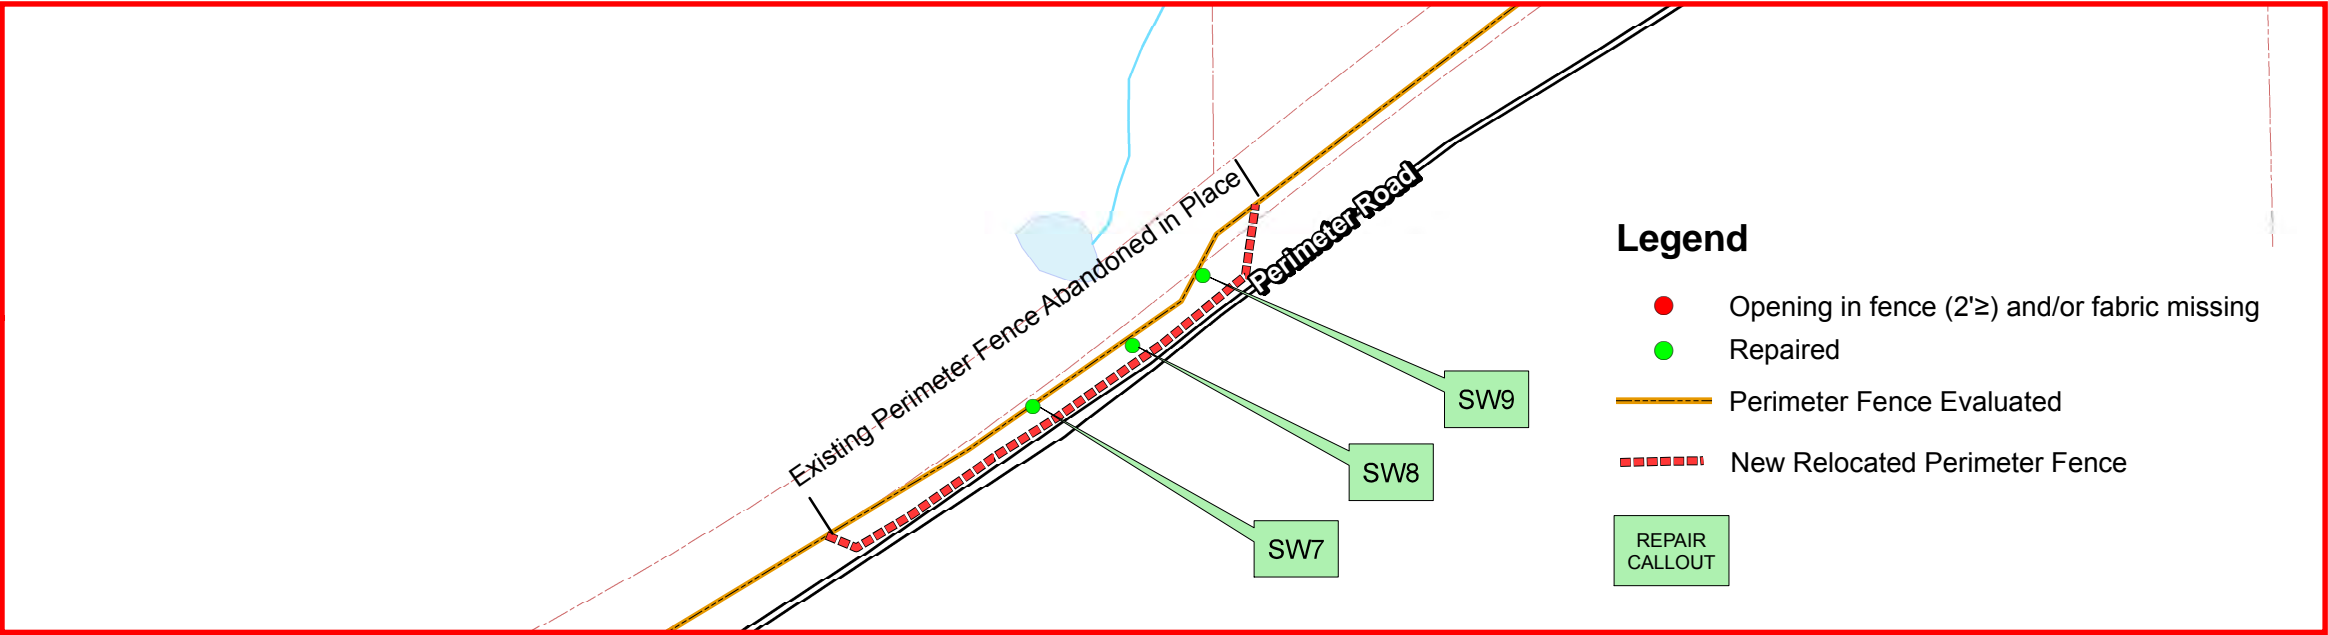
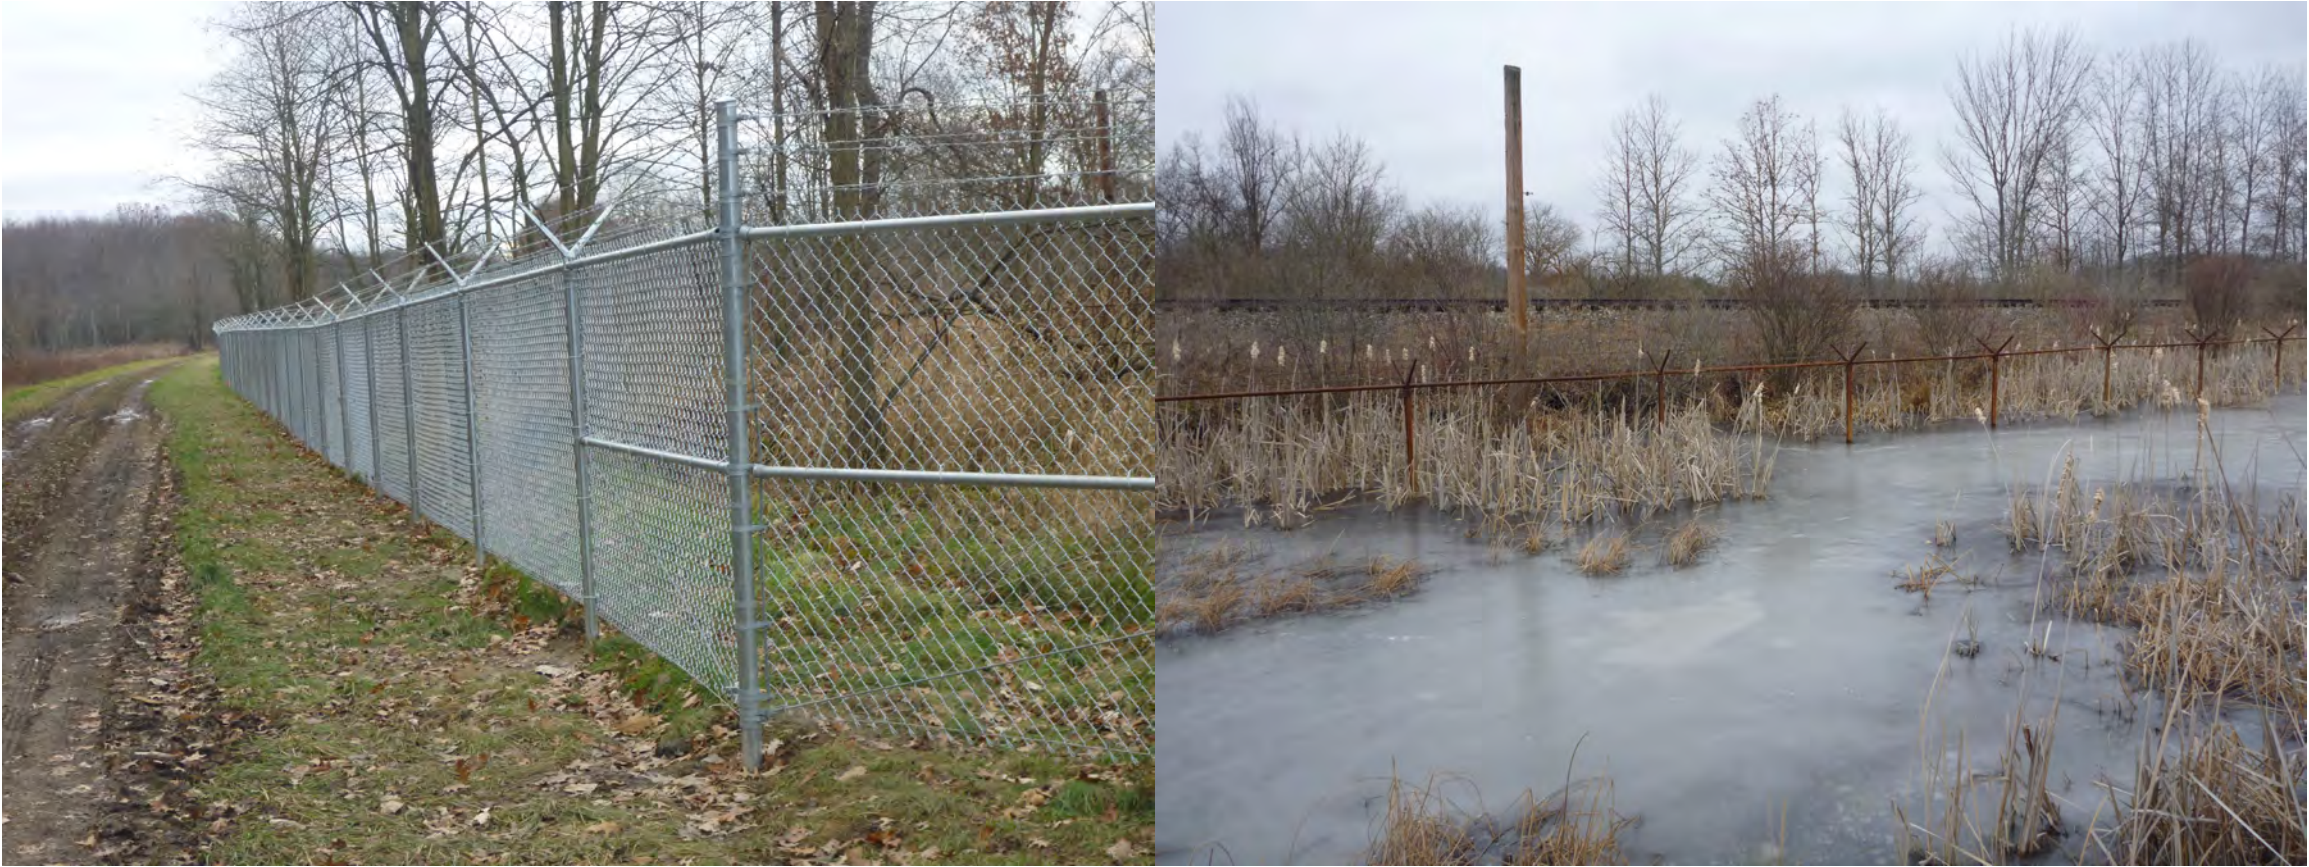
DETAIL SHEET FOR SW7, SW8 and SW9

PHOTO SW7 discovered 02/12/2013

REPAIR PHOTO SW7 DEPICTING NEW RELOCATED FENCE
dated 11/19/2013

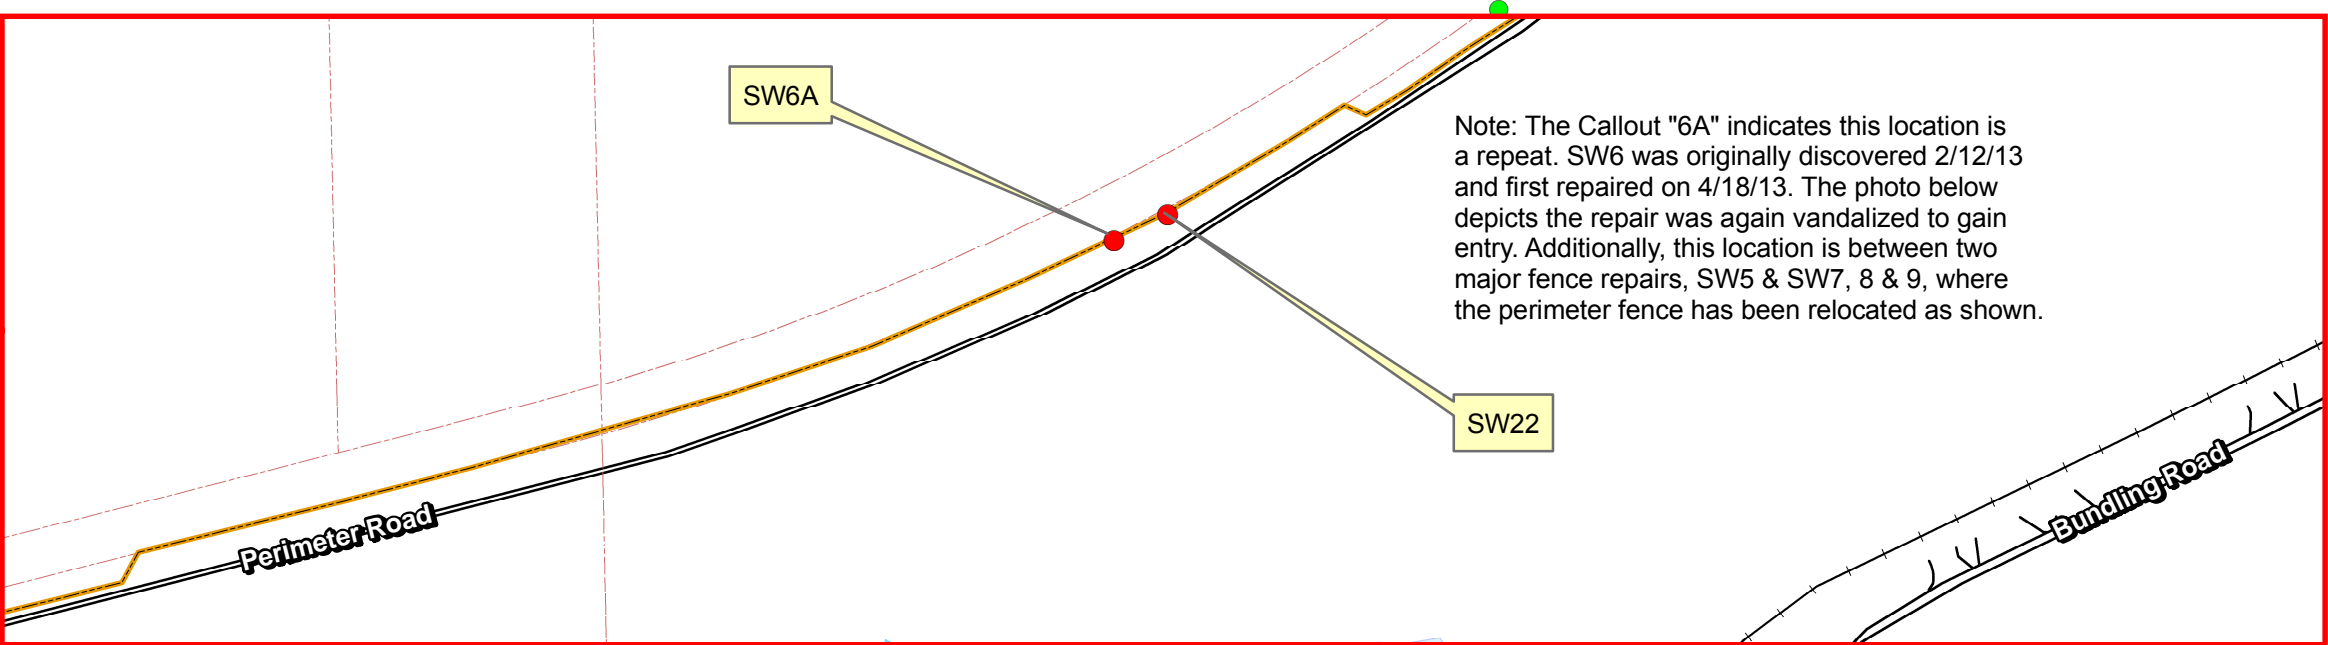
DETAIL SHEET FOR SW6A

Note: The Callout "6A" indicates this location is a repeat. SW6 was originally discovered 2/12/13 and first repaired on 4/18/13. The photo below depicts the repair was again vandalized to gain entry. Additionally, this location is between two major fence repairs, SW5 & SW7, 8 & 9, where the perimeter fence has been relocated as shown.
