Final
2015 Annual Land Use Control Monitoring Report,
RVAAP-01 Ramsdell Quarry Landfill
and
RVAAP-05 Winklepeck Burning Grounds

Camp Ravenna Joint Military Training Center
Former Ravenna Army Ammunition Plant
Portage and Trumbull Counties, Ohio

Contract No. W912QR-13-C-0031

January 27, 2016

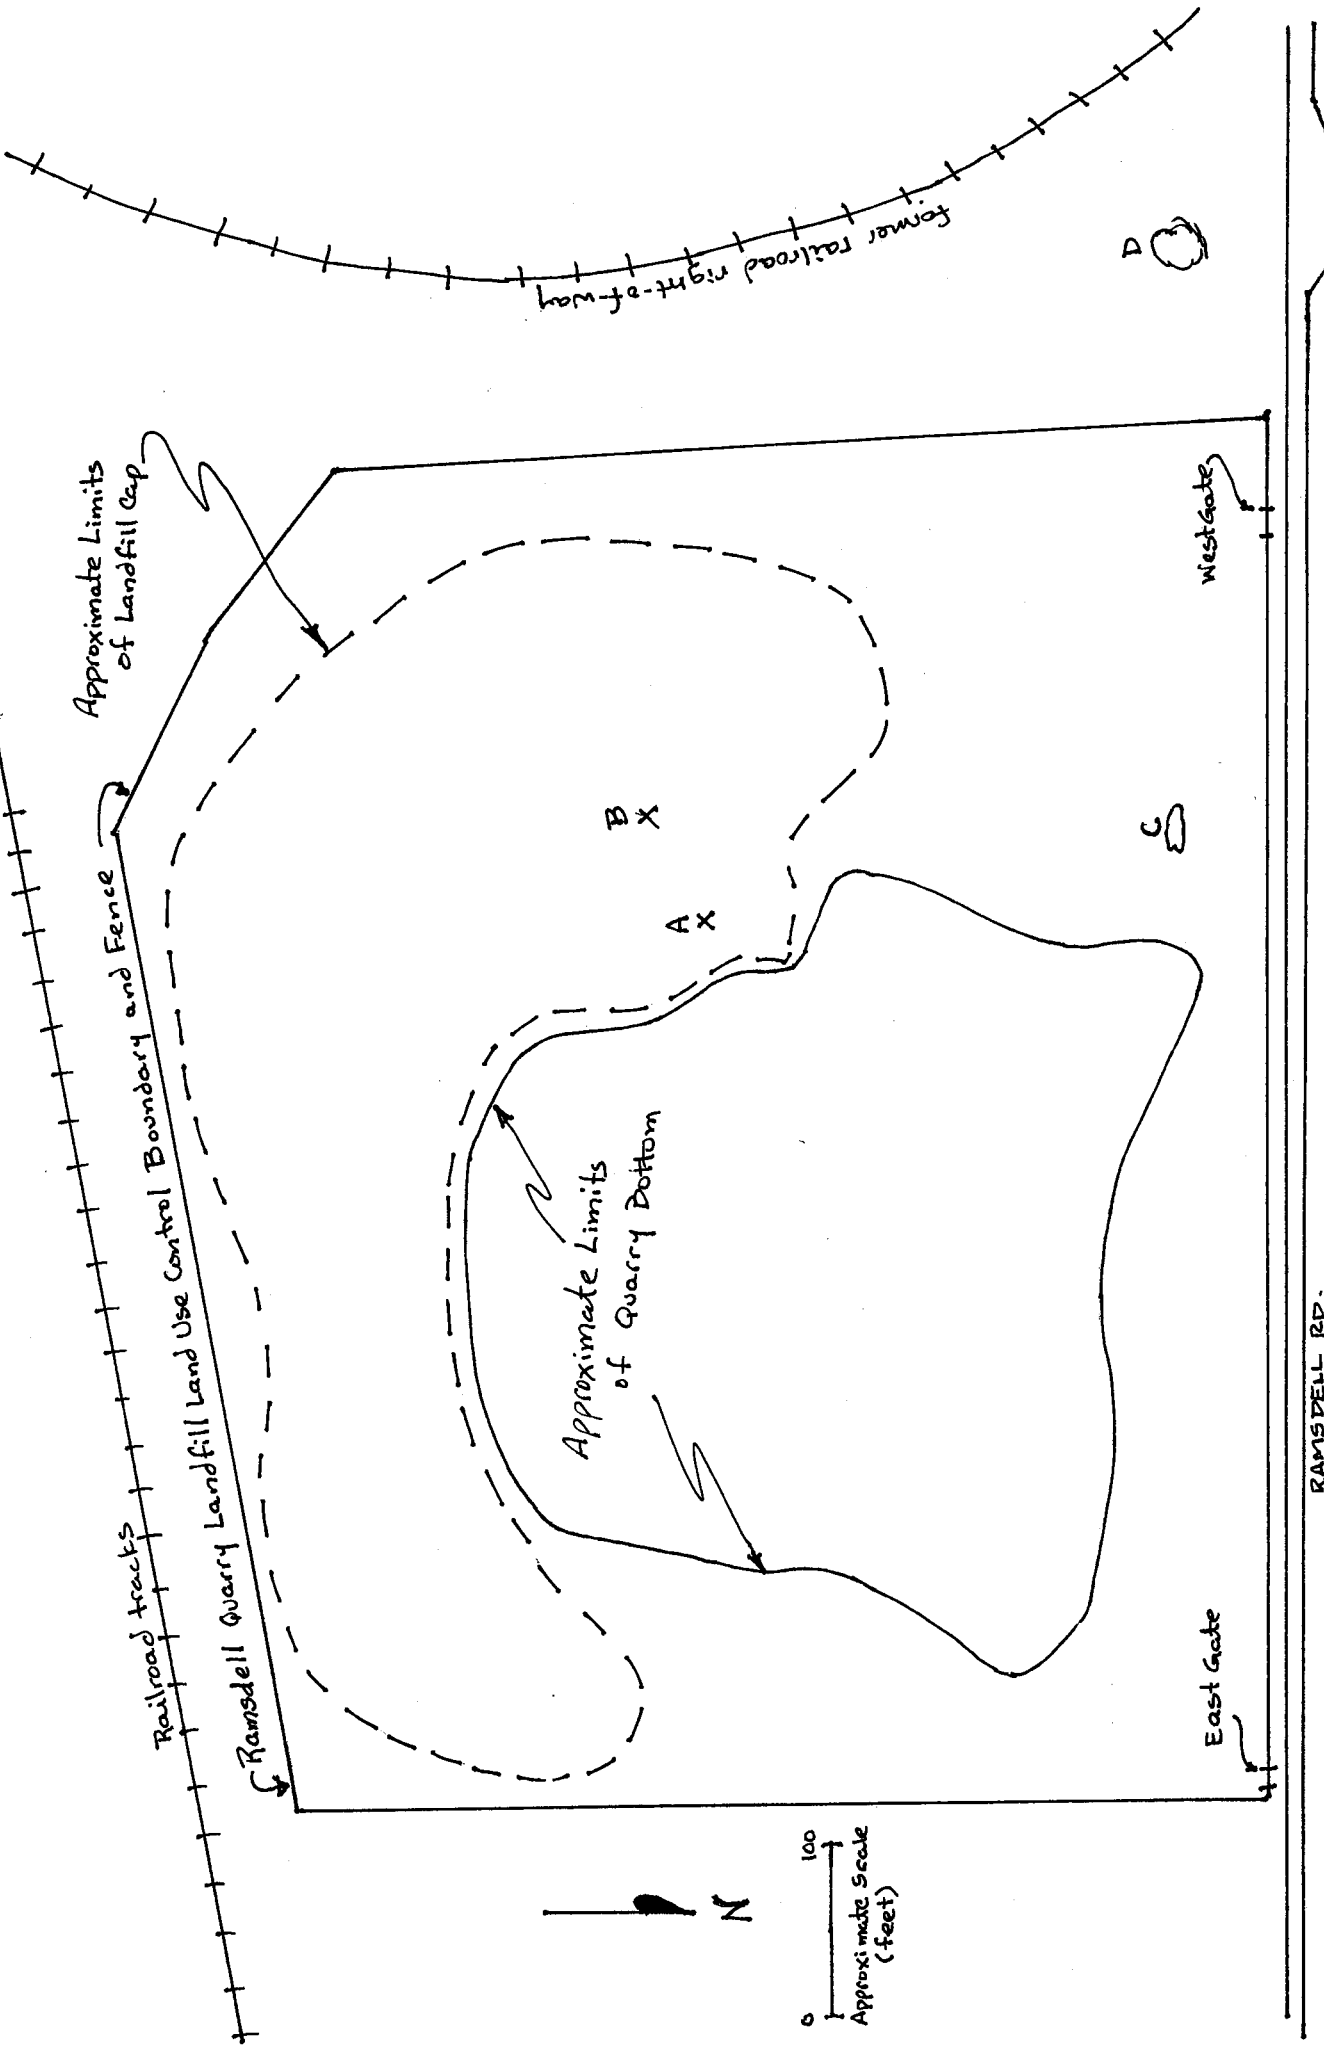
Ramsdell Quarry Landfill Repairs January 21, 2015
 Vista Sciences Corporation
 A, B, & C show repair locations. Clean soil stockpile location = D

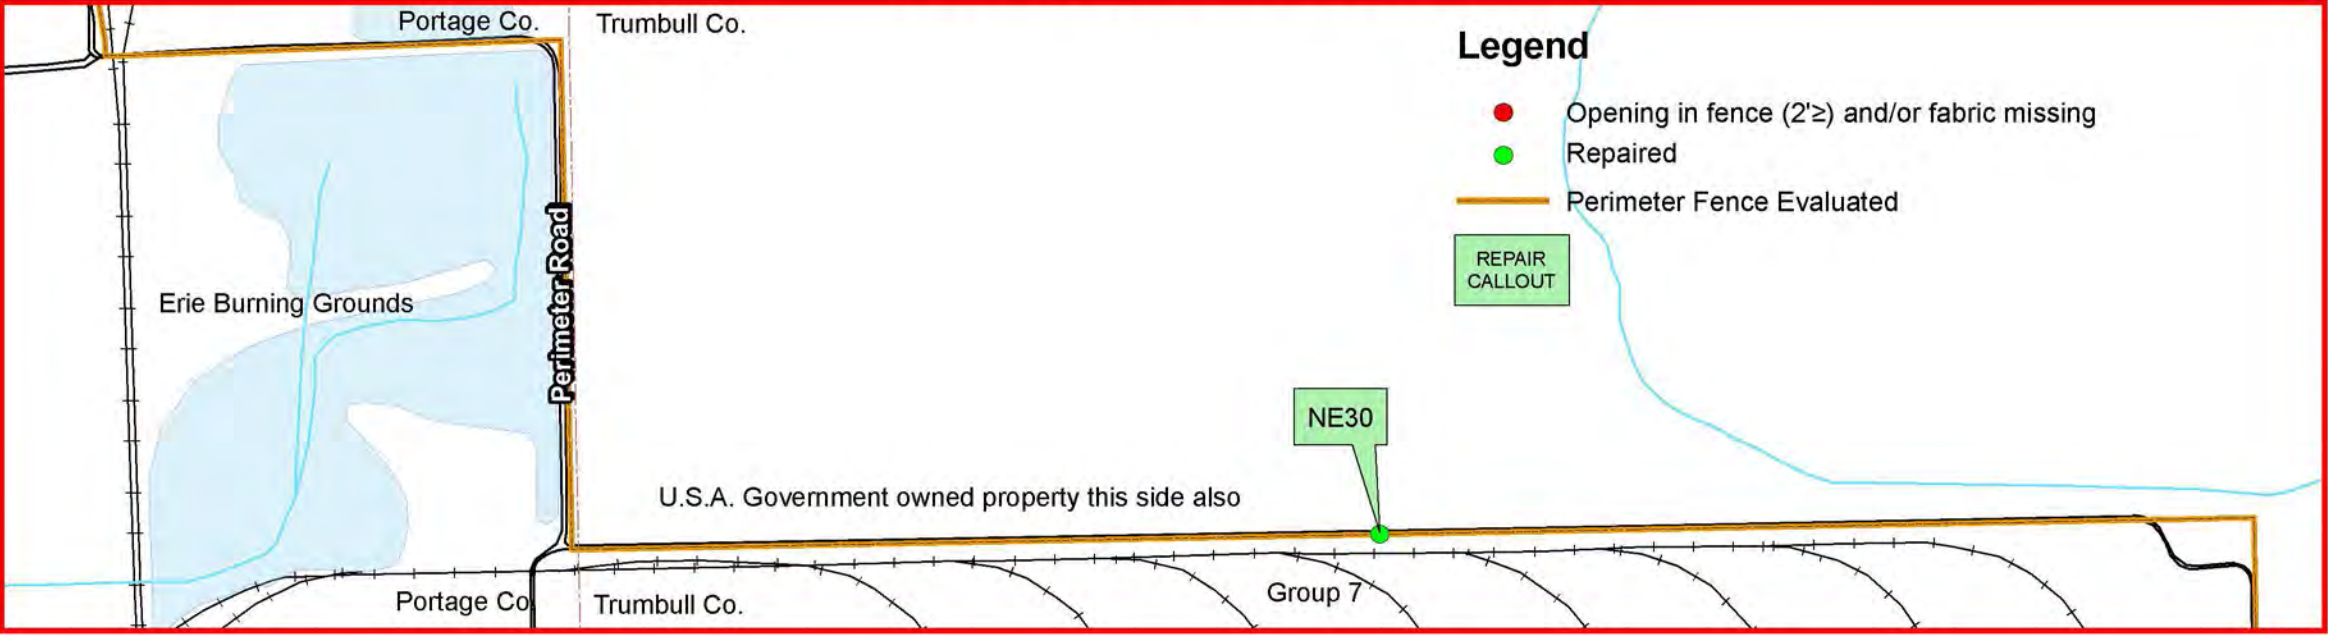
DETAIL SHEET FOR NE30

PHOTO NE30 repaired 12/04/2014

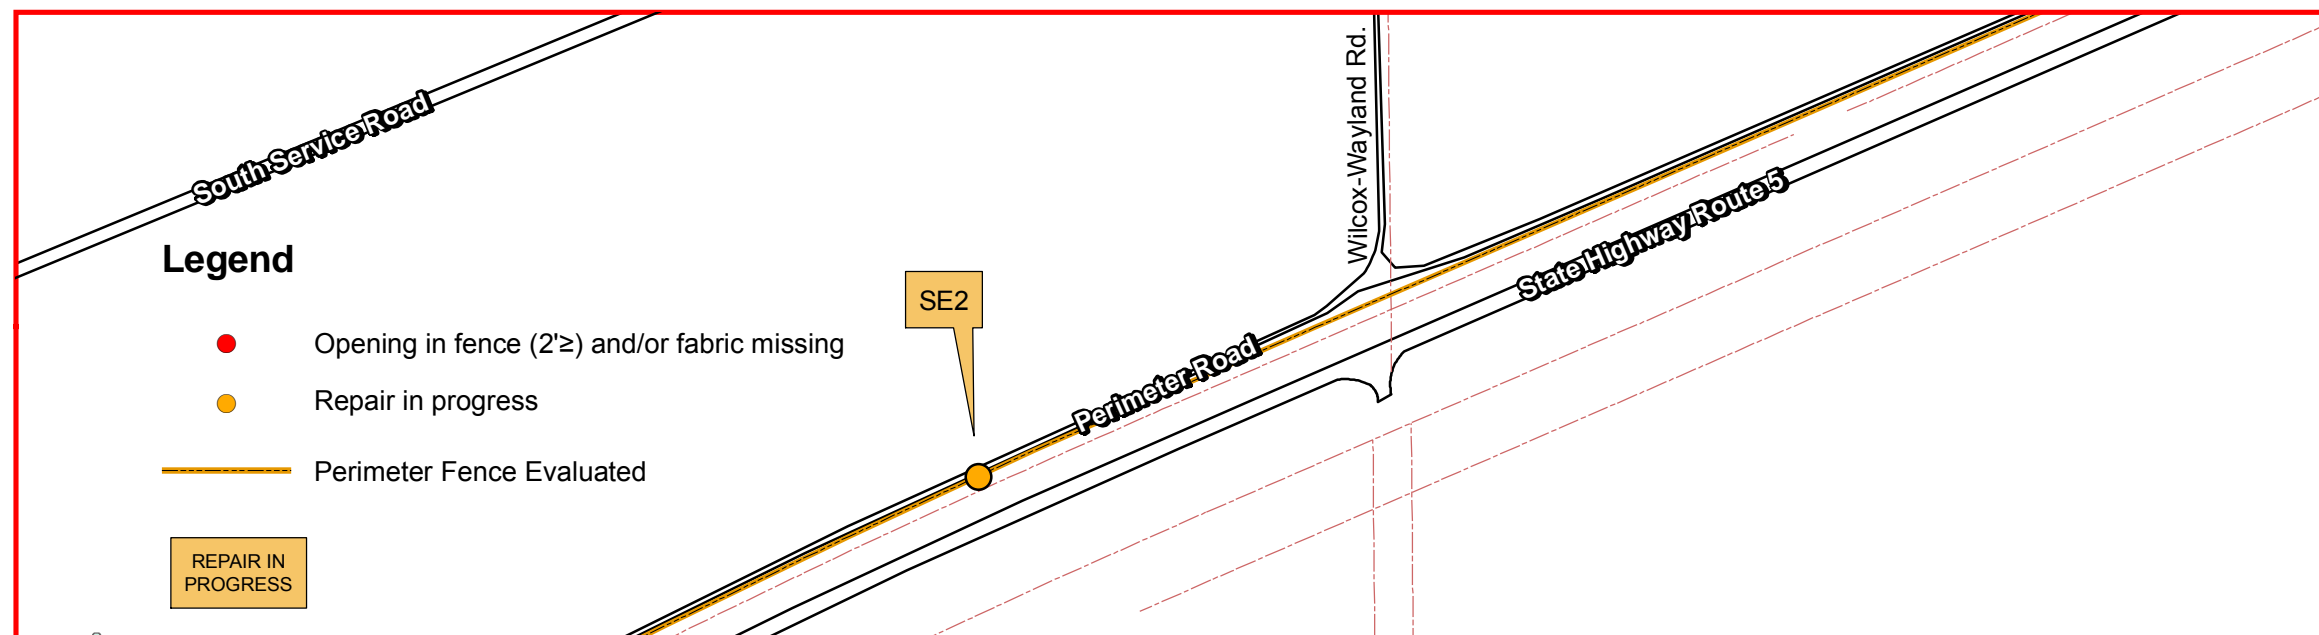
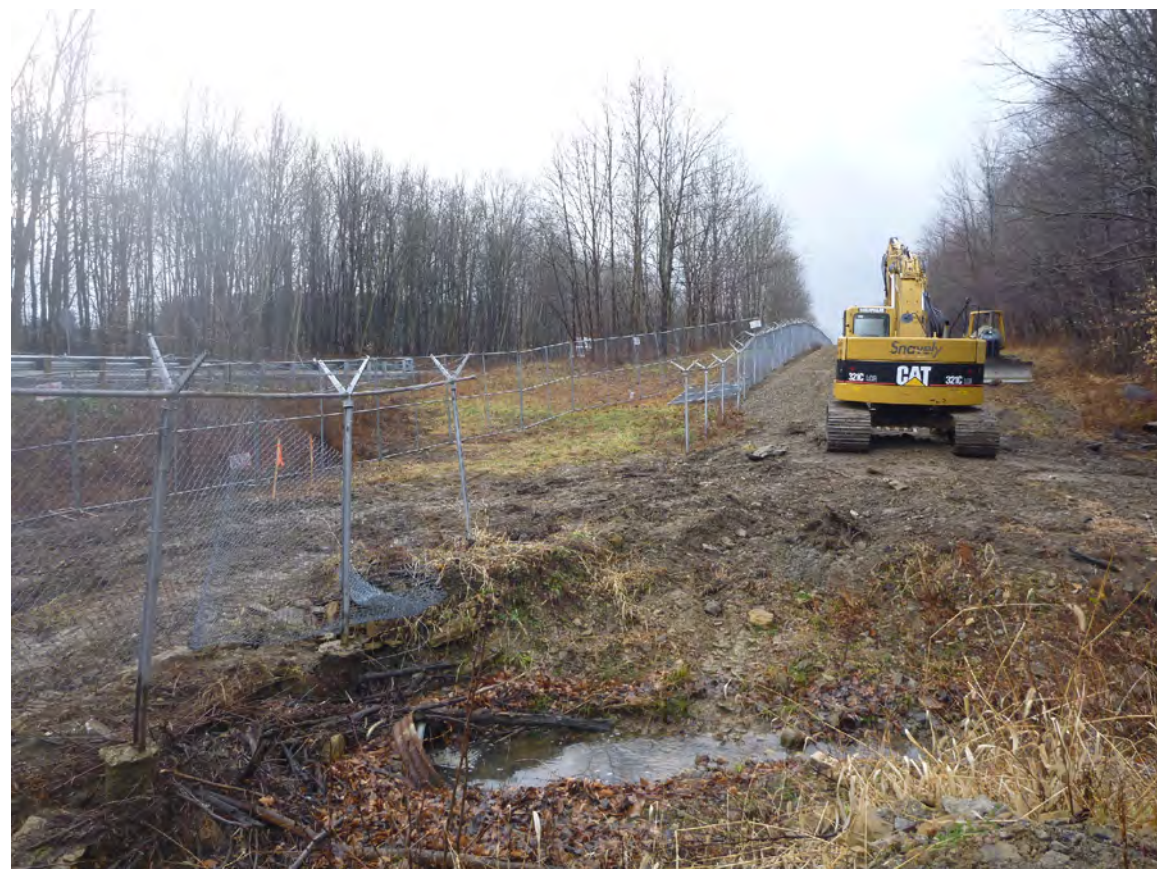
DETAIL SHEET FOR SE2

PHOTO SE2 repairs in progress 12/16/2014

PHOTO SE2 discovered 07/18/2013

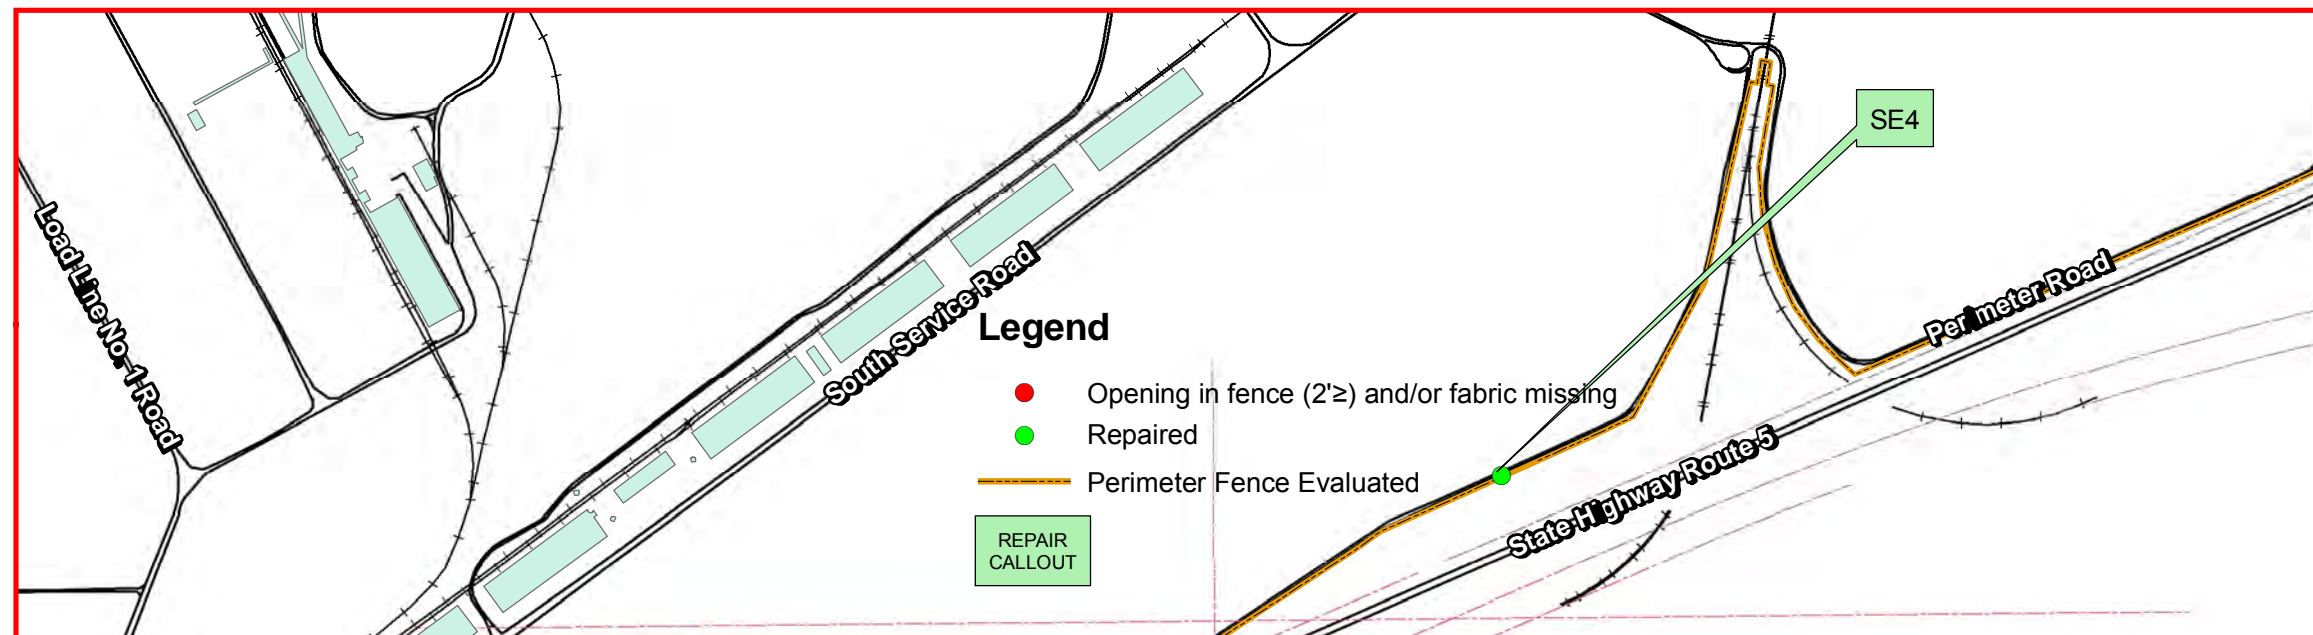
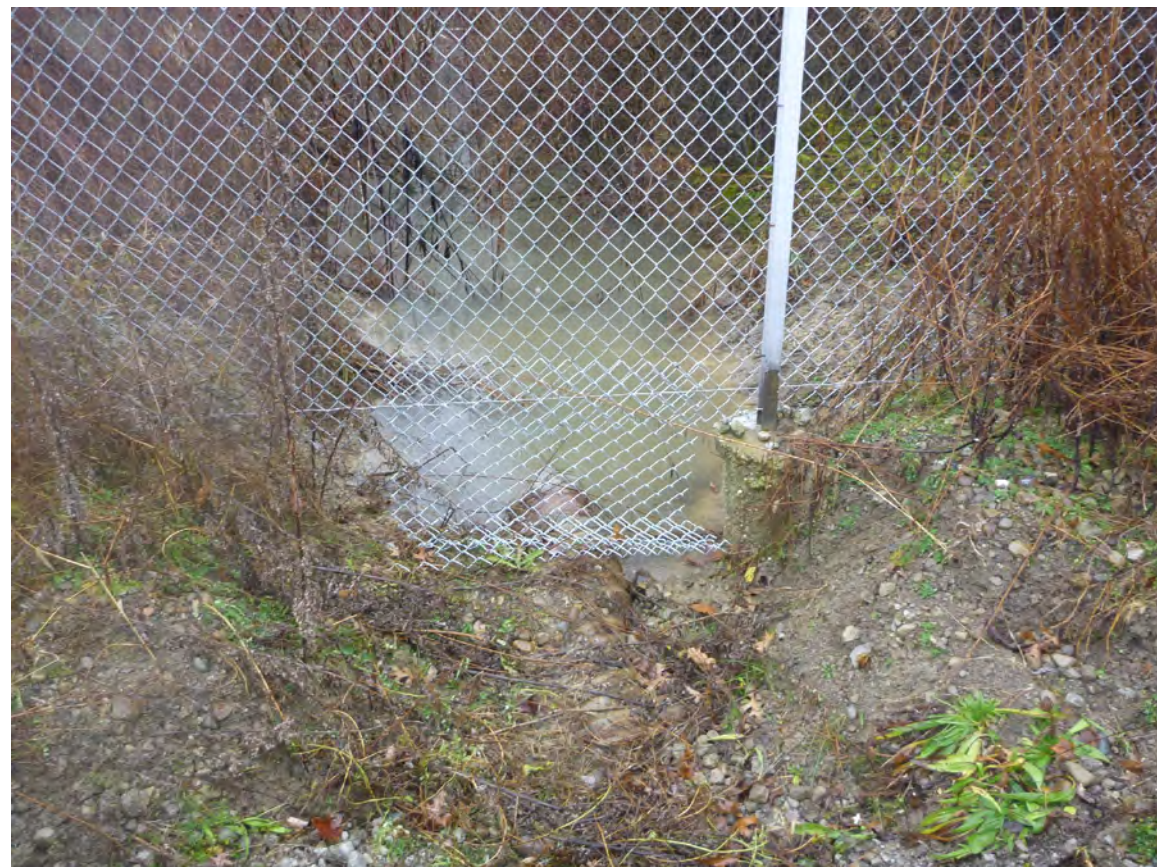
DETAIL SHEET FOR SE4

PHOTO SE4 repaired 12/16/2014

PHOTO SE4 discovered 02/27/2014

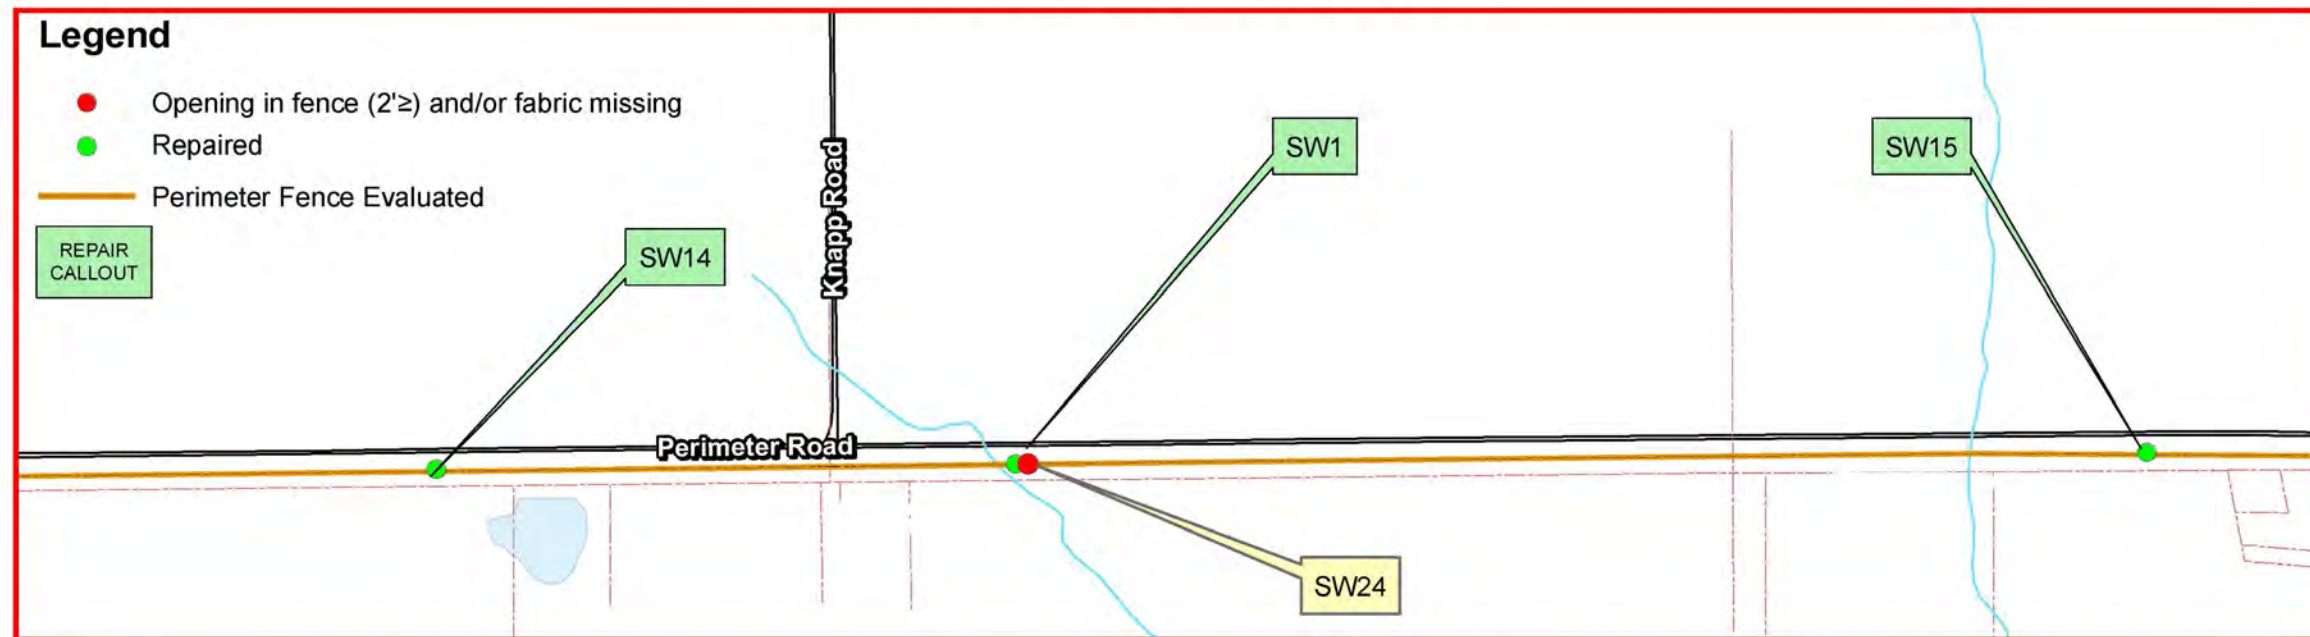
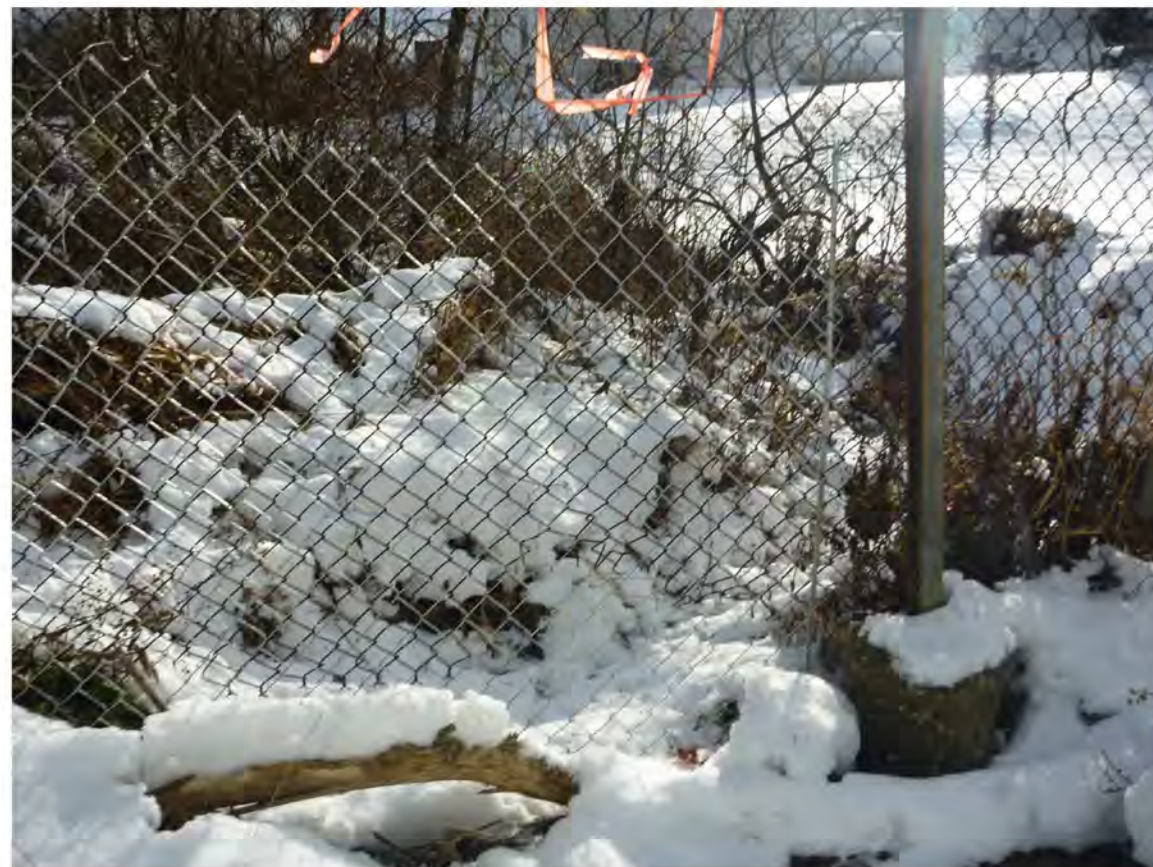
DETAIL SHEET FOR SW1

PHOTO SW1 repaired 11/20/2014

PHOTO SW1 discovered 02/07/2013

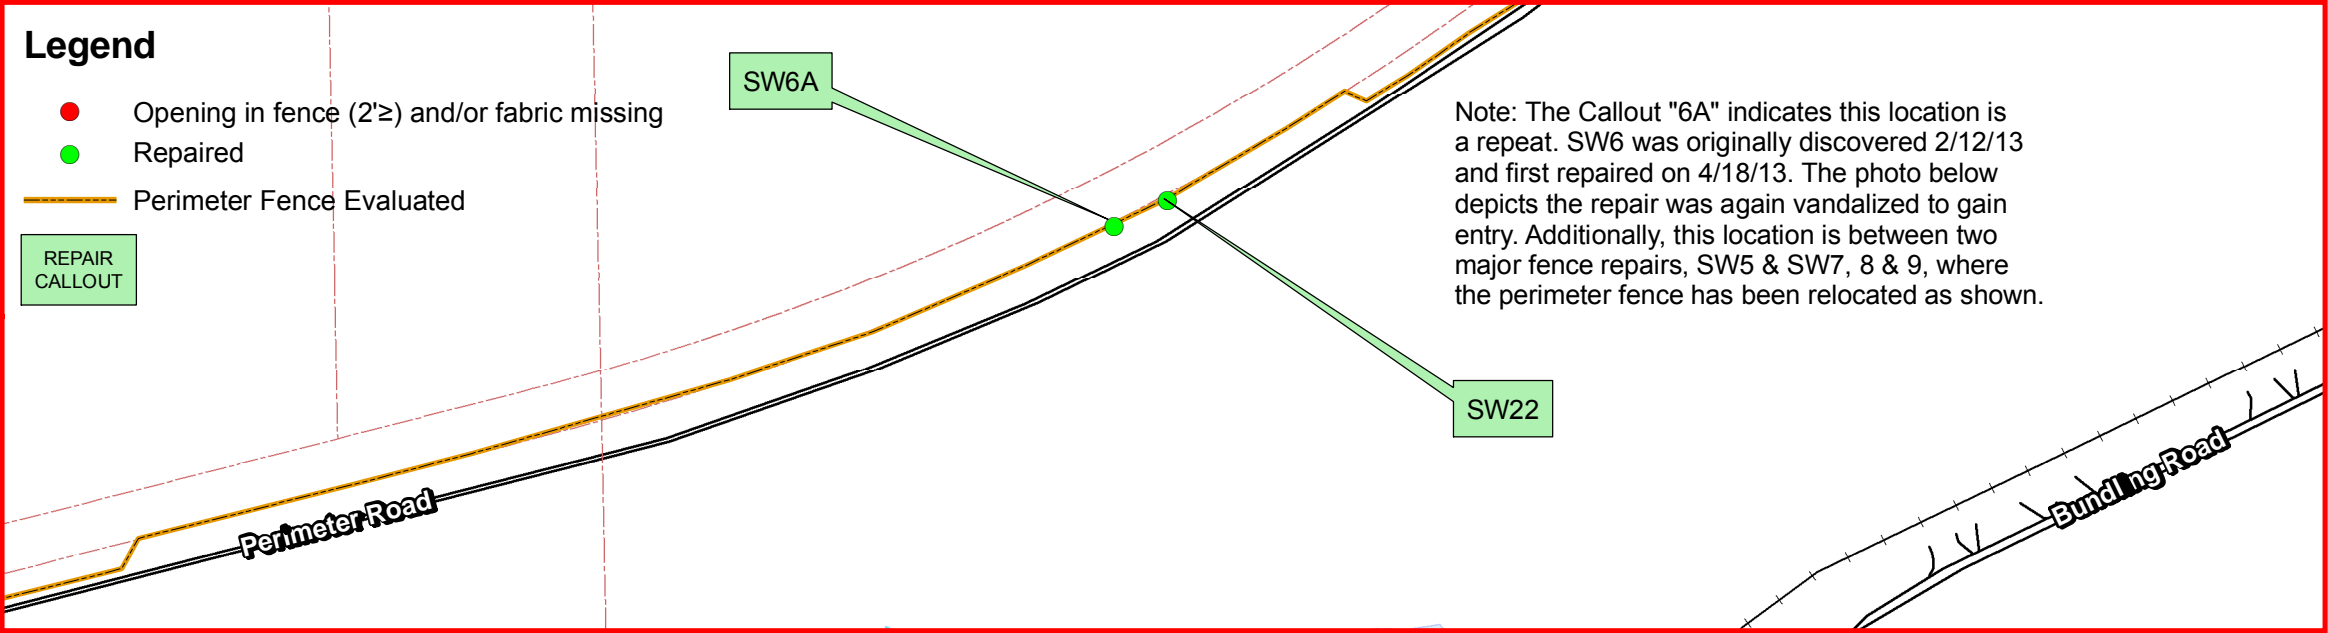
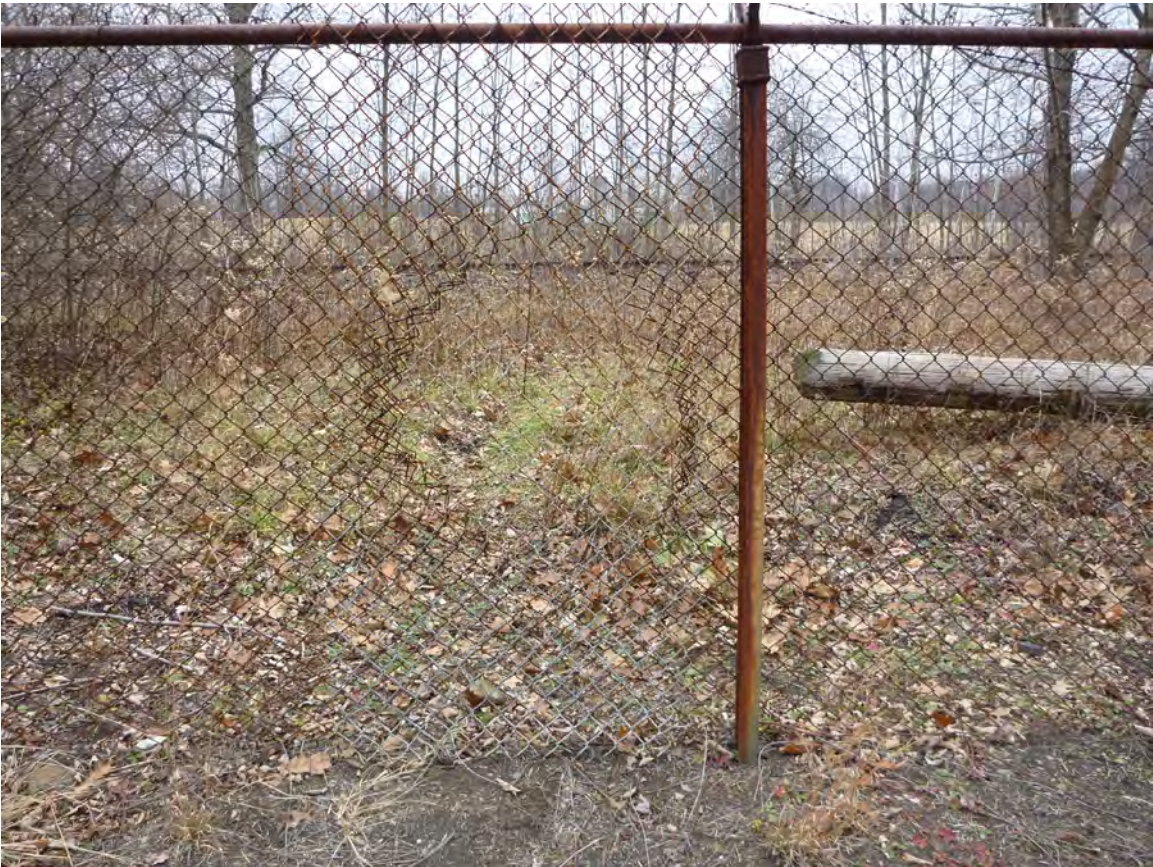
DETAIL SHEET FOR SW6A

PHOTO SW6A repaired 11/25/2014

PHOTO SW6A discovered 07/16/2014

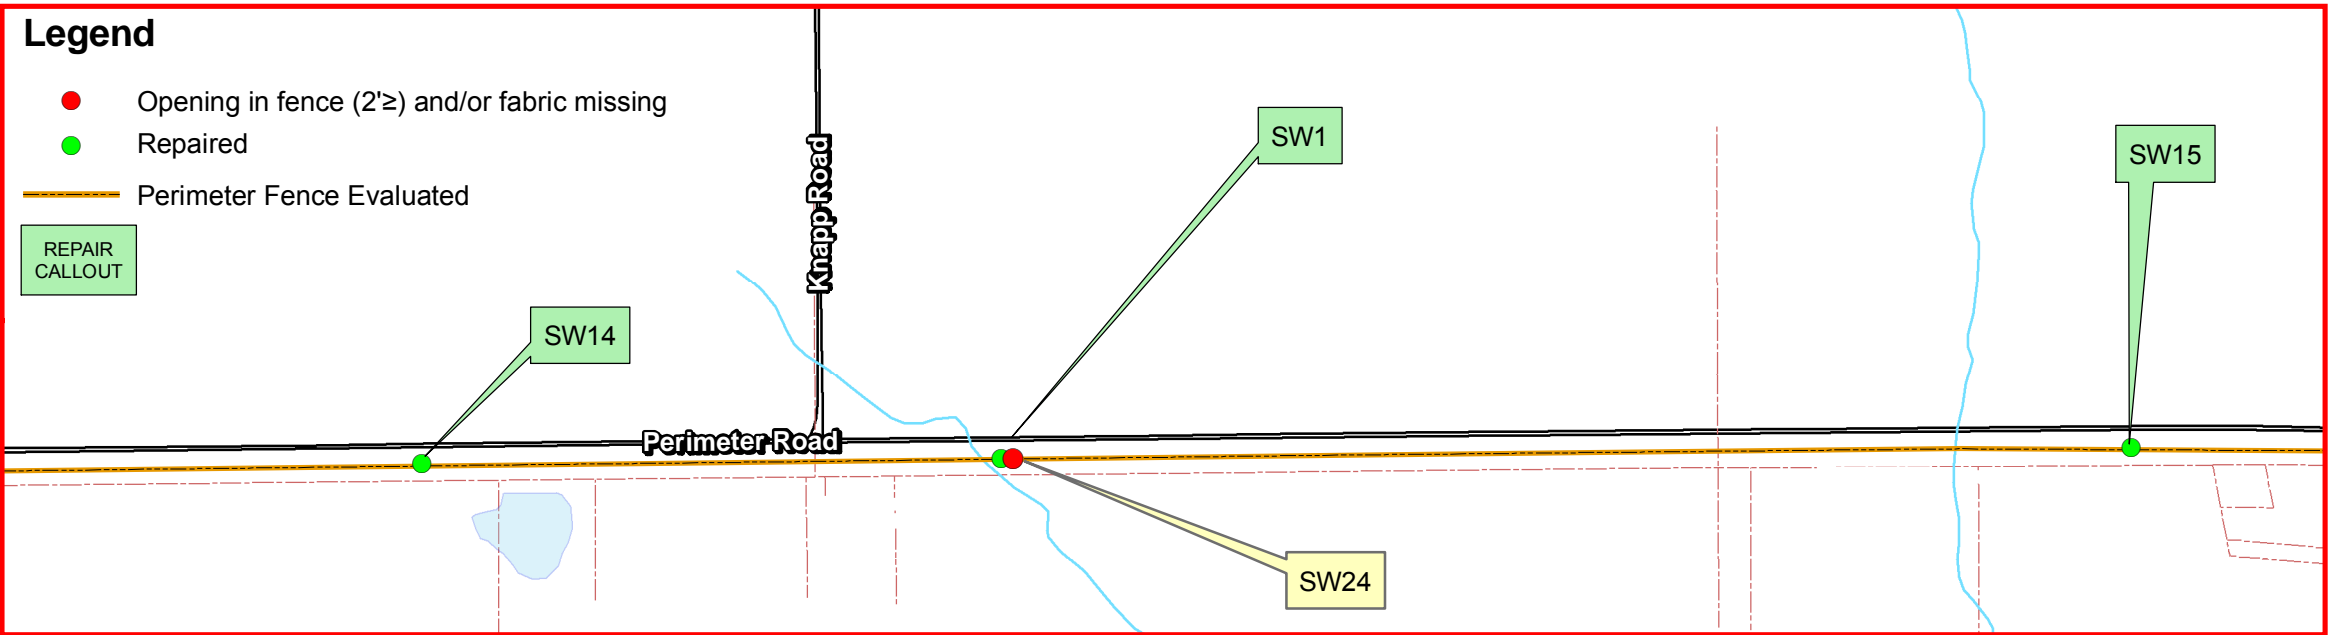
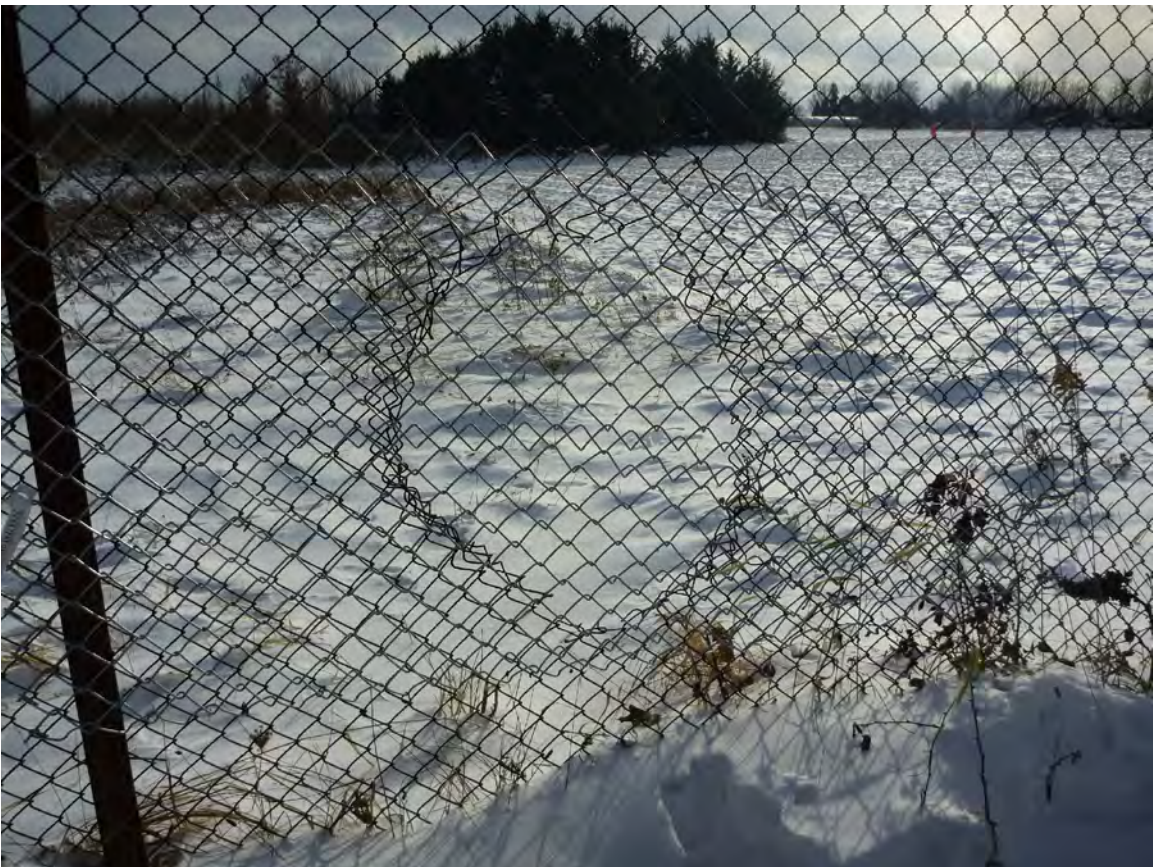
DETAIL SHEET FOR SW14

PHOTO SW14 repaired 11/20/2014

PHOTO SW14 discovered 04/14/2014

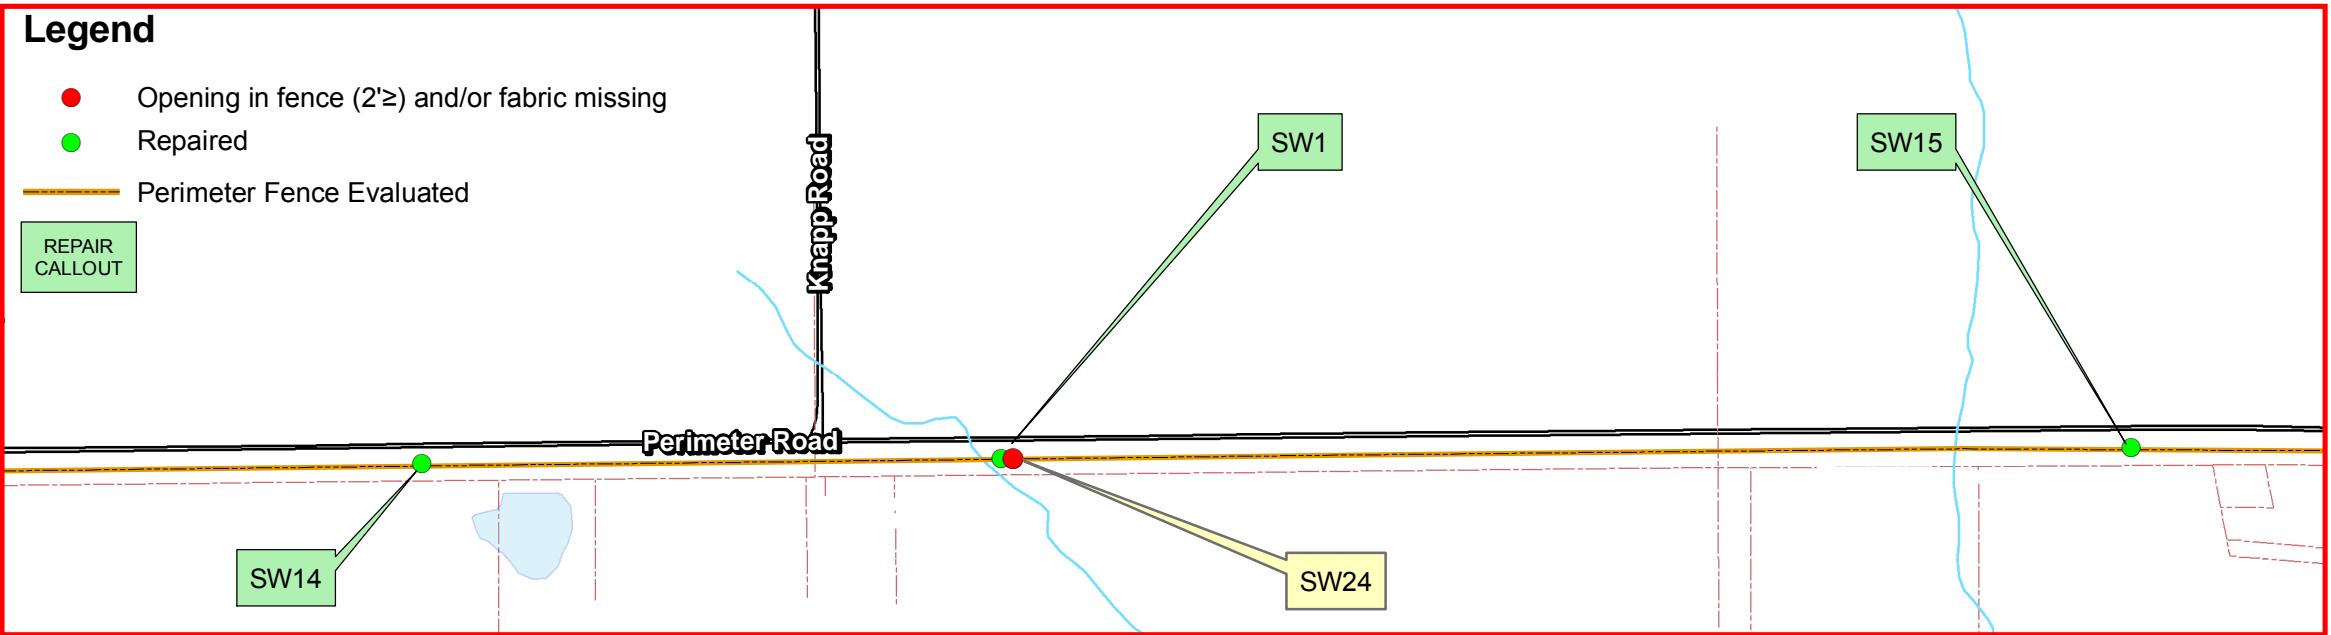
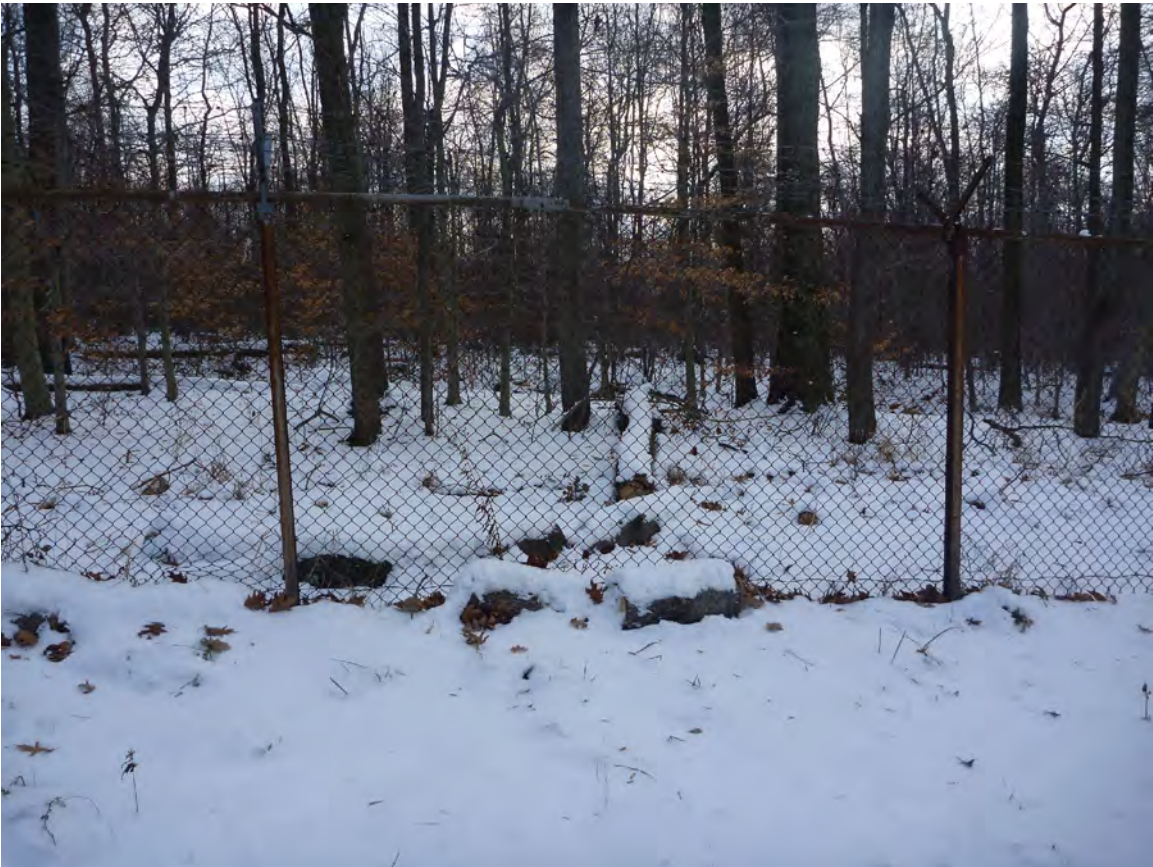
DETAIL SHEET FOR SW15

PHOTO SW15 repaired 11/20/2014

PHOTO SW15 discovered 07/15/2014

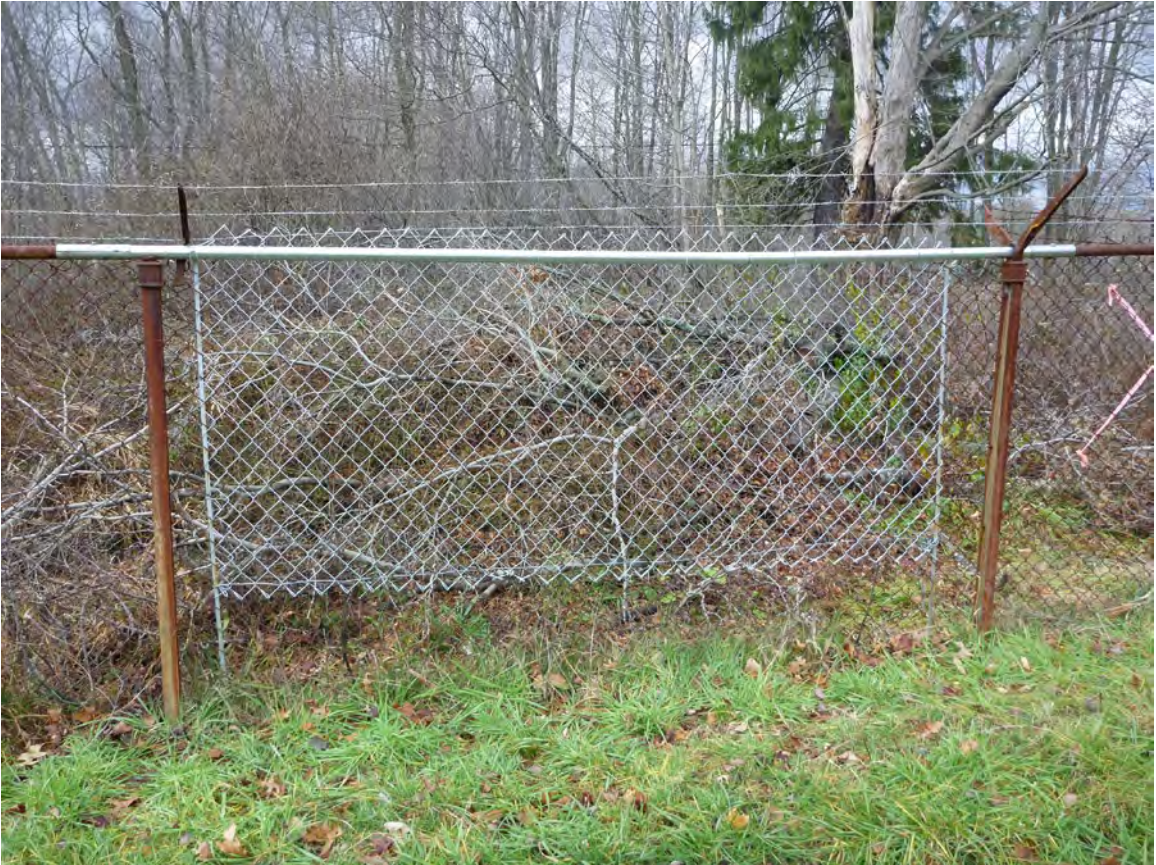
PHOTO SW16 repaired 11/24/2014

PHOTO SW16 discovered 07/15/2014

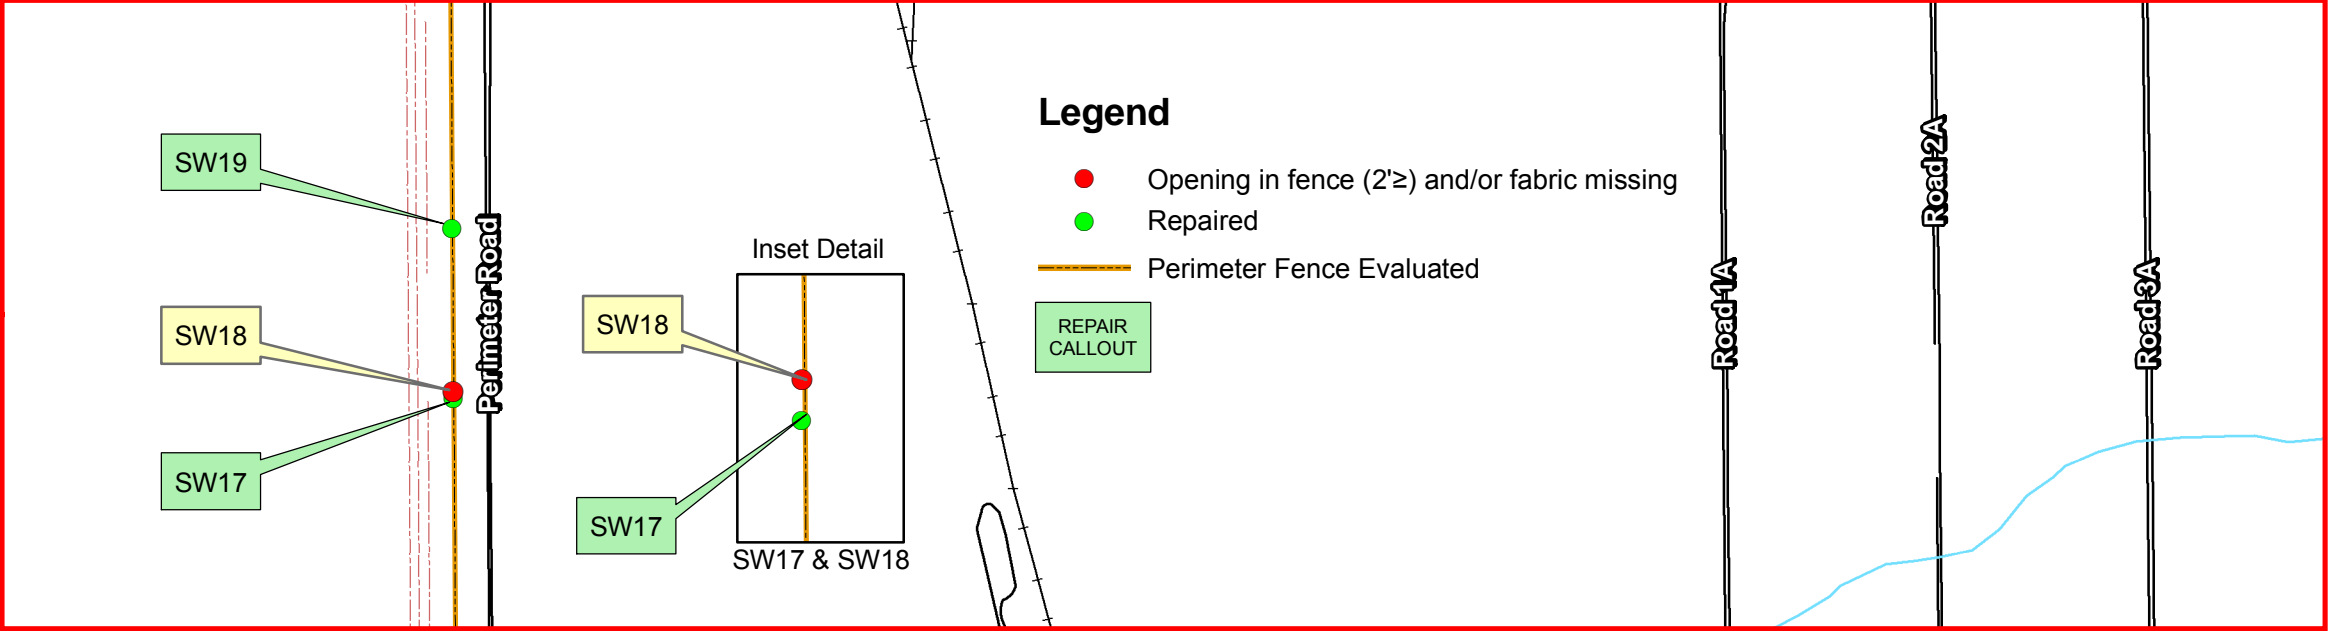
DETAIL SHEET FOR SW17

PHOTO SW17 repaired 11/25/2014

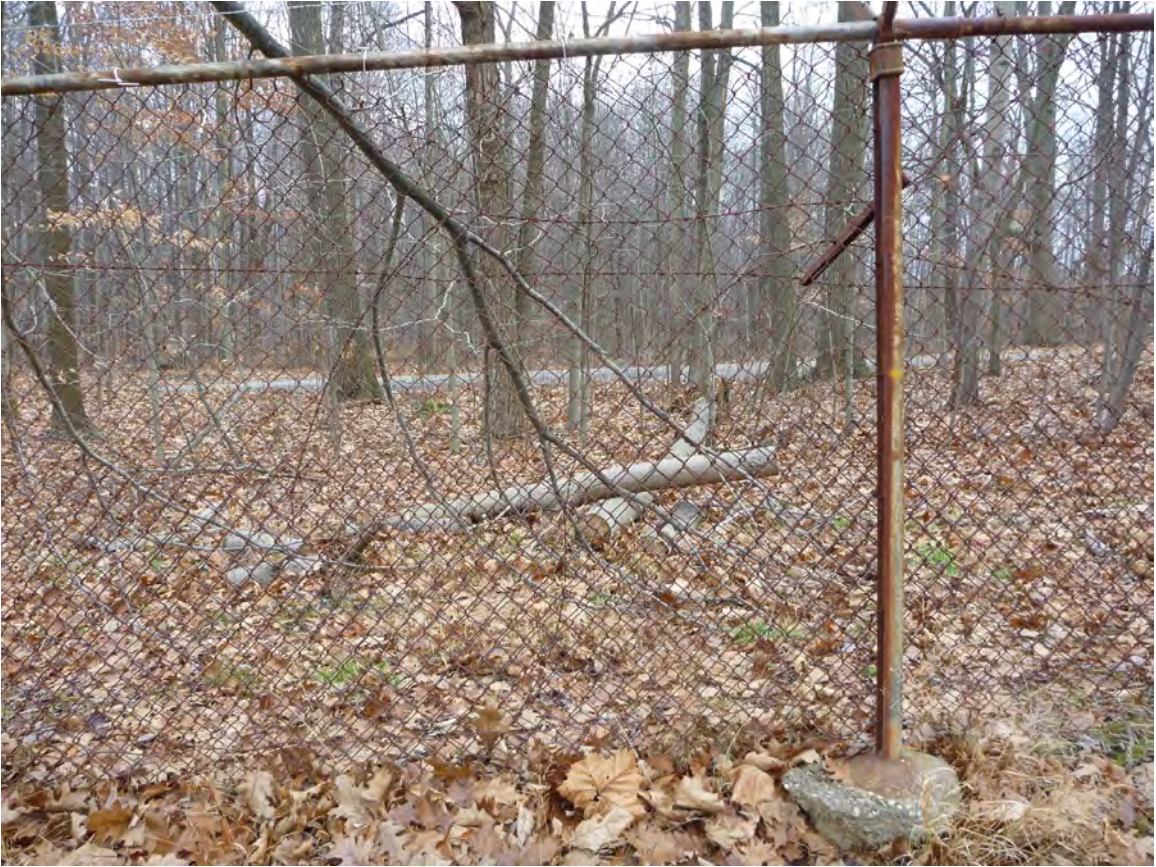
PHOTO SW19 repaired 11/25/2014

PHOTO SW19 discovered 07/15/2014
