Final
2015 Annual Land Use Control Monitoring Report,
RVAAP-01 Ramsdell Quarry Landfill
and
RVAAP-05 Winklepeck Burning Grounds

Camp Ravenna Joint Military Training Center
Former Ravenna Army Ammunition Plant
Portage and Trumbull Counties, Ohio

Contract No. W912QR-13-C-0031

January 27, 2016

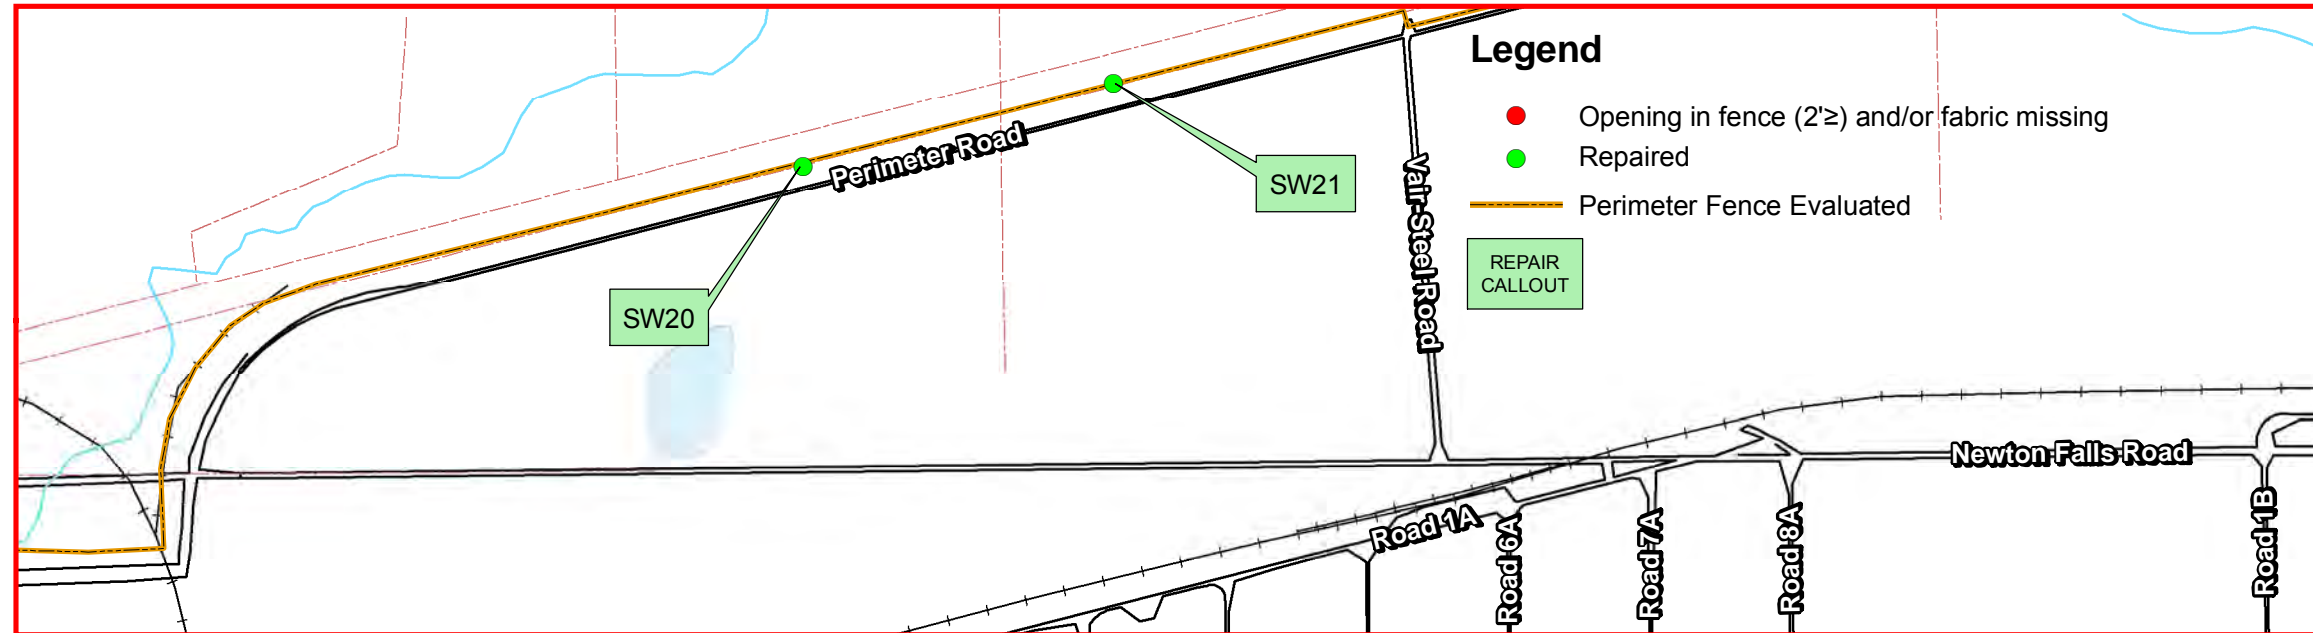
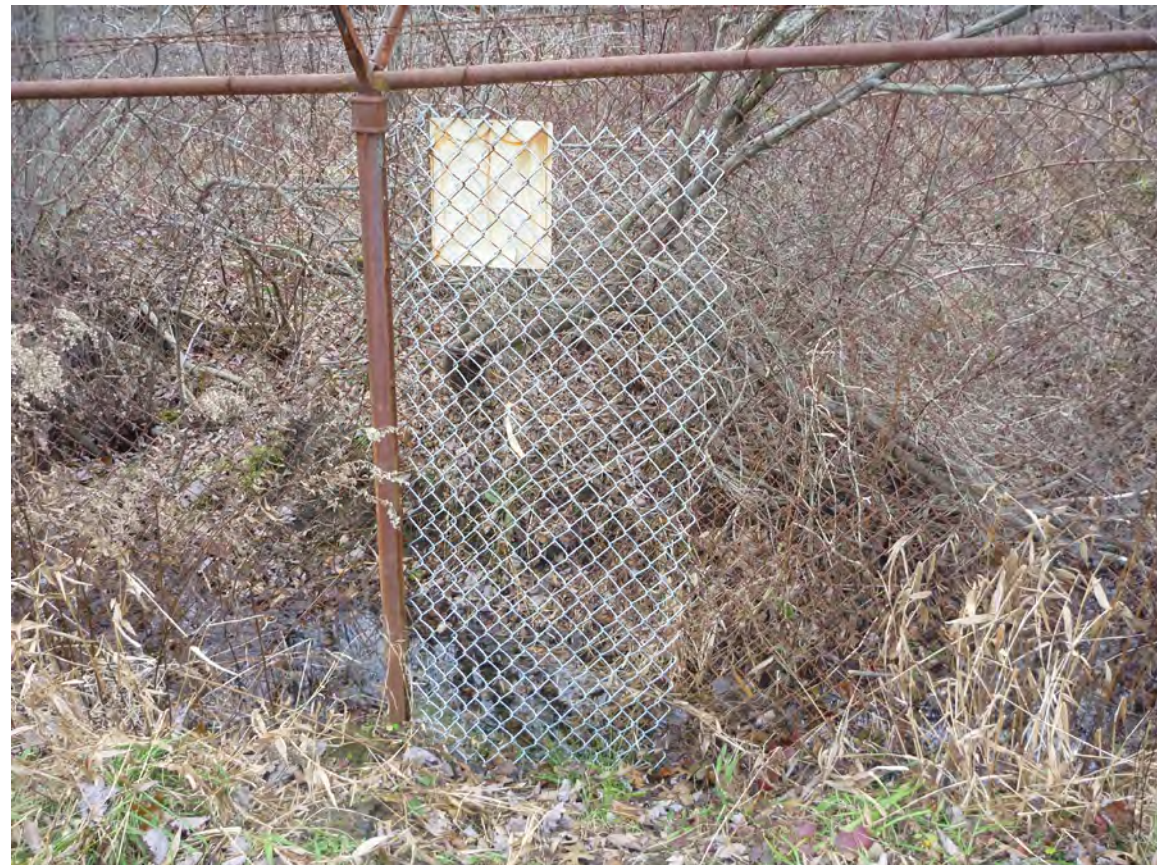
DETAIL SHEET FOR SW20

PHOTO SW20 repaired 11/25/2014

PHOTO SW20 discovered 07/15/2014

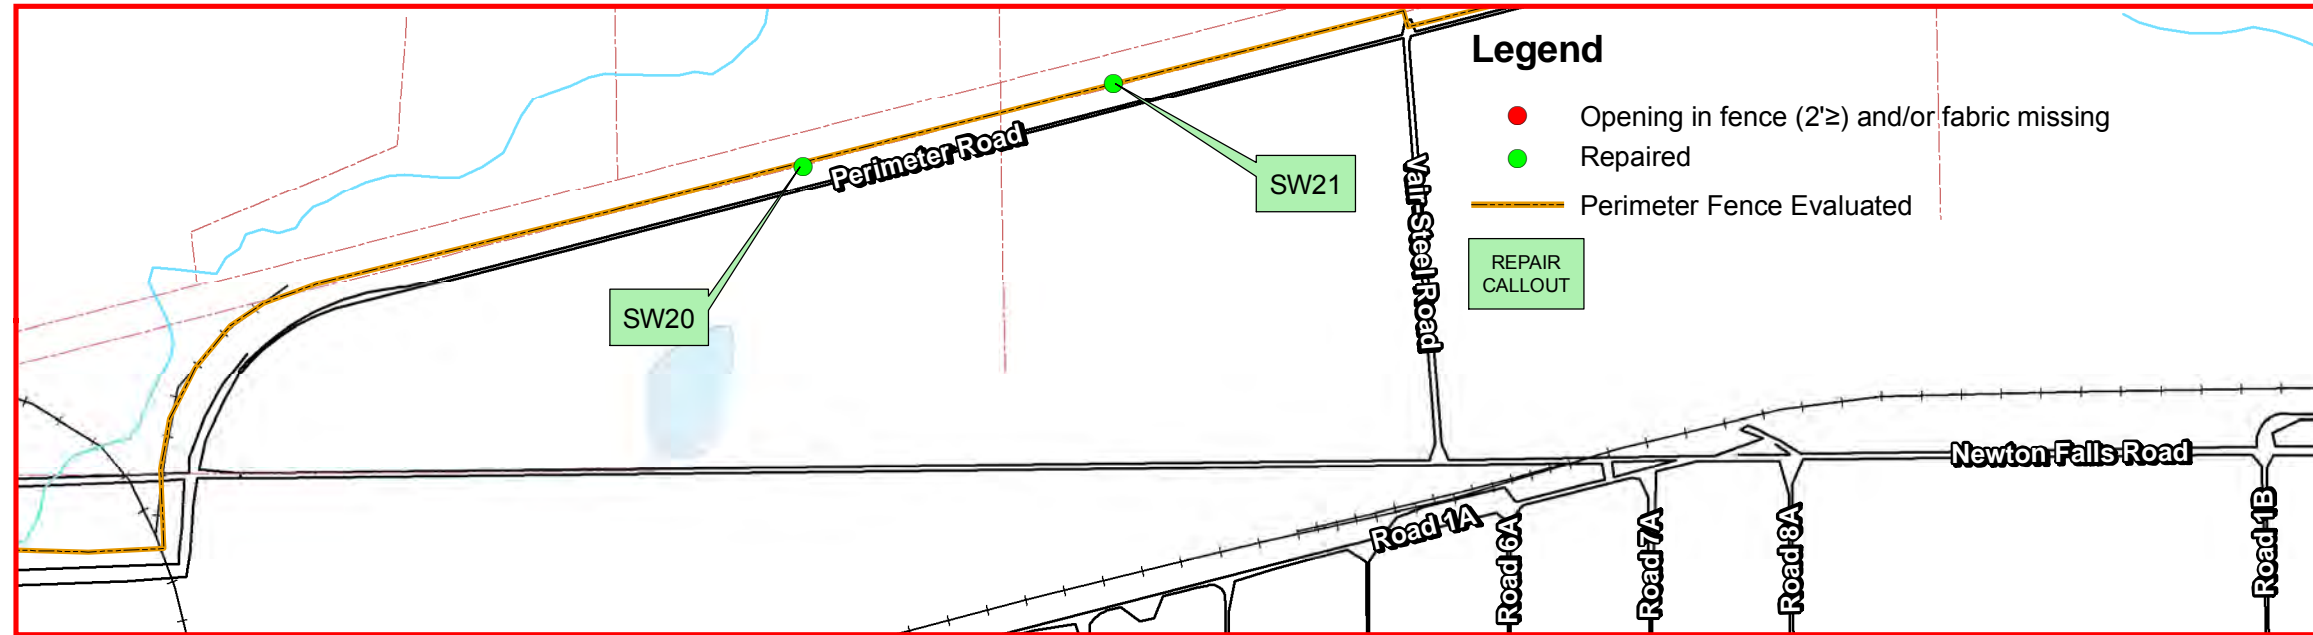
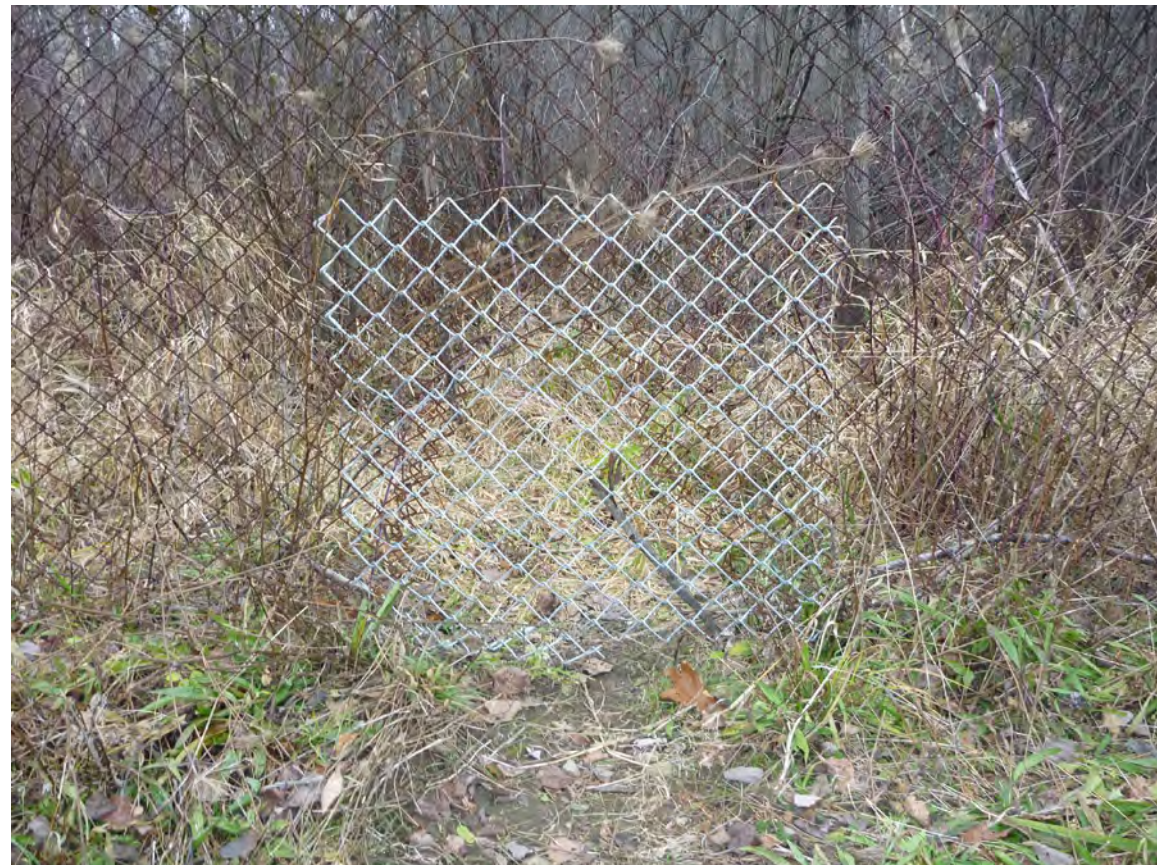
DETAIL SHEET FOR SW21

PHOTO SW21 repaired 11/25/2014

PHOTO SW21 discovered 07/15/2014

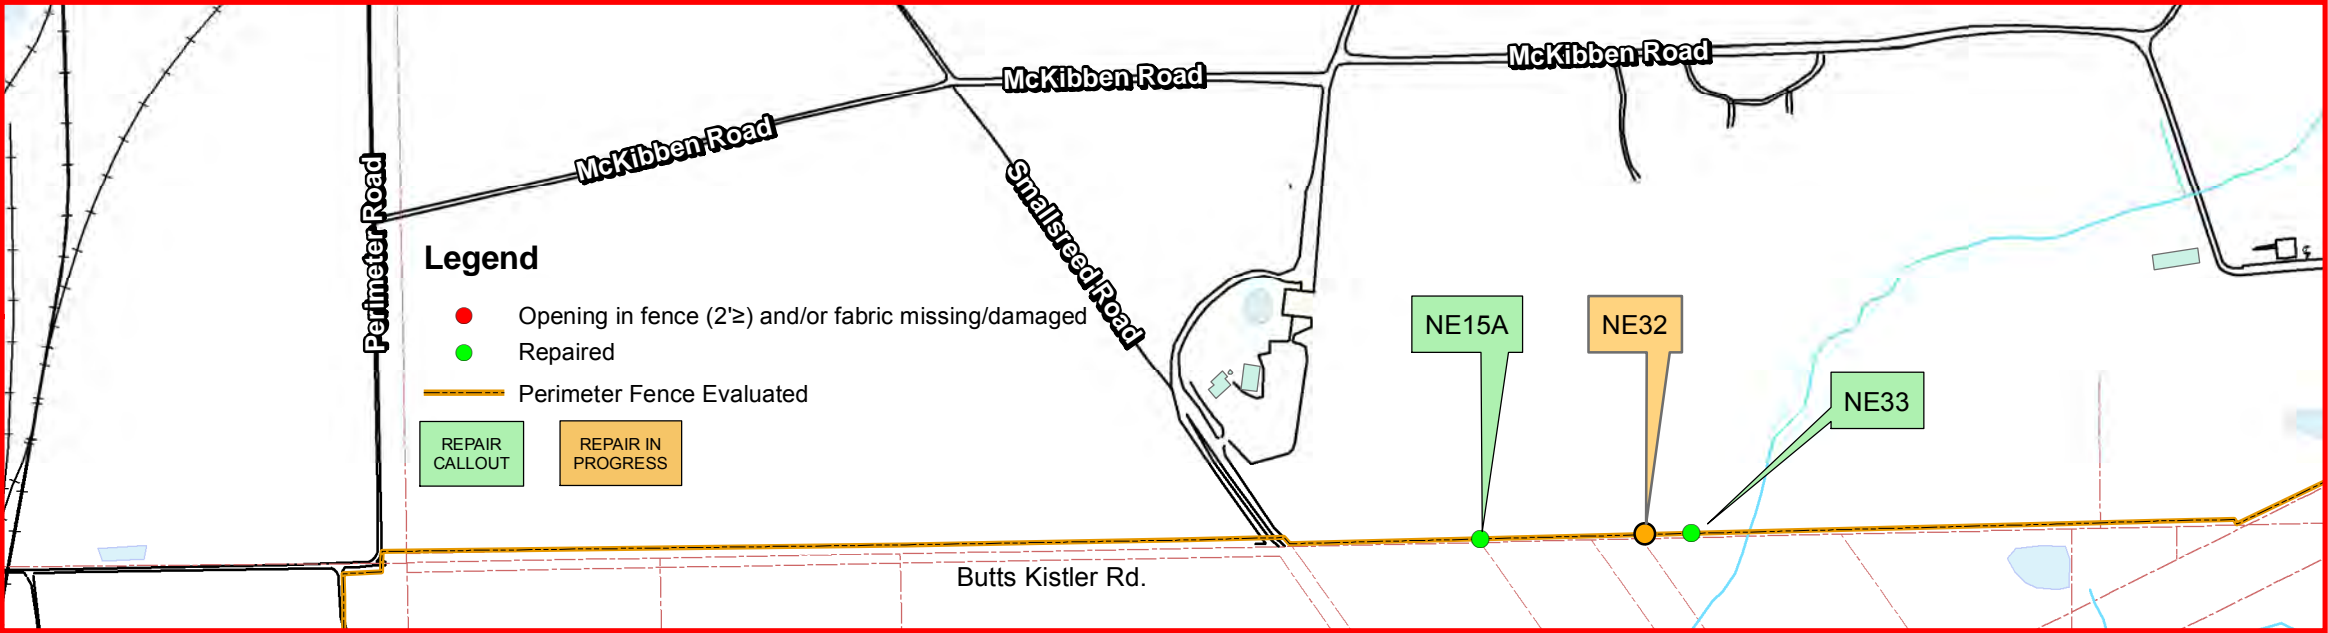
DETAIL SHEET FOR NE32

PHOTO NE32 as observed on 03/30/2015

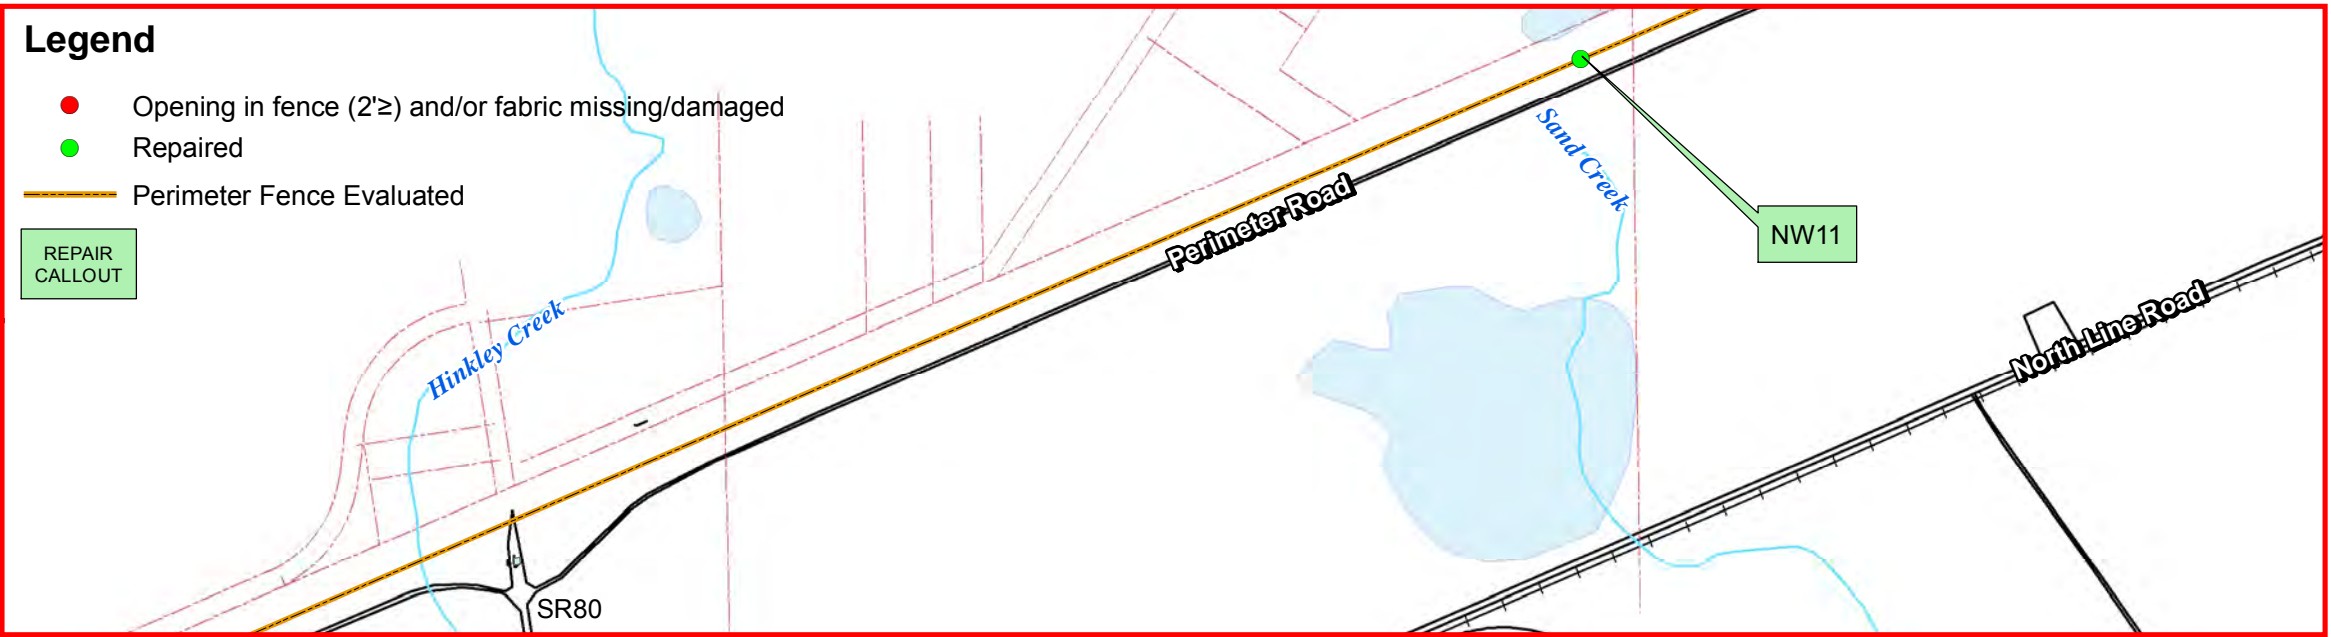
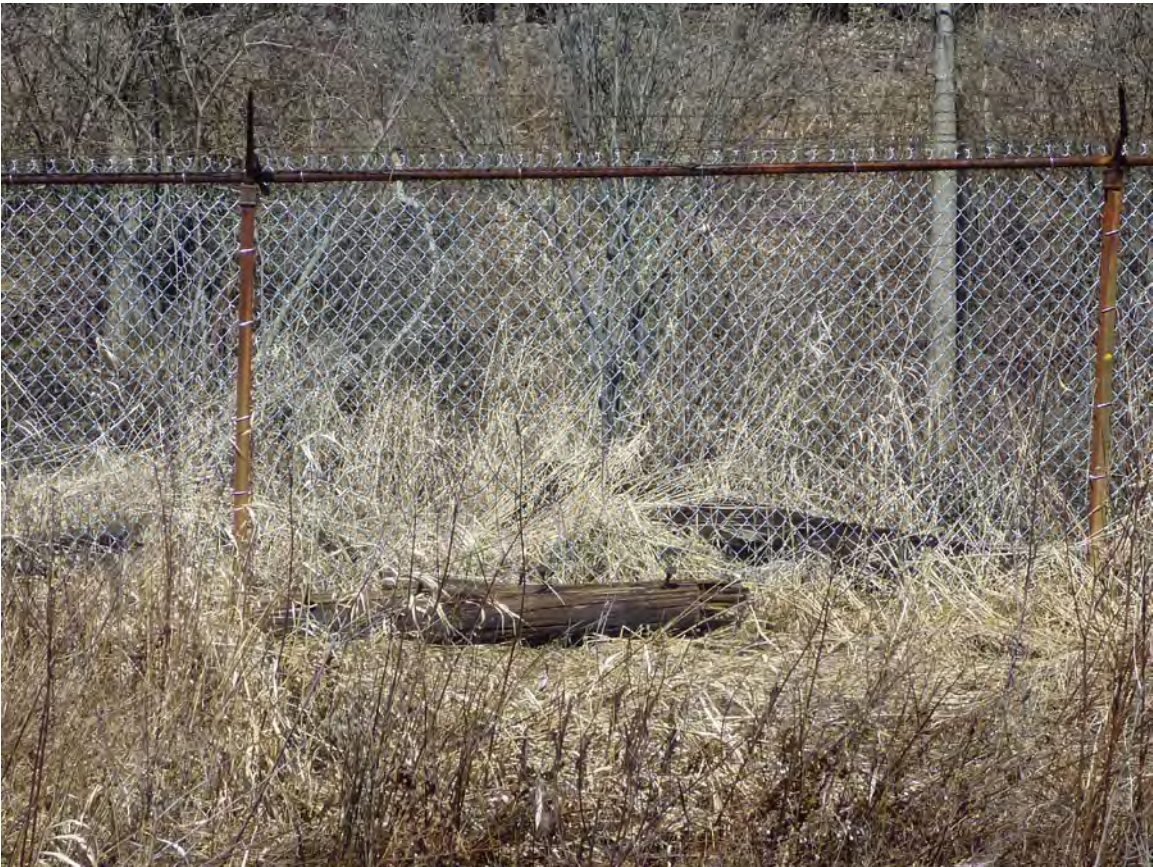
DETAIL SHEET FOR NW11

PHOTO NW11 as observed on 03/18/2015

PHOTO NW11 discovered 11/26/2014

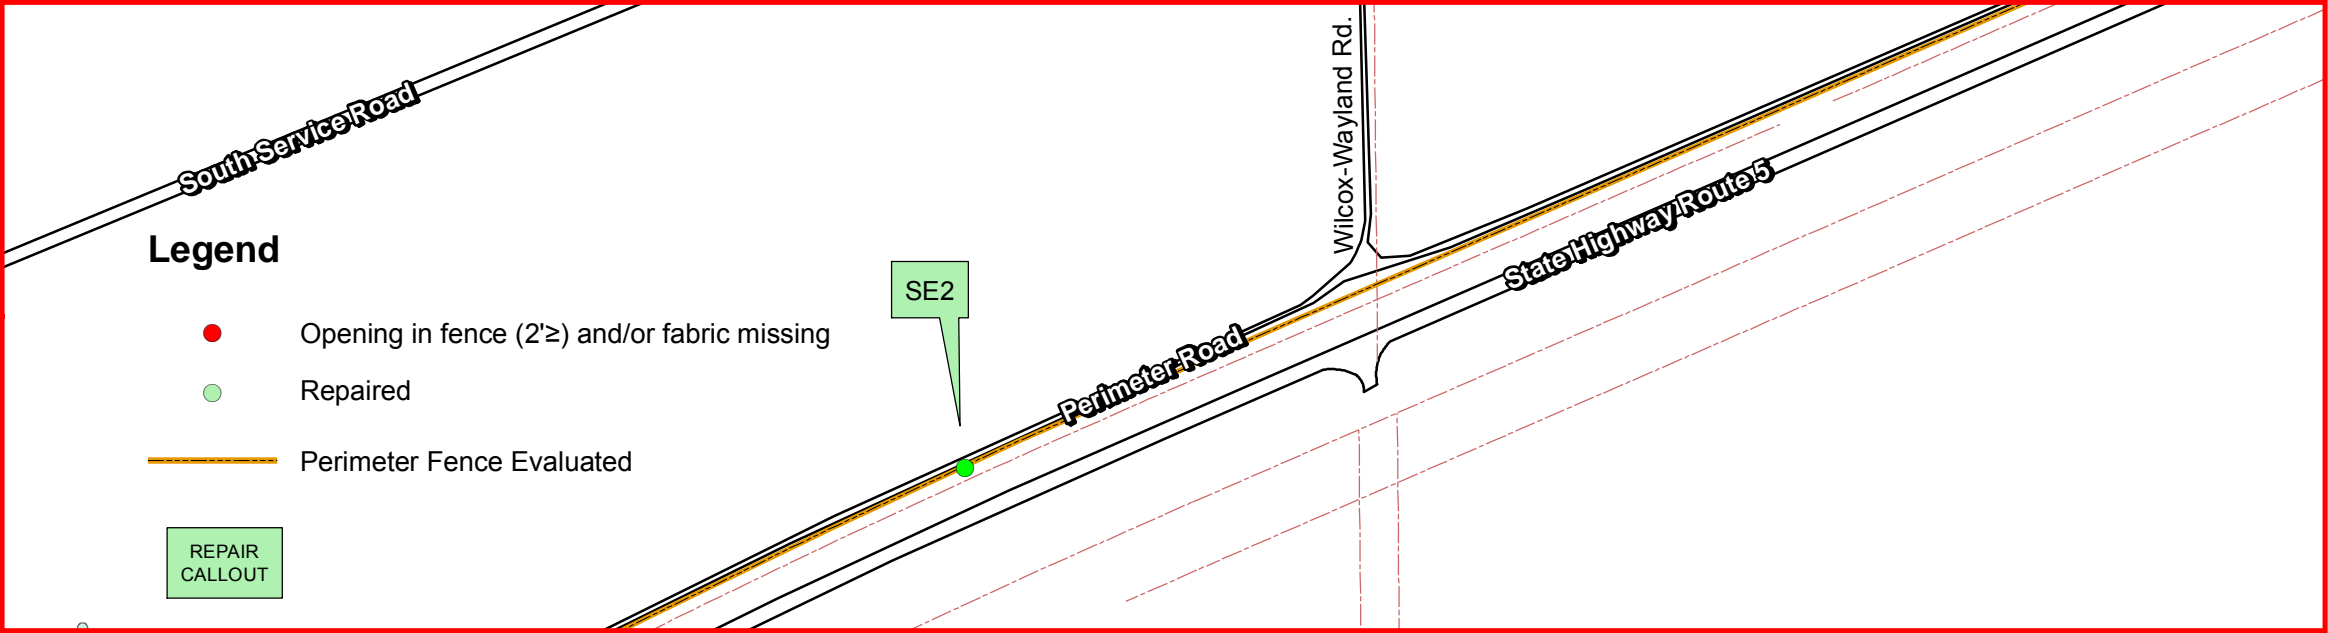
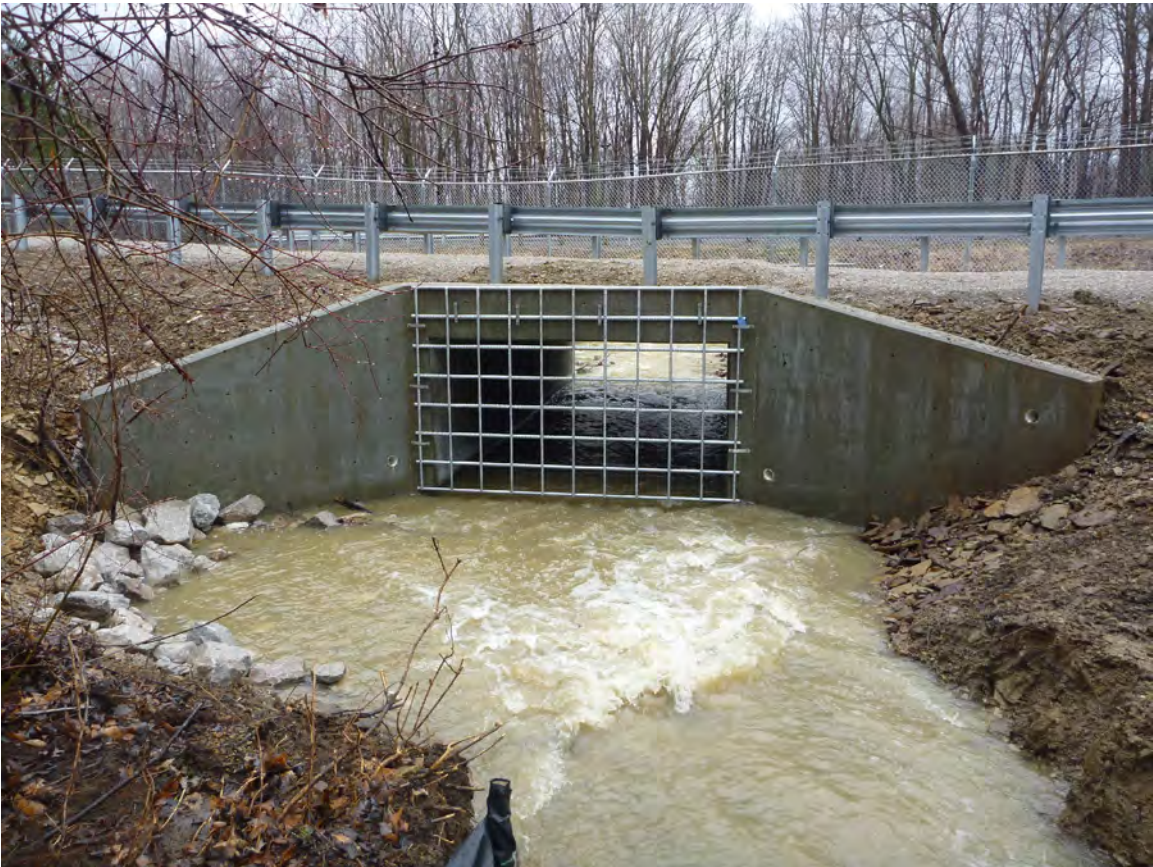
DETAIL SHEET FOR SE2

PHOTO SE2 as observed on 03/26/2015, Date of repair is 04/10/2015

PHOTO SE2 discovered 07/18/2013

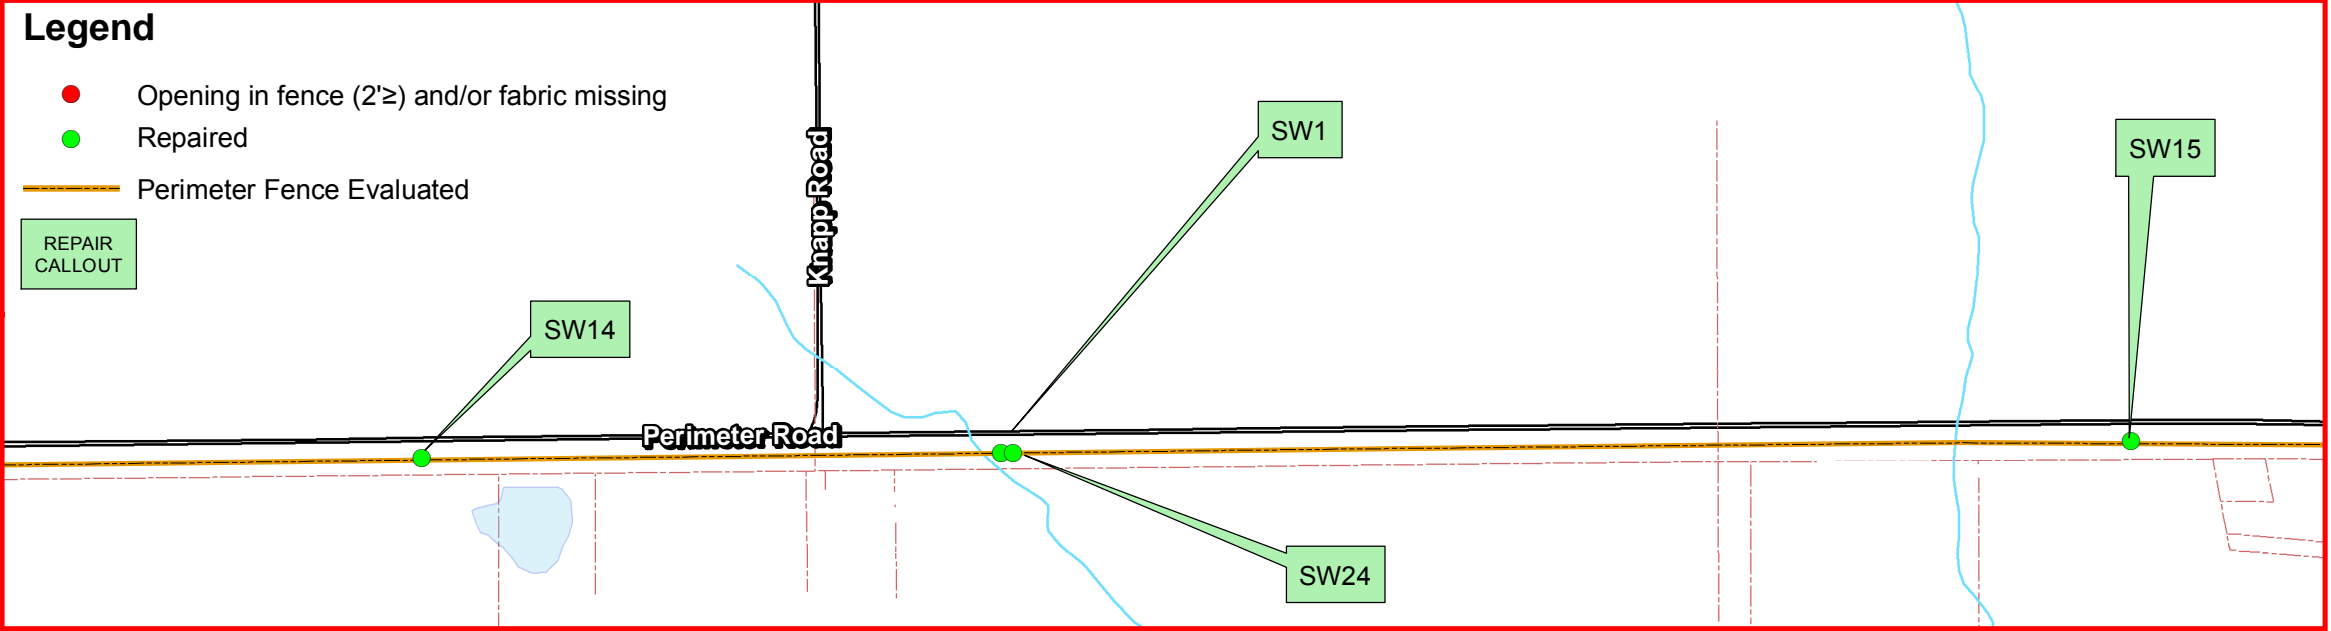
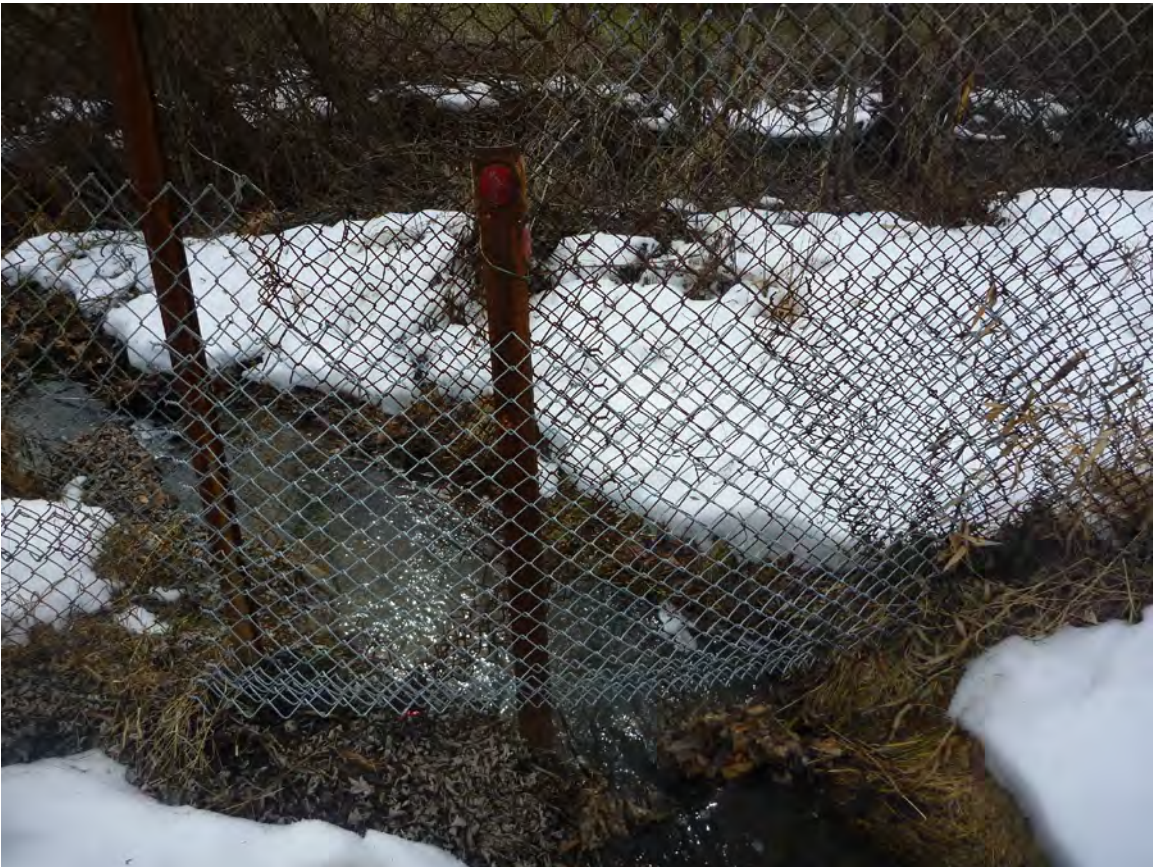
DETAIL SHEET FOR SW24

PHOTO SW24 as observed on 03/16/2015

PHOTO SW24 discovered 11/20/2014

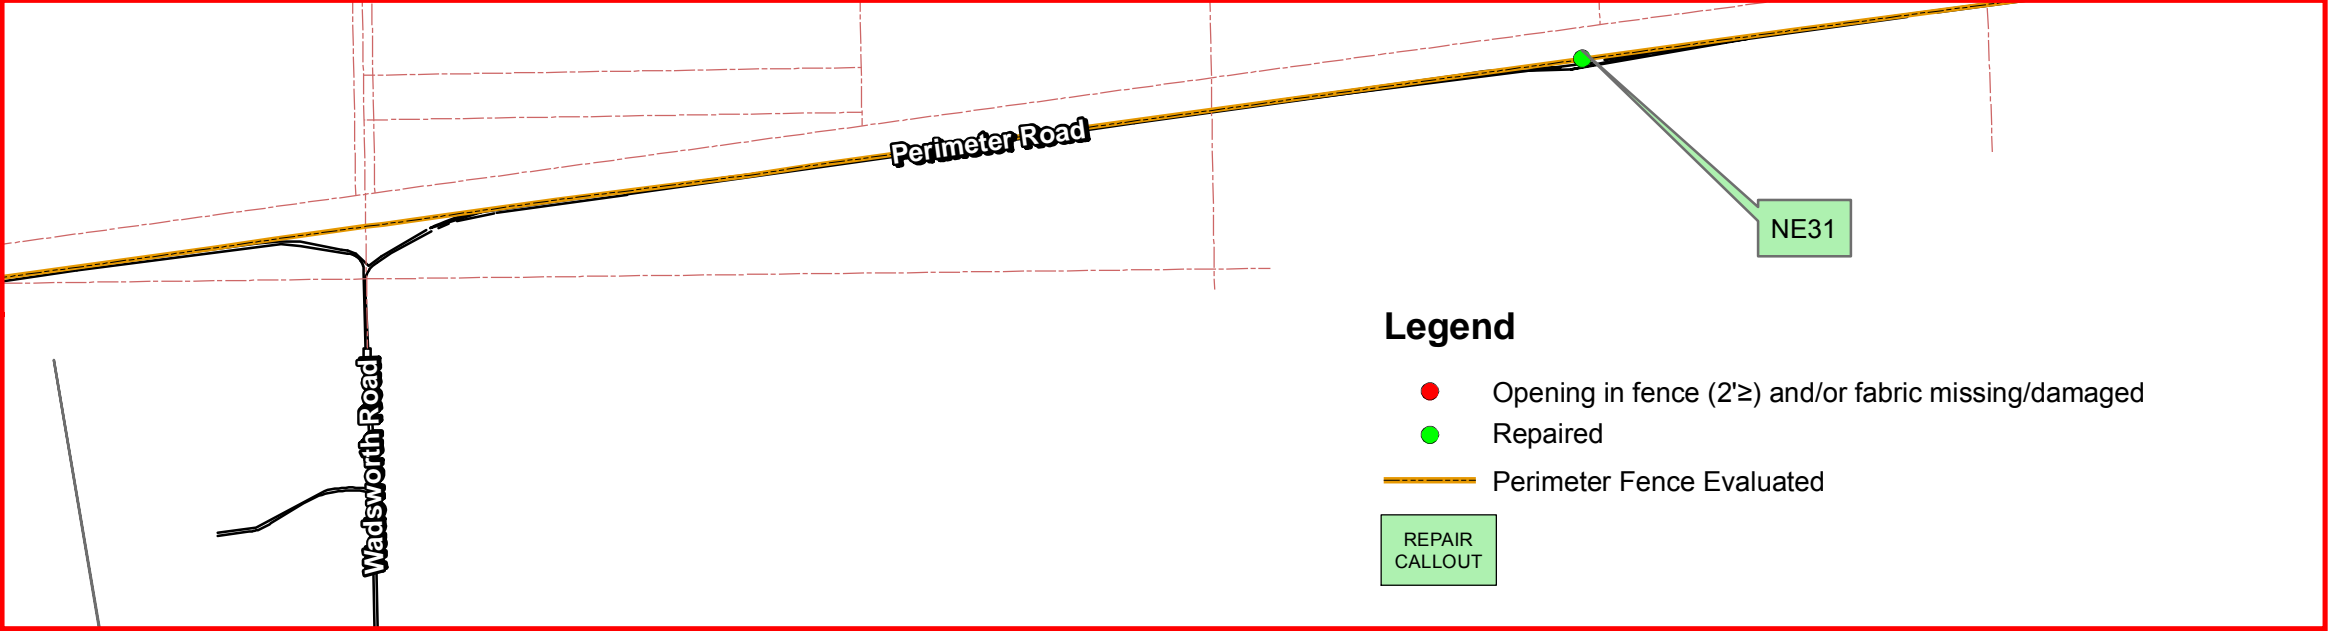
DETAIL SHEET FOR NE31

REPAIR PHOTO NE31 dated 06/03/2015

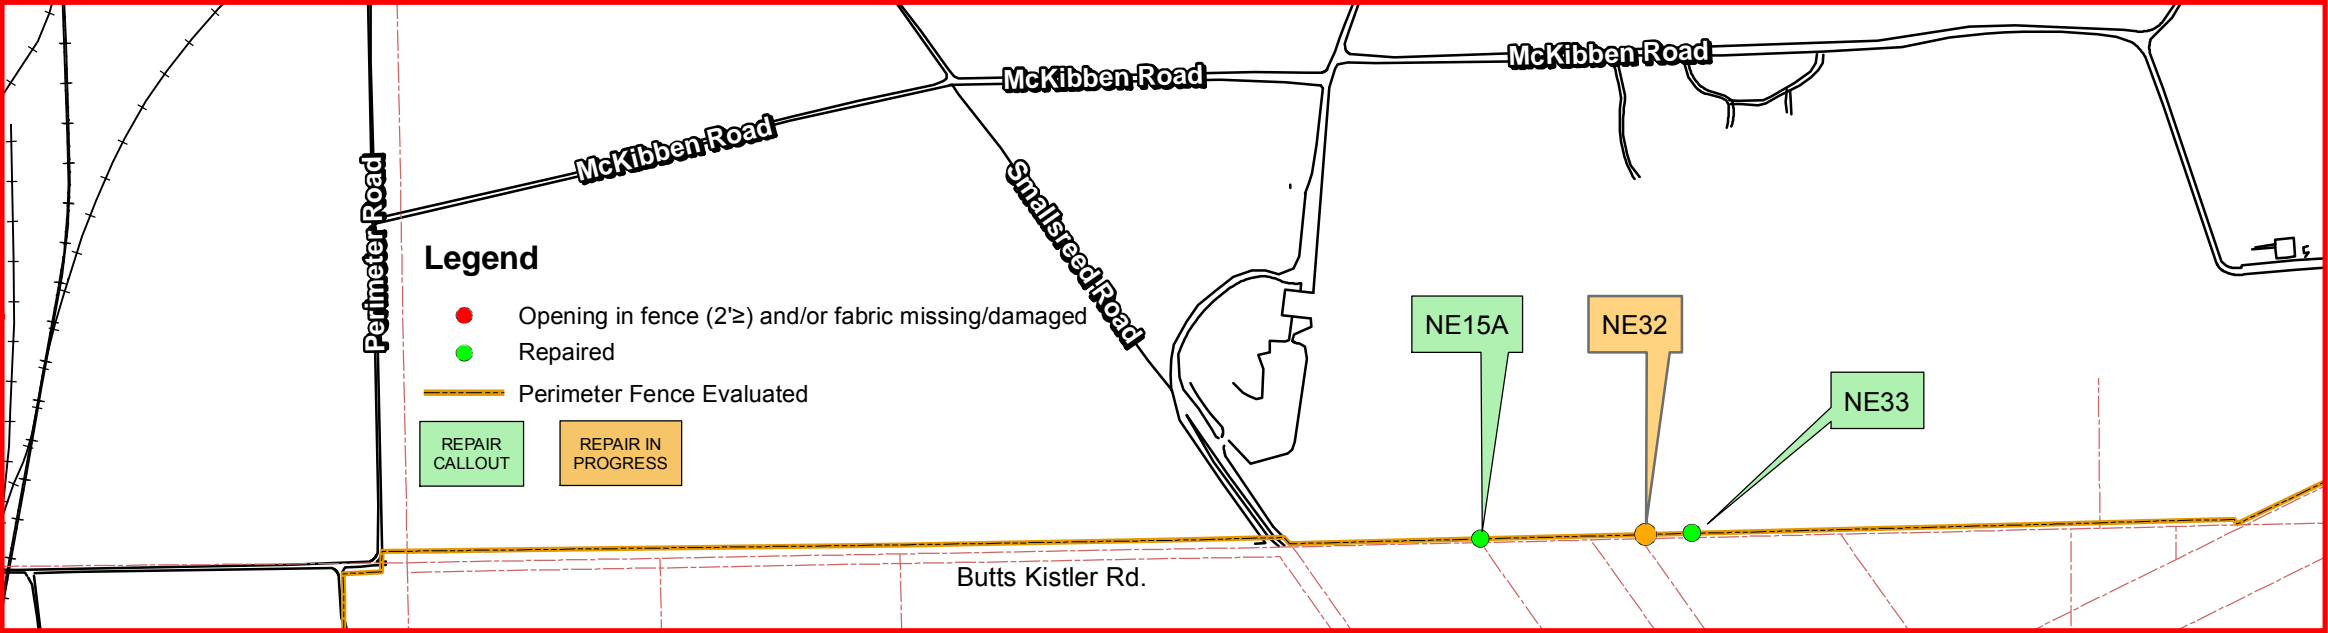
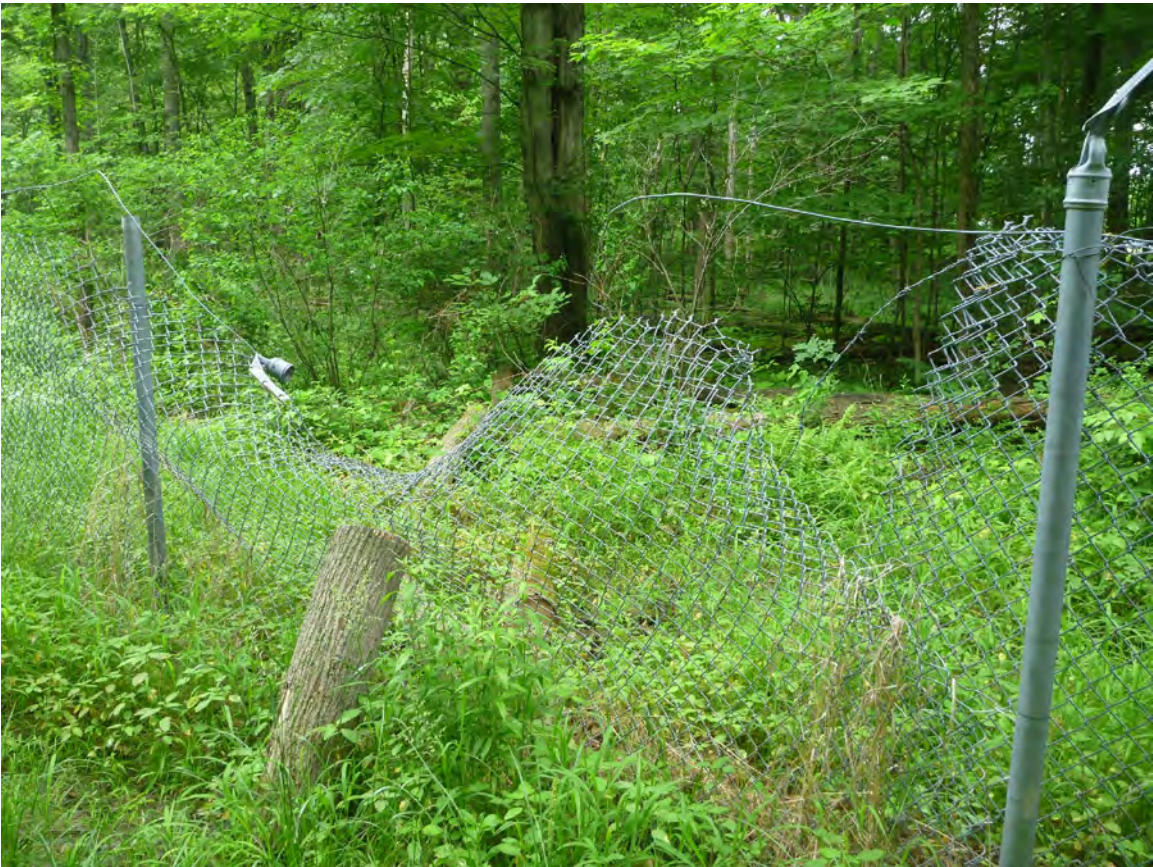
DETAIL SHEET FOR NE32

PHOTO NE32 dated 06/08/2015 showing partial repair

PHOTO NE32 discovered 12/15/2014

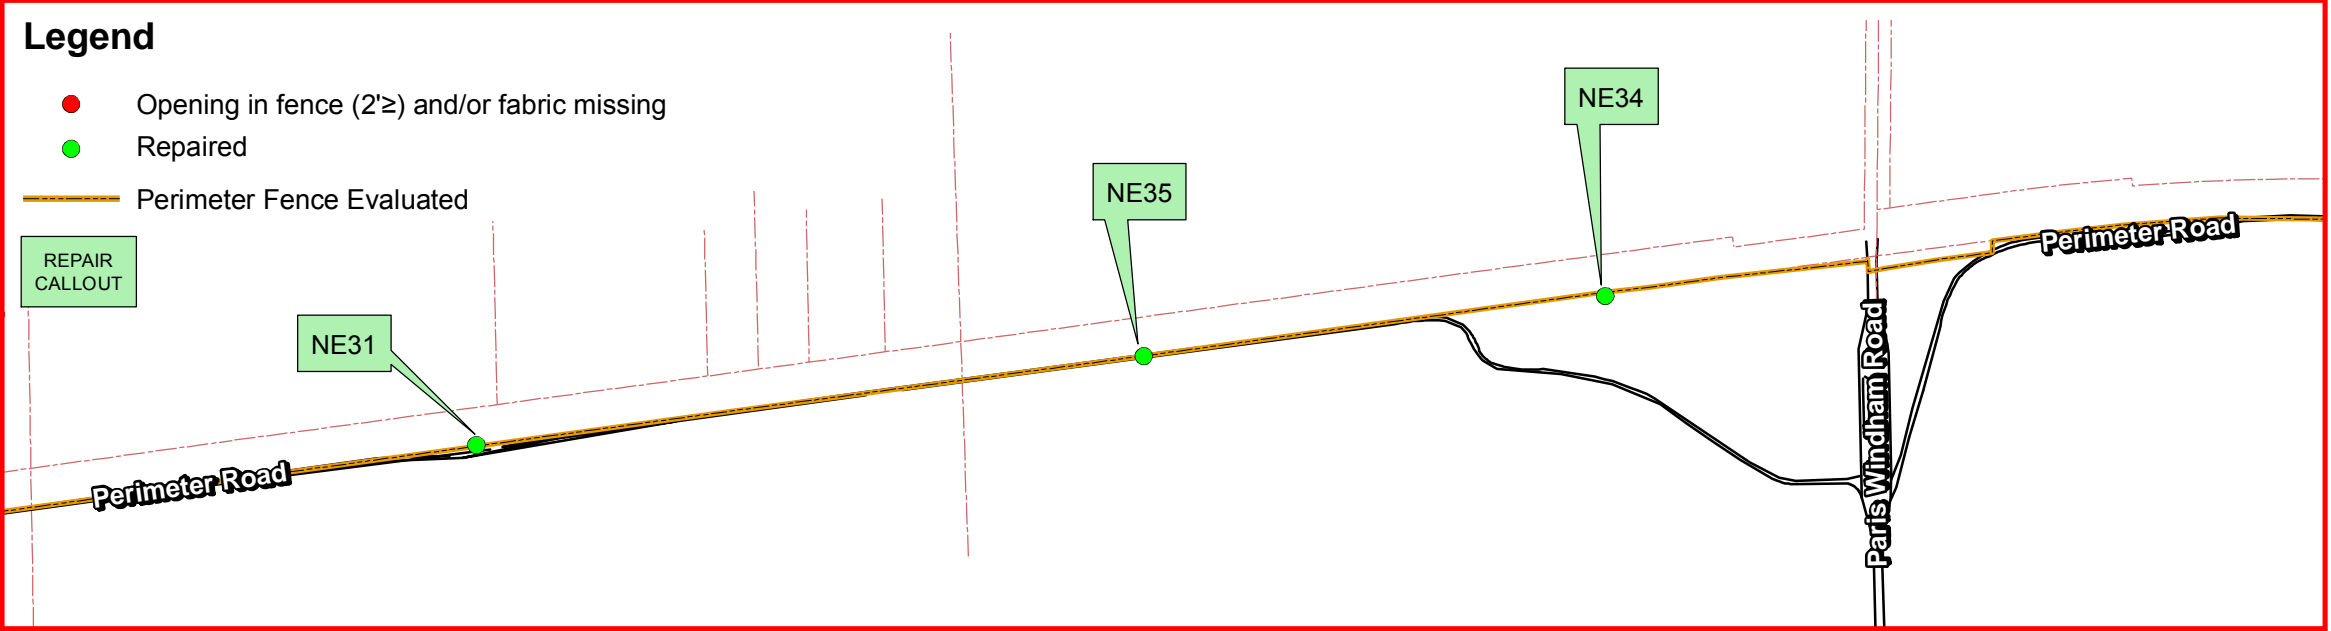
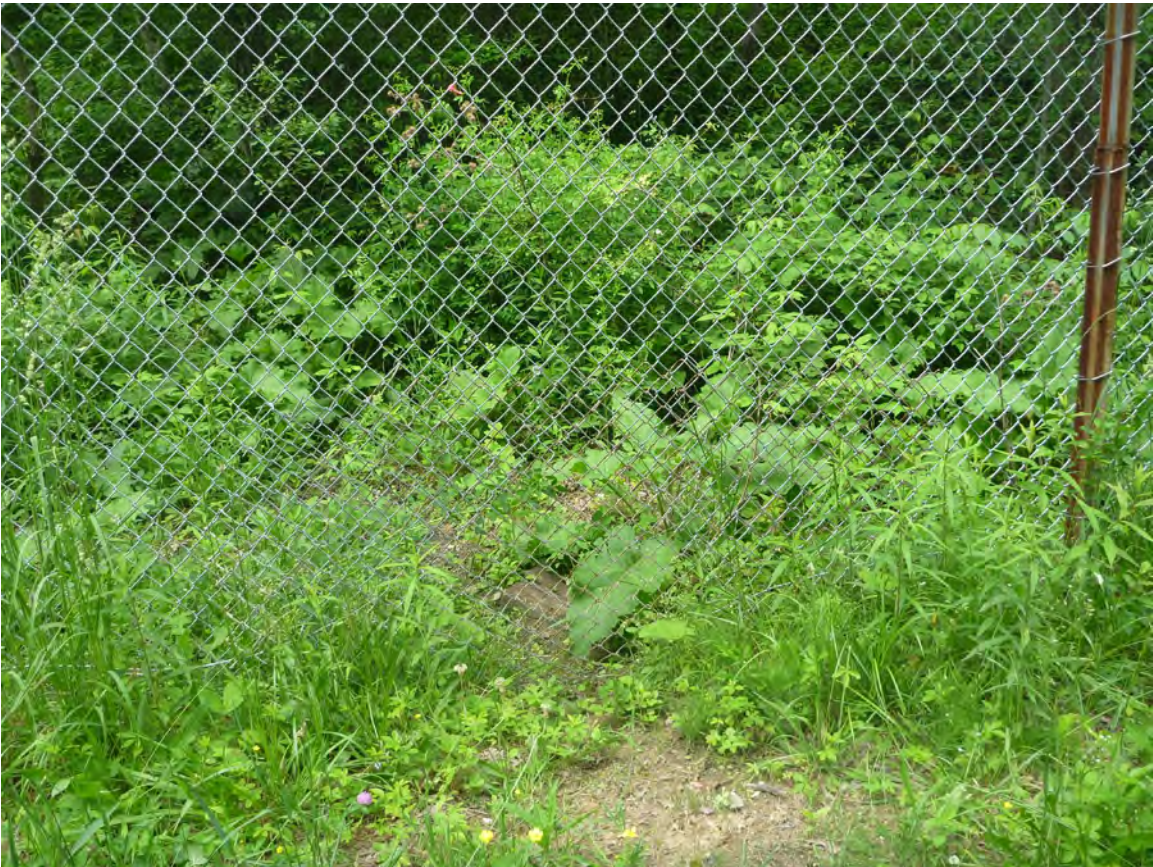
DETAIL SHEET FOR NE34

REPAIR PHOTO NE34 dated 06/03/2015

PHOTO NE34 discovered 03/19/2015

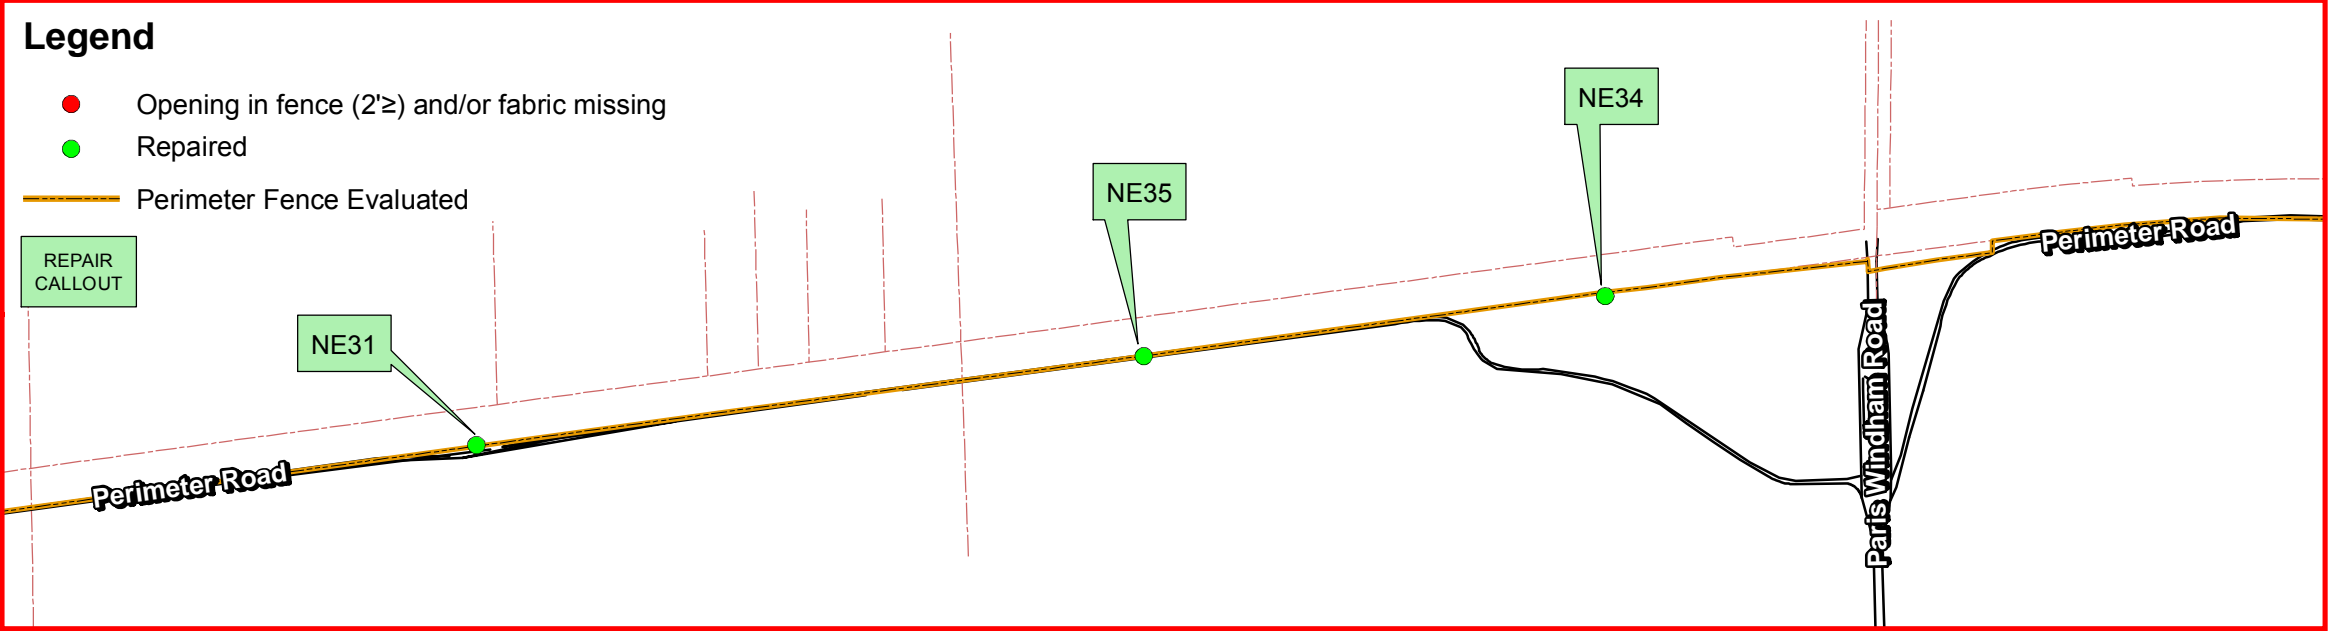
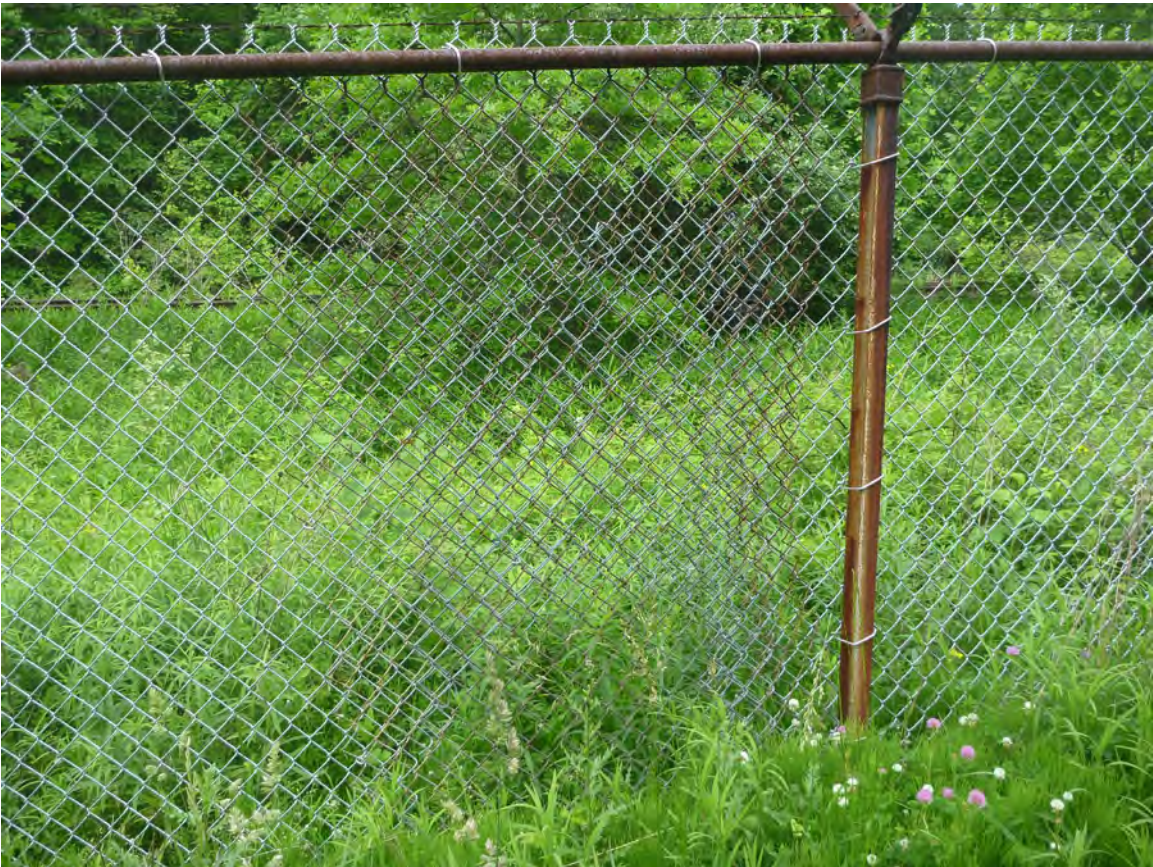
DETAIL SHEET FOR NE35

REPAIR PHOTO NE35 dated 06/03/2015

PHOTO NE35 discovered 03/19/2015
