Final
2015 Annual Land Use Control Monitoring Report,
RVAAP-01 Ramsdell Quarry Landfill
and
RVAAP-05 Winklepeck Burning Grounds

Camp Ravenna Joint Military Training Center
Former Ravenna Army Ammunition Plant
Portage and Trumbull Counties, Ohio

Contract No. W912QR-13-C-0031

January 27, 2016

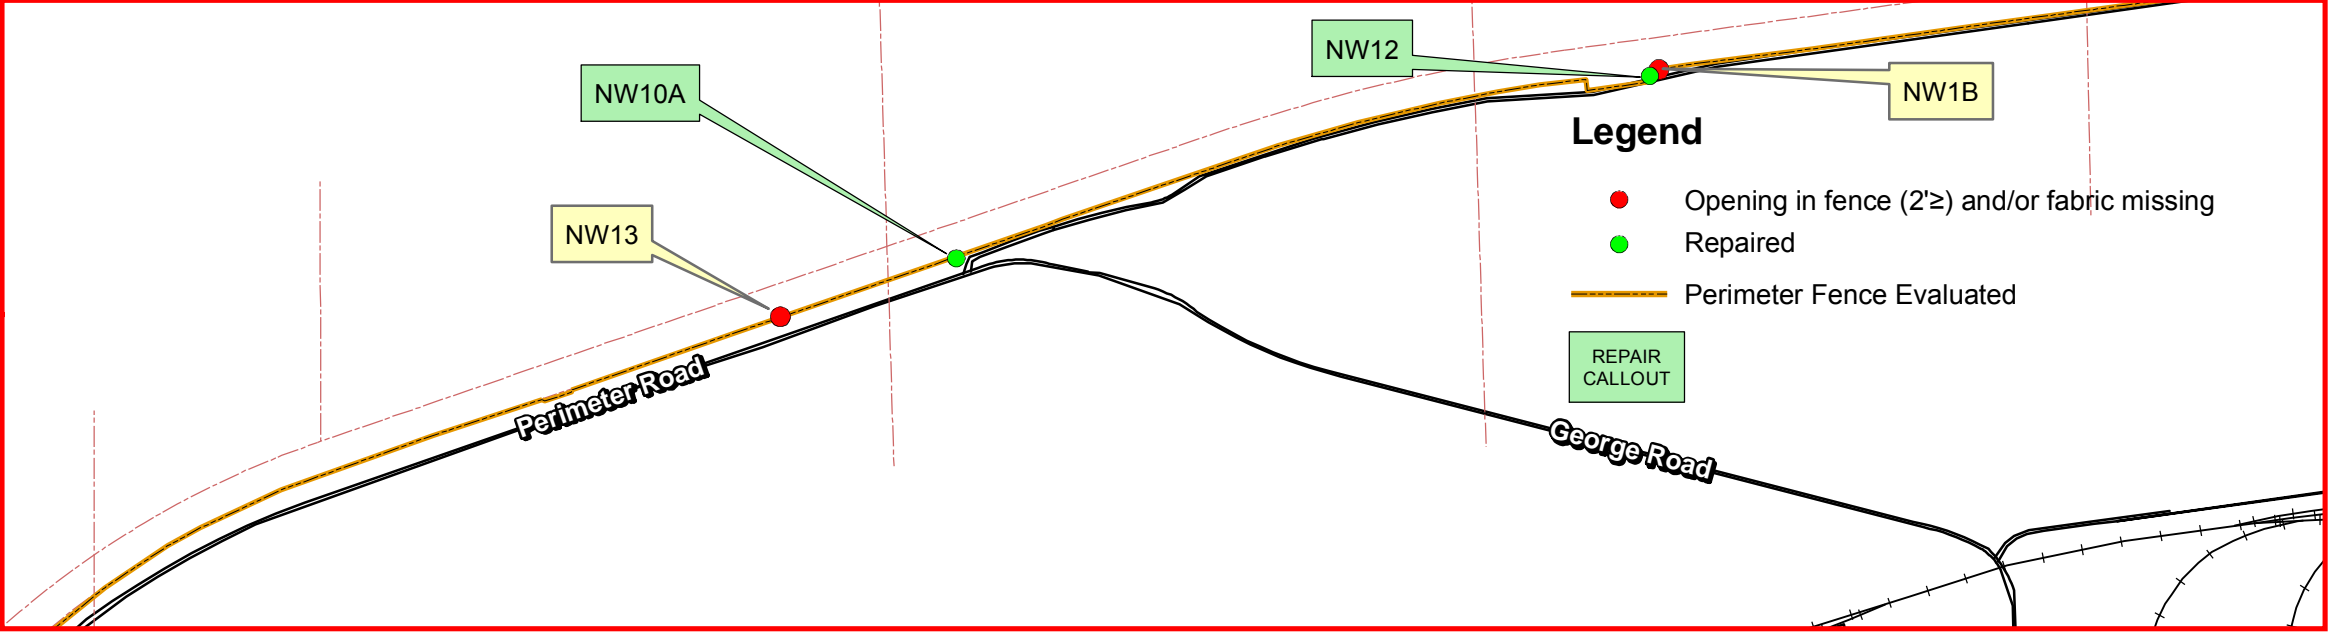
DETAIL SHEET FOR NW10A

REPAIR PHOTO NW10A dated 06/02/2015

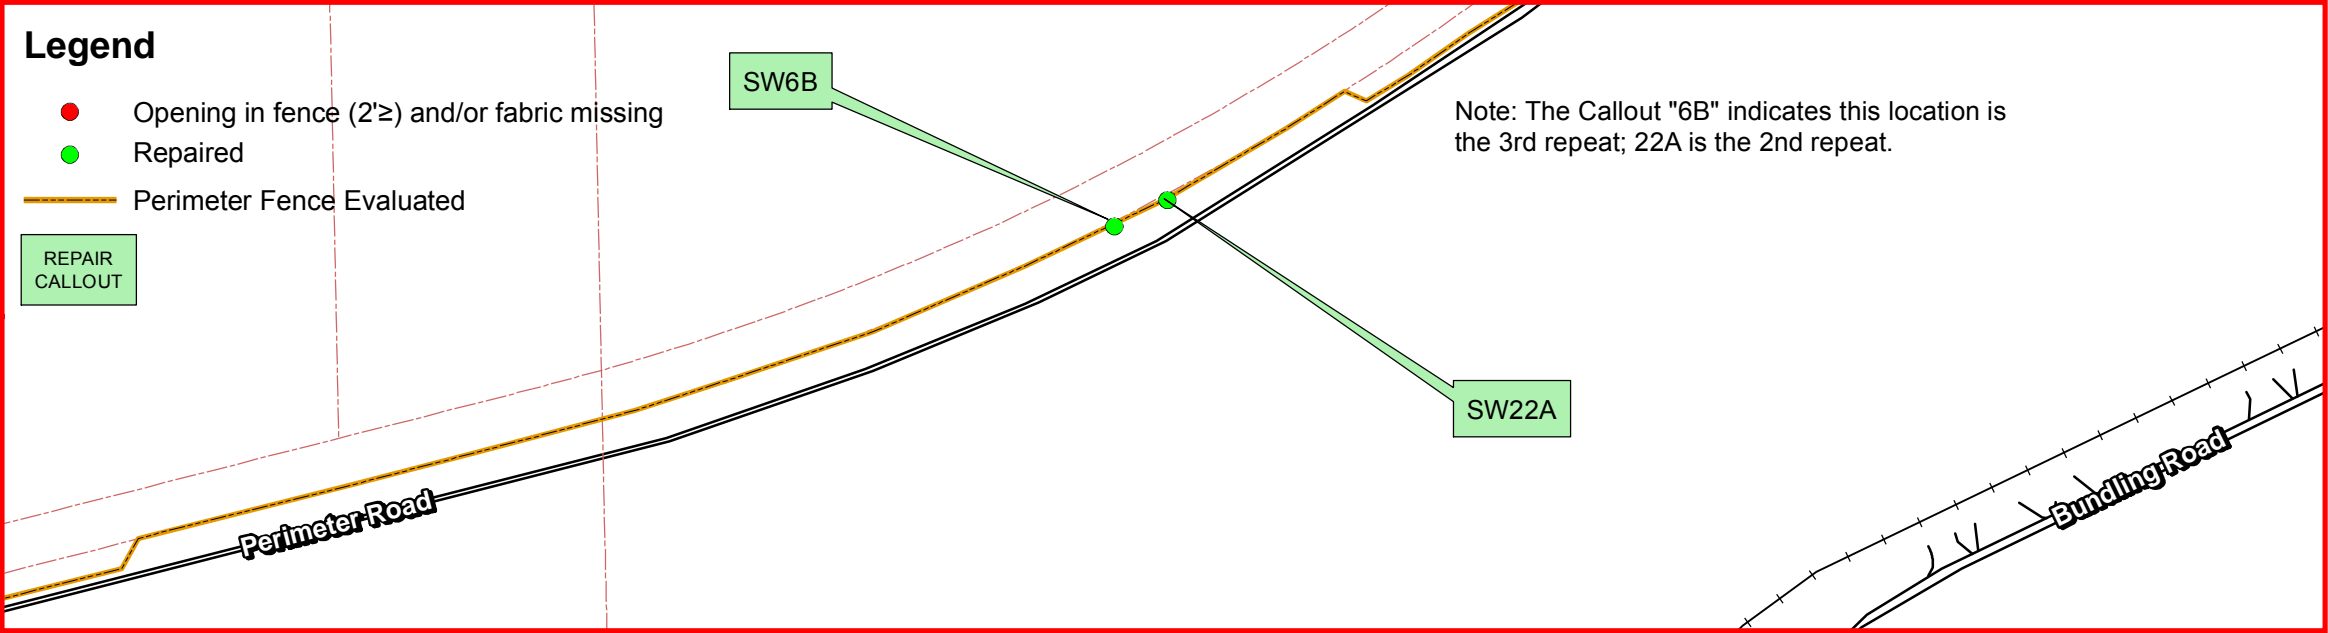
DETAIL SHEET FOR SW6B

REPAIR PHOTO SW6B dated 06/01/2015

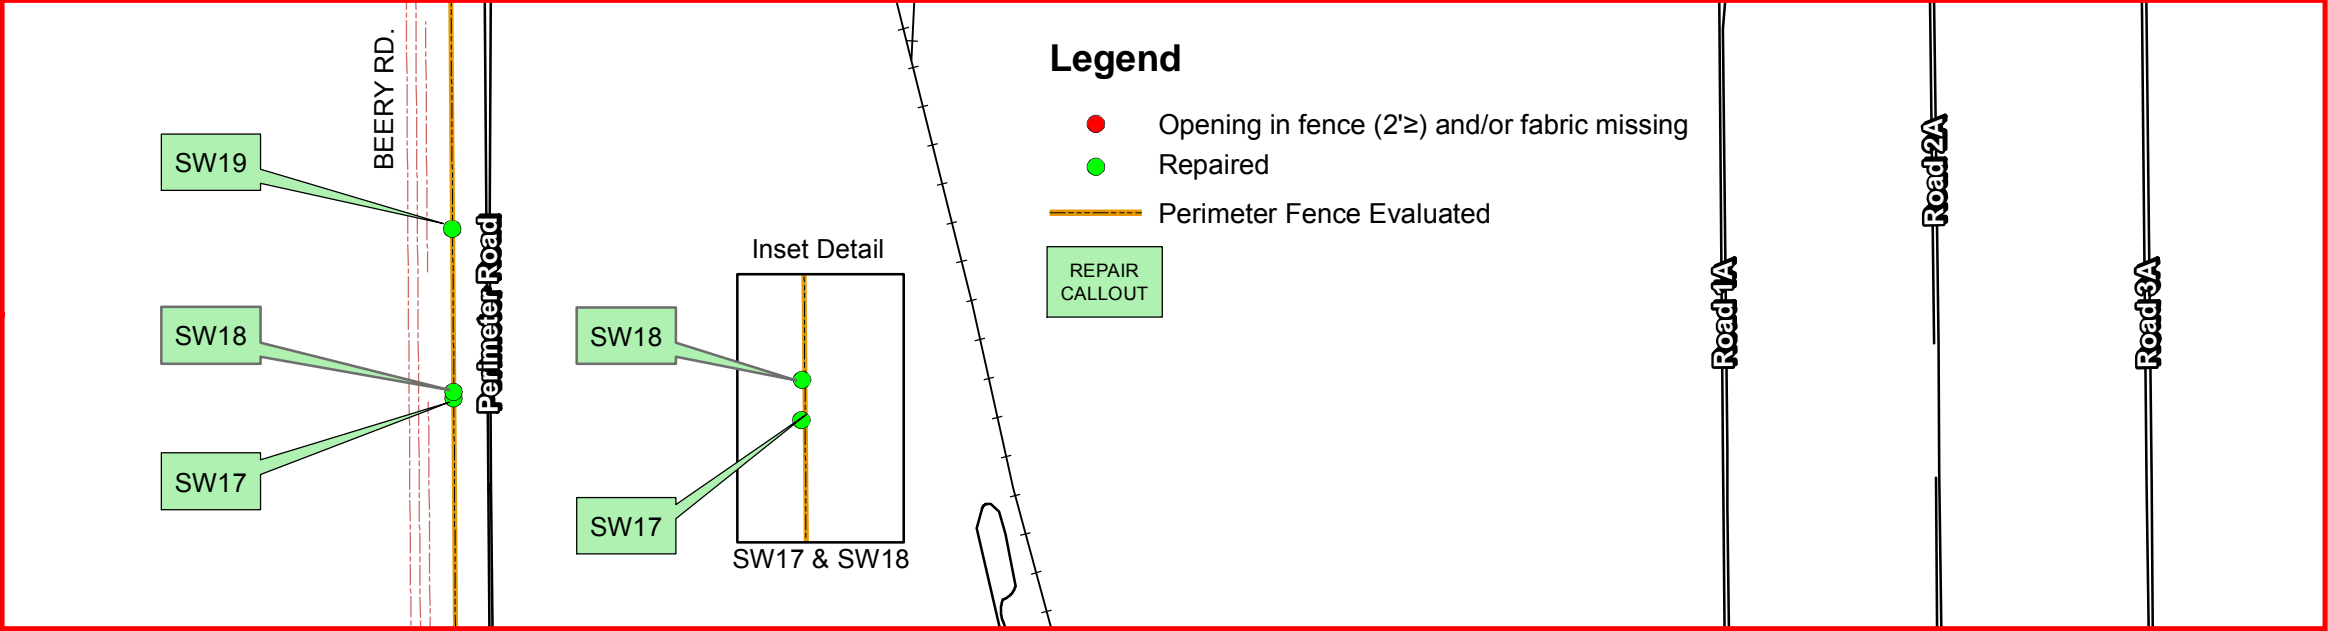
DETAIL SHEET FOR SW18

REPAIR PHOTO SW18 dated 06/01/2015

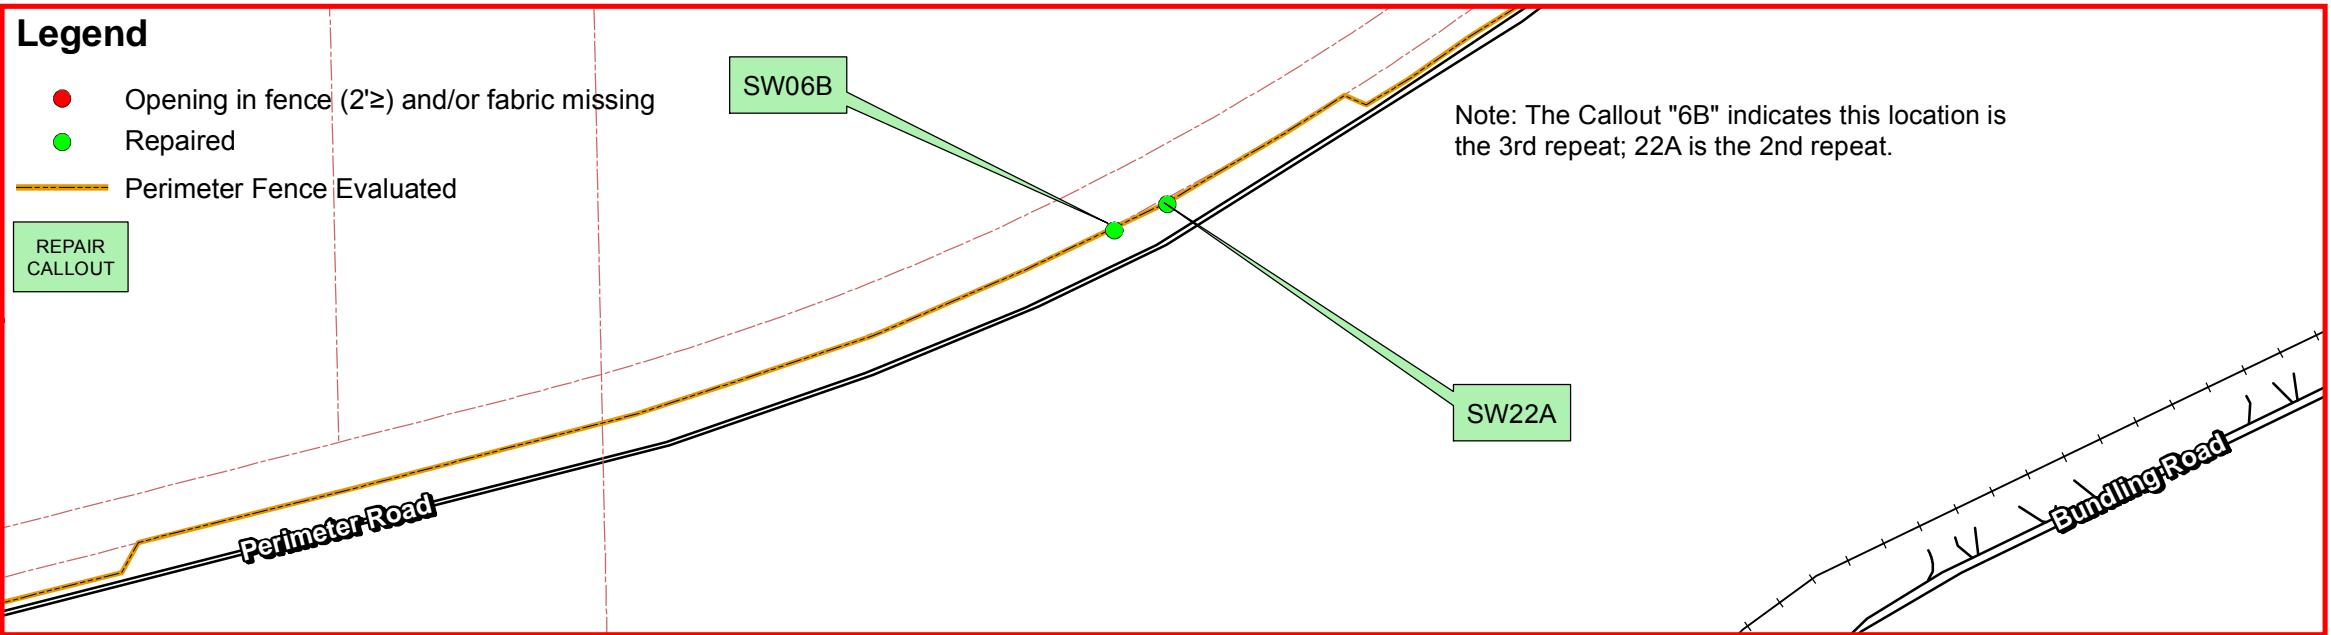
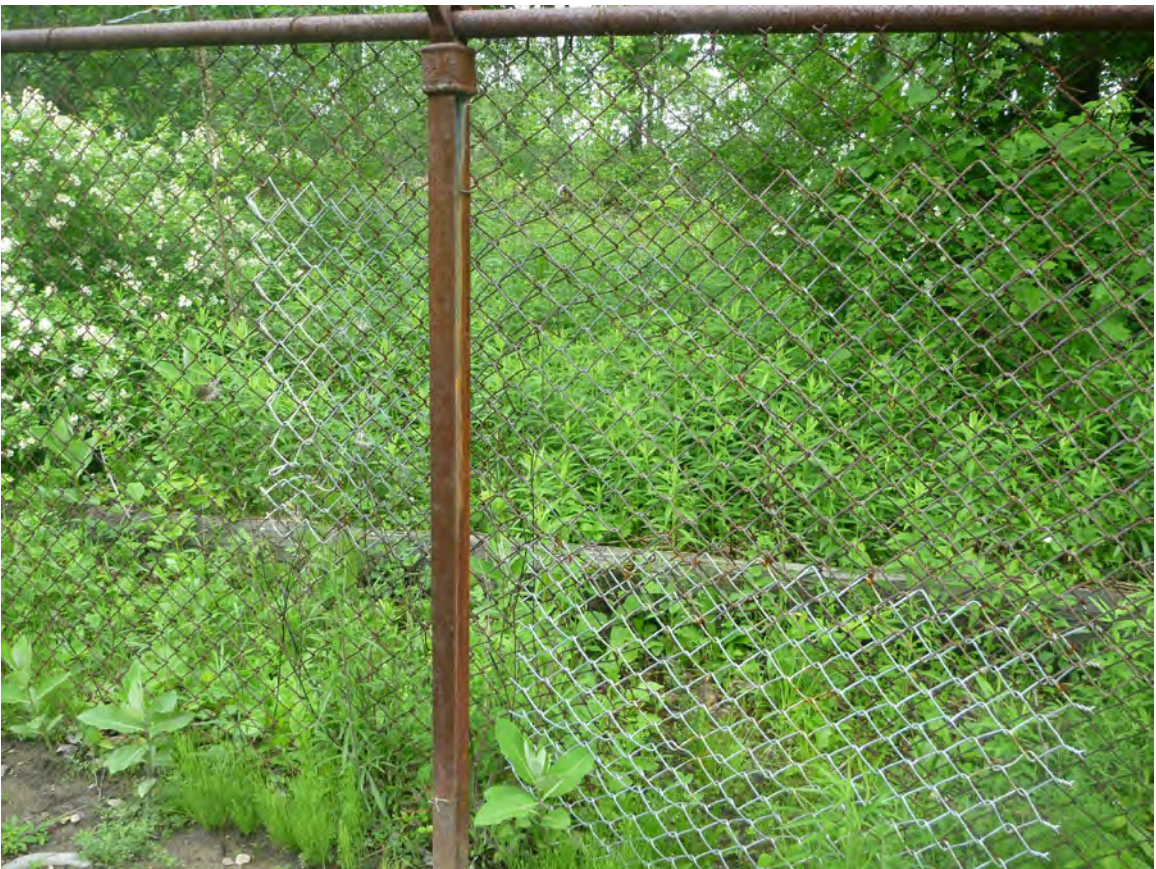
DETAIL SHEET FOR SW22A

REPAIR PHOTO SW22A dated 06/01/2015

PHOTO SW22A discovered 03/17/2015

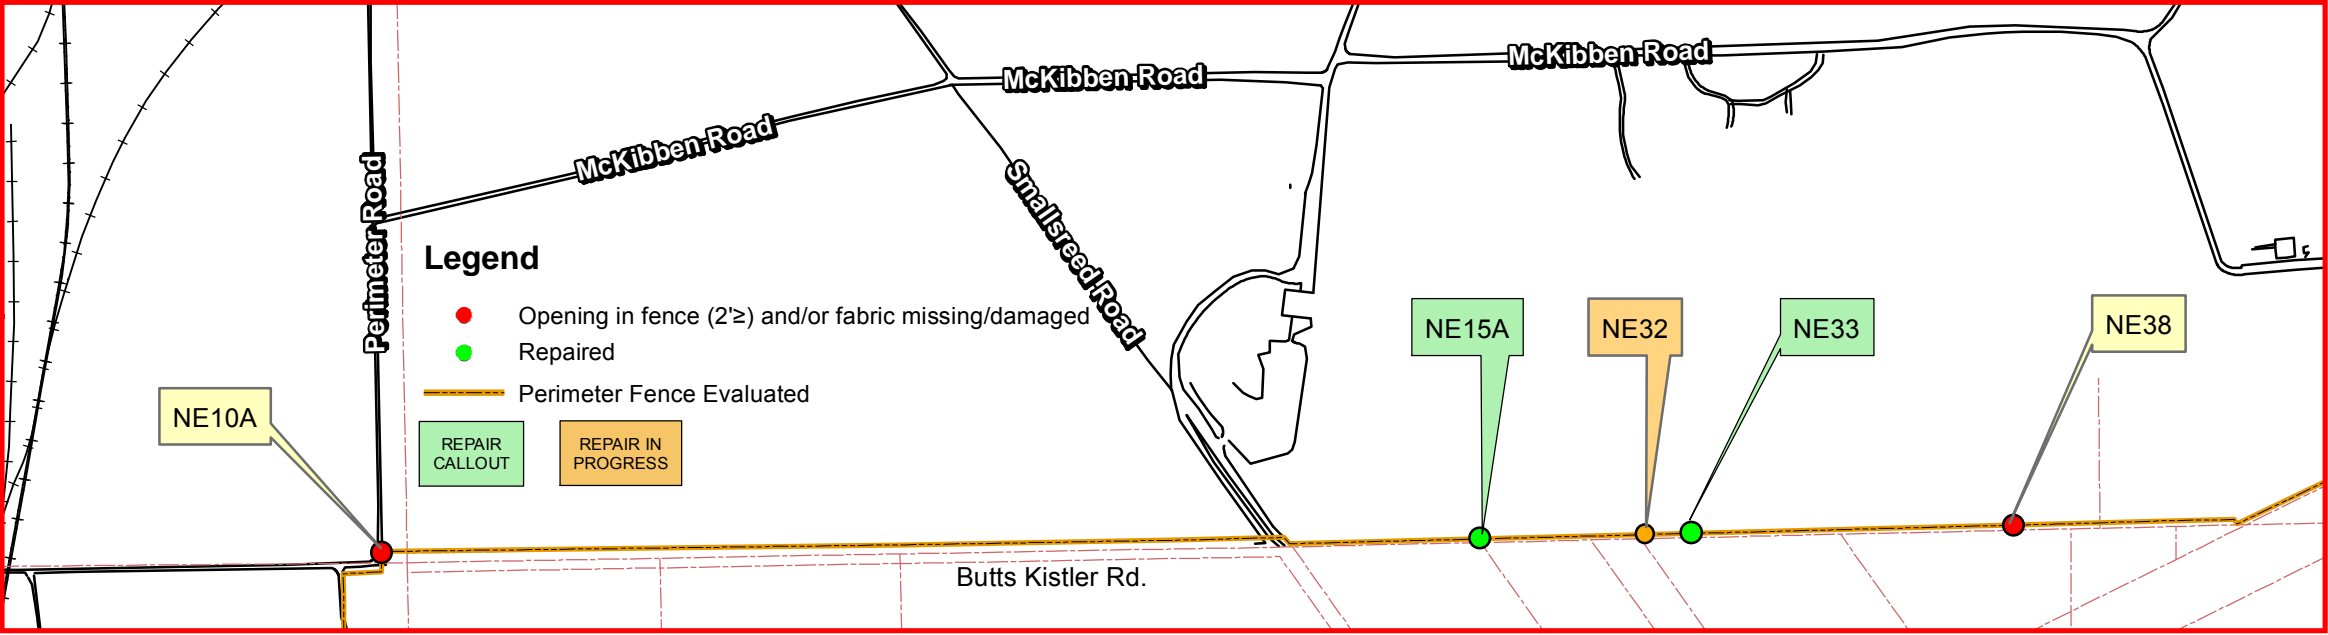
DETAIL SHEET FOR NE32

REPAIR PHOTO NE32 dated 08/05/2015 (In Progress)

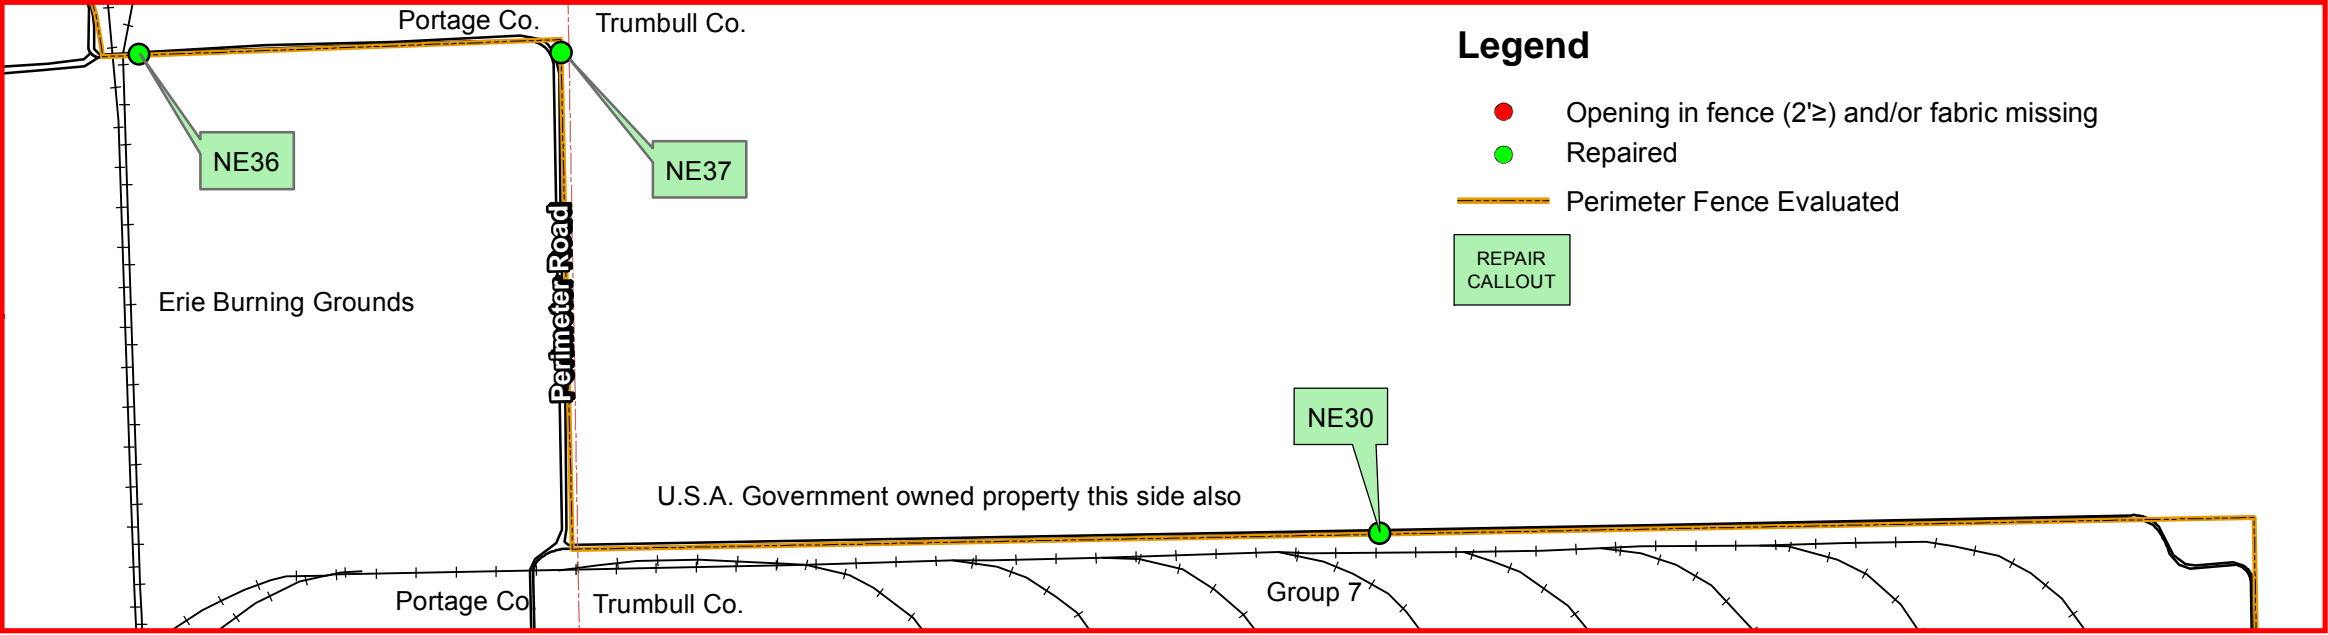
DETAIL SHEET FOR NE36

REPAIR PHOTO NE36 dated 08/04/2015

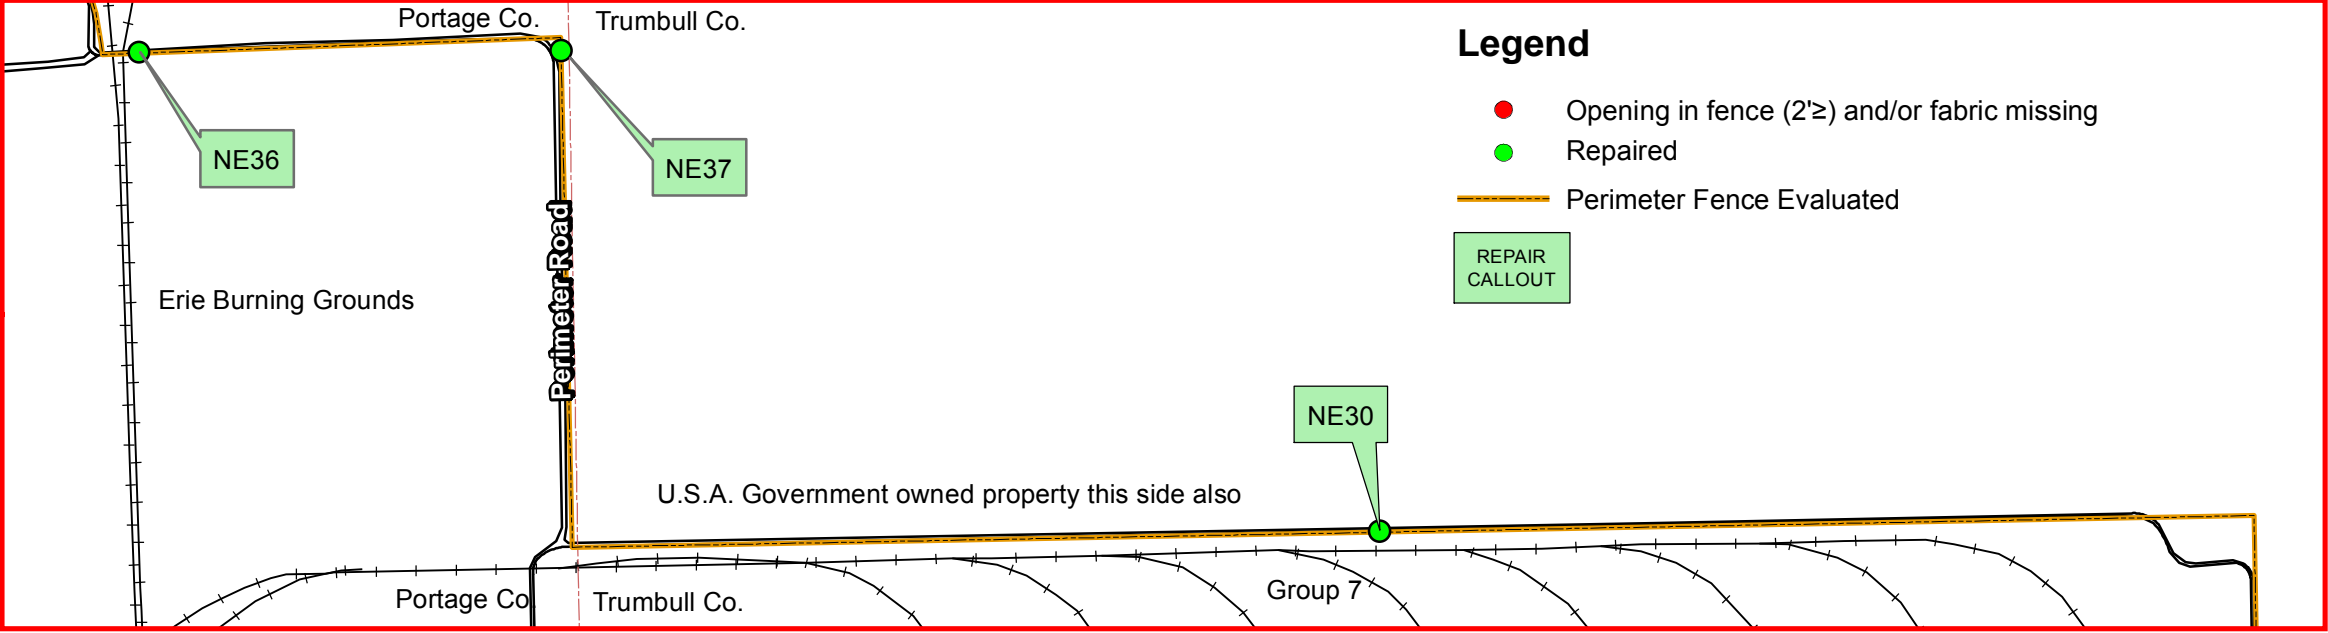
DETAIL SHEET FOR NE37

REPAIR PHOTO NE37 dated 08/04/2015

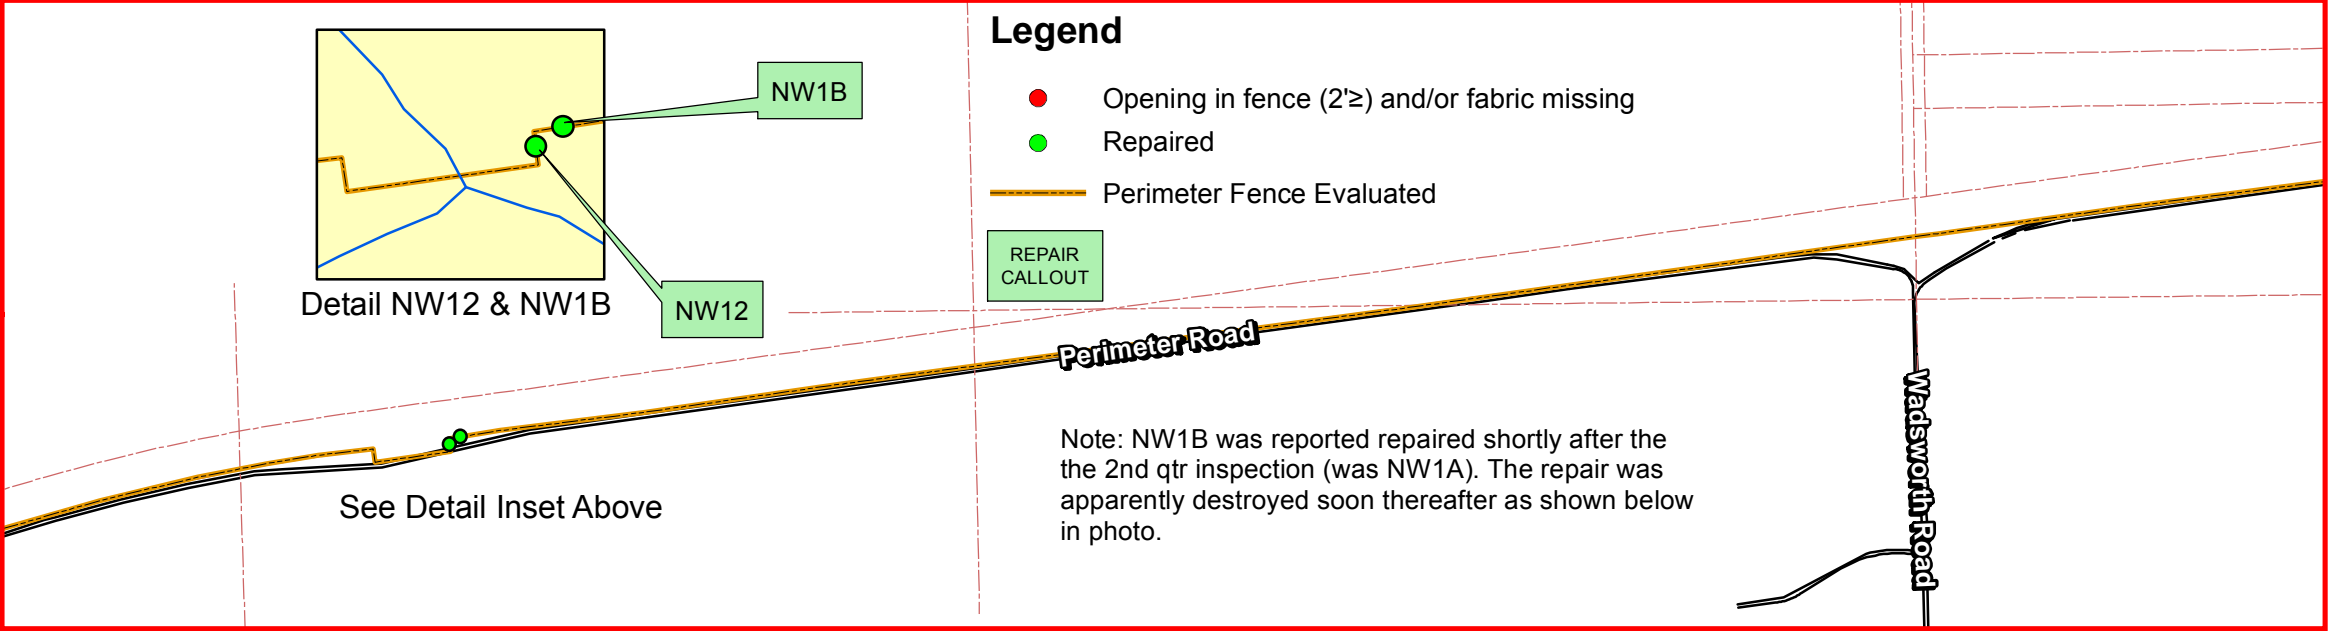
DETAIL SHEET FOR NW1B

REPAIR PHOTO NW1B dated 08/03/2015

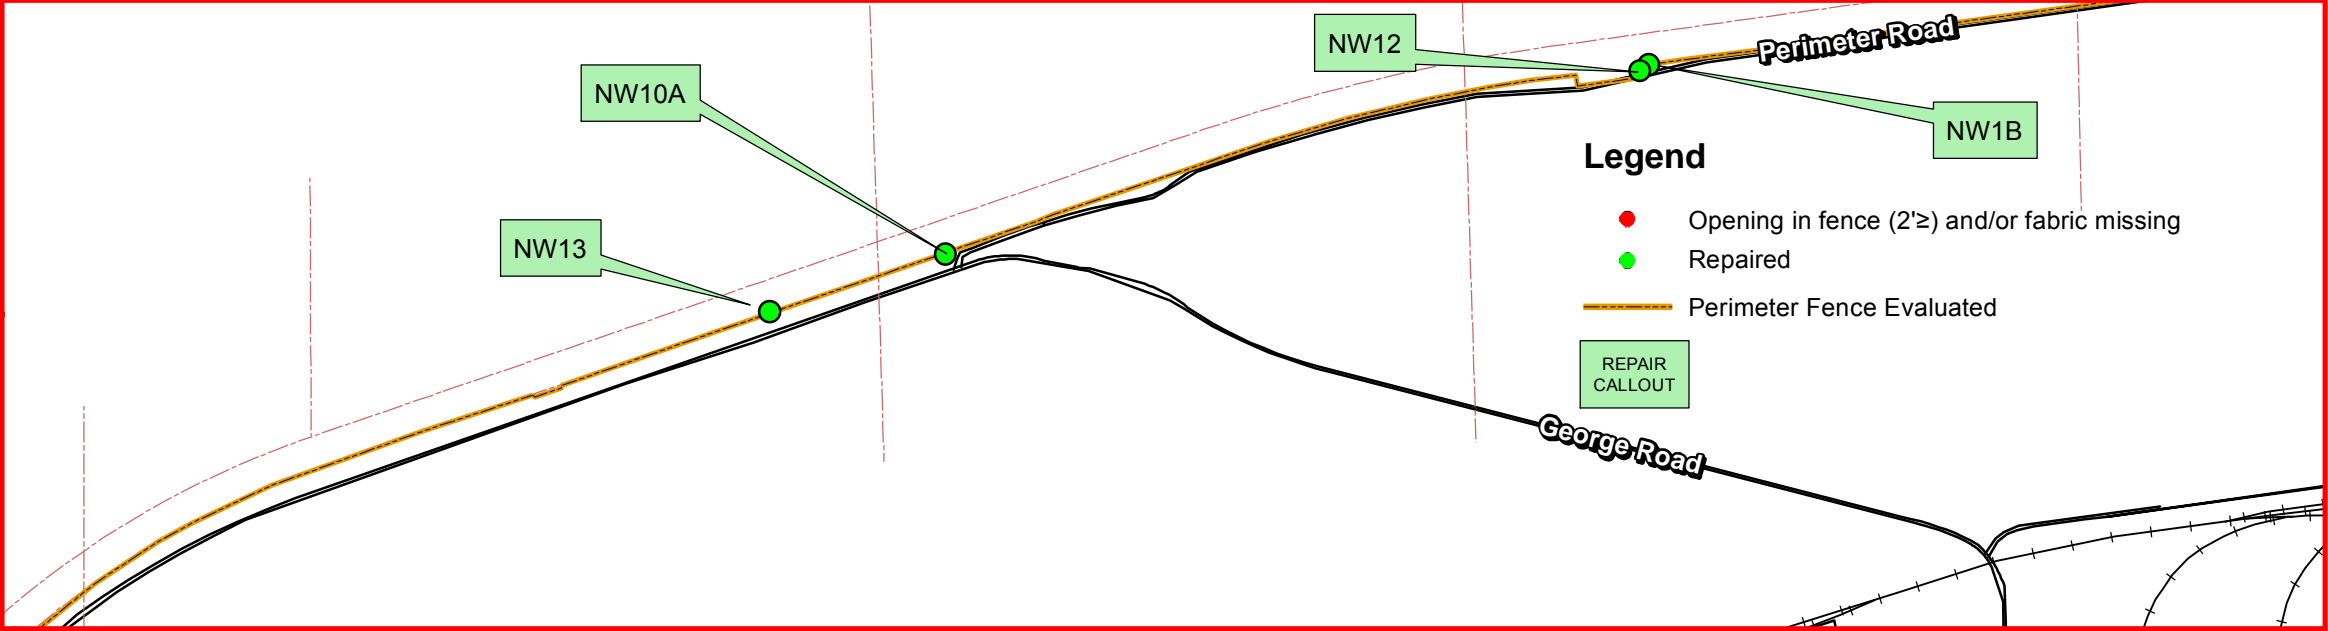
DETAIL SHEET FOR NW13

REPAIR PHOTO NW13 dated 08/05/2015
