Final
2019 Annual Land Use Control Monitoring Report,
RVAAP-01 Ramsdell Quarry Landfill,
RVAAP-05 Winklepeck Burning Grounds,
RVAAP-08 through RVAAP-11 (Load Lines 1 through 4),
RVAAP-12 (Load Line 12) and RVAAP-51 (Dump Along Paris-Windham
Road)

Camp James A. Garfield Joint Military Training Center
Former Ravenna Army Ammunition Plant
Portage and Trumbull Counties, Ohio

Contract No. W912QR-18-C-0013

May 20, 2020

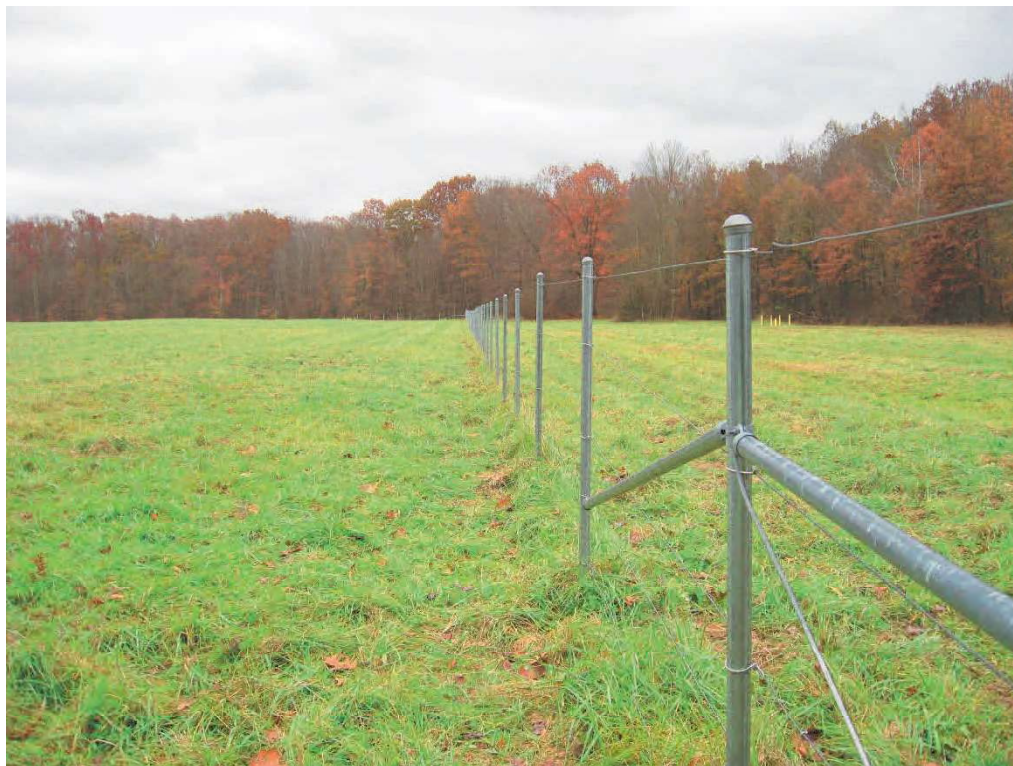
West part of Ramsdell Quarry Landfill, looking south from north fence and showing 5-wire tensile fence.

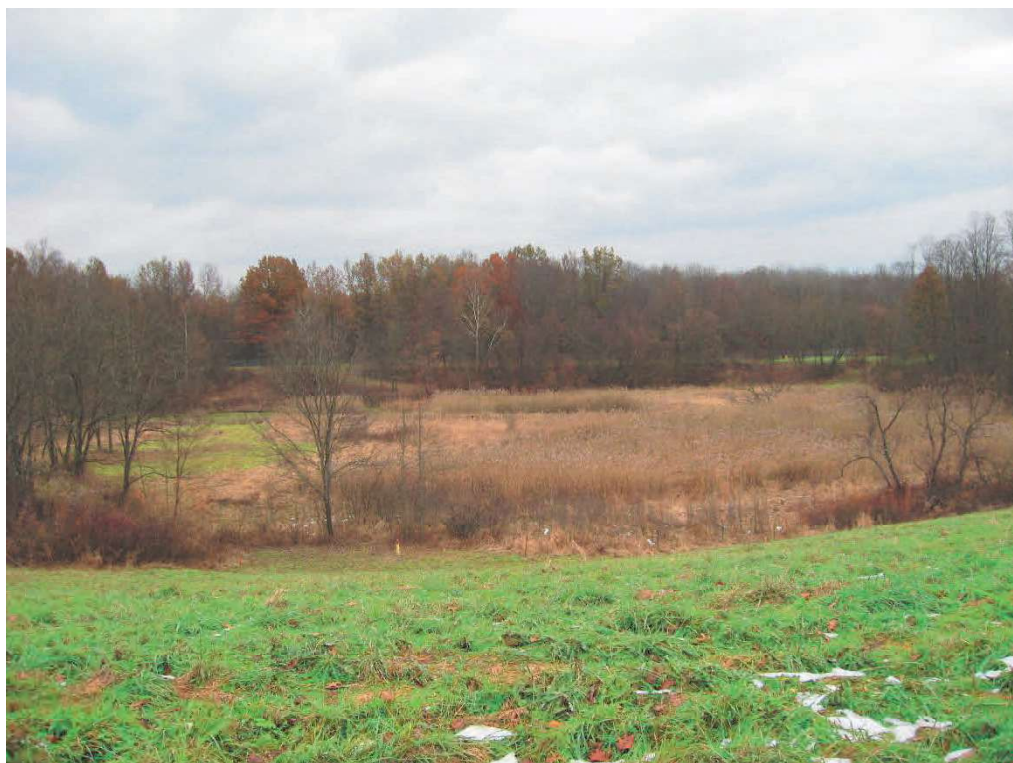
Looking north from the mid-southern fence line.

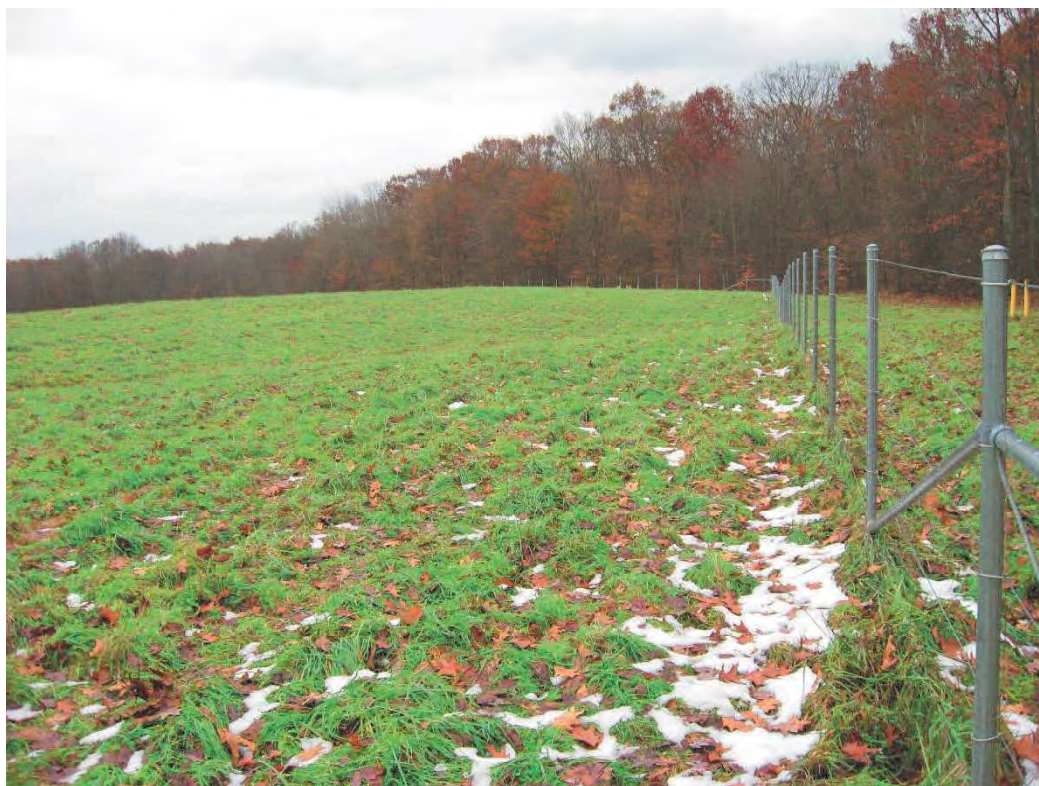
Southwest corner of Ramsdell Quarry Landfill, looking east.

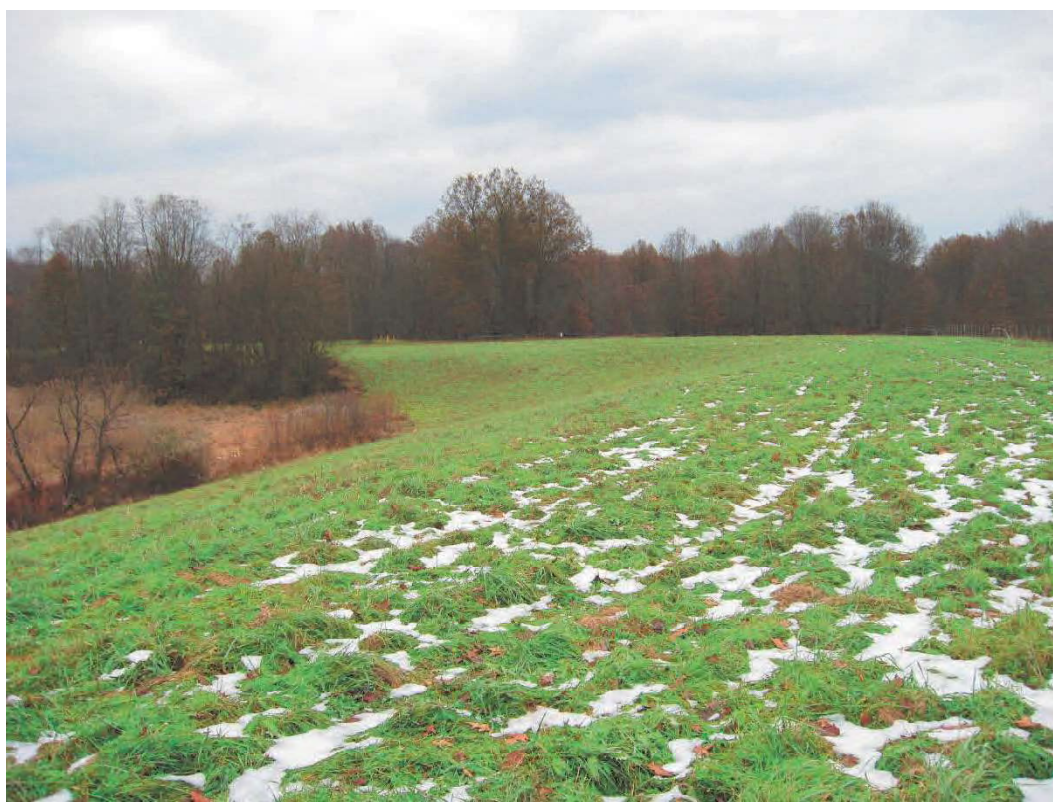
Southeast corner of Ramsdell Quarry Landfill as seen from the mid-southern portion of the site.

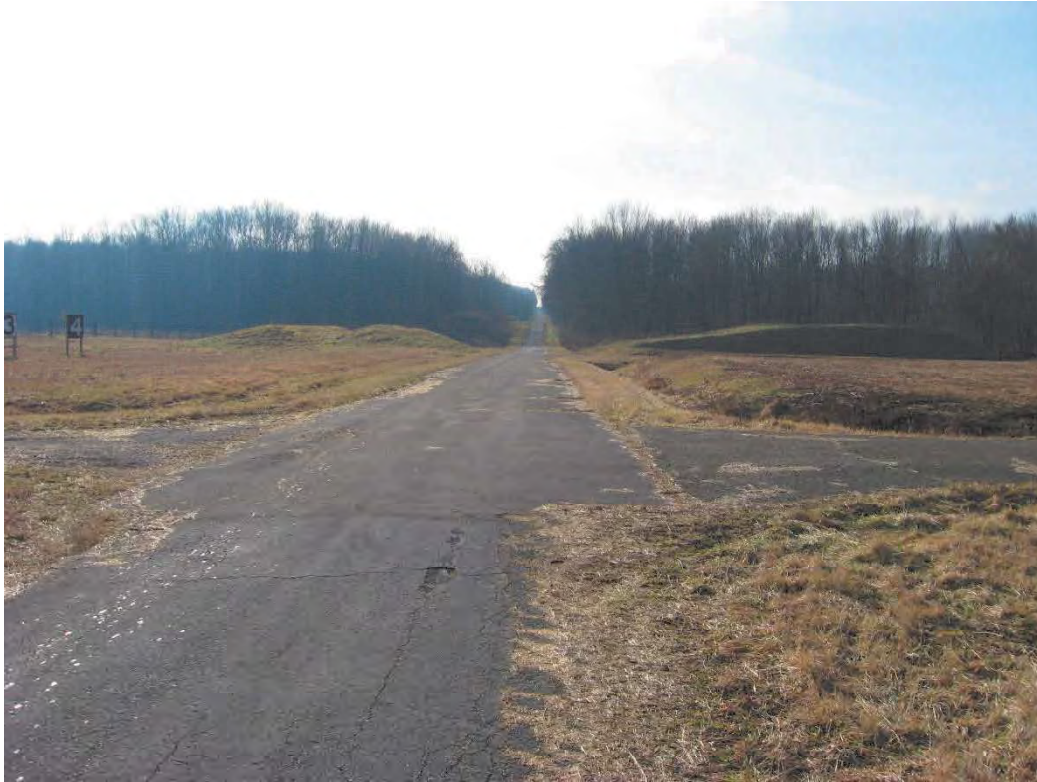
Winklepeck Burning Grounds field, looking south from the central portion of the site.

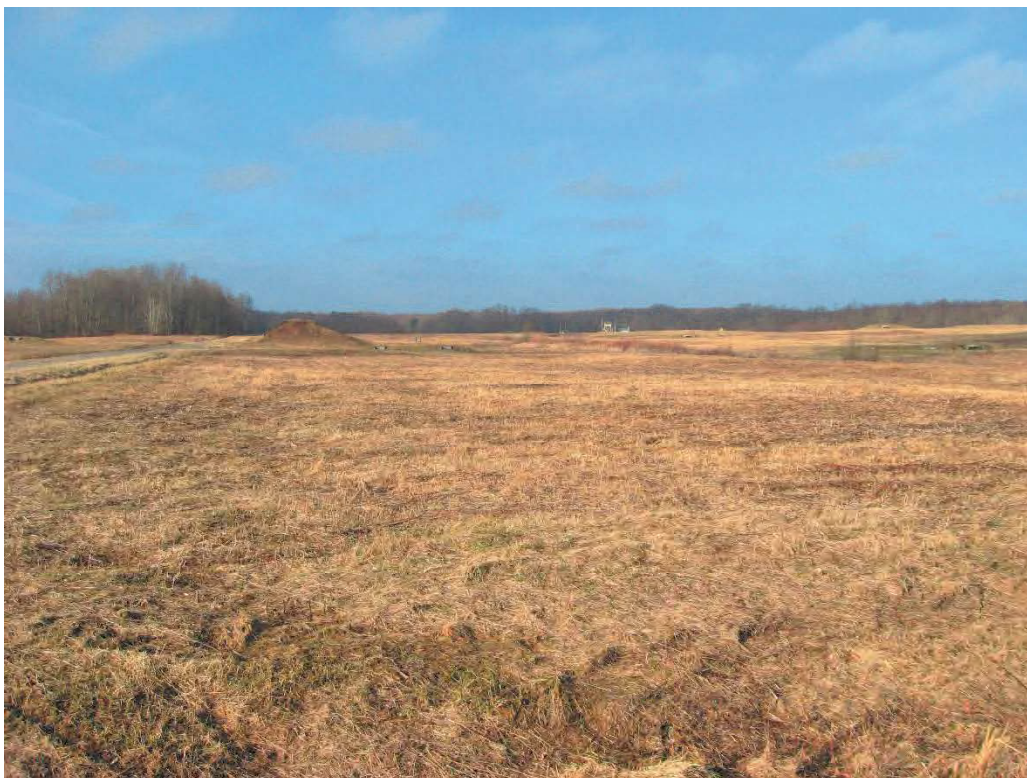
Winklepeck Burning Grounds field, looking west from central portion of the site.

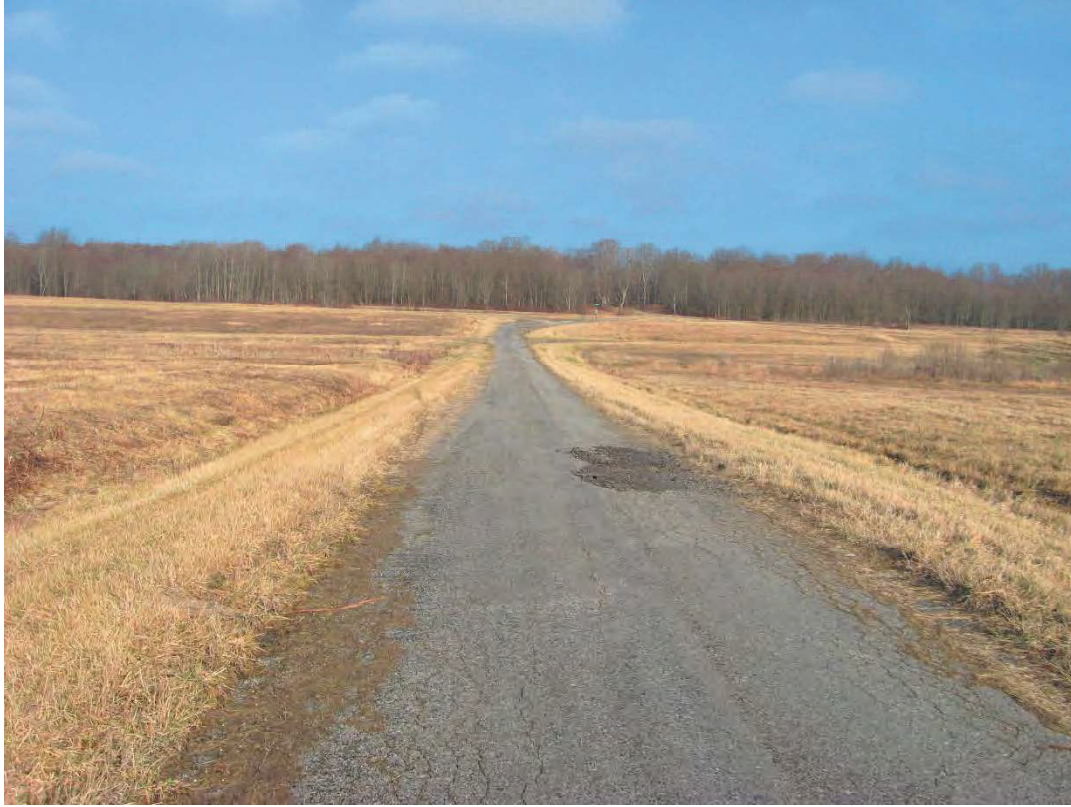
Winklepeck Burning Grounds field, looking north from the central portion of the site.

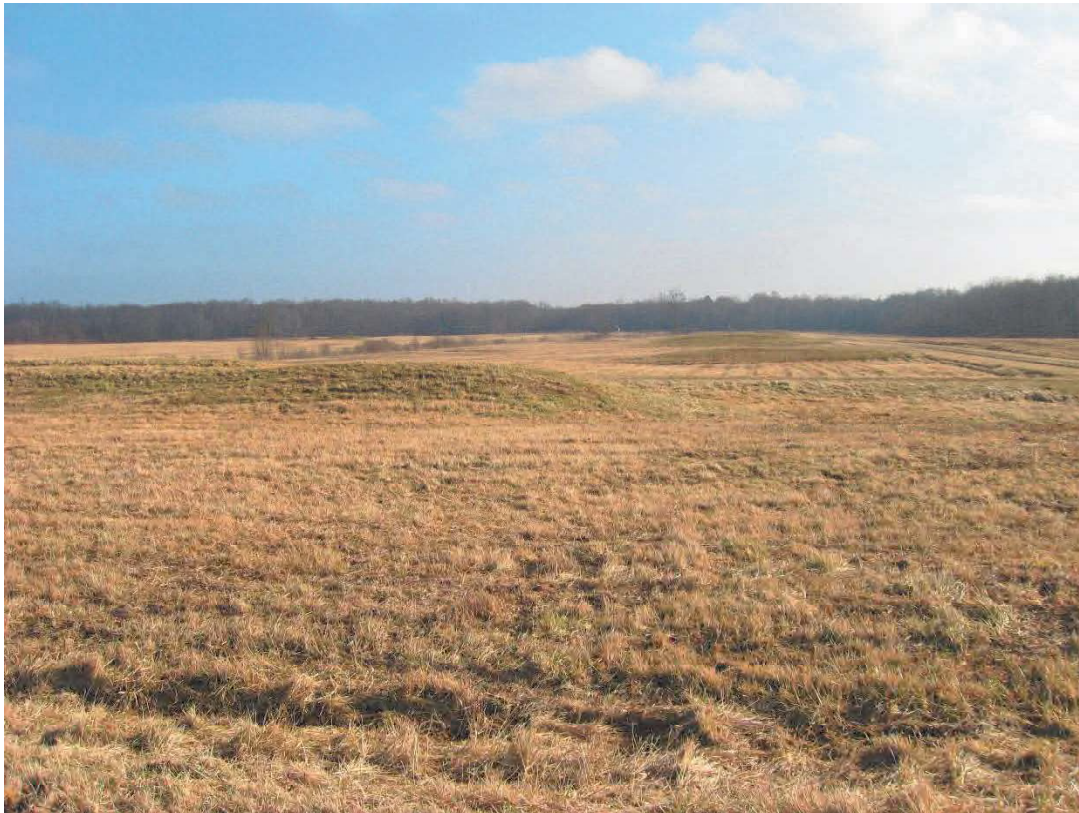
Winklepeck Burning Grounds field, looking east from the central portion of the site.

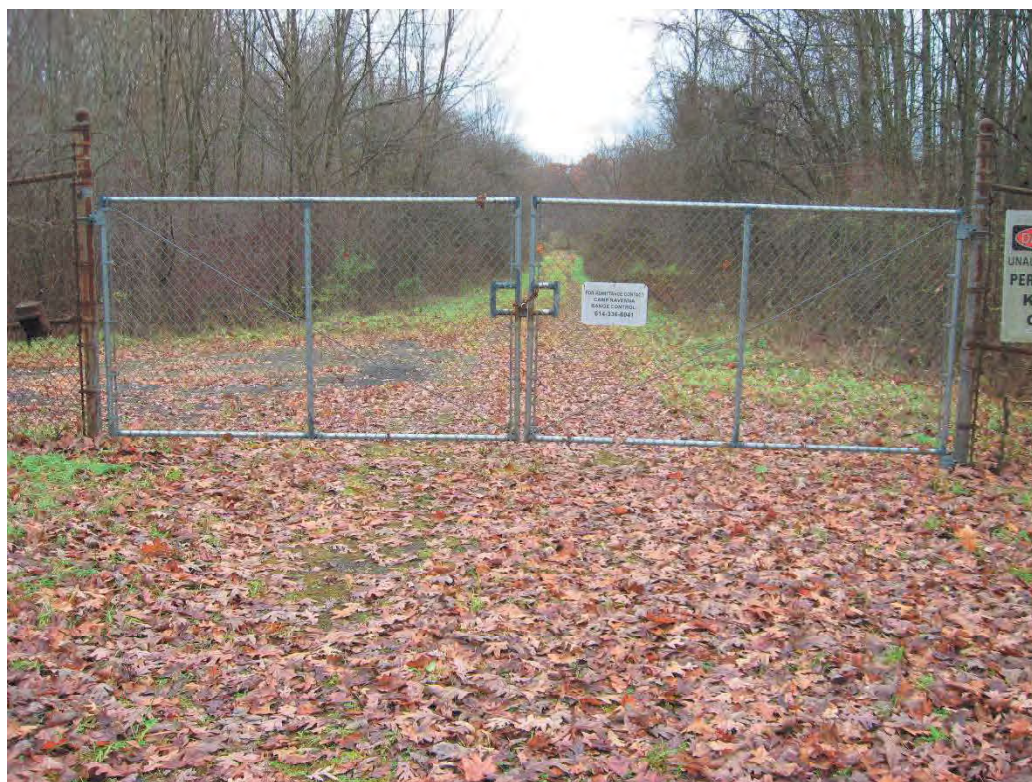
Load Line 1 south gate.

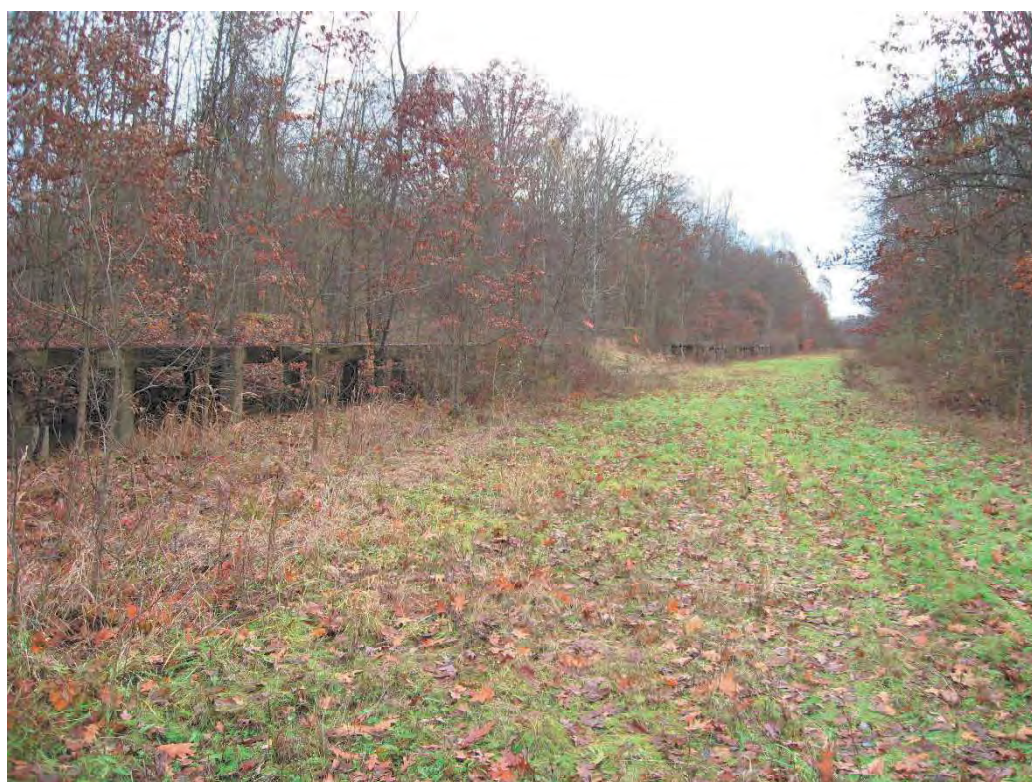
Load Line 1 field, from central western portion of the site looking southeast.

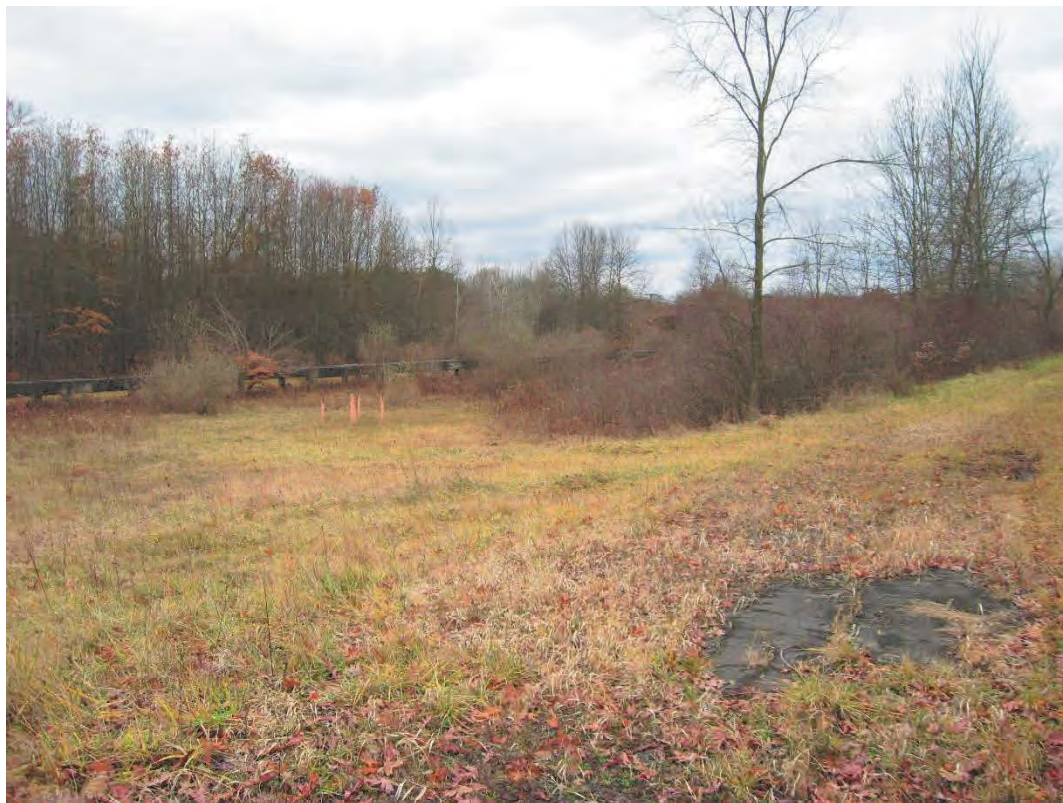
Load Line 2 field, east-central portion of the site looking northwest.

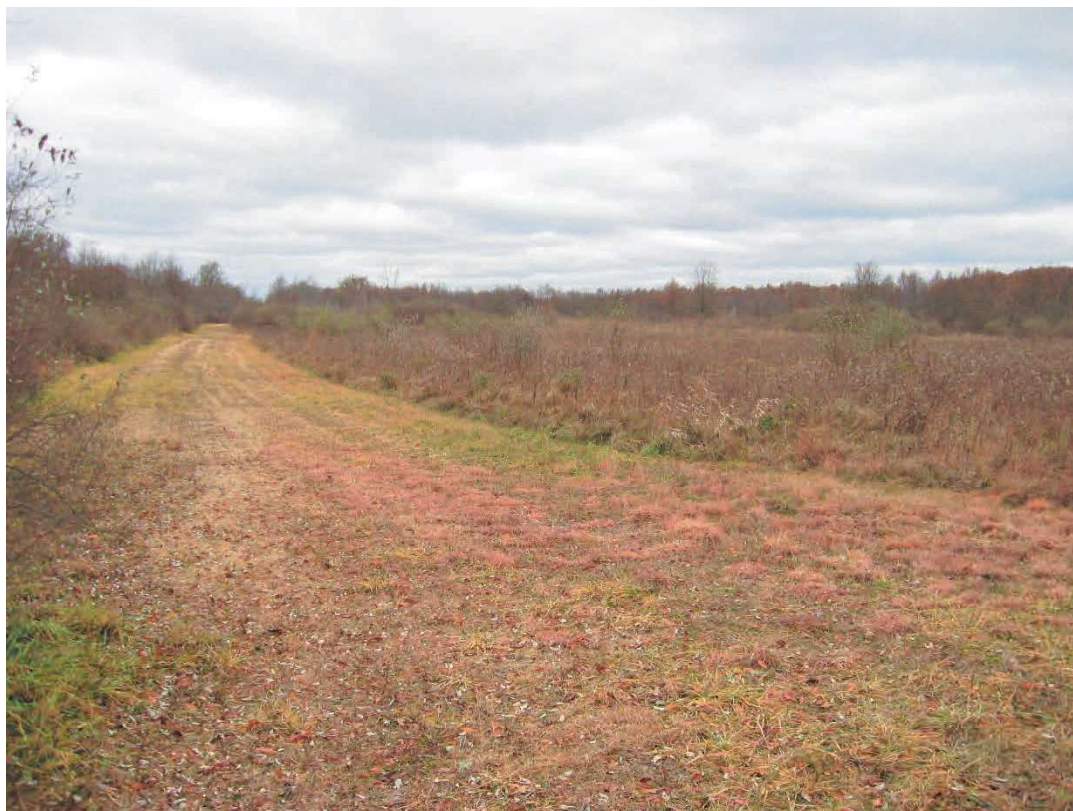
Load Line 2 field, from southeast portion of the site looking northwest.

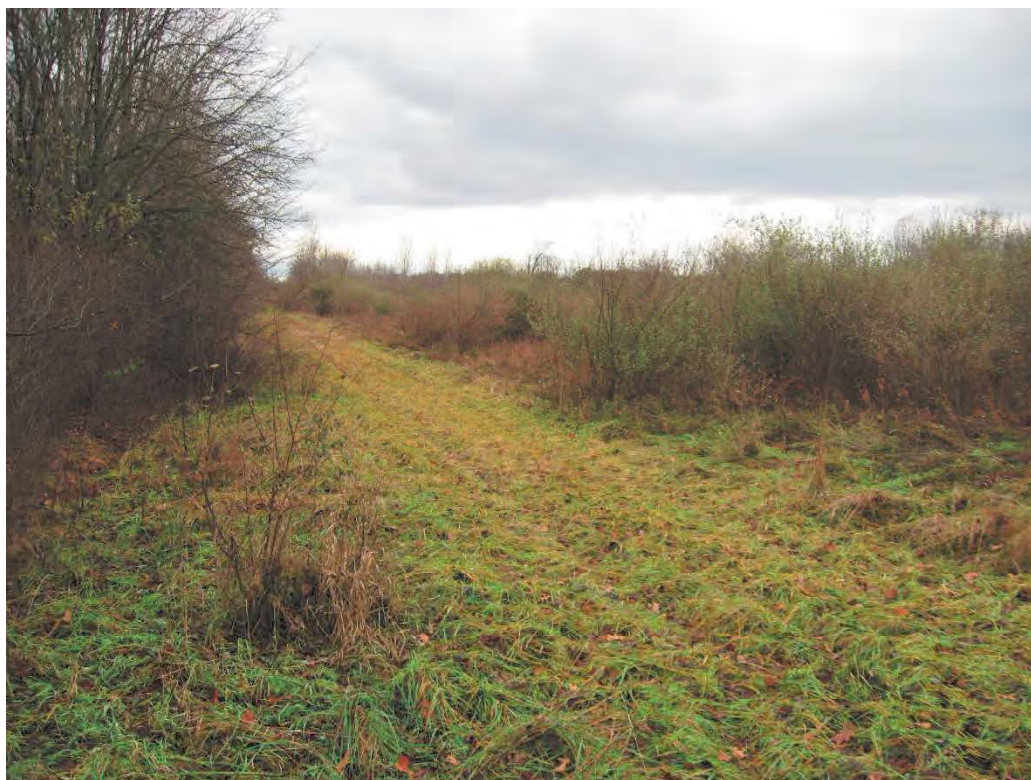
Load Line 3 field, from southwest portion of the site looking northeast.

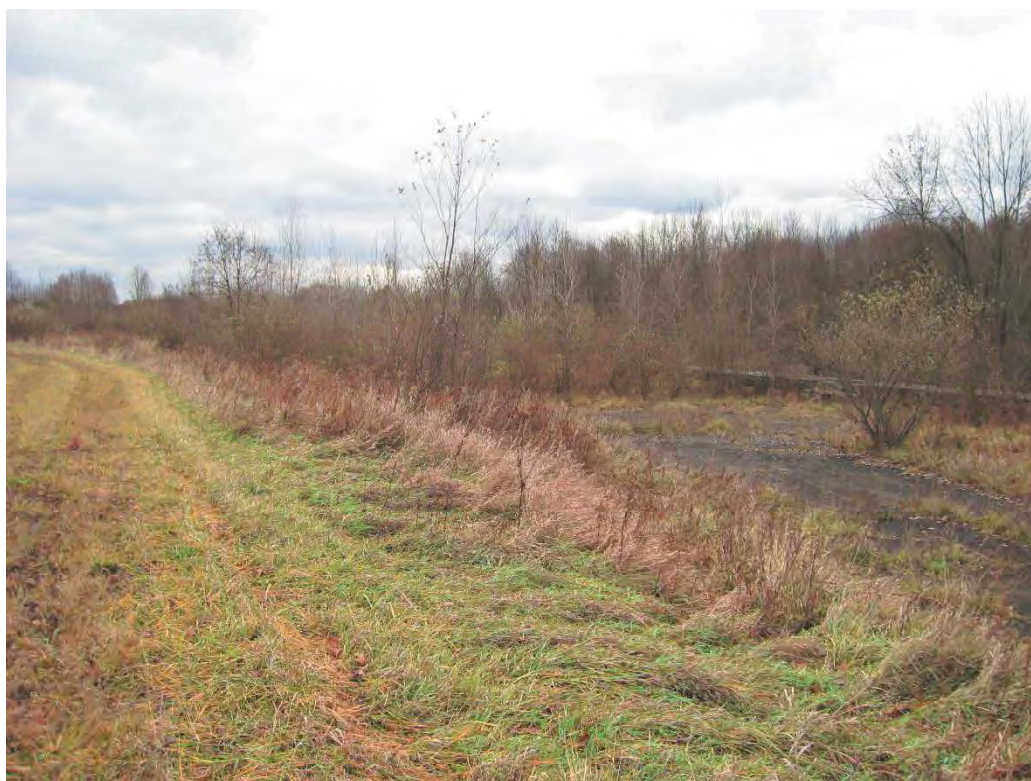
Load Line 3 field, from northeast portion of the site looking southwest.

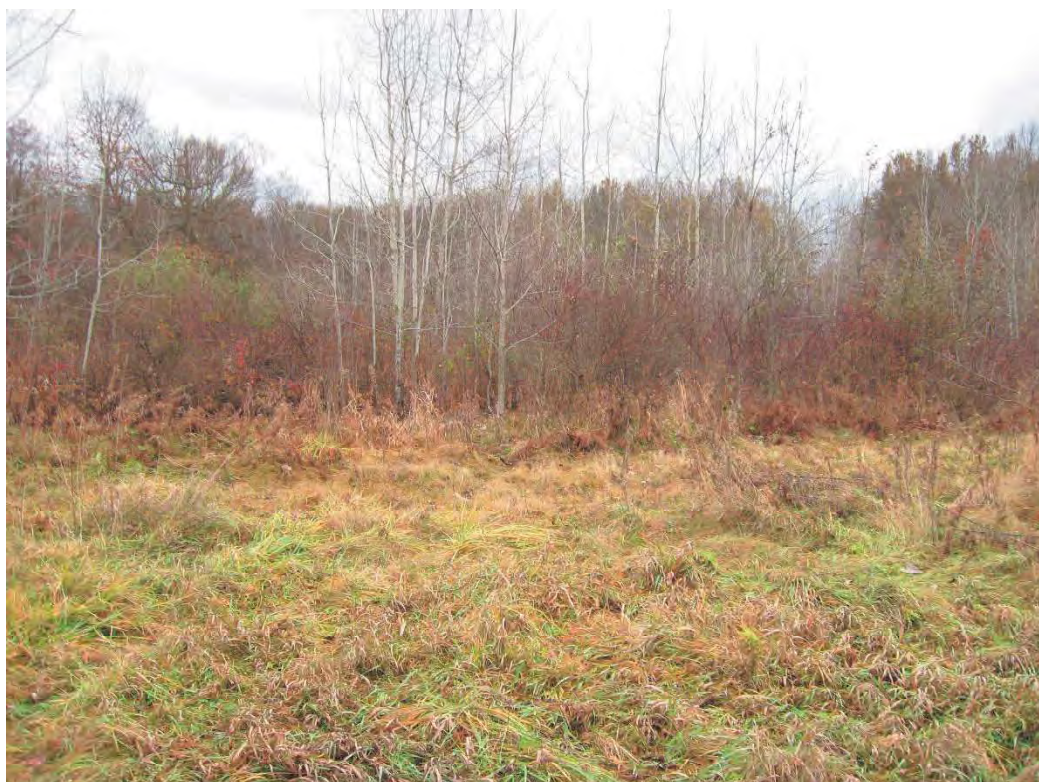
Load Line 4 field, from west-central portion of the site looking east.

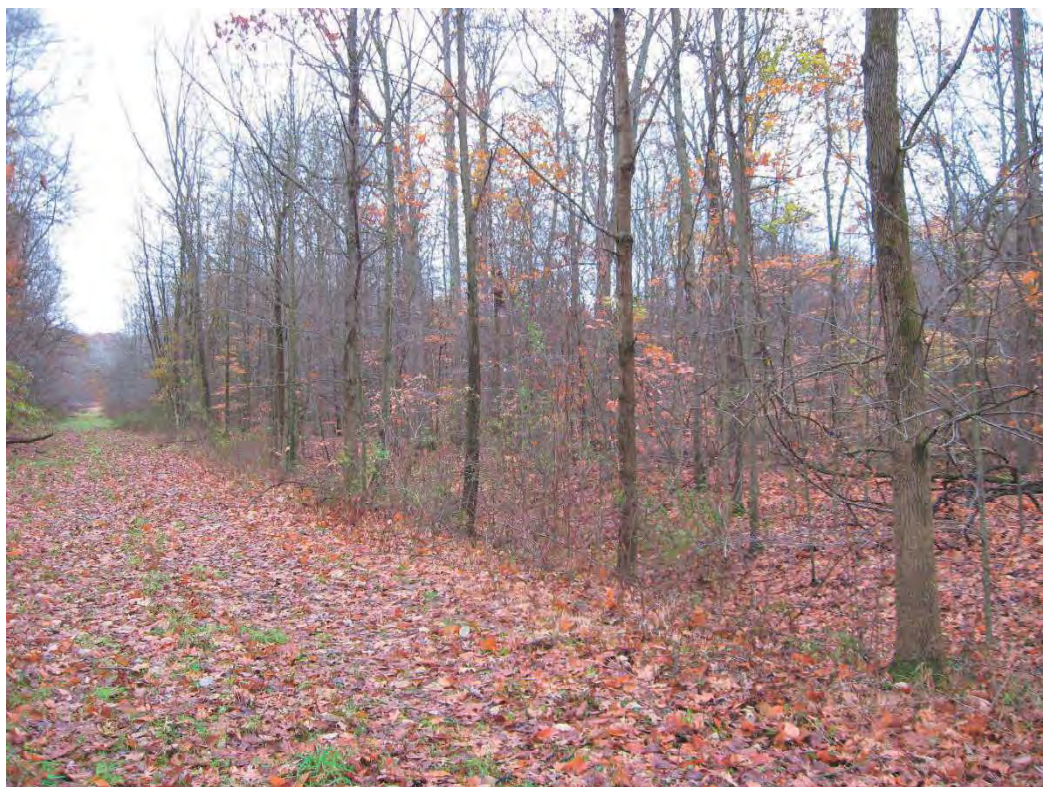
Load Line 4 field, from the northeast portion of the site looking south.

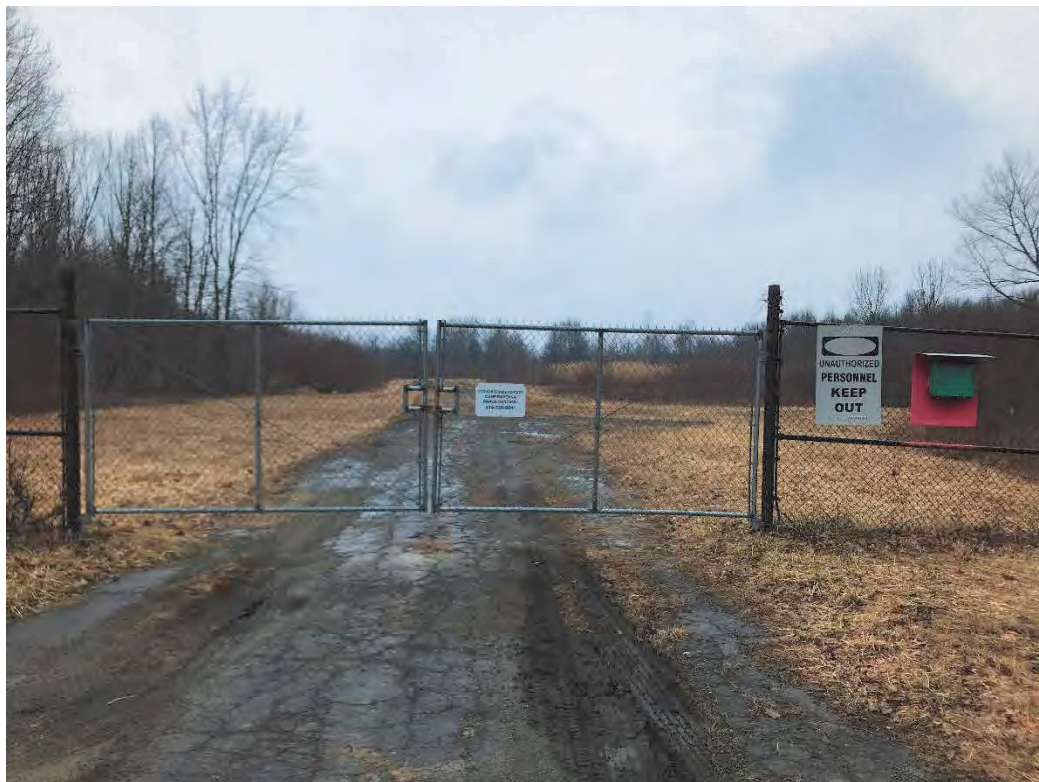
Load Line 12, looking north from the south gate.

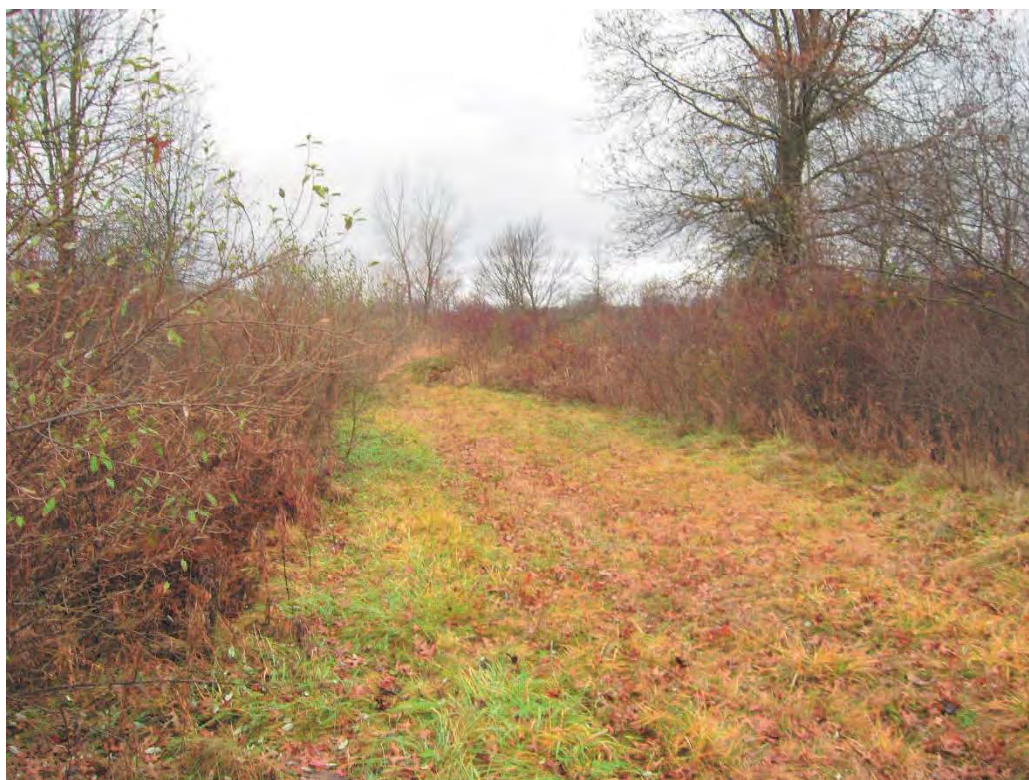
Load Line 12 field, from the south-central portion of the site looking north.

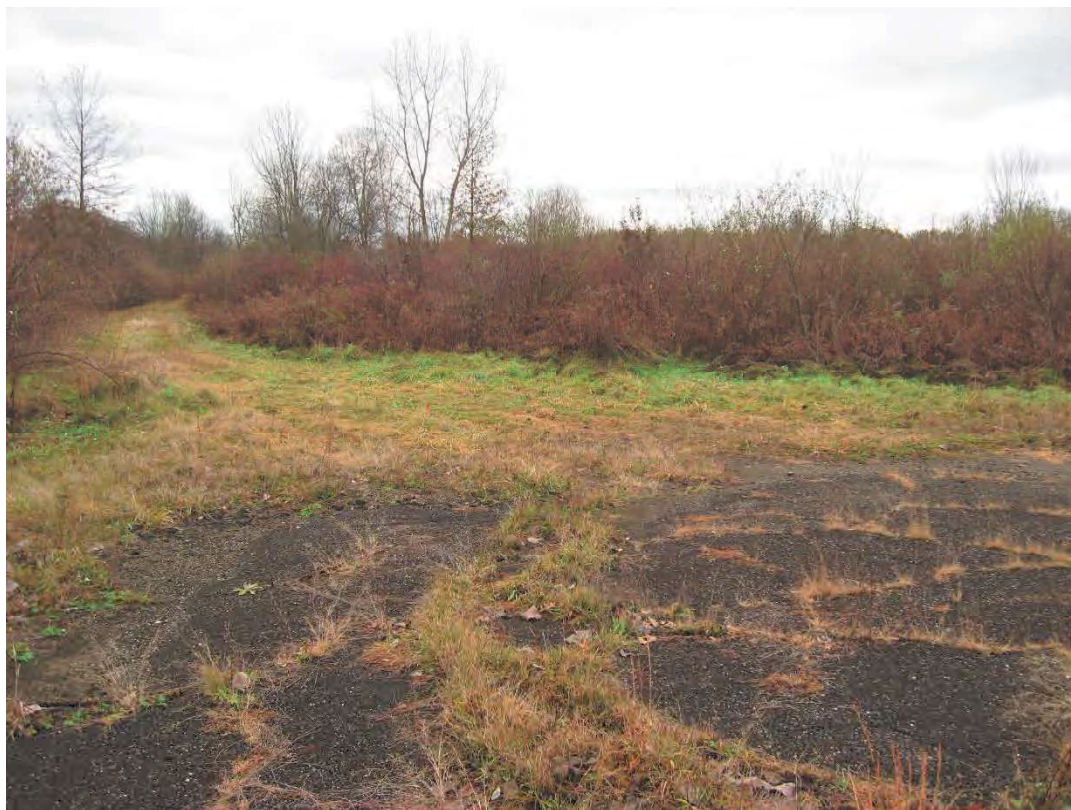
Load Line 12 field, from the north portion of the site looking south.

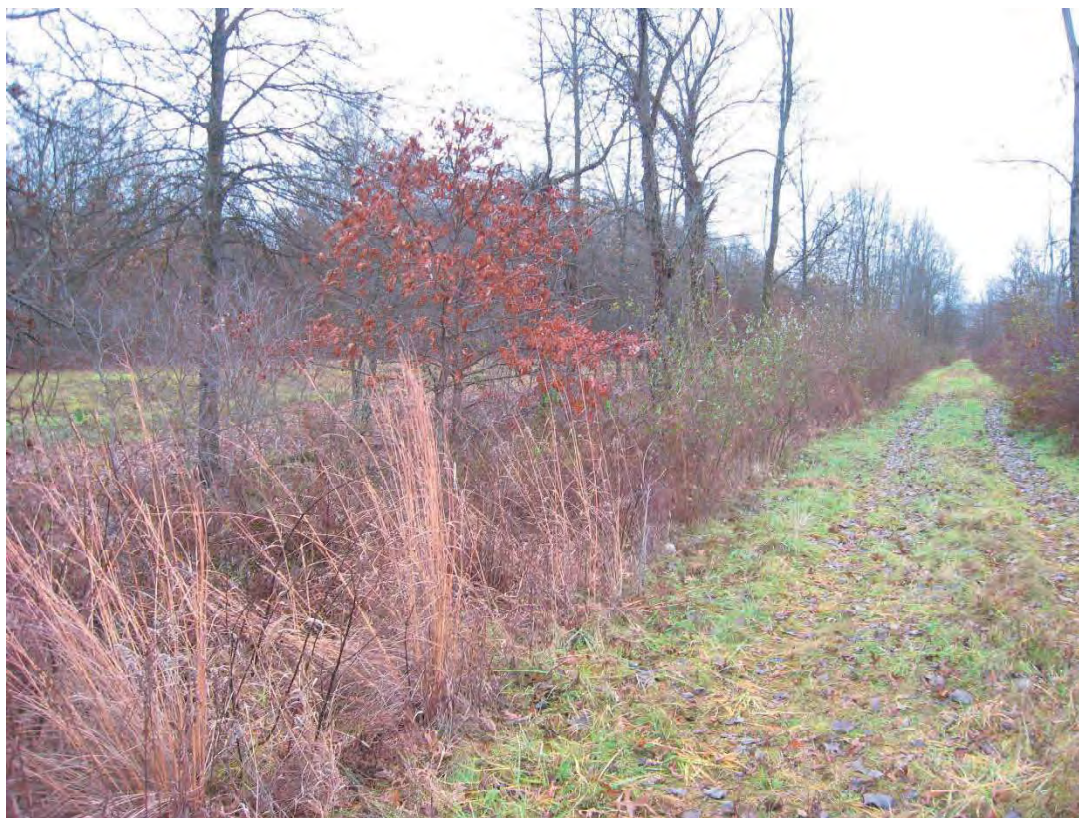
Load Line 12 field, from the north-central portion of the site looking south.

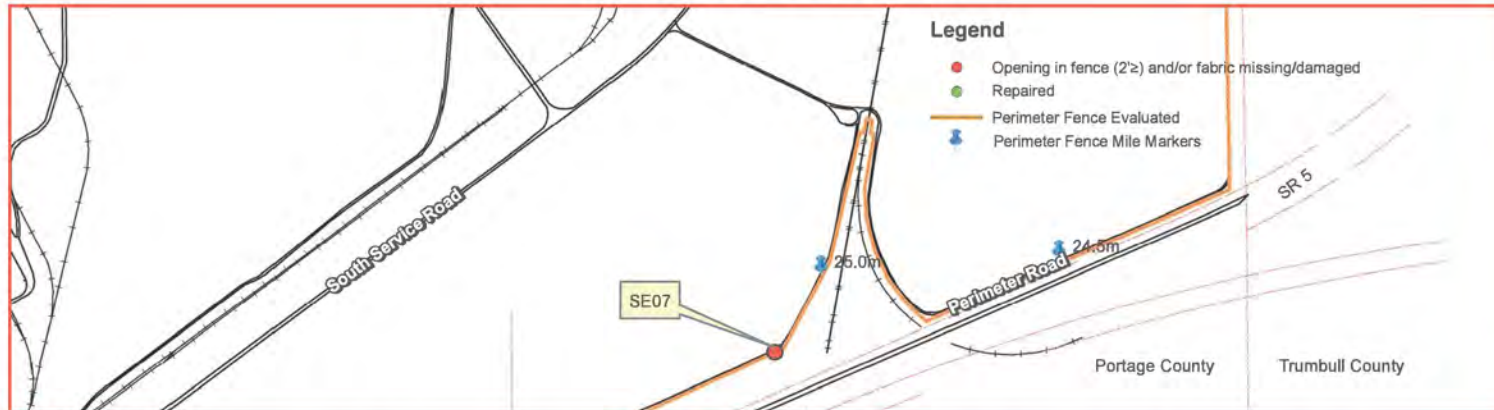
PHOTO SE07 discovered 12/31/2018

All of the perimeter fence defects called out during the 2018 inspection have been repaired as of January 7, 2020, except for SW48 and SE07. SW48 and SE07 are culvert washouts. Culvert washout repairs are beyond the capability of the in-house maintenance staff. Culvert repairs are contracted out to qualified contractors. Photographs of the repairs completed after the 2019 fence inspection will be presented in the 2020 Annual LUC Report (if required).

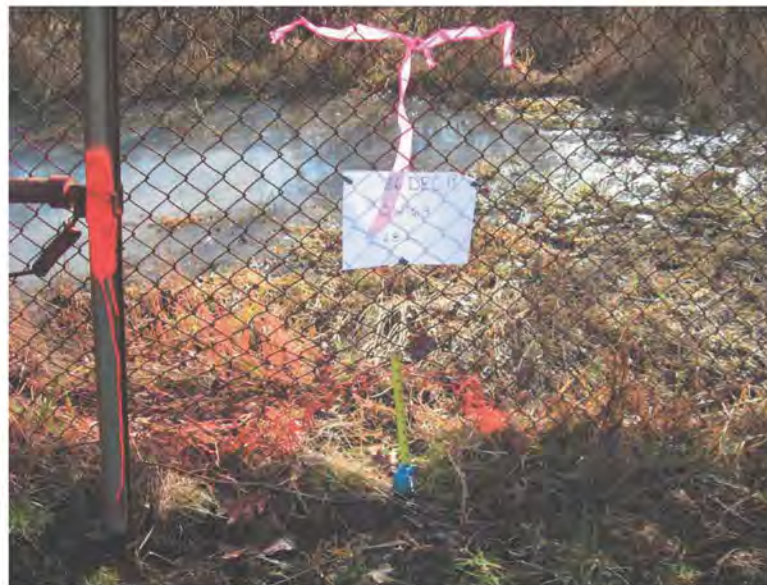
PHOTO SW64 discovered 12/26/2019

- Opening in fence (2"x) and/or fabric missing/damaged
- Repaired
- Perimeter Fence Evaluated

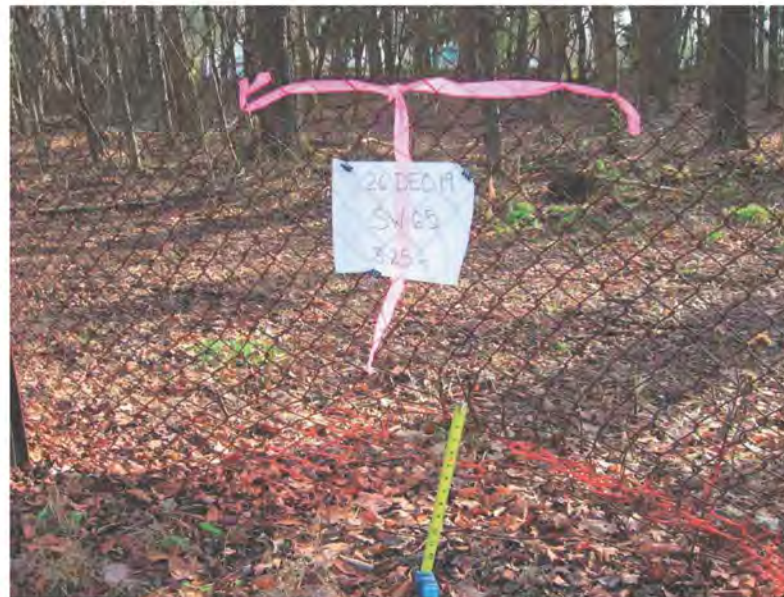
PHOTO SW65 discovered 12/26/2019

- Opening in fence (2'±) and/or fabric missing/damaged
- Repaired
- Perimeter Fence Evaluated

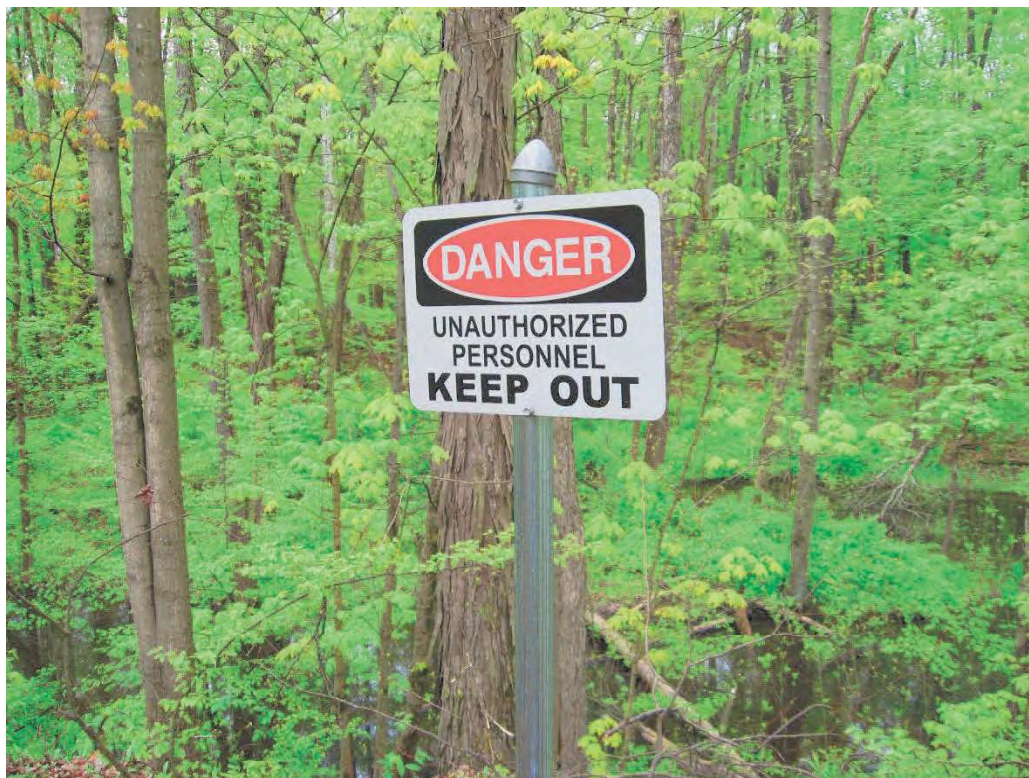
RVAAP-51, asbestos warning sign delineating Land Use Control area along Paris-Windham Road.

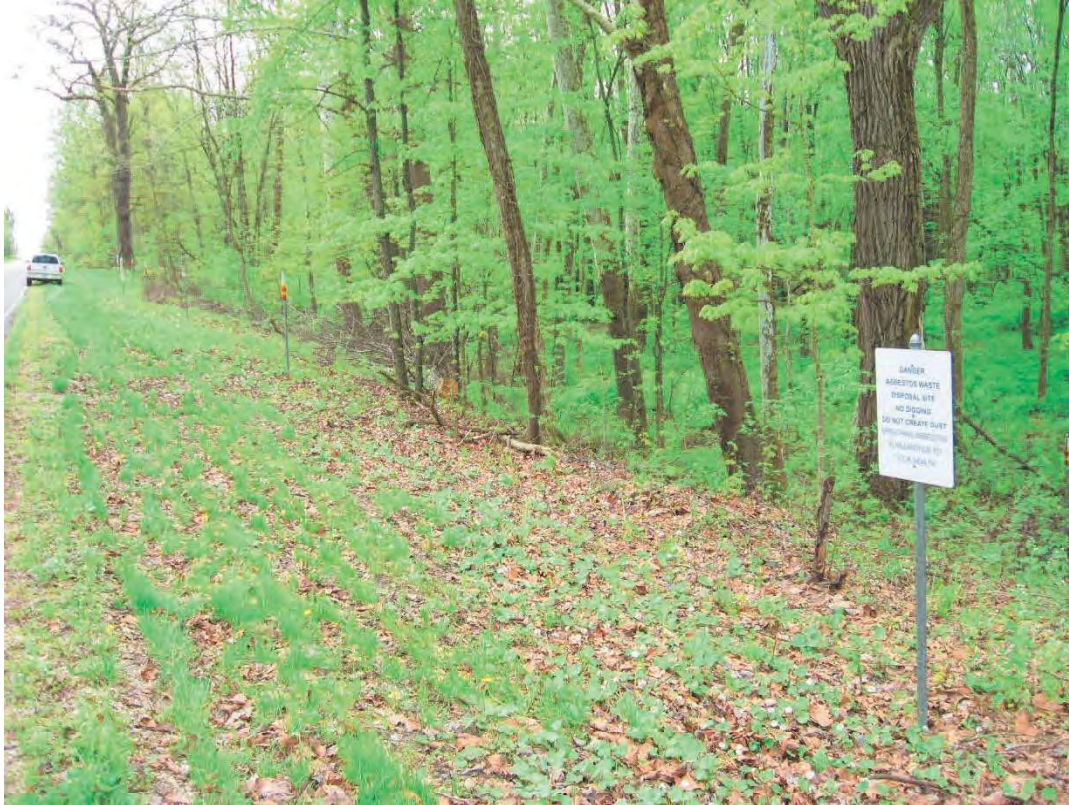
RVAAP-51, Land Use Control area delineated by signs along Paris-Windham Road, looking south.

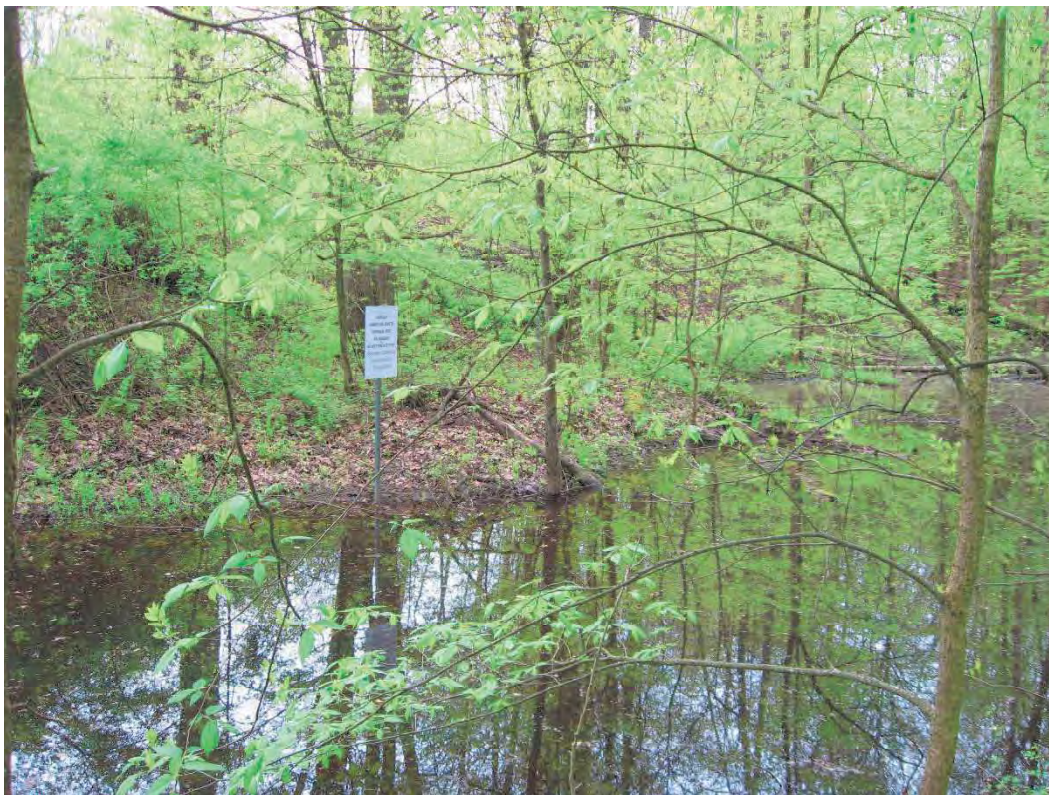
RVAAP-51, Land Use Control area delineated by signs along Paris-Windham Road, looking southeast from northwest portion of the site.
