**Final Propellant Removal Summary Report for MEC Support for  
RVAAP 08 Load Line 1**

Ravenna Army Ammunition Plant  
Ravenna, Ohio

**Prepared by:**  
Shaw Environmental, Inc.  
100 Technology Center Drive  
Stoughton, MA 02072

January 24, 2008

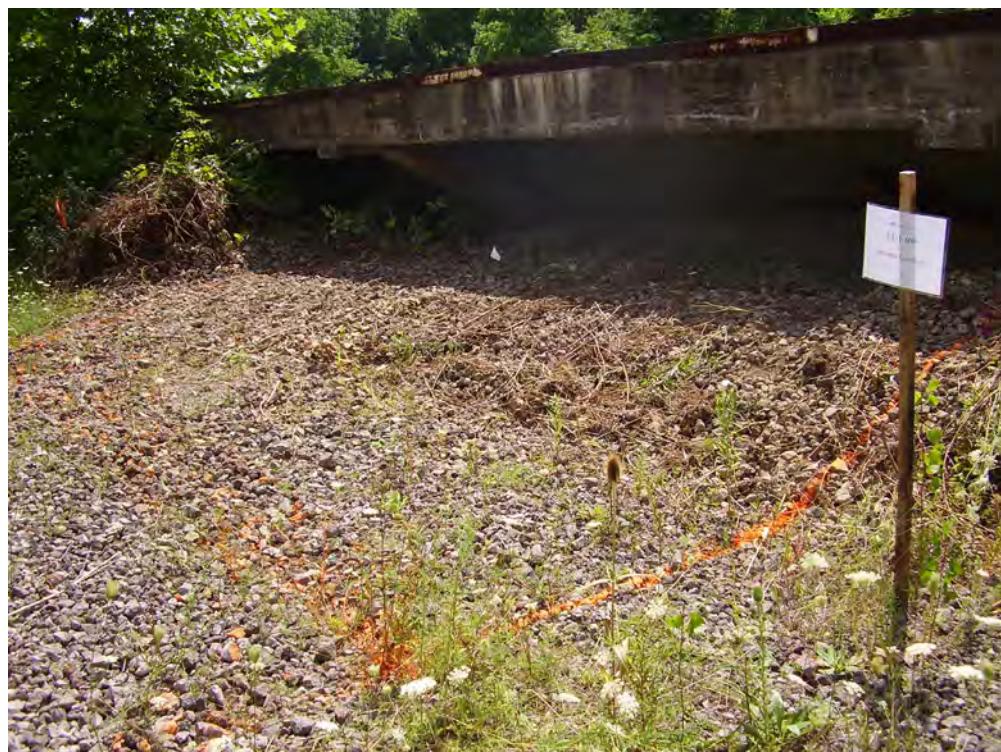
Excavation area to the east of Building CA-14 identified as containing smokeless propellant nodules prior to excavation.

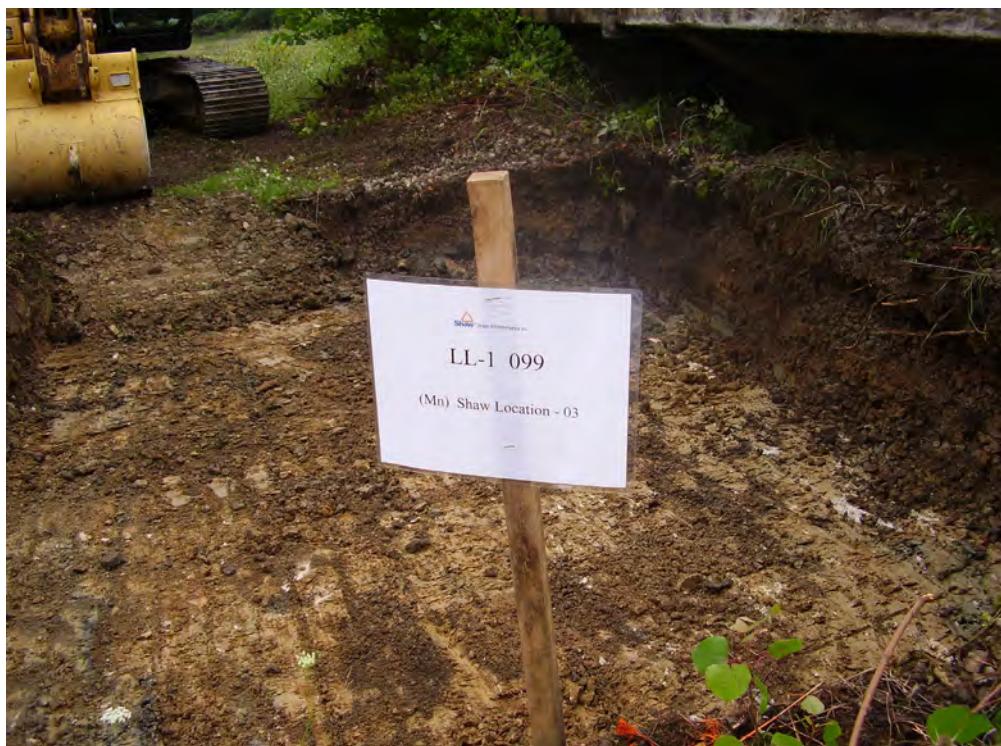
Post excavation area to the east of Building CA-14.

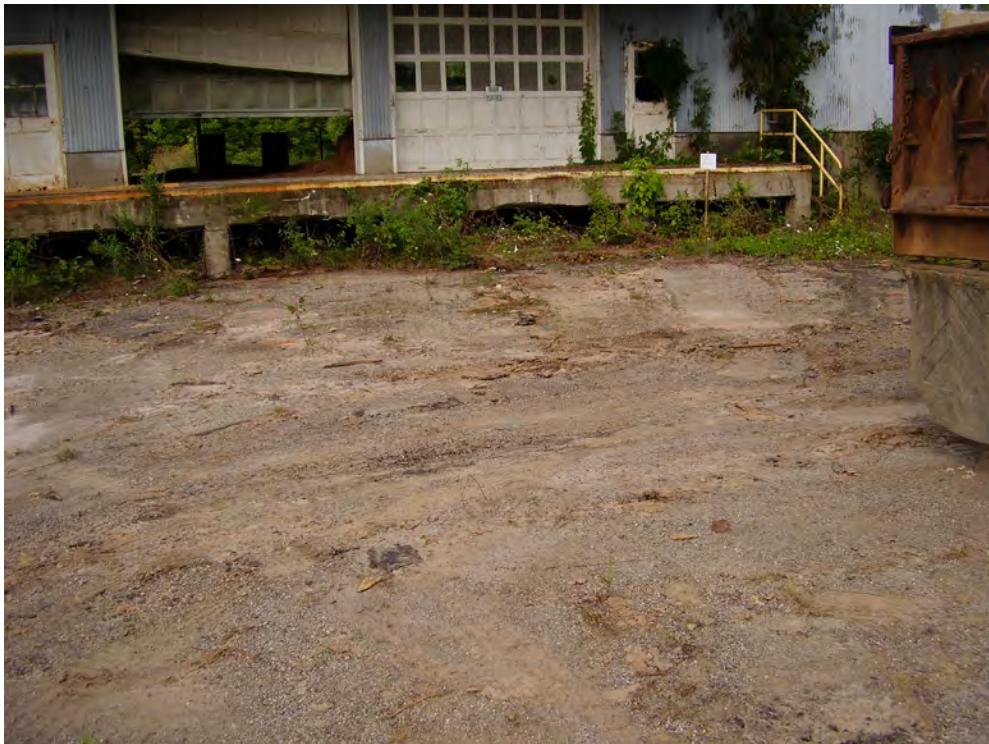
Excavation area to the east of Building CB-13B identified as containing smokeless propellant nodules prior to excavation.

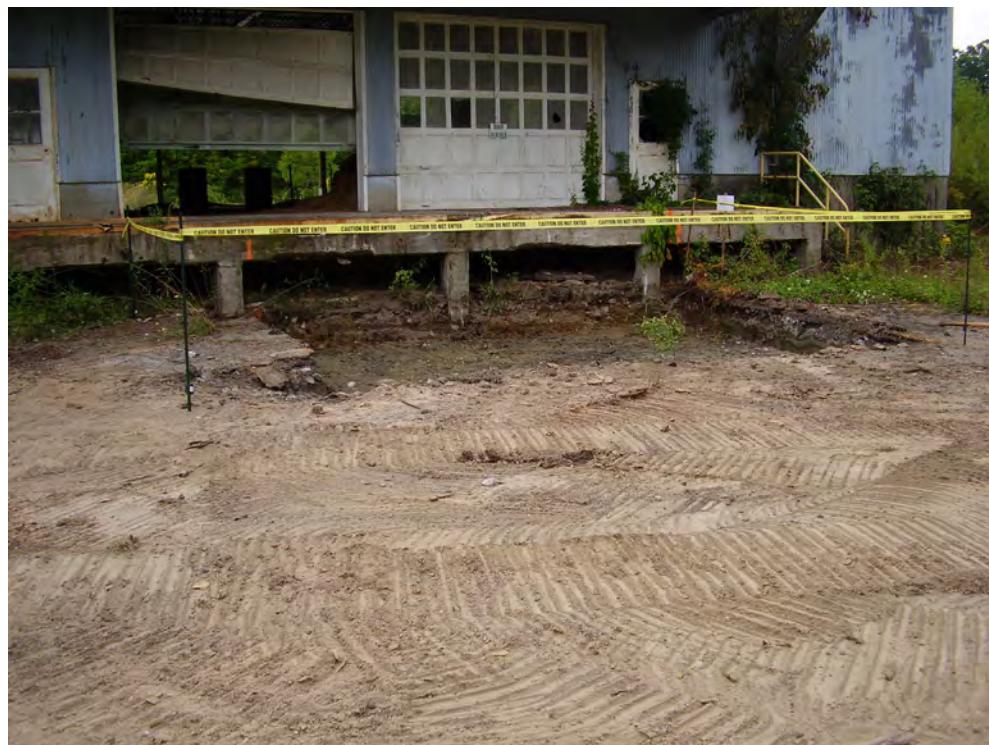
Post excavation area to the east of Building CB-13B.
