APPENDIX H

Site Photographs

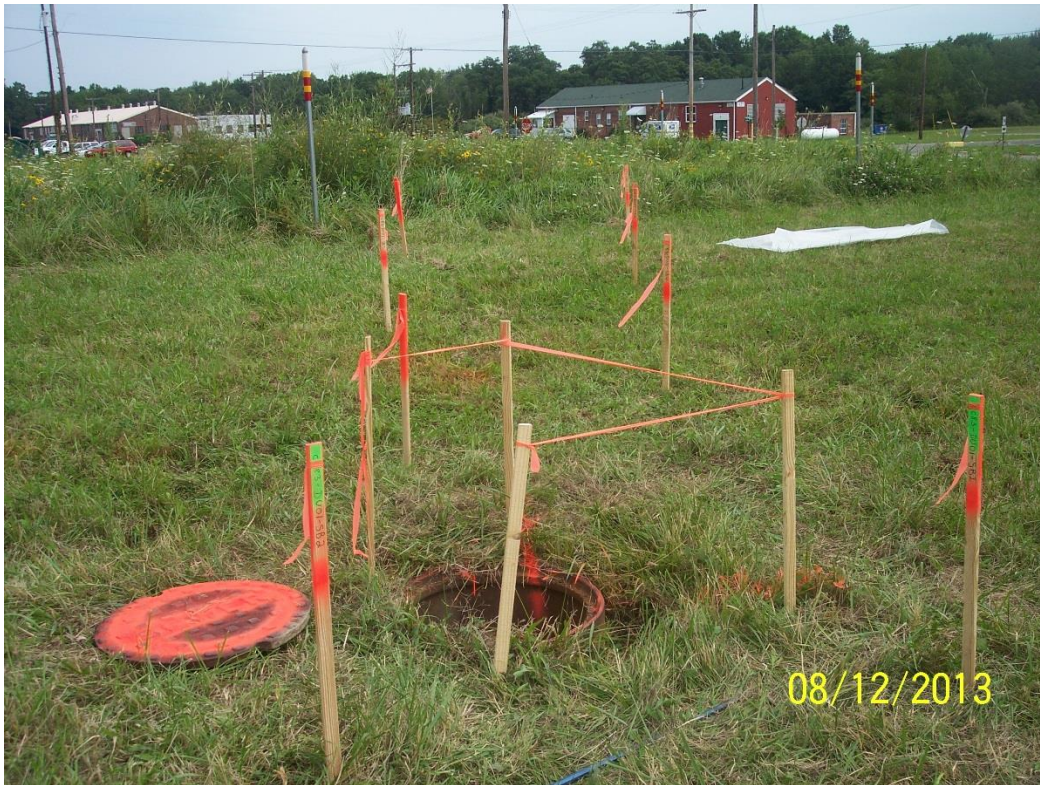
View is looking towards the northeast. Note orange paint line on edge of manhole rim. This denotes direction of incoming pipe at the bottom of the manhole.

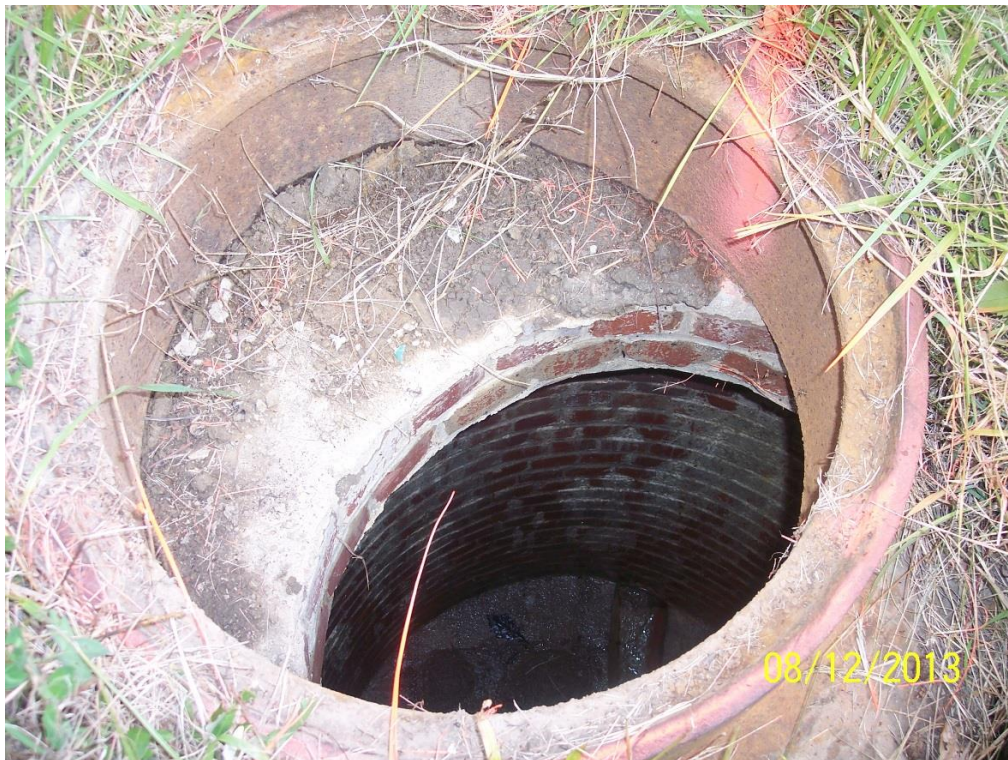
View is looking into the manhole. Note orange line on manhole rim aligns with incoming pipe visible in the bottom of the manhole.

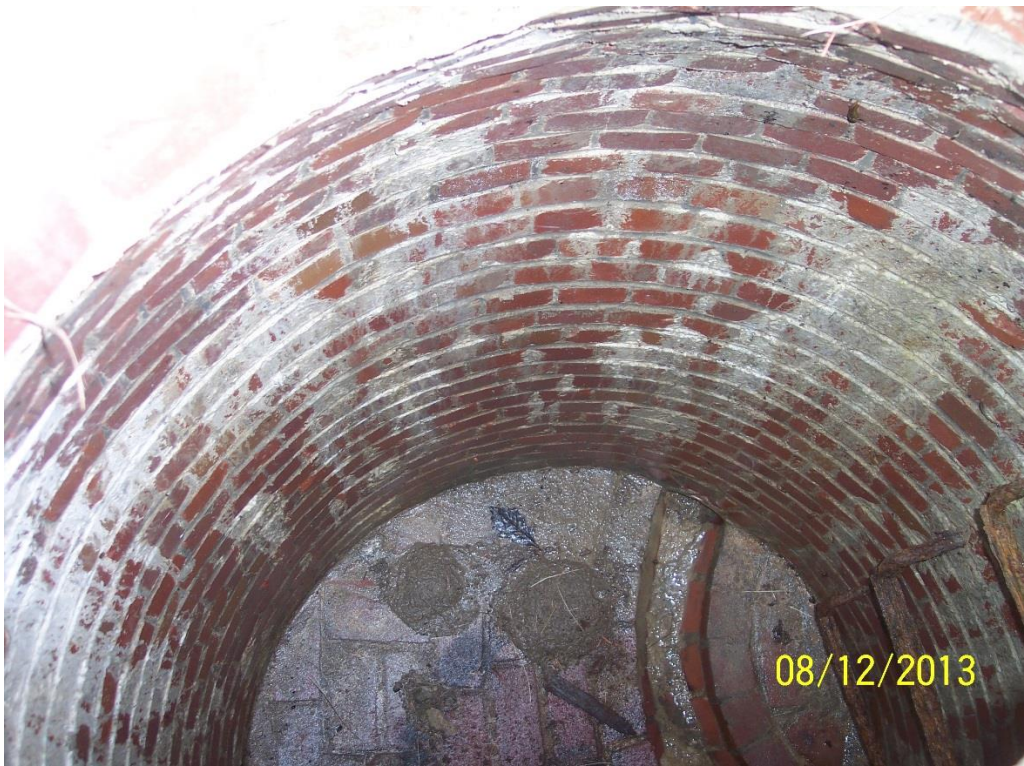
View of incoming pipe in manhole. Manhole bottom is at 7 ft bgs.

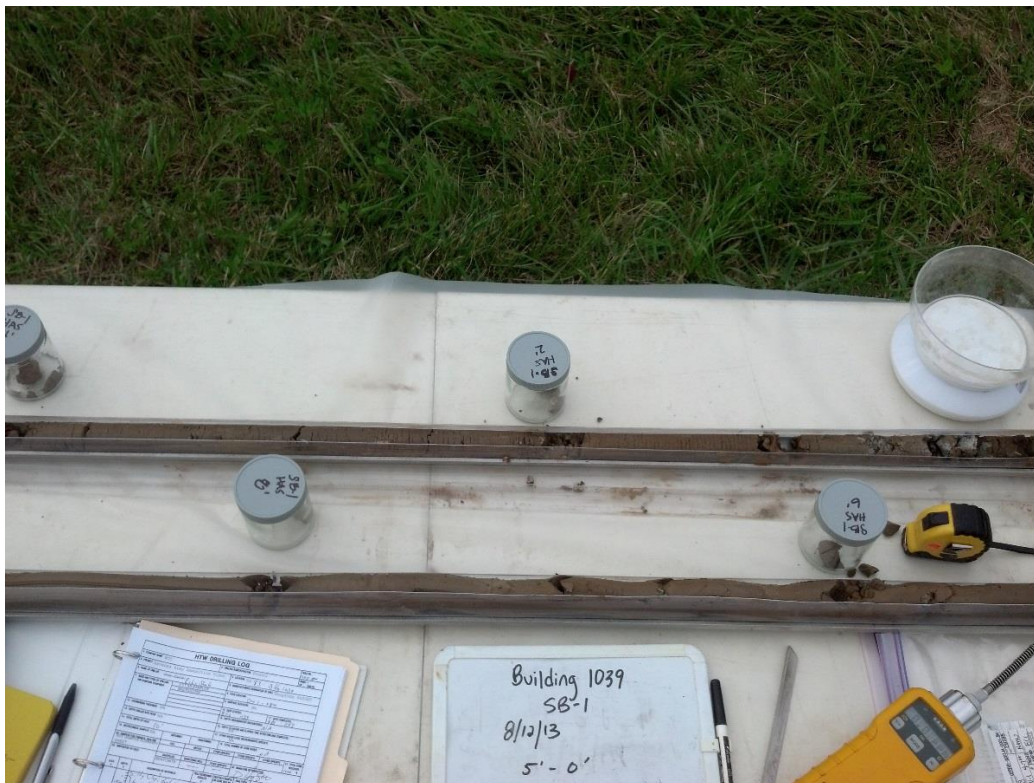
Photo No. 1 – CC RVAAP-83 DU01 SB01 sample intervals 0-5 ft and 5-10 ft.

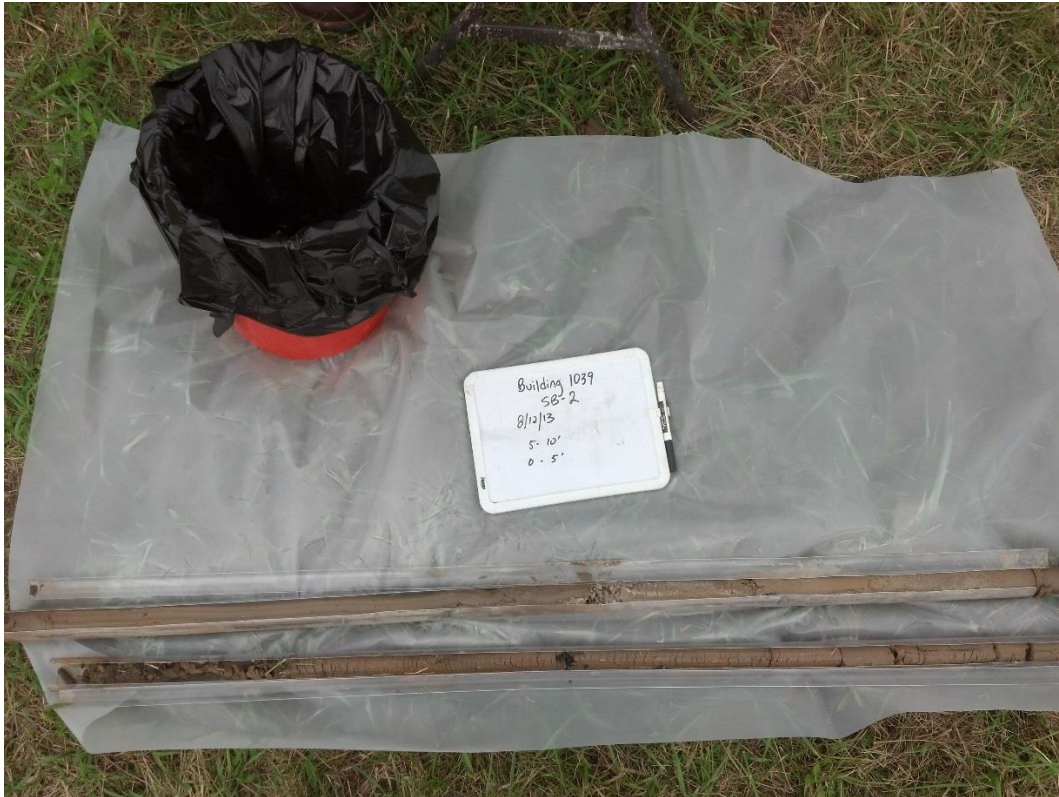
Photo No. 2 – CC RVAAP-83 DU01 SB02 sample intervals 0-5 ft and 5-10 ft.

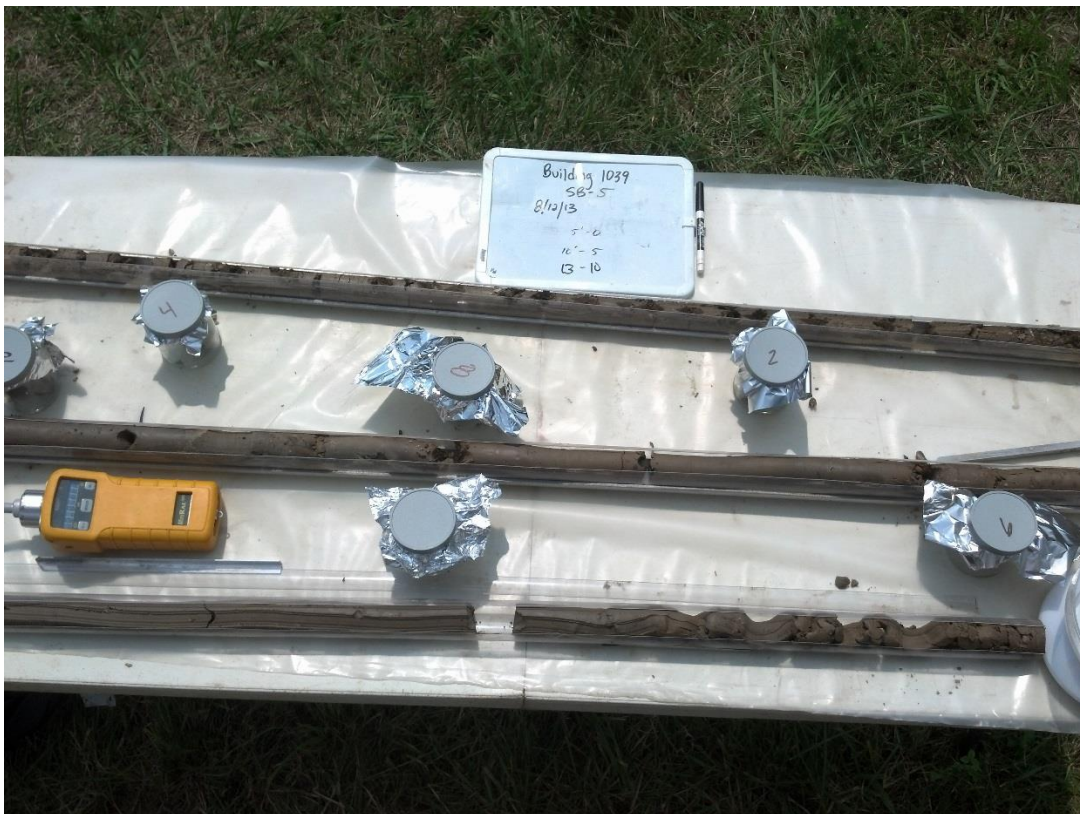
Photo No. 3 – CC RVAAP-83 DU01 SB05 sample intervals 0-5 ft, 5-10 ft, and 10-13 ft.
