**DEPARTMENT OF THE ARMY**  
**BALTIMORE DISTRICT, CORPS OF ENGINEERS**  
**2 HOPKINS PLACE**  
**BALTIMORE, MD 21201**

MEMORANDUM FOR RECORD

SUBJECT: Summary of Findings, Magnetometer-Assisted Survey of Sand Creek conducted on 31 May to 4 June 2022 as related to the Time Critical Removal Action for Open Demolition Area #2 at Camp James A. Garfield Joint Military Training Center, Newton Falls, OH

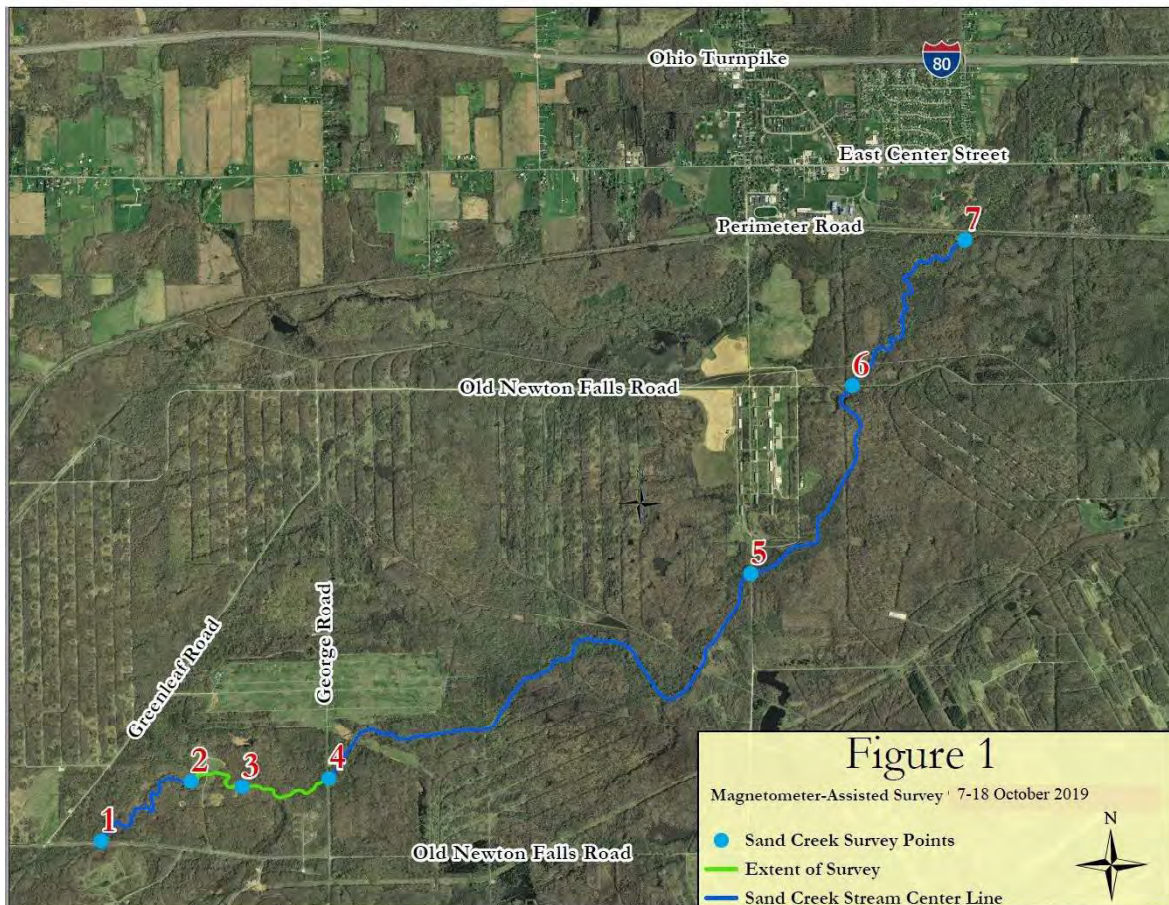
- a) *Dates of Extent of Survey.* The Sand Creek survey was conducted on 31 May to 4 June 2022.
- b) *Personnel.* The survey was conducted by OESS Personnel (Mr. Ricky Whitten and Mr. David Carlin).
- c) *Areas Surveyed.* Seven (7) way-points were established and evaluated during the initial survey (**Figure 1**) completed on 12-16 October 2016. These waypoints were used as markers/reference for the sweep conducted on 31 May to 4 June 2022. For this event, approximately 1.5 line-miles were surveyed in and around the creek line between the ODA2 MRS western boundary (waypoint 2) to George Road (Waypoint 4), as illustrated on **Figure 1**. This survey did not extend beyond Waypoint 4 based on field observations based on the absence of magnetic anomalies in the creek.

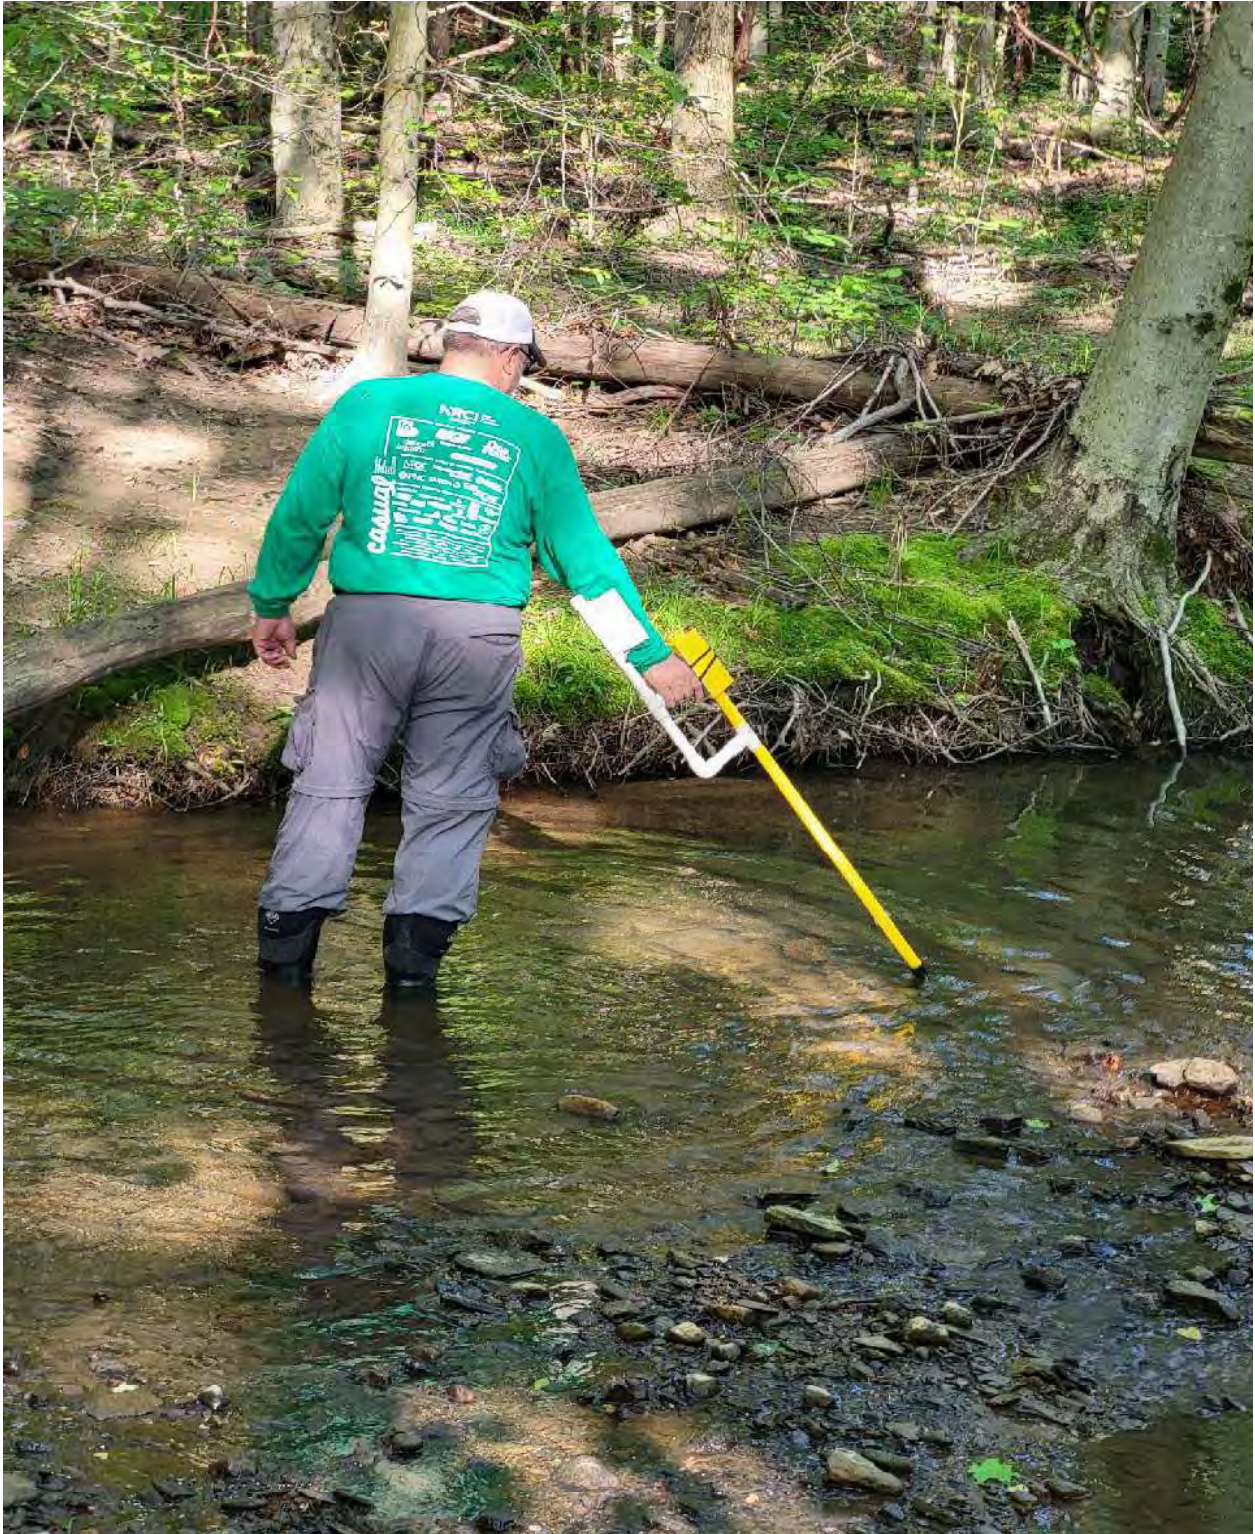
**Sweeping on east side of culvert.**

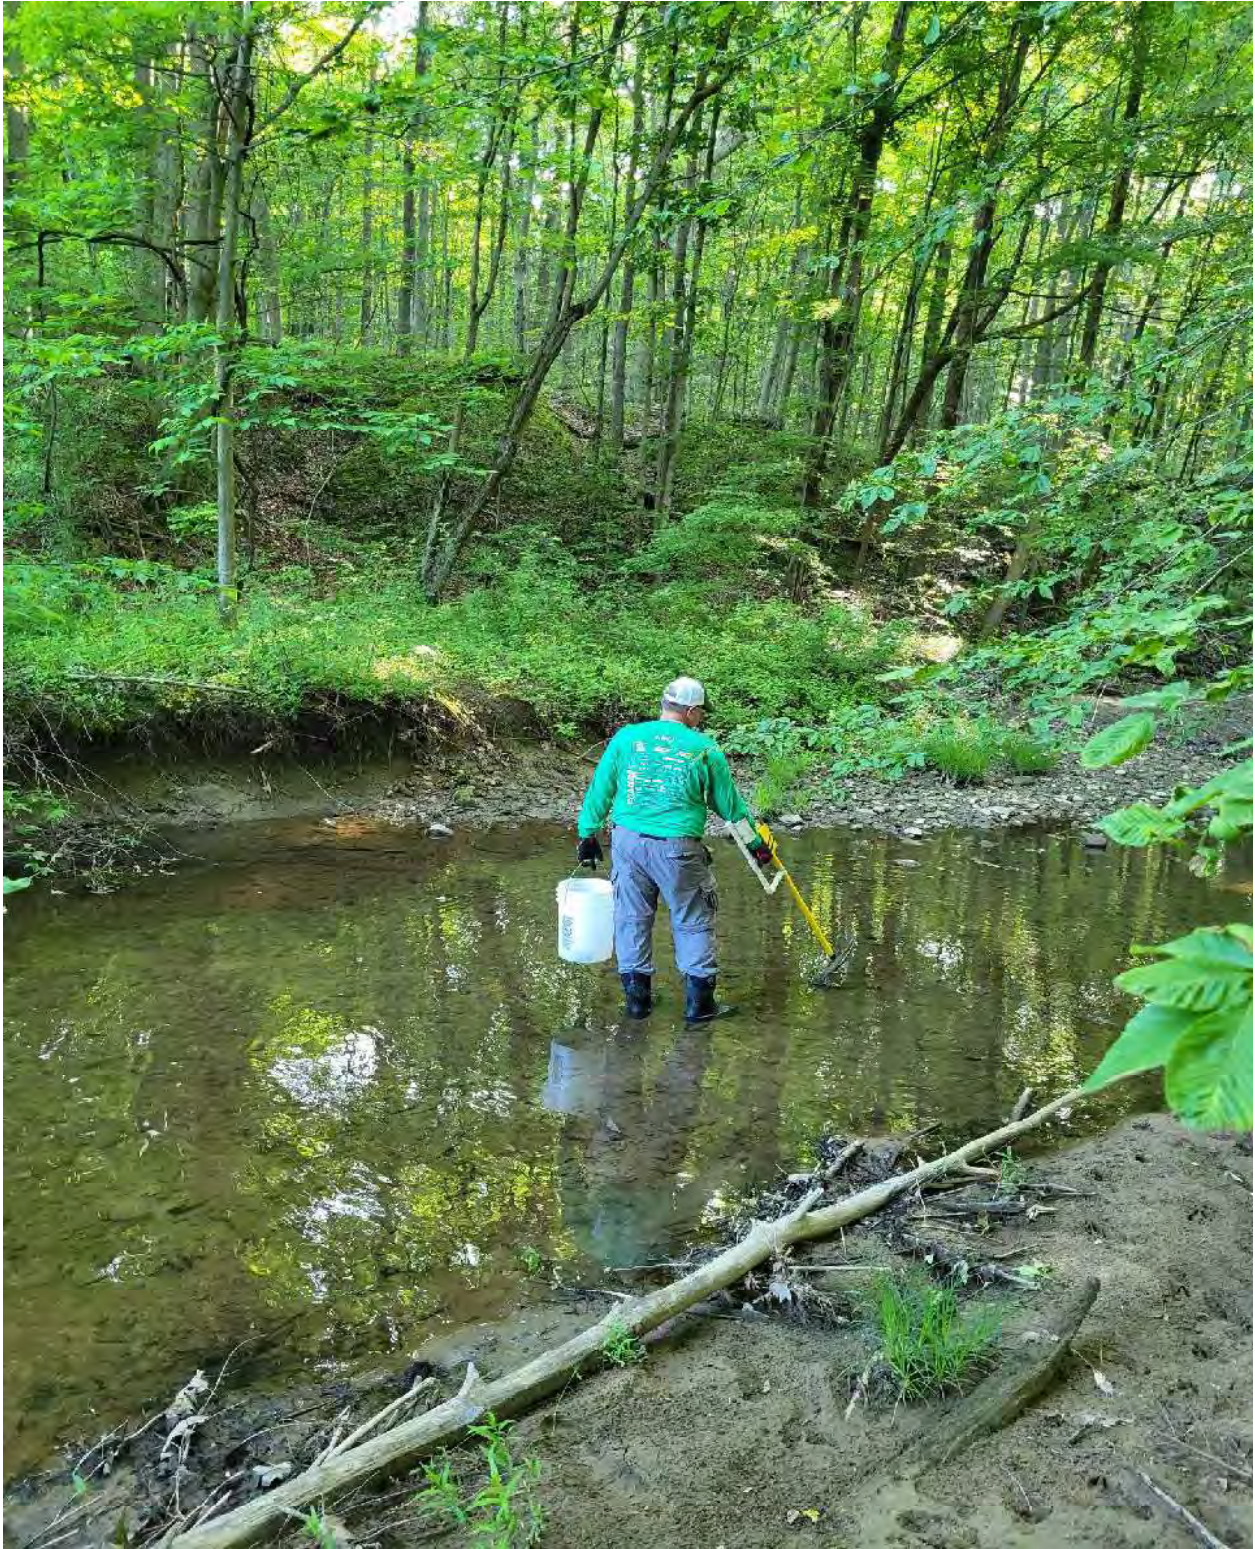
**East side of culvert.**

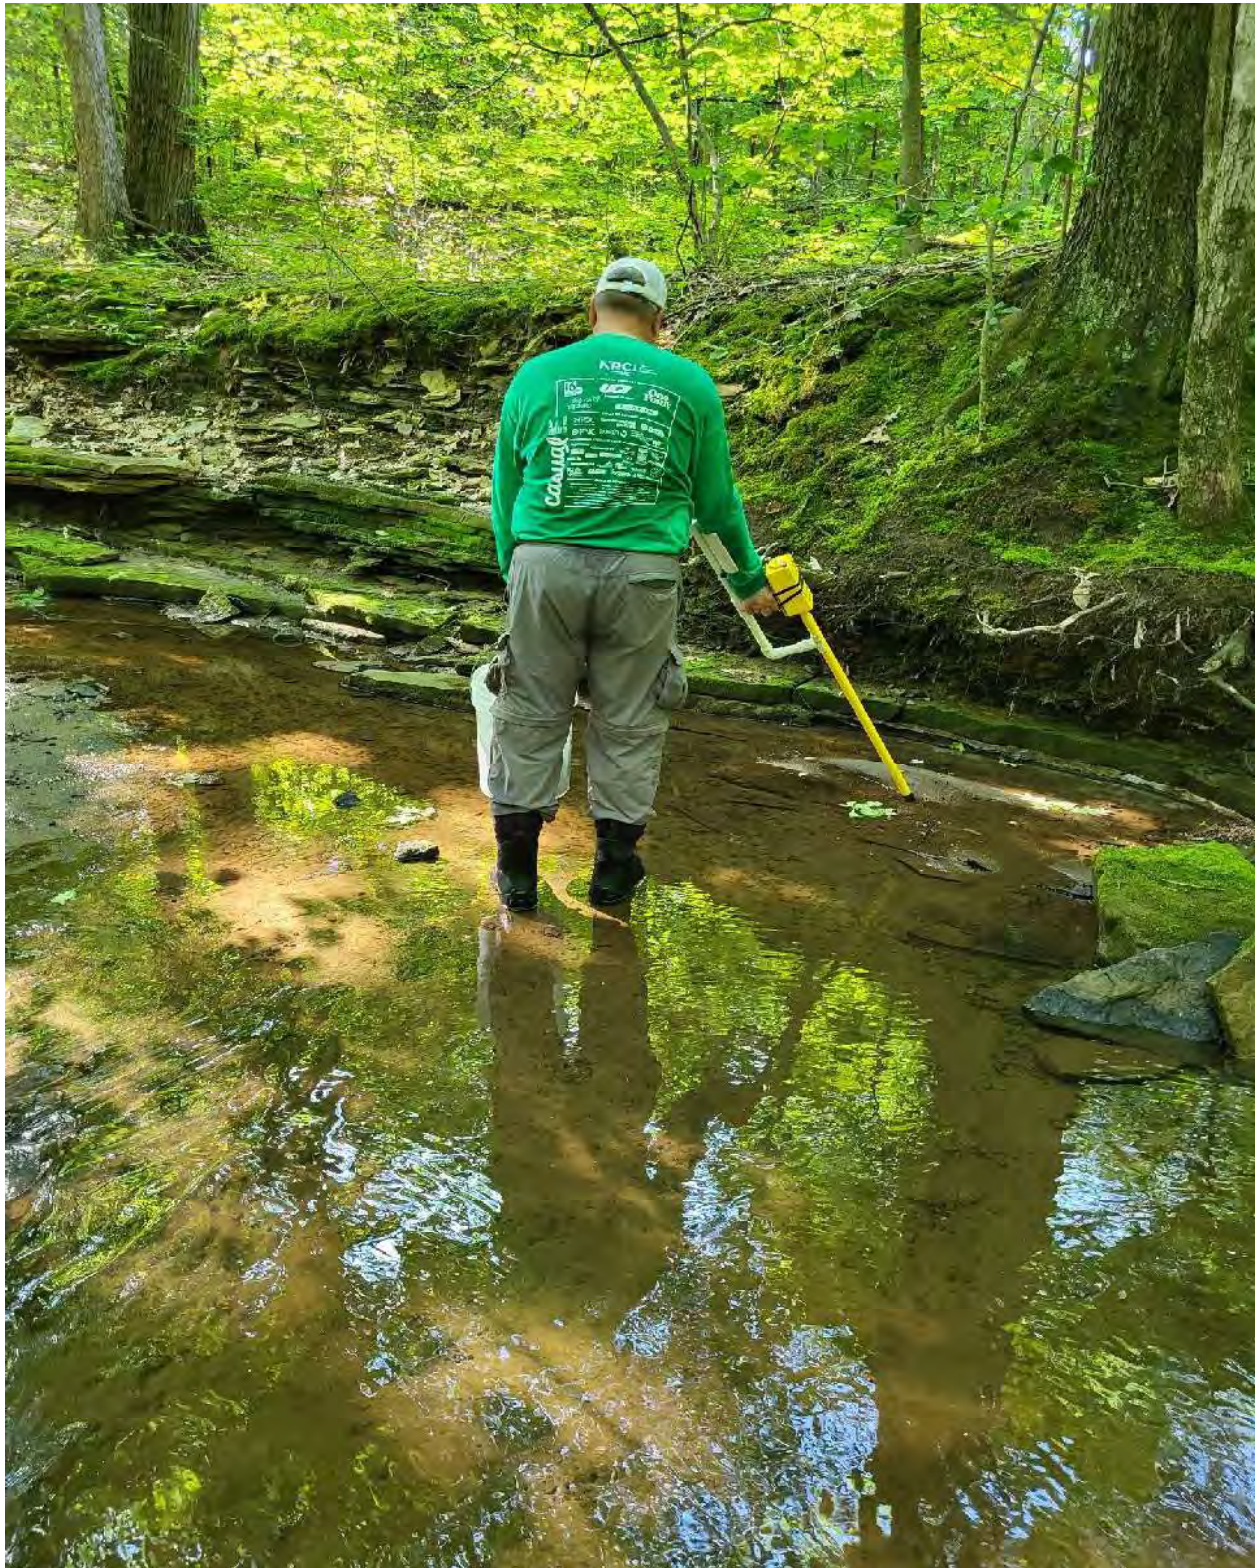
**Sweeping the creek bed.**

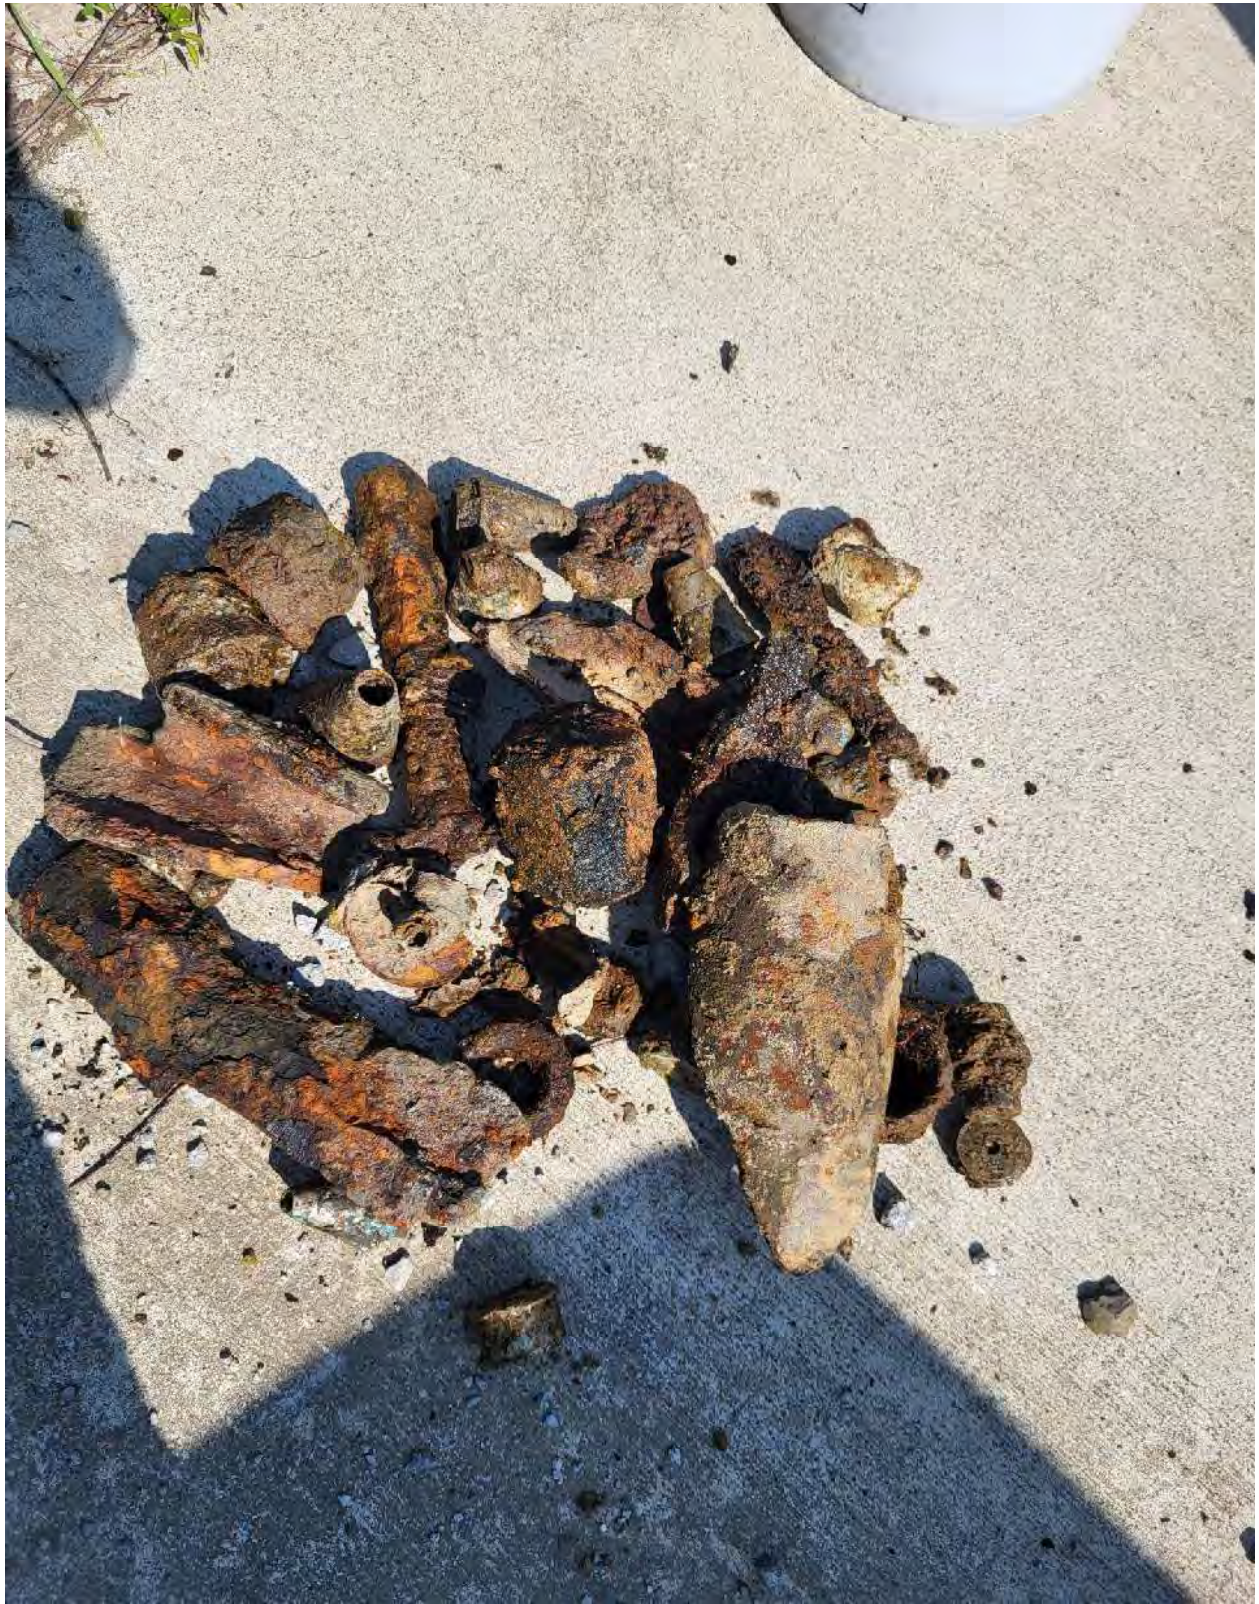
- b) MPPEH/MD was recovered between Waypoint 3 to Waypoint 4. 40lb of MPPEH/MD was recovered between Waypoint 3 and Waypoint 4. All of the big pieces were near the culvert. The items were inspected and determined to be MDAS. These items most likely originated from an upstream source (area between Waypoint 2 and Waypoint 3) and were deposited in this area during a high-energy storm event.

**MDAS recovered east side of culvert.**

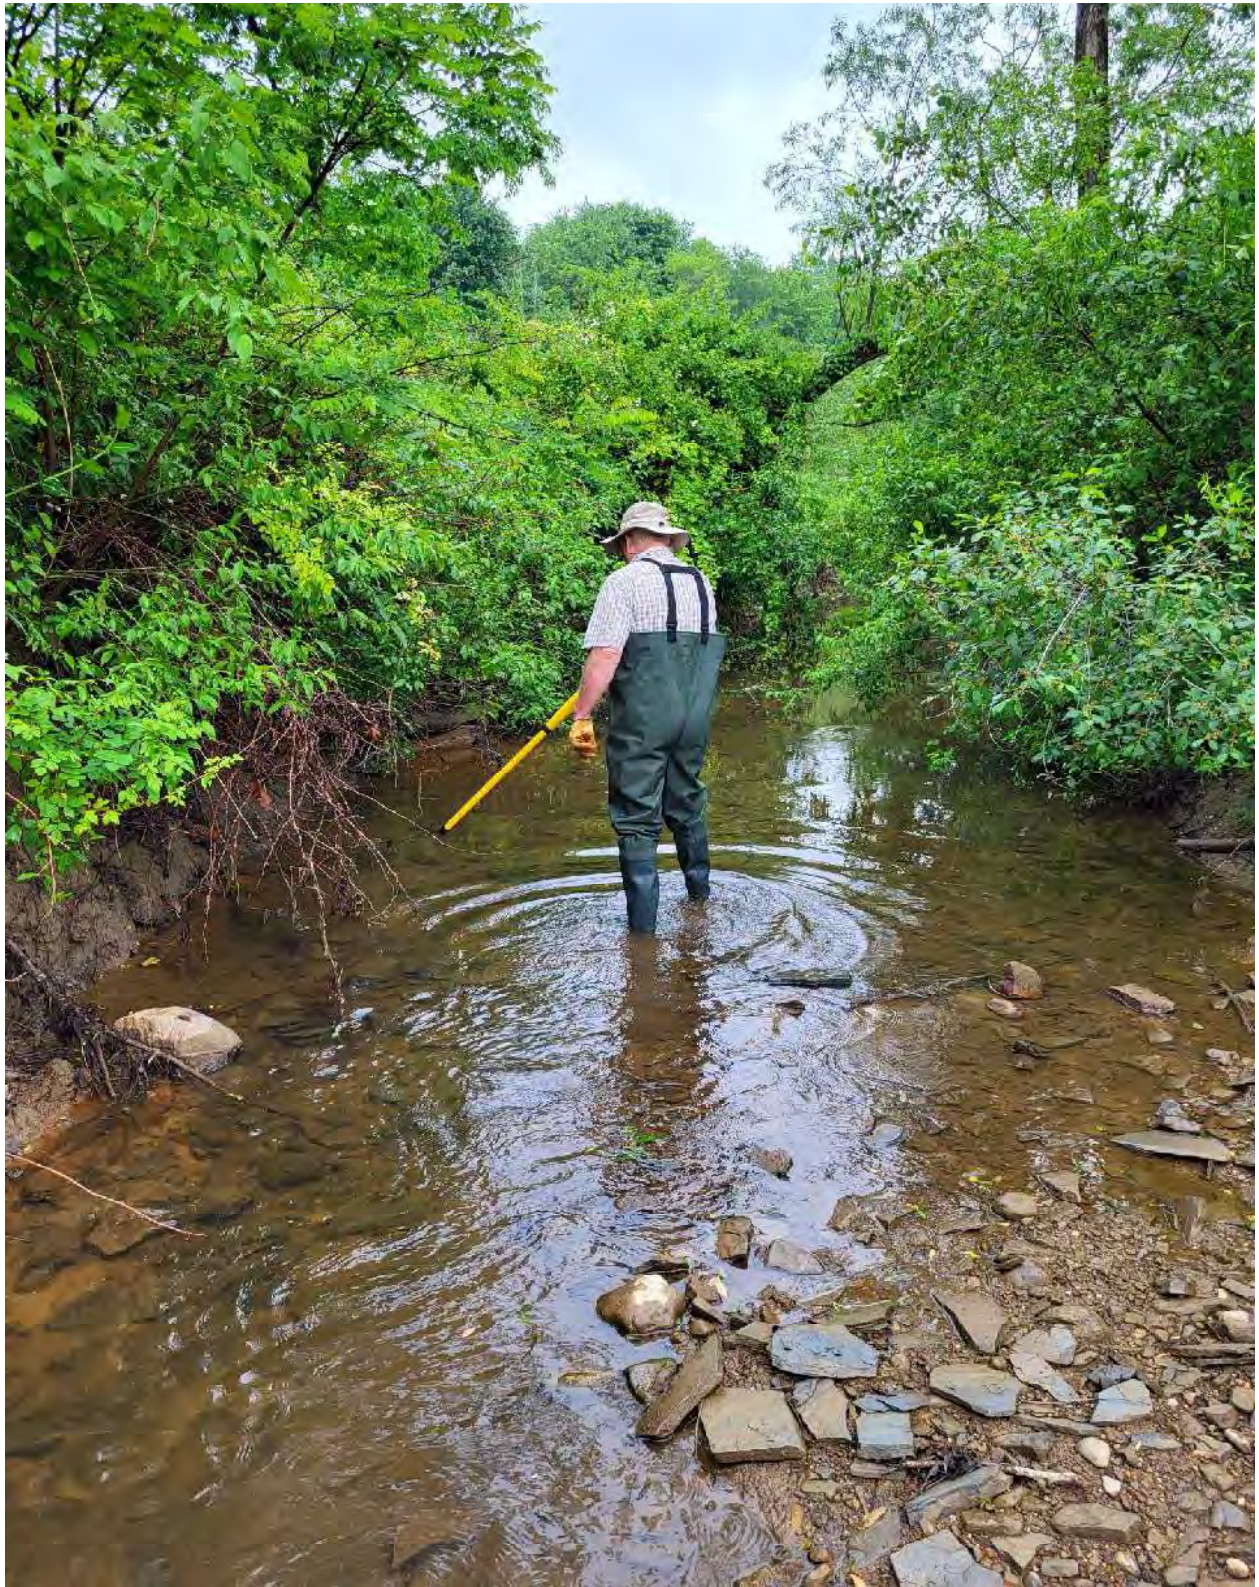
**Sweeping on west side of culvert**

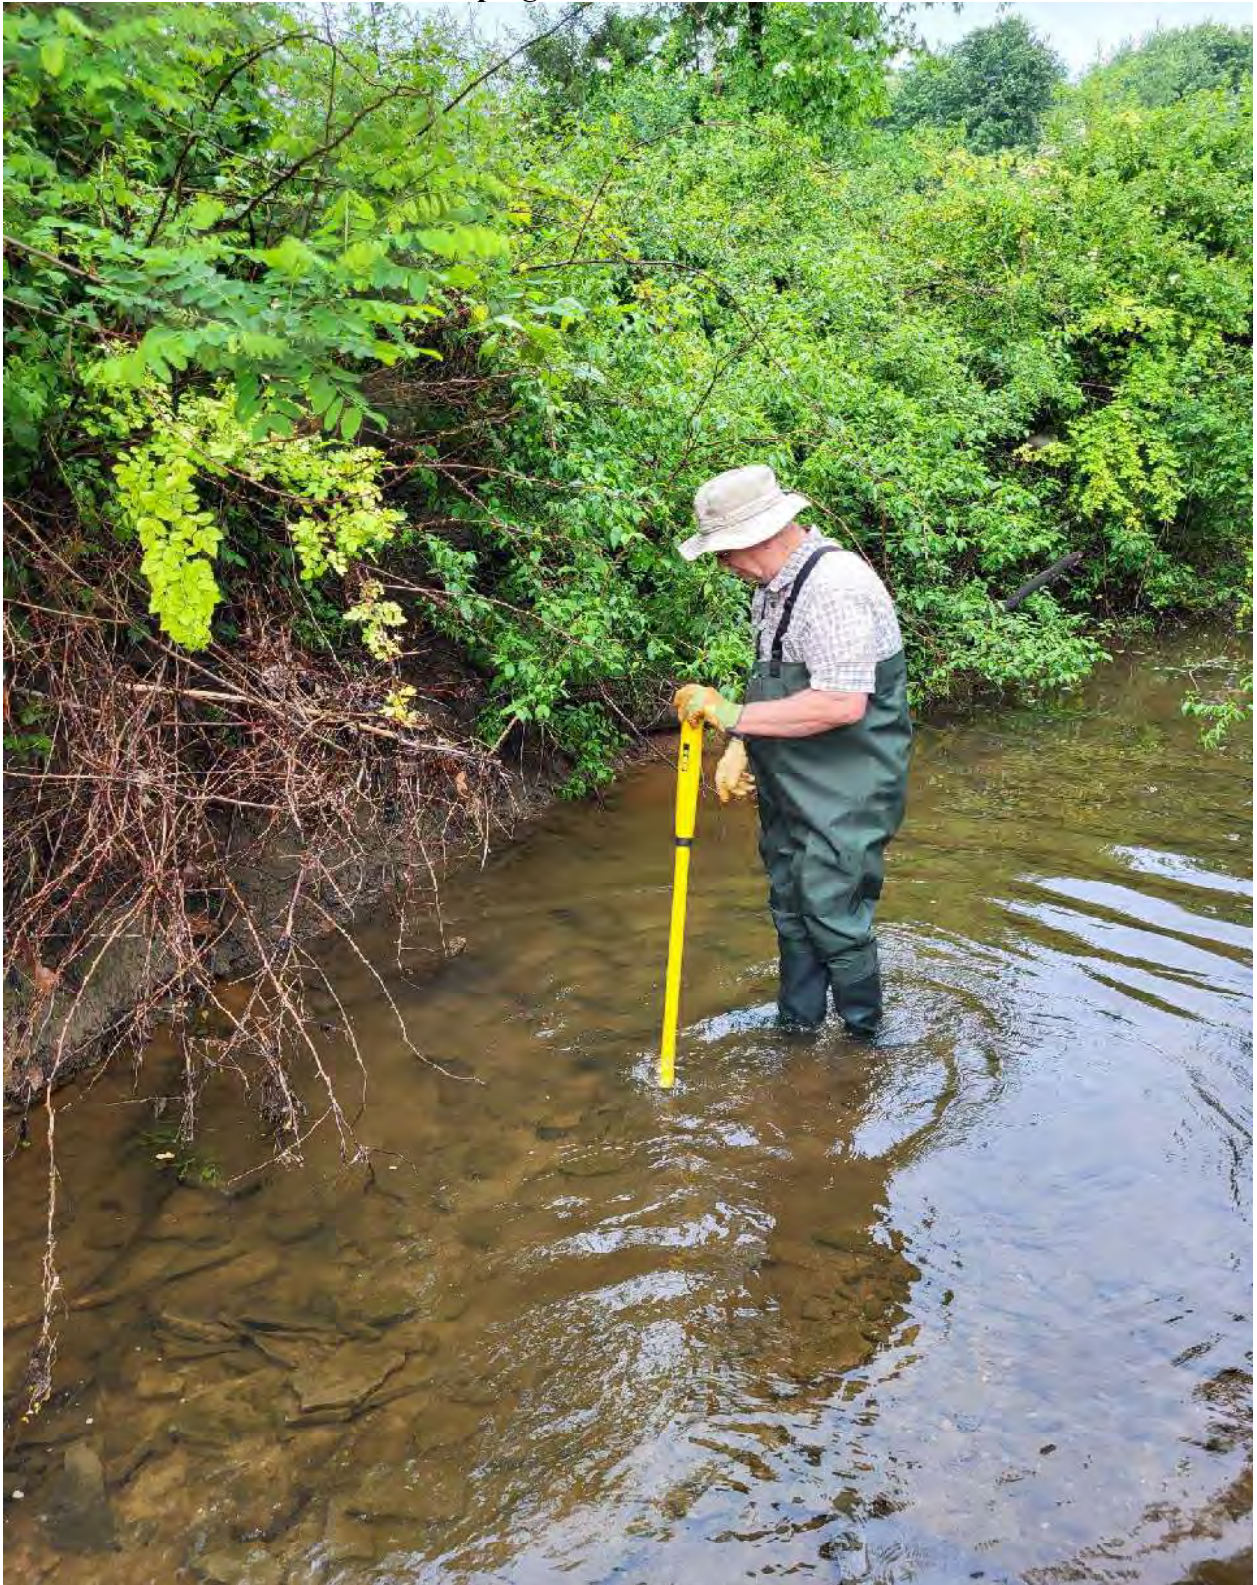
**Sweeping on west side of culvert.**

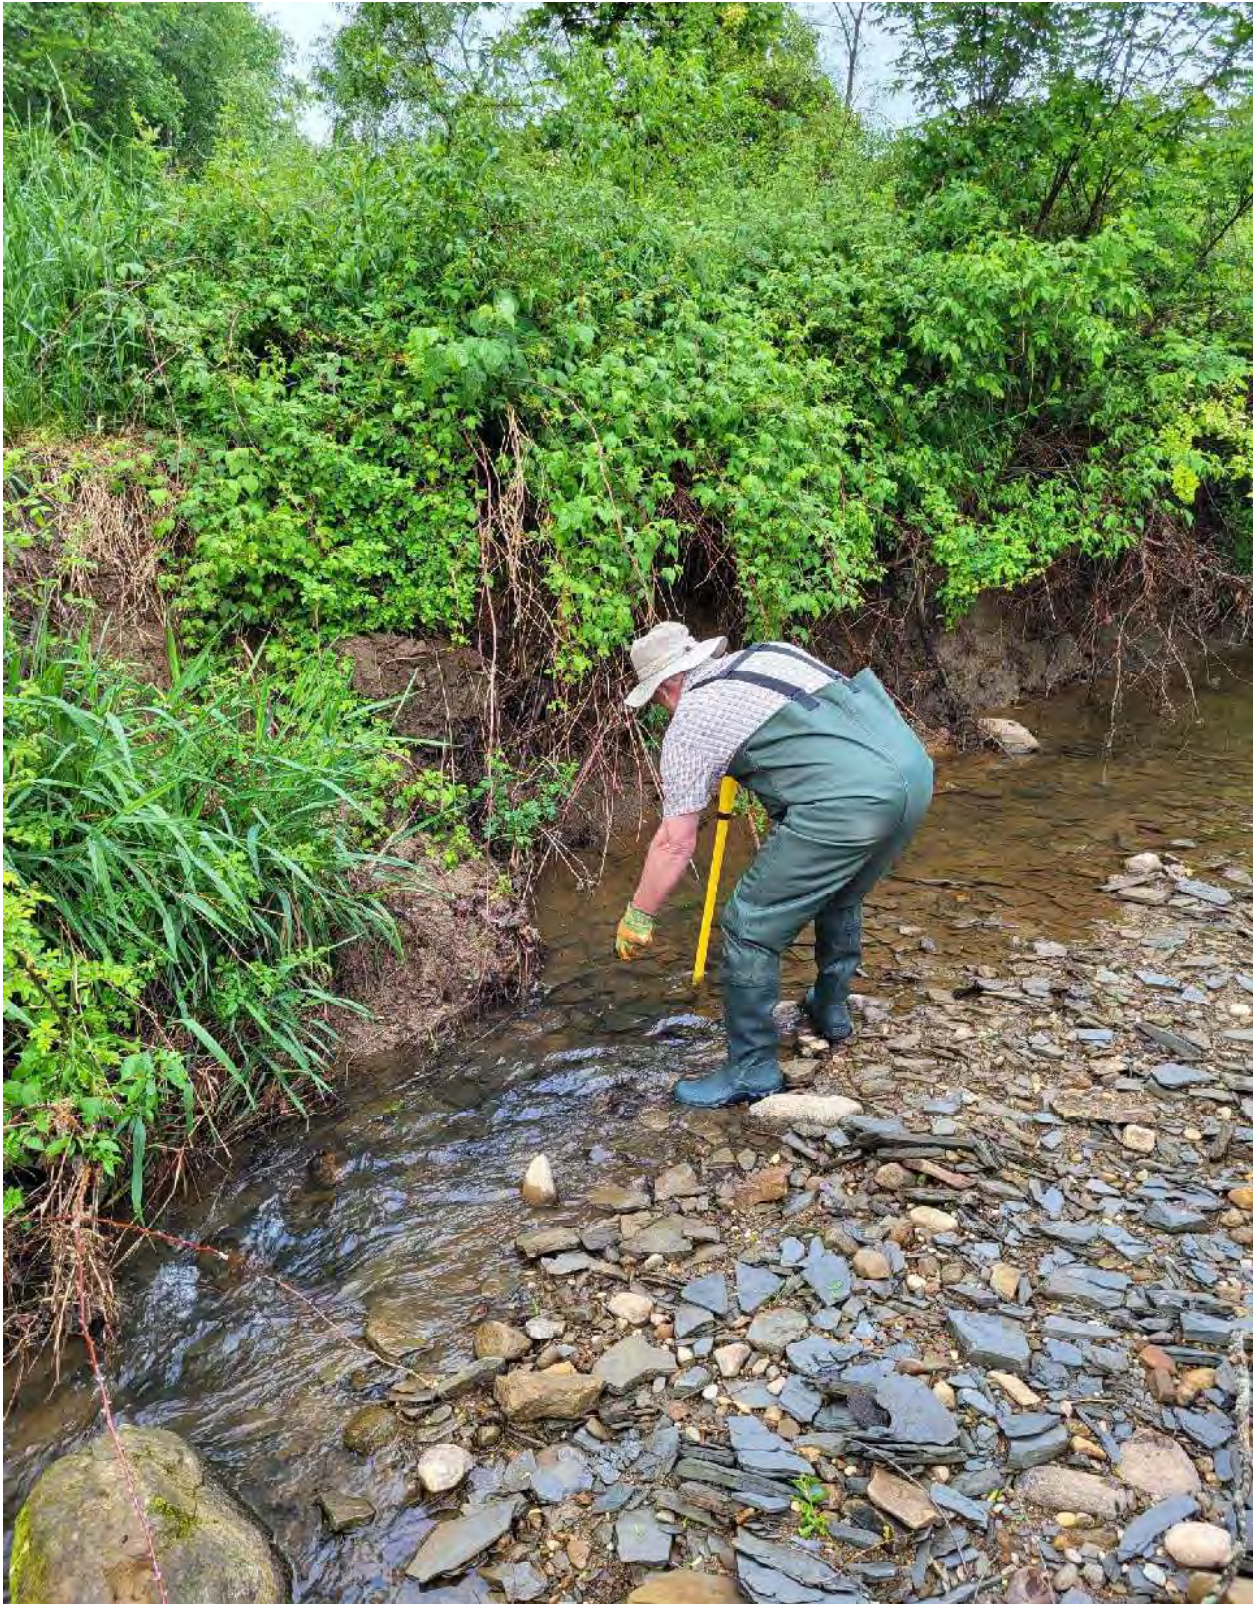
**MDAS recovery, west side of culvert.**

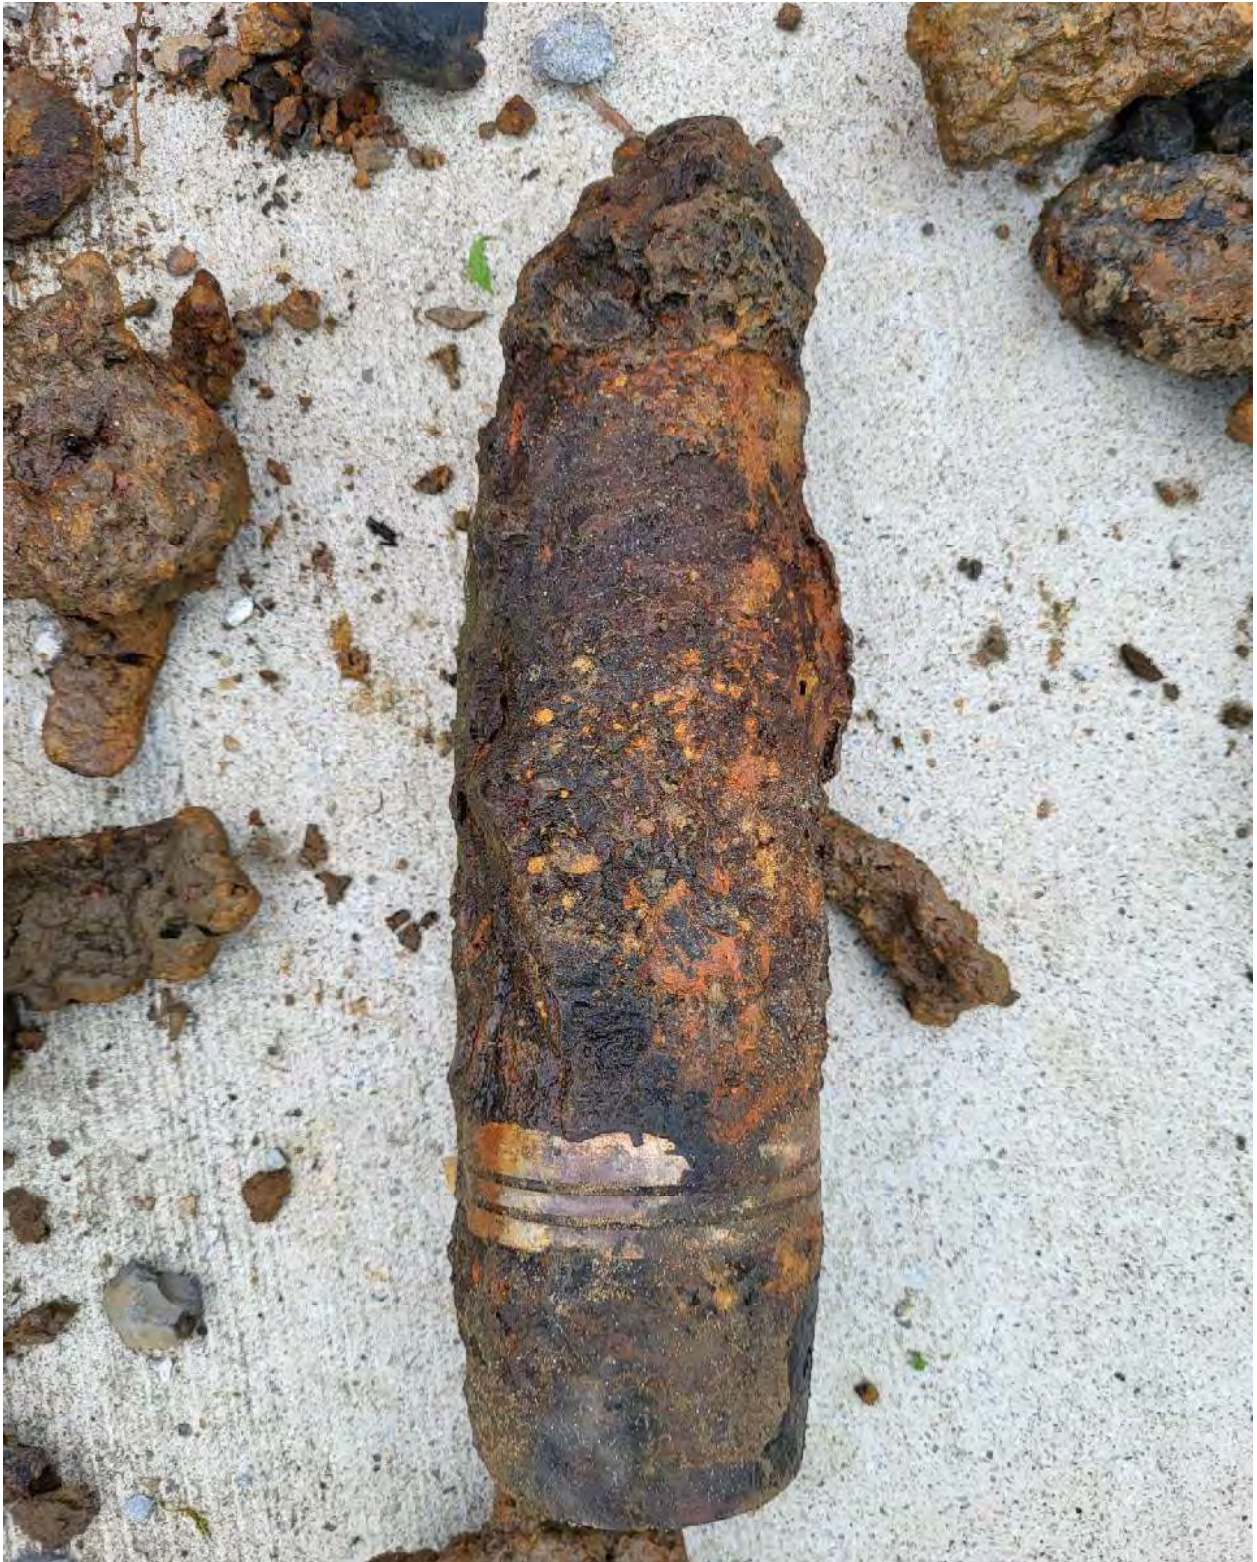
MEC was not encountered during the survey. Most recovered MPPEH/MD items were inspected and determined to be MDAS. One item remains MPPEH and will require further action to determine its explosive safety status. All MDAS was transported to the earth covered magazine (Bldg 1501) at ODA2 and stored for final disposition (recycling) at a future date.

**105mm MPPEH**

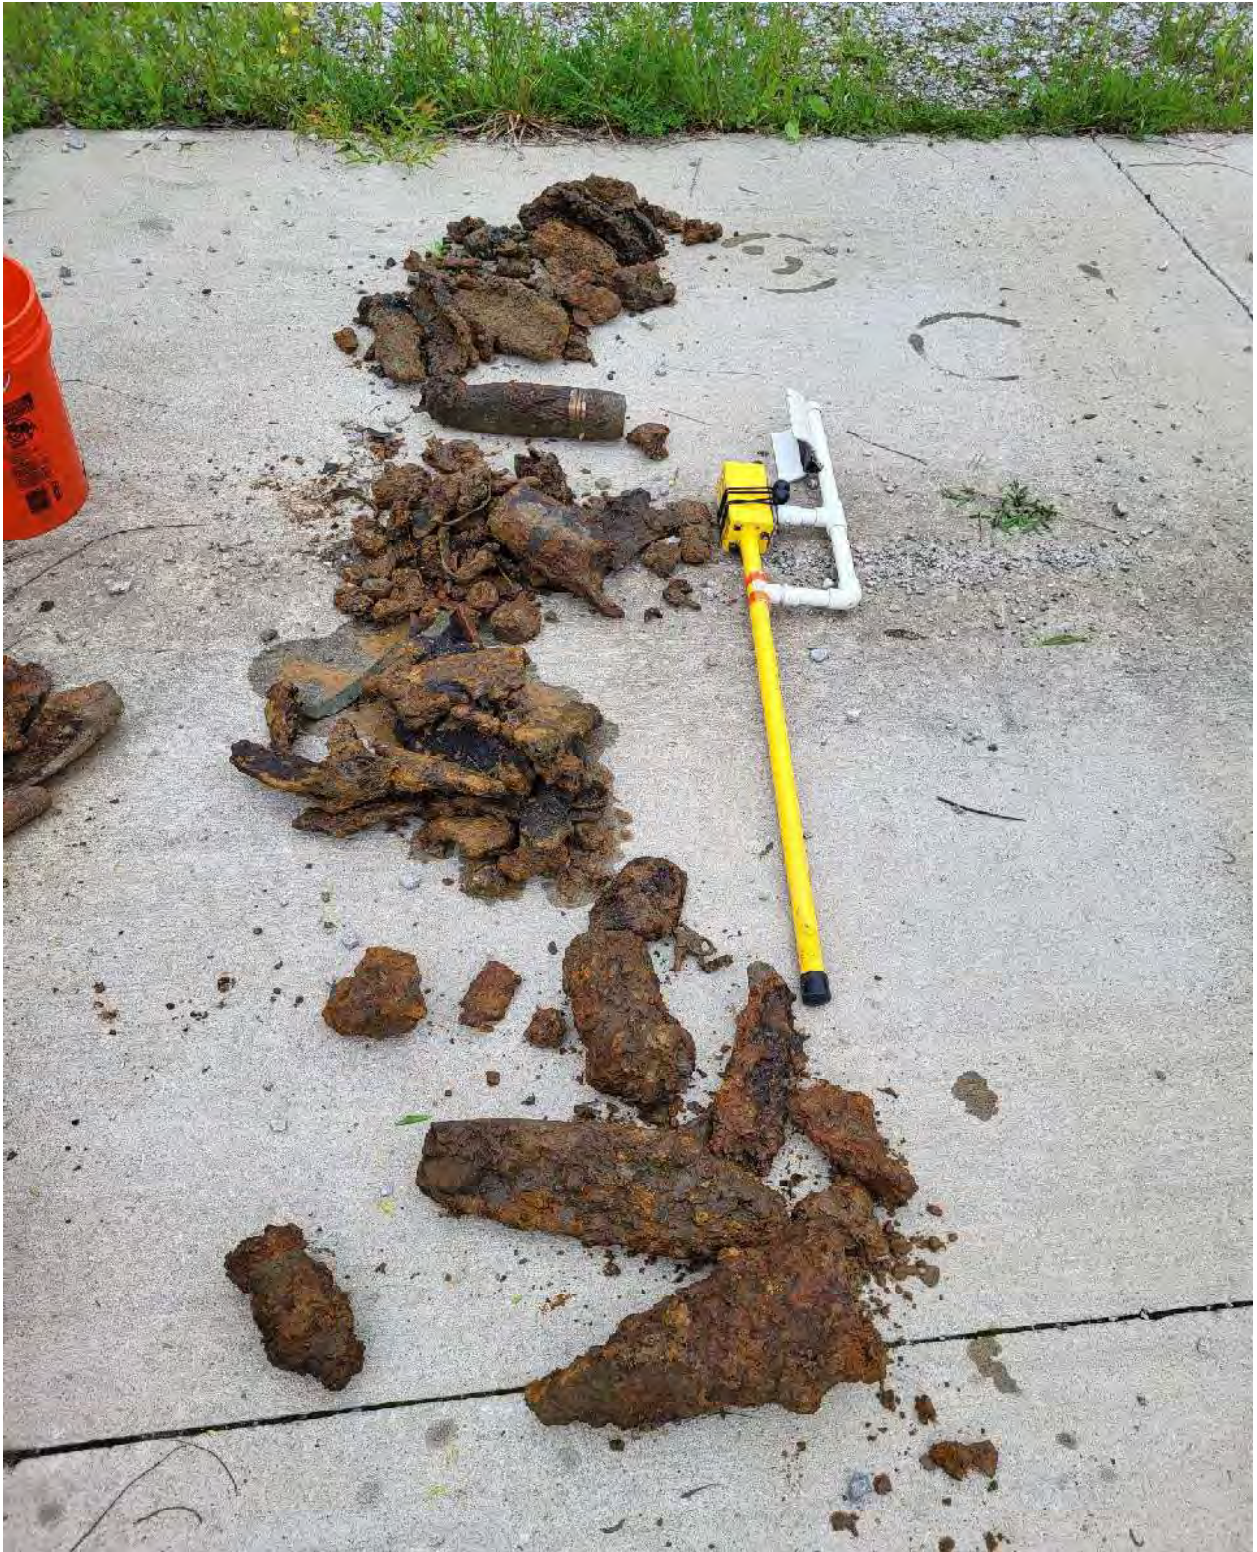
**MPPEH/MDAS recovered from west side of culvert.**
