**Time Critical Response Action for the
Rocket Ridge Area of Open Demolition Area #2
(RVAAP-004-R-01 Open Demolition Area #2 MRS)
Military Munitions Response Program
Ravenna Army Ammunition Plant
Ravenna, Ohio**

**OPERATIONS AND MAINTENANCE TRIP PREPORTS
and QUARTERLY EFFECTIVENESS EVALUATION REPORTS**

**TIME CRITICAL RESPONSE ACTION for the
ROCKET RIDGE AREA OF OPEN DEMOLITION AREA #2
(RVAAP-004-R-01 Open Demolition Area #2 MRS)**

**MILITARY MUNITIONS RESPONSE PROGRAM
RAVENNA ARMY AMMUNITION PLANT
RAVENNA, OHIO**

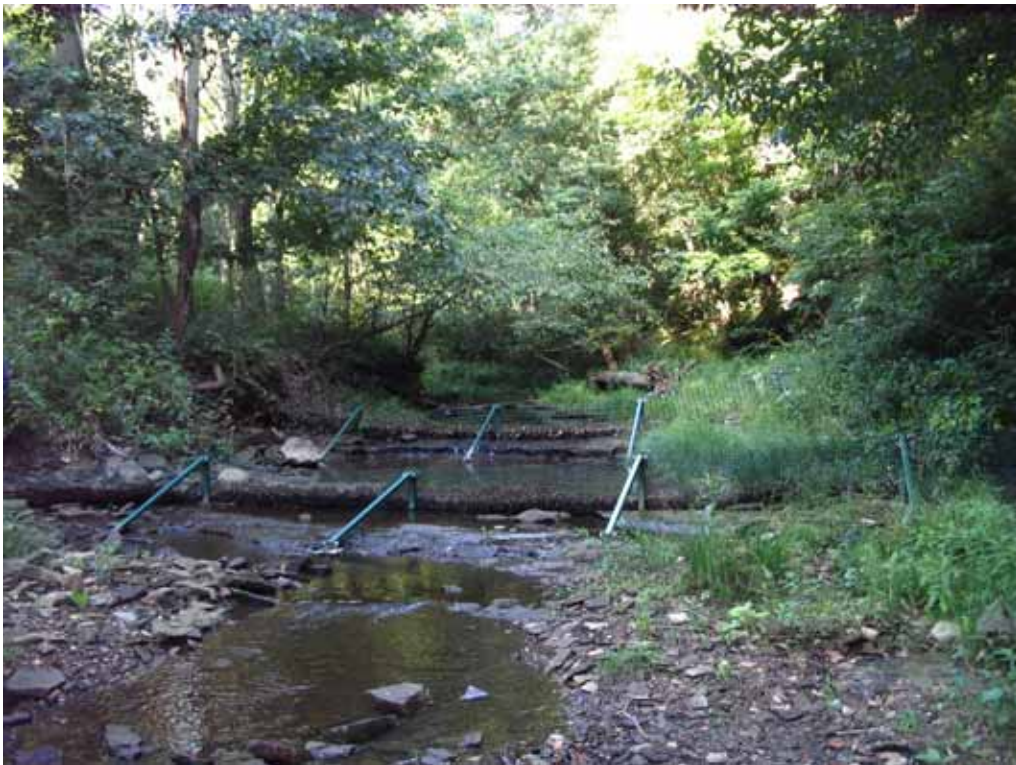
View of barriers upon arrival.

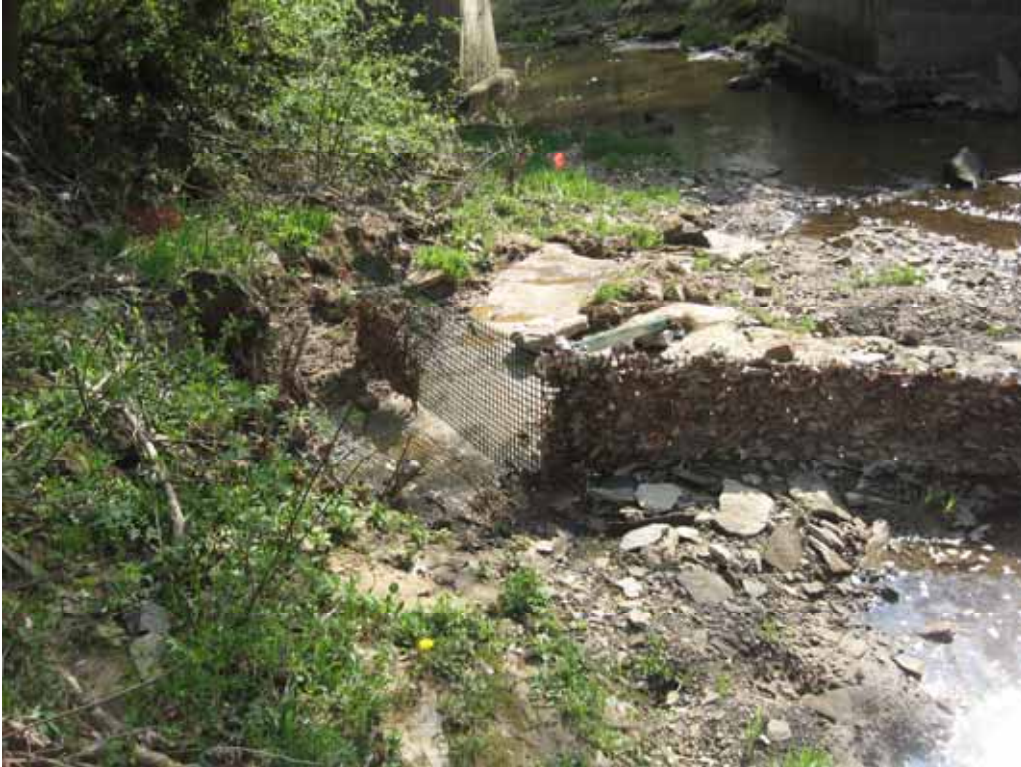
Picture showing north end of the bottom screen detached from stream bank.

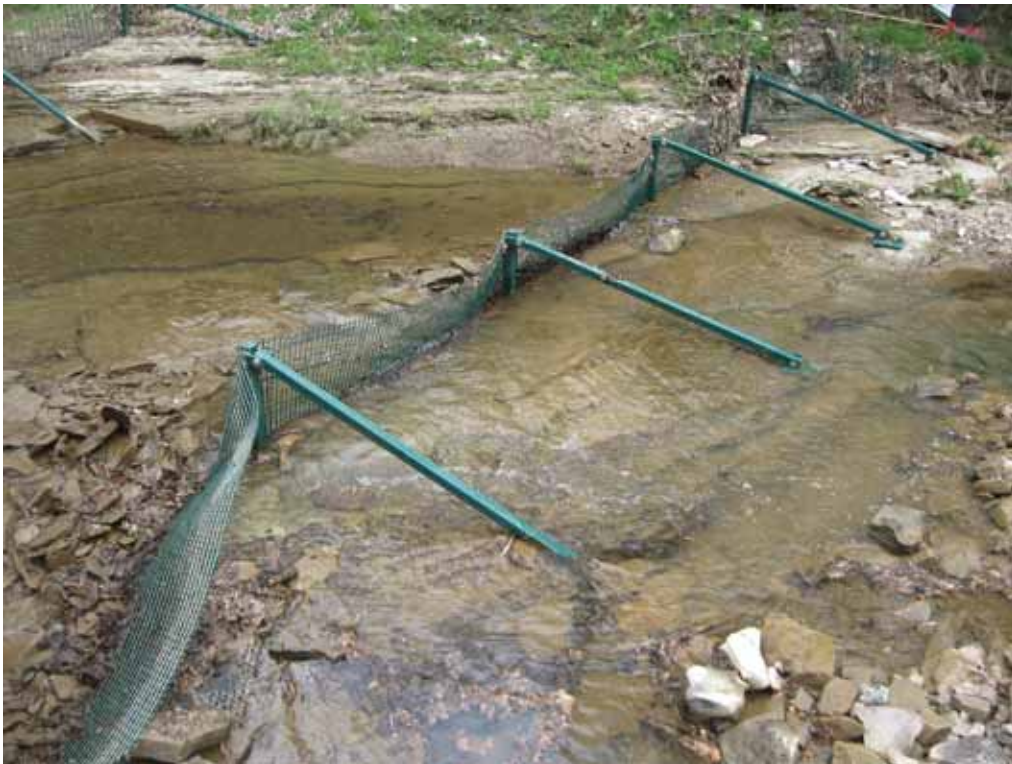
Picture showing south end of the bottom screen detached from stream bank.

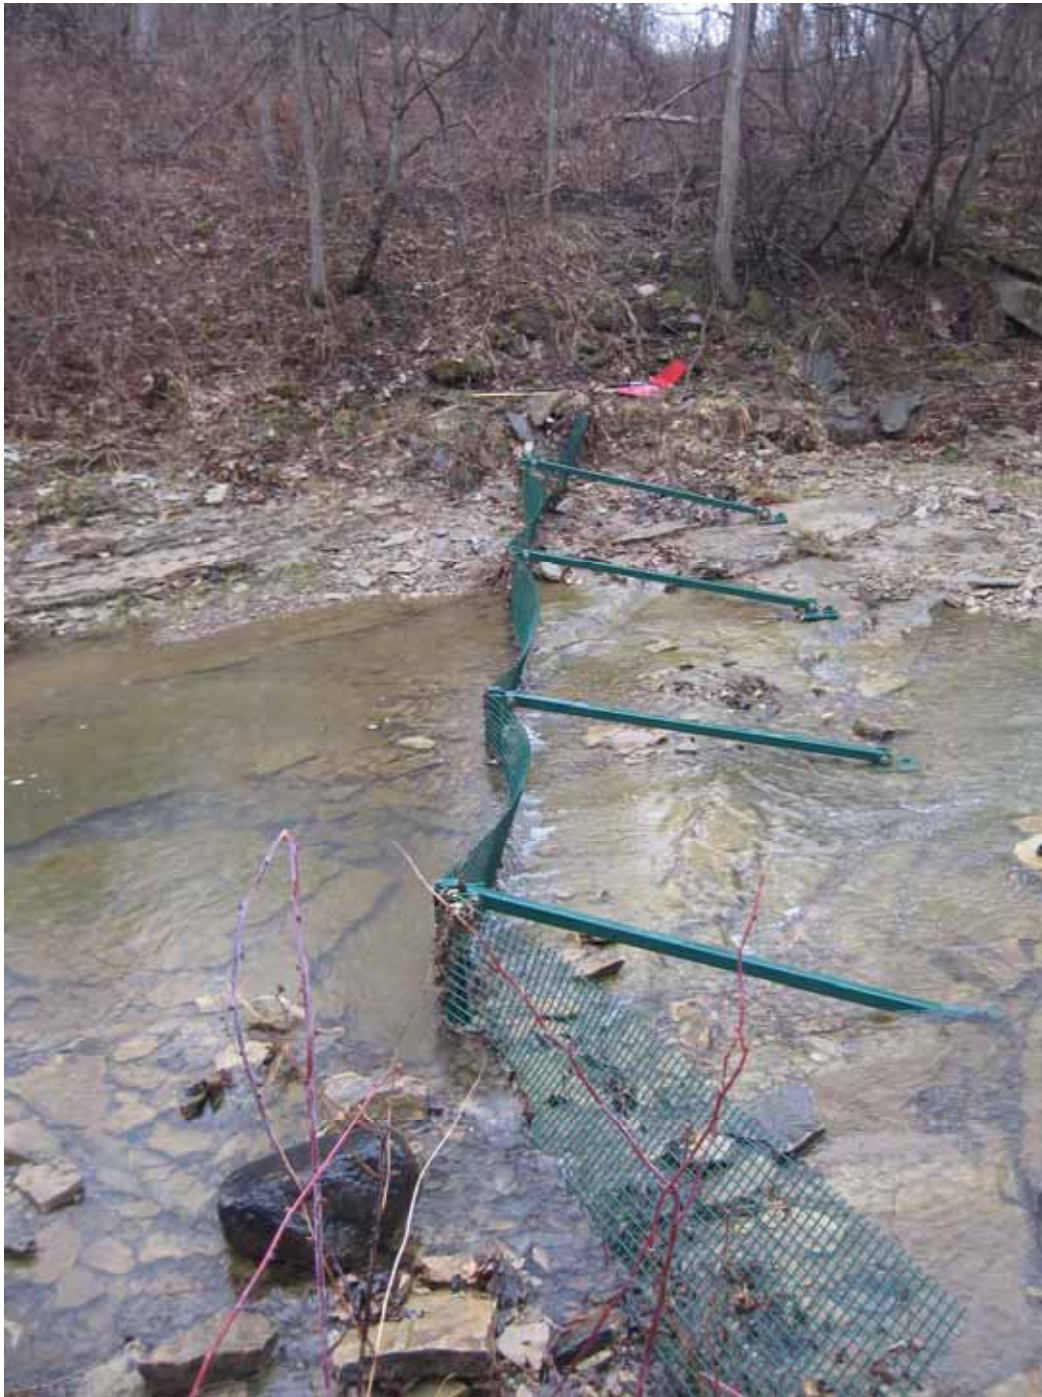
View showing degree of bowing on bottom screen.

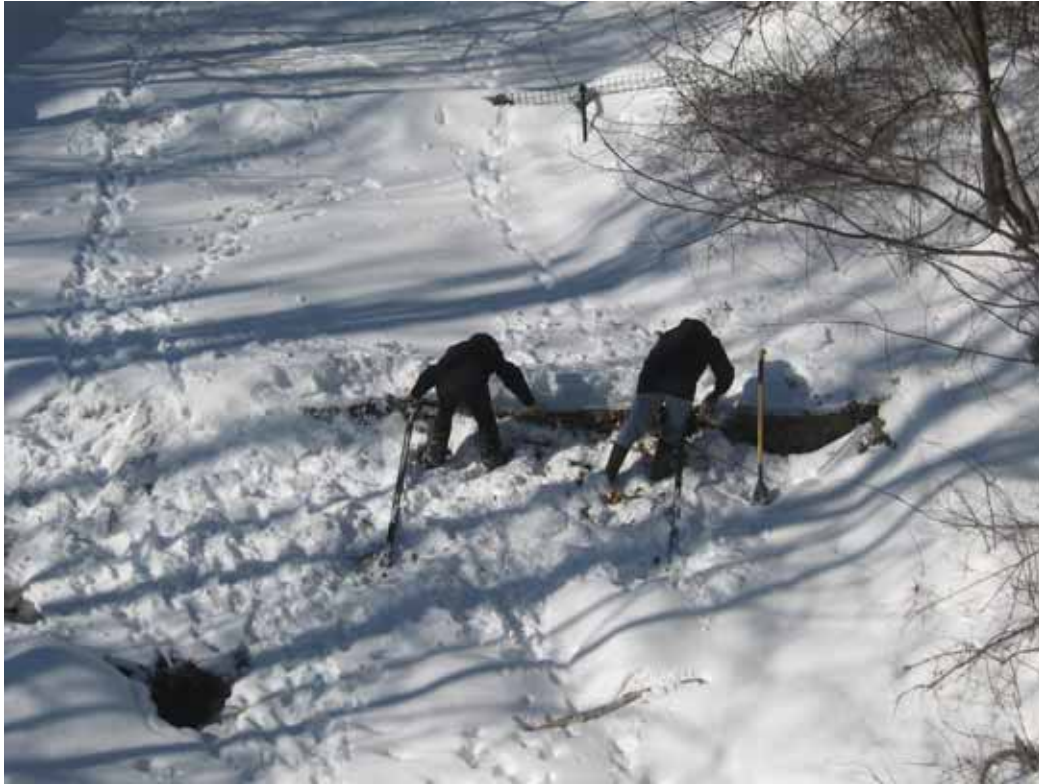
Measuring the bowing of screen

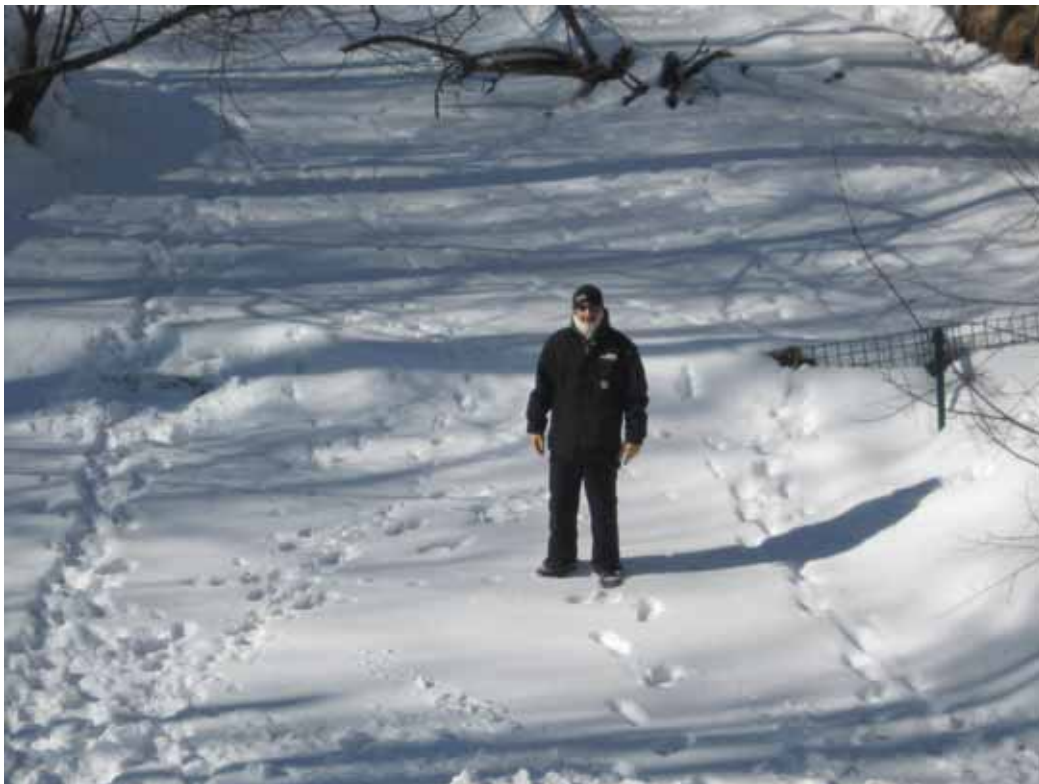
Photo depicts the thickness of ice at Sand Creek

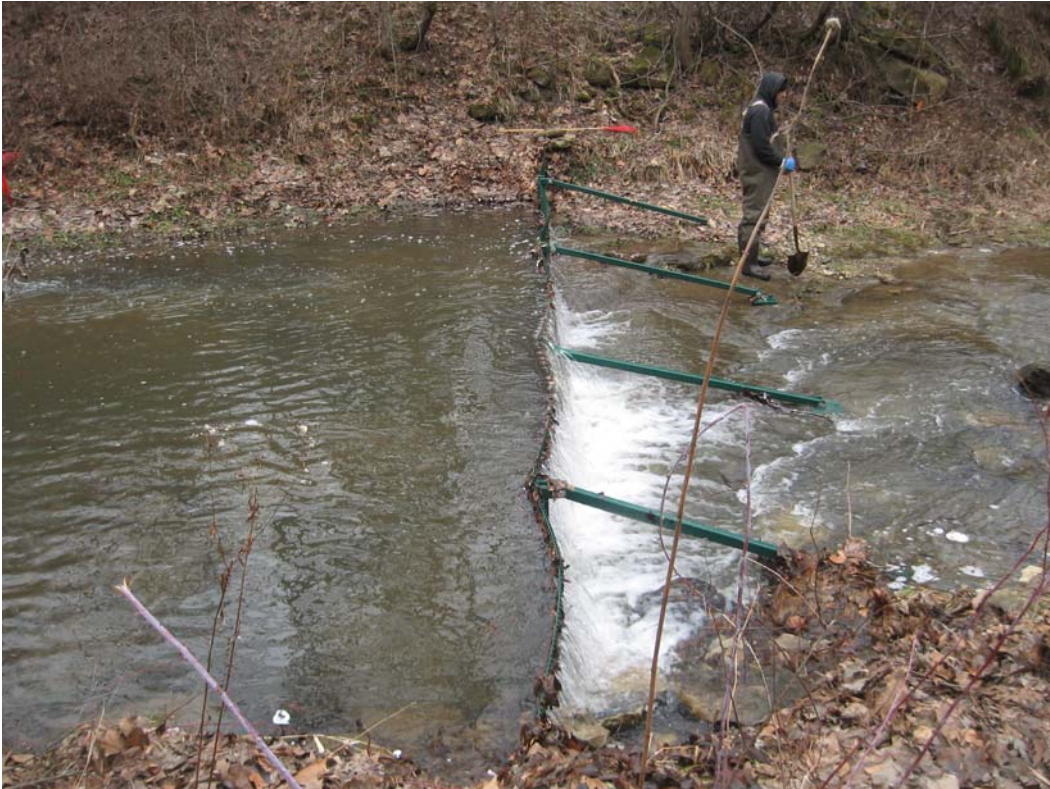
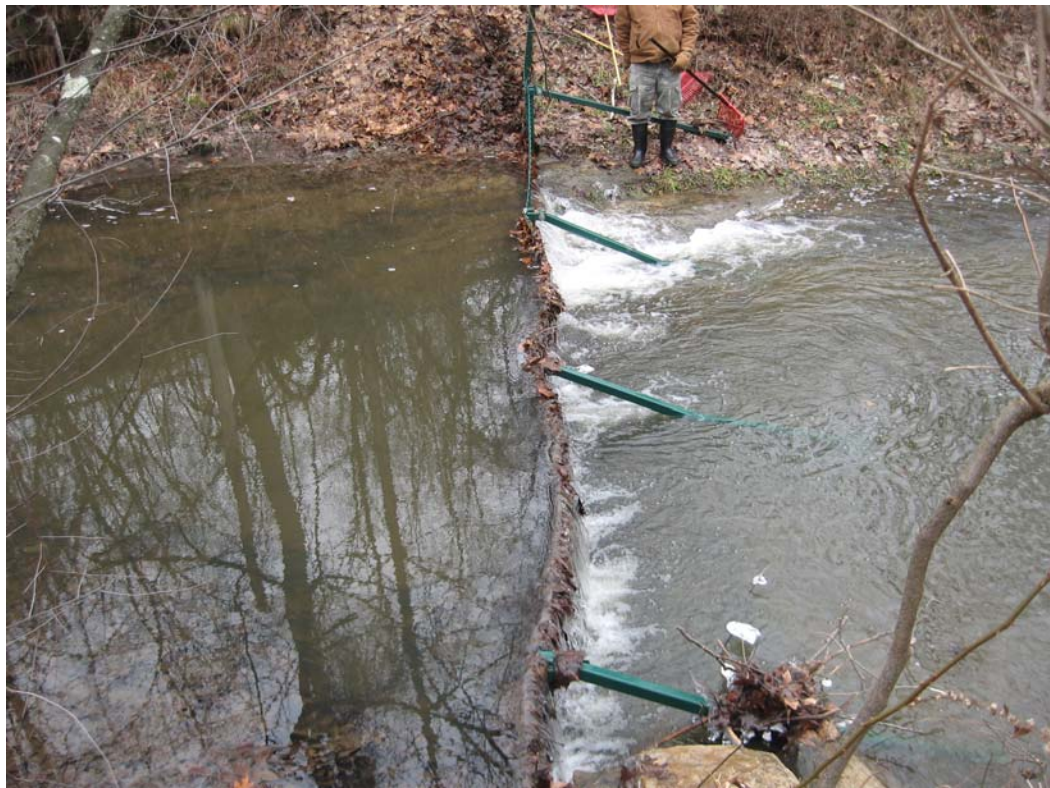
Screens bowing

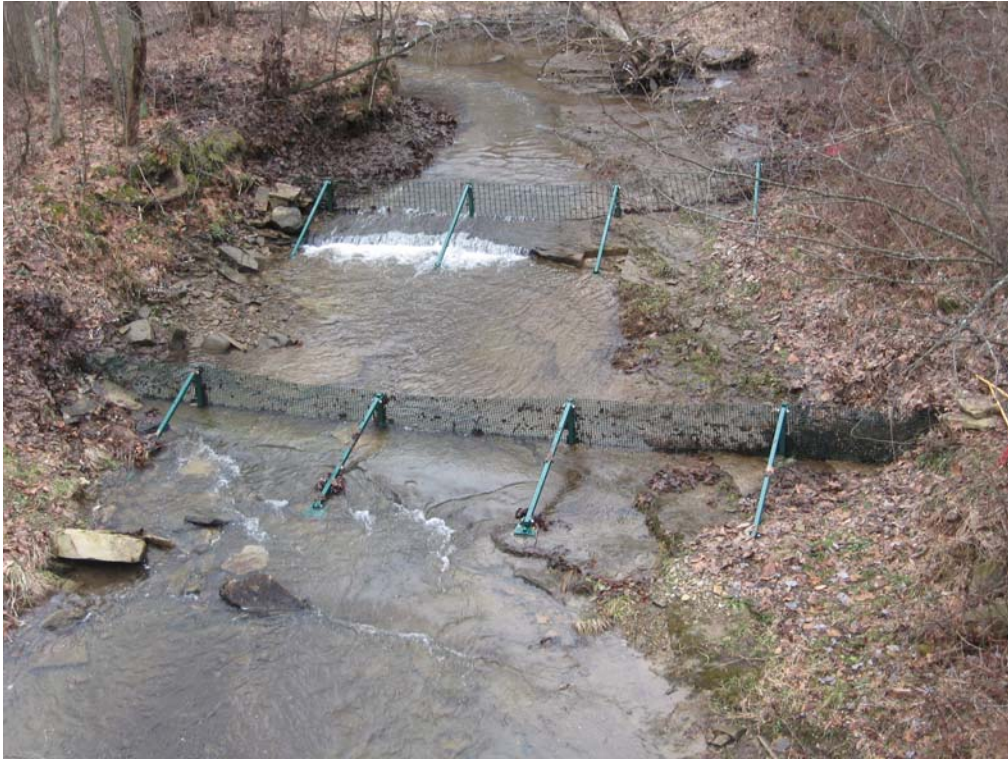
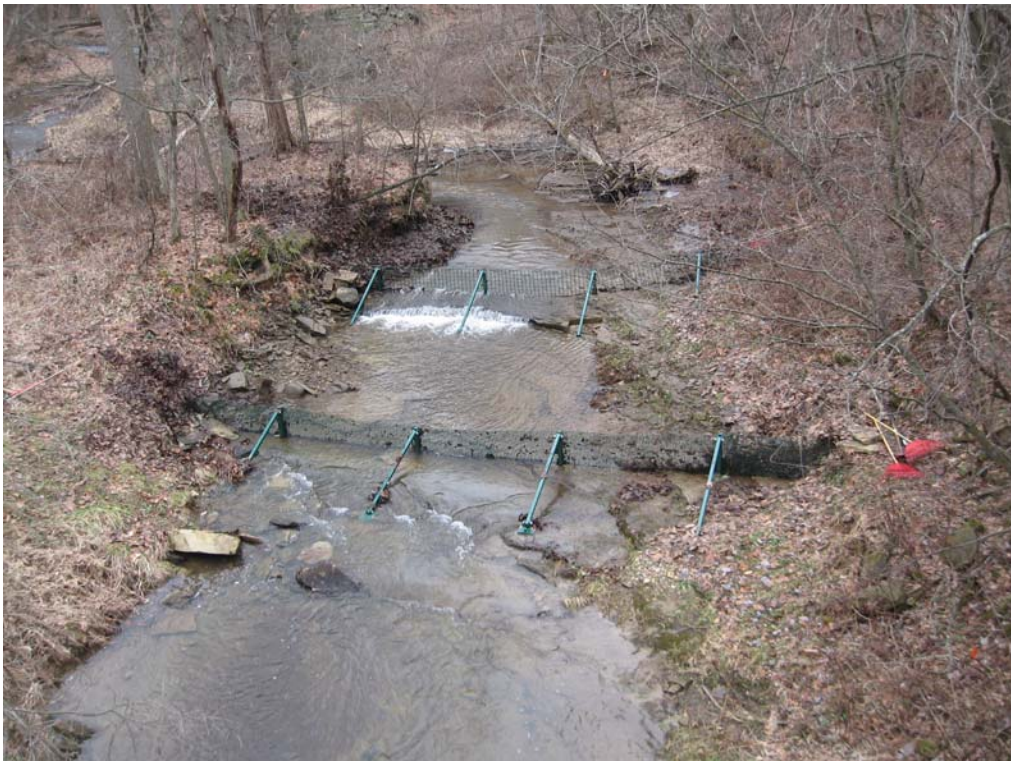
Overview of barriers following cleaning operations.
Note: Remaining debris seen on screens is frozen to the screens.

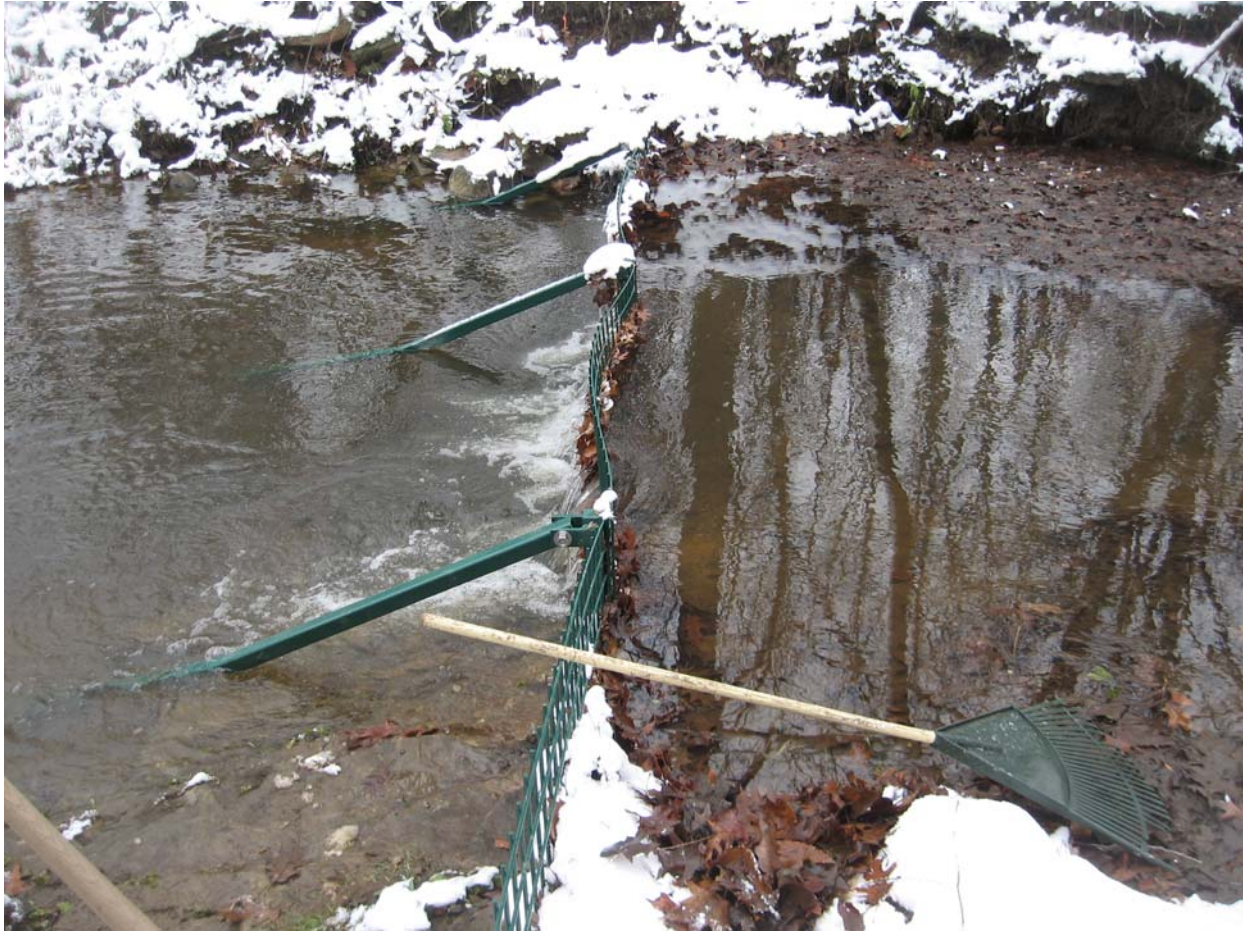
Screens bowing.

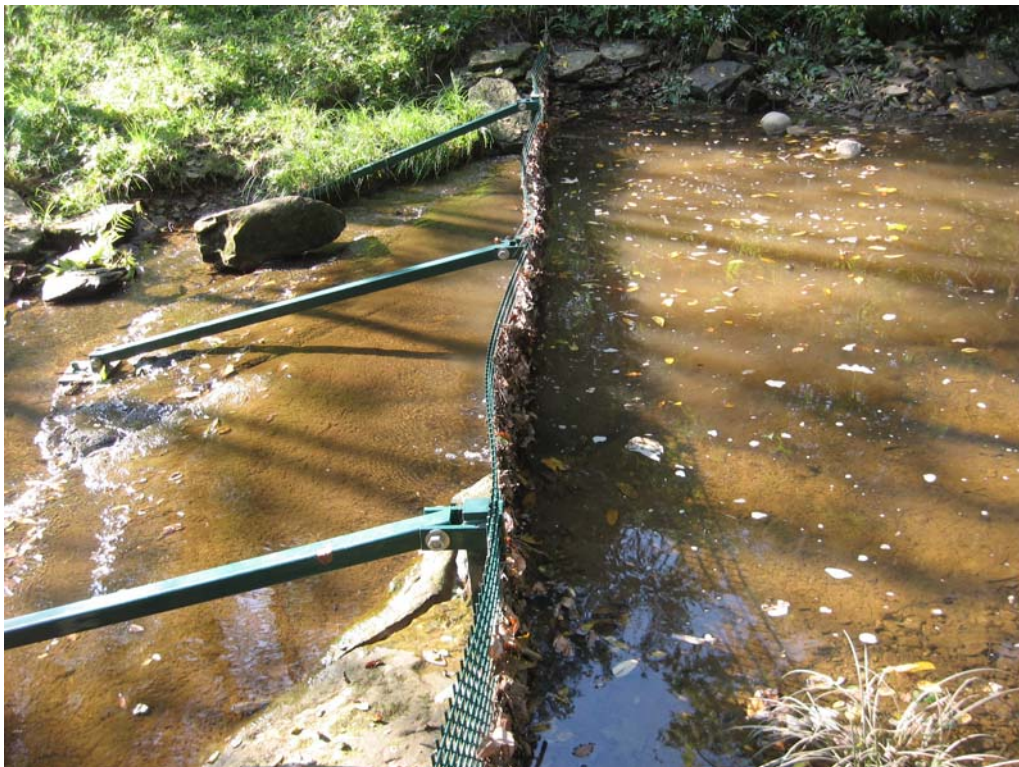
Bowing of barrier

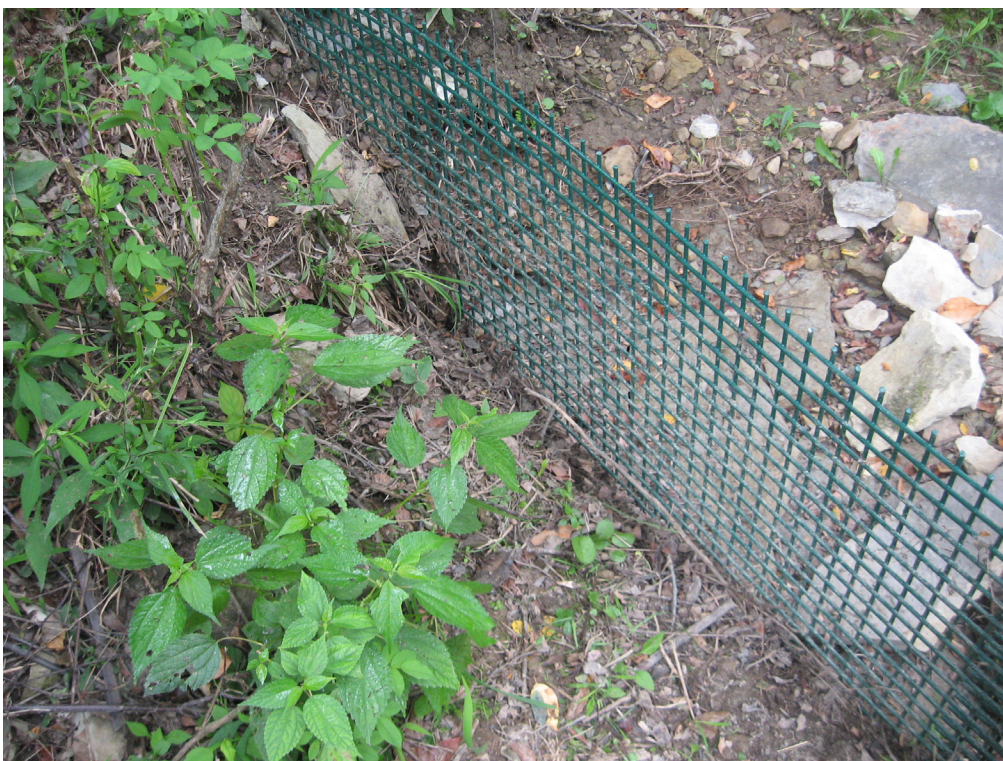
Washout area at second barrier

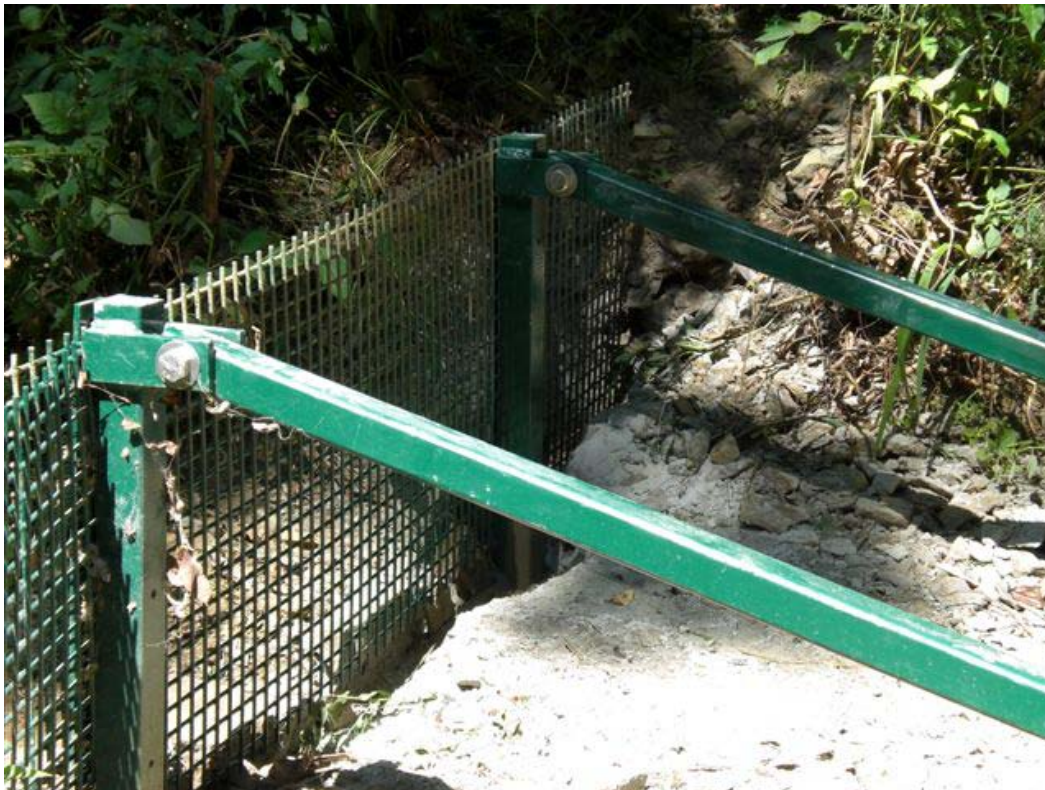
Photo 5: New post at north end of downstream barrier (2 September 2009)

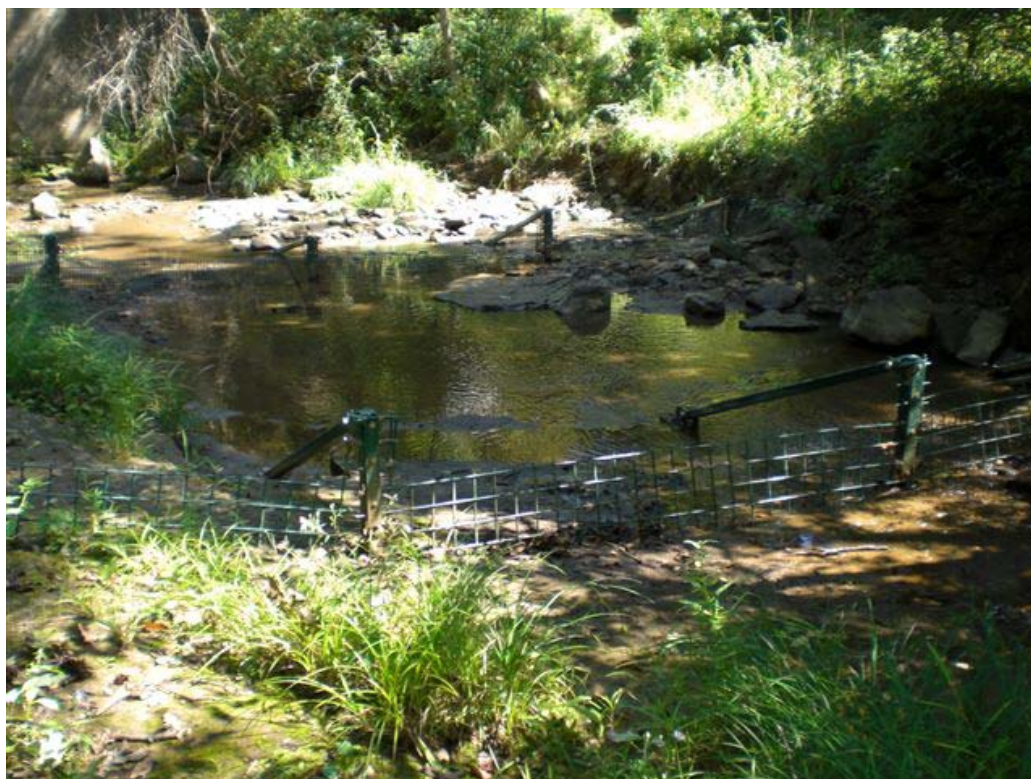
Photo 6: Upstream panels after height reduction (2 September 2009)

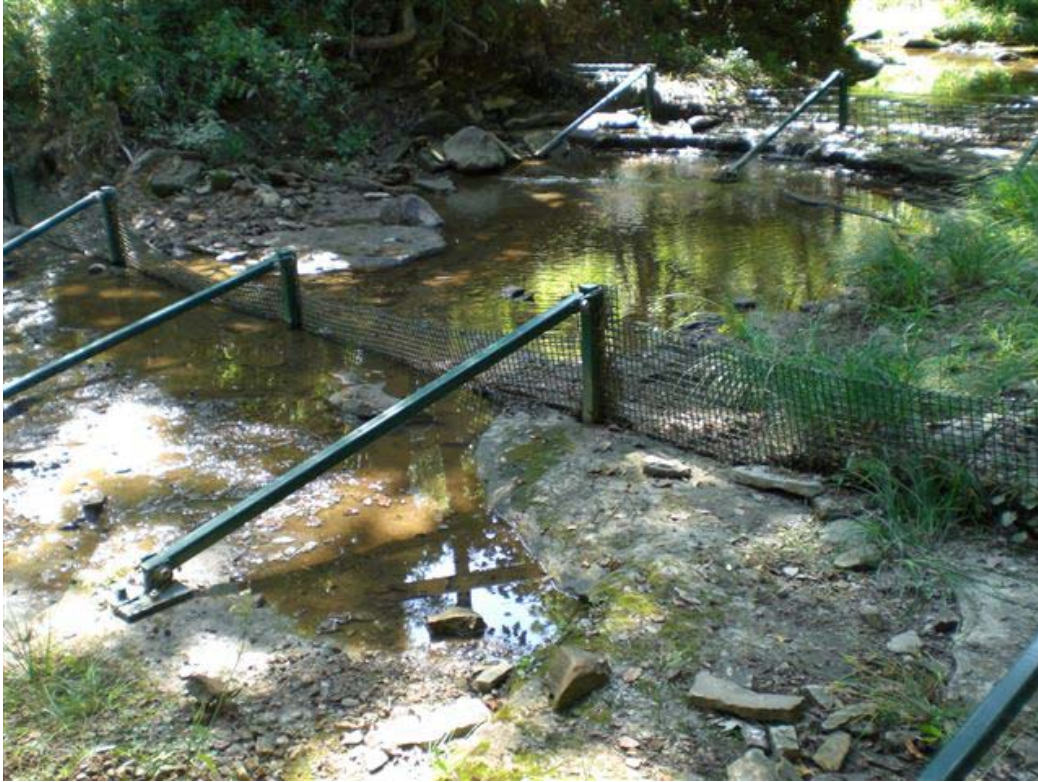
Photo 7: Downstream panels after height reduction (2 September 2009)

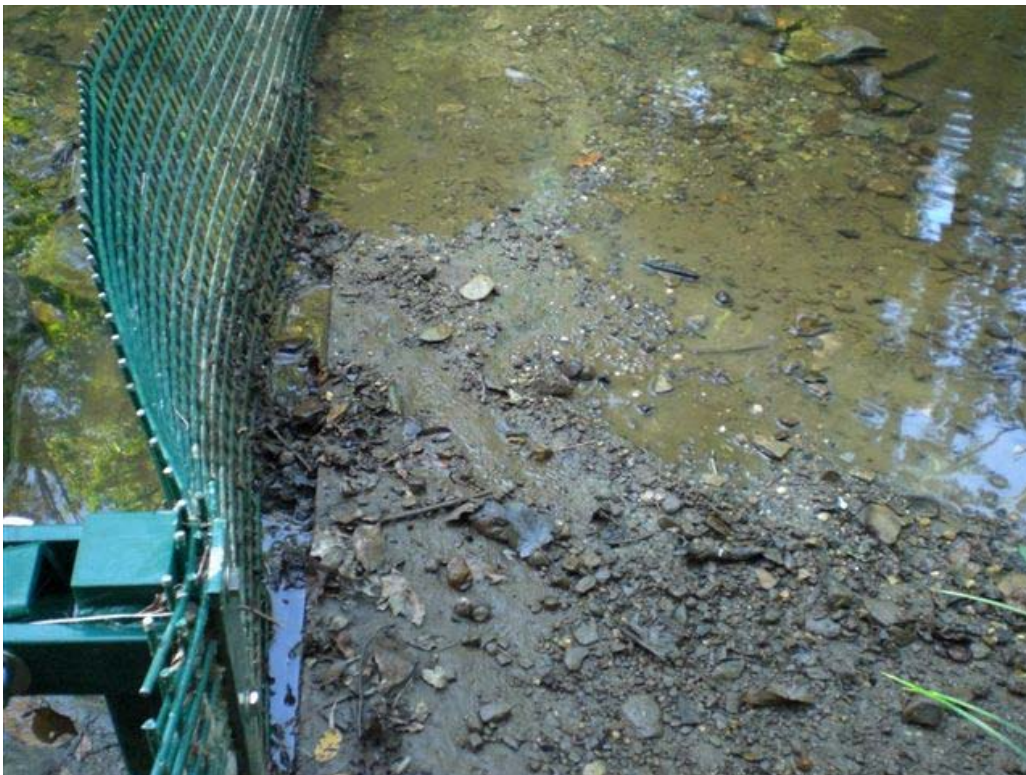
Photo 8: Area in front of downstream barrier after the removal of sand and gravel accumulation (2 September 2009)

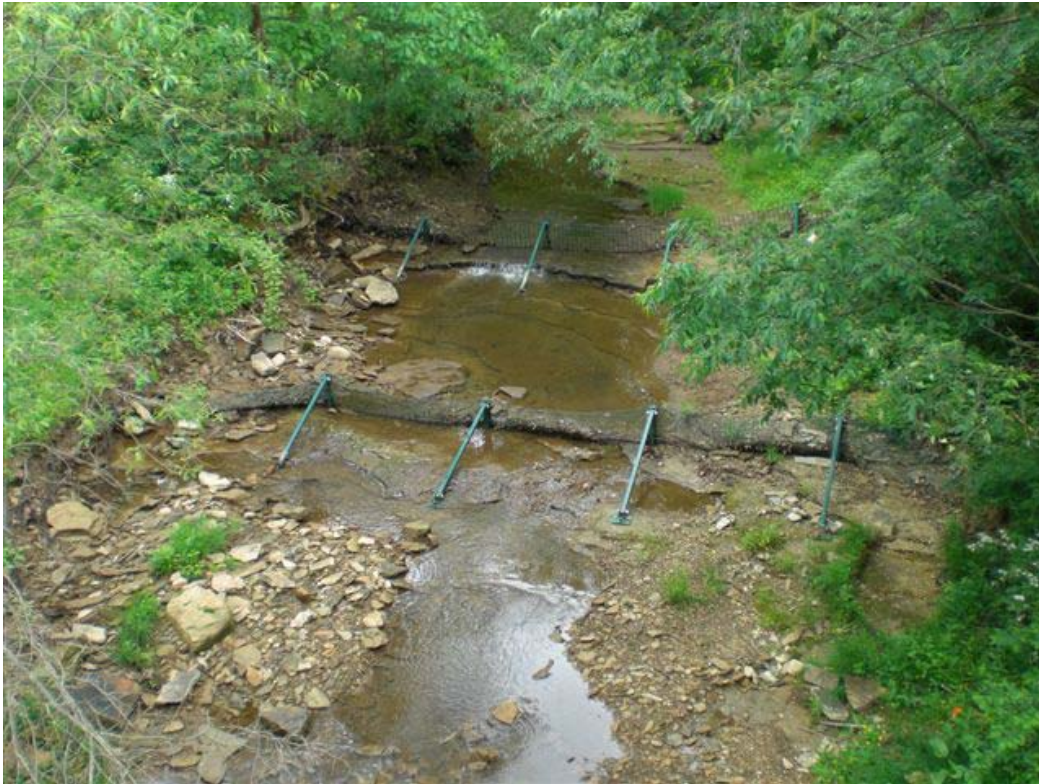
Materials found on the screens: Leaves, branches, sticks, sand and gravel. No munitions-related materials were found on the screens (see Photo #1).

Photo 1: Sand Creek Barrier System (27 May 2009)

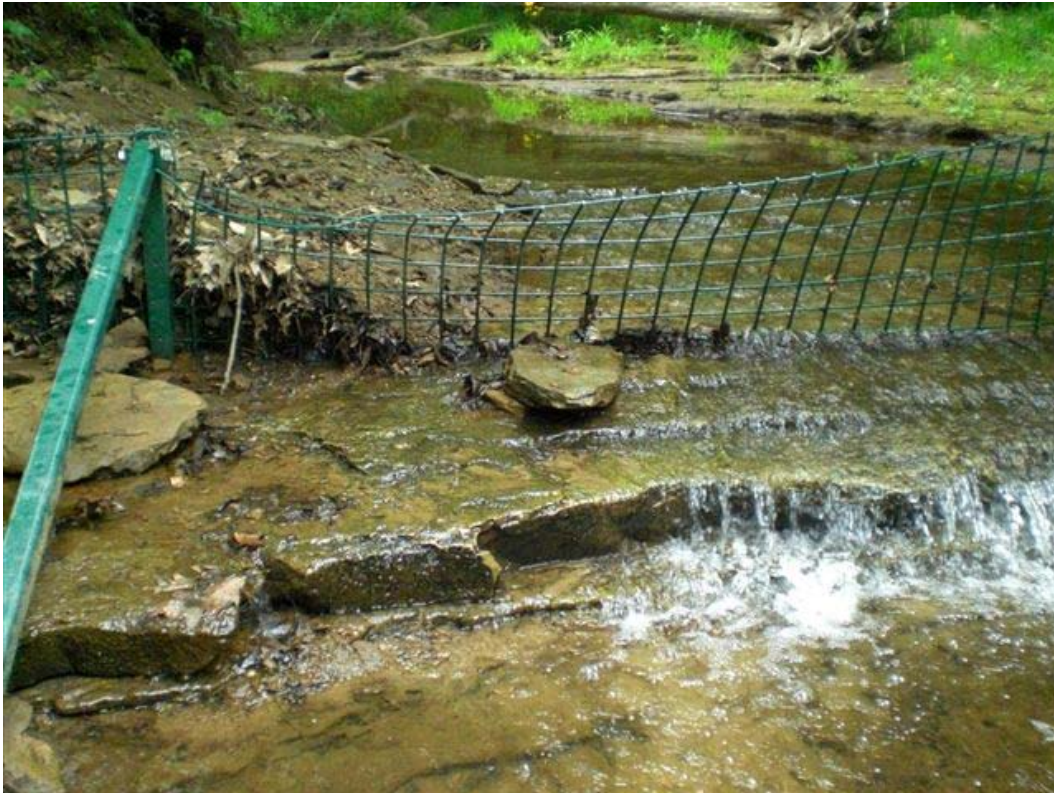
Photo 3: Upstream barrier, second panel from the south (27 May 2009)

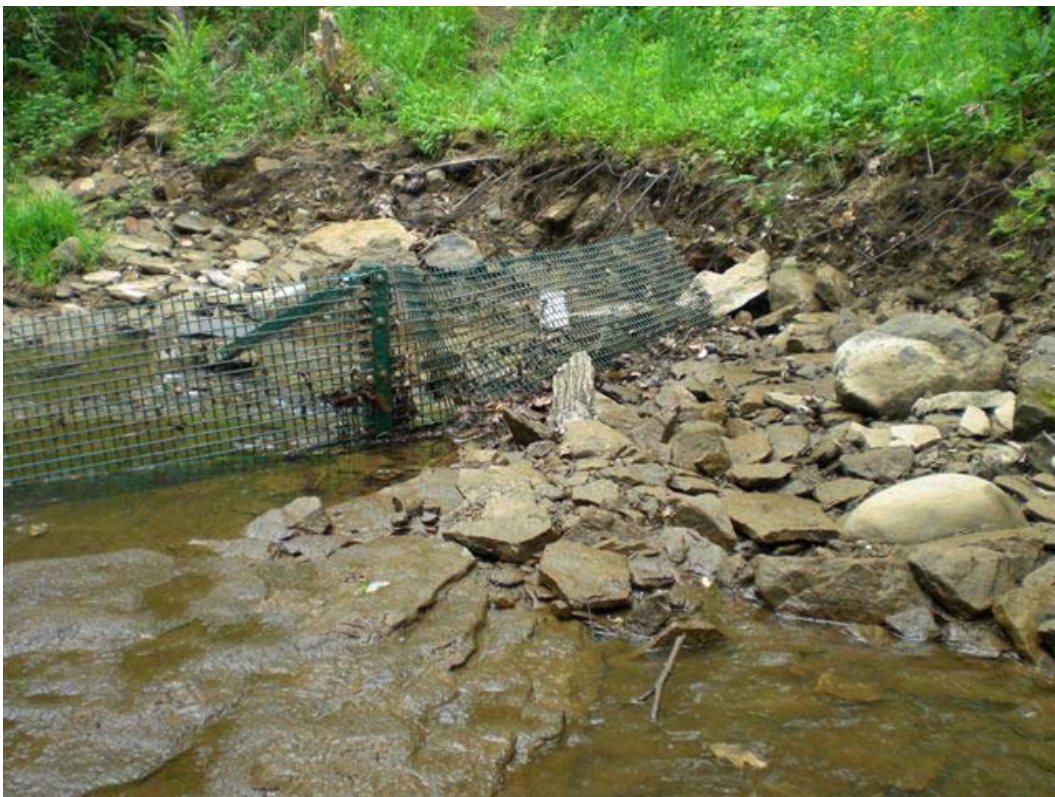
Photo 4: Downstream barrier, south end panel (27 May 2009)

2. Install new post and back brace at the south end of the downstream barrier. The new post will be installed approximately 4 - 5 feet south of the existing post. A 24-inch high screen panel will be installed between the new post and the creek bank. The new panel will be keyed into the bank at a point one to three feet in front (upstream) of the barrier line. The angle of this panel will create a component of the stream force that will press the panel against the bank, therefore reducing the potential for the south end of the panel to become loose.

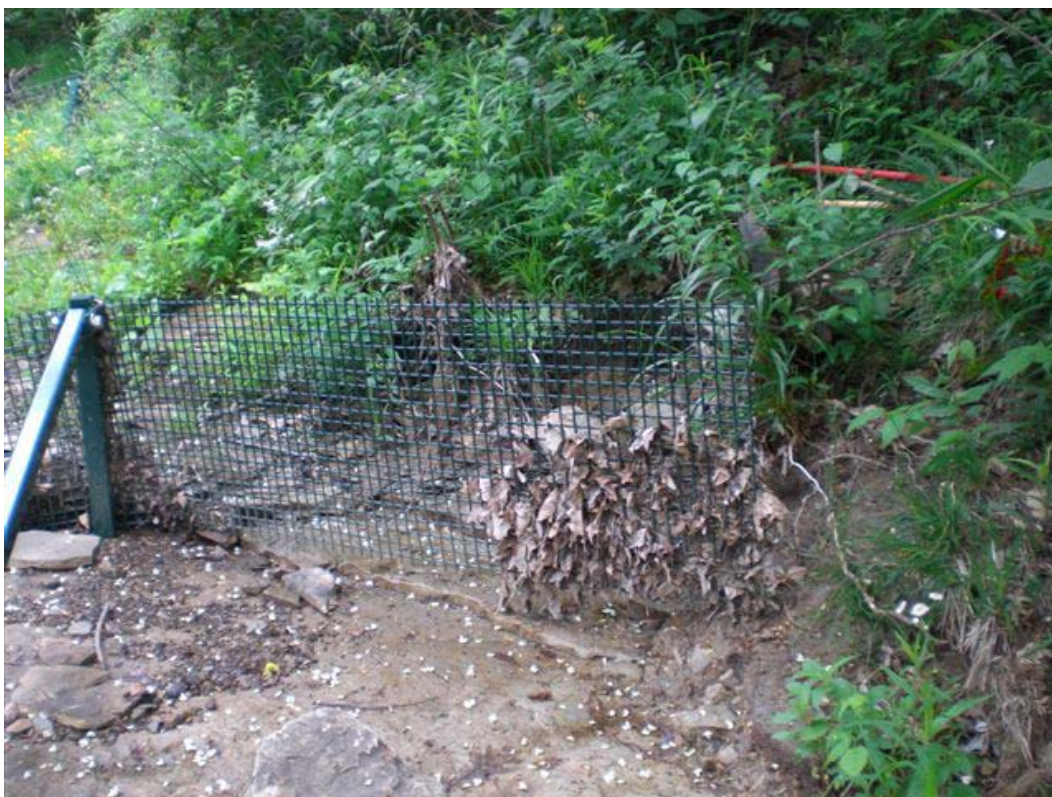
Photo 5: Downstream barrier, north end panel (27 May 2009)

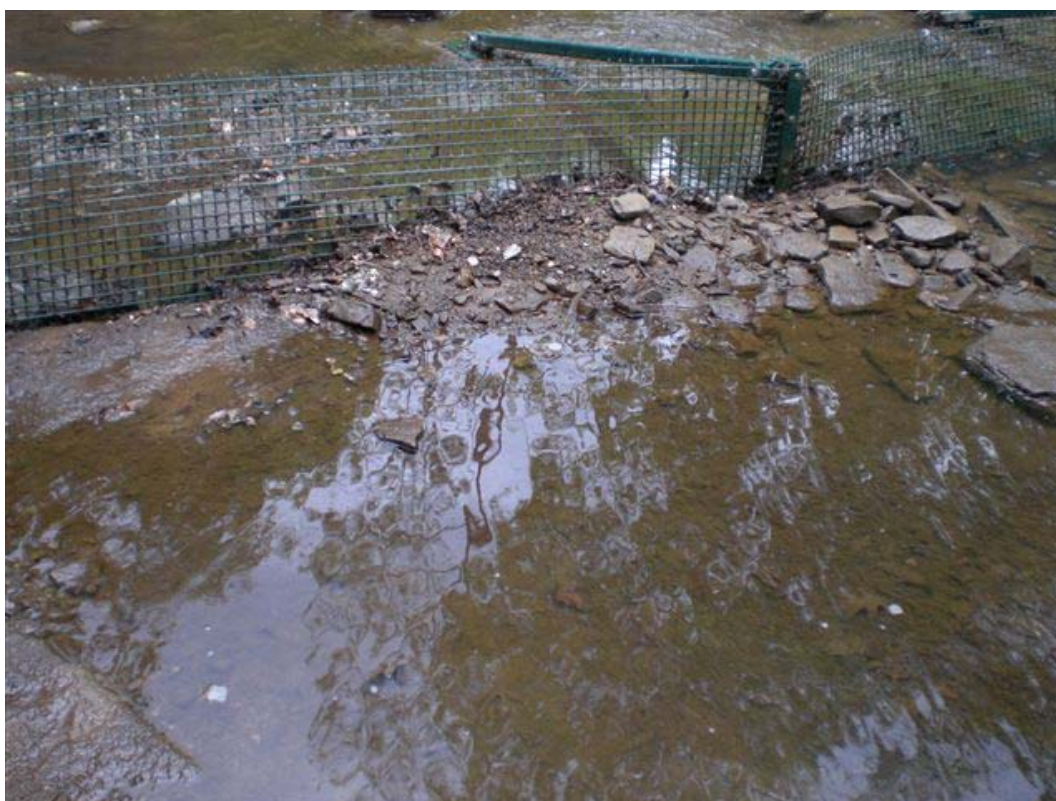
Photo 6: Downstream barrier, sand and gravel accumulation (27 May 2009)

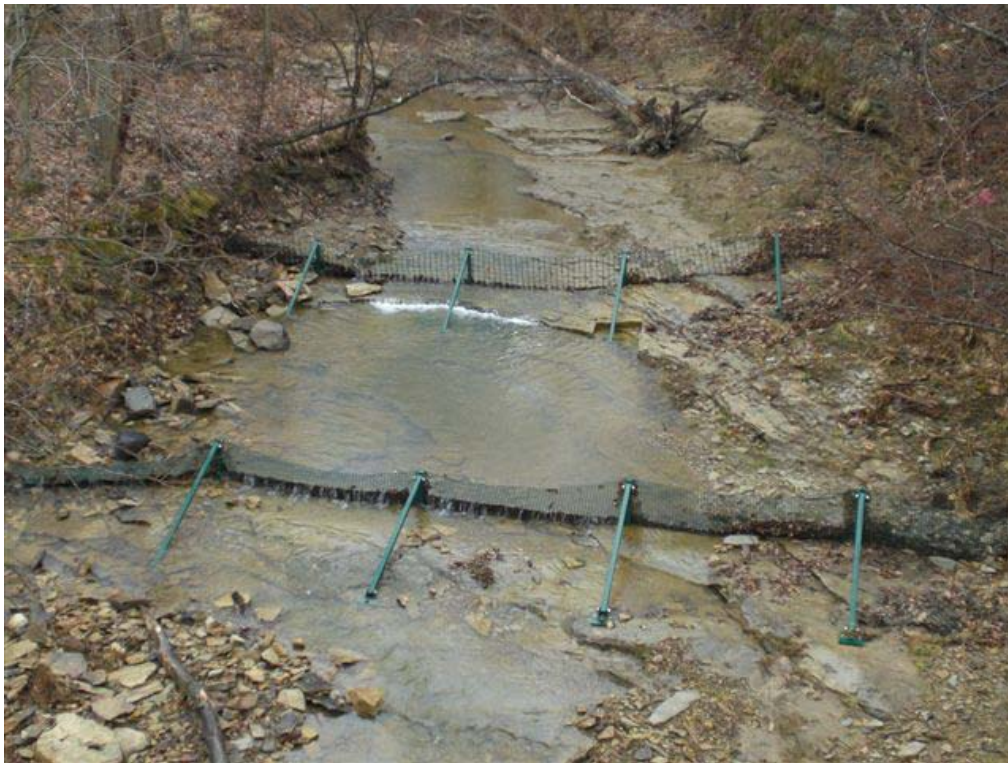
Since the 5 February 2009 site visit, when the barrier system was almost completely covered in ice and snow, the snow melt, rain, breaking ice, wood debris, and high creek water have resulted in damage to the some of the screen panels (see Photo #1).

Photo 1: Sand Creek Barrier System (25 March 2009)

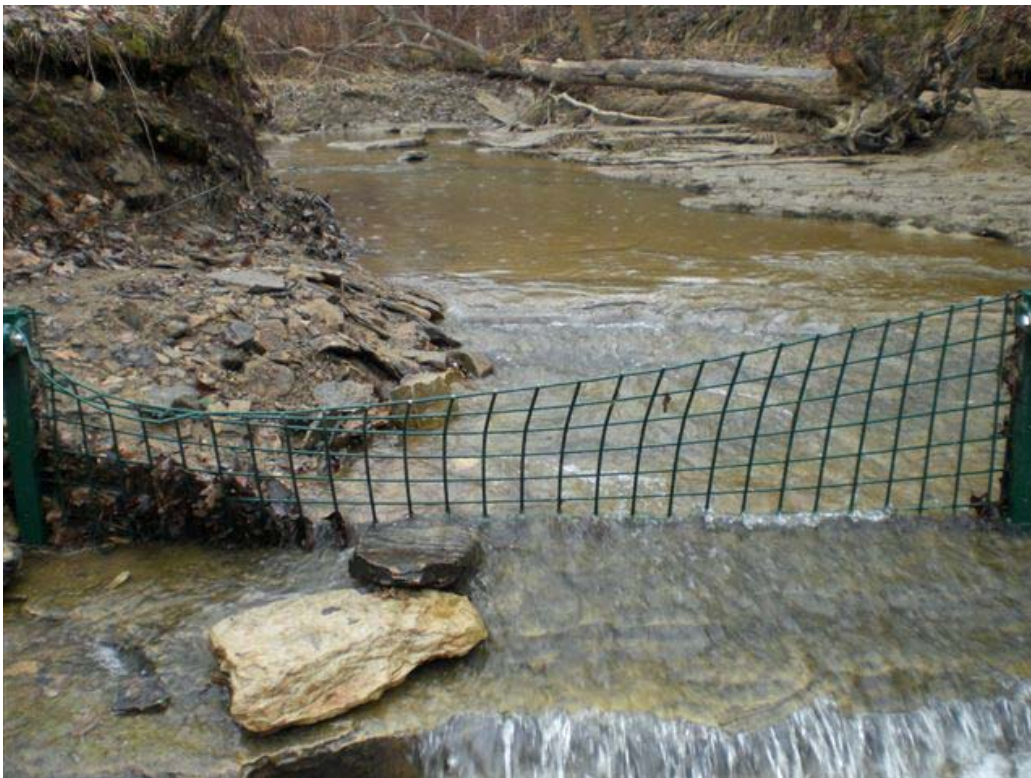
Photo 2: Upstream barrier, second panel from the south (25 March 2009)

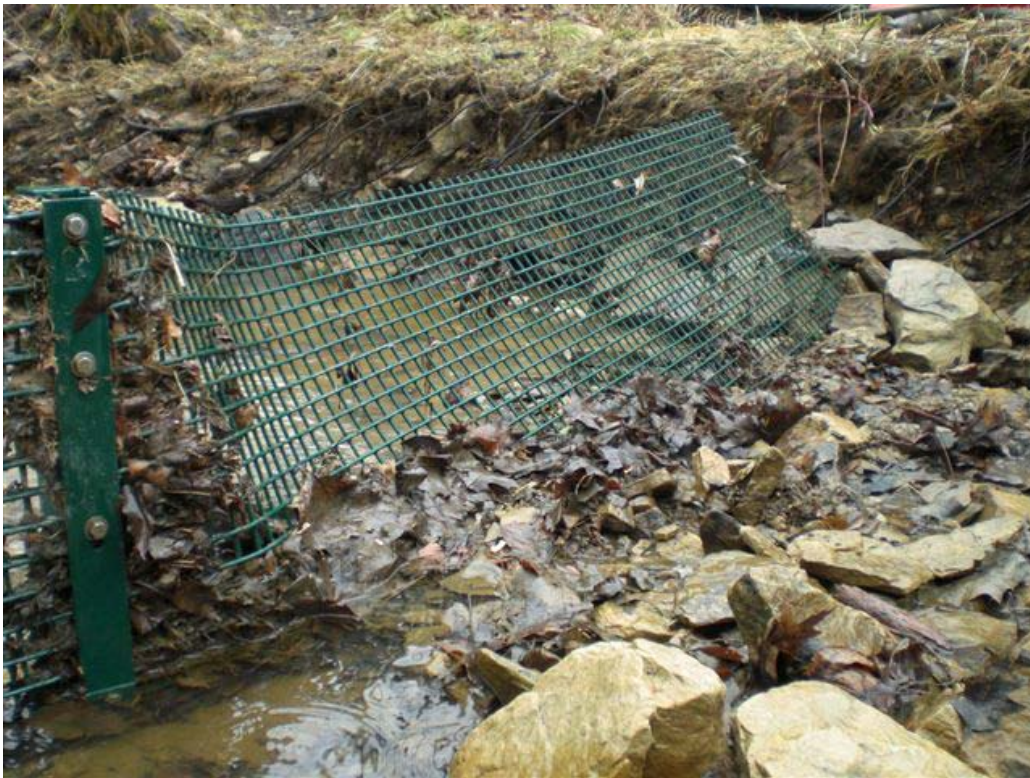
Photo 3: Downstream barrier, first panel from the south (25 March 2009)

2. Install new post and back brace at the south end of the downstream barrier. The new post will be installed approximately 4 - 5 feet south of the existing post. A 24-inch high screen panel will be installed between the new post and the creek bank. The new panel will be keyed into the bank at a point one to three feet in front (upstream) of the barrier line. The angle of this panel will create a component of the stream force that will press the panel against the bank, therefore reducing the potential for the south end of the panel to become loose.

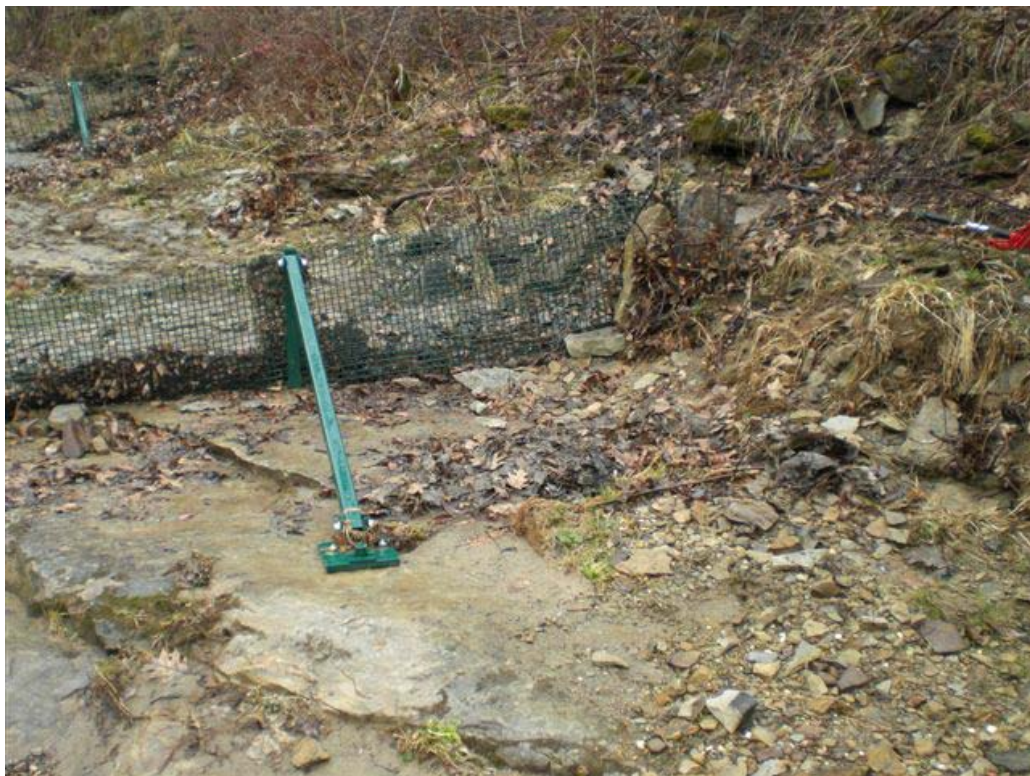
Photo 4: Downstream barrier, north end panel (25 March 2009)
