**Time Critical Response Action for the
Rocket Ridge Area of Open Demolition Area #2
(RVAAP-004-R-01 Open Demolition Area #2 MRS)
Military Munitions Response Program
Ravenna Army Ammunition Plant
Ravenna, Ohio**

**OPERATIONS AND MAINTENANCE TRIP PREPORTS
and QUARTERLY EFFECTIVENESS EVALUATION REPORTS**

**TIME CRITICAL RESPONSE ACTION for the
ROCKET RIDGE AREA OF OPEN DEMOLITION AREA #2
(RVAAP-004-R-01 Open Demolition Area #2 MRS)**

**MILITARY MUNITIONS RESPONSE PROGRAM
RAVENNA ARMY AMMUNITION PLANT
RAVENNA, OHIO**

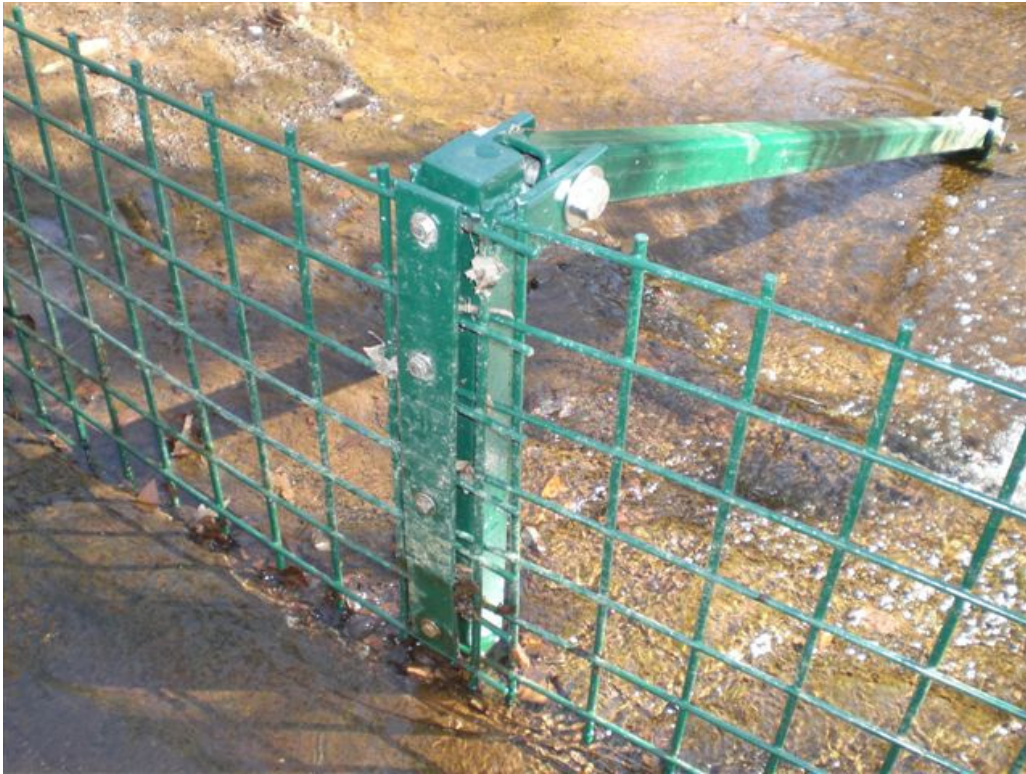
Photo 1: Upstream barrier post and back brace

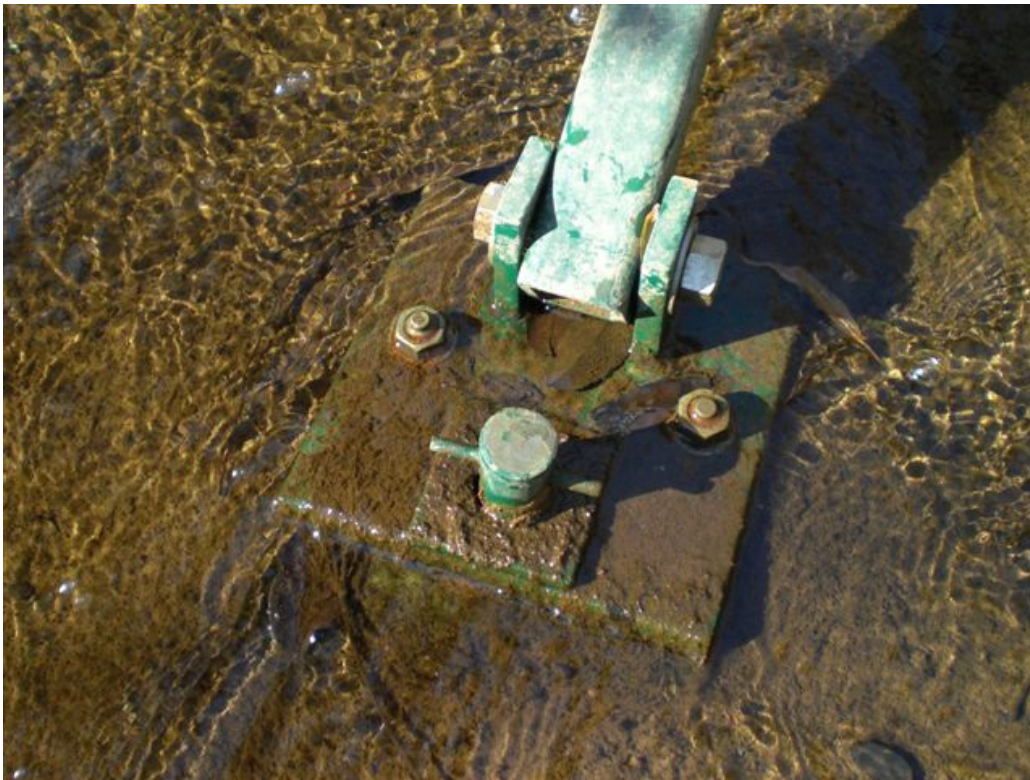
Photo 2: Anchor plate

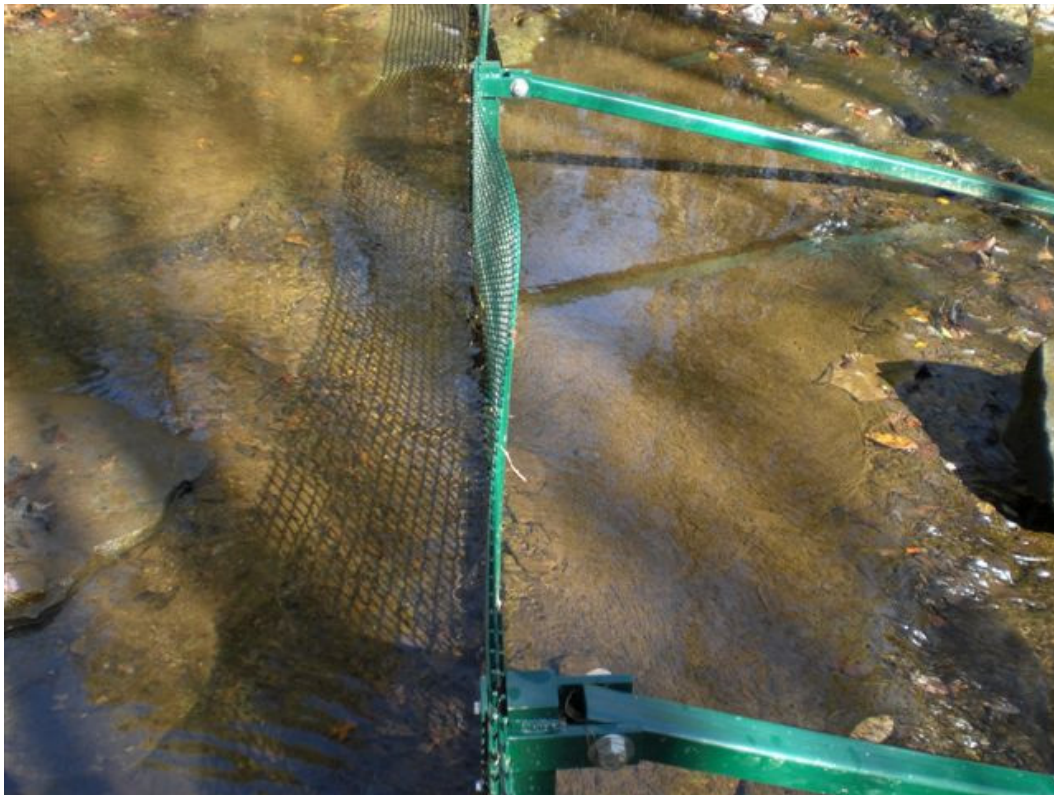
Photo 3: Downstream (1-inch grid opening) screen deflection

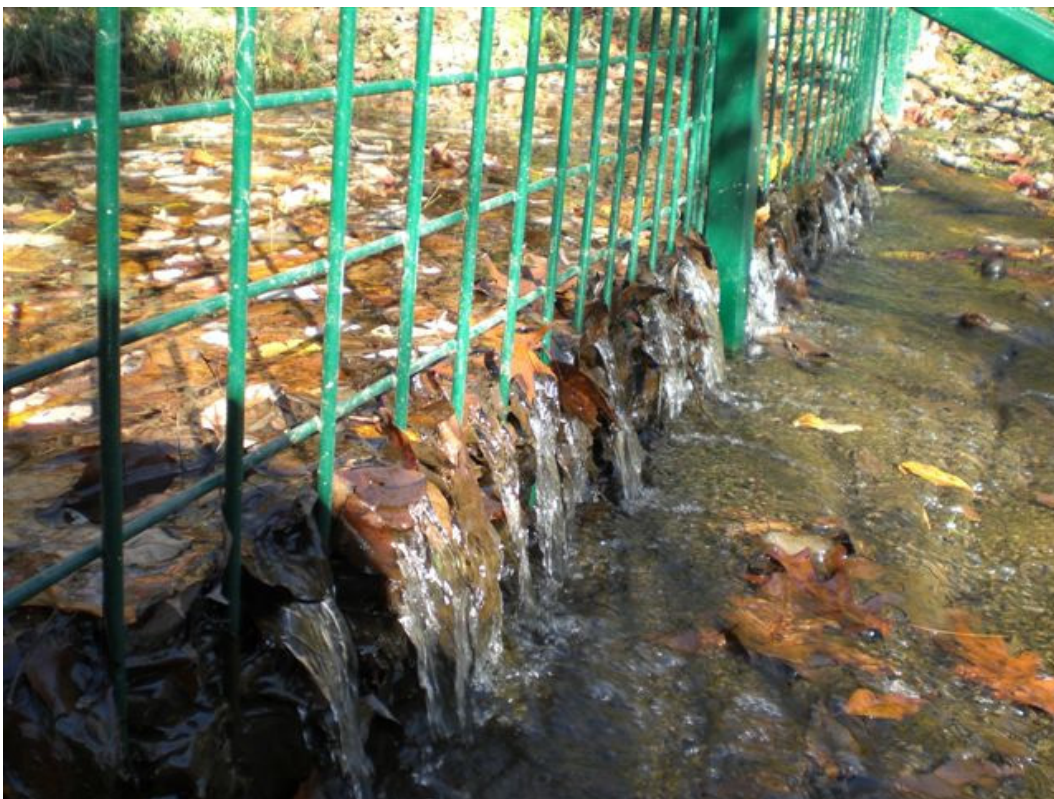
Photo 4: 7 – 8-inch deep leaves accumulated on the screen
