Operations and Maintenance Trip Reports and Quarterly Effectiveness  
Evaluation Reports Time Critical Response Action for the Rocket Ridge  
Area at RVAAP-004-R-01 Open Demolition Area #2

## Quarterly Effectiveness Evaluation Report

### Sand Creek Barrier System

### Time Critical Response Action (TCRA) for the Rocket Ridge Area of Open Demolition Area #2

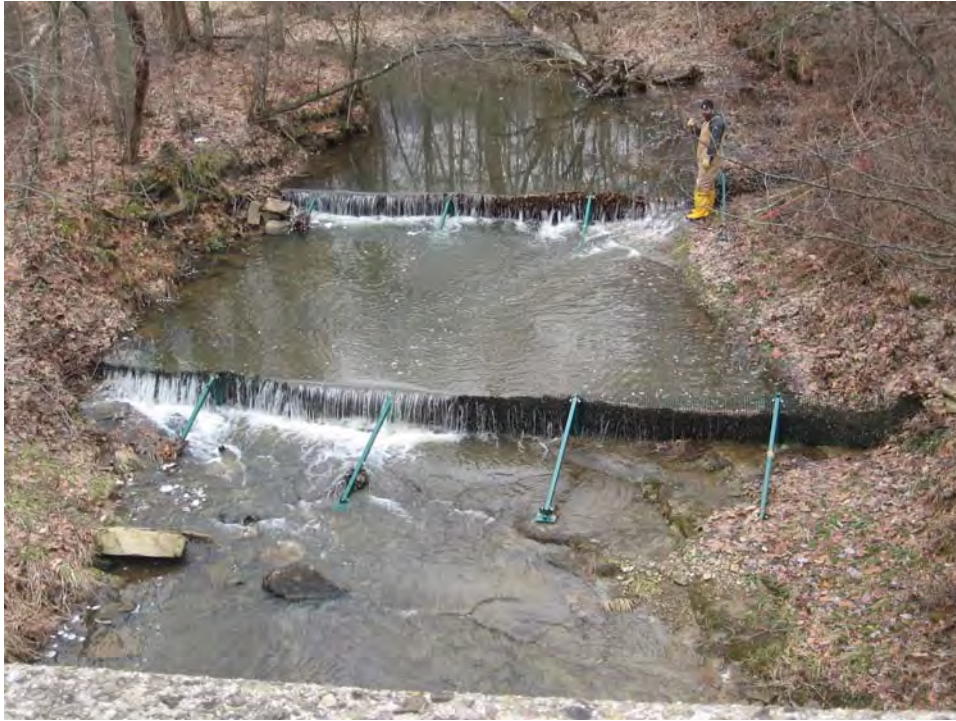
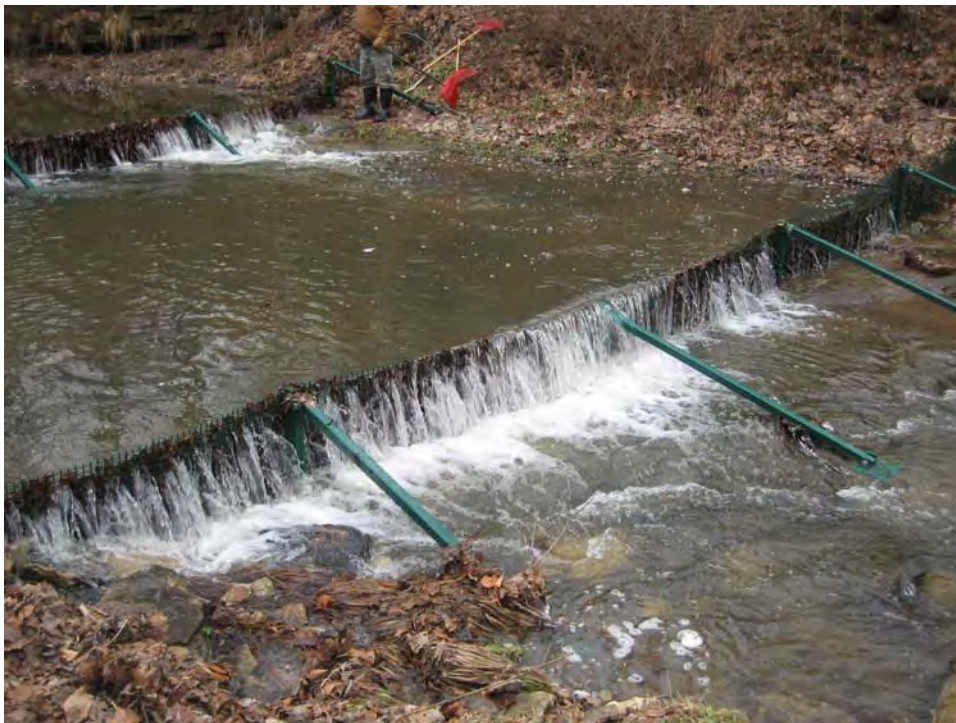
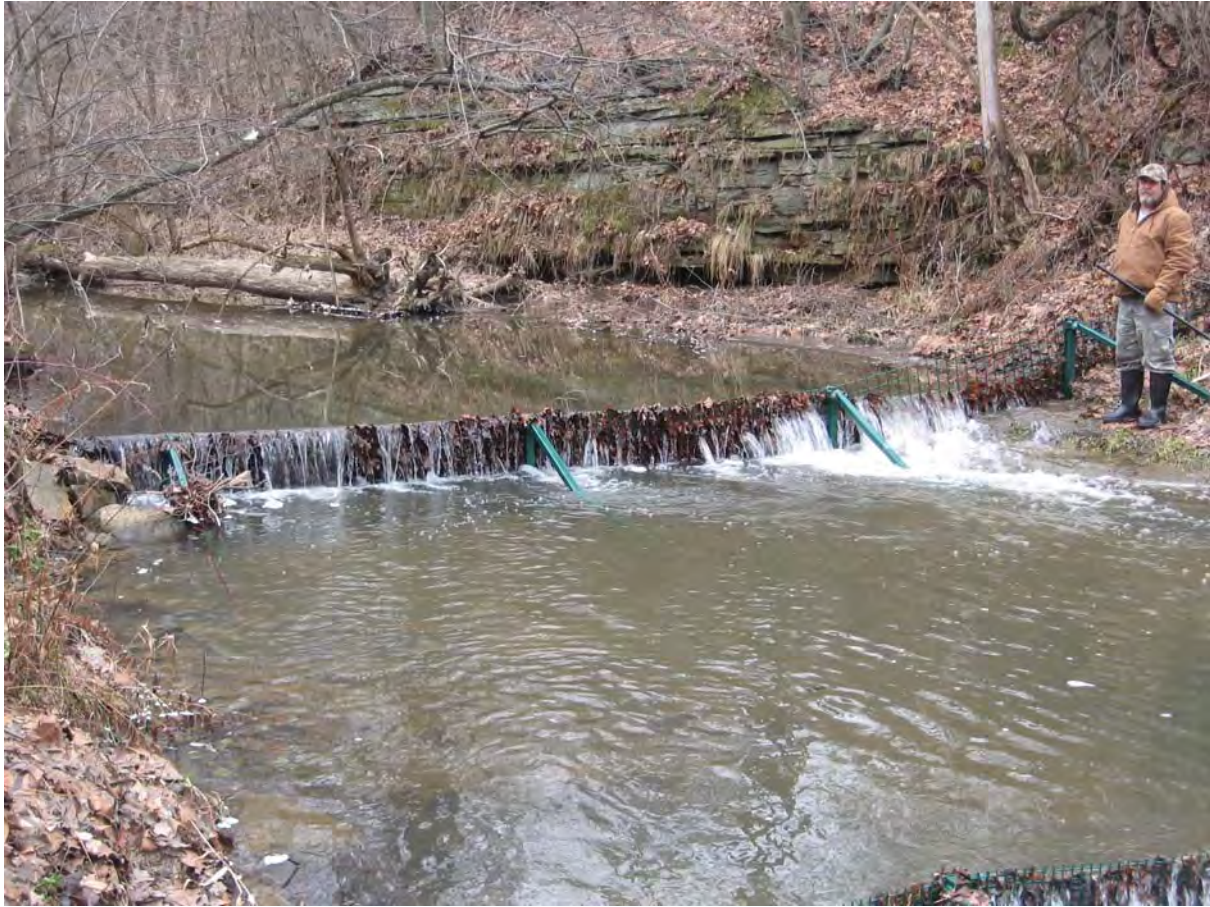
Overview of Screens upon arrival

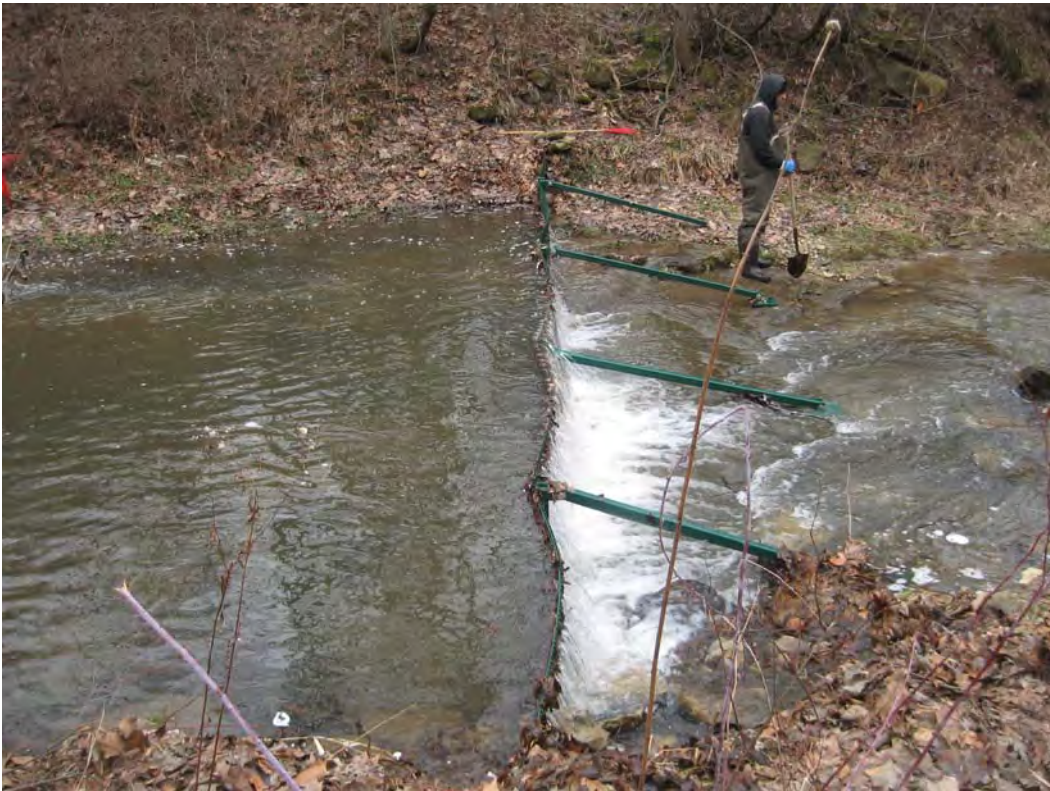
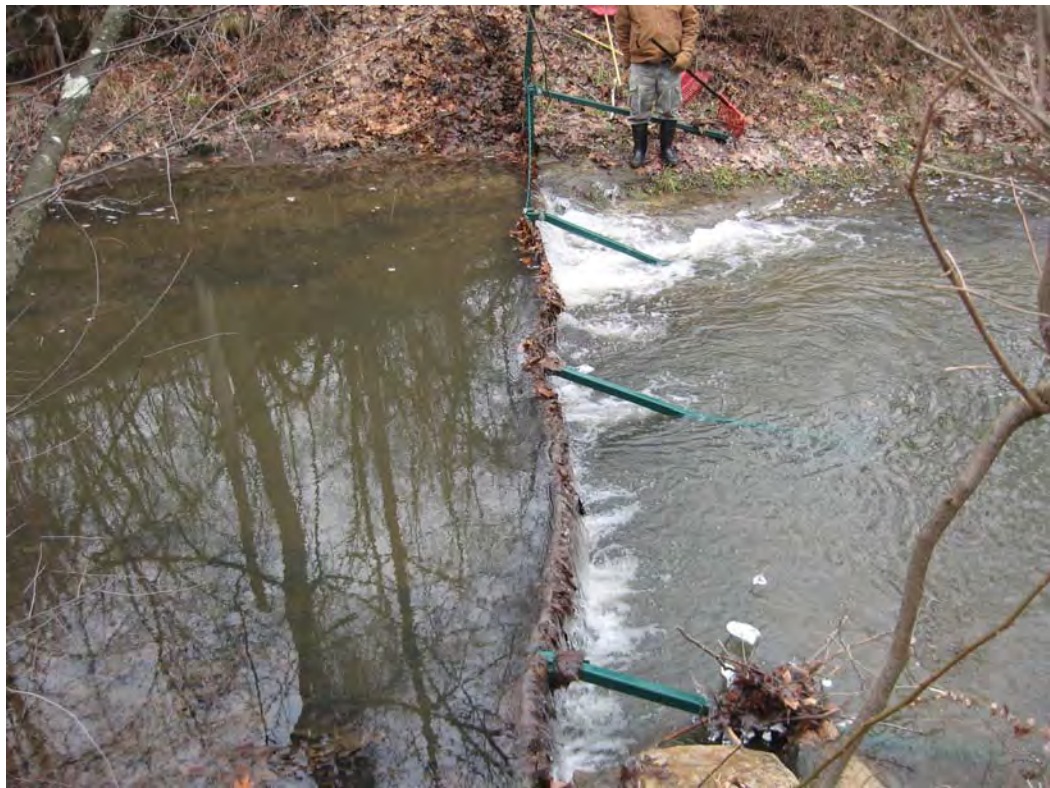
<b>Prime Contract No:</b>	E2M-S08-039		<b>Report No.</b>	5
<b>PIKA JOB #:</b>	08-53-134		<b>Date:</b>	12-16-08
<b>Project:</b>	Operation and Maintenance of the Sand Creek Barrier System			
<b>Environmental Conditions:</b>				
Weather Conditions (Bright Sun, Clear, Overcast, Rain, Snow):		Overcast		
Temperature:		22° F		
Wind (Still, Moderate, High):		Moderate		
Humidity (Dry, Moderate, Humid):		Dry		
<b>Field Activities:</b>				
<b>Description of debris inspection &amp; removal activities:</b> Removed leaves, sticks and mud from barrier. Numerous amounts of leaves on both screens. No MEC/MD found.				
<b>Barrier Integrity:</b> Barrier is operable, there are no gaps that would allow MEC/MD to pass through.				
<b>Assessment of any changes since previous visit:</b> Both screens appear to be bent more than at the previous inspection.				
<b>Repairs made or need to be made:</b> None at this time.

Screens bowing

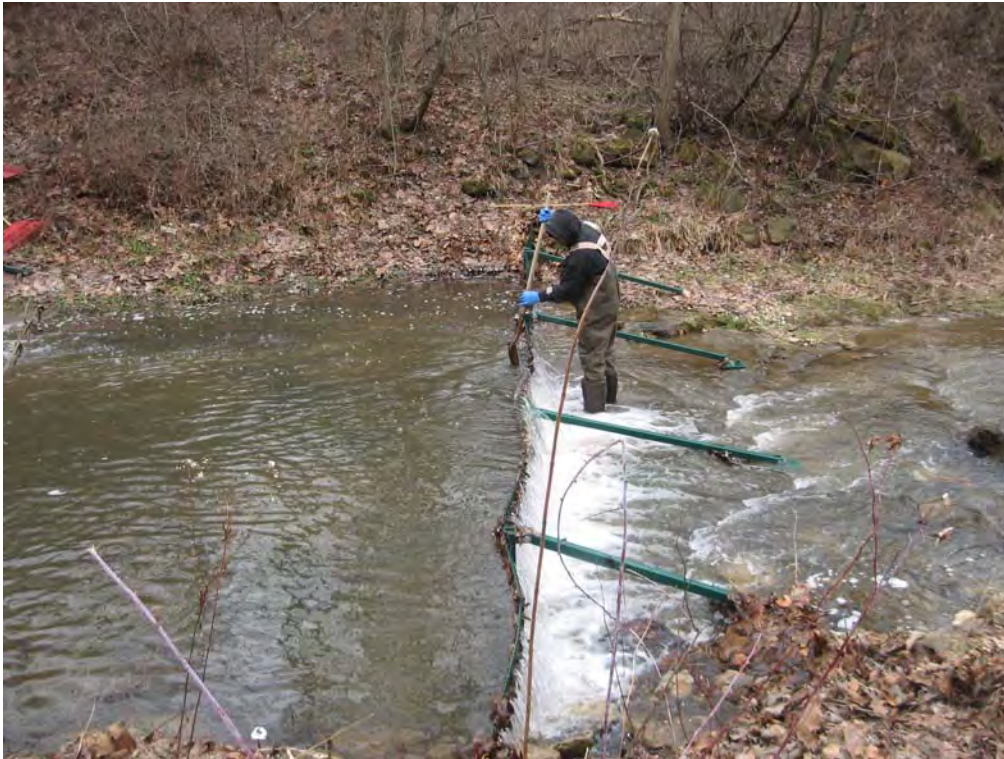
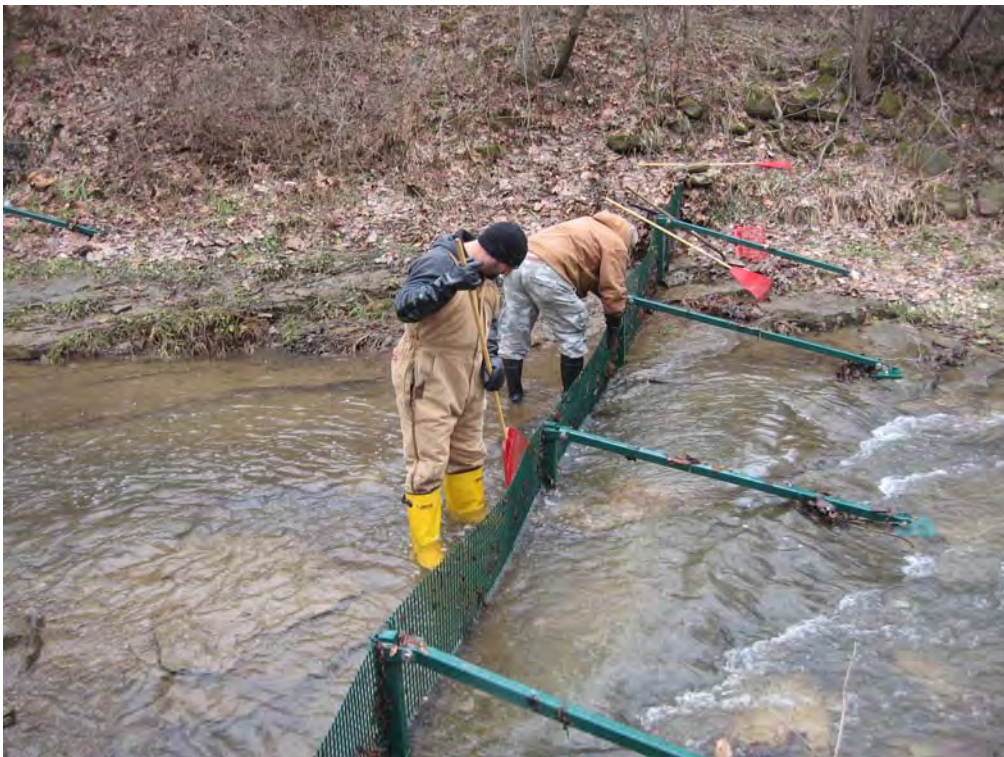
Cleaning Screens

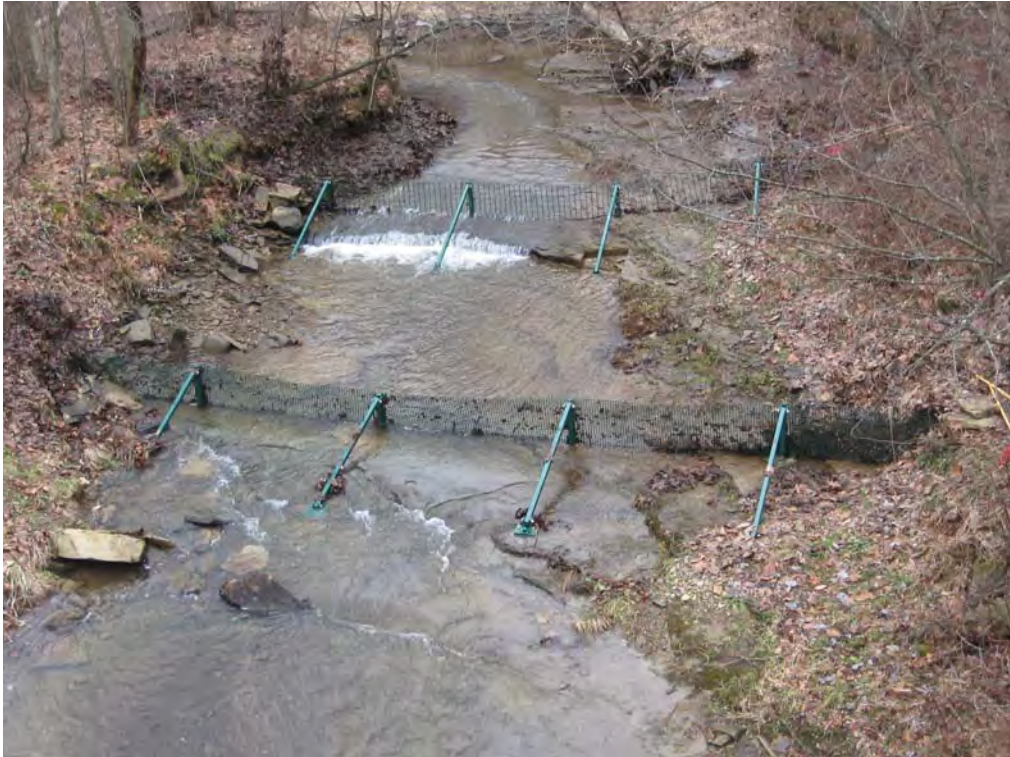
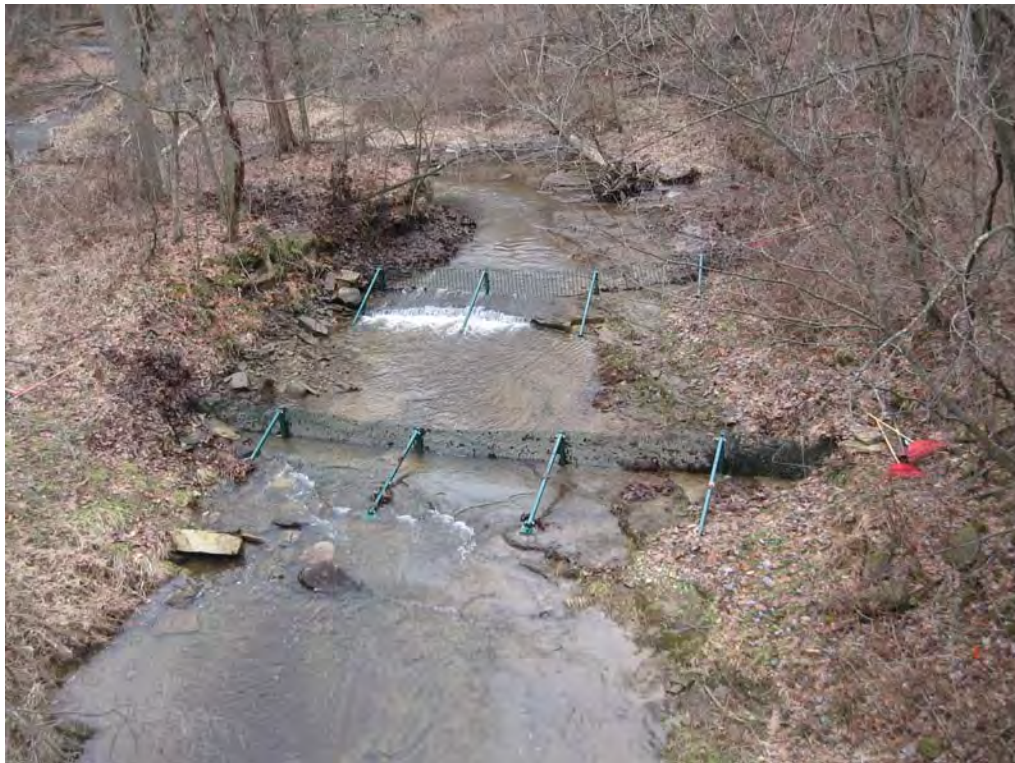
Overview of barriers following cleaning operations.  
Note: Remaining debris seen on screens is frozen to the screens.

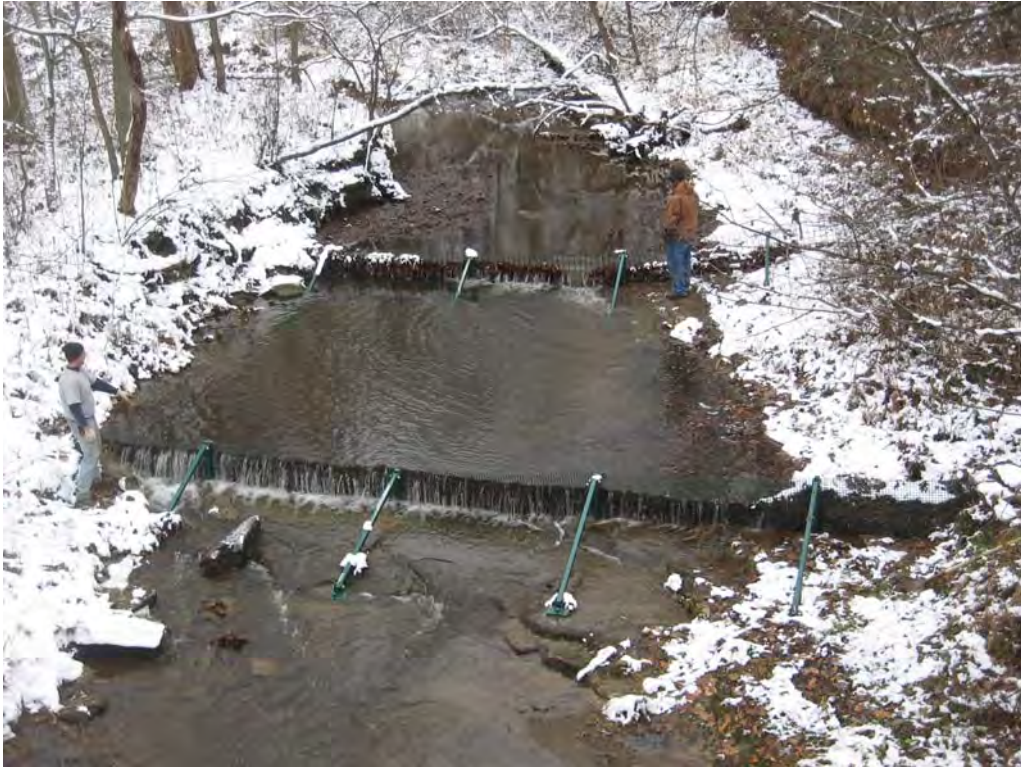
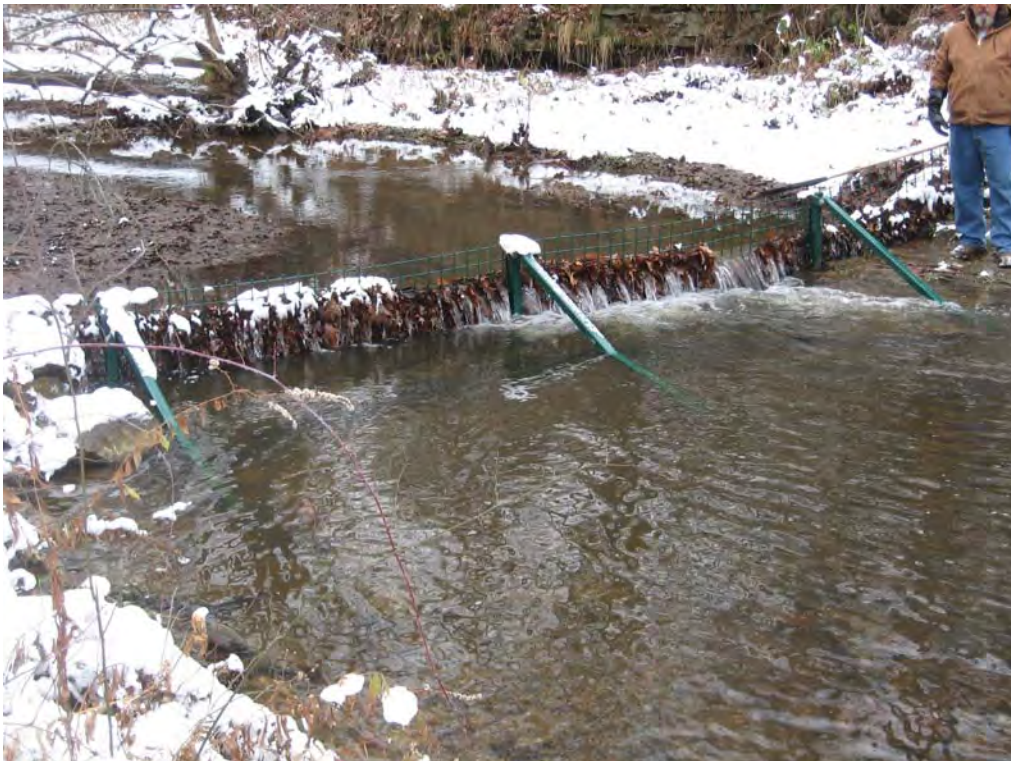
Overview of barrier upon arrival

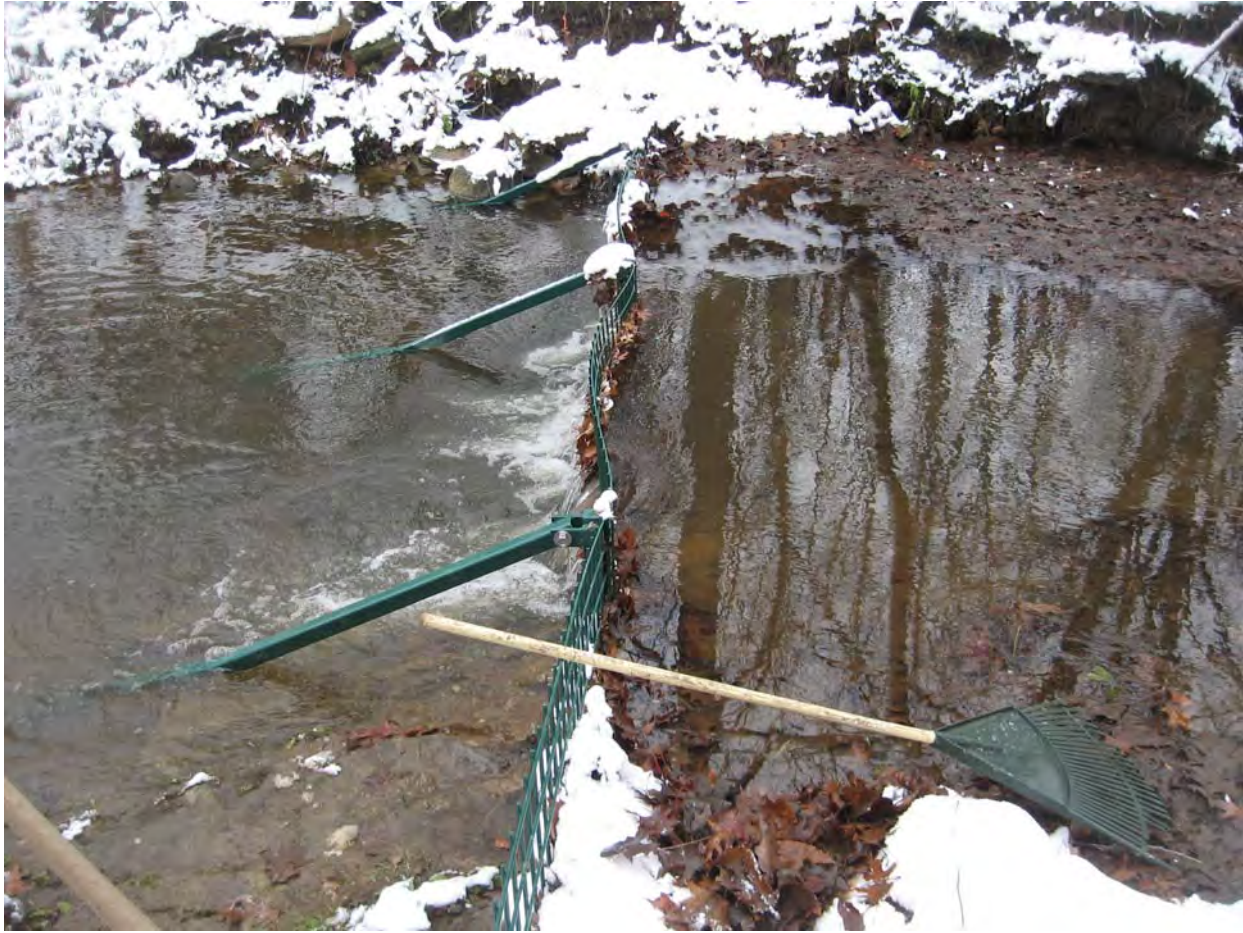
<b>Prime Contract No:</b>	E2M-S08-039		<b>Report No.</b>	4
<b>PIKA JOB #:</b>	08-53-134		<b>Date:</b>	11-19-08
<b>Project:</b>	Operation and Maintenance of the Sand Creek Barrier System			
<b>Environmental Conditions:</b>				
Weather Conditions (Bright Sun, Clear, Overcast, Rain, Snow):		Overcast		
Temperature:		26° F		
Wind (Still, Moderate, High):		Moderate		
Humidity (Dry, Moderate, Humid):		Dry		
<b>Field Activities:</b>				
<p><b>Description of debris inspection &amp; removal activities:</b> Removed numerous amounts of leaves and sticks from barrier. Recommend for future inspection/cleaning in late fall/early winter assign two additional persons to help with cleanup.</p>				
<p><b>Barrier Integrity:</b> Both screens slightly bent, but no breaks or cracks.</p>				
<p><b>Assessment of any changes since previous visit:</b> Both screens are bent more than the previous inspection.</p>				
<p><b>Repairs made or need to be made:</b> None at this time.</p>

Screens bowing.

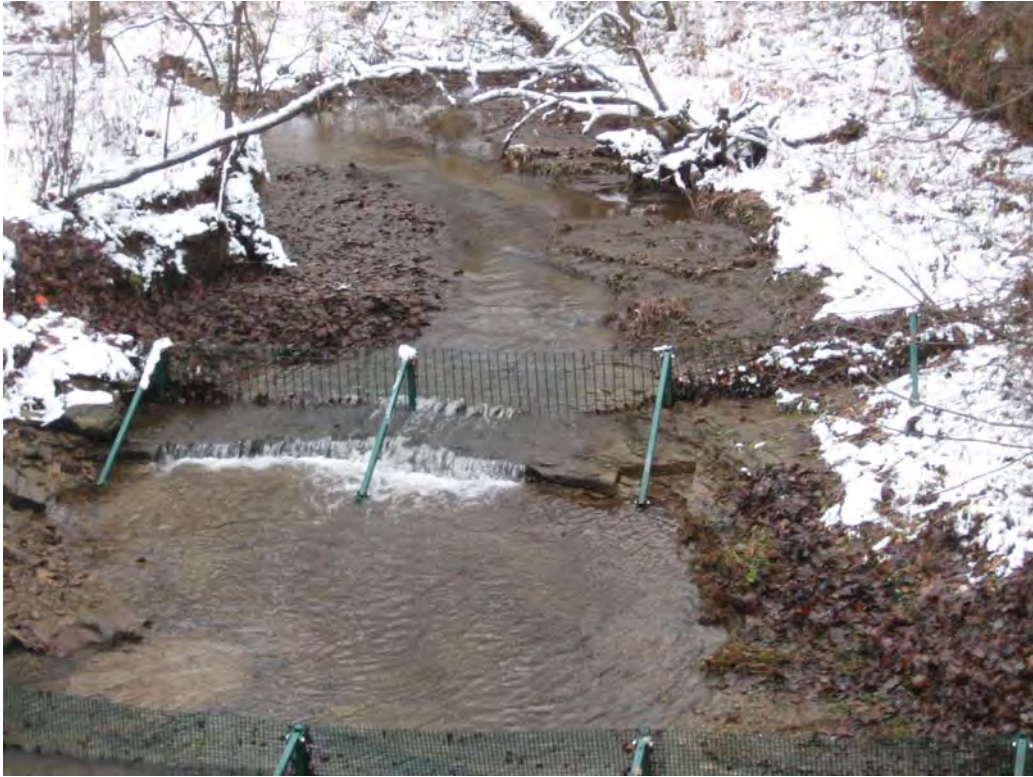
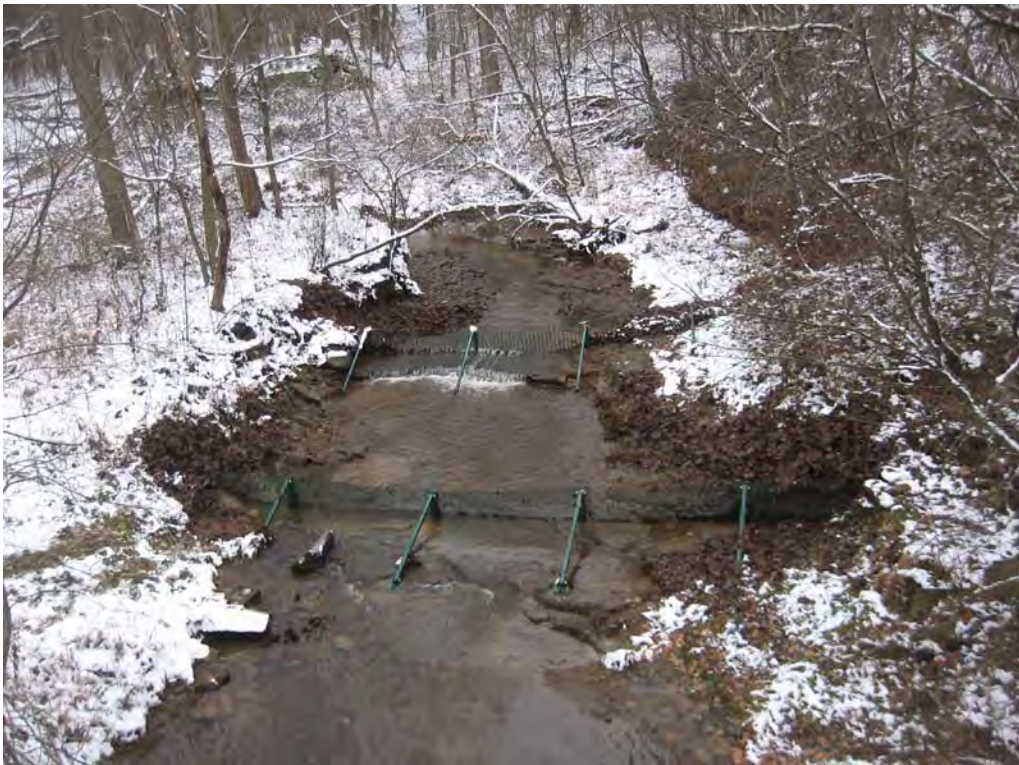
Overview of barriers before demobilization

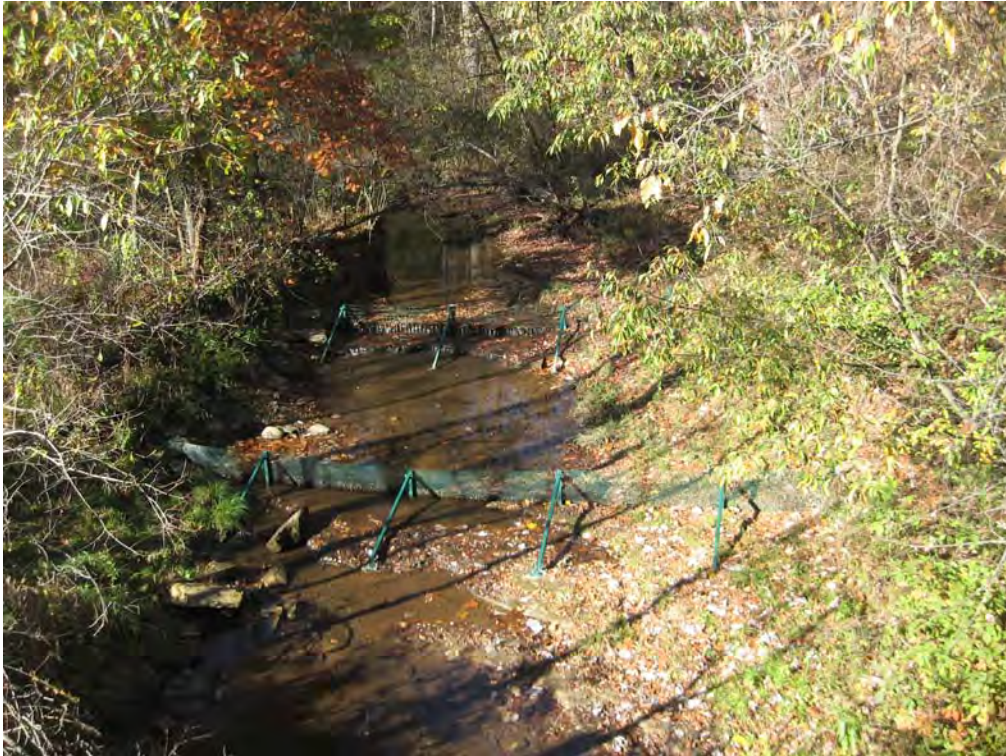
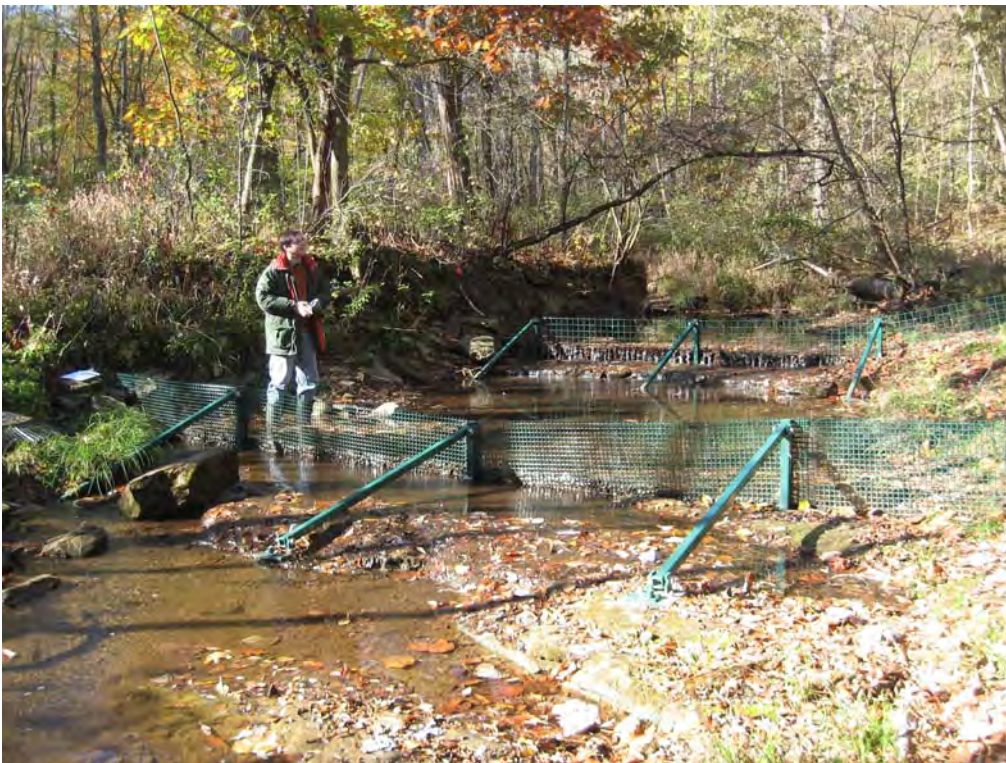
Overview of Screens upon arrival

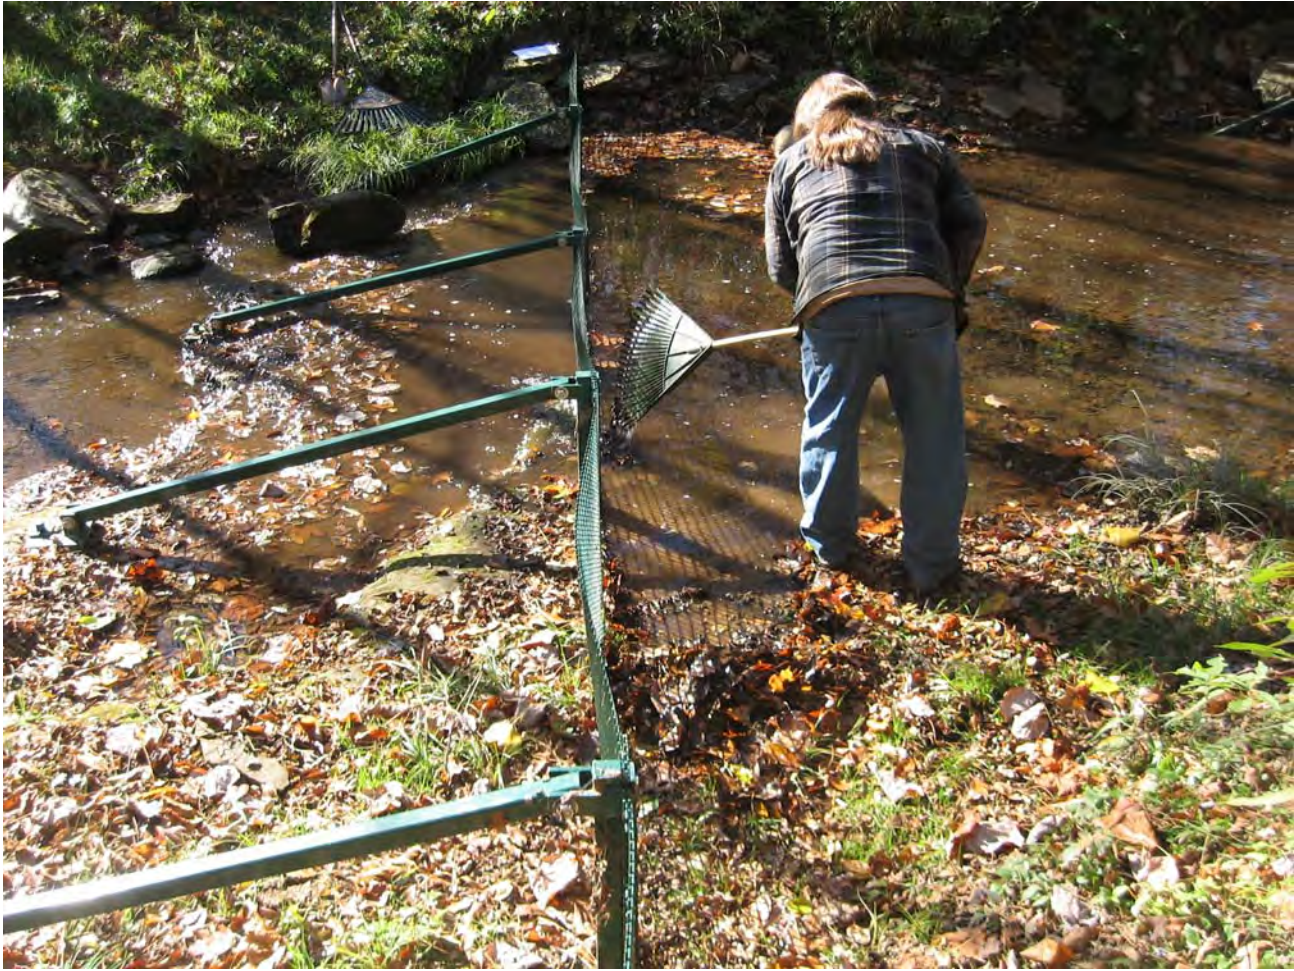
Cleaning Screen

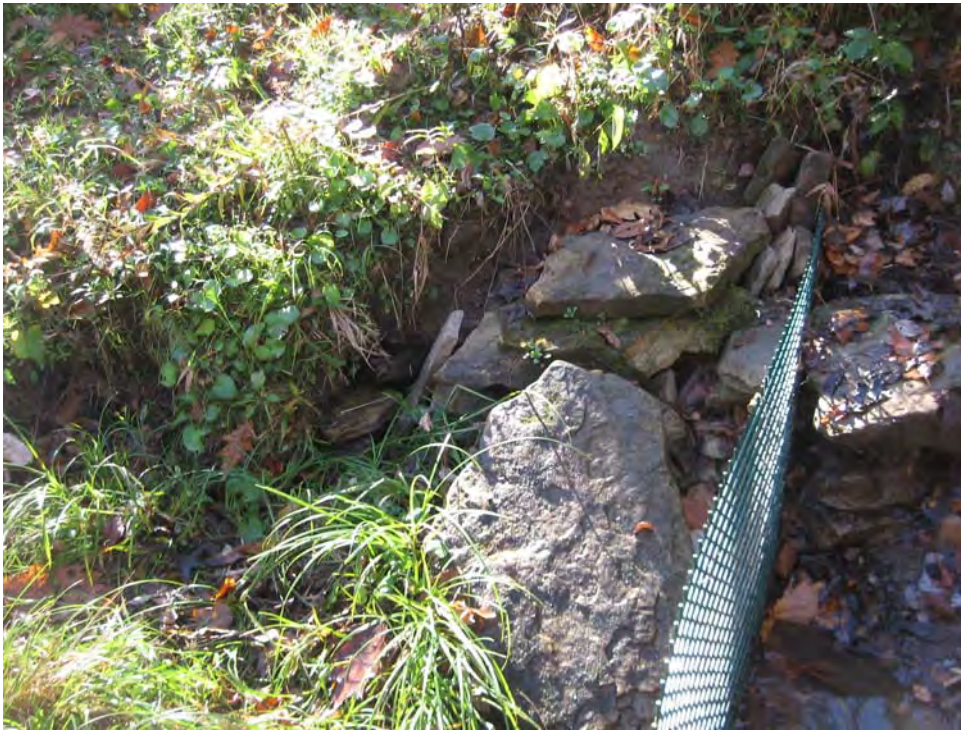
Washout area at barrier

<b>Prime Contract No:</b>	E2M-S08-039		<b>Report No.</b>	3
<b>PIKA JOB #:</b>	08-53-134		<b>Date:</b>	10-23-08
<b>Project:</b>	Operation and Maintenance of the Sand Creek Barrier System			
<b>Environmental Conditions:</b>				
Weather Conditions (Bright Sun, Clear, Overcast, Rain, Snow):		Clear, sunny		
Temperature:		47° F		
Wind (Still, Moderate, High):		Still		
Humidity (Dry, Moderate, Humid):		Dry		
<b>Field Activities:</b>				
<b>Description of debris inspection &amp; removal activities:</b> Leaves, branches, silt/mud, and sticks. Removed debris from both screens.				
 <b>Barrier Integrity:</b> Good				
 <b>Assessment of any changes since previous visit:</b> Slight washout. Erosion on southern ends of both barriers.				
 <b>Repairs made or need to be made:</b> Placed rocks at south ends of both barriers to stop erosion.

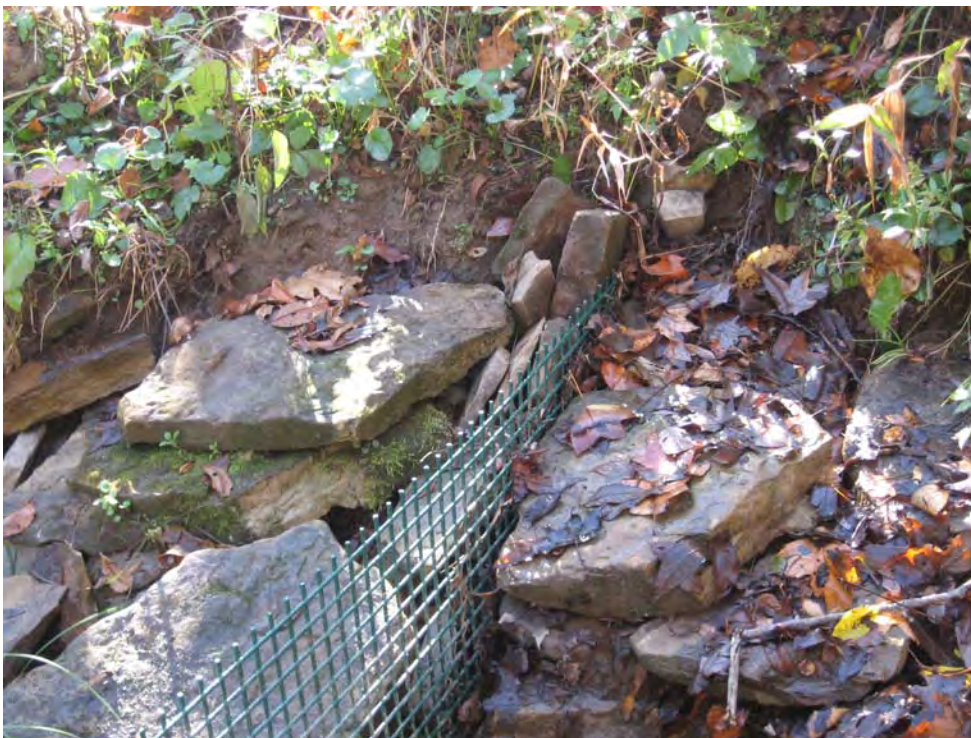
Washout area reinforced with rocks

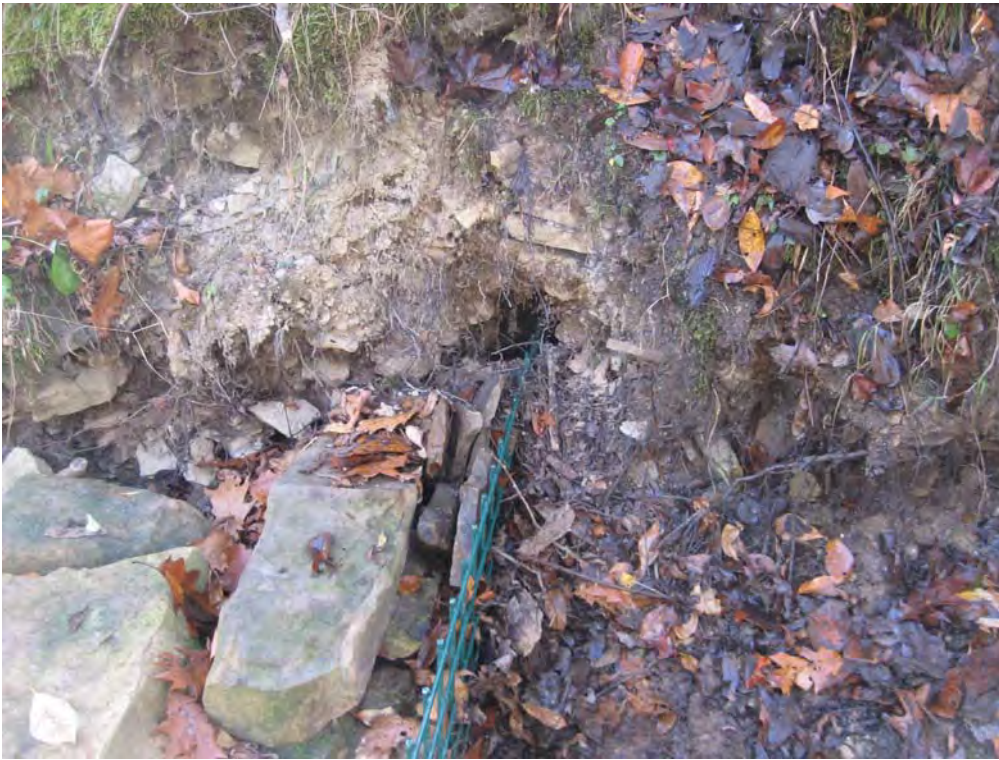
Washout area at barrier

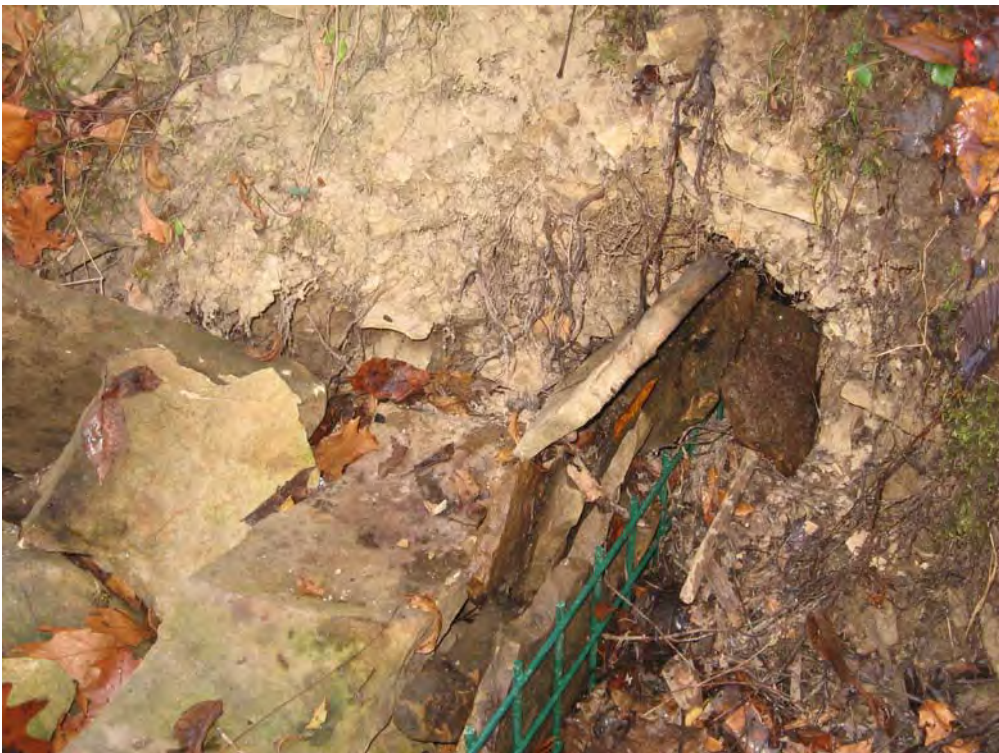
Washout area reinforced with rocks

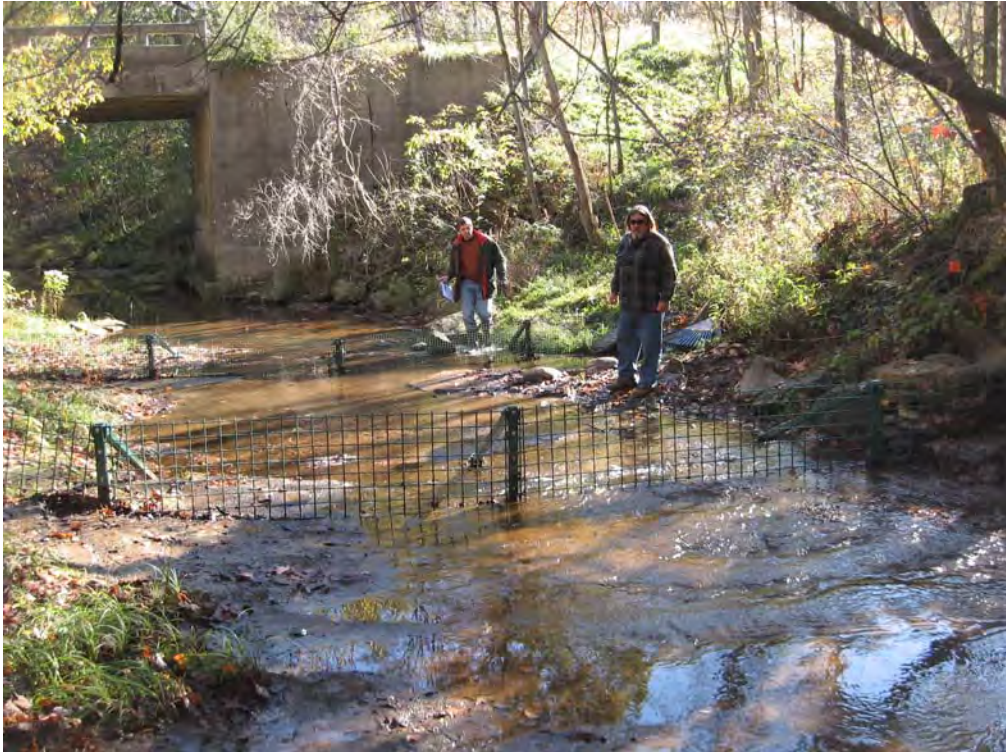
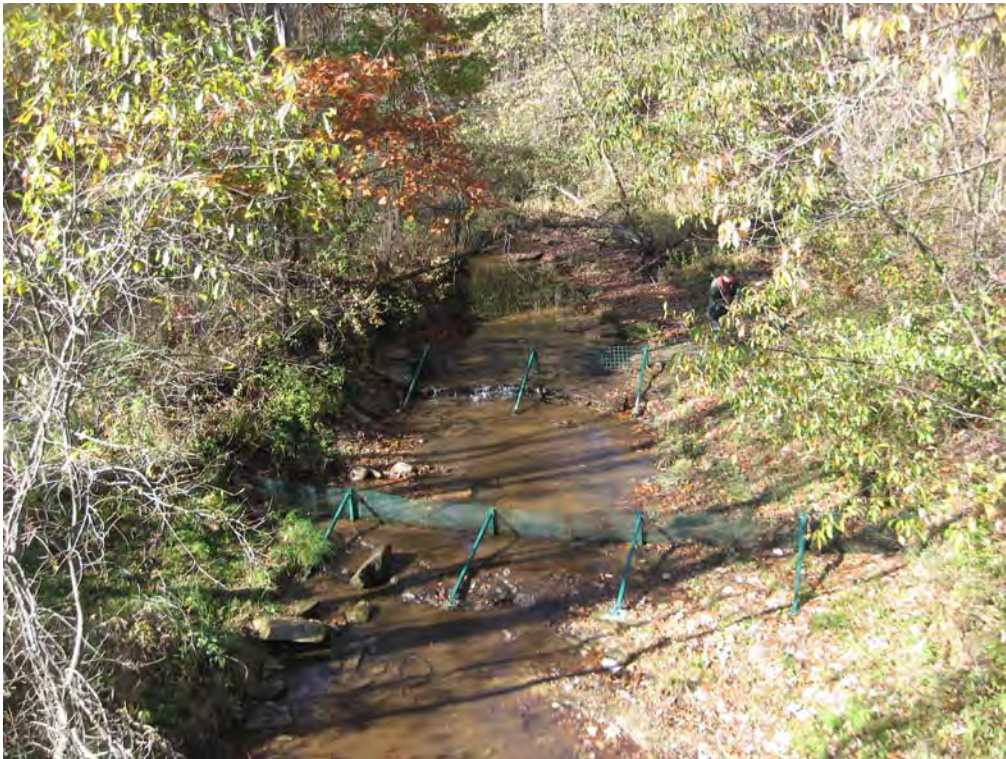
Overview of barriers before demobilization

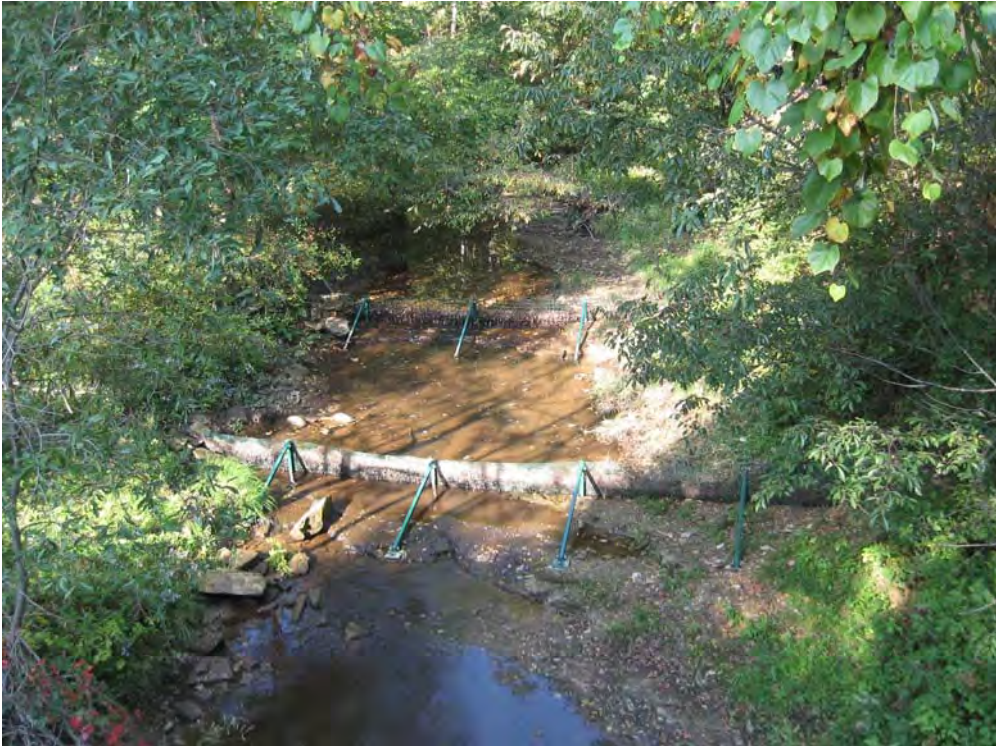
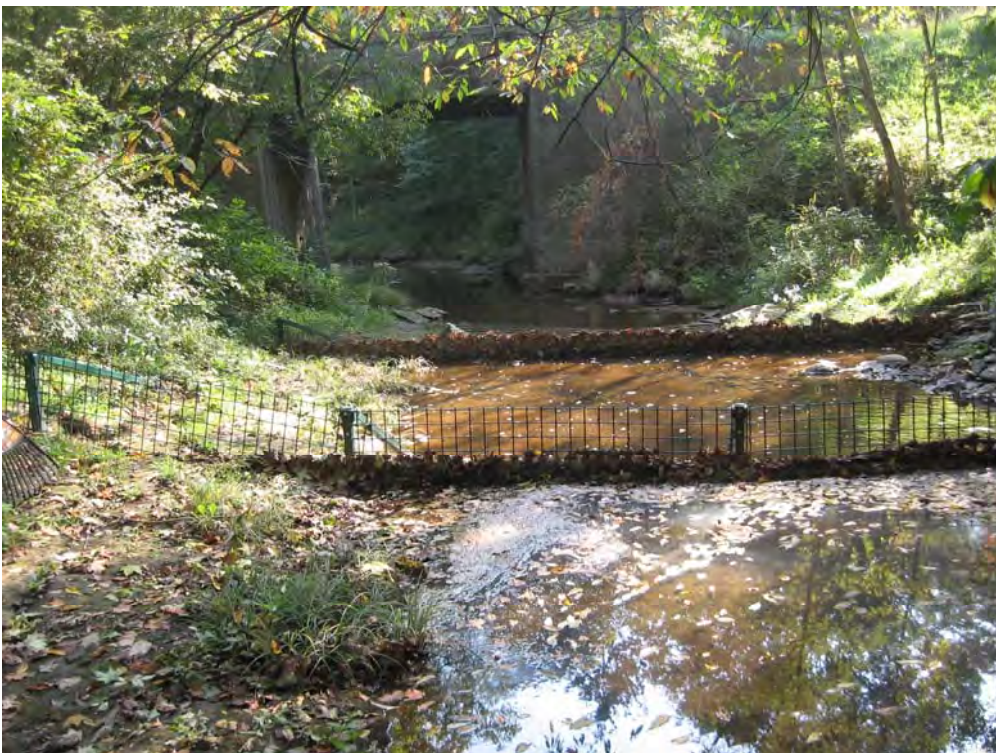
Overview of Screens upon arrival

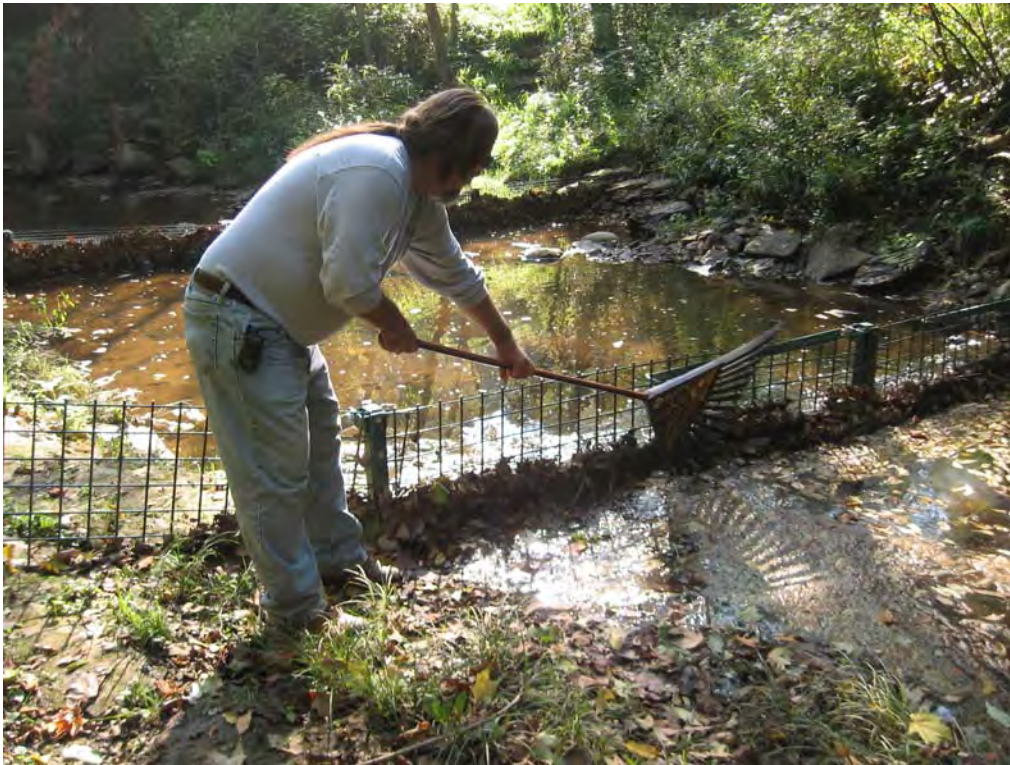
Cleaning Screen

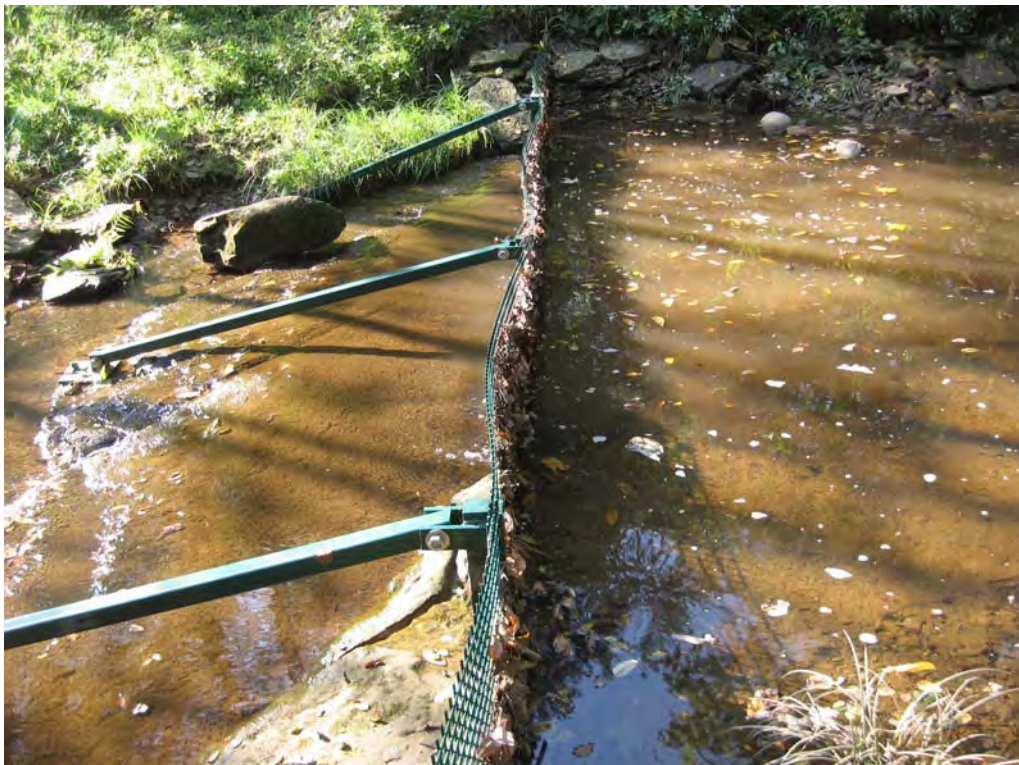
<b>Prime Contract No:</b>	E2M-S08-039		<b>Report No.</b>	2
<b>PIKA JOB #:</b>	08-53-134		<b>Date:</b>	9-22-08
<b>Project:</b>	Operation and Maintenance of the Sand Creek Barrier System			
<b>Environmental Conditions:</b>				
Weather Conditions (Bright Sun, Clear, Overcast, Rain, Snow):		Clear, sunny		
Temperature:		68° F		
Wind (Still, Moderate, High):		Still		
Humidity (Dry, Moderate, Humid):		Dry		
<b>Field Activities:</b>				
<b>Description of debris inspection &amp; removal activities:</b> Leaves, branches, mud, sticks and rocks. Removed debris from both screens.				
<b>Barrier Integrity:</b> Both Barriers bowed slightly due to branches and leaves approximately 3-5" thick on the screens from bottom to top.				
<b>Assessment of any changes since previous visit:</b> Barrier screens slightly more bowed (no breaks or cracks in screen).				
<b>Repairs made or need to be made:</b> None.

Bowing of barrier
