Operations and Maintenance Trip Reports and Quarterly Effectiveness  
Evaluation Reports Time Critical Response Action for the Rocket Ridge  
Area at RVAAP-004-R-01 Open Demolition Area #2

## Quarterly Effectiveness Evaluation Report

### Sand Creek Barrier System

### Time Critical Response Action (TCRA) for the Rocket Ridge Area of Open Demolition Area #2

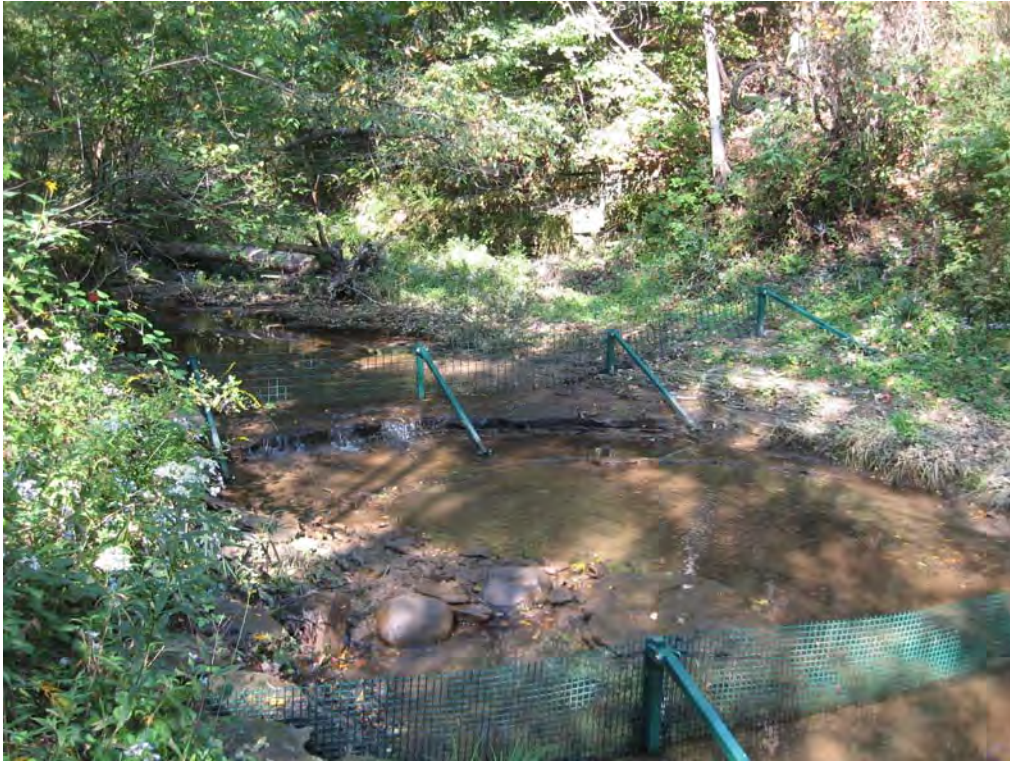
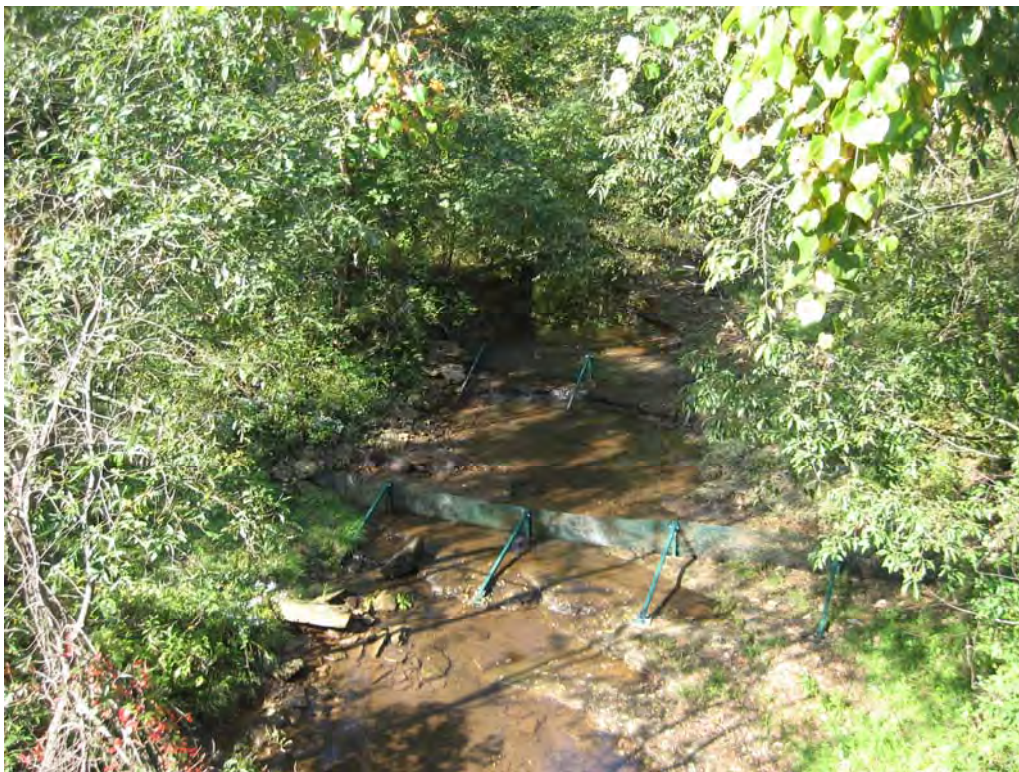
Overview of barriers before demobilization

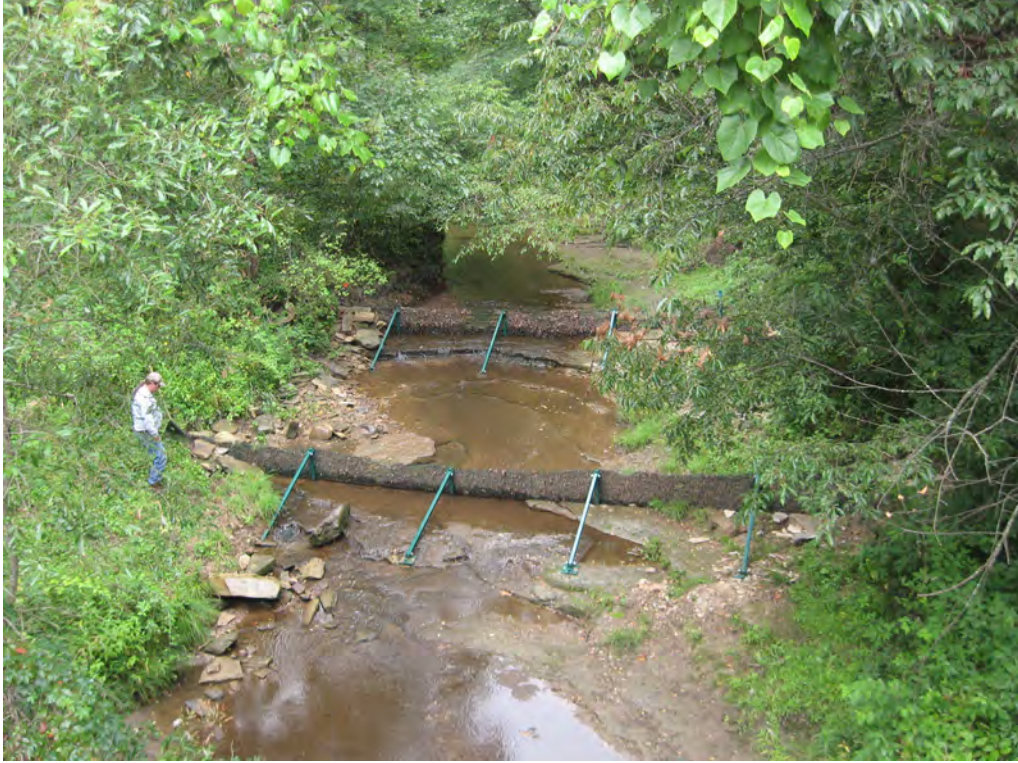
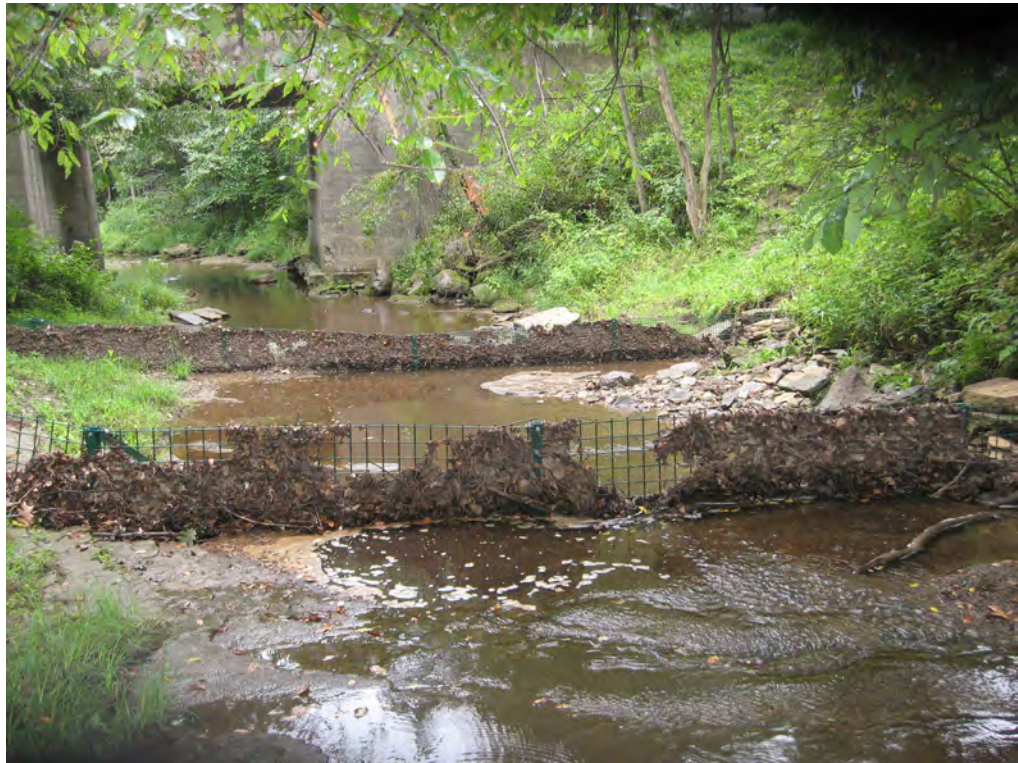
Overview of Screens upon arrival

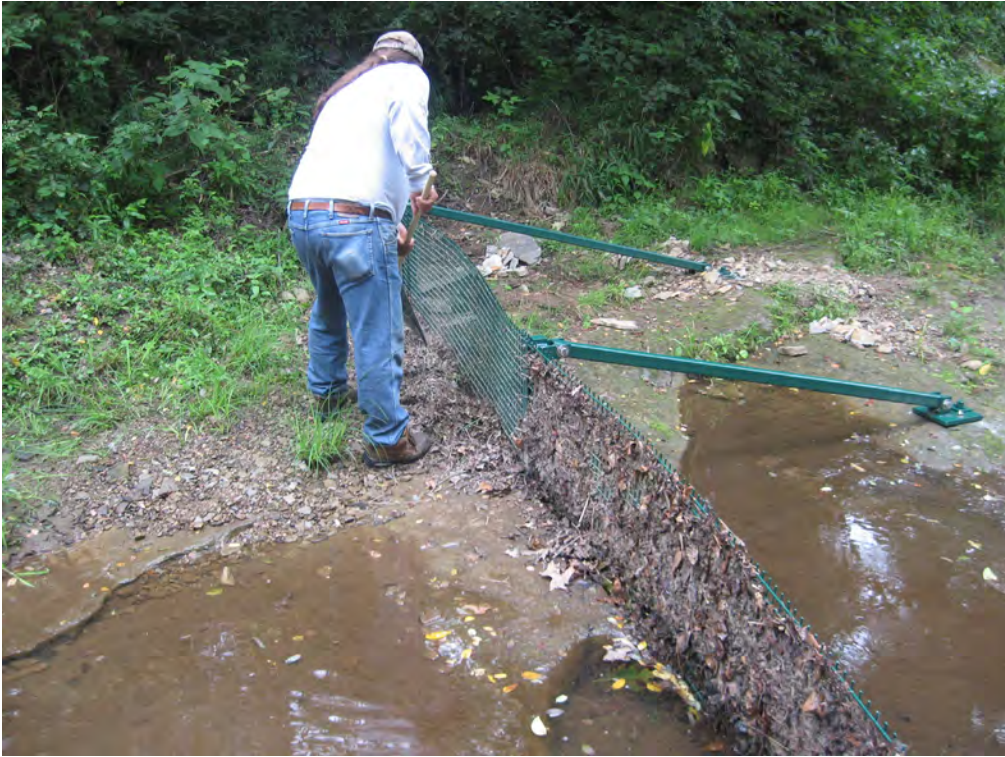
Cleaning Screen

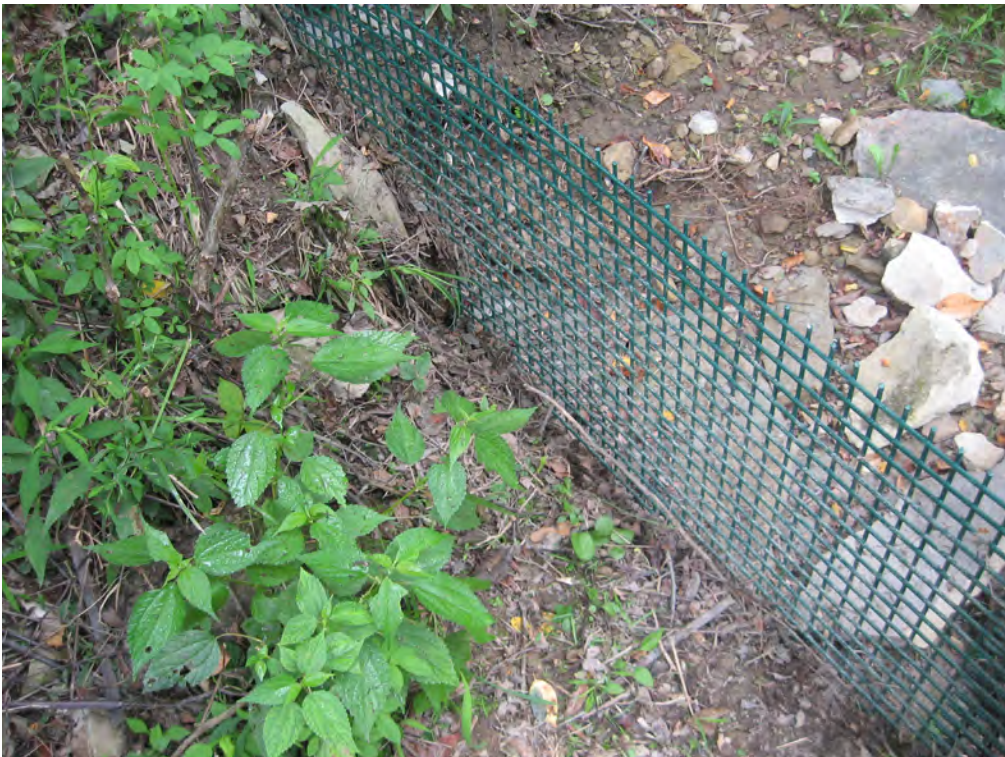
Washout area at second barrier

<b>Prime Contract No:</b>	E2M-S08-039		<b>Report No.</b>	1
<b>PIKA JOB #:</b>	08-53-134		<b>Date:</b>	8-19-08
<b>Project:</b>	Operation and Maintenance of the Sand Creek Barrier System			
<b>Environmental Conditions:</b>				
Weather Conditions (Bright Sun, Clear, Overcast, Rain, Snow):		Overcast, light rain		
Temperature:		71° F		
Wind (Still, Moderate, High):		moderate		
Humidity (Dry, Moderate, Humid):		moderate		
<b>Field Activities:</b>				
<b>Description of debris inspection &amp; removal activities:</b> Leaves, branches, sticks and rocks. Removed debris from both screens.				
 <b>Barrier Integrity:</b> Second Barrier bowed slightly due to leaves, branches etc. Debris built up due to high water. Debris was up to top of both screens at the high water mark. North side of barrier had slight washout.				
 <b>Assessment of any changes since previous visit:</b> N/A				
 <b>Repairs made or need to be made:</b> Repaired washout with available rocks.

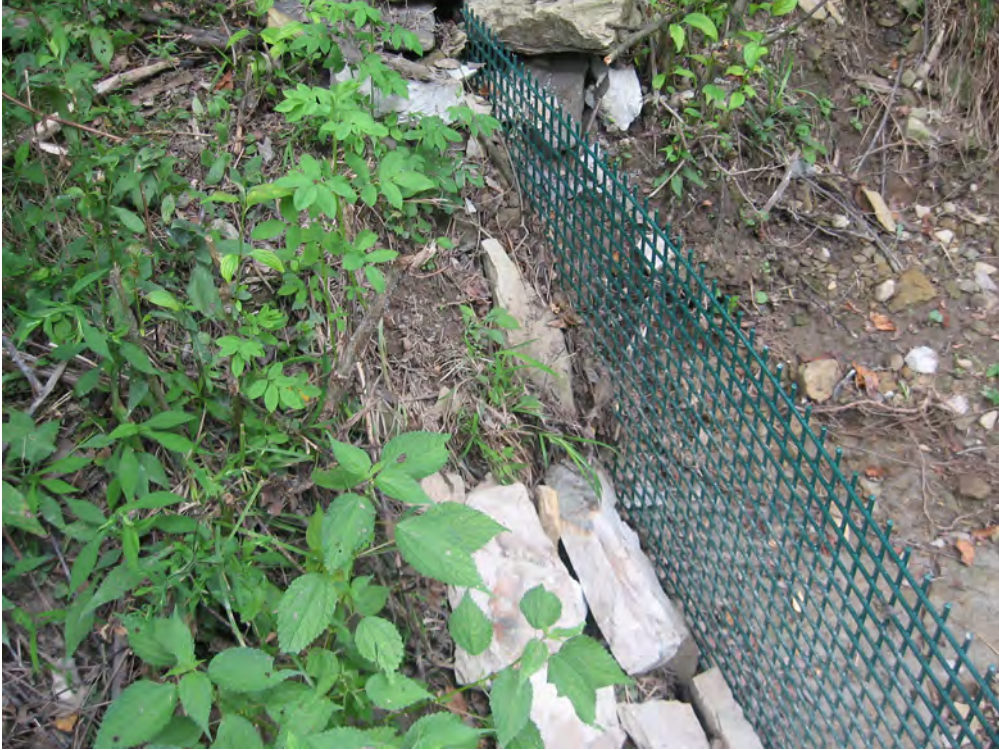
Washout area reinforced with rocks

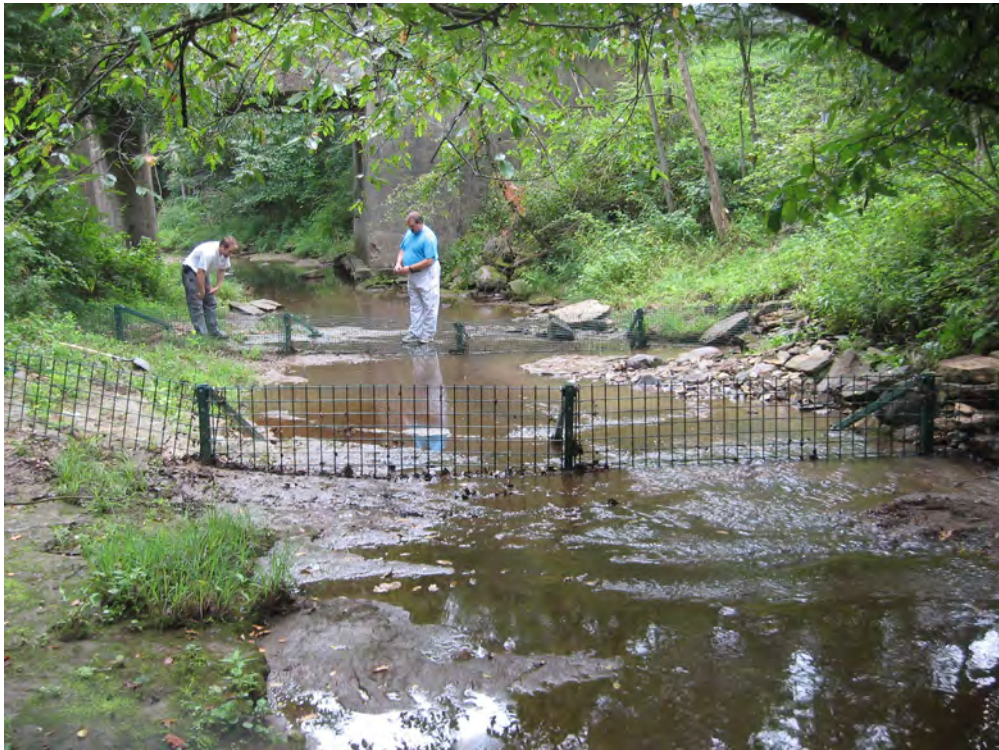
Ohio EPA inspection of Sand Creek Barrier

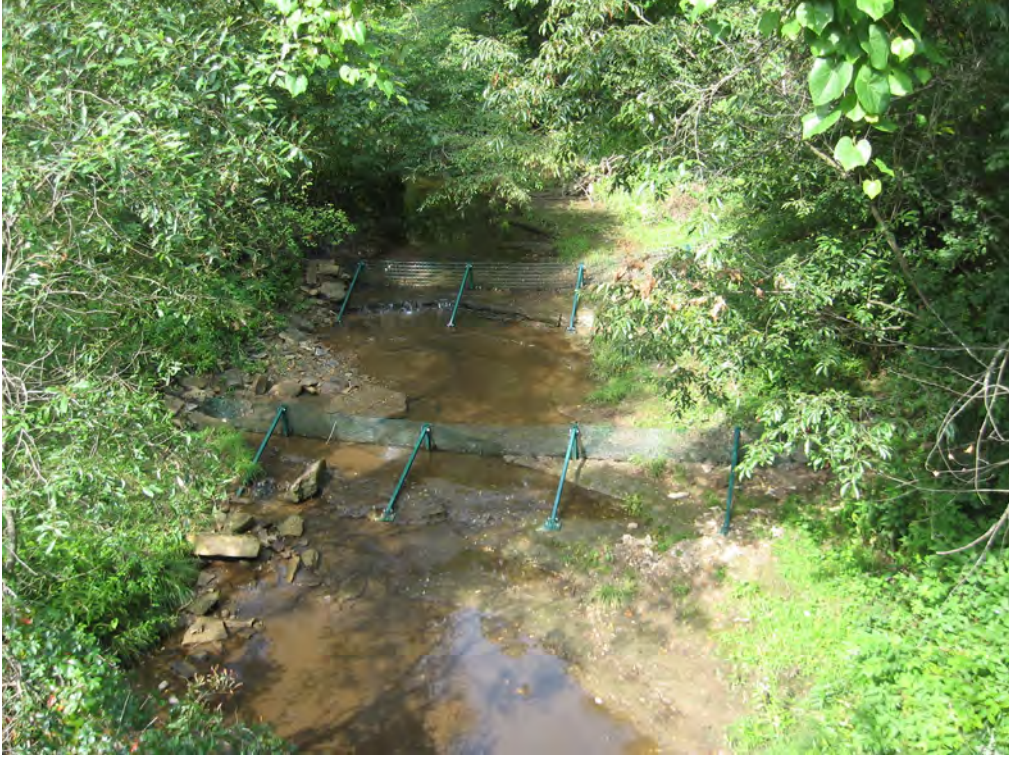
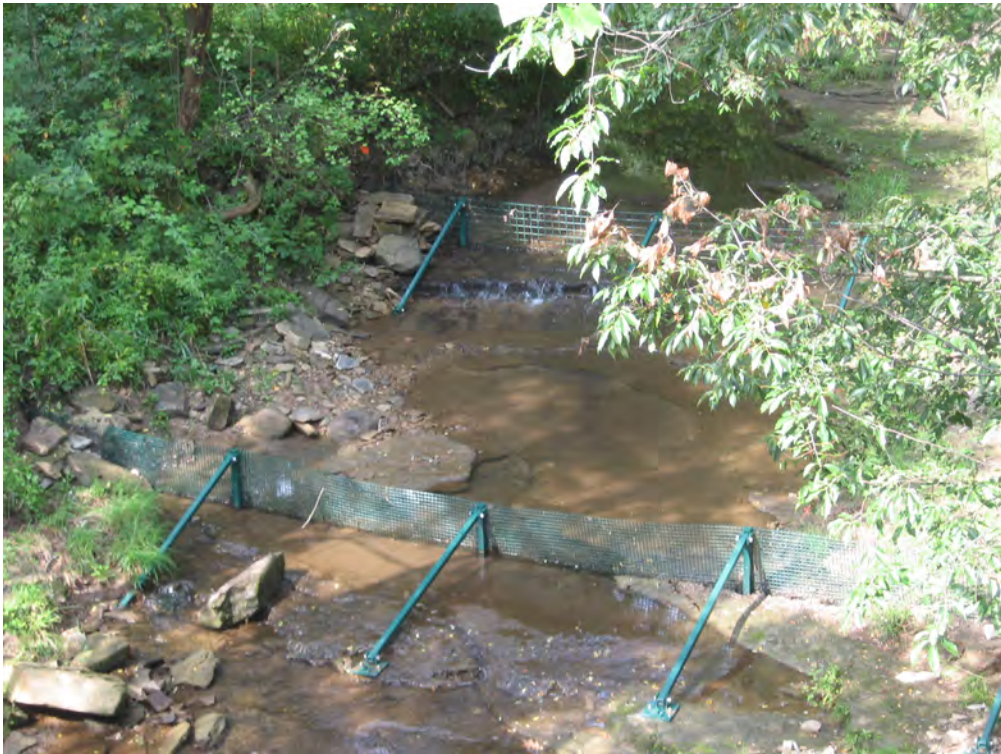
Overview of barriers before demobilization

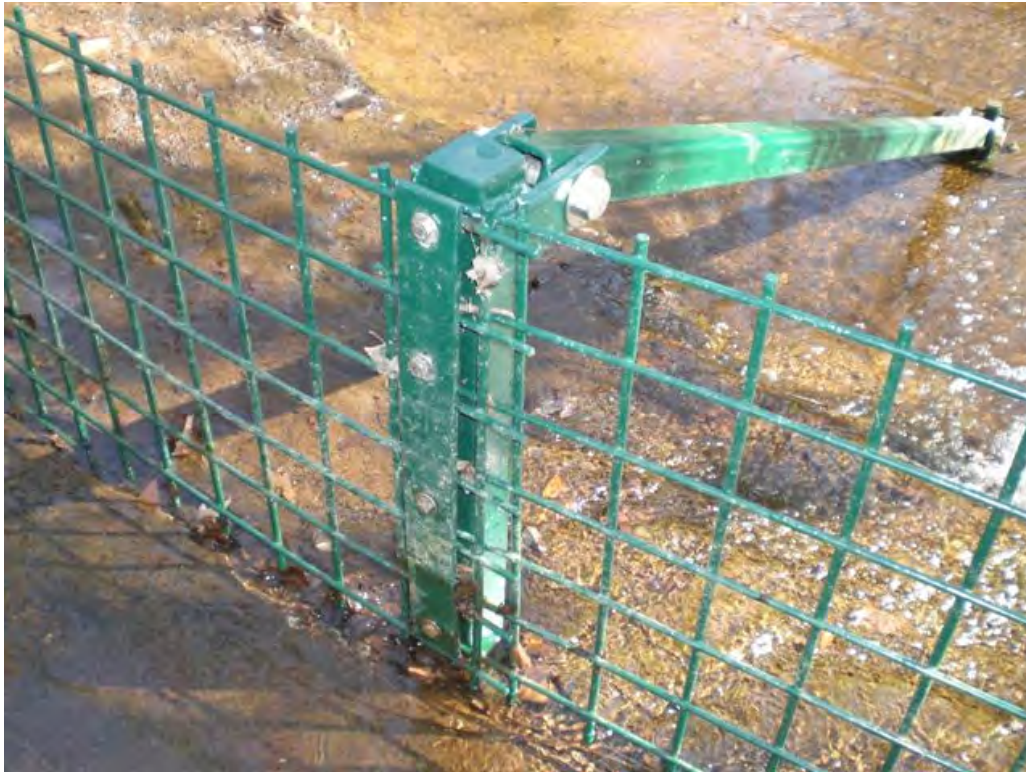
All posts, back braces, and anchor plates are intact and solidly anchored (Photos 1 and 2). Most of the screen panels have been slightly bowed by water pressure (Photo 3). During storm events, leaves build up on the screens, generating pressure that increases with water depth. As a result, the maximum screen deflection is observed at the top of the screens. The maximum deflection reaches 2 inches on the 3-inch opening barrier and 4 inches on the 1-inch opening barrier. The difference is due to the larger amount of leaves on the barrier with smaller grid opening. The screen panel deflection appears to have been stabilized within the first couple of months after construction. At the time of the QEE visit, before the O&M debris removal work, the leaves accumulated on the barriers were 7 - 8 inches deep (Photo 4).

Photo 1: Upstream barrier post and back brace

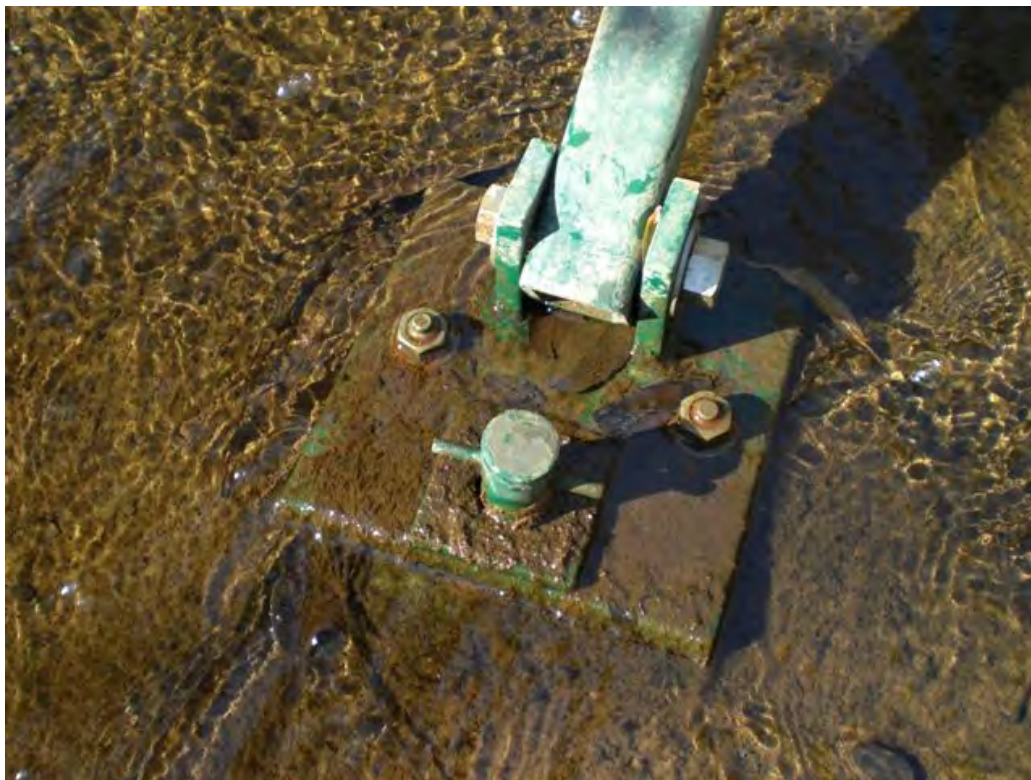
Photo 2: Anchor plate

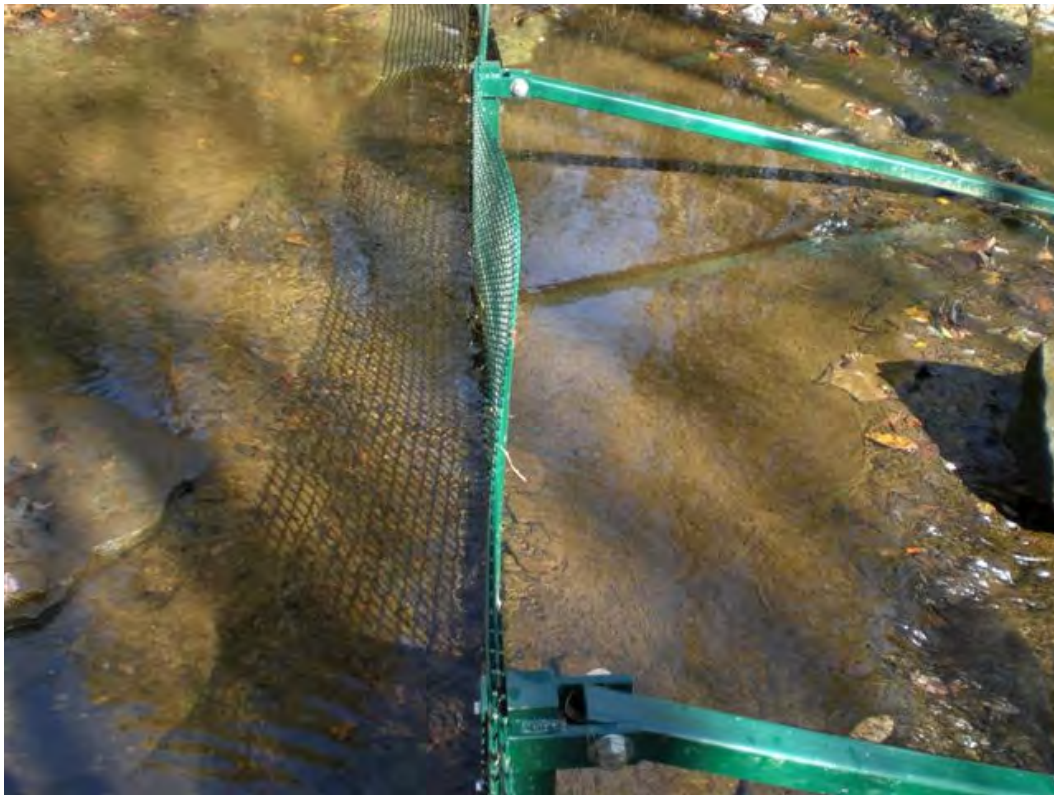
Photo 3: Downstream (1-inch grid opening) screen deflection

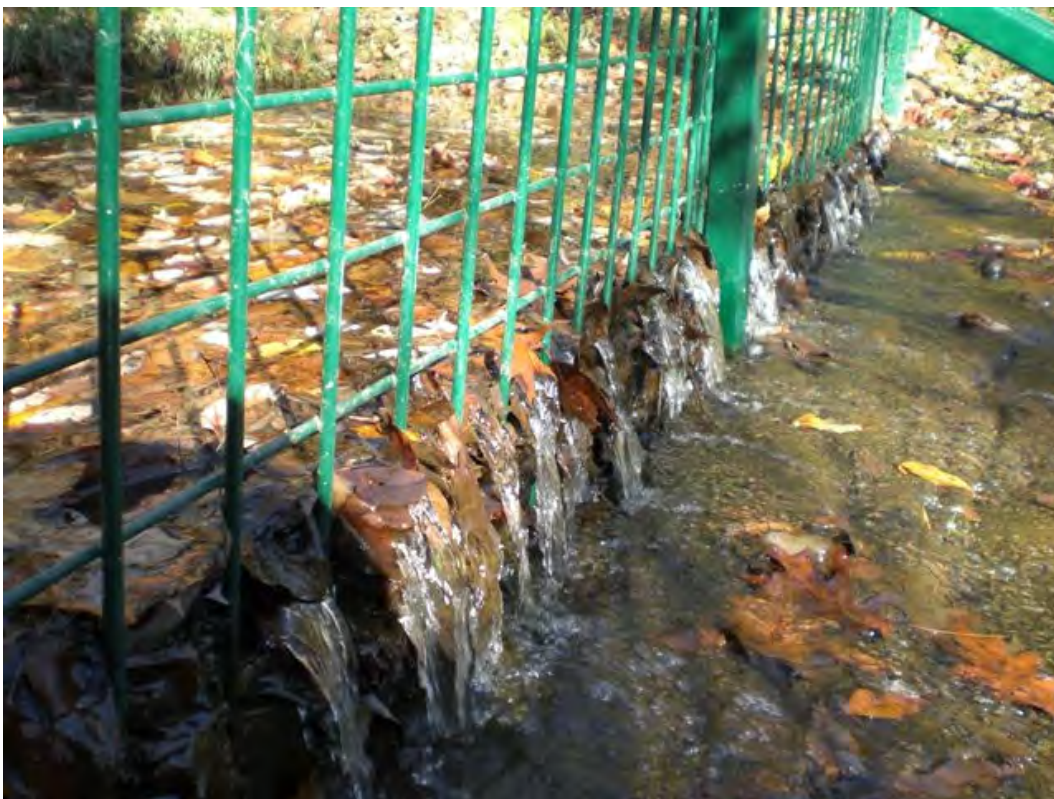
Photo 4: 7 – 8-inch deep leaves accumulated on the screen

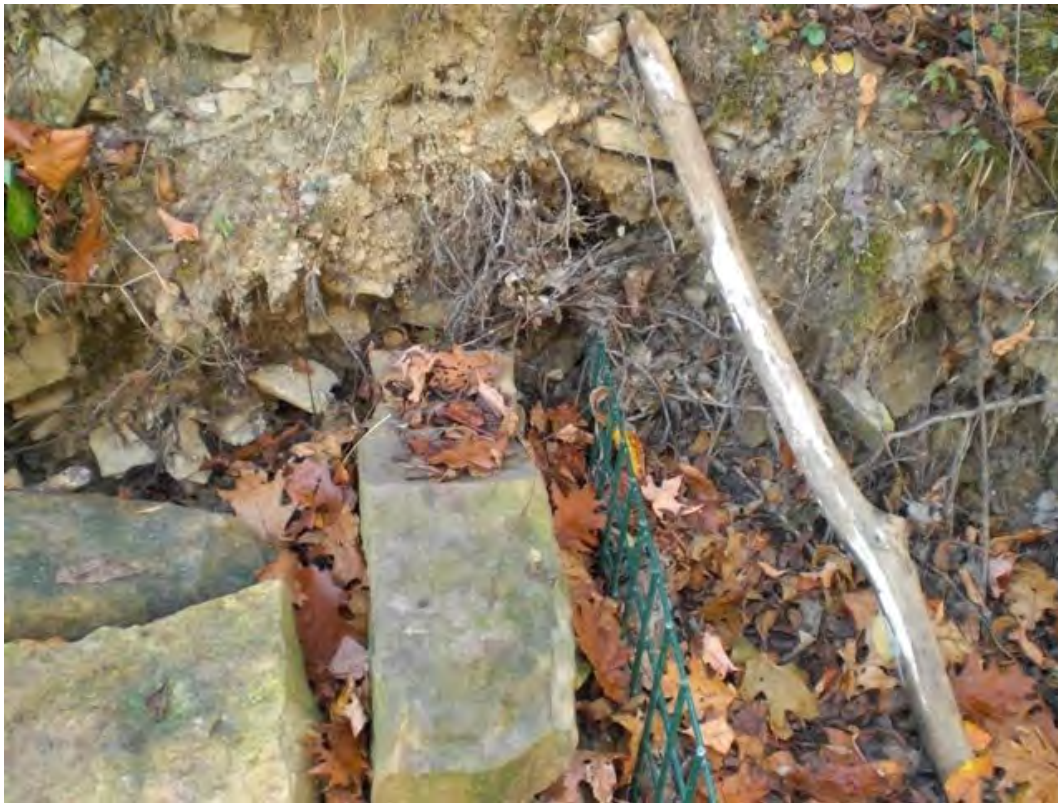
Creek bank scouring was observed at the south end of each of the two barriers, where the creek is deeper and the creek bank is steep (Photo 5). The scouring features are located

approximately at the height of the screens, which indicates that they were produced during storm events. The scouring effects are limited by the rocks present in the bank and the root mass of the vegetation. During the O&M trips the scoured areas have been partially filled with rocks. The rocks and roots present in the creek bank, as well as the O&M repairs, have limited the extent of scouring and its impact on the barrier integrity.

Photo 5: Scouring at south end of upstream (3-inch grid opening) barrier

No repairs are needed for the Barrier System elements. The monthly O&M trips will continue to focus on removing the debris accumulated on the screens and filling in any scoured areas on the creek banks.

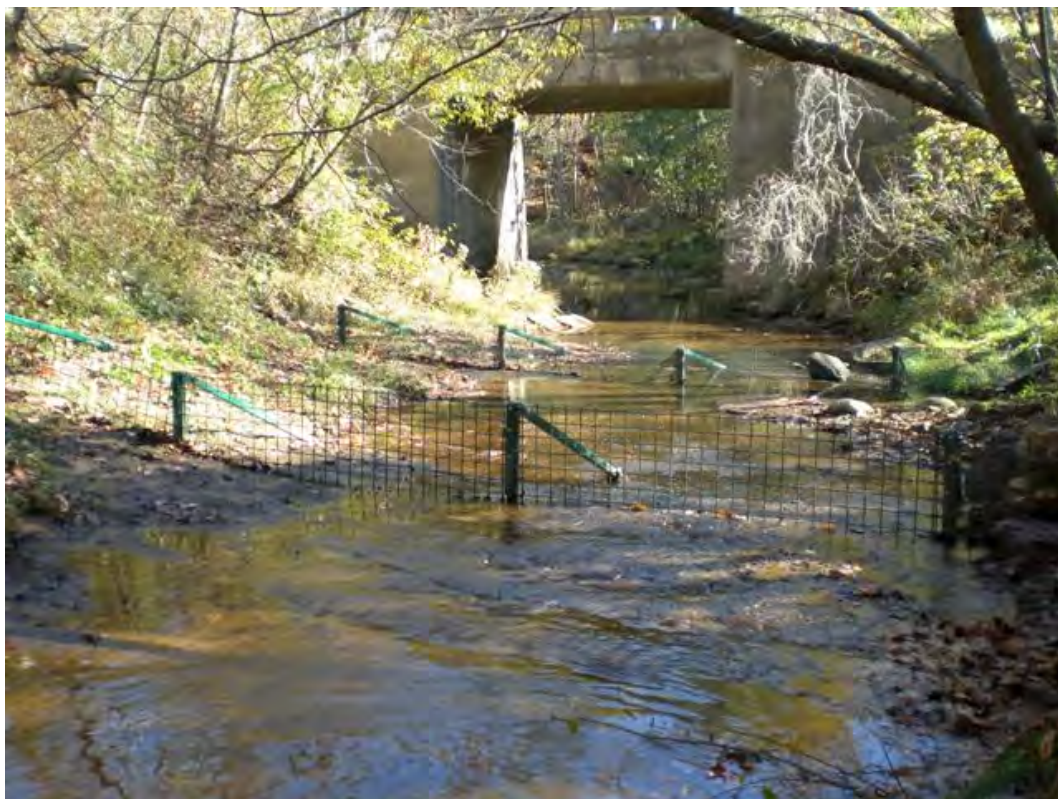
In the first three months of operation, the Barrier System has effectively performed as designed (Photos 6 and 7).

Photo 6: Barrier System, looking downstream

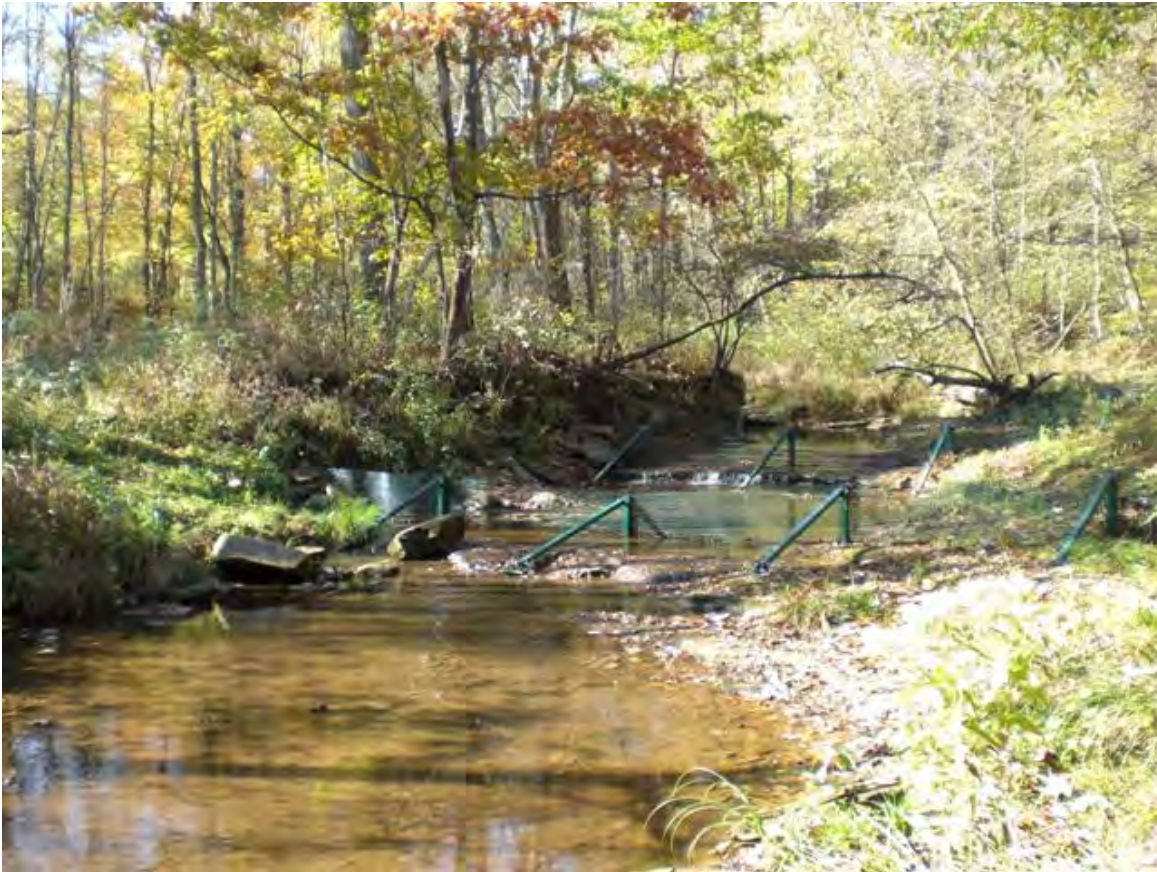
Photo 7: Barrier System, looking upstream
