# CY 2009

Operations and Maintenance Trip Reports and Quarterly Effectiveness  
Evaluation Reports Time Critical Response Action for the Rocket Ridge  
Area at RVAAP-004-R-01 Open Demolition Area #2

## Trip Report

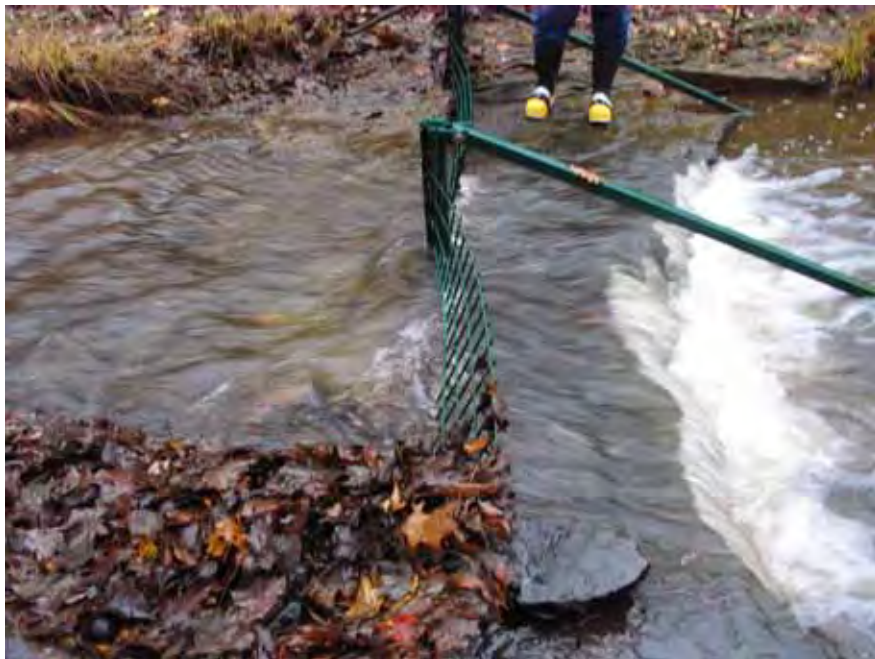
VIEW OF SLIGHT "BEND" NOTED IN THE UPSTREAM BARRIER.

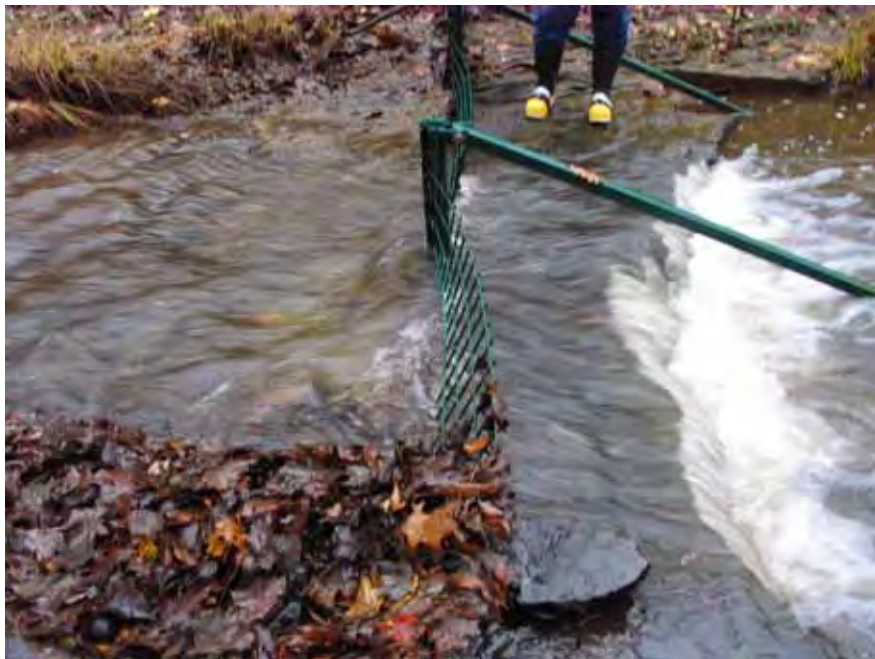
VIEW OF SLIGHT "BEND" NOTED IN THE UPSTREAM BARRIER.

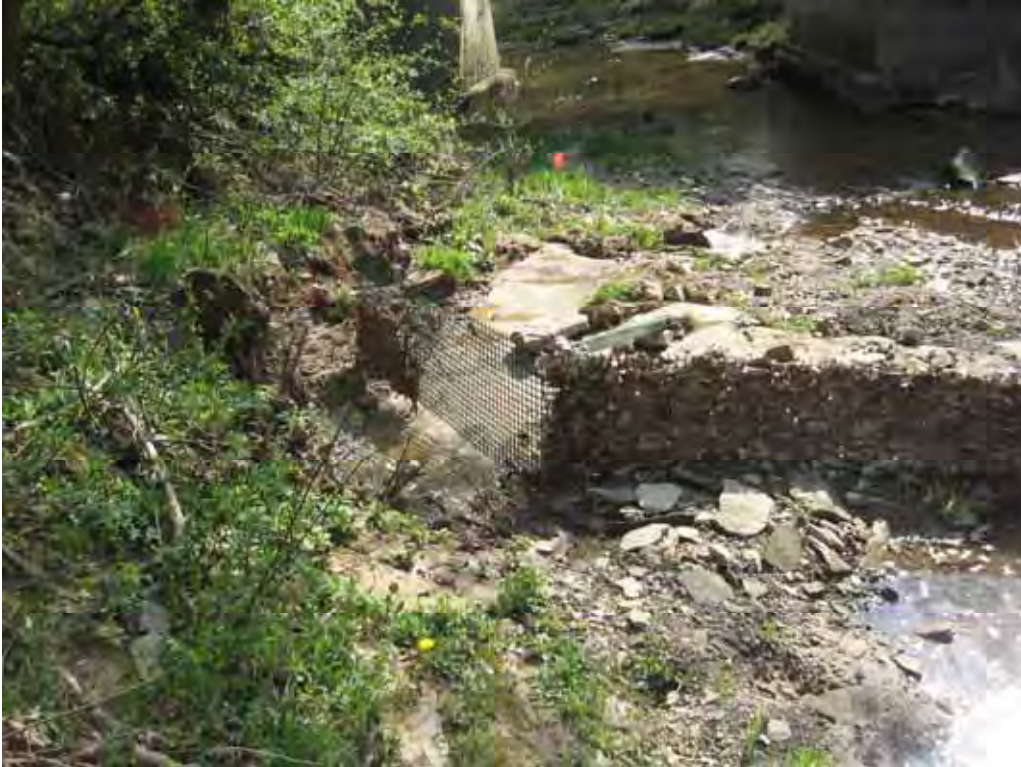
Picture showing north end of the bottom screen detached from stream bank.

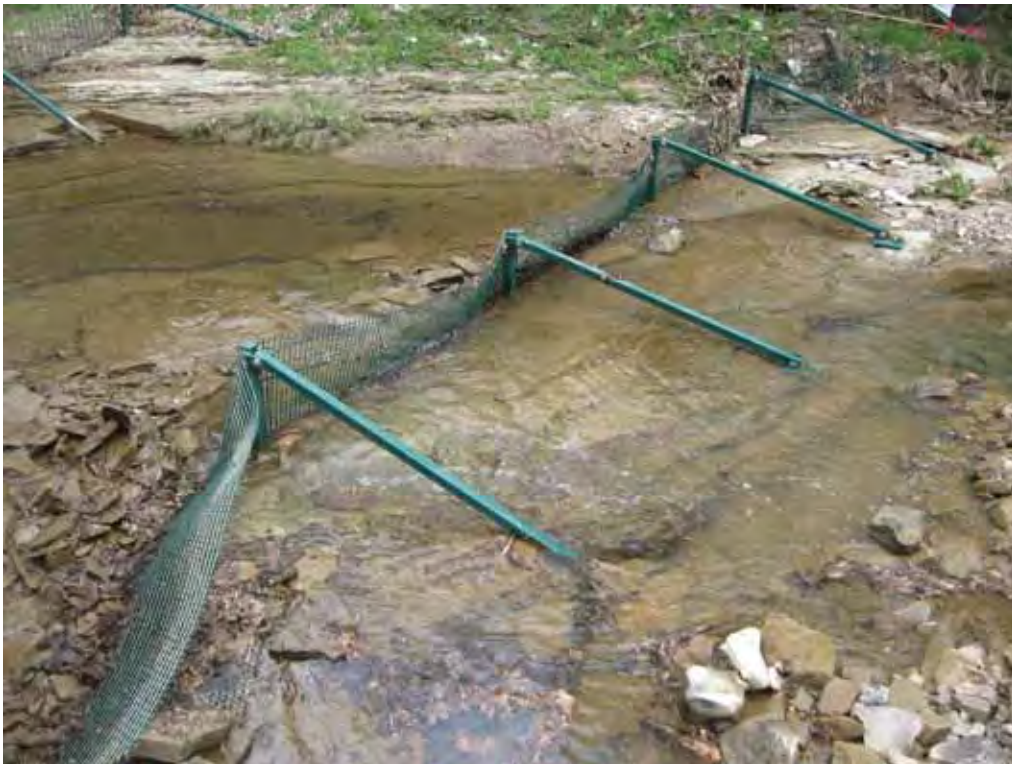
Picture showing south end of the bottom screen detached from stream bank.

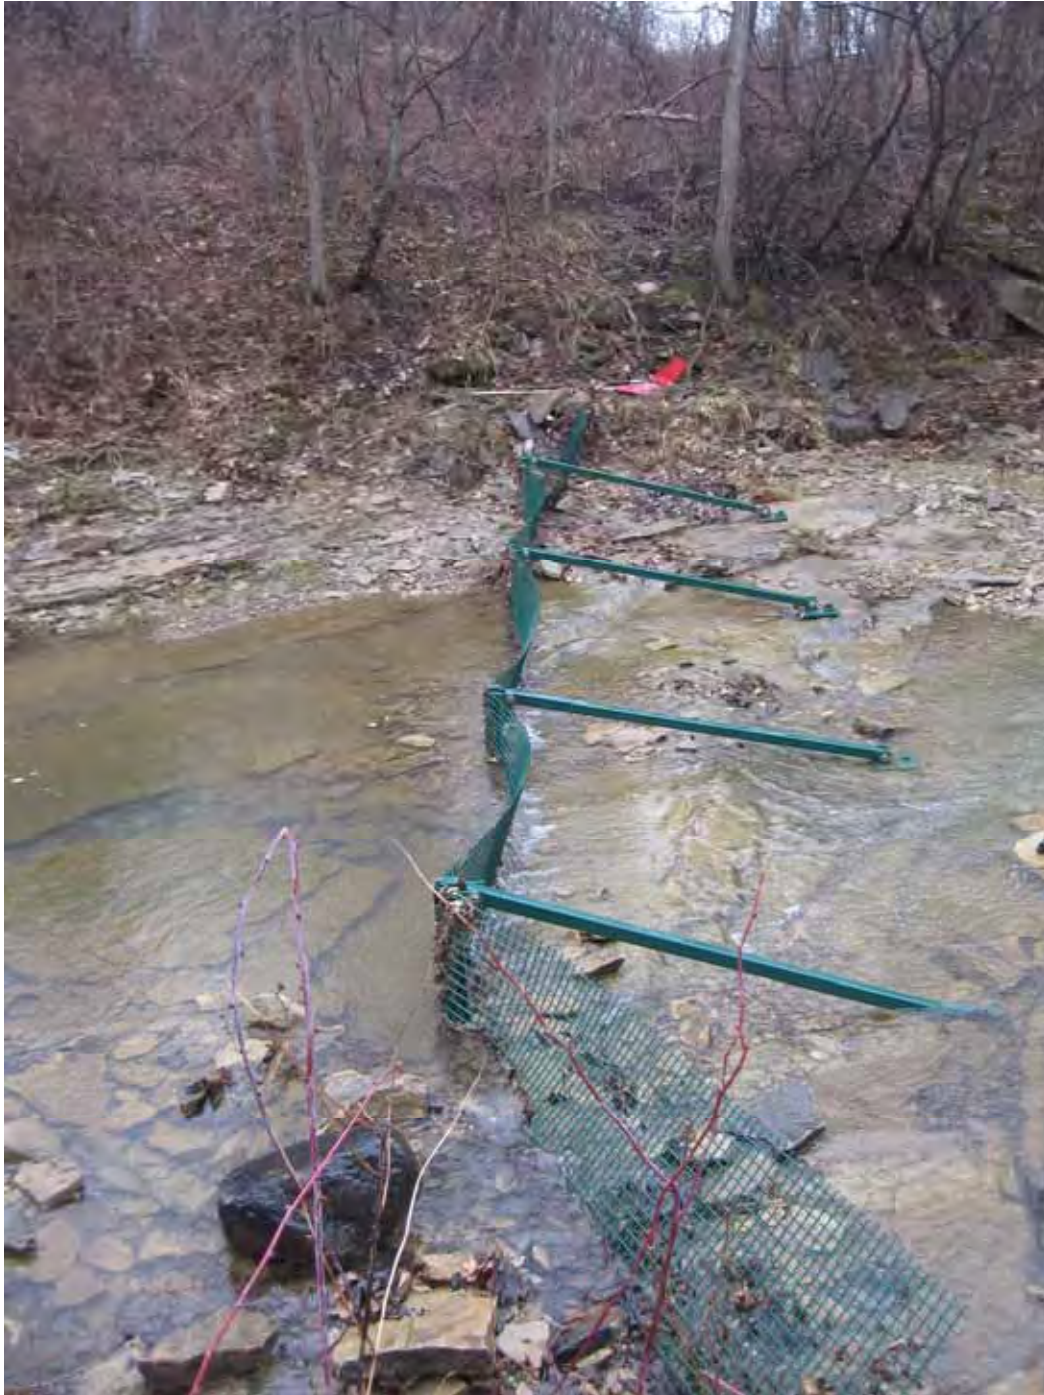
View showing degree of bowing on bottom screen.

<b>Repairs made or need to be made:</b> The gap between south screen panel and bank was filled with rocks to about 10-12 inches above creek bottom. PIKA will tighten the bolts on all posts. E2M will coordinate the repairs to the barrier system.

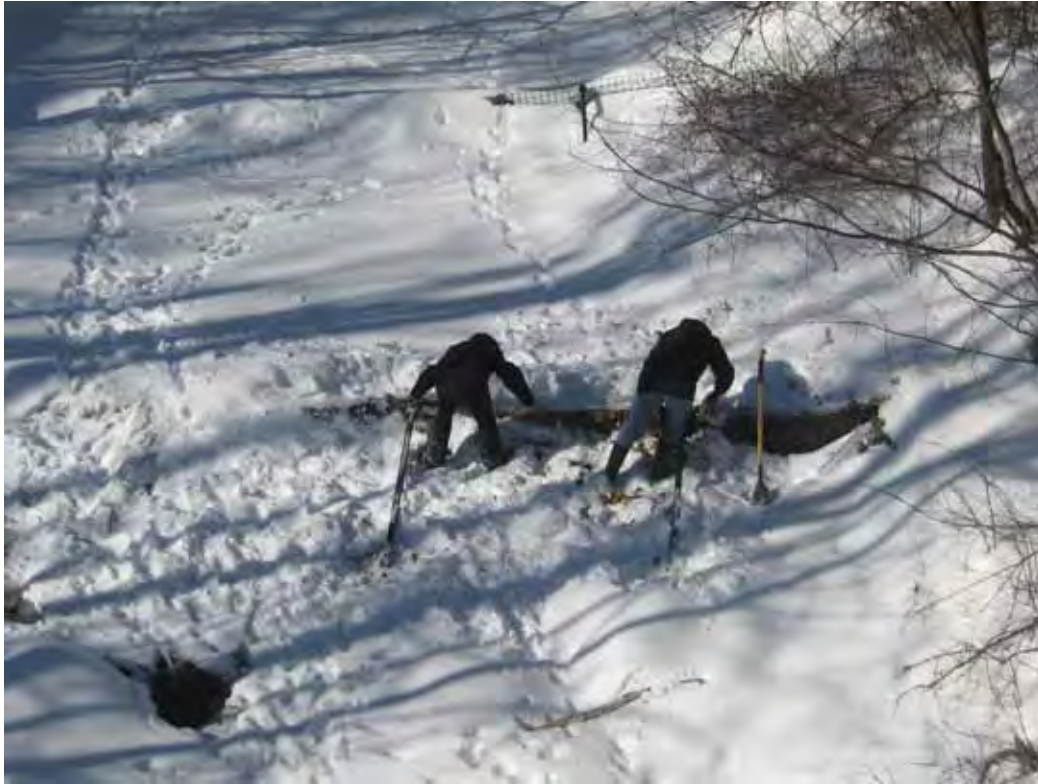
Measuring the bowing of screen

**Other changes observed:** The water pressure on the screen panels covered with leaves results in the elongation, or bowing, of the panels. During the 5 February 2009 site visit, the length of the forth panel from the south bank (in the 1-inch grid opening barrier) was measured to be approximately 96.75 inches, or 0.75 inches longer than the original size. This represents an elongation of approximately 0.8% or a strain of 0.008.

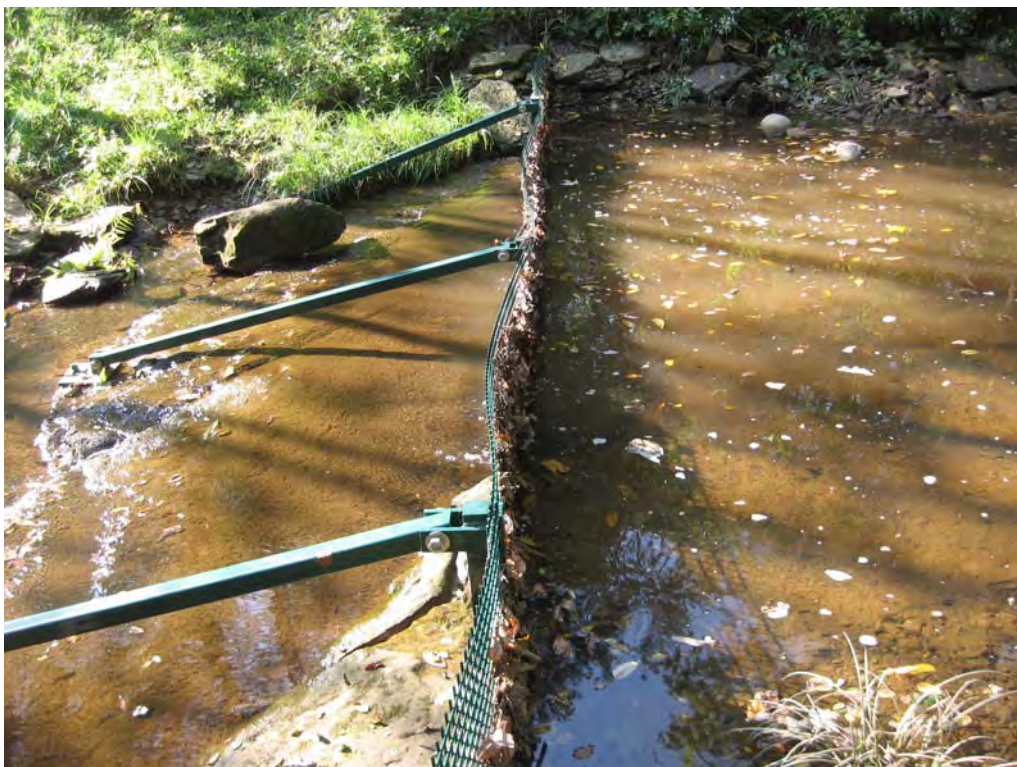
Bowing of barrier

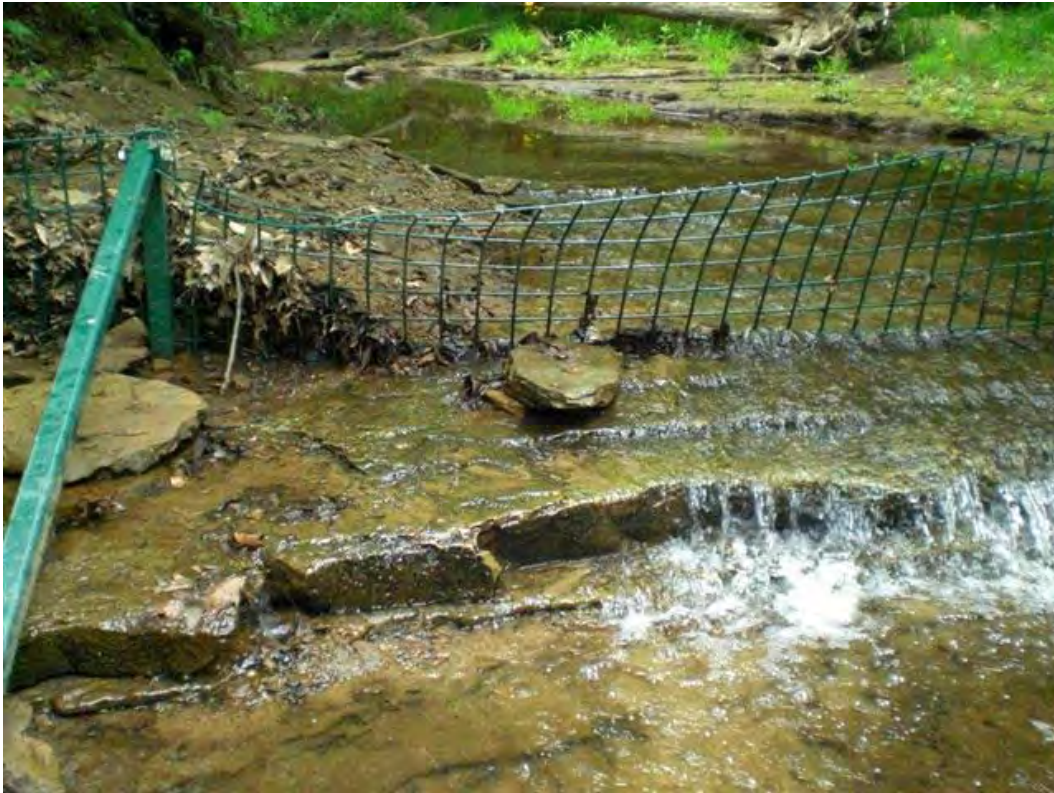
**Upstream (3-inch grid) barrier:** All barrier elements were in place and there were no gaps between the screen panels and creek bed and banks. The ends of the top two horizontal wires of the second panel from the south were observed detached from the post clamping system. The tops of the panels were bowed in the direction of the water flow.

Photo 3: Upstream barrier, second panel from the south (27 May 2009)

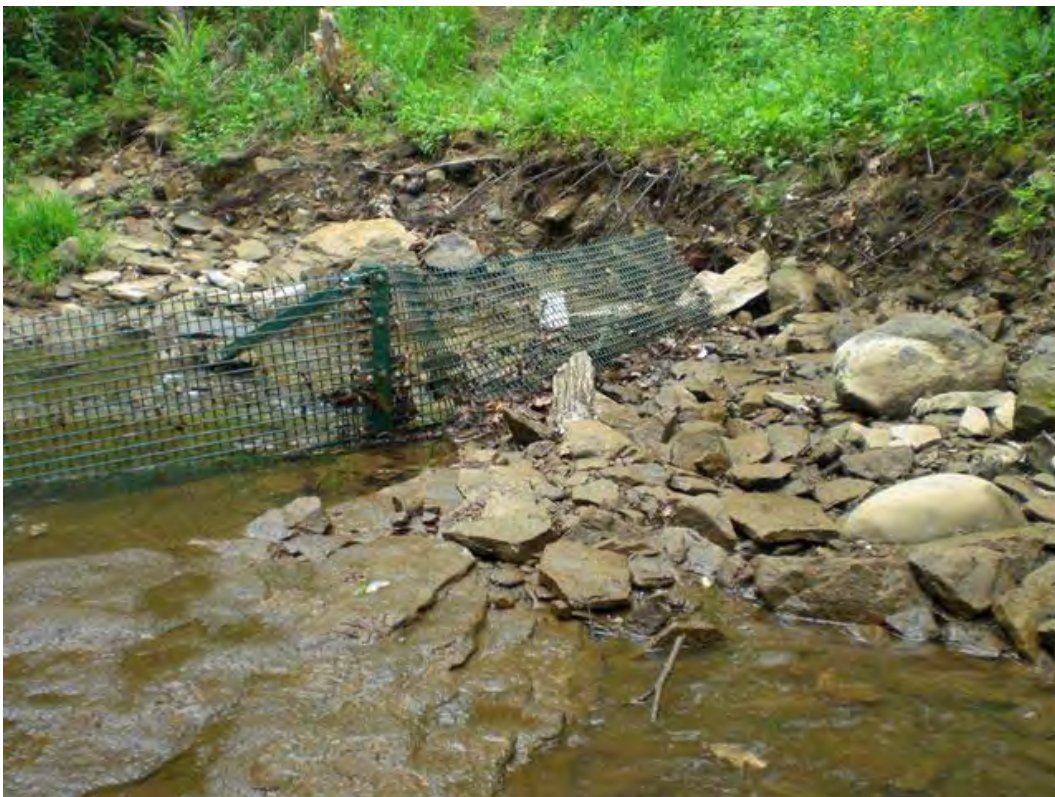
During the QEE Report #4 period (27 May - 2 September 2009), the barrier system continued to be effective in its capacity to trap potential munitions-related debris. Before the 2 September 2009 repairs, the downstream barrier no longer provided full redundancy because of the separation of the end panels from the creek banks.

Photo 4: Downstream barrier, south end panel (27 May 2009)

2. Install new post and back brace at the south end of the downstream barrier. The new post will be installed approximately 4 - 5 feet south of the existing post. A 24-inch high screen panel will be installed between the new post and the creek bank. The new panel will be keyed into the bank at a point one to three feet in front (upstream) of the barrier line. The angle of this panel will create a component of the stream force that will press the panel against the bank, therefore reducing the potential for the south end of the panel to become loose.

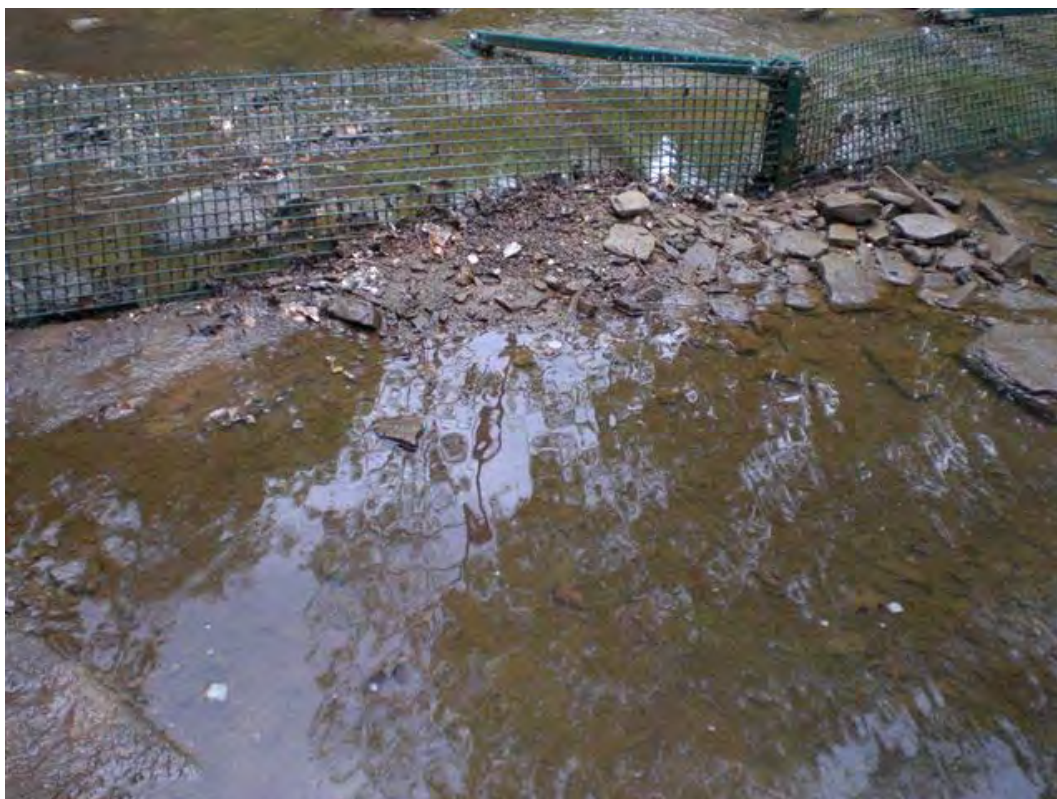
Photo 6: Downstream barrier, sand and gravel accumulation (27 May 2009)

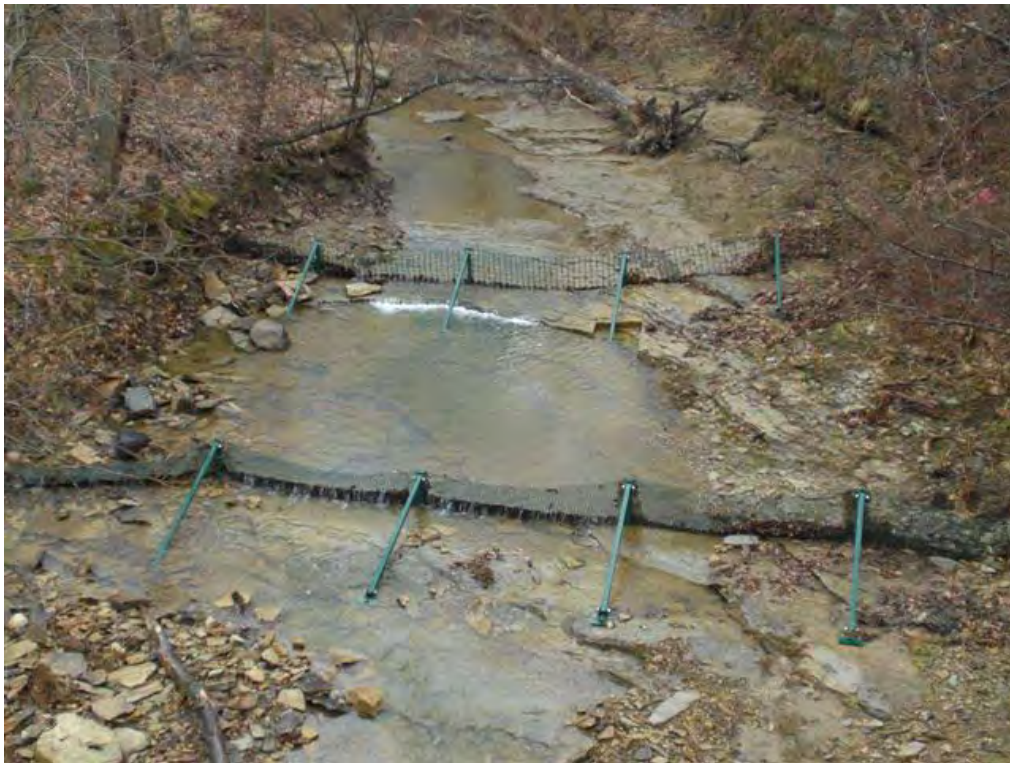
Since the 5 February 2009 site visit, when the barrier system was almost completely covered in ice and snow, the snow melt, rain, breaking ice, wood debris, and high creek water have resulted in damage to the some of the screen panels (see Photo #1).

Photo 1: Sand Creek Barrier System (25 March 2009)

1. Reduce the height of the central screen panels to 10-12 inches. The height of the end panels will remain 24 inches. Benefits include:
  - Reduced amount of leaves accumulated on the screens;
  - Reduced water pressure on the screens;
  - Less bowing of the screens and potential for screen rupture;

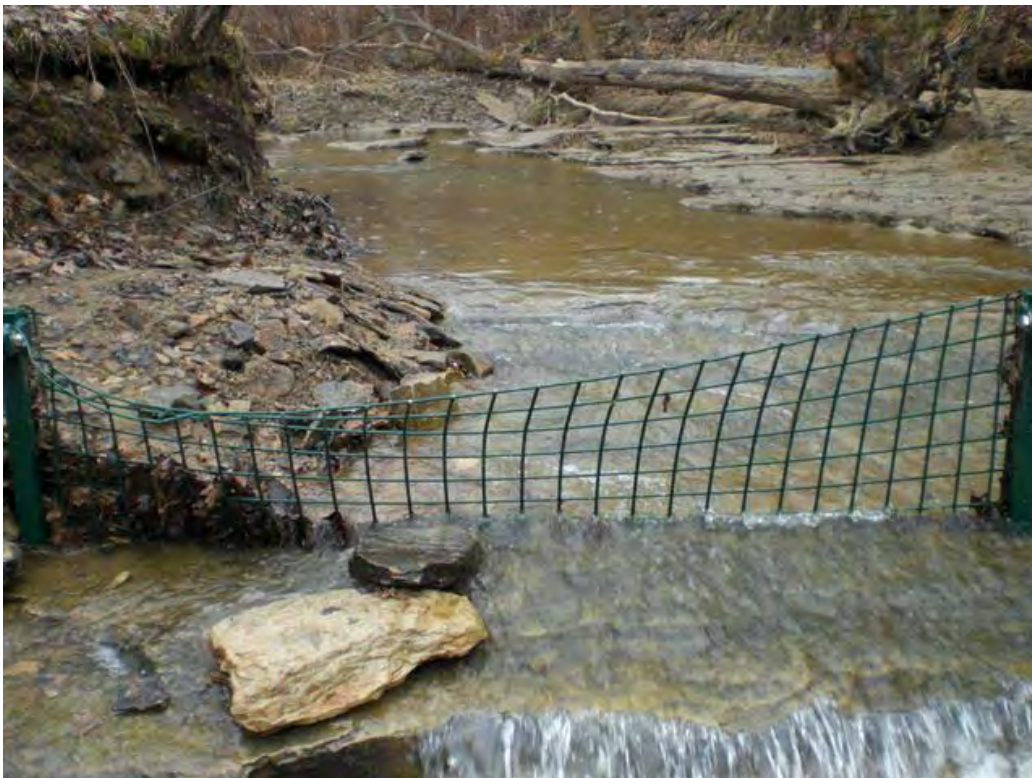
Photo 2: Upstream barrier, second panel from the south (25 March 2009)

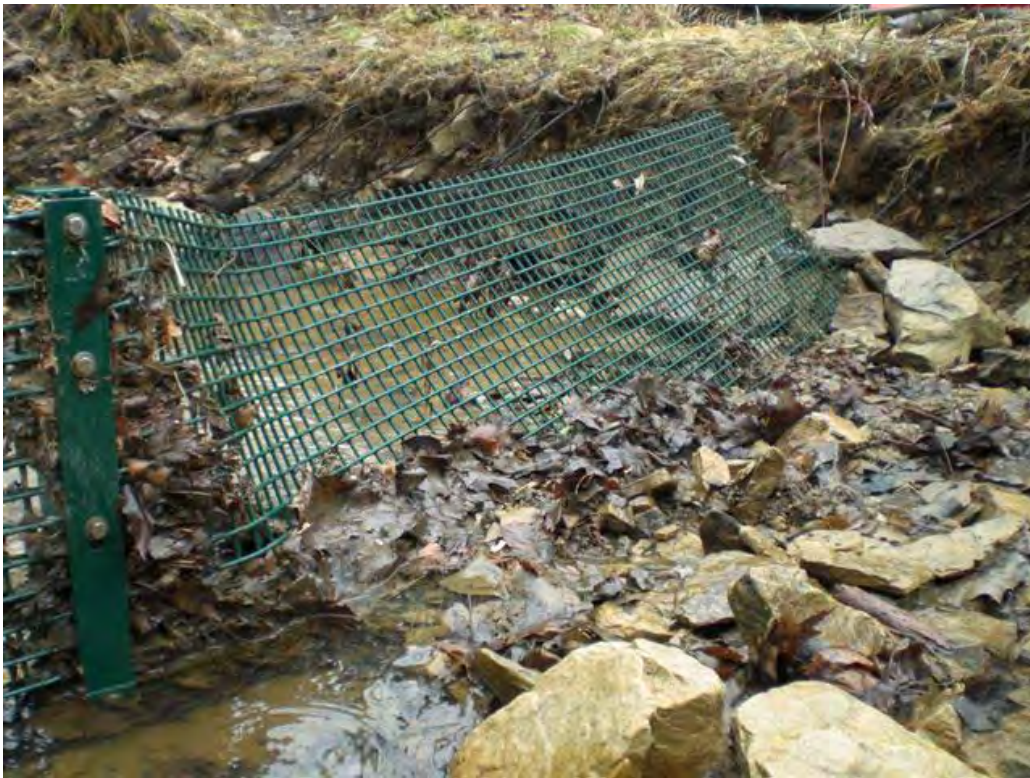
Photo 3: Downstream barrier, first panel from the south (25 March 2009)

2. Install new post and back brace at the south end of the downstream barrier. The new post will be installed approximately 4 - 5 feet south of the existing post. A 24-inch high screen panel will be installed between the new post and the creek bank. The new panel will be keyed into the bank at a point one to three feet in front (upstream) of the barrier line. The angle of this panel will create a component of the stream force that will press the panel against the bank, therefore reducing the potential for the south end of the panel to become loose.

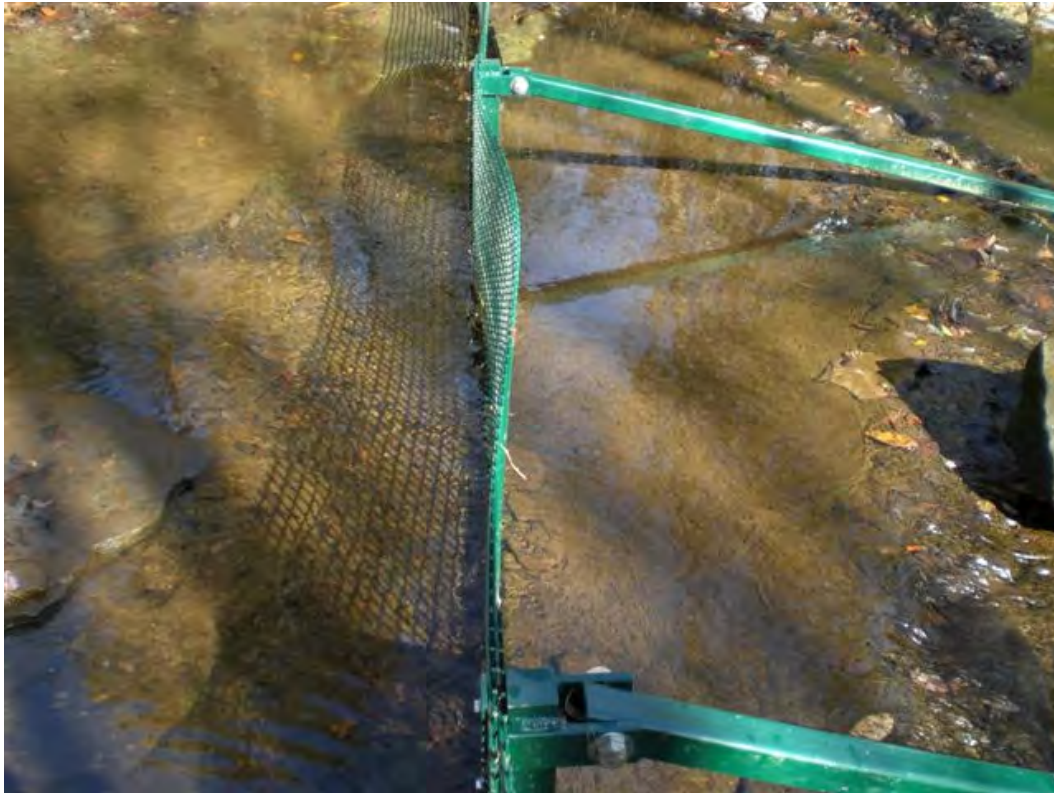
Photo 3: Downstream (1-inch grid opening) screen deflection

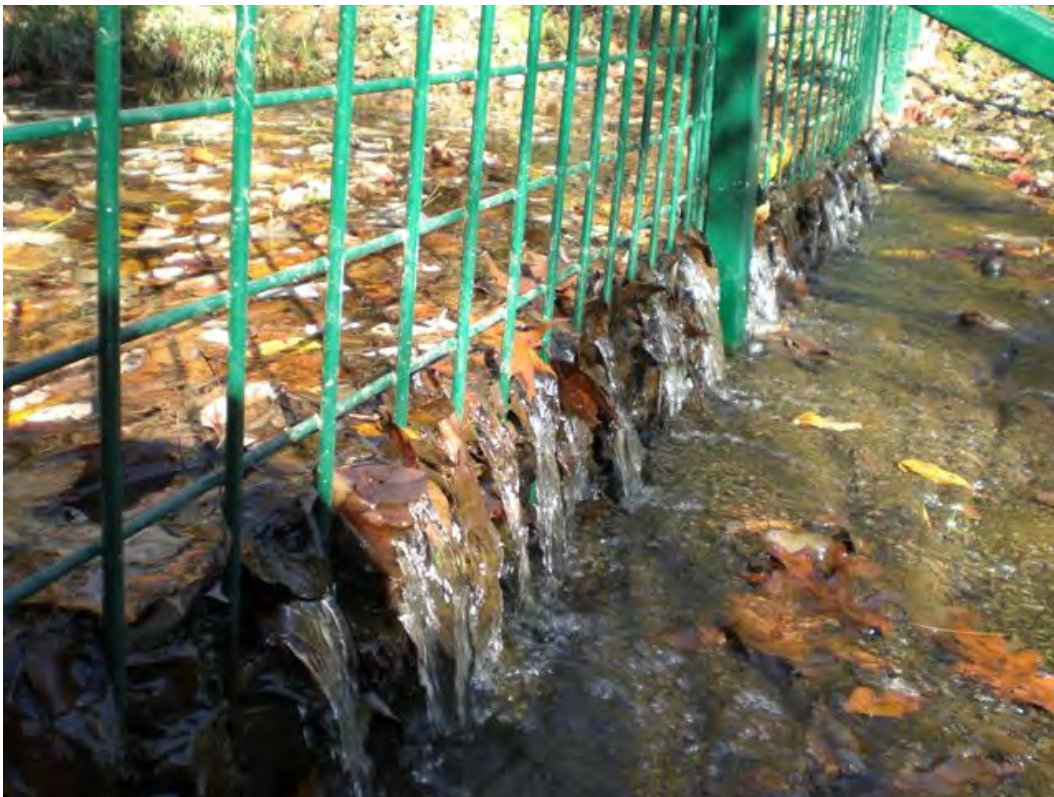
Photo 4: 7 – 8-inch deep leaves accumulated on the screen

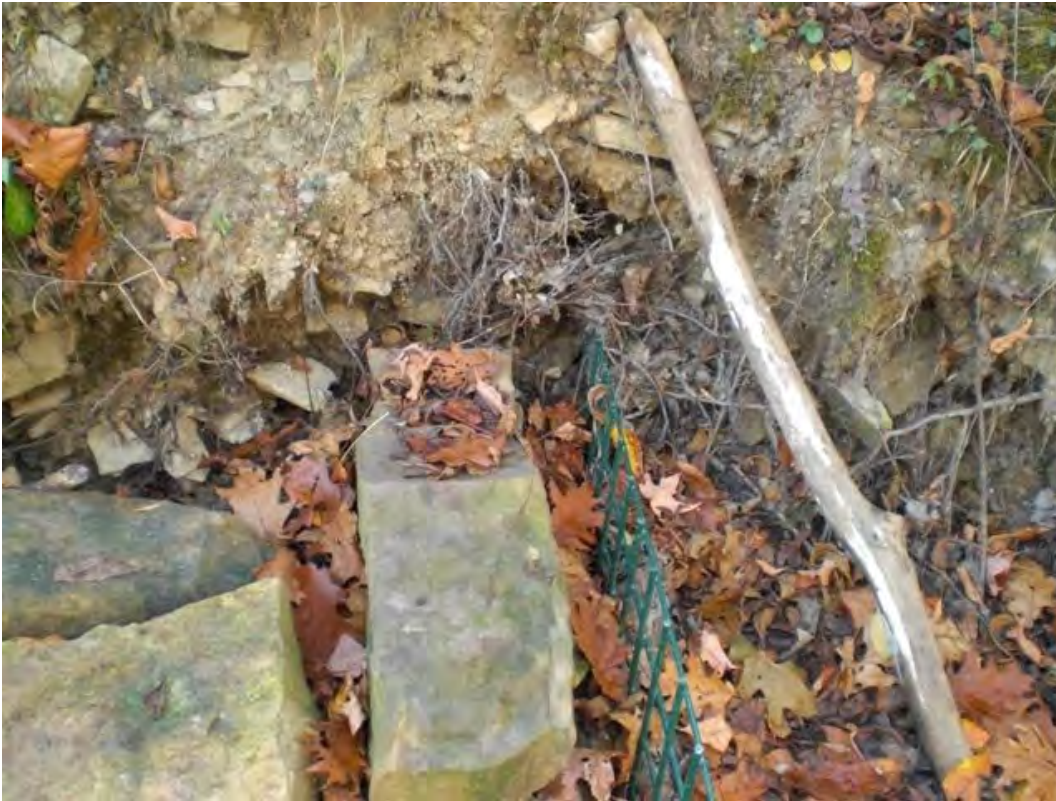
Photo 5: Scouring at south end of upstream (3-inch grid opening) barrier
