CY 2011

Operations and Maintenance Trip Reports and Quarterly Effectiveness
Evaluation Reports Time Critical Response Action for the Rocket Ridge
Area at RVAAP-004-R-01 Open Demolition Area #2

Trip Report

Quarterly Effectiveness Evaluation Report
Sand Creek Barrier System
Time Critical Response Action (TCRA) for the Rocket Ridge Area of
Open Demolition Area #2

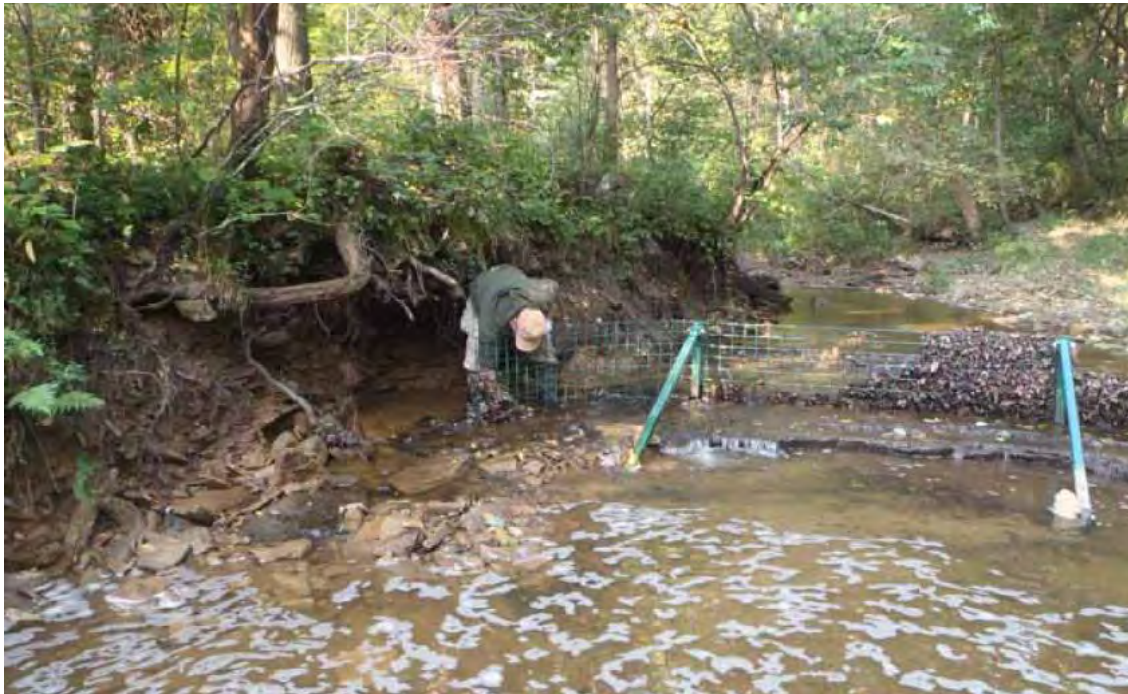
PICTURE SHOWING UXO TECHNICIAN REMOVING ACCUMULATED DEBRIS FROM BARRIER

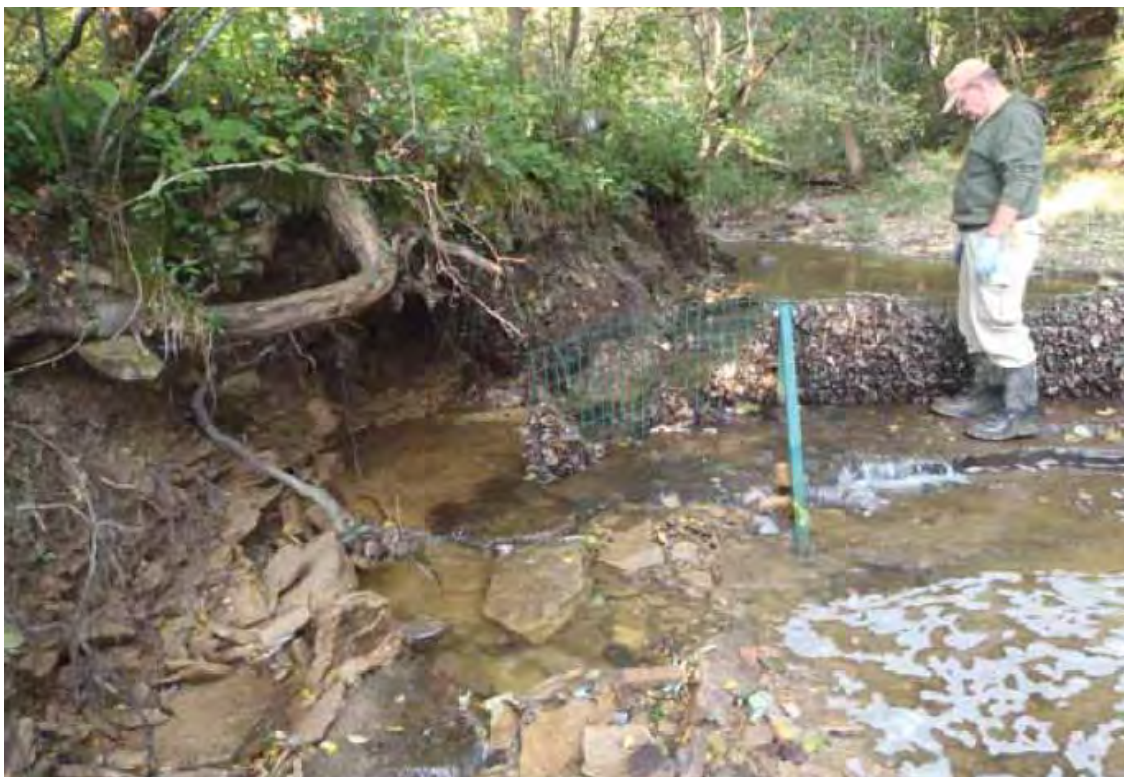
PICTURES SHOWING EROSION OF STREAM BANK NEAR SOUTH END OF BARRIER

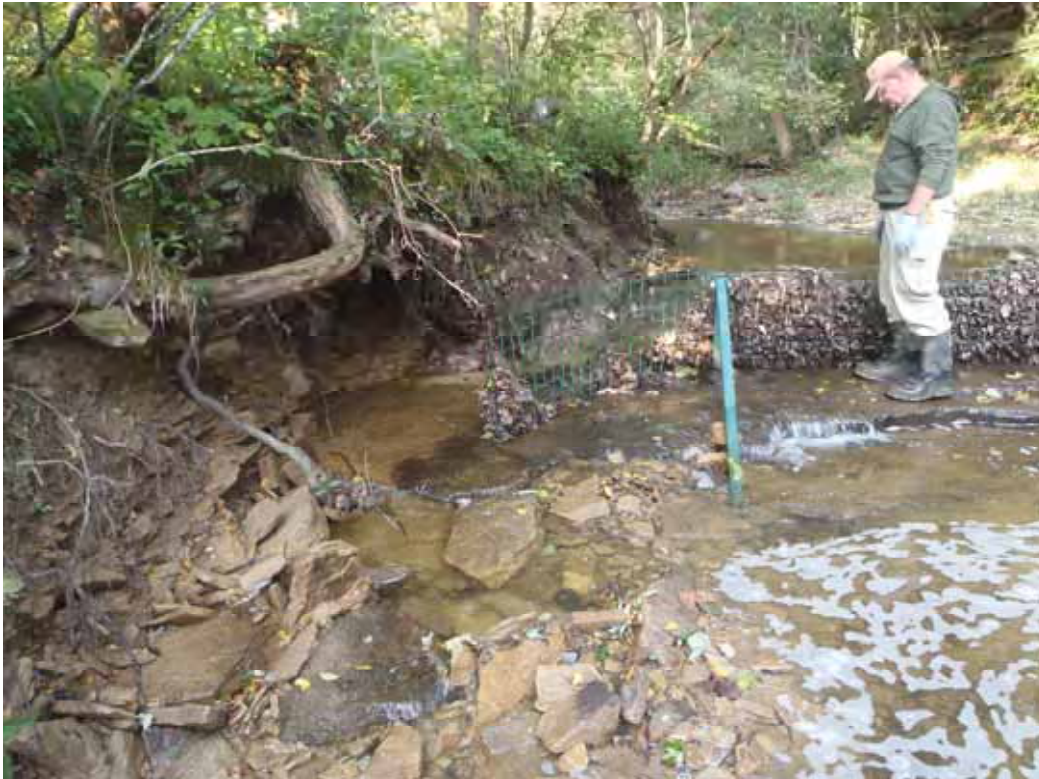
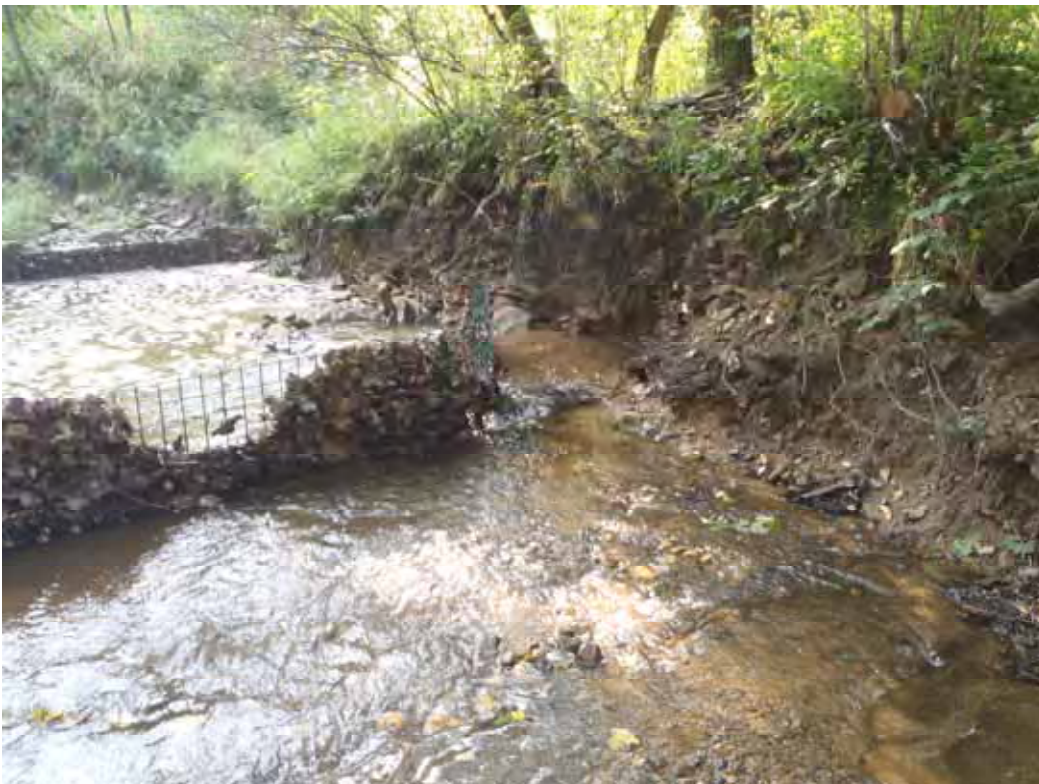
PICTURES SHOWING EROSION OF STREAM BANK NEAR SOUTH END OF BARRIER

Prime Contract No:			Report No.	14
PIKA JOB #:	09-46-169		Date:	9/14/11
Project:	Operation and Maintenance of the Sand Creek Barrier System			
Environmental Conditions:				
Weather Conditions (Bright Sun, Clear, Overcast, Rain, Snow):		Sunny		
Temperature:		66° F		
Wind (Still, Moderate, High):		Still		
Humidity (Dry, Moderate, Humid):		Dry		
<p>Field Activities:</p> <p>Description of debris inspection & removal activities: Removed sticks, mud, and leaves from barriers. No MEC/MD encountered</p> <p>Barrier Integrity: The Upper Barrier integrity has been compromised as the stream bank around south end of barrier has eroded (see photos). The lower barrier is upright and intact.</p> <p>Assessment of any changes since previous visit: Barrier is in need of repair due to erosion of Stream bank. Large amounts of silt have accumulated and should be removed.</p> <p>Repairs made or need to be made: Remove accumulated silt and repair barrier where it is separated from the stream bank.</p>

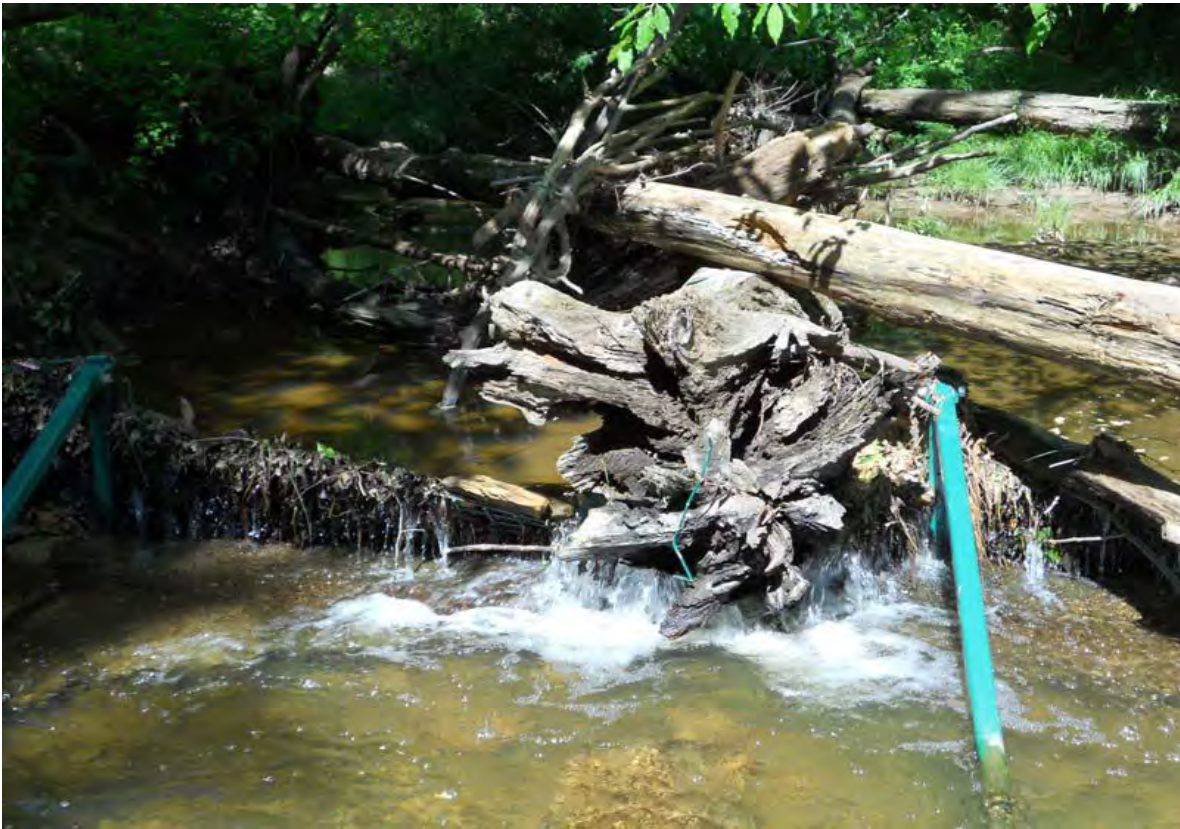
During the 6-2-11 High Water Flow Inspection several trees and deposits of sand stone were found. This had damaged the barriers. The trees and sand stone were removed and the barriers were repaired to their original condition. (See attached photos.)

PICTURES SHOWING DAMAGE TO BARRIERS.

Maintenance performed: Removed all materials from screens. Repaired barriers in June, 2011.

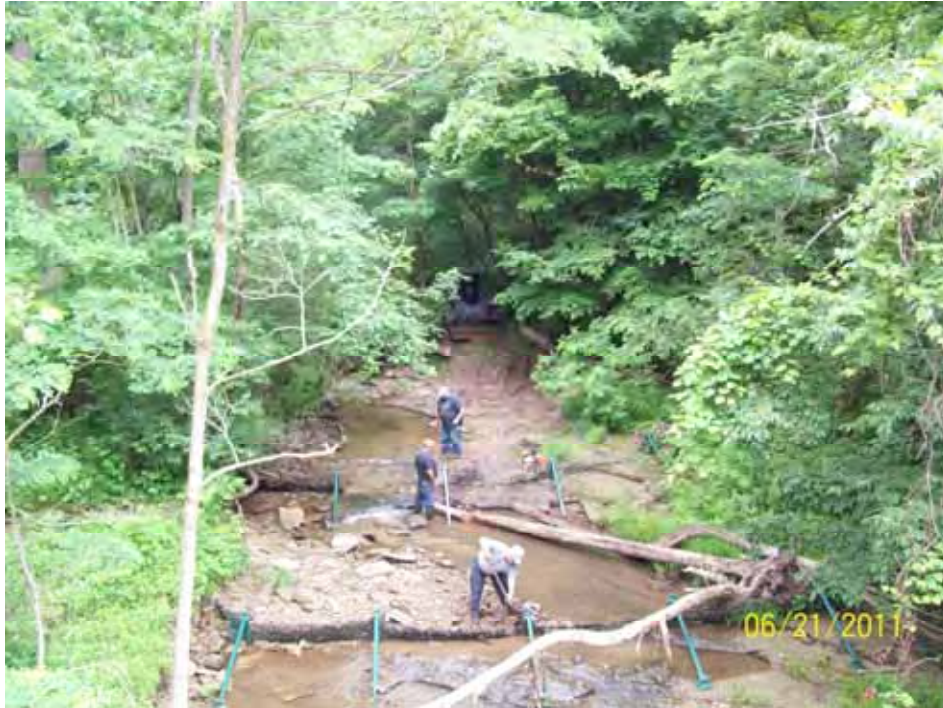
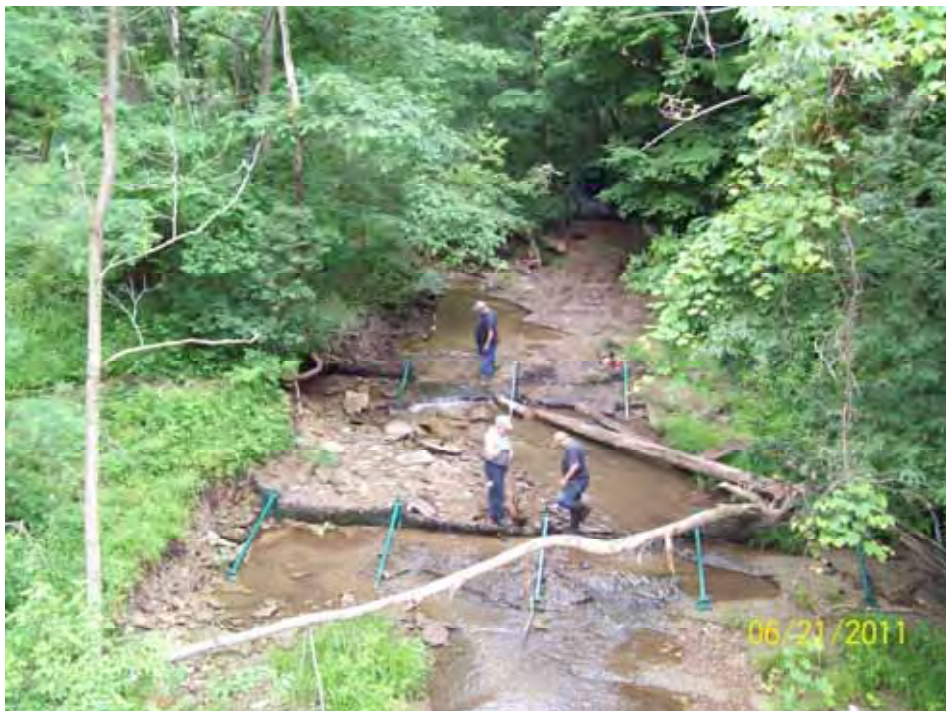
PICTURES SHOWING FRANK MAINTENANCE DOING REPAIR WORK AT SAND CREEK BARRIERS

Prime Contract No:			Report No.	11
PIKA JOB #:	09-46-169		Date:	6/21/11
Project:	Operation and Maintenance of the Sand Creek Barrier System			
Environmental Conditions:				
Weather Conditions (Bright Sun, Clear, Overcast, Rain, Snow):		Sunny		
Temperature:		72° F		
Wind (Still, Moderate, High):		Still		
Humidity (Dry, Moderate, Humid):		Dry		
<p>Field Activities:</p> <p>Description of debris inspection & removal activities: Provided ordnance avoidance and construction support during repairs by Frank's Maintenance. No ordnance items were located.</p> <p>Barrier Integrity: Trees have fallen onto the barriers and rocks piled up against the lower barrier warranting repairs. Another large rain event could compromise several panels. Barrier is in serious need of repair.</p> <p>Assessment of any changes since previous visit: None</p> <p>Repairs made or need to be made: Franks Maintenance on site to perform repairs. Trees removed. Rocks, mud, and silt removed from the second screen. Replaced damaged panels.</p>

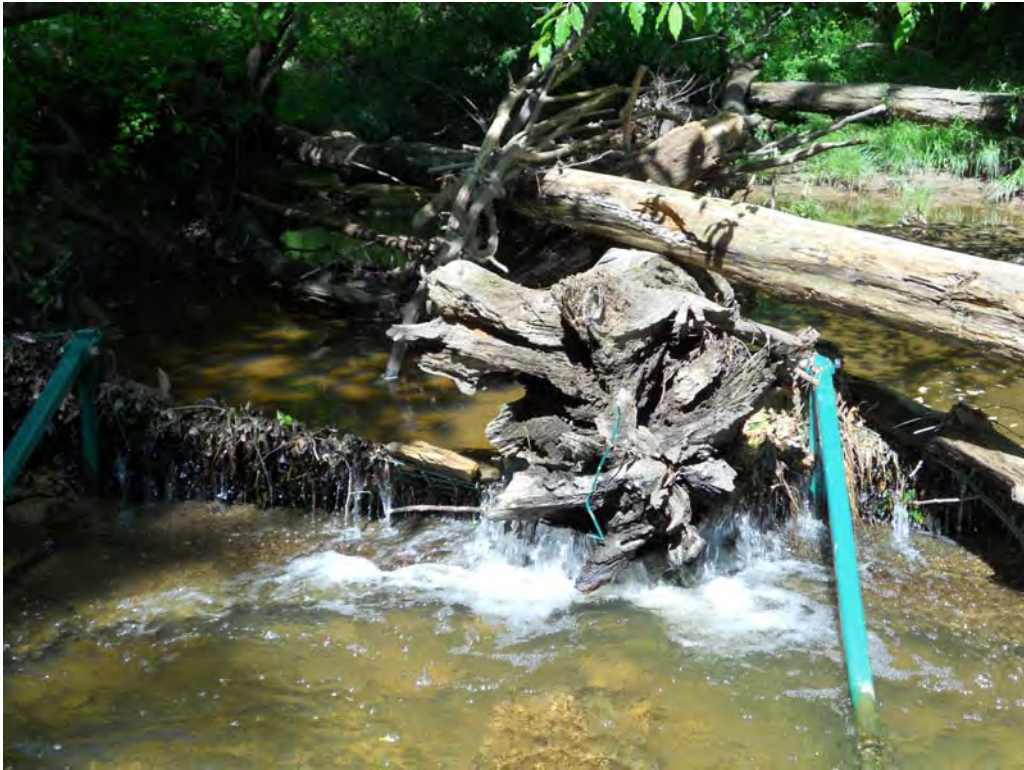
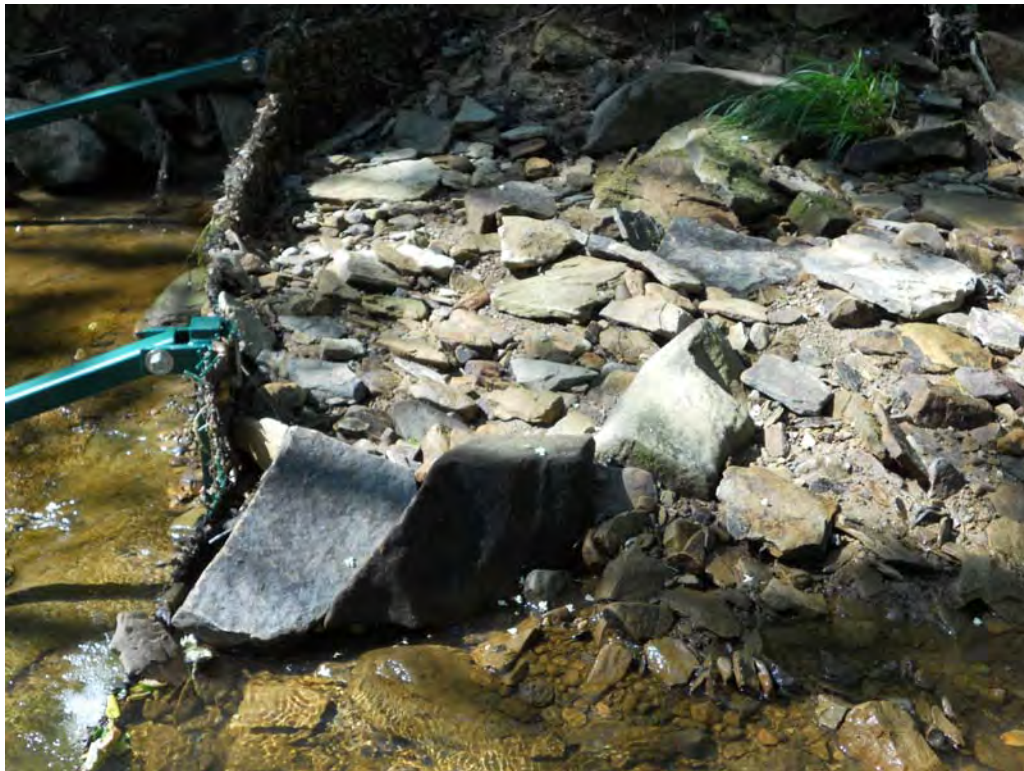
PICTURES SHOWING DAMAGE TO BARRIERS

Prime Contract No:			Report No.	10
PIKA JOB #:	09-46-169		Date:	6/02/11
Project:	Operation and Maintenance of the Sand Creek Barrier System			
Environmental Conditions:				
Weather Conditions (Bright Sun, Clear, Overcast, Rain, Snow):		Sunny		
Temperature:		68° F		
Wind (Still, Moderate, High):		Still		
Humidity (Dry, Moderate, Humid):		Dry		
<p>Field Activities:</p> <p>Description of debris inspection & removal activities: Conducted visual inspection of barriers and around fallen trees. No ordnance items were located. Removed rocks, sticks, mud, etc. from barriers.</p> <p>Barrier Integrity: Trees have fallen onto the barriers and rocks have started to pile up against the lower barrier. Another large rain event could compromise several panels. Barrier is in serious need of repair.</p> <p>Assessment of any changes since previous visit: Trees have fallen on screen panels. Rocks, silt, and mud have given way from the left side bank and now covers approximately one-third of barriers middle. It continues to cover almost all of the second screen one-third of the way across.</p> <p>Repairs made or need to be made: Trees need removed. Rocks, mud, and silt need to be removed from the stream and from the second screen. Replace 4 to 5 panels depending on the damage caused after debris is removed.</p>

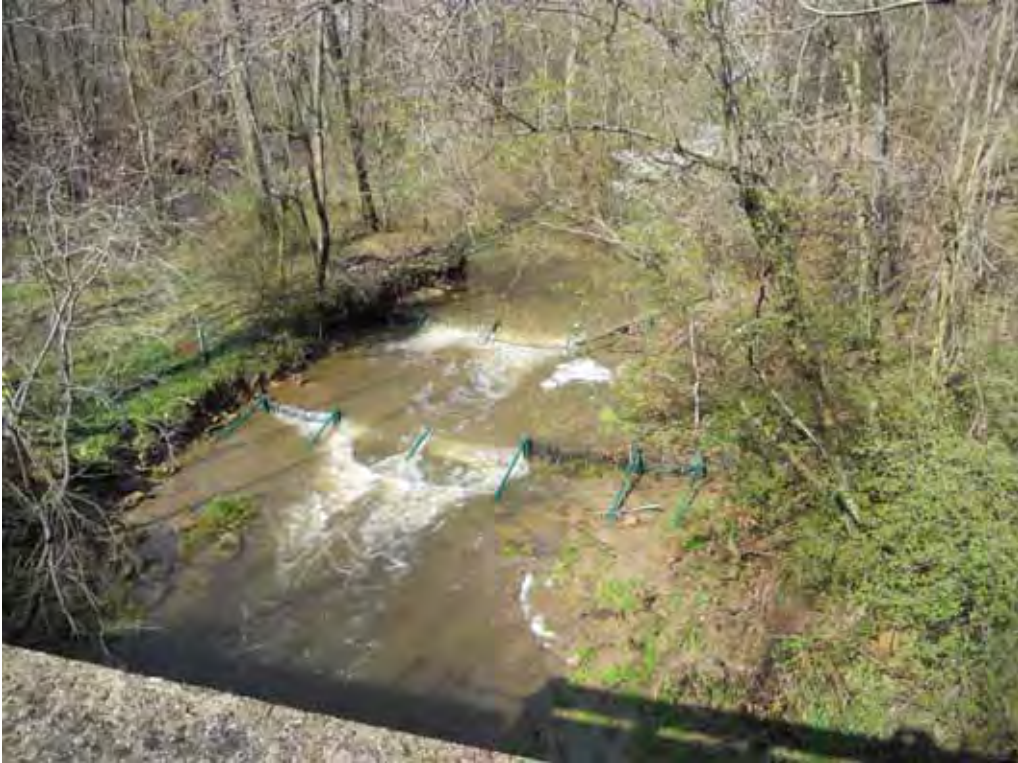
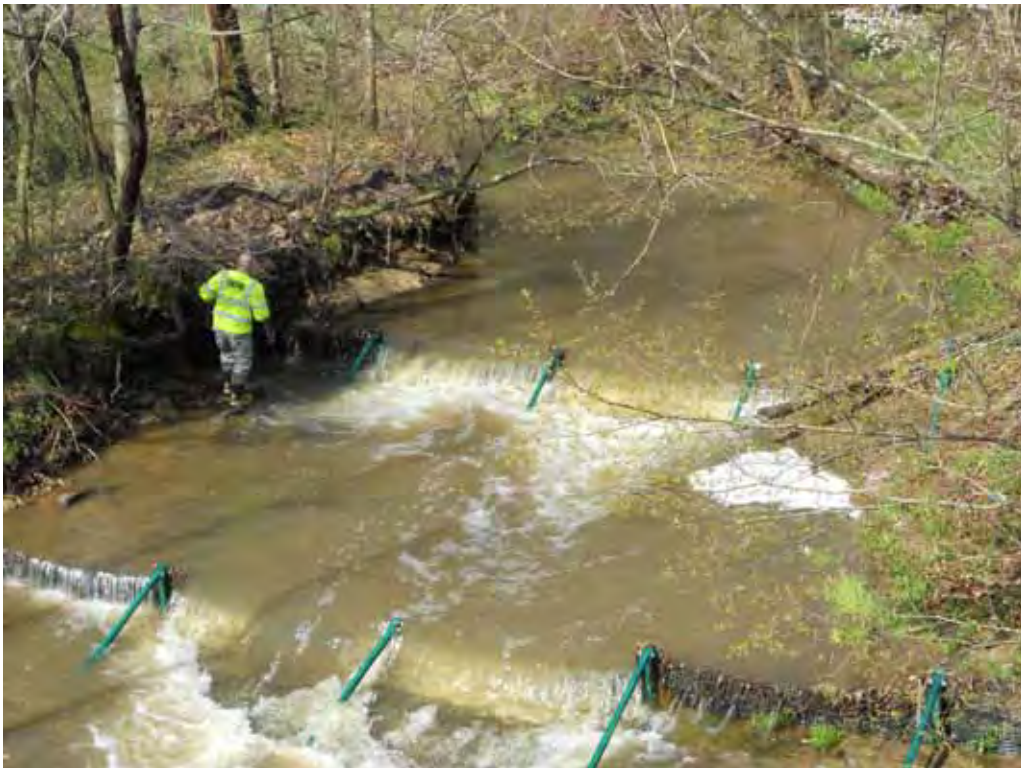
PICTURES OF SAND CREEK BARRIERS UPON ARRIVAL. CREEK OVERFLOWING BARRIERS DUE TO HIGH WATER.

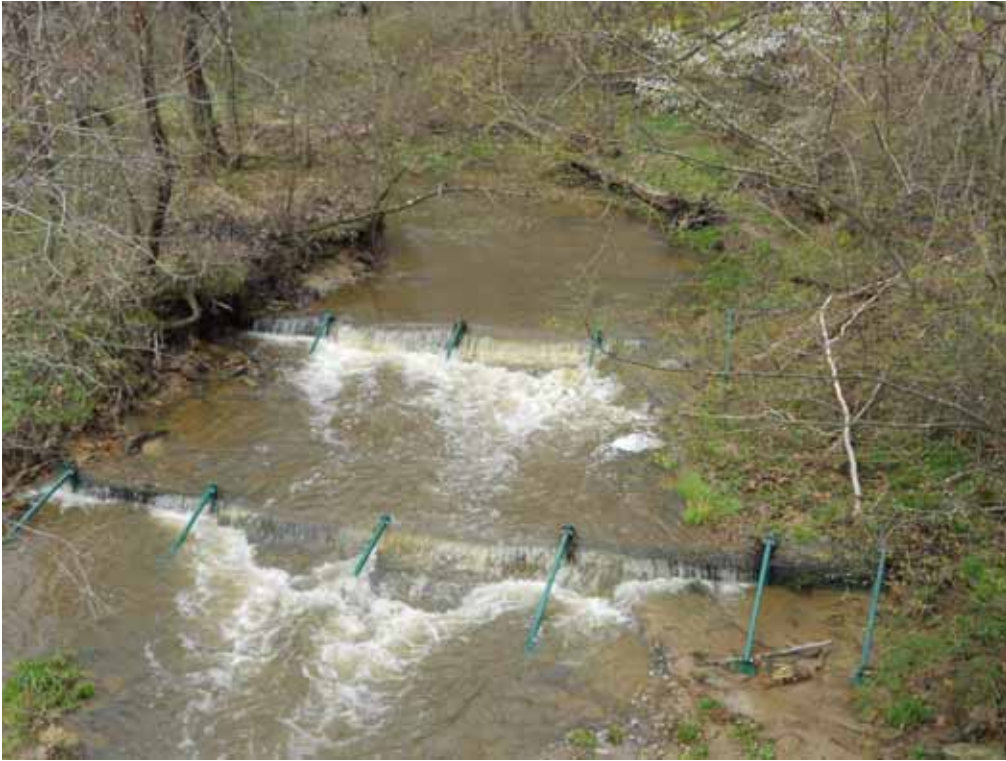
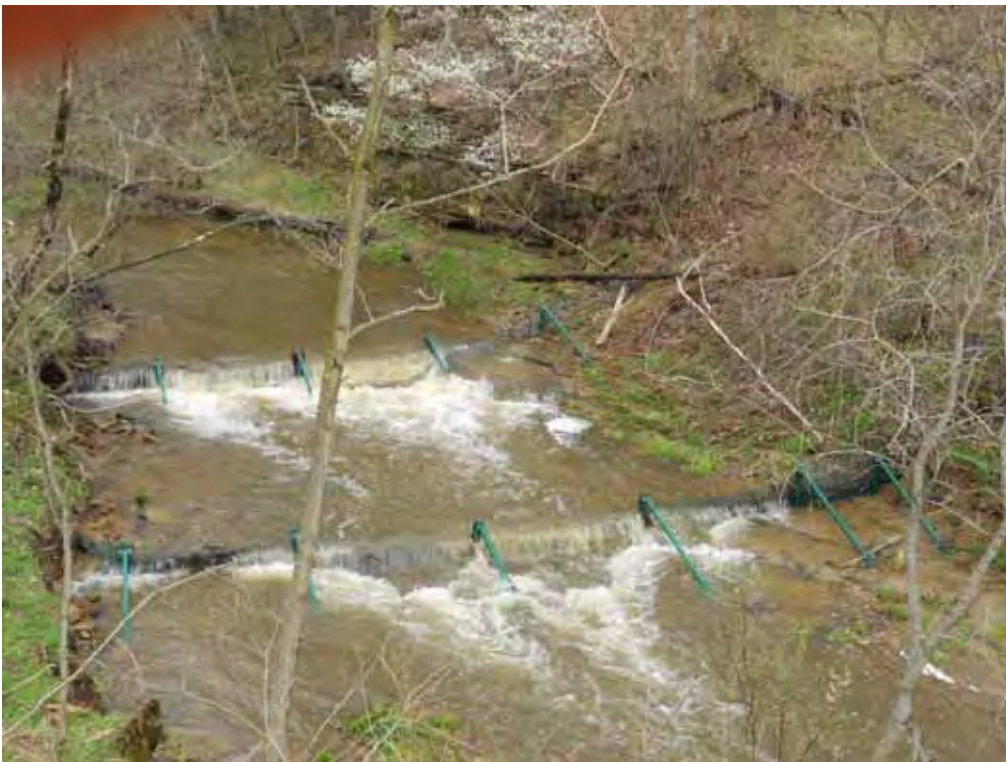
OVERVIEW OF BARRIERS UPON DEPARTURE. CREEK OVERFLOWING BARRIERS DUE TO HIGH WATER FROM RECENT HEAVY RAINS.

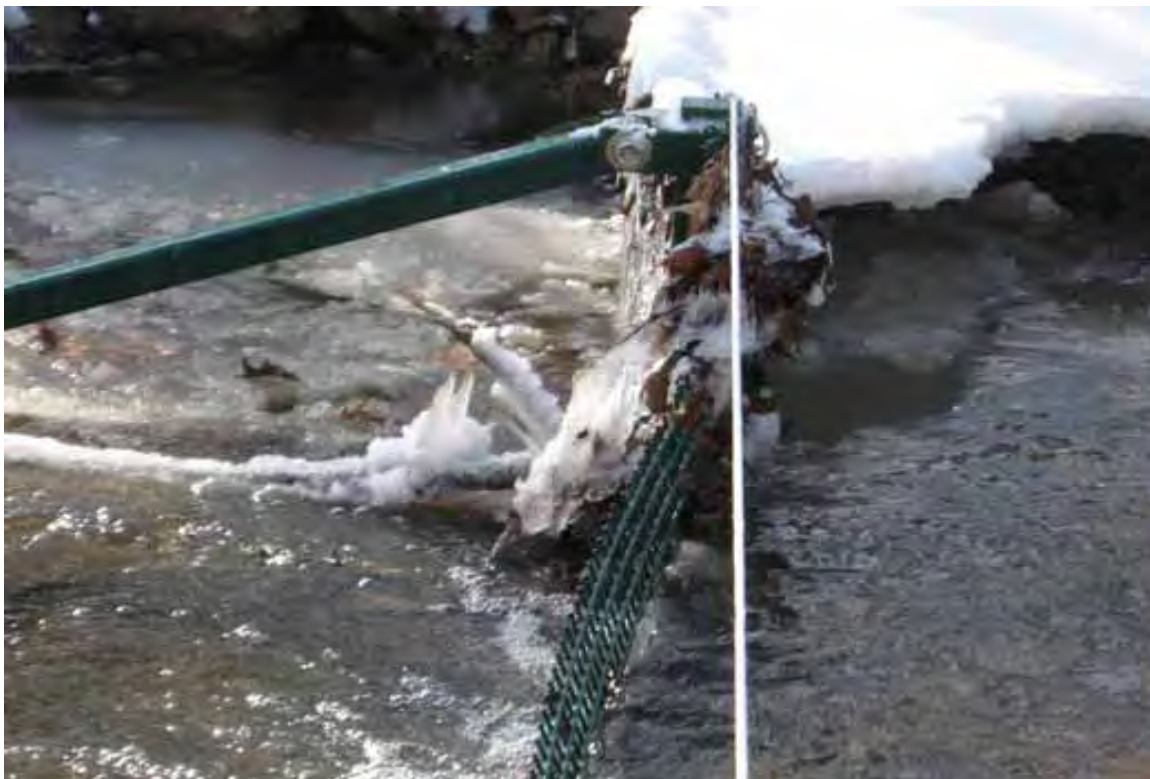
PICTURE SHOWING EXTENT OF BEND IN DOWNSTREAM BARRIER TO DATE.

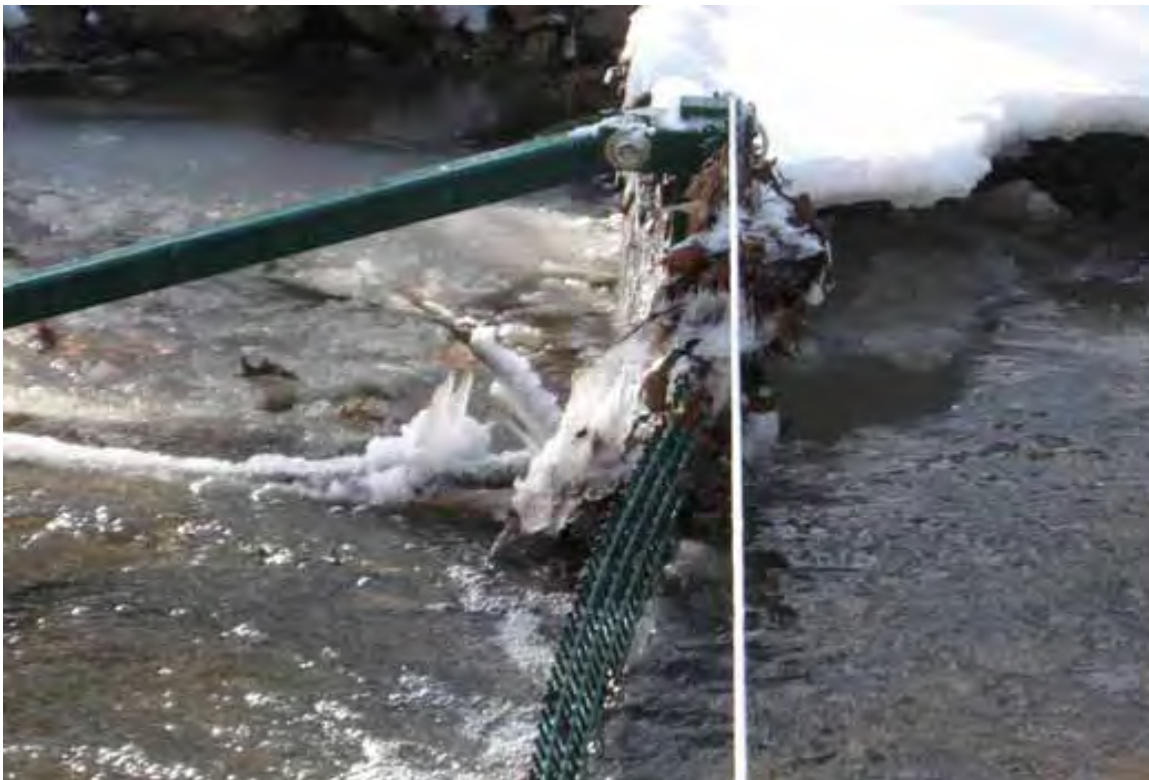
PICTURE SHOWING EXTENT OF BEND IN DOWNSTREAM BARRIER TO DATE
