Quarterly Effectiveness Evaluation (QEE) Report Including Summary of Barrier Repairs

Sand Creek Barrier System Time Critical Response Action (TCRA) for the Rocket Ridge Area of Open Demolition Area #2

Project No:	4100-979-01			QEE Report No:	4	
Date of QEE Site Visit:	2 September 2009		009			
Time Period Covered by	From	27 M	27 May 2009			
QEE Report:	То:	2 Sep	2 September 2009			
Dates of O&M Trips During Period Covered by QEE Report:			24 June 2009 (O&M Trip #10)			
			29 July 2009 (O&M Trip #11)			
.,	2		2 Sep	ptember 2009 (O&M Trip #12)

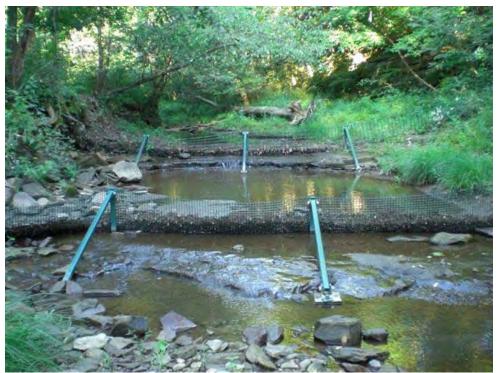
Materials found on the screens: Leaves, branches, sticks, sand and gravel. No munitions-related materials were found at the barrier (see Photo #1 in Attachment 1).

Photo 1: Sand Creek Barrier System (2 September 2009, before O&M)

Maintenance performed during O&M Trips: Inspected the barrier and removed the materials accumulated on the screens.

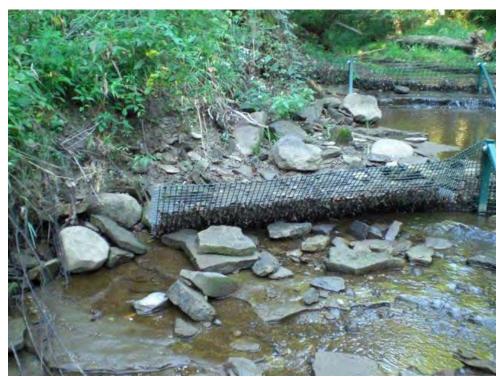
Downstream (1-inch grid) barrier: All posts and back braces were intact. The end panels had detached from the creek banks (see Photos #2 and #3). The tops of the panels were bowed in the direction of the water flow. Sand and gravel, approximately 2-3 inches deep, had accumulated in front of the third panel from the south.

Photo 2: Downstream barrier, south end panel (2 September 2009, before O&M)

- One new post and back brace were installed at the south end of the downstream barrier. The new post is approximately 6.5 feet south of the next post. The screen panel that was detached from the creek bank was attached to the new post. A new panel was installed and keyed into the bank in front (upstream) and at 45 degrees to the barrier line (see Photo #4).

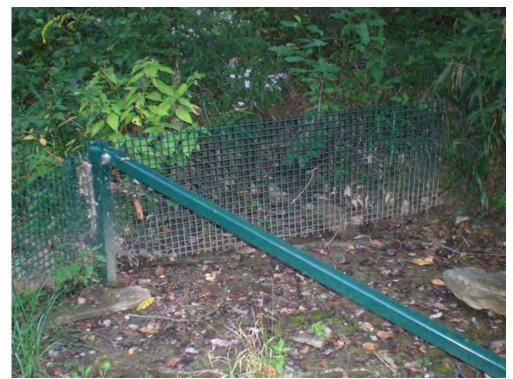
Photo 3: Downstream barrier, north end panel (2 September 2009, before O&M)

- One new post and back brace were installed at the north end of the downstream barrier. The new post was installed at 3 feet 11 inches from the next post. The screen panel that was detached from the bank was attached to the new post amd keyed into the bank (see Photo #5).

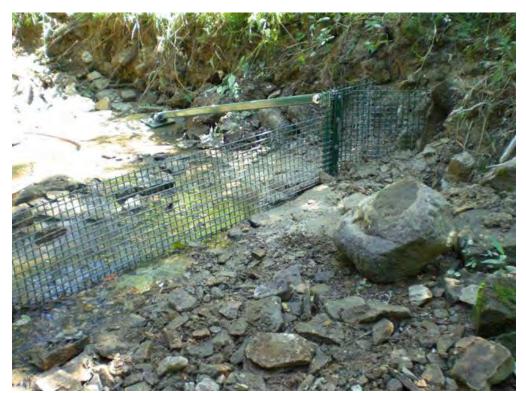
Photo 4: New post and panel at south end of downstream barrier (2 September 2009)

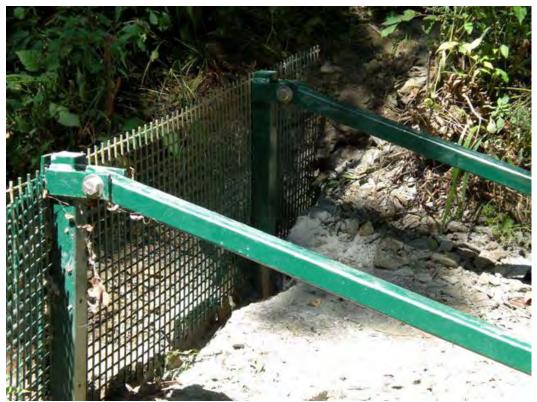
Photo 5: New post at north end of downstream barrier (2 September 2009)

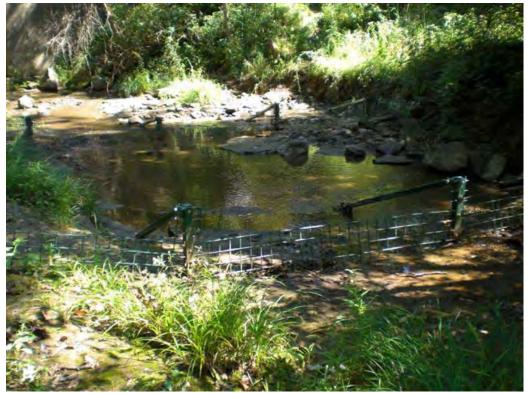
Upstream (3-inch grid) barrier: All barrier elements were in place and there were no gaps between the screen panels and creek bed and banks. The ends of the top two horizontal wires of the second panel from the south were observed detached from the post clamping system. The tops of the panels were bowed in the direction of the water flow.

Photo 6: Upstream panels after height reduction (2 September 2009)

- The height of the central screen panels was reduced. At the upstream barrier, the height of the three central panels was reduced to 12 inches (see Photo #6). At the downstream barrier, the panel height was reduced, from south to north, to: panel 1 height not changed; panel 2 16 inches; panel 3 12 inches; panel 4 11 to 12 inches; panel 5 10 to 16 inches (height varies due to uneven creek bottom); panels 6 and 7 height not changed (see Photo #7).

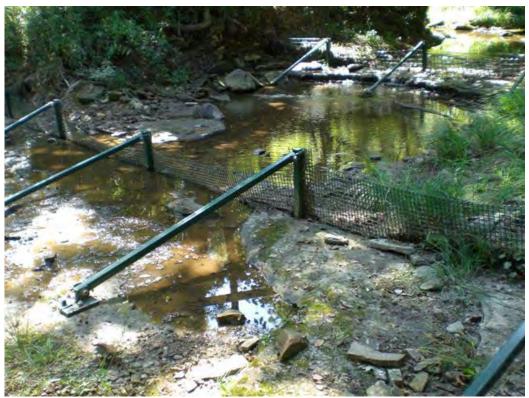
Photo 7: Downstream panels after height reduction (2 September 2009)

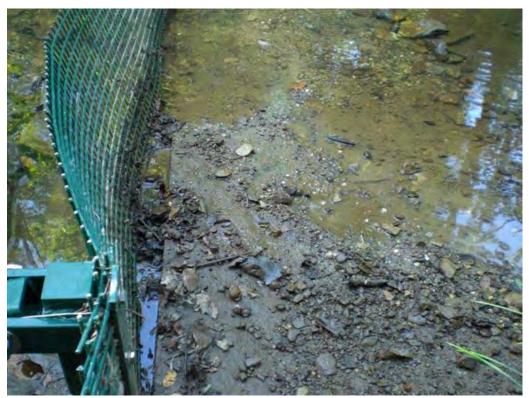
Photo 8: Area in front of downstream barrier after the removal of sand and gravel accumulation (2 September 2009)

- The sand and gravel accumulated in front of the downstream barrier was removed (see Photo #8).
