ENGINEERING SURVEY REPORT #6

LOAD LINE 2

RAVENNA ARMY AMMUNITION PLANT

March 27, 2003

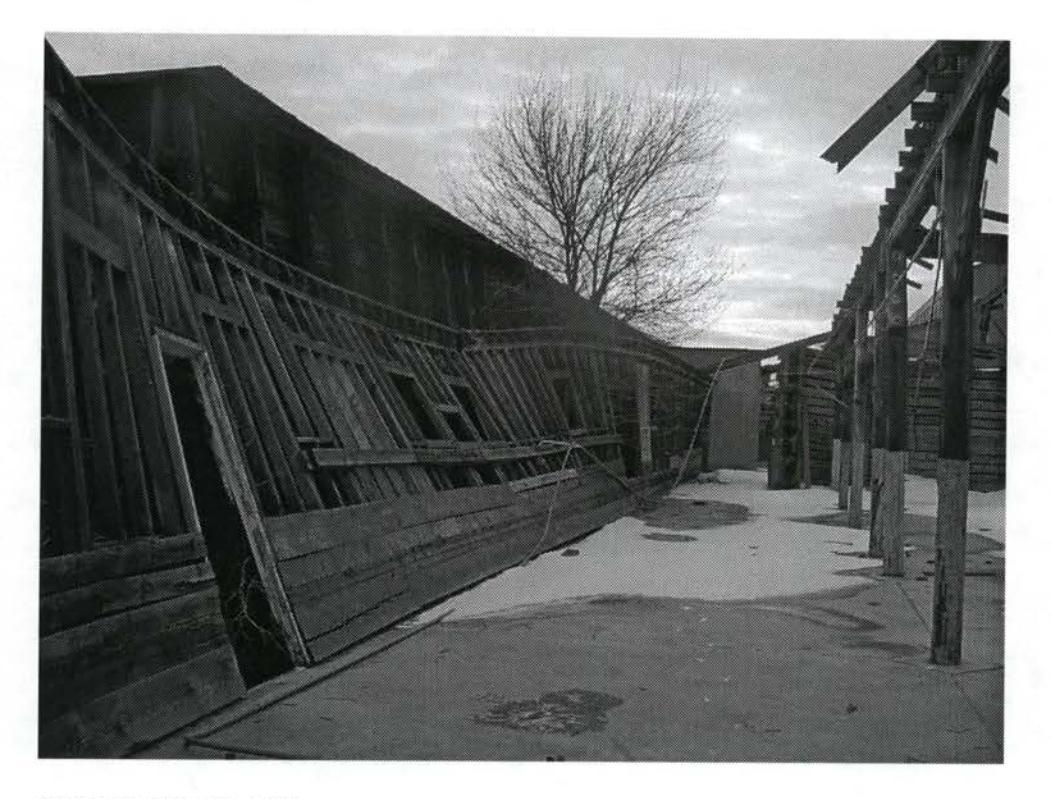
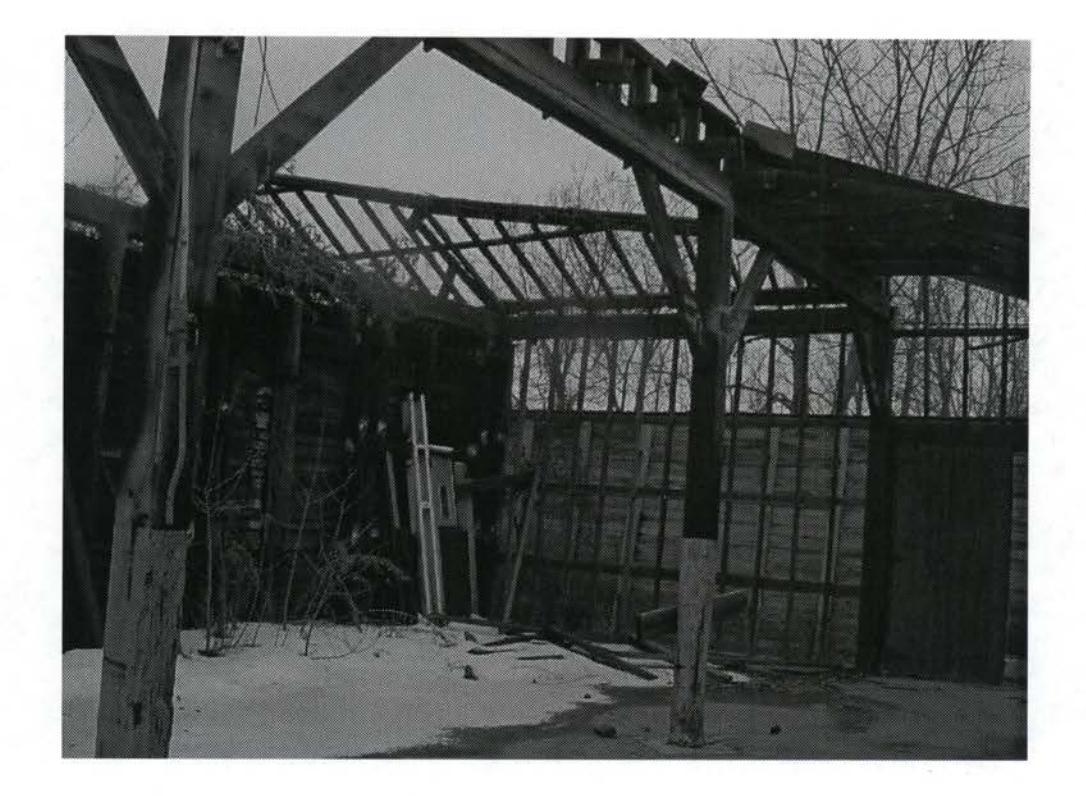
BUILDING DB-13A

Located to the north of the building DB-13, Building DB-13A is a one story wooden structure on an elevated concrete floor. There is a T-shape earth-filled timber barricade in the middle of the building that divides the building into three sections- the east, west, and the south sections. The entire roof, roof trusses, and most roof support beams have been removed leaving the remaining wooden structure to decay. Both the east and west exterior stud walls have fallen down, and the north exterior stud wall, with the asbestos siding removed, has partially collapsed.

In the east and west sections of the building, the only remaining structures are two rows of free standing columns running in the north-south direction with a continuous beam at the top of the columns. These remaining freestanding wood frames have decayed and are unstable. Thus, they will eventually fall down.

In the south section of the building located to the south of the timber barricade, the columns, some of the beams in both the north-south and east-west directions at ceiling level, and a section of the stud wall frame standing unsupported above the ceiling along the original ridge are still in place. With the roof removed, all these remaining wood members have decayed due to weathering. The unsupported stud wall frame might collapse unexpectedly any time and might cause the remaining wood framing of the ceiling to fall down.

The remaining structures of this building are structurally **unstable and the might collapse unexpectedly.** UEA's recommendation is to seal off this area. At the demolition stage, all the work should be performed from outside the building, and begin at the top of the remaining structure and then proceed downward.
