| REPORT DOCUMENTATION PAGE | | | | | Form Approved<br>OMB No. 0704-0188 | |
|---|---|---|---|---|---|--|
| 4. TITLE AND SUBTITLE<br><br>Remedial Investigation Report for RVAAP-062-R-01 Water Works #4 Dump MRS, Version 1.0 | | | | 5a. CONTRACT NUMBER<br>W912DR-09-D-0005 | | |
| 14. ABSTRACT<br>This Remedial Investigation (RI) Report presents the findings and conclusions of the RI field activities conducted at RVAAP-062-R-01 Water Works #4 Dump Munitions Response Site (MRS) between September and October 2011 at the former Ravenna Army Ammunition Plant. The purpose of the RI was to determine whether the Water Works #4 Dump MRS warrants further response action pursuant to the Comprehensive Environmental Response, Compensation, and Liability Act of 1980 and the National Oil and Hazardous Substances Pollution Contingency Plan. More specifically, the RI was intended to determine the nature and extent of munitions and explosives of concern (MEC) and munitions constituents (MC) and subsequently determine the hazards and risks posed to human health and the environment by MEC and MC. Also, this RI Report presents additional data to assist in determining what remediation alternatives, if any,

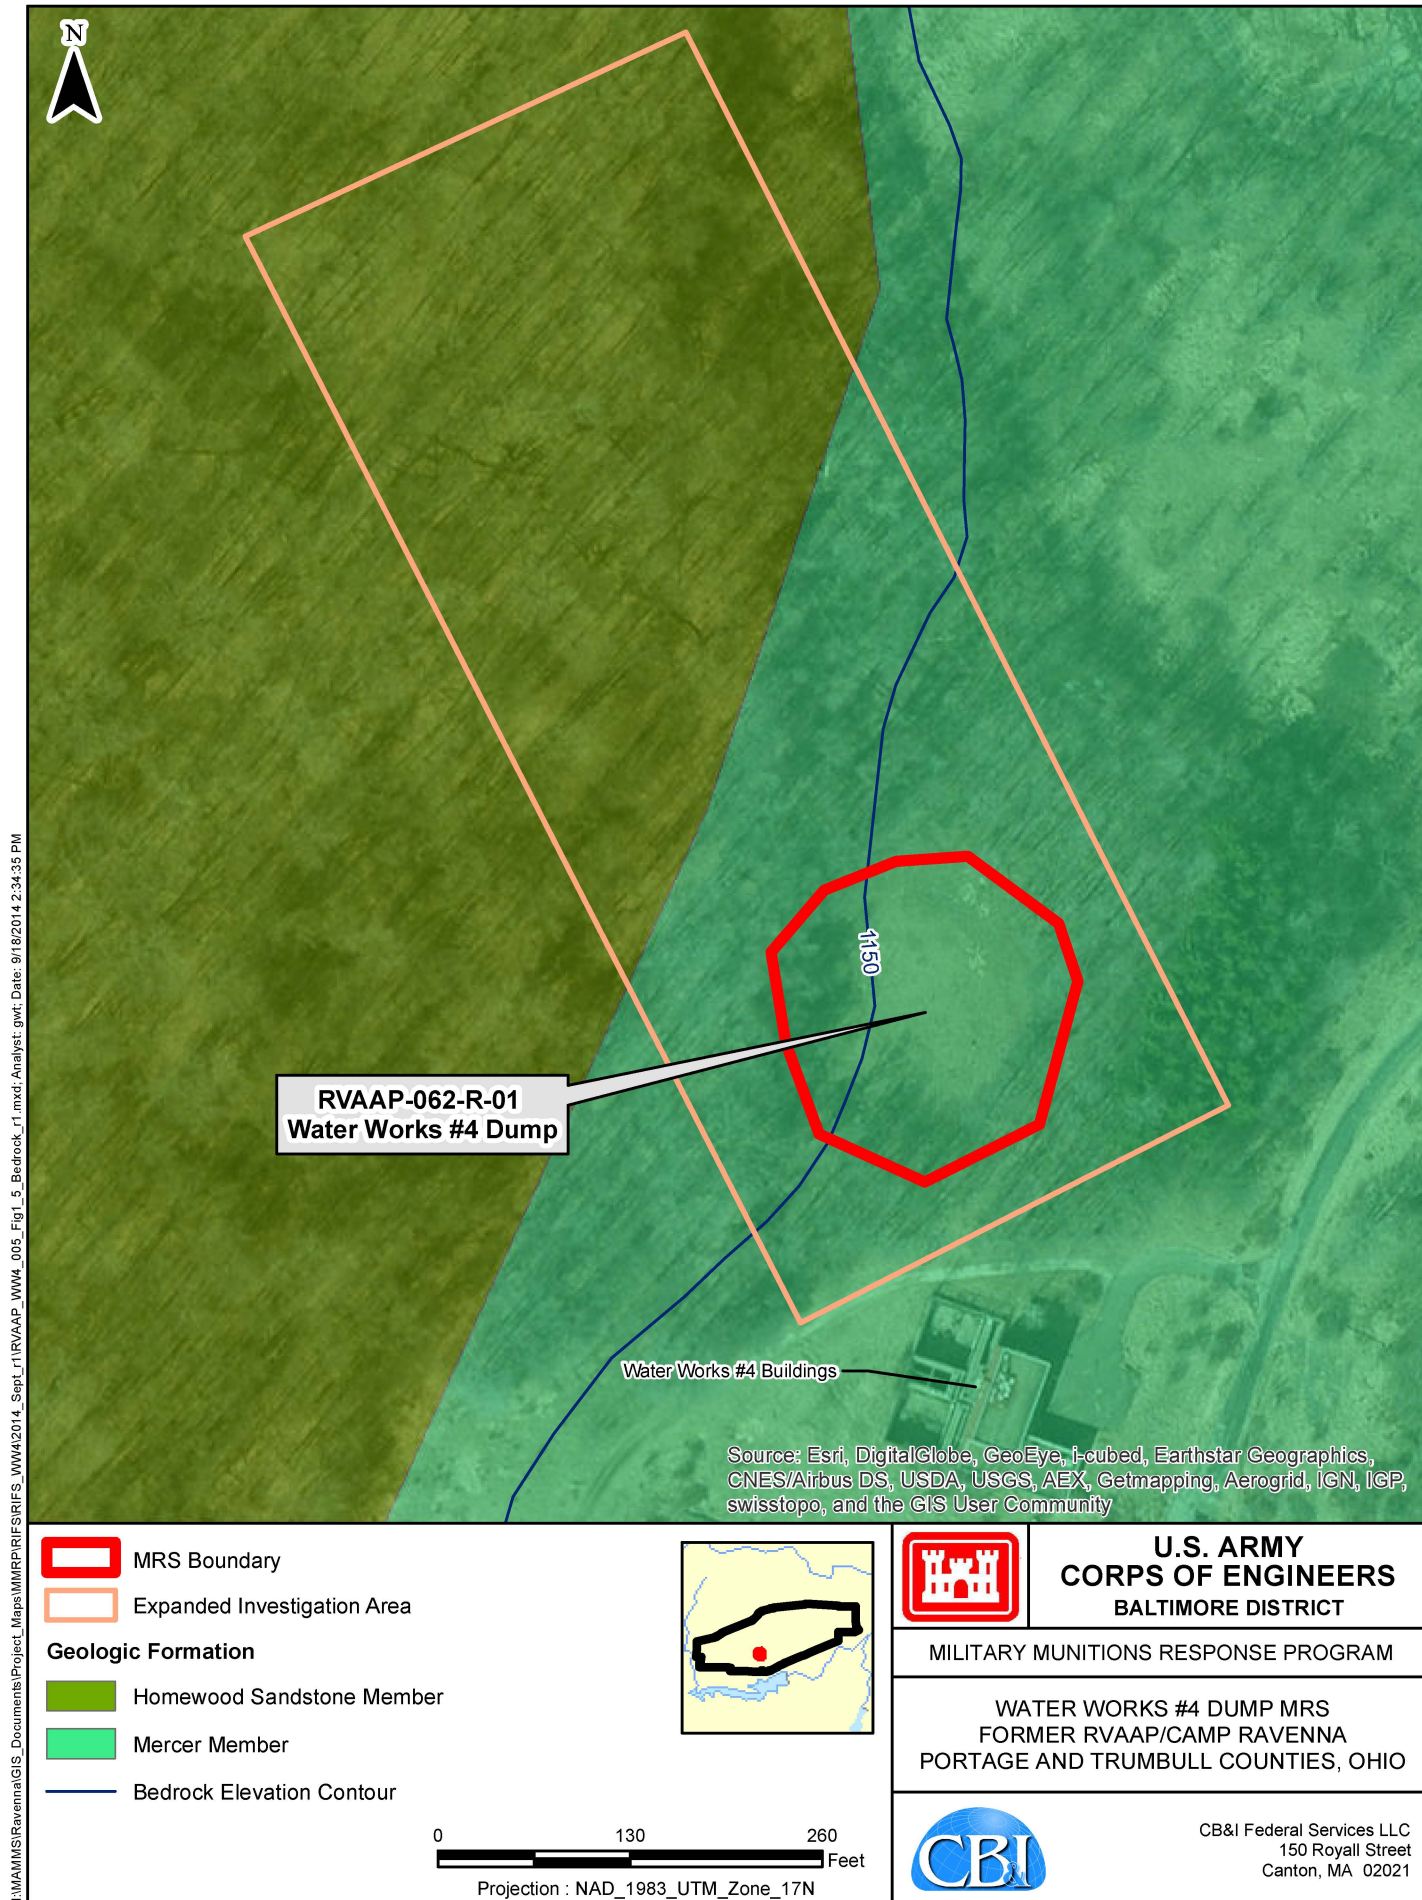
**FIGURE 1-5 BEDROCK MAP**

The Water Works #4 Dump MRS is located over the Mercer Member geologic formation and the bedrock elevation ranges from 1,100 to 1,150 feet amsl (AMEC, 2008). No bedrock formations were observed or encountered at the MRS during the RI; however, bedrock at the MRS appears to be relatively shallow, at depths less than 10 feet across the MRS (USDA et al, 1978). **Figure 1-5** depicts the bedrock formation beneath the Water Works #4 Dump MRS.

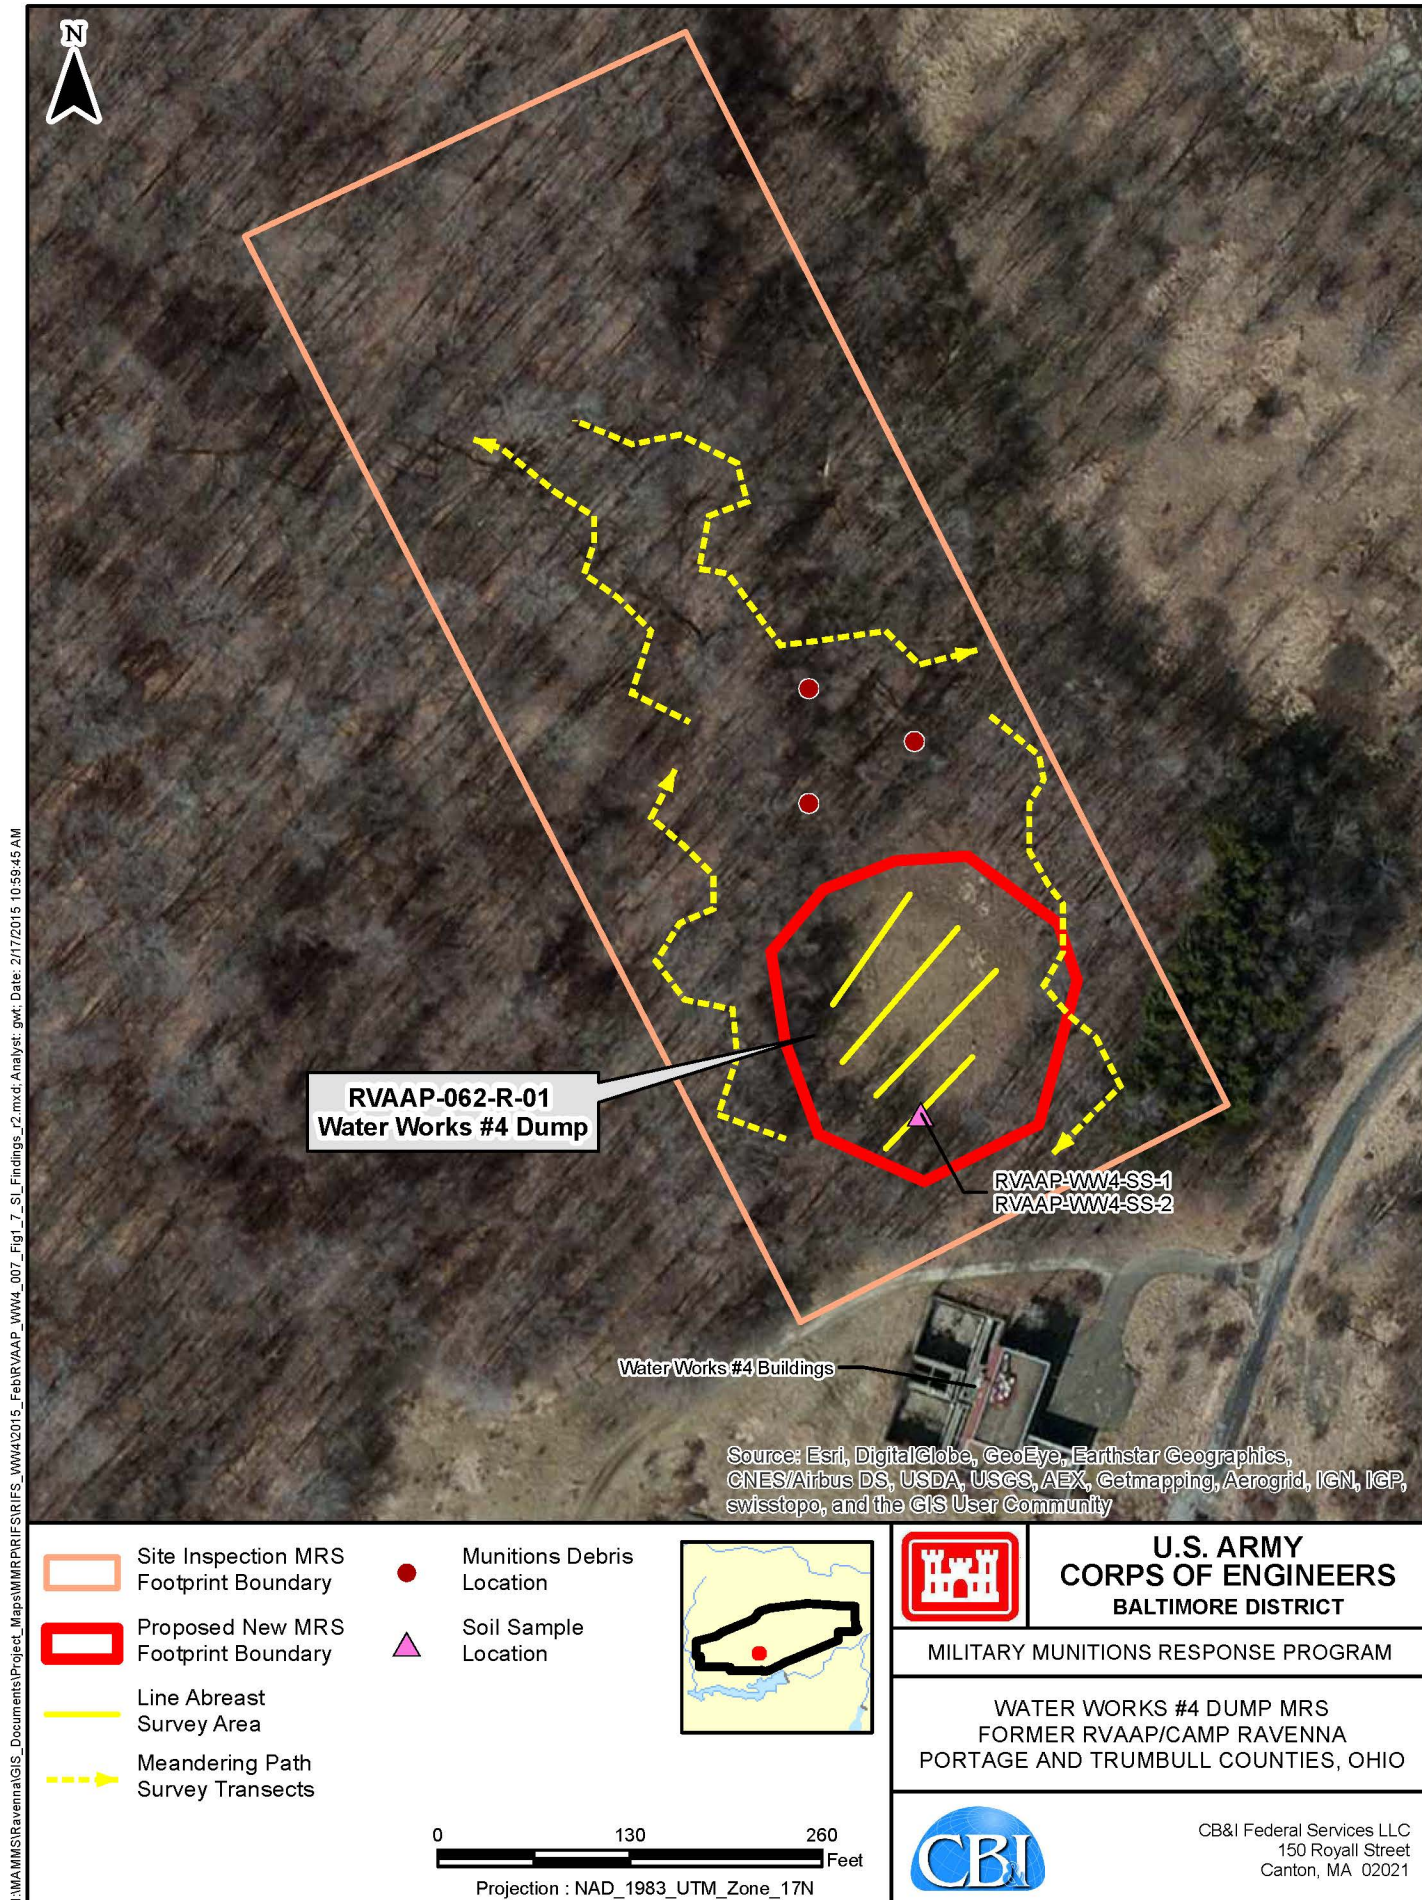
**FIGURE 1-7 SI FIELDWORK AND FINDINGS**

At the time of the SI, the size of the Water Works #4 Dump MRS was approximately 6.15 acres, which included the open field portion where dumping activities occurred and the wooded area where large-caliber casings and ogives were previously documented. As part of the SI field activities, a line-abreast magnetometer and metal-detector-assisted UXO survey were conducted at the open field portion of the MRS and a meandering-path UXO survey was conducted in the wooded area where the large-caliber casings and ogives were previously reported. No MEC was found; however, 20 inert ogives were discovered scattered throughout the wooded area. Several subsurface anomalies were detected in the open field portion of the MRS; however, the nature of anomalies remained unknown, since an intrusive investigation was not performed during the SI. The areas investigated during the SI field activities are presented in **Figure 1-7**.

One composite surface soil sample (RVAAP-WW4-SS-1) and a duplicate (RVAAP-WW4-SS-2) were collected from the open field portion of the MRS during the SI field work using the Cold Regions Research and Engineering Laboratory (CRREL) seven-wheel sample method. The sample was collected at 0 to 6 inches bgs and was submitted for off-site laboratory analysis for Target Analyte List metals, propellants, and explosives using U.S. Environmental Protection Agency (EPA) Methods 6010C and 8330B. The samples were compared to the EPA Region 9 Residential Soil Preliminary Remediation Goals (PRGs), the screening criteria used at the time of the SI. Thallium was detected at estimated concentrations (B-flagged) of 1.1 milligrams per kilogram (mg/kg) in the original sample and 0.95 mg/kg in the duplicate sample and was the only metal identified to exceed one-tenth the non-carcinogenic PRG screening criteria (0.52 mg/kg for thallium). However, thallium was dismissed as non-munitions related. No explosives or propellants were detected in the soil samples. Since no MC was identified above the screening criteria, additional characterization of MC was not recommended for the MRS (e<sup>2</sup>M, 2008). The SI soil sample location is shown on **Figure 1-7** (e<sup>2</sup>M, 2008).

Based on the SI results, it was recommended in the SI Report (e<sup>2</sup>M, 2008) that the MRS be reduced to include only the 0.77-acre open field portion of the MRS (**Figure 1-7**). The new footprint was recommended for further characterization of MEC to evaluate the subsurface anomalies detected at this area during the SI field activities.

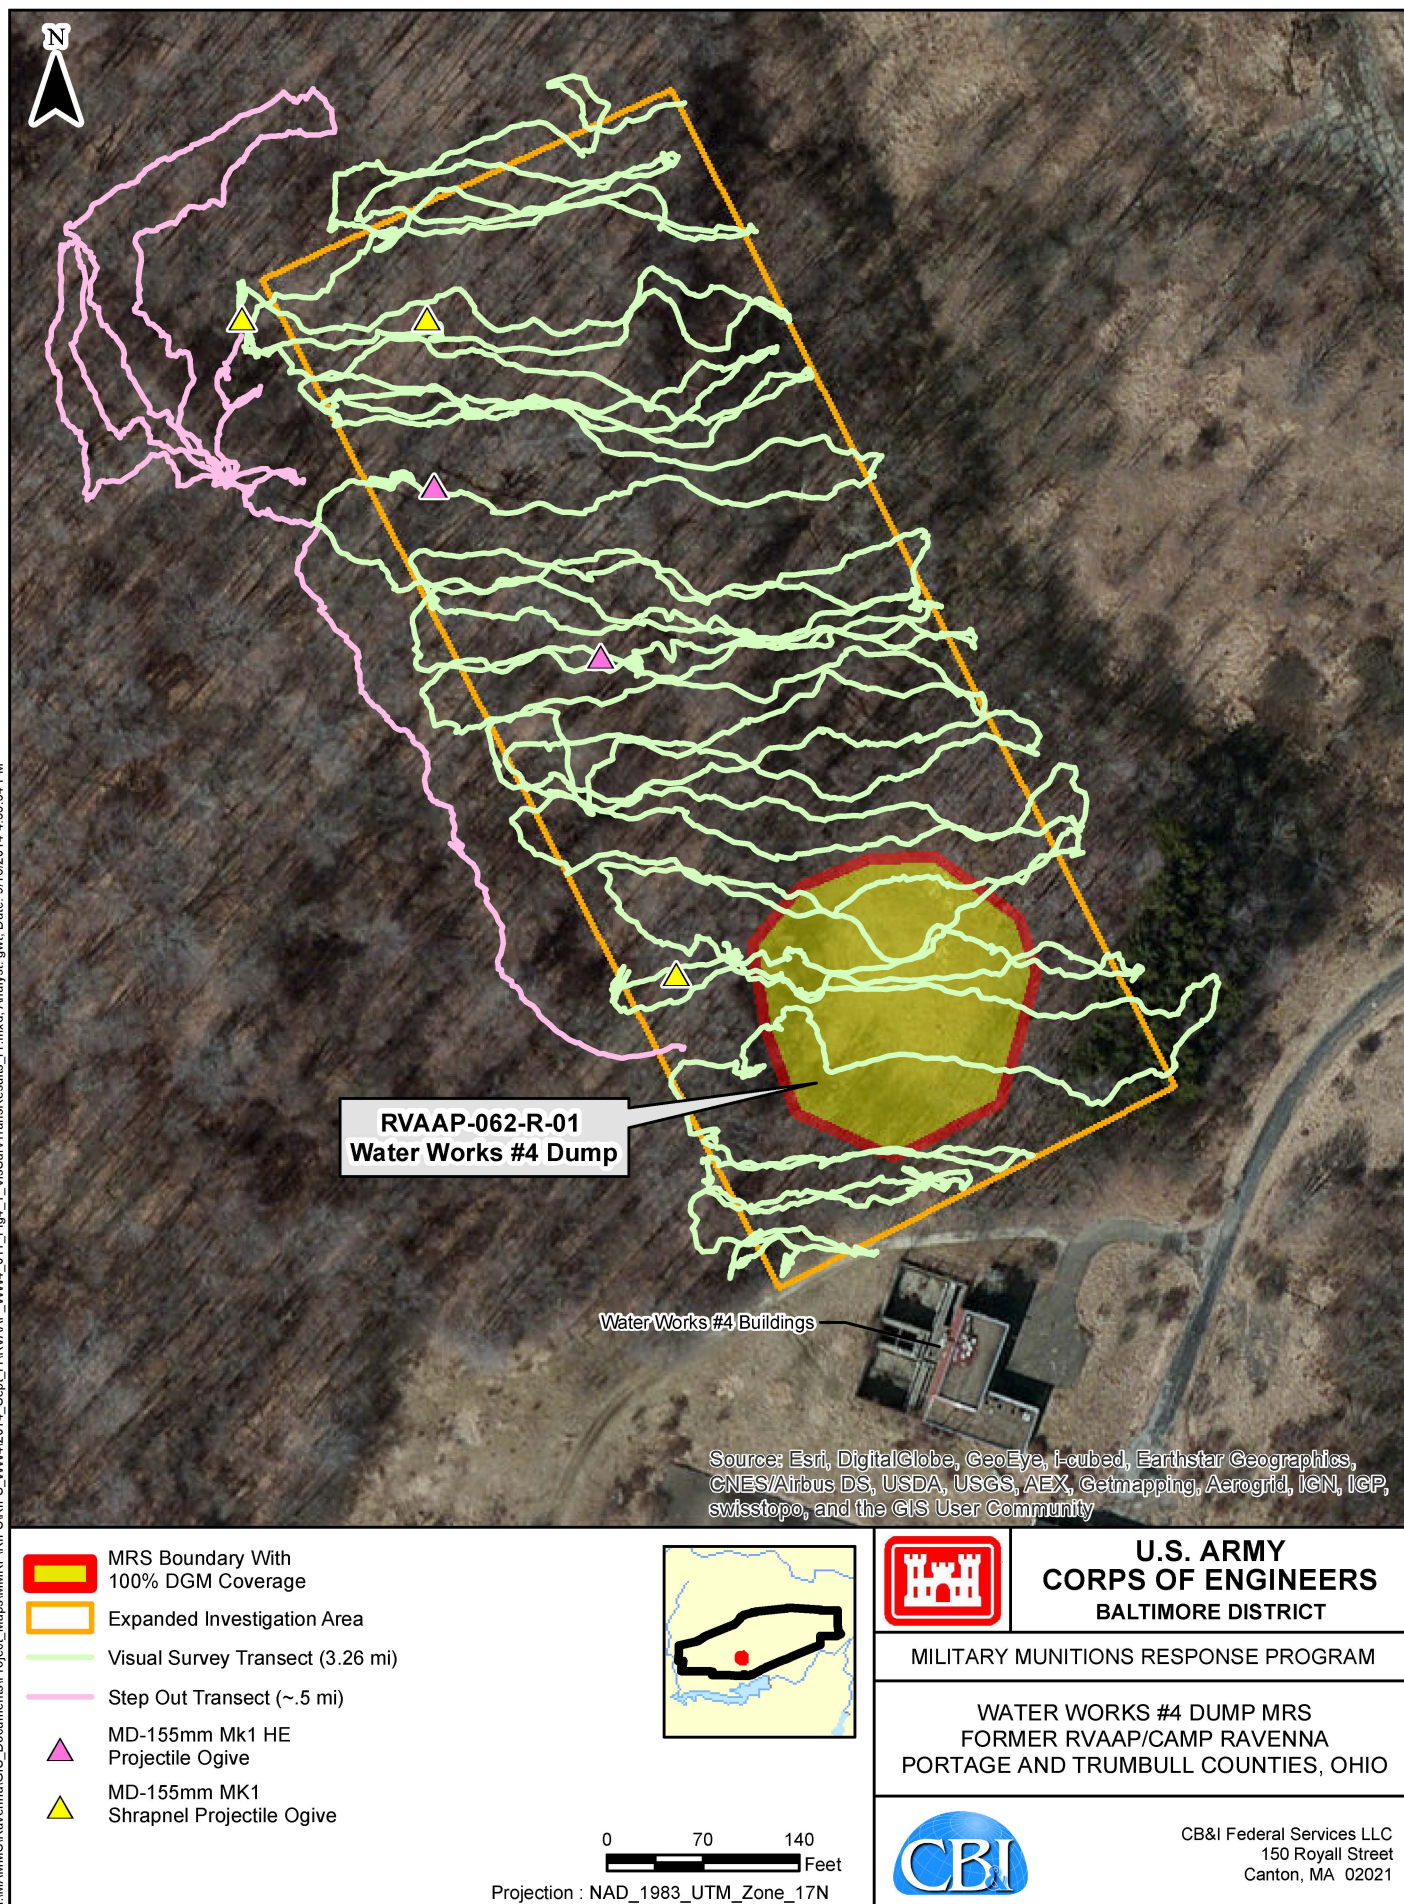
**FIGURE 4-1 VISUAL SURVEY RESULTS**

Five MPPEH items were identified during the Schonstedt-assisted visual survey. All five MPPEH items were inspected by the UXO-qualified personnel in the field, were determined to be MDAS, and were managed as MD. The MD was located on the ground surface at the expanded investigation area and consisted of three 155mm Mk I shrapnel projectile ogives and two 155mm Mk I high-explosive (HE) projectile ogives. The total weight of the MD items was approximately 10 pounds [lbs]). No MEC was found during the Schonstedt-assisted visual survey. **Figure 4-1** identifies the results of the Schonstedt-assisted visual survey and the locations where the MD items were found. The results and descriptions of the Schonstedt-assisted visual survey findings at the Water Works #4 Dump MRS are presented in **Appendix C**.

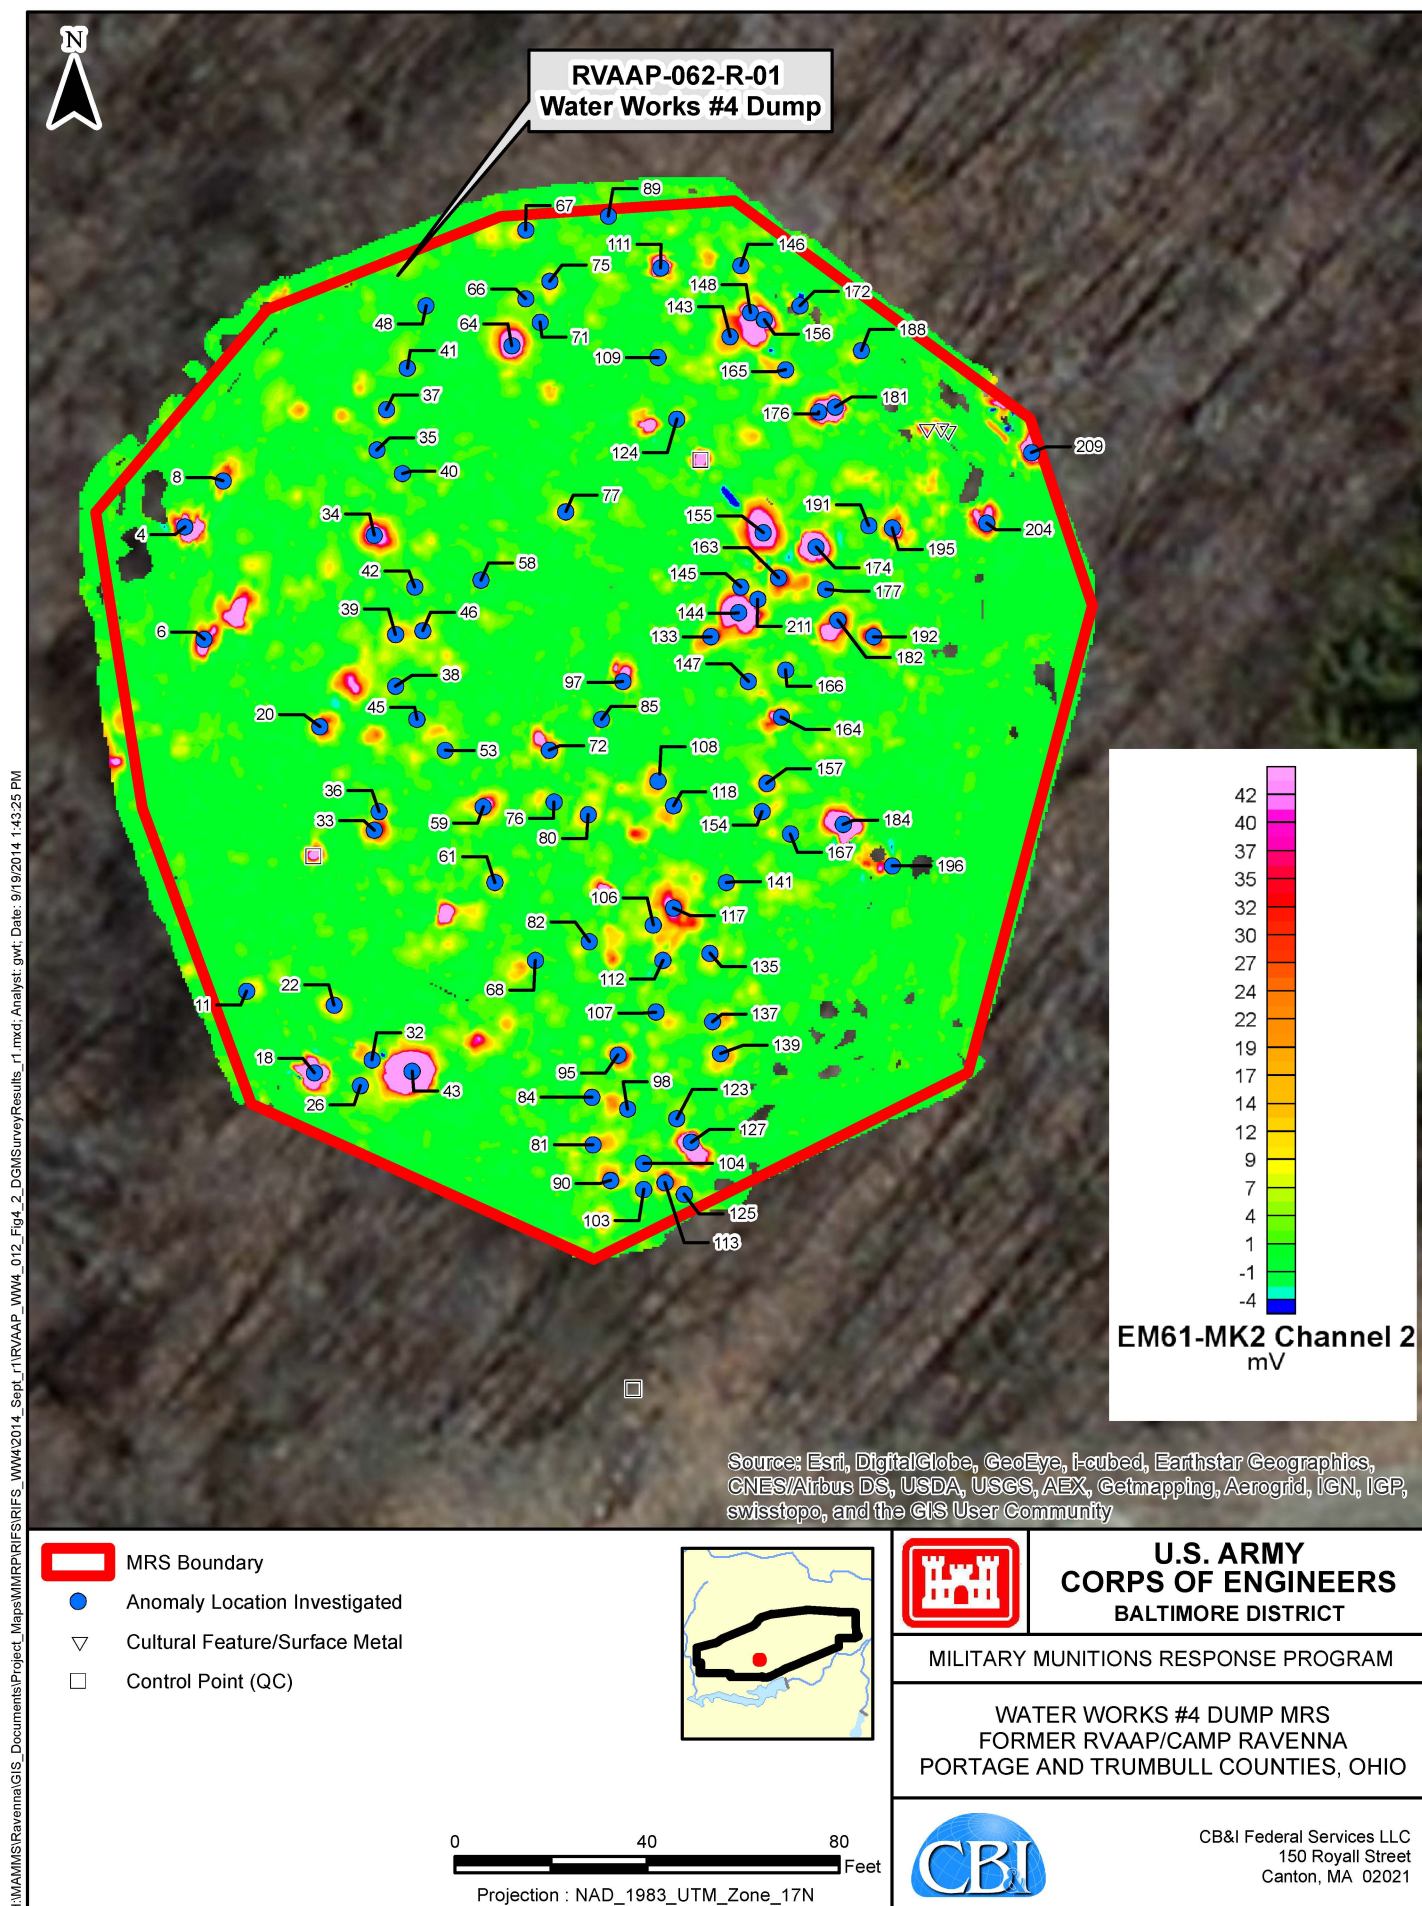
**FIGURE 4-2 DGM SURVEY RESULTS**

Ninety-three of 205 anomalies, which represent nearly 45 percent of the anomalies within the MRS, were originally selected for intrusive investigation based on the anomaly selection and prioritization process presented in the Work Plan Addendum (Shaw, 2011) and discussed in Section 3.1.3.1, “Target List Development.” All of the anomalies selected for intrusive investigation were manually investigated by hand digging. The anomalies identified by the DGM effort were selected randomly and are distributed throughout the current MRS.

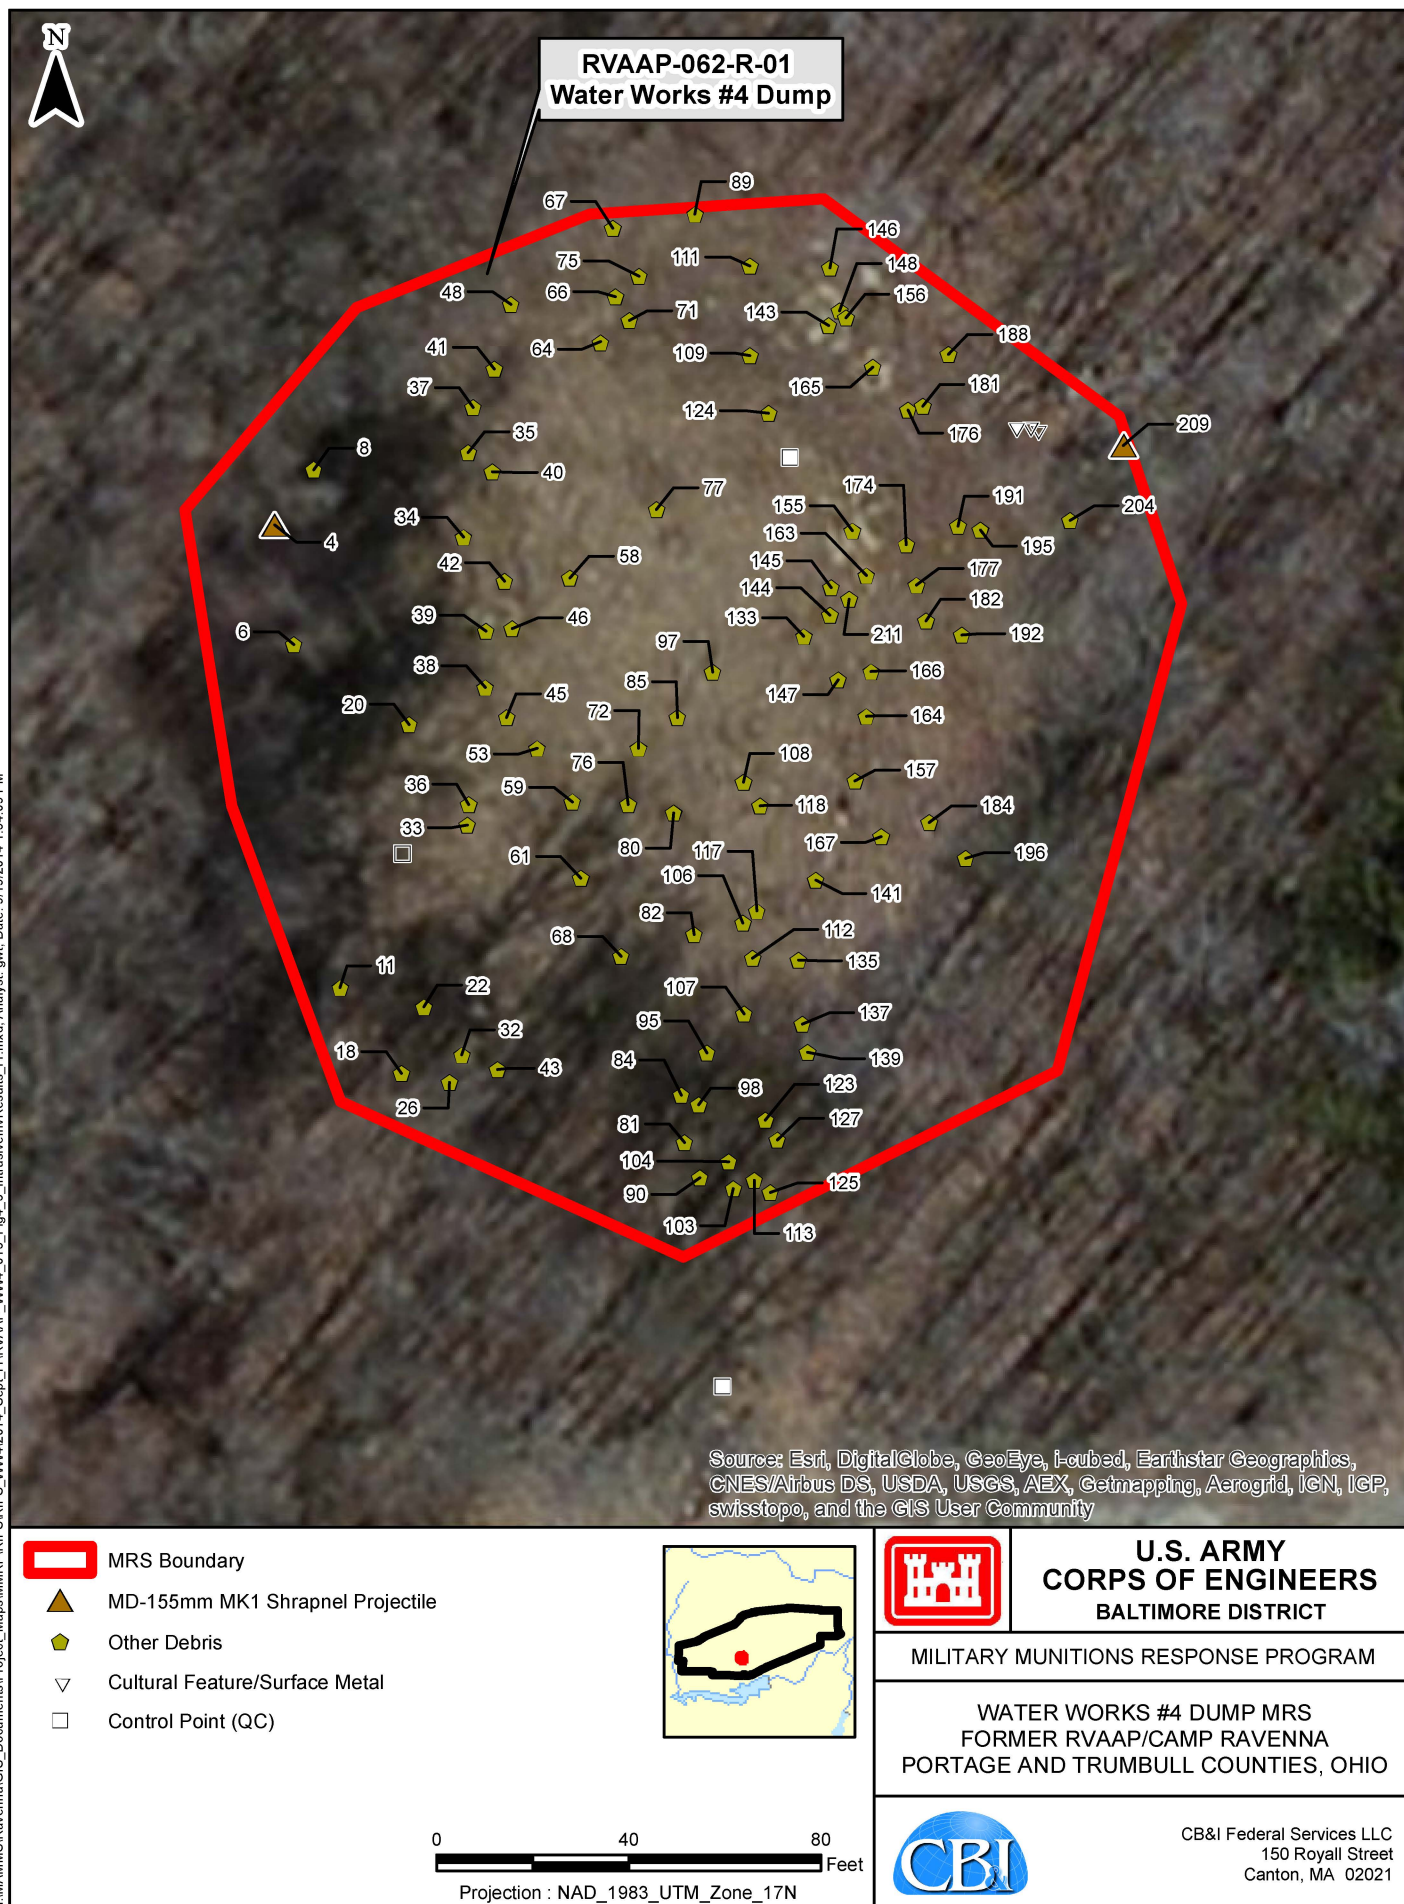
**FIGURE 4-3 INTRUSIVE INVESTIGATION RESULTS**

Two MPPEH items were found at isolated locations during the initial intrusive investigation activities: one on the ground surface (target 209) and one at a depth of 1 inch bgs (target 4). These items were verified as MDAS and considered MD by the UXO-qualified personnel in the field. The MD consisted of 155mm Mk I shrapnel projectile ogives. The total weight of the MD found at the MRS was estimated at 9 lbs. No MEC was identified on or below the ground surface during the intrusive investigation of any of the target locations.
