1. REPORT DATE (DD-MM-YYYY) 10-03-2015		2. REPORT TYPE Final		3. DATES COVERED (From - To) September 2011 - October 2011	
4. TITLE AND SUBTITLE Remedial Investigation Report for RVAAP-062-R-01 Water Works #4 Dump MRS, Version 1.0			5a. CONTRACT NUMBER W912DR-09-D-0005		
			5b. GRANT NUMBER N/A		
			5c. PROGRAM ELEMENT NUMBER N/A

14. ABSTRACT This Remedial Investigation (RI) Report presents the findings and conclusions of the RI field activities conducted at RVAAP-062-R-01 Water Works #4 Dump Munitions Response Site (MRS) between September and October 2011 at the former Ravenna Army Ammunition Plant. The purpose of the RI was to determine whether the Water Works #4 Dump MRS warrants further response action pursuant to the Comprehensive Environmental Response, Compensation, and Liability Act of 1980 and the National Oil and Hazardous Substances Pollution Contingency Plan. More specifically, the RI was intended to determine the nature and extent of munitions and explosives of concern (MEC) and munitions constituents (MC) and subsequently determine the hazards and risks posed to human health and the environment by MEC and MC. Also, this RI Report presents additional data to assist in

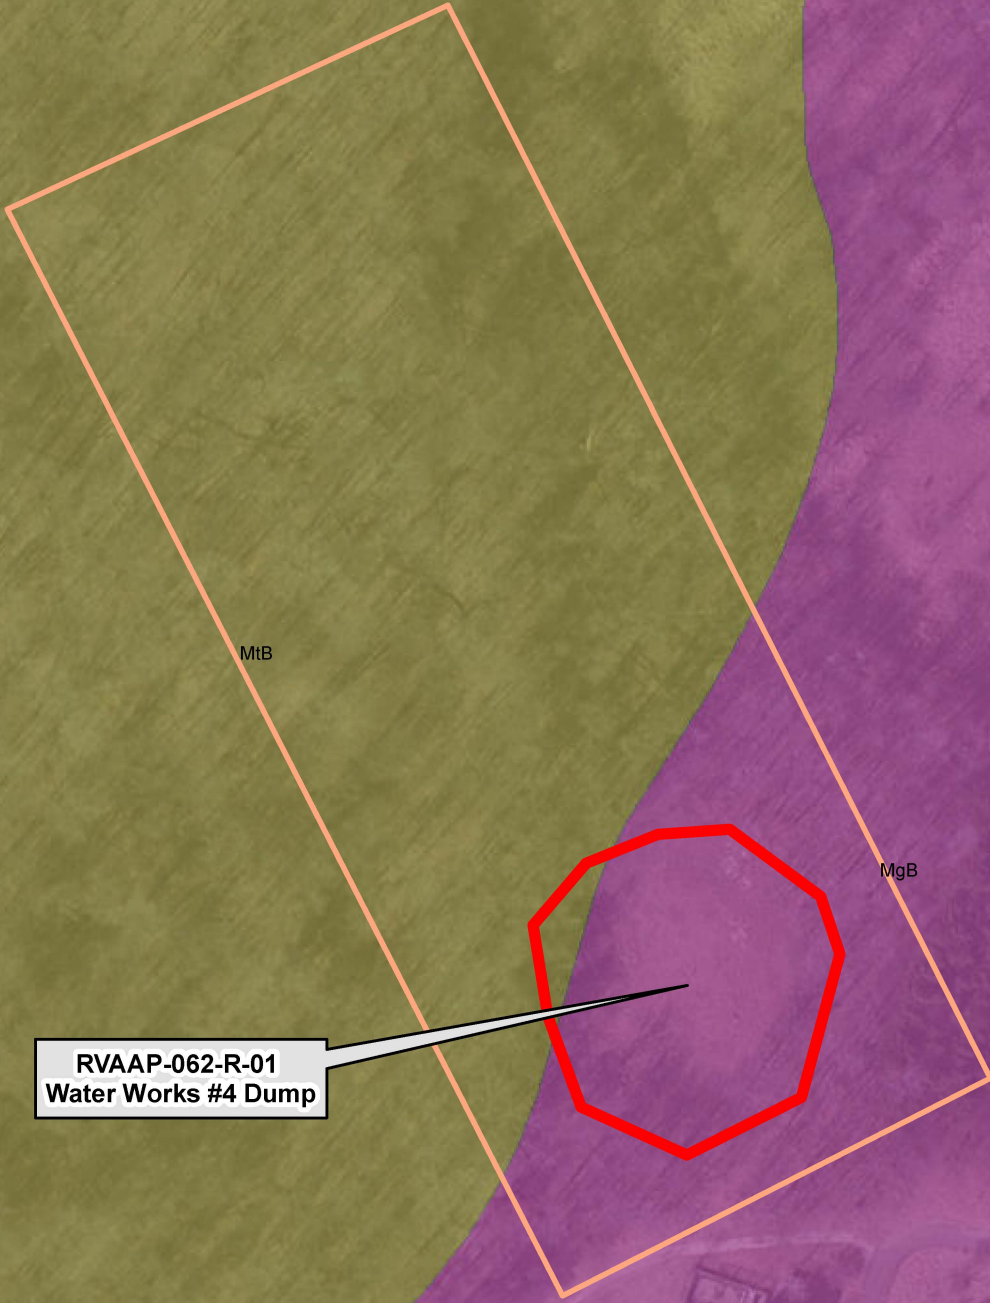
H:\MAMMS\Ravenna\GIS_Documents\Project_Maps\MMR\PIR\FSRFS_WW4\2014_Sep\11\RVAAP_WW4_004_Fig1_4_Soils_r1.mxd; Analyst: gwt; Date: 9/18/2014 2:24:05 PM

The plant communities present at and in the vicinity of the Water Works #4 Dump MRS and the expanded investigation area are a combination of red maple woods and oak-maple-tulip tree forest classifications (AMEC, 2008), while the open field consists mainly of grasses. Vegetation at the current MRS (open field area) may have been influenced/disturbed by the former use of the land as a dumping area.

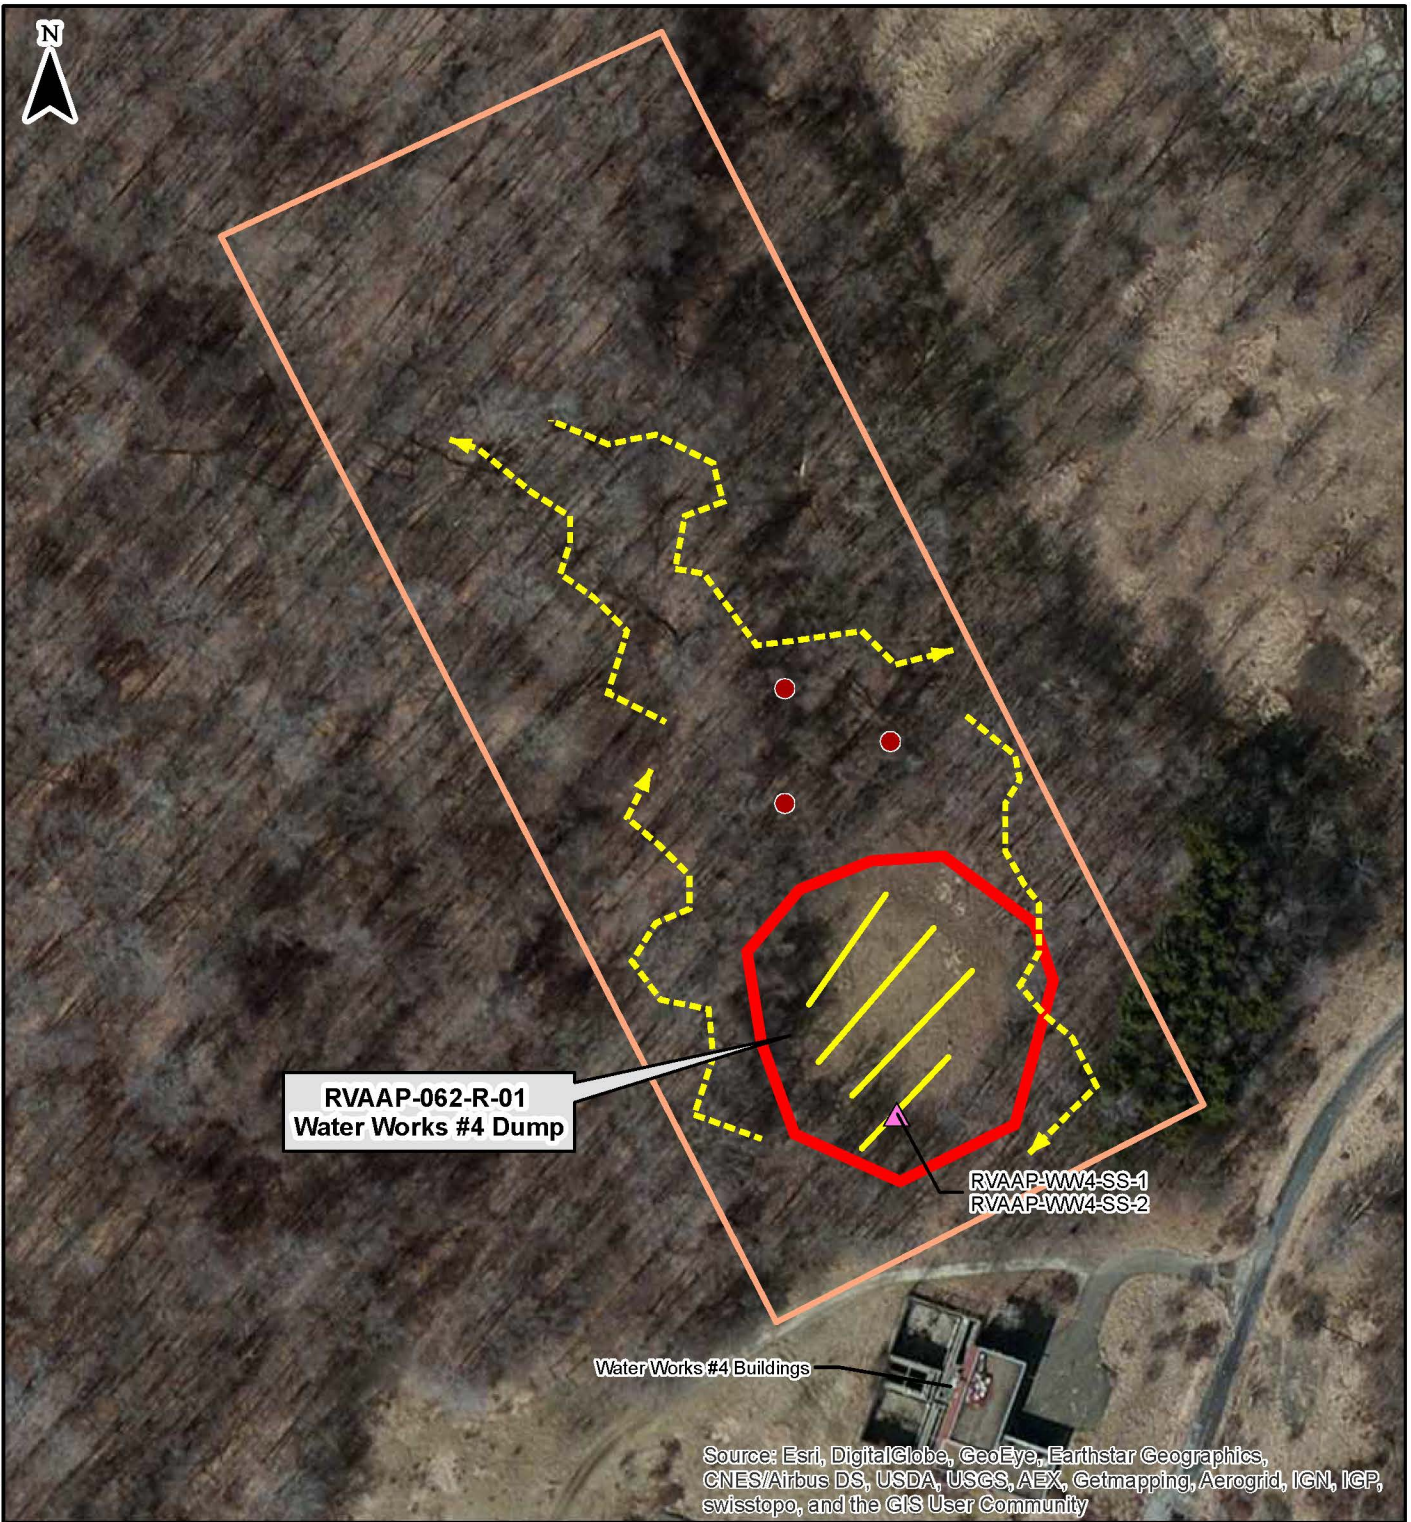
At the time of the SI, the size of the Water Works #4 Dump MRS was approximately 6.15 acres, which included the open field portion where dumping activities occurred and the wooded area where large-caliber casings and ogives were previously documented. As part of the SI field activities, a line-abreast magnetometer and metal-detector-assisted UXO survey were conducted at the open field portion of the MRS and a meandering-path UXO survey was conducted in the wooded area where the large-caliber casings and ogives were previously reported. No MEC was found; however, 20 inert ogives were discovered scattered throughout the wooded area. Several subsurface anomalies were detected in the open field portion of the MRS; however, the nature of anomalies remained unknown, since an intrusive investigation was not performed during the SI. The areas investigated during the SI field activities are presented in **Figure 1-7**.

Based on the SI results, it was recommended in the SI Report (e²M, 2008) that the MRS be reduced to include only the 0.77-acre open field portion of the MRS (**Figure 1-7**). The new footprint was recommended for further characterization of MEC to evaluate the subsurface anomalies detected at this area during the SI field activities.

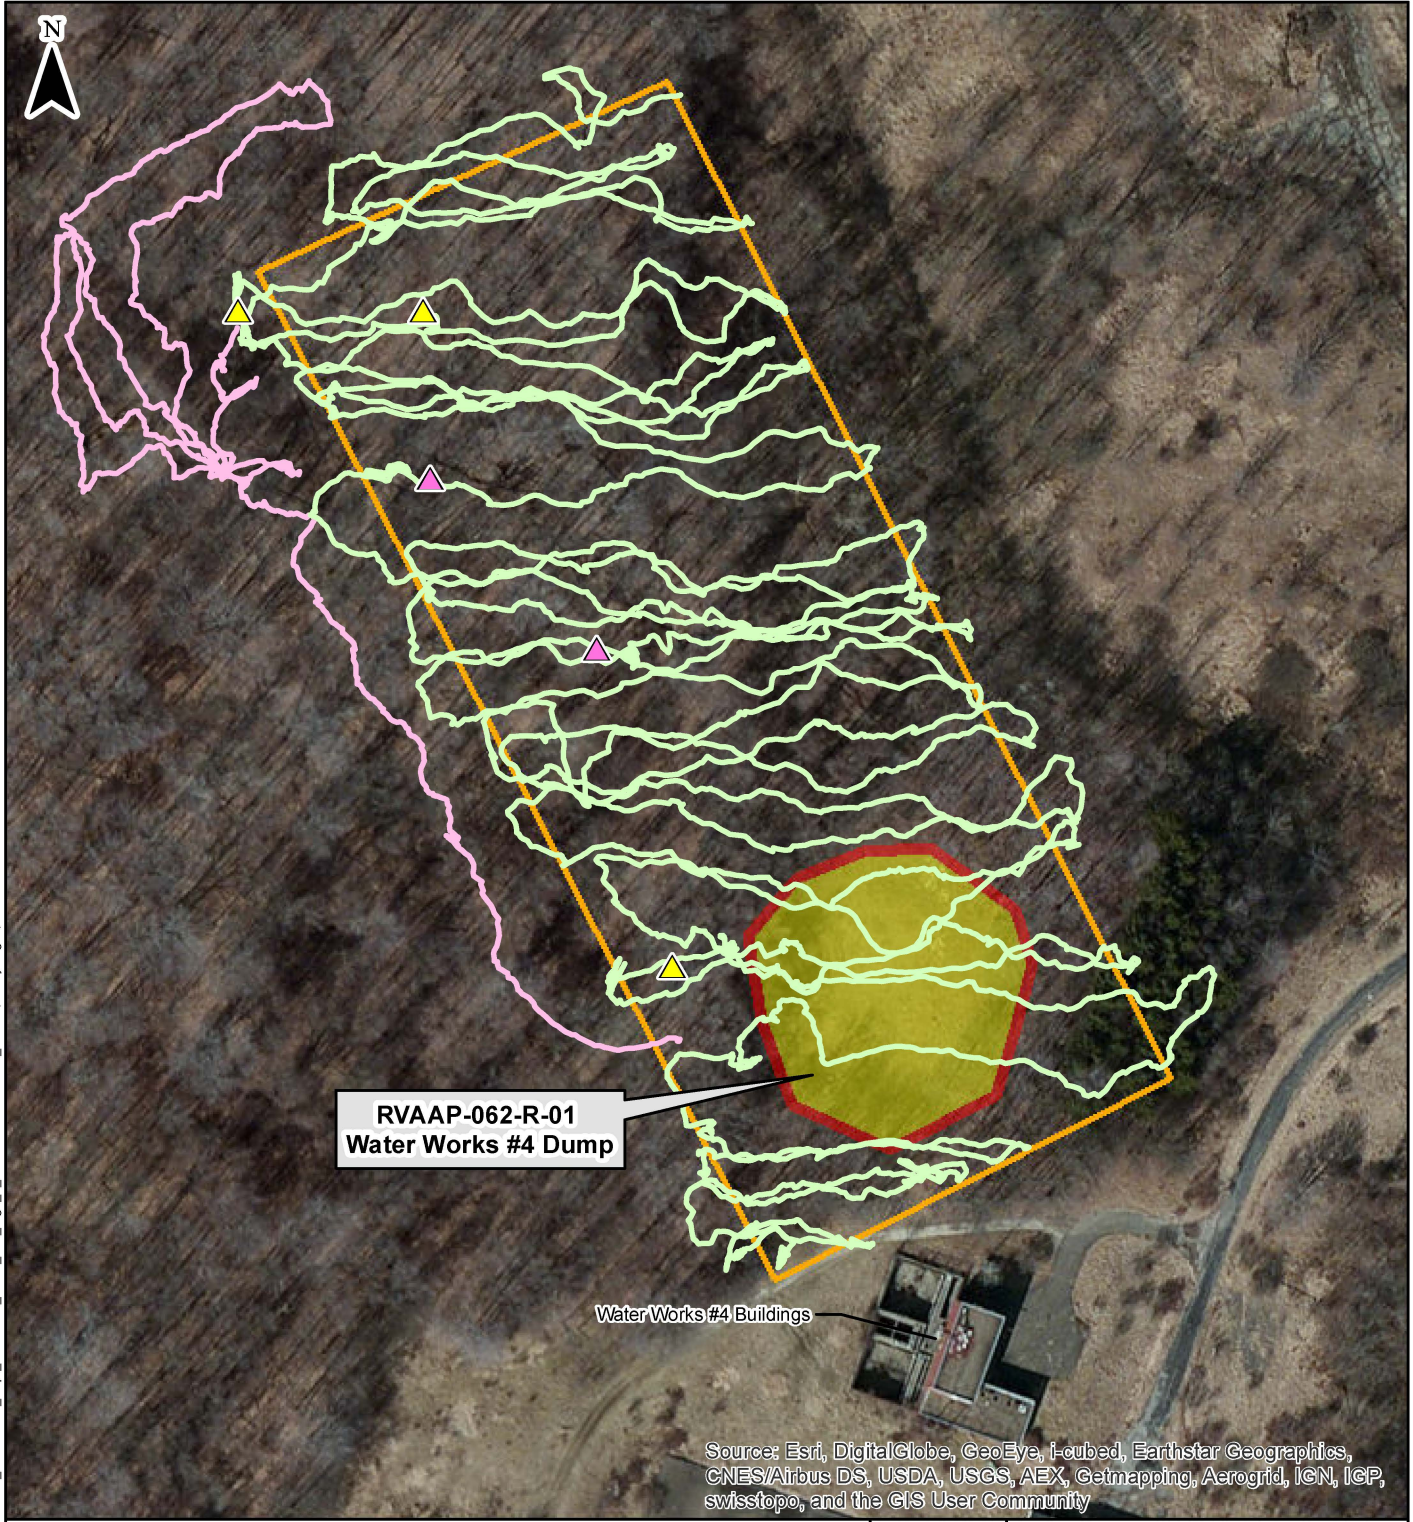
Five MPPEH items were identified during the Schonstedt-assisted visual survey. All five MPPEH items were inspected by the UXO-qualified personnel in the field, were determined to be MDAS, and were managed as MD. The MD was located on the ground surface at the expanded investigation area and consisted of three 155mm Mk I shrapnel projectile ogives and two 155mm Mk I high-explosive (HE) projectile ogives. The total weight of the MD items was approximately 10 pounds [lbs]). No MEC was found during the Schonstedt-assisted visual survey. **Figure 4-1** identifies the results of the Schonstedt-assisted visual survey and the locations where the MD items were found. The results and descriptions of the Schonstedt-assisted visual survey findings at the Water Works #4 Dump MRS are presented in **Appendix C**.

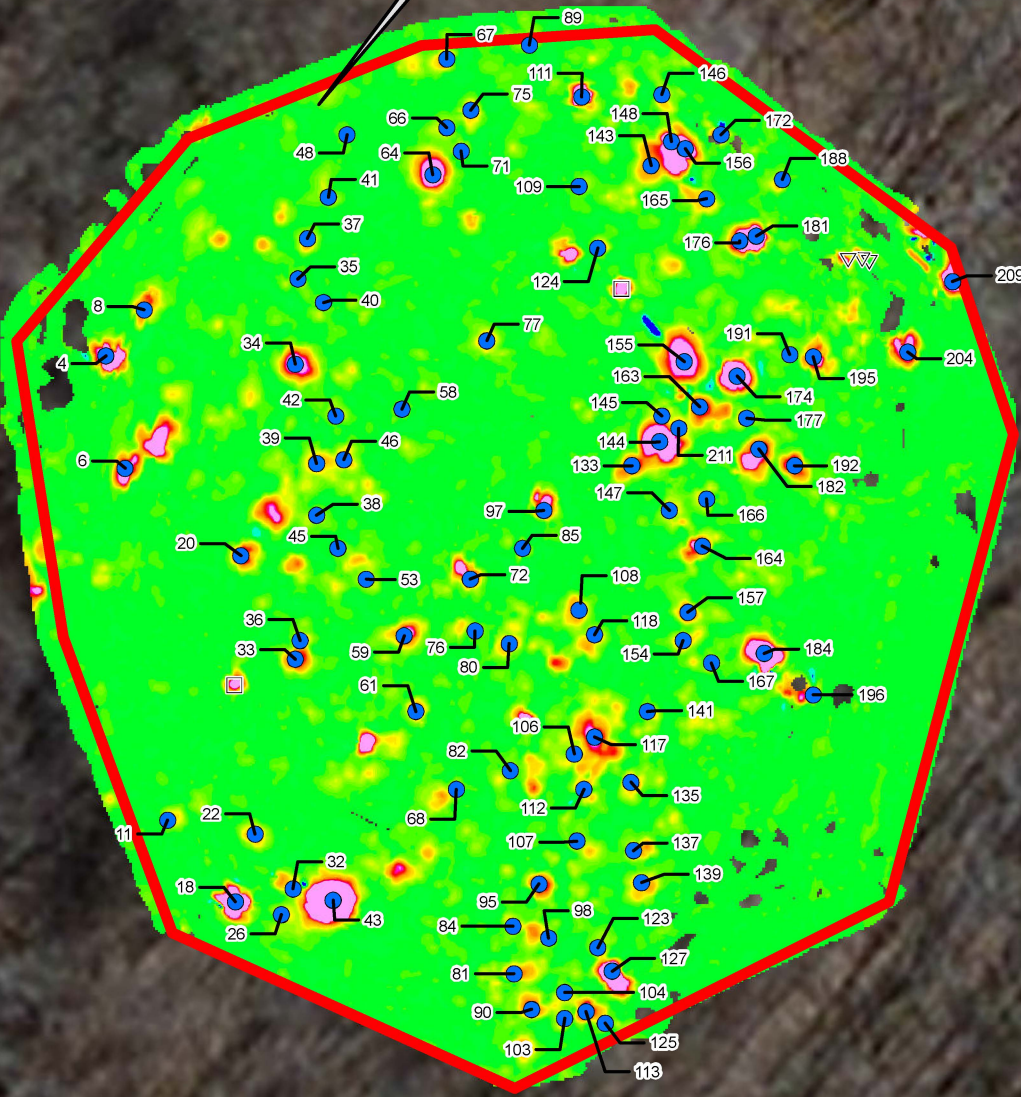
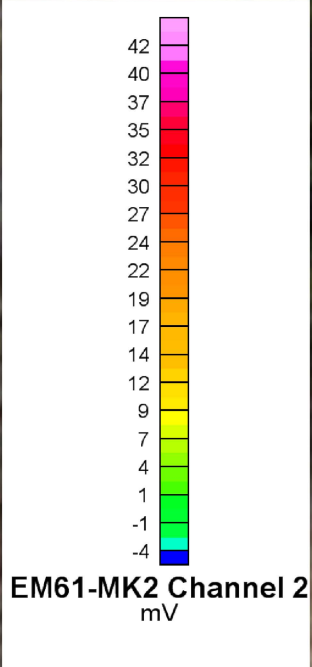
H:\MAMMS\Ravenna\GIS_Documents\Project_Maps\MMR\PIR\PIRFS\WW4\2014_Sept_r1\RVAAP_WW4_012_Fig4_2_DGMSurveyResults_r1.mxd; Analyst: gwt; Date: 9/19/2014 1:43:25 PM

**EM61-MK2 Channel 2
mV**

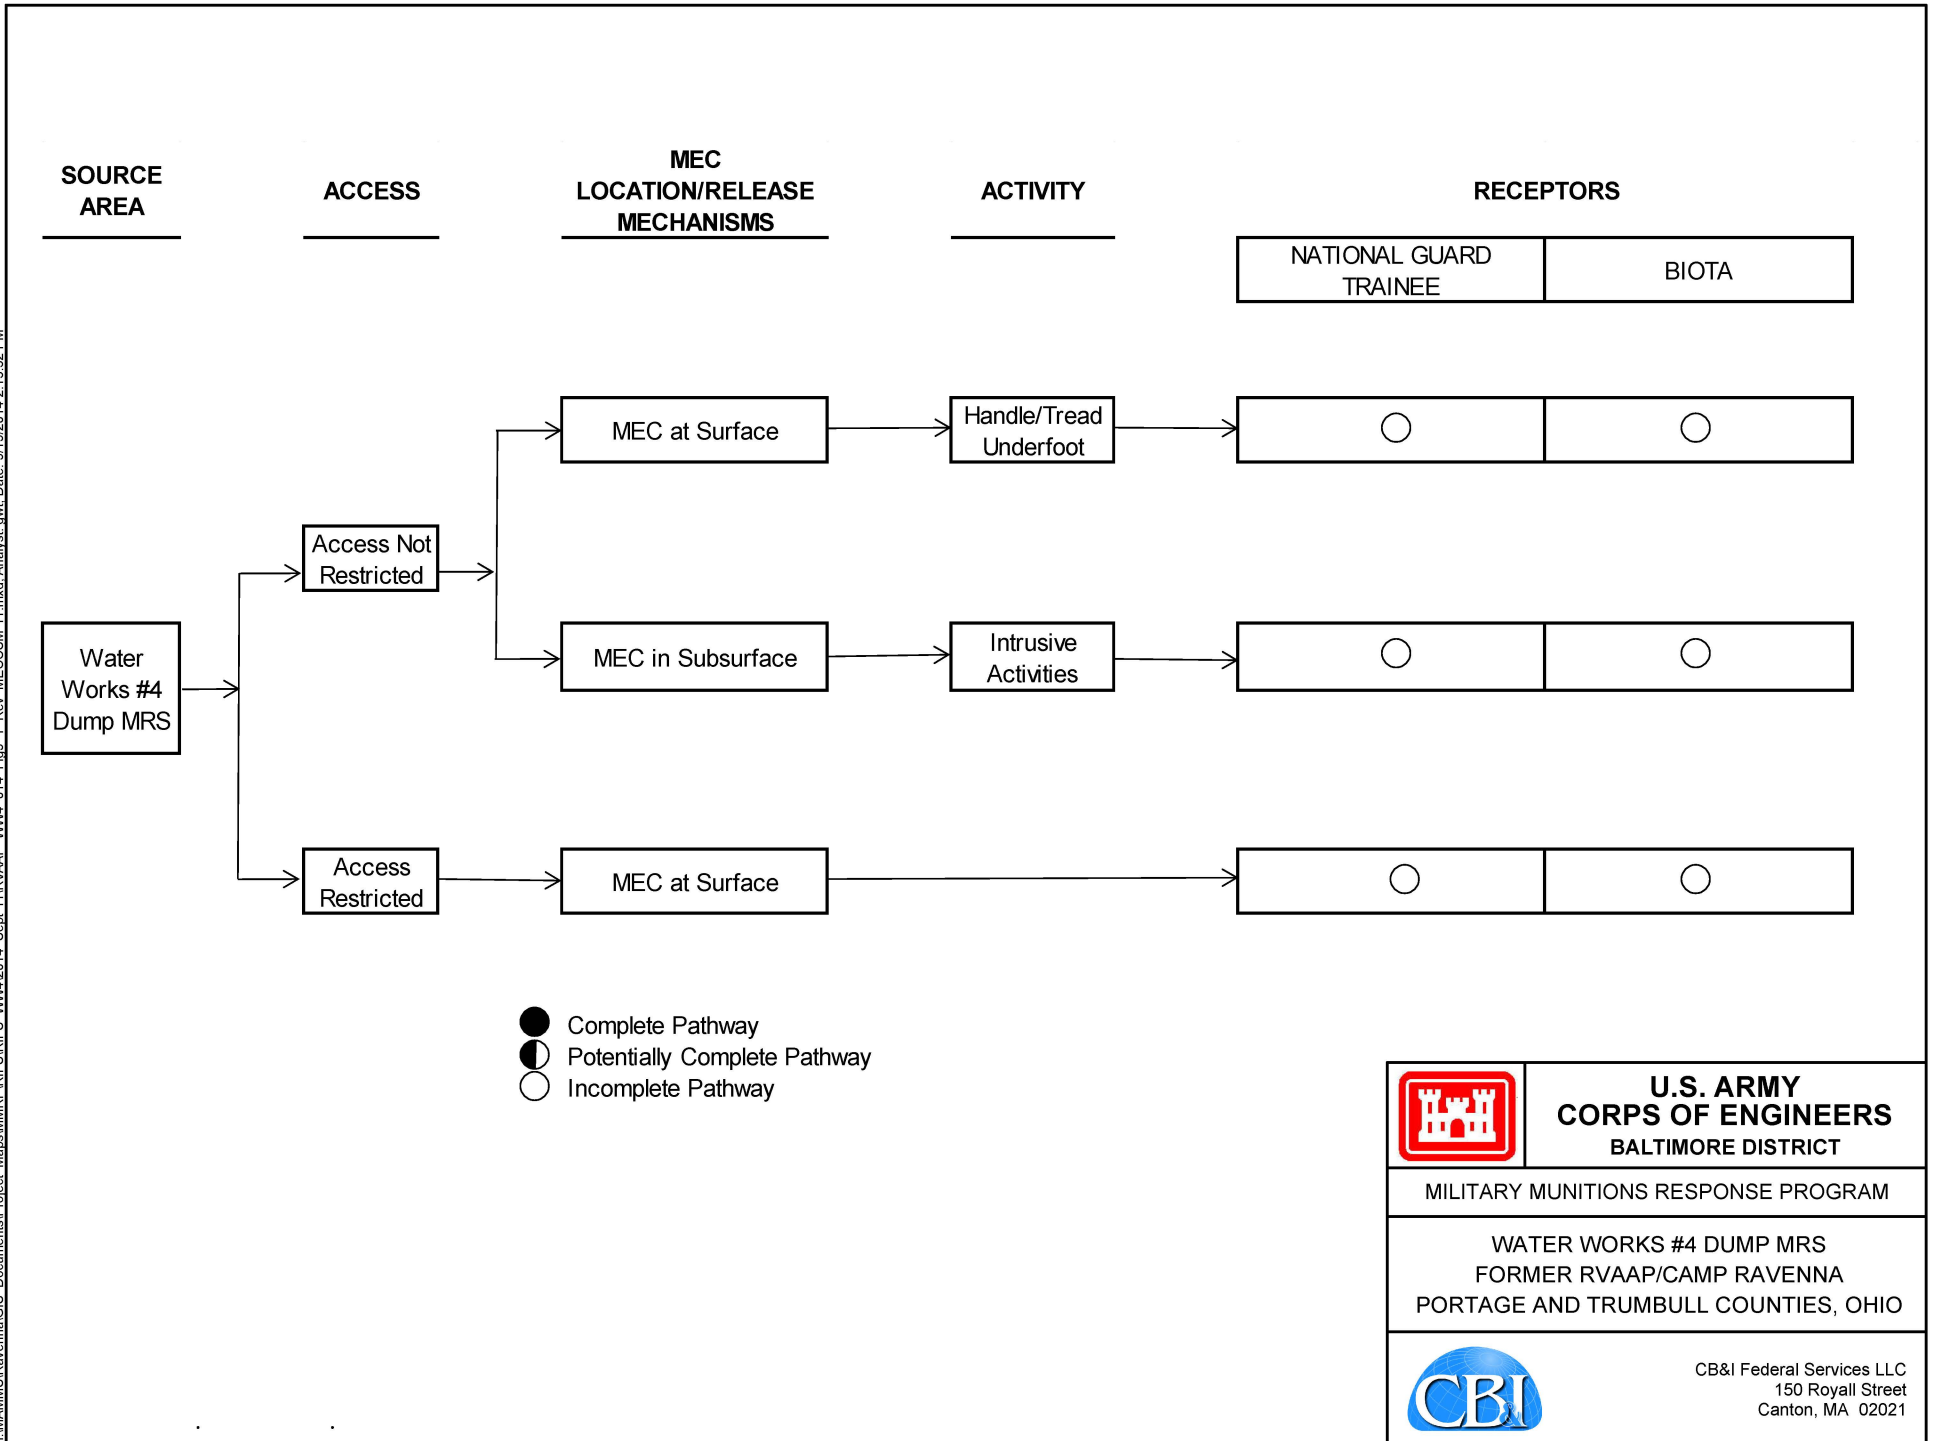
FIGURE 9-1 REVISED MEC CONCEPTUAL SITE MODEL

Based on the results of the MC sampling during the SI field activities and the MEC investigation portion of the RI field activities, it was determined that no potential source of MC is present at the Water Works #4 Dump MRS. Therefore, no media sampling was conducted at the MRS and incomplete pathways exist for MC for all receptors.
