Final Construction Completion Report

**Time Critical Response Action for the
Rocket Ridge Area of Open Demolition Area #2
(RVAAP-004-R-01 Open Demolition Area #2 MRS)
Military Munitions Response Program
Ravenna Army Ammunition Plant
Ravenna, Ohio**

September 2008

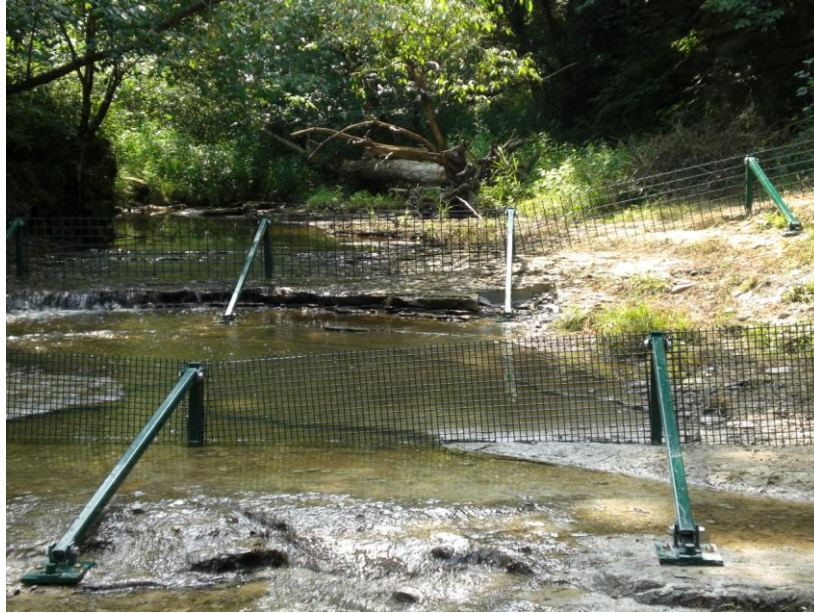
Photograph 1. Completed Barrier System

The barrier system is comprised of two parallel rigid screens crossing Sand Creek. The screens were installed at 42- and 66-feet upstream of George Road Bridge. The screen panels of the upstream barrier have 3-inch openings, while the panels of the downstream barrier have 1-inch openings. Each of the barriers consists of four solid steel square posts, with attached diagonal stay posts and base plates (see as-built details in **Appendix A**), and five screen panels (**Photograph I**). All of the barrier materials are galvanized and polyester powder coated green. As depicted in the **Photograph I**, the barriers were installed to the contour of the stream floor.

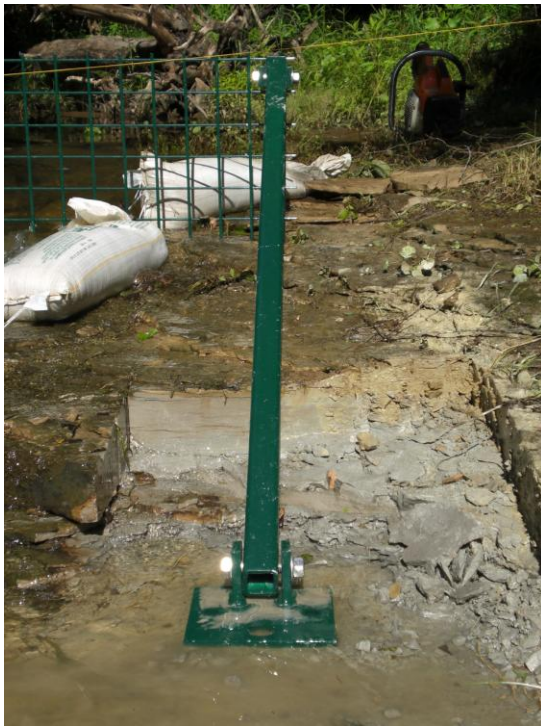
Photograph 2. Diagonal Stay Post and Base Plate

Prior to construction, the water flow was temporarily diverted using sand bags. Pneumatic rotary hammer equipment was used to drill holes for the barrier posts and diagonal stay posts. To securely attach the base plates to the stream floor, the rock surface was flattened at some locations (see **Photograph 2**). The base plates were attached using one solid galvanized steel pin and two anchors. Each post and pin was set in an underwater grout (Euco Tremie Grout) and the anchors were set in epoxy (Hilti HIT-RE 500). Drawings of as-built construction details can be found in **Appendix A**.

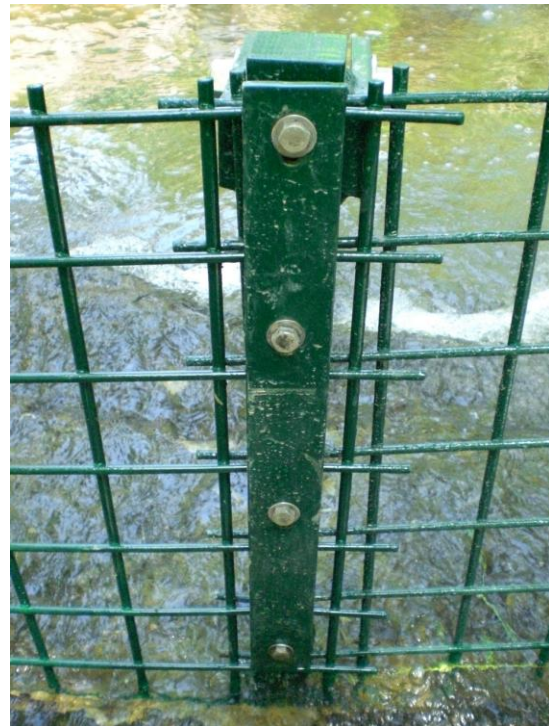
Photograph 3. Overlapping Fence Panels

A gas-powered chop saw was used to cut a 1.5-inch wide channel in the sandstone bedrock. The cut extended the width of the screen system to allow each screen panel to sit below the surface of the bedrock. The sides of the barriers were buried into the stream banks. This construction ensured that there are no gaps between the screen panels and the stream floor and stream banks. In addition, the screen panels were overlapped to increase the overall barrier rigidity and strength (**Photograph 3**).

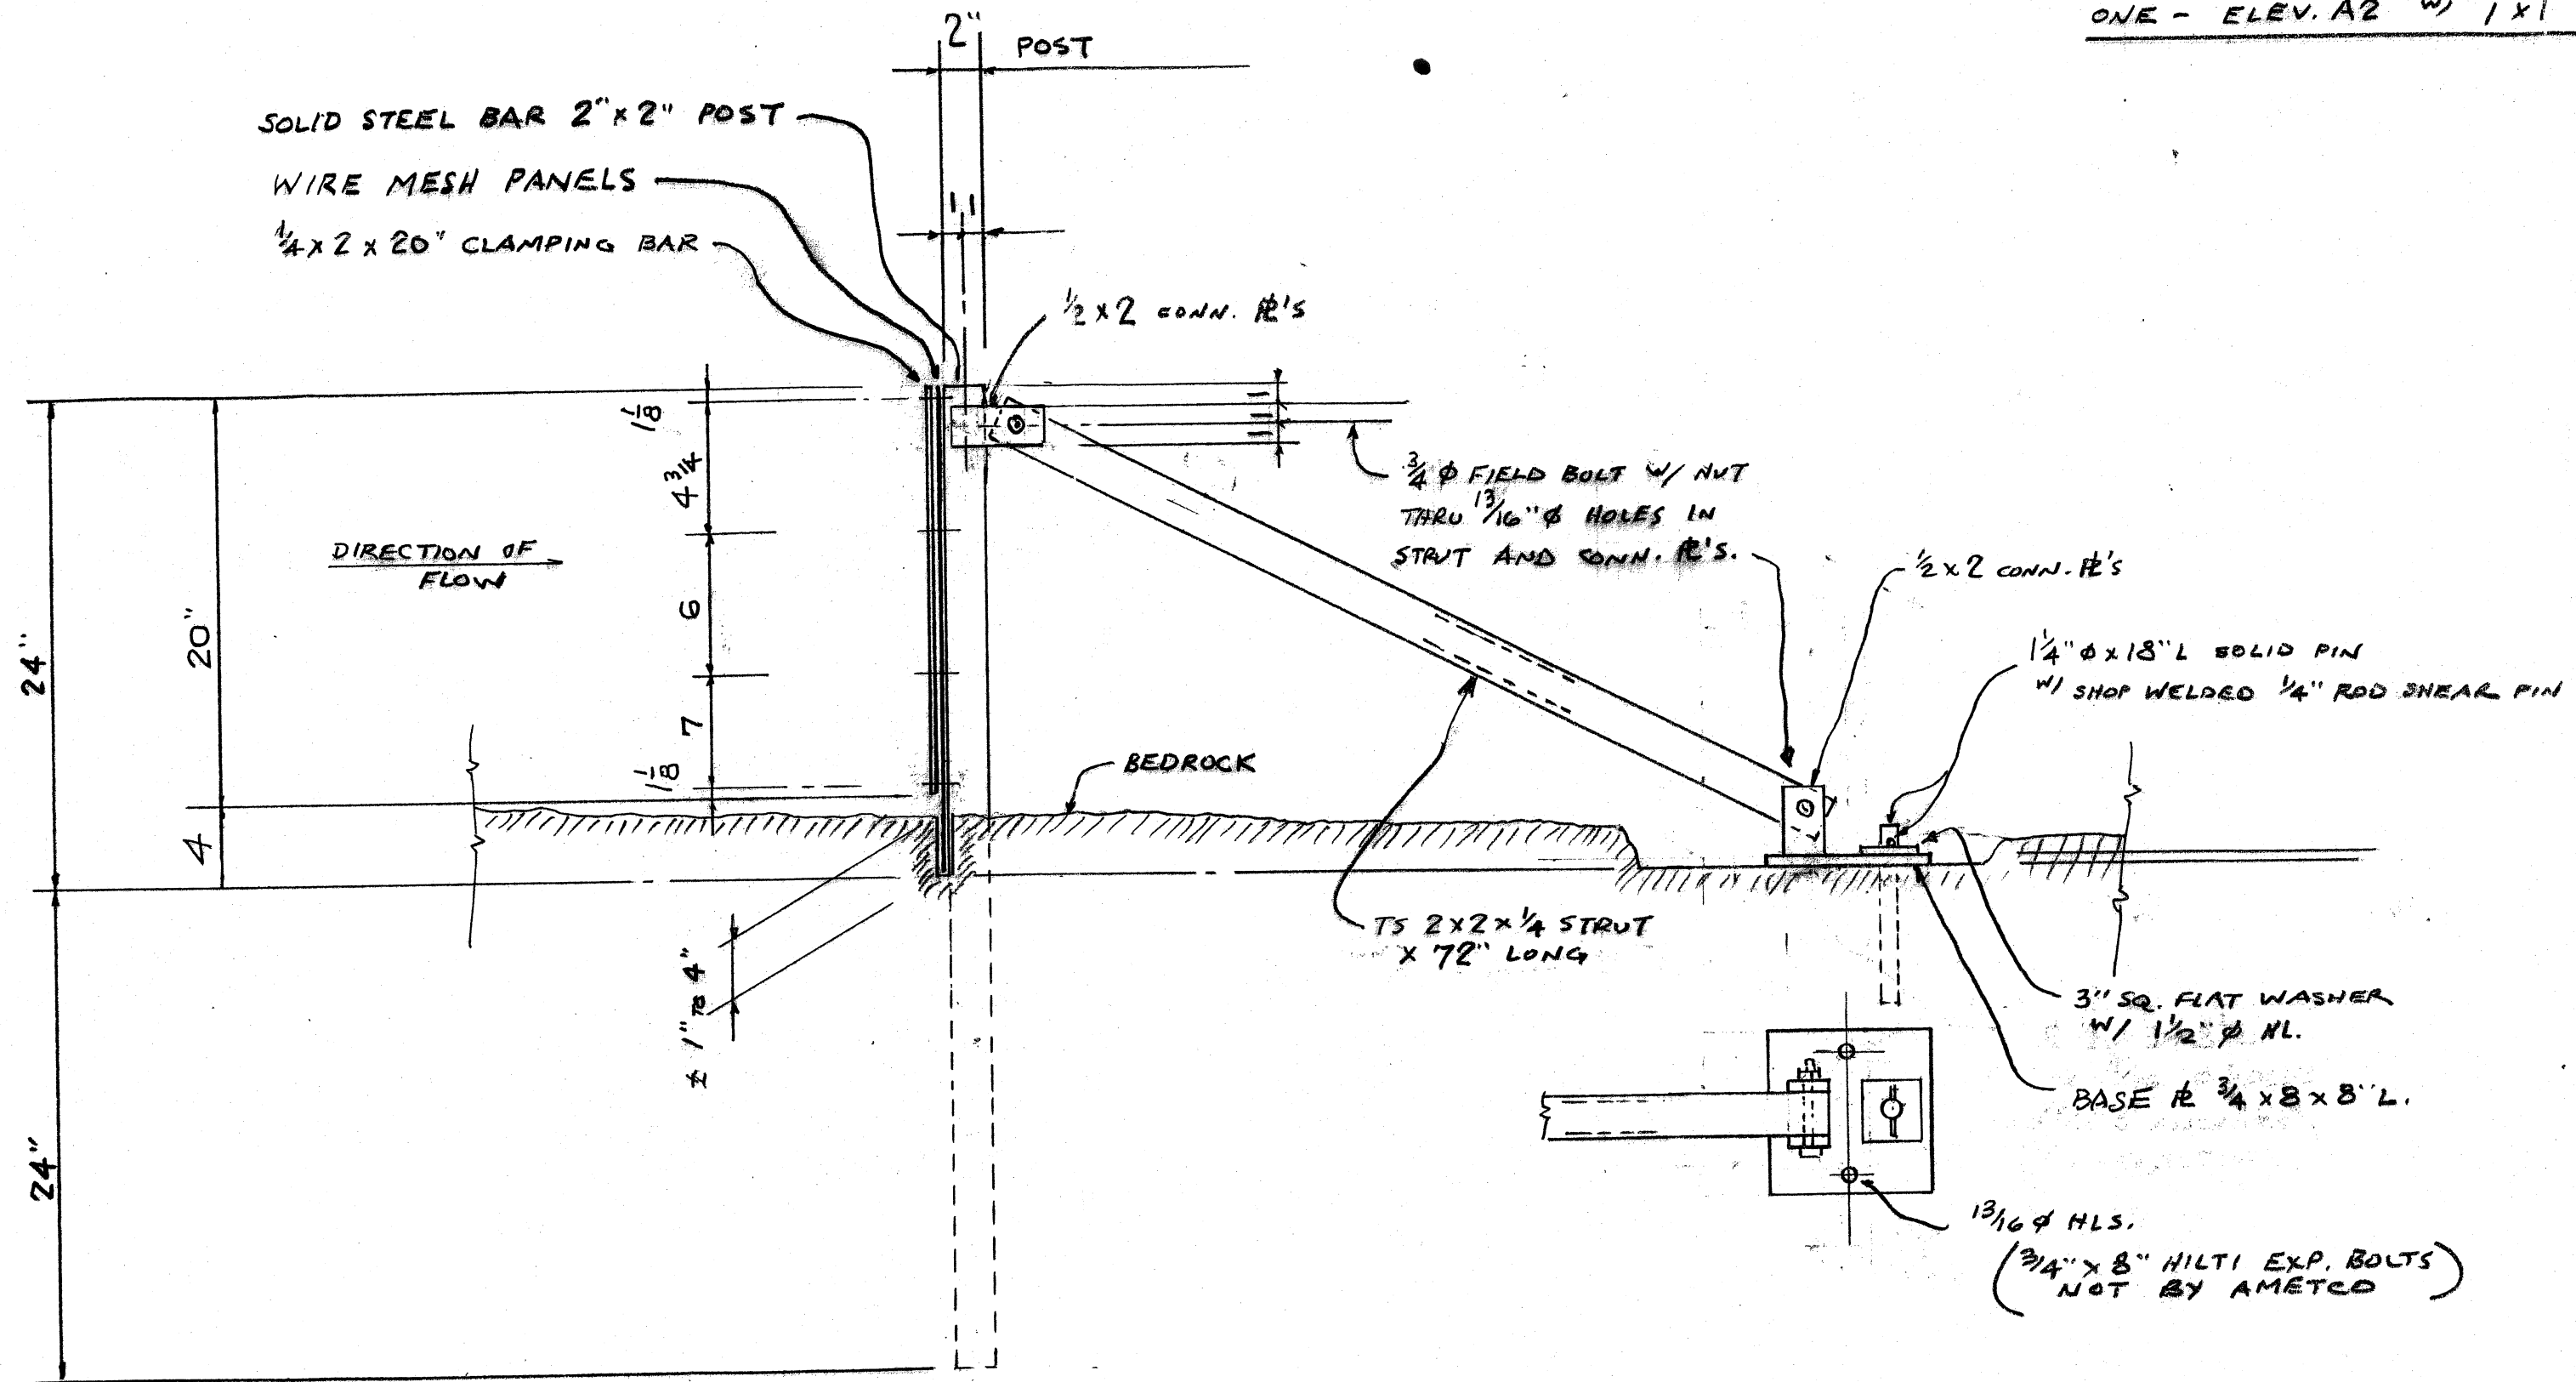
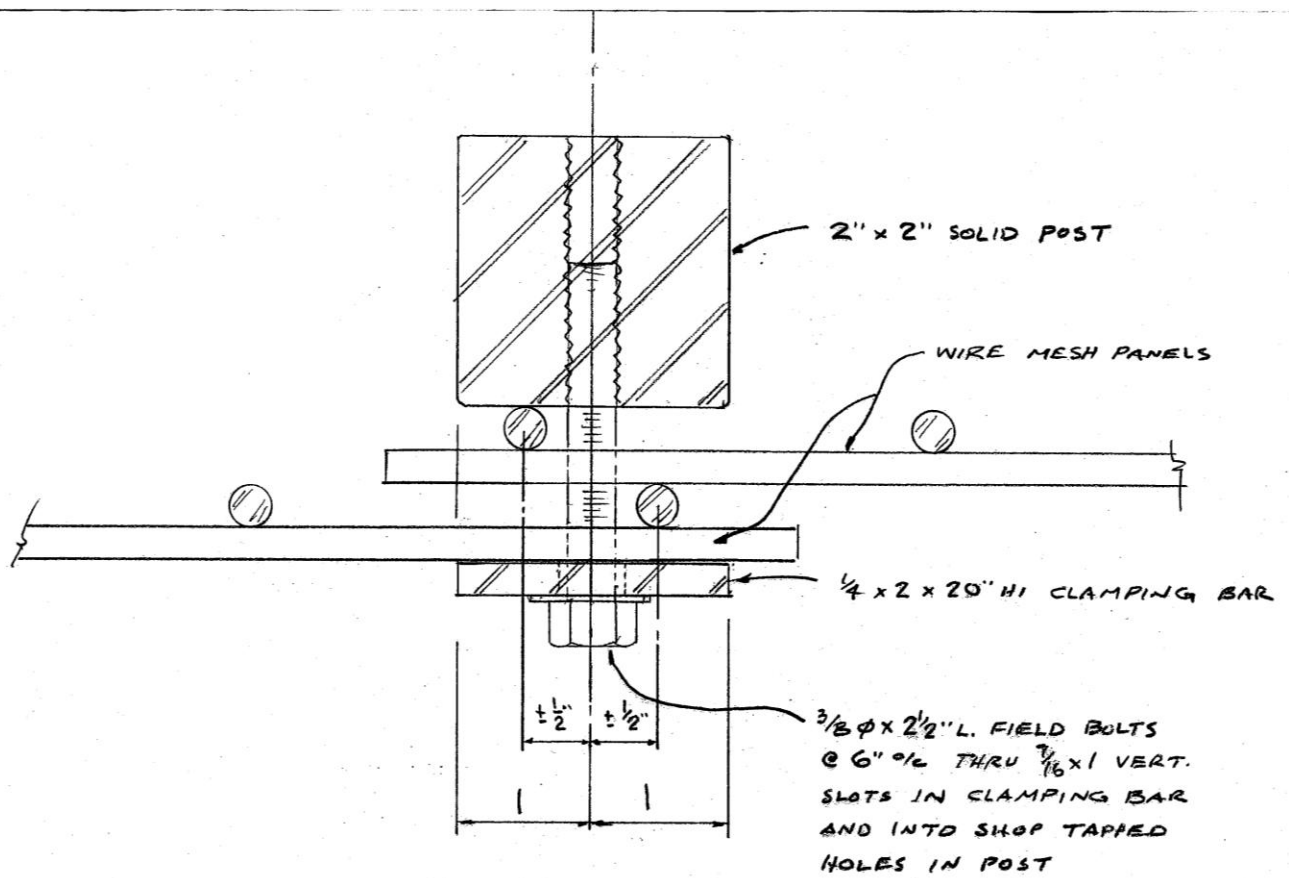
APPENDIX A
SAND CREEK BARRIER SYSTEM AS-BUILT DETAILS

ONE - ELEV. A1 W/ 3x3 W/

ONE - ELEV. A2 W/ 1x1 W/

SECTION

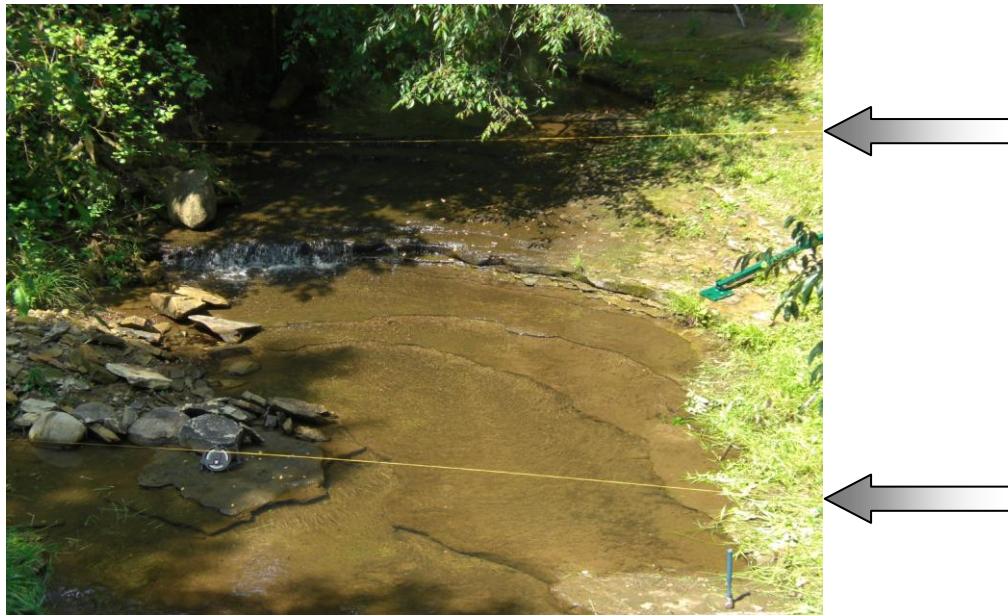
Photograph 1. Photograph taken from George Road Bridge. Prior to installation, the locations of the screens were delineated with yellow lines attached to stakes on each side of the stream. The arrows above help to distinguish the yellow lines in the picture. The upstream line is the location of the 3-inch barrier and the downstream line is the location of the 1-inch barrier.

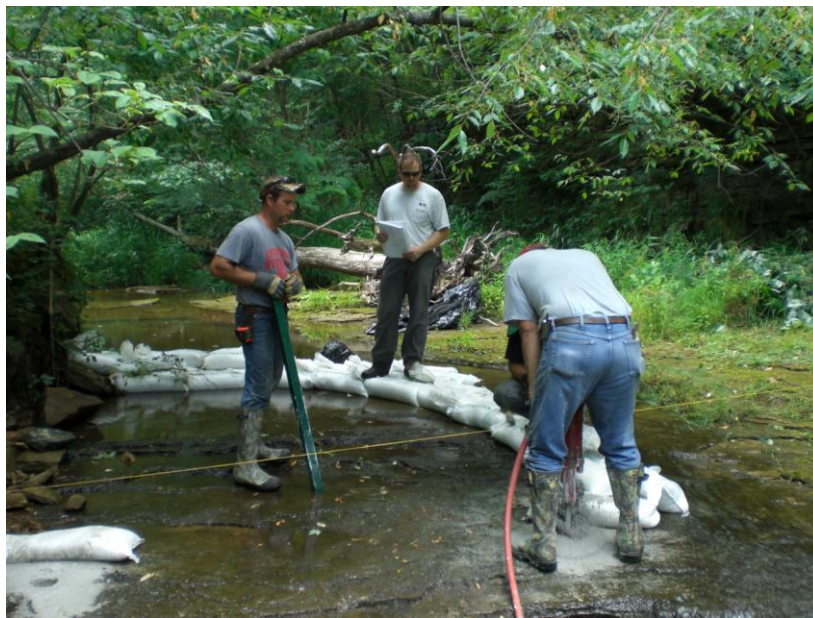
Photograph 2. Water flow was temporarily diverted from the work area with sand bags. A pneumatic rotary hammer was used to drill each of the post holes into the sandstone. In this picture, Able Fence is drilling the second hole for the upstream system.

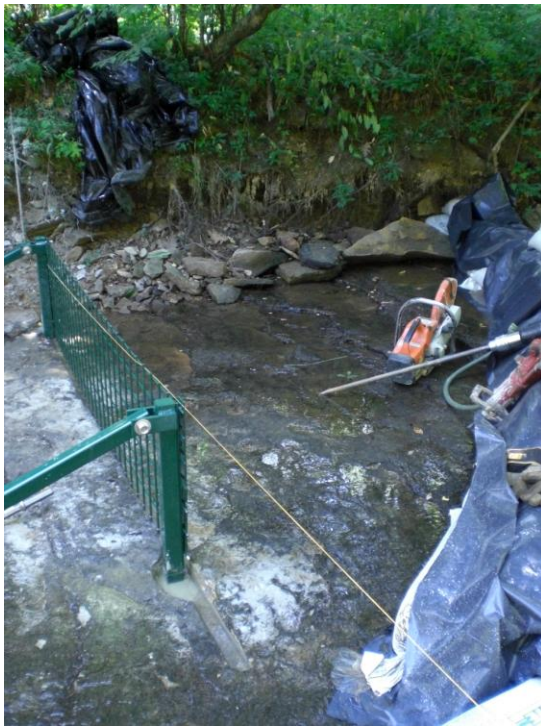
Photograph 4. Installation of a panel of the upstream system. Work area in the right of the photograph was sand bagged to divert water. Bottom of photograph shows the channel cut into the stream floor.

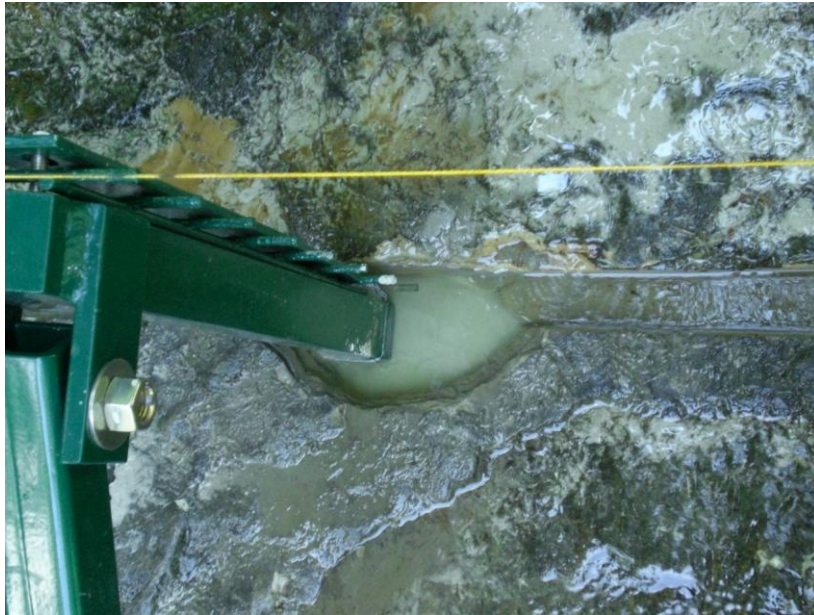
Photograph 5. Shows close-up of post-hole and channel.

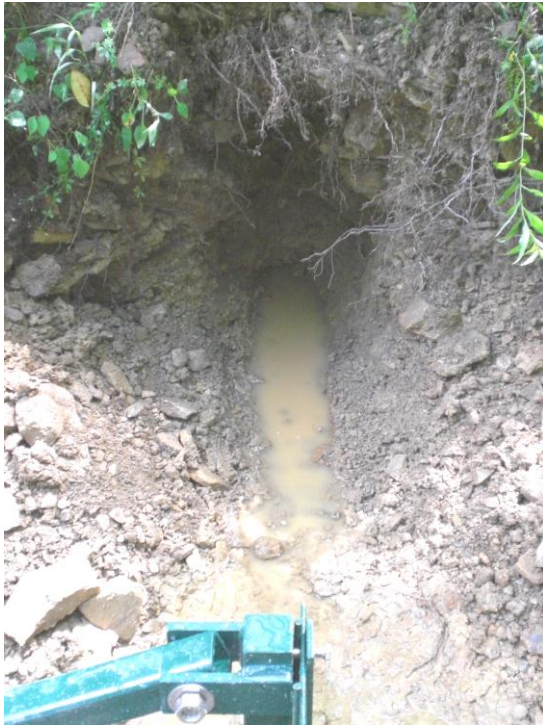
Photograph 6. A portion of the bank was excavated to allow for the panel to be buried into the bank.

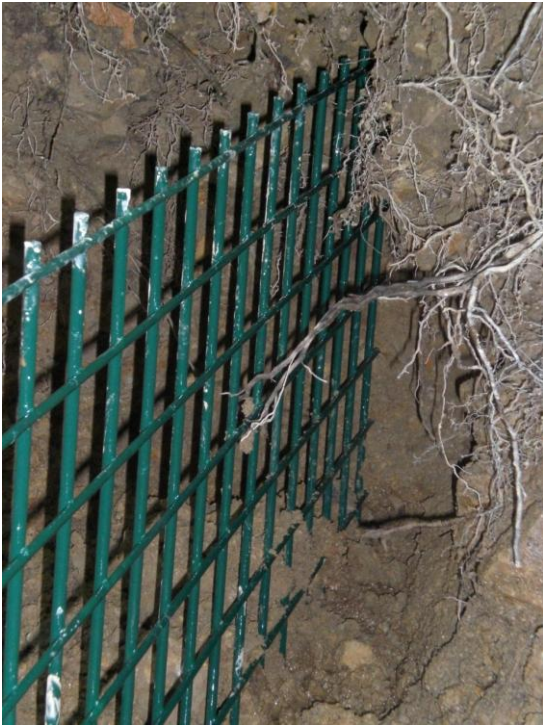
Photograph 7. The panel was buried 2.5 feet into the bank.

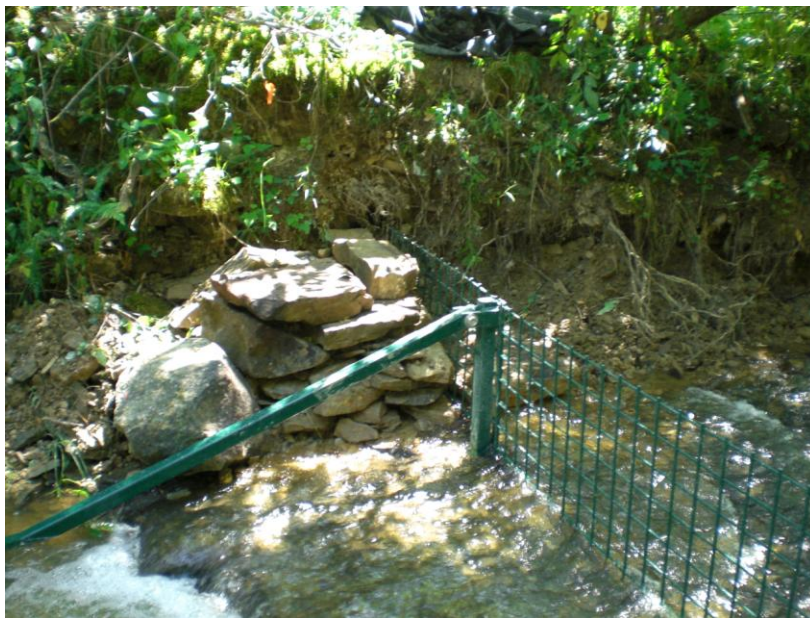
Photograph 8. After the panel had been installed and buried into the bank, rocks were placed on the downstream side of the 3-inch panel. Each of the posts had an attached diagonal stay post and base plate.

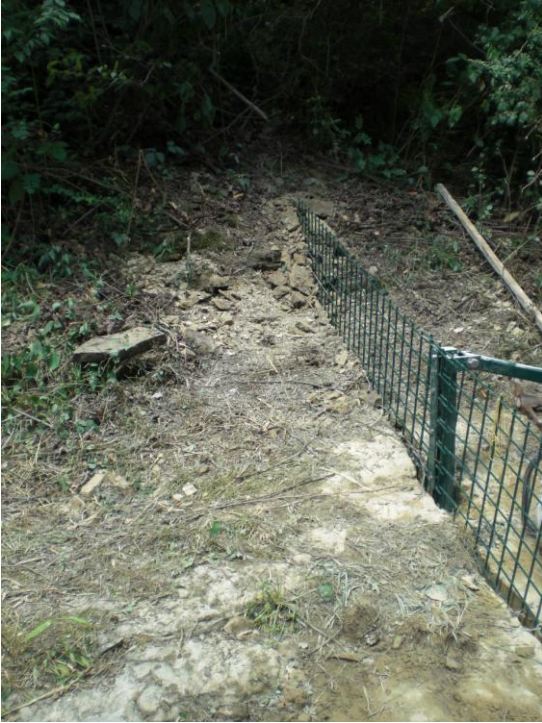
Photograph 9. The barrier system was extended into both banks of Sand Creek.

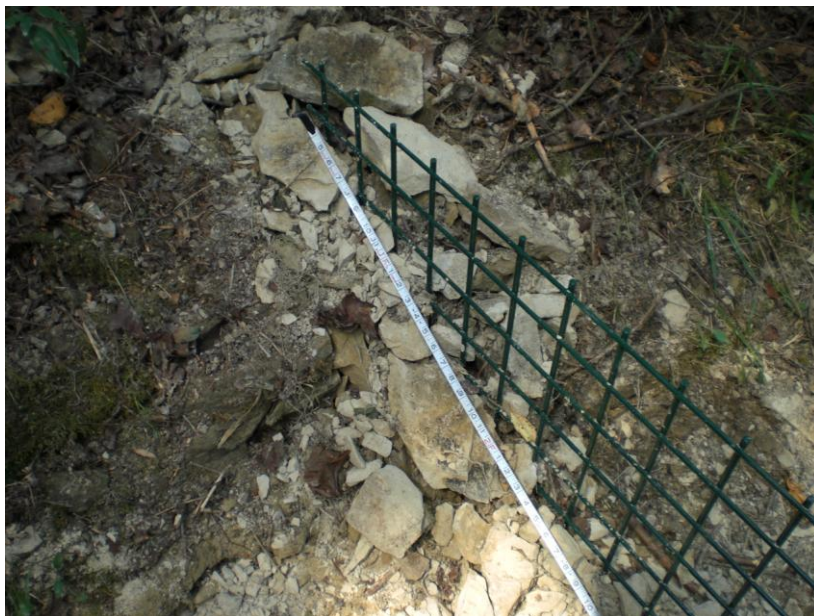
Photograph 10. After the panel was installed, the excavated material was used to surround the panel.

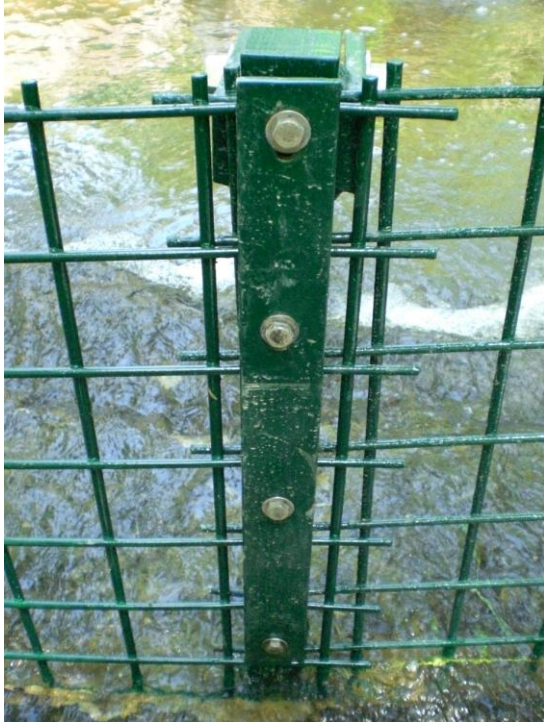
Photograph 11. The panels were overlapped to add strength and rigidity. A clamping bar with four bolts secures the panels to the post.

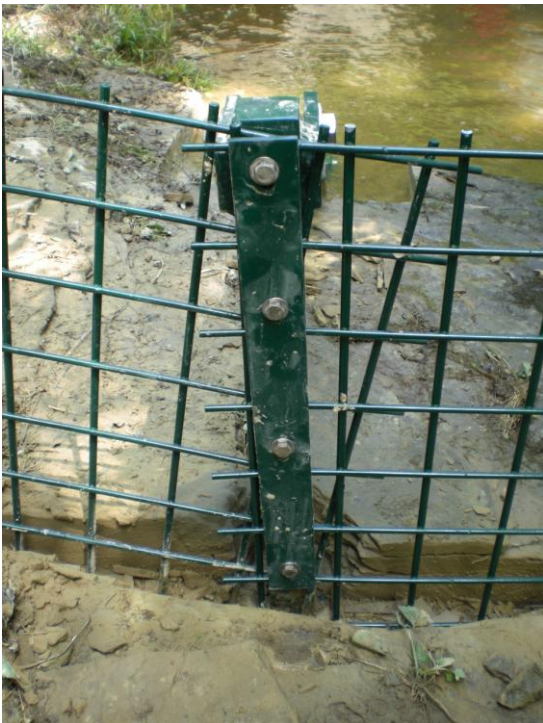
Photograph 12. The barrier system was installed to follow the contour of the stream floor, which, in this picture, can be seen as one of the panels is diagonal to the other.

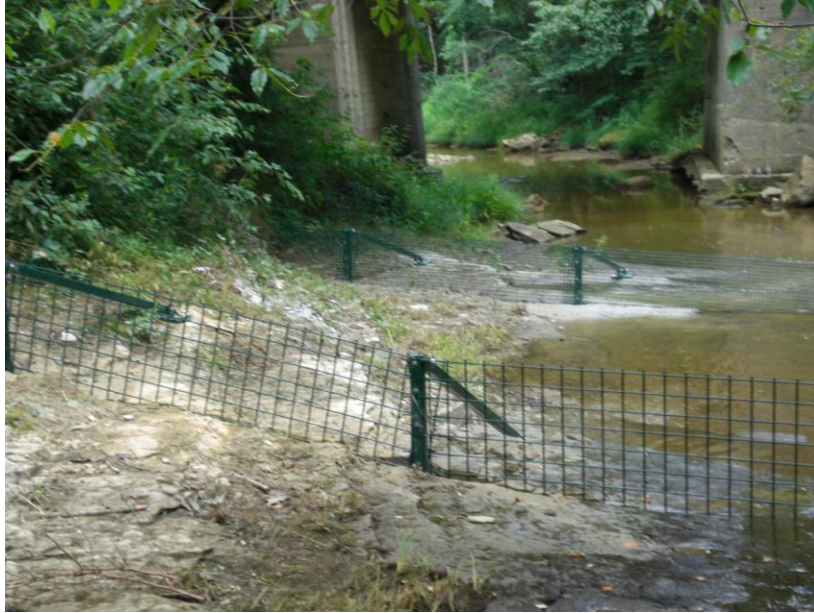
Photograph 13. The barrier system was installed to follow the contour of the stream floor. This photograph shows both barrier systems in place.

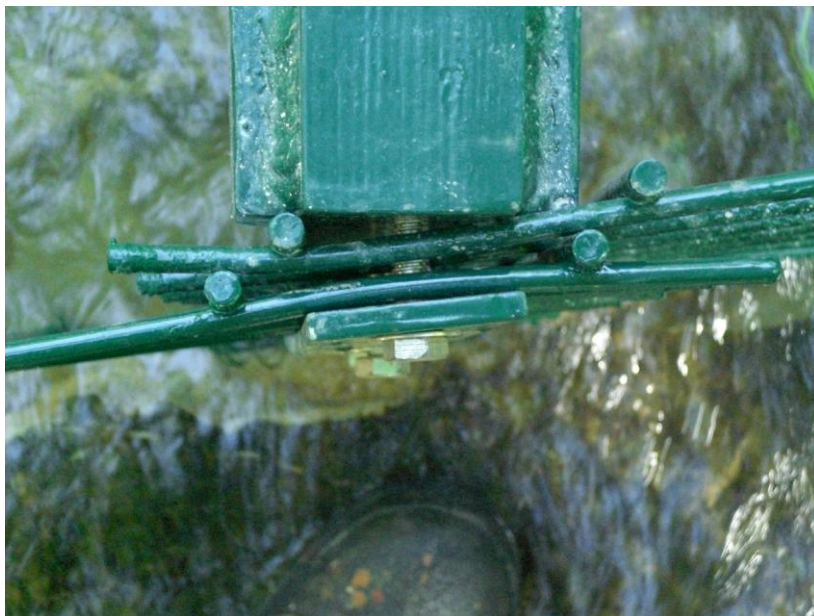
Photograph 14. This top view shows the two 3-inch panels clamped together.

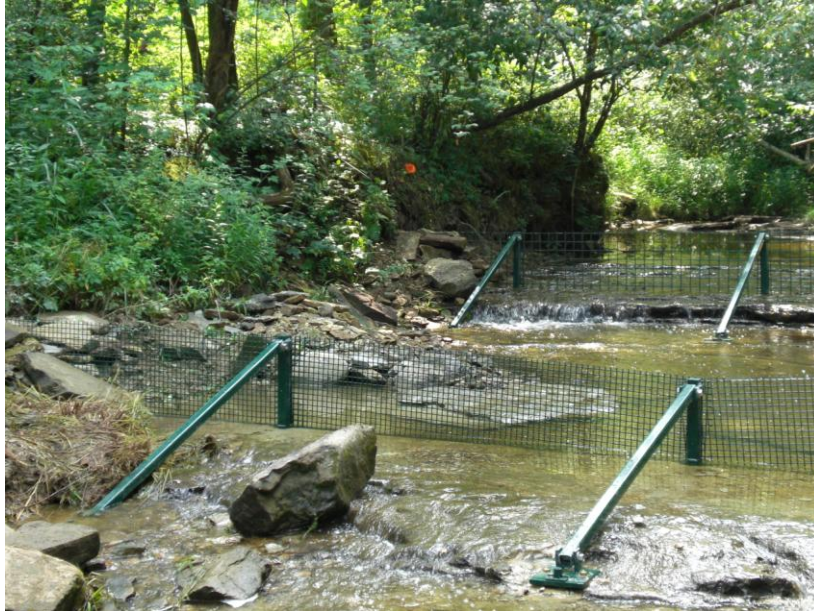
Photograph 15. Each of the posts had an attached diagonal stay post.

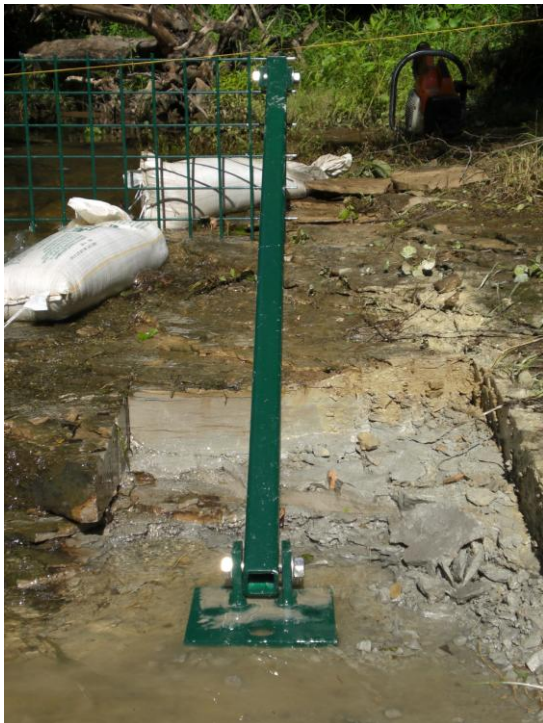
Photograph 16. To allow the base plate to sit level on the stream floor, some material had to be removed.

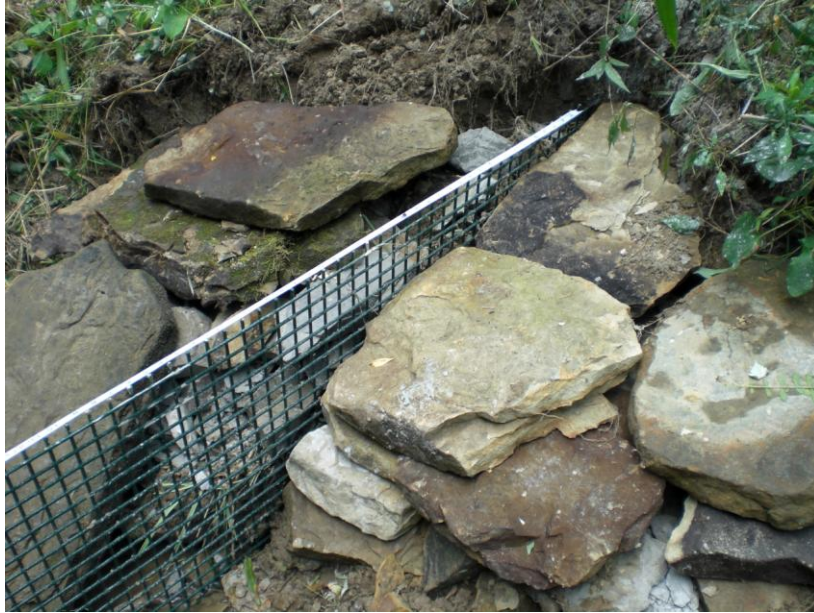
Photograph 17. After the panel had been installed and buried into the bank, rocks were placed on both sides of the 1-inch panel. This was also done to the panel entering the opposite bank.

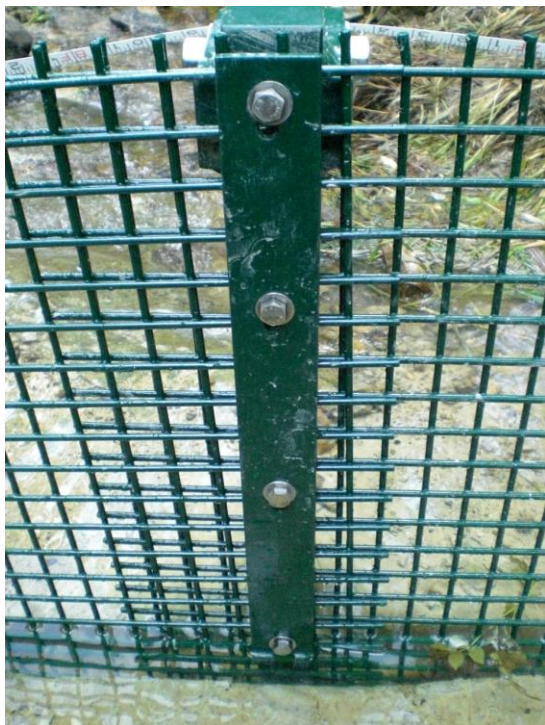
Photograph 18. Installation of the 1-inch panels was conducted identically to the 3-inch panels. Panels were overlapped to add strength and rigidity. A clamping bar with four bolts secures the panels to the post.

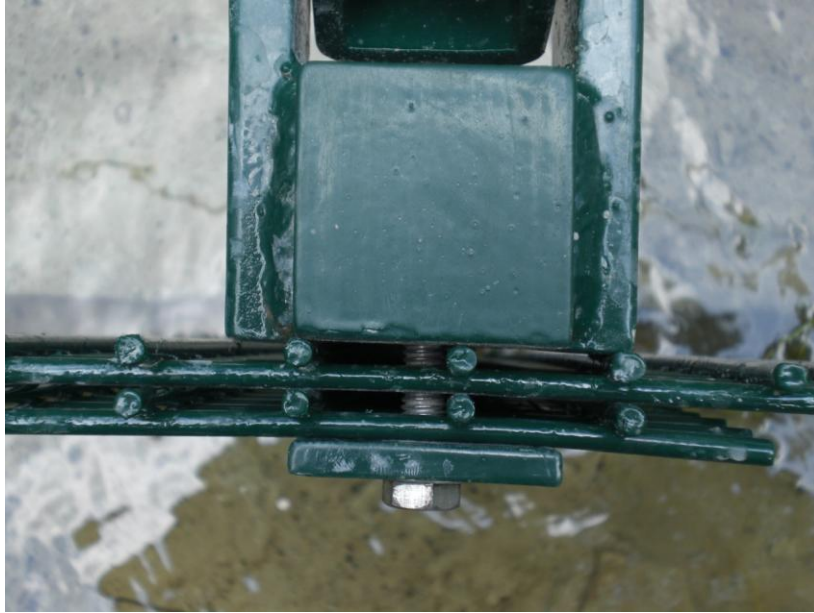
Photograph 19. This top view shows the two 1-inch panels clamped together..

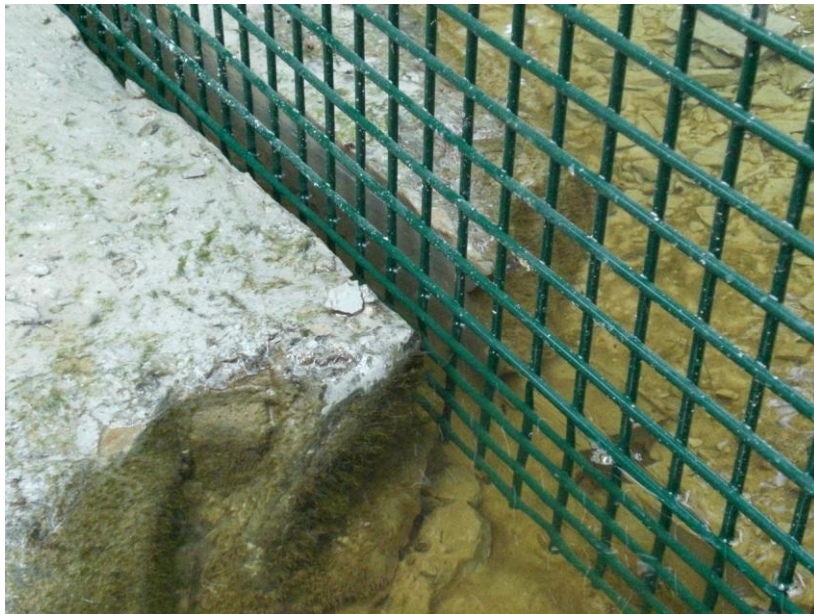
Photograph 20. The 1-inch panels were installed into a channel cut into the stream floor.

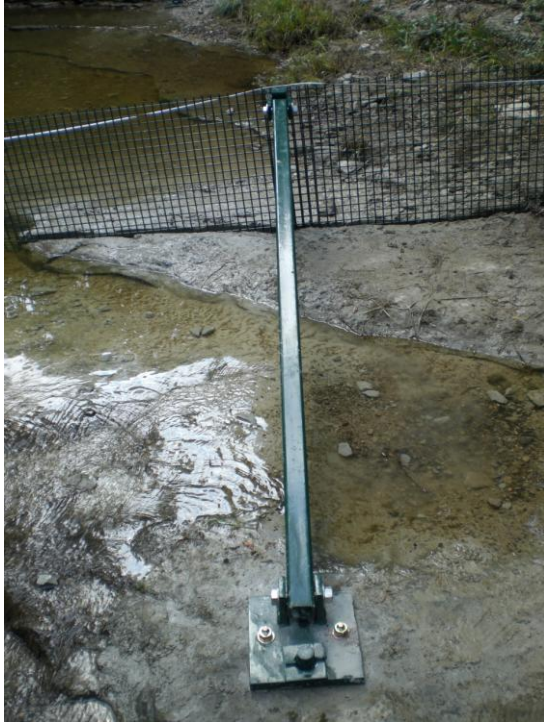
Photograph 21. Each base plate was attached to the stream floor with two anchor bolts and one pin.

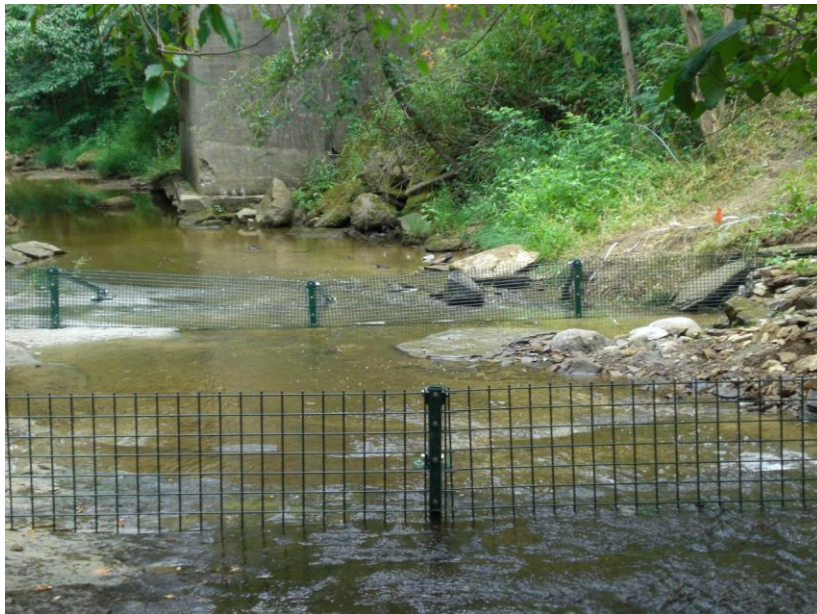
Photograph 22. Completed barrier system.
