Final
FY2013/2015 Annual Sand Creek Stream Monitoring
Within
RVAAP-004-R-01 Open Demolition Area #2 MRS
For the Rocket Ridge Project
Letter Reports

Subject: Ravenna Army Ammunition Plant Restoration Program
Rocket Ridge (Sand Creek Stream Relocation) Project Summaries for 2013, 2014
and 2015
RVAAP-004-R-01 Open Demolition Area 2 MRS
Ohio EPA ID #267-000859-089
Camp Ravenna, Portage/Trumbull Counties, Ohio

RE: *Rocket Ridge Project Summary*—Sand Creek Stream Relocation, Year 3
Monitoring, Camp Ravenna Joint Military Training Center, Paris Township,
Portage County, Ohio

RE: *Rocket Ridge Project Summary*—Sand Creek Stream Relocation, Year 1
Monitoring, Camp Ravenna Joint Military Training Center, Paris Township,
Portage County, Ohio

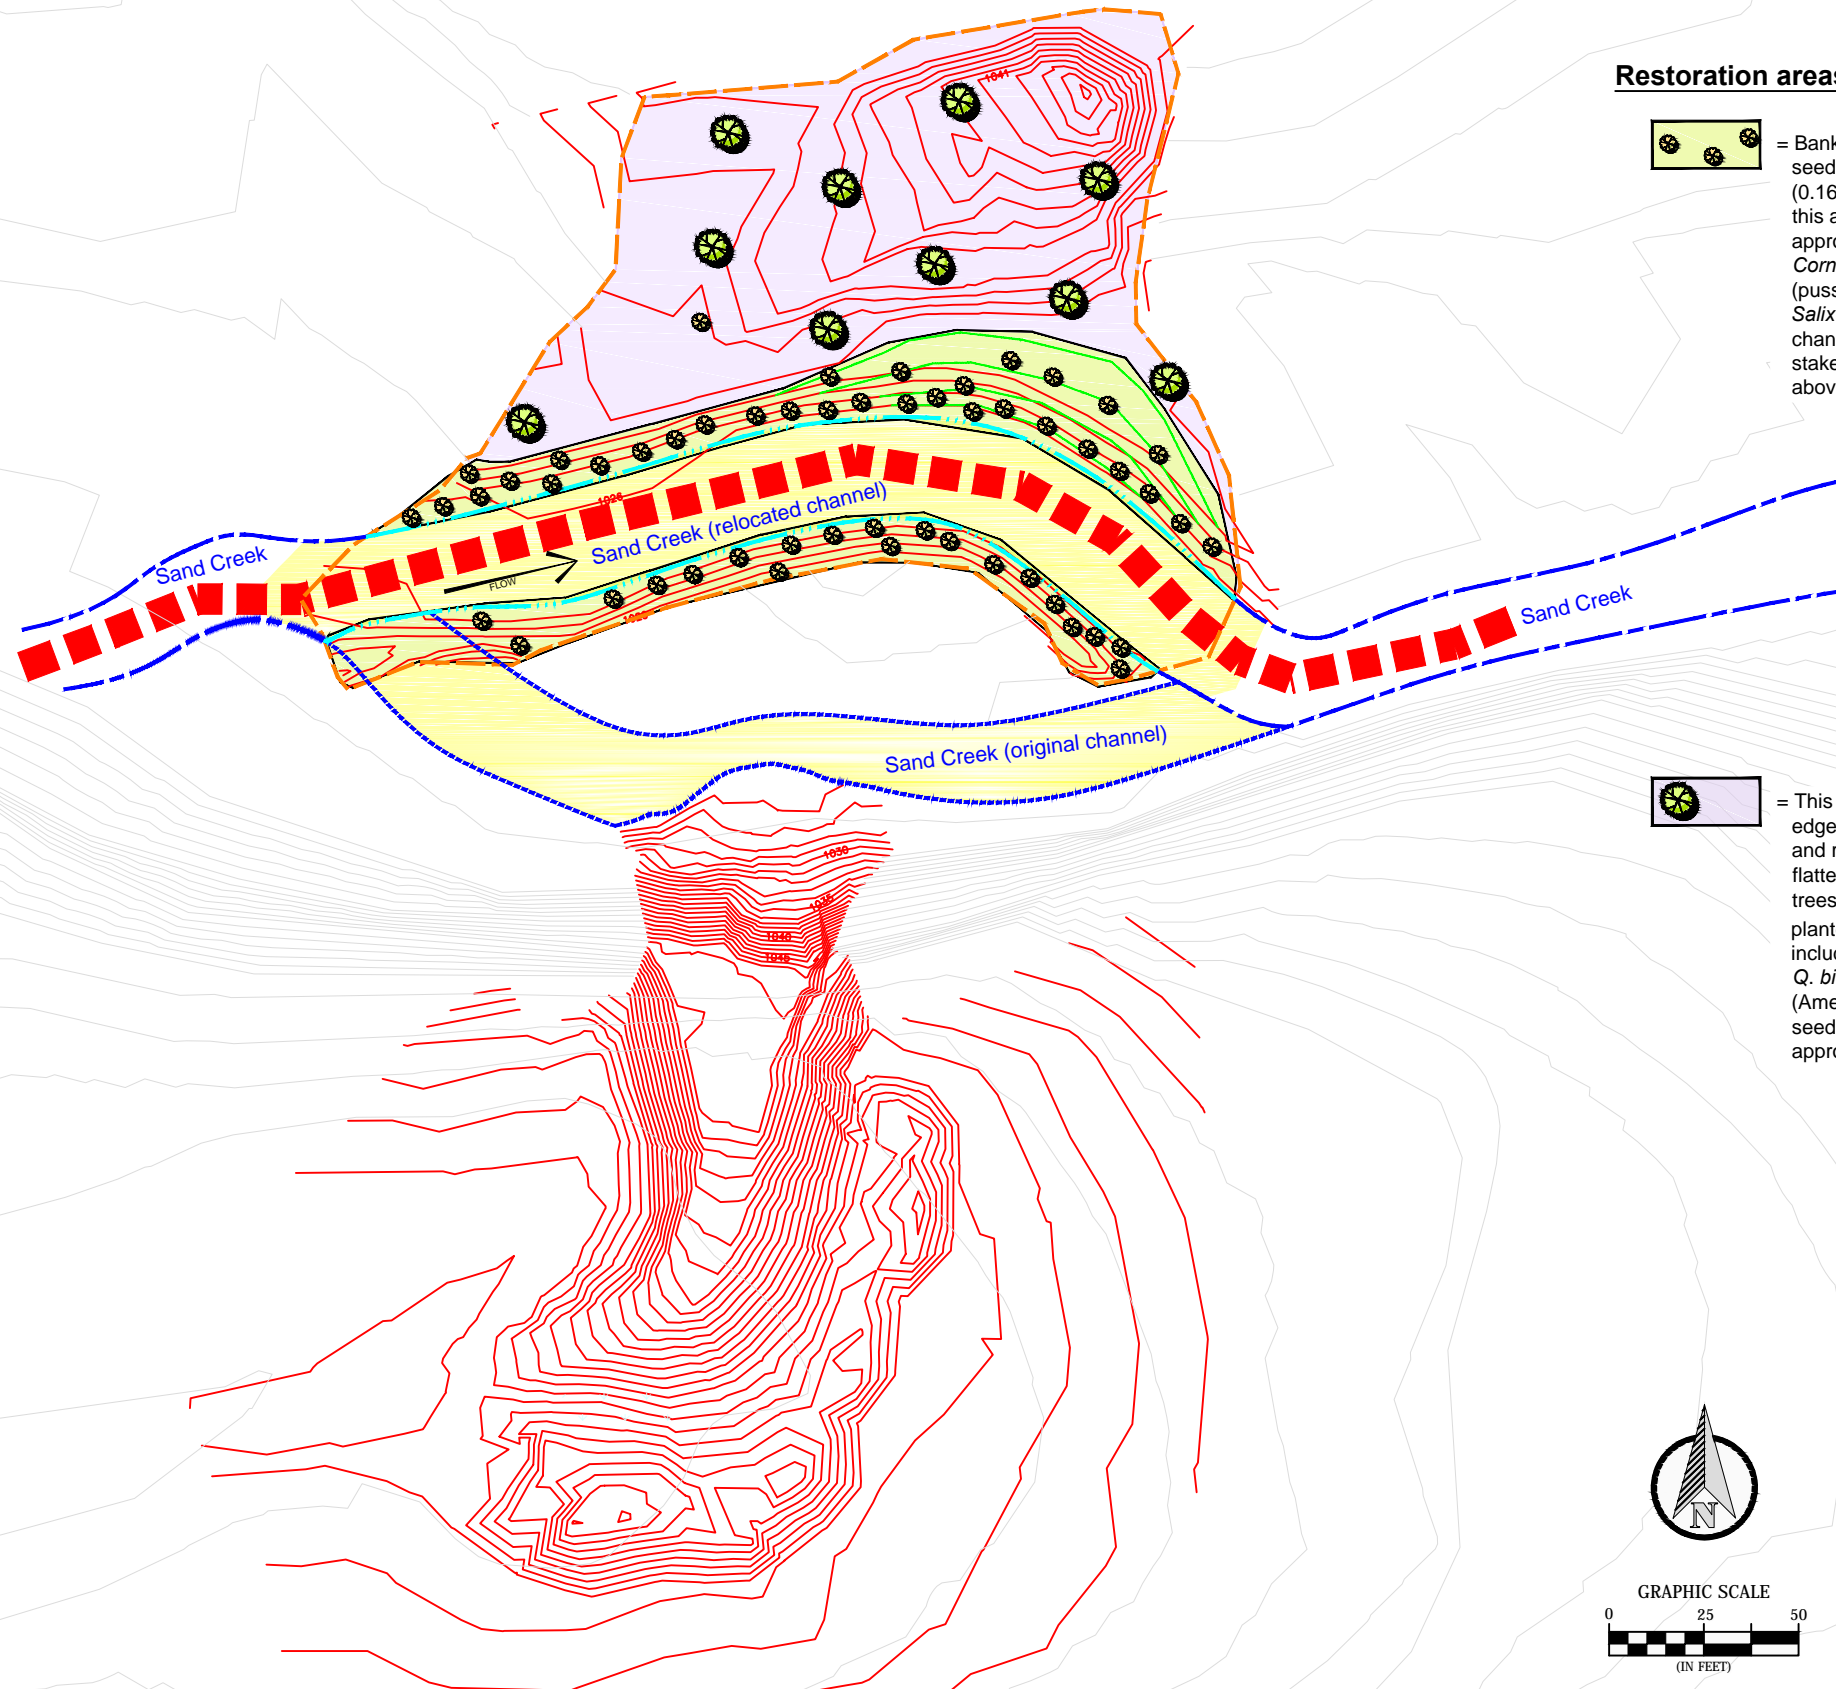
As-built Restoration Map

= Bank restoration area was seeded with a floodplain seed mix and stabilized with erosion control blanket (0.16 acre). After seeding and blanket installation, this area was planted with 110, 3-gallon shrubs, approximately 4-8 foot on center. Shrubs included *Cornus amomum* (silky dogwood), *Salix discolor* (pussy willow), *Salix exigua* (sandbar willow), and *Salix sericea* (silky willow). The toe of the restored channel area was installed with 400 live stakes. Live stake species included native willow species listed above.

= This re-graded open area was seeded with a woodland edge seed mix (0.30 acre). This area was re-shaped and roughly re-graded. Grading was done to create a flatter mound while keeping soils away from existing trees and wet areas. After shaping, this area was planted with ten 1 1/2" to 2-inch caliper trees. Trees included five *Quercus rubra* (northern red oak), three *Q. bicolor* (swamp white oak), and two *Tilia americana* (American linden). After tree planting, this area was seeded and straw mulch was applied at the appropriate rate.

= Approximate project area (0.6 acre)
-

= Sand Creek stream (existing)
-

= Relocated stream channel
-

= Original stream channel is now a floodplain-engaged backwater
-

= Approximate IBI reach (425 linear feet)
-

= Approximate QHEI reach (550 linear feet; includes restored channel and backwater)

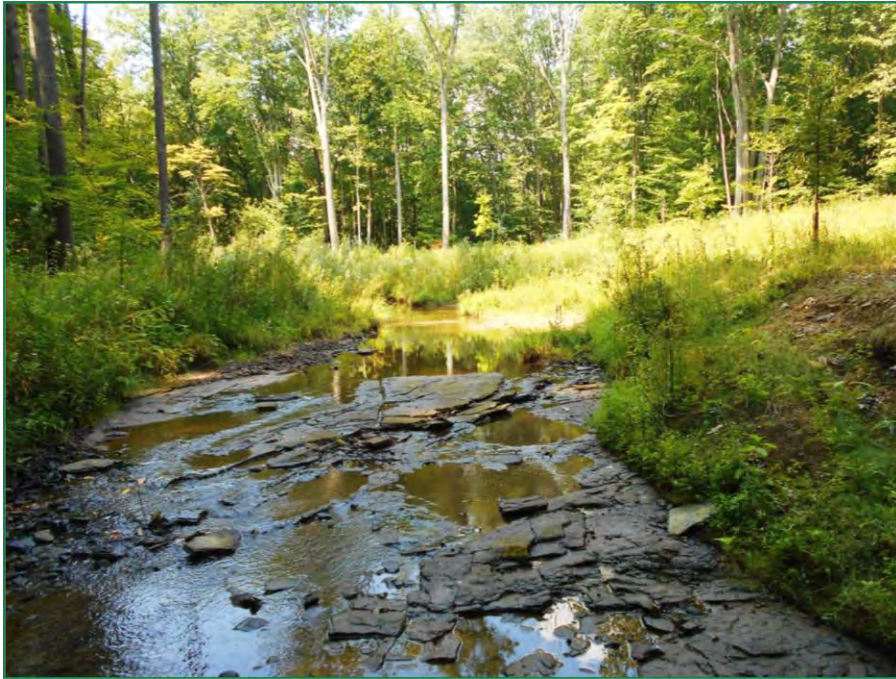
Photograph 1 (August 31, 2015). The eastern limit of the relocated stream channel looking upstream toward the western limit.

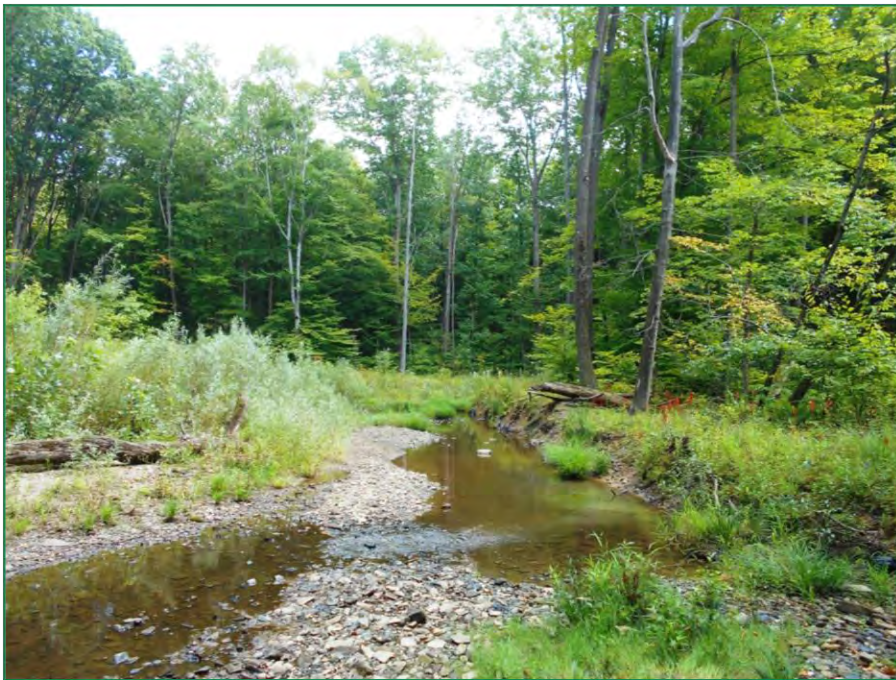
Photograph 2 (August 31, 2015). The western limit of the relocated stream channel looking downstream toward the eastern limit.

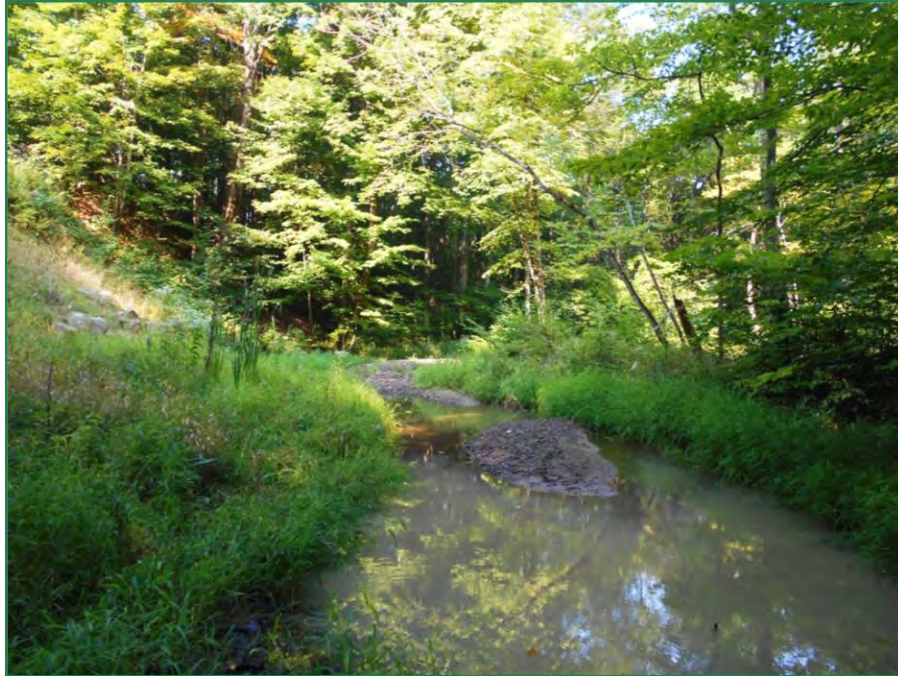
Photograph 3 (August 31, 2015). Upstream view of the original stream channel which has now become a functional backwater.

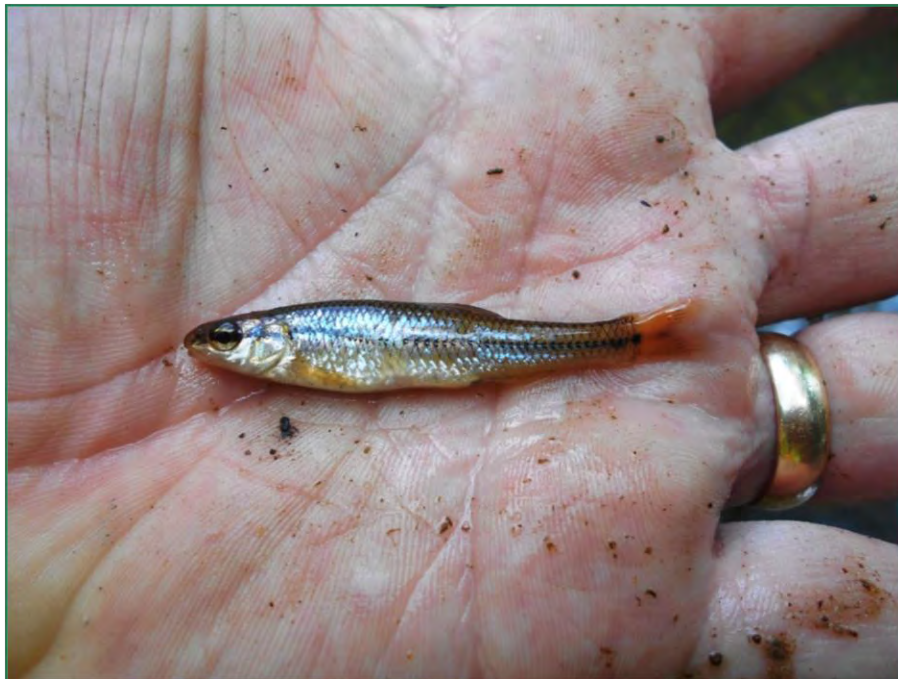
Photograph 4 (August 31, 2015). The bluntnose minnow (*Pimephales notatus*) was the most common fish species captured during the 2015 IBI fish survey. Of the 1,043 total fish captured, 437 (41.8%) were bluntnose minnows.

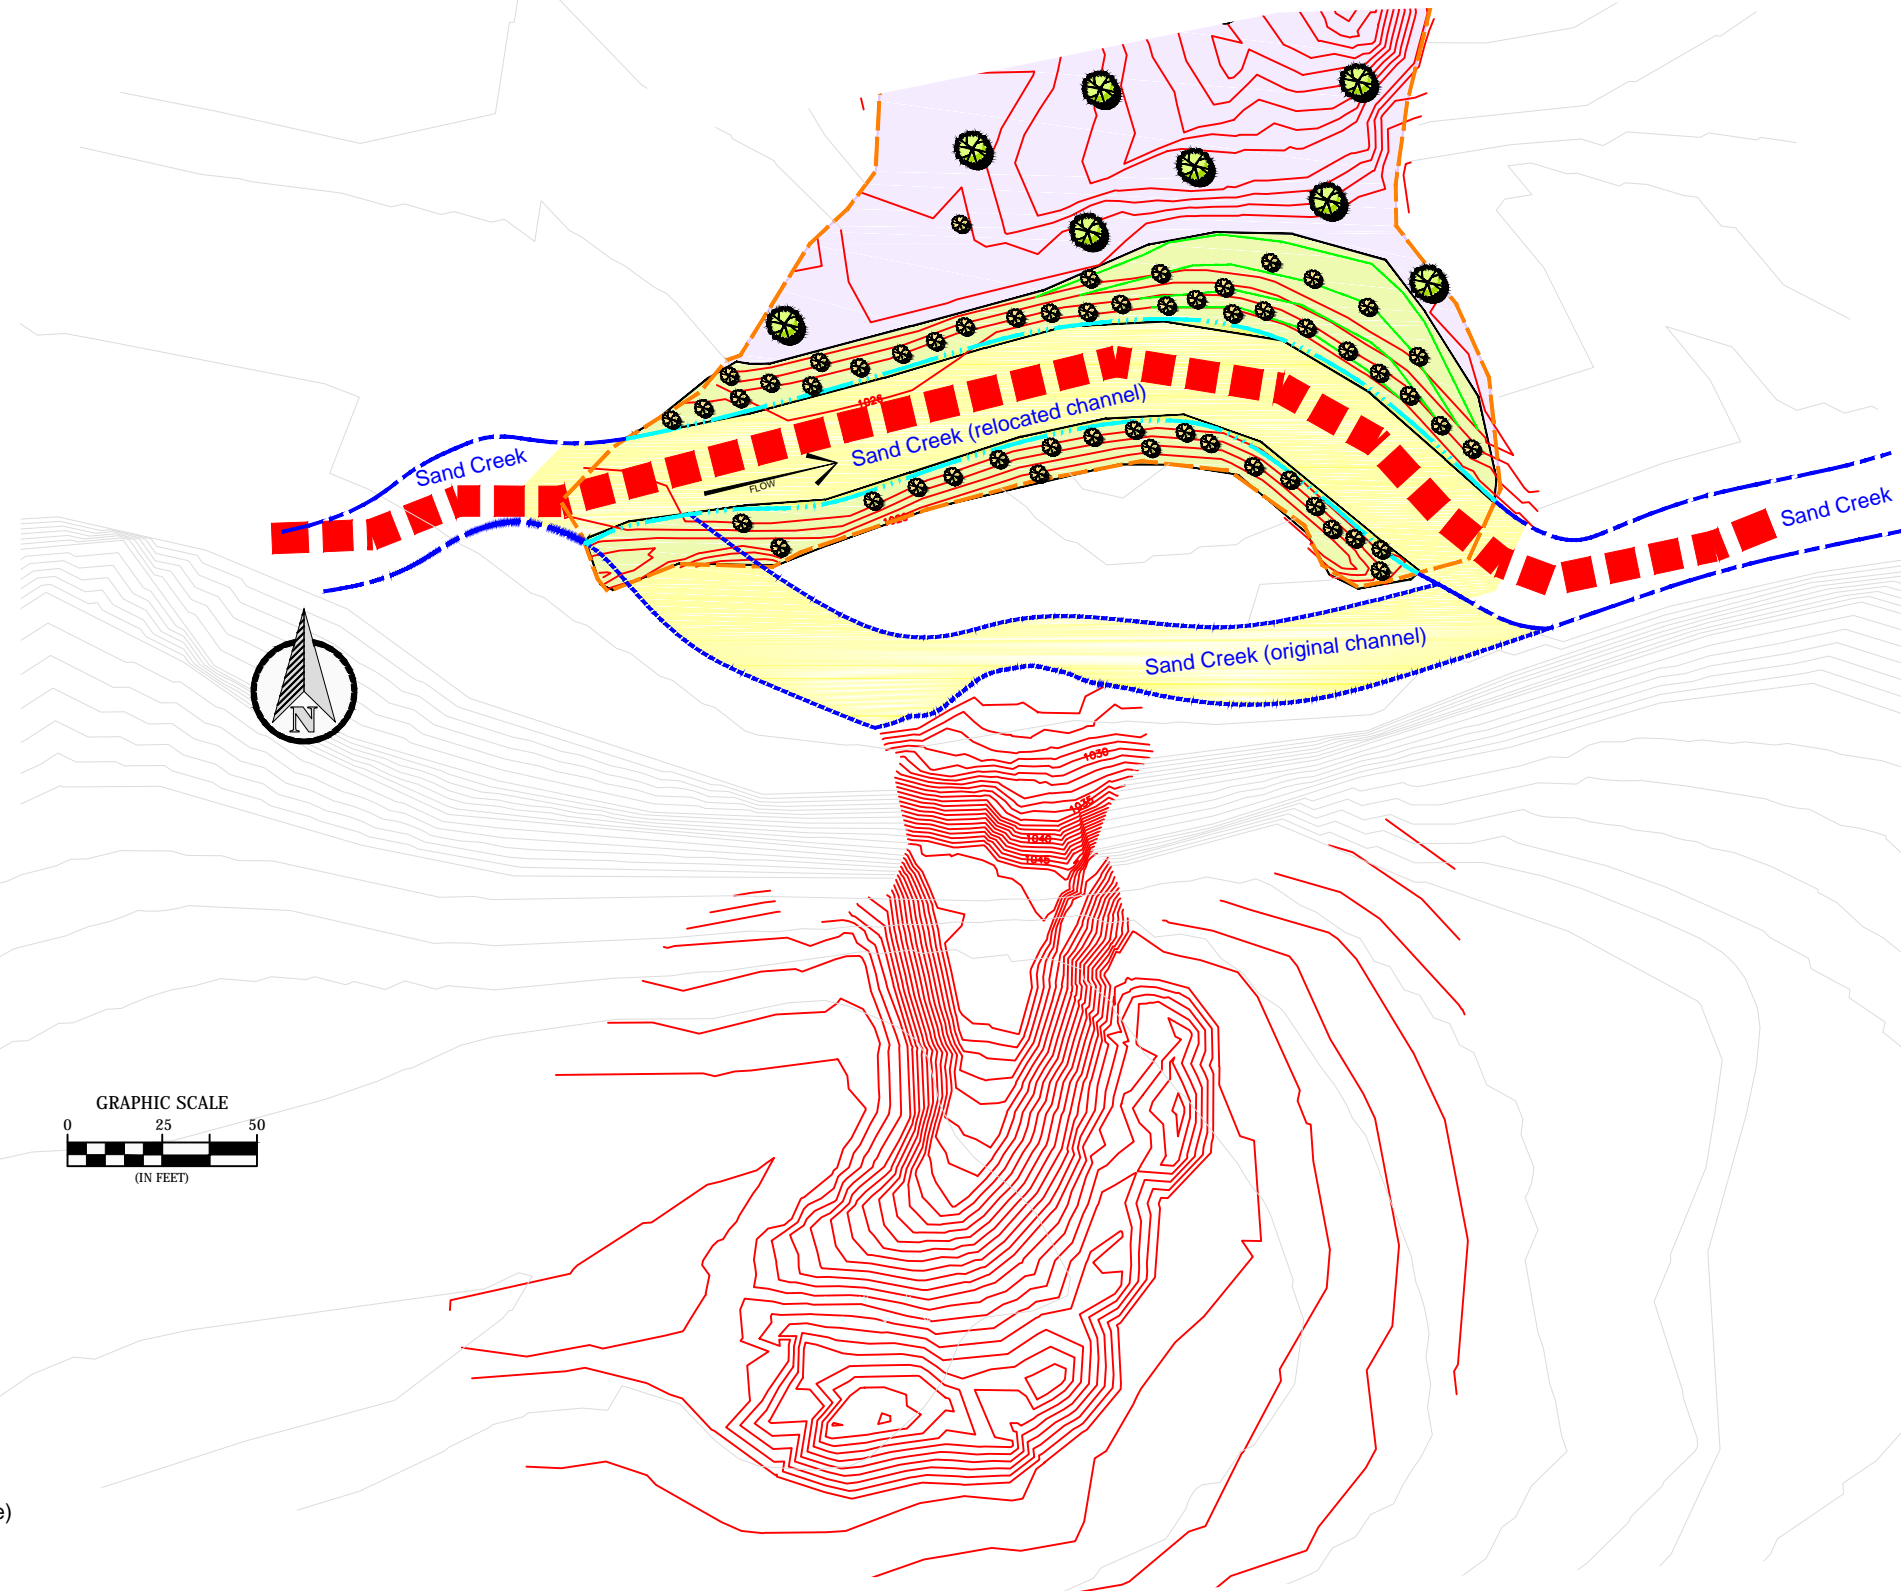
Appendix A
As-built Restoration Map

NOTE: Seeding rates were 10 lbs. per acre for both the native seed mixes. In addition to the native seed mixes; *Lolium multiflorum* (annual rye grass) at a rate of 20 lbs. per acre and/or *Secale cereale* (winter rye) at rate of 1-bushel (56 lbs.) per acre was broadcast over all the restored areas prior to mulching.

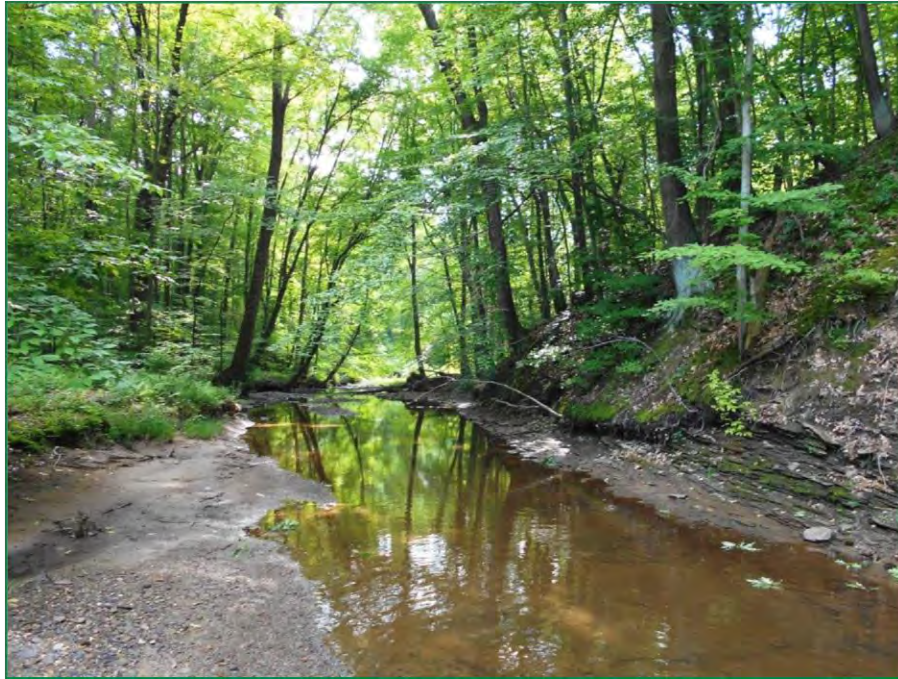
Photograph 1 (July 2, 2014). Eastern edge of restoration area looking at downstream habitat.

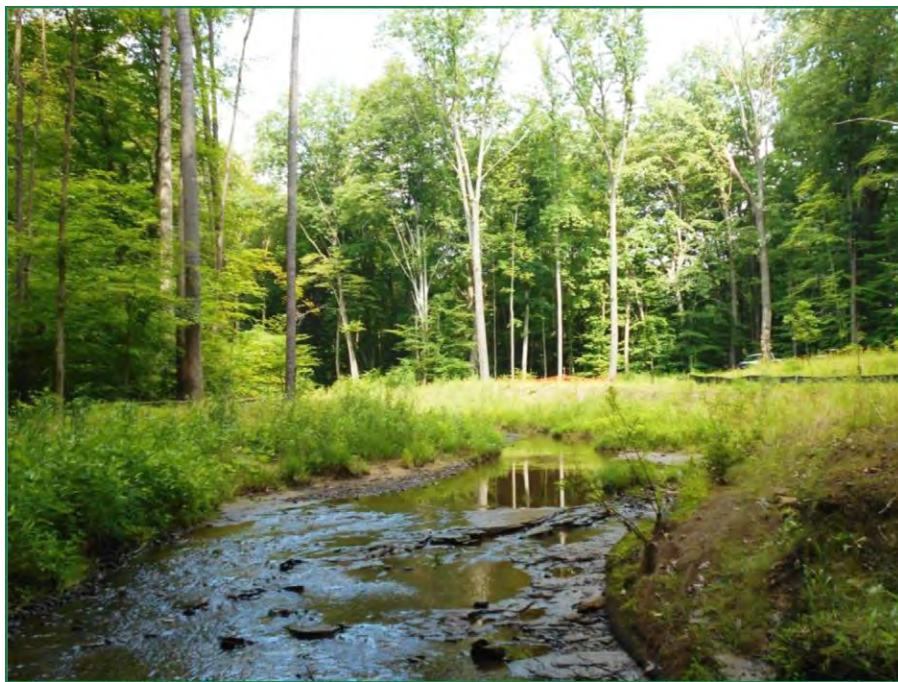
Photograph 2 (July 2, 2014). Eastern edge of restoration area looking upstream toward western edge.

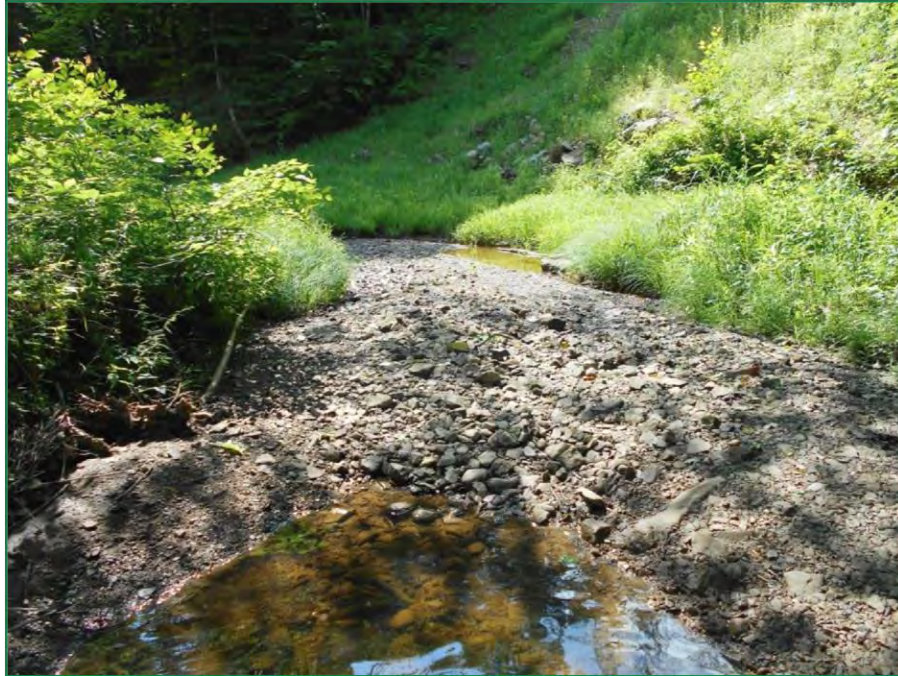
Photograph 3 (July 2, 2014). The original stream channel, now an oxbow, before redirection.

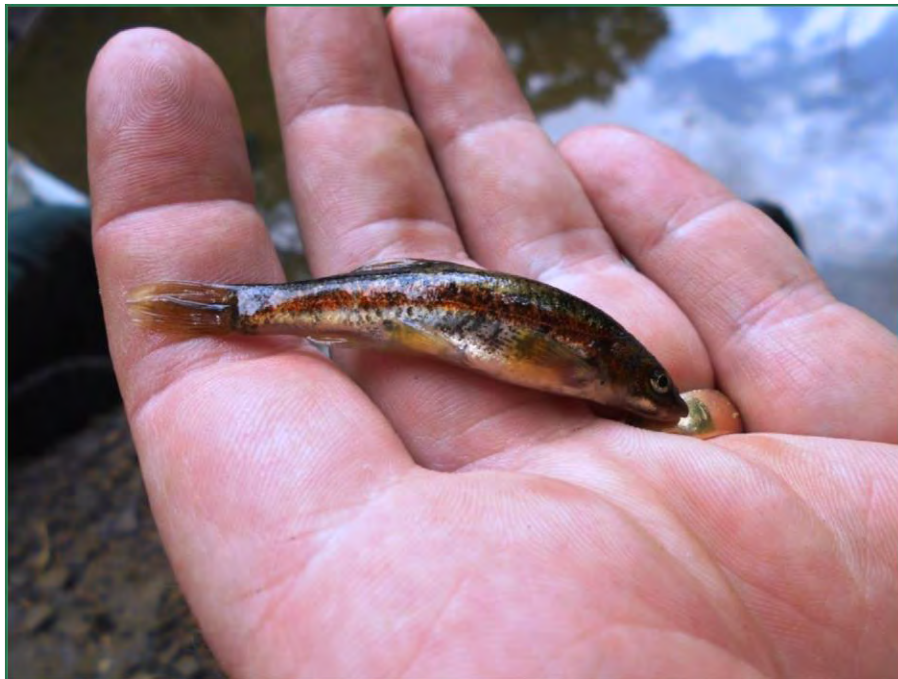
Photograph 4 (July 2, 2014). Western blacknose dace (*Rhinichthys obtusus*), a fish species indicative of good water quality.

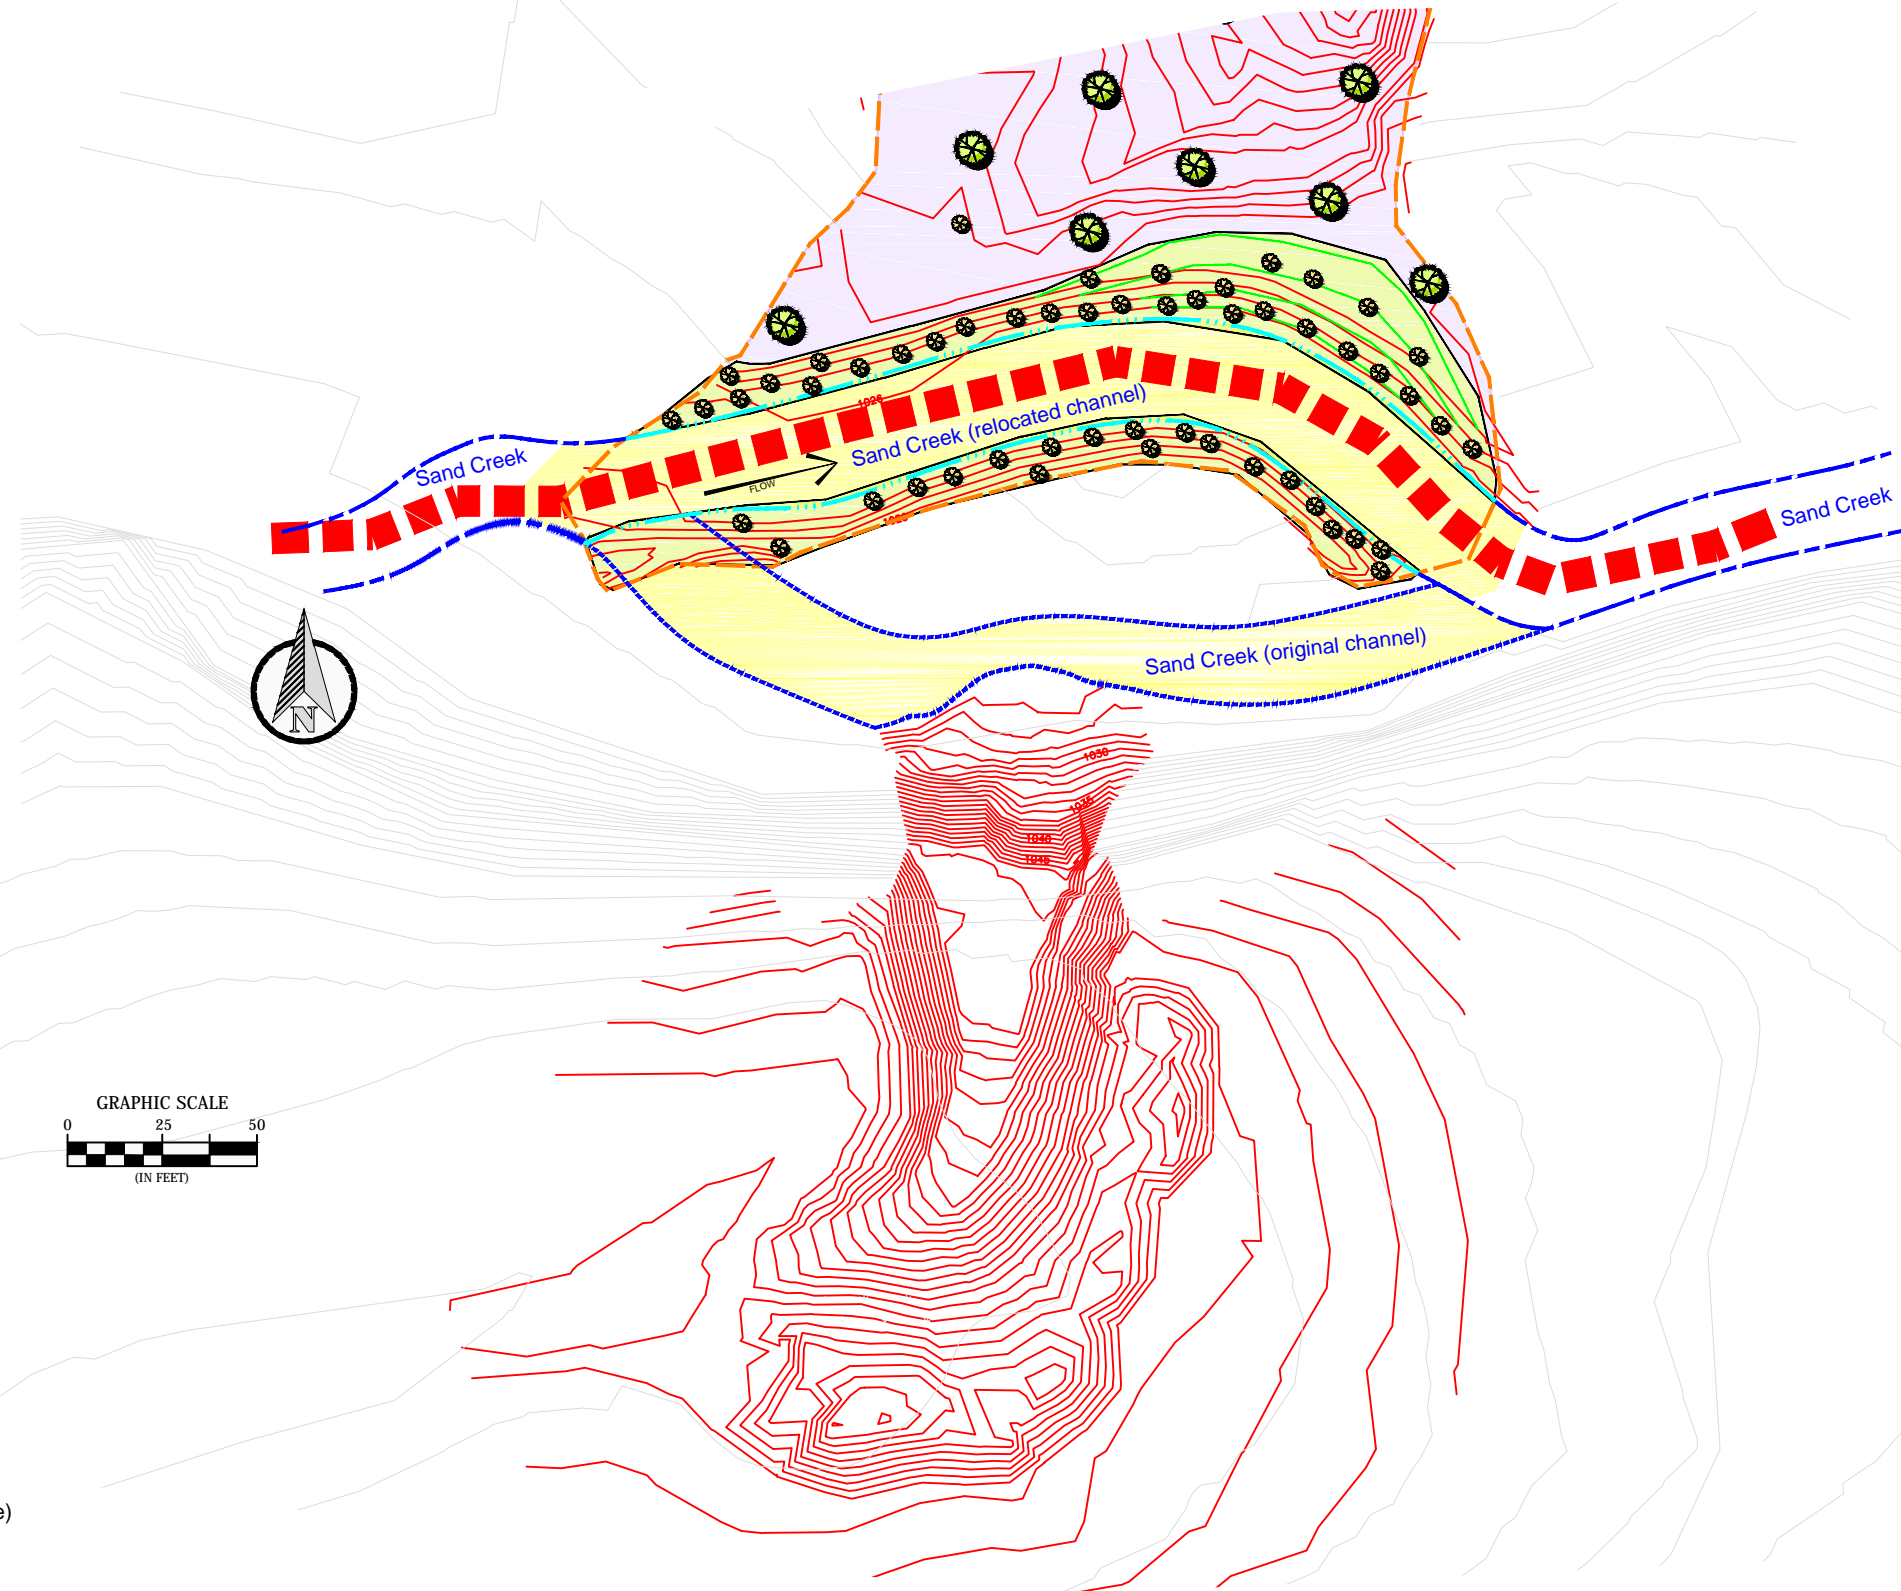
NOTE: Seeding rates were 10 lbs. per acre for both the native seed mixes. In addition to the native seed mixes; *Lolium multiflorum* (annual rye grass) at a rate of 20 lbs. per acre and/or *Secale cereale* (winter rye) at rate of 1-bushel (56 lbs.) per acre was broadcast over all the restored areas prior to mulching.

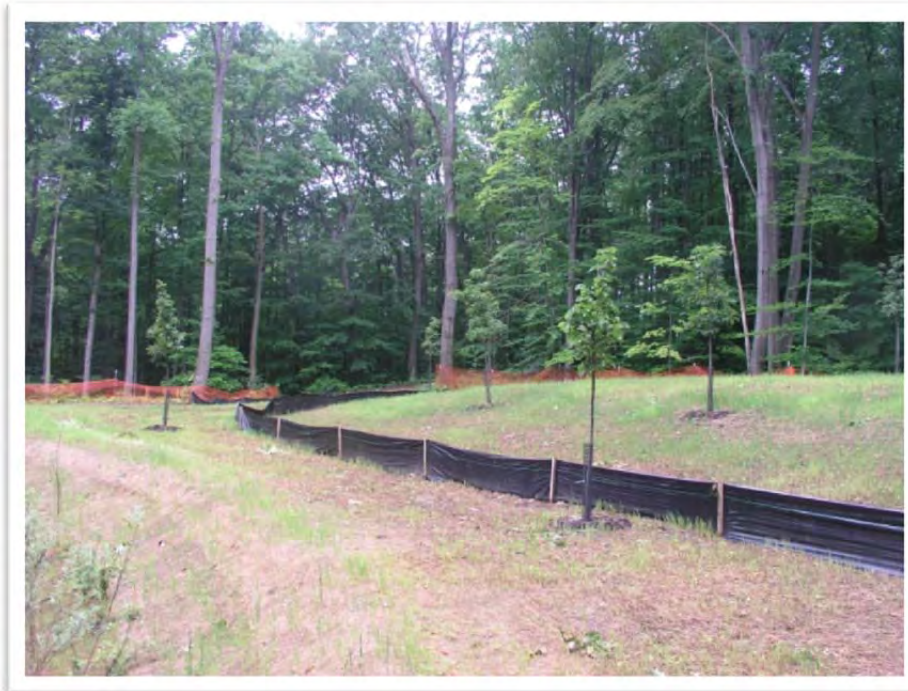
Photograph 1 (August 13, 2013) The open area adjacent to the relocated channel has been seeded and planted with young trees.

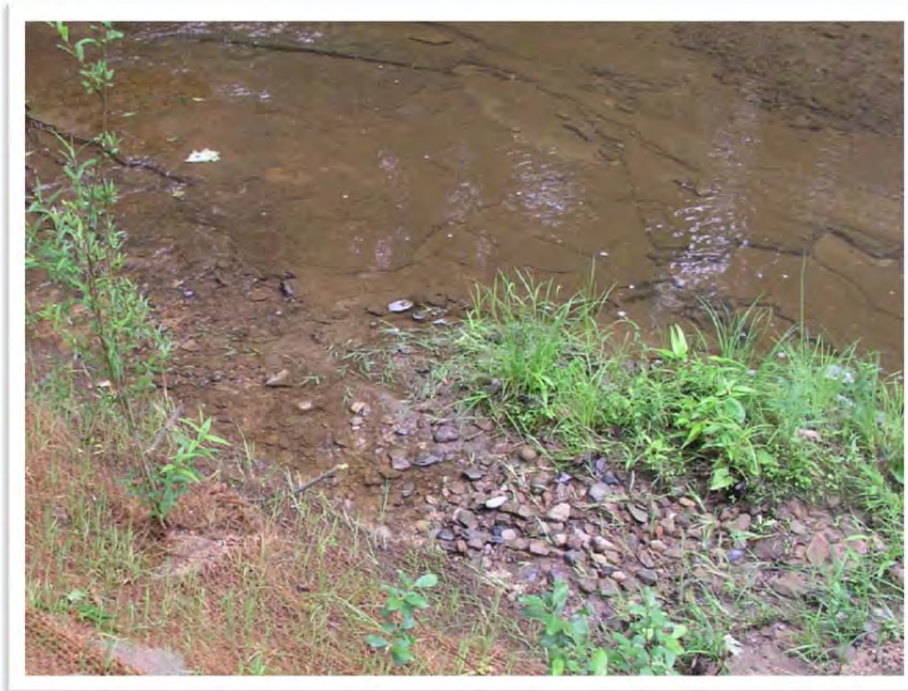
Photograph 2 (August 13, 2013) The substrate of the relocated portion of Sand Creek is composed primarily of sand and gravel. Large proportions of bedrock also occur.

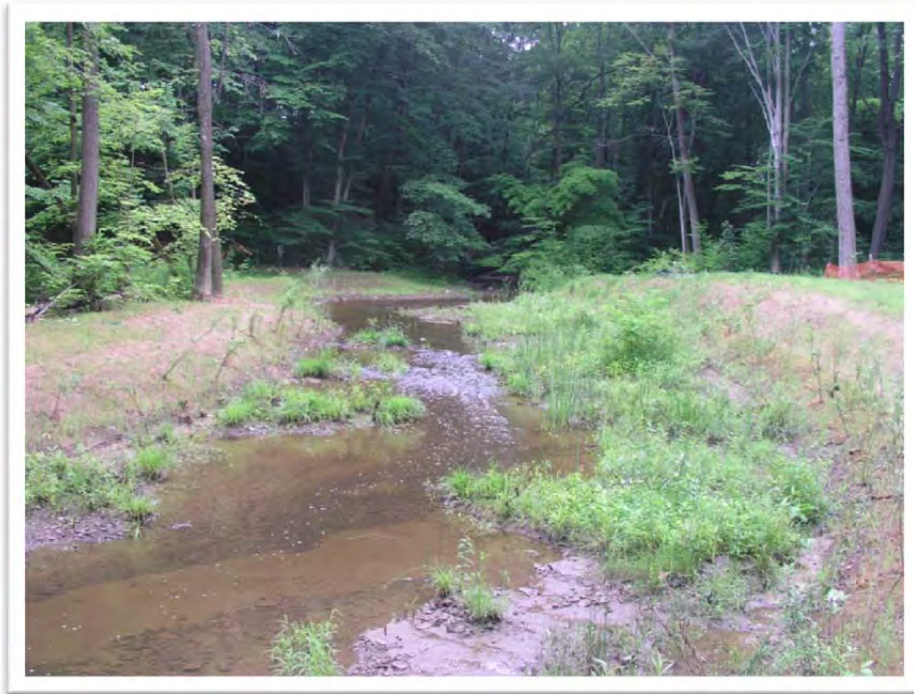
Photograph 3 (August 13, 2013) This is a view of the relocated stream channel facing upstream. Good quality riffle habitat can be seen in this photograph.

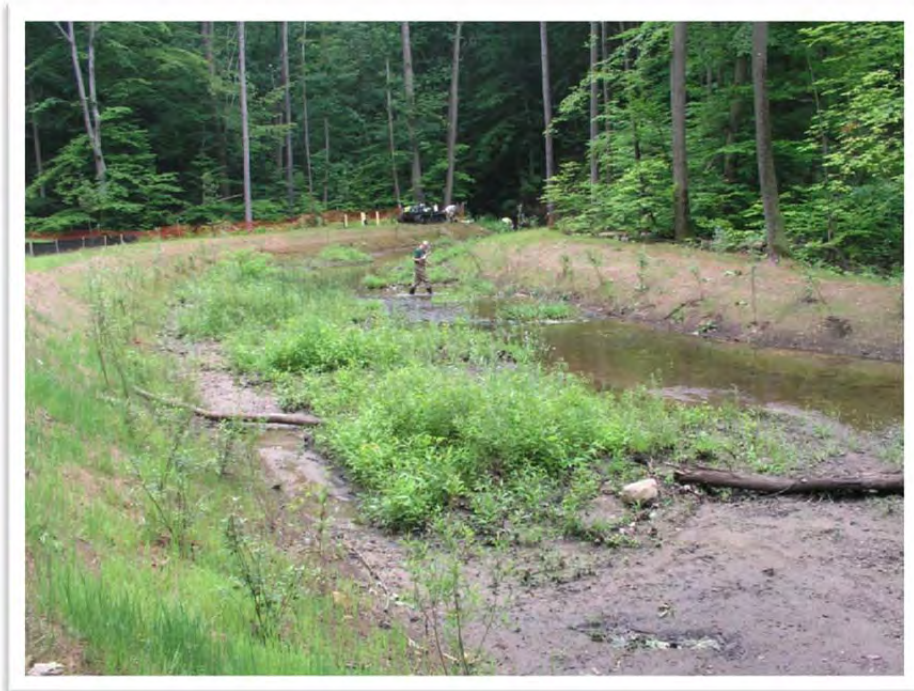
Photograph 4 (July 2, 2013) This is a view of the relocated stream channel facing downstream. Shrubs and aquatic macrophytes are beginning to establish.

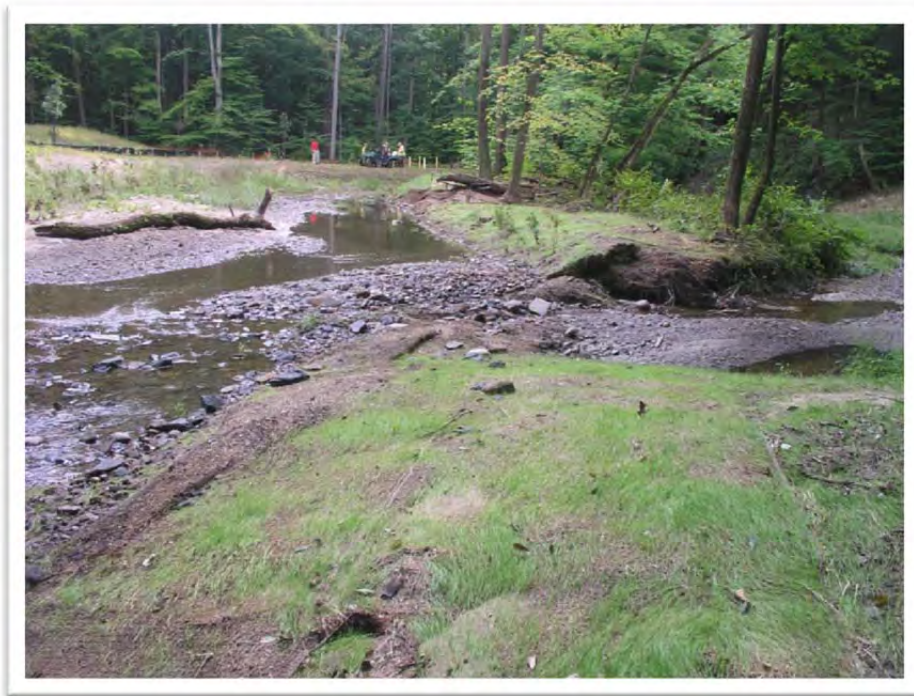
Photograph 5 (July 2, 2013) As can be seen to the right of this photograph, the original channel has been modified so that it does not have through flow, thereby functioning as an oxbow. The relocated channel is to the left.

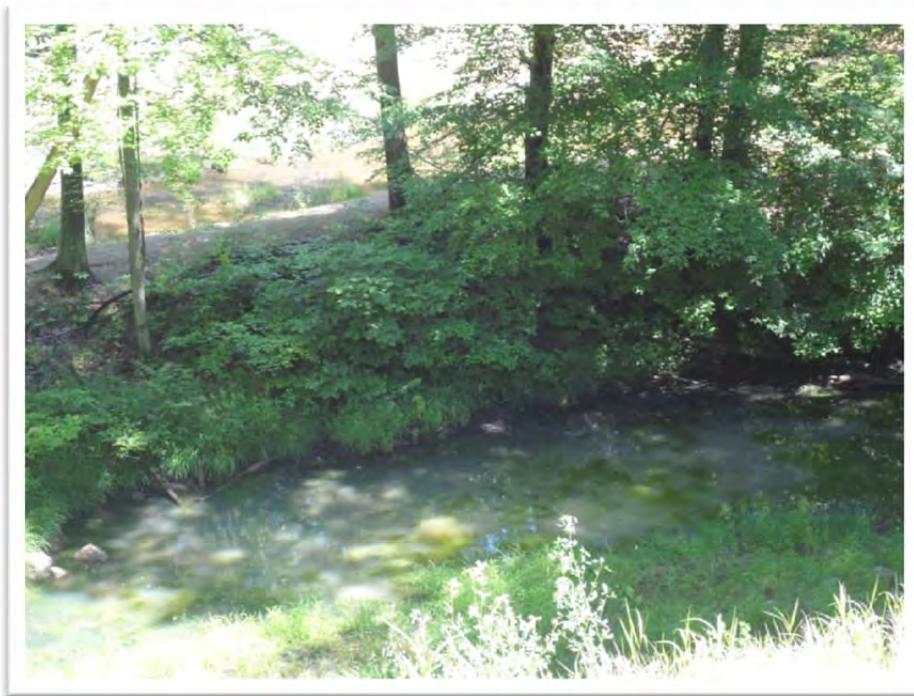
Photograph 6 (July 2, 2013) The riparian zone around the original stream channel has not been disturbed during the restoration and relocation. The habitat in this reach accounts for most of the in-stream cover in the QHEI assessment.
