**Remedial Action Report
for Soil, Sediment, and Surface Water
at RVAAP-13 Building 1200**

**Ravenna Army Ammunition Plant
Portage and Trumbull Counties, Ohio**

May 14, 2015

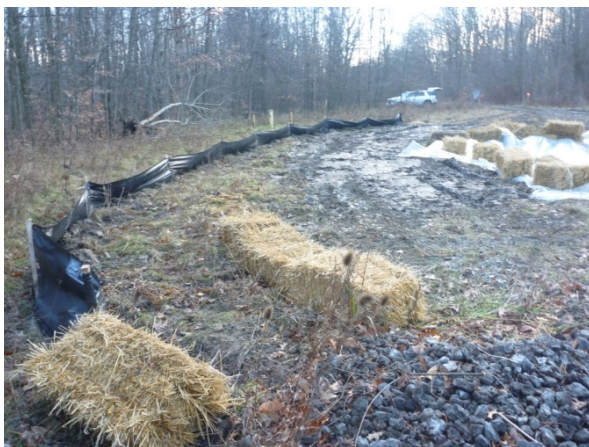
Photograph 5-1. Silt Fence Installed Downgradient of the Open Area

In accordance with the RD, silt fencing was installed to prevent siltation from the construction area at both excavation areas. In addition to the RD specifications, a straw bale check dam was placed within the two ditches north and east of the Open Area and at the north end of the Drainage Ditch. A portion of the Open Area was used as a stockpile area; a straw bale berm was constructed around the stockpile area. Photograph 5-1 shows the silt fence downgradient of the Open Area, and Photograph 5-2 shows the straw bale berm around the stockpile area. Photograph 5-3 shows the silt fence downgradient of the Drainage Ditch, and Photograph 5-4 shows the straw bale check dam north of the Drainage Ditch. Excavation areas and stockpiles area were opened at the beginning of each day and covered with impermeable plastic sheeting at the end of each day's activities, where appropriate. Stormwater controls were inspected by the Leidos Construction Manager on a daily basis during construction activities, and on a weekly basis between construction phases. The completed stormwater construction site inspection reports are presented in Appendix E.

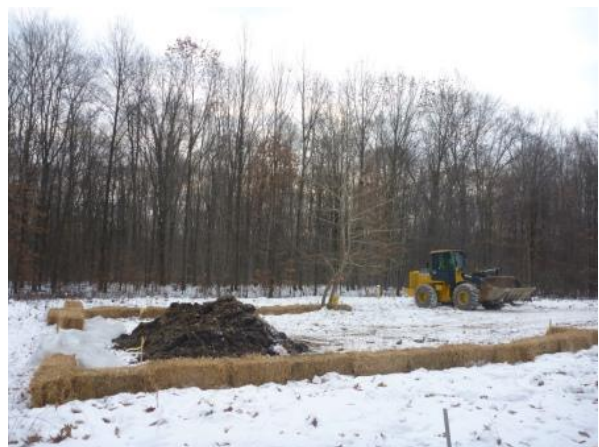
Photograph 5-2. Straw Bale Berm around the Stockpile Area

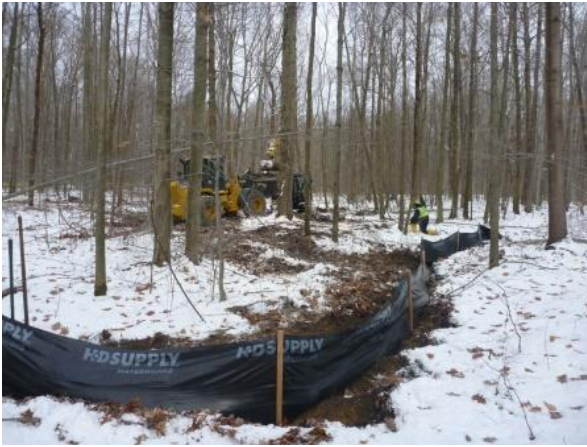
Photograph 5-3. Silt Fence Installed Downgradient of the Drainage Ditch

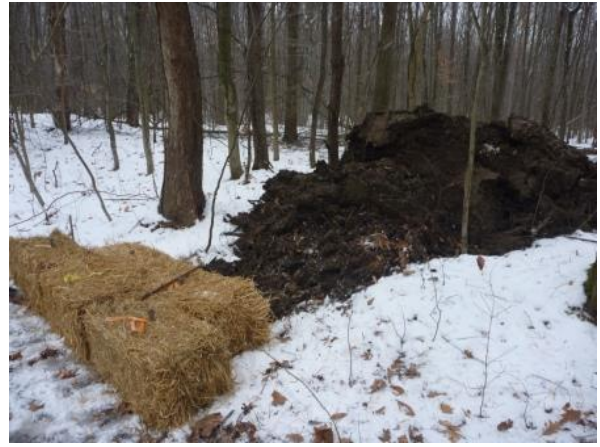
Photograph 5-4. Straw Bale Check Dam at the Drainage Ditch

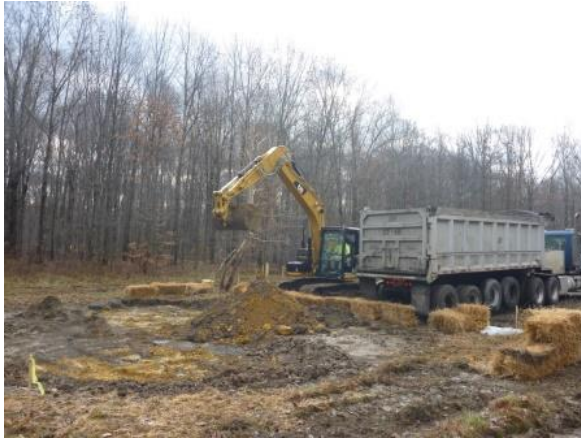
Photograph 6-1. Removing and Loading Surface Soil from the Open Area

Surface soil removed from the Open Area consisted mainly of ballast, gravel, topsoil, and sandstone. The excavation bottom was sandstone with some large rocks. The excavated soil was directly loaded into lined on-road haul trucks. Photograph 6-1 shows the removal and loading of surface soil from the contaminated area, and Photograph 6-2 shows the covered and secured excavated area and remaining stockpile.

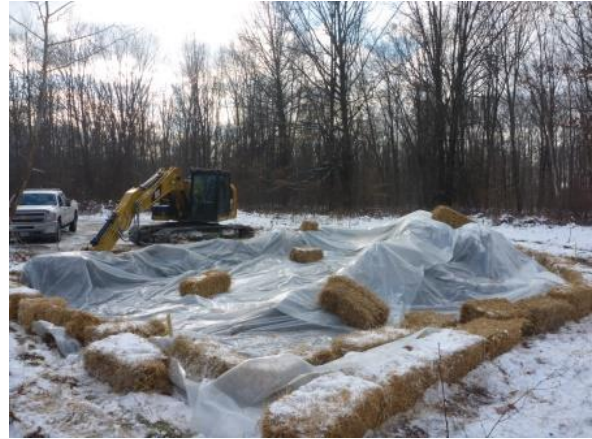
Photograph 6-2. Covered and Secured Excavated Open Area and Stockpile

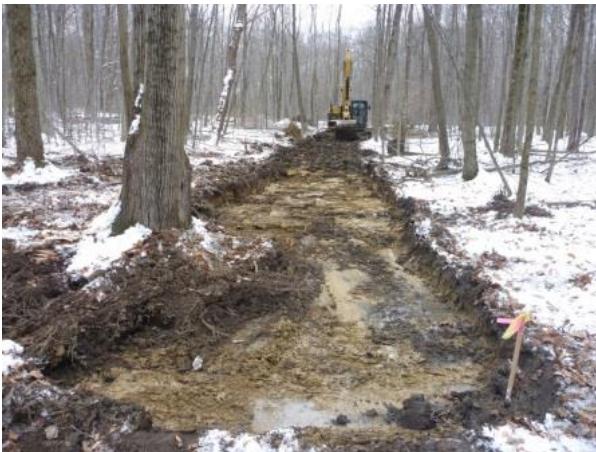
Photograph 6-3. Removing Surface Soil from the Drainage Ditch (Phase 1)

Phase 1 excavation of the Drainage Ditch consisted of removing the entirety of ISM location B12ss-022M to 1 ft bgs. Soil was excavated with the 312E Hydraulic Excavator and loaded into a Terramac RT9 tracked, off-road haul truck to transport the soil to the stockpile area. Excavated material mainly consisted of saturated organic material, silt and clay (excavation floor). Photograph 6-3 shows the removal of surface soil from the Drainage Ditch, and Photograph 6-4 shows the loading of contaminated soil into the tracked off-road haul truck. Photograph 6-5 shows the completed Phase 1 removal of surface soil from the contaminated ditch area, and Photograph 6-6 shows the loading of stockpiled soil into an on-road haul truck.

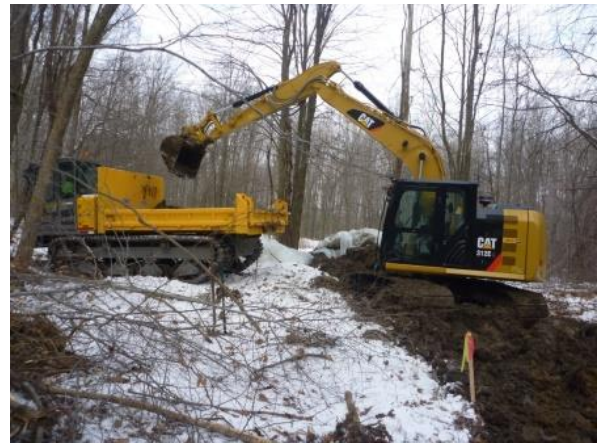
Photograph 6-4. Loading Contaminated Soil into the Tracked Truck (Phase 1)

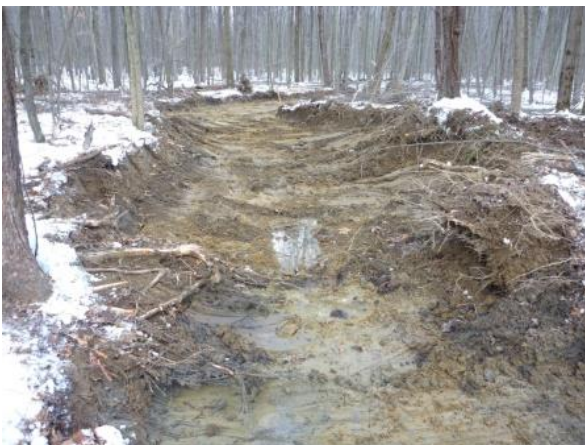
Photograph 6-5. Completed Excavation at northern end of Drainage Ditch (Phase 1)

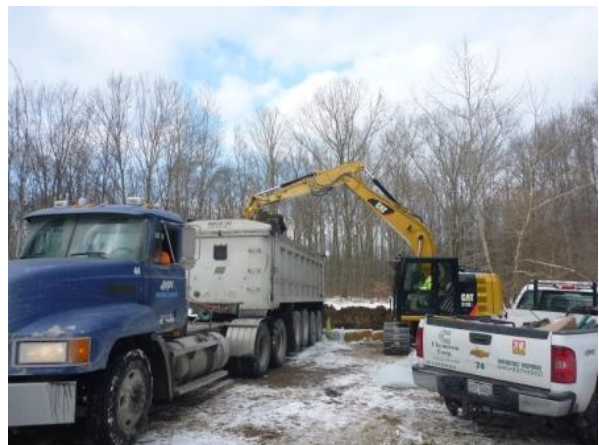
Photograph 6-6. Loading Stockpiled Soil

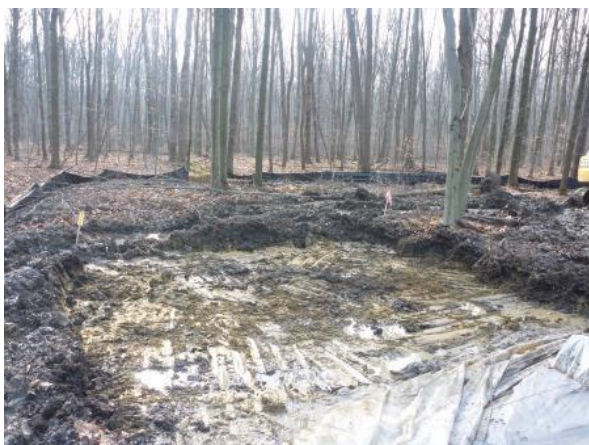
Photograph 6-7. Completed Phase 3 Excavation

Phase 3 excavation of the southern wall (ISM sample B12cs-068M), soil stockpiling, and loadout was performed on December 22 and 23, 2014. The southern wall was excavated for an additional 15 ft laterally (0-1 ft bgs). One confirmation ISM sample, B12cs-075M (Figure 6-3, Point 19 to Point 20), and one field duplicate were collected on December 22, 2014. The laboratory results indicate manganese concentrations were slightly above the remedial action CUG. Photograph 6-7 shows the completed Phase 3 excavation, and Photograph 6-8 shows the Phase 3 stockpile area. The

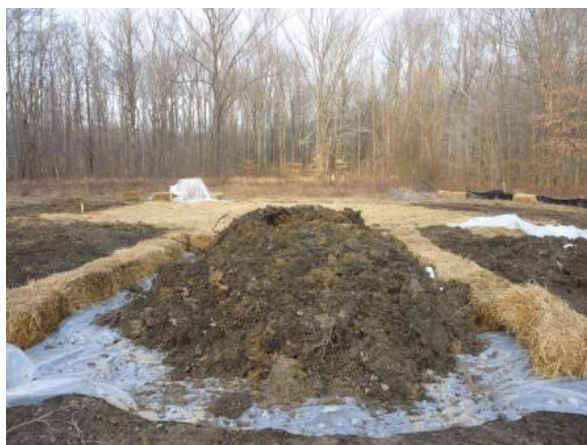
Photograph 6-8. Phase 3 Soil Stockpile Area

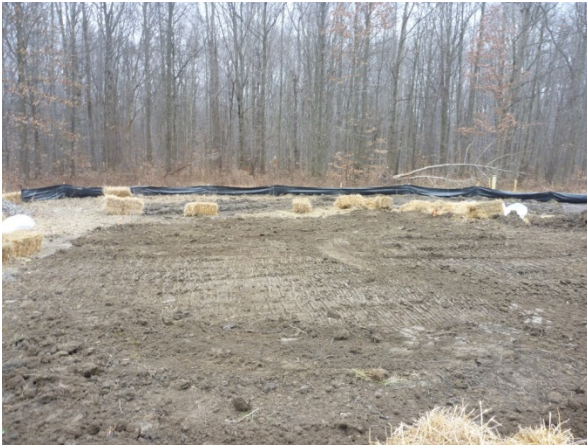
Photograph 7-1. Backfilled “Open” Excavation Area

Upon confirming that no further excavation was required, the excavation footprint in the Open Area was backfilled using soil from the approved source and graded to match the existing drainage pattern and neighboring and/or original elevations. The backfill material was graded and compacted. Disturbed areas adjacent to the excavation area were re-graded to fix ruts as necessary. Photograph 7-1 shows the backfilled excavation area at the Open Area, and Photograph 7-2 shows the excavation area after seeding and mulching.

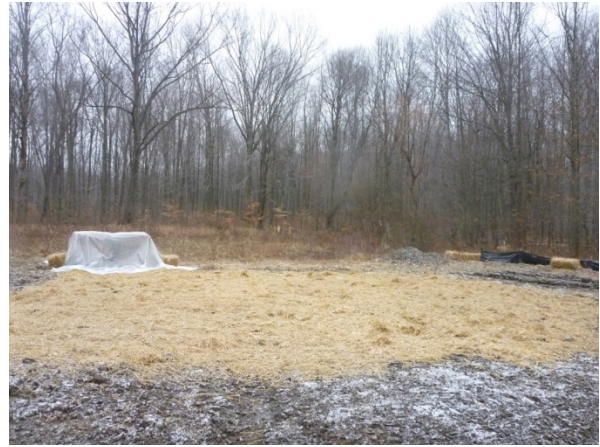
Photograph 7-2. “Open” Excavation Area after Backfill, Seeding, and Mulching

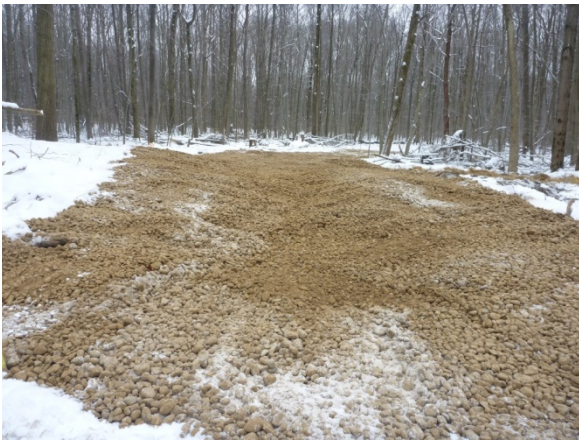
Photograph 7-3. Backfilled “Ditch” Excavation Area

The excavation footprint of the Drainage Ditch was backfilled using No. 3 coarse aggregate and graded to match the neighboring and/or original elevations. Disturbed areas adjacent to the ditch and haul route were re-graded as necessary. Photograph 7-3 shows the backfilled excavation area, and Photograph 7-4 shows the haul route after re-grading and mulching.

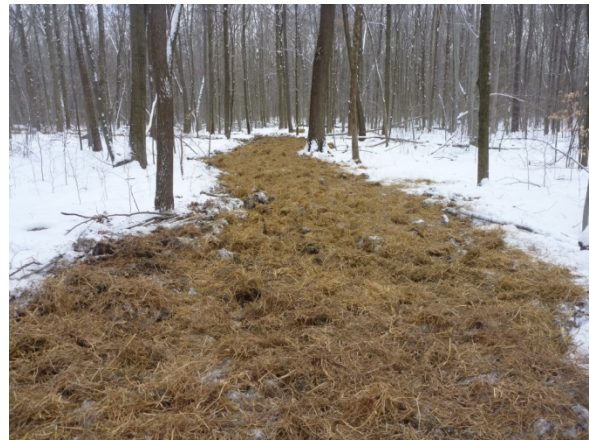
Photograph 7-4. Haul Route after Re-grading, and Mulching
