APPENDIX H

Surface Geophysical Survey Report
(Note – Report attachments provided on disc only)

RE: Summary Report for Ground Penetrating Radar Survey at RV-4/RV-87, RV-41, RV-46, RV-86, RV-88, and RV-89, Ravenna Army Ammunition Plant, Ravenna, Ohio.

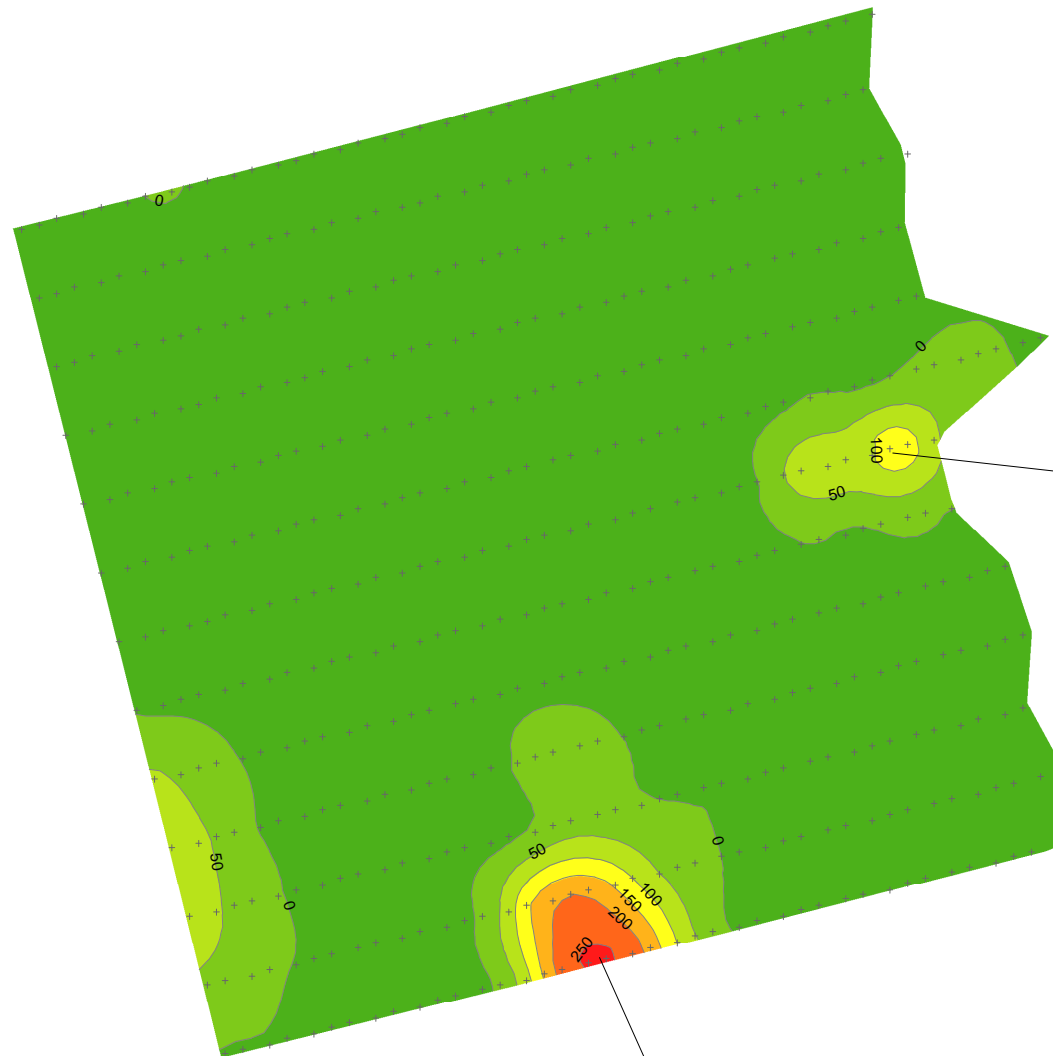
DATE: NOV 2012
FILE NO: Fig9_RV88_EMResults_Ravenna.mxd

The results of the EM-61 survey identified several small metallic objects, but no magnetic anomalies of UST scale. The GPR survey confirmed this finding with no additional evidence of a UST within the survey area. The larger magnetic anomaly on the eastern boundary of the survey area was investigated to the east of the original survey grid. Its source was traced to a bank of metallic conduits. The data collected was further examined for the presence of a UST excavation, but no UST excavation could be interpreted from the survey data. The results of the EM-61 and GPR survey can be found in Figure 9 and Figure 10 respectively.

SMALL METALLIC OBJECT

RV-88 Findings: The survey at RV-88 finished with no conclusive evidence of a UST in place within the survey area.

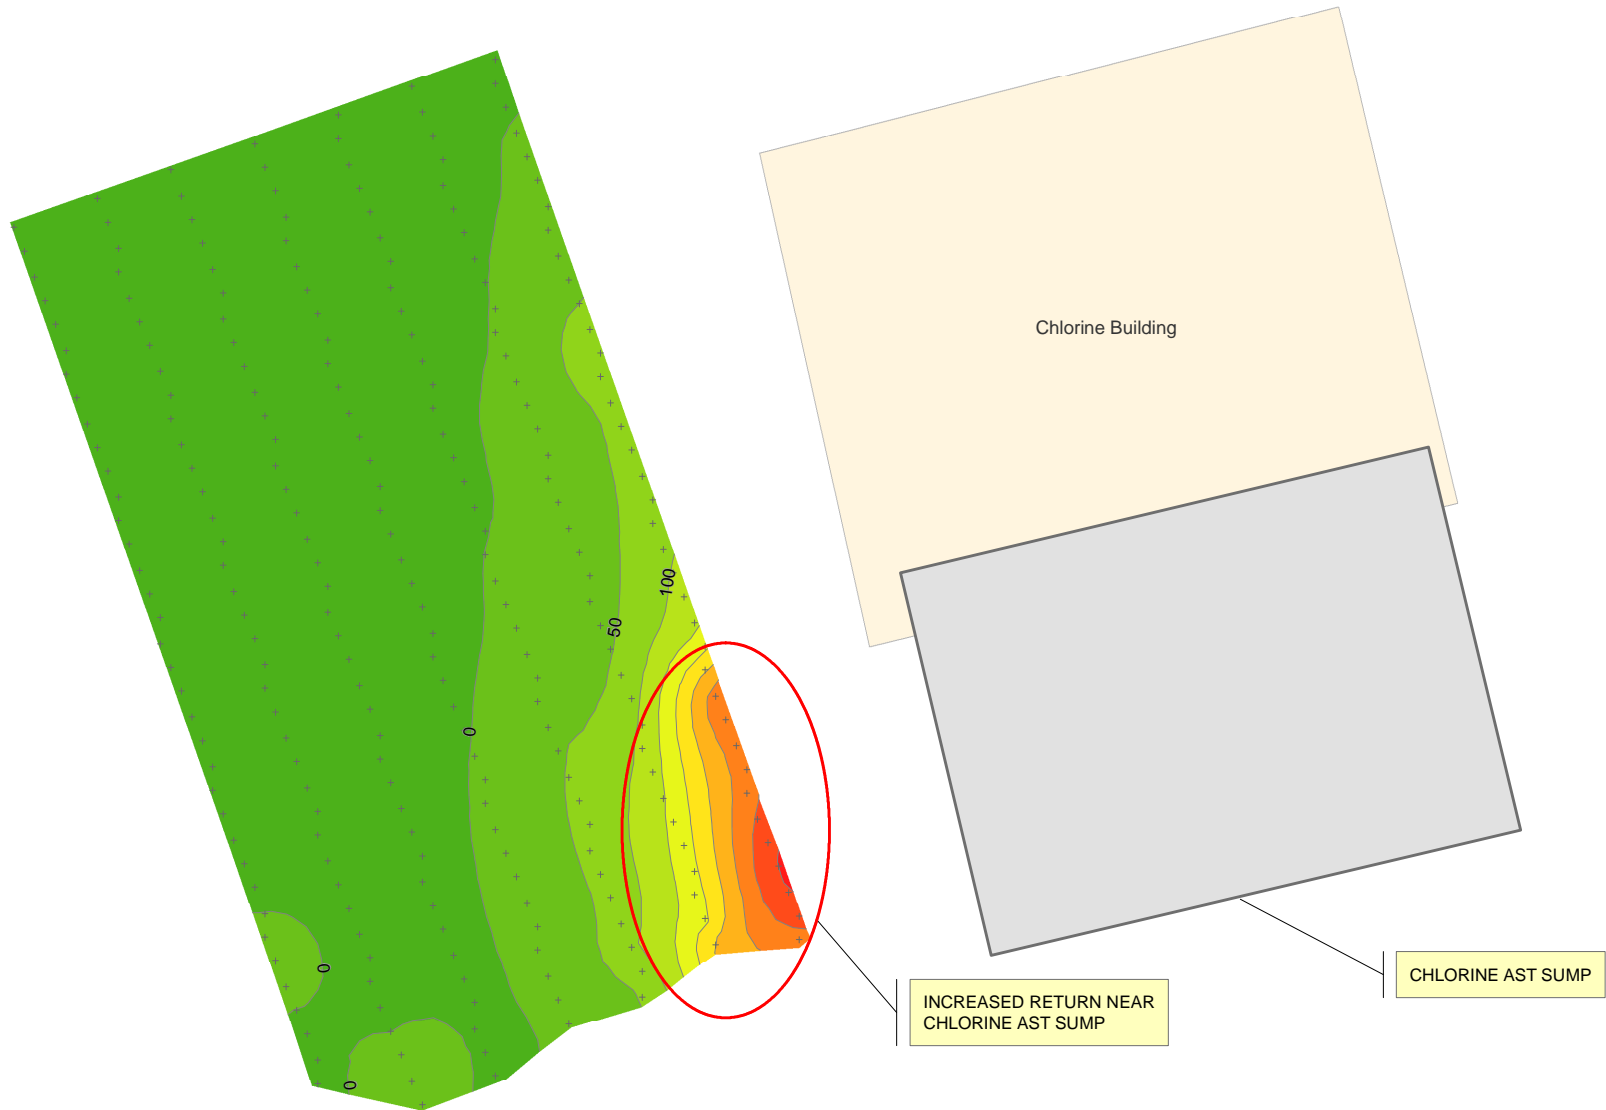
DATE: NOV 2012
FILE NO: Fig11_RV89_EMResults_Ravenna.mxd

The results of the EM-61 survey identified a large magnetic anomaly on the southeastern boundary of the survey area adjacent to a partially backfilled chlorine AST sump. The GPR survey did not identify a UST in place within the survey area. While a survey could not be conducted over the chlorine AST sump, the EM-61 was lifted over this basin, yielding a strong return indicating this was the likely source of the magnetic anomaly. Copper lines were observed coming out of this feature. An attempt to trace the vent pipes was made using radio line locator but results were inconclusive. The lines were either cut below grade or extend below the range of the radio line detector. The data collected was further examined for the presence of a UST excavation, but no UST excavation was visible in the survey data. The results of the EM-61 and GPR survey can be found in Figure 11 and Figure 12 respectively.

RV-89 Findings: The survey at RV-89 was completed with no conclusive evidence of a UST in place within the survey area. A potential vent pipe was located but could not be traced and may be cut below grade.
