QUARTERLY EFFECTIVENESS EVALUATION REPORT (#1)

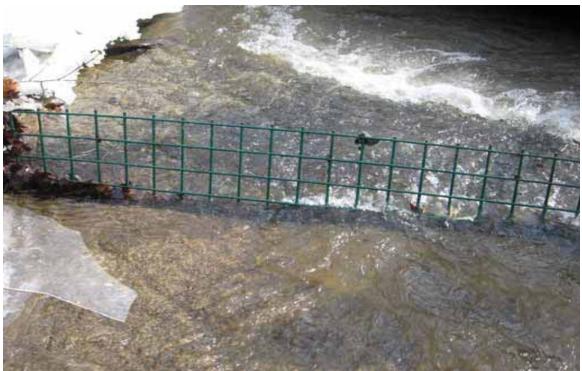
CLOSEUP OF UPSTREAM BARRIER FOLLOWING CLEANUP.

Maintenance performed: Removed all materials from screens and removed soil sediment.

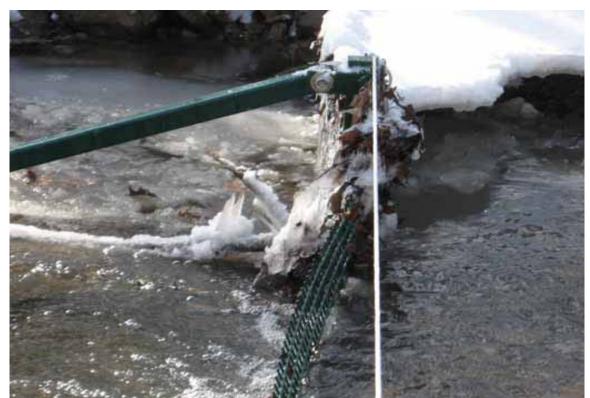
All barrier components are intact and solidly anchored. Most screen panels are bowed due to water pressure building up when water flow is limited because of debris build up. See photos.

The deflection in the screen panels does not limit the effective performance of the barrier system.

PICTURE SHOWING EXTENT OF BEND IN DOWNSTREAM BARRIER TO DATE
