Building Inspection Form

Property Owner:	Department of the Army BRAC Technical Support Office Rock Island Arsenal, Rock Island, IL	Site	Load Line 6
		Building Number	2F-7
Facility Address:	Ravenna Army Ammunition Plant 8451 St. Route 5 Ravenna, OH 44266	Function	Powder Pelleting
		Date of Inspection:	07/08/05

ENGINEERING SURVEY REPORT #3

BUILDING 2F-1 THROUGH 2F-4, 2F-6 THROUGH 2F-10, 2F-12,
2F-13, 2F-15, 2F-18 THROUGH 2F-20, 2F-31, 6-51,

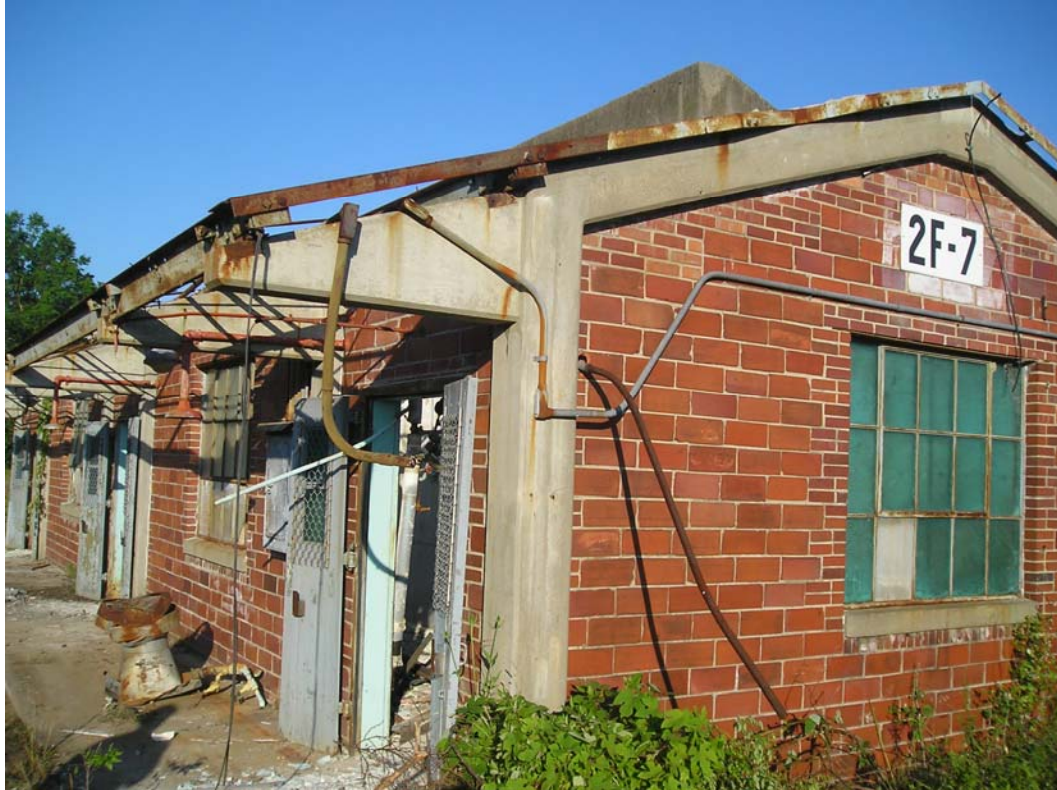
Picture of building

One story concrete and brick structure on concrete slab with transite roof.

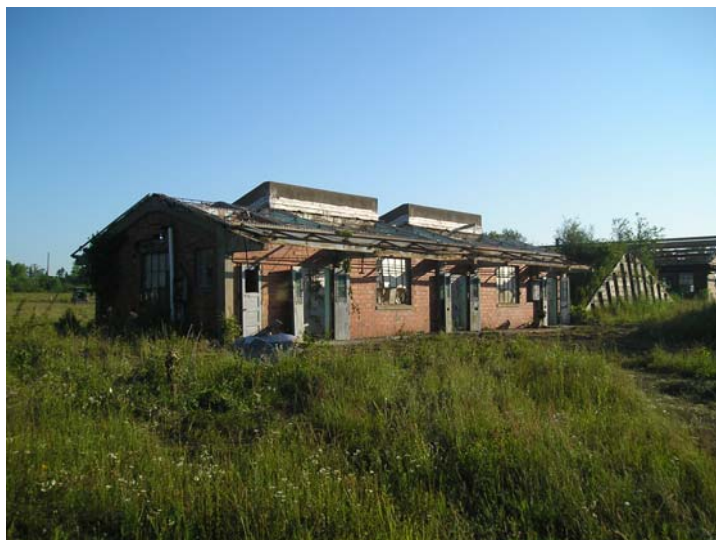
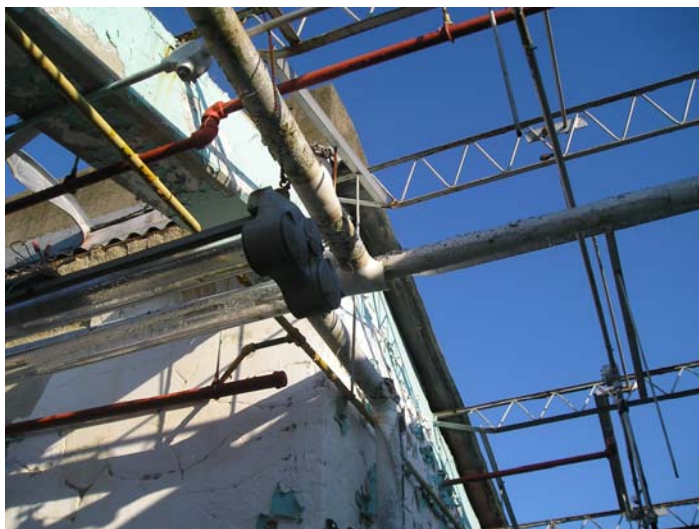
Pictures of roof inside and outside of building

Roof Type ☒ Transite Panels ☐ Shingled ☐ Tar ☐ Concrete ☒ Removed

Roof Condition : ☐ Intact ☐ Holes or Openings Observed ☐ Collapsed and Unsafe ☒ Removed

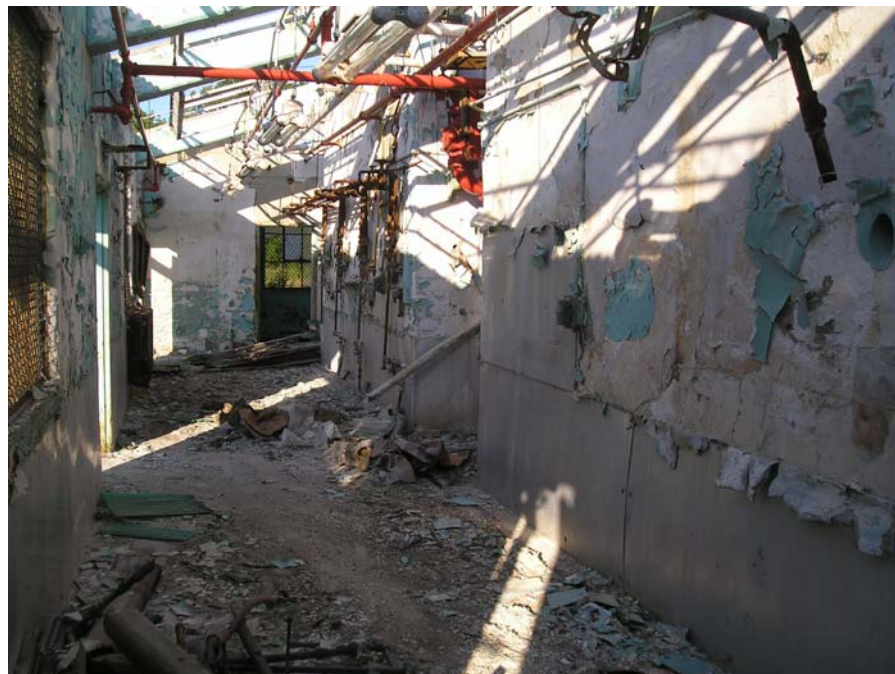
Floor Type ☒ Concrete ☐ Wood ☐ Steel ☐ Other

Are Slab Cracks, Crevices, Openings bigger than a hairline: ☒ Yes ☐ No

Entrapment of Explosive Residues in Cracks, Crevices, or Openings observed in floor slab. ☐ Yes ☒ No

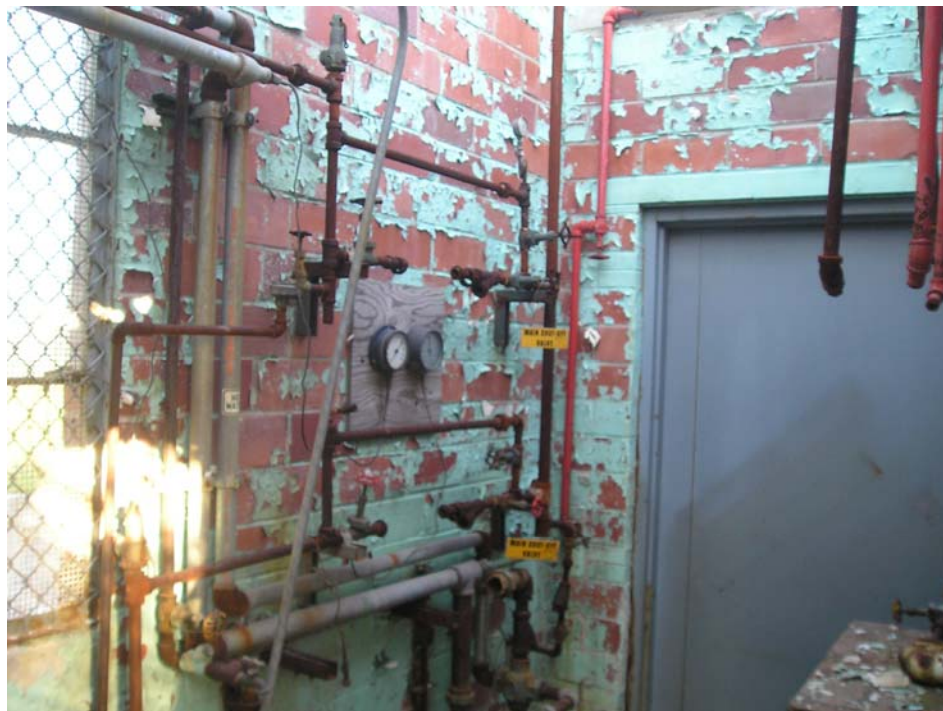
Steam lines present ☒Yes ☐No Water Lines present ☒Yes ☐No ☒Other (identify below)

Description of other Fixtures: Ventilation System

Non Explosive Hazards of Concern	
<input checked="" type="checkbox"/>	Residual Peeling Paint Chips on the Walls, Equipment and Piping, and Structural Members
<input type="checkbox"/>	Observation of animal droppings and miscellaneous debris on floor of buildings
<input type="checkbox"/>	Asbestos Containing Material (Transite, Utility Pipe Insulation, lighting fixtures, etc.)
<input type="checkbox"/>	Overhead Conveyors and Belt Systems, and Elevators
<input type="checkbox"/>	Mercury Switches
<input type="checkbox"/>	PCB Light Ballast
<input type="checkbox"/>	Physical Safety Hazard from Removed or Damaged Building Structural Members
<input type="checkbox"/>	Other (please explain)

<input type="checkbox"/> Thermal Decomposition	<input checked="" type="checkbox"/> Demo with Engineering Controls	<input type="checkbox"/> Conventional Demo
<p>Conclusions: No process equipment or bulk/visible explosives present. Recommend demolition using hardened earth moving machinery as added safety measure. Follow the established demolition procedures and follow-on inspection requirements prescribed in the approved RVAAP ESS.</p>

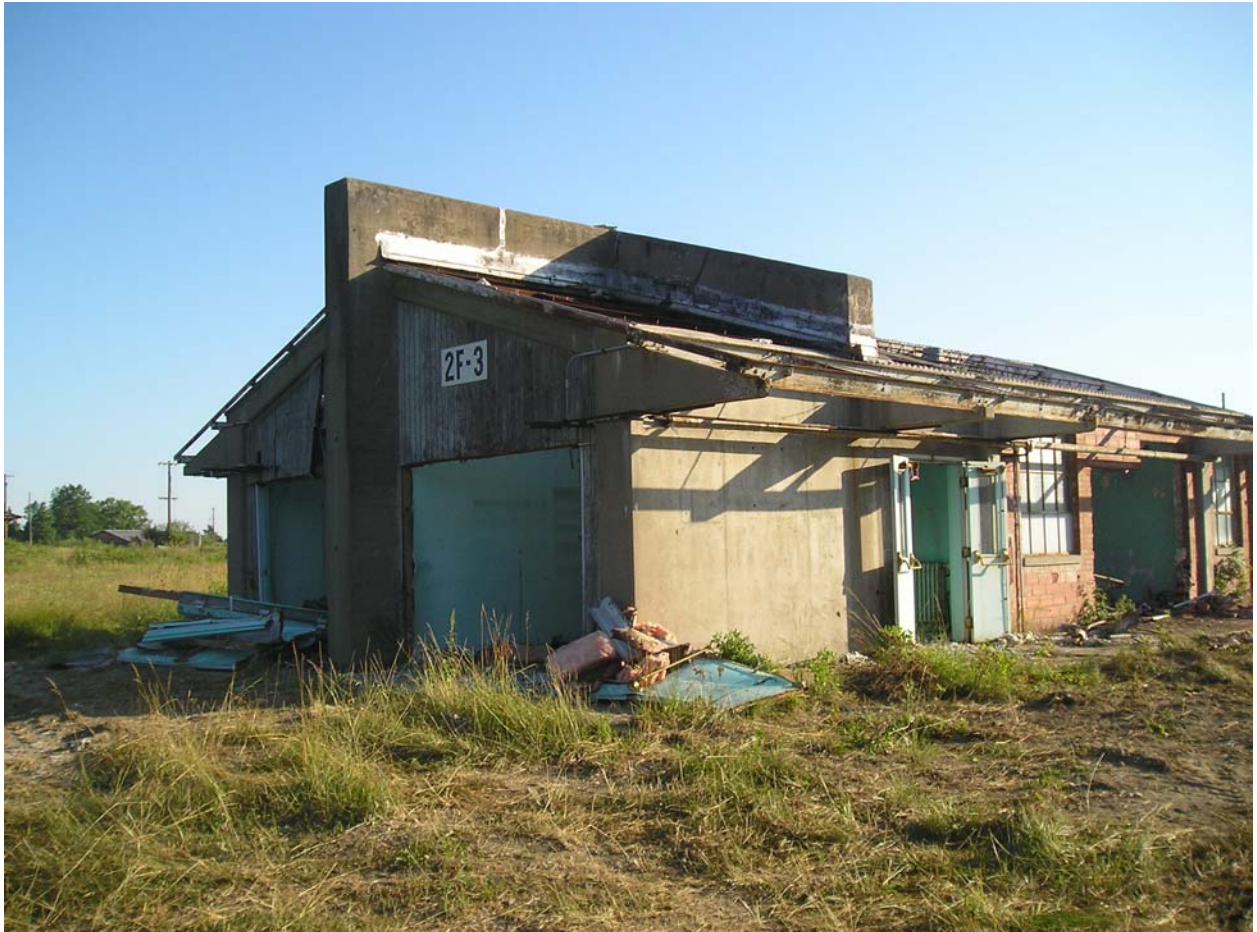
Small one story concrete and brick structure on concrete slab with transite roof.

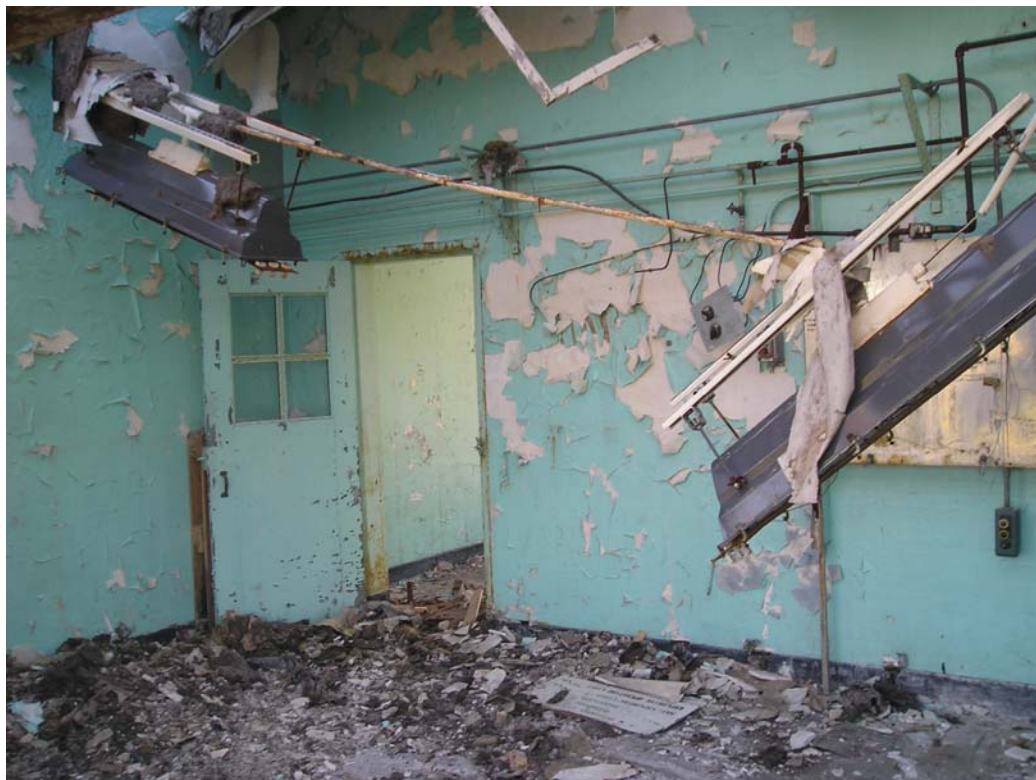
Are Surfaces Painted :	<input checked="" type="checkbox"/> Yes	<input type="checkbox"/> No	If Yes, Was Peeling of Paint Observed:	<input checked="" type="checkbox"/> Yes	<input type="checkbox"/> No
------------------------	---	-----------------------------	--	---	-----------------------------

Are Cracks, Crevices, Openings bigger than a hairline:	<input checked="" type="checkbox"/> Yes	<input type="checkbox"/> No
--	---	-----------------------------

Entrapment of Explosive Residues in Cracks, Crevices, or Openings observed:	<input type="checkbox"/> Yes	<input checked="" type="checkbox"/> No
---	------------------------------	--

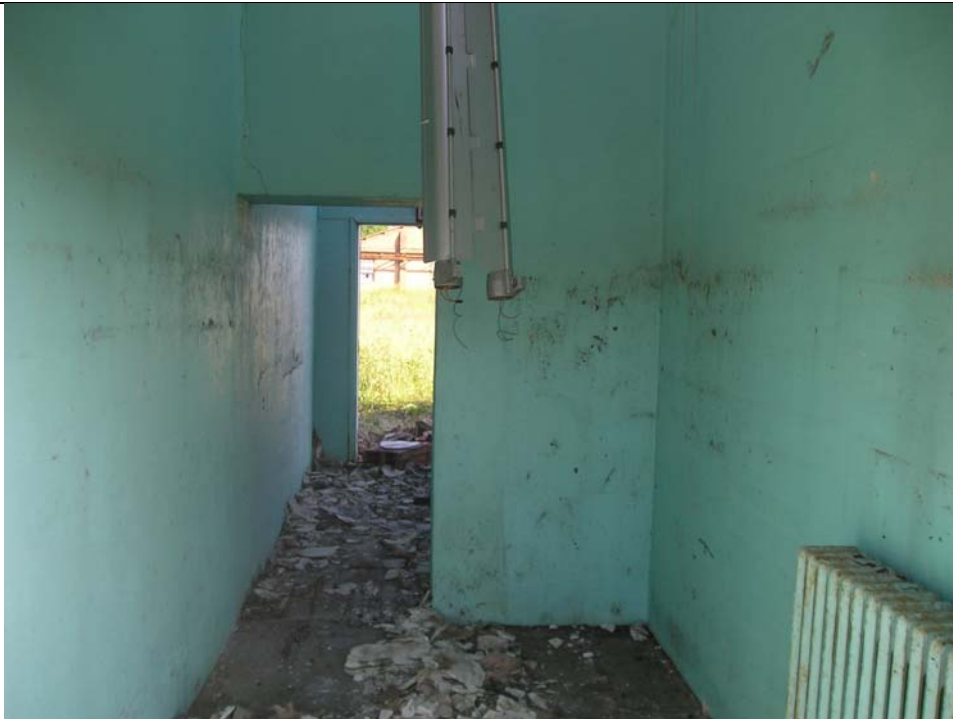
Floor Type ☒ Concrete ☐ Wood ☐ Steel ☐ OtherFloor Liner ☒ Lead ☐ Rubber ☐ Composite ☐ NoneVisible Explosives Present: ☐ Yes ☒ No If yes identify location below.

Thickness of liner > 1/8" ☒ Yes ☐ No ☐ NA If Yes to either answer below:Are Slab Cracks, Crevices, Openings bigger than a hairline: ☒ Yes ☐ NoAre floor liner Cracks, Crevices, Openings bigger than a hairline: ☐ Yes ☒ No ☐ NAEntrapment of Explosive Residues in Cracks, Crevices, or Openings observed in floor slab. ☐ Yes ☒ NoEntrapment of Explosive Residues in Cracks, Crevices, or Openings observed in floor liner. ☐ Yes ☐ No ☒ NASuspect surfaces present that are not accessible for Visual Inspection. ☐ Yes ☒ No

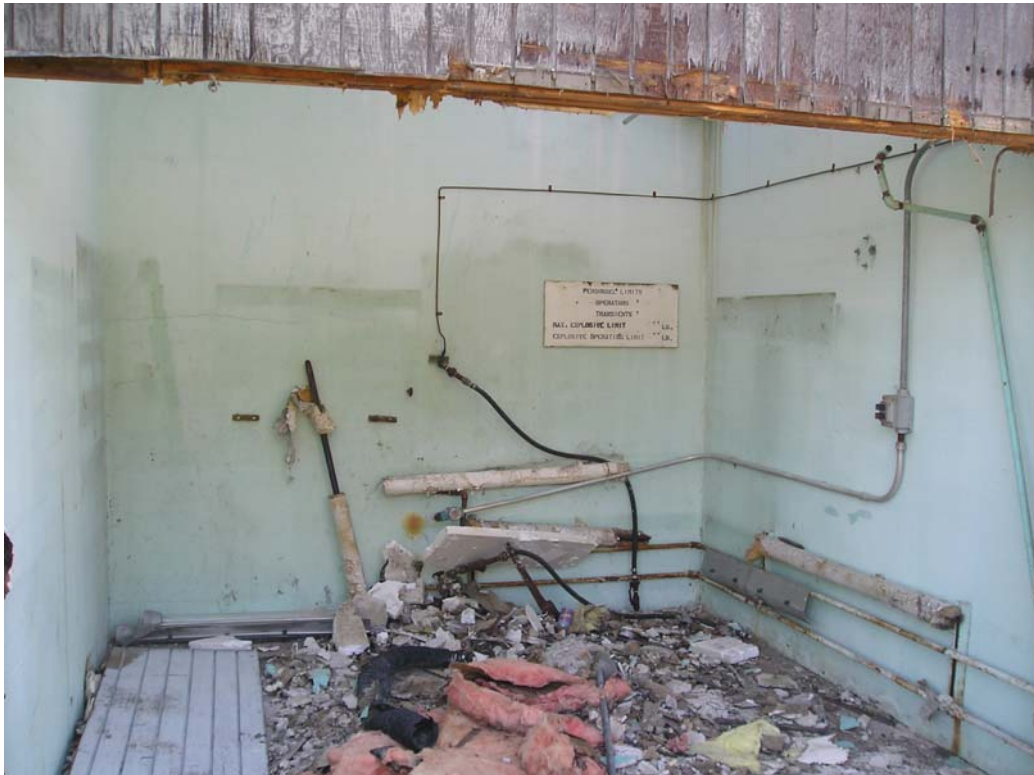
Steam lines present ☒Yes ☐No Water Lines present ☒Yes ☐No ☒Other (identify below)

Description of other Fixtures: Ventilation System

Non Explosive Hazards of Concern	
<input checked="" type="checkbox"/>	Residual Peeling Paint Chips on the Walls, Equipment and Piping, and Structural Members
<input type="checkbox"/>	Observation of animal droppings and miscellaneous debris on floor of buildings
<input type="checkbox"/>	Asbestos Containing Material (Transite, Utility Pipe Insulation, lighting fixtures, etc.)
<input type="checkbox"/>	Overhead Conveyors and Belt Systems, and Elevators
<input type="checkbox"/>	Mercury Switches
<input type="checkbox"/>	PCB Light Ballast
<input type="checkbox"/>	Physical Safety Hazard from Removed or Damaged Building Structural Members
<input type="checkbox"/>	Other (please explain)

<input type="checkbox"/> Thermal Decomposition	<input checked="" type="checkbox"/> Demo with Engineering Controls	<input type="checkbox"/> Conventional Demo
<p>Conclusions: No process equipment or bulk/visible explosives present. Recommend demolition using hardened earth moving machinery as added safety measure. Follow the established demolition procedures and follow-on inspection requirements prescribed in the approved RVAAP ESS.</p>

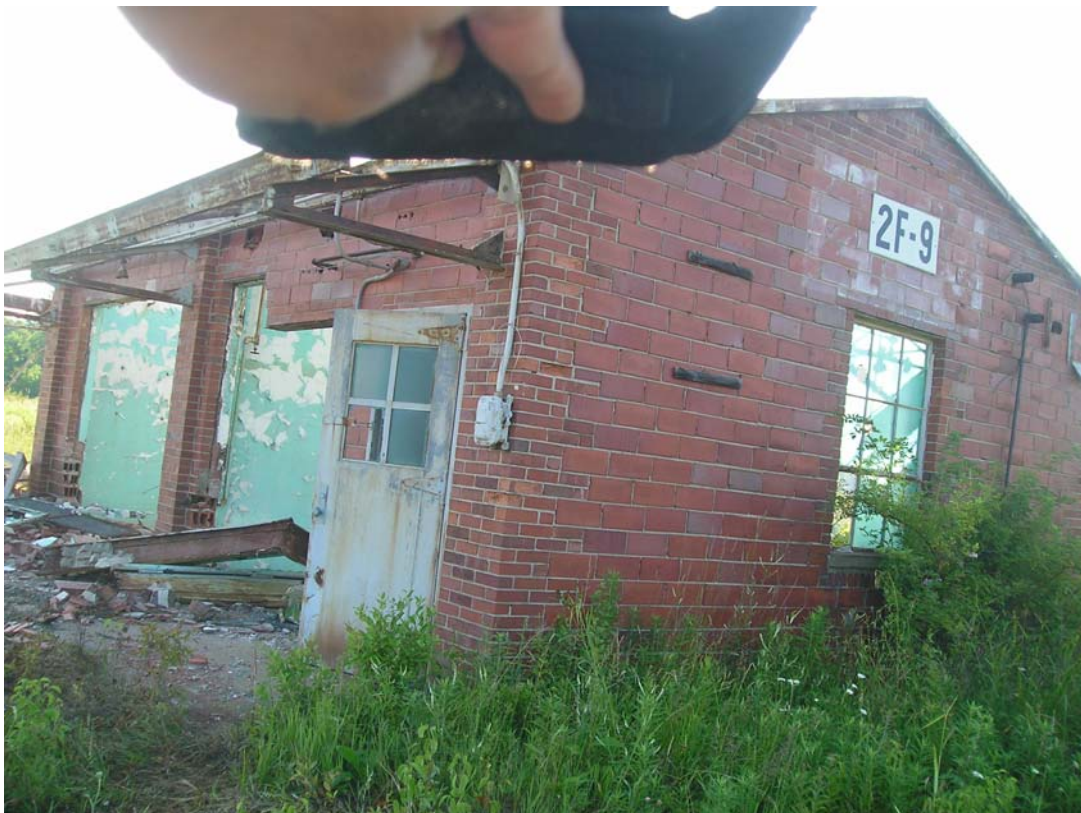
Small one story concrete and brick structure on concrete slab with transite roof.

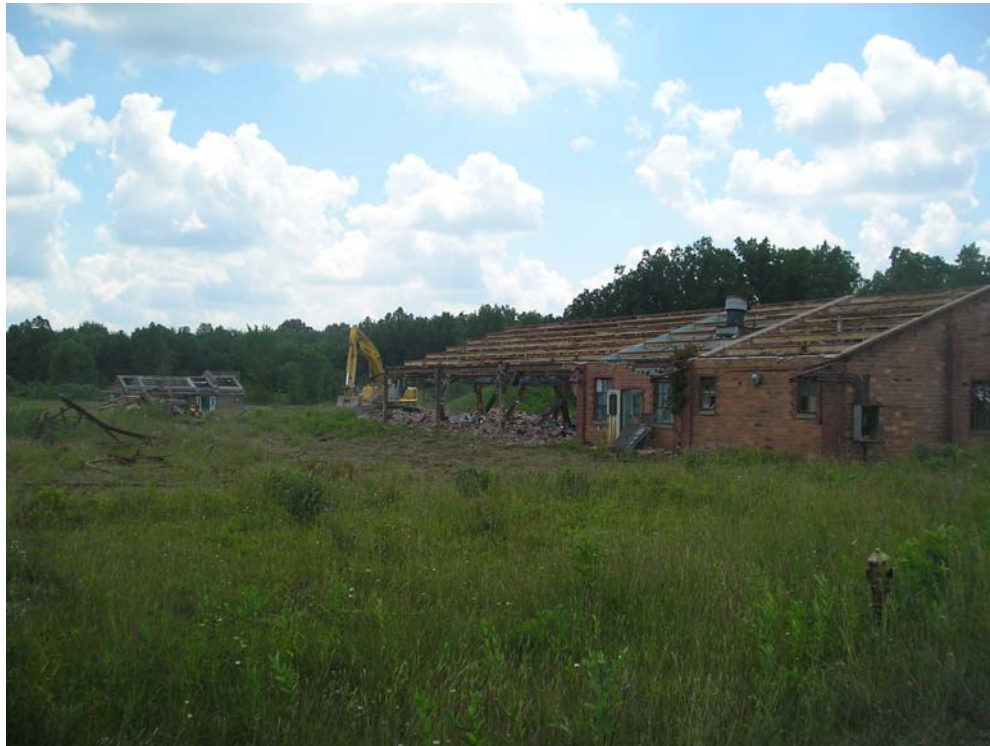
Roof Type ☒ Transite Panels ☐ Shingled ☐ Tar ☐ Concrete ☒ Removed

Roof Frame ☐ Wood ☒ Steel

Roof Condition : ☐ Intact ☐ Holes or Openings Observed ☐ Collapsed and Unsafe ☒ Removed

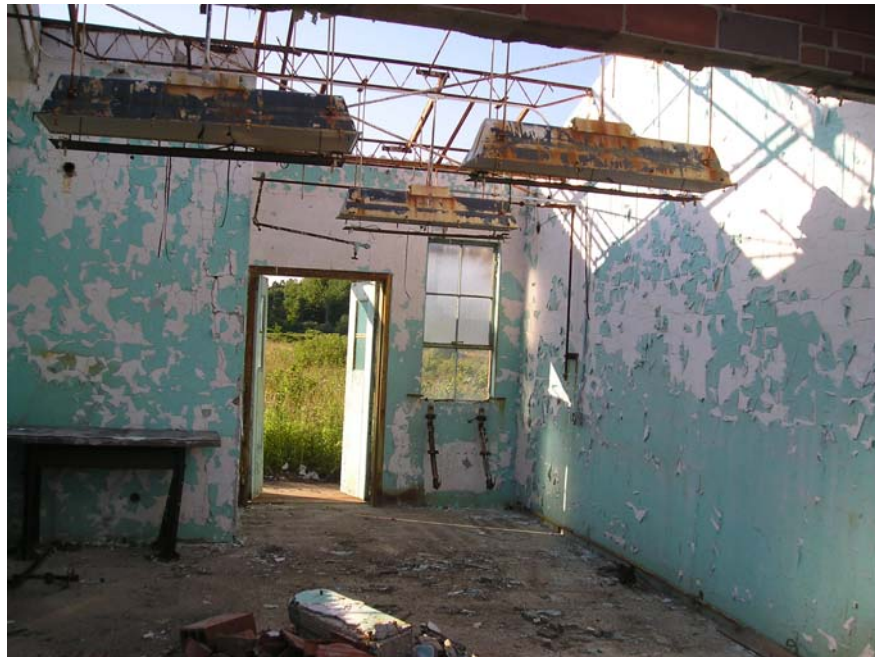
Floor Type ☒ Concrete ☐ Wood ☐ Steel ☐ Other

Are Slab Cracks, Crevices, Openings bigger than a hairline: ☒ Yes ☐ No

Entrapment of Explosive Residues in Cracks, Crevices, or Openings observed in floor slab. ☐ Yes ☒ No

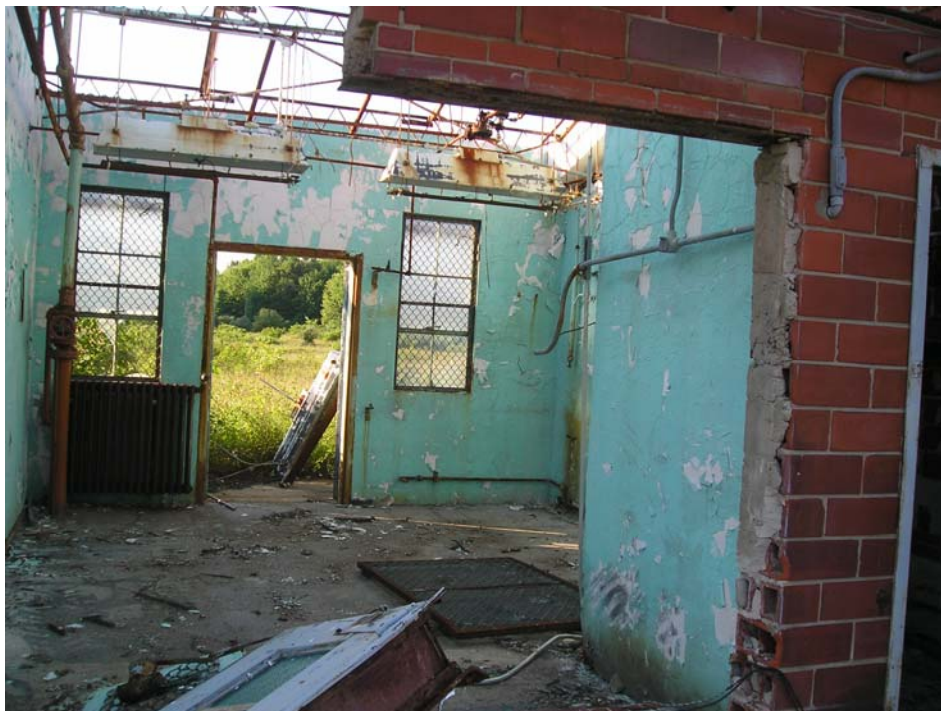
Steam lines present ☒ Yes ☐ No Water Lines present ☒ Yes ☐ No ☒ Other (identify below)

Description of other Fixtures: Ventilation System

Non Explosive Hazards of Concern	
<input checked="" type="checkbox"/>	Residual Peeling Paint Chips on the Walls, Equipment and Piping, and Structural Members
<input type="checkbox"/>	Observation of animal droppings and miscellaneous debris on floor of buildings
<input type="checkbox"/>	Asbestos Containing Material (Transite, Utility Pipe Insulation, lighting fixtures, etc.)
<input type="checkbox"/>	Overhead Conveyors and Belt Systems, and Elevators
<input type="checkbox"/>	Mercury Switches
<input type="checkbox"/>	PCB Light Ballast
<input type="checkbox"/>	Physical Safety Hazard from Removed or Damaged Building Structural Members
<input type="checkbox"/>	Other (please explain)

<input type="checkbox"/> Thermal Decomposition	<input checked="" type="checkbox"/> Demo with Engineering Controls	<input type="checkbox"/> Conventional Demo
<p>Conclusions: No process equipment or bulk/visible explosives present. Recommend demolition using hardened earth moving machinery as added safety measure. Follow the established demolition procedures and follow-on inspection requirements prescribed in the approved RVAAP ESS.</p>

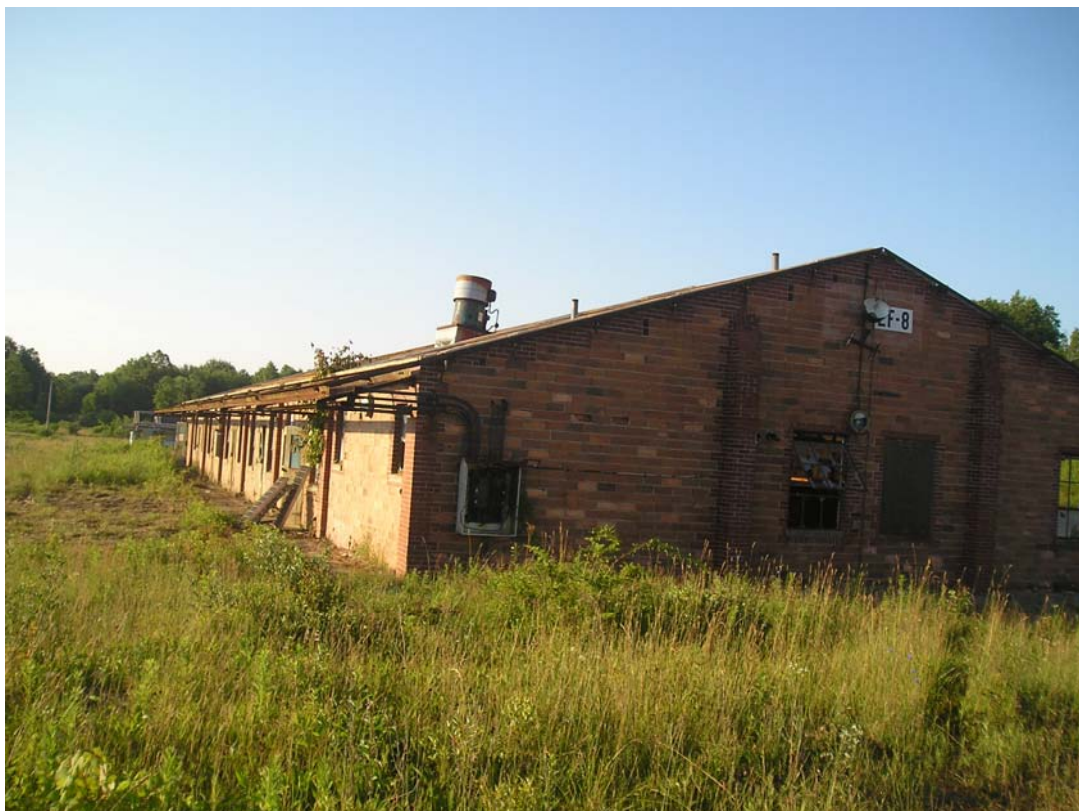
Large one story brick and block structure on concrete slab with transite roof.

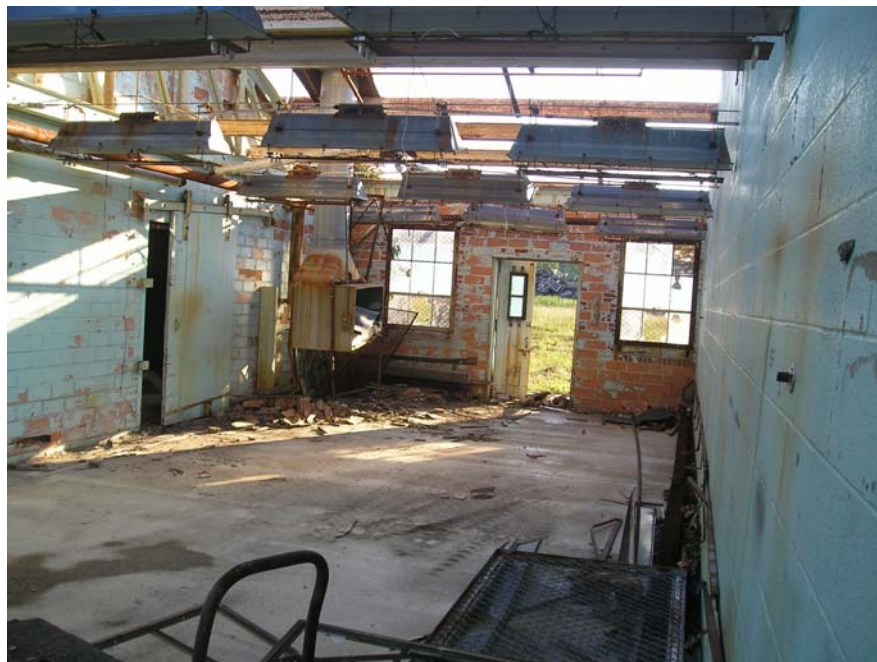
Floor Type ☒ Concrete ☐ Wood ☐ Steel ☐ OtherFloor Liner ☐ Lead ☐ Rubber ☐ Composite ☒ NoneVisible Explosives Present: ☐ Yes ☒ No If yes identify location below.

Thickness of liner > 1/8" ☐ Yes ☐ No ☒ NA If Yes to either answer below:Are Slab Cracks, Crevices, Openings bigger than a hairline: ☒ Yes ☐ NoAre floor liner Cracks, Crevices, Openings bigger than a hairline: ☐ Yes ☐ No ☒ NAEntrapment of Explosive Residues in Cracks, Crevices, or Openings observed in floor slab. ☐ Yes ☒ NoEntrapment of Explosive Residues in Cracks, Crevices, or Openings observed in floor liner. ☐ Yes ☐ No ☒ NASuspect surfaces present that are not accessible for Visual Inspection. ☐ Yes ☒ No

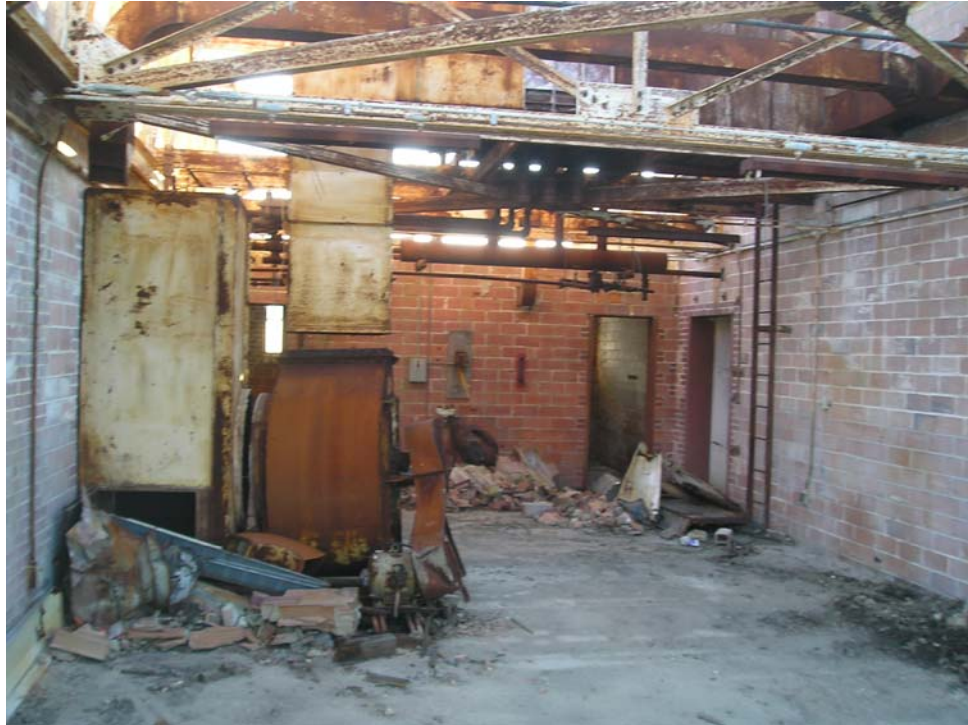
Process Piping Present
☐ Yes ☒ No

Process Equipment Present
☐ Yes ☒ No

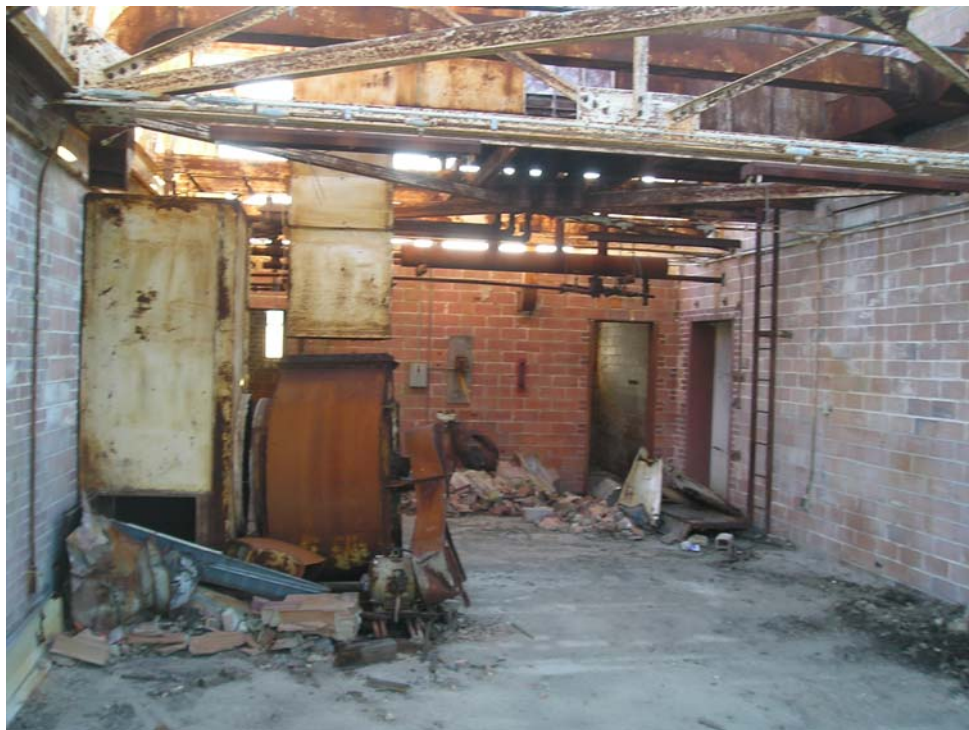
Steam lines present ☐ Yes ☒ No Water Lines present ☒ Yes ☐ No ☒ Other (identify below)

Description of other Fixtures: Ventilation System

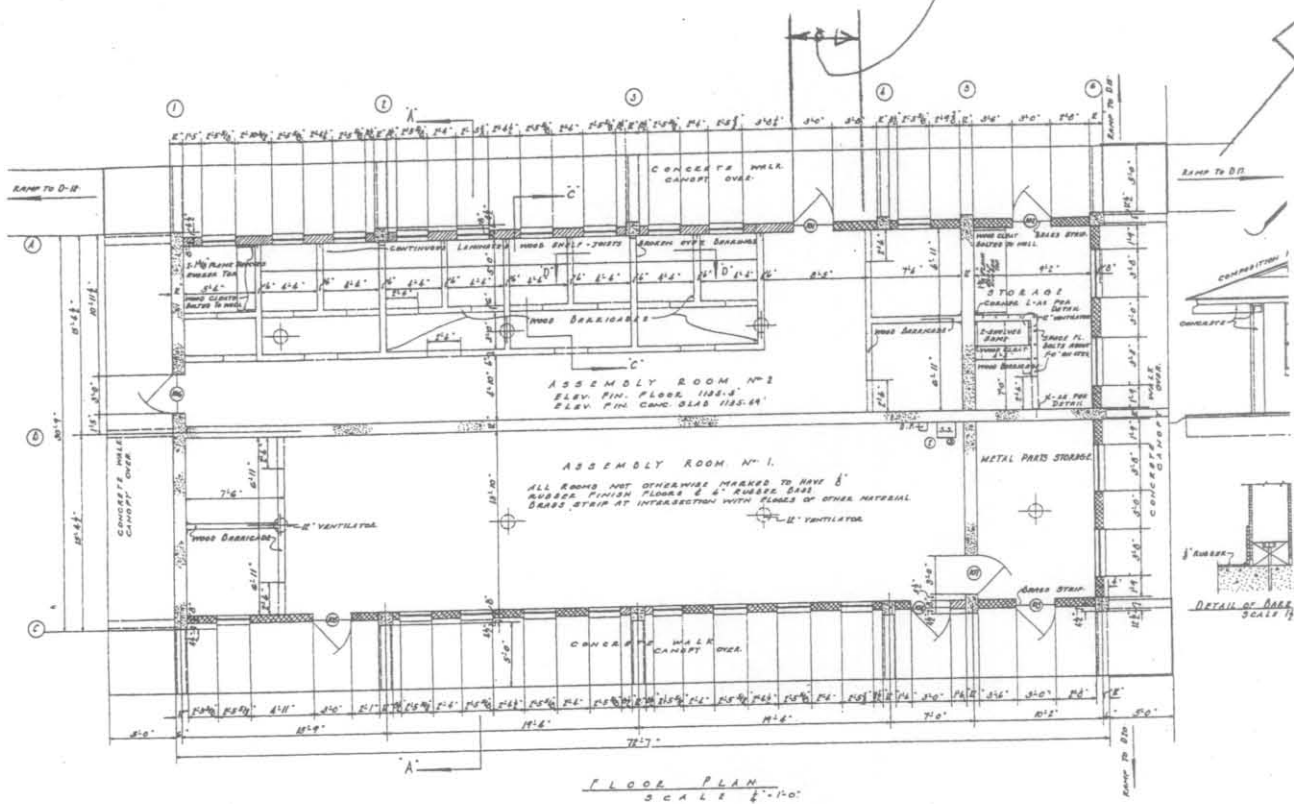
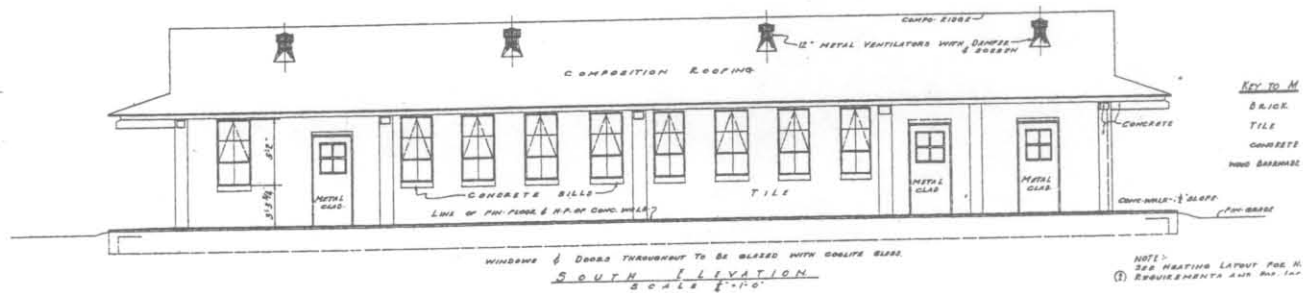
BUILDING DT-14

RECOMMENDED ACCESS LOCATION
 -REMOVE DOOR AND BRICK WALL FROM GROUND
 FLOOR TO THE BOTTOM OF THE STEEL BEAM ABOVE.

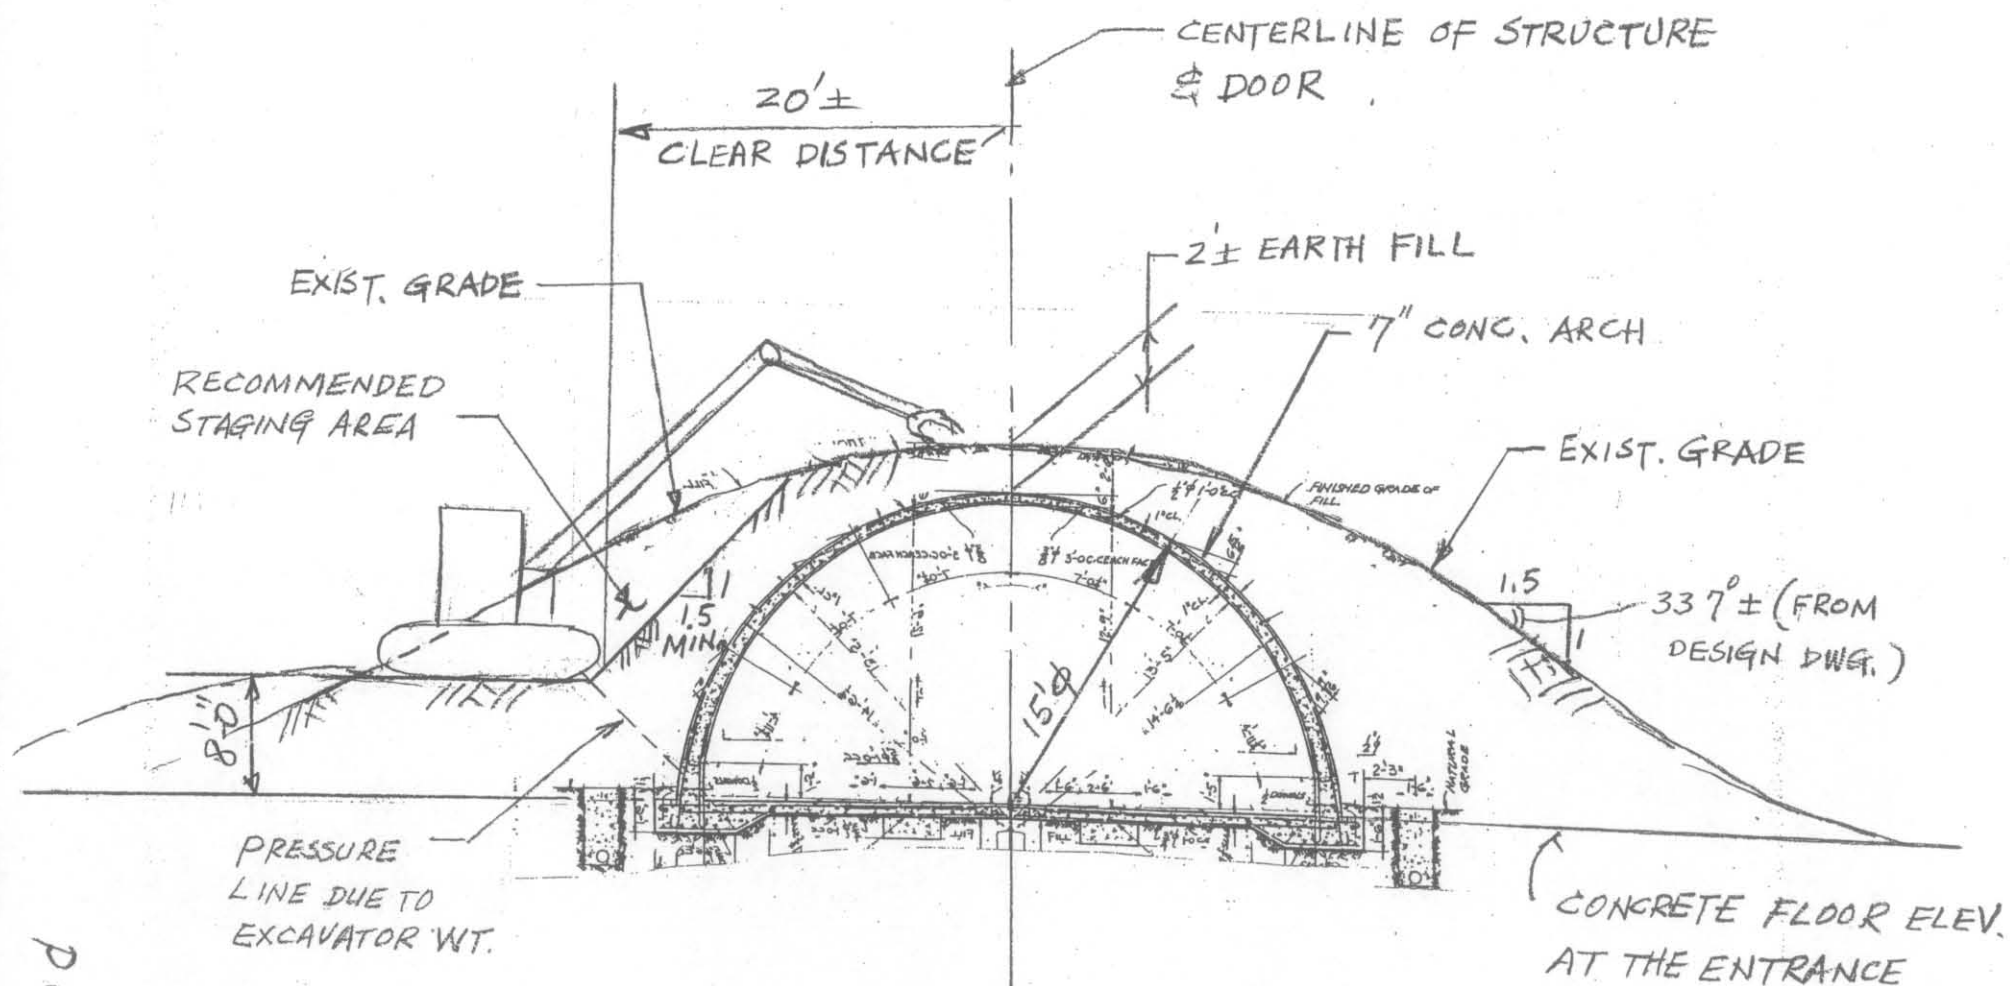
SECTION A-A

1. BAT recommends that the maximum ventilation hole size for the WS2 and WS2A magazines be 10 inches in diameter and located at the center of the arch roof as shown on the sketches on page 4. Install two ventilations holes of 10 inches in diameter if one ventilation hole is not sufficient for ventilation consideration. Ventilation hole locations are shown on page 5.
