FACILITIES AND METHODS USED IN FULL-SCALE  
AIRPLANE CRASH-FIRE INVESTIGATION

By Dugald O. Black

Lewis Flight Propulsion Laboratory  
Cleveland, Ohio

March 10, 1952  
Declassified April 3, 1953

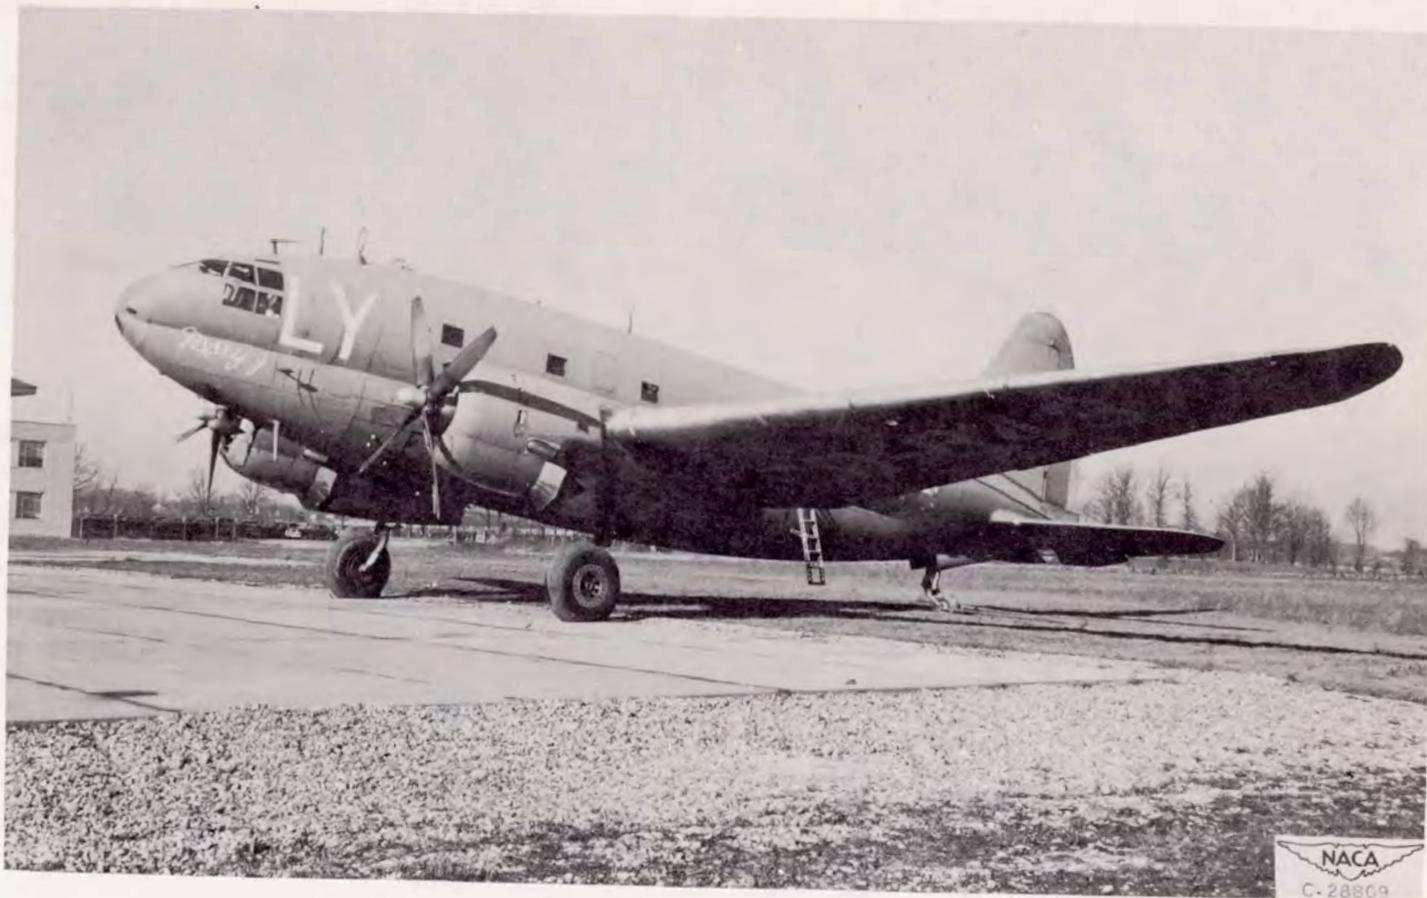
(a) C-46.

Figure 1. - Airplanes used in full-scale crash-fire investigation.

The NACA full-scale crash-fire investigation was conducted on C-46 and C-82 airplanes of the type shown in figure 1. The United States Air Force provided valuable assistance in conducting the investigation by supplying the war-weary and obsolete test airplanes.

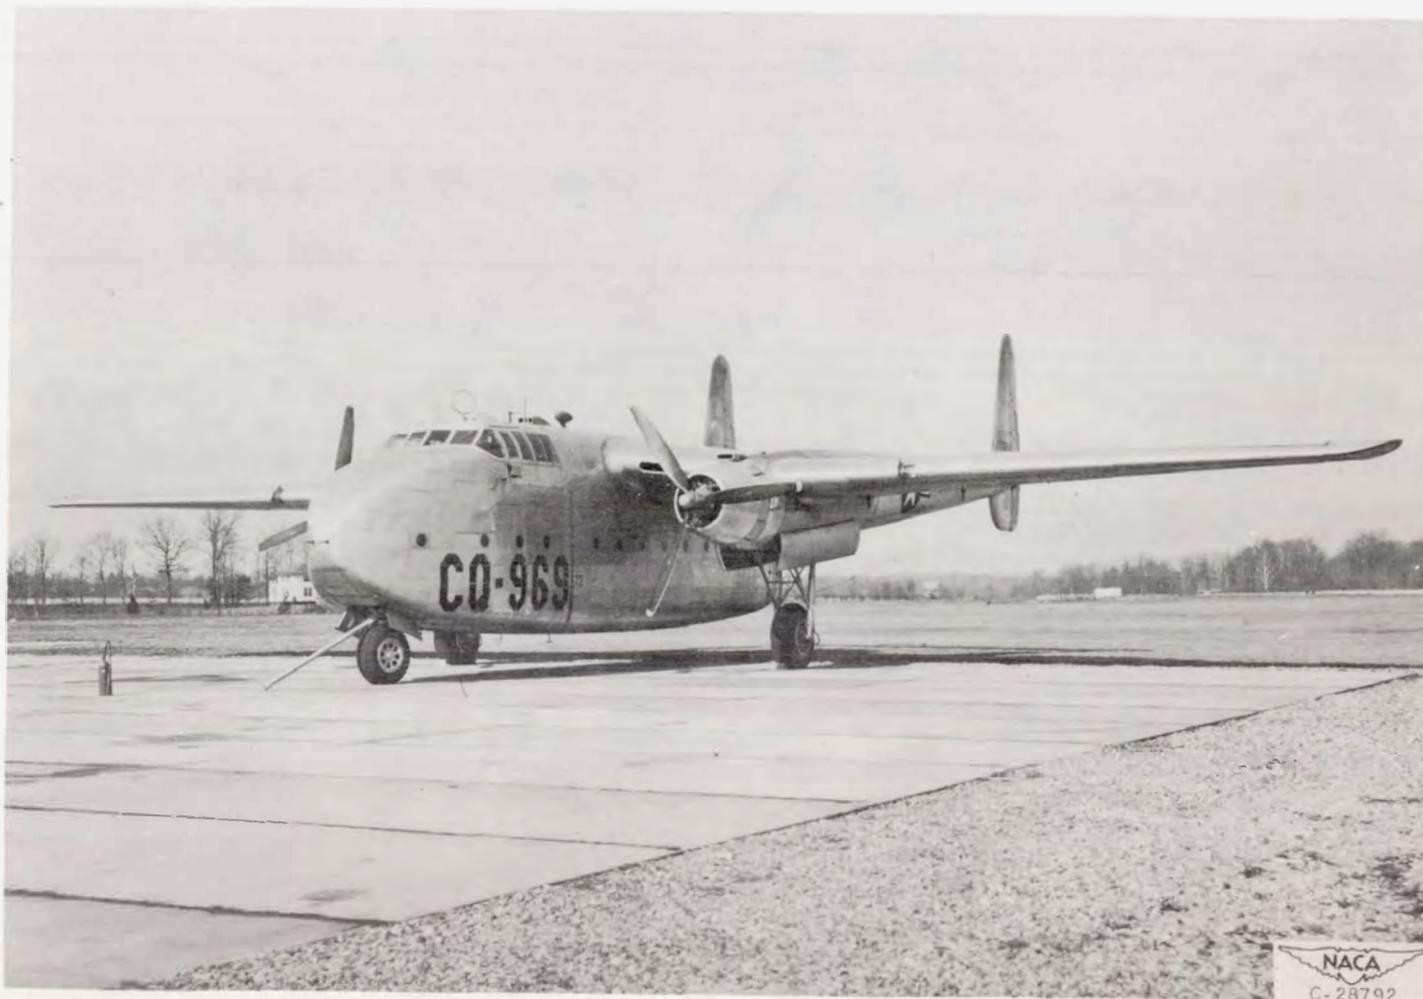
(b) C-82.

Figure 1. - Concluded. Airplanes used in full-scale crash-fire investigation.

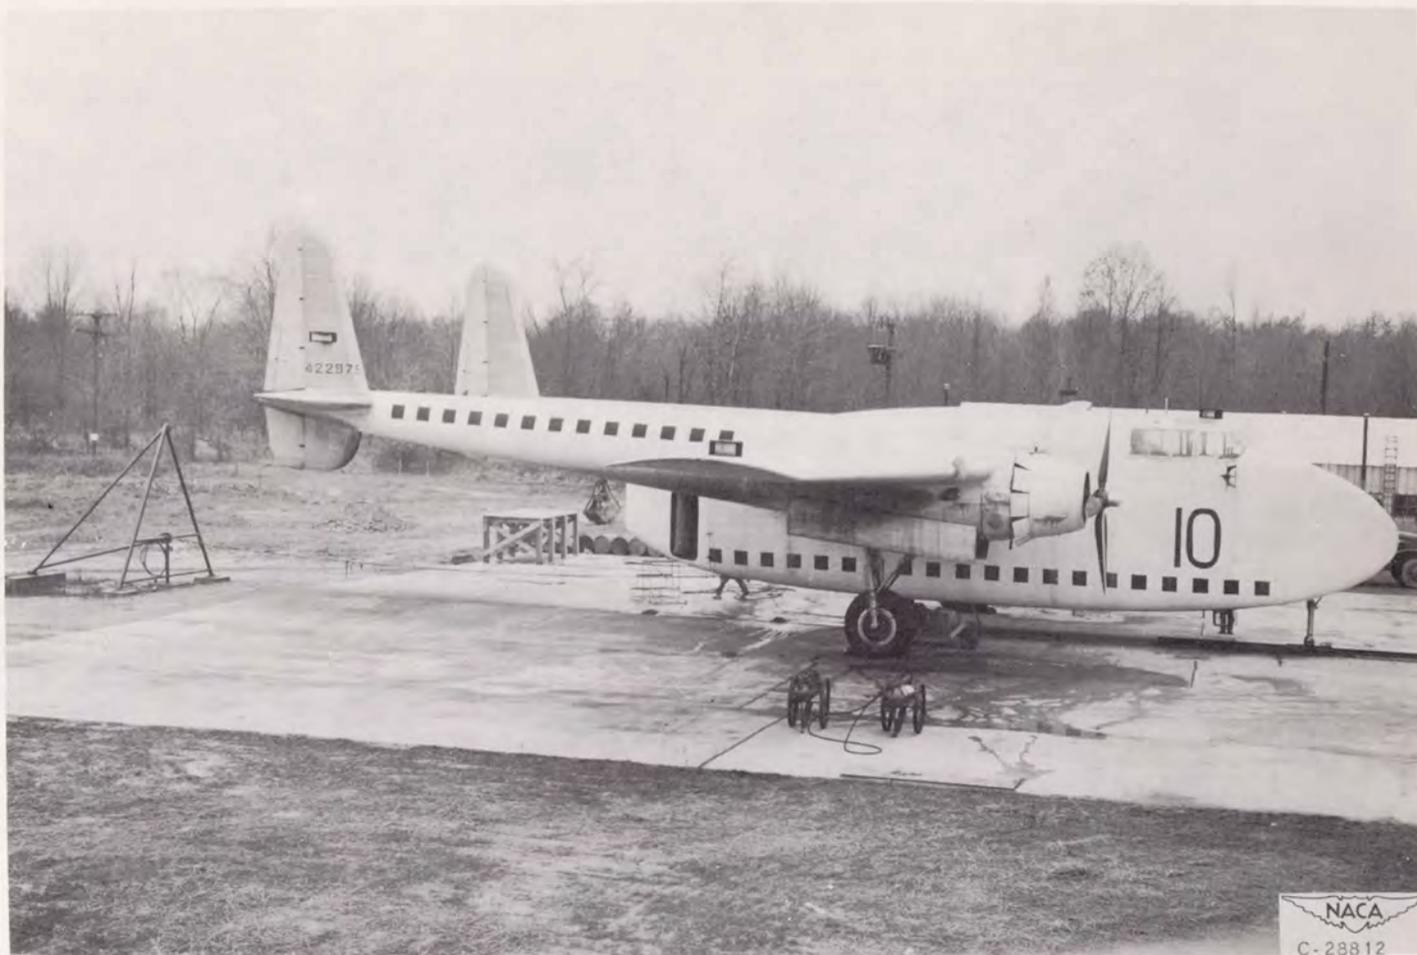
(a) Side view.

Figure 5. - C-82 Airplane being readied in preparation area for test.

Plan and profile views of the crash area in which the crash-fire investigation was conducted are shown in figure 4. Photographs showing the side and front views of a C-82 airplane being prepared for a crash test are presented in figures 5(a) and 5(b), respectively.

An anchor pier (fig. 10) was erected at the end of the guide rail in the preparation area to retain the airplane under take-off power without brakes just before release. It was constructed of four separate concrete piers set in the ground with heavy iron framework connecting them. The restraining cable attached between the anchor pier and the glider tow mechanism of the C-82 airplane is shown in figure 5(a).

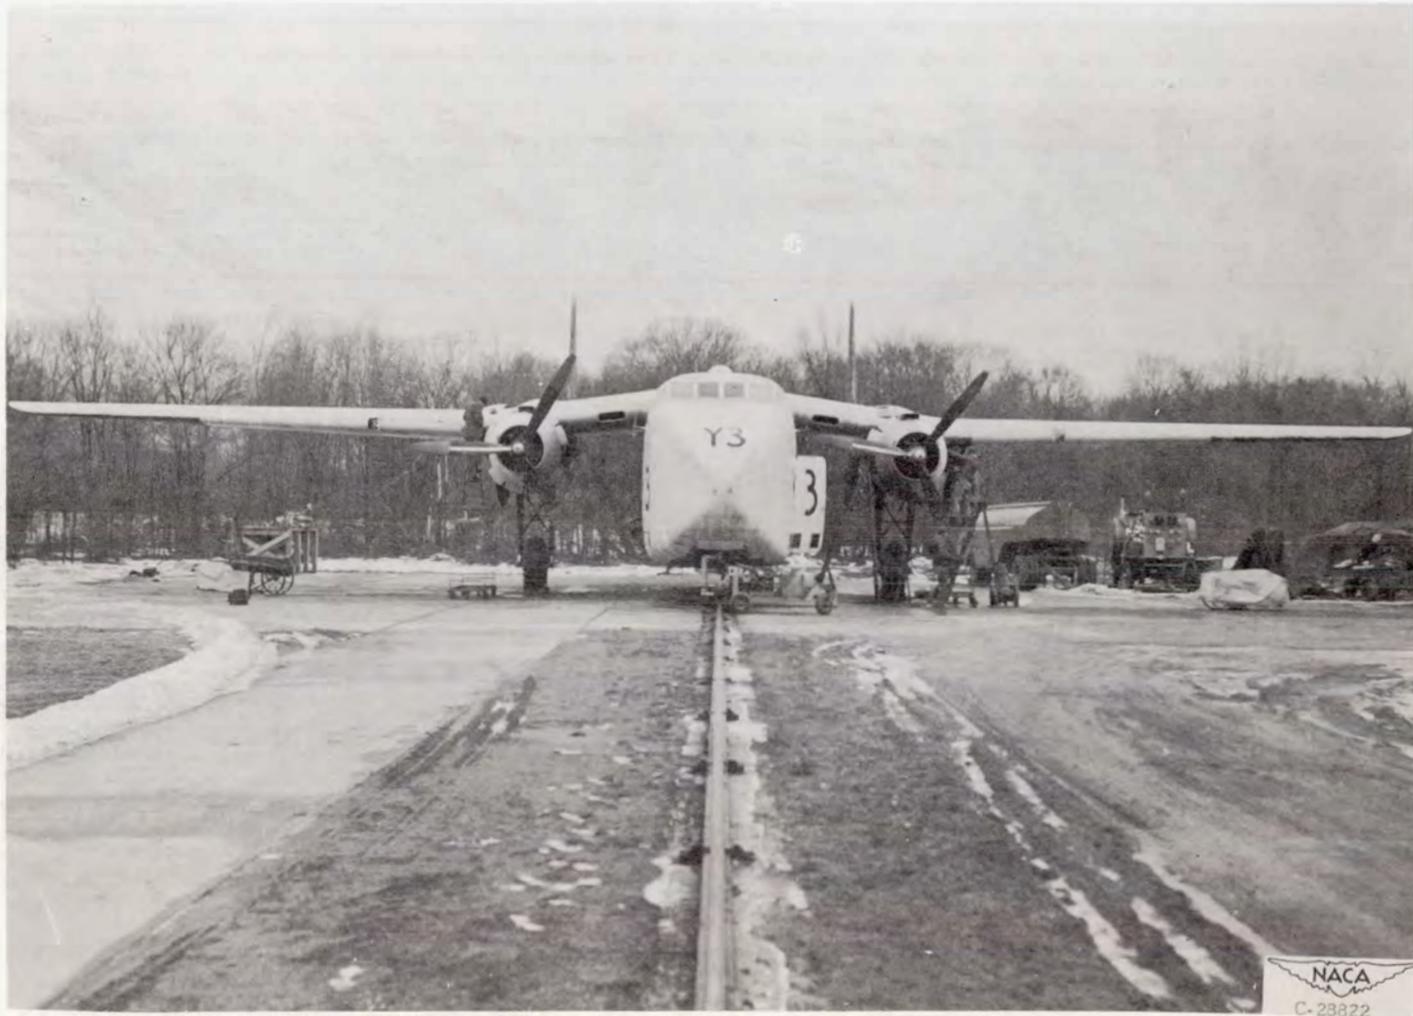
(b) Front view.

Figure 5. - Concluded. C-82 airplane being readied in preparation area for test.

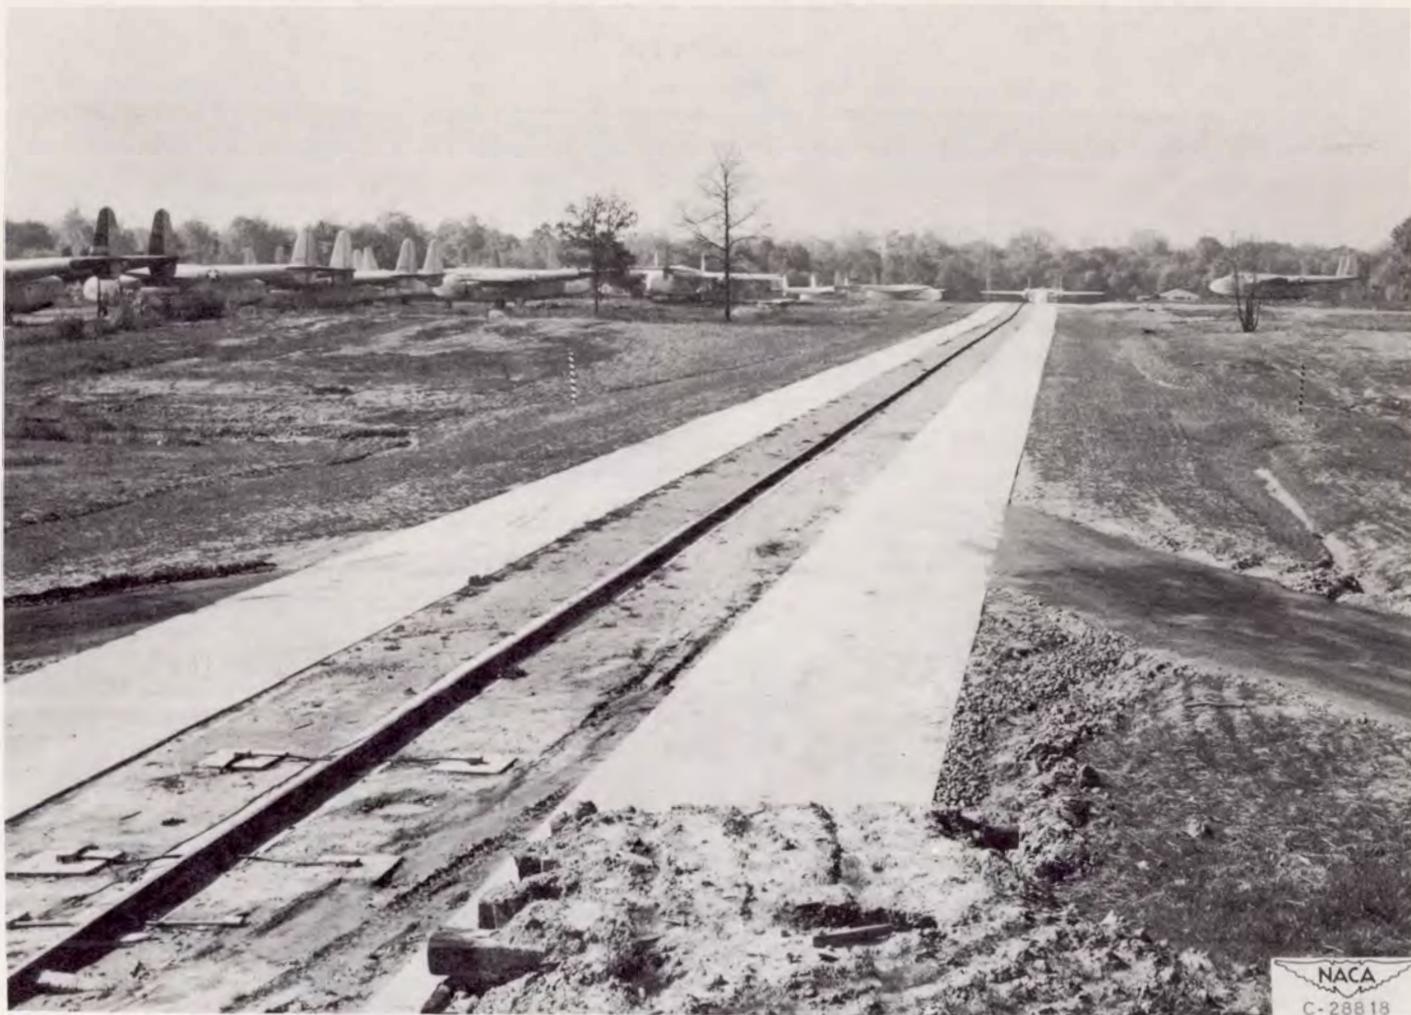
Figure 6. - Runway and center rail for guiding airplane to crash barrier.

The specially prepared runway and the center rail used to guide the test airplanes to the crash barrier are shown in figure 6. The rail and the runway were 1700 feet long. The runway was constructed of two concrete strips 10 feet wide separated by 15 feet. Between these two concrete strips one 80-pound rail was installed.

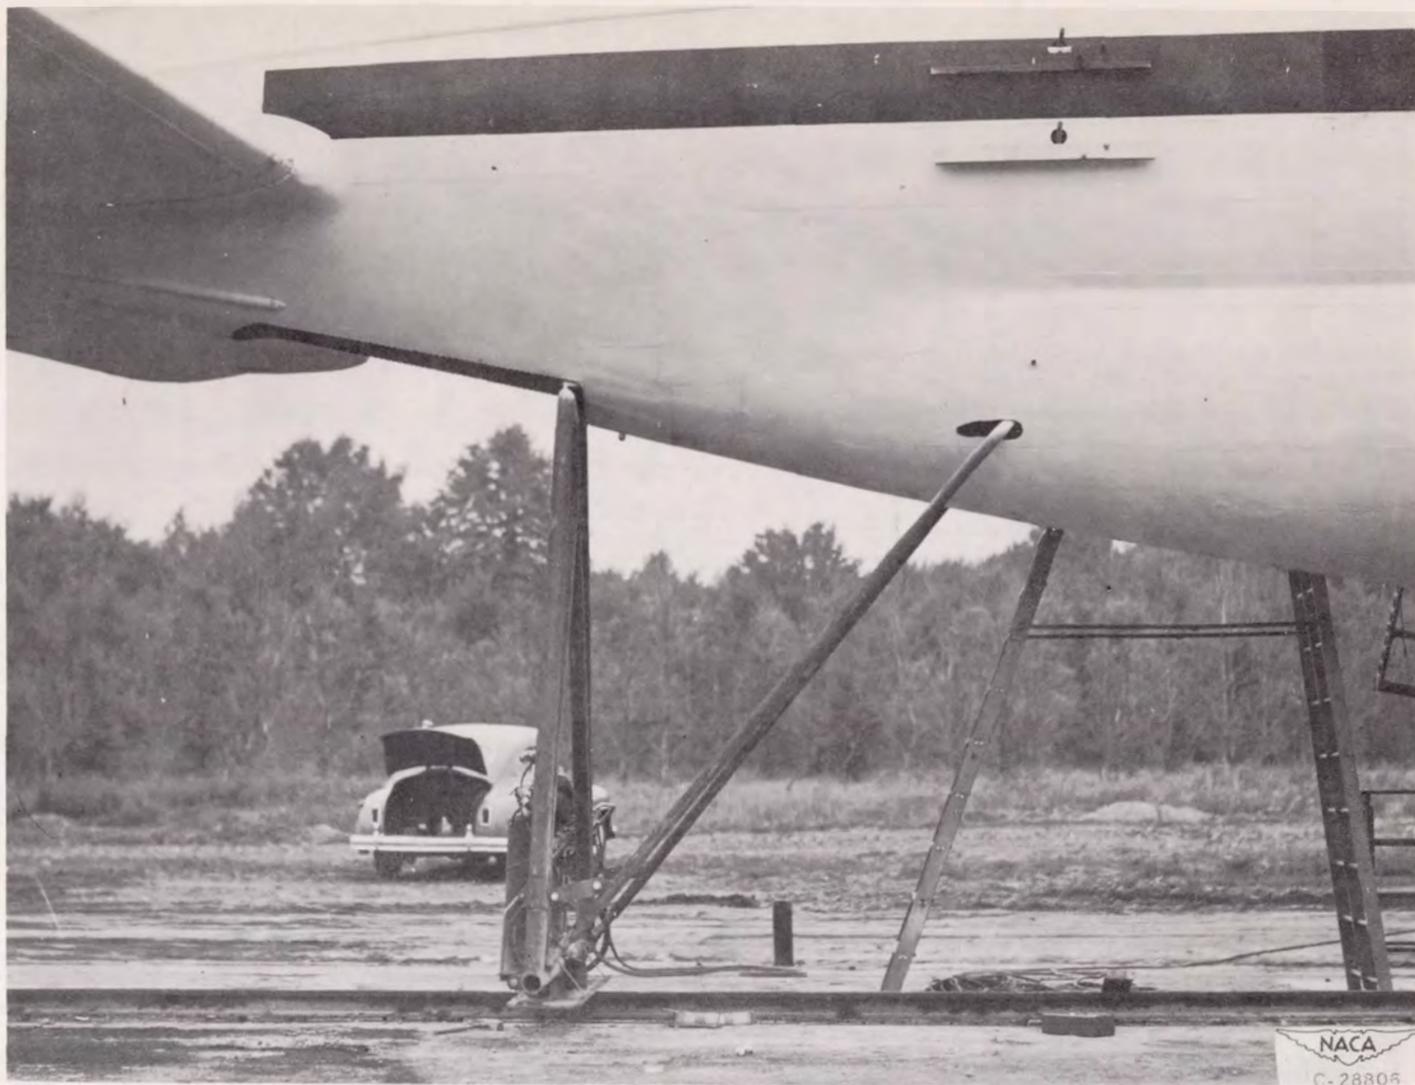
Figure 8. - Extended tail-truss support for holding C-46 airplane in flight attitude.

In order to support the C-46 airplane in flight attitude as it proceeded down the runway, a tail truss was bolted to the lugs on the tail-wheel bulkhead (fig. 8), the tail-wheel assembly having been removed. Welded to the bottom of the tail truss was a 4-inch I-beam which was attached to a 1/2-inch-thick steel plate that slid along the top of the center rail (fig. 8).

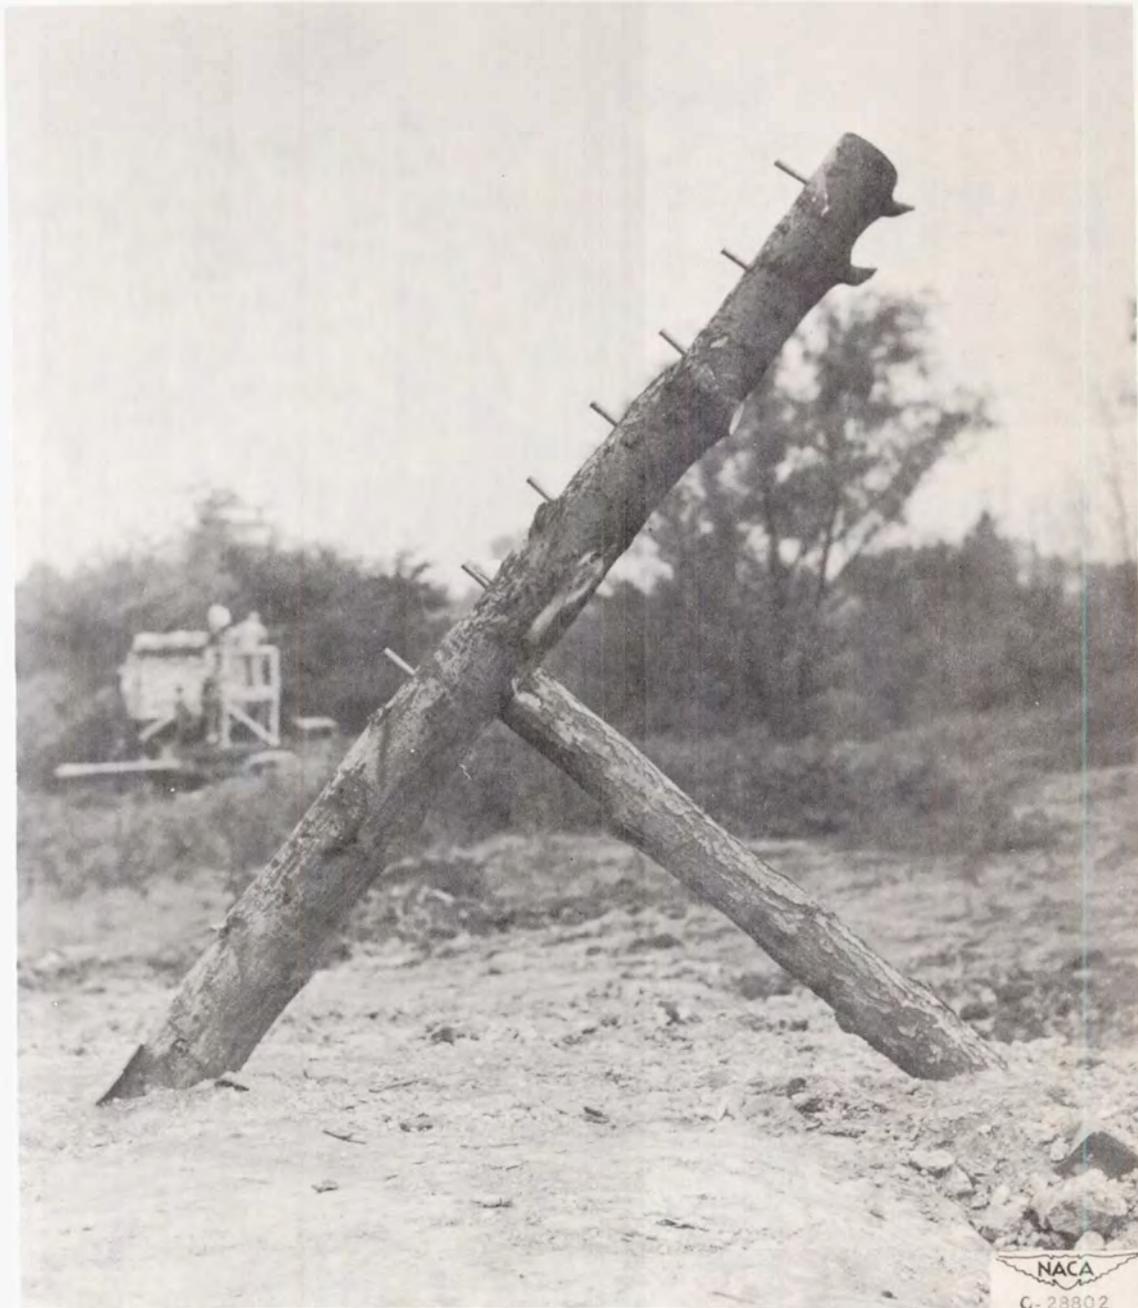
Figure 12. - Close-up of pole barrier showing steel spikes.

The poles installed behind the crash barrier simulated trees which ruptured the wings and fuel tanks of the airplanes. These poles, which had a minimum diameter of 10 inches, were buried 5 feet below the surface of the ground at a 45° angle. Each pole had seven 1-inch-diameter steel spikes 9 inches long protruding 4 inches above the upper surface and spaced 12 inches apart as shown in figure 12. The location of the two poles used in the tests with the C-46 airplane are shown in the sketch on figure 13. The location of the four poles used in the tests with the C-82 airplane are shown in figure 14. Because of differences in construction of the fuel tanks in these airplanes, four poles were required in the C-82 crash tests to duplicate the rate of fuel spillage obtained with two poles in the C-46 crash tests. A photograph showing the damage to the left wing and the fuel tanks of a C-82 airplane produced by the pole barriers is presented in figure 15.

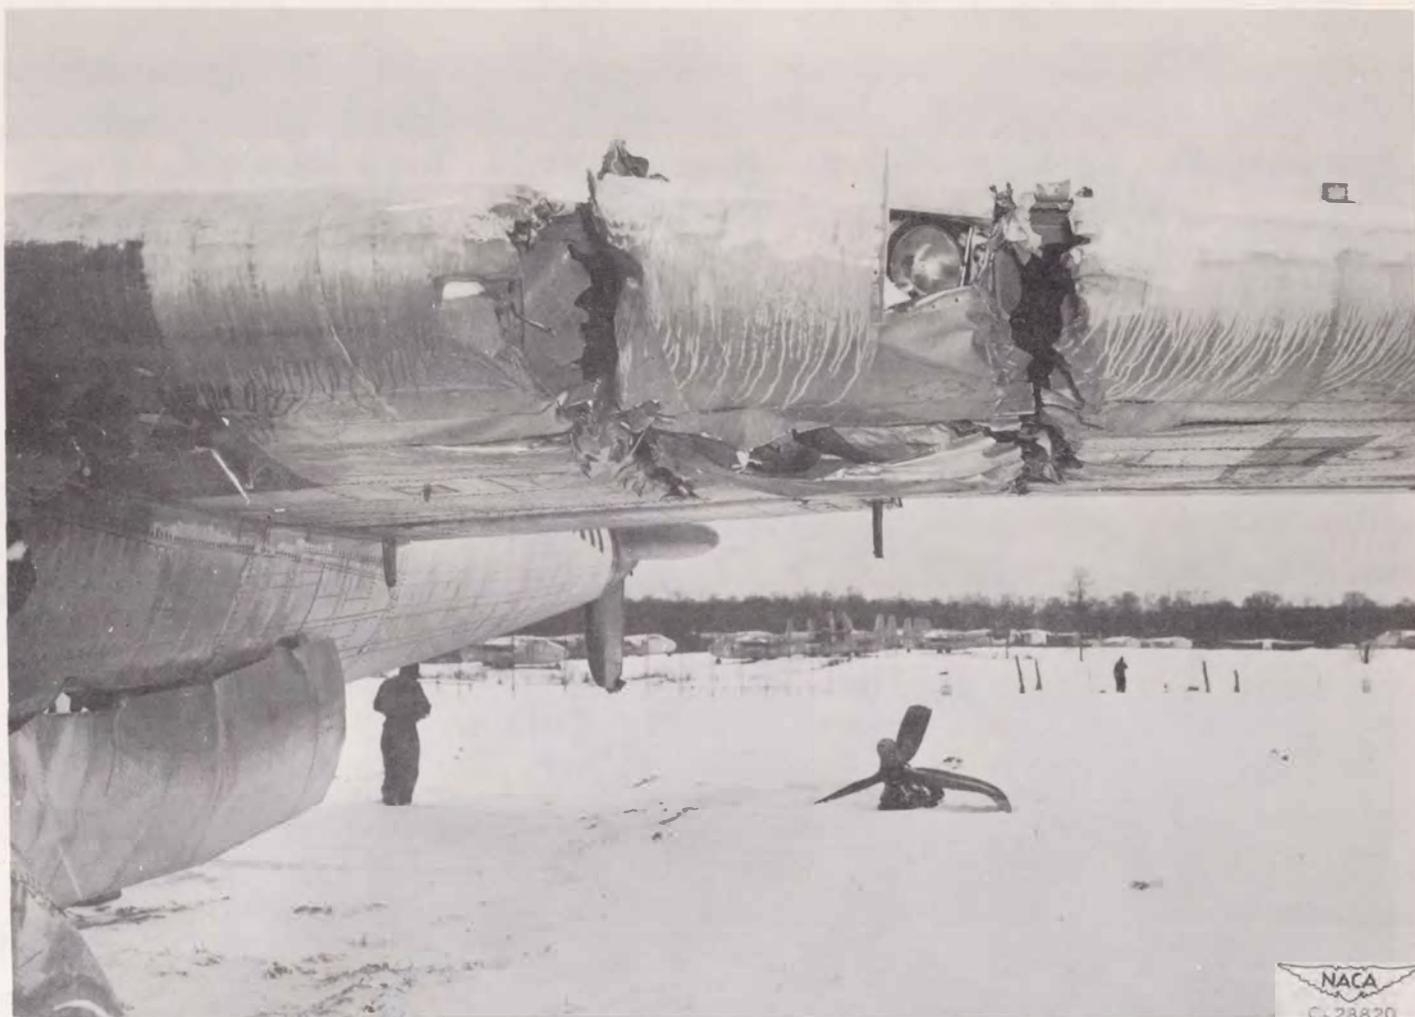
Figure 15. - Damage to left wing and fuel tanks of C-82 airplane produced by pole barriers.

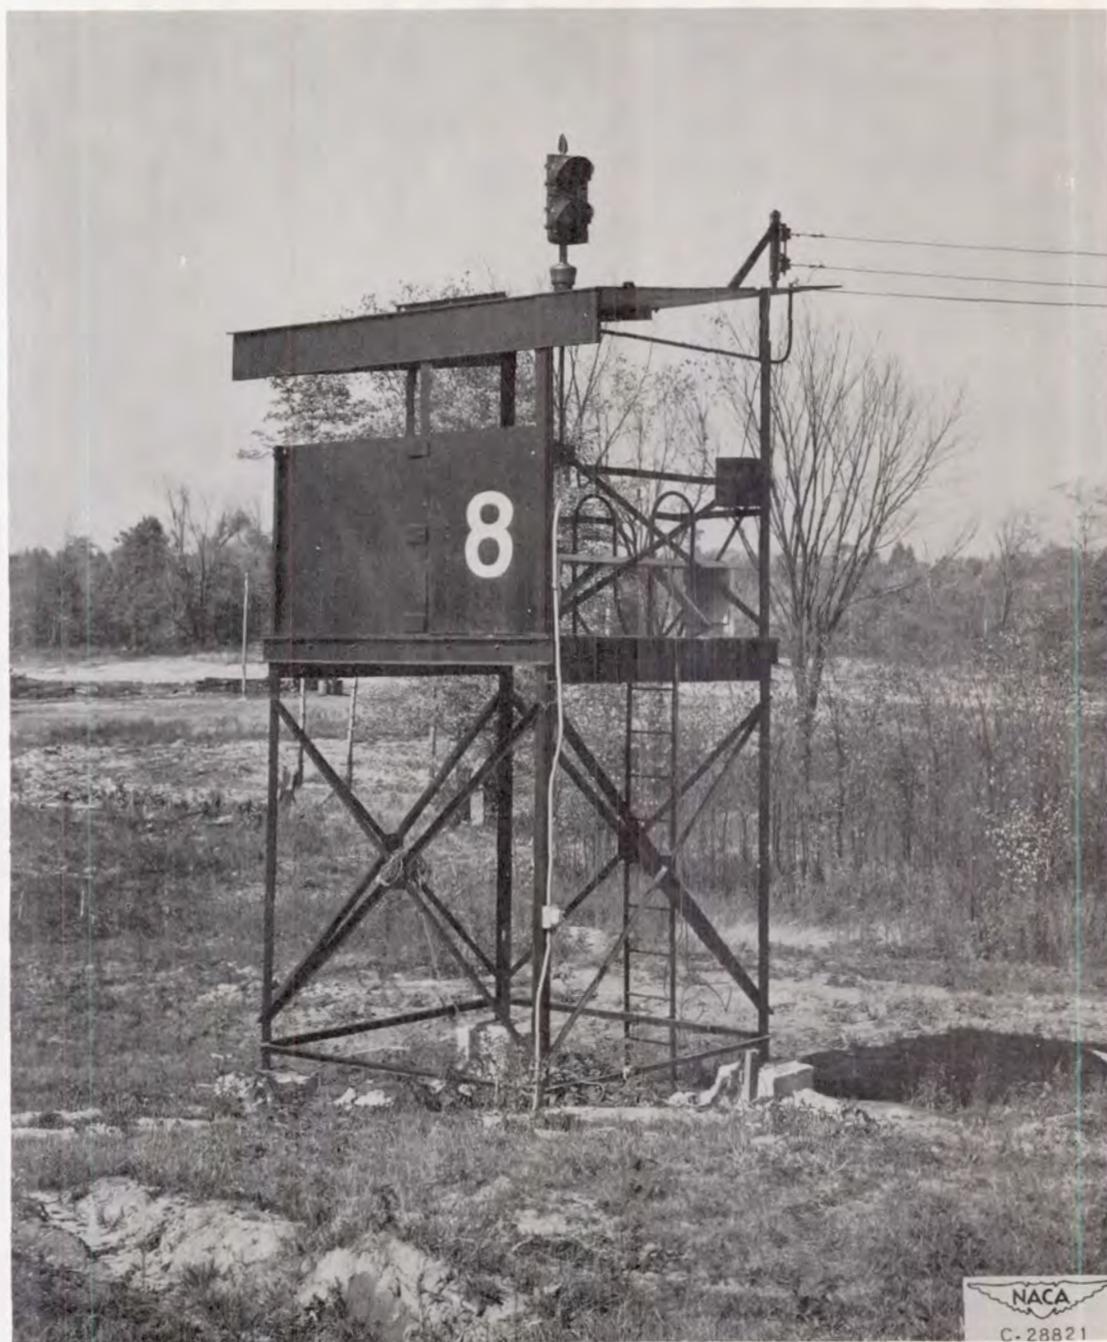
Figure 18. - Typical camera platform installation in crash area.

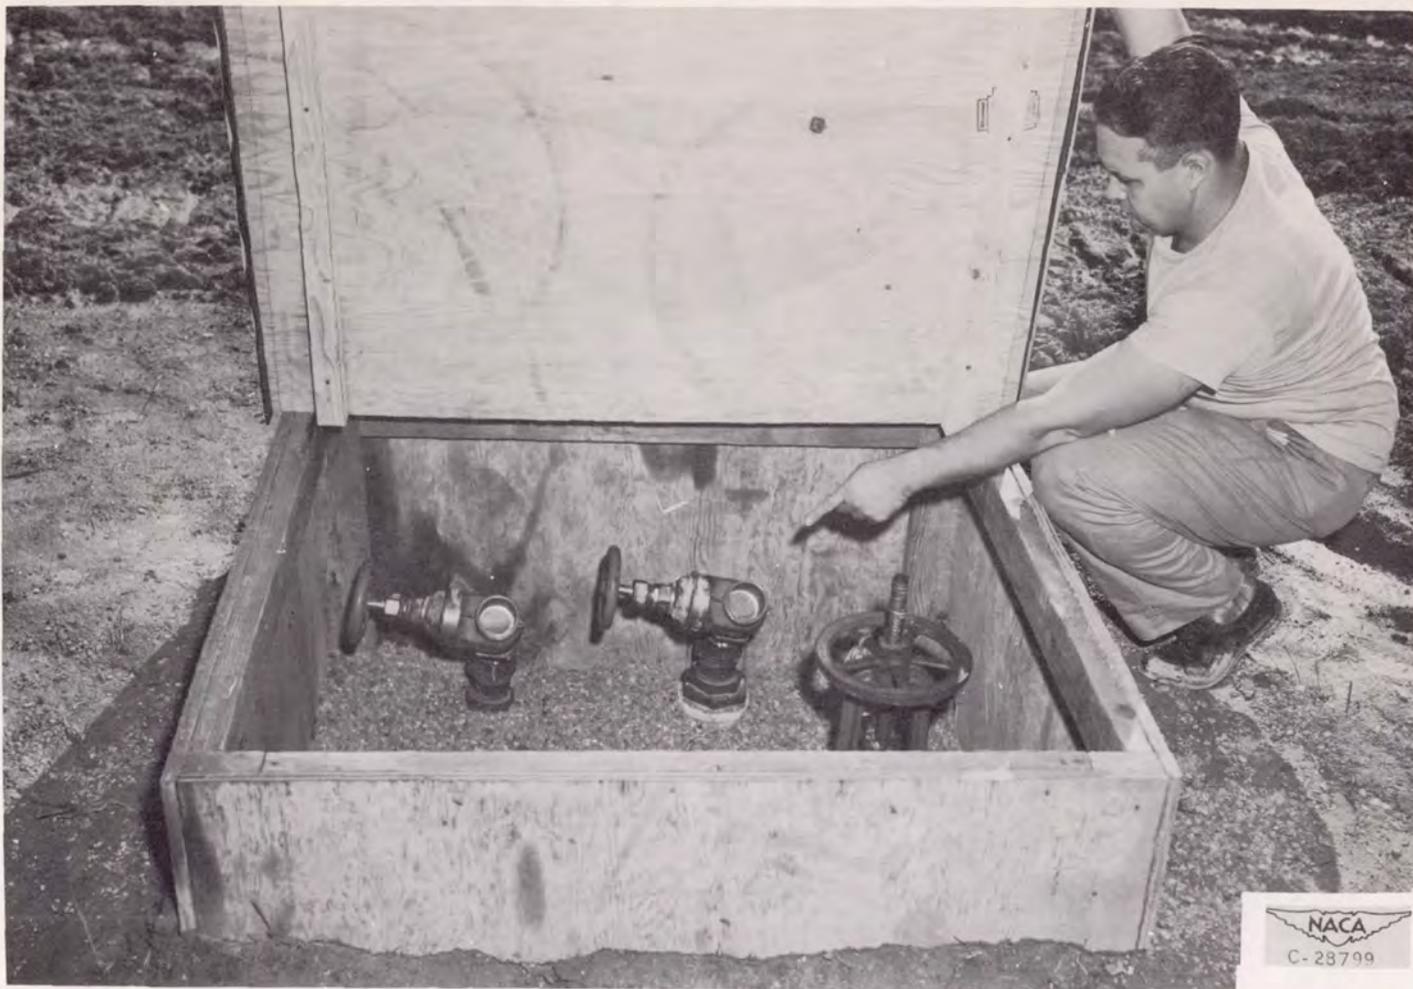
Figure 19. - Fire protection outlet located on each side of crash area.

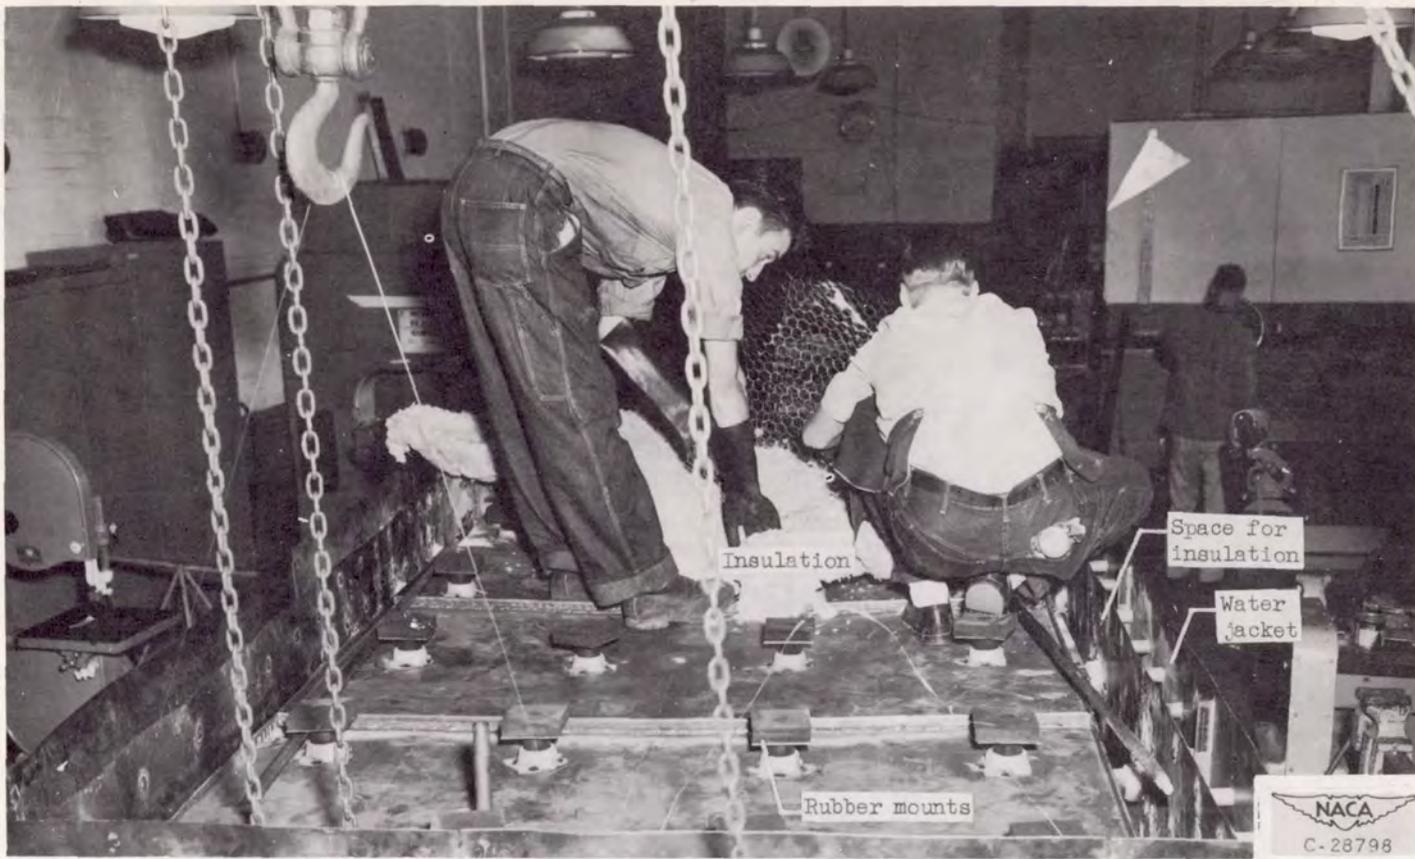
Figure 21. - Three-quarter top view showing construction of fireproof instrument box before top was installed.

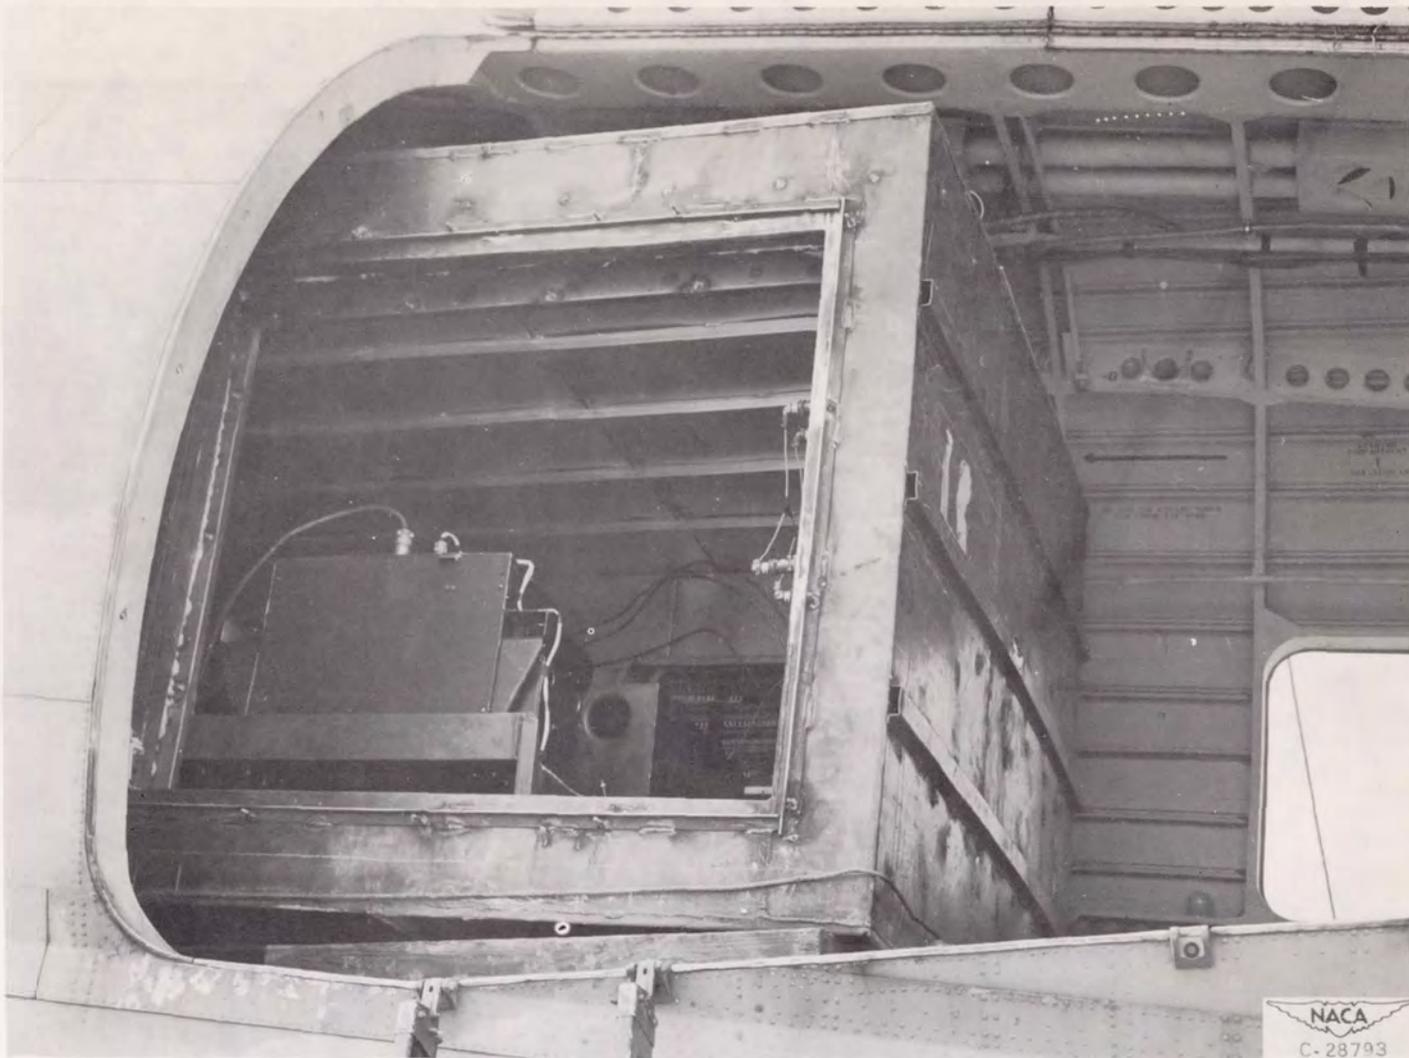
Figure 27. - Fireproof instrument box installation in C-46 airplane; side view.

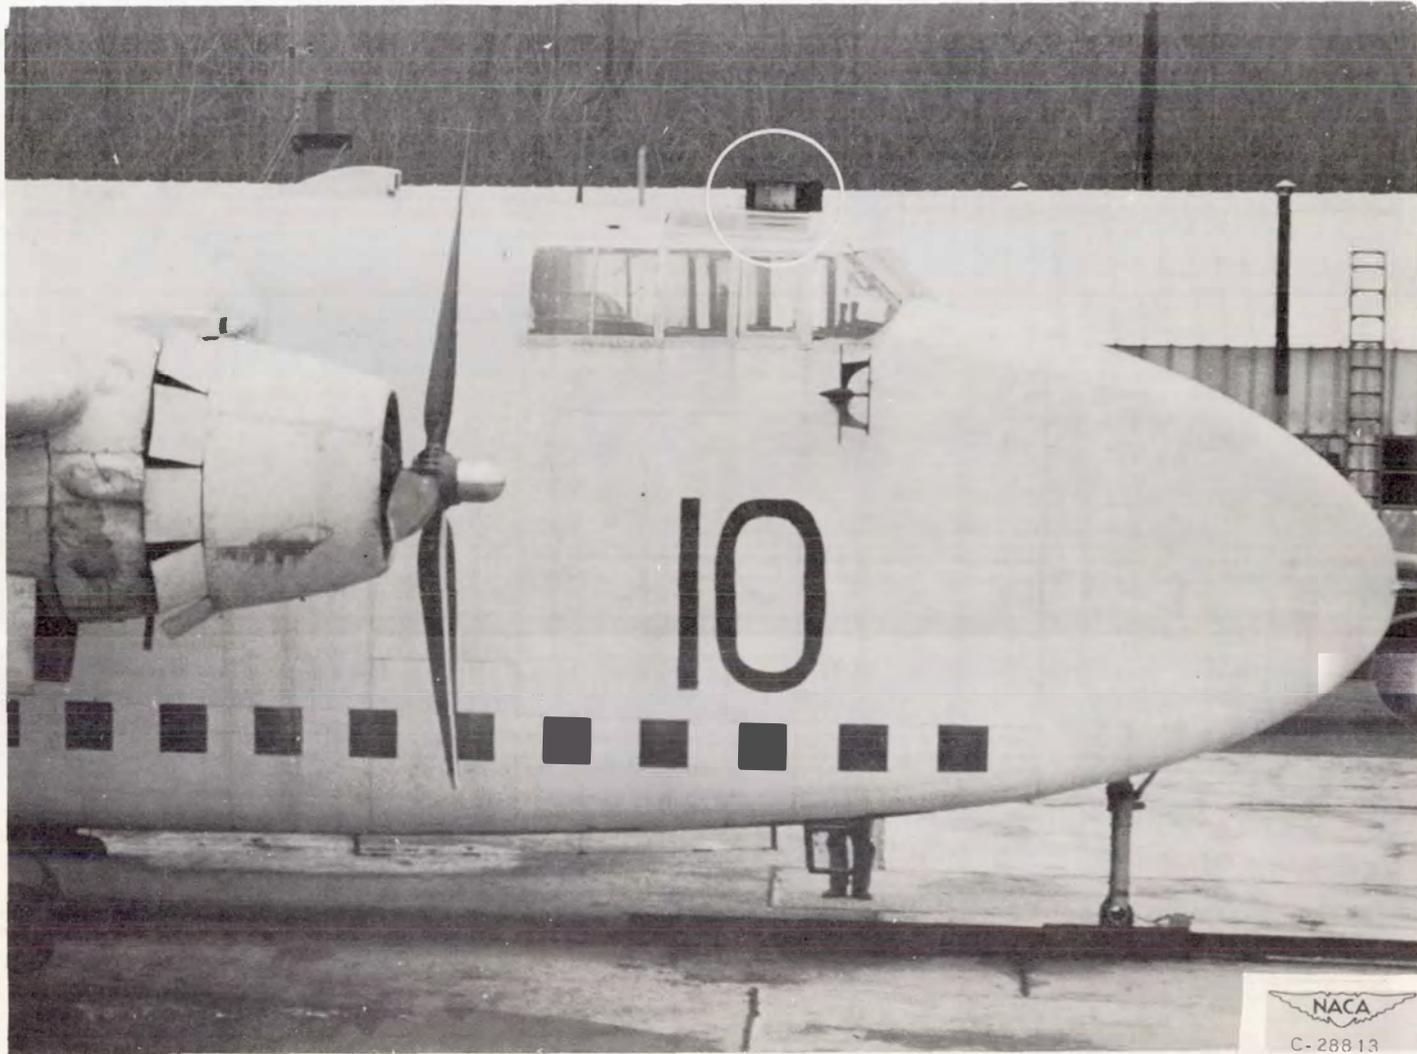
(a) On top of fuselage.

Figure 28. - Timing lights installed on C-82 airplane.

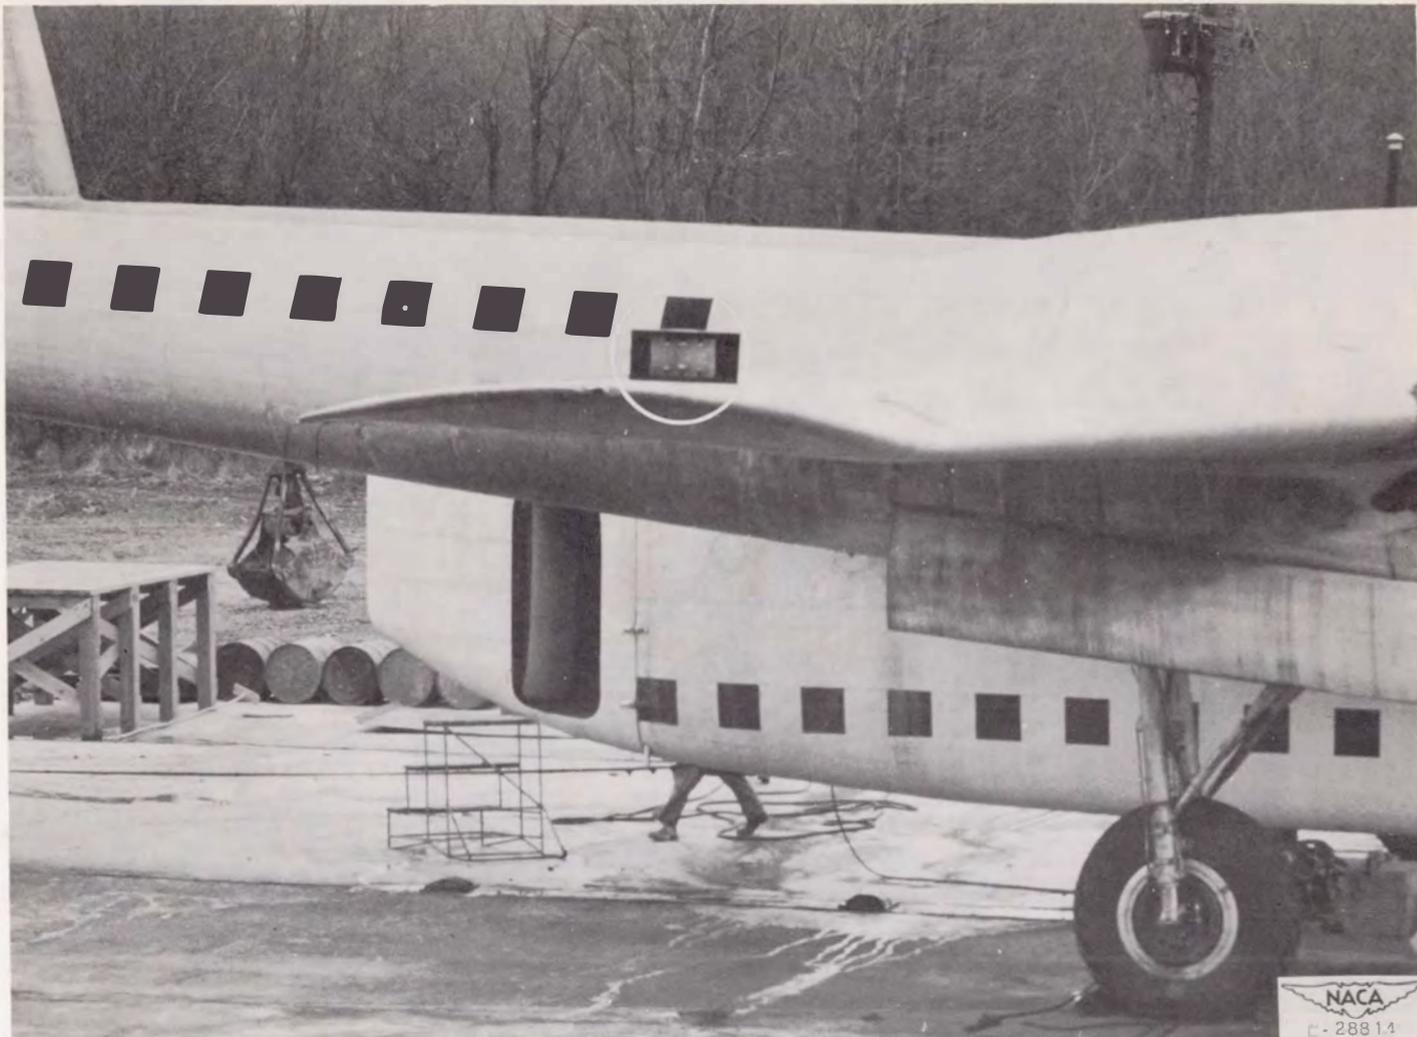
(b) On right wing tip.

Figure 28 - Continued. Timing lights installed on C-82 airplane.

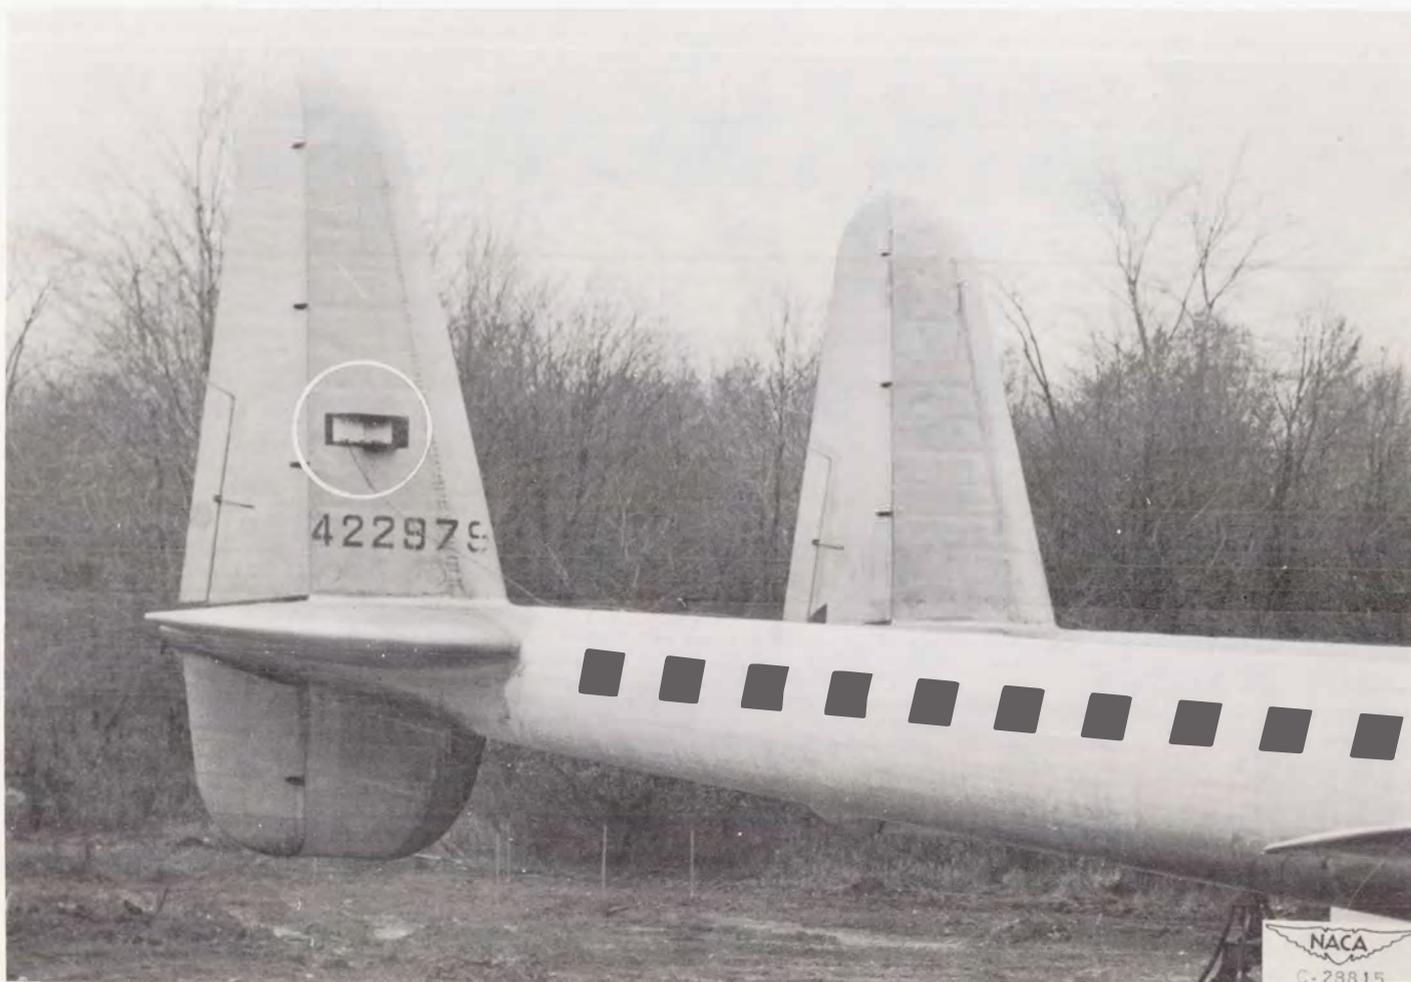
(c) On right vertical wing tip.

Figure 28. - Concluded. Timing lights installed on C-82 airplane.
