FACILITIES AND METHODS USED IN FULL-SCALE  
AIRPLANE CRASH-FIRE INVESTIGATION

By Dugald O. Black

Lewis Flight Propulsion Laboratory  
Cleveland, Ohio

March 10, 1952  
Declassified April 3, 1953

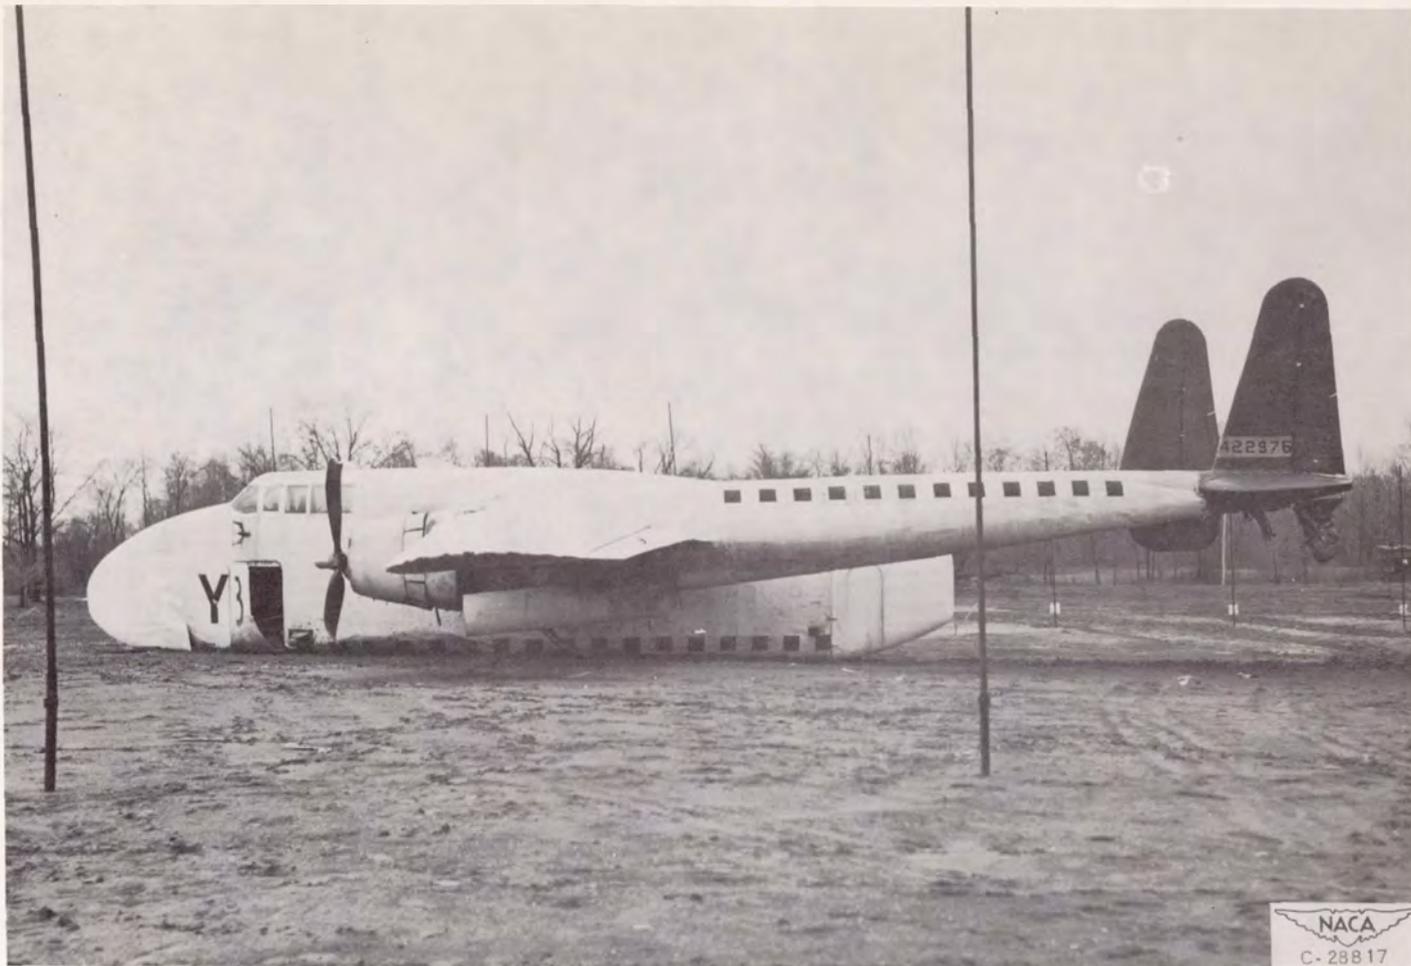
Figure 39. - Black squares painted on side of C-82 airplane and stationary poles in crash area for determining velocity.

The velocity of the airplane through the crash and subsequent slide was determined photographically. This system was based on poles located between the airplane and the motion picture cameras and 1-foot black marks painted on each side of fuselage and tail boom of the airplane at 1-foot intervals. A black mark painted on the side of the airplane lined up with one of the poles in the crash area as shown in figure 39. It was thus possible to obtain an approximate measure of the airplane speed from the motion pictures by making a frame by frame study of the position of the index marks on the airplane relative to the stationary poles.
