**Historical Records Review Report for the
2010 Phase I Remedial Investigation Services at
Compliance Restoration Sites (9 Areas of Concern)
Revision 0**

**Ravenna Army Ammunition Plant
Ravenna, Ohio**

**Contract No. W912QR-08-D-0008
Delivery Order No. 0019**

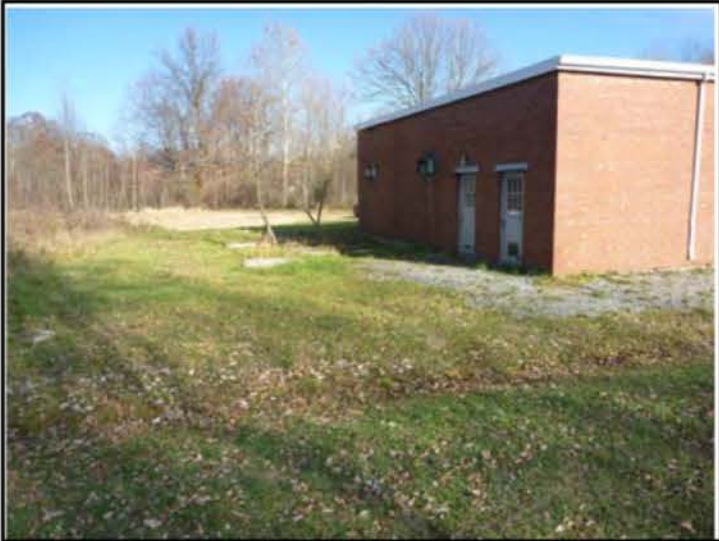
Figure 2-2. West Substation Map and Site Features

CC-RVAAP-68: WEST SUBSTATION

BUILDING 28-28: WEST SUBSTATION

The former East Substation is located approximately 325 ft from the intersection of Remalia Road and Load Line 2 Road in the eastern portion of the facility (Figure 2-1). The former West Substation is located northwest of Load Line 5 on Fuze and Booster Road in the central portion of the facility (Figure 2-2). Former Substation No. 3 is located in the Fuze and Booster Service Area southeast of Fuze and Booster Spur Road between Load Lines 10 and 11 (Figure 2-3).

The topography at the former West Substation is also generally flat. The AOC drains generally south to the roadside ditch located along Fuze and Booster Road (Figure 2-2). The substation comprised an area of approximately 3,000 ft². Grass surrounds the area where the transformers were located and around Building 28-28. In addition, there is a gravel area west of Building 28-28 used for parking by OHARNG personnel. The concrete foundations for the transformers still exist at the AOC.
