**Record of Decision
for CC RVAAP-74
Building 1034 Motor Pool Hydraulic Lift**

**Ravenna Army Ammunition Plant Restoration Program
Portage and Trumbull Counties, Ohio**

**Contract No. W912QR-12-D-0002
Delivery Order: 0003**

PARSONS
401 Diamond Drive NW
Huntsville, AL 35806
256-837-5200

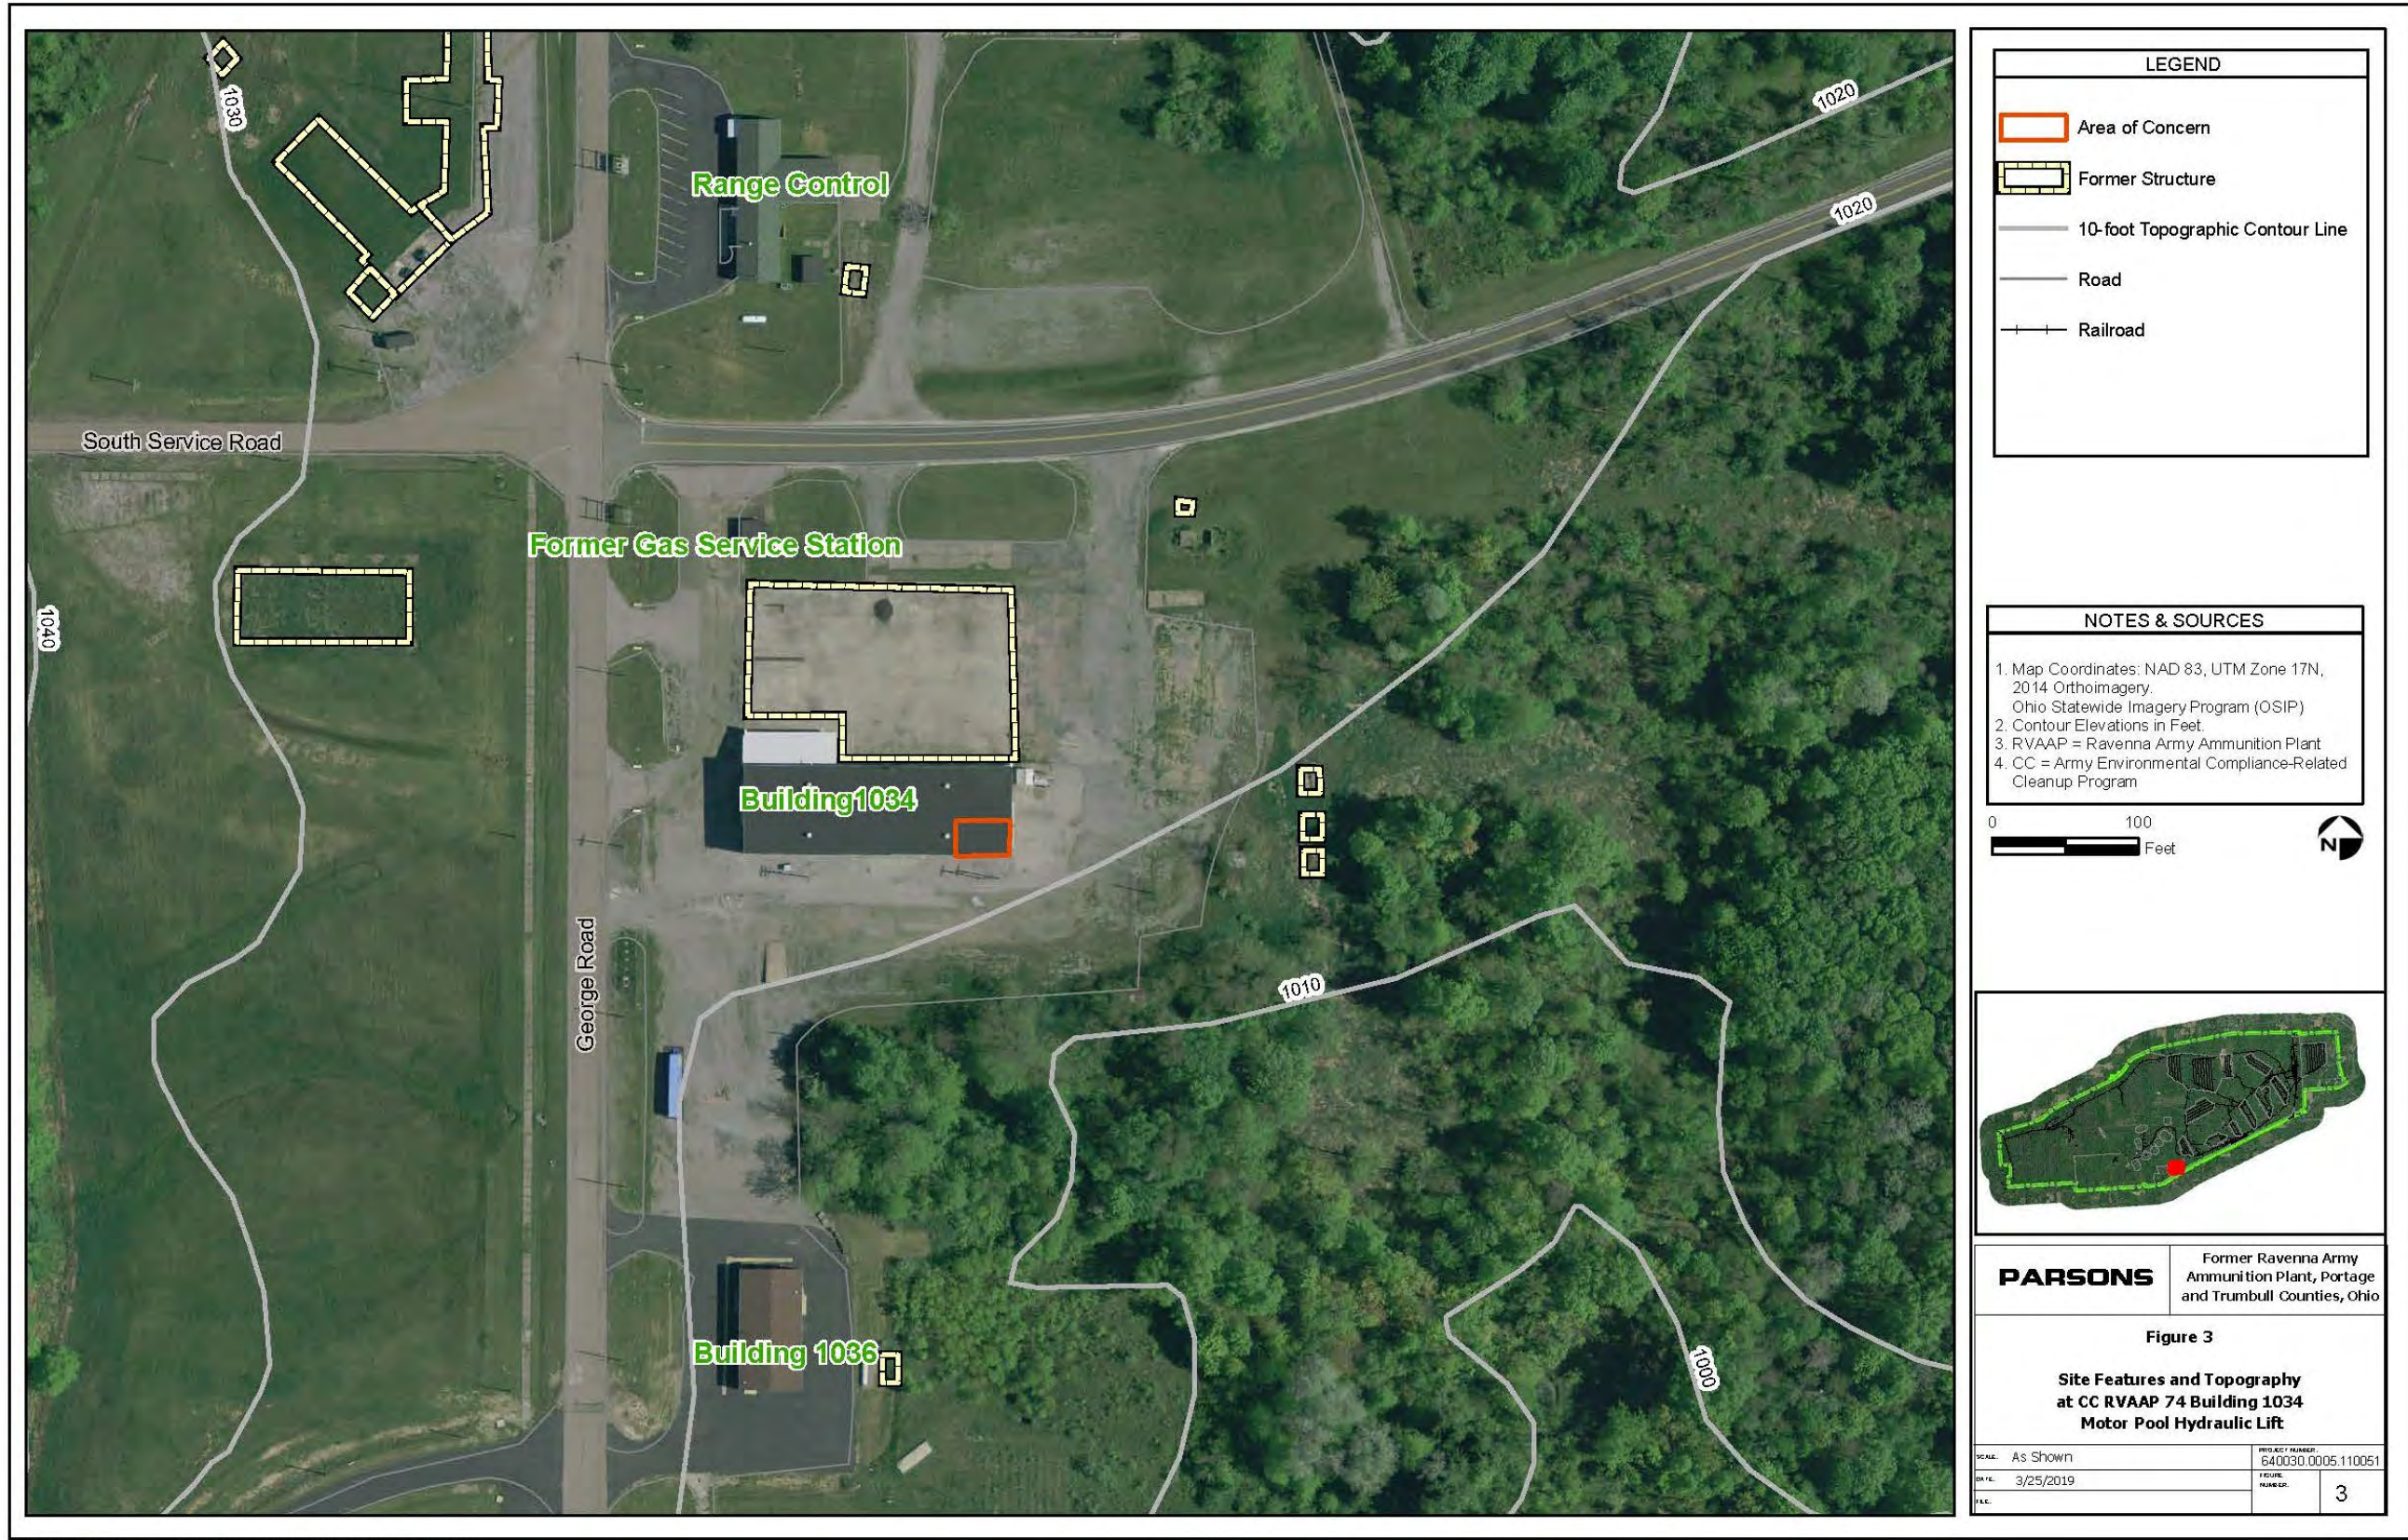
Figure 3. Site Features and Topography at CC RVAAP-74 Building 1034 Motor Pool Hydraulic Lift

Although borings at the AOC have not been advanced to the top of bedrock, the bedrock beneath the area is assumed to be the upper portion of the Pennsylvanian Pottsville Formation (Sharon Sandstone). Based on approximate surface elevation (Figure 3) and the top of bedrock elevation (Figure 4), the depth to bedrock in this area is estimated to be approximately 20 feet below ground surface (bgs).

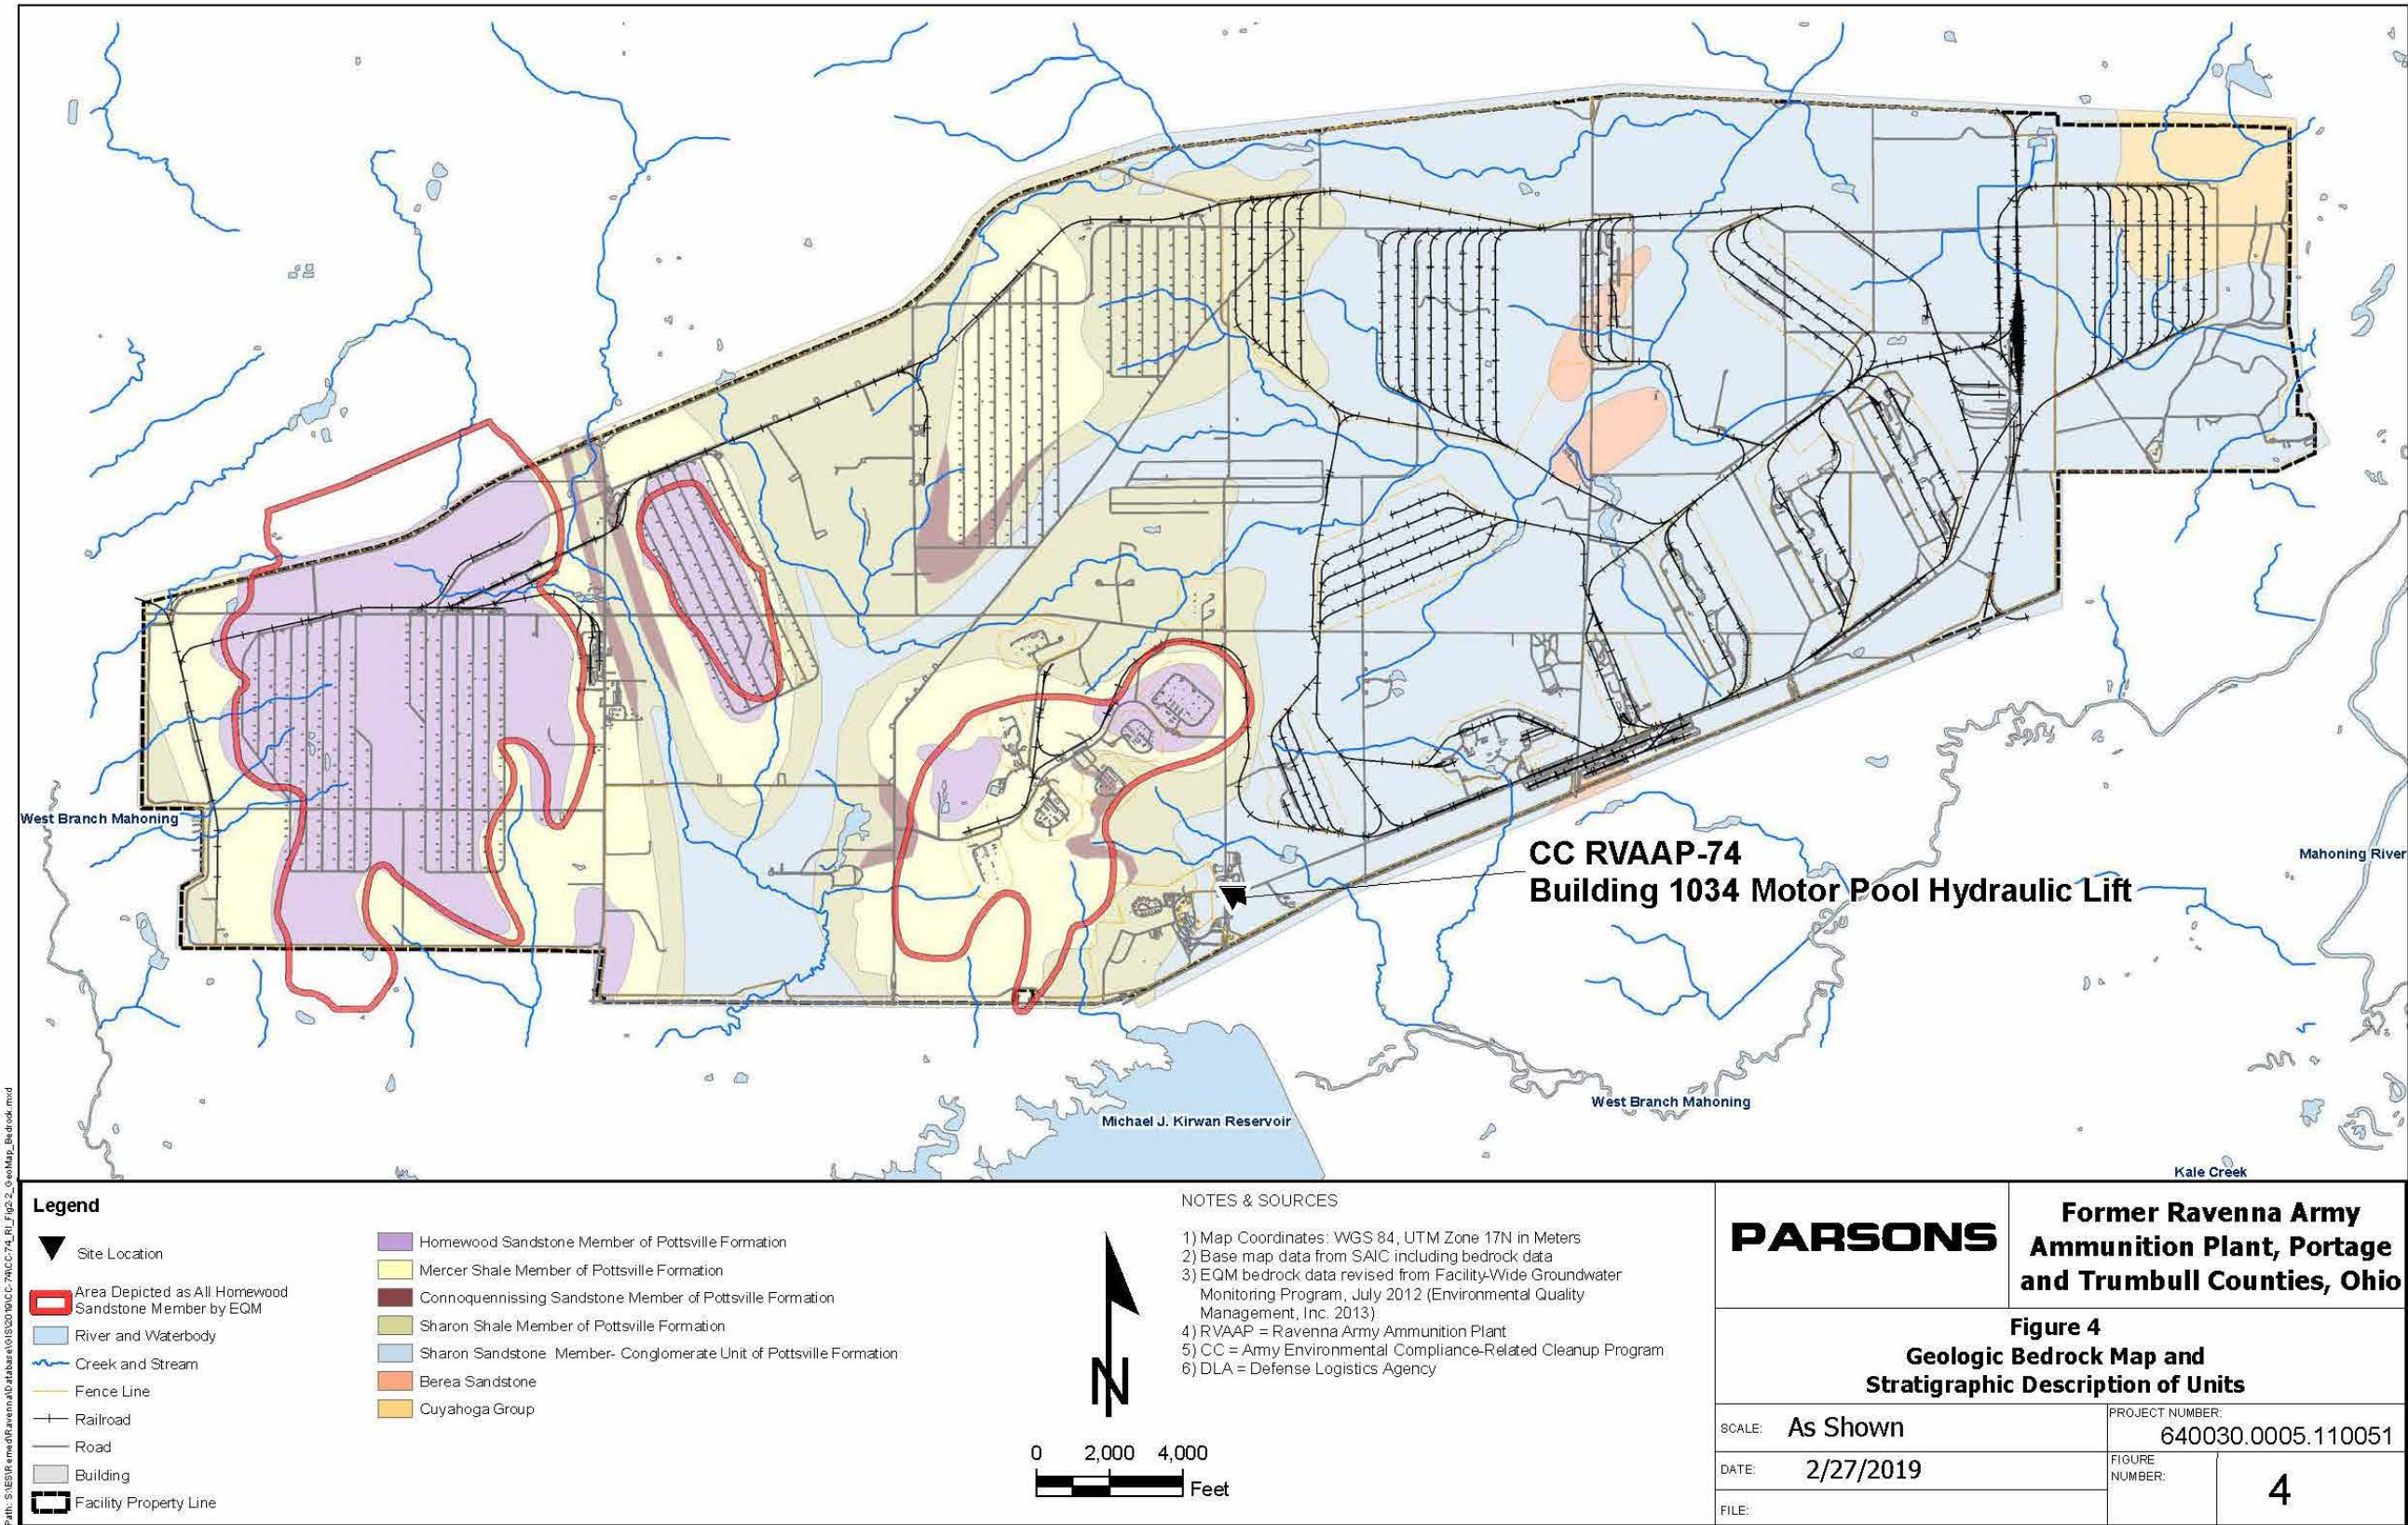
Figure 4. Geologic Bedrock Map and Stratigraphic Description of Units

The regional geology at the facility consists of horizontal to gently dipping bedrock strata of Mississippian and Pennsylvanian age overlain by varying thicknesses of unconsolidated glacial deposits. The bedrock and unconsolidated geology at CJAG are shown on Figure 4 and Figure 5, respectively, and discussed below.

The Sharon Member of the Pennsylvanian Pottsville formation is the primary bedrock unit underlying CJAG (Figure 4). The lower portion of the Sharon Sandstone Member is informally referred to as the Sharon Conglomerate. In the western portion of the facility, the upper members of the Pottsville Formation, including the Massillon Sandstone, Mercer Shale, and uppermost Homewood Sandstone, have been identified (Figure 4). Bedrock at CJAG is overlain by deposits of the Wisconsin-age Lavery Till in the western portion of CJAG and the younger Hiram Till and associated outwash deposits in the eastern two-thirds of CJAG (Figure 5). Unconsolidated glacial deposits vary considerably in their character and thickness across CJAG, from zero in some of the eastern portions of CJAG to an estimated 150 ft in the south-central portion.

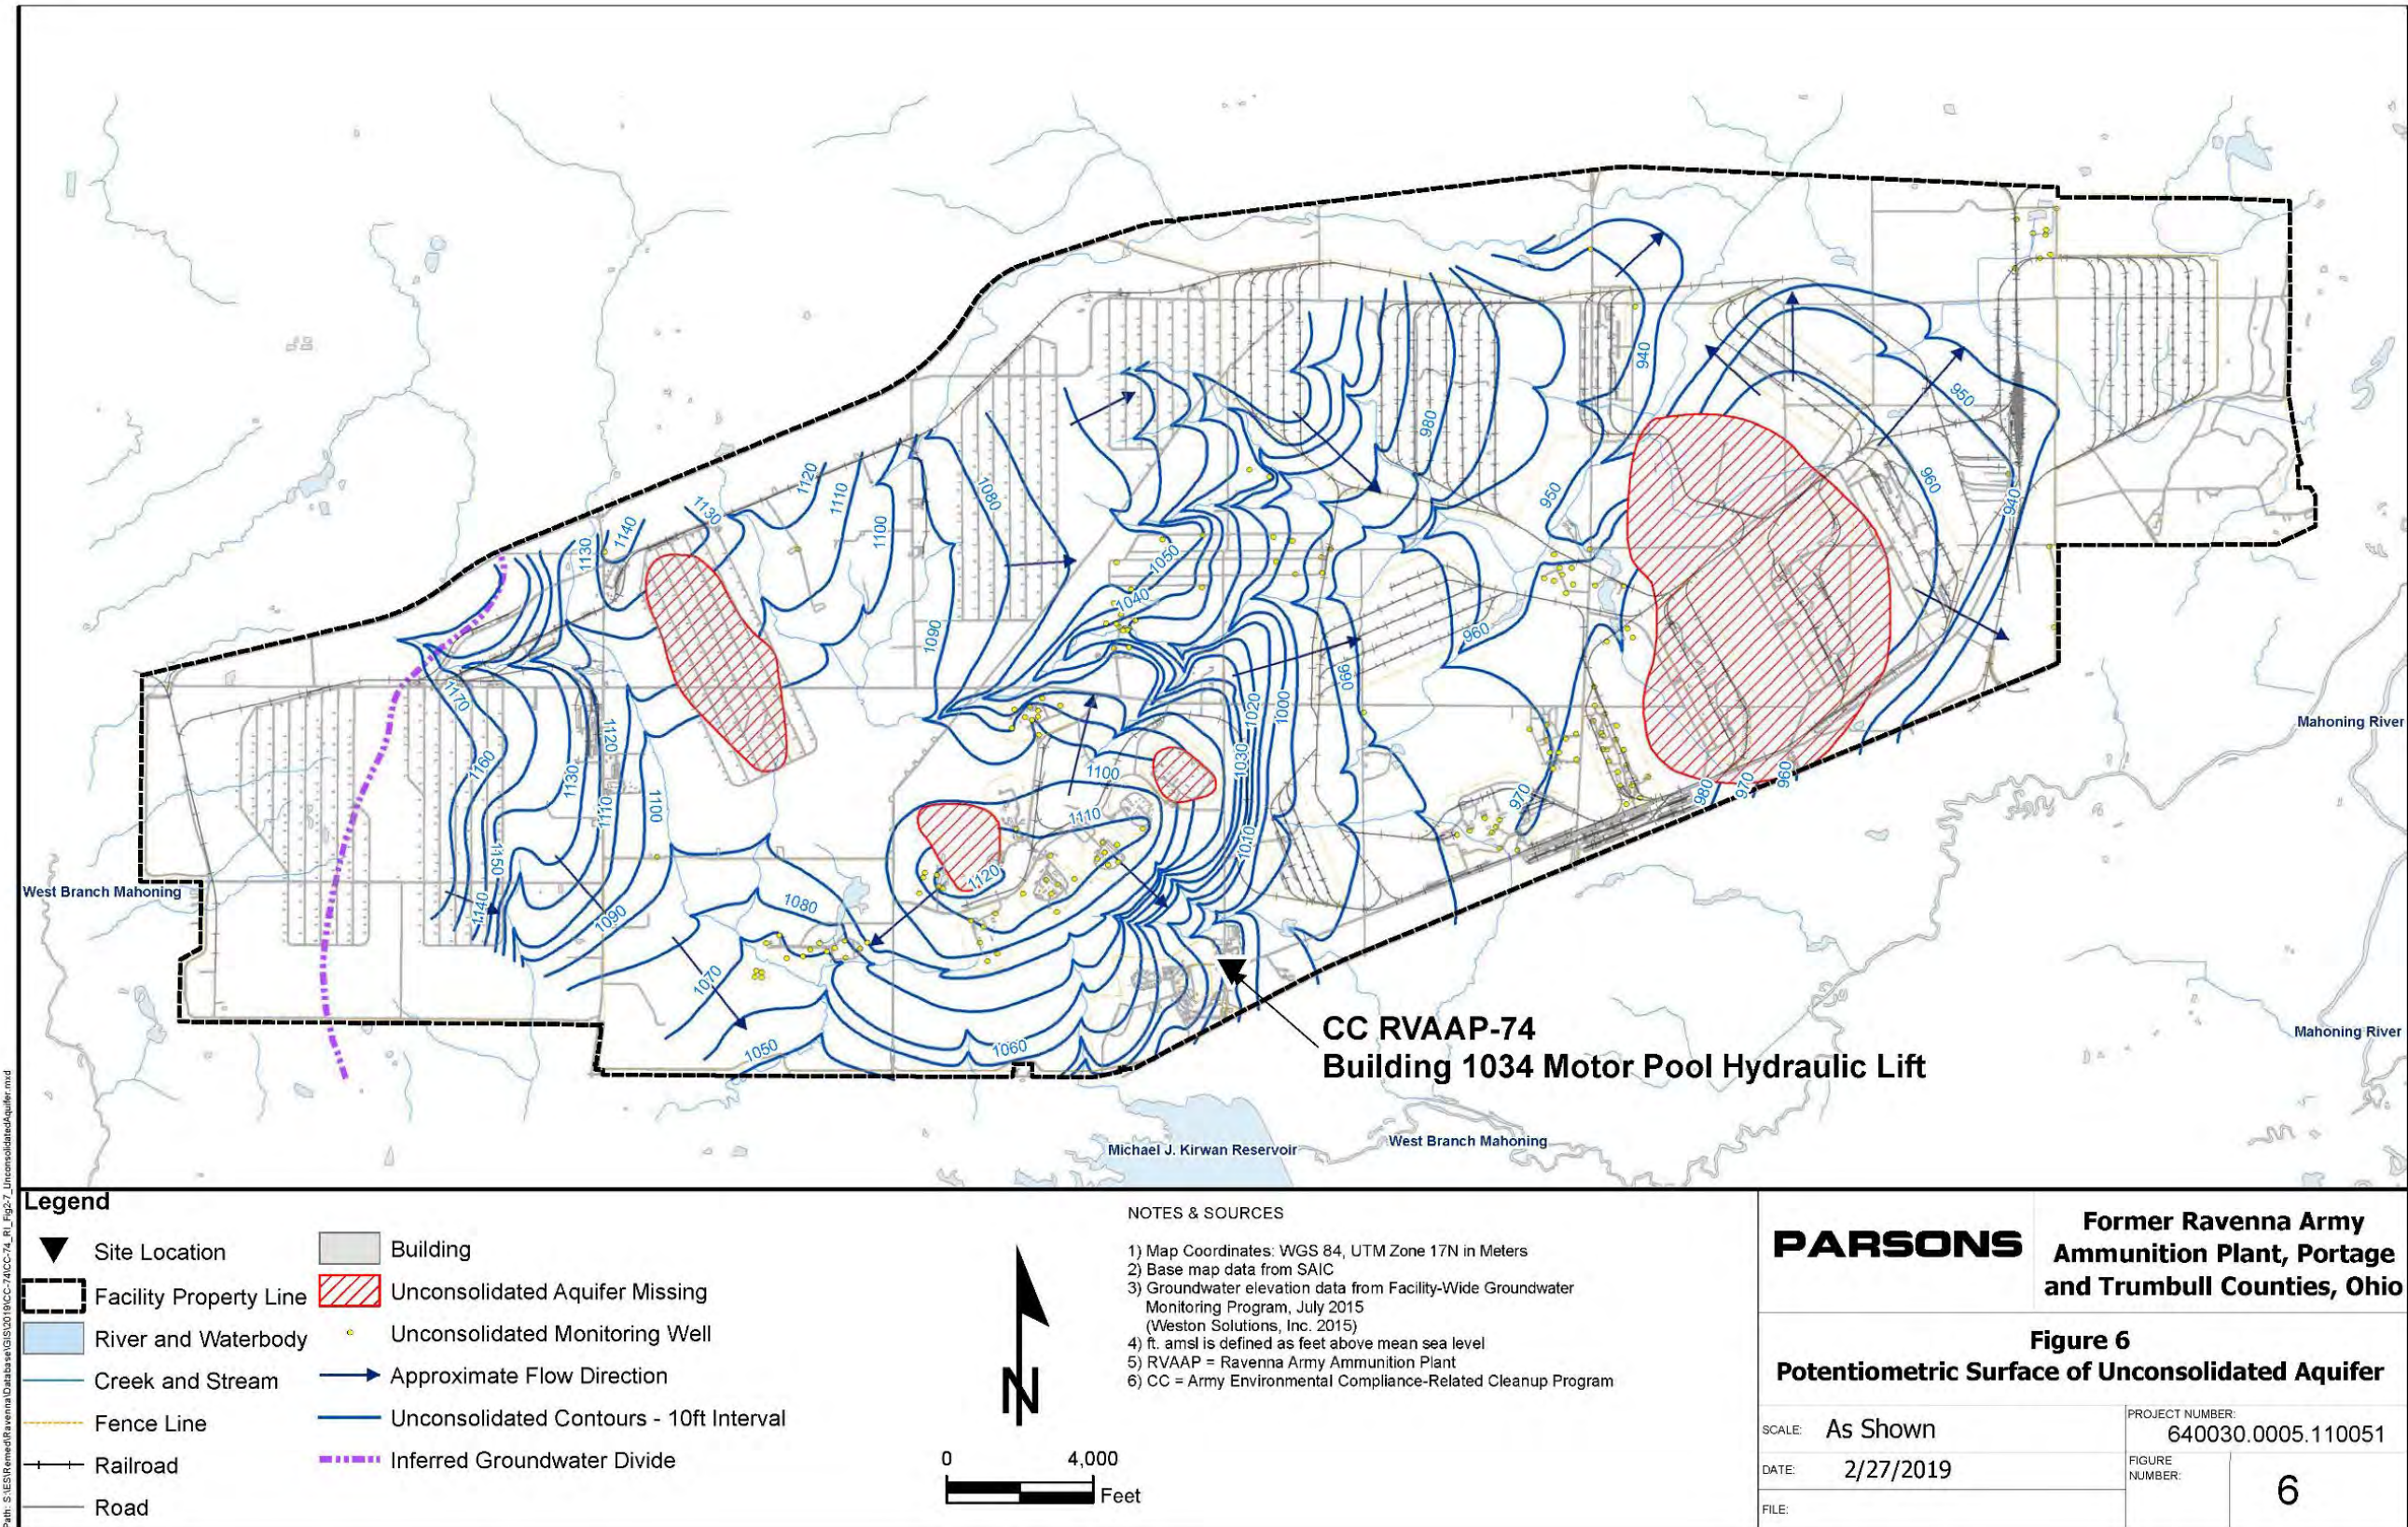
Figure 6. Potentiometric Surface of Unconsolidated Aquifer

Groundwater occurs in both the unconsolidated deposits and bedrock units beneath CJAG. The groundwater elevations of the unconsolidated deposits are shown on Figure 6. The potentiometric surface of the Homewood Sandstone Member (uppermost aquifer of the Pottsville Formation) is presented on Figure 7; the potentiometric surface of the upper Sharon Sandstone Member (intermediate aquifer of the Pottsville Formation) is presented on Figure 8; and the potentiometric surface of the Basal Sharon Sandstone Member (referred to in this RI as the Sharon Conglomerate; the deepest aquifer of the Pottsville Formation) is presented on Figure 9. The potentiometric surfaces at CJAG for unconsolidated deposits (Figure 6) and bedrock (Figures 7 to 9) are based on the facility-wide July 2015 groundwater monitoring event (TEC-Weston Joint Venture 2016).

The hydrogeology for the CC RVAAP-74 Building 1034 Motor Pool Hydraulic Lift is based on data presented in Facility-Wide Groundwater Monitoring Annual Report (TEC-Weston Joint Venture 2016) and from boring logs and wells installed at the site. Three groundwater monitoring wells (074MW-001, 074MW-002, and 074MW-003) were installed between 9 and 16 February 2018. These monitoring wells were installed with screens set approximately 10-20 feet bgs across the water table. Local groundwater flow in the unconsolidated aquifer is towards the southeast, as shown on Figure 6.

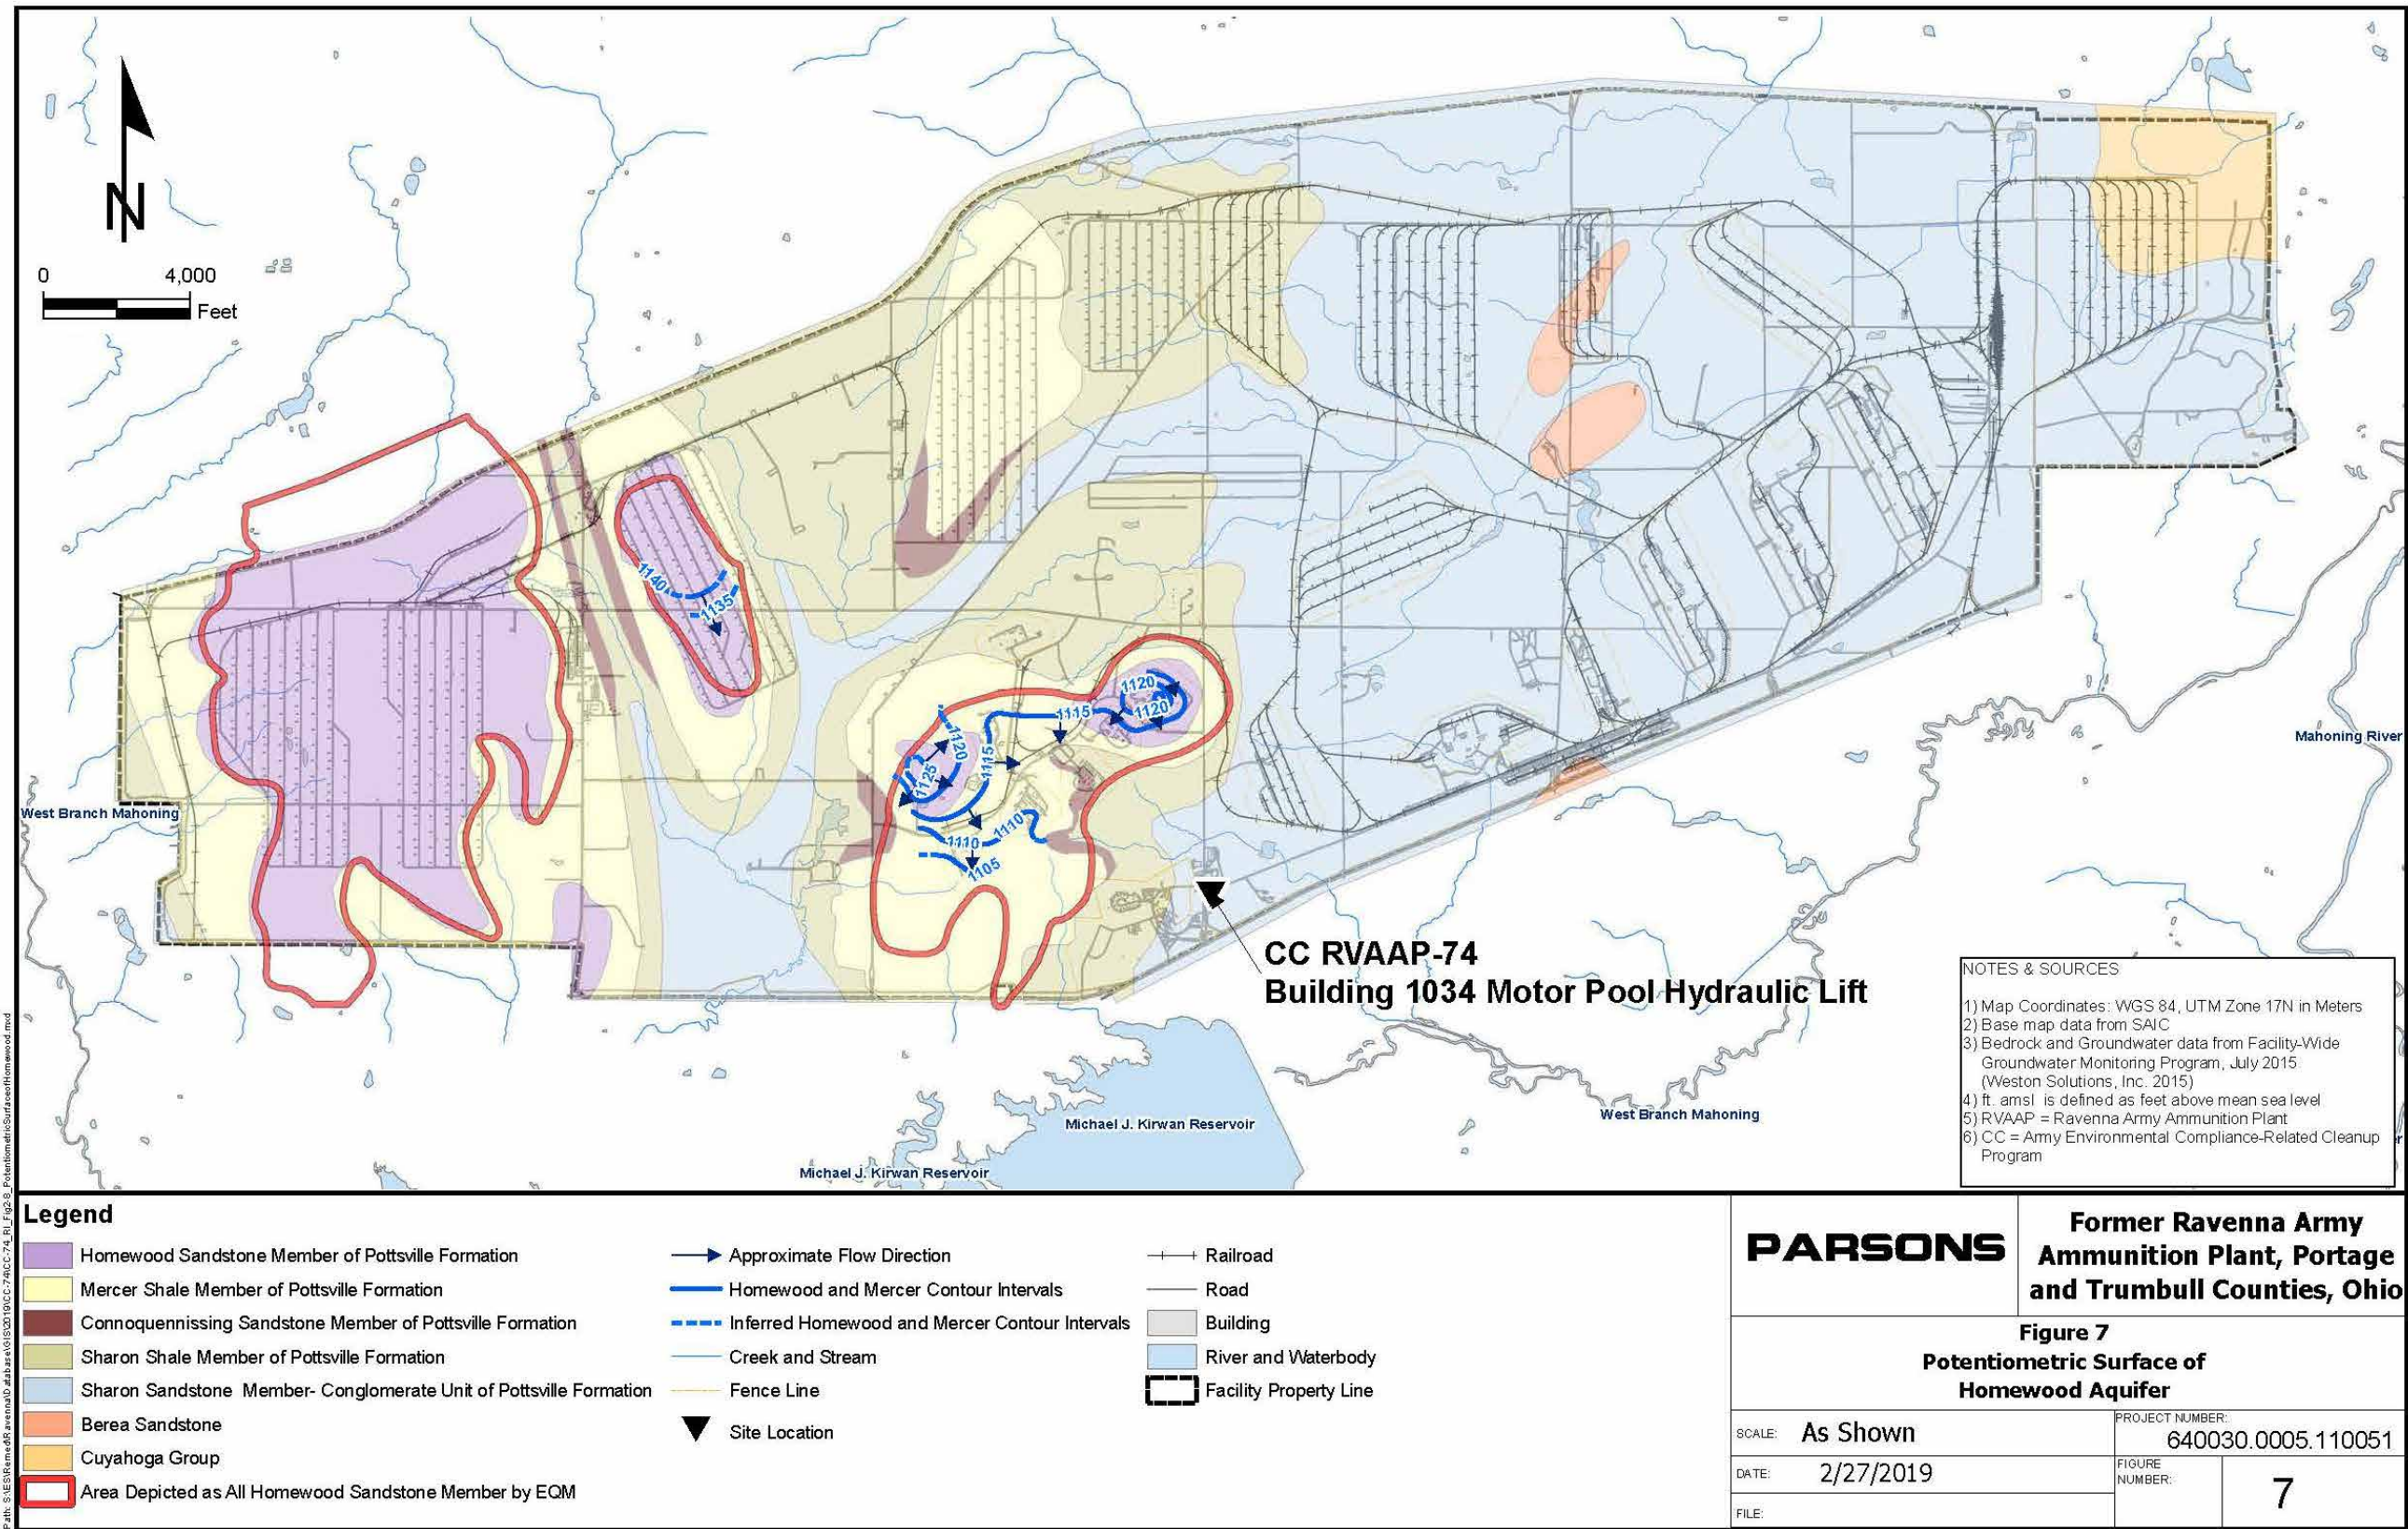
Figure 7. Potentiometric Surface of Homewood Aquifer

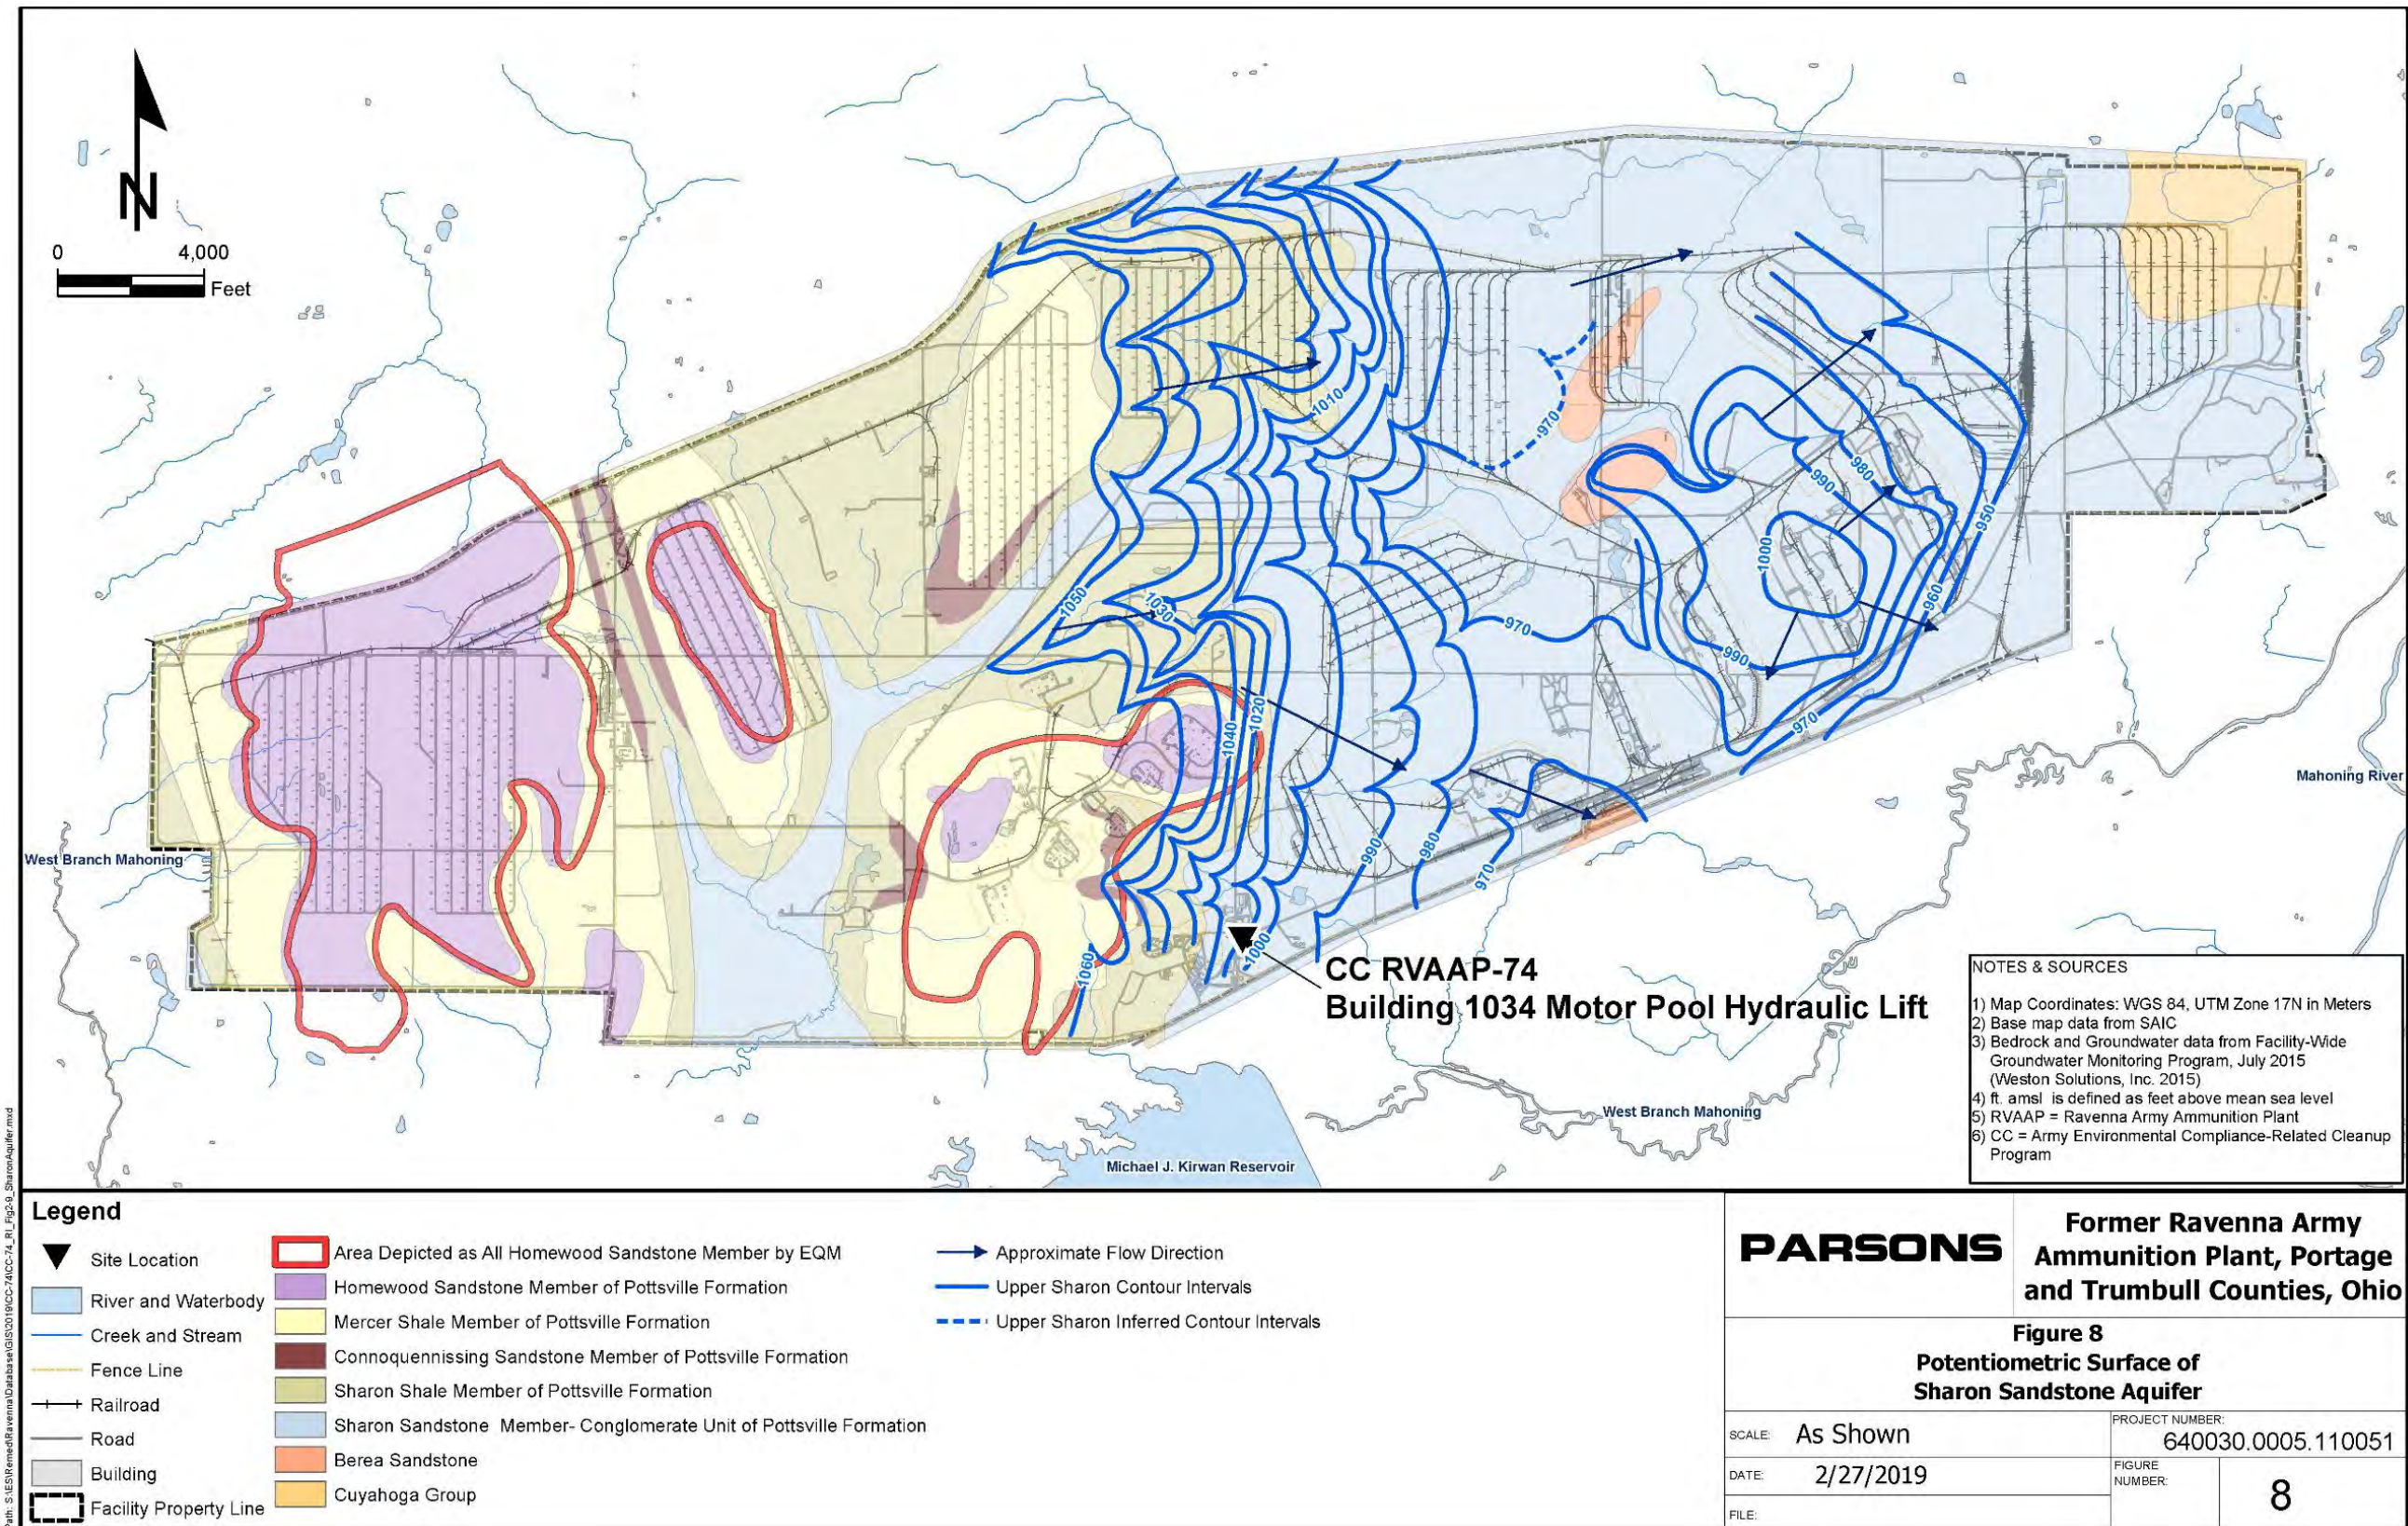
Figure 8. Potentiometric Surface of Sharon Sandstone Aquifer
