**Record of Decision
for CC RVAAP-74
Building 1034 Motor Pool Hydraulic Lift**

**Ravenna Army Ammunition Plant Restoration Program
Portage and Trumbull Counties, Ohio**

**Contract No. W912QR-12-D-0002
Delivery Order: 0003**

PARSONS
401 Diamond Drive NW
Huntsville, AL 35806
256-837-5200

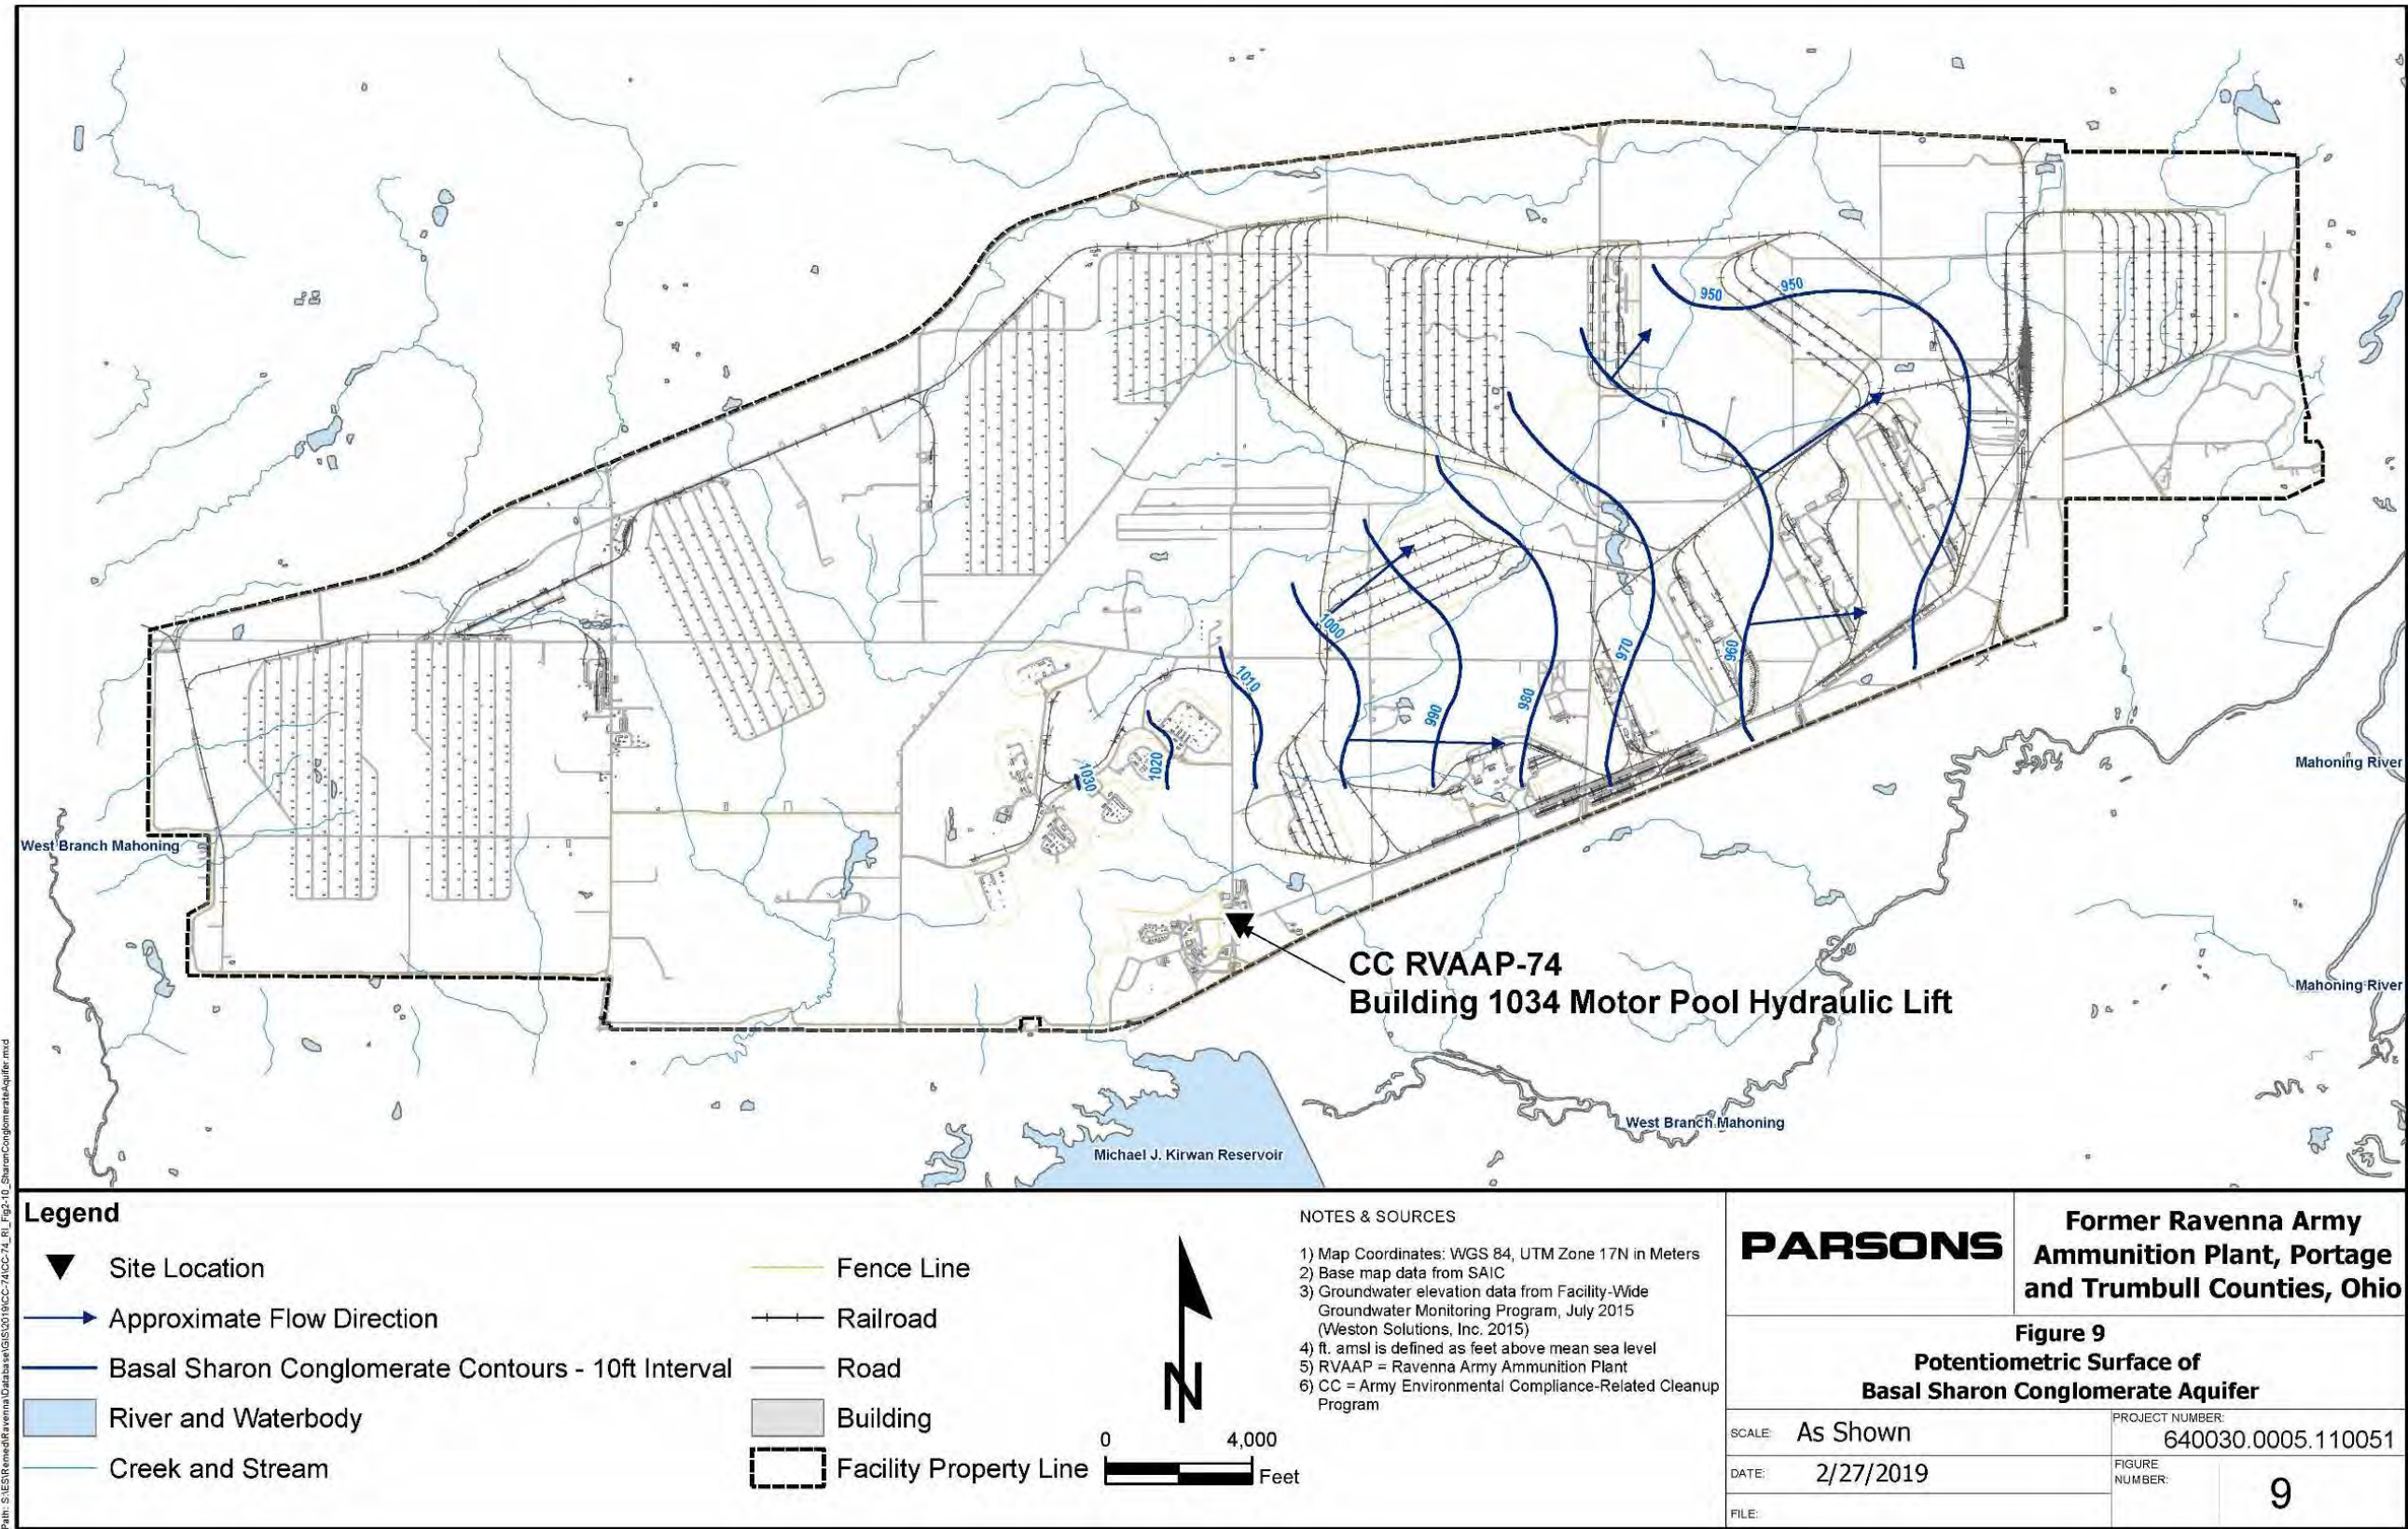
Figure 9. Potentiometric Surface of Basal Sharon Conglomerate Aquifer

Groundwater occurs in both the unconsolidated deposits and bedrock units beneath CJAG. The groundwater elevations of the unconsolidated deposits are shown on Figure 6. The potentiometric surface of the Homewood Sandstone Member (uppermost aquifer of the Pottsville Formation) is presented on Figure 7; the potentiometric surface of the upper Sharon Sandstone Member (intermediate aquifer of the Pottsville Formation) is presented on Figure 8; and the potentiometric surface of the Basal Sharon Sandstone Member (referred to in this RI as the Sharon Conglomerate; the deepest aquifer of the Pottsville Formation) is presented on Figure 9. The potentiometric surfaces at CJAG for unconsolidated deposits (Figure 6) and bedrock (Figures 7 to 9) are based on the facility-wide July 2015 groundwater monitoring event (TEC-Weston Joint Venture 2016).
