# Final Former Water Production Wells and Oil and Gas Wells Survey at Ravenna Army Ammunition Plant and Camp Ravenna

Ravenna Army Ammunition Plant Ravenna, Ohio

Contract No. W912QR-11-P-0086 Task Number 2

April 17, 2013

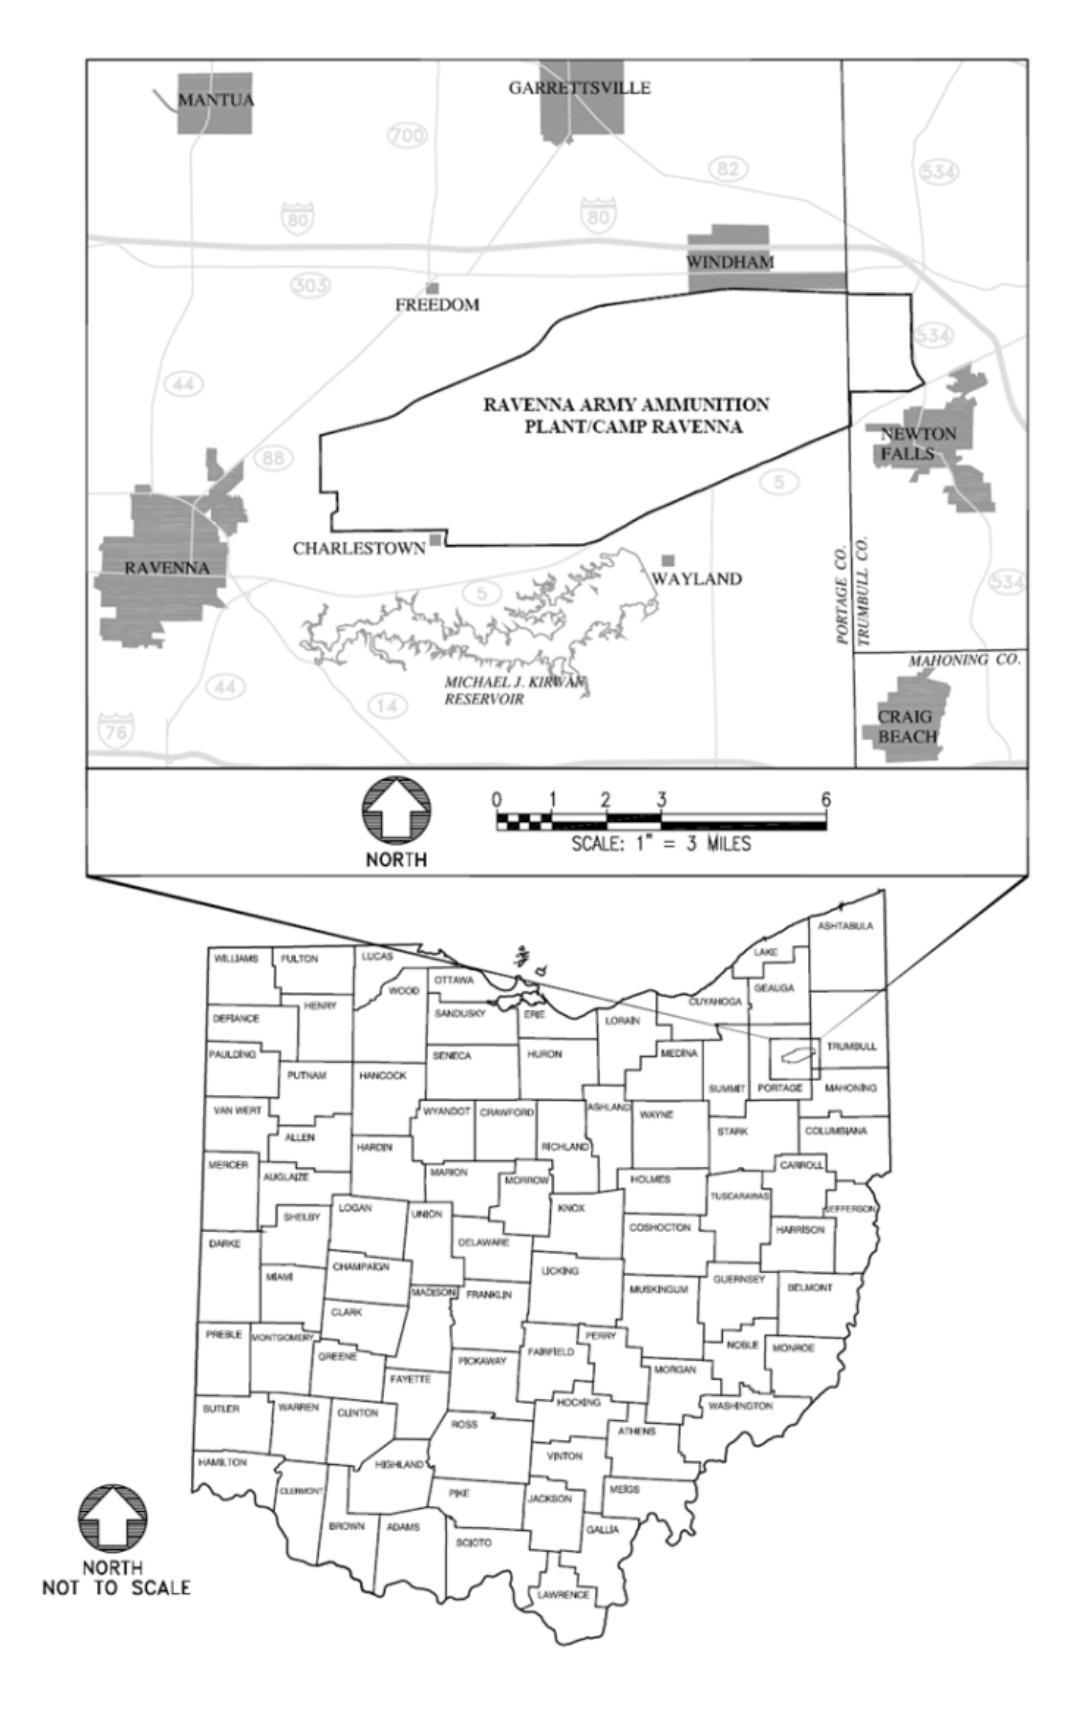
Figure 1.1 The General Location and Orientation of the RVAAP/Camp Ravenna

The facility is located in northeastern Ohio and spans two counties, Portage and Trumbull (see Figure 1.1). The RVAAP portion (approximately 1,260 acres) of the facility is situated only in Portage County while portions (approximately (20,423 acres) of the Camp Ravenna Joint Military Training Center (CRJMTC) are located in both counties. The general climate of the area is considered that of a continental interior and is characterized by moderately warm, humid summers and cold, cloudy winters, along with wide fluctuations in precipitation from year to year. The decline of RVAAP's maintenance and the climatic conditions created a proliferation of dense vegetative overgrowth, which characterizes much of the current day facility. This dense vegetation hindered visual observation for identifying and locating the former production wells at RVAAP and CRJMTC.

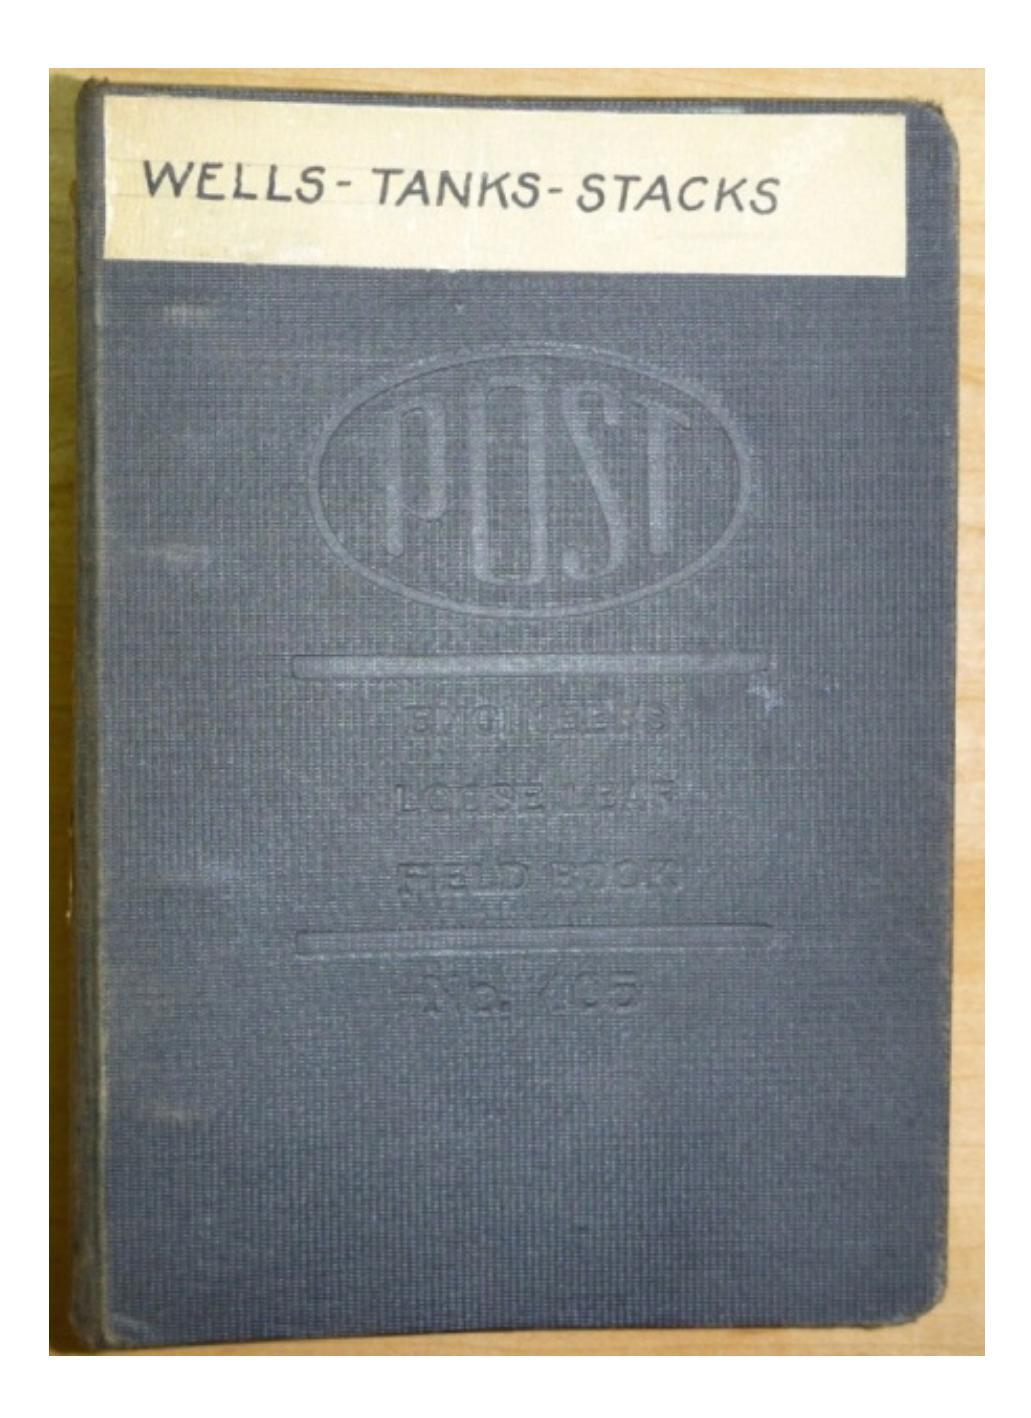
Figure 2.1 Wells-Tanks-Stacks surveyor's field book

The notebook titled, 'Wells-Tanks-Stacks' is a surveyor's field book (see Figure 2.1). The field book notes were kept by survey crews from the H&C Company who was the Ravenna Arsenal General Contractor. The field book is a log containing handwritten measurements from observations in the field during the period December 1940 to December 1941. The field book contains raw field data, horizontal angles and measured distances, referencing the wells to man-made features, i.e., road intersections, buildings, and railroads. Vertical angles were observed to tops of water towers "tanks" to determine elevations. Vertical angles were also observed to smoke "stacks" to determine if they were leaning and out of plumb. Also embedded within the field book were sections of "level notes". The survey crews not only established the horizontal location of some of the wells, they also determined the elevation above sea level. Typically, in those days, the raw field data was then later "reduced" in the office to arrive at the final calculations, i.e., northing and easting coordinates and elevations.

The coordinates shown on well permit applications are approximate. The search area needed to be reduced. Further document review led to the discovery of additional old surveyor field books. One field book titled, "Well-Tanks-Stacks" was responsible for 85% or more of the wells which were eventually found (see Figure 2.1).

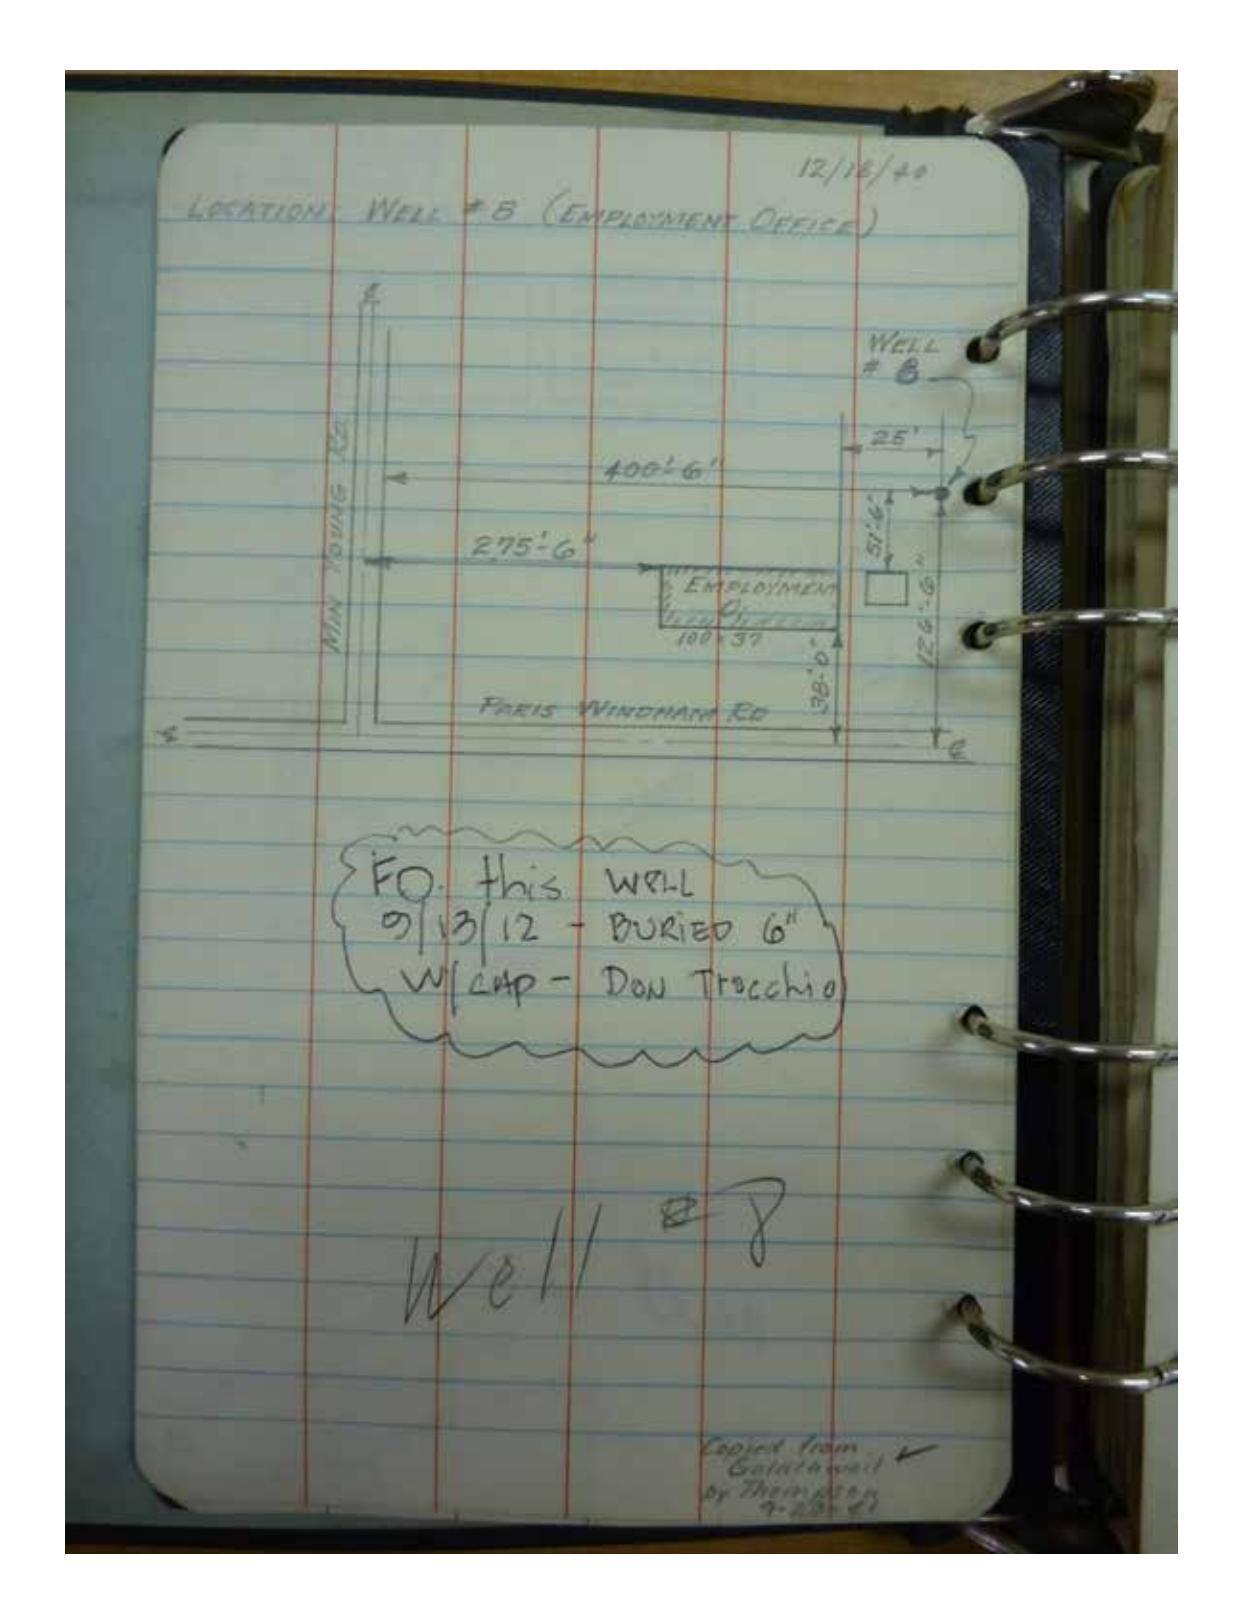
The location of Well No. 8 was referenced to roads (see Figure 2.3). Minyoung Road has been vacated and unused for many years but can still be seen on a 1952 aerial map of the facility. This particular well is a good example of how the location was calculated from the notes and base maps thus shrinking the search area to a small window. Once the calculated position was established on the ground the area was searched for visible signs. The magnetic locator detected this well casing just under the surface close to the calculated position.

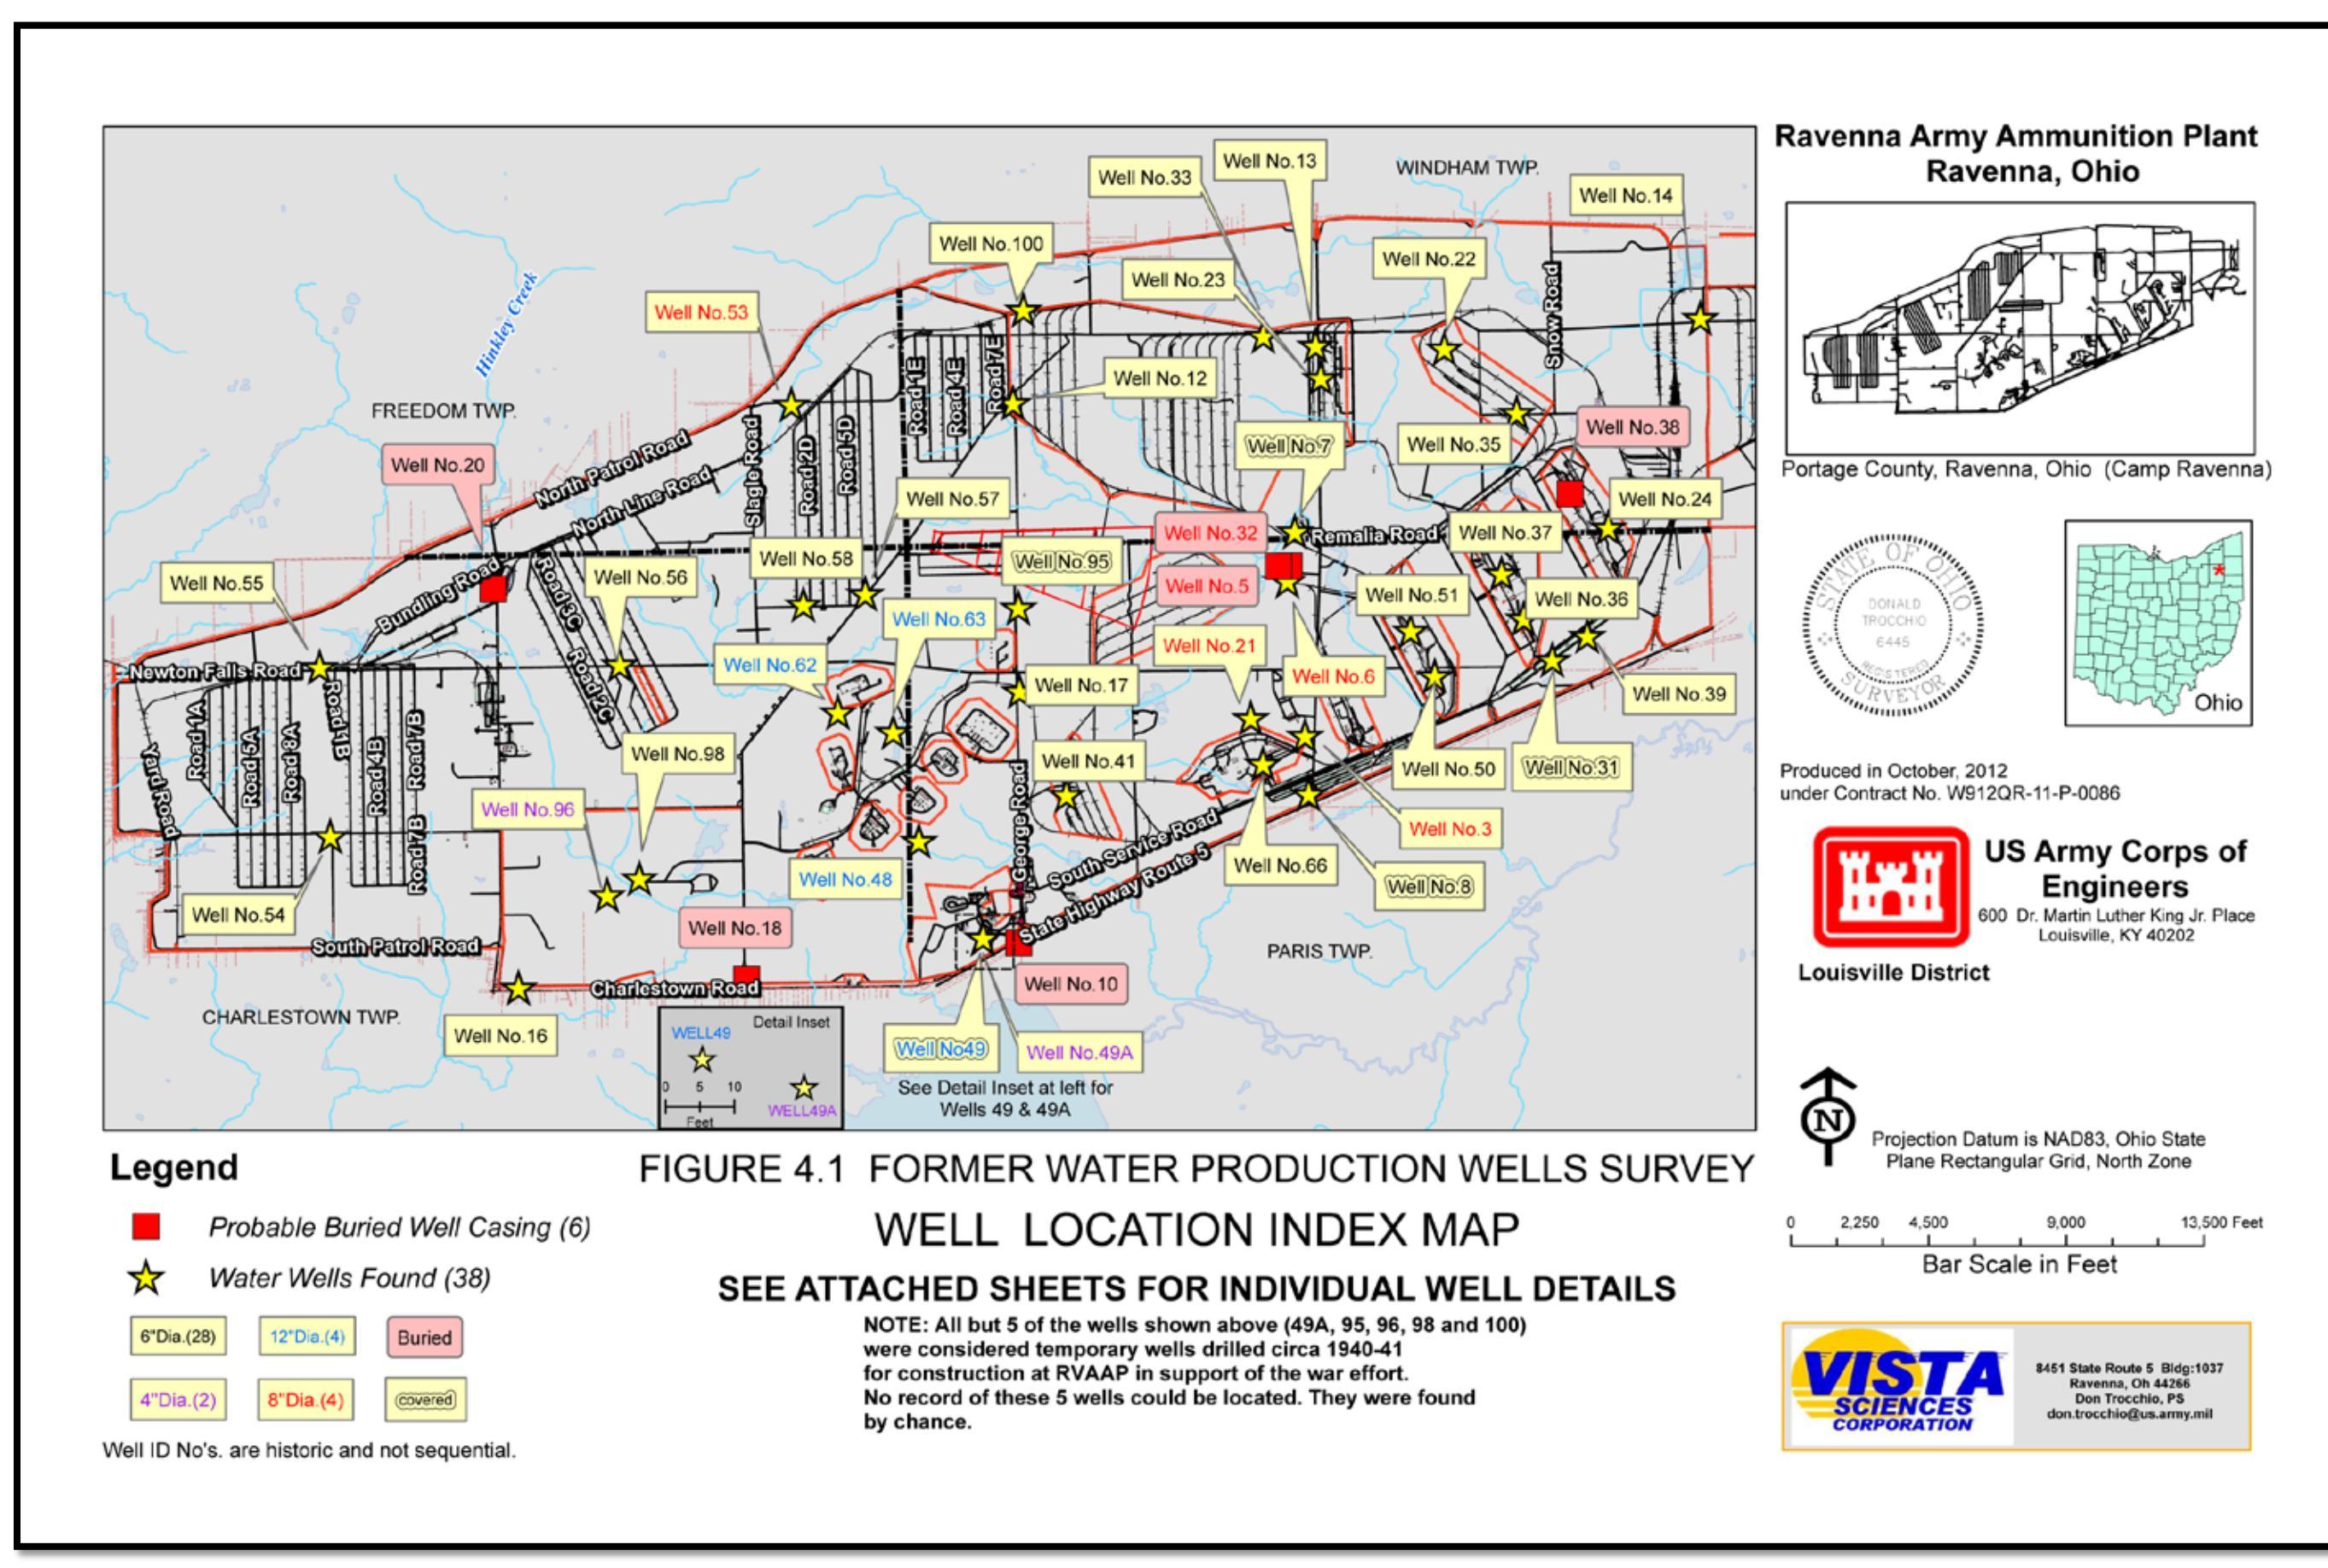
Figure 4.1 is a comprehensive map of the area searched for the former temporary construction wells within the facility. It serves as an index map to the general location of each well casing and suspected well casing found and directs the reader to each specific well detail sheet (see Appendix A – Detail Sheet of Each Located Former Production Water Wells as Shown on Figure 4.1). The legend provides a quick reference to the status and data pertinent to each well. The key utilizes colors, symbols and text (i.e., diameter of well and Well ID), for both confirmed and suspected wells including those wells which were found covered. The well ID numbers direct the user to detail sheets of each well. Data along the right hand side of the Figures 4.1 thru 4.5 outside of the map area is self-explanatory.

Additionally there are six (6) "suspected" water well casings which were detected using a magnetic locator (See Figure 4.1). The term "suspected" refers to the strong magnetic pull exhibited by the magnetic locator very close to the calculated position where the well casing top has been broken off and lies buried approximately 2-3 feet under the surface.

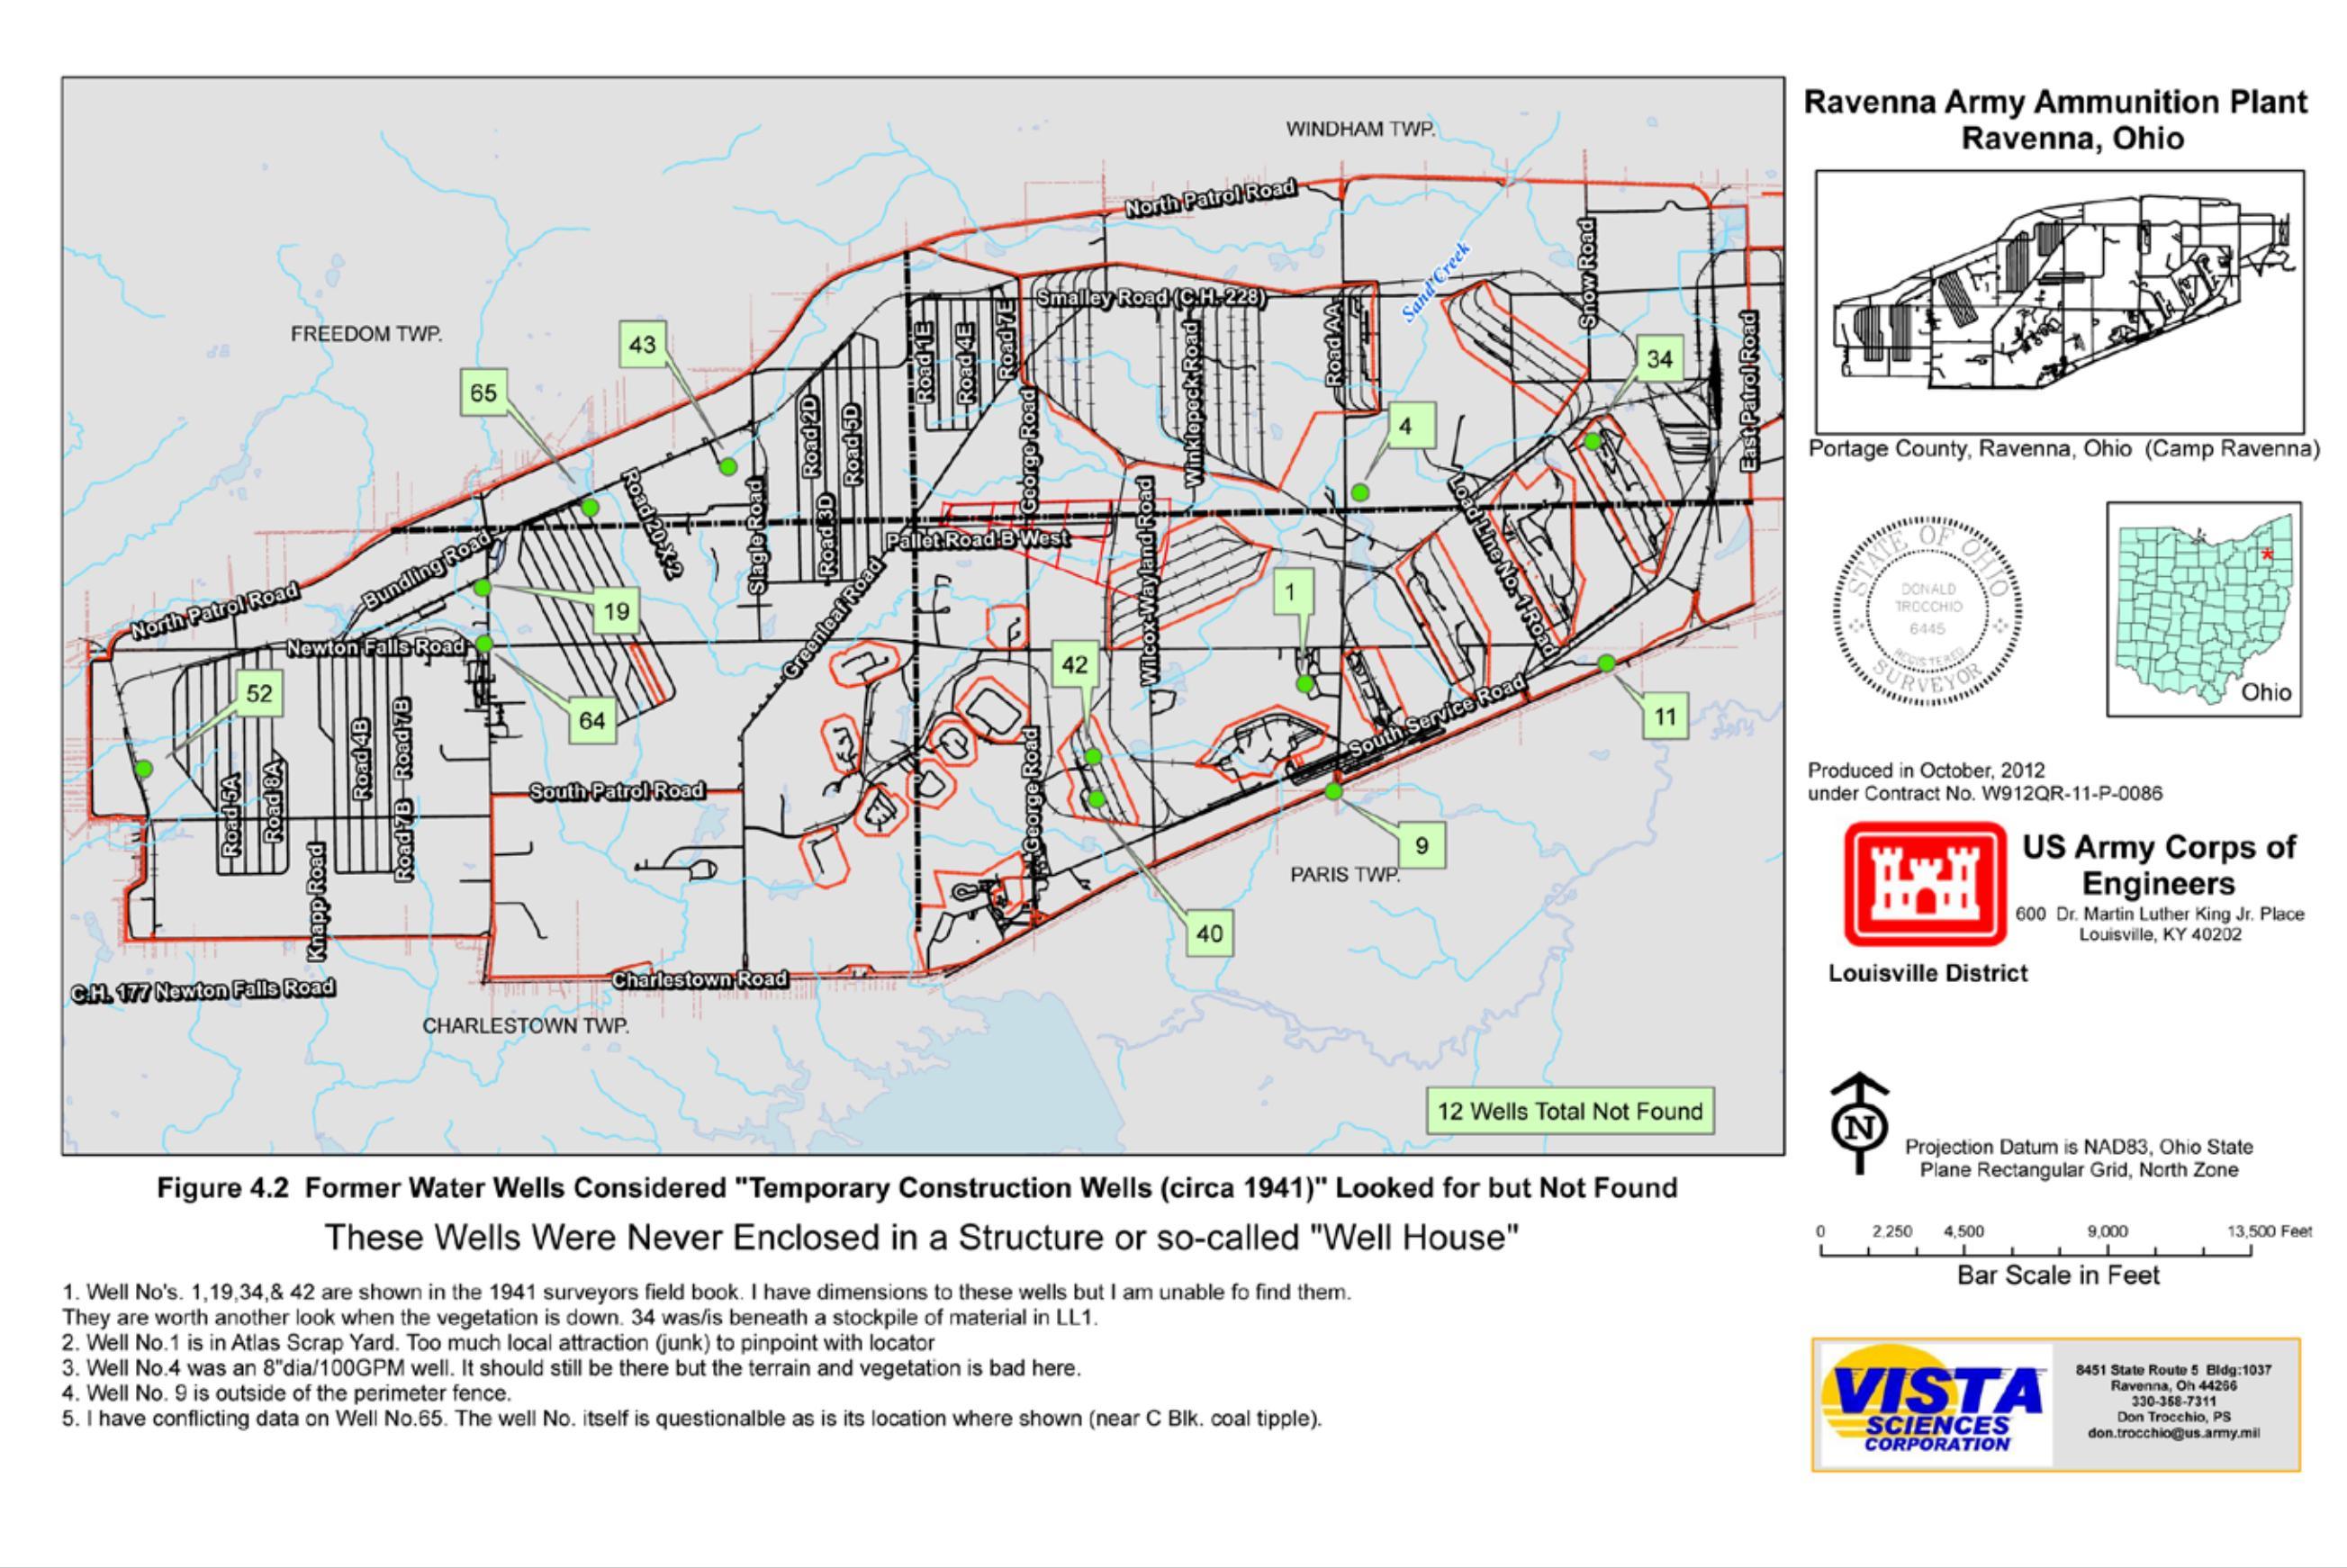
Figure 4.2 is a comprehensive map of the area searched within the facility's boundary. It serves as an index map to the general location of wells that were searched for but not found. No detail sheets were prepared for these wells.

There were a total of twelve (12) water wells that could not be located (See Figure 4.2). Only four (4) of these wells are shown in the 1941 surveyors field book (See Section 2.0 Initial Investigation).

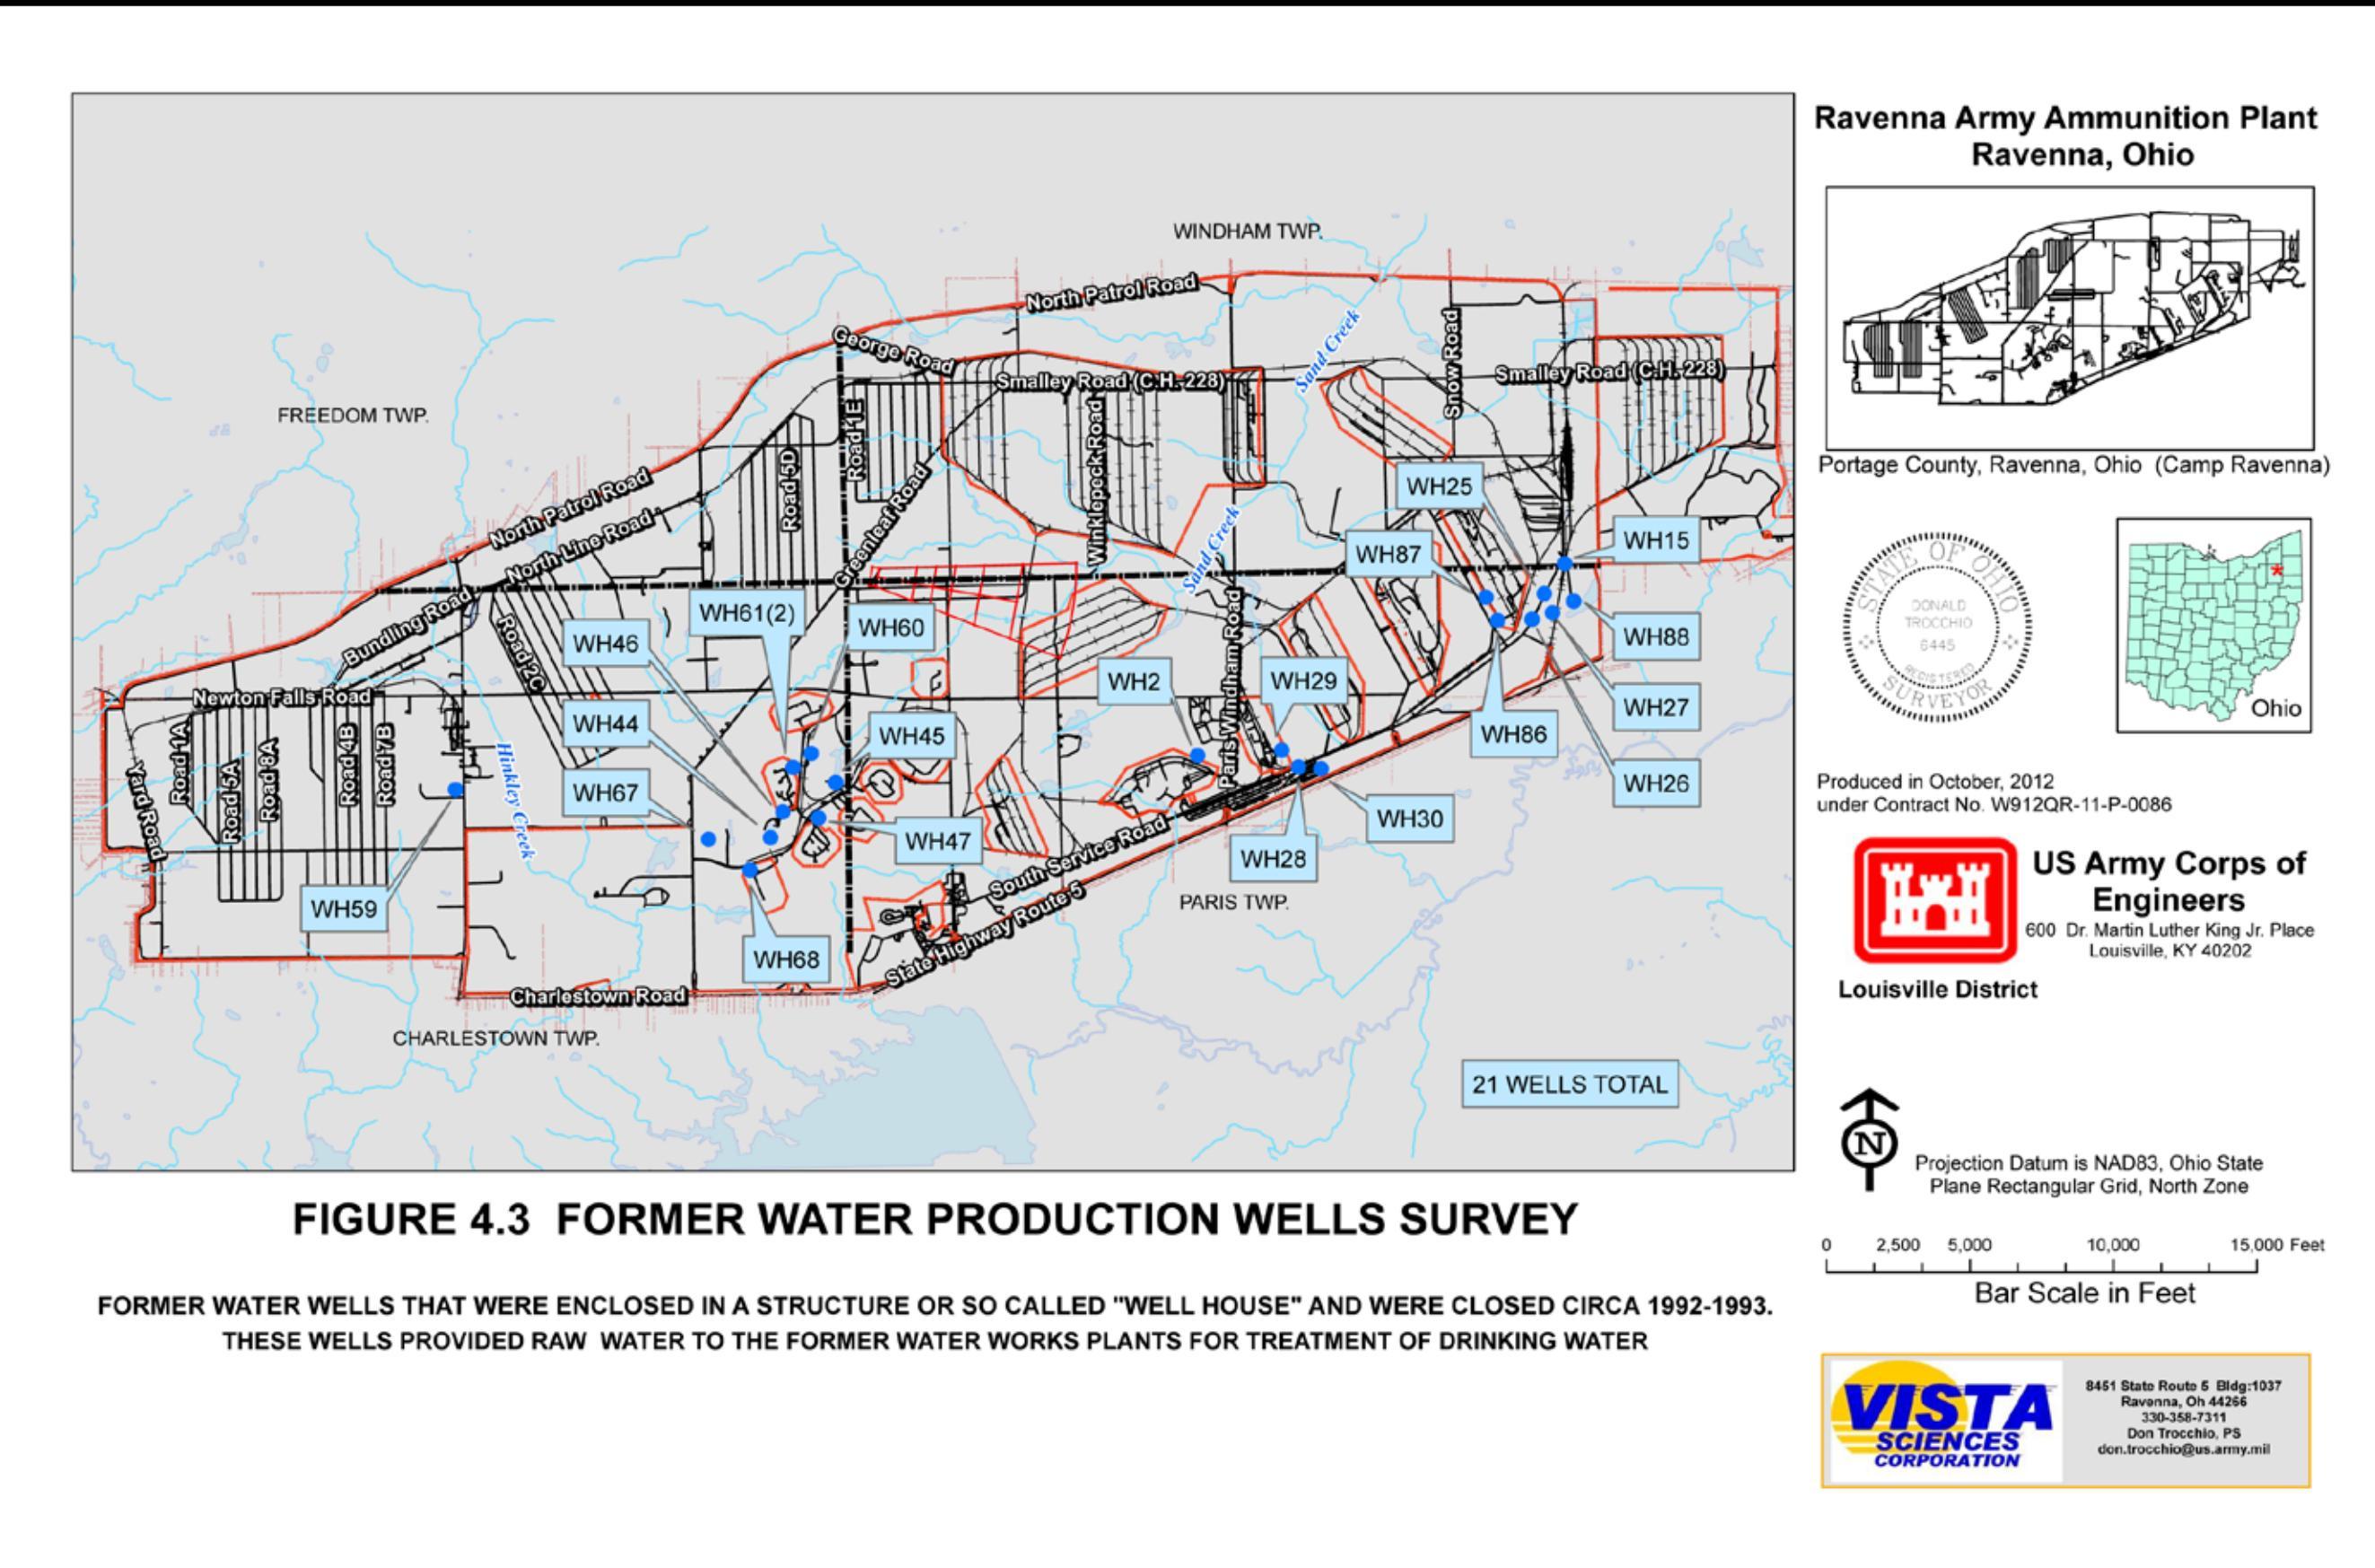
Figure 4.3 is a comprehensive map of the area searched within the facility. It serves as an index map to the general location of each well which was formerly used for drinking water. No detail sheets were prepared for these wells. It is the intent of Figure 4.3 to indicate:

- 1. Which of the wells were formerly used for drinking water
- 2. Which of the wells were enclosed in a 10' x 10' brick structure referred to as a "Well House"
- 3. And which of the wells were closed and sealed (refer to Appendix C Historical Abandoned Wells Documentation 1992 1993)

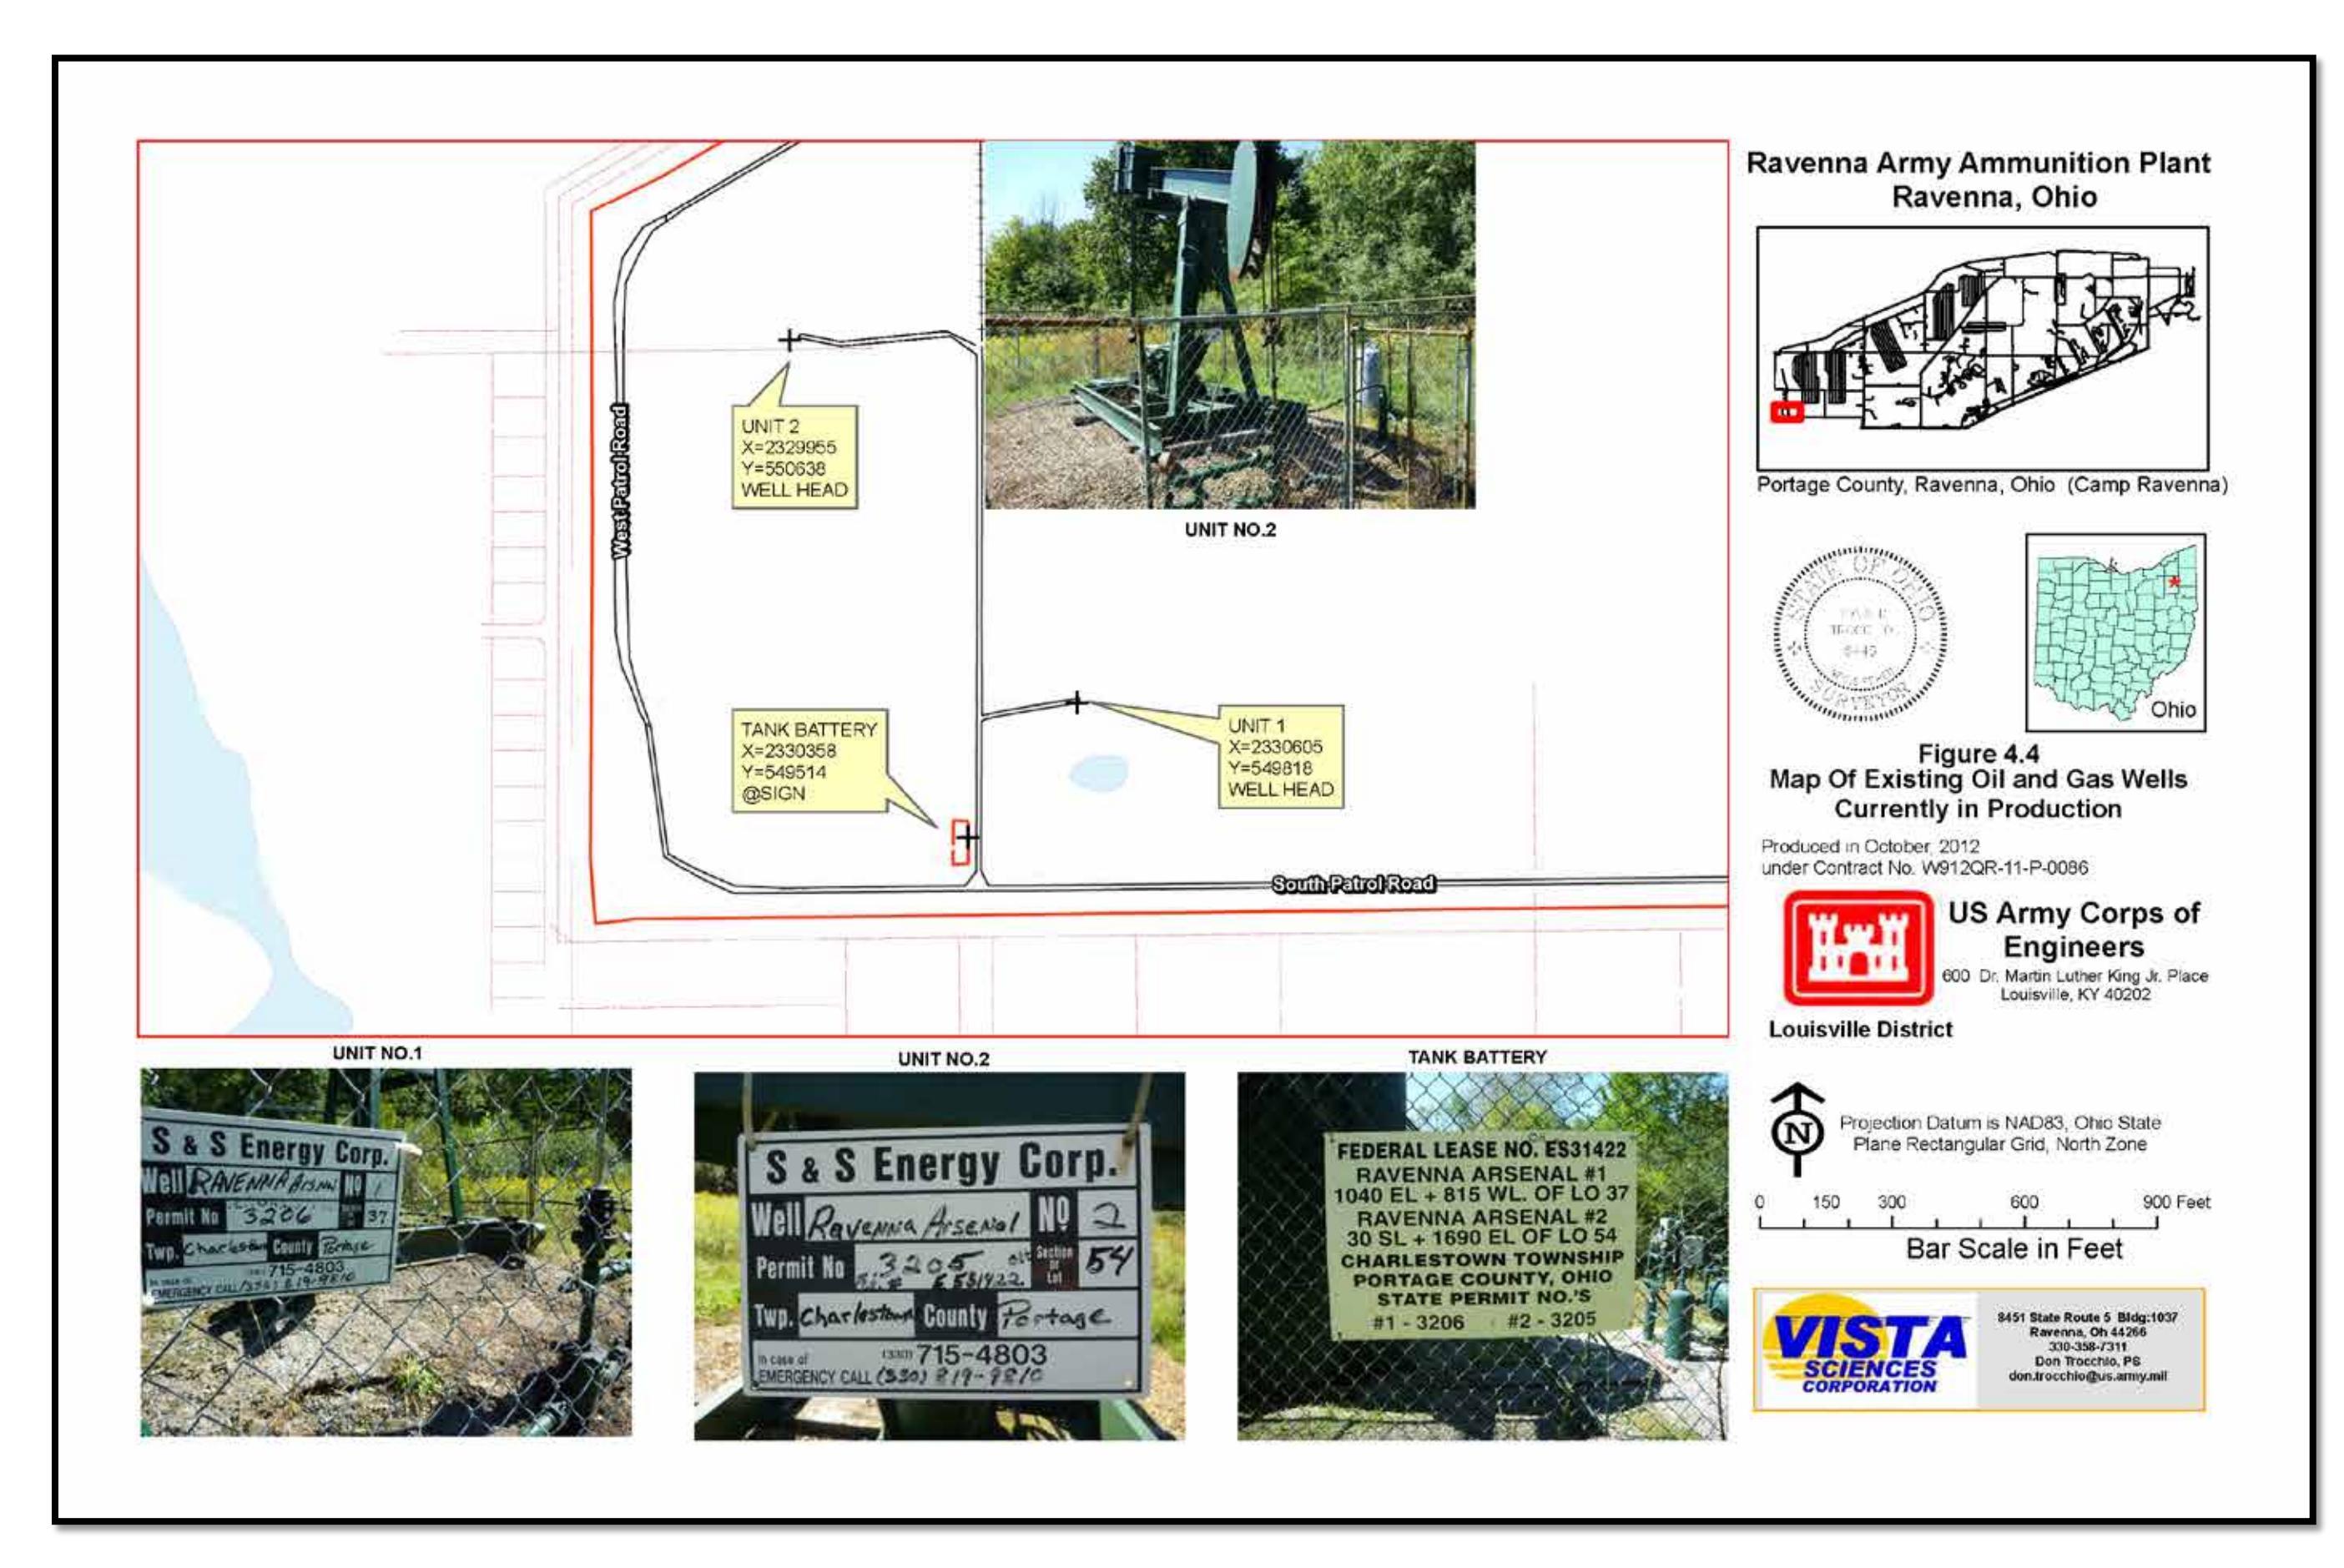
Figure 4.4 depicts an area near the west central portion of the facility where there are two (2) active and producing oil and gas wells. The images incorporated within the figure identify them as Units 1 and 2. A tank battery (a series of vessels and connecting lines designed to separate oil, water, and gas) is located near the south end of the lease road and is identified and shown on the figure.

The two (2) abandoned oil and gas wells could not be located (See Figure 4.5). However the two (2) active oil and gas wells currently in production along with the tank battery were located (See Figure 4.4).
