# Final Former Water Production Wells and Oil and Gas Wells Survey at Ravenna Army Ammunition Plant and Camp Ravenna

Ravenna Army Ammunition Plant Ravenna, Ohio

Contract No. W912QR-11-P-0086 Task Number 2

April 17, 2013

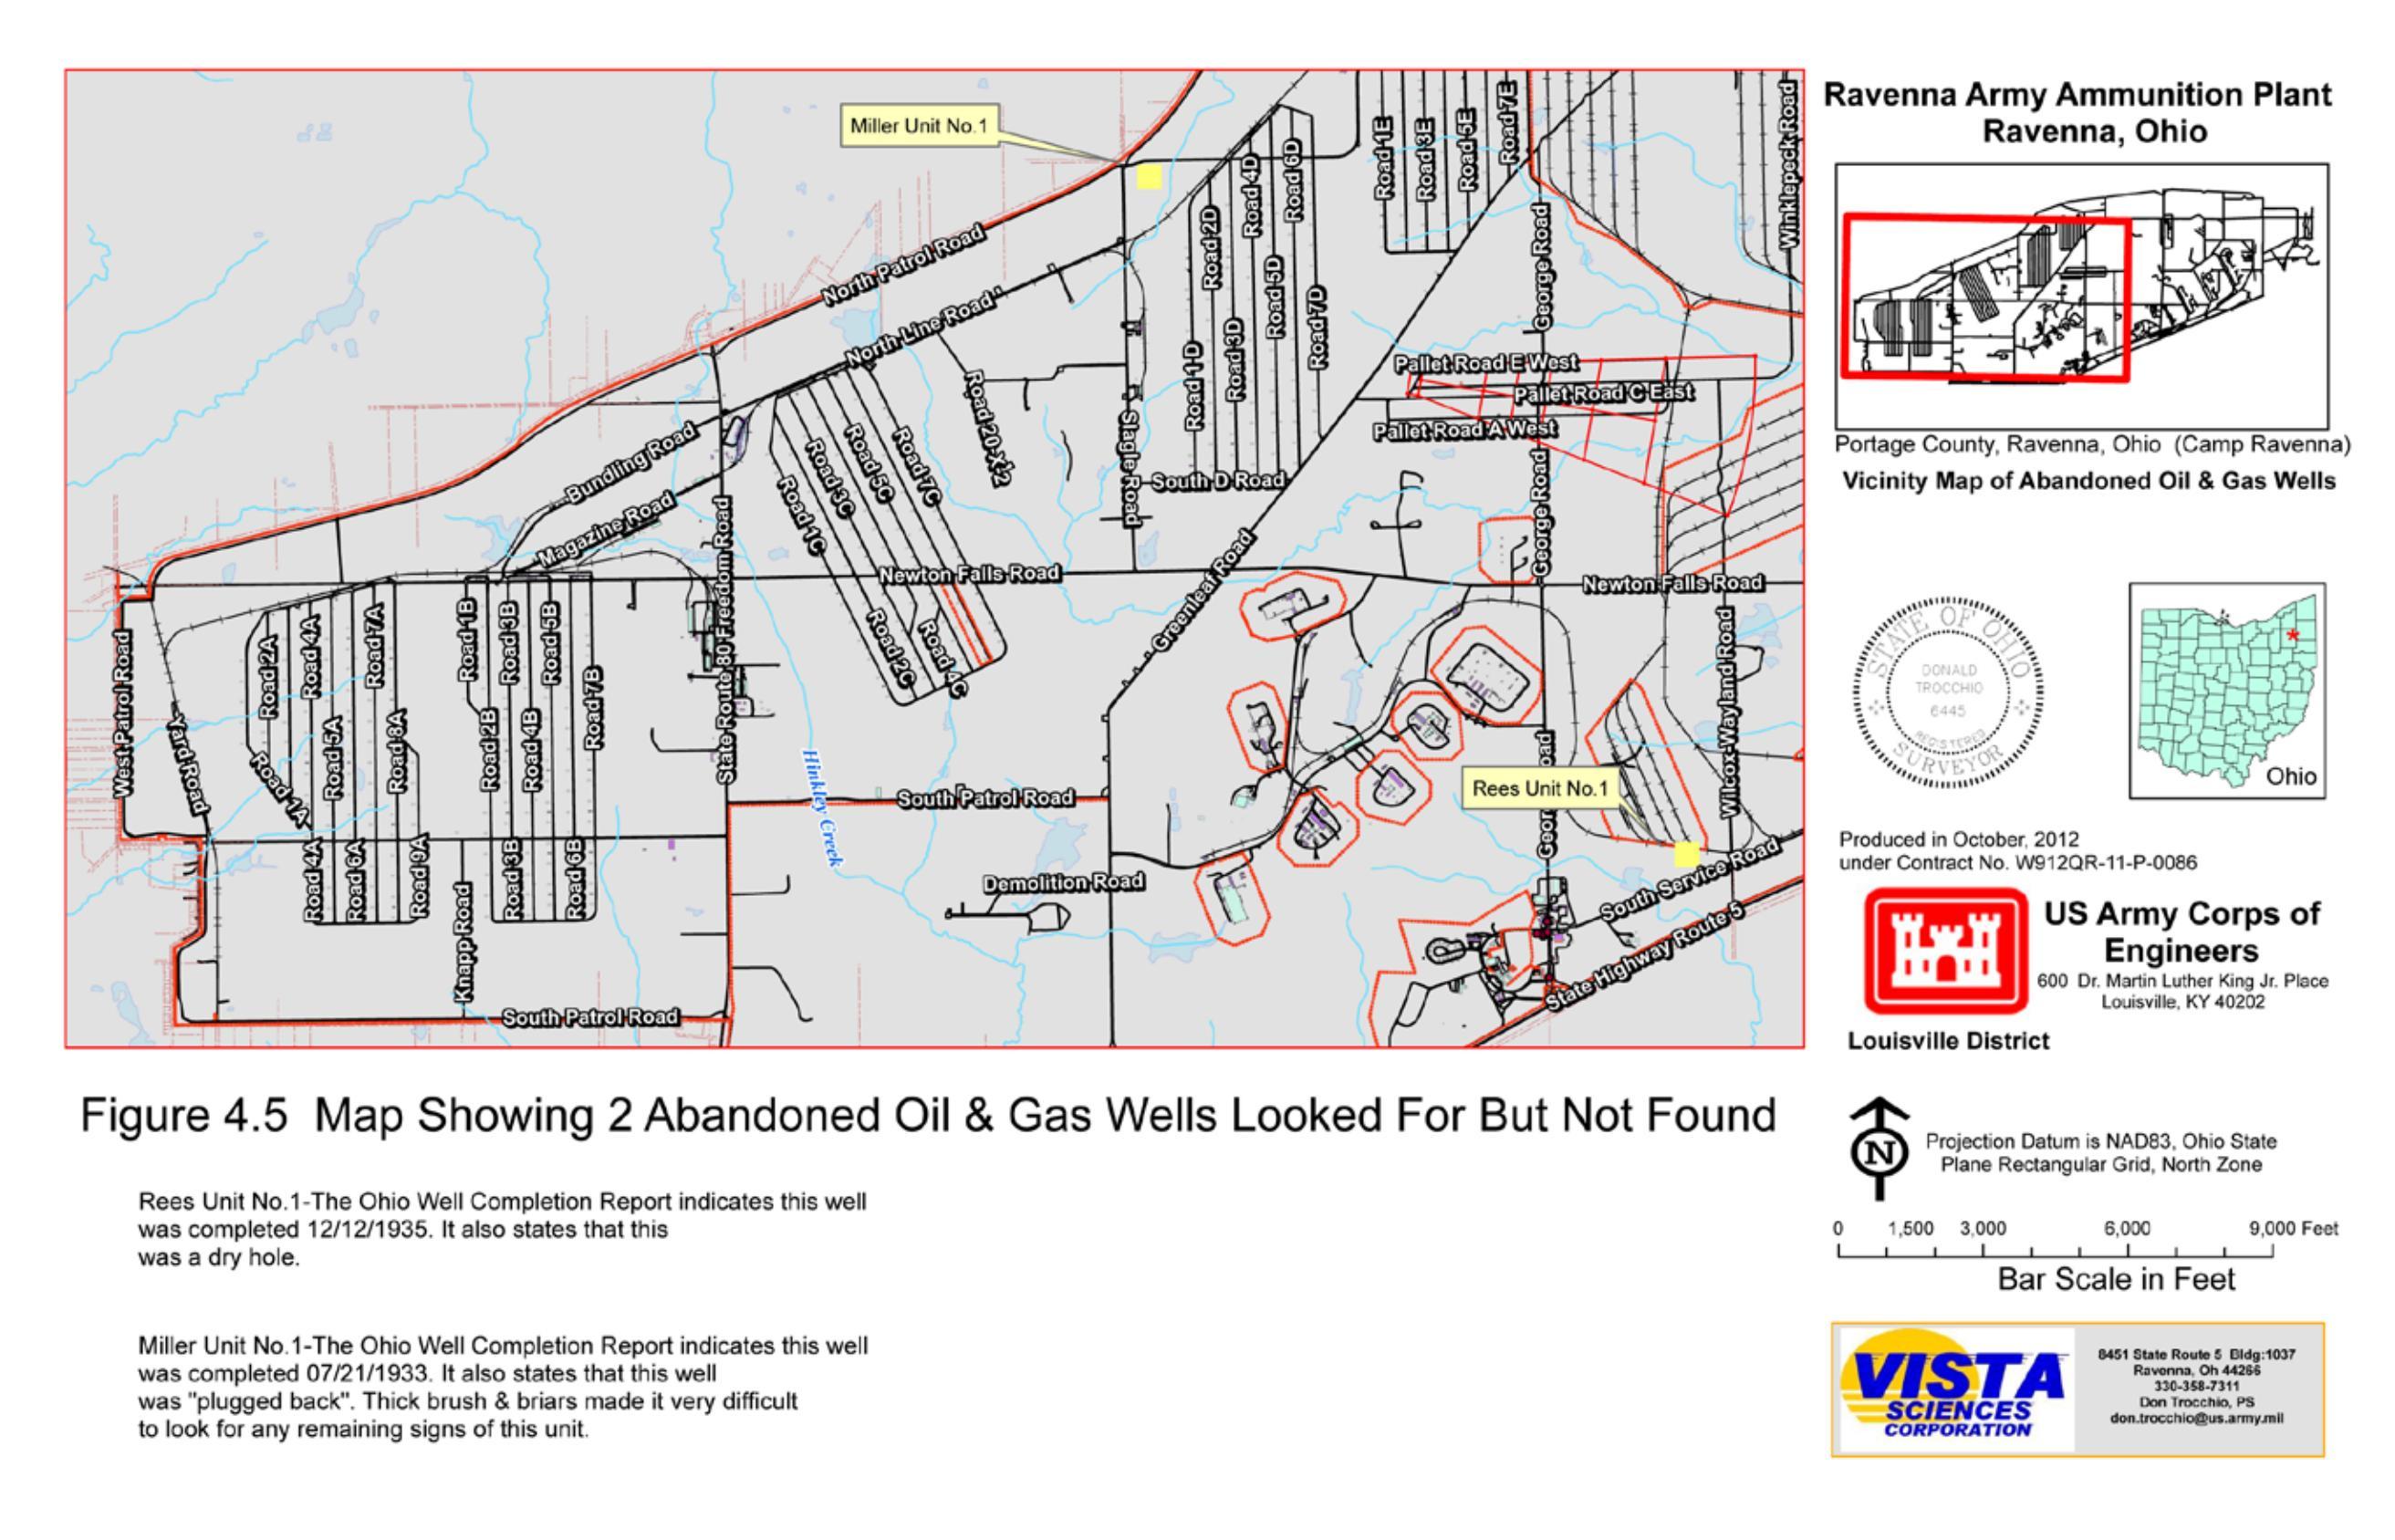
Figure 4.5 depicts the area near the central portion of the facility where two (2) oil and gas wells were drilled but apparently were never brought into production. As shown in Figure 4.5, the Rees Unit No.1 was a "dry hole" and the Miller Unit No.1 was "plugged back" per the Ohio Well Completions Report , an online Oil and Gas database (updated 01/28/2009) of the Ohio Department of Natural Resources Division (ODNR). These 2 units were completed in 1935 and 1933 respectively. Based on the coordinates given in the report, no visible remaining evidence of these wells could be found. The Rees Unit No.1 is just south of Group 4 in a wooded area with visibility being only fair. The Miller Unit No.1 is near the southeast corner of Slagle and Smalley Rds. and is located within heavily overgrown vegetation where visibility and access to this area is poor.

The two (2) abandoned oil and gas wells could not be located (See Figure 4.5). However the two (2) active oil and gas wells currently in production along with the tank battery were located (See Figure 4.4).
