# 1. INTRODUCTION

This report documents the results of the Phase II Remedial Investigation (RI) of Load Line (LL) 1 at the Ravenna Army Ammunition Plant (RVAAP), Ravenna, Ohio (Figures 1-1 and 1-2). The Phase II RI was conducted under the U.S. Department of Defense (DoD) Installation Restoration Program (IRP) by Science Applications International Corporation (SAIC) and their subcontractors, under contract number DACA62-00-D-0001, Delivery Order No. CY09, with the U.S. Army Corps of Engineers (USACE), Louisville District. The Phase II RI was conducted in compliance with the Comprehensive Environmental Response, Compensation, and Liability Act of 1980 (CERCLA following work plans reviewed and commented on by the Ohio Environmental Protection Agency (Ohio EPA).

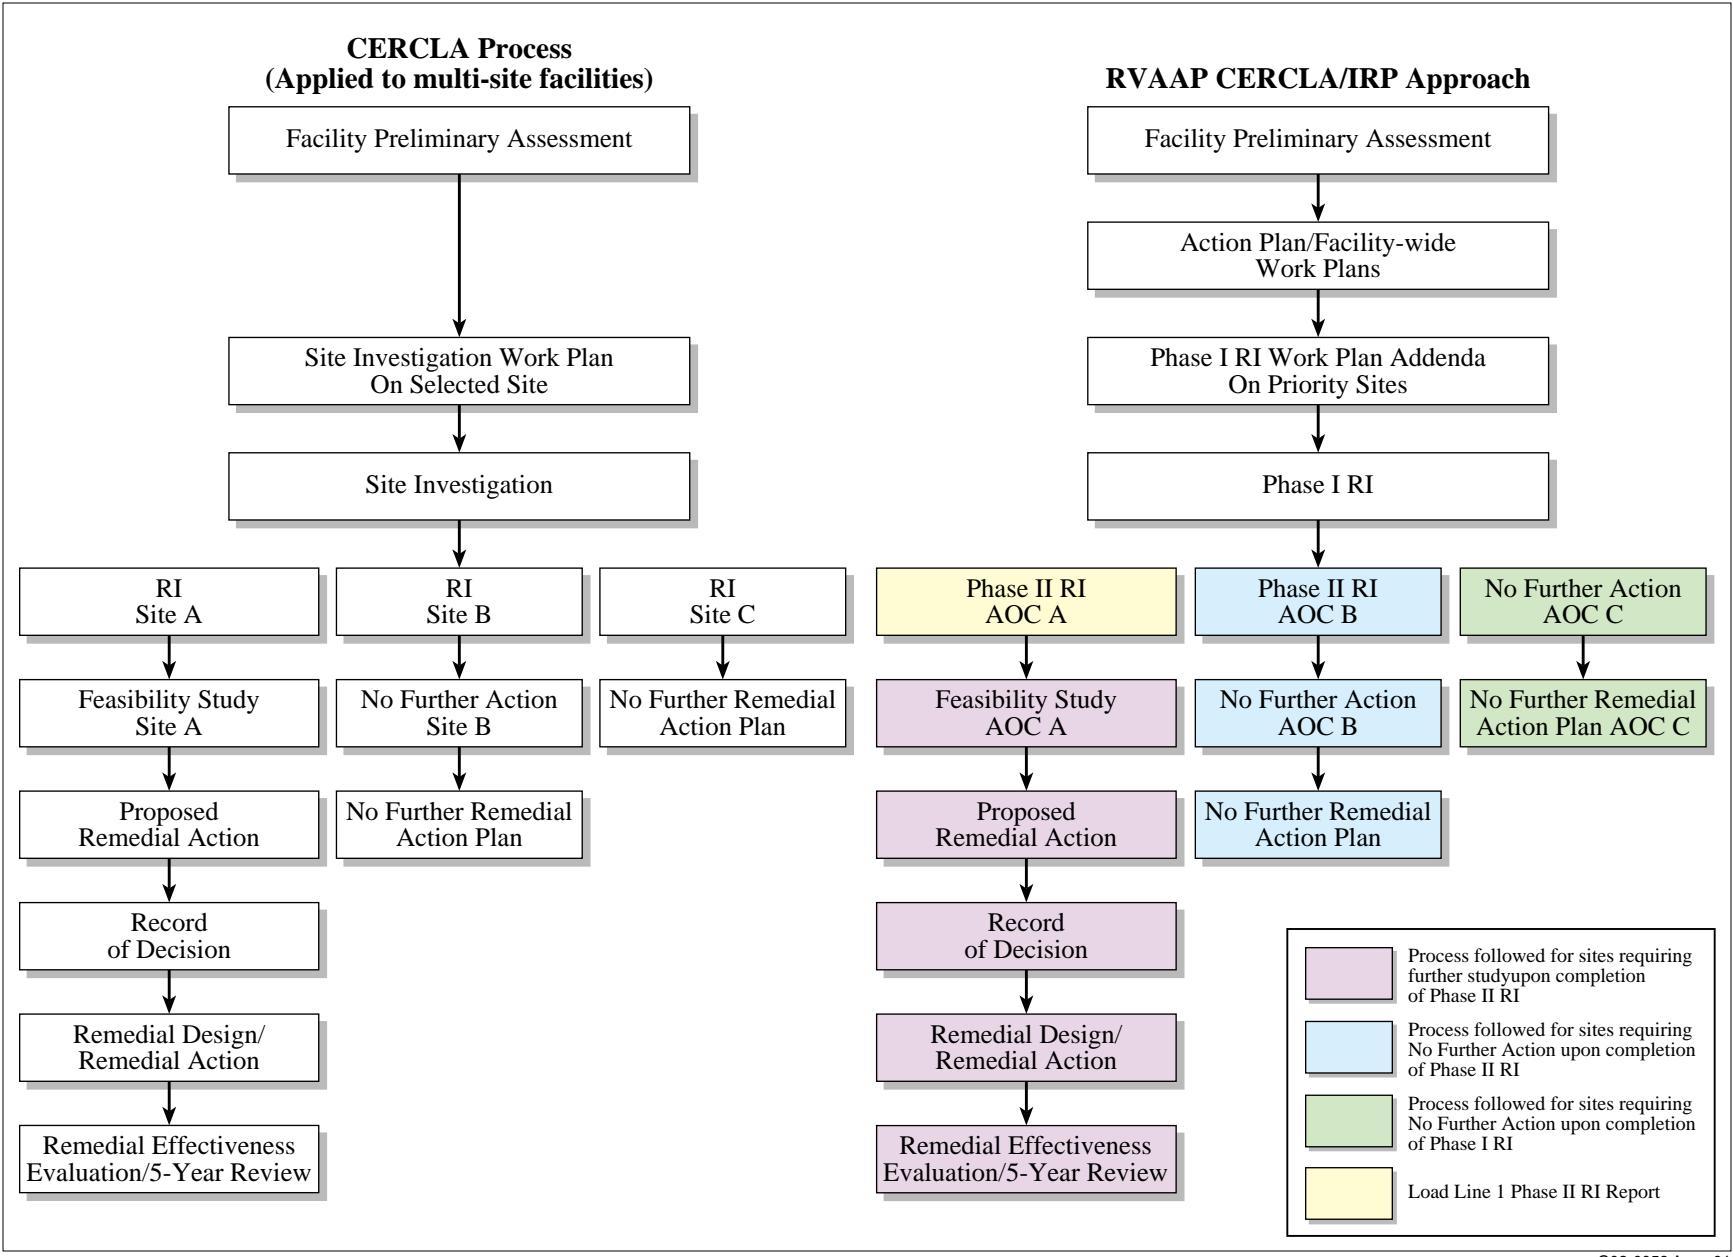
Figure 1-3. CERCLA Approach at RVAAP

Figure 1-3 presents the approach to implementing the CERCLA process under the guidance of the IRP. Priorities for environmental restoration at areas of concern (AOCs) at RVAAP are based on their relative potential threat to human health and the environment, derived from Relative Risk Site Evaluations (RRSEs). Thirty-eight AOCs were identified in *The Facility-wide Preliminary Assessment (PA) for the Ravenna Army Ammunition Plant, Ravenna, Ohio* (USACE 1996). Thirteen additional AOCs were identified in 1998 in records searches and site walkovers. These were ranked by the U.S. Army Center for Health Promotion and Preventive Medicine (USACHPPM) and entered into the OSC's database. AOCs ranked as high-priority sites (i.e., those with high RRSE scores) are targeted for Phase I RIs. Medium-and low-priority sites will be characterized in Phase I RIs following completion of the RIs for high-priority AOCs. Not all AOCs are CERCLA sites, but those that are will follow the CERCLA process in order of priority as funding becomes available.

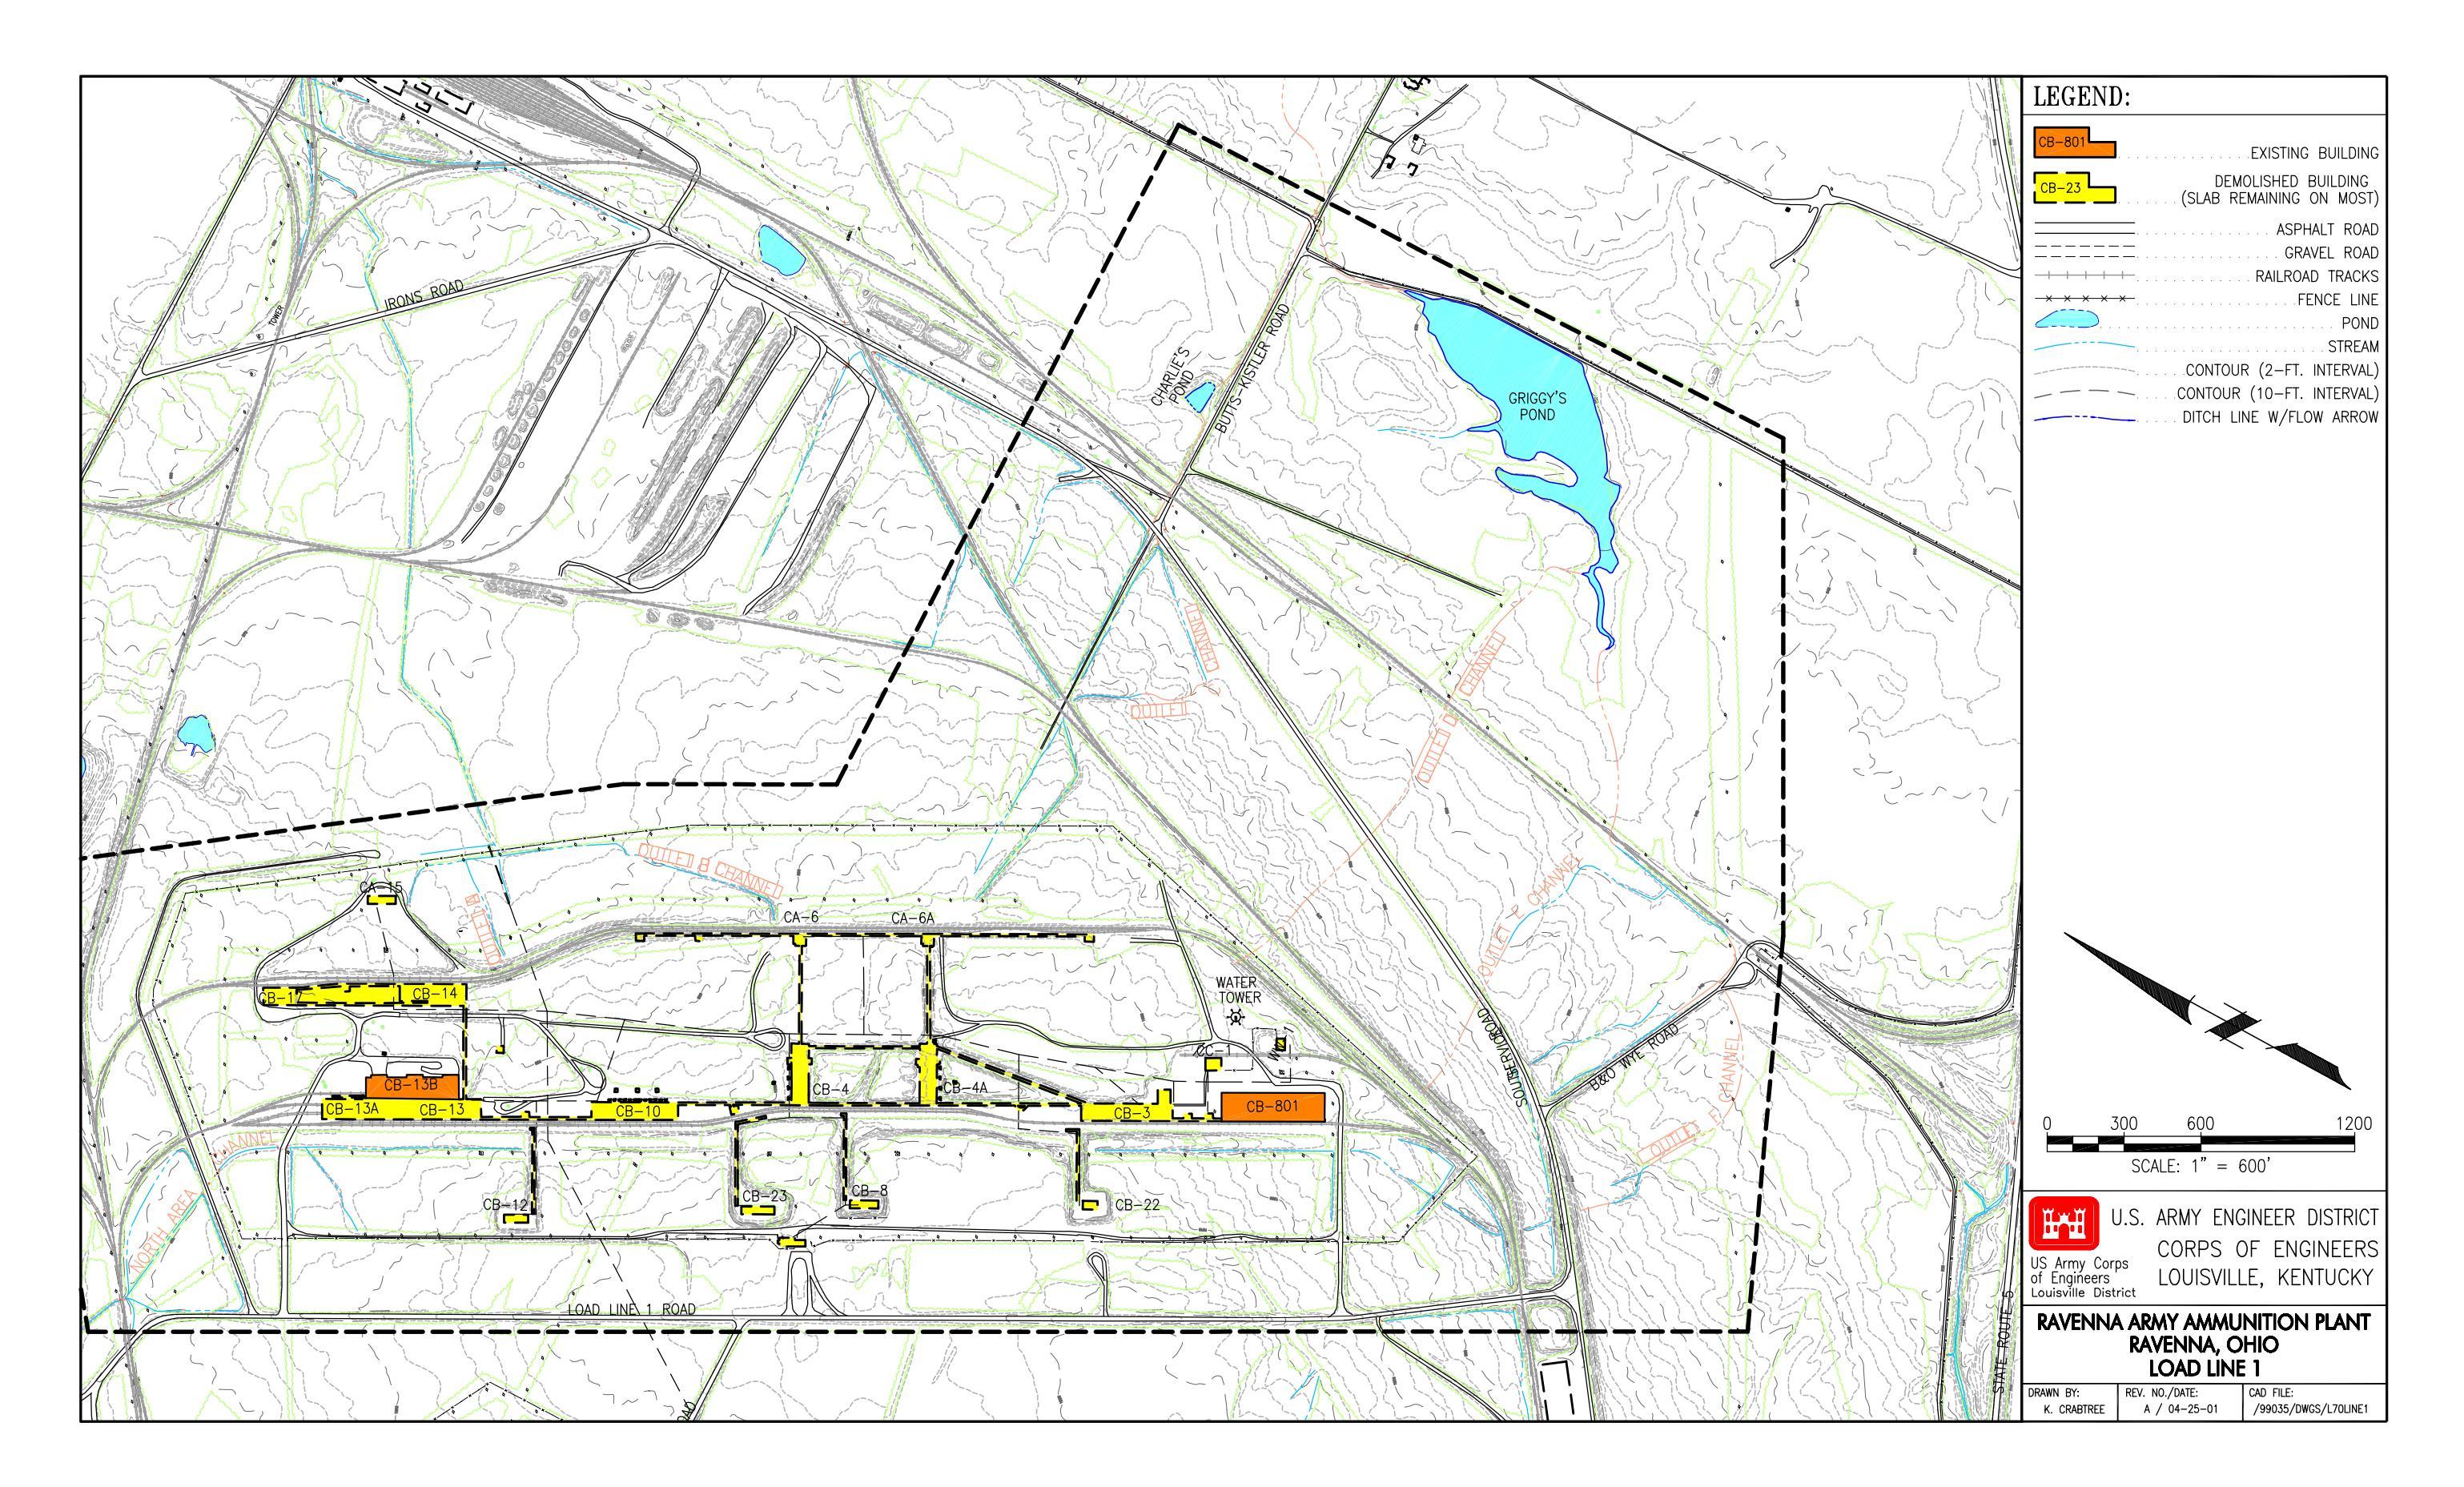
Figure 1-4. Topography and Cultural Features at Load Line 1

LL 1 (RVAAP-08) is located in the southeastern portion of RVAAP (Figure 1-2). It began operation in 1941 and was used until 1971. A detailed site map of LL 1 is presented in Figure 1-4. During World War II (1941 through 1945) and the Korean War (1951 through 1957), LL 1 was used to melt and load TNT and Composition B explosives into large-caliber shells. Composition B is a mixture of TNT and RDX. Cadmium was applied to various components of the shells to deter rust. The operation on the load line produced explosive dust, spills, and vapors that collected on the floors and walls of several buildings. These residues were periodically washed from walls and floors with water and steam. During building wash down, pink water or loose explosive flakes, chips, or dust were occasionally swept out of doorways onto the ground. The majority of the wastewater, known as pink water, was collected in concrete sumps located throughout the load line area. The pink water was then pumped to a sawdust filtration unit for clarification and removal of nitro-compounds prior to discharge. Sawdust filtration units consisted of a set of three parallel  $3 - \times 9.1 - \times 0.9$ -m ( $10 - \times 30 - \times 3$ -ft) concrete settling tanks and a set of three  $1.5 - \times 4.6 - \times 0.9$ -m ( $5 - \times 15 - \times 3$ -ft) filter blocks in the bottom of the filtration tanks. Sawdust from the filtration unit near Building CA-6A was disposed of at Winklepeck Burning Grounds (WBG).

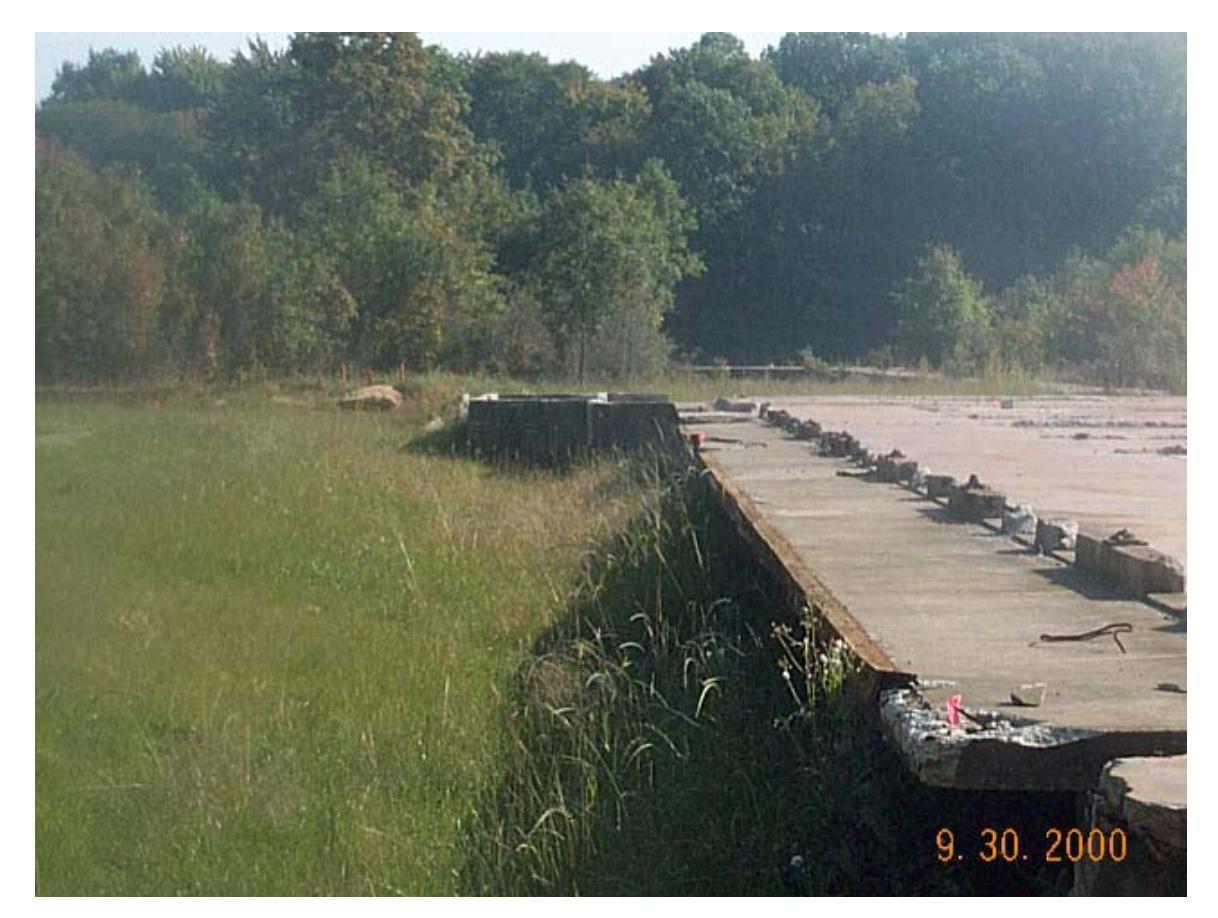
Salvage and demolition activities at LL 1 were complete as of June 2000. All buildings (except for CB-13 and CB-801) have been demolished, and the debris either has been removed from the site or, if inert, placed in "clean, hard fill" areas at the locations of the former change houses (CB-12, CB-8, CB-22, and CB-23). Metal piping that is suspected to be contaminated with PCB-laden paint is staged on the ground near CB-801 for removal. Floor slabs of the demolished buildings and all below-grade infrastructure remain in place. Several manholes or other storm/sanitary sewer access points were filled in or obstructed during the demolition process. Figure 1-5 depicts current site conditions.

Figure 1-5. Current Conditions at Load Line 1. View to East from Northwest Corner of Former Building CB-4

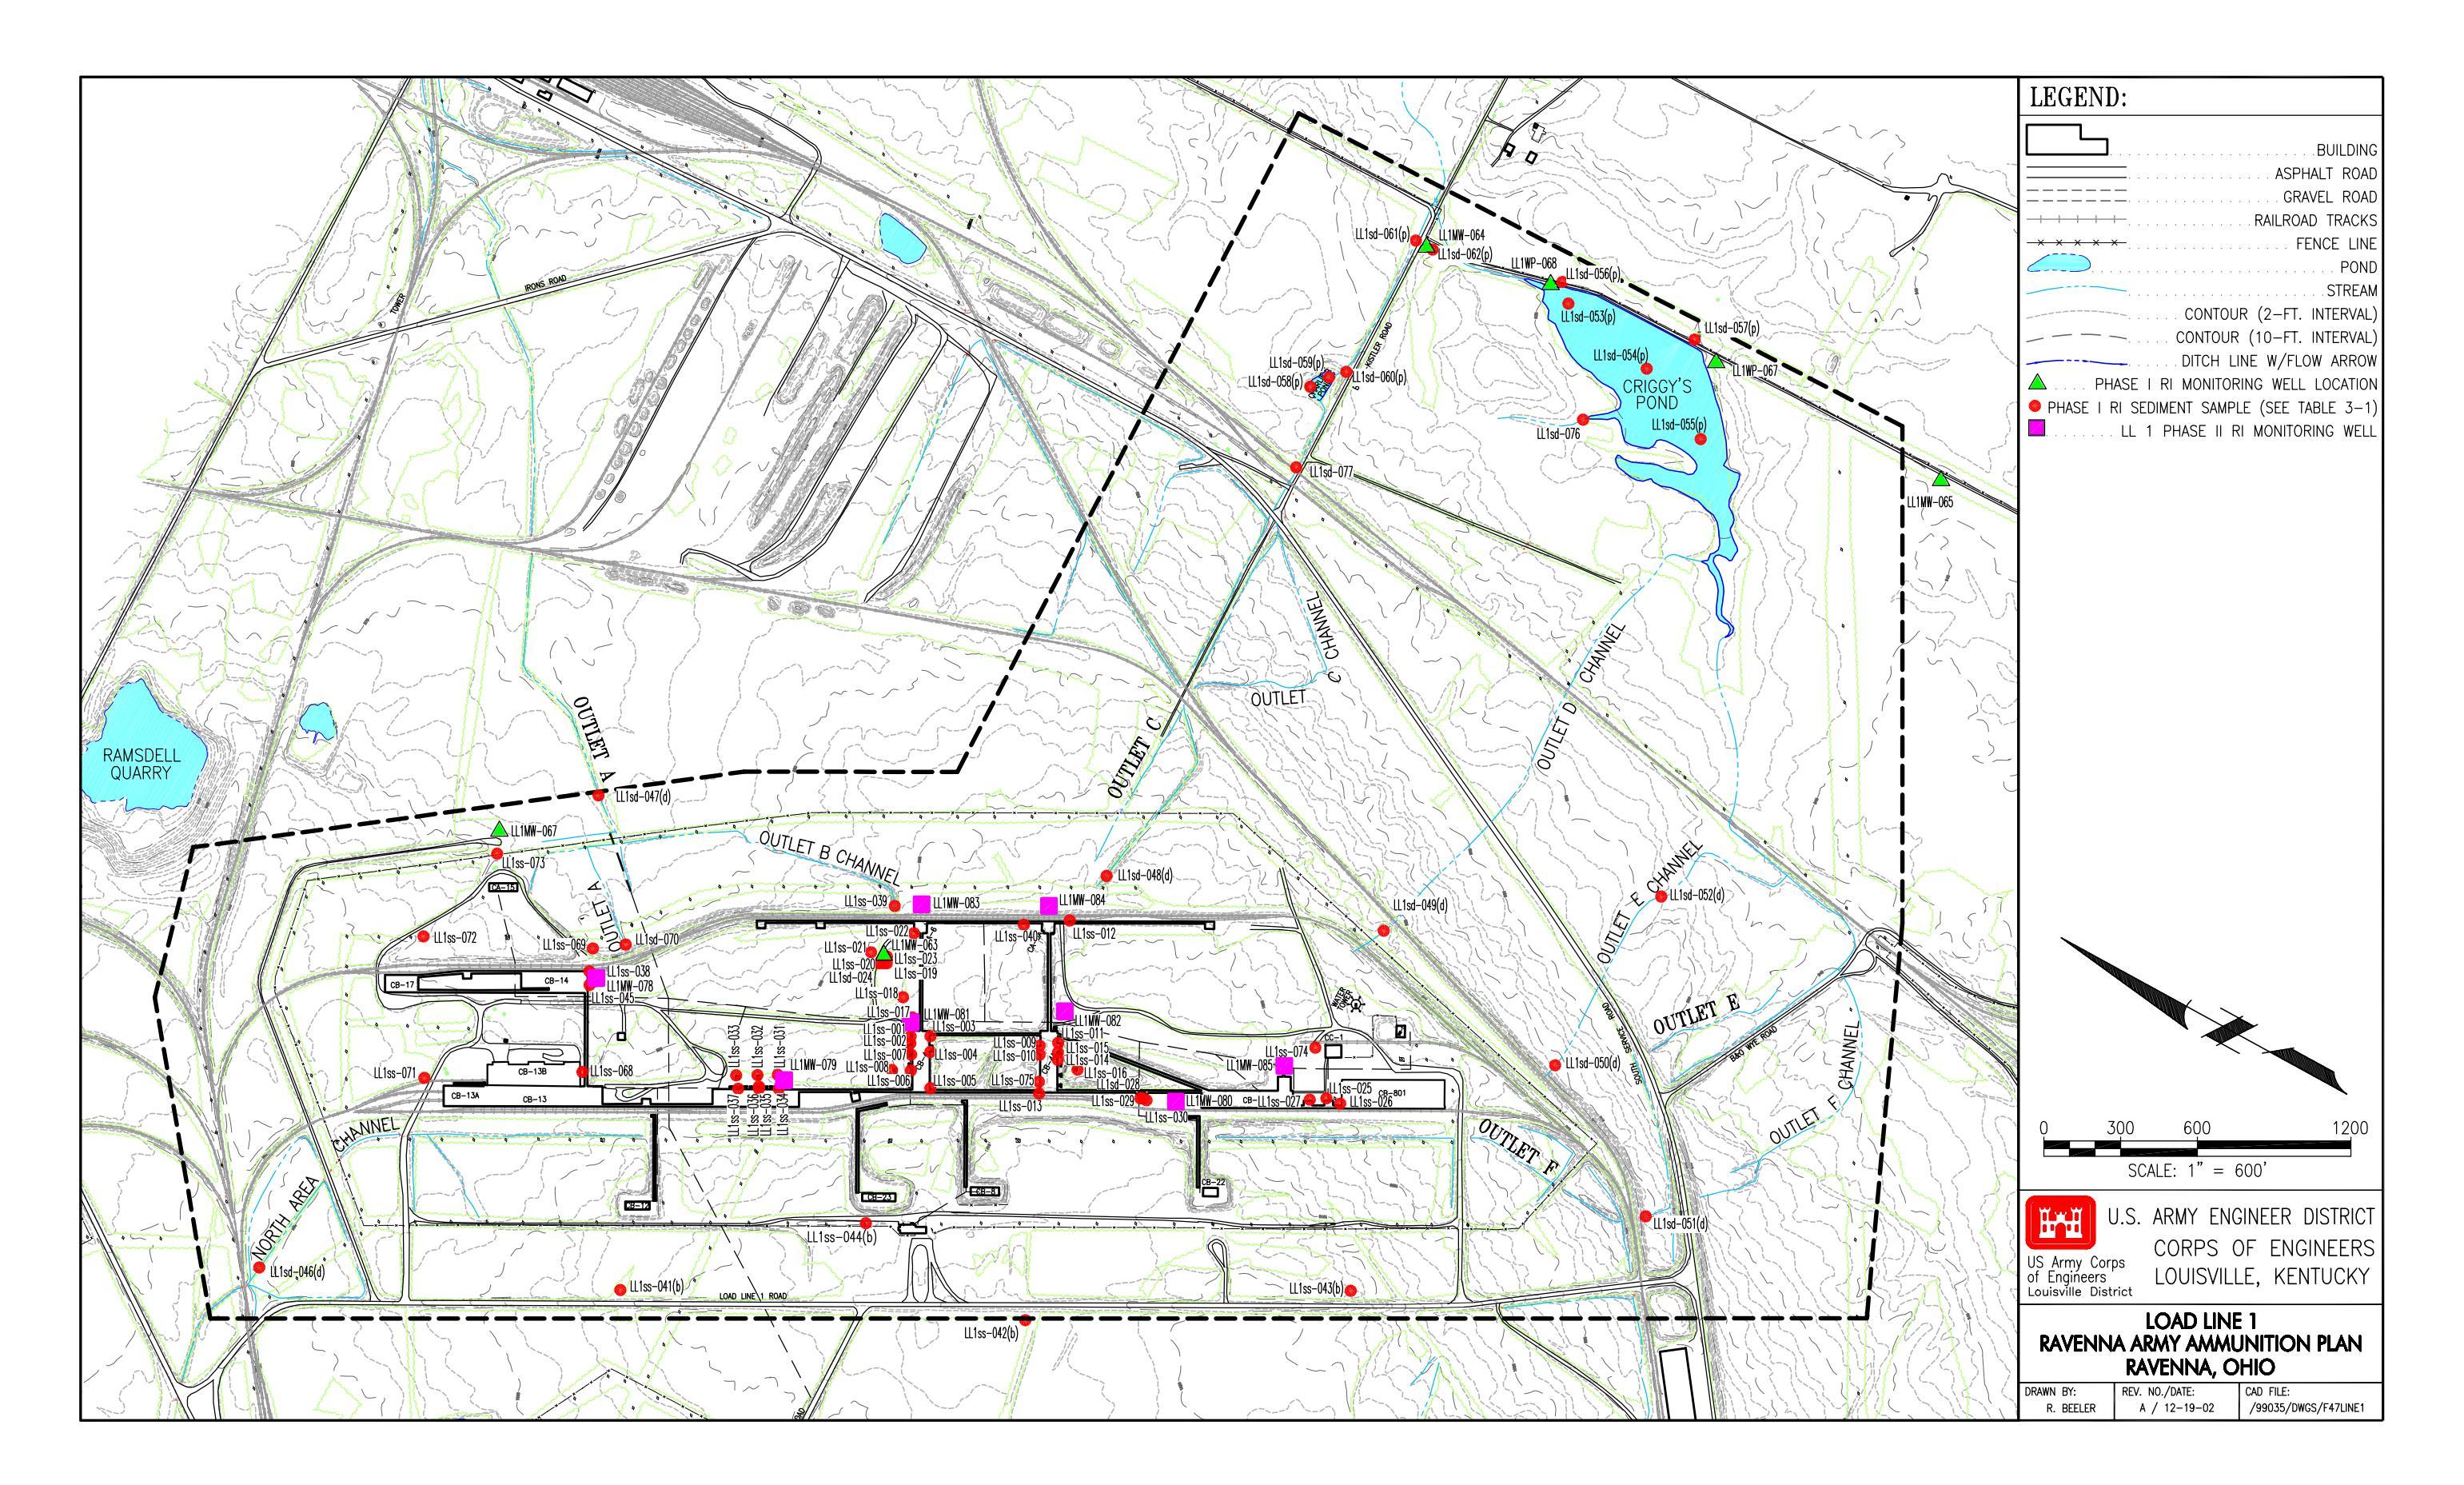
Figure 1-6. Existing Phase I RI Sampling Locations and Phase II RI Monitoring Wells at Load Line 1

Six monitoring wells were installed and sampled as part of the Phase I RI (LL2mw-059 and LL2mw-060, LL1mw-063, LL1mw-064, LL1mw-065, and LL1mw-067). Appendix D contains Phase I RI monitoring well boring logs and construction data. No explosives were detected during the Phase I sampling event. Eight Phase II RI monitoring wells were installed in 1999. The eight Phase II wells and the six Phase I wells were sampled in September of 1999 for explosives, propellants, TAL metals, and cyanide. Two samples were also analyzed for volatile organic compounds (VOCs), SVOCs, and PCB/pesticides. The explosives TNT and 1,3,5-trinitrobenzene (TNB) were detected in five of the wells during this sampling round (LL1mw-078, LL1mw-079, LL1mw-080, LL1mw-081, and LL1mw-083). The maximum concentration of any explosive in groundwater was  $15 \,\mu$ g/L for 2,4,6-TNT in LL1mw-084. This concentration exceeds the U. S. Environmental Protection Agency (EPA) Region 9 tap-water PRG of 2.2  $\mu$ g/L. Given that the Phase II wells were installed at the sites of Phase I maximum soil contamination with explosives, these results suggest a very low vertical mobility of explosives from soils to groundwater.
