1. REPORT DATE (DD-MM-YYYY) 24-03-2015		2. REPORT TYPE Final		3. DATES COVERED (From - To) August 2010 to August 2013	
4. TITLE AND SUBTITLE Remedial Investigation Report for RVAAP-034-R-01 Sand Creek Dump MRS, Version 1.0				5a. CONTRACT NUMBER W912DR-09-D-0005	
				5b. GRANT NUMBER N/A	
				5c. PROGRAM ELEMENT NUMBER N/A

**RVAAP-034-R-01
Sand Creek Dump**

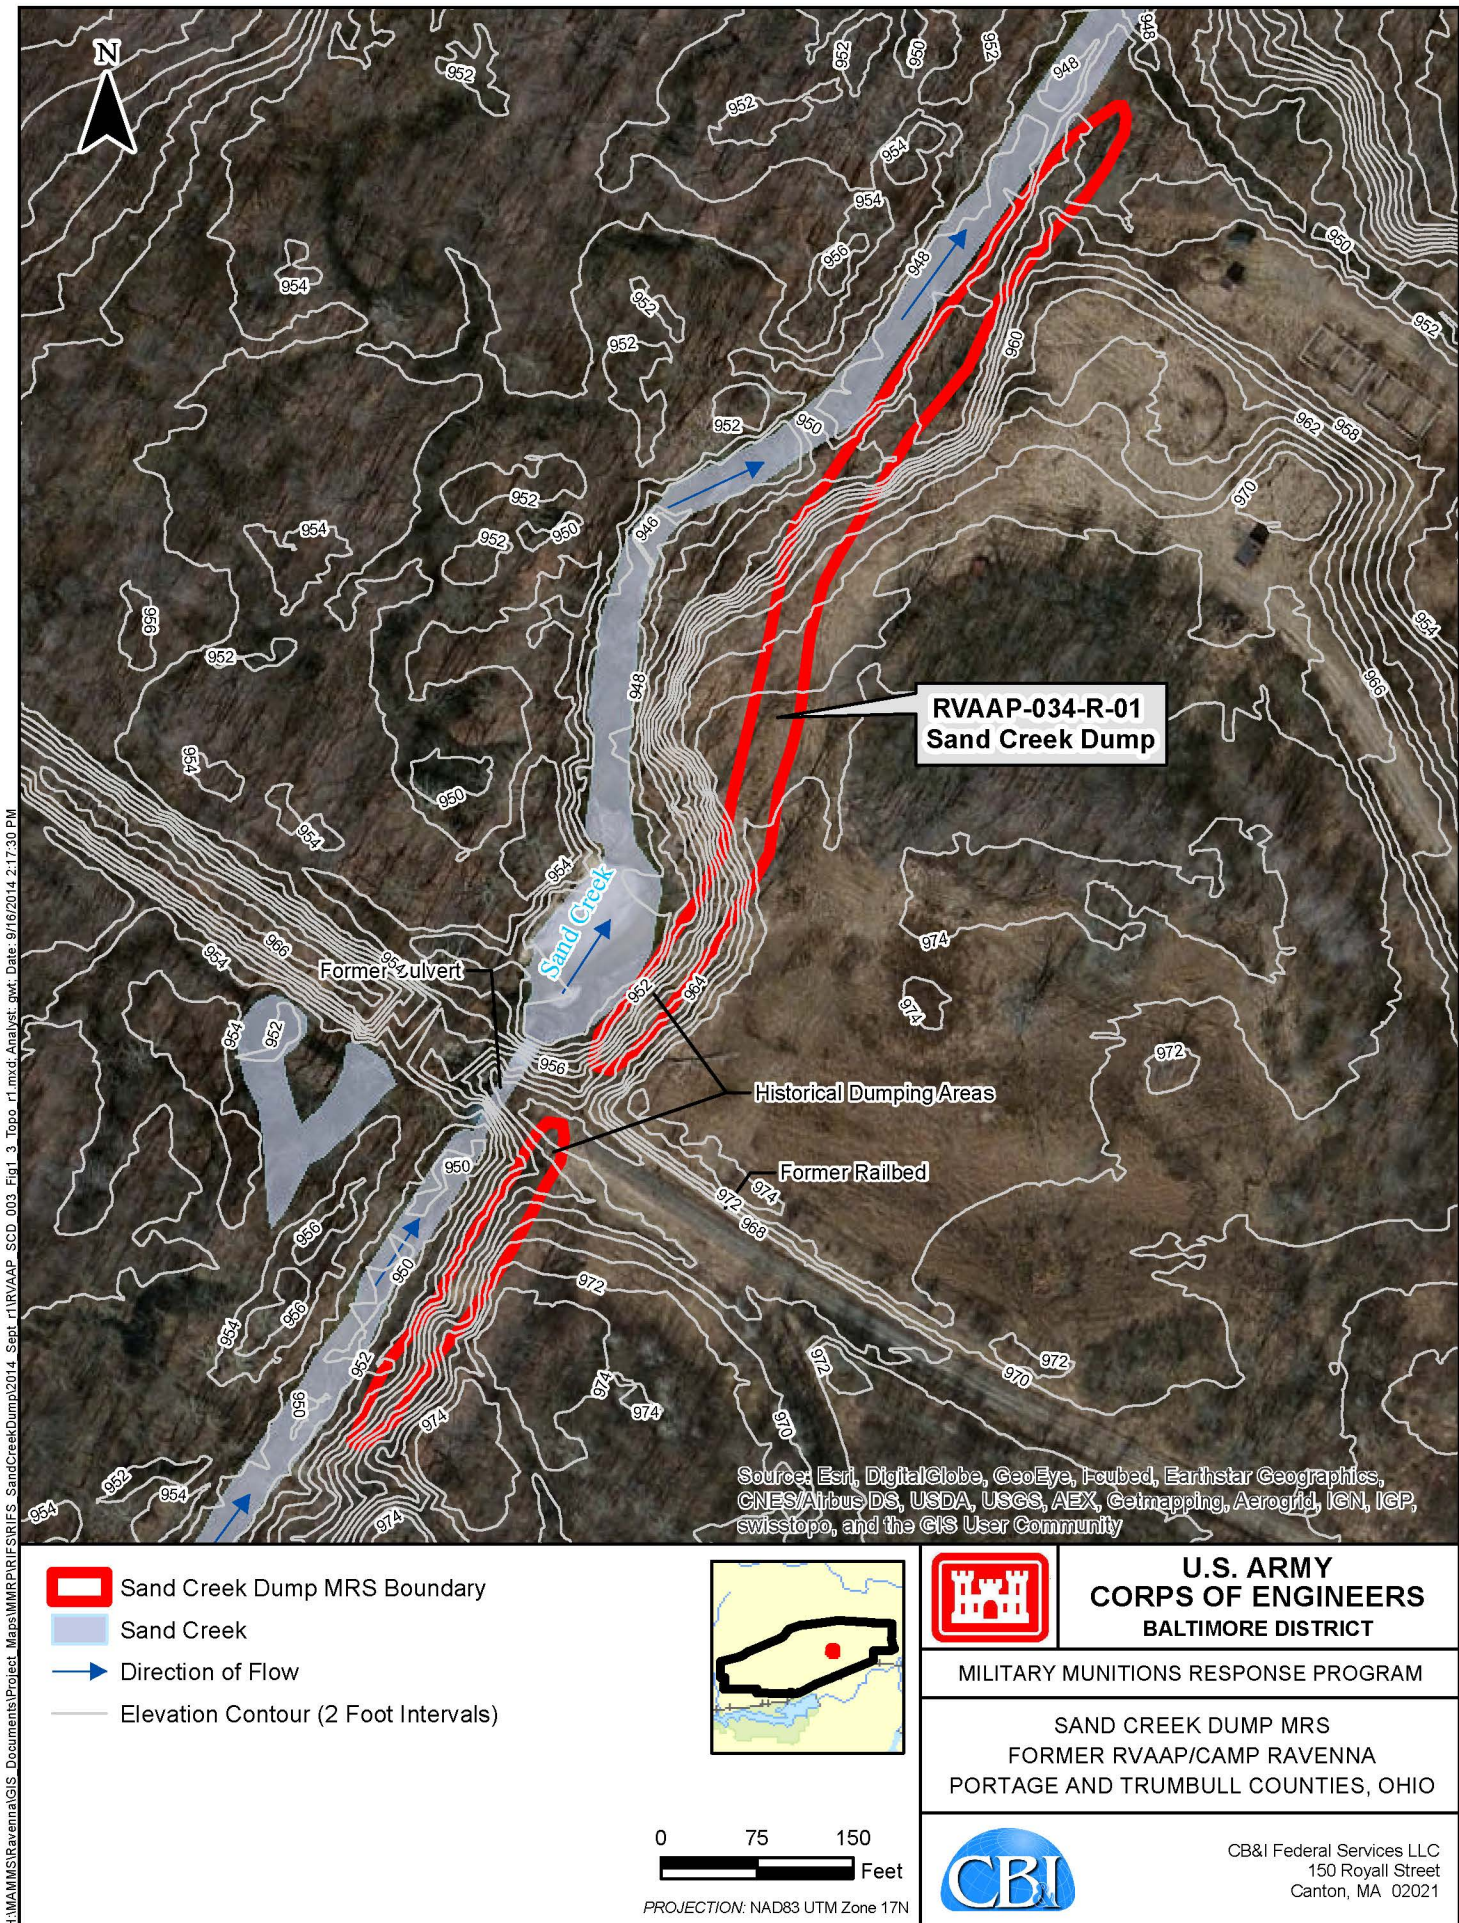
FIGURE 1-3 TOPOGRAPHY

The Sand Creek Dump MRS is located in the eastern portion of the facility and encompasses 0.85 acres along the eastern bank of Sand Creek. The bank slopes from east to west towards Sand Creek 40 to 60 degrees from horizontal. Topographic relief between the top of embankment and the surface of Sand Creek varies across the MRS, but ranges from approximately 15 to 25 feet. The slope of the embankment is the area at the MRS where construction debris was historically dumped. A former railroad bed bisects the MRS and the top of the embankment at both the northern and southern portions of the MRS are relatively level with elevations ranging between approximately 965 to 970 feet above mean sea level (amsl). A narrow floodplain occupies the land between the bottom of the embankment and Sand Creek. The bottom of the embankment represents the lowest elevation at the MRS at approximately 950 amsl. The topography for the MRS and the surrounding area is presented in **Figure 1-3**.

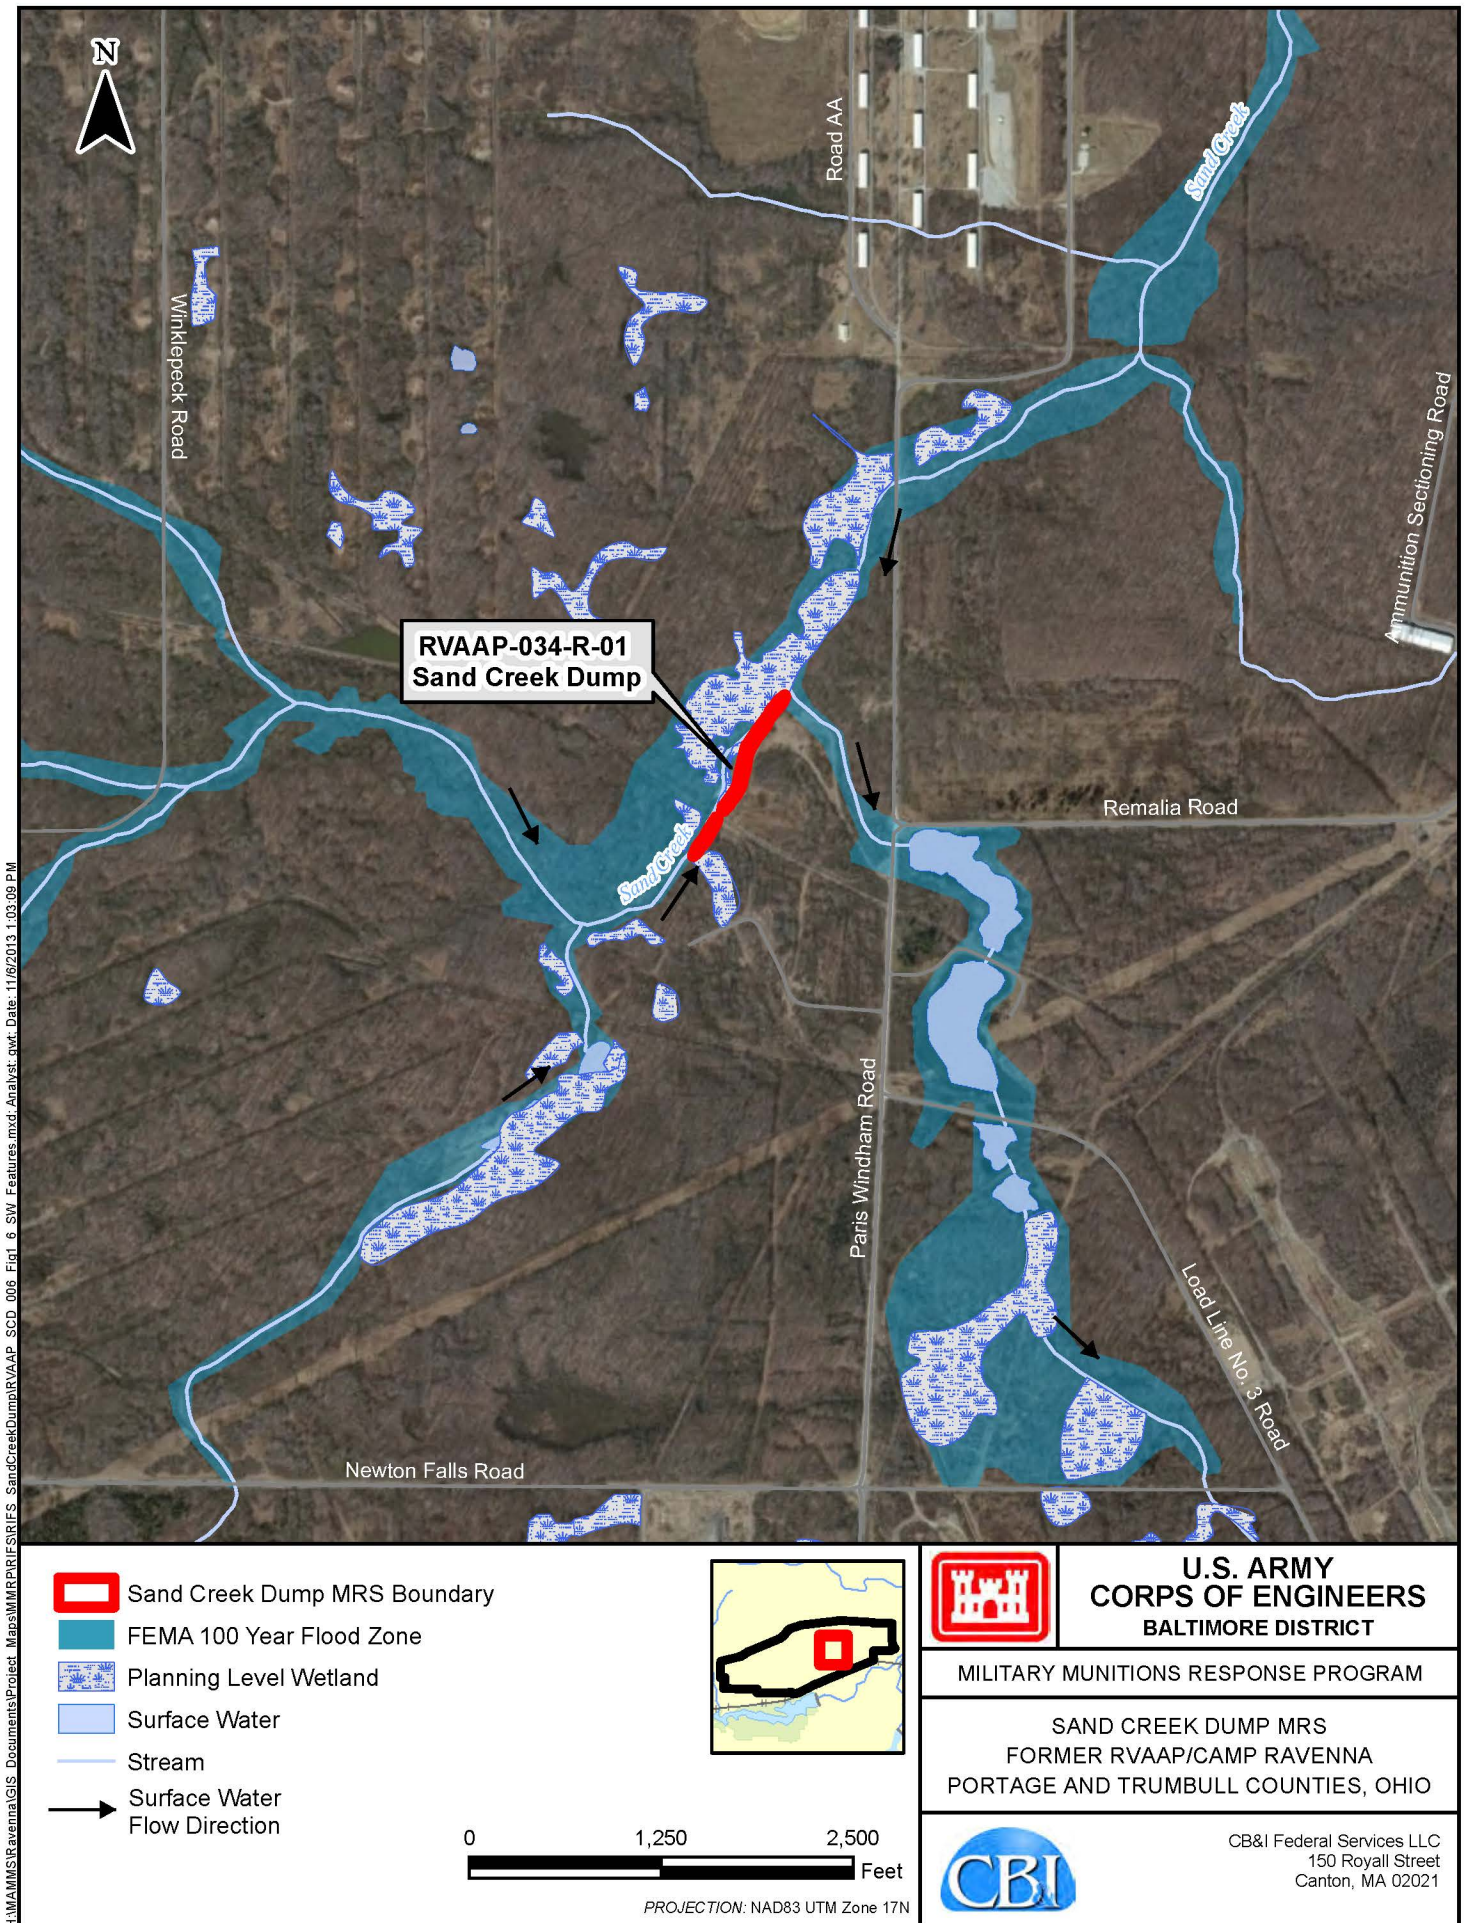
FIGURE 1-6 SURFACE WATER FEATURES MAP

There are various depressions and several areas of standing water at the top of the embankment which is indicative of the silt-clay soils that are present in the surface and subsurface soils. However, in general surface water runoff follows the topography of the site and flows in a westerly direction where it enters Sand Creek. Sand Creek flows in a southwest to northeast direction along the western edge of the MRS. Sand Creek flows approximately 1,300 feet downstream of the MRS into Cobb's Pond, which forms the headwaters of a perennial stream. The perennial stream flows south and exits the facility beneath State Route 5. The local and regional surface water features associated with the MRS are presented in **Figure 1-6**.

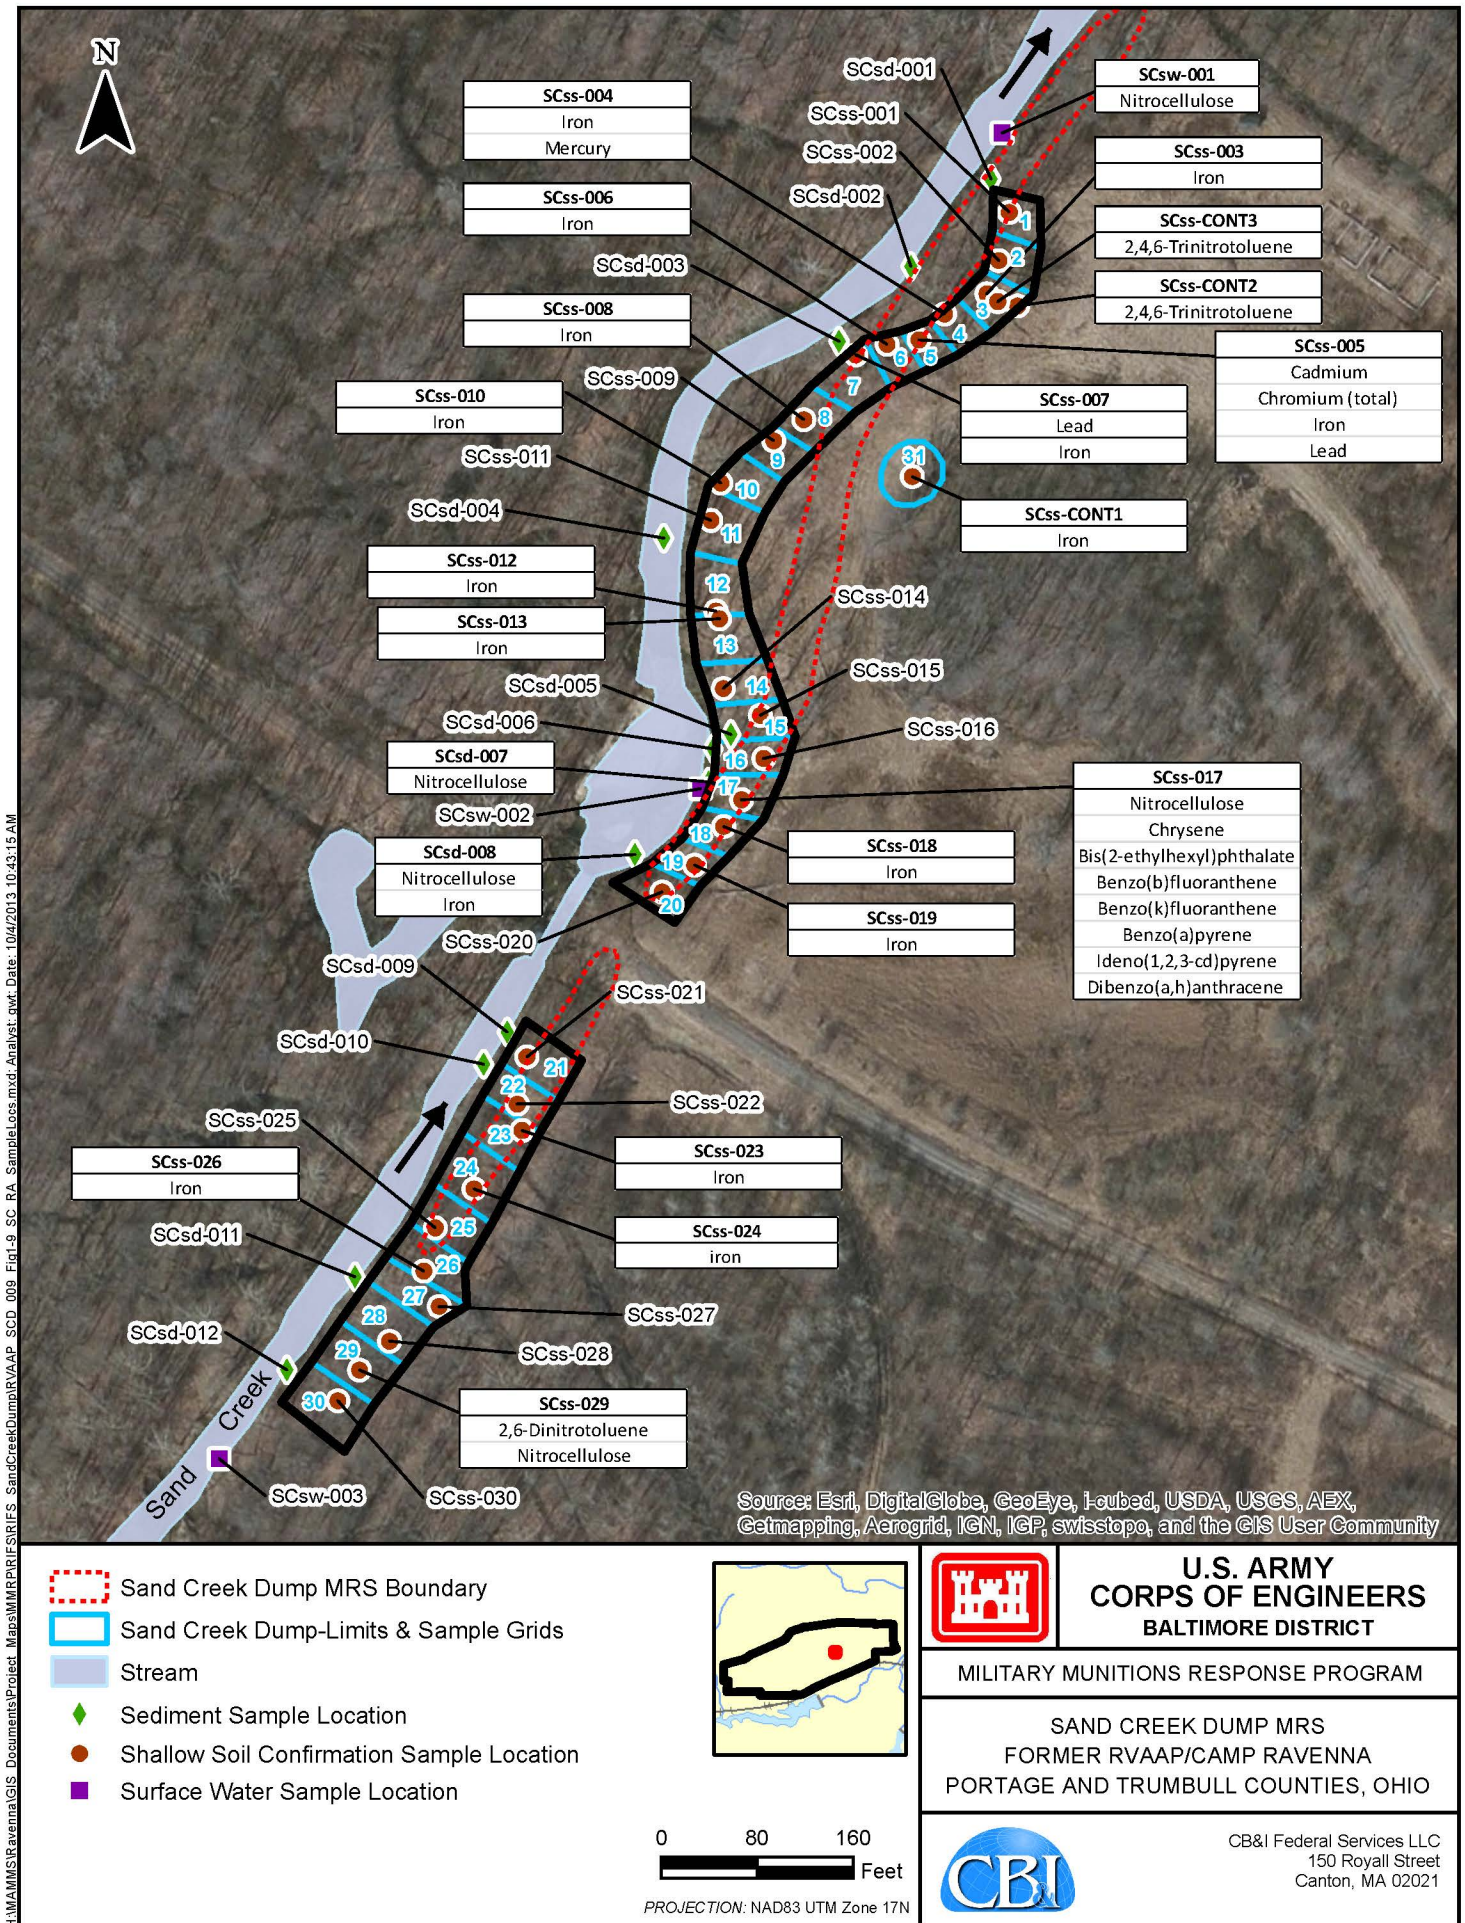
FIGURE 1-9 2003 REMOVAL ACTION SAMPLE LOCATIONS AND AREAS WITH POTENTIAL MC

Location of 2-75mm projectiles (MD) found during 2003 Removal Action

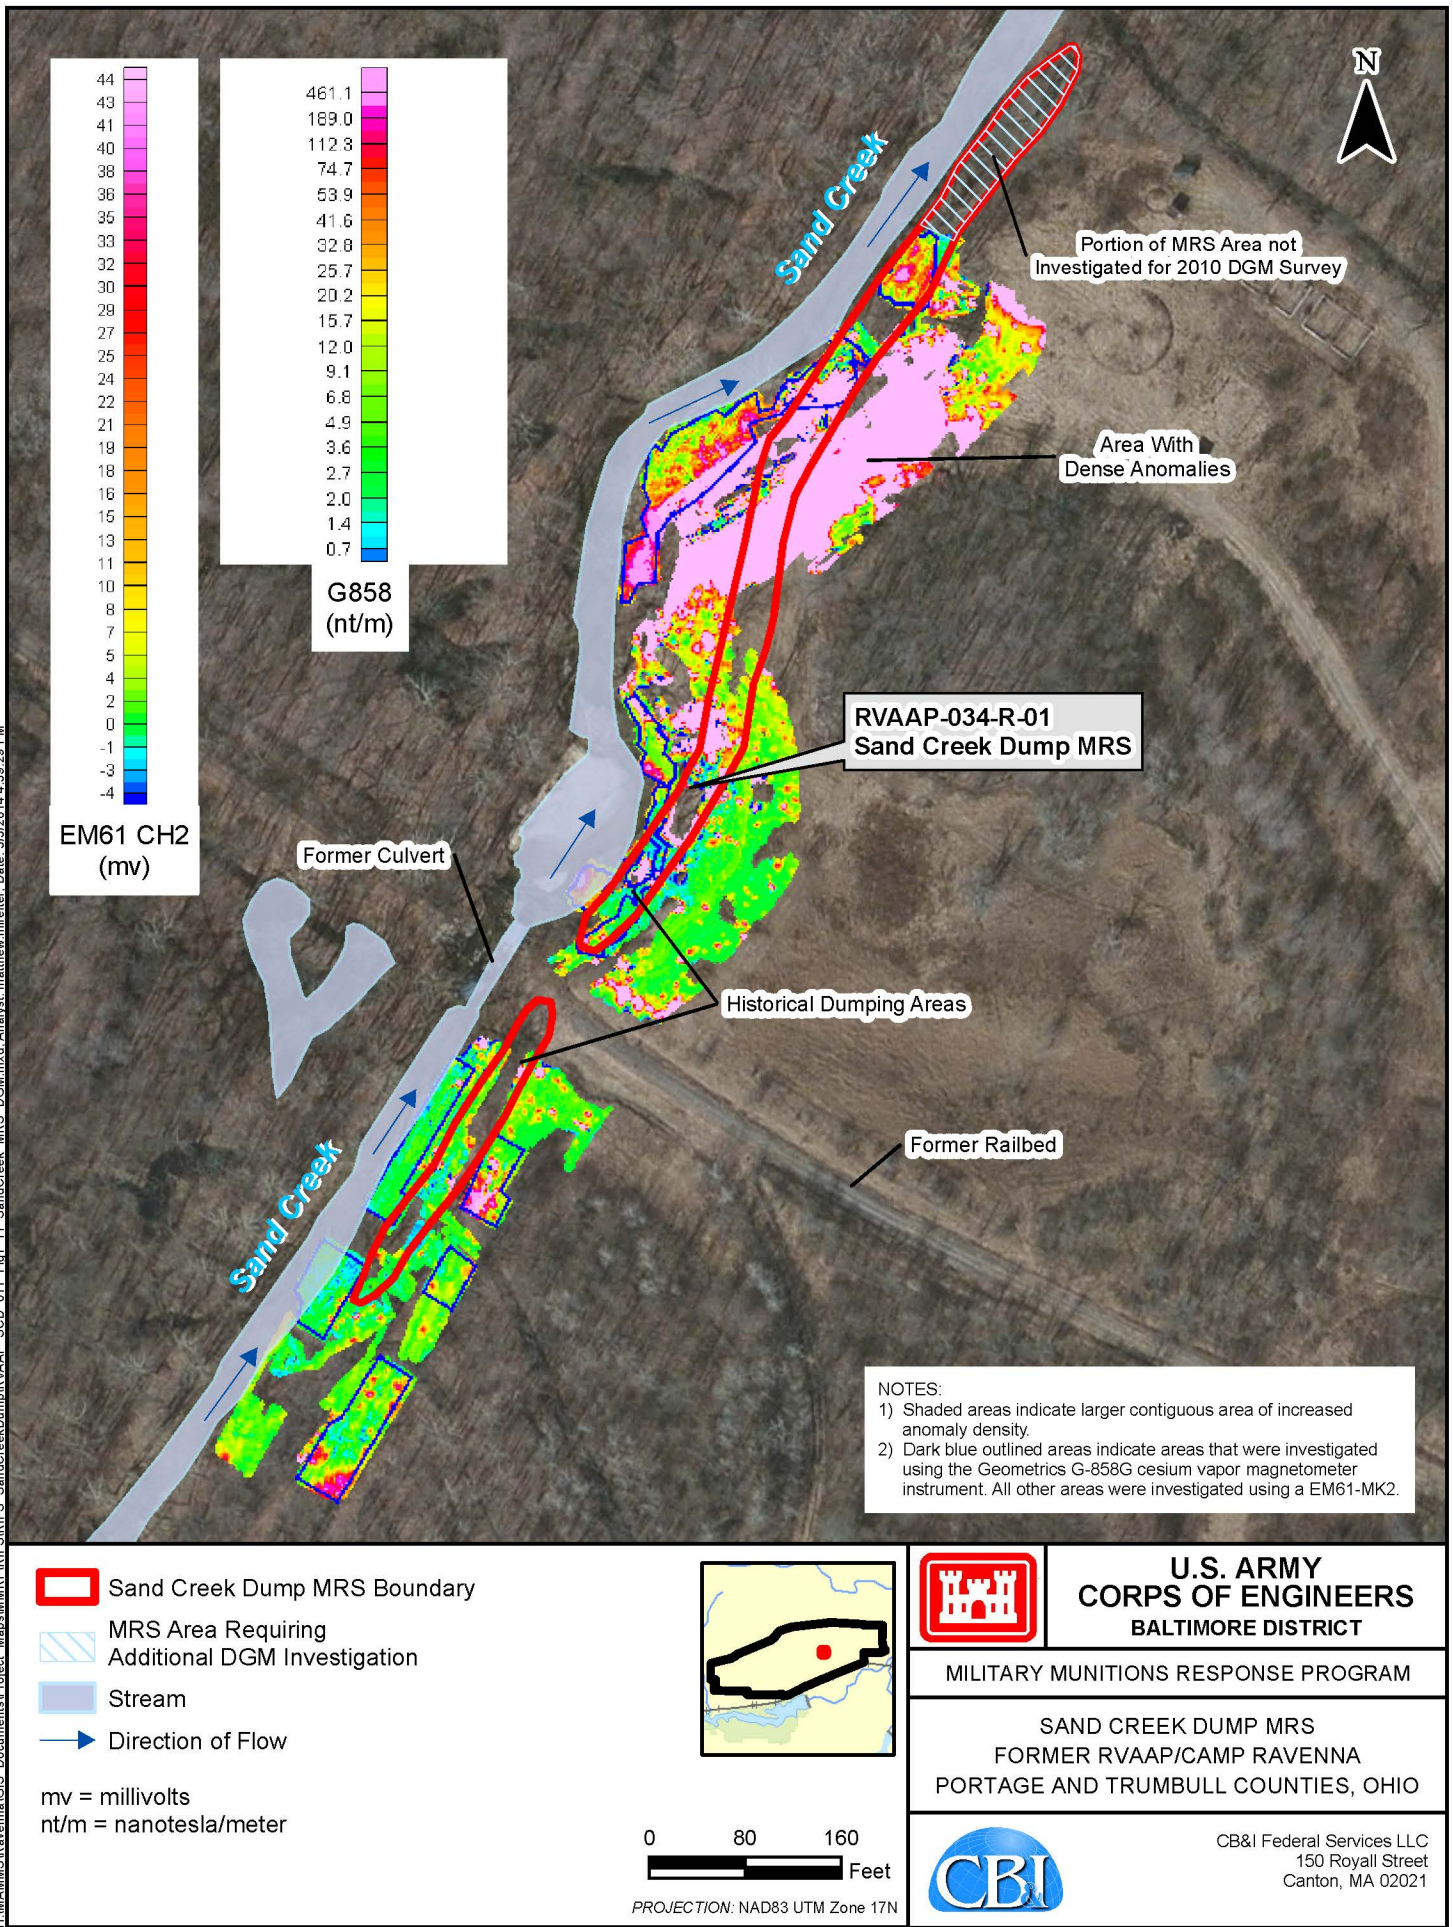
FIGURE 1-11 2010 DGM SURVEY RESULTS

CB&I conducted a digital geophysical mapping (DGM) survey under the IRP in 2010 at and in the immediate vicinity of the Sand Creek Disposal Road Landfill AOC where historical

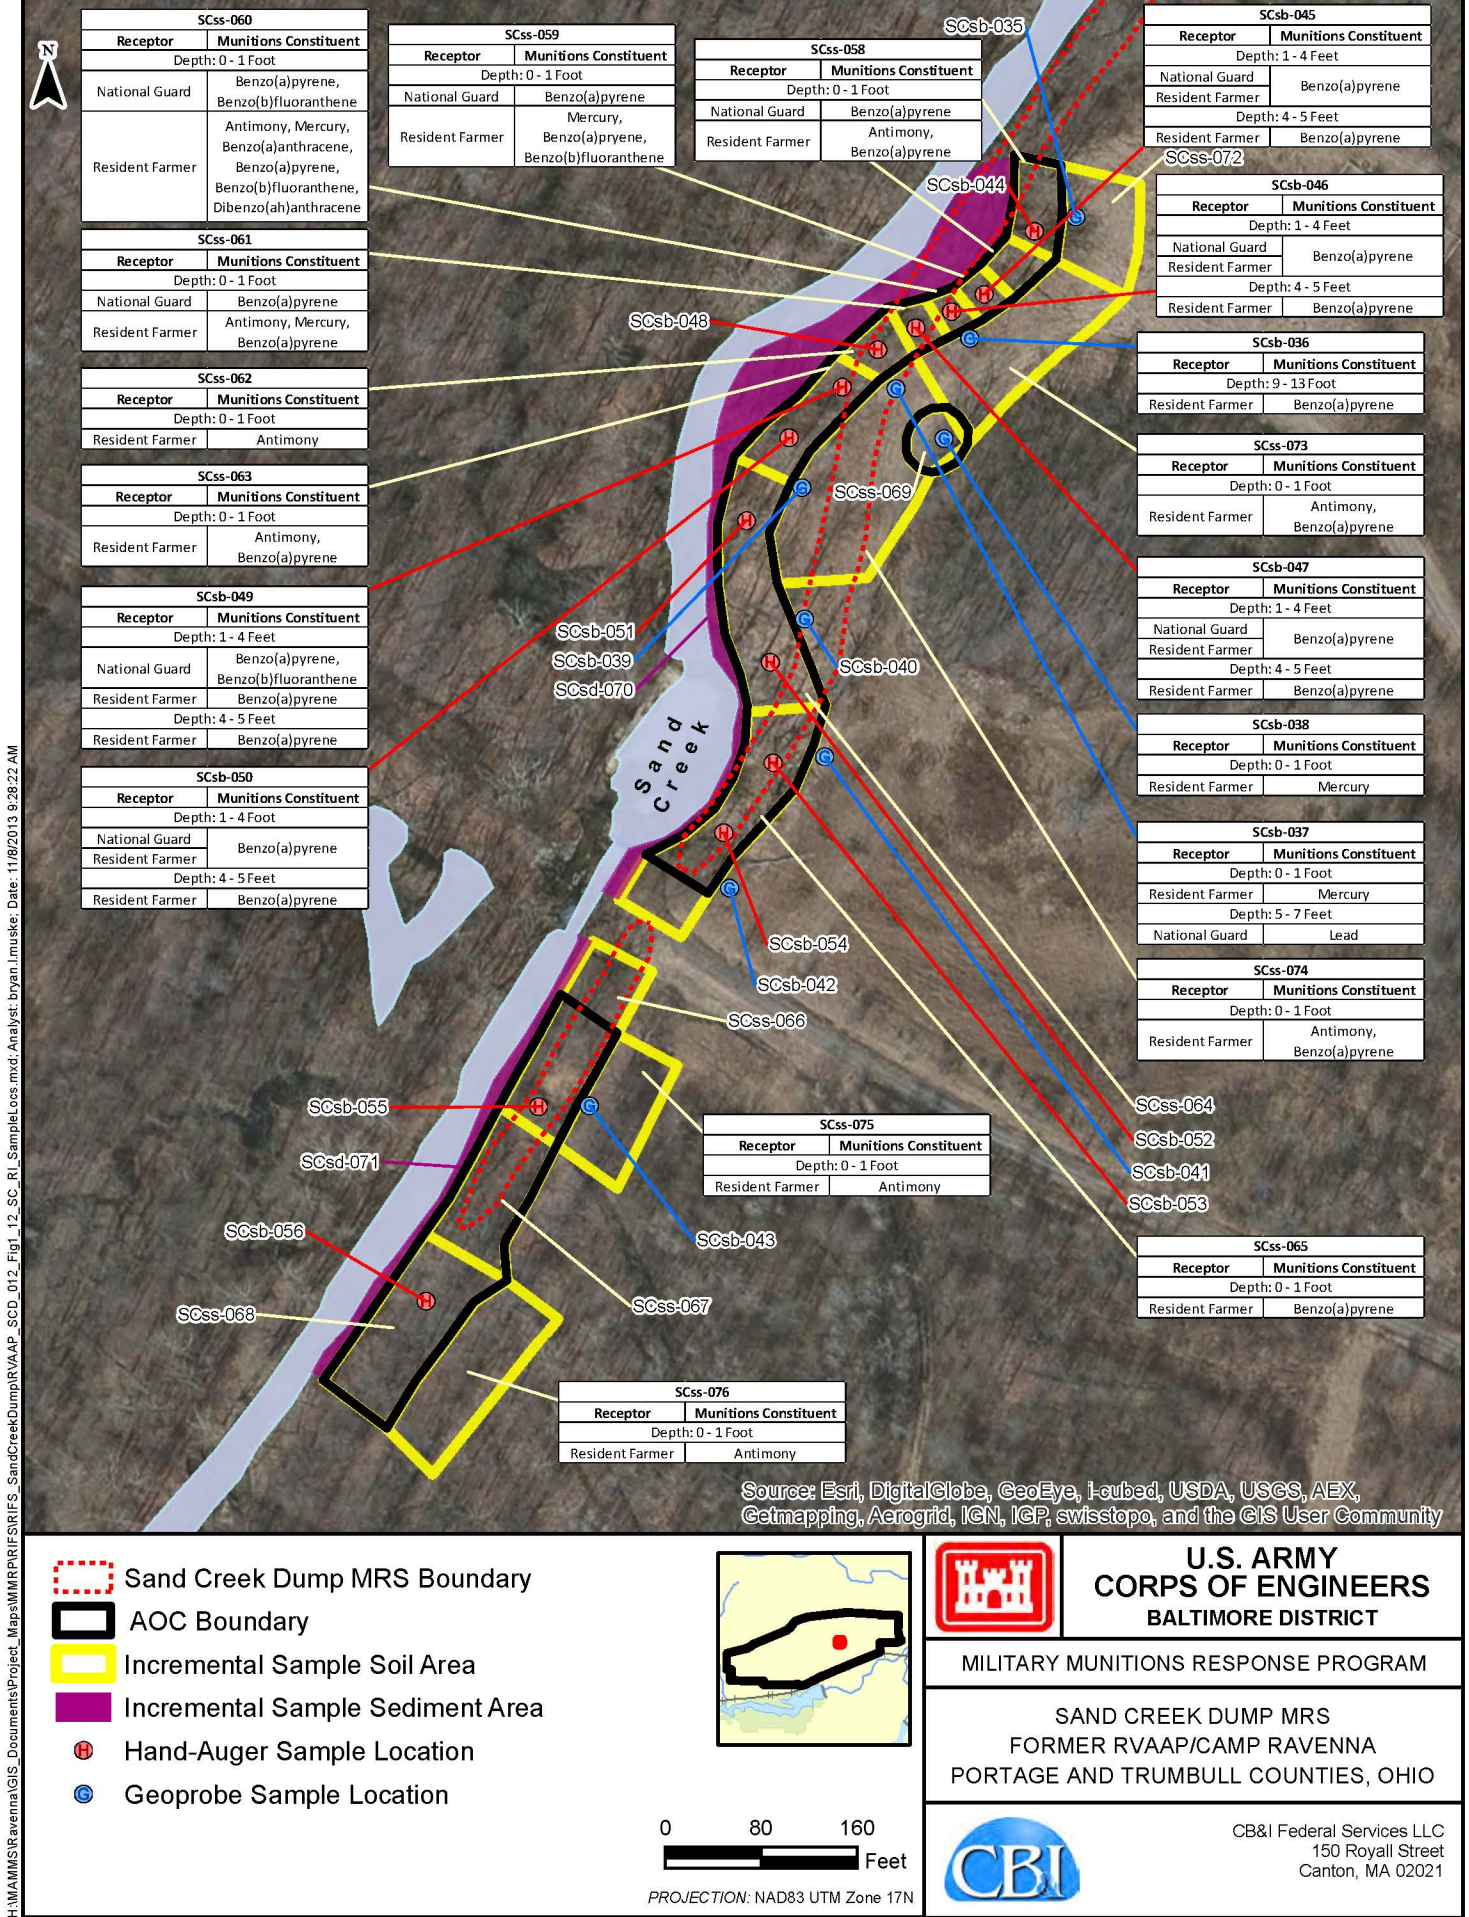
FIGURE 1-12 2010 PHASE I RI SAMPLE LOCATIONS AND AREAS WITH POTENTIAL MC

No COCs were identified in sediment or surface water for the Resident Receptor (Adult and Child) or the National Guard Trainee. **Figure 1-12** illustrates the sampling locations at the AOC for the Phase I RI and presents the results where COCs considered as potential MC were identified at the collocated MRS. The HHRA results are summarized in **Table 1-5**.

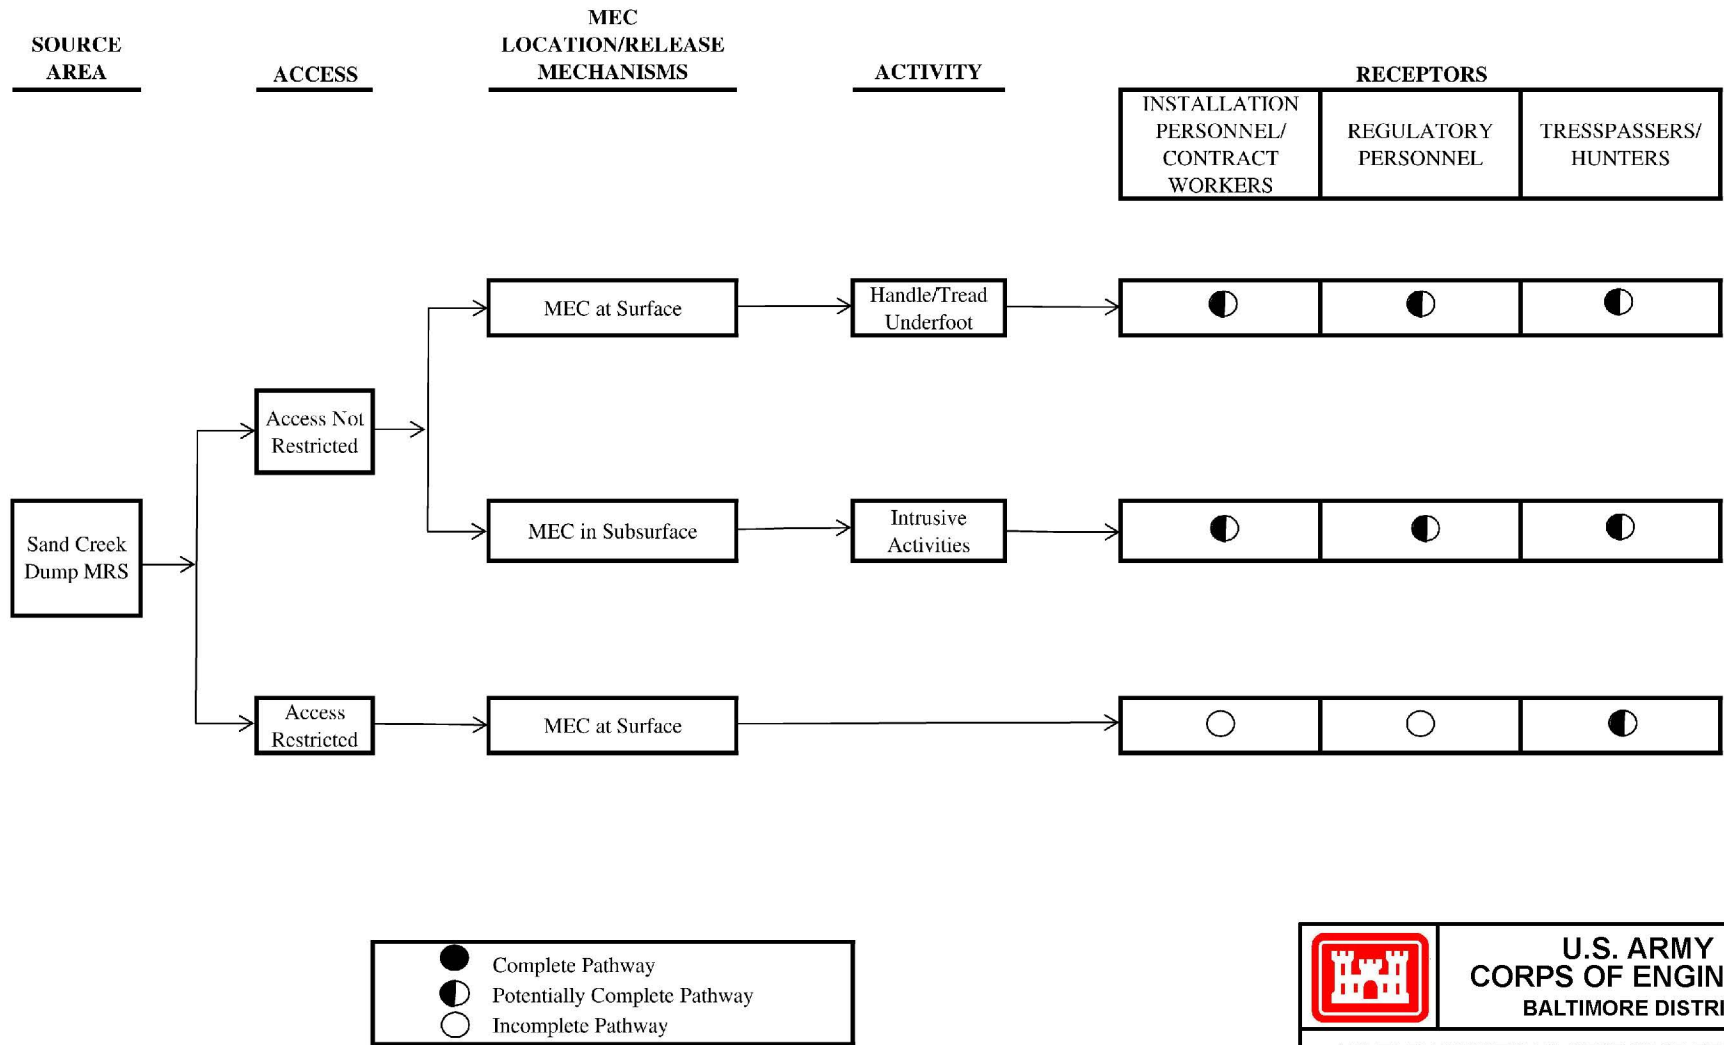
FIGURE 2-1 PRELIMINARY MEC CONCEPTUAL SITE MODEL

The preliminary CSMs for the Sand Creek Dump MRS are based on MRS-specific data and general historical information including literature reviews, maps, training manuals, technical manuals, and field observations. The preliminary CSM for MEC exposure was originally developed during the 2007 SI based on guidance from Engineer Manual 1110-1-1200, *Conceptual Site Models for Ordnance and Explosives (OE) and Hazardous, Toxic, and Radioactive Waste (HTRW) Projects* (USACE, 2003b) and is represented by the diagram provided as **Figure 2-1**. The preliminary CSM for MC exposure is represented by the diagram provided as **Figure 2-2** and is based on the SRCs associated with the munitions historically found at the MRS as identified in the Phase I RI Report (Shaw, 2012). A summary of each of the factors evaluated for the preliminary CSM is discussed below.

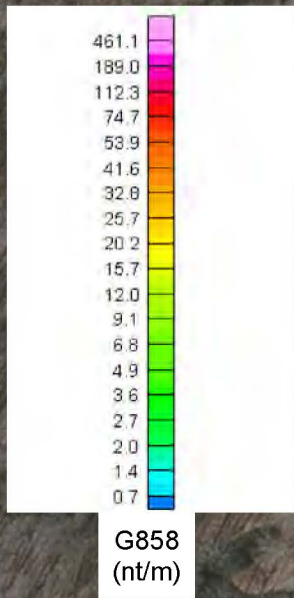
An approximately 0.06-acre (2,800-square-foot) area at the northern portion of the collocated AOC/MRS was surveyed using a G-858 magnetometer during the 2010 DGM survey. This instrument was used at areas that were inaccessible for the EM61-MK2. The reading output for the G-858 magnetometer is in units of nanoteslas per meter (nT/m). There is no anomaly selection criterion in the Work Plan Addendum for this instrument; however, sensitivity readings of approximately 20 nT/m correlate to the 8 mV threshold and was the threshold

NOTES:
 1) Shaded areas indicate larger contiguous area of increased anomaly density.
 2) Dark blue outlined areas indicate areas that were investigated using the Geometrics G-858G cesium vapor magnetometer instrument. All other areas were investigated using a EM61-MR2.

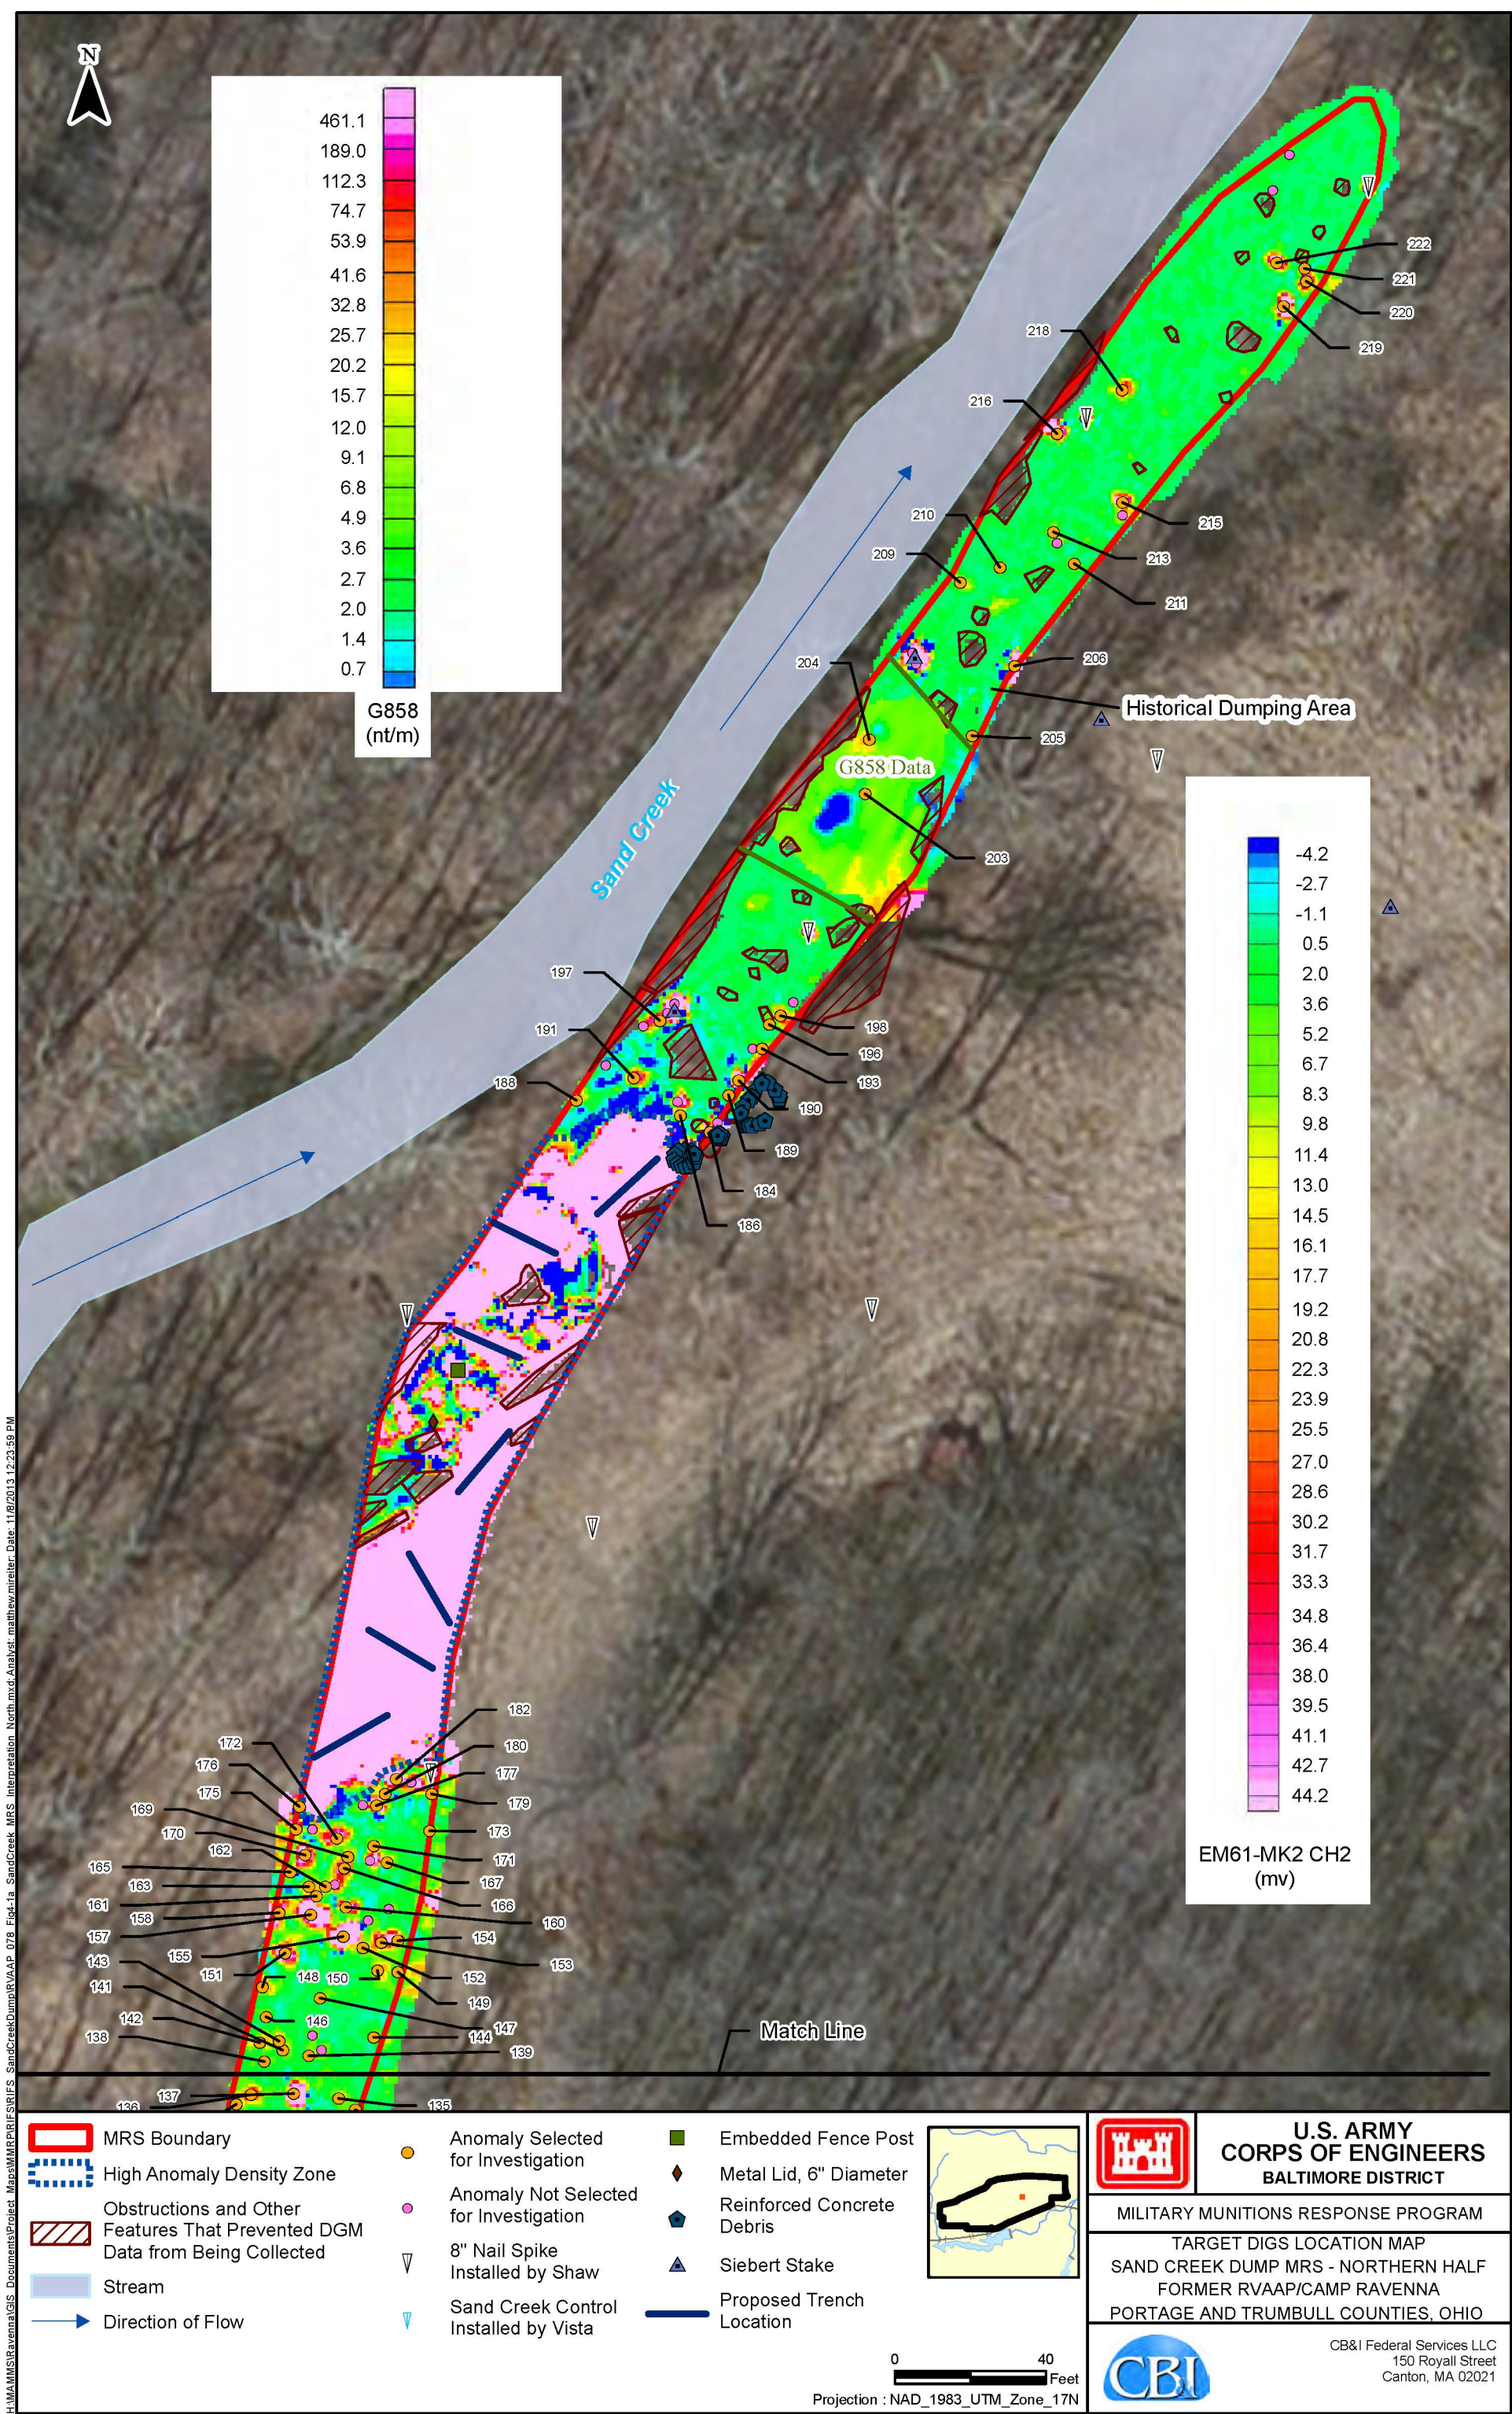
FIGURE 4-1A DGM RESULTS AND ANOMOLIES SELECTED FOR INTRUSIVE INVESTIGATION - NORTH SECTION

Figures 4-1a and **4-1b** display the results of the EM61-MK2 DGM survey and provide a color-scale that highlights all anomalies that were selected for intrusive investigation above signal thresholds of 8 mV (Channel 2) or 20 nT/m on the G-858 magnetometer. A comprehensive discussion of the DGM survey results is presented in the DGM Report in **Appendix A**.
