1. REPORT DATE (DD-MM-YYYY) 24-03-2015		2. REPORT TYPE Final		3. DATES COVERED (From - To) August 2010 to August 2013	
4. TITLE AND SUBTITLE Remedial Investigation Report for RVAAP-034-R-01 Sand Creek Dump MRS, Version 1.0				5a. CONTRACT NUMBER W912DR-09-D-0005	
				5b. GRANT NUMBER N/A	
				5c. PROGRAM ELEMENT NUMBER N/A

**RVAAP-034-R-01
Sand Creek Dump**

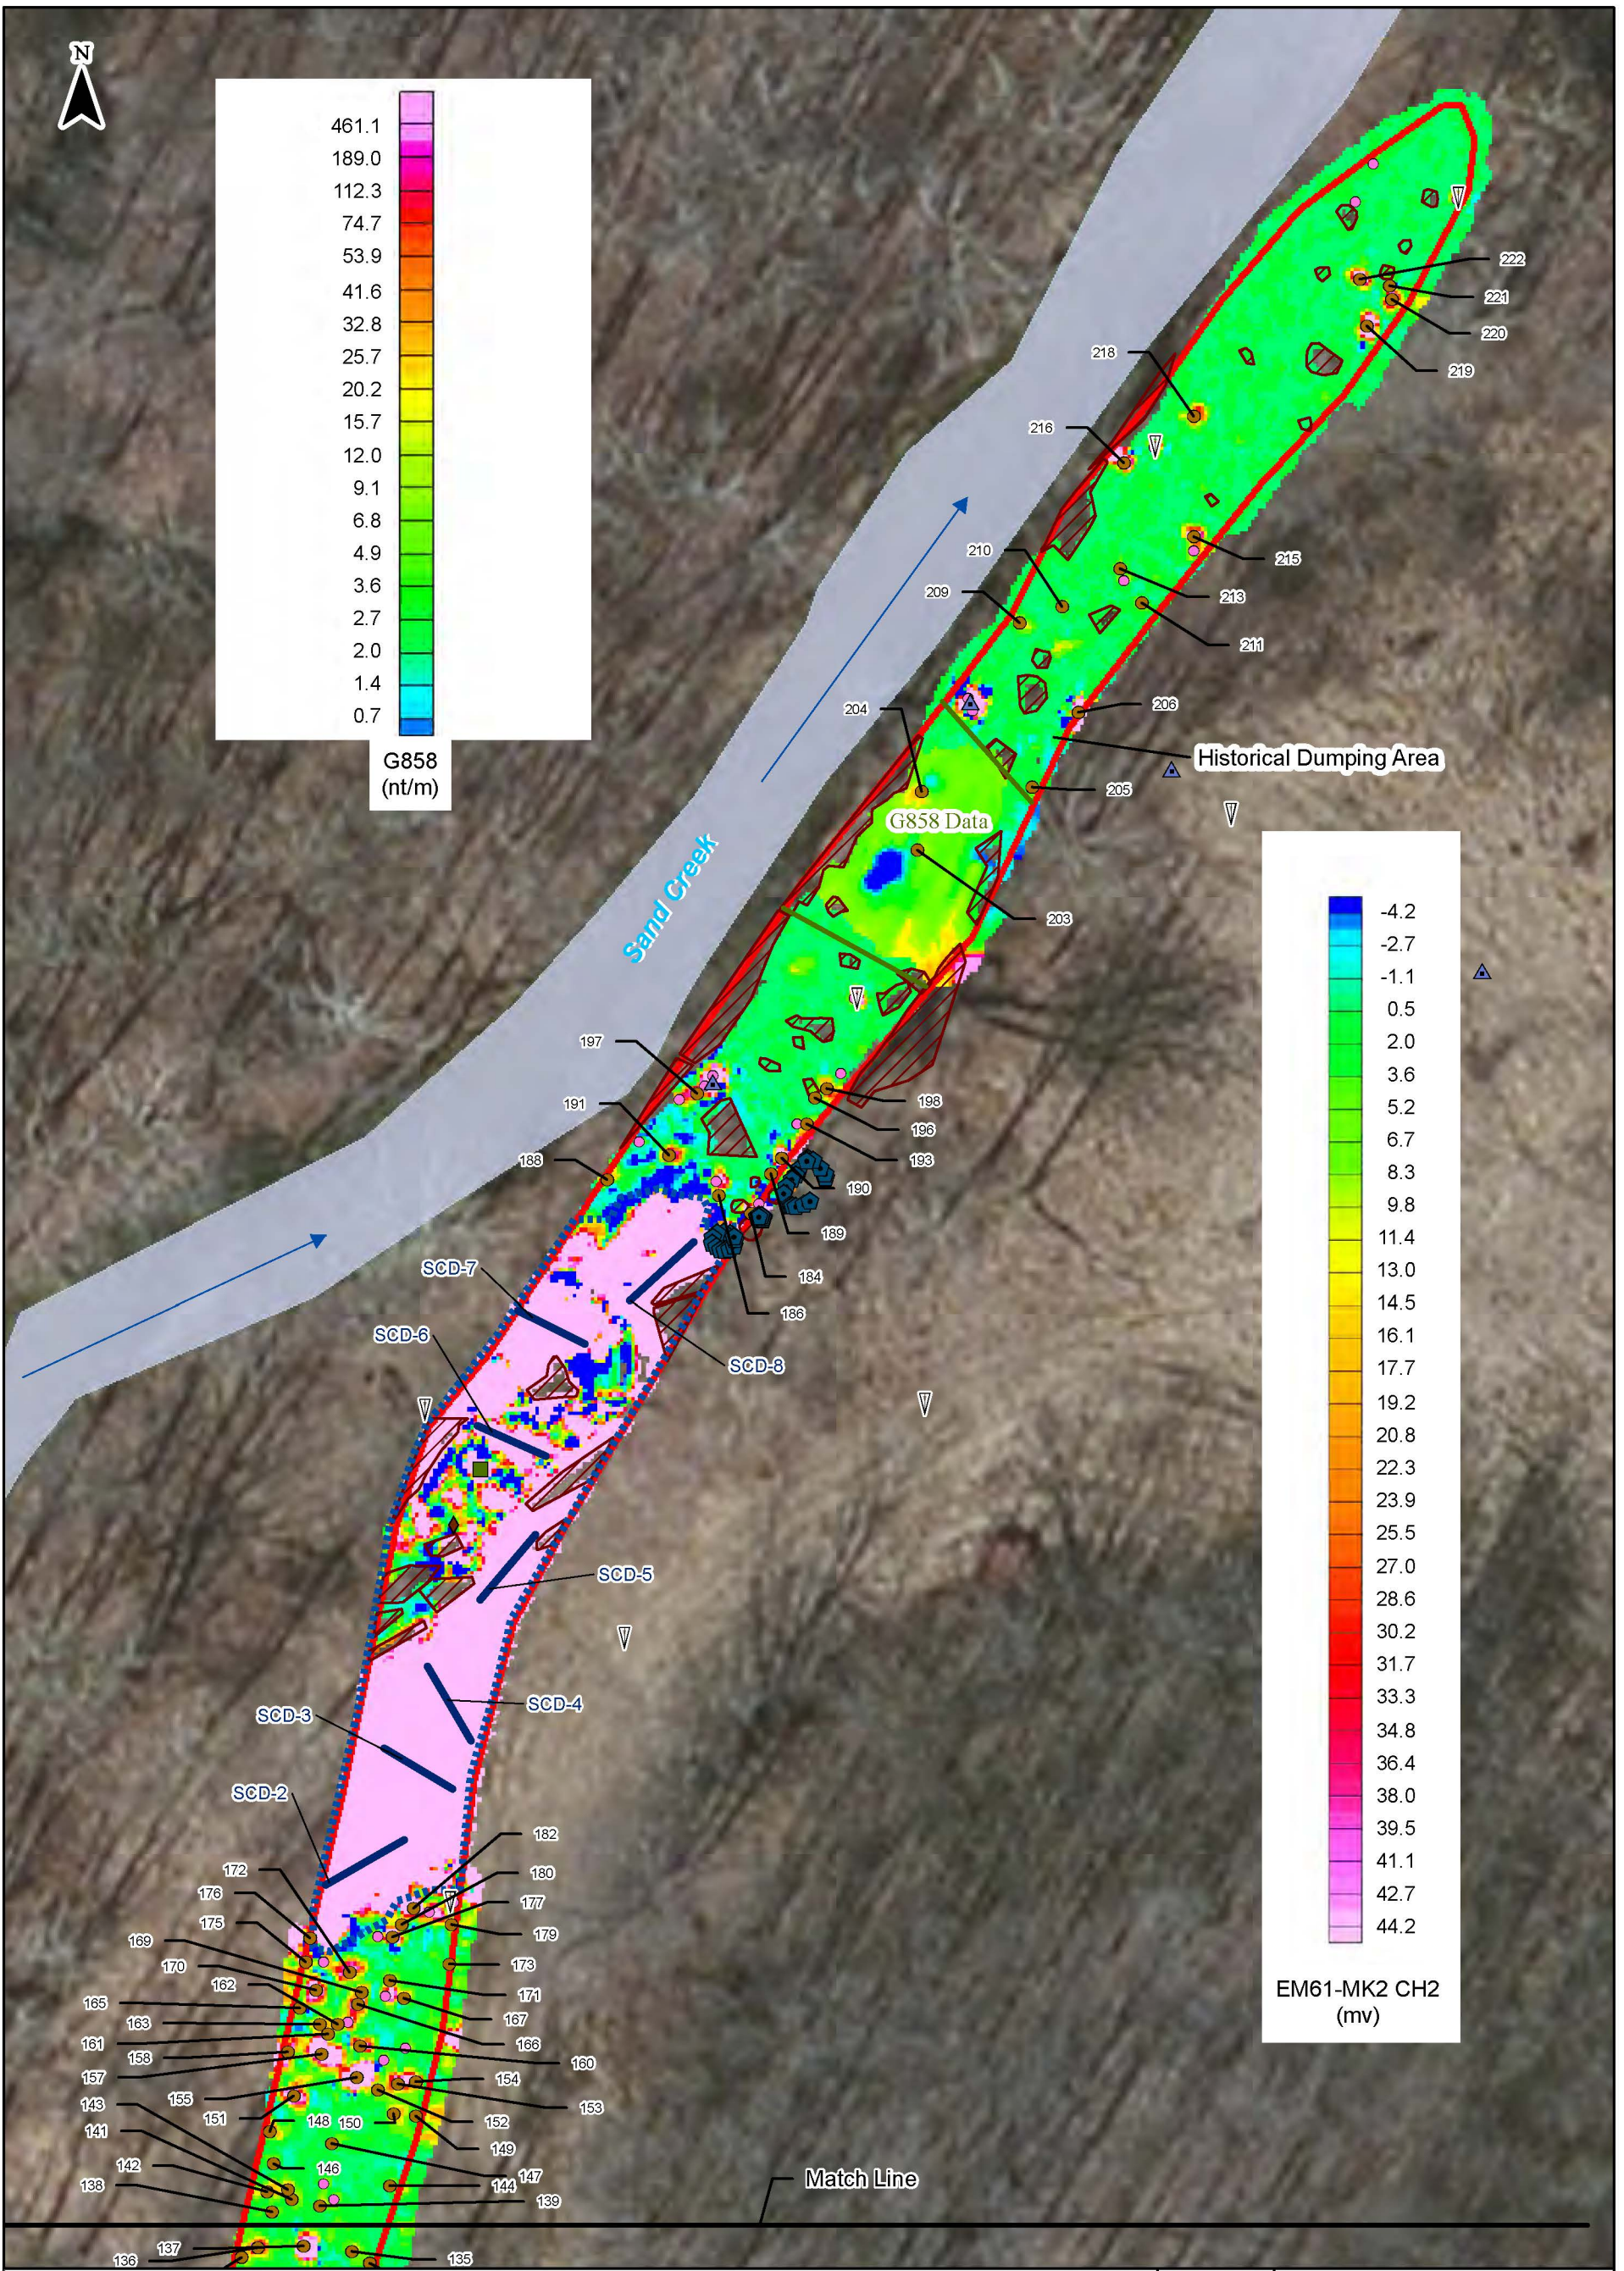
FIGURE 4-2A INTRUSIVE RESULTS - NORTH SECTION

A total of 165 individual target anomalies were discovered for reacquisition following evaluation of the combined DGM surveys and 157 of the anomalies were successfully reacquired. The eight anomalies that were not located were targets 15, 39, 53, 55, 59, 197, 203, and 204. Targets 55, 59, and 197 had relatively low initial detection responses on the EM61-MK2 (less than 20 mV). Targets 203 and 204 were selected as anomalies for intrusive investigation based on the 2010 DGM survey results using the G-858 magnetometer and also had relatively low initial detection responses (less than 60 nT/m). The combination of the low responses and difficult terrain at the MRS may have contributed to the difficulty for reacquisition at these locations. Targets 15 and 53 had relatively high initial detection responses (between 87 and 254 mV) but were not able to be reacquired. Debris consisting of

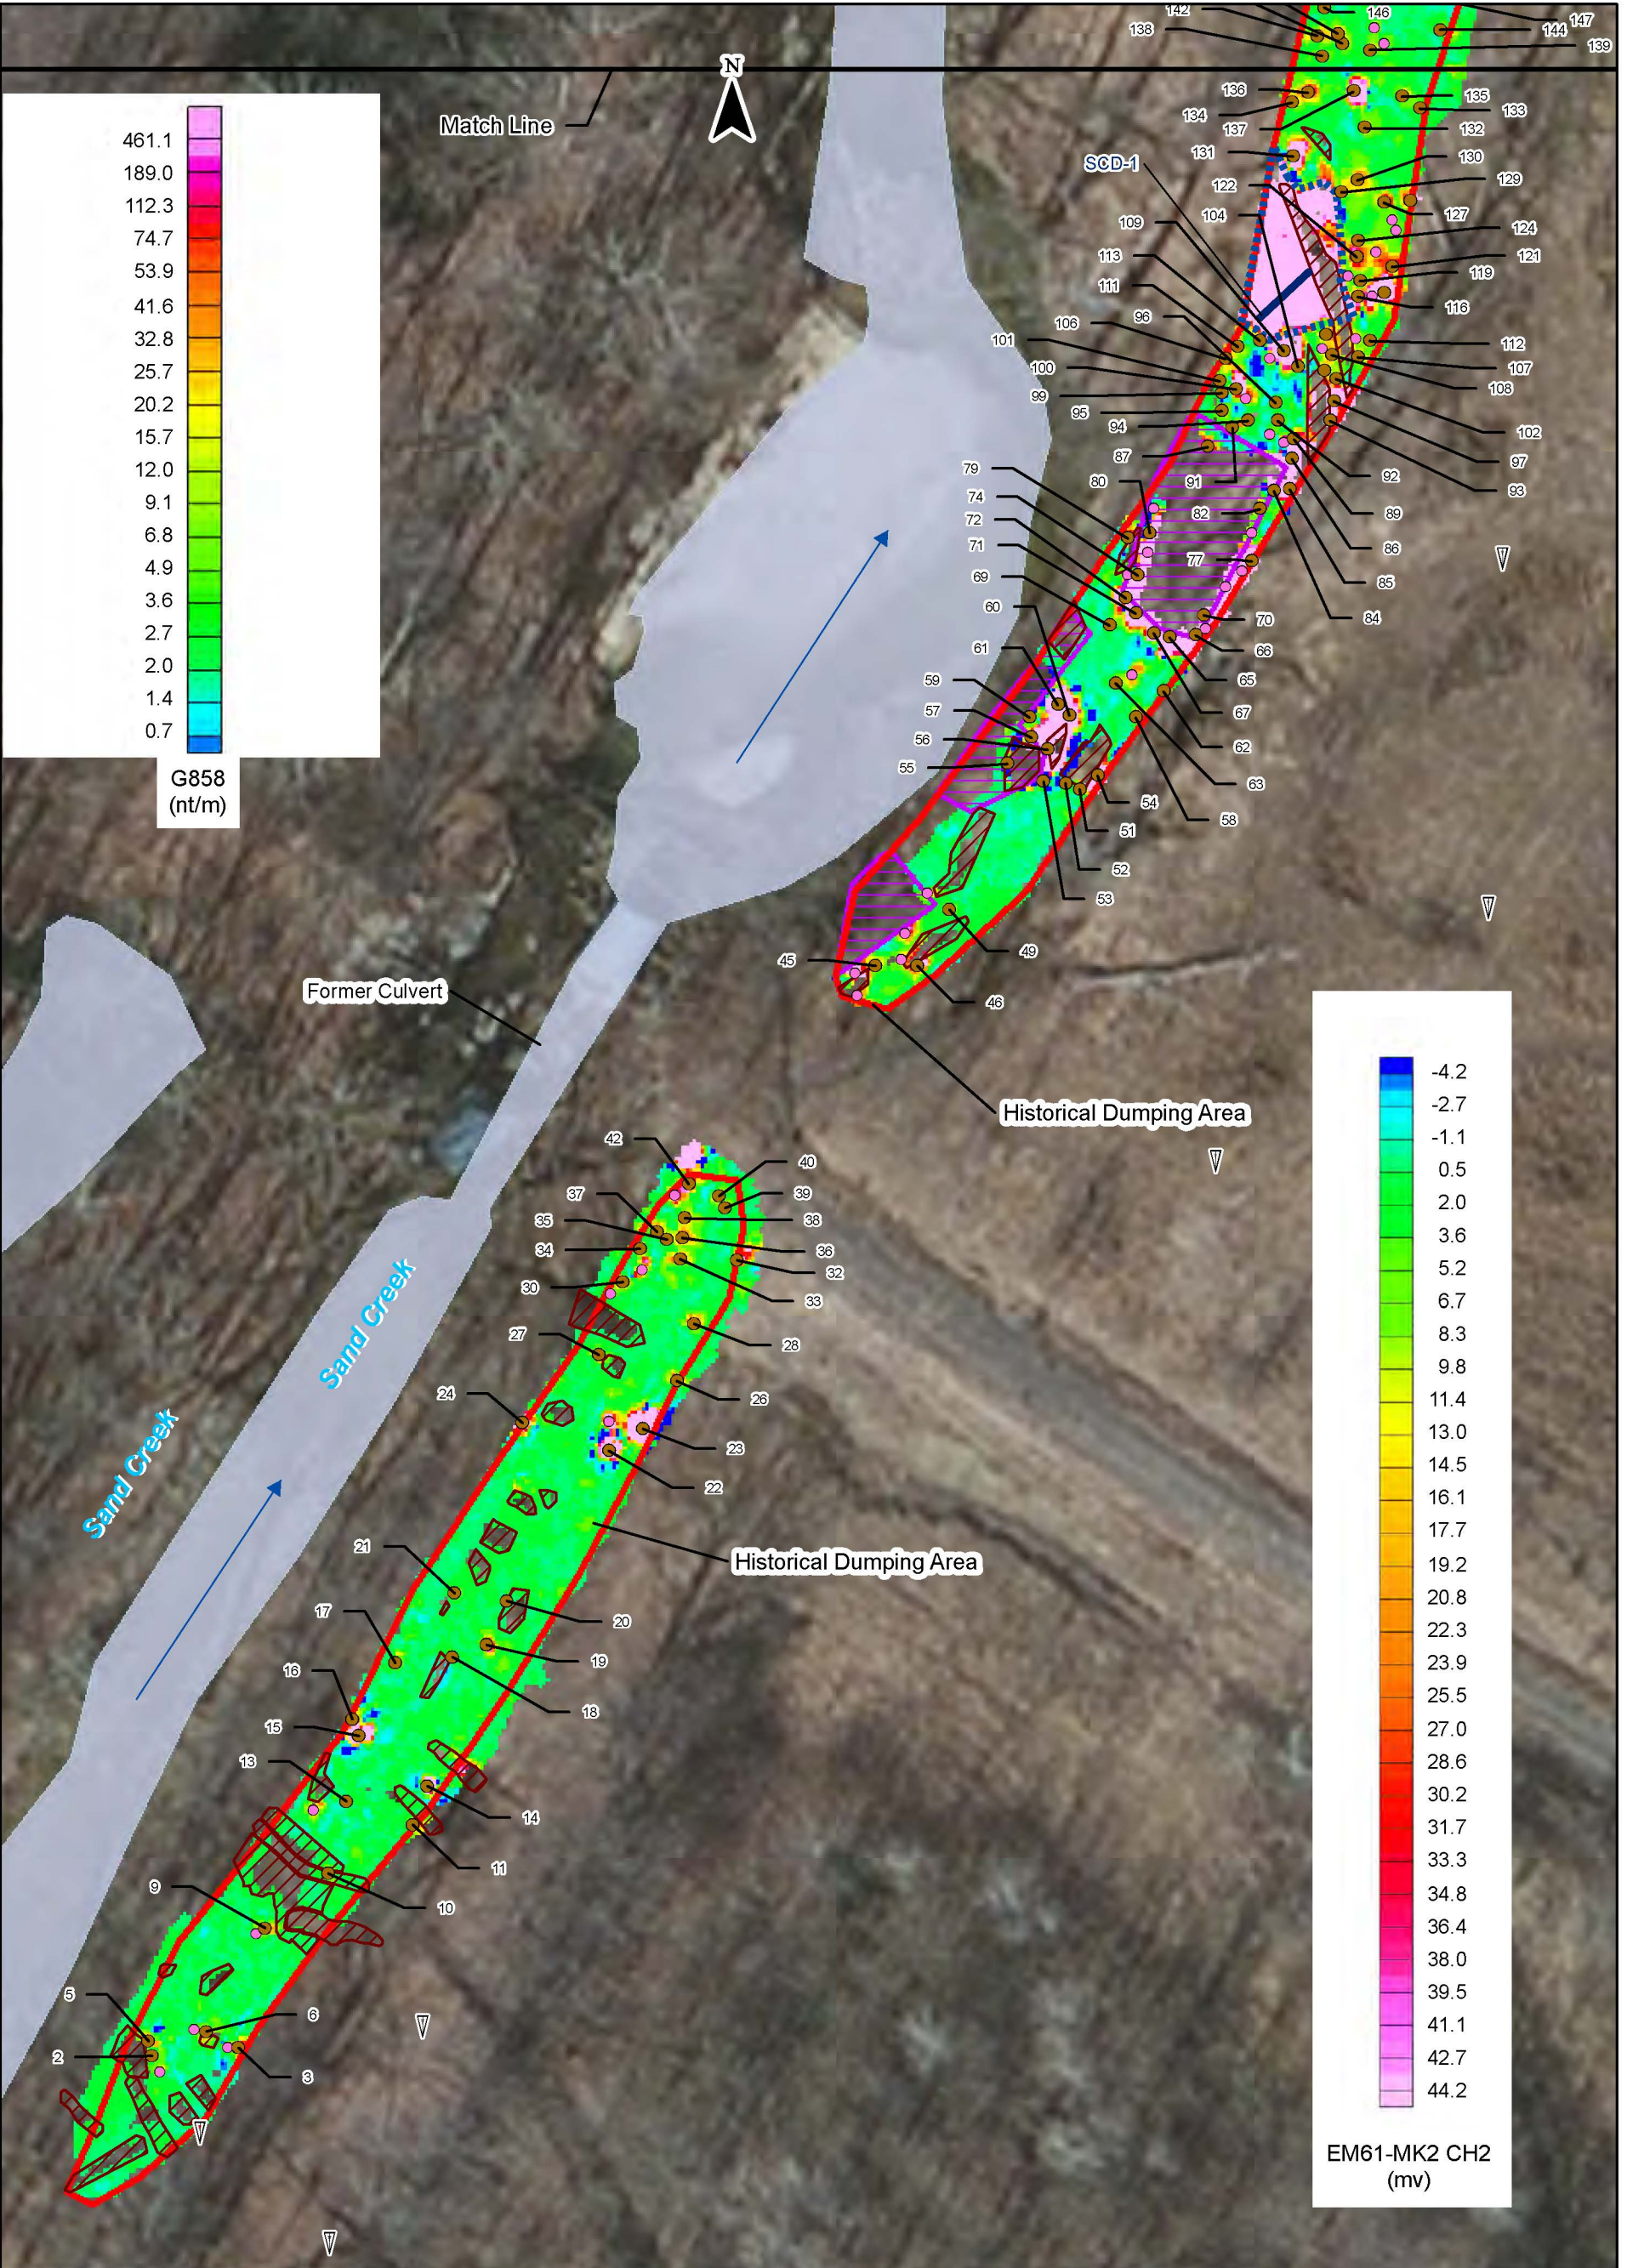
FIGURE 4-2B INTRUSIVE RESULTS - SOUTH SECTION

This section presents the results of the intrusive investigations performed at the Sand Creek Dump MRS based on the DGM survey findings. The individual target anomalies selected for intrusive investigation were excavated by hand. The high-density anomalous areas were investigated using mechanical excavation methods. A summary of the proposed intrusive activities is presented **Table 4-1**. The results of the intrusive investigation activities are presented in **Figures 4-2a** and **4-2b**. The investigation results for the intrusive investigation activities are presented in the data sheets in **Appendix C**.

MRS Boundary	Embedded Fence Post
High Anomaly Density Zone	Metal Lid, 6" Diameter
Obstructions and Other Features That Prevented DGM Data from Being Collected	Reinforced Concrete Debris
Stream	Siebert Stake
Direction of Flow	Trench Investigated-Other (non-munitions) Debris Identified
8" Nail Spike Installed by Shaw	Anomaly Not Selected for Investigation
Sand Creek Control Installed by Vista	Anomaly Investigated-Other (non-munitions) Debris Identified

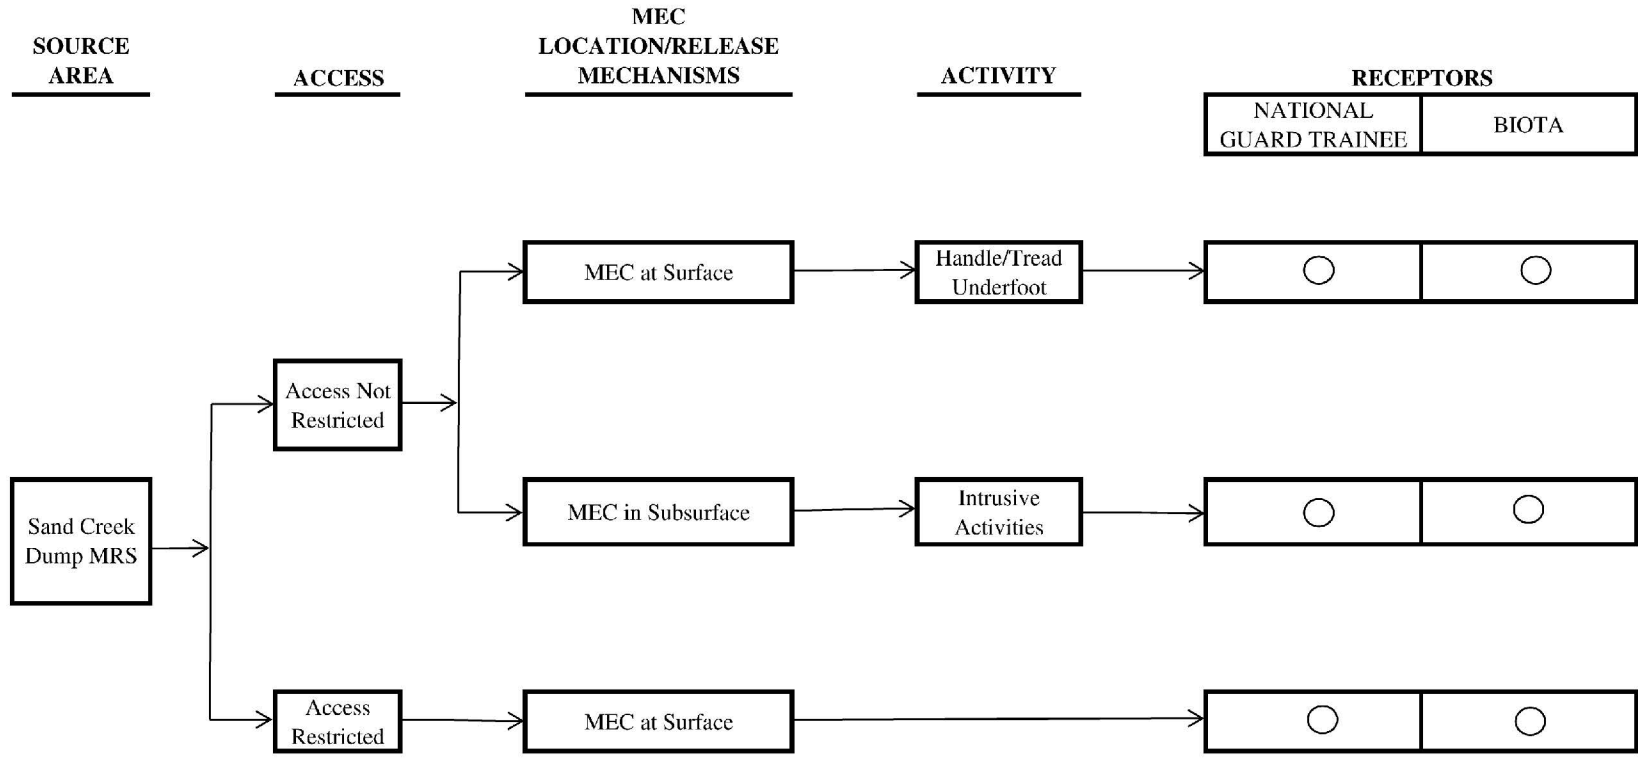
The information collected during the RI was used to update the preliminary CSM for MEC at the Sand Creek Dump MRS and to identify actual, potentially complete, or incomplete source-receptor interactions for the MRS, for current and anticipated future land uses. Evaluation of end use receptors for future land use in the revised CSM is consistent with the facility HHRA approach presented in the HHRAM (USACE, 2005a). The revised MEC Exposure Pathway Analysis is presented on **Figure 9-1**.

●	Complete Pathway
◐	Potentially Complete Pathway
○	Incomplete Pathway

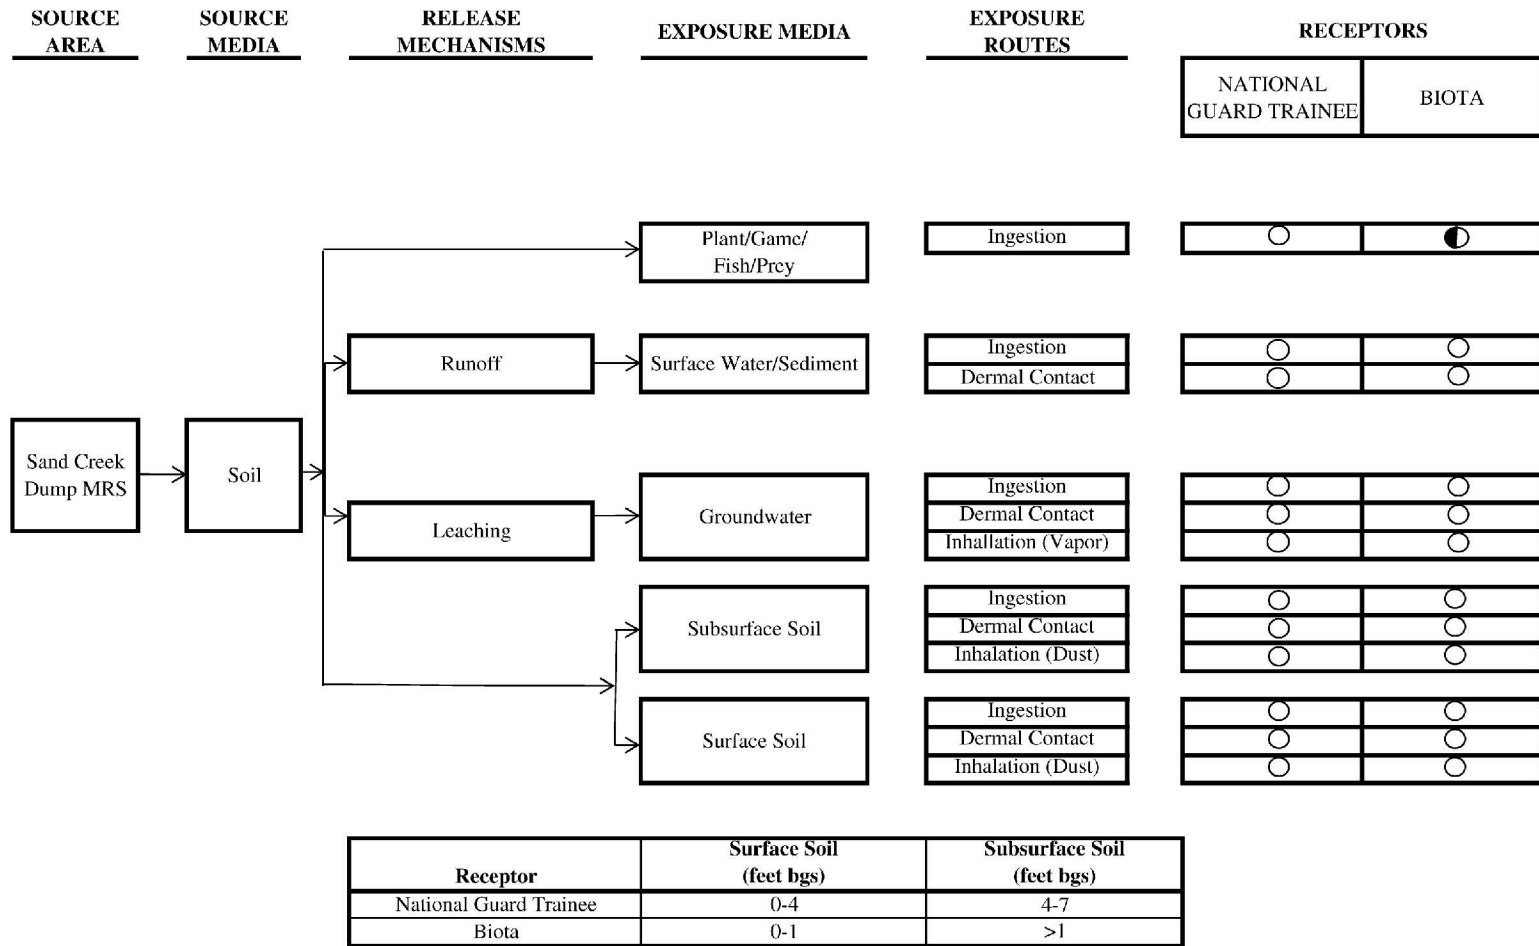
●	Complete Pathway
◐	Potentially Complete Pathway
○	Incomplete Pathway
