**Final
Remedial Investigation Report
CC RVAAP-73 Facility-Wide Coal Storage**

**Former Ravenna Army Ammunition Plant
Portage and Trumbull Counties, Ohio**

February 17, 2017

**Contract No. W912QR-12-D-0002
Delivery Order: 0003**

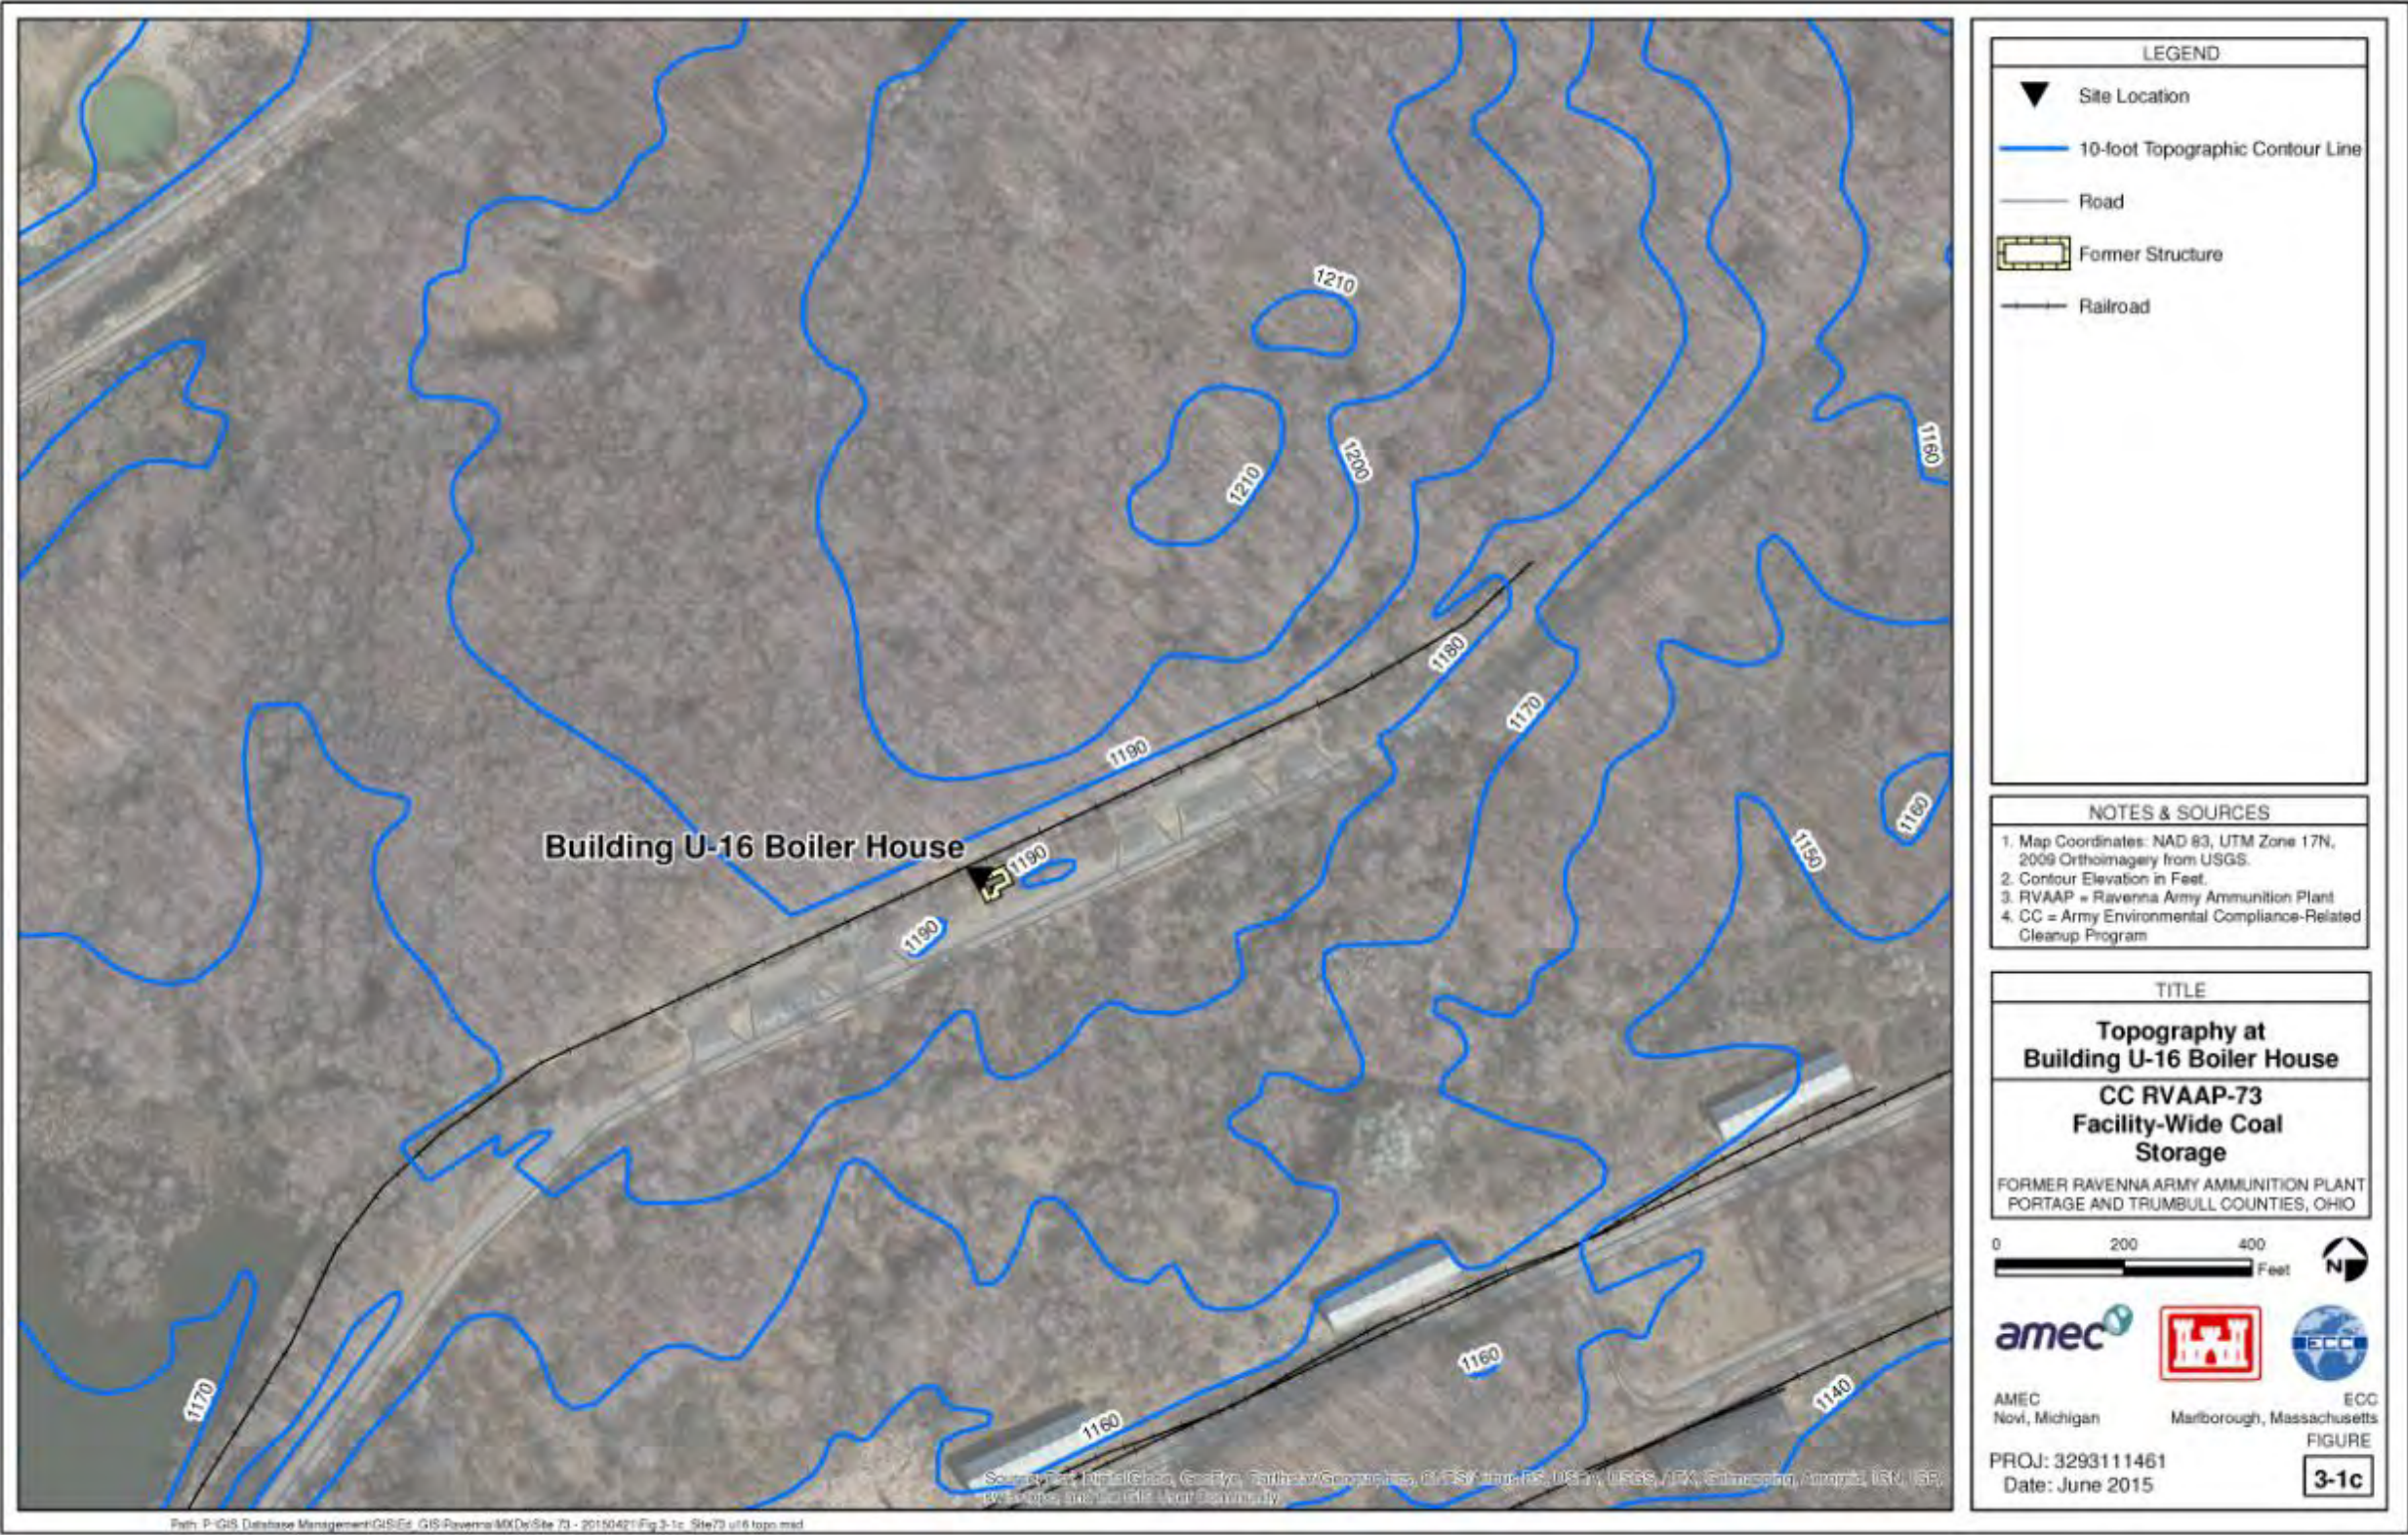
Figure 3-1c Topography at Building U-16 Boiler House

Building U-16 Boiler House—As shown on Figure 3-3c, there are no wetlands, creeks, streams, or other water bodies within the Building U-16 Boiler House area. Based on the topography map of this area (Figure 3-1c), the ground surface is relatively flat. Light precipitation likely infiltrates or pools on the surface. However, during periods of sustained precipitation, surface water would flow in a generally south-southeastern direction. The nearest downgradient surface water body is a tributary (and associated wetlands) of Hinckley Creek, located approximately 1,100 ft south of the Building U-16 Boiler House area.

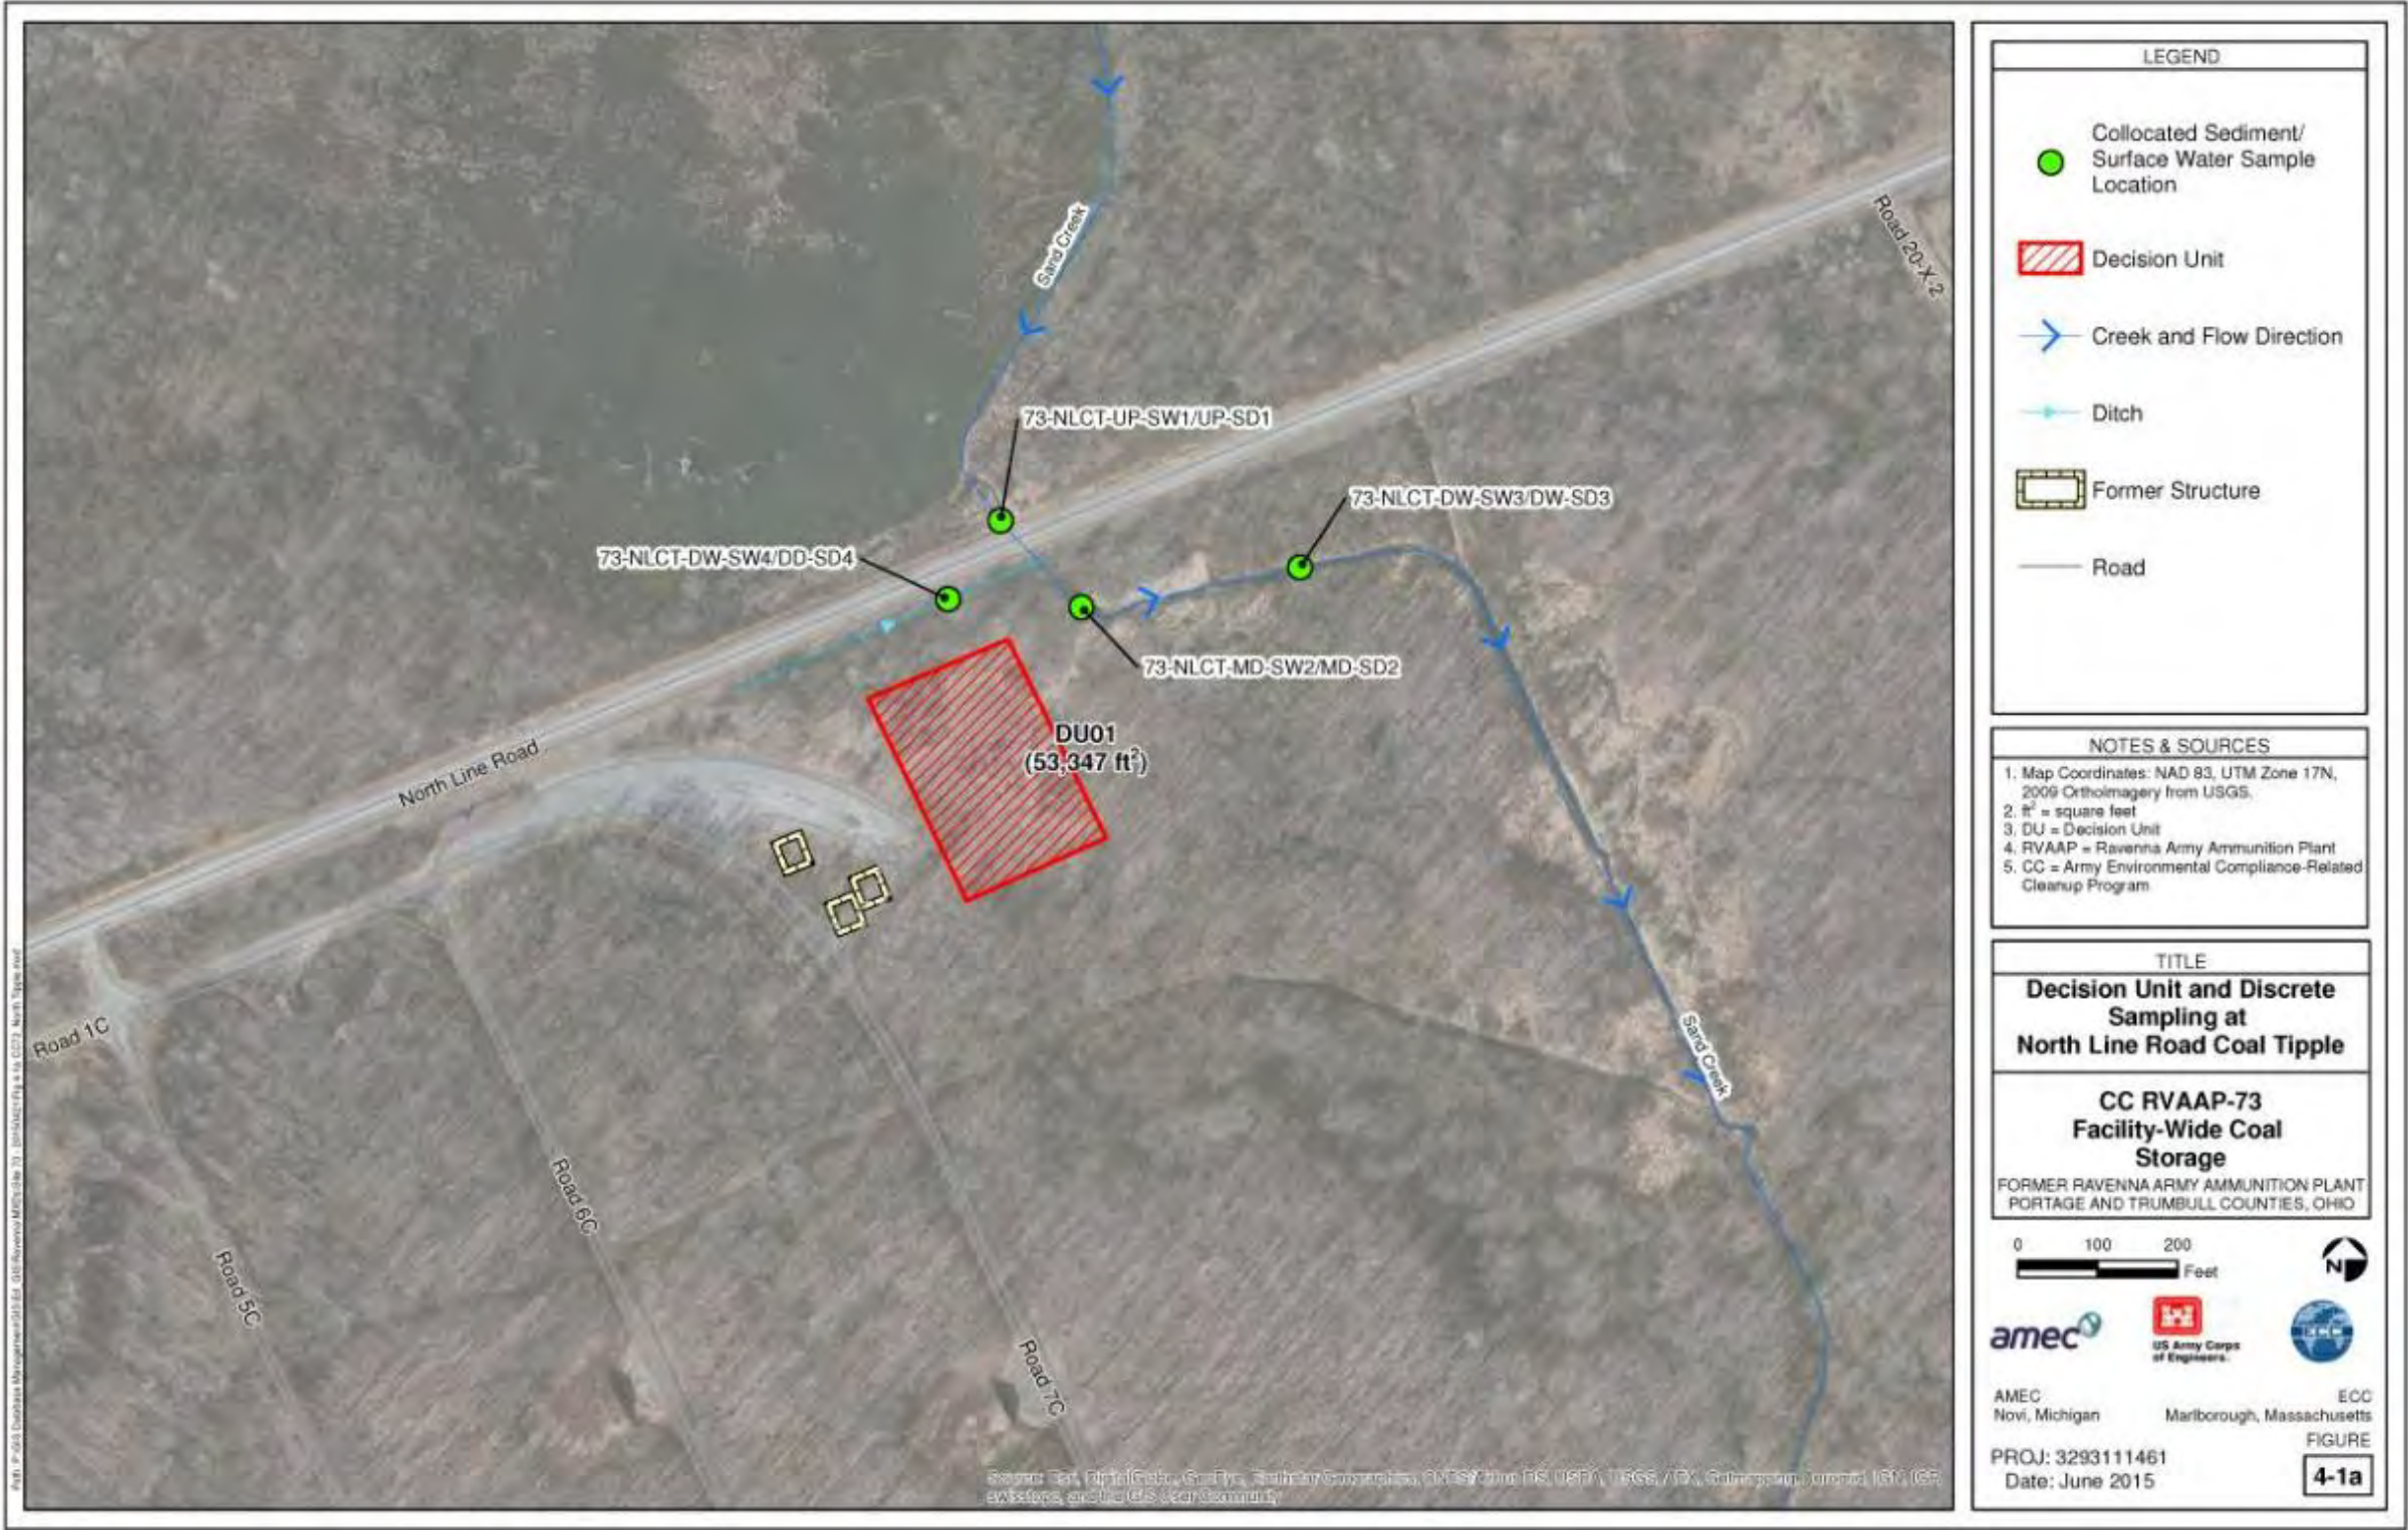
Figure 4-1a Decision Unit at North Line Road Coal Tipple

North Line Road Coal Tipple (53,347 ft²)—As shown on Figure 4-1a, DU01 covers the investigative area of approximately 53,347 ft² at this former coal storage area. ISM sampling of surface and subsurface soils was conducted in DU01; 1 ISM surface soil sample (0-1 ft bgs) 2 horizontal ISM subsurface soil samples (1 from 1 to 4 ft bgs and 1 from 4 to 7 ft bgs), and 5 vertical ISM subsurface soil samples (1-7 ft bgs). In addition, a vertical composite soil sample was collected from one DSB (7-13 ft bgs) in DU01.

one where runoff may enter the creek, and one further downgradient. One additional collocated wet sediment and surface water sample was collected from an upgradient ditch that parallels North Line Road, approximately 70 ft north of DU01, and discharges to Sand Creek. The wet sediment and surface water samples were analyzed for TAL metals, including mercury, and SVOCs. One sediment and 1 surface water sample were also analyzed for organochlorine pesticides, PCBs, VOCs, and explosives/propellants. Sampling locations are shown on Figure 4-1a.

Figures 4-1a through 4-1c depict the location, size, and layout of each DU. Figures 4-1a and 4-1b also show the collocated surface water and wet sediment sampling locations. Boring locations for the subsurface ISM samples are shown on Chapter 5 figures. Field activities within CC RVAAP-73 Facility-Wide Coal Storage AOC were completed between November 8, 2012 and April 1, 2013.

The wet sediment and surface water samples were analyzed for TAL metals, including mercury, and SVOCs. One sediment and 1 surface water sample were also analyzed for organochlorine pesticides, PCBs, VOCs, and explosives/propellants. Sampling locations are shown on Figures 4-1a and 4-1b for the North Line Road Coal Tipple and Sand Creek Coal Tipple, respectively. The surface water and sediment sampling results are shown in Tables 6-1 and 6-2 for the North Line Road Coal Tipple and Tables 6-3 and 6-4 for the Sand Creek Coal Tipple, respectively. The analytes listed in the tables are those that were retained as SRCs in surface soil within the DU (Table 5-1).

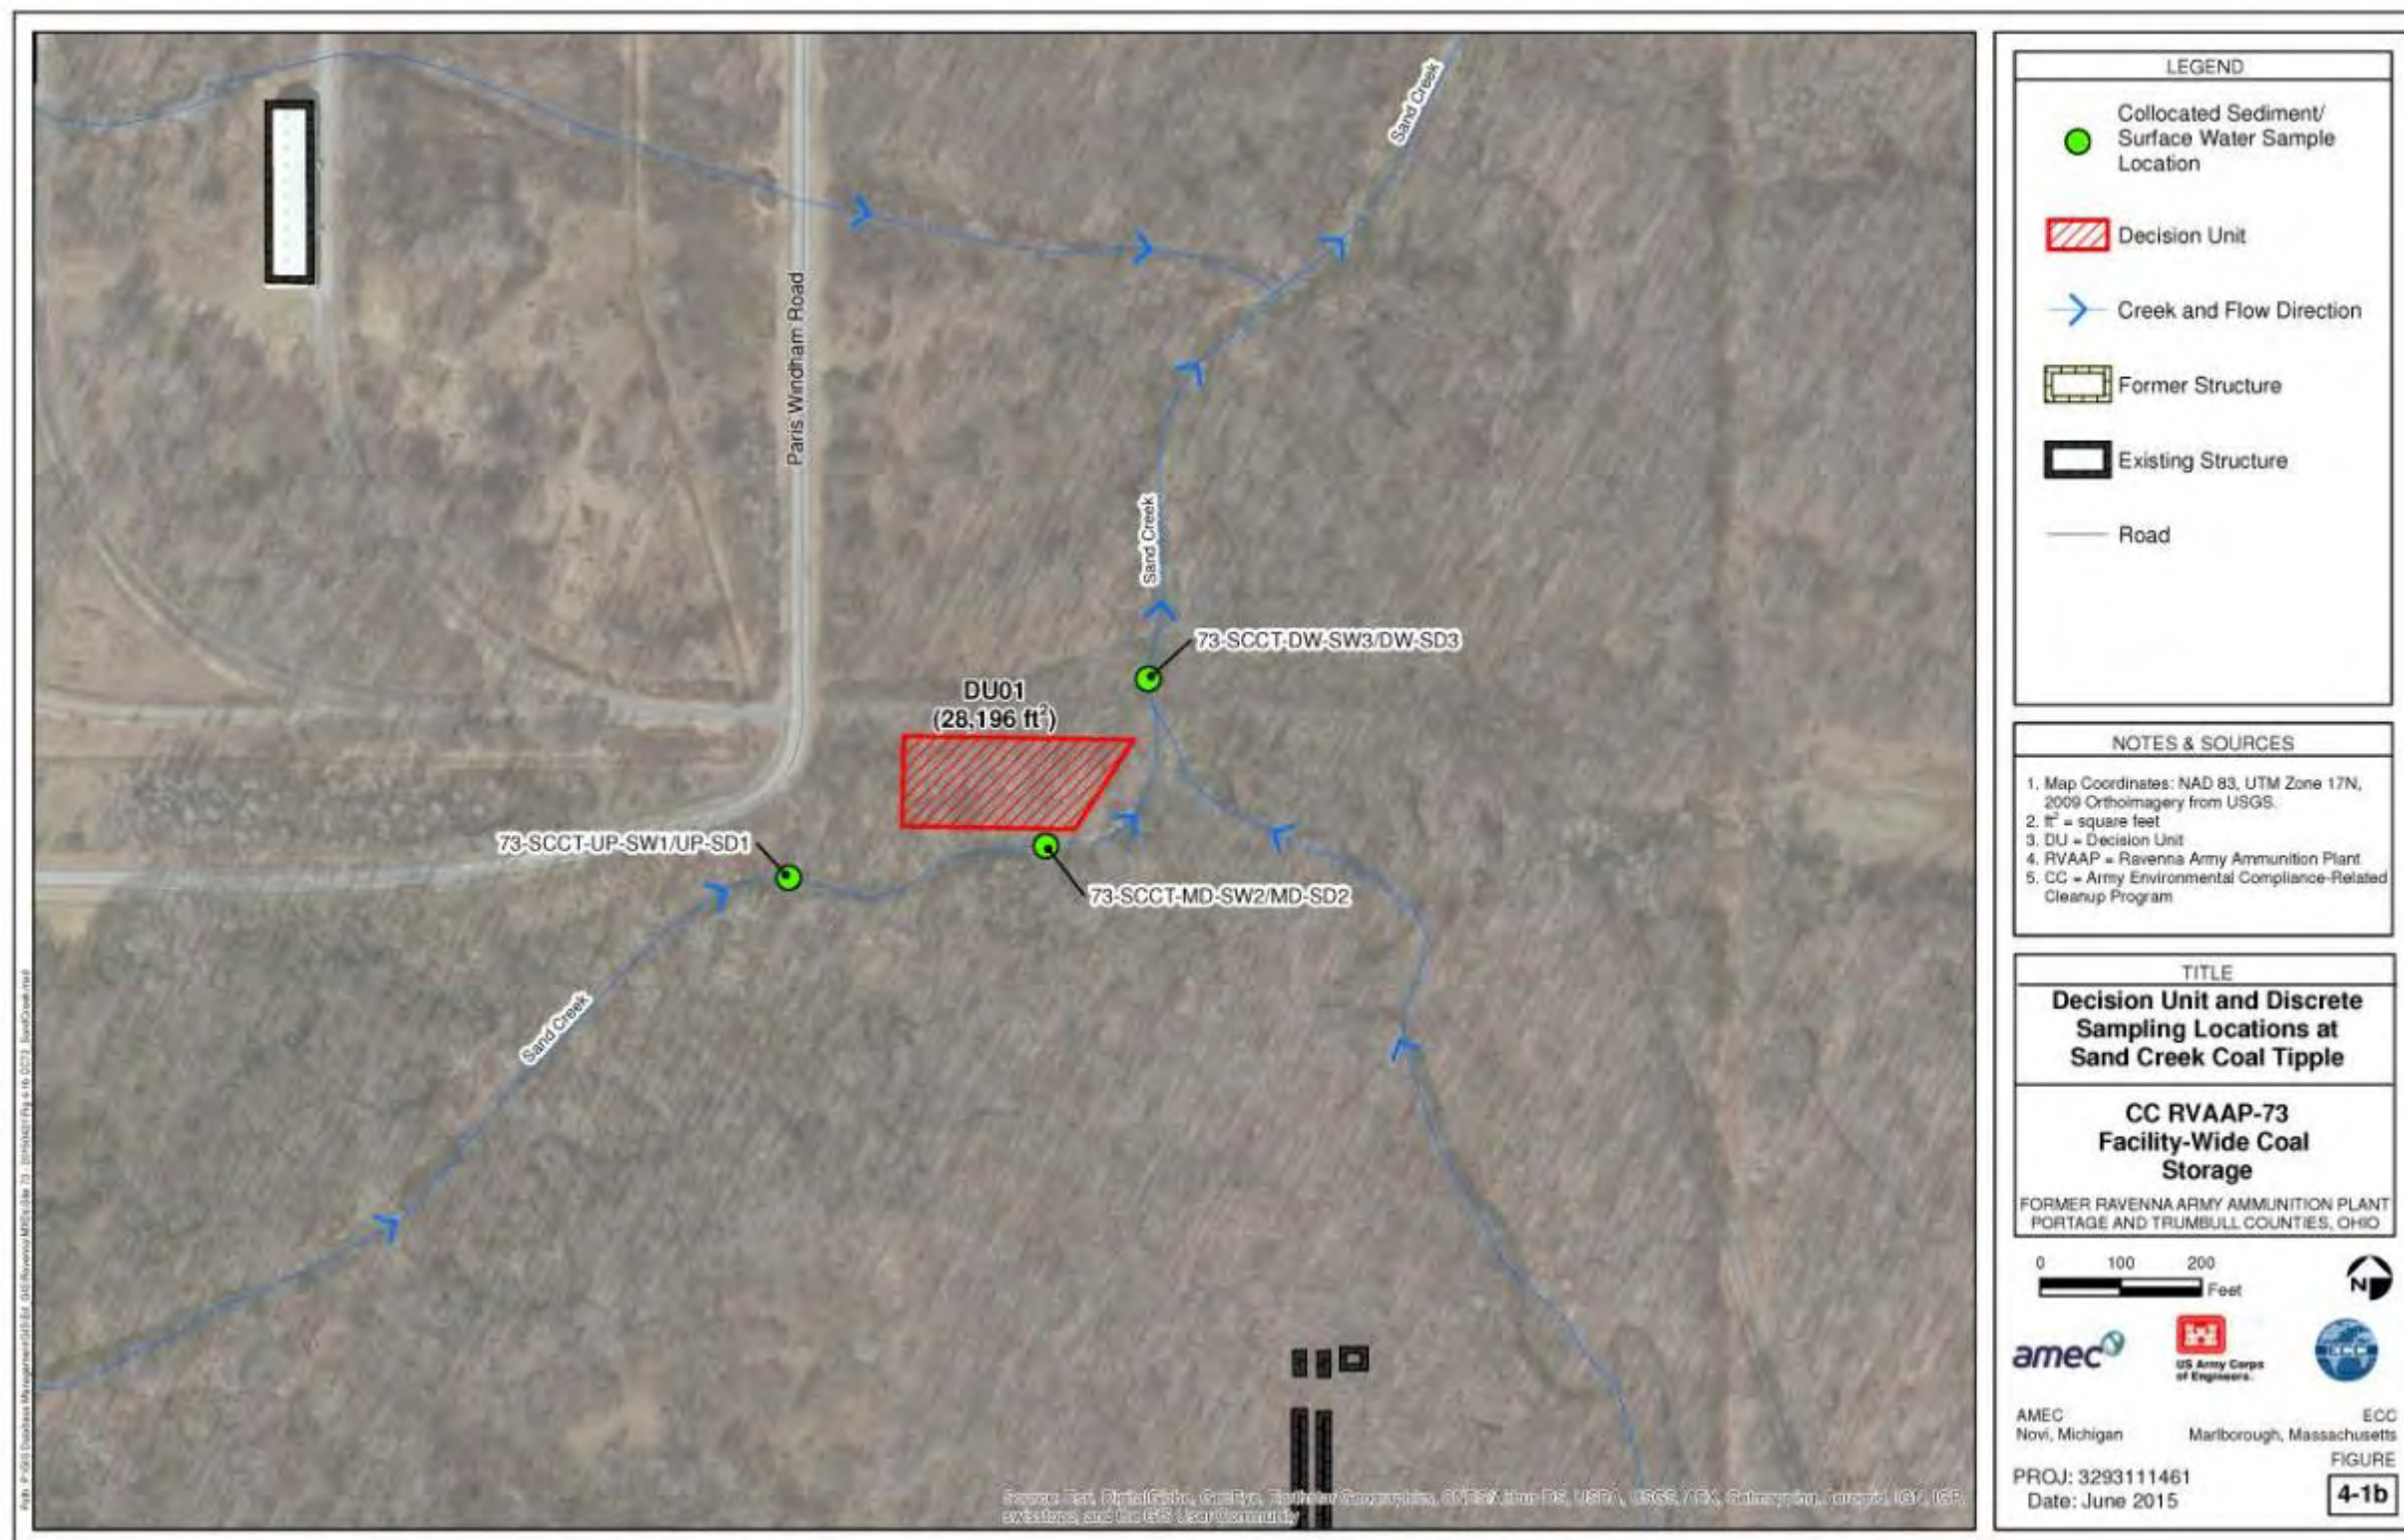
Figure 4-1b Decision Unit at Sand Creek Coal Tipple

Sand Creek Coal Tipple (28,196 ft²)—As shown on Figure 4-1b, DU01 covers the investigative area of approximately 28,196 ft² at this former coal storage area. ISM sampling of surface and subsurface soils was conducted in DU01; 1 ISM surface soil sample (0-1 ft bgs) 2 horizontal ISM subsurface soil samples (1 from 1 to 4 ft bgs and 1 from 4 to 7 ft bgs), and 5 vertical ISM subsurface soil samples (1-7 ft bgs). In addition, a vertical composite soil sample was collected from one DSB (7-13 ft bgs) in DU01.

In addition to soil samples, a total of 3 collocated wet sediment and surface water samples were collected from Sand Creek, located approximately 50 ft east of DU01: one upgradient, one where runoff may enter the creek, and one further downgradient. The wet sediment and surface water samples were analyzed for TAL metals, including mercury, and SVOCs. Sampling locations are shown on Figure 4-1b.

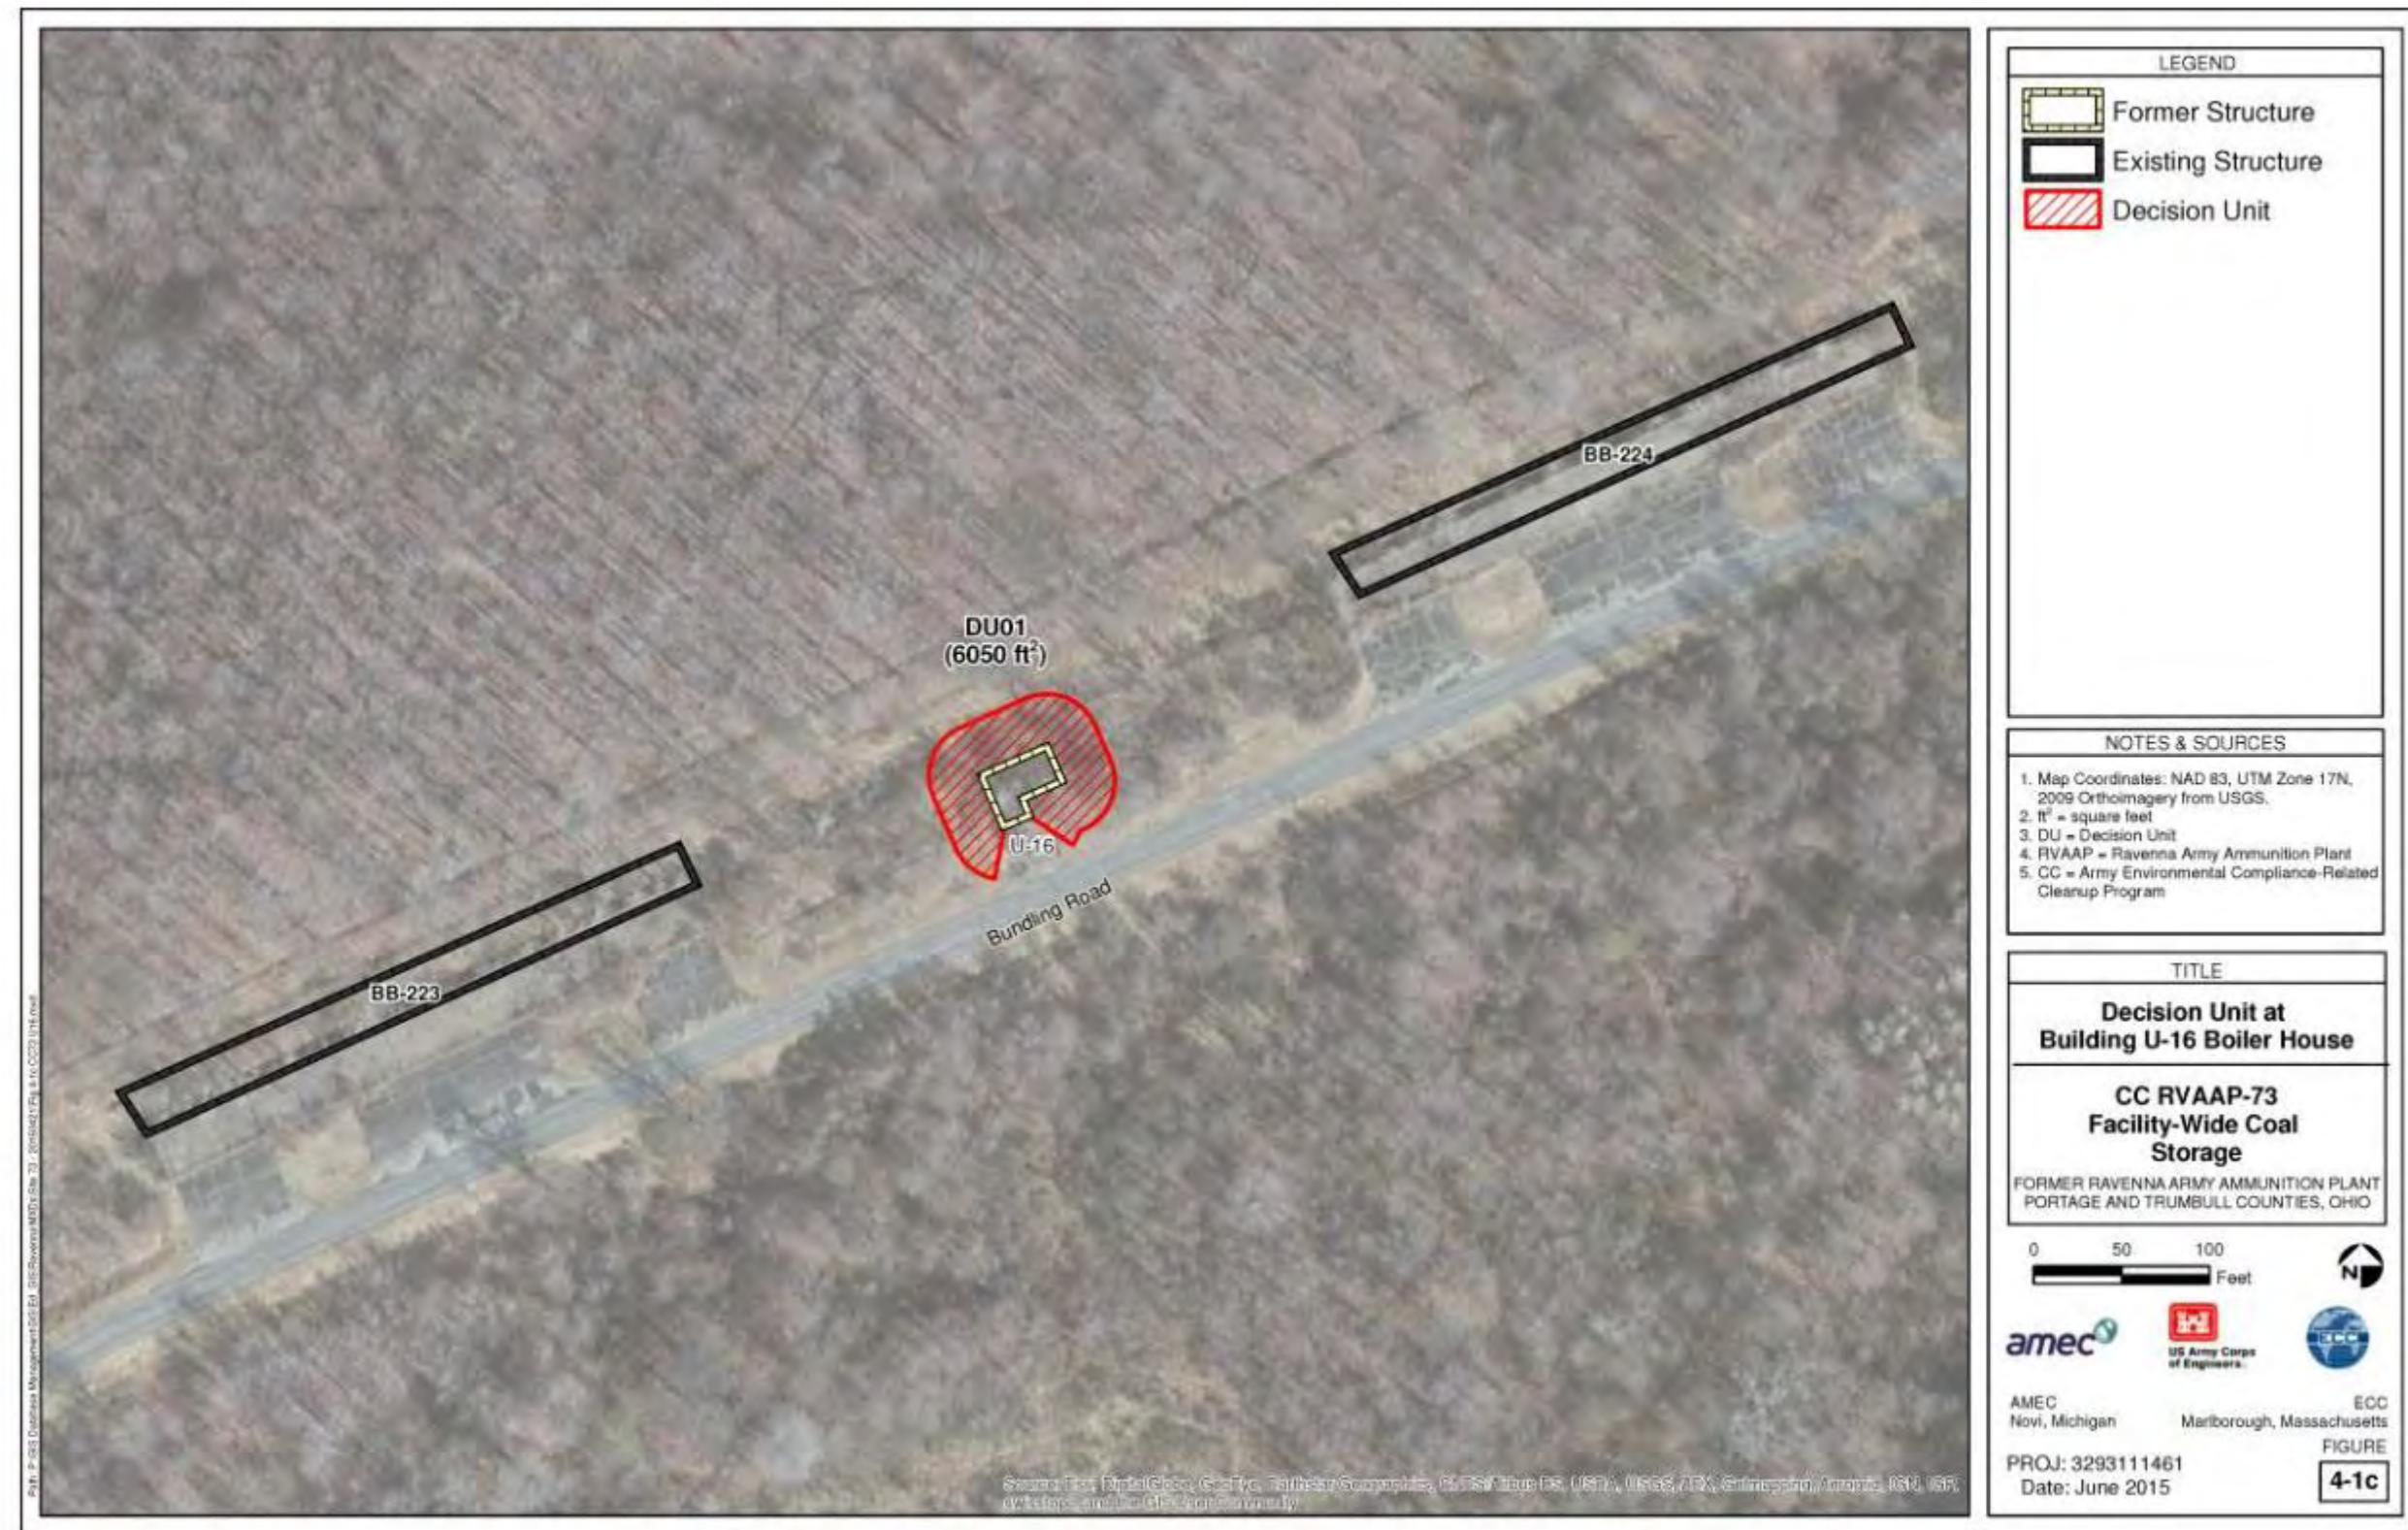
Building U-16 Boiler House (6,050 ft²)—As shown on Figure 4-1c, DU01 covers the investigative area of approximately 6,050 ft² surrounding former Building U-16. ISM sampling of surface and subsurface soils was conducted in DU01; 1 ISM surface soil sample (0-1 ft bgs) 2 horizontal ISM subsurface soil samples (1 from 1 to 4 ft bgs and 1 from 4 to 7 ft bgs), and 5 vertical ISM subsurface soil samples (1-7 ft bgs). In addition, a vertical composite soil sample was collected from one DSB (7-13 ft bgs) in DU01.

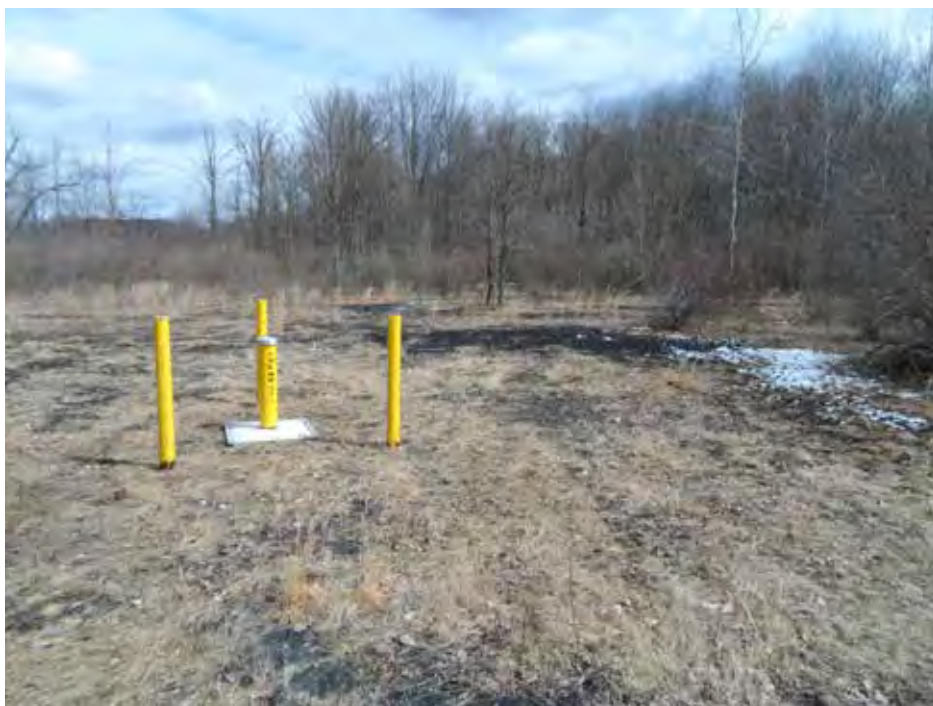
Overview of North Line Road Coal Tipple (March of 2013).

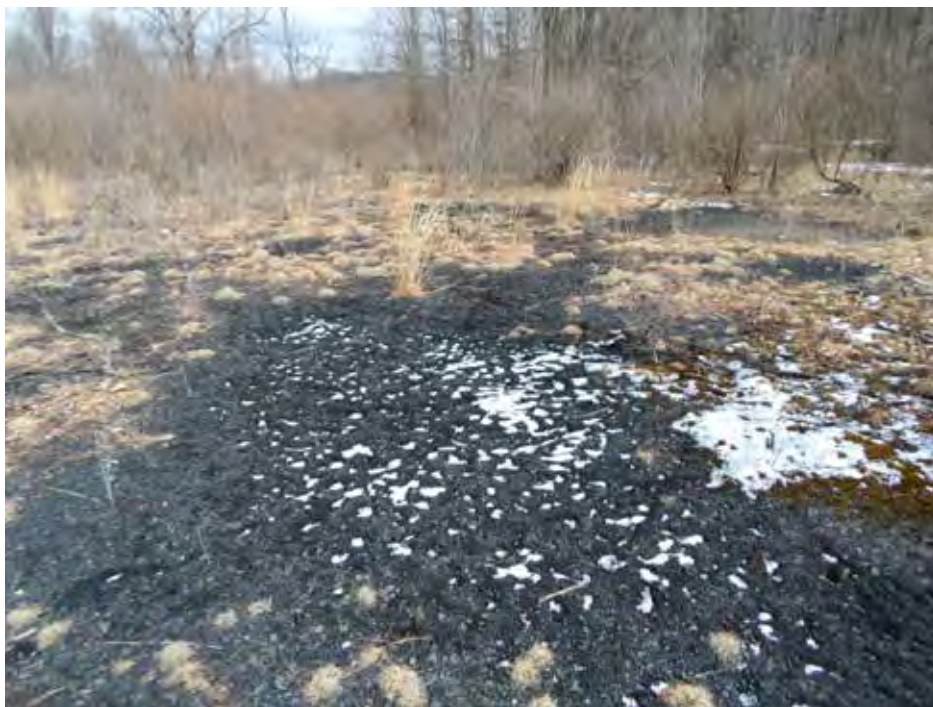
View of coal at North Line Road Coal Tipple (March of 2013).

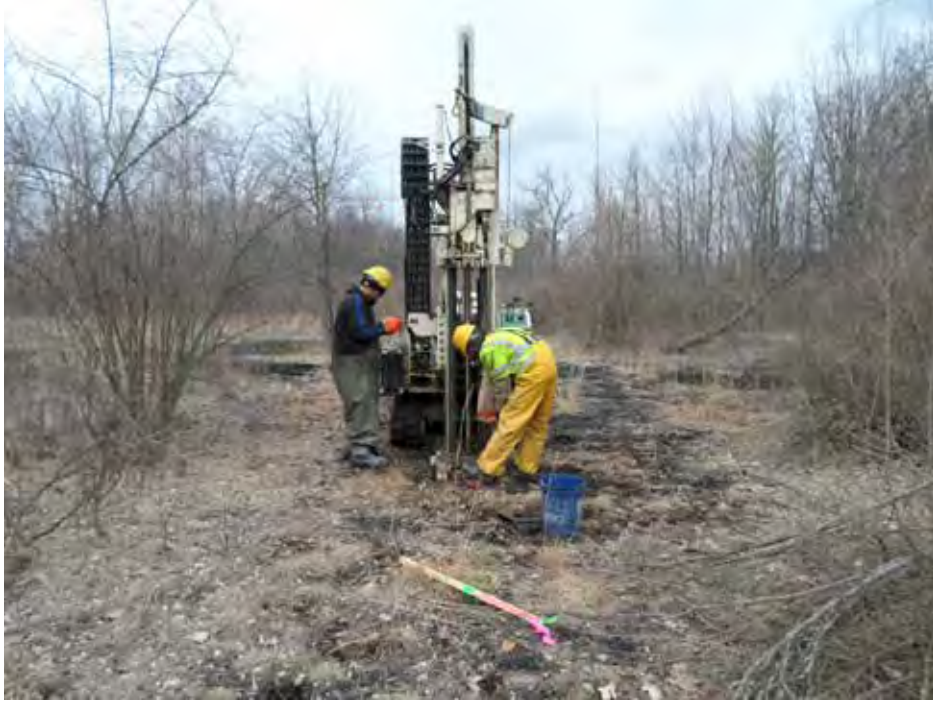
Soil boring utilizing a GeoProbe at North Line Road Coal Tipple (March of 2013).

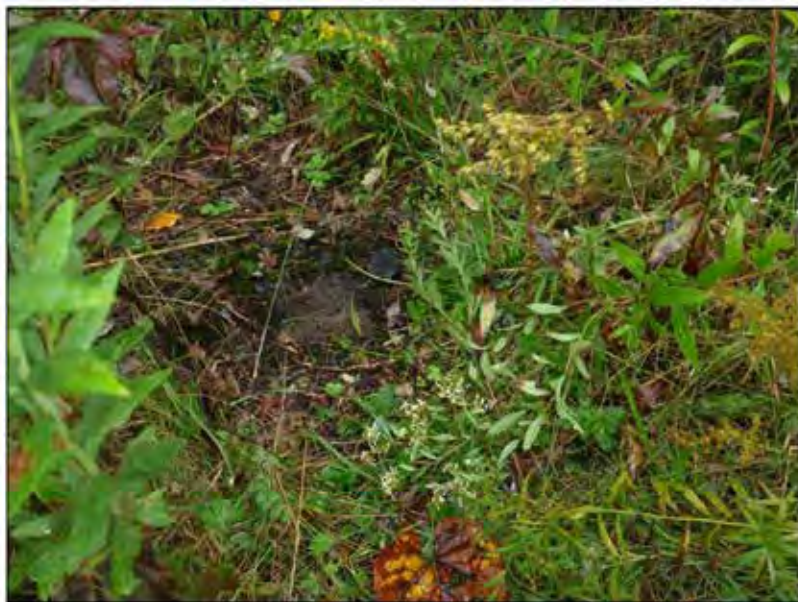
Evidence of former coal storage site at former Building U-16 Broiler House Location, minimum coal was observed (September of 2011).
