FINAL
Revised Property Management Plan for the Designated Areas of Concern and
Munitions Response Sites
Version 4.1
Former Ravenna Army Ammunition Plant
Camp James A. Garfield Joint Military Training Center,
Portage and Trumbull Counties, Ohio

Prepared for:
Ohio Army National Guard
Camp James A. Garfield Joint Military Training Center,
Portage and Trumbull Counties, Ohio

US Army Corps of Engineers
600 Martin Luther King Jr Place Dr.
Louisville, Kentucky 40202

February 2023

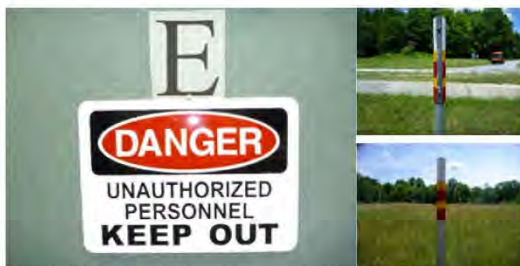
Figure 1 - "As-Installed" Seibert Markers, Signs and Asbestos Warning Sign Locations

Alternating Seibert Stakes (11) and “Unauthorized Personnel” warning signs (5) and Asbestos Waste Disposal Site warning signs are placed along the perimeter at approximately 50-foot intervals. (Figure 1). The “Unauthorized Personnel” warning signs read:

Black stripe faces AOC

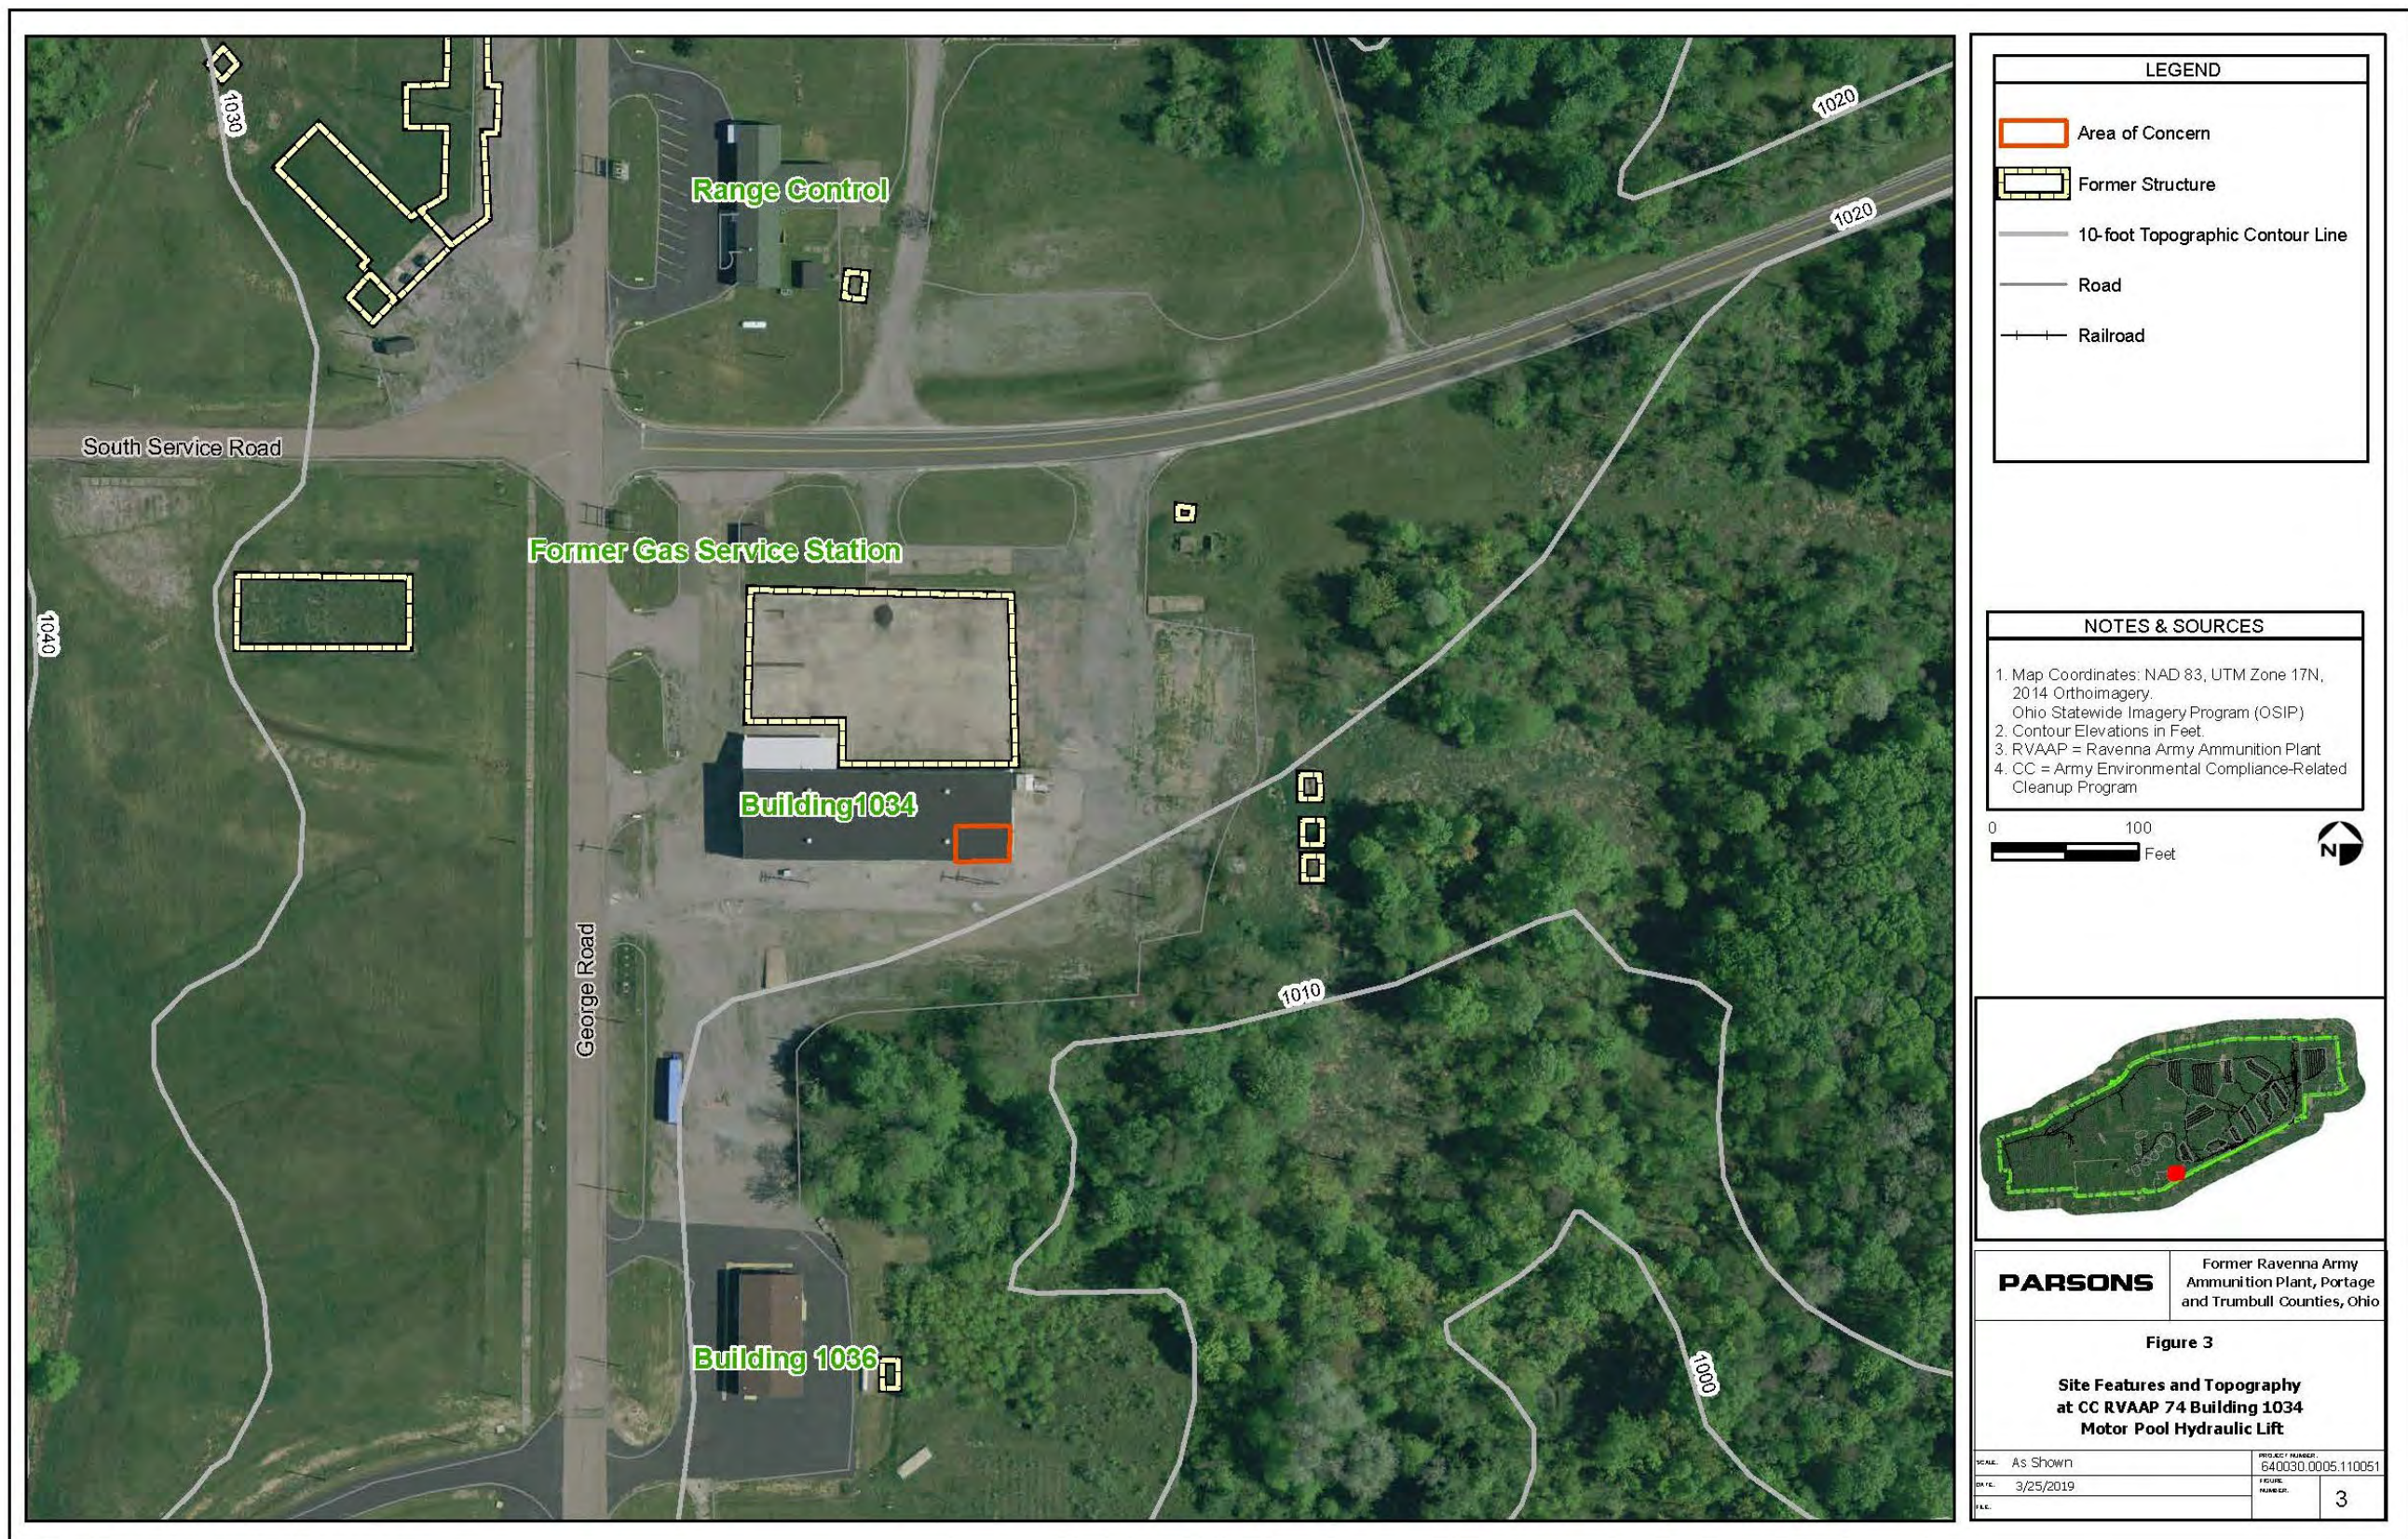
Site Features and Topography at CC RVAAP-74 Building 1034 Motor Pool Hydraulic Lift
