**MUNITIONS RESPONSE FOR THE DEMOLITION OF
RVAAP-41 LOAD LINE 8
RVAAP-43 LOAD LINE 10
Addendum No. 1
DEMOLITION OF BUILDING 1034**

**Ravenna Army Ammunition Plant (RVAAP)
Ravenna, Ohio**

February, 2008

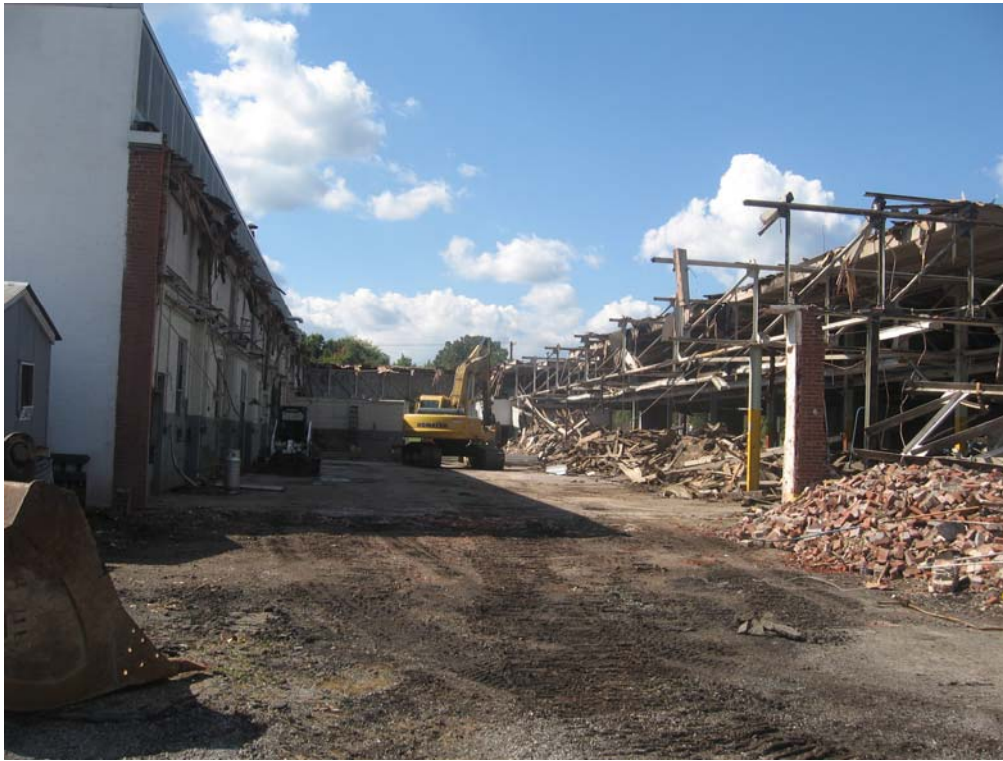
Detaching north end of 1034 (right) from southern section of 1034 that will be saved for continued use (left).

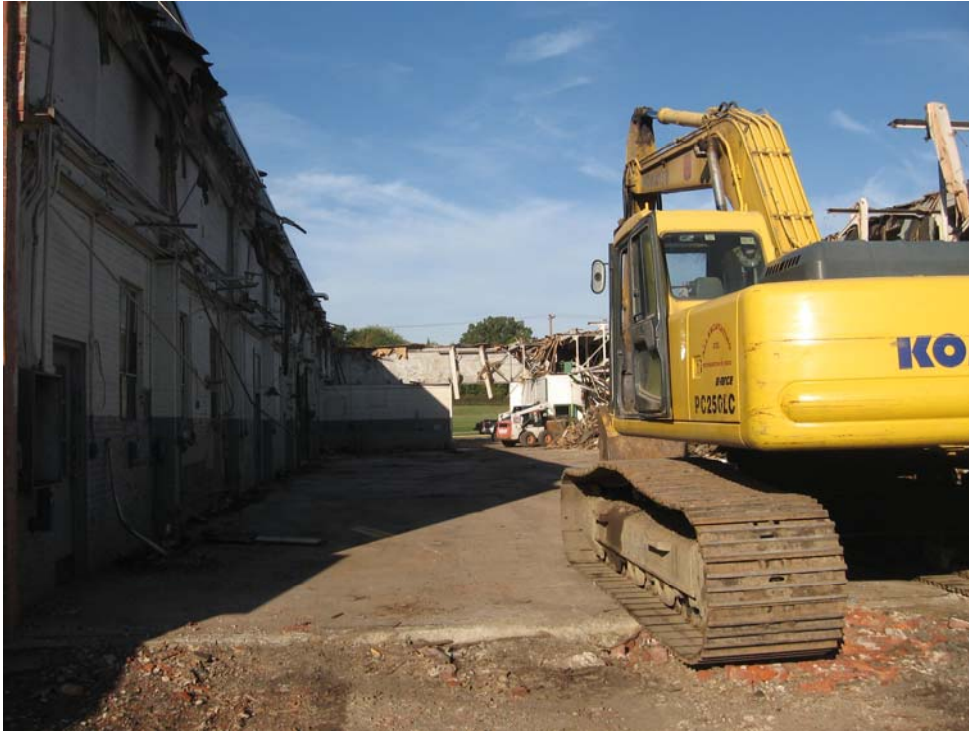
Close up of shared wall between northern and southern section prior to removal of truss supports & conduit etc..

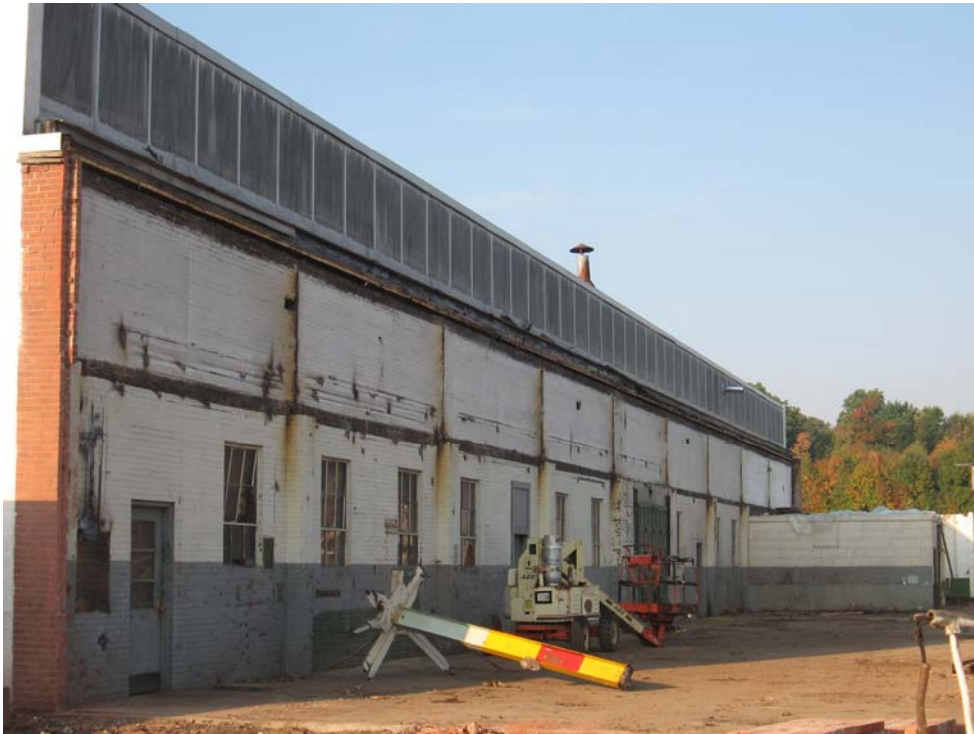
Close up of shared wall (now exterior wall of southern section of 1034 to be saved) with truss supports removed. The connecting restroom that will be salvaged is also shown.

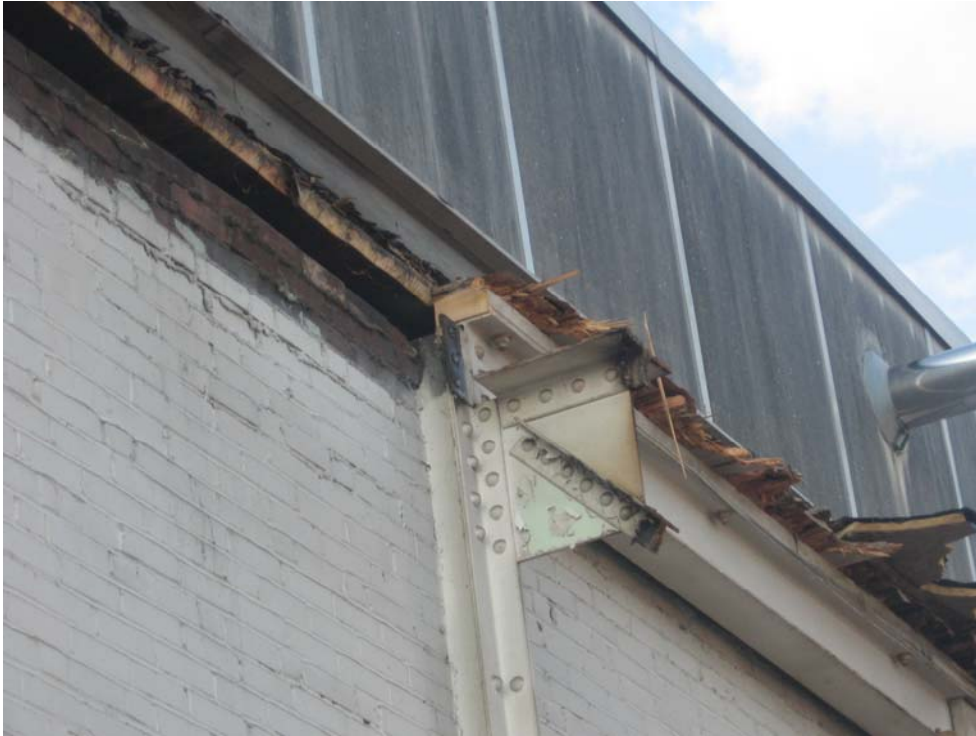
Picture showing opening in wall that exists when truss supports are removed from the adjoining wall between southern and northern sections of 1034. Opening will require weather proofing with sheet metal flashing.

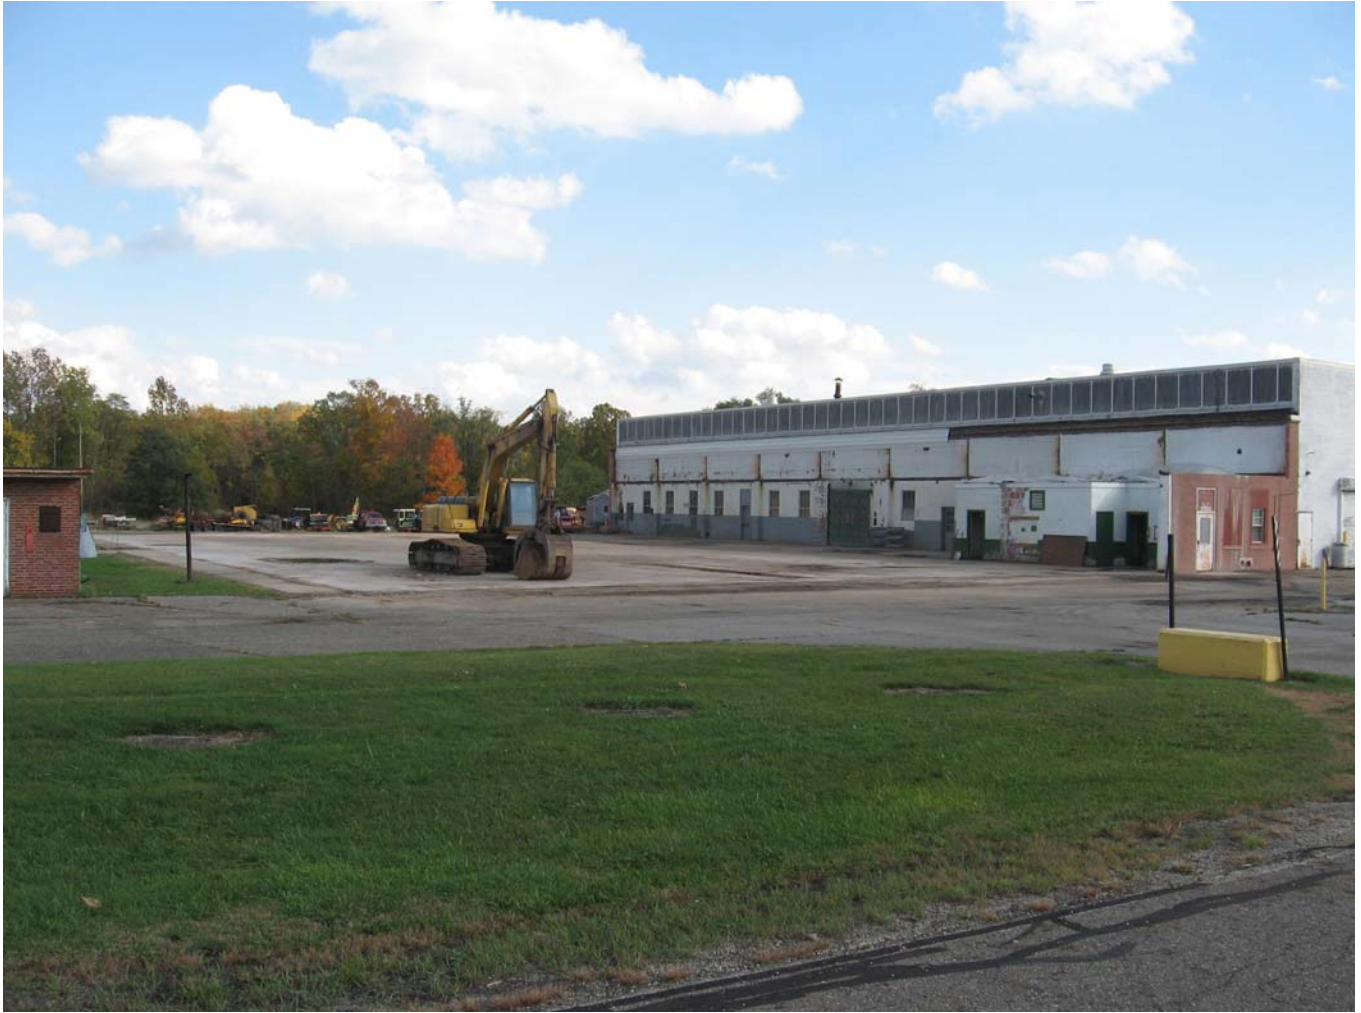
Picture showing demolition and debris removal complete.
Remaining southern section and exposed restroom visible in background.

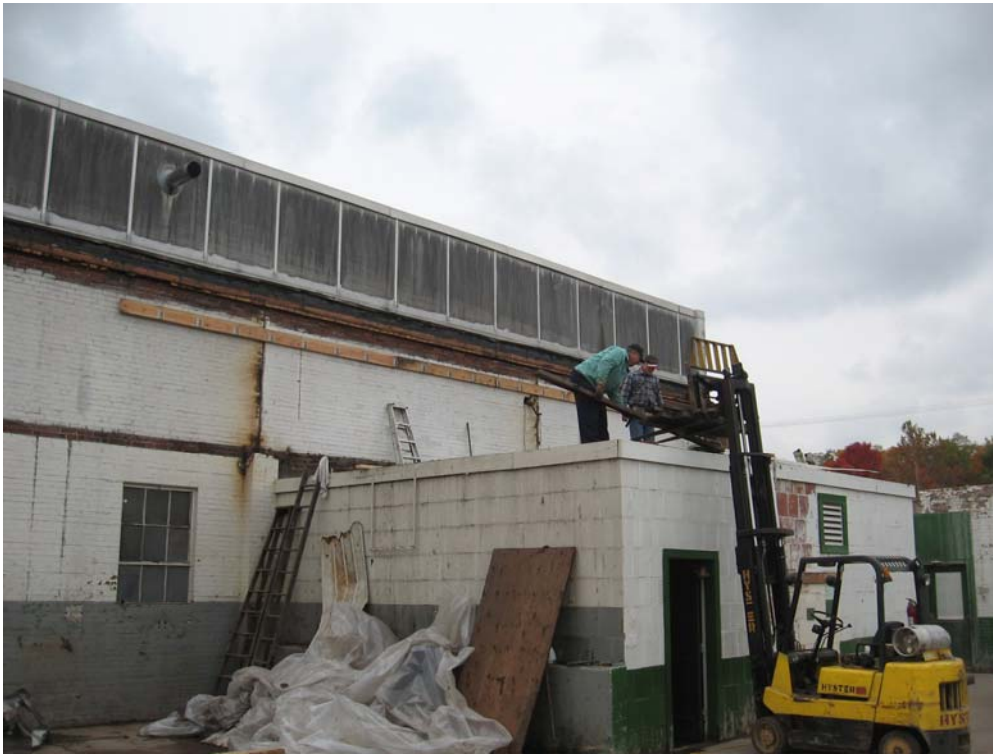
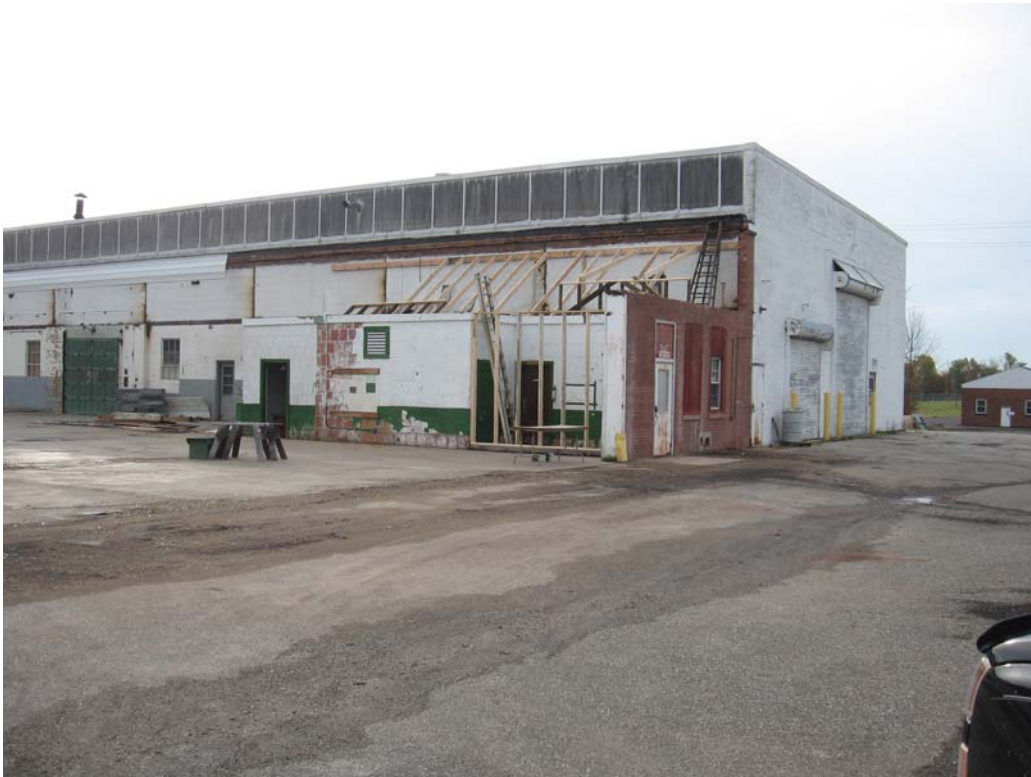
Pictures showing progress of roof construction to date.

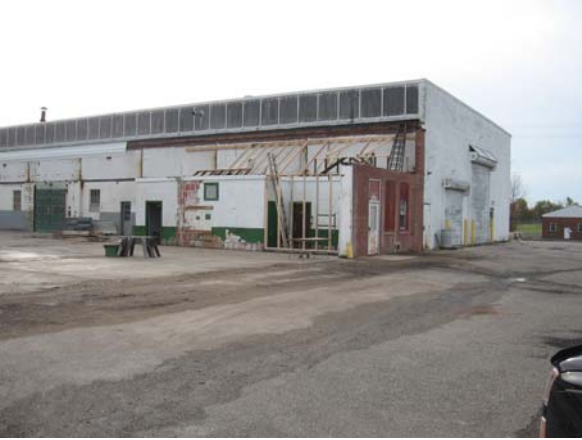
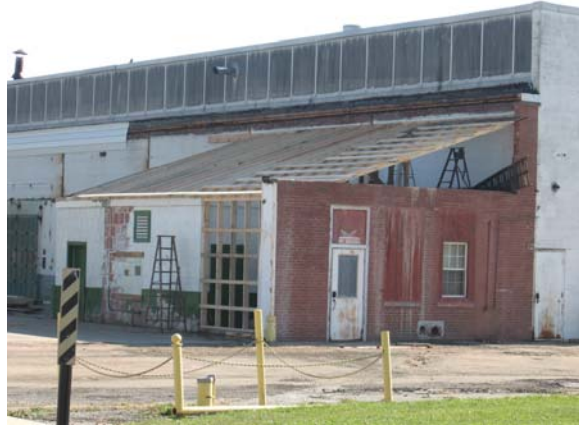
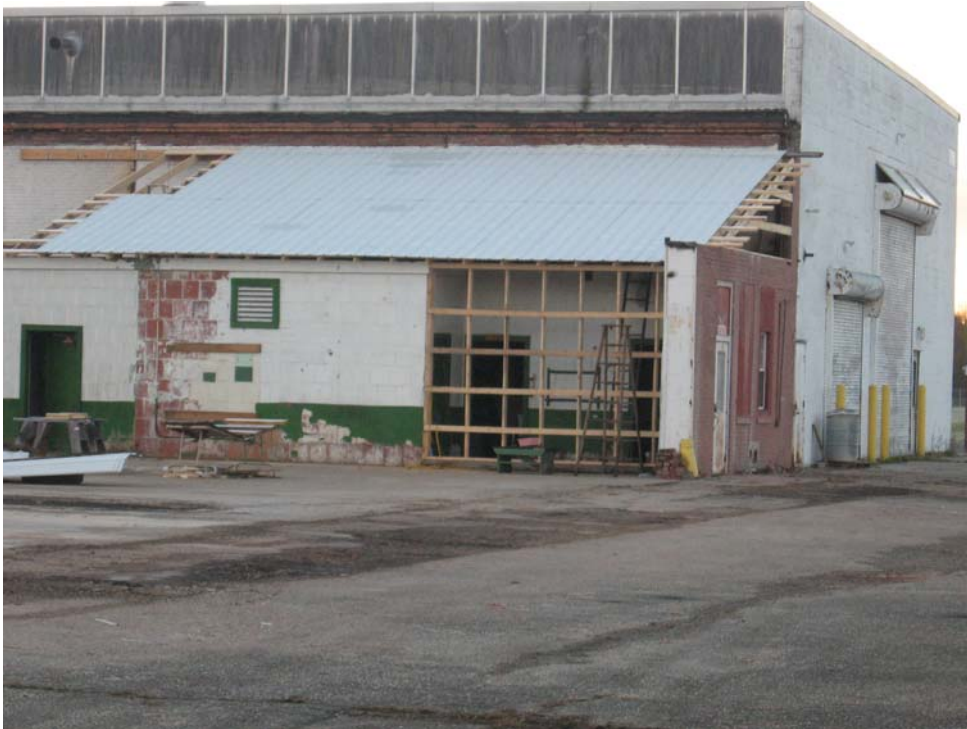
Pictures showing progress of roof construction.

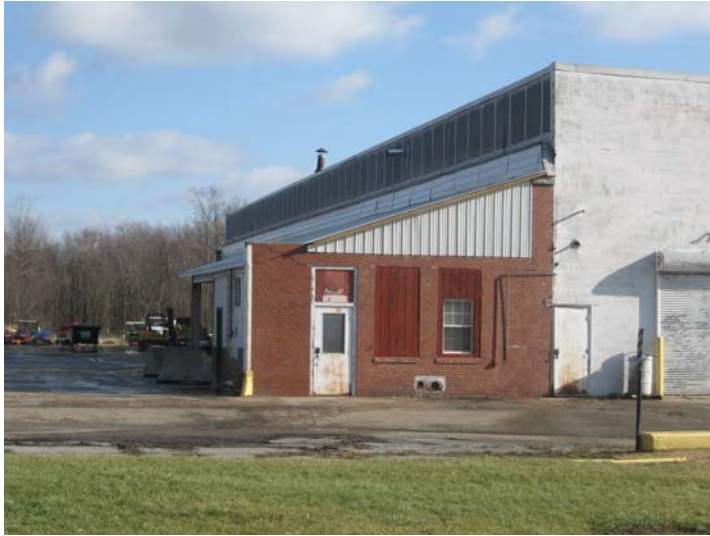
Complete installation of roofing material and east and west building gable ends.
