# **QUARTERLY EFFECTIVENESS EVALUATION REPORT (#3)**

**(O & M TRIP's #7, #8, & #9)**

**JULY 28, 2010**

Quarterly Effectiveness Evaluation Report  
Sand Creek Barrier System  
Time Critical Response Action (TCRA) for the Rocket Ridge Area of  
Open Demolition Area #2

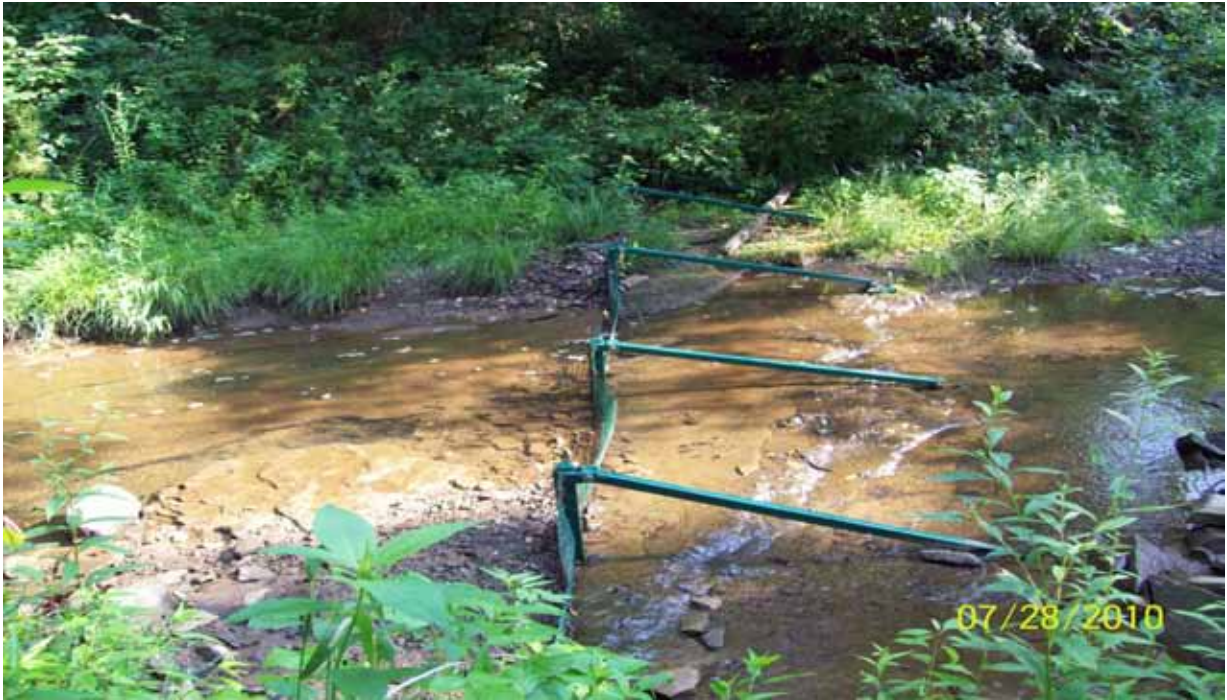
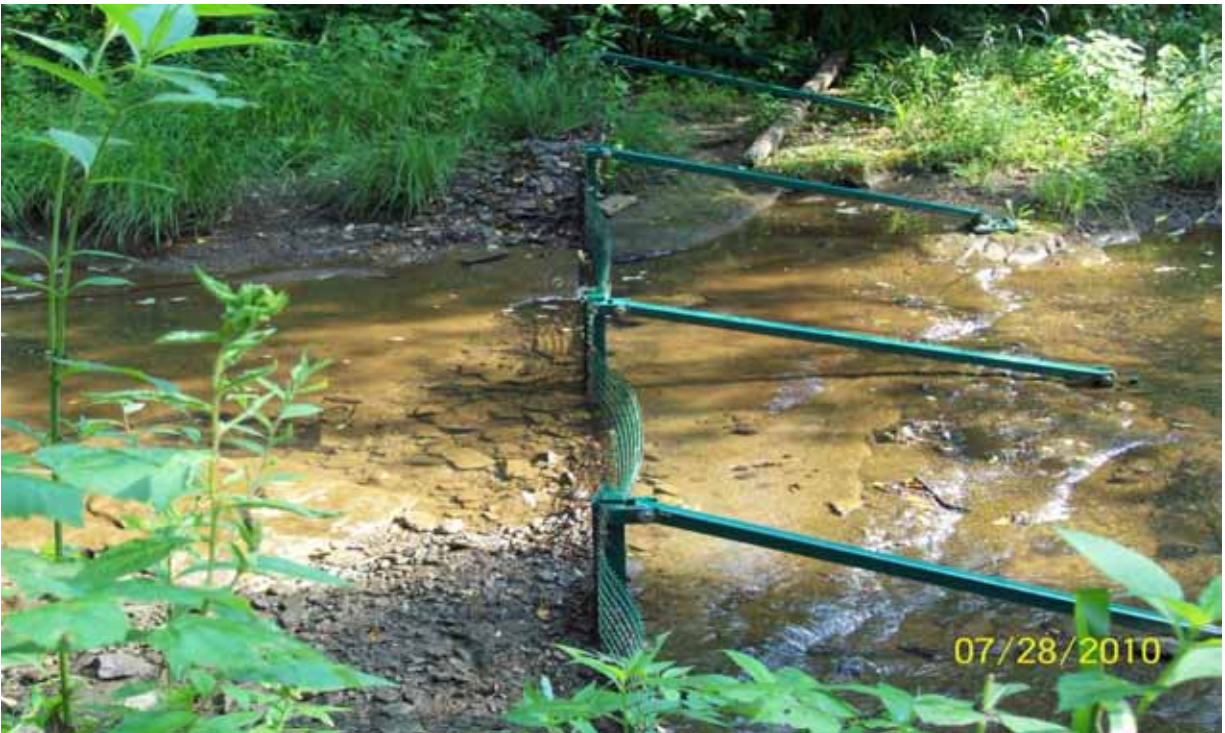
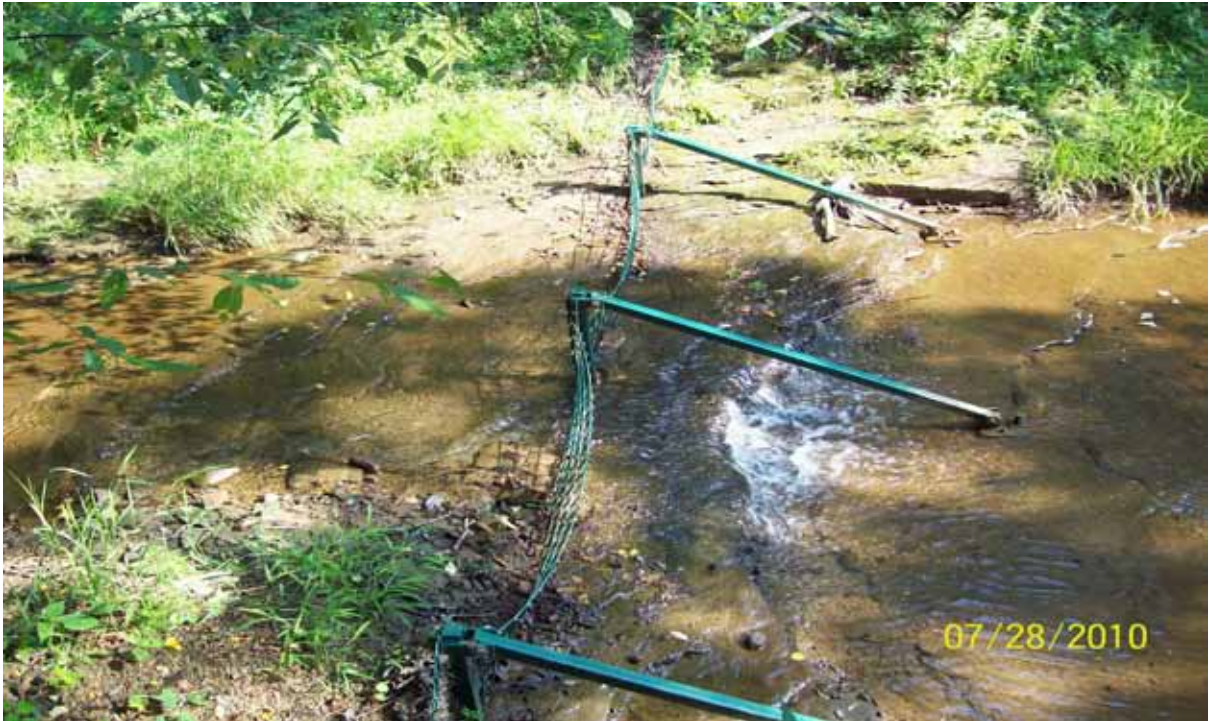
**QUARTERLY EFFECTIVENESS EVALUATION  
JULY 24, 2010  
PHOTOGRAPHIC LOG**

Barrier integrity: Barrier screens are bowed due to water pressure on leaves-covered screens. No broken or cracked barrier structure components were observed. See photos.

Other changes observed: A build up of soil on the north side of Sand Creek on the up stream side of the west screen is causing the stream water to flow toward the east at that point, (See Photos). Jim McGee will discuss this issue with Mark Patterson and Derek Kinder to determine if corrective action is required.

All barrier components are intact and solidly anchored. Most screen panels are bowed due to water pressure building up when water flow is limited because of debris build up. See photos.

The deflection in the screen panels does not limit the effective performance of the barrier system.

Maintenance performed: Removed all materials from screens.
