Final
2018 Annual Land Use Control Monitoring Report,
RVAAP-01 Ramsdell Quarry Landfill,
RVAAP-05 Winklepeck Burning Grounds,
RVAAP-08 through RVAAP-11 (Load Lines 1 through 4), and
RVAAP-12 (Load Line 12)

Camp James A. Garfield Joint Military Training Center
Former Ravenna Army Ammunition Plant
Portage and Trumbull Counties, Ohio

May 24, 2019

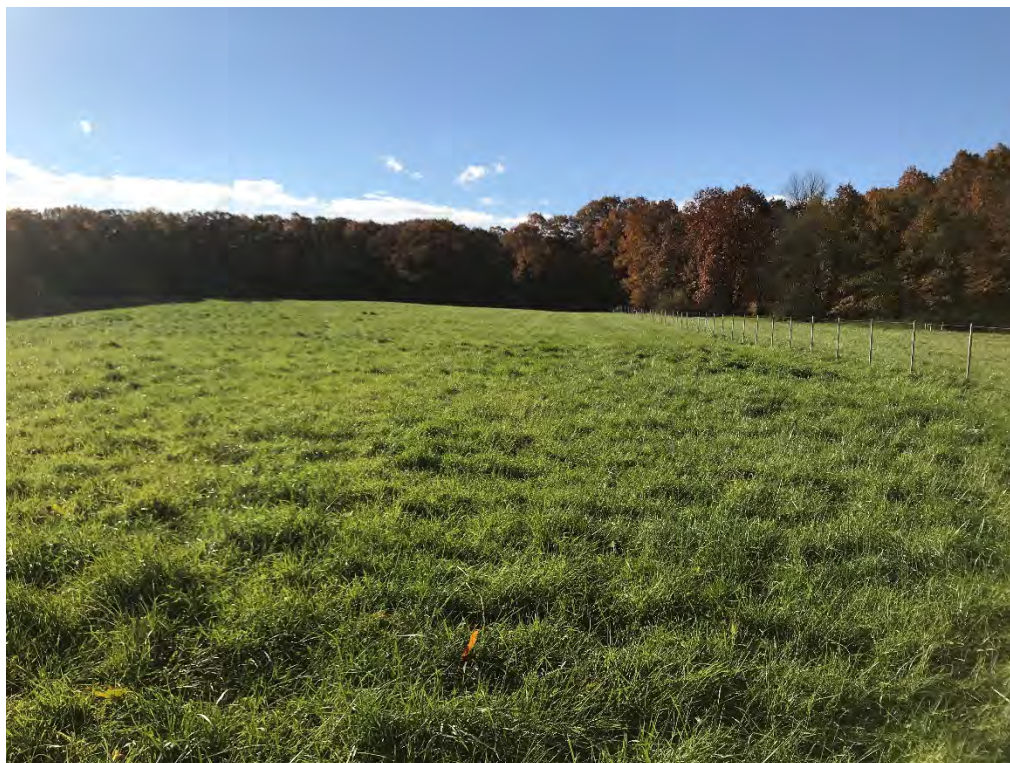
West part of Ramsdell Quarry Landfill, looking south from north fence.

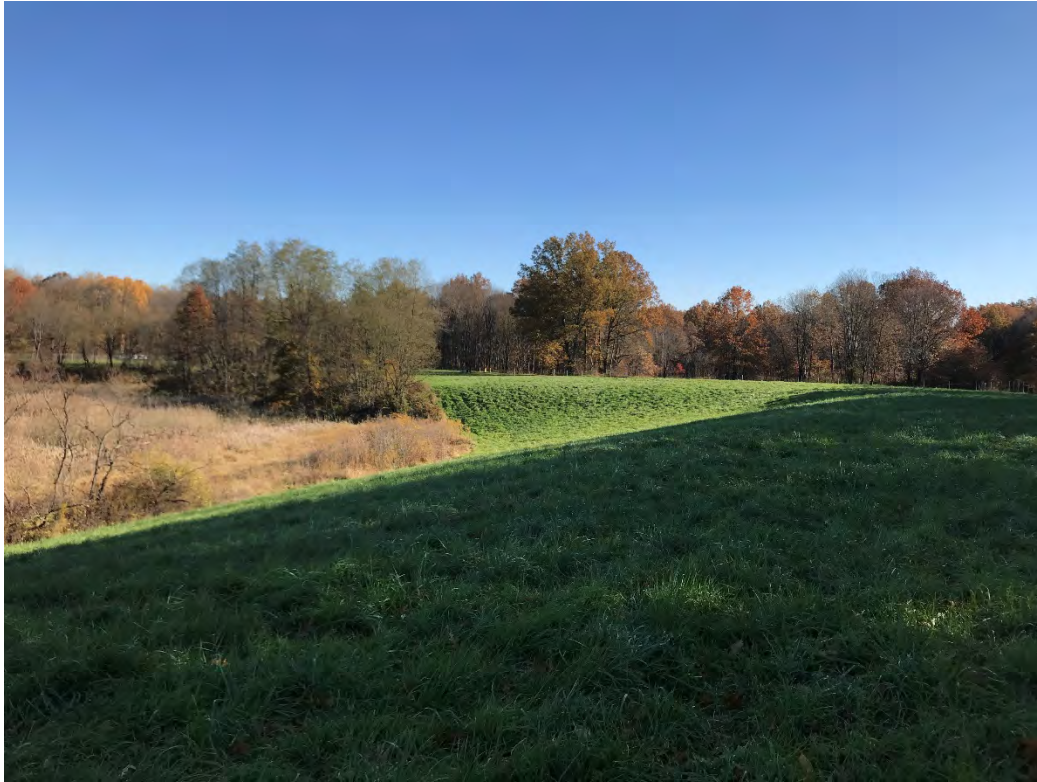
Southeast corner of Ramsdell Quarry Landfill, looking east.

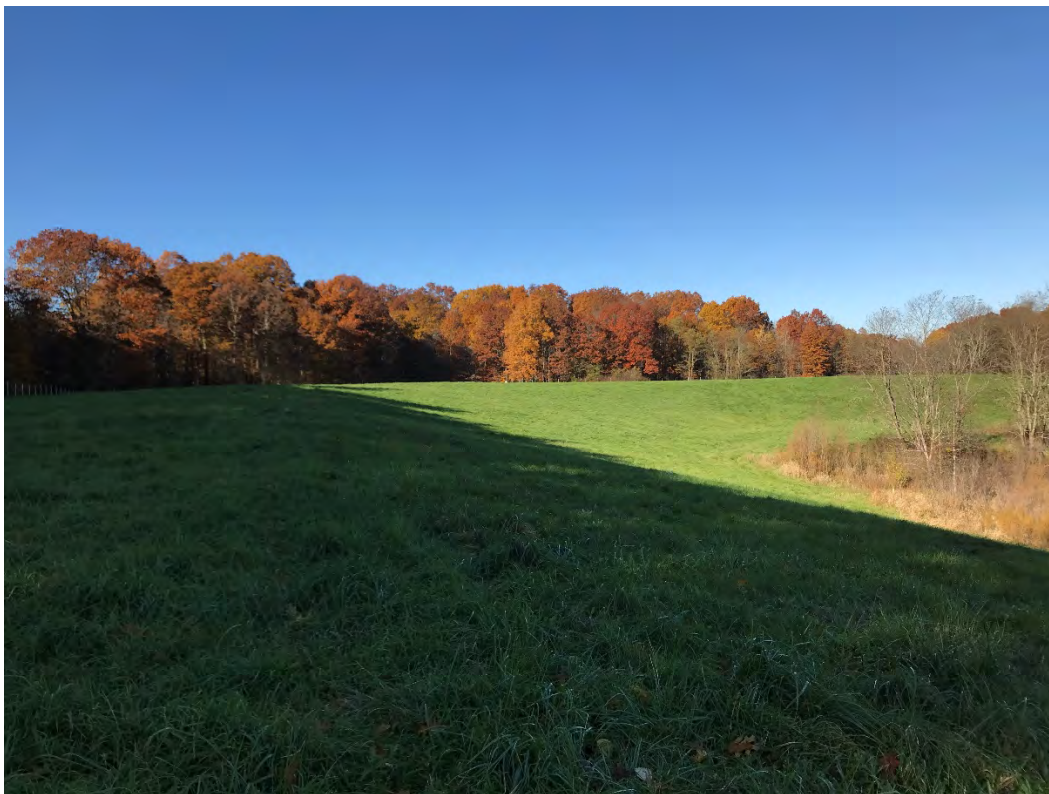
Southwest corner of Ramsdell Quarry Landfill, looking west.

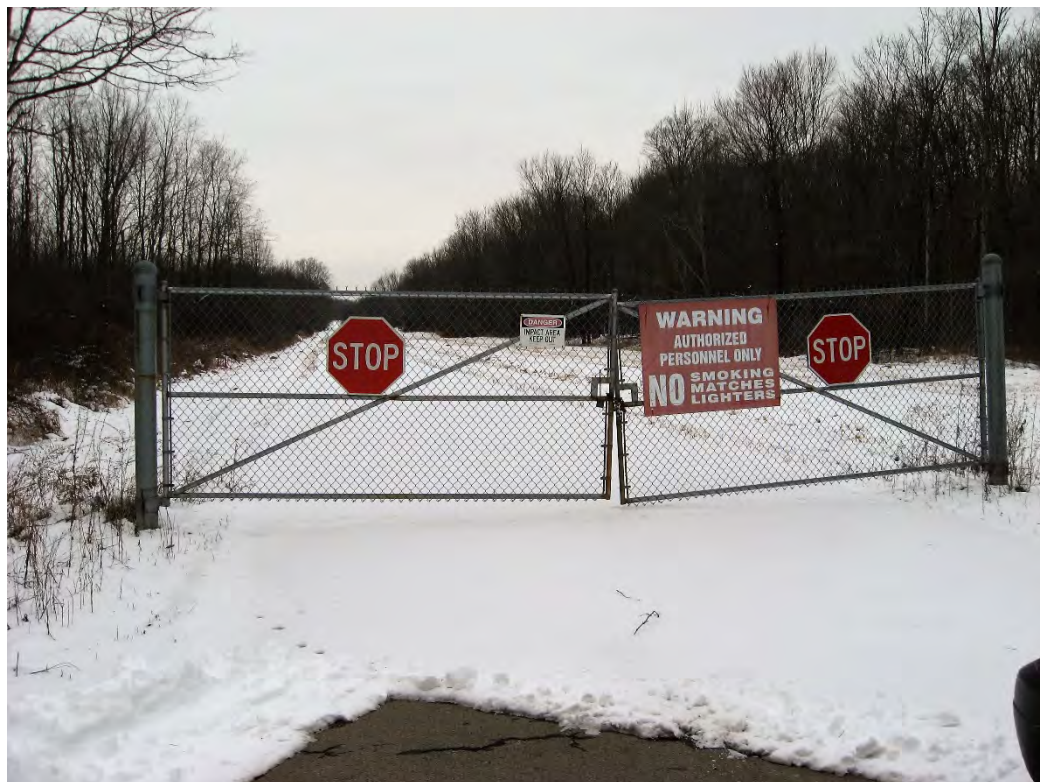
Winklepeck Burning Grounds south gate.

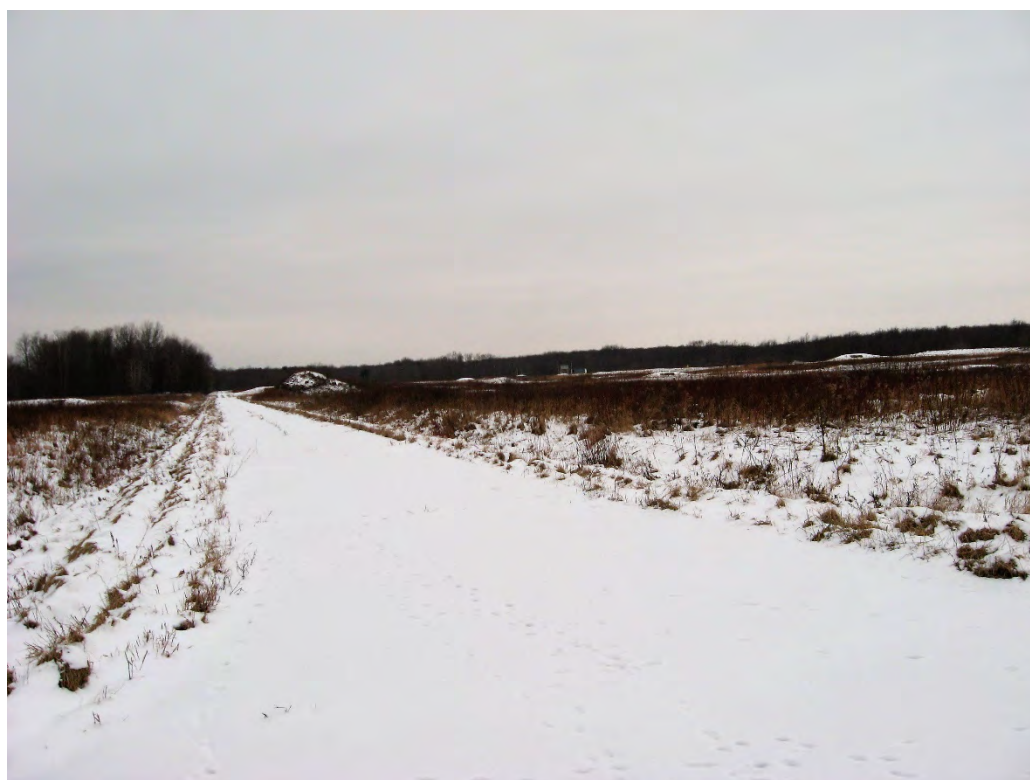
Winklepeck Burning Grounds field, looking west from central portion of the site.

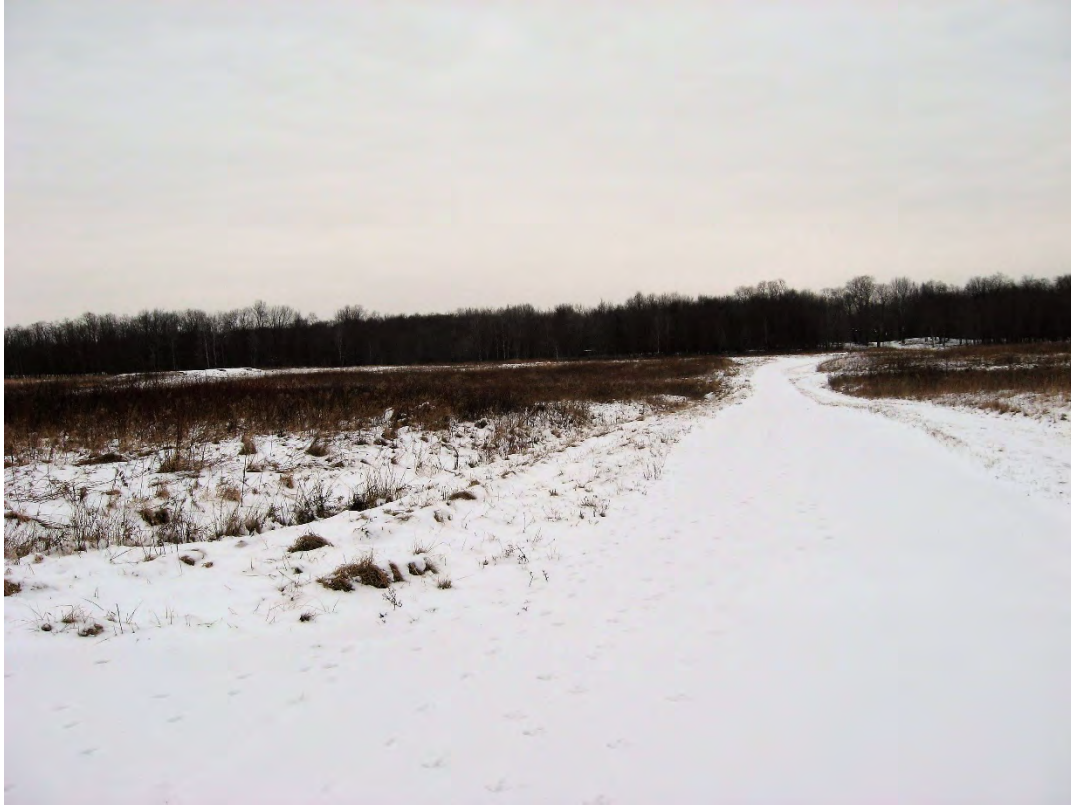
Winklepeck Burning Grounds field, looking north from the central portion of the site.

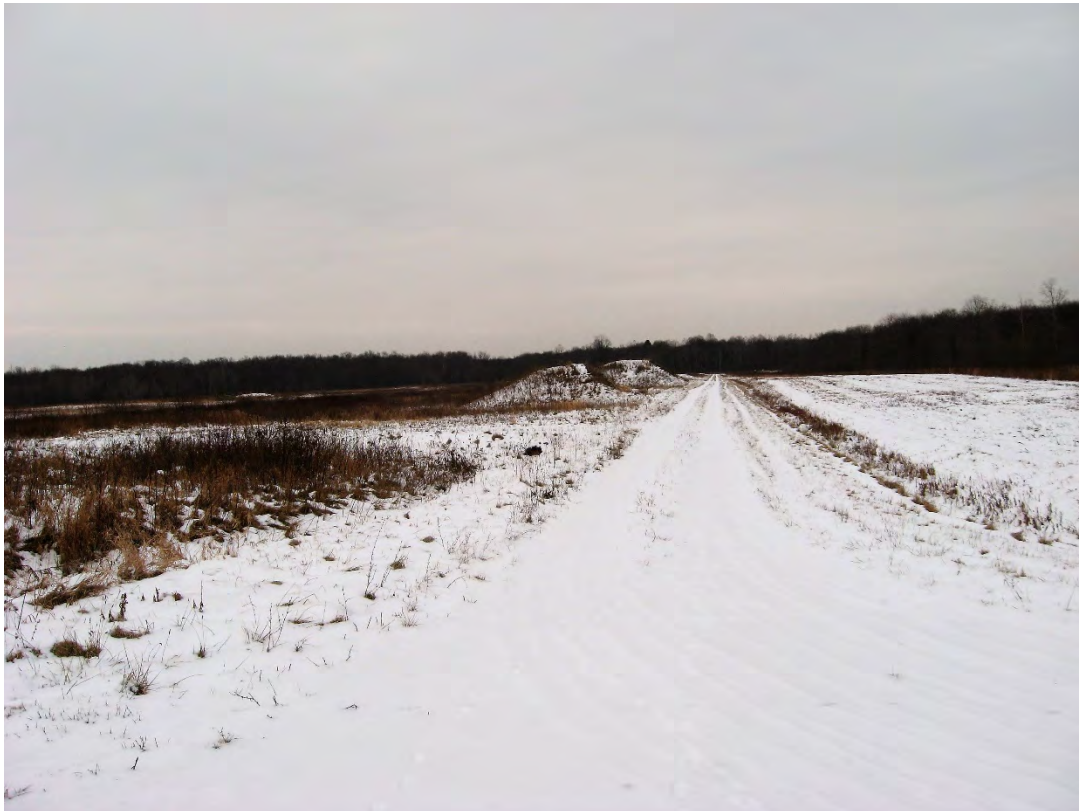
Winklepeck Burning Grounds field, looking east from the central portion of the site.

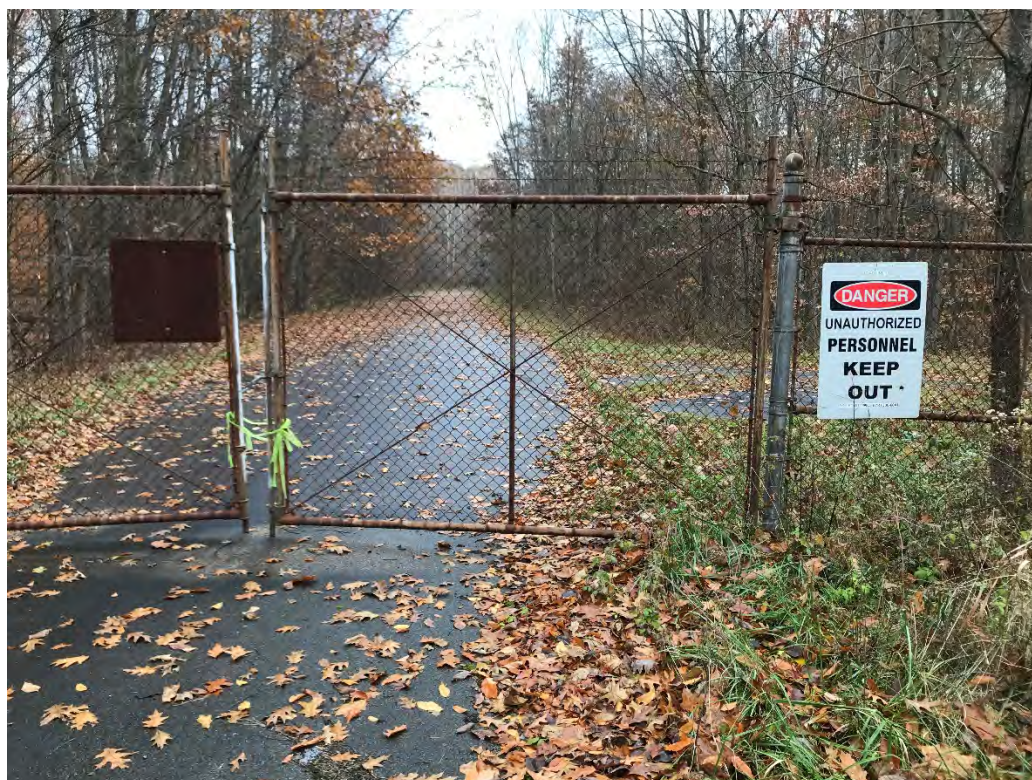
Load Line 1 north gate.

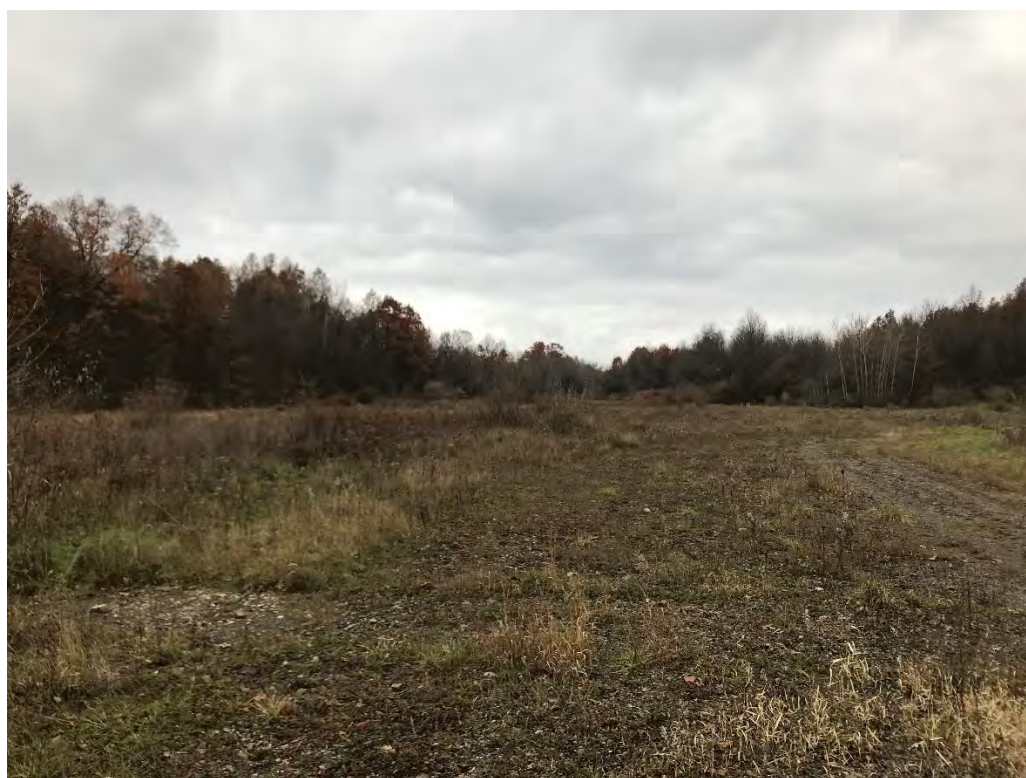
Load Line 1 field, from southeast portion of the site looking northwest.

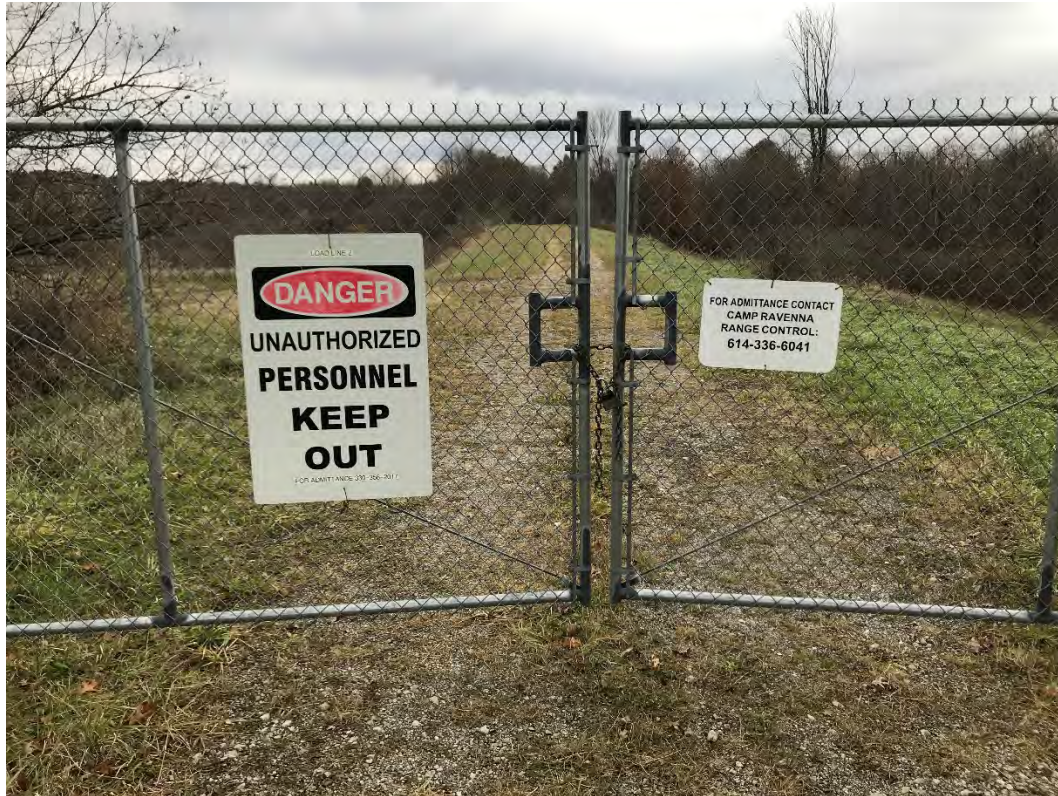
Load Line 2 south gate.

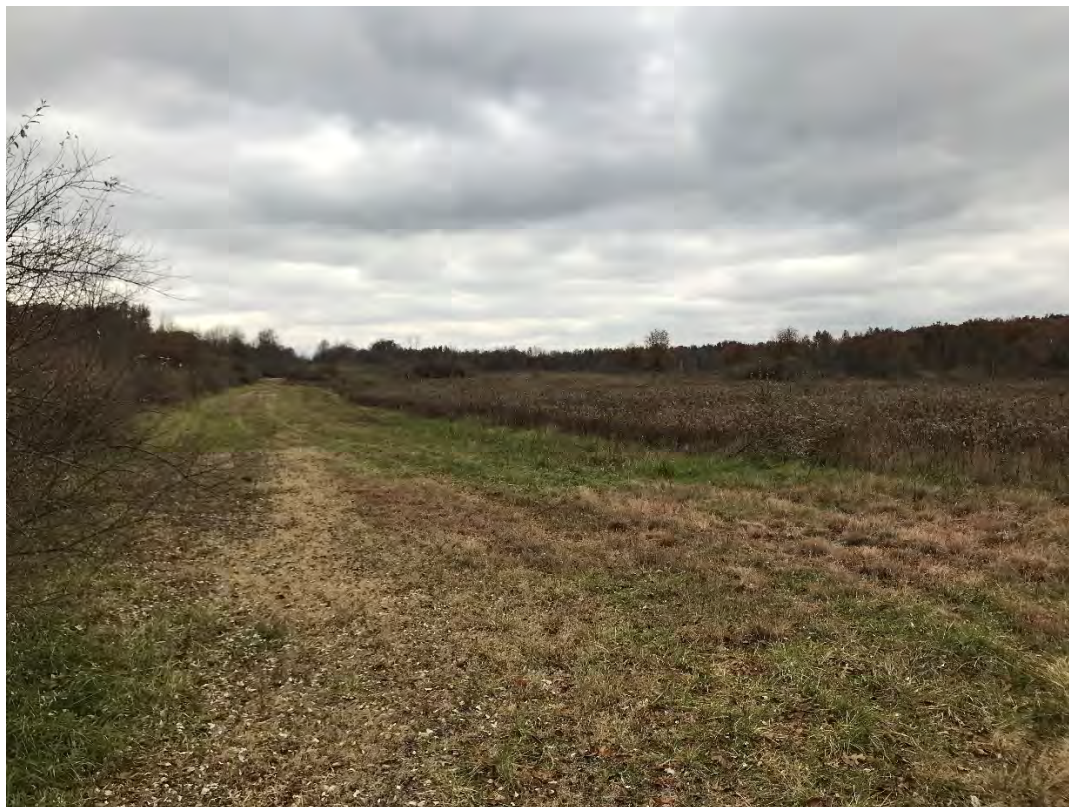
Load Line 2 field, from southeast portion of the site looking northwest.

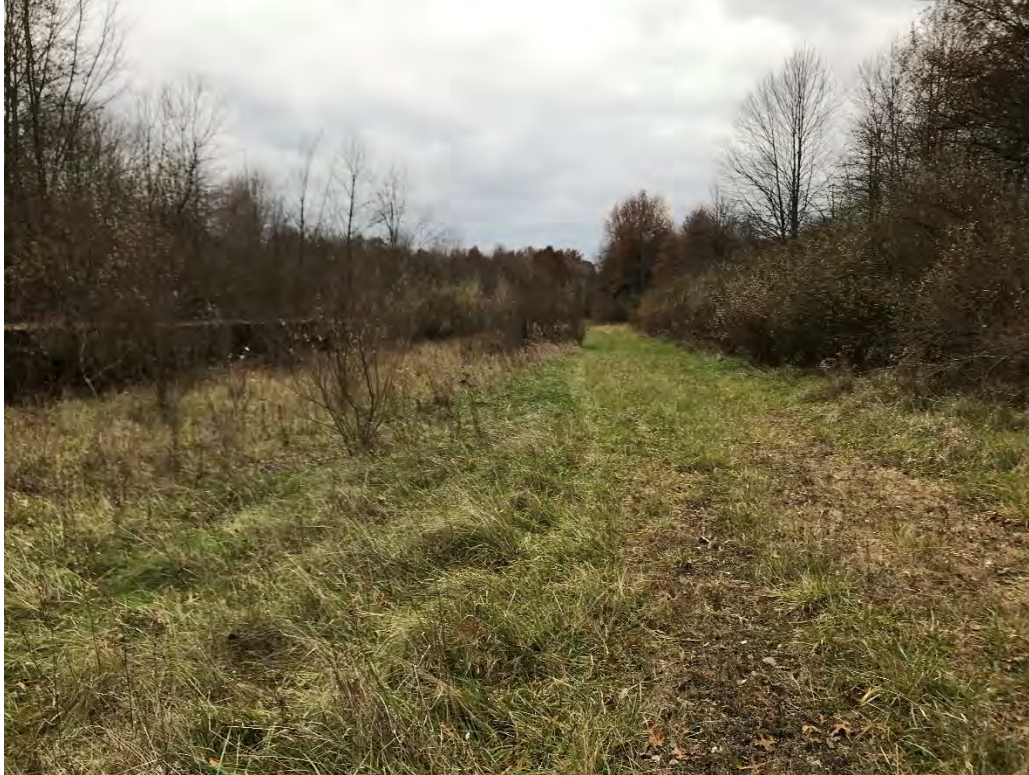
Load Line 3 field, from west-central portion of the site looking northwest.

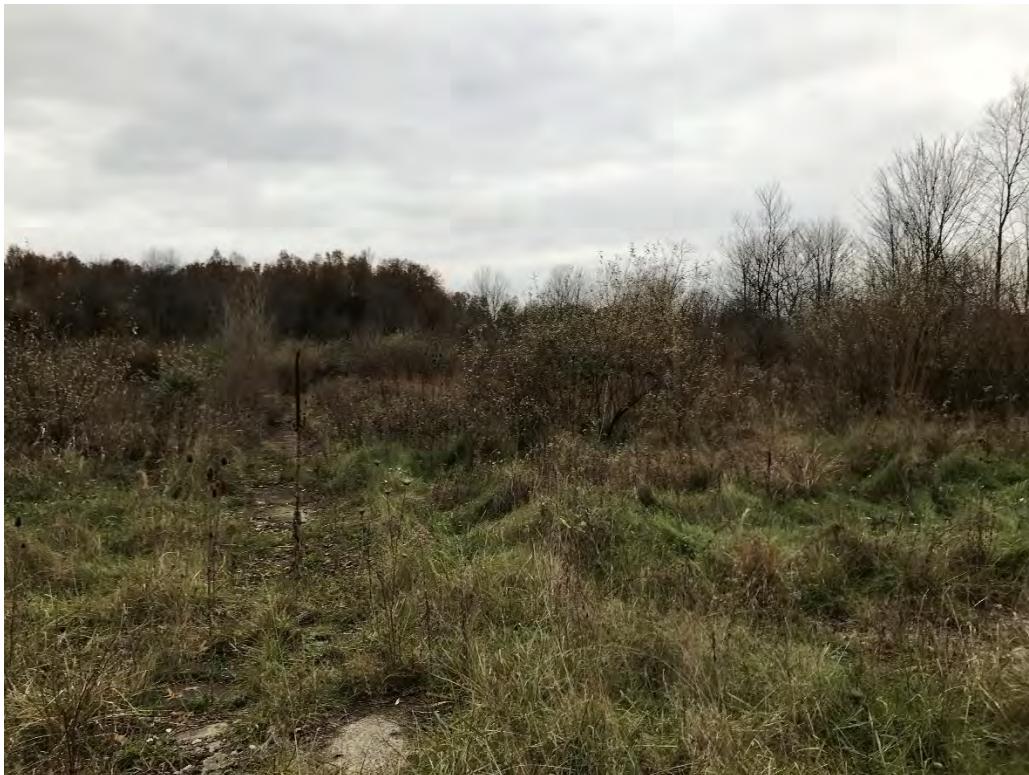
Load Line 3 field, from central portion of the site looking west.

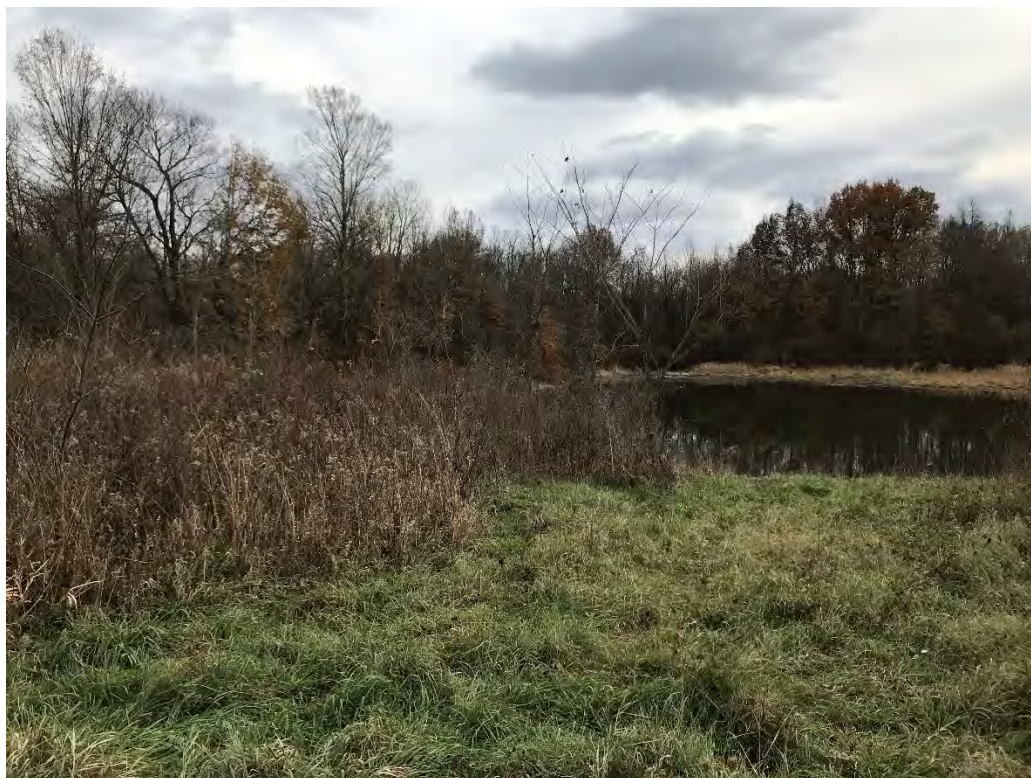
Load Line 4 field, from central portion of the site looking south towards the pond.

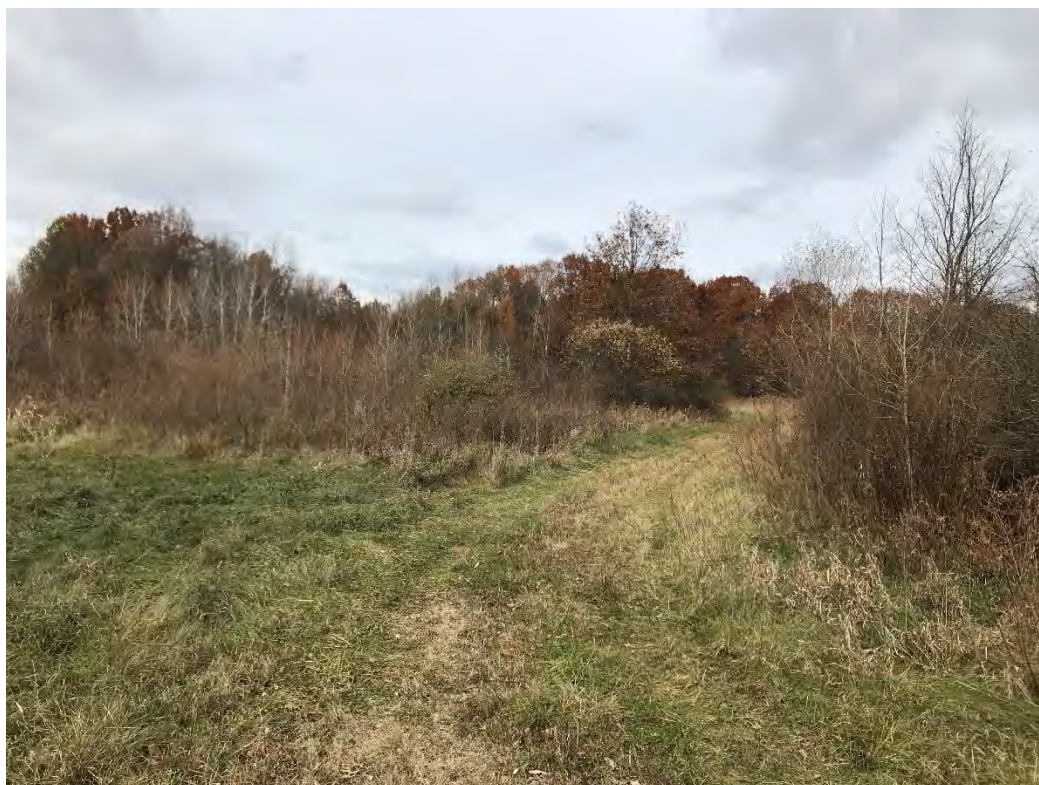
Load Line 4 field, from the southeast portion of the site looking north.

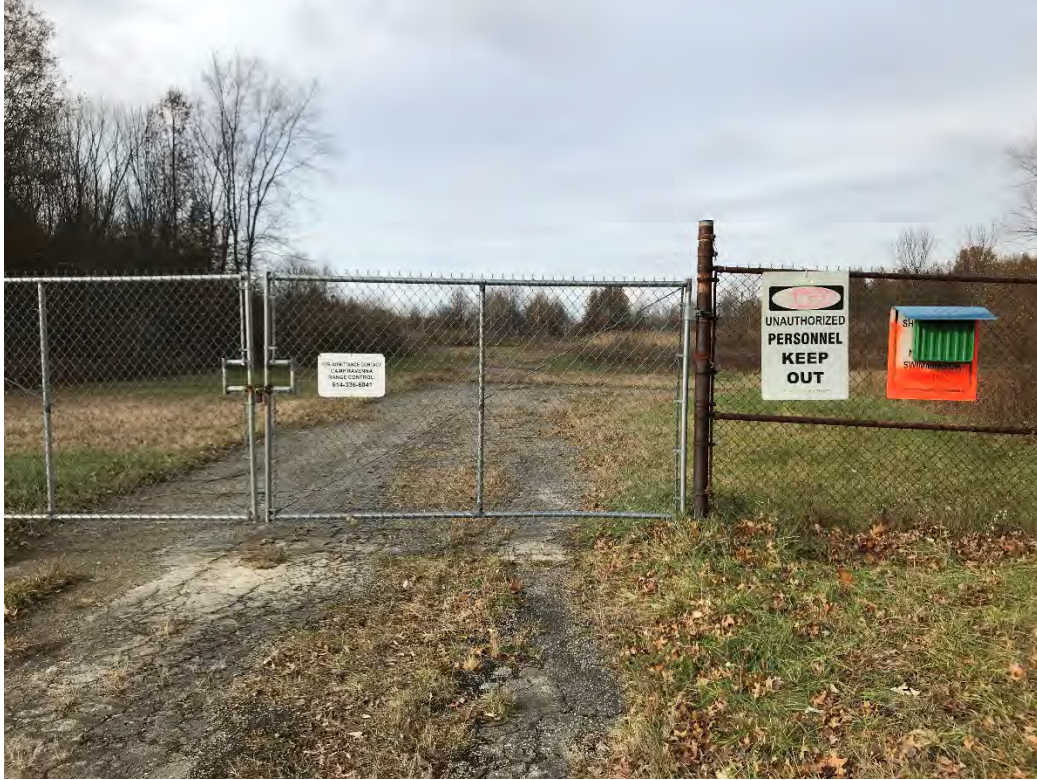
Load Line 12 south gate.

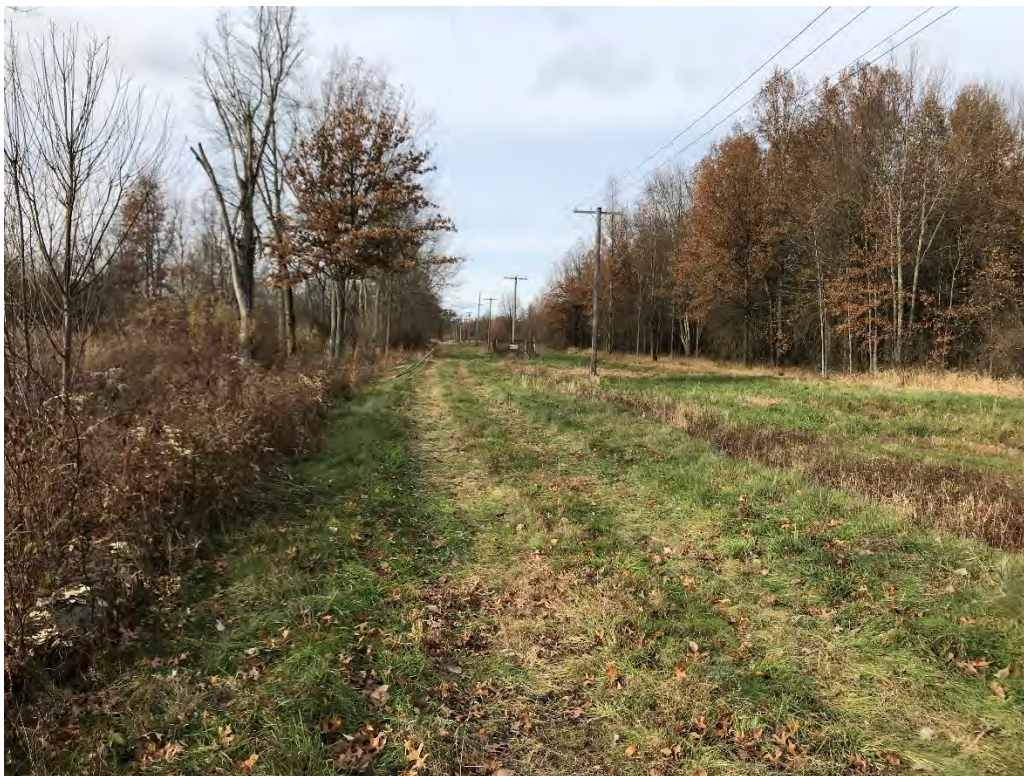
Load Line 12 field, from the south-central portion of the site looking north.

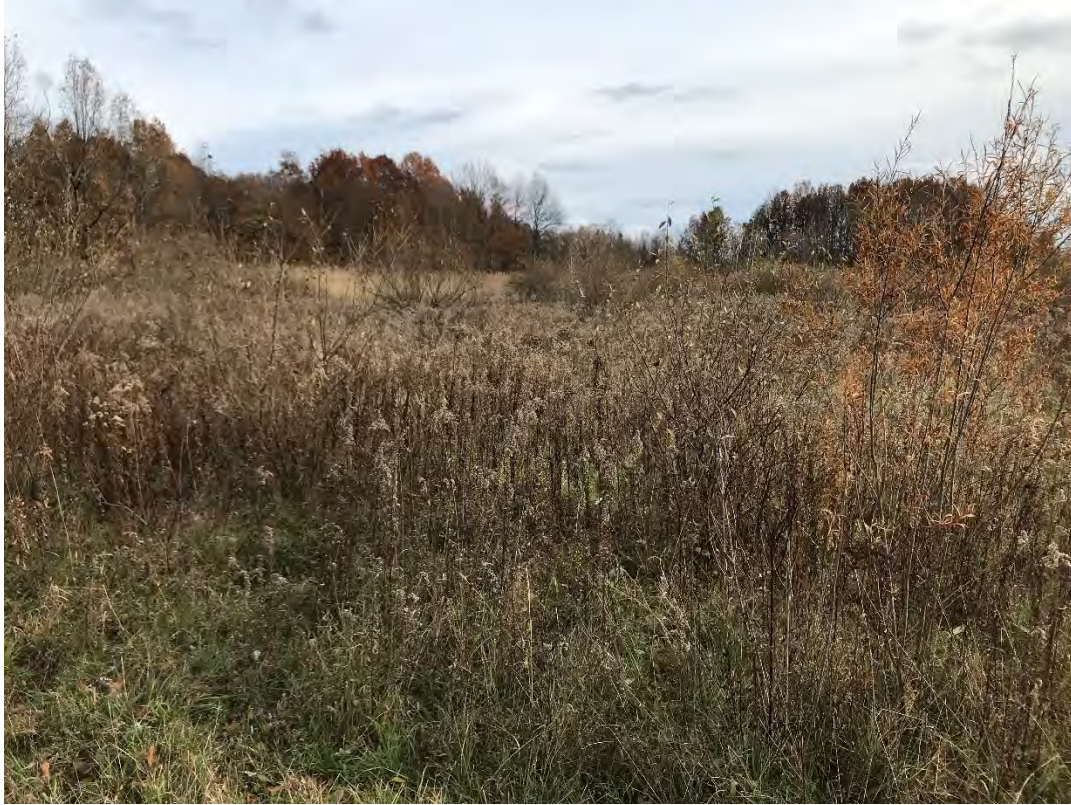
Load Line 12 field, from the central portion of the site looking west.

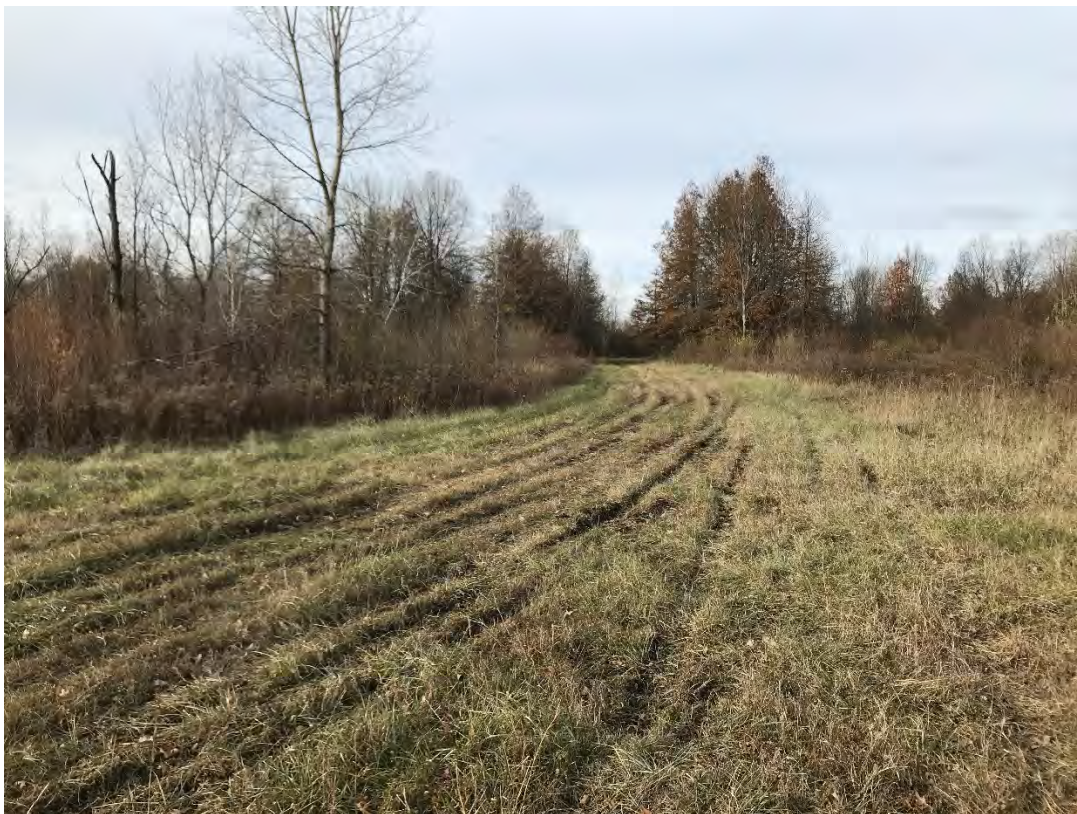
Load Line 12 field, from the north-central portion of the site looking south.
