Final
FY 2014 Annual Report for the
Quarterly Land Use Control Inspections,
RVAAP-05 Winklepeck Burning Grounds

Camp Ravenna Joint Military Training Center
Former Ravenna Army Ammunition Plant
Portage and Trumbull Counties, Ohio

January 8, 2015

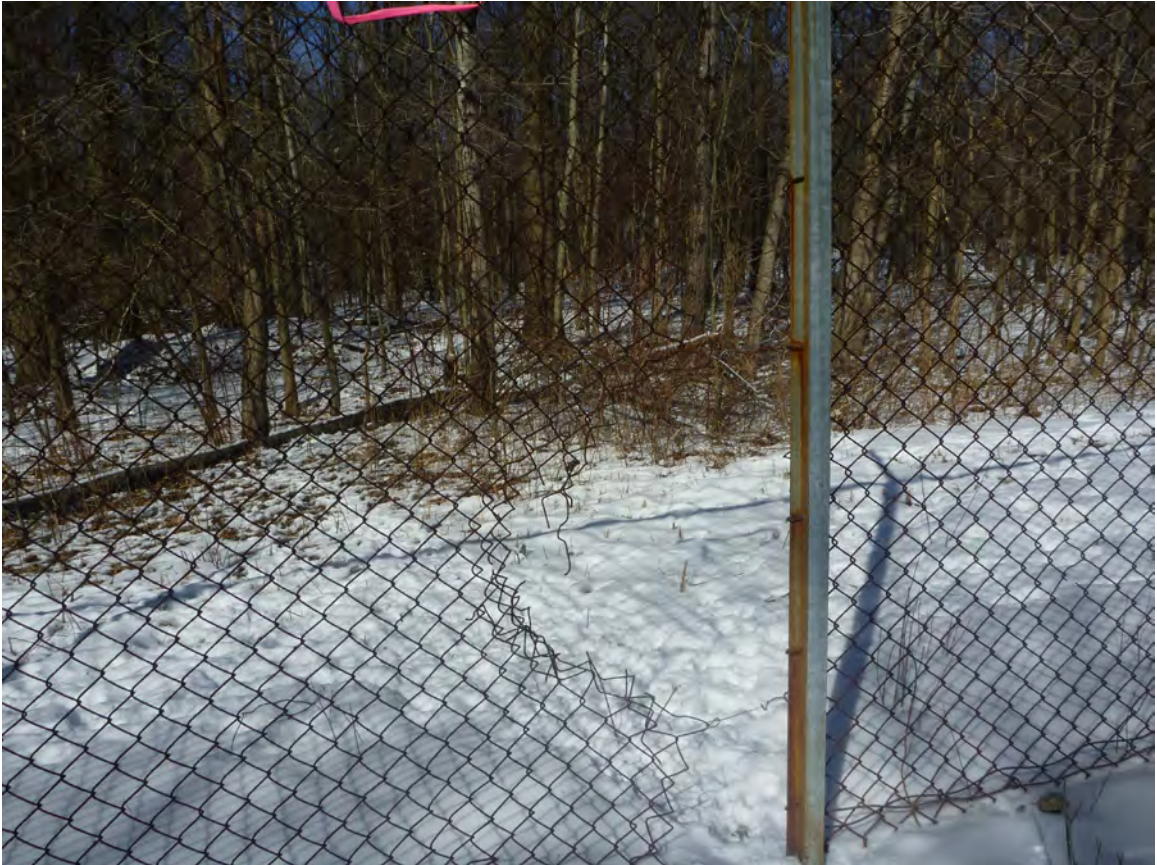
PHOTO NE28 discovered 03/03/2014

NE28	03/03/2014	c:\My Documents\My ArcPad\P1010367.JPG	hole in fence	571112	2383373	c:\My Documents\My ArcPad\P1010395.JPG
NE29	03/05/2014	c:\My Documents\My ArcPad\P1010371.JPG	hole in fence	570046	2384741	c:\My Documents\My ArcPad\P1010398.JPG
		REPAIRED 1ST QTR				
		REPAIRED 2ND QTR

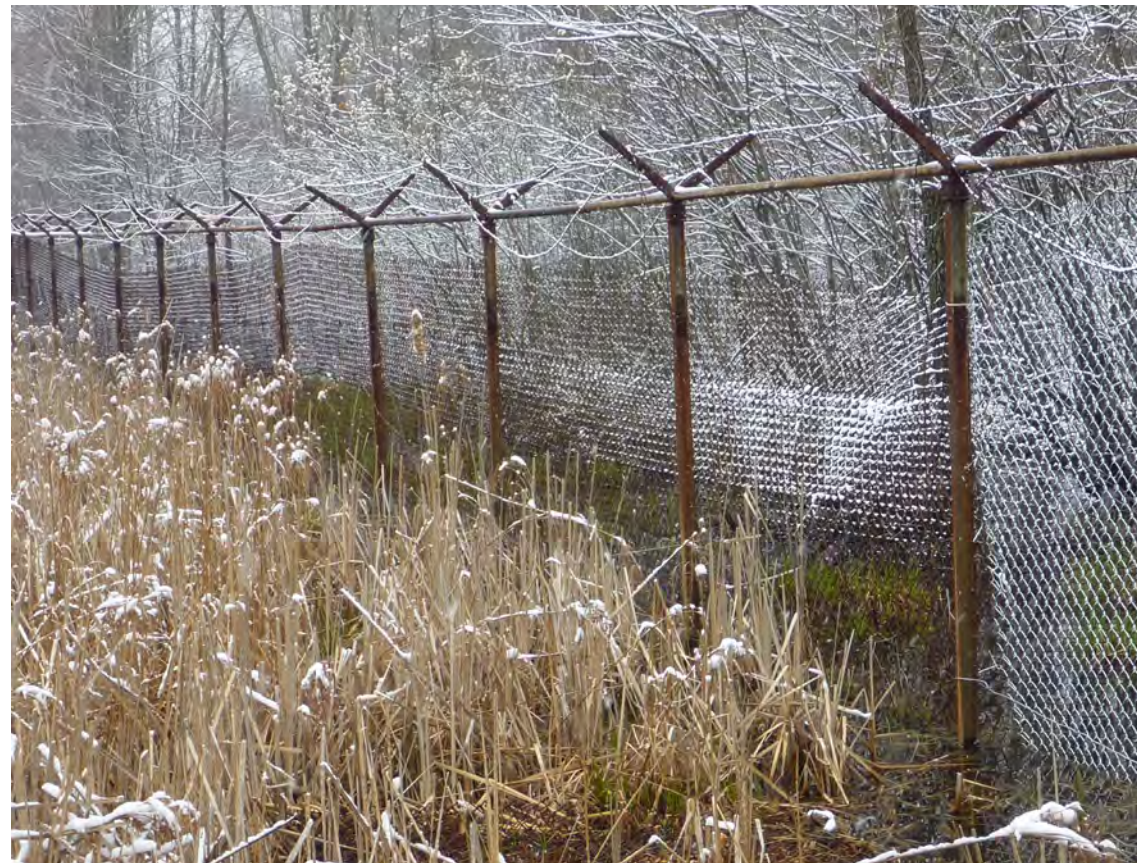
PHOTO NW8 discovered 07/16/2013

Camp Ravena Joint Military Training Center 3rd Qtr FY2014 LUC Inspection Summary Table				US Survey F1		
Callout	Date	Path to Photo Location	Comments	Northting	Easting	Path to Repair Photo
NW08	07/16/2013	c:\My Documents\My ArcPad\P1010333.JPG	open along top ax 6 sections(swampy)	567746	2349644	
SW01	02/07/2013	c:\My Documents\My ArcPad\P1010322.JPG	bottom open	549403	2336048	
SW12	11/19/2013	c:\My Documents\My ArcPad\P1010323.JPG	storm washout about 2 sections inlet needs cleared	552357	2330086	
SW14	04/14/2014	c:\My Documents\My ArcPad\P1010379.JPG	poacher hole in fence	549386	2334237	
SE02	02/13/2013	c:\My Documents\My ArcPad\P1010353.JPG	washout...worse now 7.18.2013	551498	2361141	
SE04	11/25/2013	c:\My Documents\My ArcPad\P1010351.JPG	washout logged as type 2 on 2-27-14 0271 photo	558980	2377933	
SE05	04/22/2014	c:\My Documents\My ArcPad\P1010402.JPG	washout below undamaged fence	550299	2358581

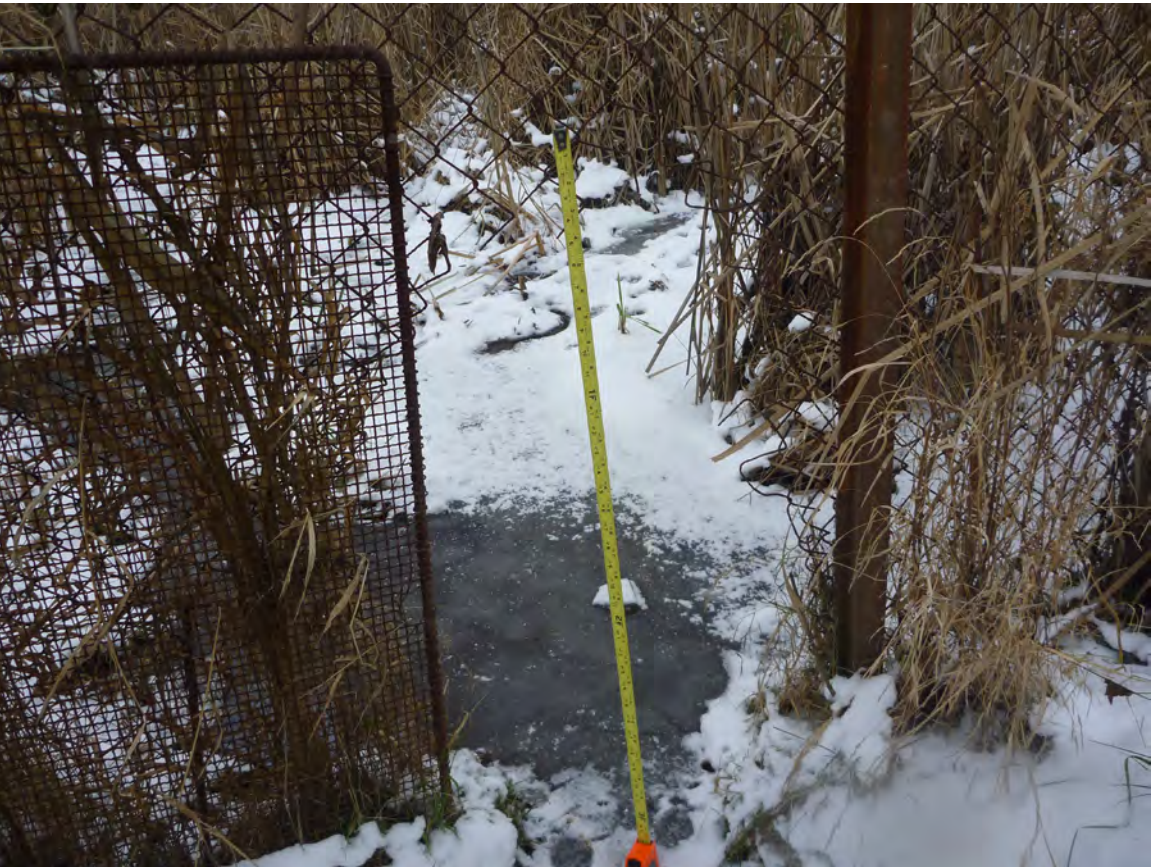
PHOTO SE3 discovered 11/25/2013

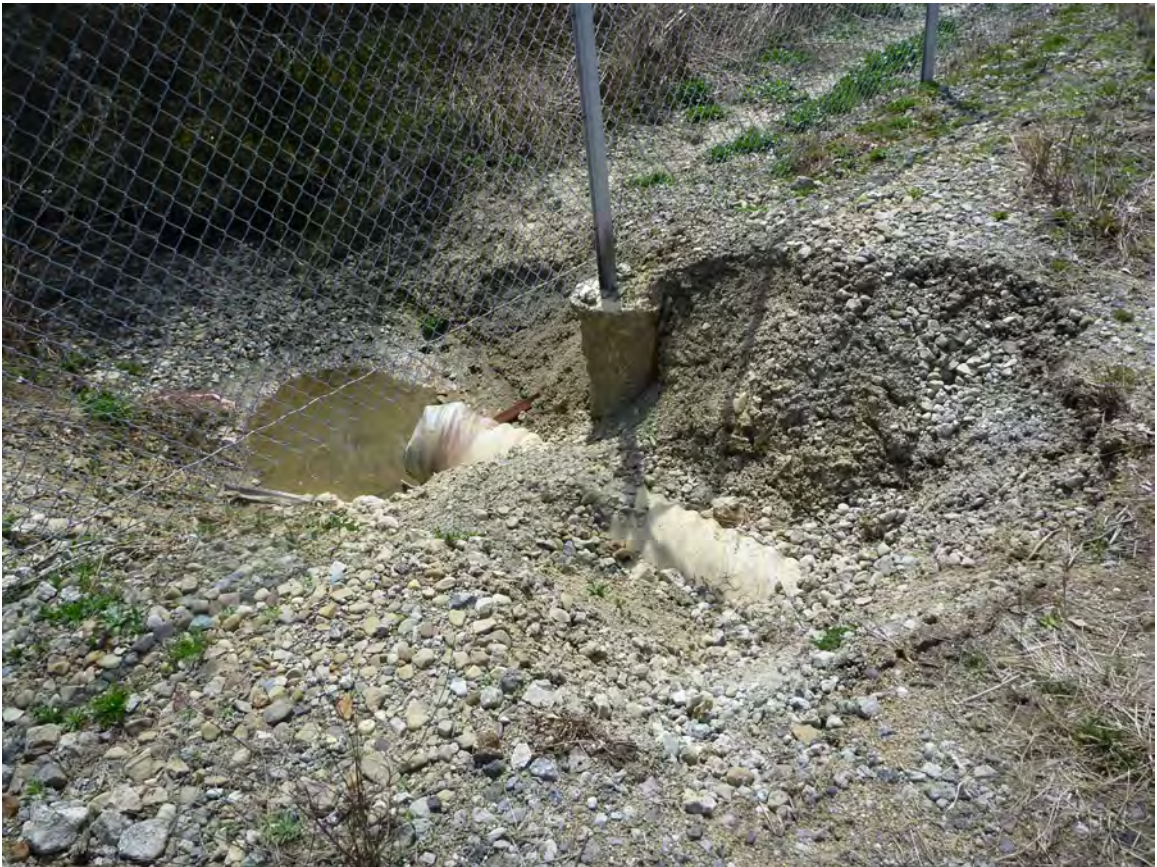
PHOTO SE4 discovered 02/27/2014

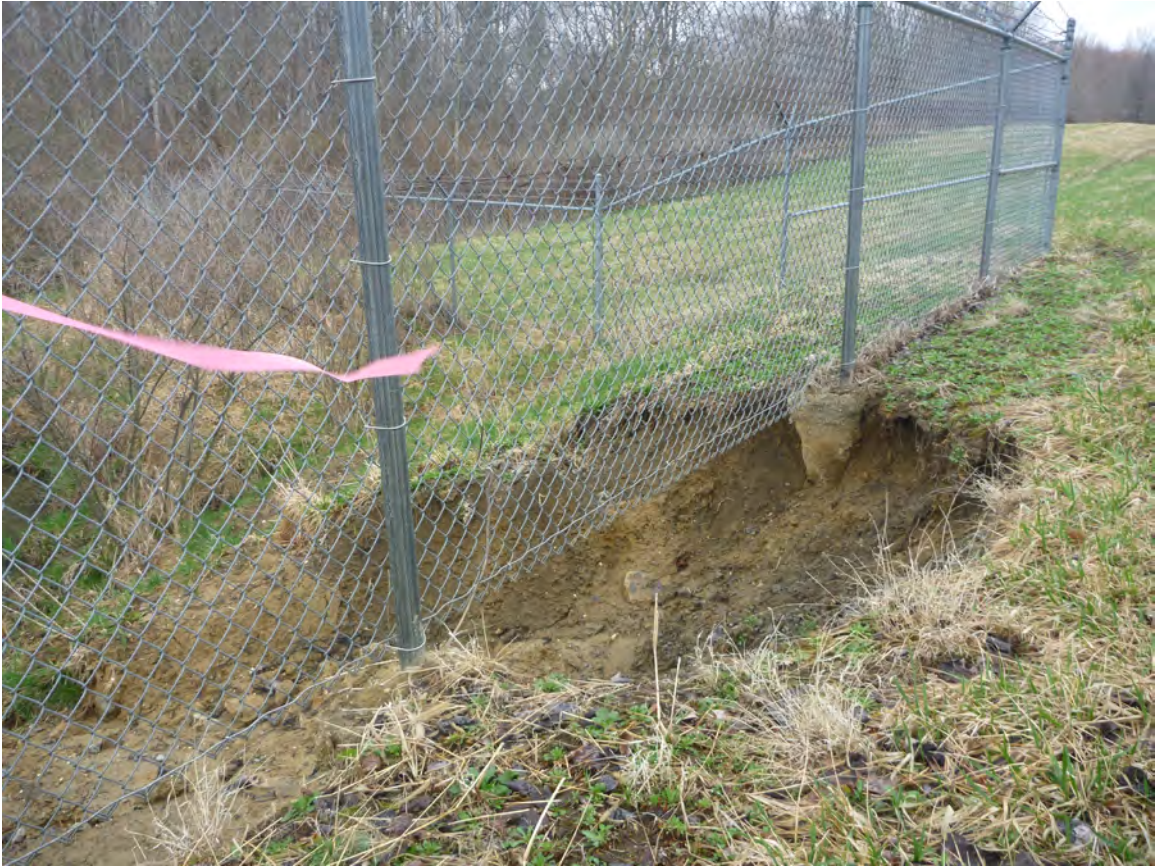
PHOTO SW12 discovered 11/18/2013

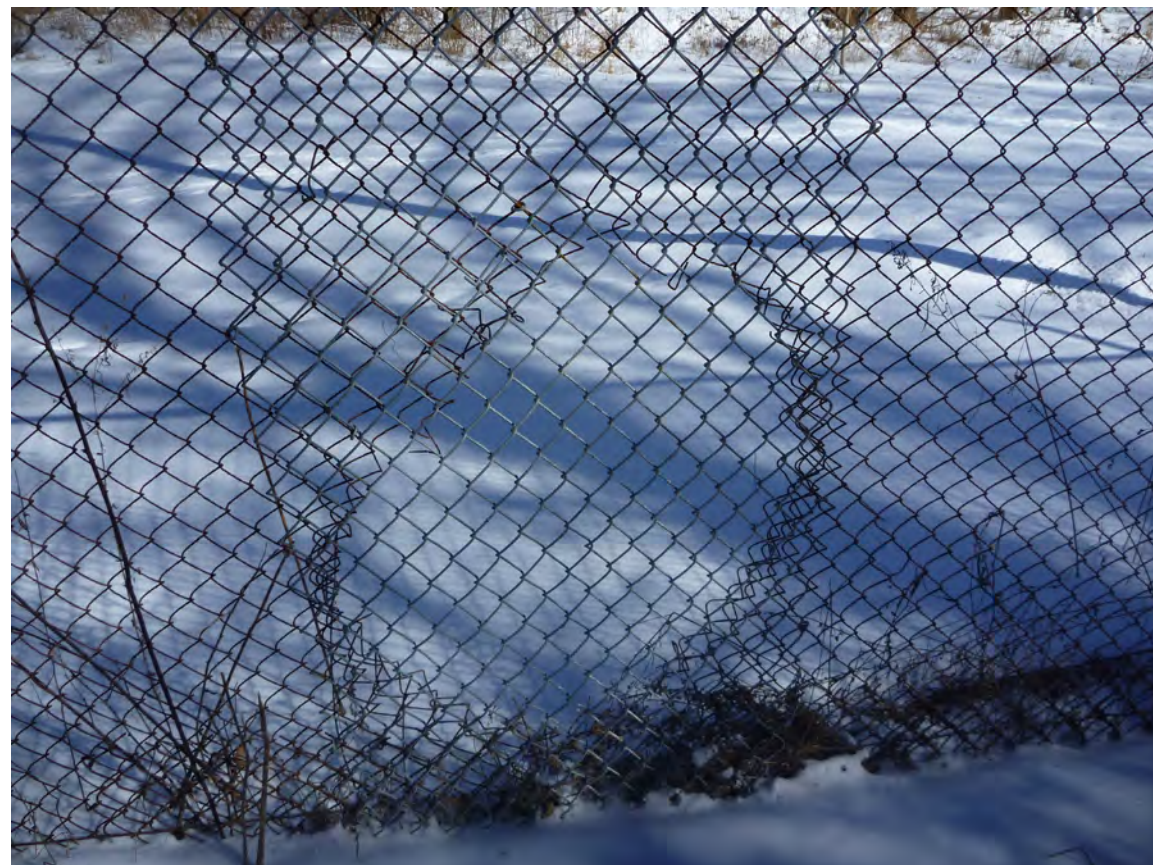
PHOTO NE5 repair 03/03/2014

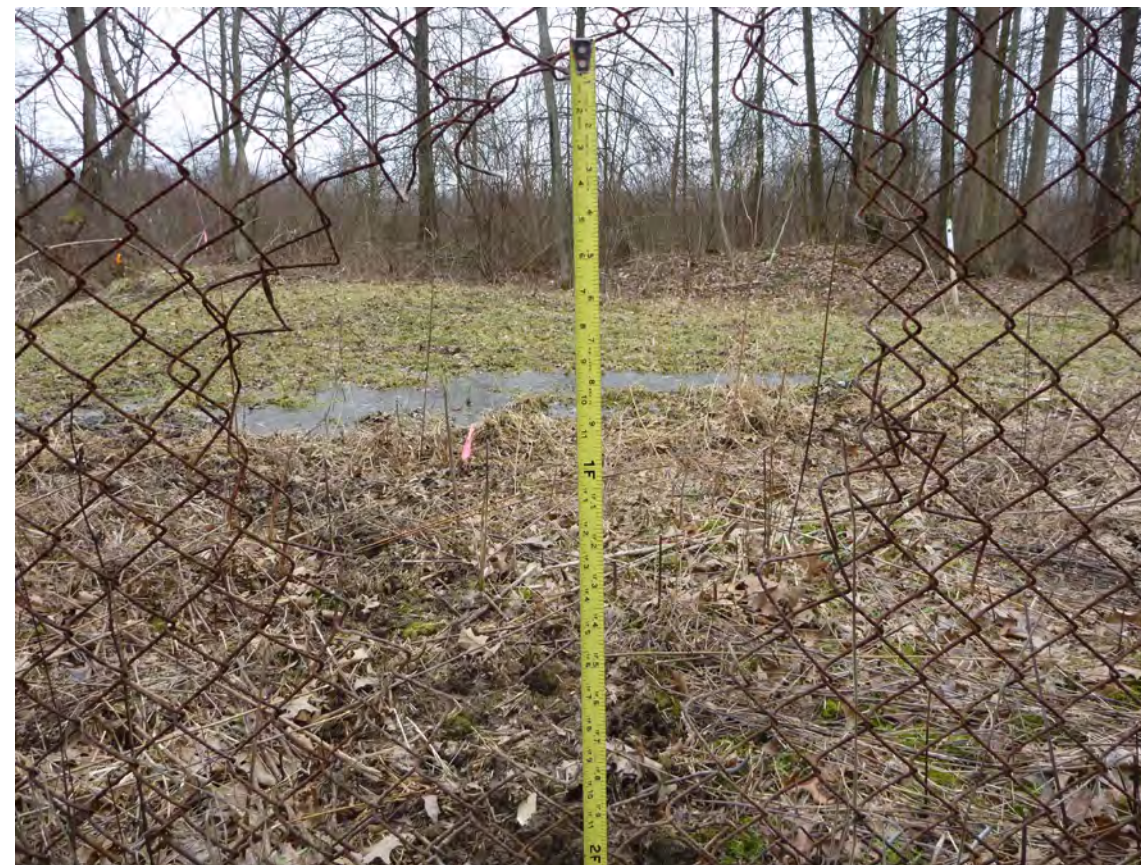
PHOTO NE5 discovered 02/13/2013

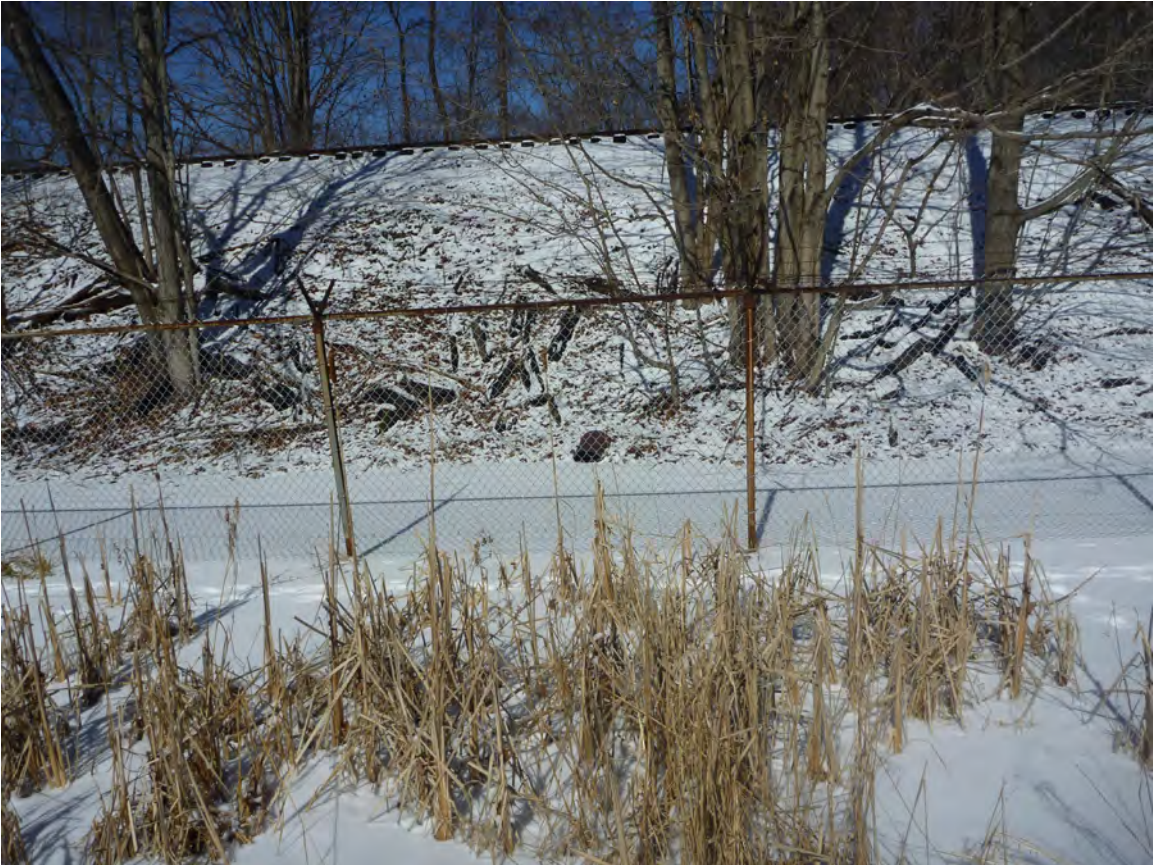
PHOTO NE21 repair 03/03/2014

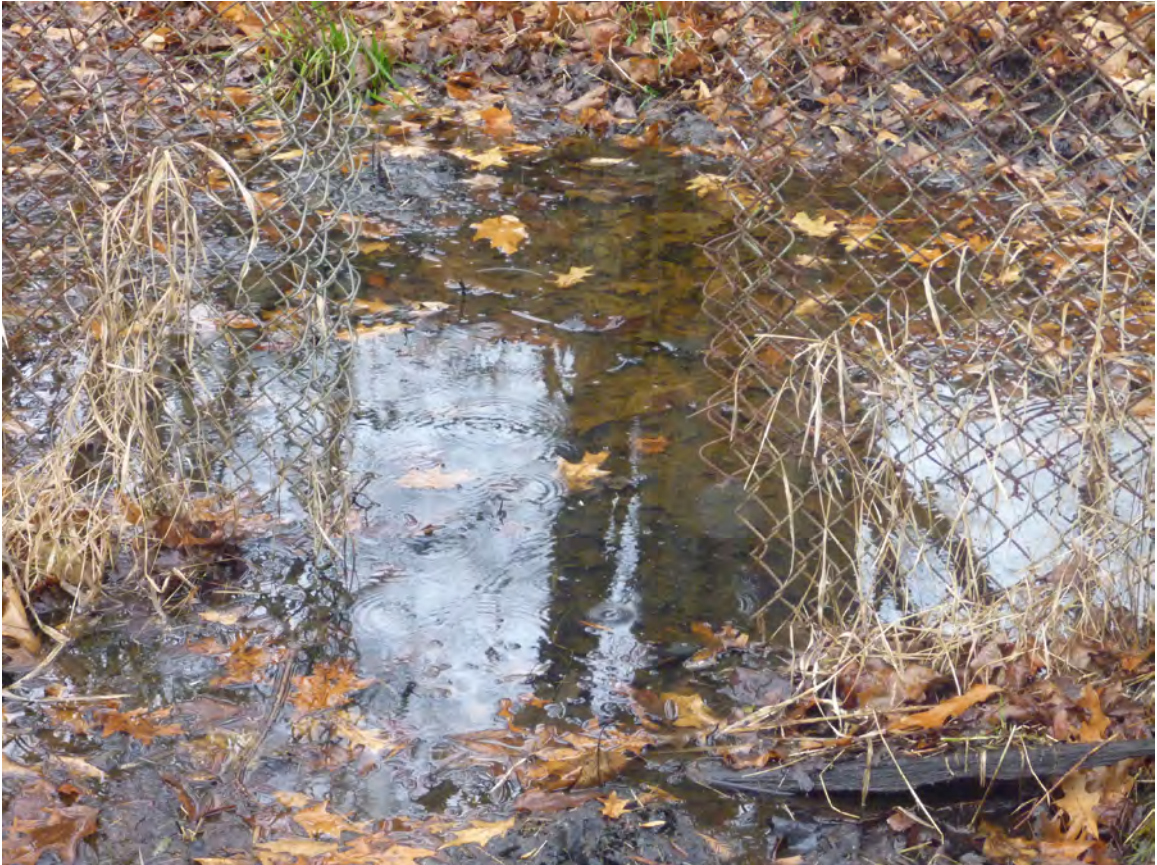
PHOTO NE21 discovered 11/21/2013

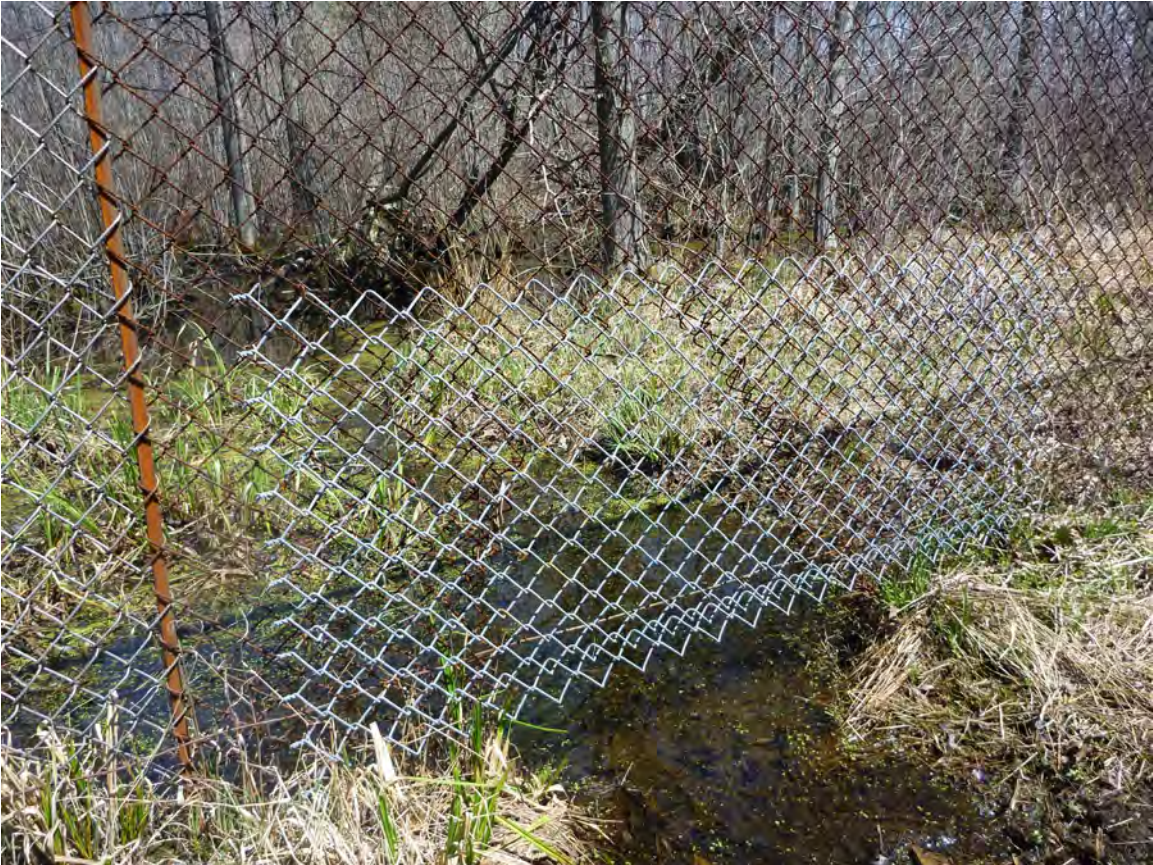
PHOTO NE24 repaired 04/17/2014

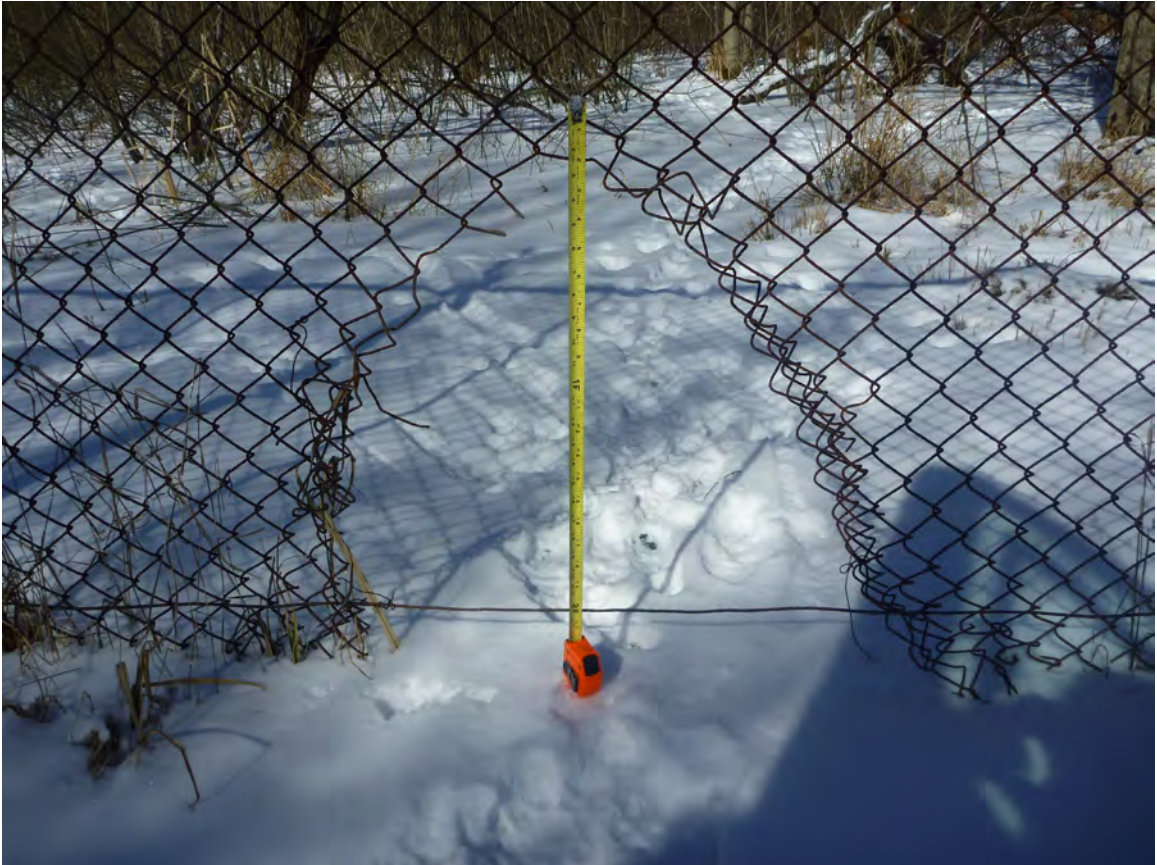
PHOTO NE24 discovered 03/03/2014

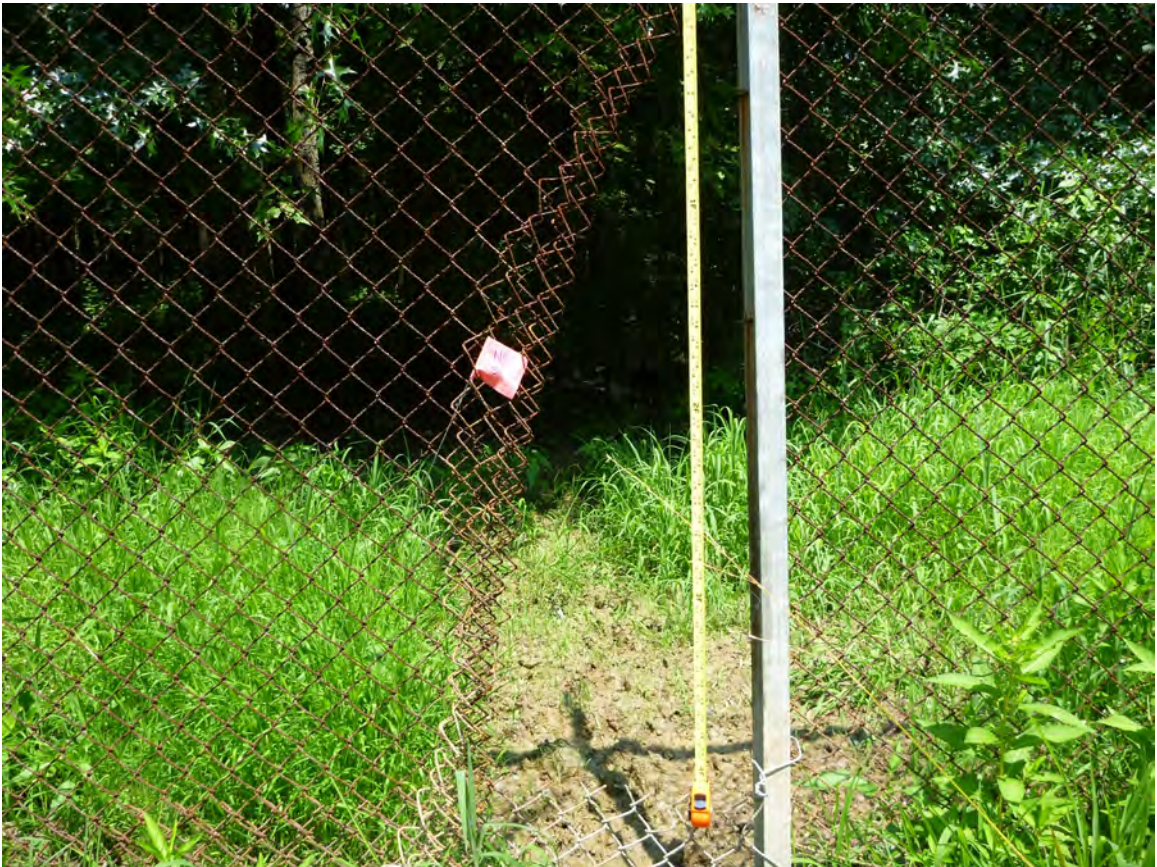
PHOTO NE30 discovered 07/21/2014

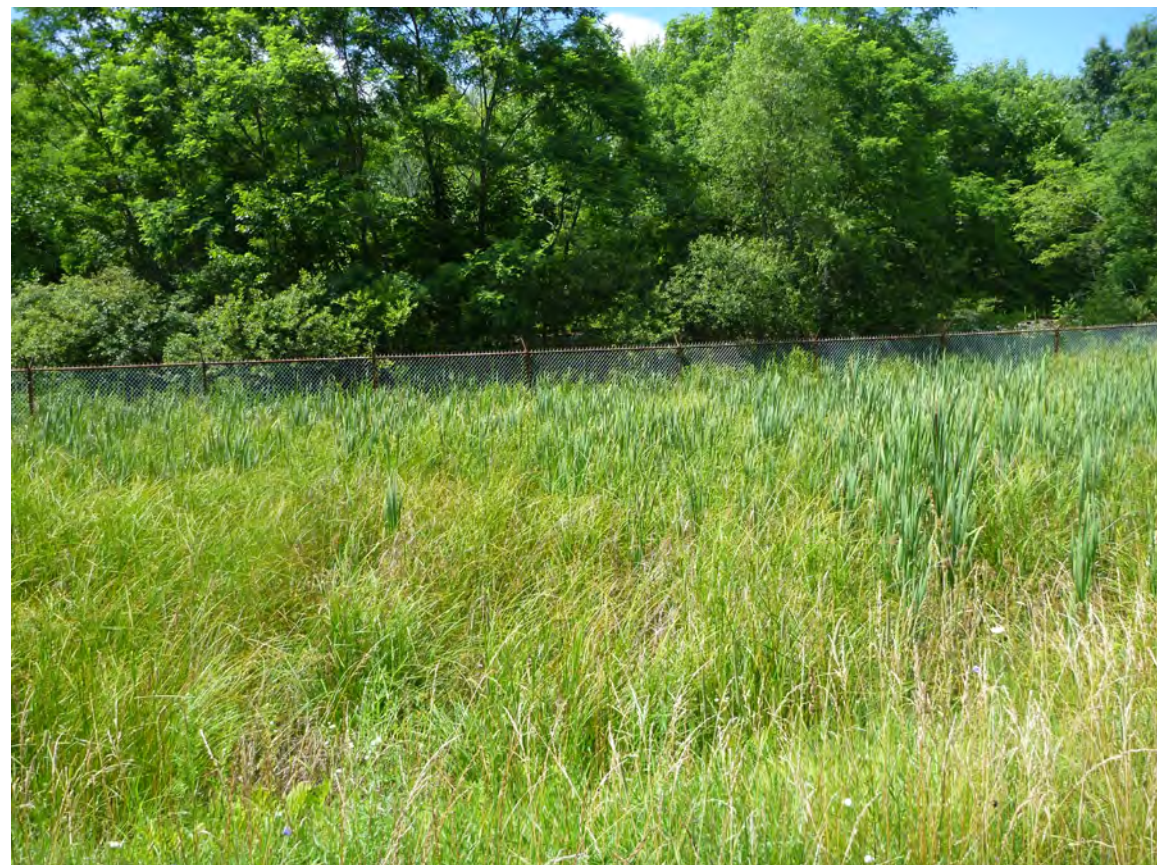
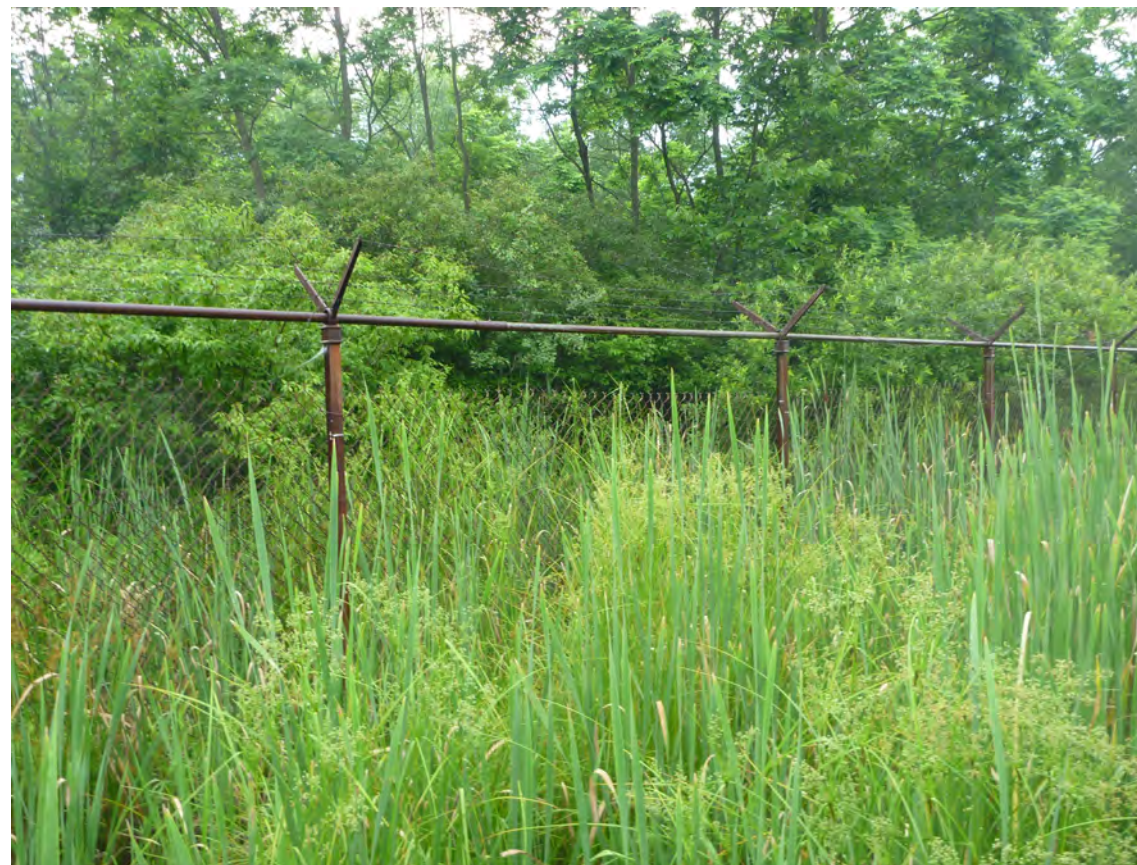
Repair PHOTO NW8 dated 07/16/2014

PHOTO NW8 discovered 07/16/2013

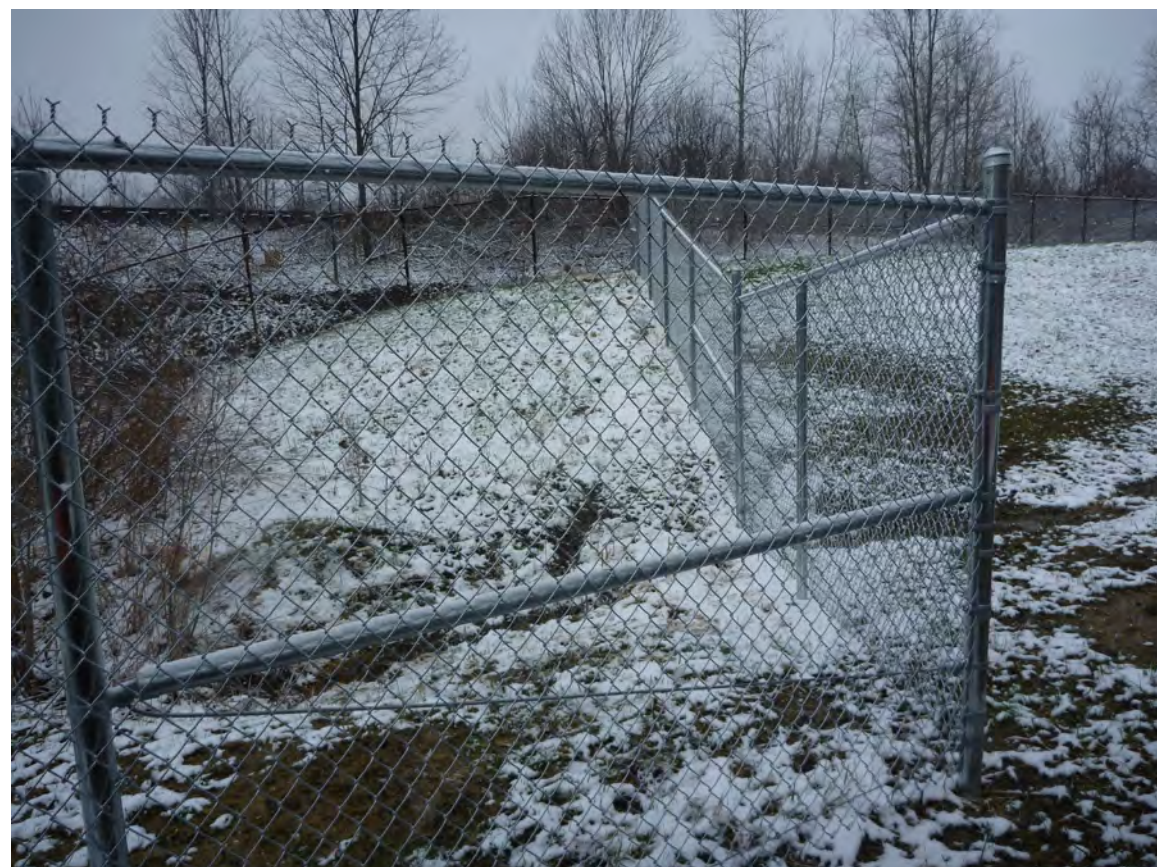
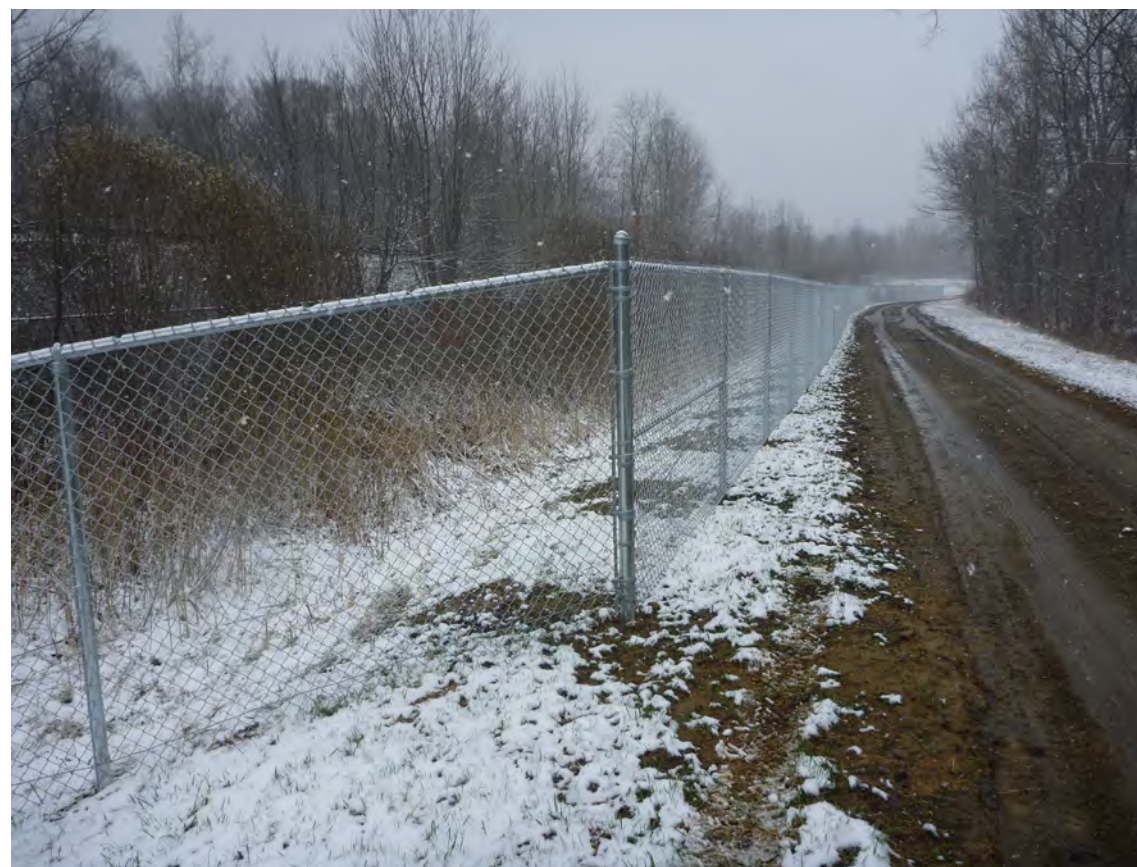
DETAIL SHEET FOR NW9

PHOTO No.2 dated April 15, 2014

PHOTO No.1 dated April 15, 2014

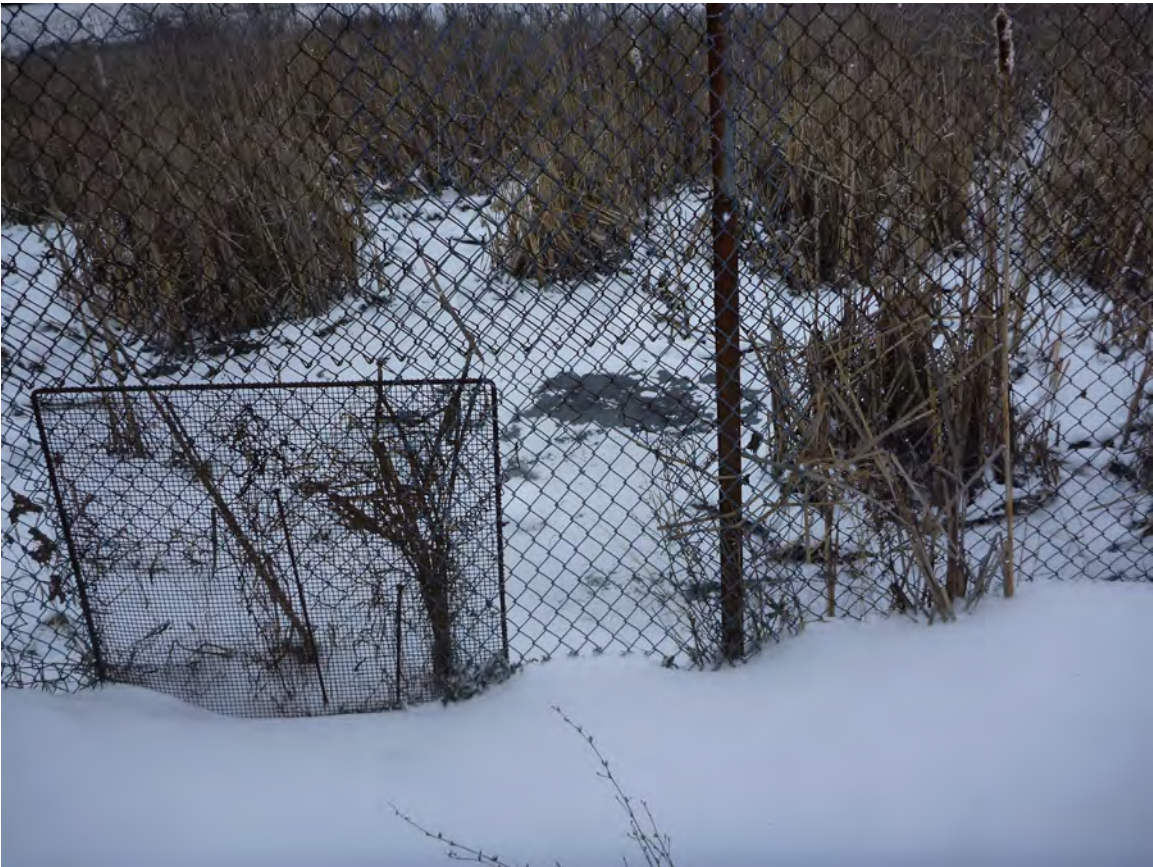
PHOTO SE3 repair 02/27/2014

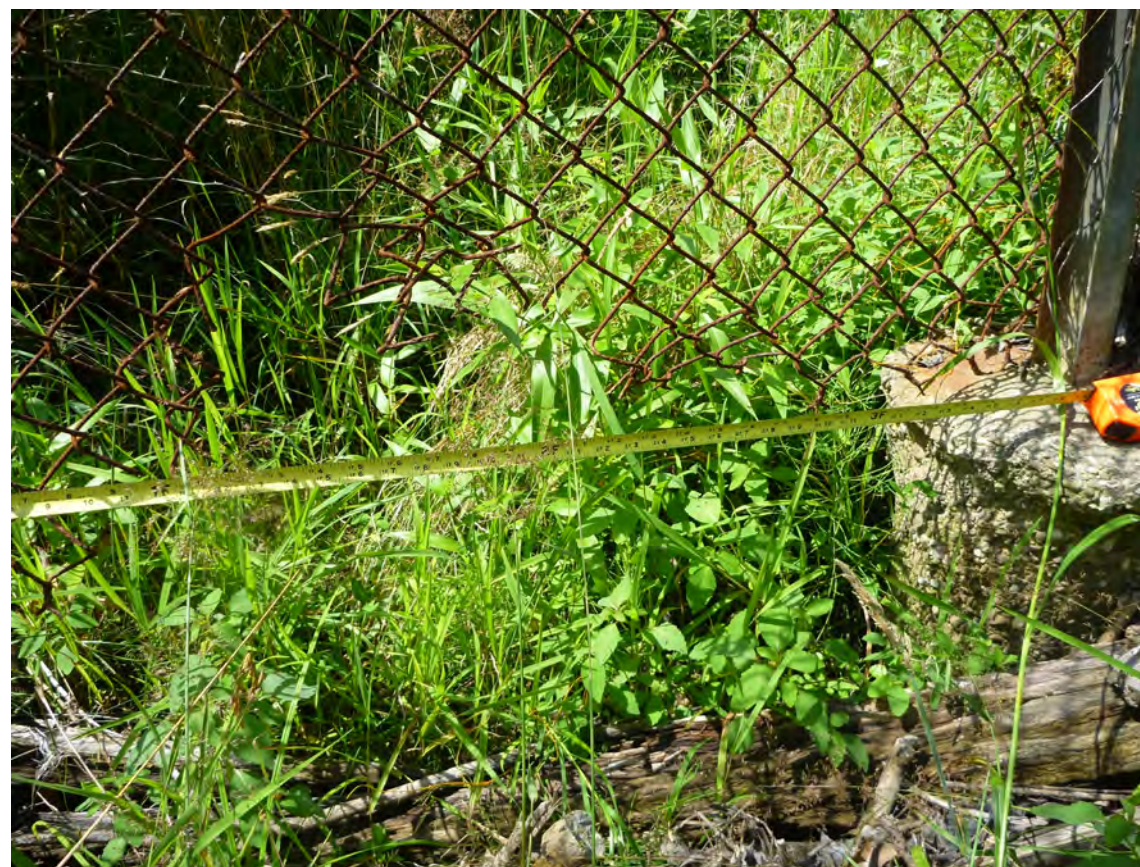
DETAIL SHEET FOR SW1

Callout	Date	Comments	US Survey Ft		Callout
			Northing	Easting	
NE30	07/21/2014	poacher hole	571083	2382464	NE30
SW01	02/07/2013	bottom open	549403	2336048	SW01
SW06A	07/16/2014	poacher hole in fence (repeat)	560708	2335572	SW06A
SW12	11/18/2013	storm washout about 2 sections inlet needs cleared	552357	2330086	SW12
SW14	04/14/2014	poacher hole in fence	549386	2334237	SW14
SW15	07/15/2014	tree blow down	549438	2339580	SW15
SW16	07/15/2014	tree blow down/damaged fence	554267	2328362	SW16
SW17	07/15/2014	tree blow down/fence top damaged	556228	2328345	SW17
SW18	07/15/2014	hole under fence at culvert outlet	556241	2328345	SW18
SW19	07/15/2014	tree blow down/top fence damaged	556581	2328342	SW19
SW20	07/15/2014	hole in bottom of fence below sign	559398	2330974	SW20
SW21	07/15/2014	hole at bottom of fence	559659	2331945	SW21
SW22	07/16/2014	poacher hole	560762	2335683	SW22
SE02	07/22/2014	washout...worse now 7.18.2013	551498	2361141	SE02

PHOTO SW1 discovered 02/07/2013

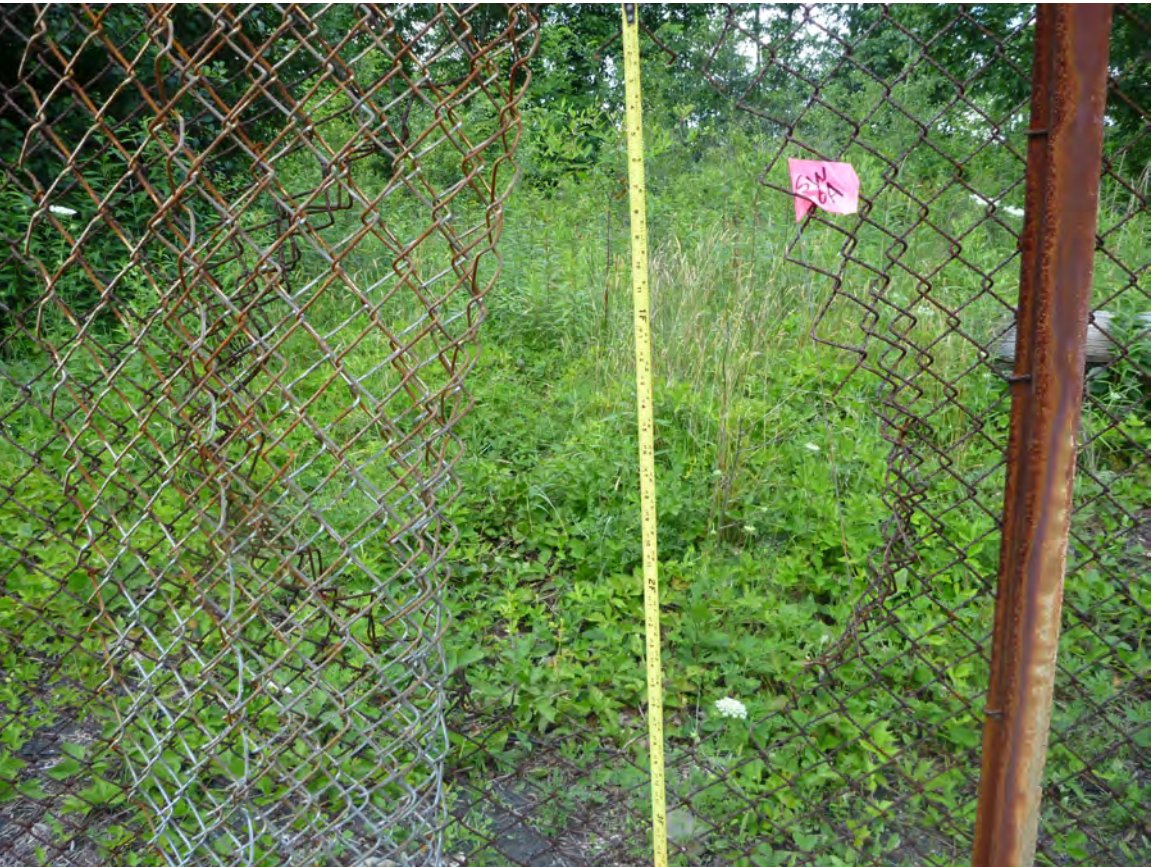
Note: The Callout "6A" indicates this location is a repeat. SW6 was originally discovered 2/12/13 and first repaired on 4/18/13. The photo below depicts the repair was again vandalized to gain entry. Additionally, this location is between two major fence repairs, SW5 & SW7, 8 & 9, where the perimeter fence has been relocated as shown.

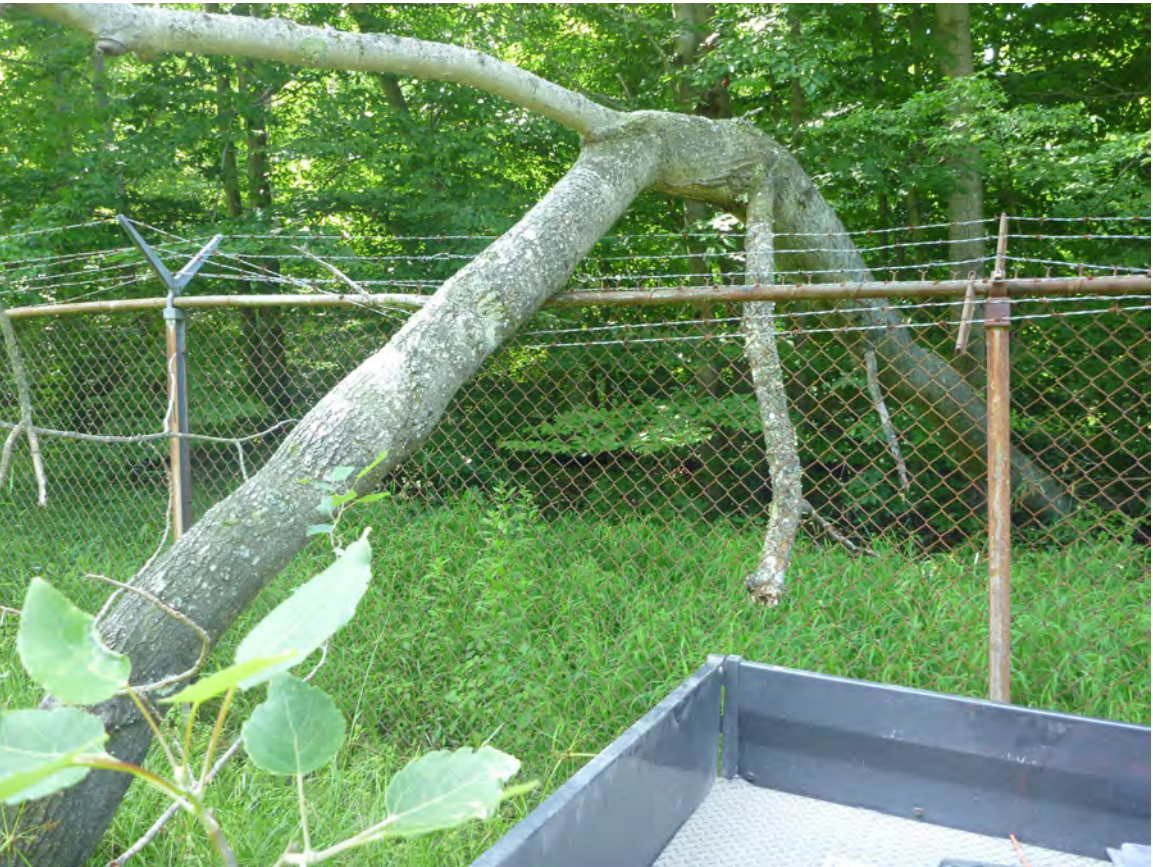
DETAIL SHEET FOR SW15

PHOTO SW15 discovered 07/15/2014

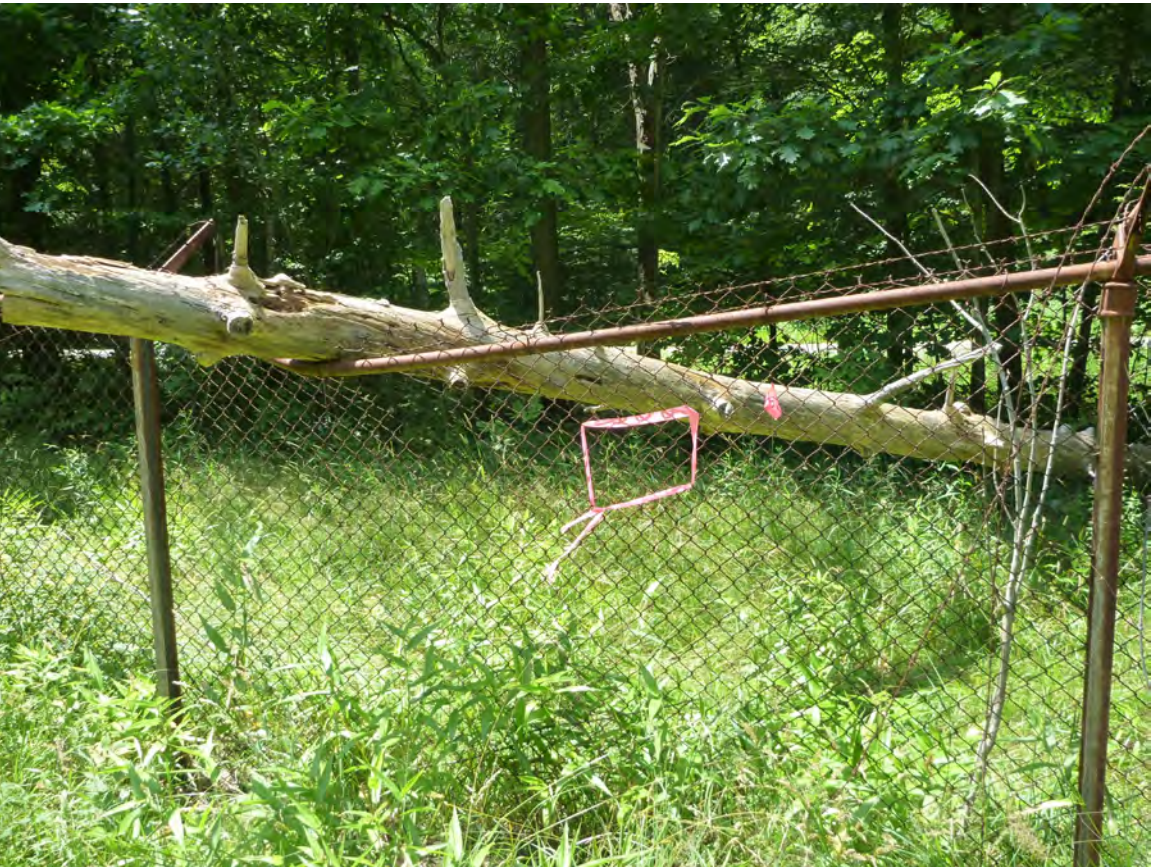
PHOTO SW17 discovered 07/15/2014

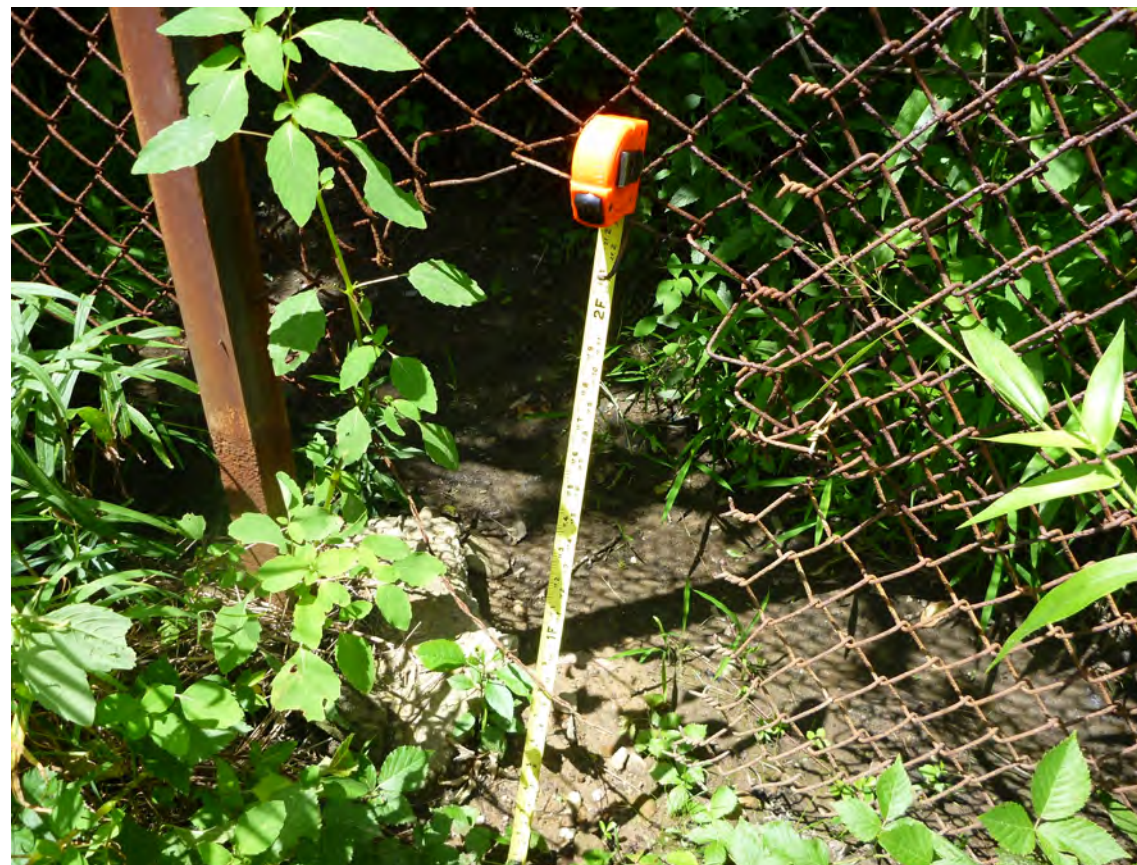
PHOTO SW20 discovered 07/15/2014
