Final
FY 2014 Annual Report for the
Quarterly Land Use Control Inspections,
RVAAP-05 Winklepeck Burning Grounds

Camp Ravenna Joint Military Training Center
Former Ravenna Army Ammunition Plant
Portage and Trumbull Counties, Ohio

January 8, 2015

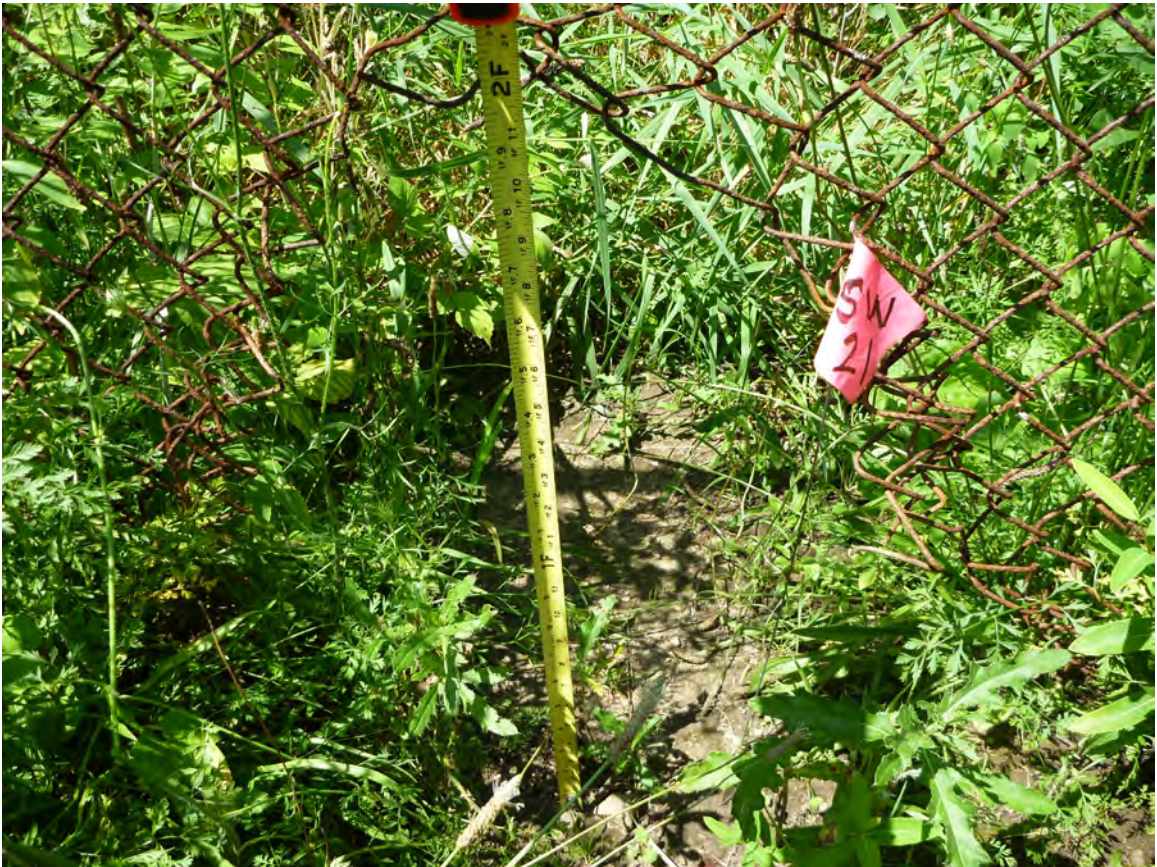
PHOTO SW21 discovered 07/15/2014

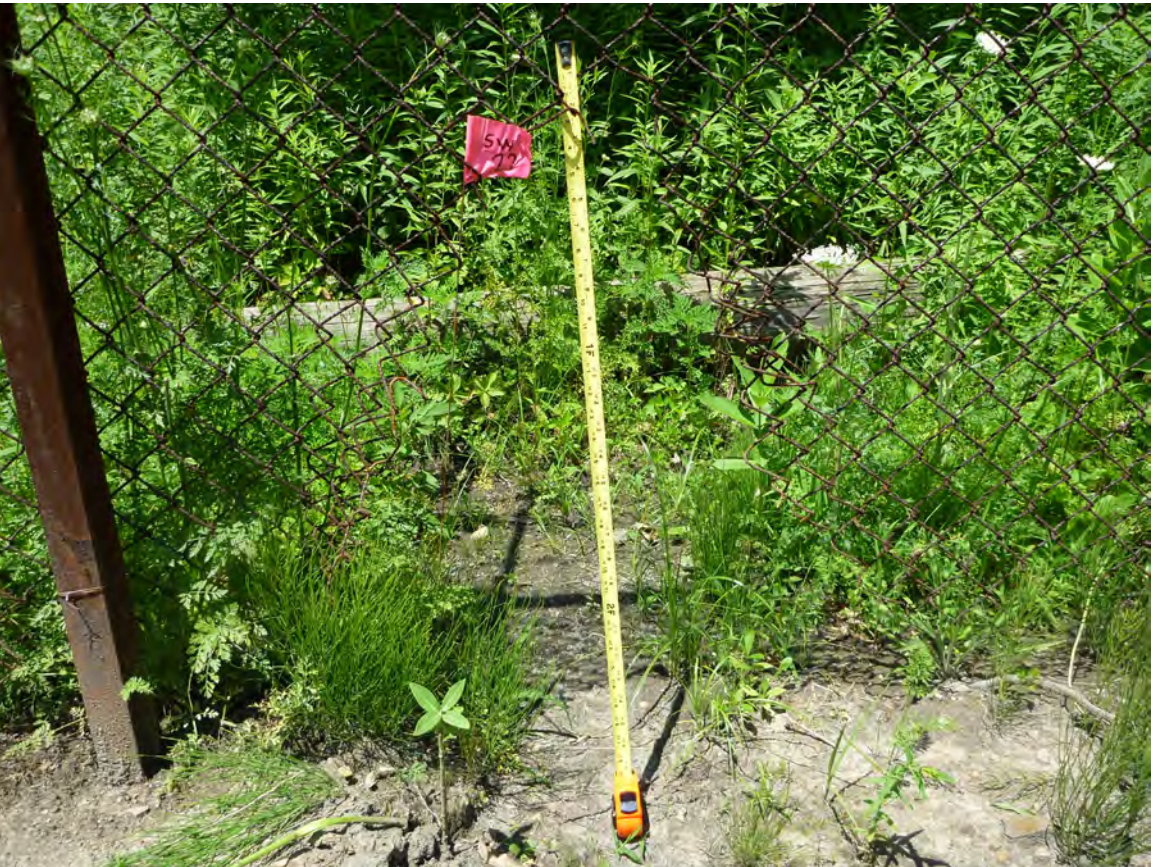
PHOTO SW22 discovered 07/16/2014

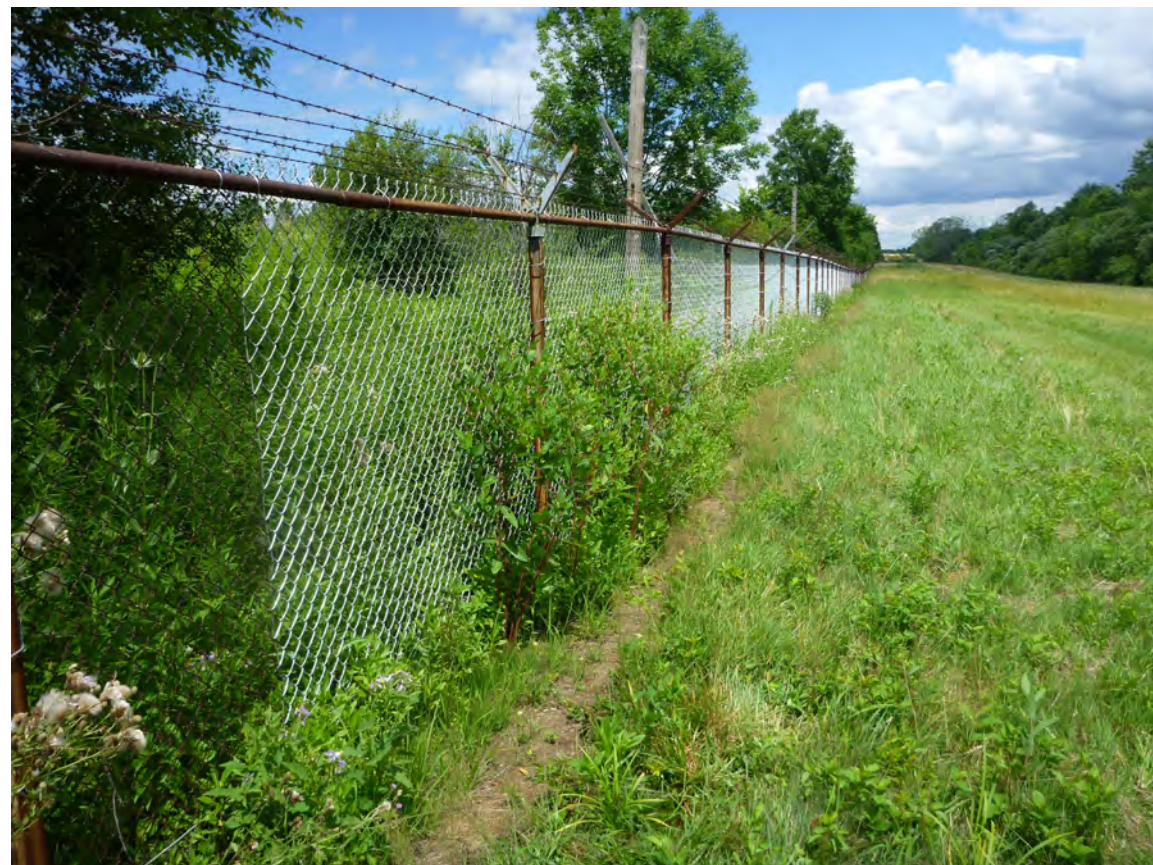
PHOTO NO.1 07/16/2014 (Begin new fence fabric clockwise from here)

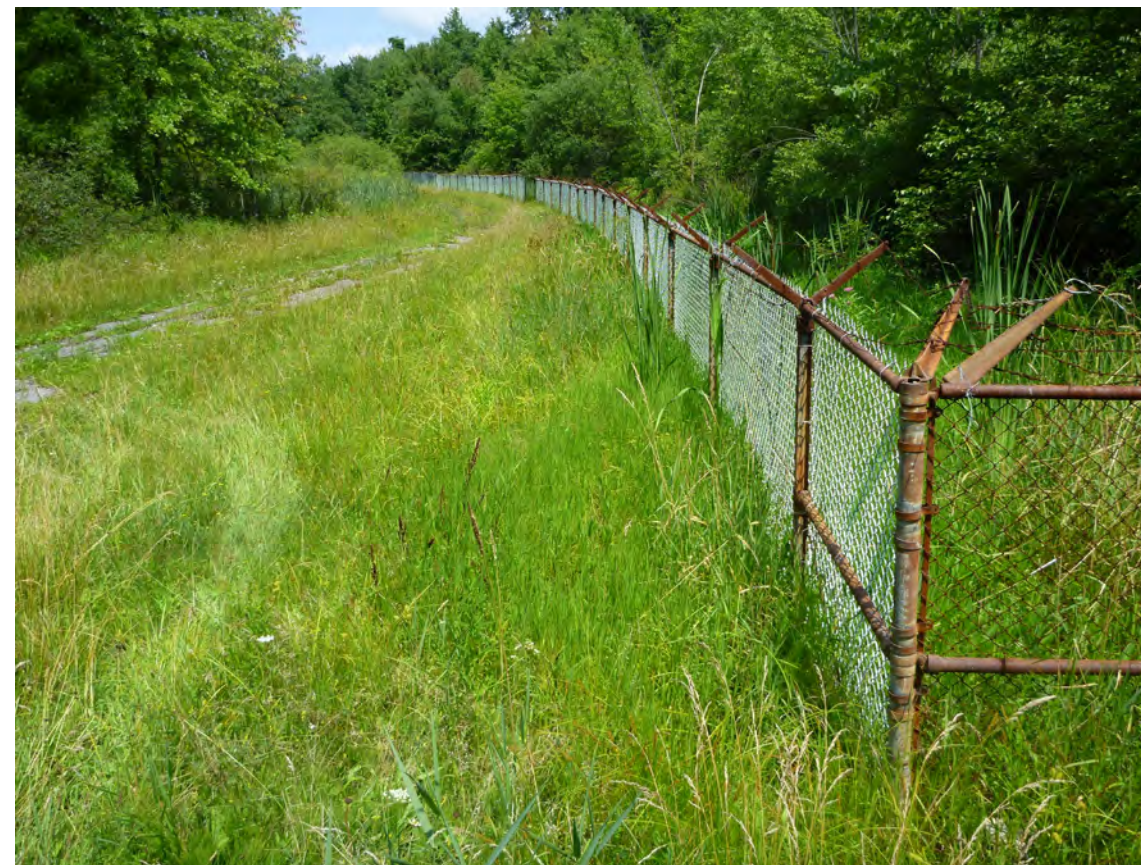
PHOTO No.2 (End new fence fabric here) 07/21/2014
