Final
2015 Annual Land Use Control Monitoring Report,
RVAAP-01 Ramsdell Quarry Landfill
and
RVAAP-05 Winklepeck Burning Grounds

Camp Ravenna Joint Military Training Center
Former Ravenna Army Ammunition Plant
Portage and Trumbull Counties, Ohio

Contract No. W912QR-13-C-0031

January 27, 2016

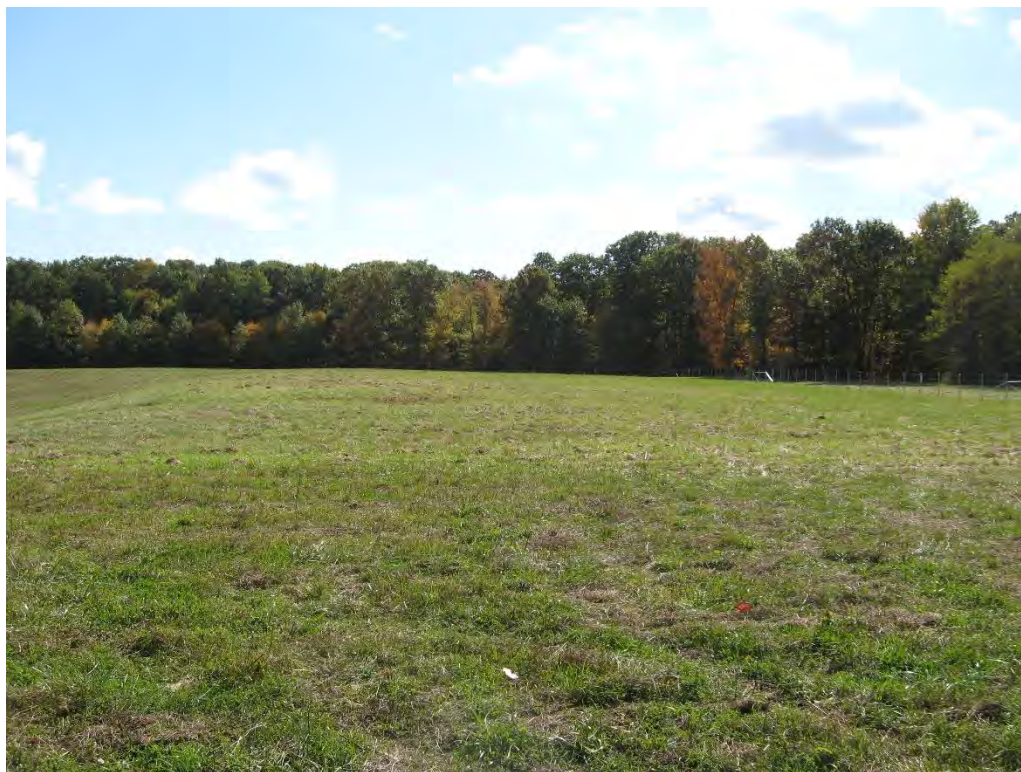
West side of Ramsdell Quarry Landfill, looking south from west gate.

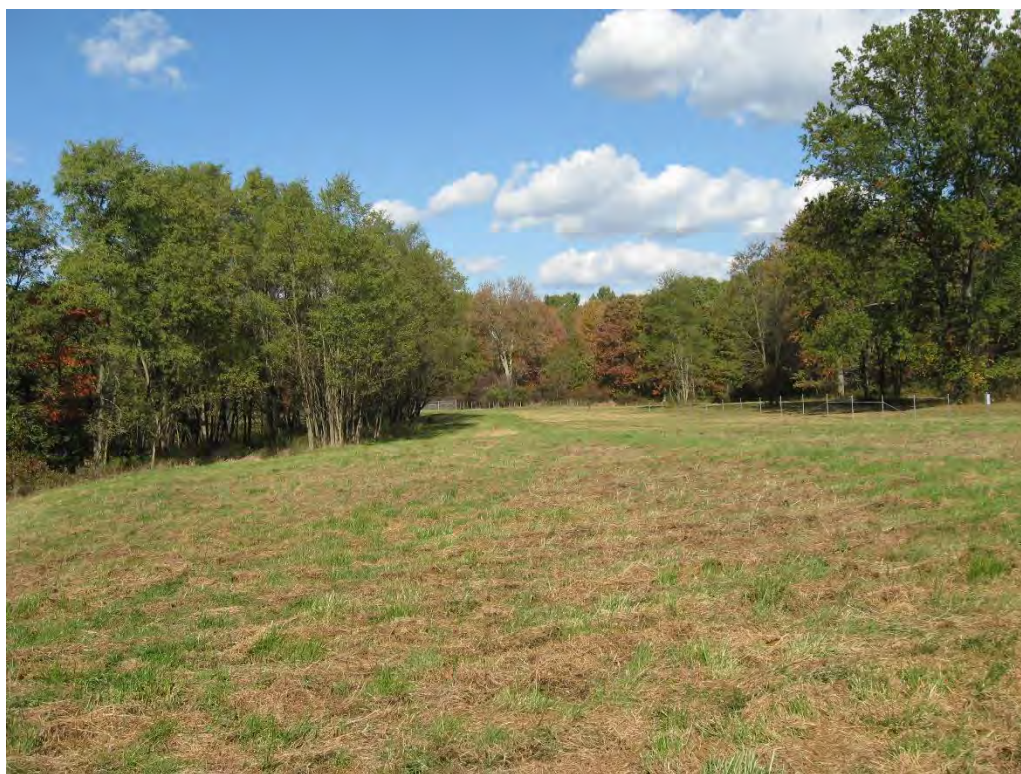
East side of Ramsdell Quarry Landfill, looking north from southeast corner.

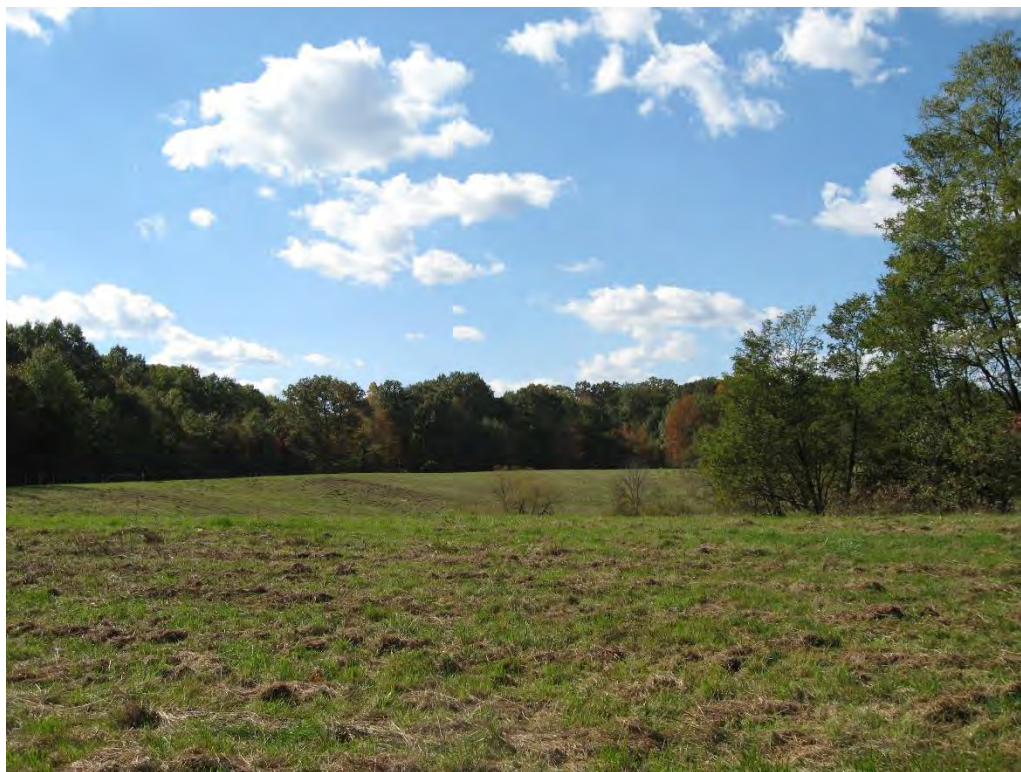
East and south side of Ramsdell Quarry Landfill, looking southwest from east side.

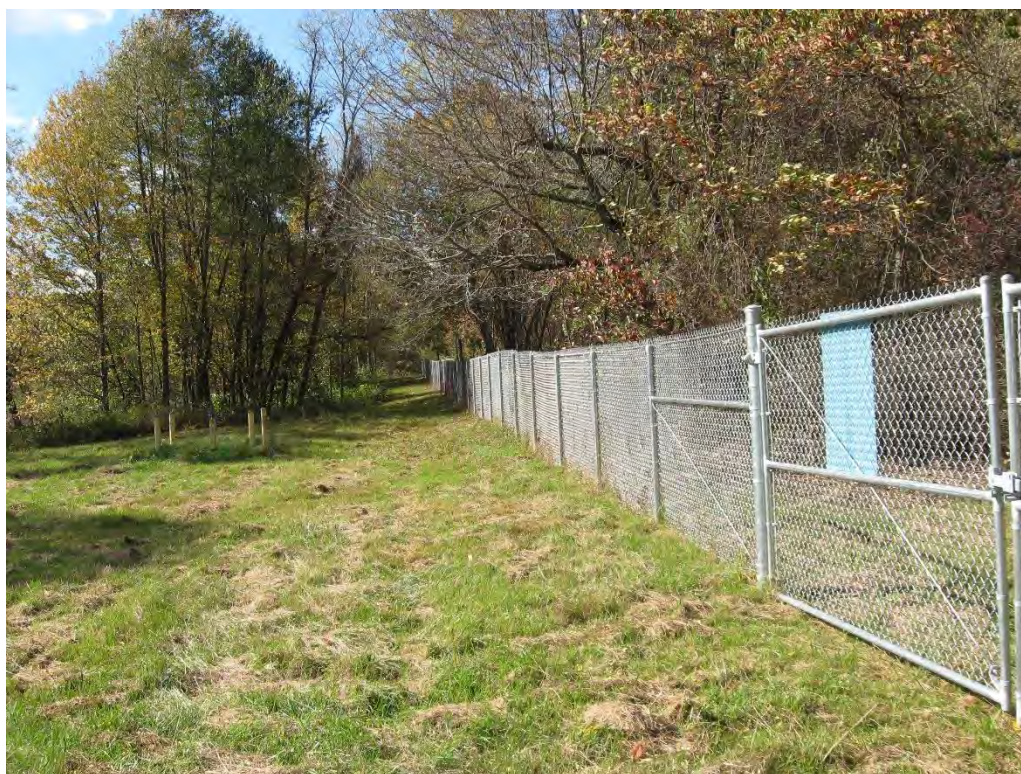
East gate and north fence of Ramsdell Quarry Landfill, looking west from east gate.

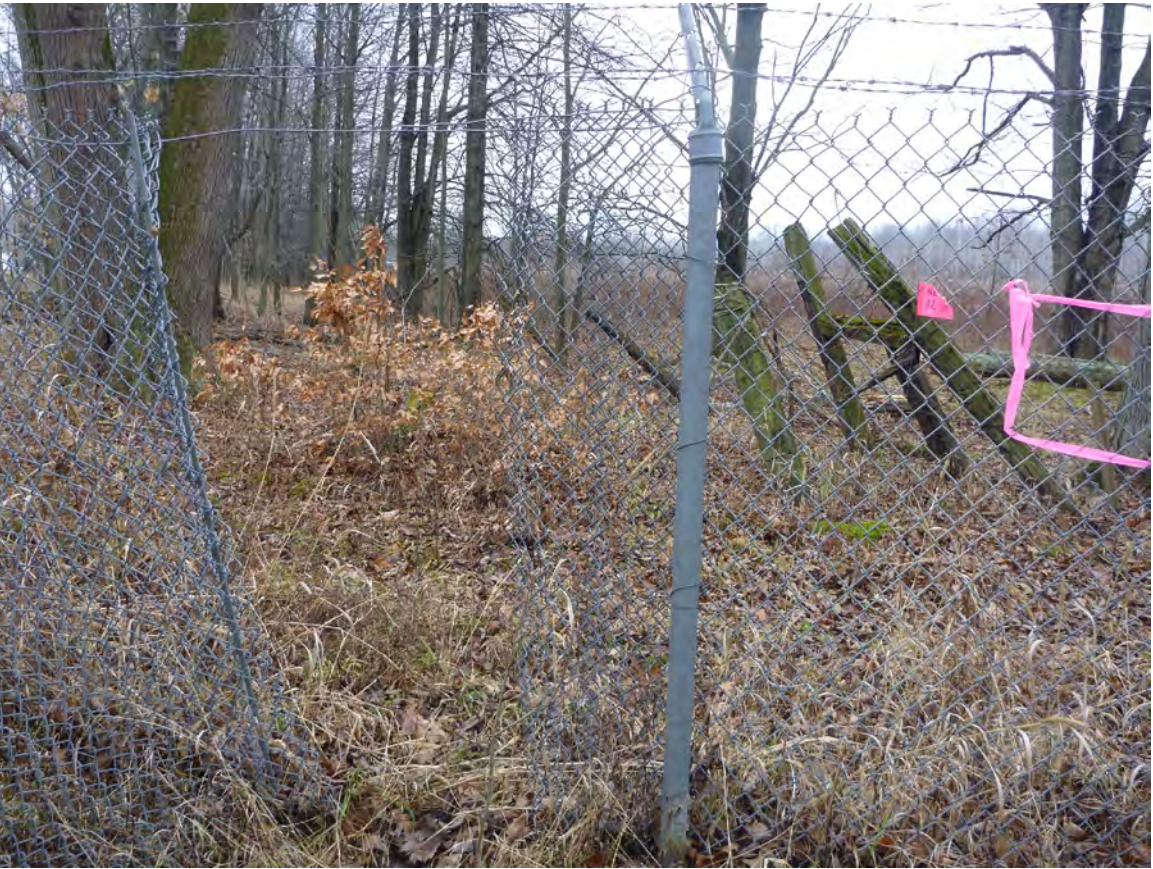
DETAIL SHEET FOR NE15A

PHOTO NE15A discovered 12/15/2014

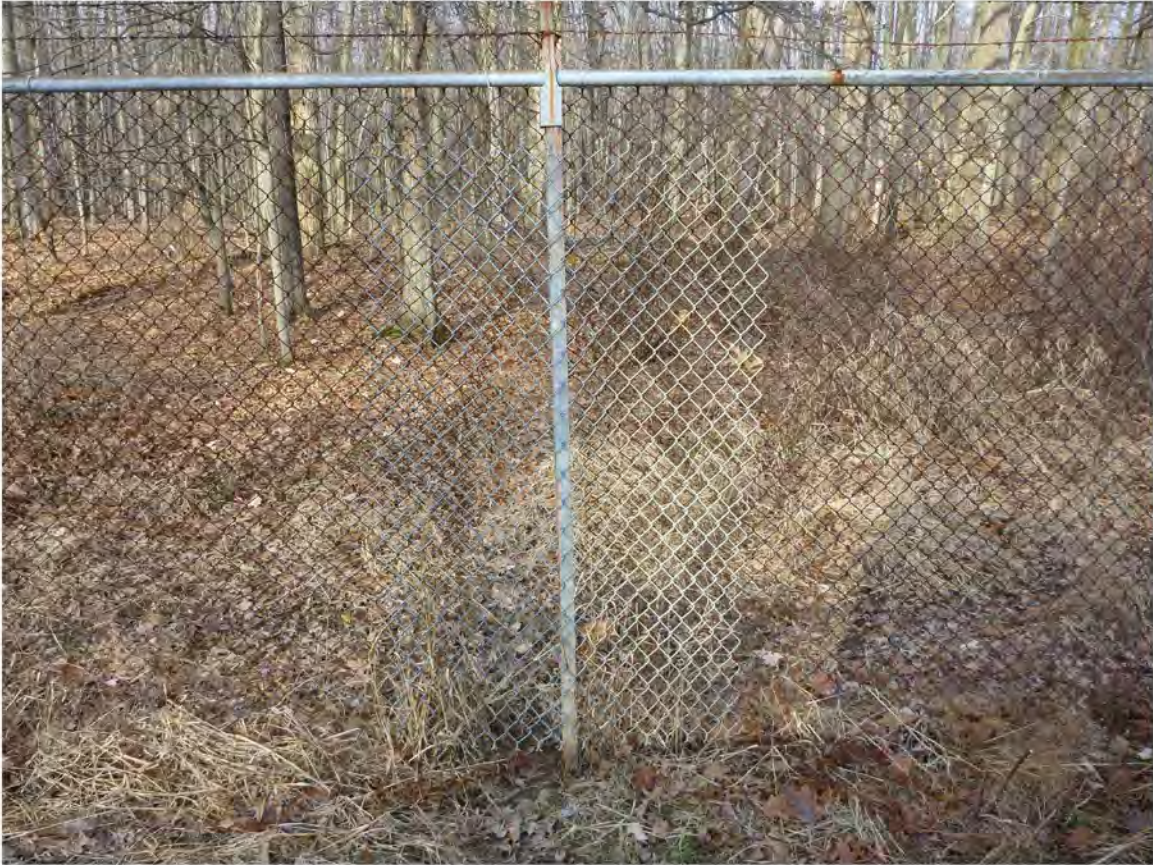
PHOTO NE30 repaired 12/04/2014

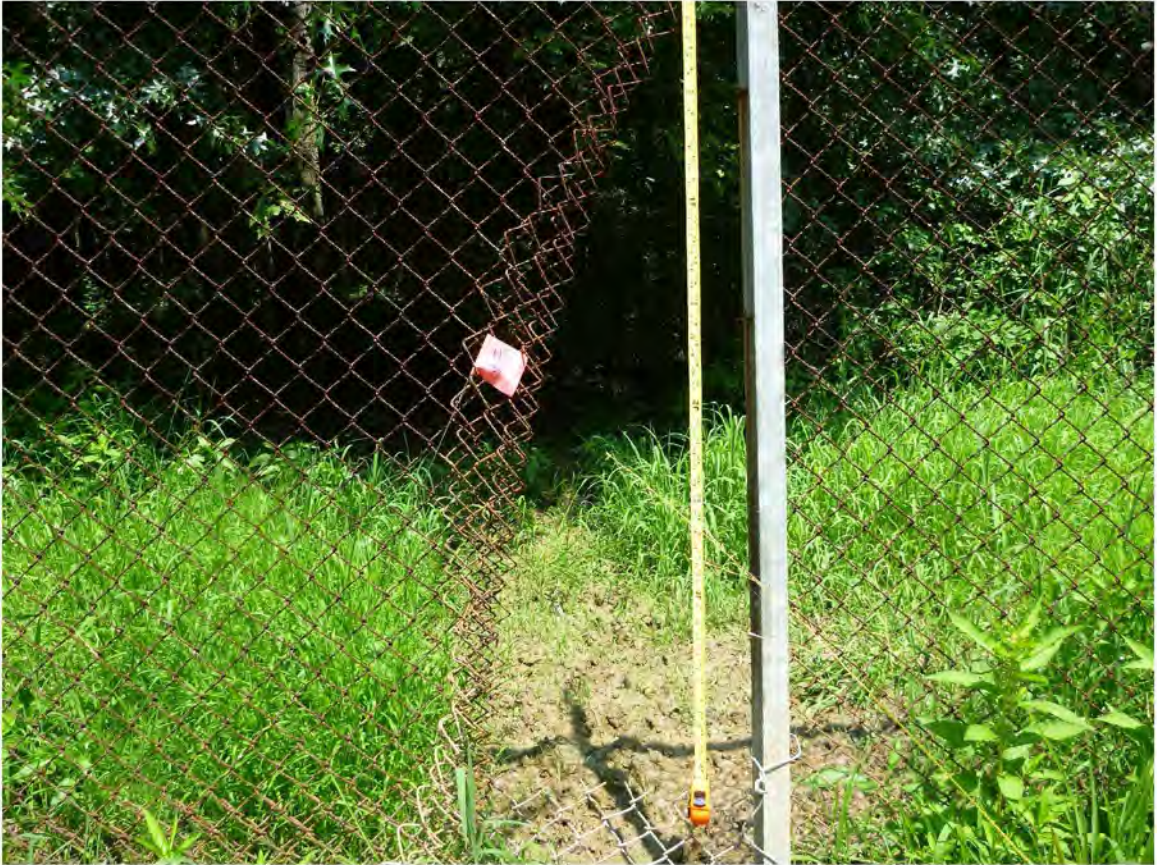
PHOTO NE30 discovered 07/21/2014

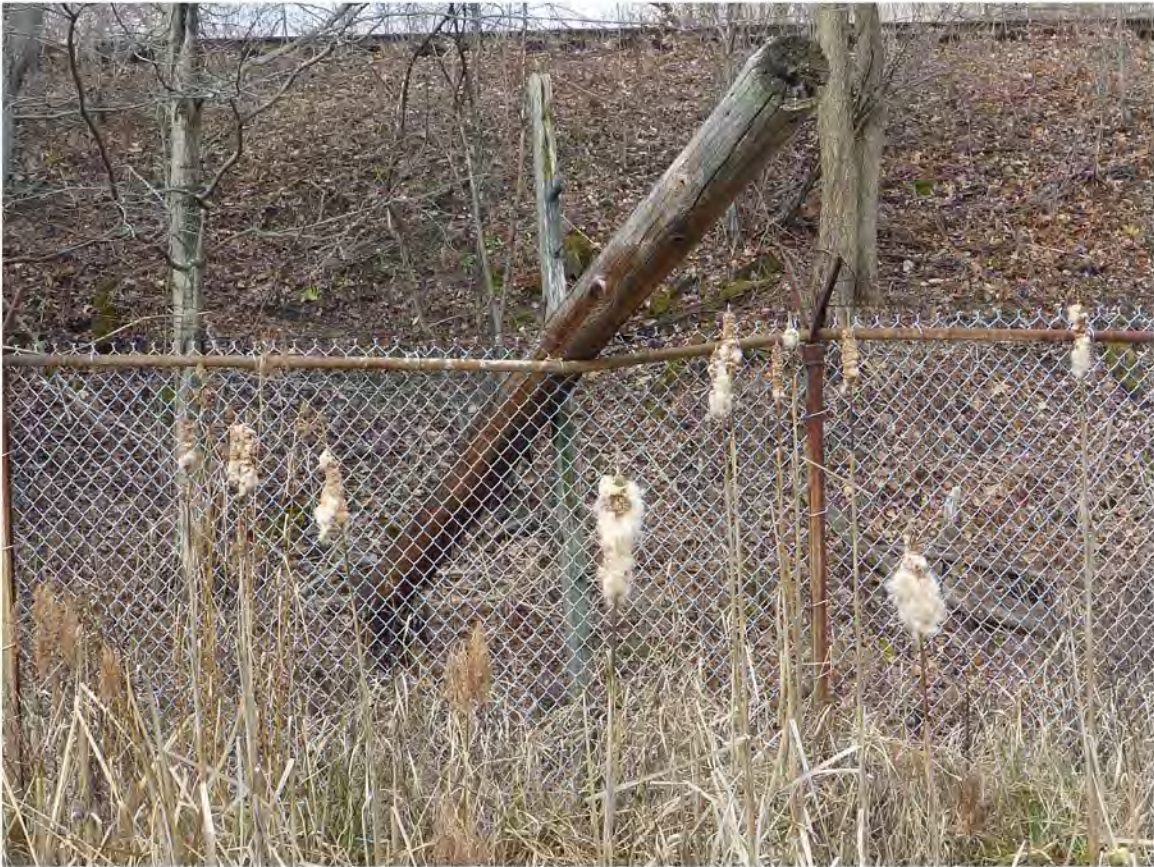
DETAIL SHEET FOR NE31

PHOTO NE31 discovered 12/03/2014

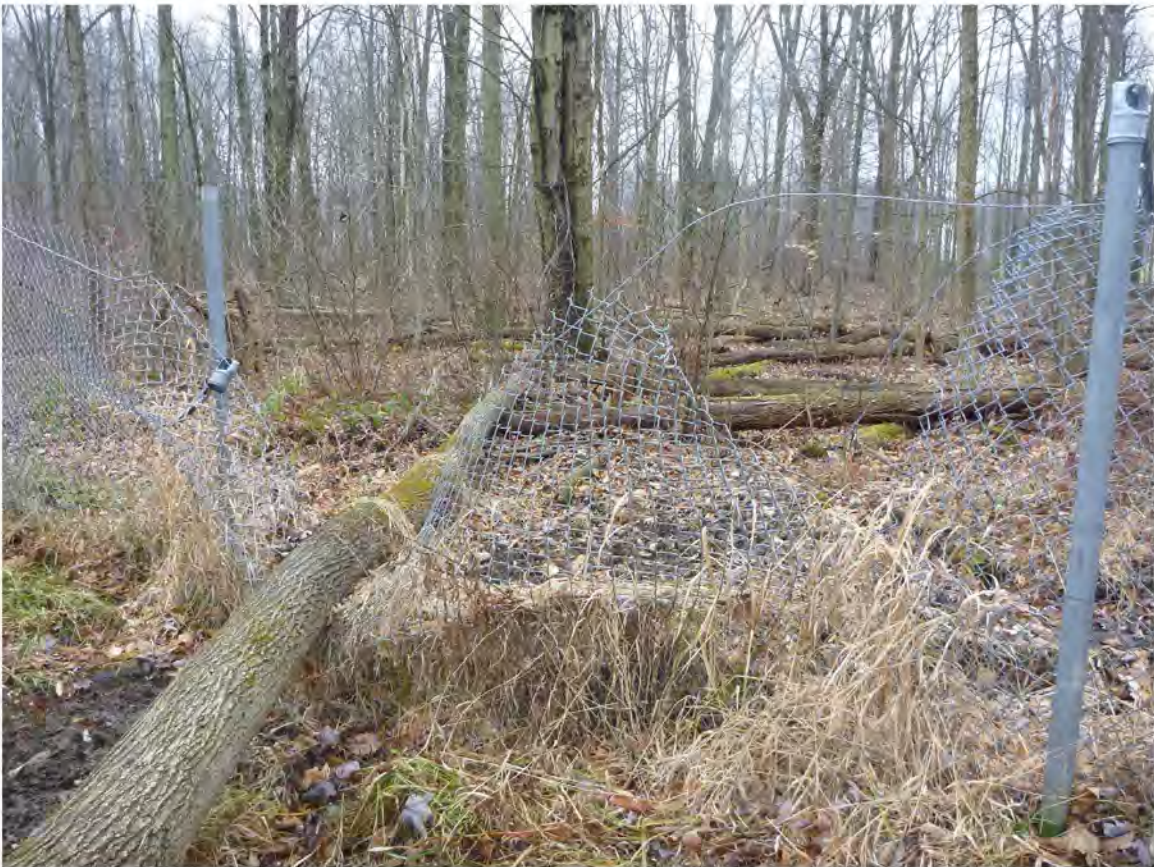
DETAIL SHEET FOR NE32

PHOTO NE32 discovered 12/15/2014

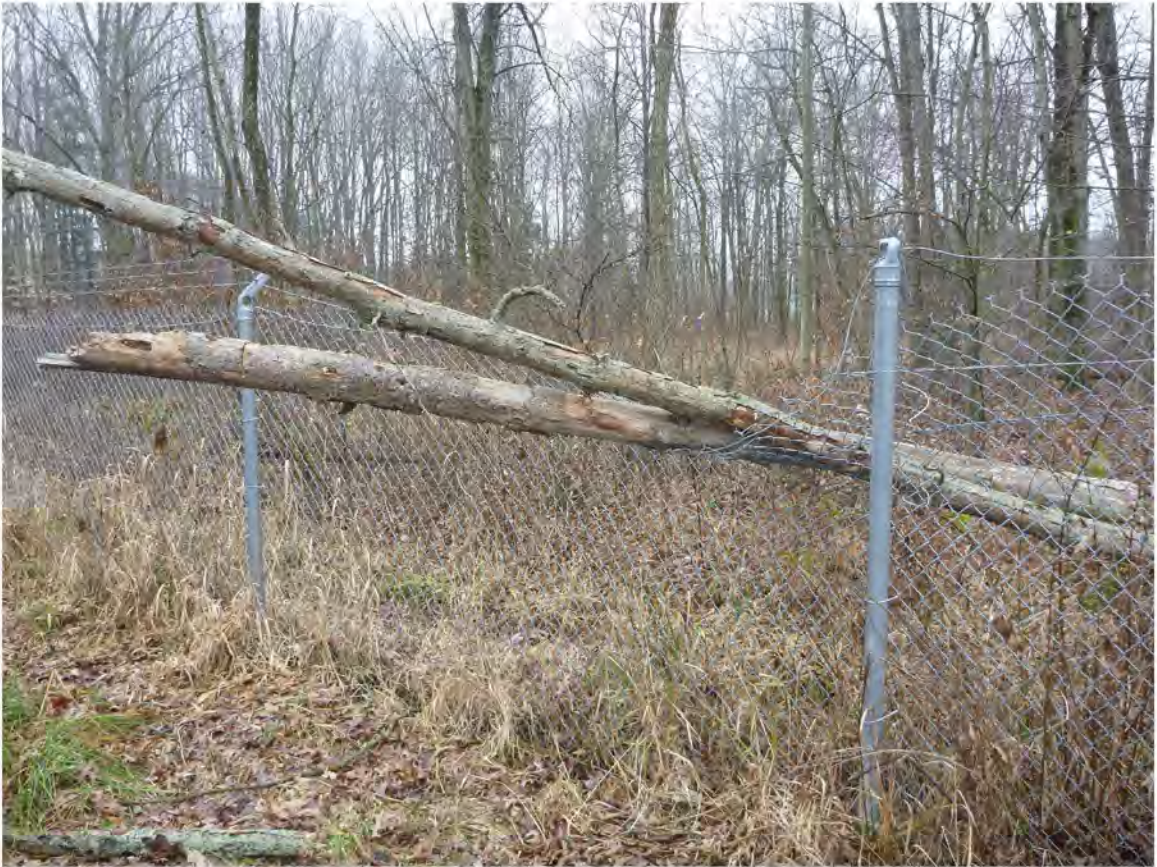
DETAIL SHEET FOR NE33

PHOTO NE33 discovered 12/15/2014

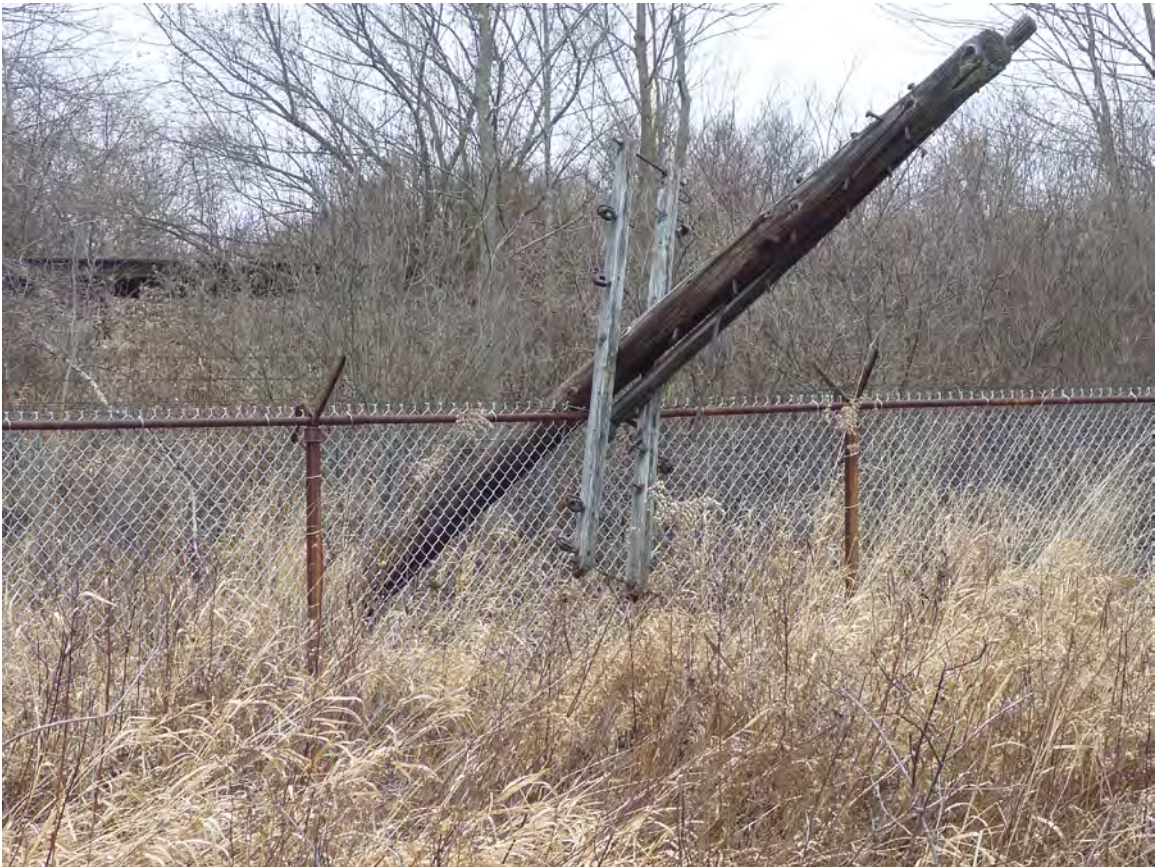
DETAIL SHEET FOR NW11

PHOTO NW11 discovered 11/26/2014

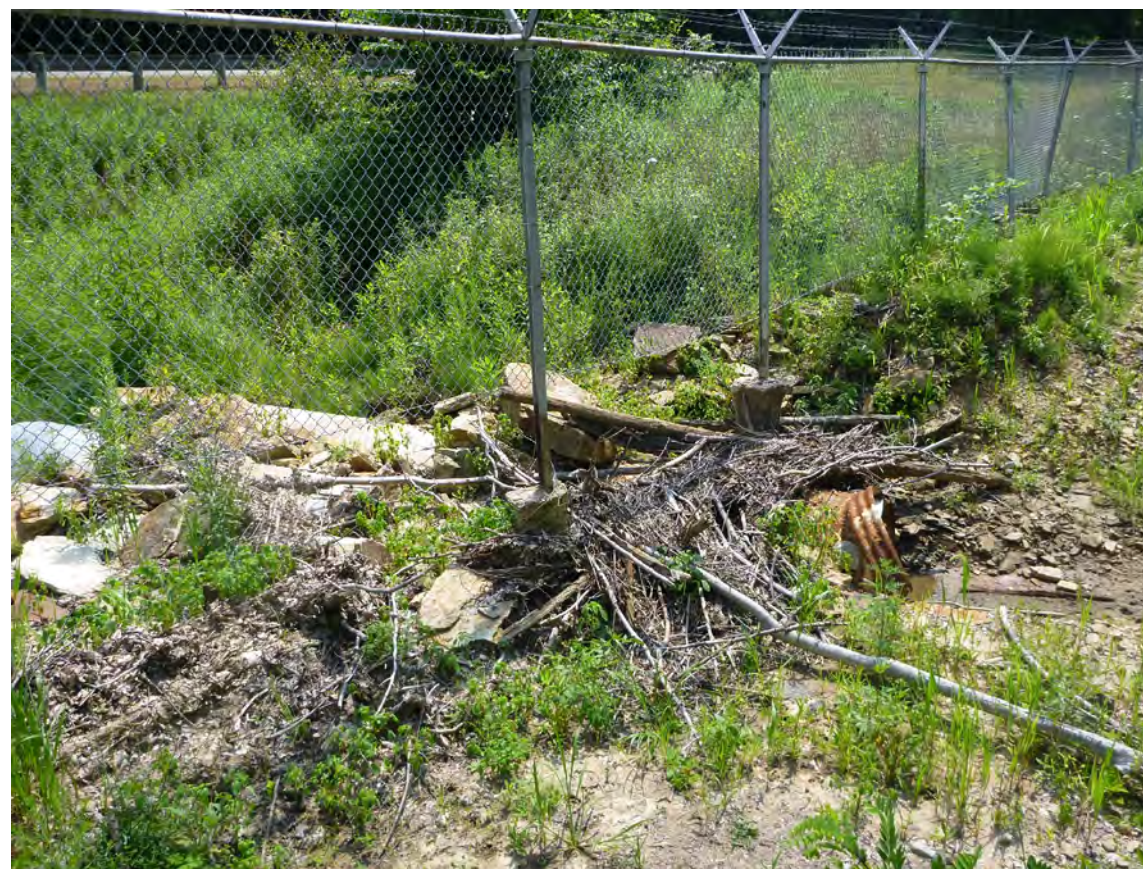
PHOTO SE2 discovered 07/18/2013

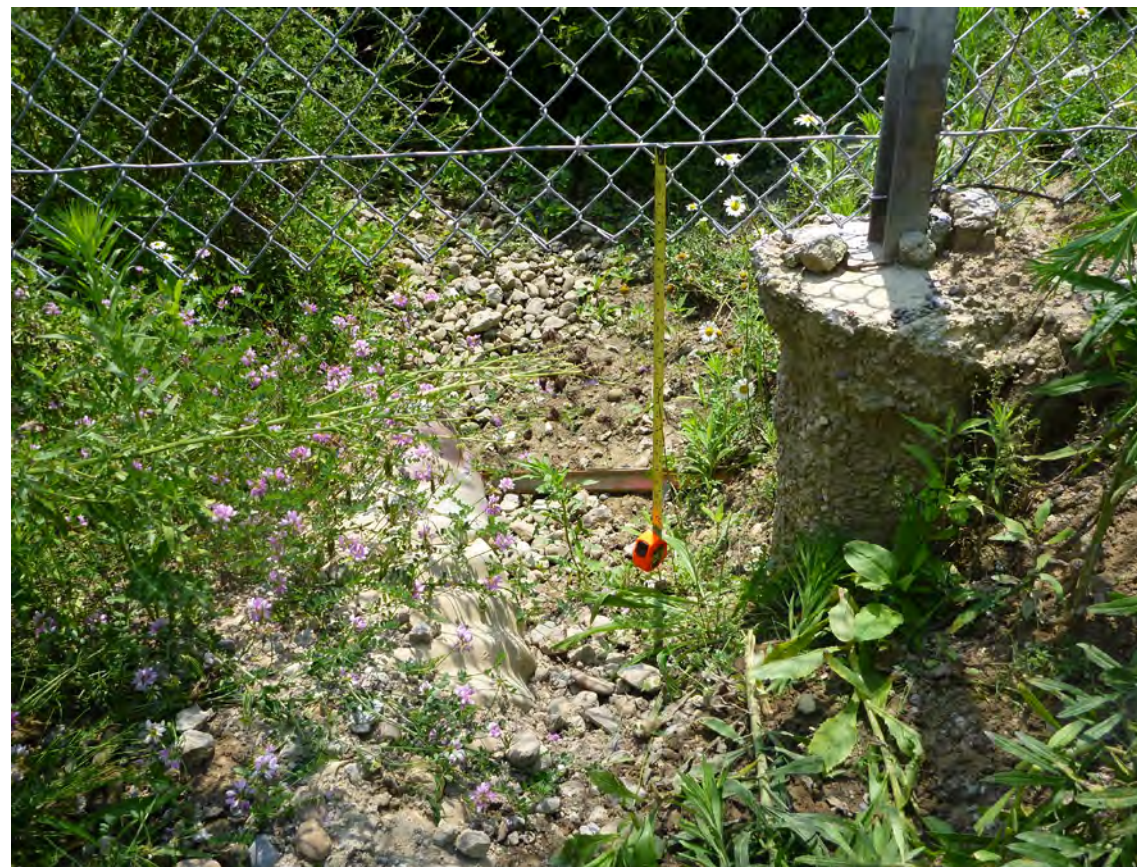
PHOTO SE4 discovered 02/27/2014

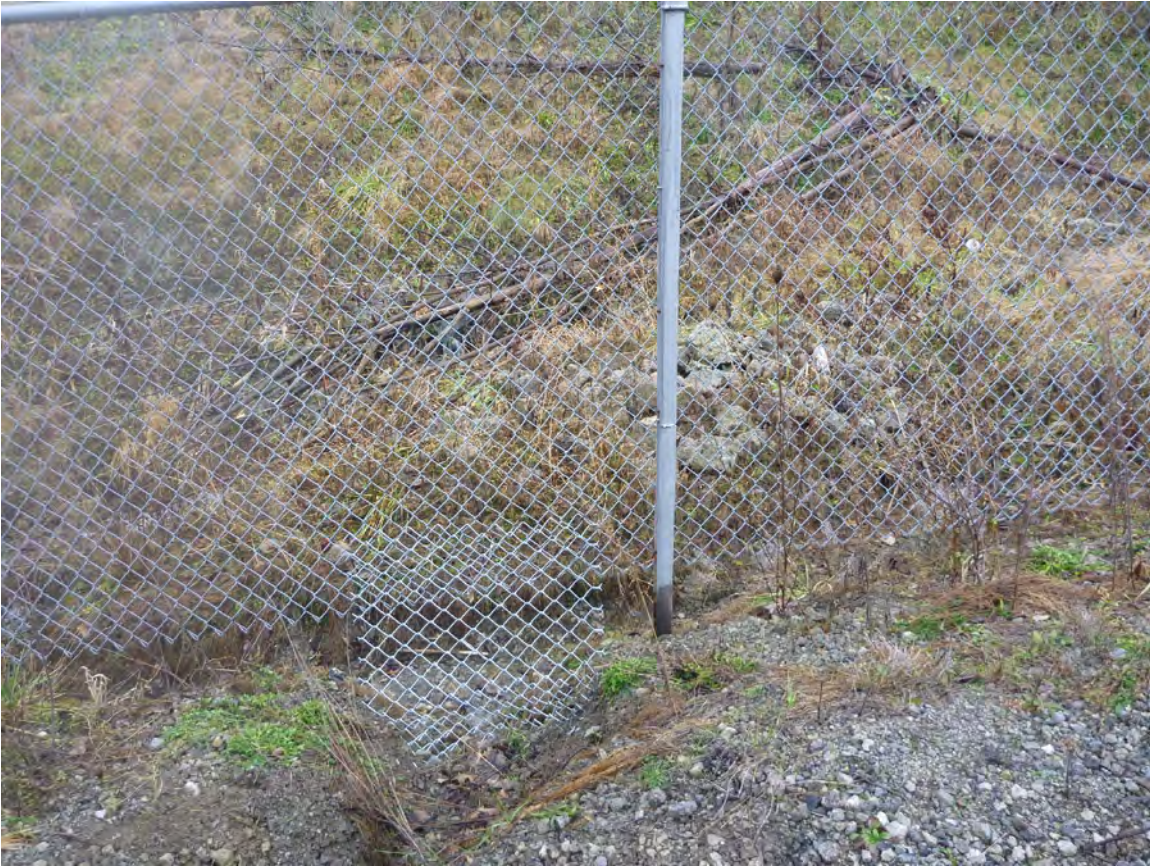
PHOTO SE5 repaired 12/16/2014

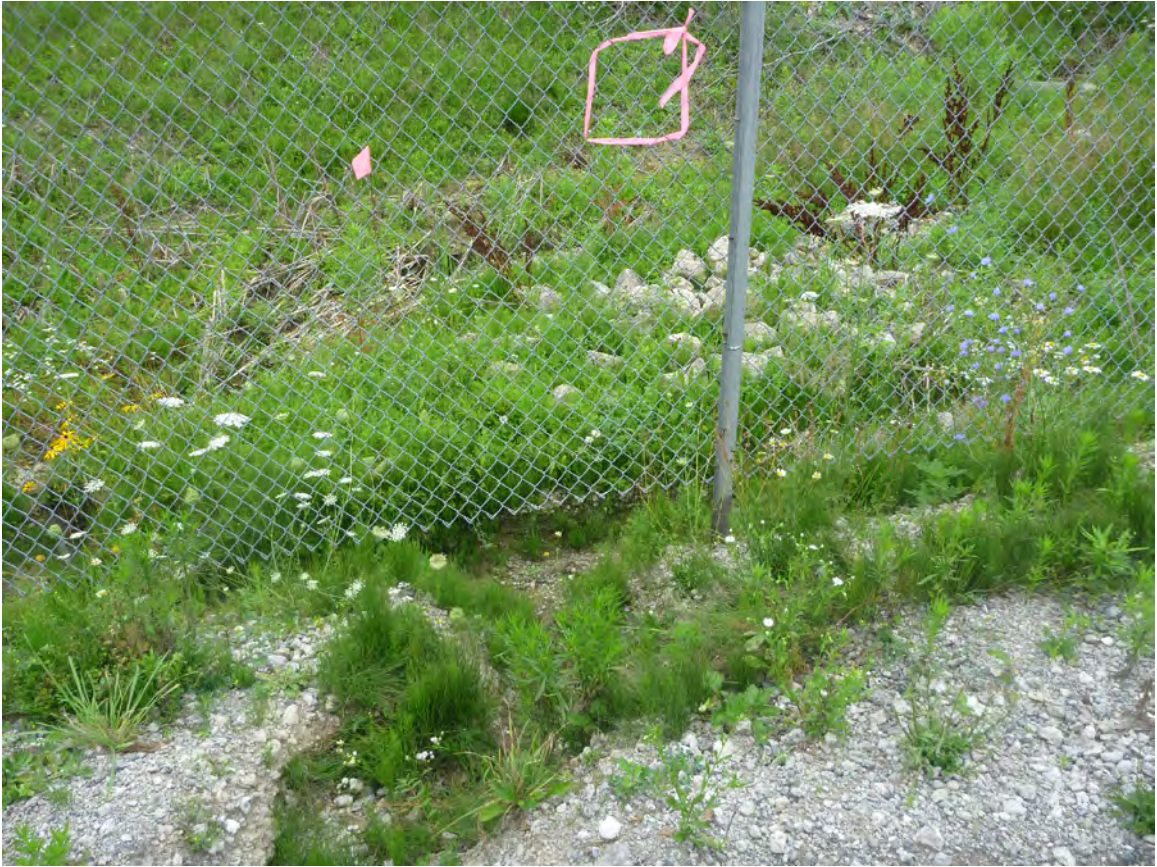
PHOTO SE5 discovered 04/22/2014

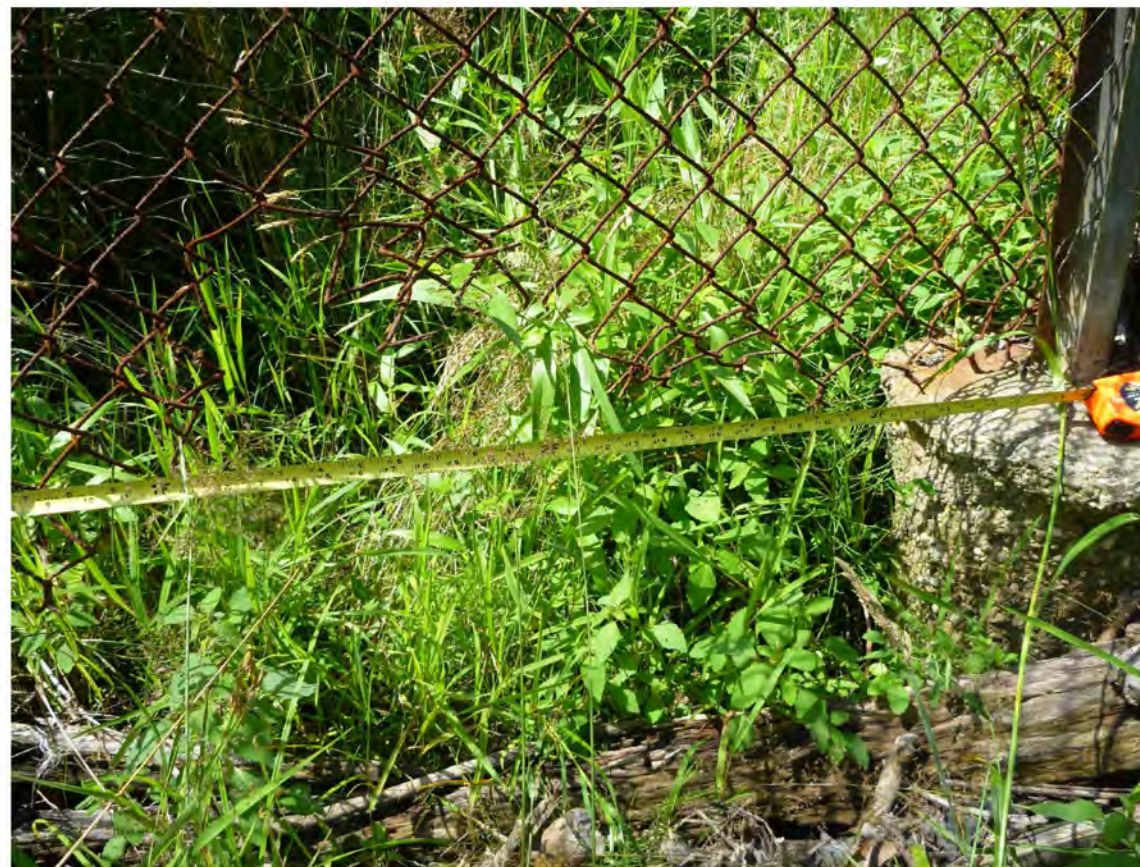
PHOTO SW1 discovered 02/07/2013

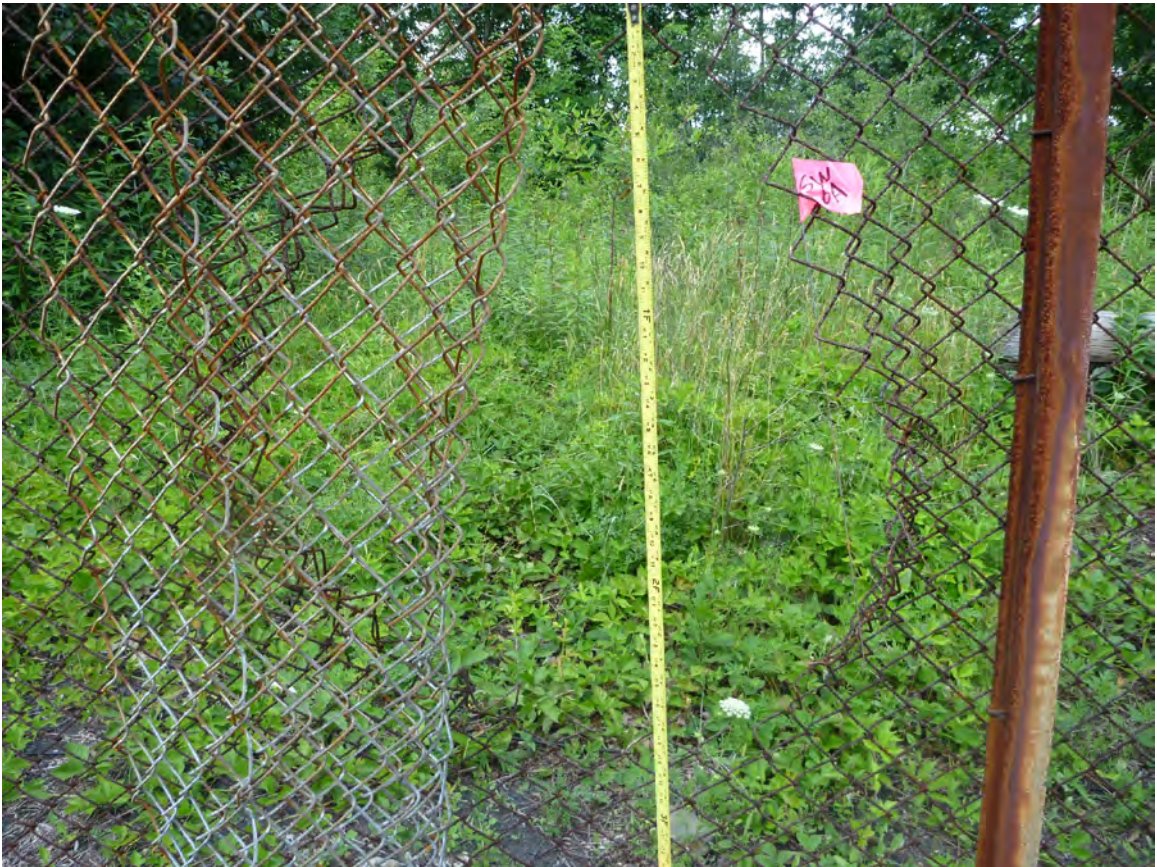
PHOTO SW6A discovered 07/16/2014

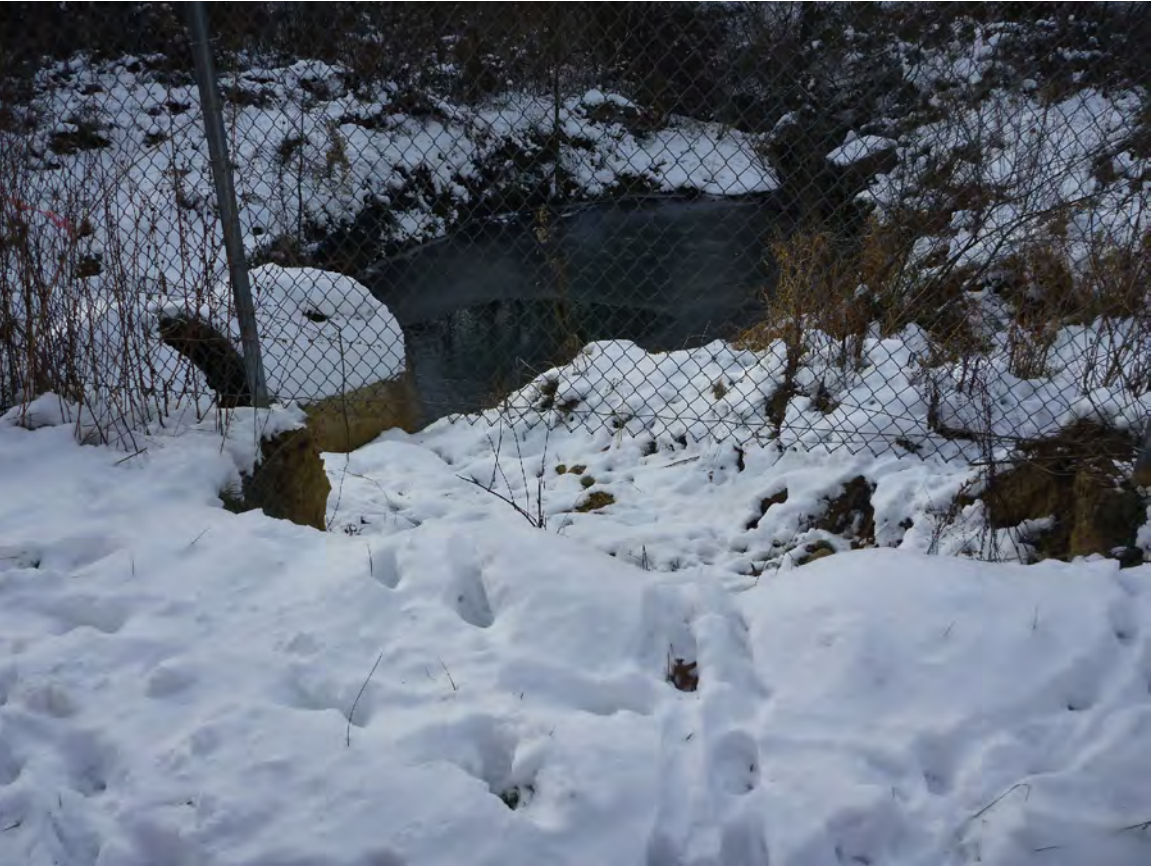
PHOTO SW12 discovered 11/18/2013

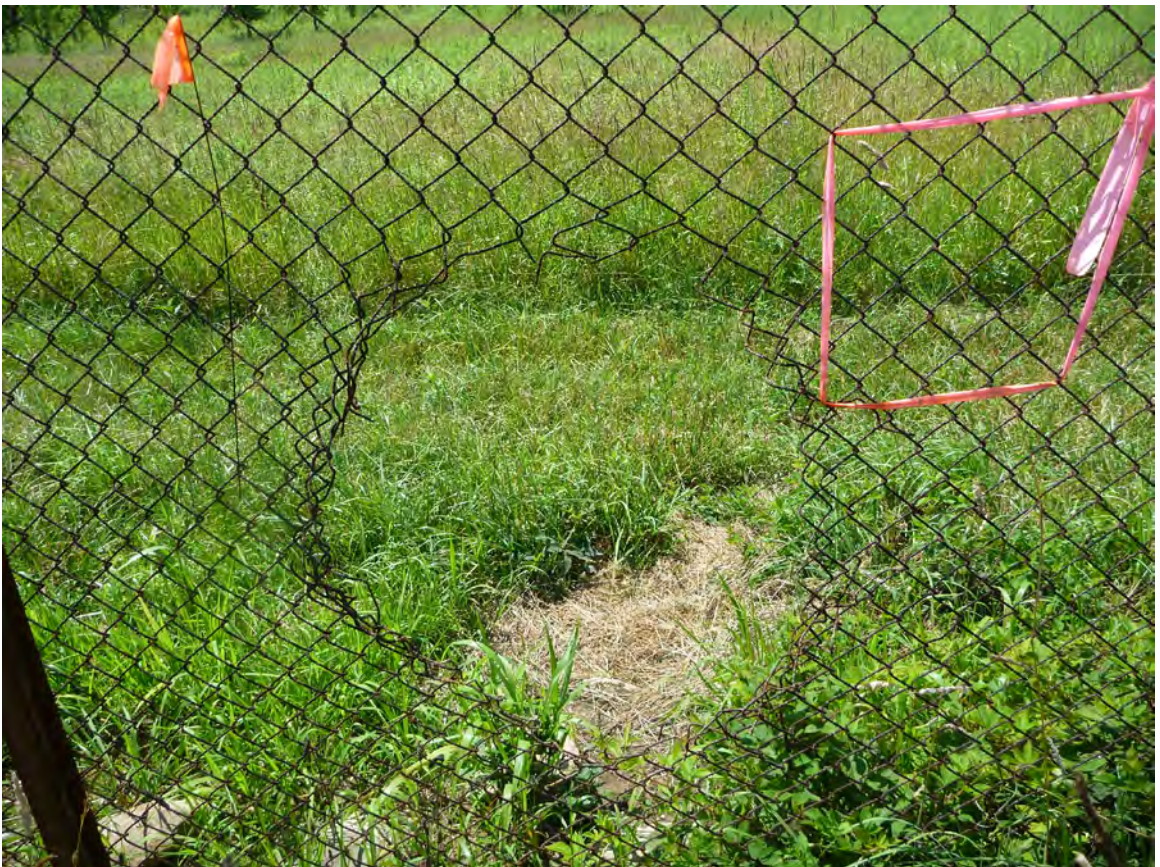
PHOTO SW14 discovered 04/14/2014

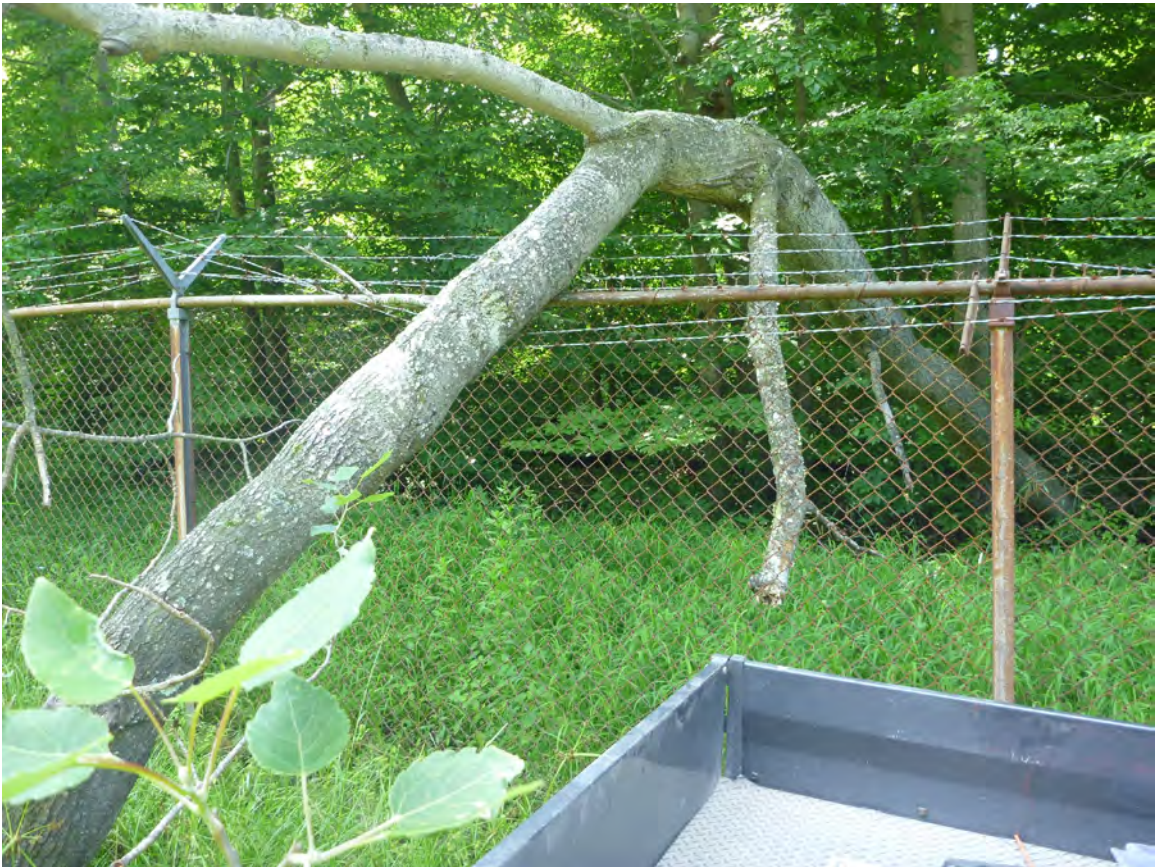
PHOTO SW15 discovered 07/15/2014

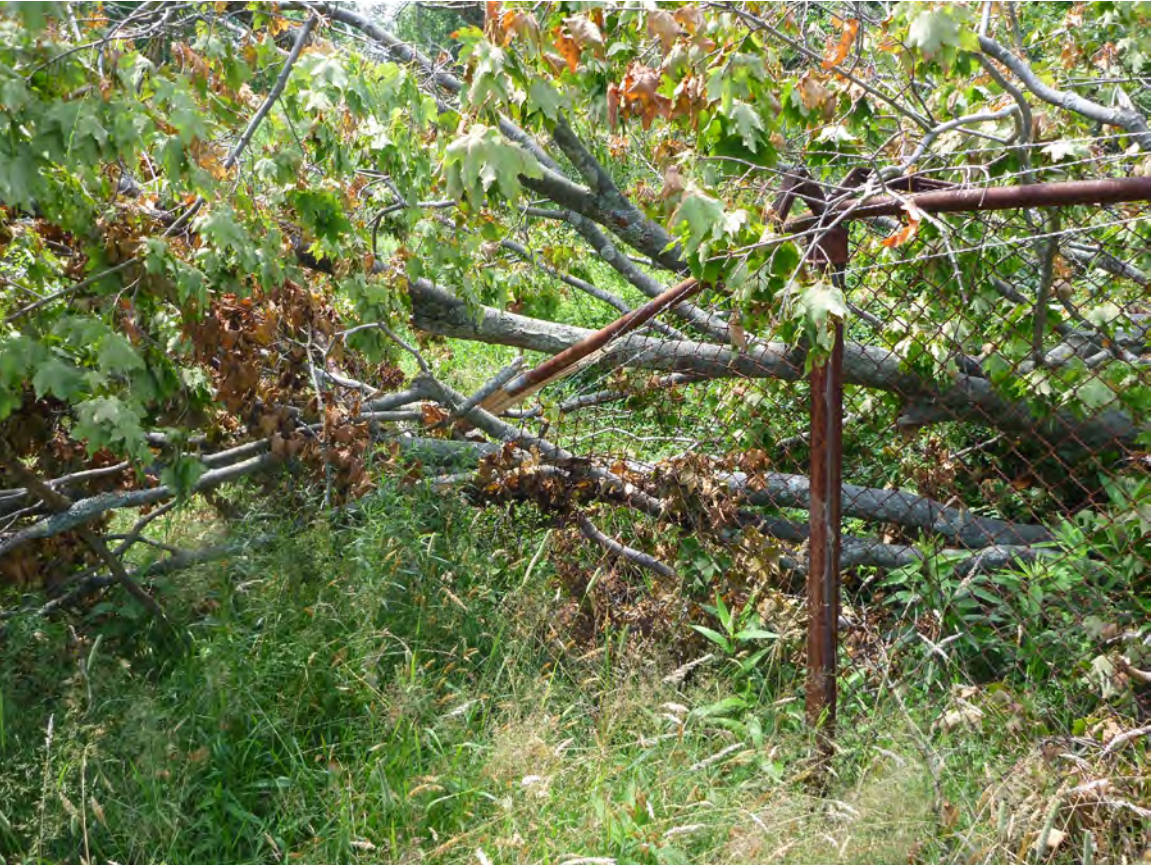
PHOTO SW16 discovered 07/15/2014

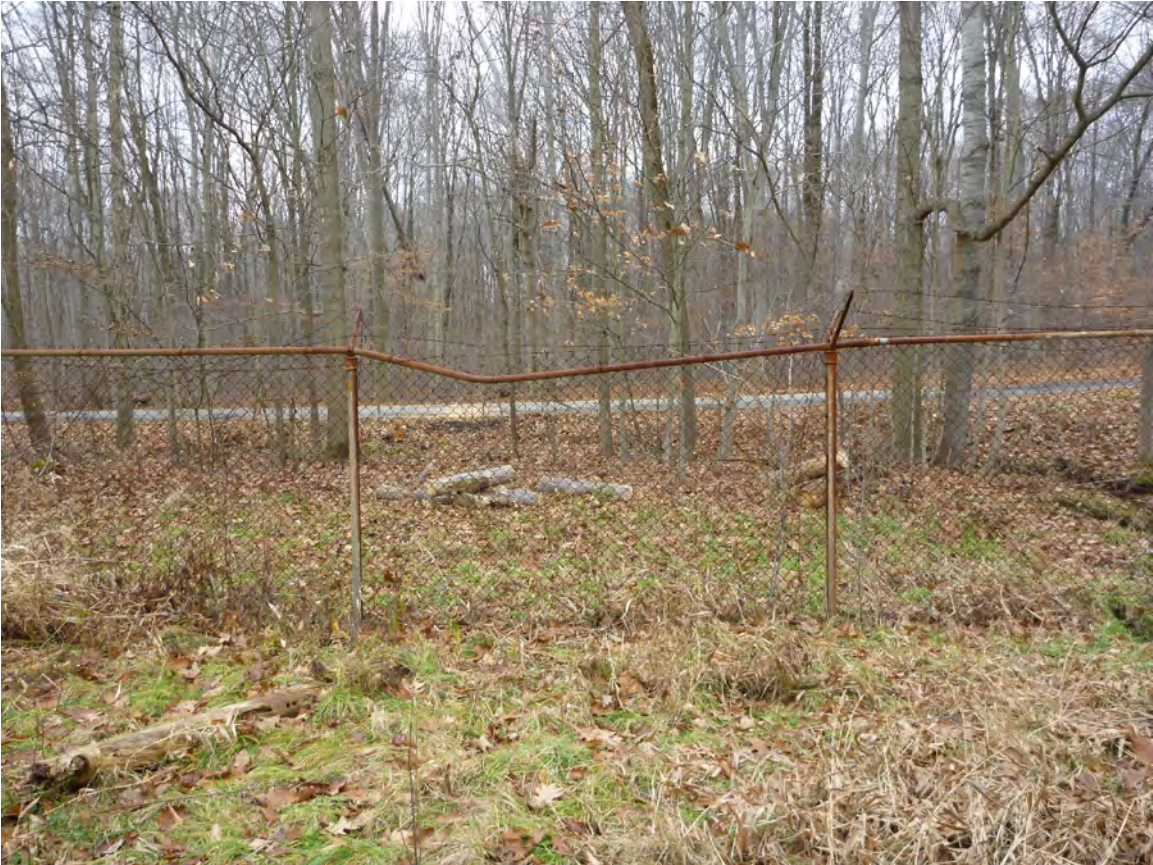
PHOTO SW17 repaired 11/25/2014

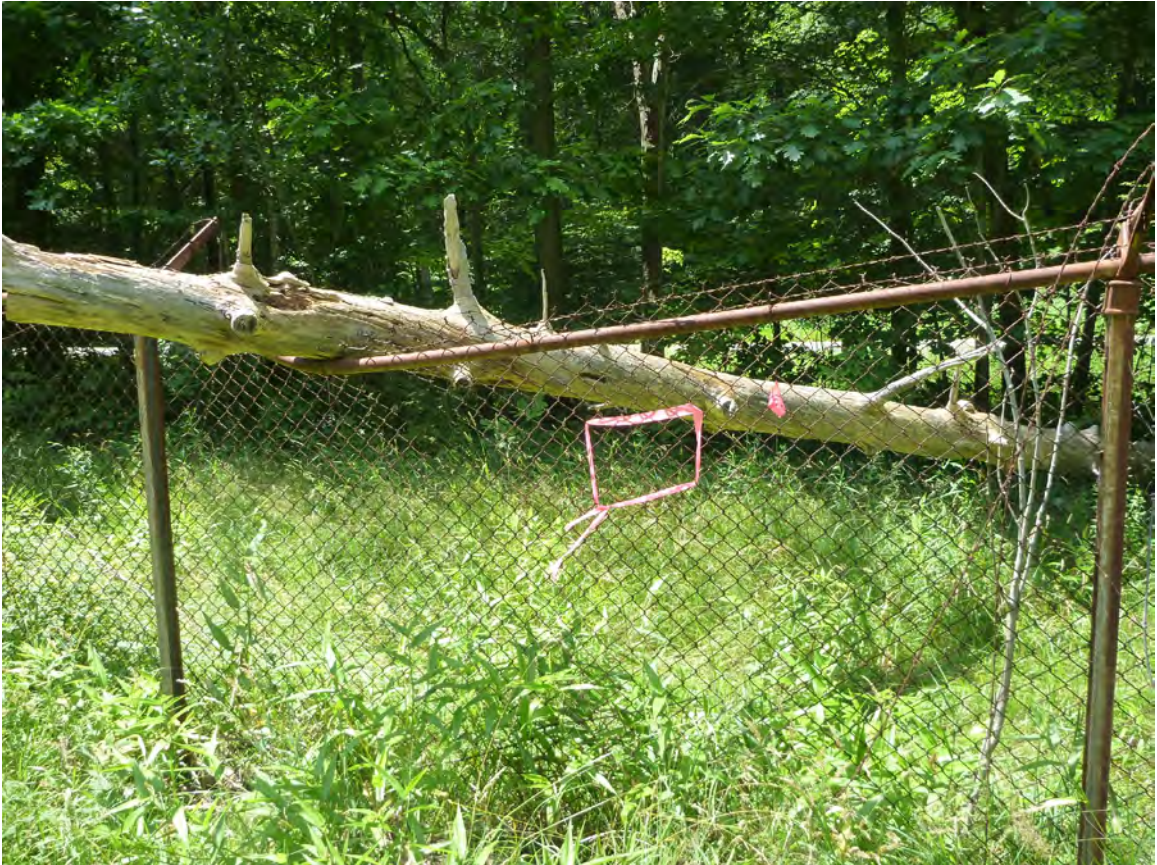
PHOTO SW17 discovered 07/15/2014
