Final
2015 Annual Land Use Control Monitoring Report,
RVAAP-01 Ramsdell Quarry Landfill
and
RVAAP-05 Winklepeck Burning Grounds

Camp Ravenna Joint Military Training Center
Former Ravenna Army Ammunition Plant
Portage and Trumbull Counties, Ohio

Contract No. W912QR-13-C-0031

January 27, 2016

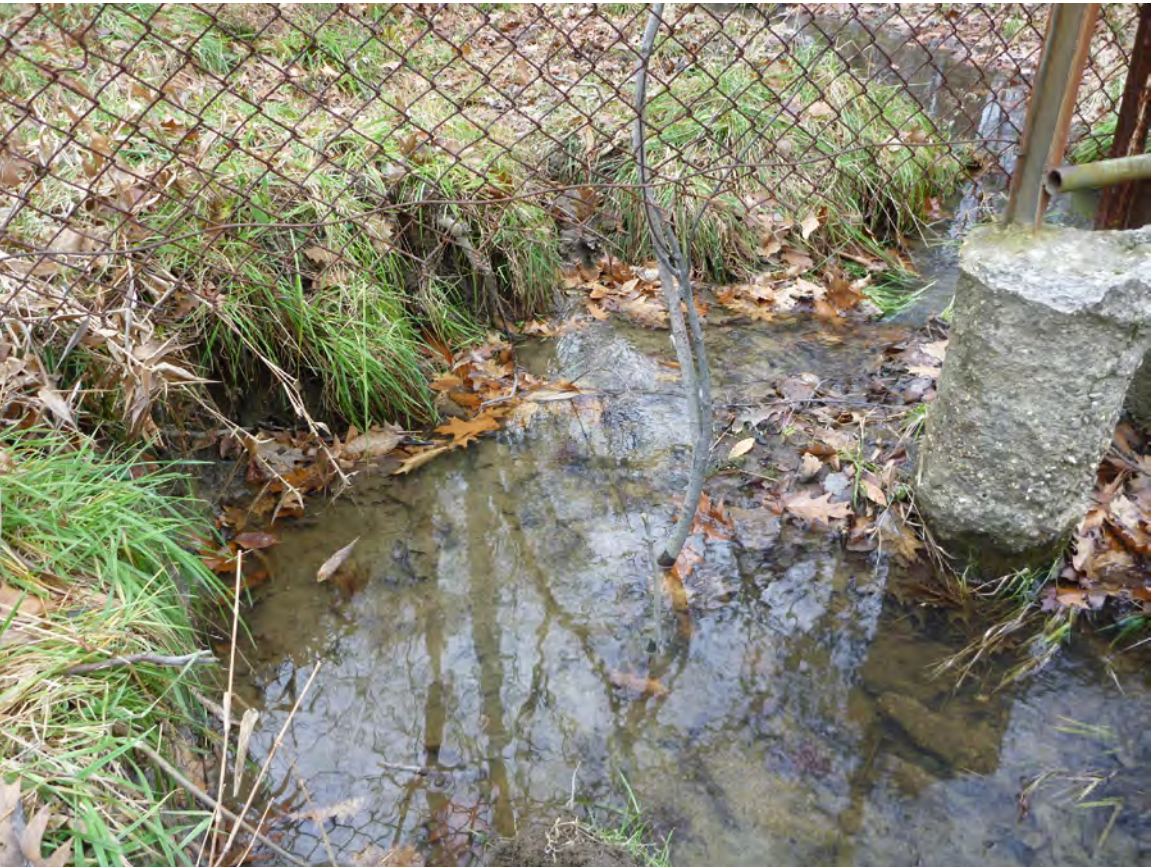
PHOTO SW18 discovered 07/15/2014

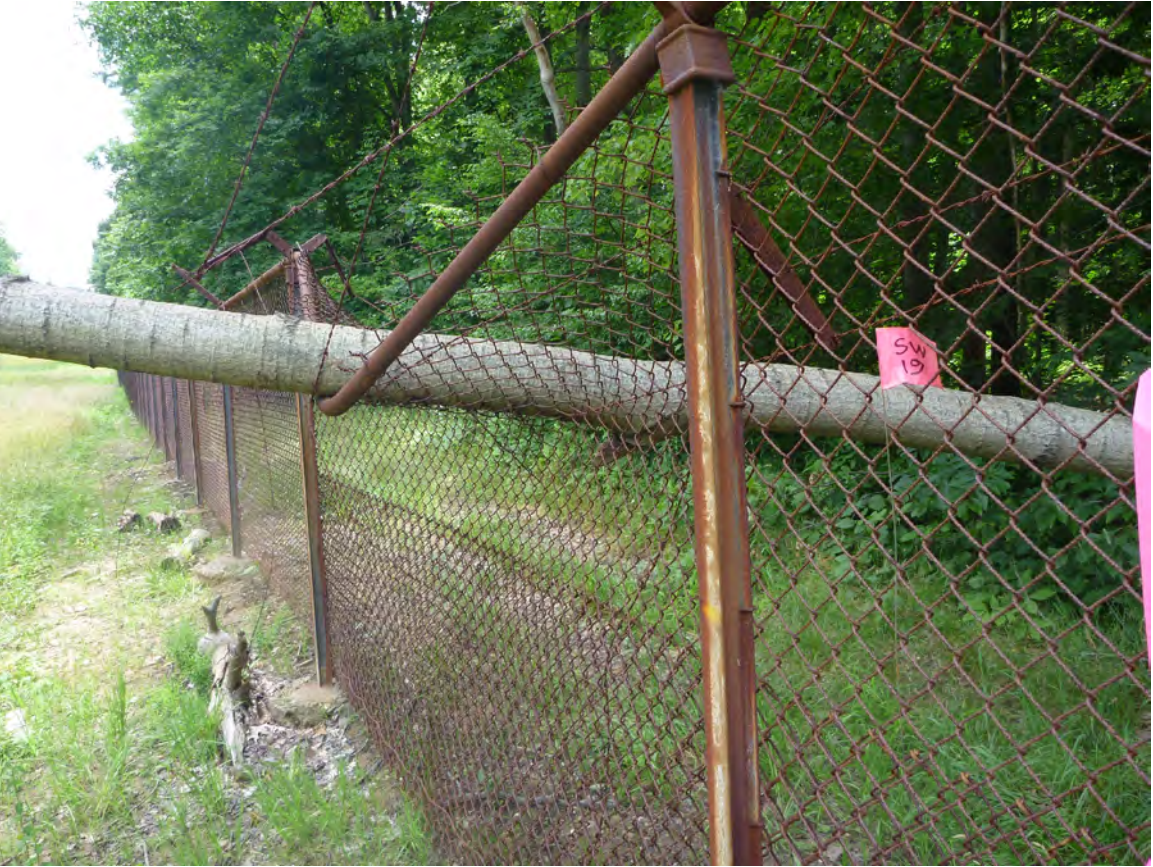
PHOTO SW19 discovered 07/15/2014

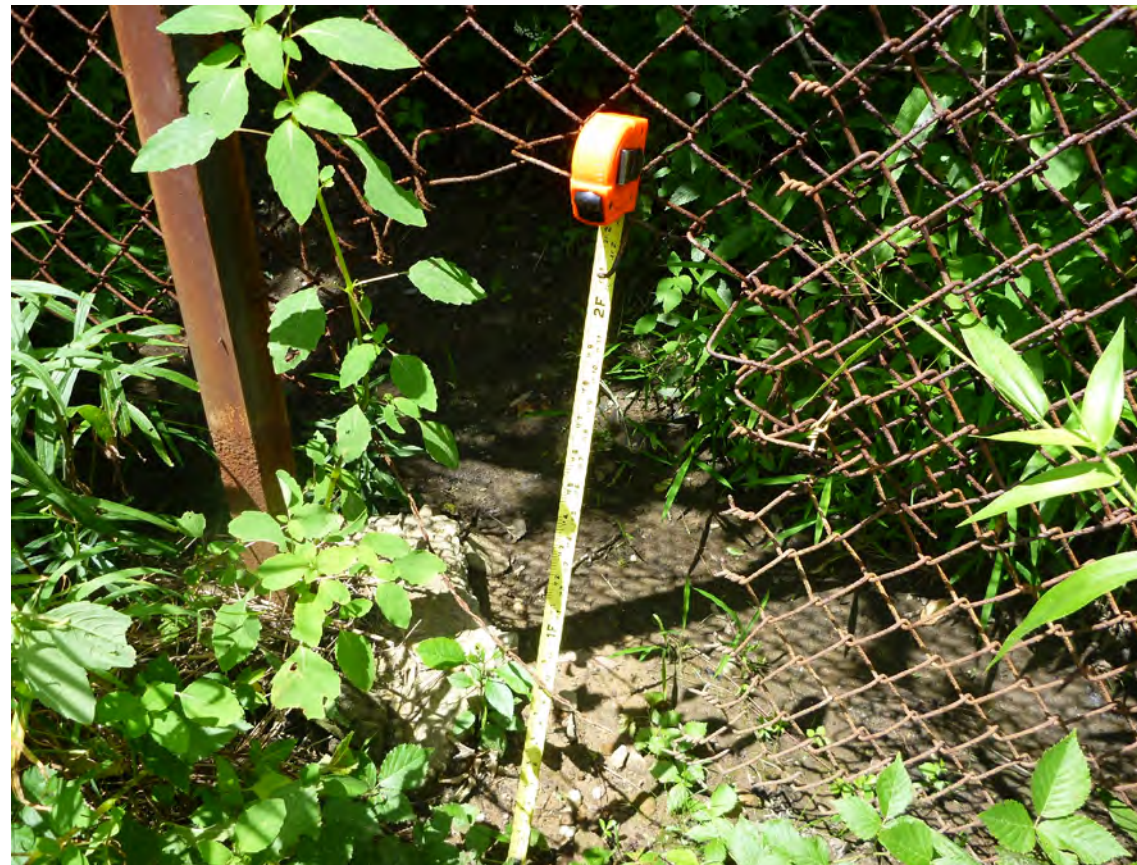
PHOTO SW20 discovered 07/15/2014

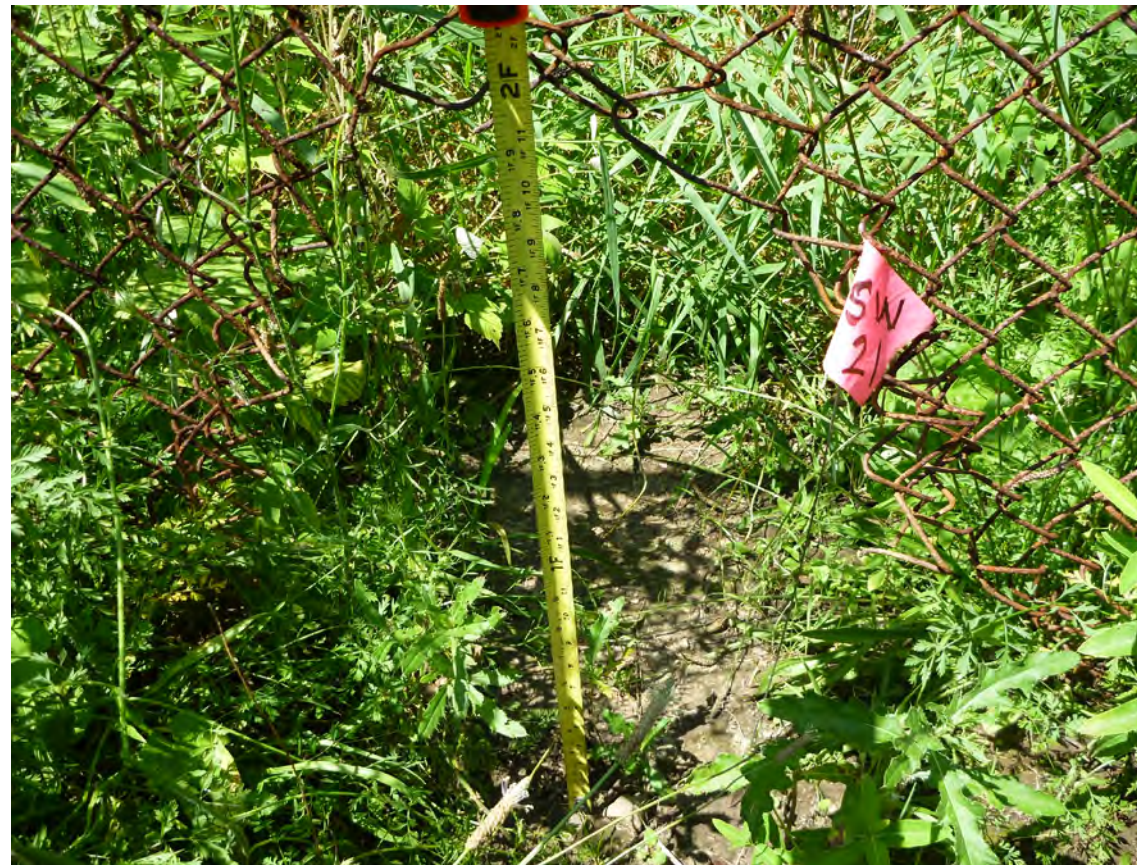
PHOTO SW21 discovered 07/15/2014

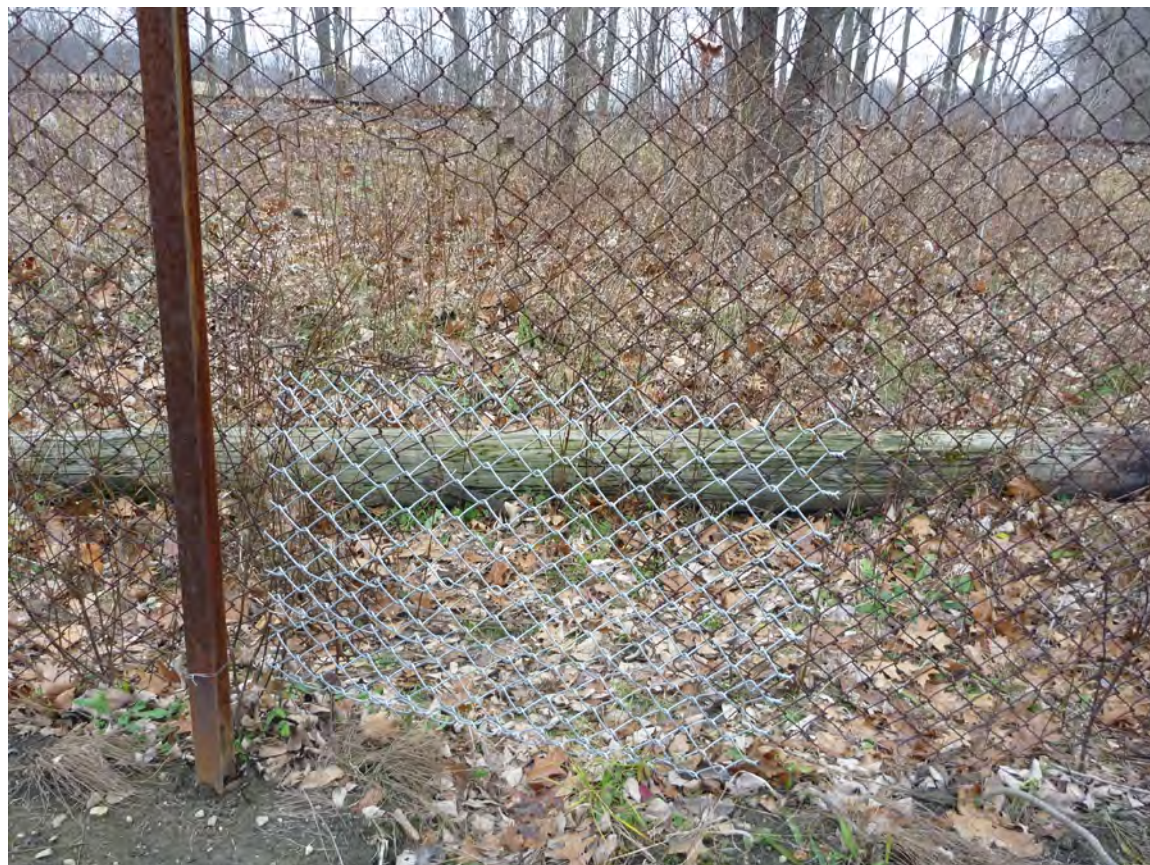
PHOTO SW22 repaired 11/25/2014

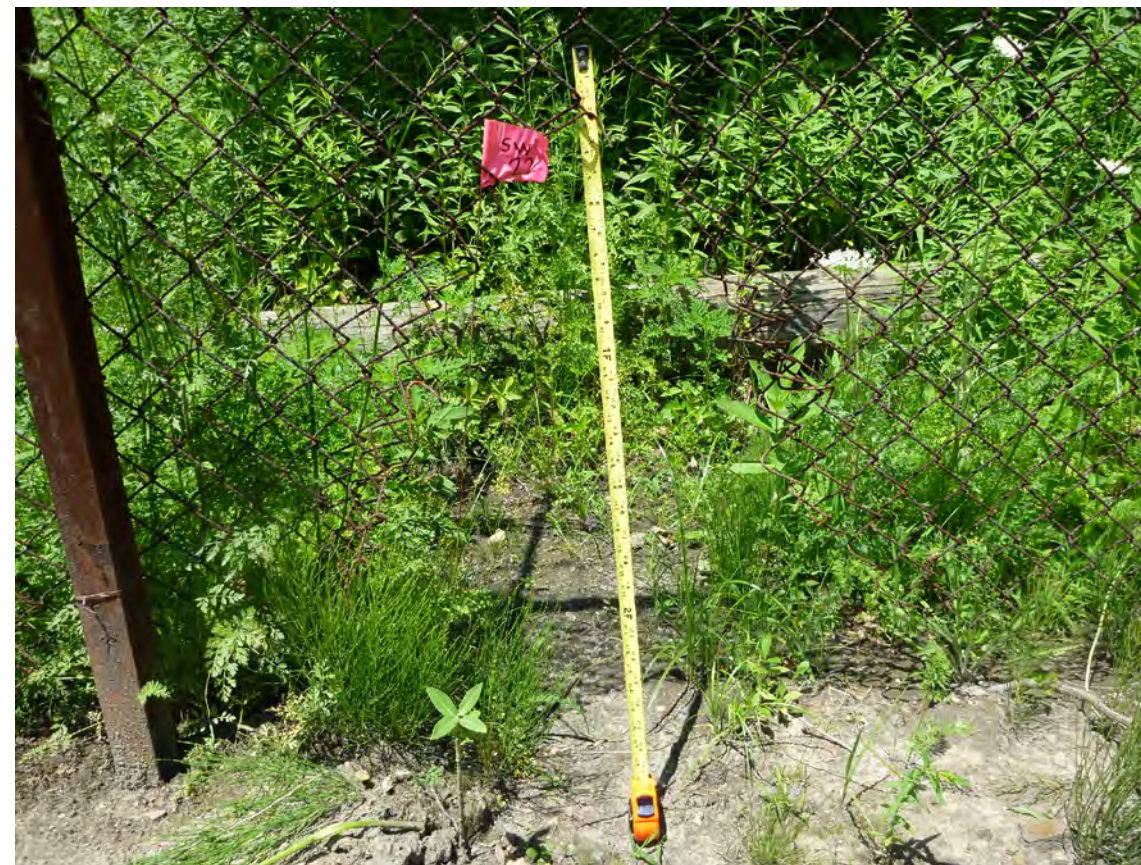
PHOTO SW22 discovered 07/16/2014

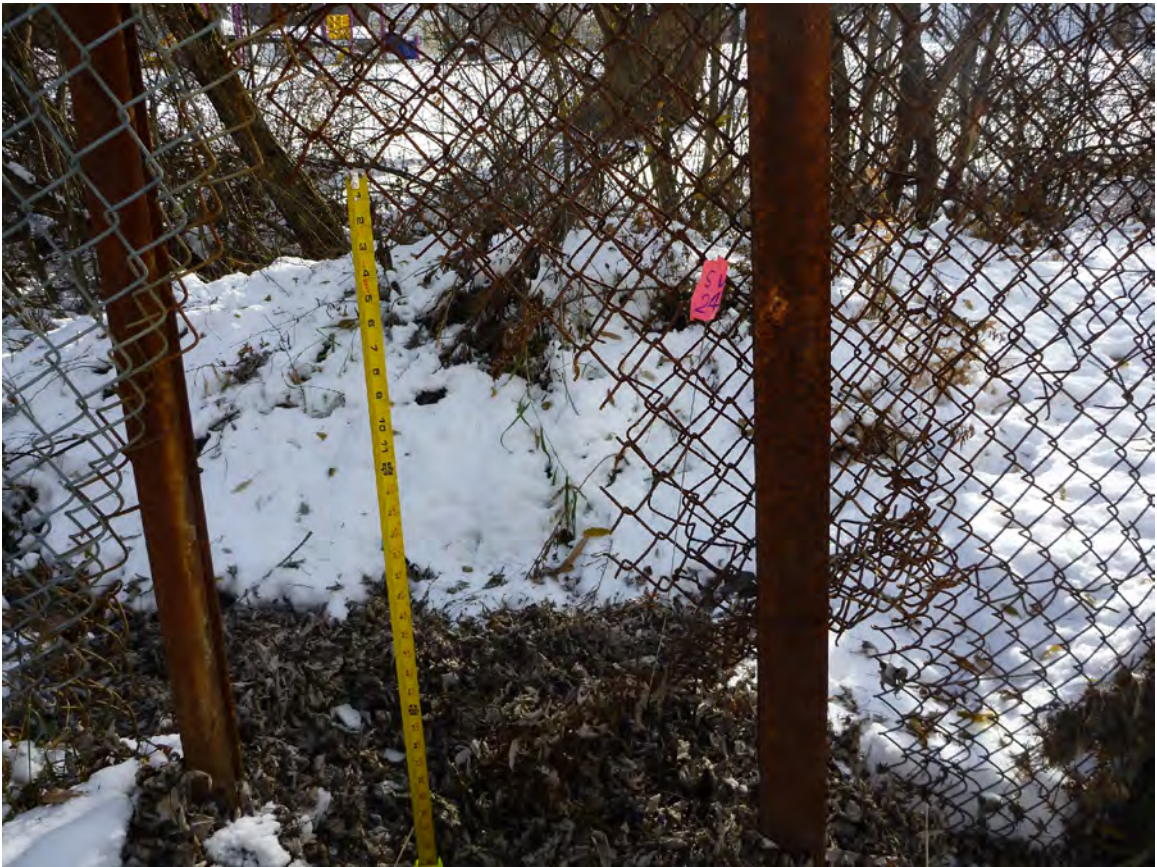
PHOTO SW24 discovered 11/20/2014

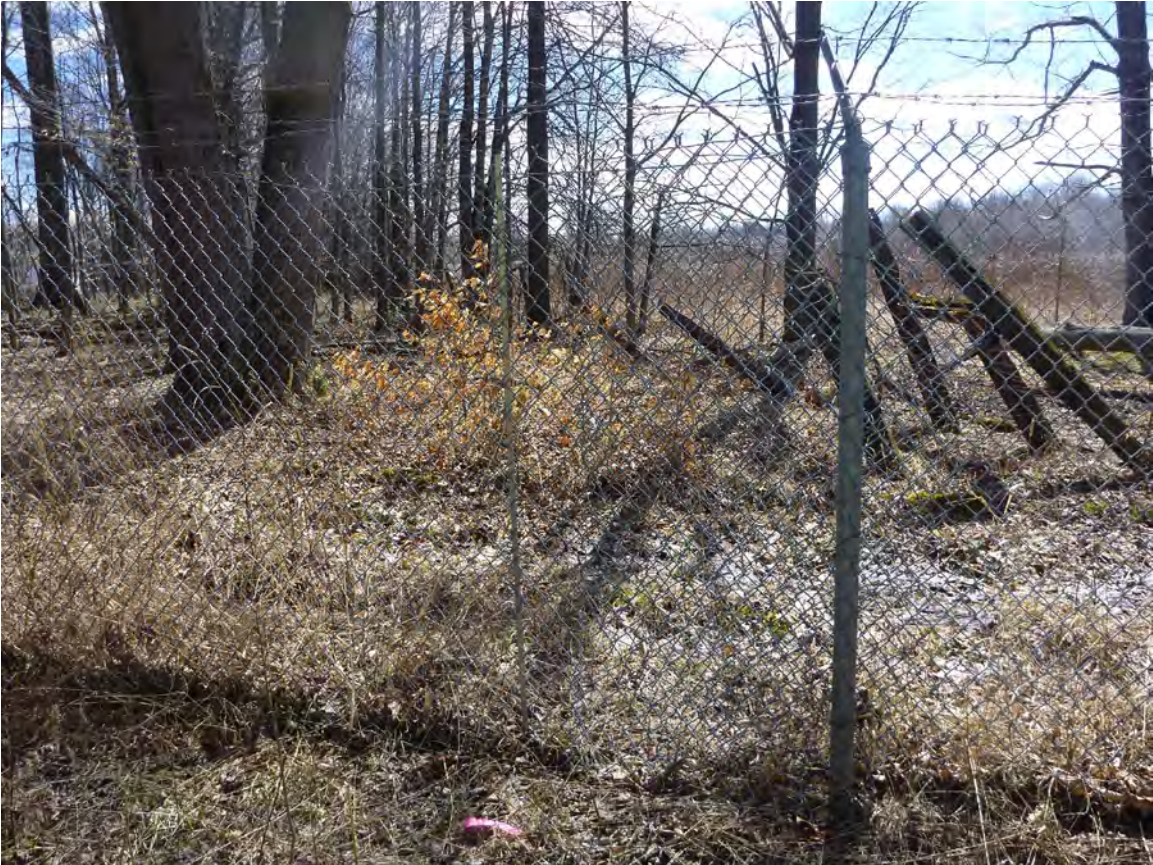
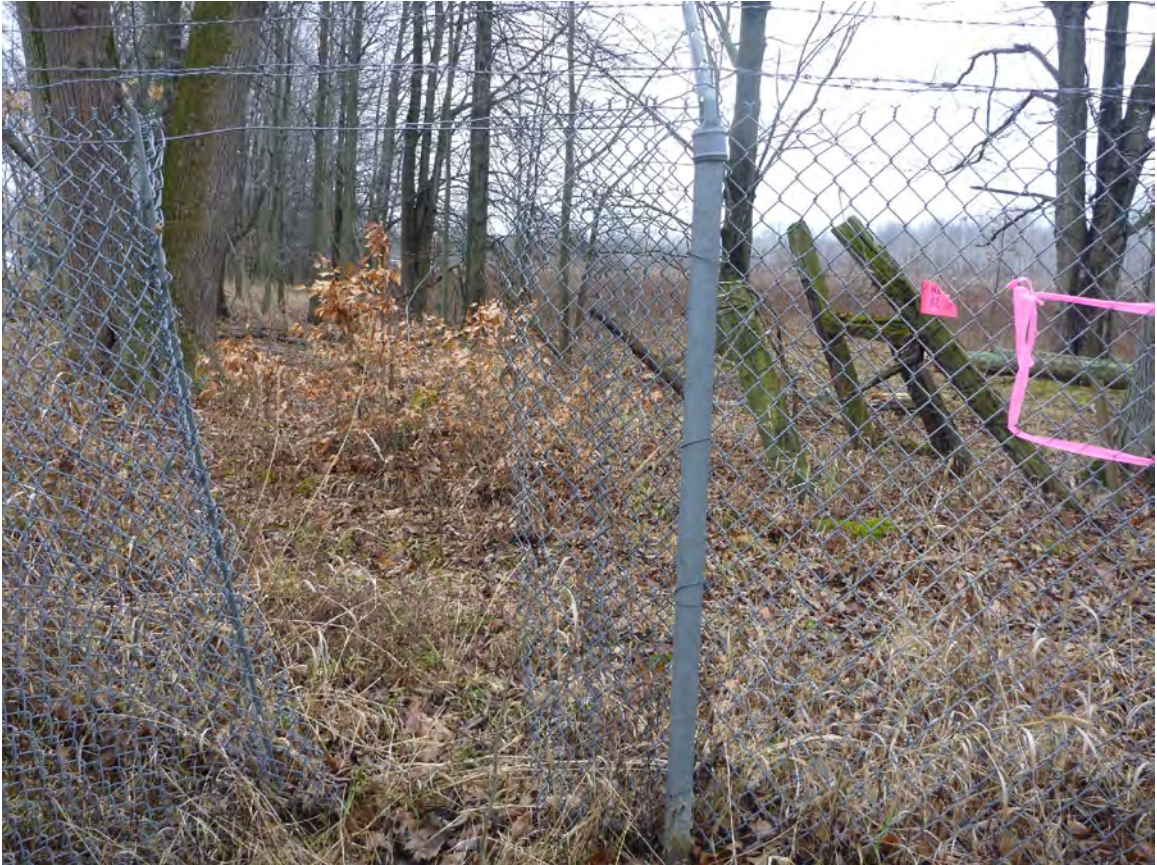
DETAIL SHEET FOR NE15A

PHOTO NE15A as observed on 03/30/2015

PHOTO NE15A discovered 12/15/2014

As observed during the second quarter LUC inspection, the following perimeter fence defects were repaired: NW11, NE15A, NE33, SE02, SW12 and SW24. Additionally, the following areas were reported to have been repaired on March 25, 2015 after the damaged areas had been inspected: NW12, SW22, NE34, NE35, SW6B, NW1A, and NW10A.

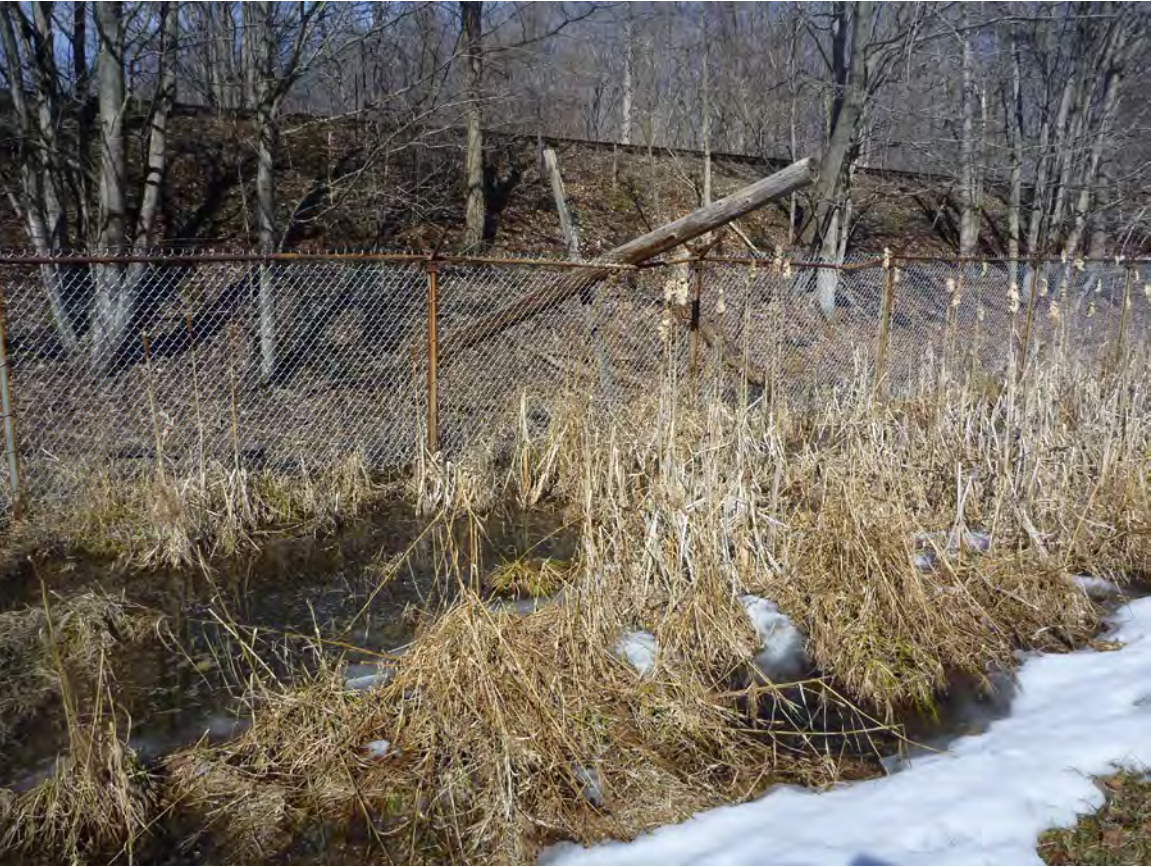
DETAIL SHEET FOR NE31

PHOTO NE31 discovered 12/03/2014

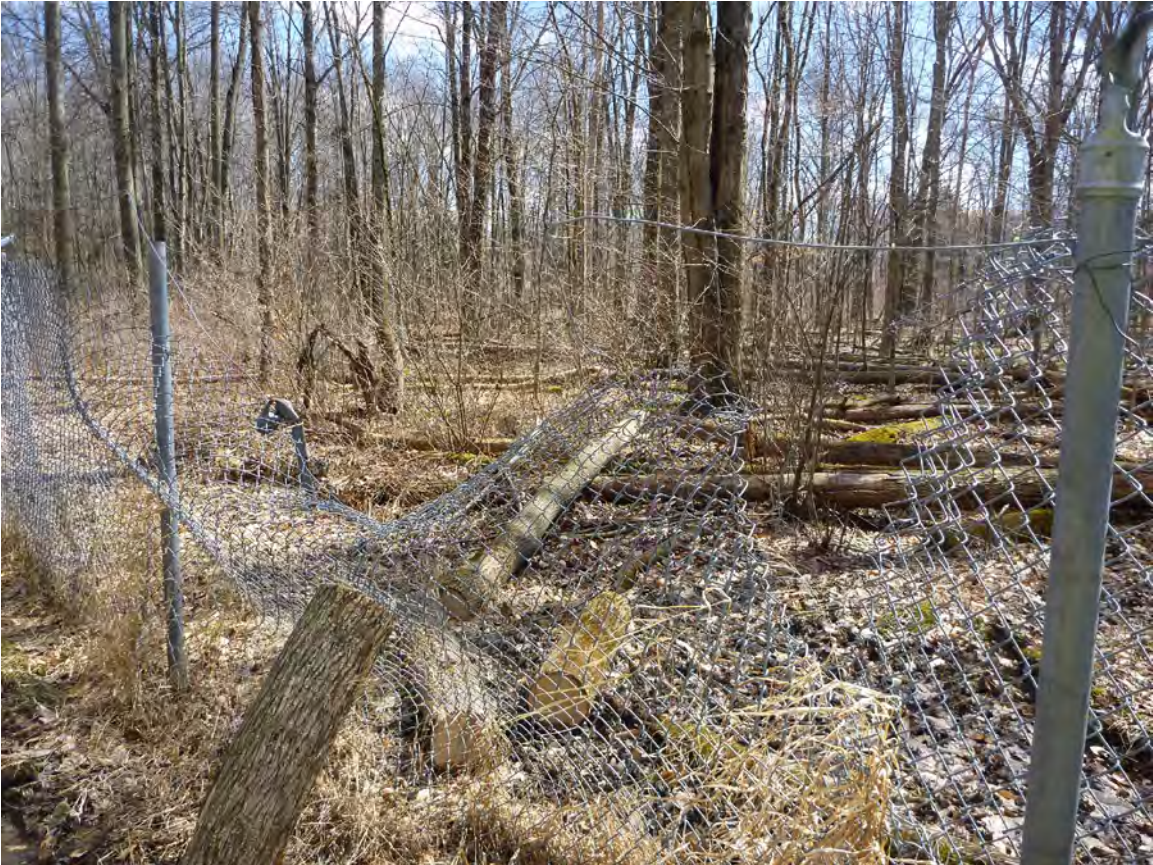
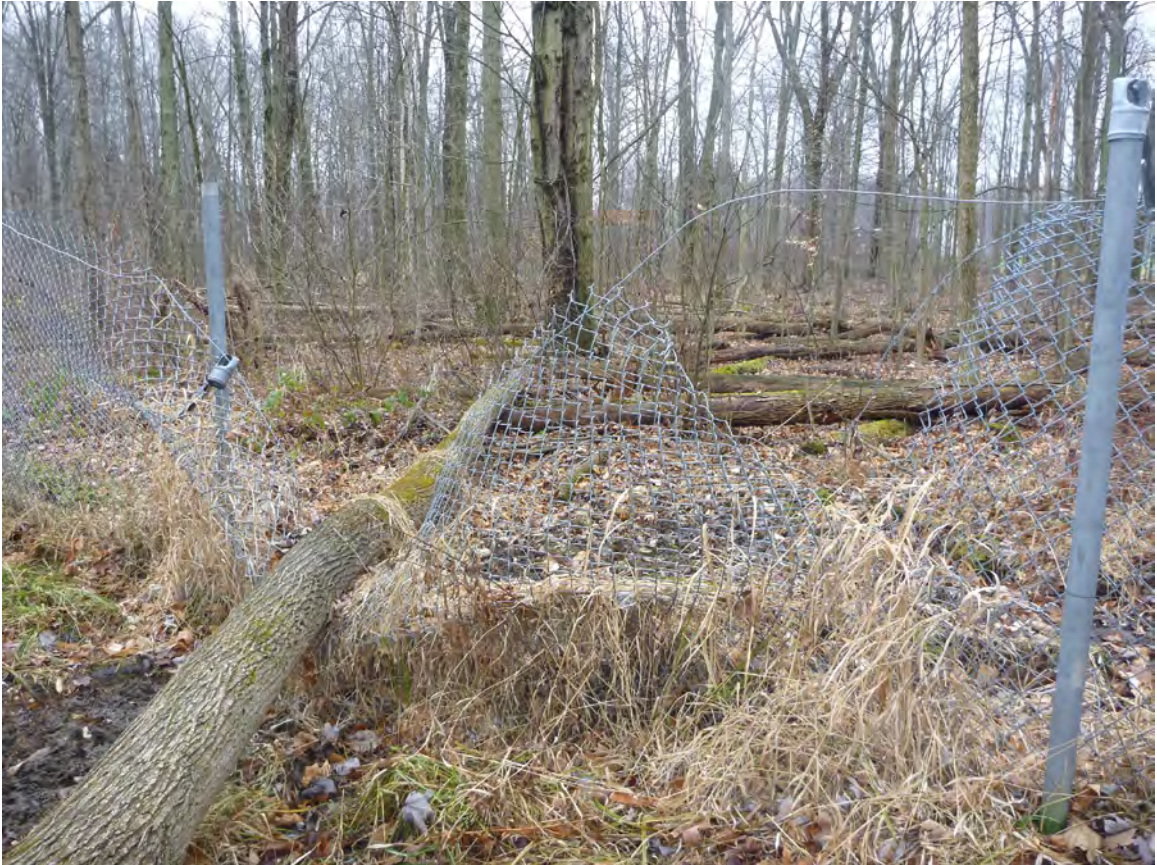
PHOTO NE32 as observed on 03/30/2015

PHOTO NE32 discovered 12/15/2014

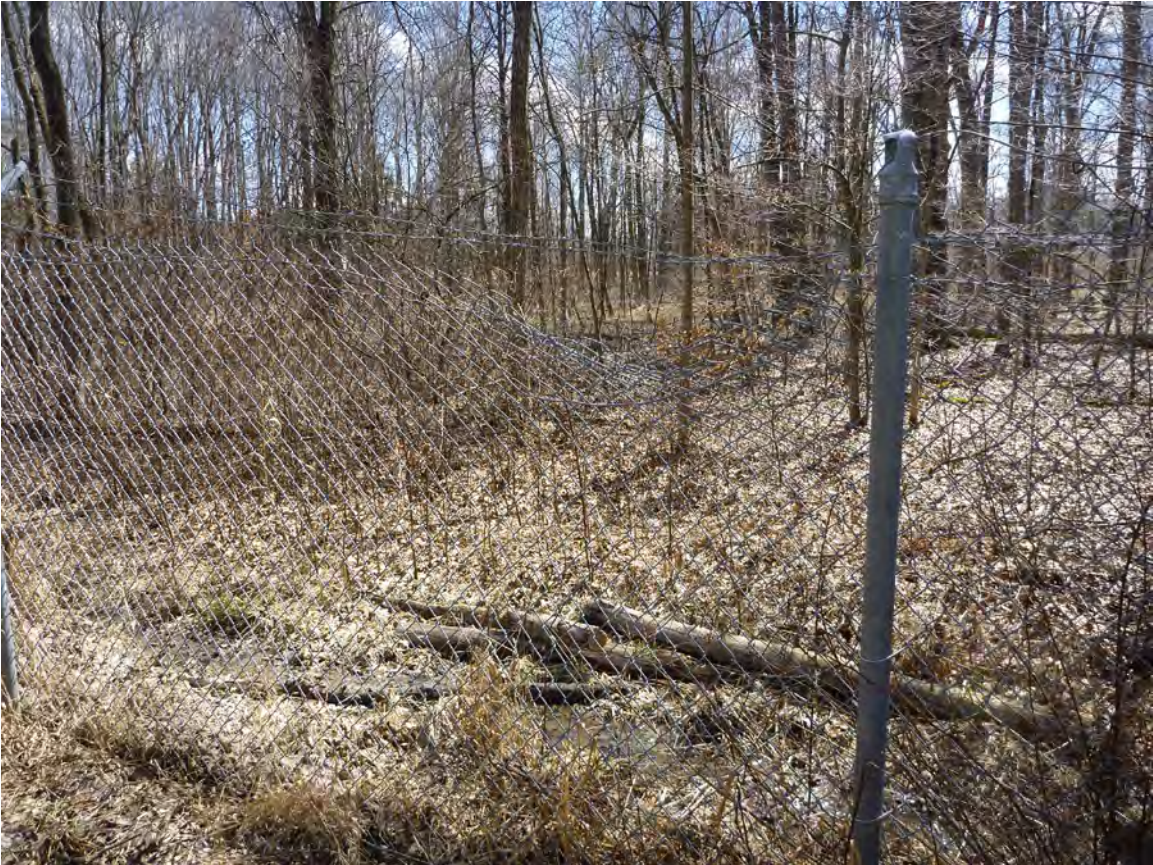
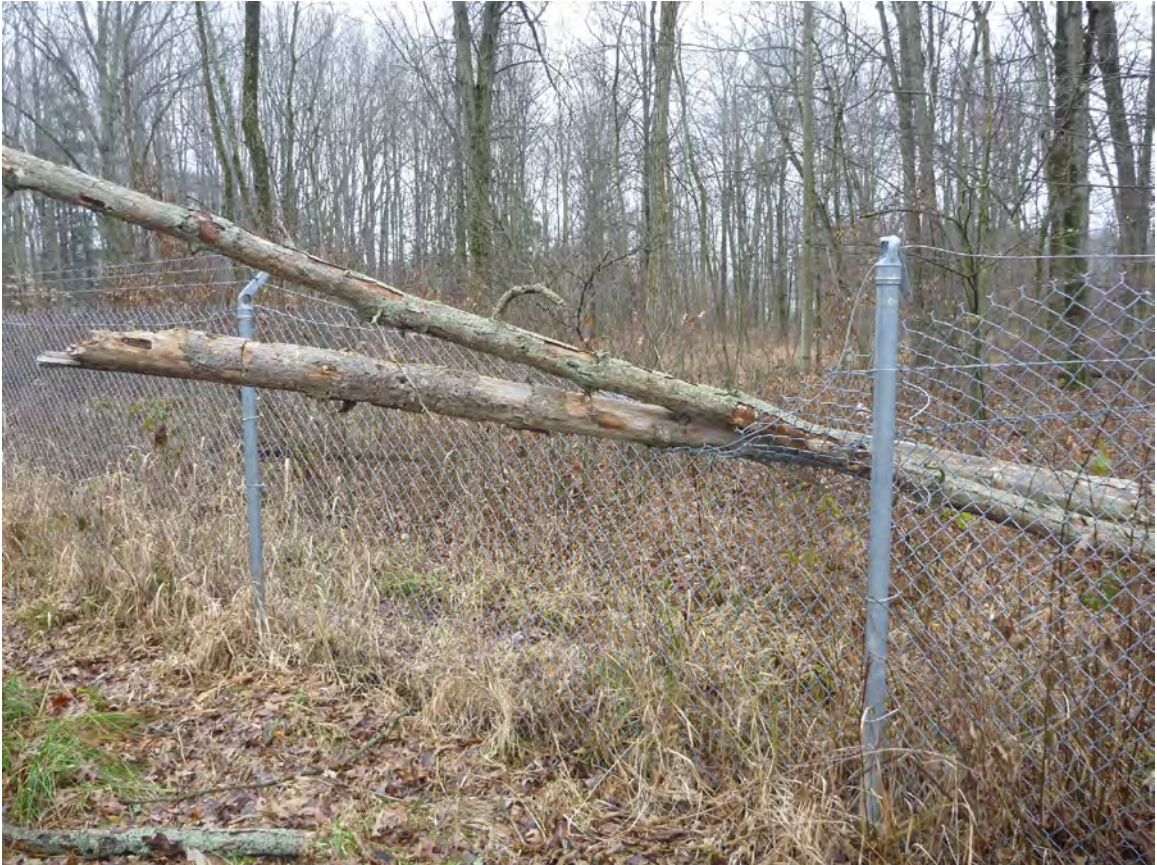
DETAIL SHEET FOR NE33

PHOTO NE33 as observed on 03/30/2015

PHOTO NE33 discovered 12/15/2014

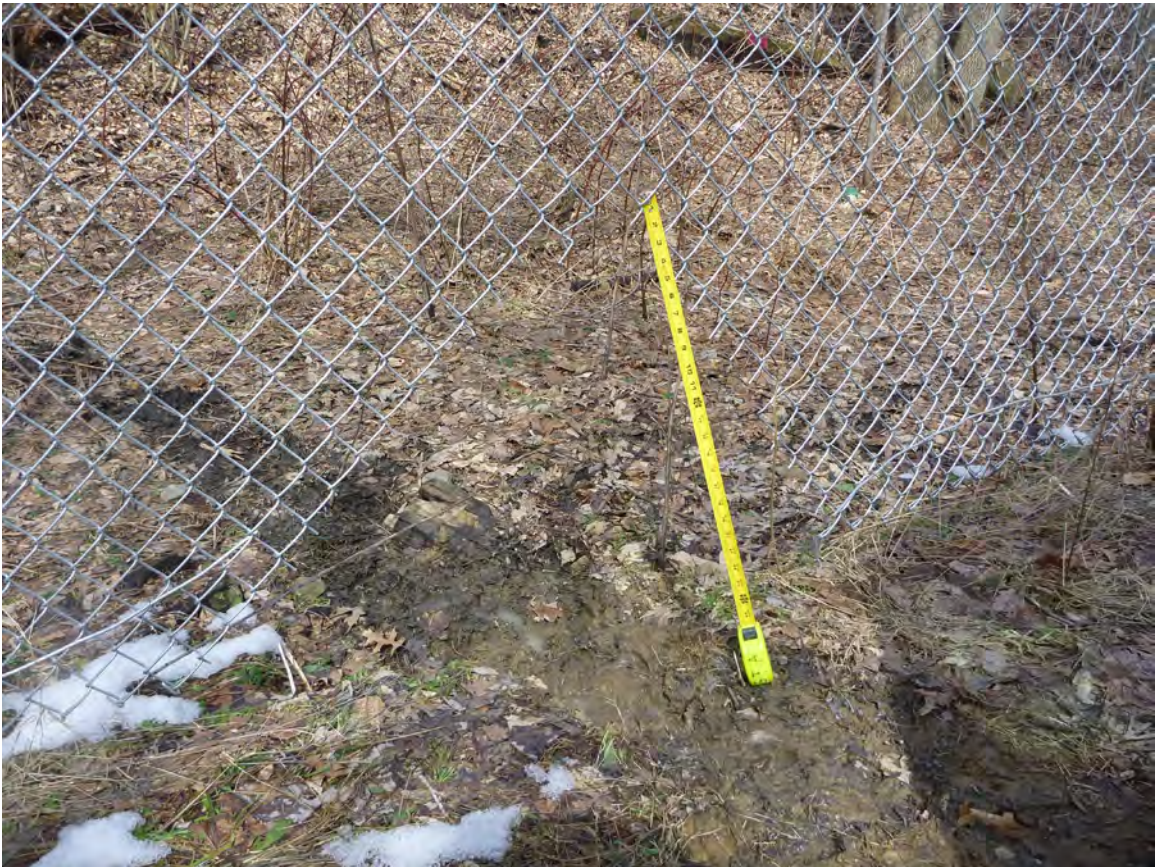
DETAIL SHEET FOR NE34

PHOTO NE34 discovered 03/19/2015

NOTE: Repairs to this callout were completed on March 25, 2015. A photograph of this repair will be presented in the FY 2015 3rd Quarter LUC Inspection Report.

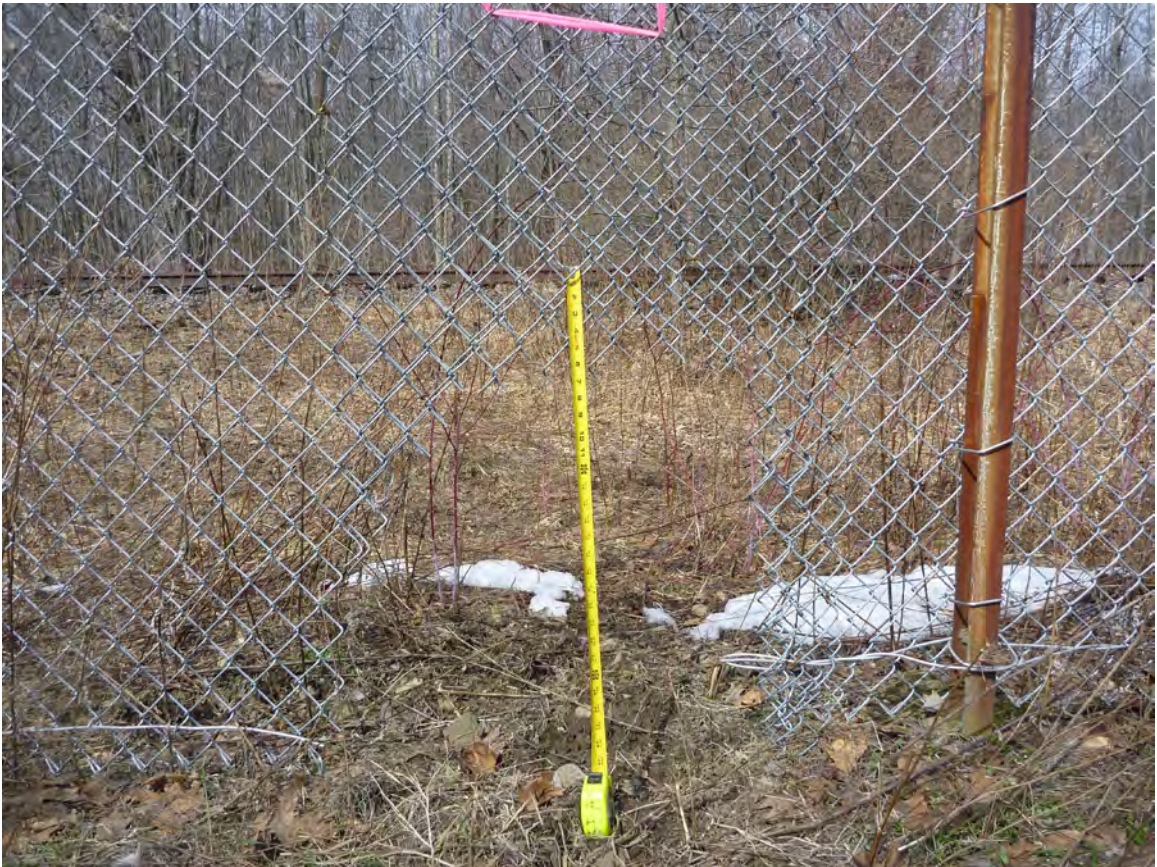
DETAIL SHEET FOR NE35

PHOTO NE35 discovered 03/19/2015

NOTE: Repairs to this callout were completed on March 25, 2015. A photograph of this repair will be presented in the FY 2015 3rd Quarter LUC Inspection Report.

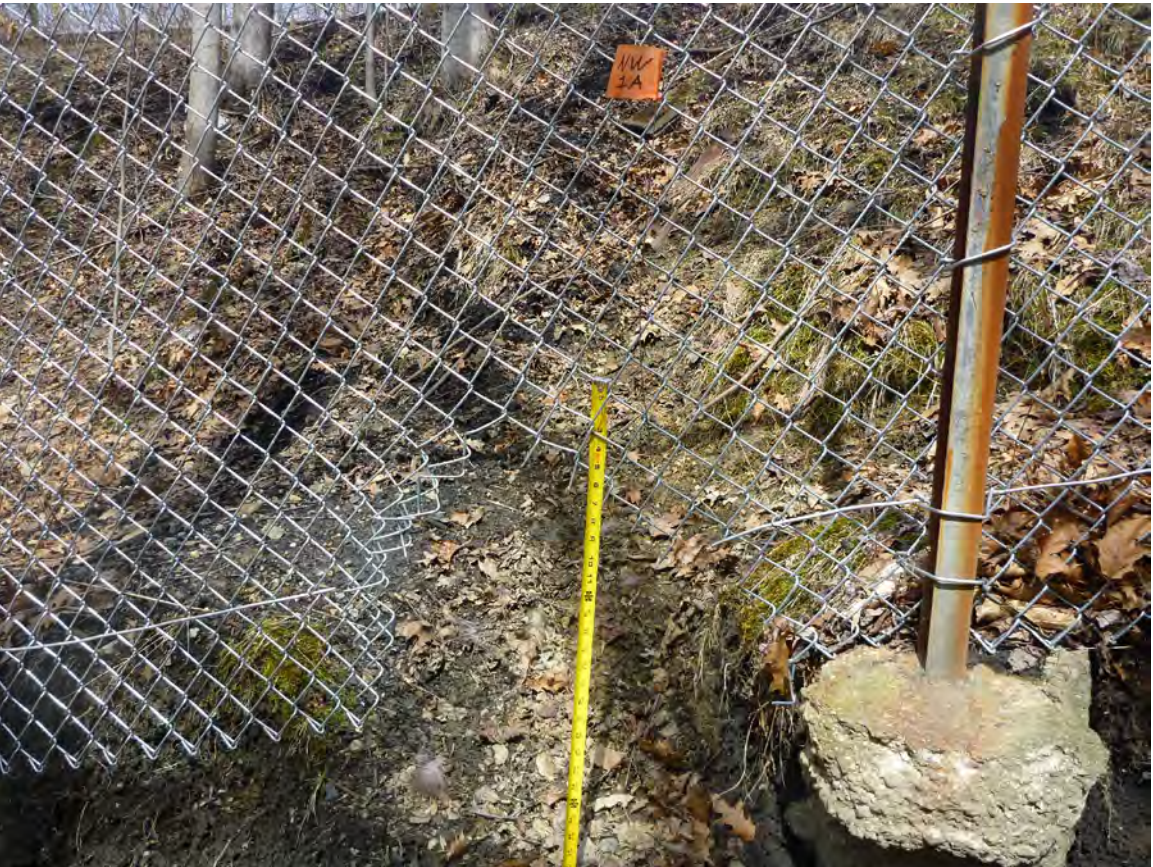
DETAIL SHEET FOR NW1A

PHOTO NW1A discovered 03/19/2015

NOTE: Repairs to this callout were completed on March 25, 2015. A photograph of this repair will be presented in the FY 2015 3rd Quarter LUC Inspection Report.

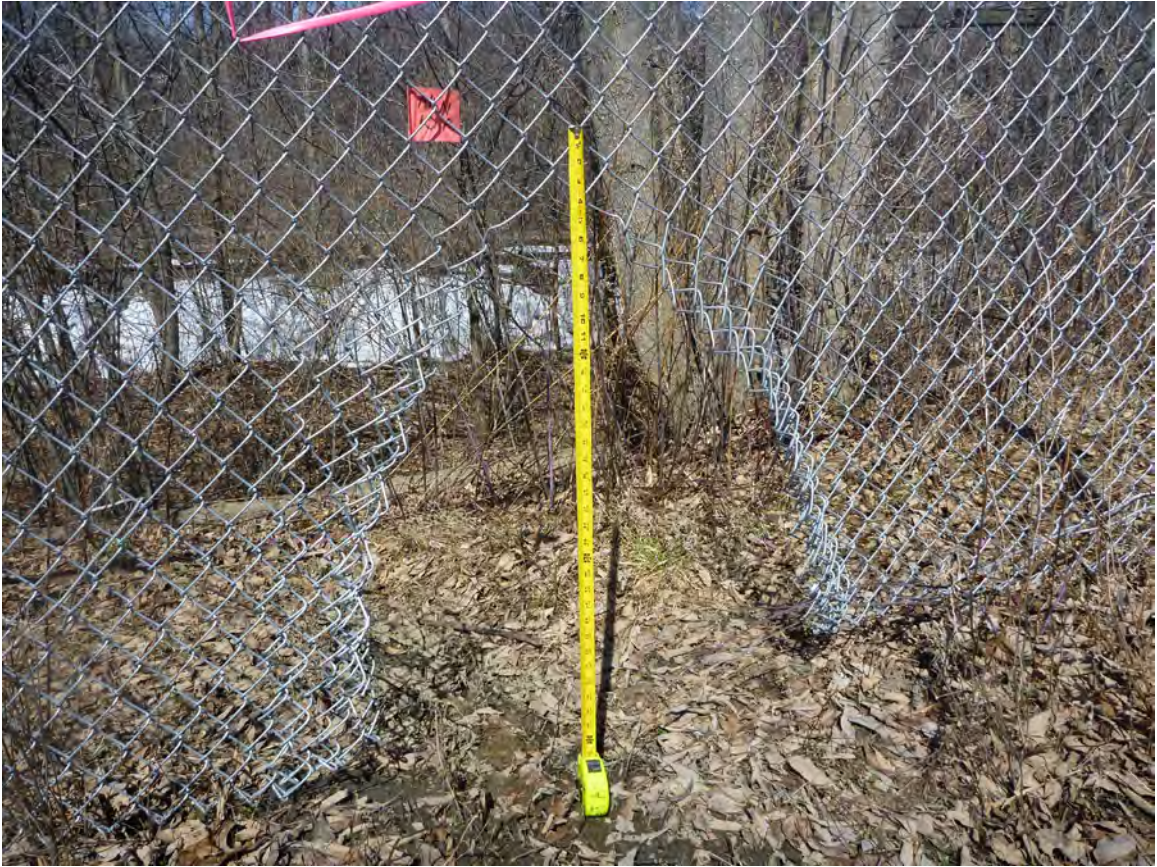
DETAIL SHEET FOR NW10A

PHOTO NW10A discovered 03/18/2015

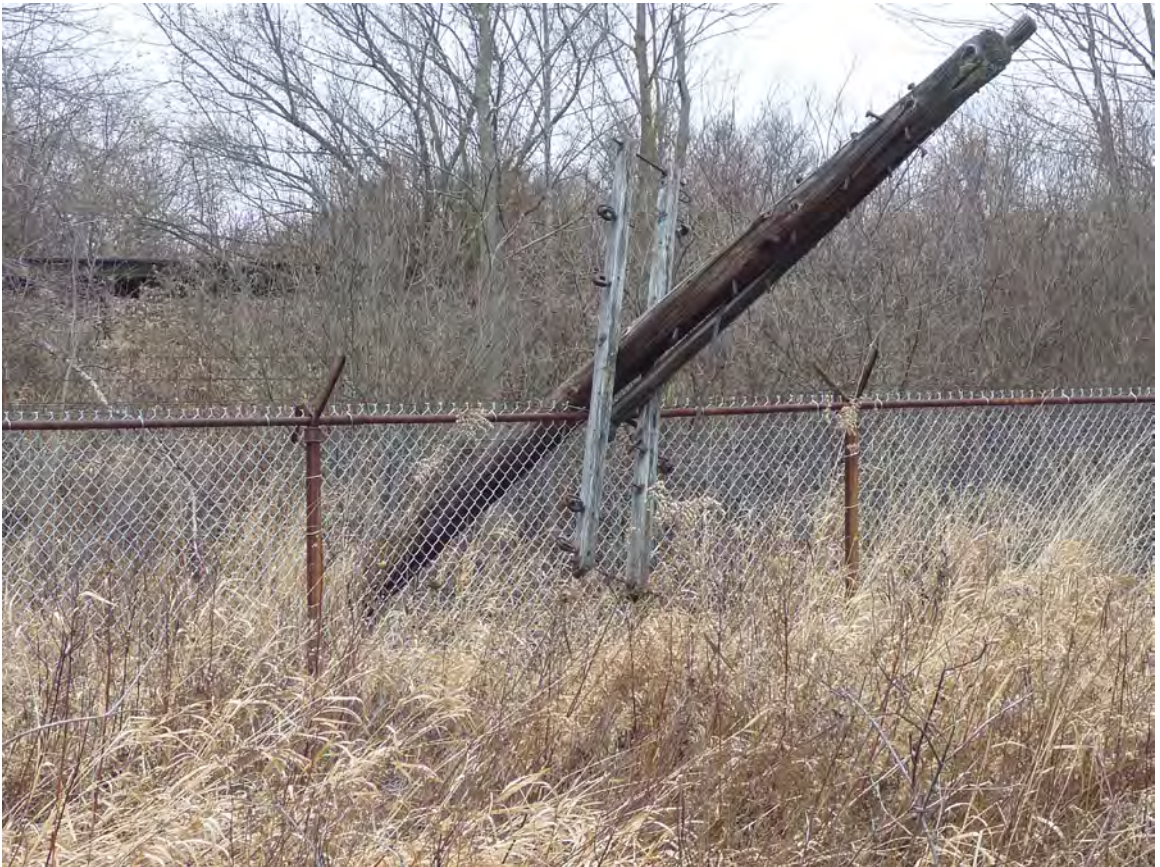
PHOTO NW11 discovered 11/26/2014

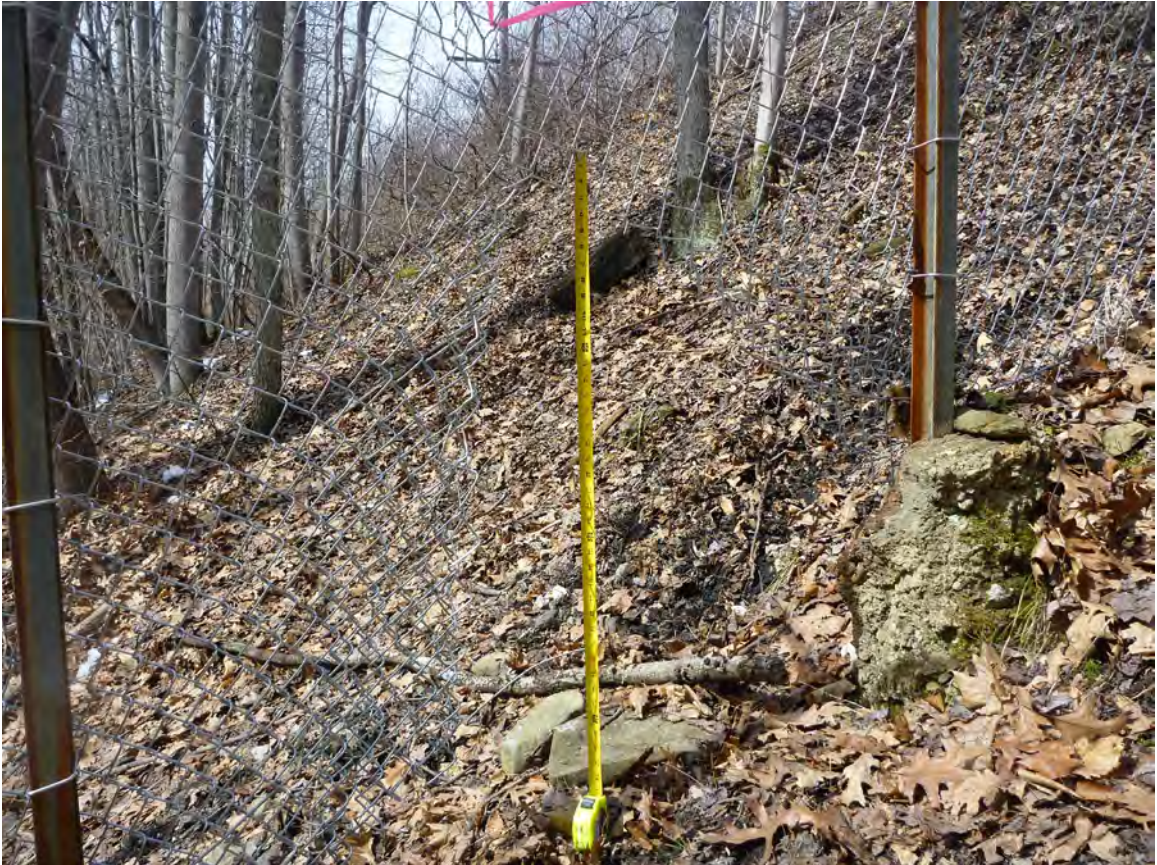
DETAIL SHEET FOR NW12

PHOTO NW12 discovered 03/19/2015

NOTE: Repairs to this callout were completed on March 25, 2015. A photograph of this repair will be presented in the FY 2015 3rd Quarter LUC Inspection Report.

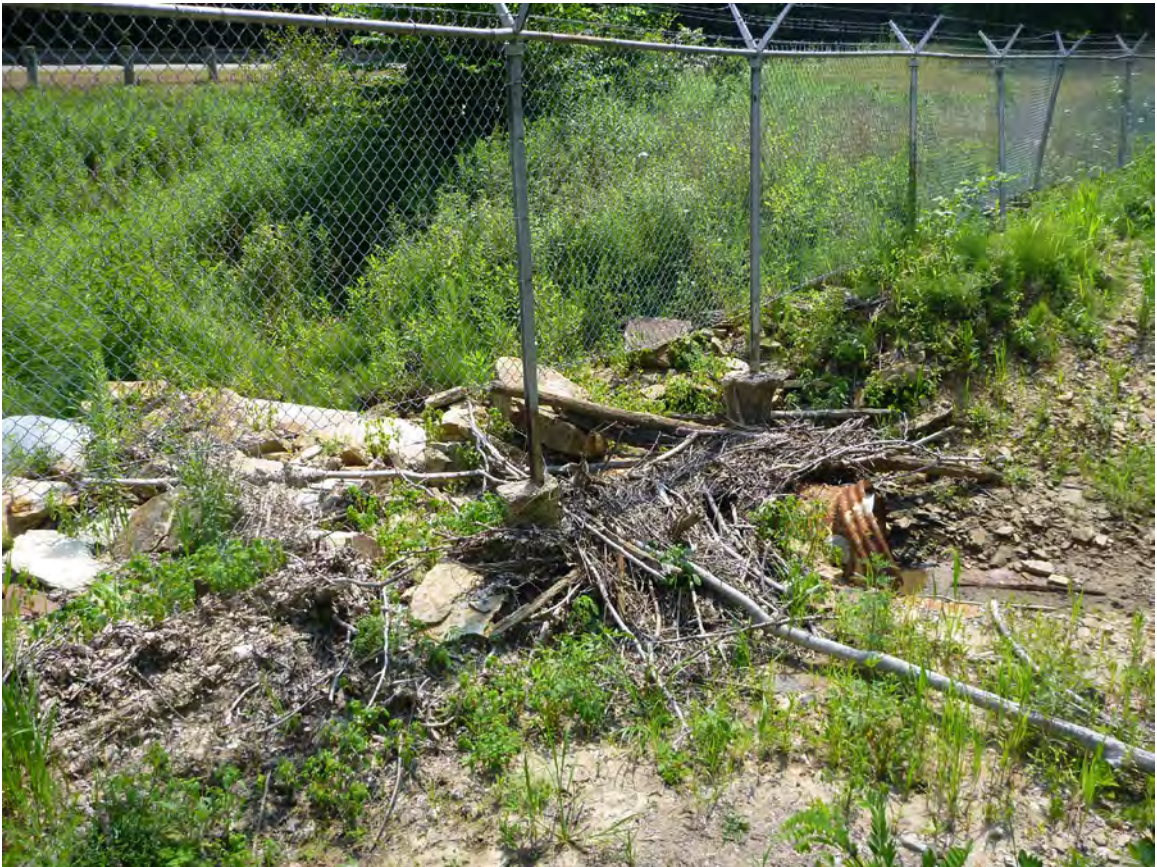
PHOTO SE2 discovered 07/18/2013

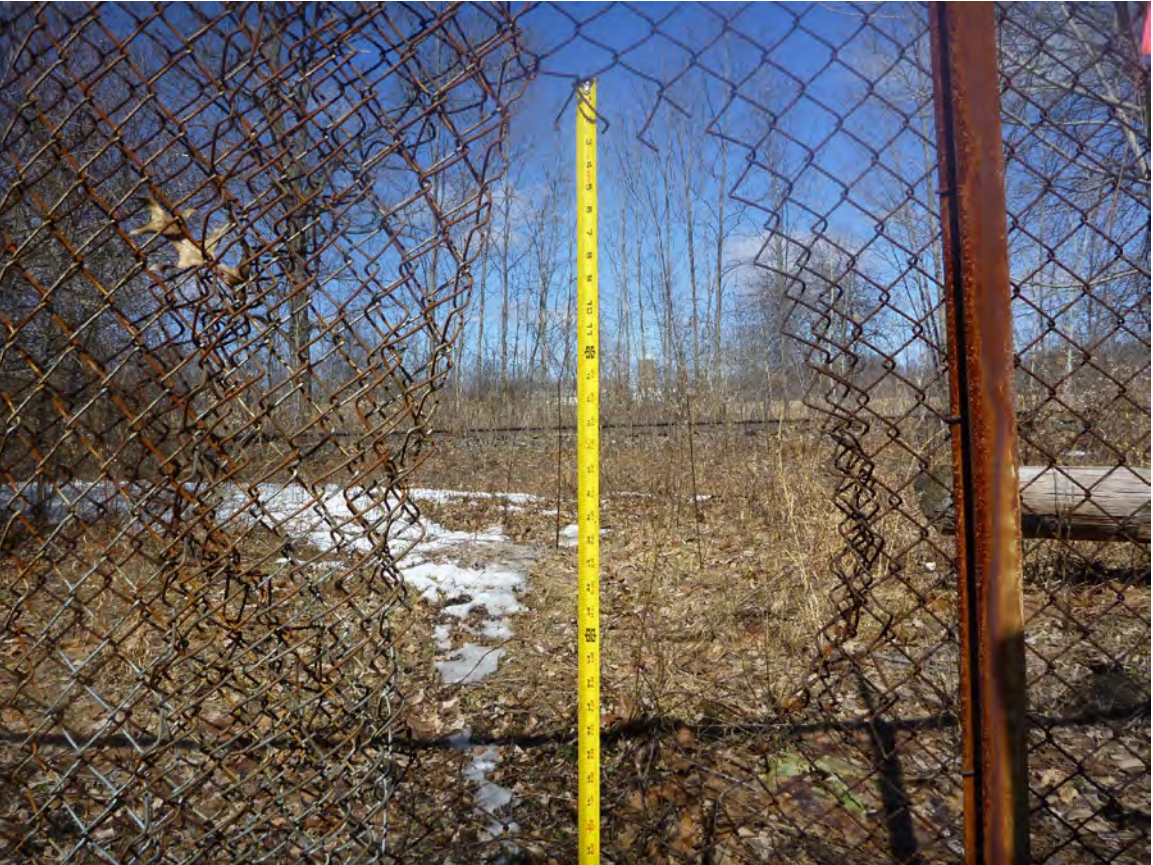
DETAIL SHEET FOR SW6B

PHOTO SW6B discovered 03/17/2015

NOTE: Repairs to this callout were completed on March 25, 2015. A photograph of this repair will be presented in the FY 2015 3rd Quarter LUC Inspection Report.
