Final
2015 Annual Land Use Control Monitoring Report,
RVAAP-01 Ramsdell Quarry Landfill
and
RVAAP-05 Winklepeck Burning Grounds

Camp Ravenna Joint Military Training Center
Former Ravenna Army Ammunition Plant
Portage and Trumbull Counties, Ohio

Contract No. W912QR-13-C-0031

January 27, 2016

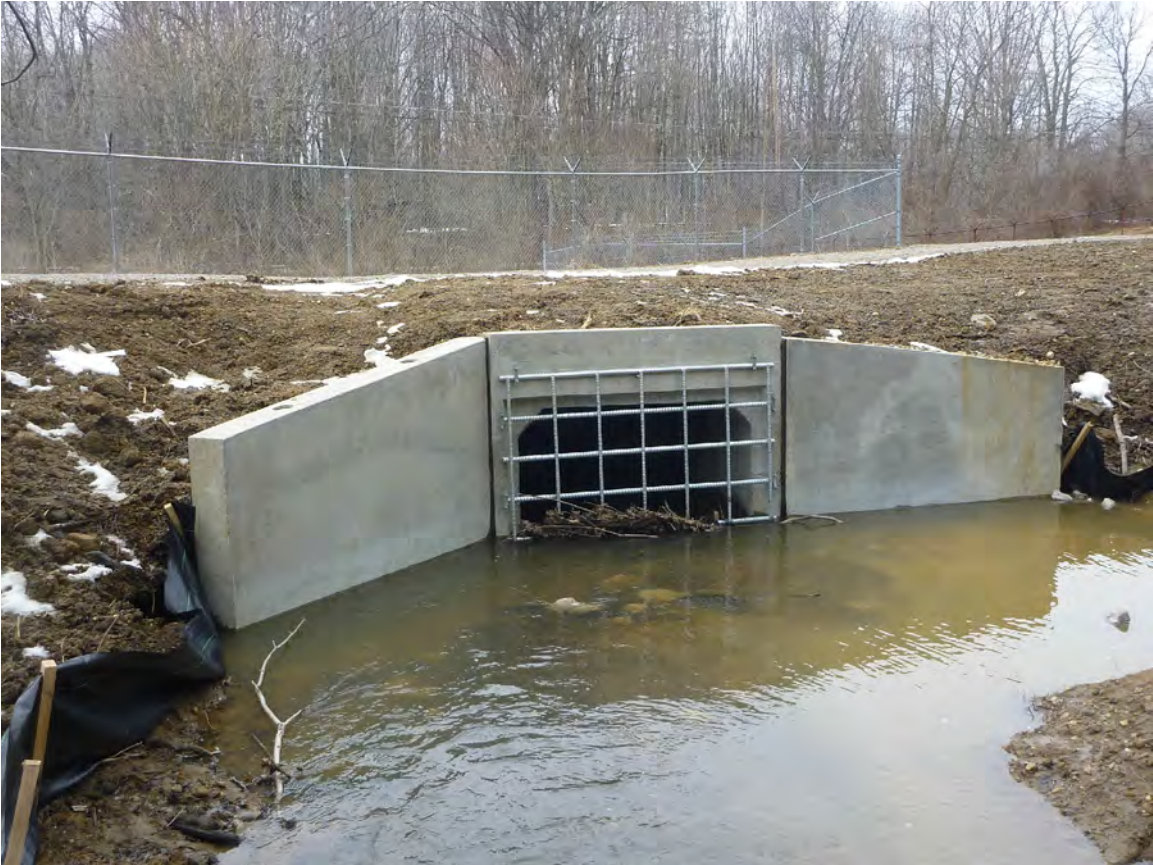
PHOTO SW12 as observed on 03/16/2015. Repair date is February 2015.

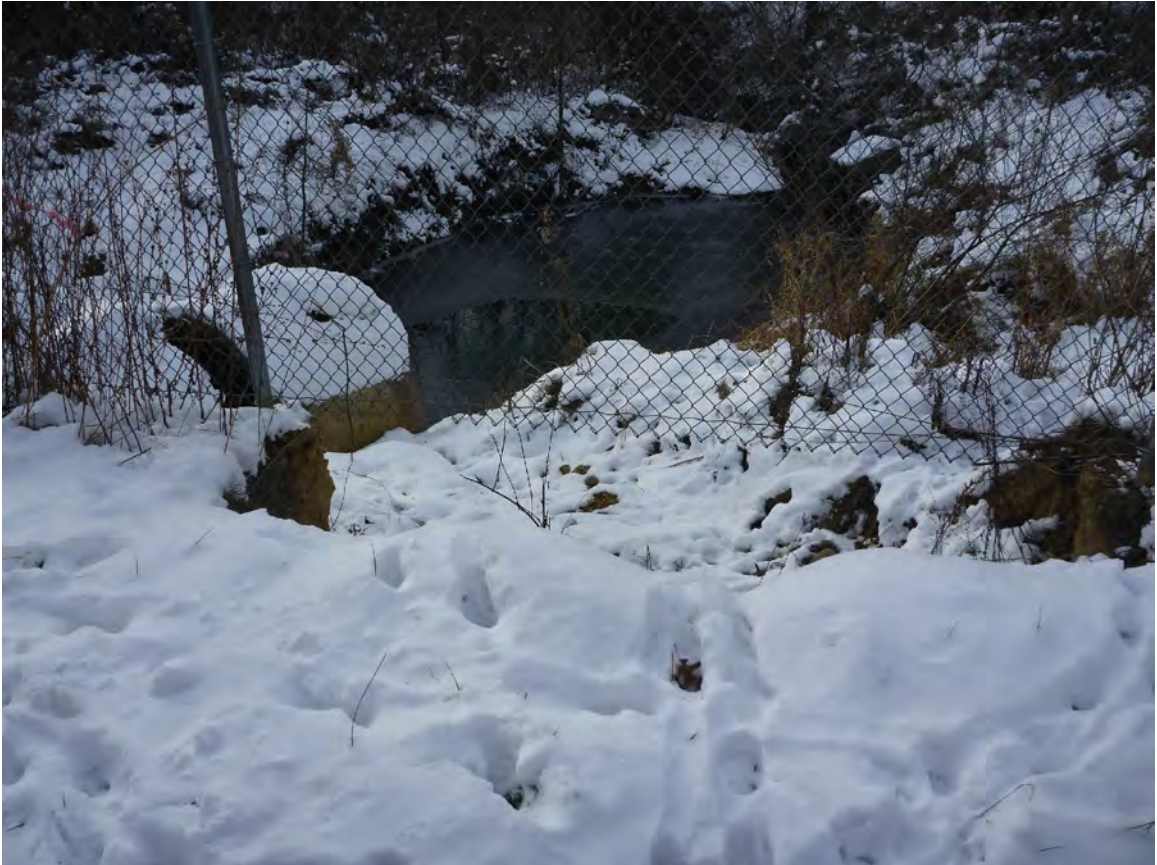
PHOTO SW12 discovered 11/18/2013

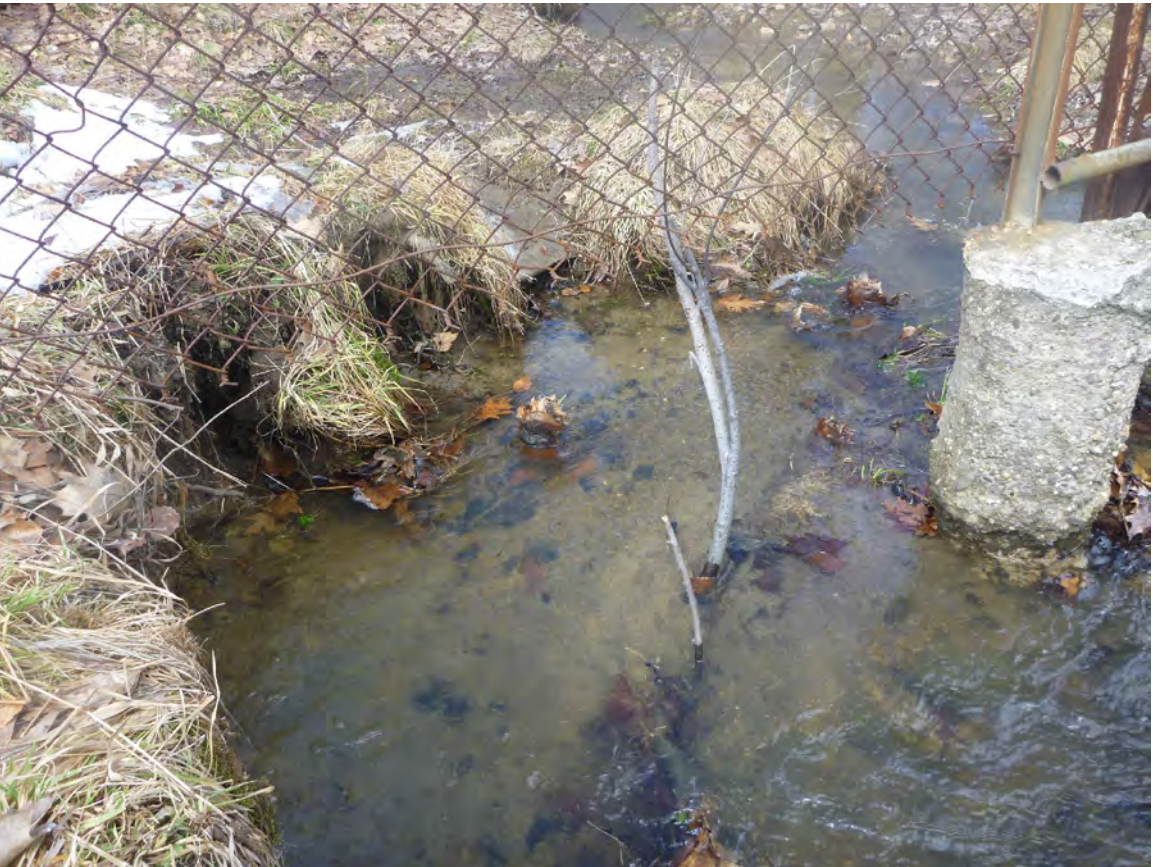
DETAIL SHEET FOR SW18

PHOTO SW18 discovered 07/15/2014

As observed during the third quarter LUC inspection, the following perimeter fence defects were repaired: NE31, NE34, NE35, SW6B, SW18, SW22A, NW10A and NW12.

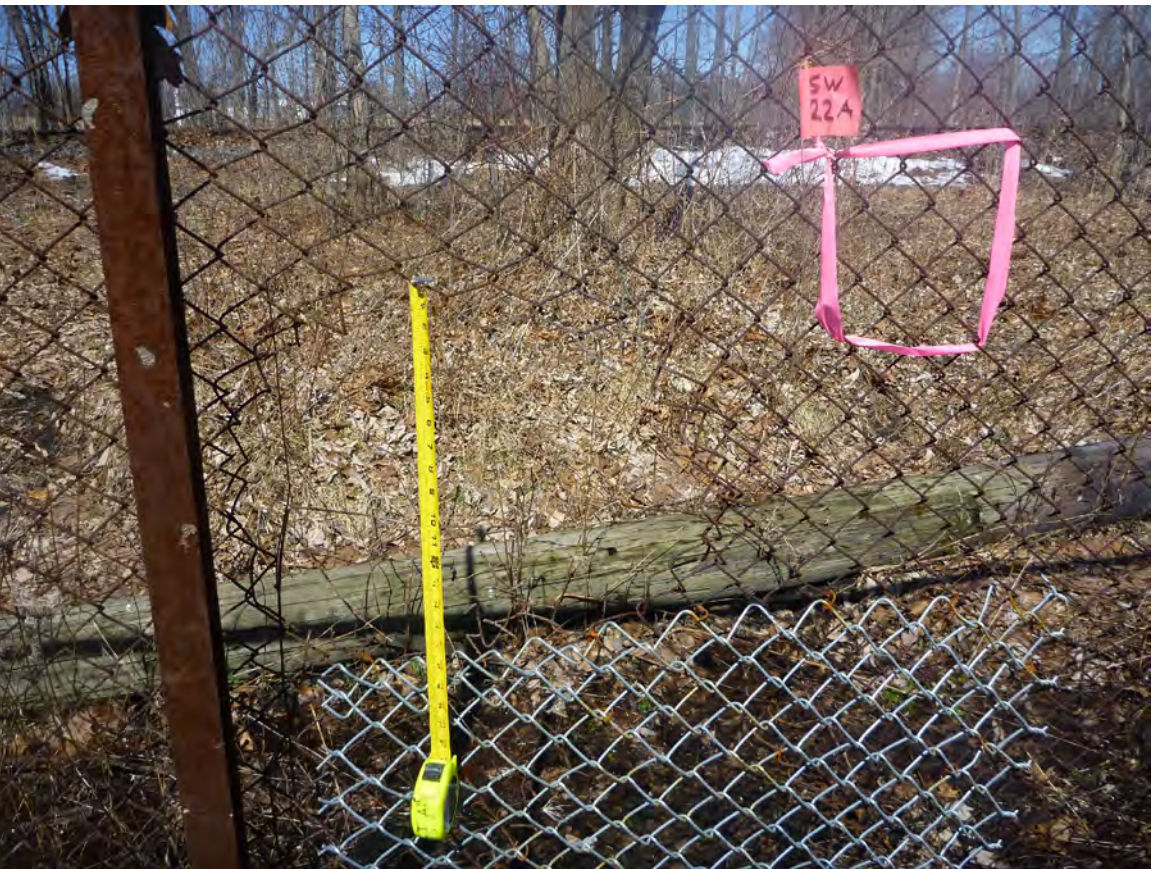
DETAIL SHEET FOR SW22A

PHOTO SW22A discovered 03/17/2015

NOTE: Repairs to this callout were completed on March 25, 2015. A photograph of this repair will be presented in the FY 2015 3rd Quarter LUC Inspection Report.

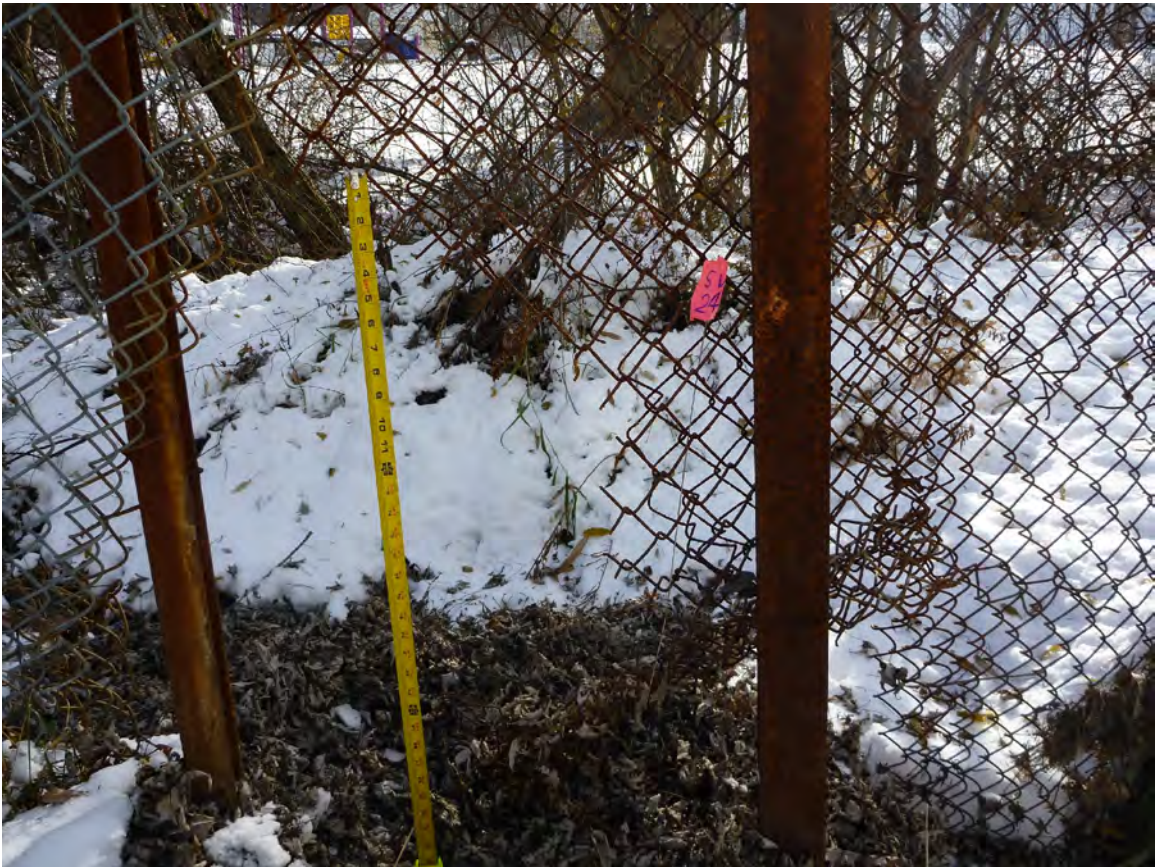
PHOTO SW24 discovered 11/20/2014

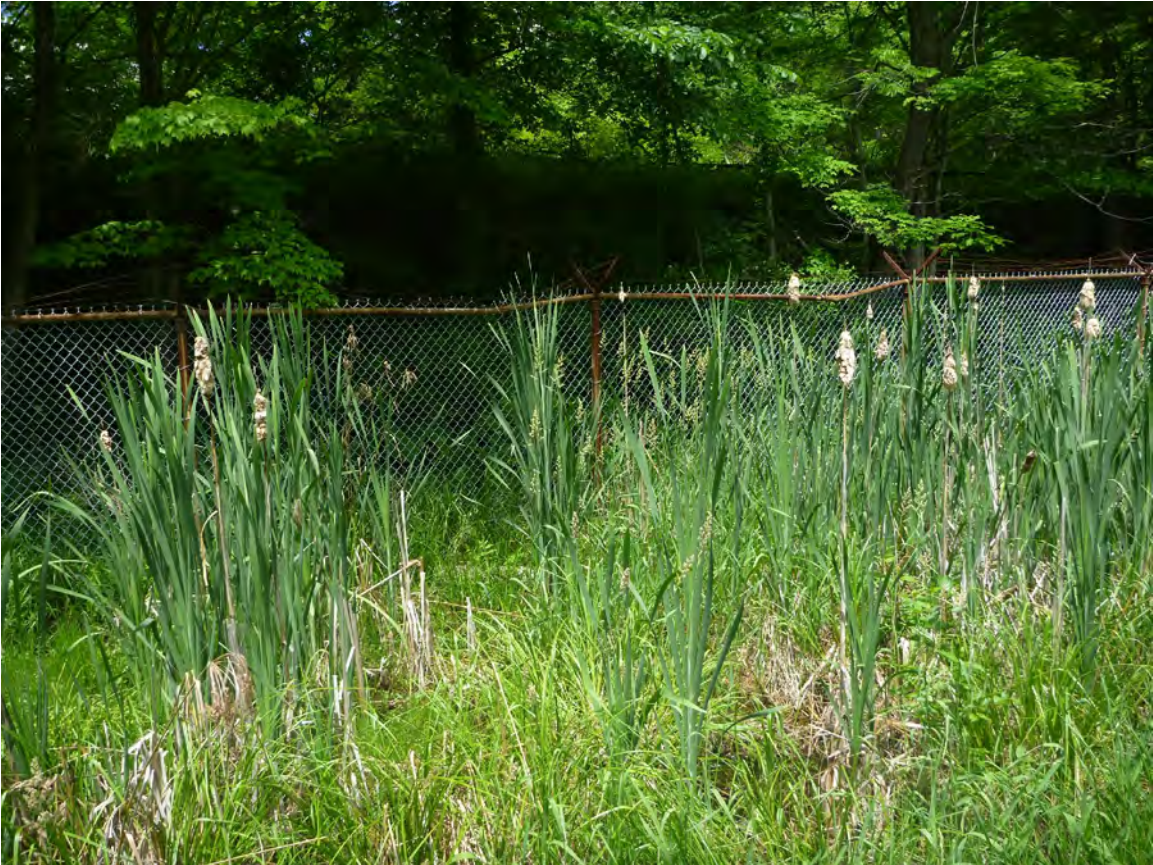
REPAIR PHOTO NE31 dated 06/03/2015

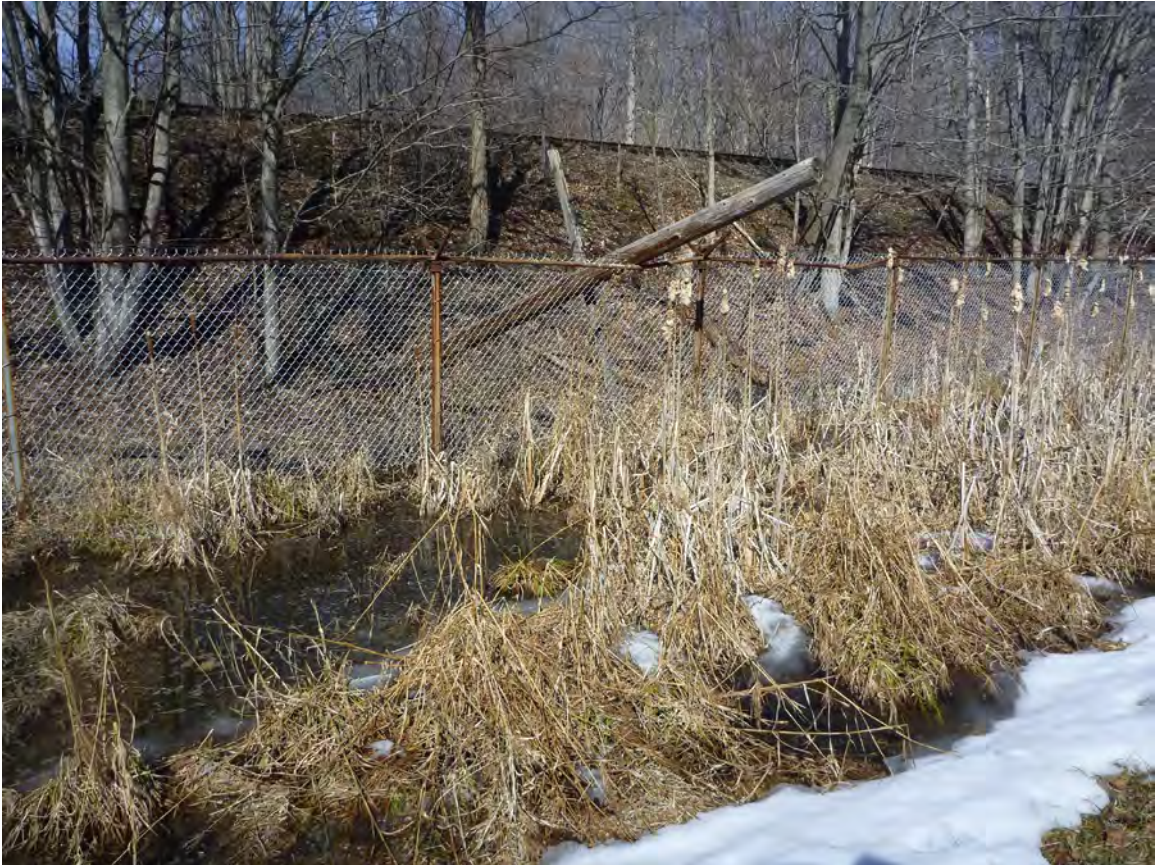
PHOTO NE31 discovered 12/03/2014

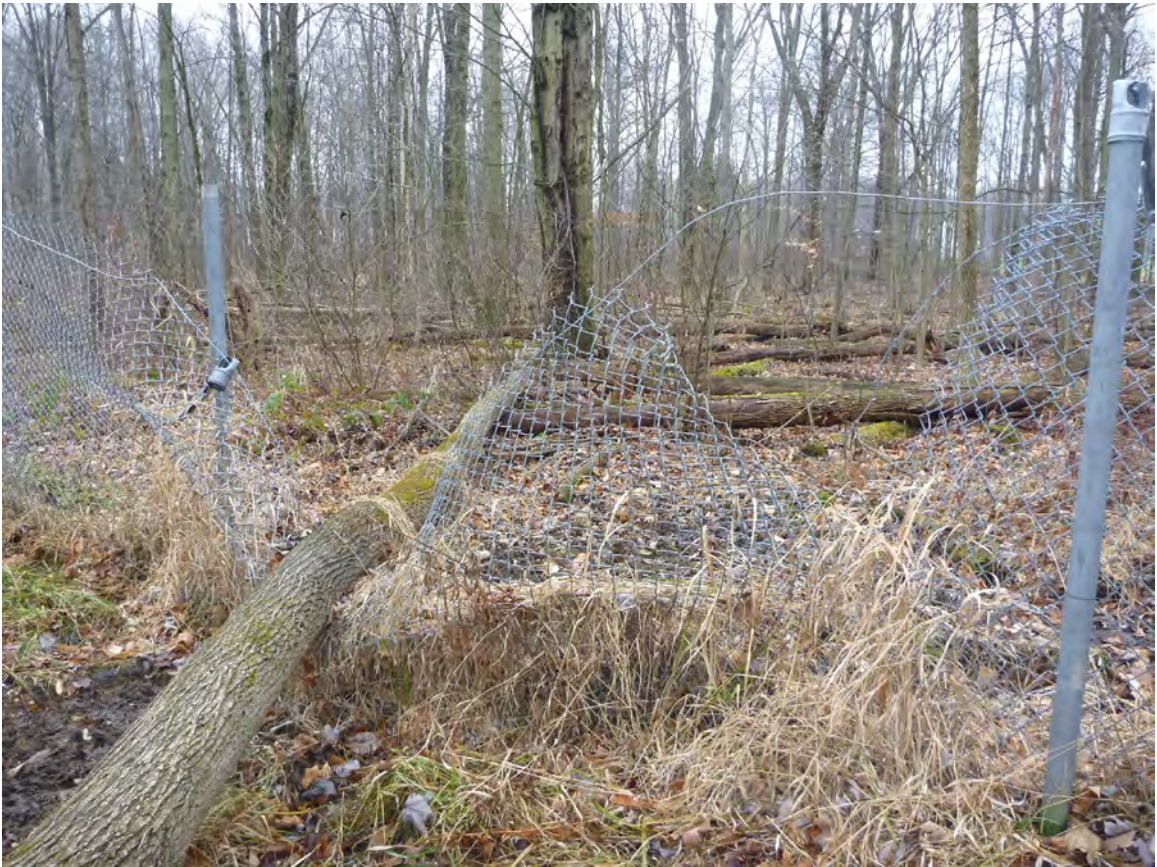
The Camp Ravenna perimeter fence has 5 missing sections/openings/holes in the fence fabric and areas that are in disrepair as documented in this report. These areas have been assigned the following call-out numbers: NW1B, NW13, NE32, NE36 and NE37. See Attachment 1 – Figure 1 Index Map to Facility Perimeter Fence Inspection and attached Detail Sheets.

PHOTO NE32 discovered 12/15/2014

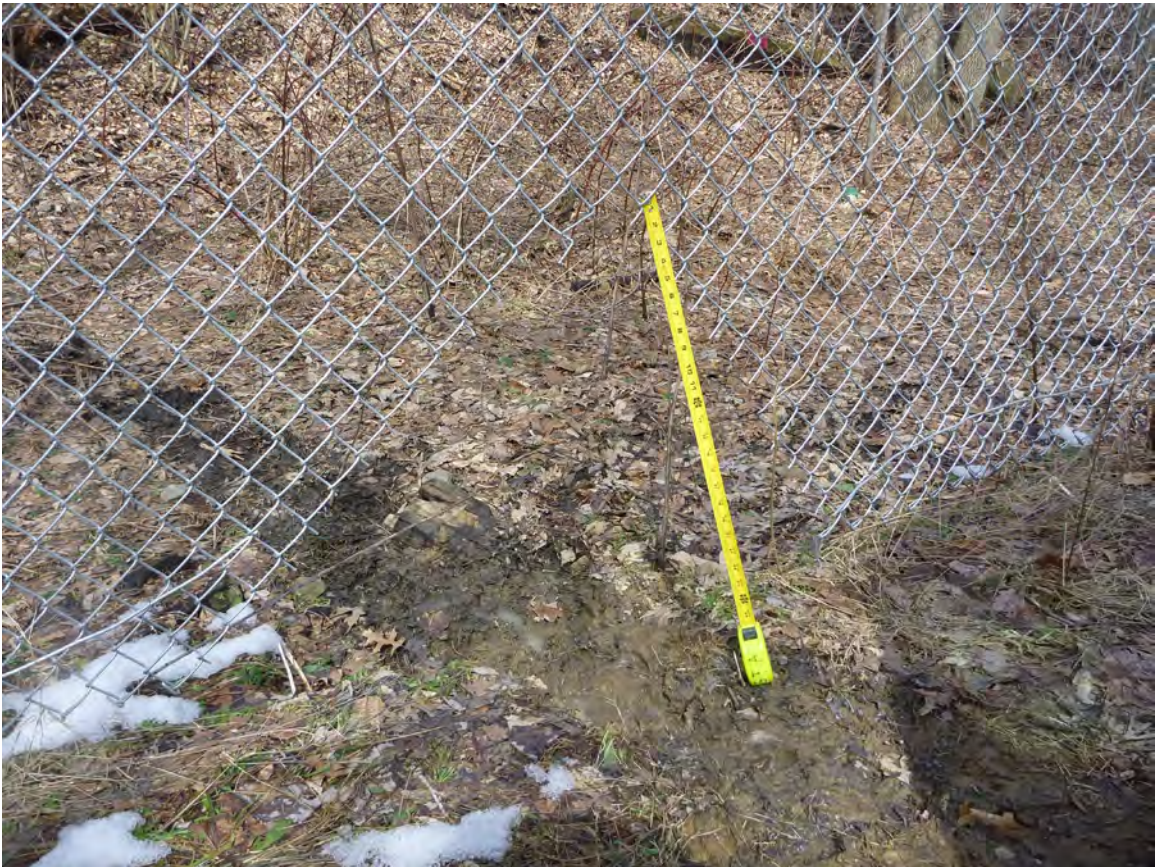
PHOTO NE34 discovered 03/19/2015

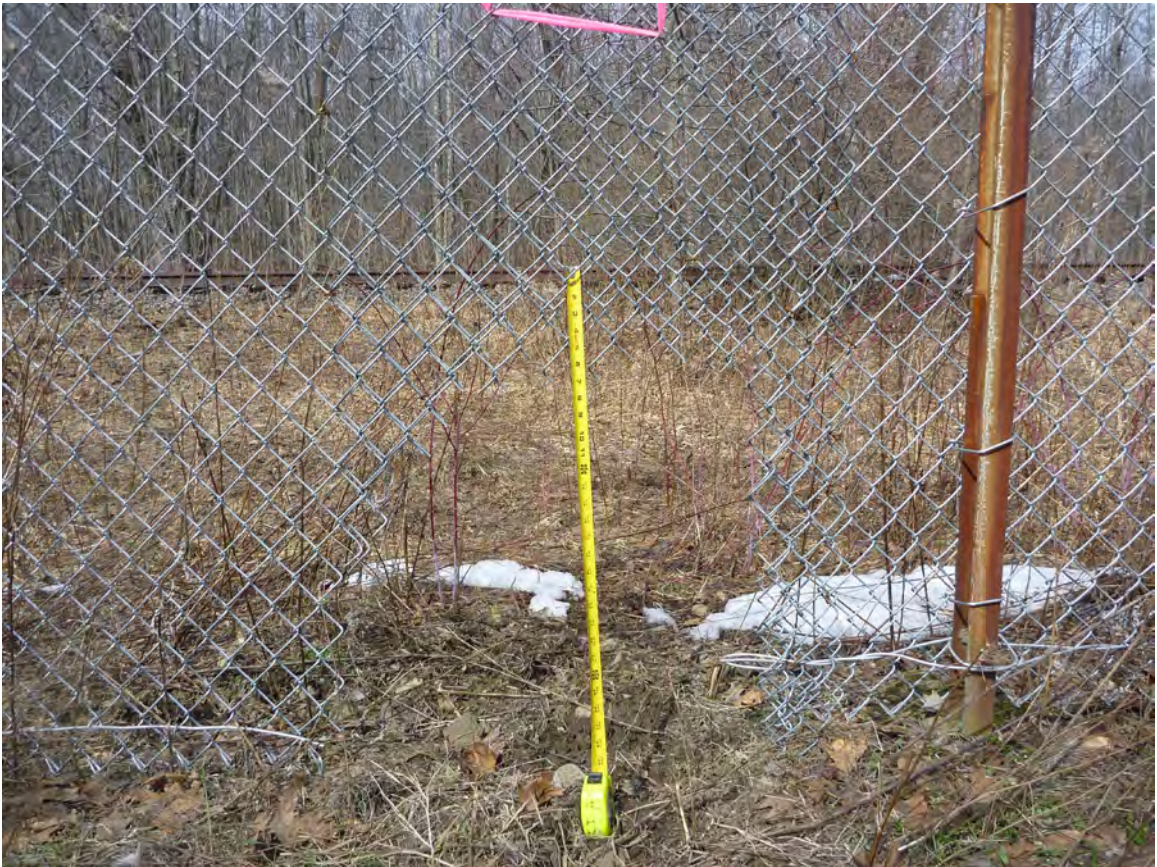
PHOTO NE35 discovered 03/19/2015

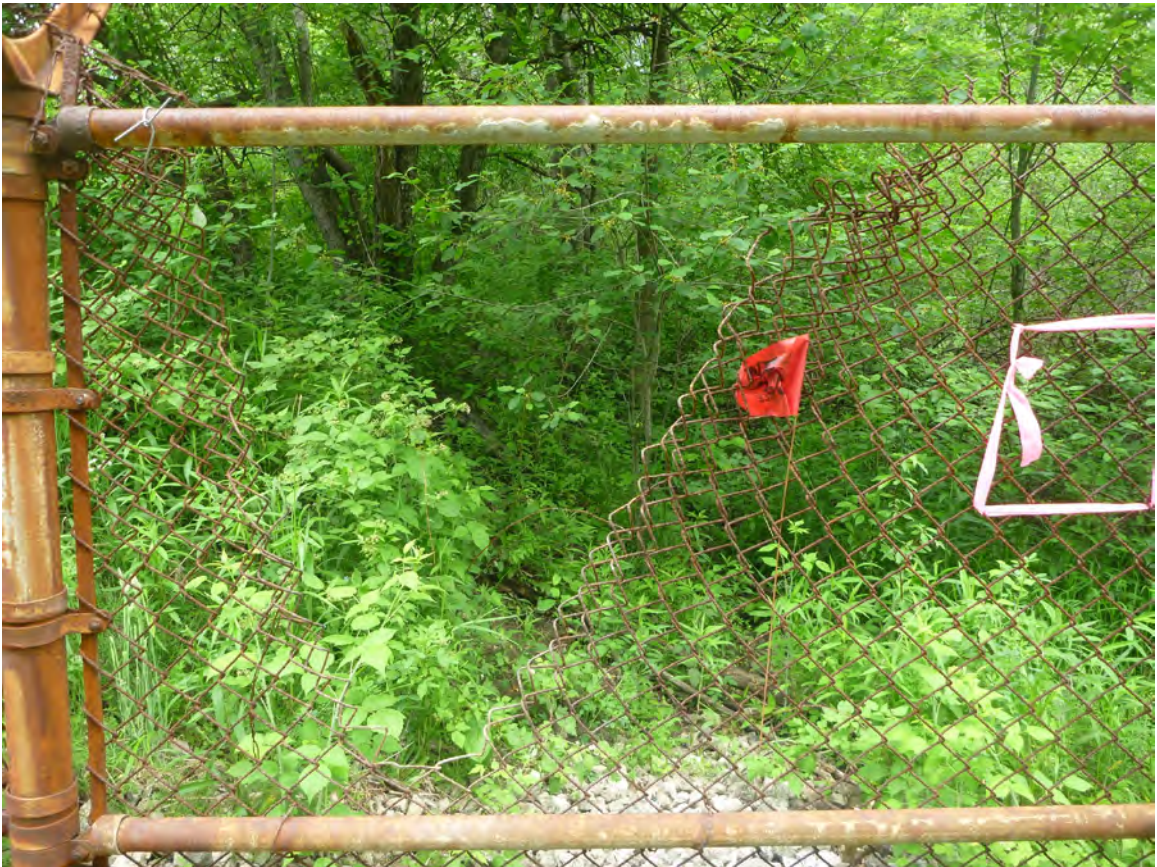
DETAIL SHEET FOR NE36

PHOTO NE36 discovered 06/04/2015

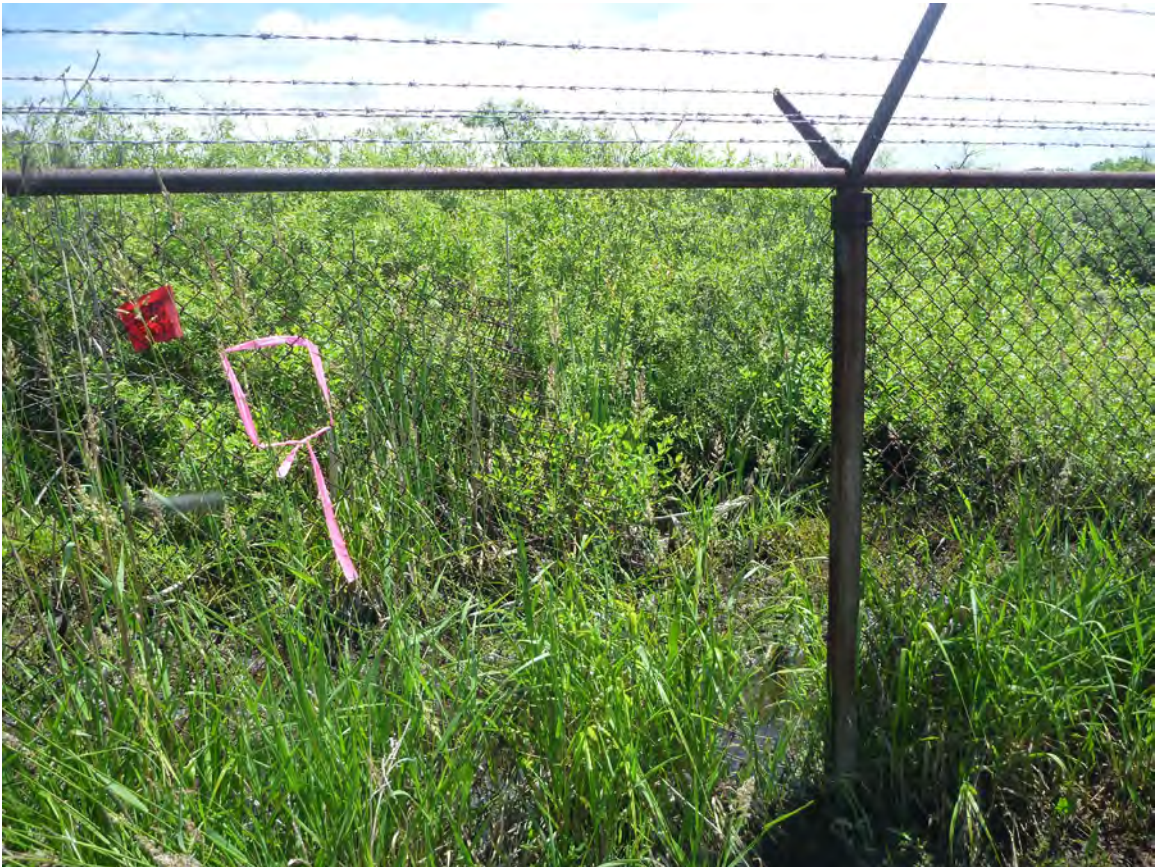
PHOTO NE37 discovered 06/04/2015

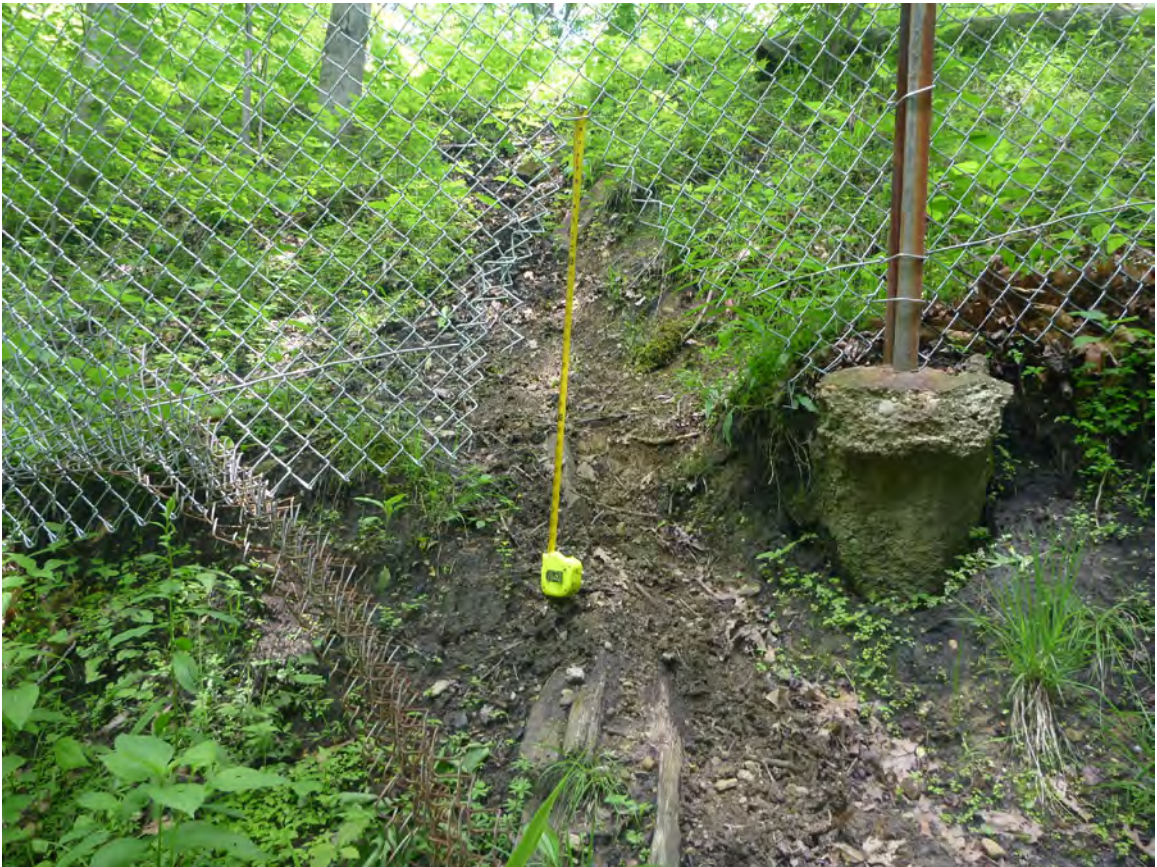
DETAIL SHEET FOR NW1B

PHOTO NW1B dated 06/03/2015

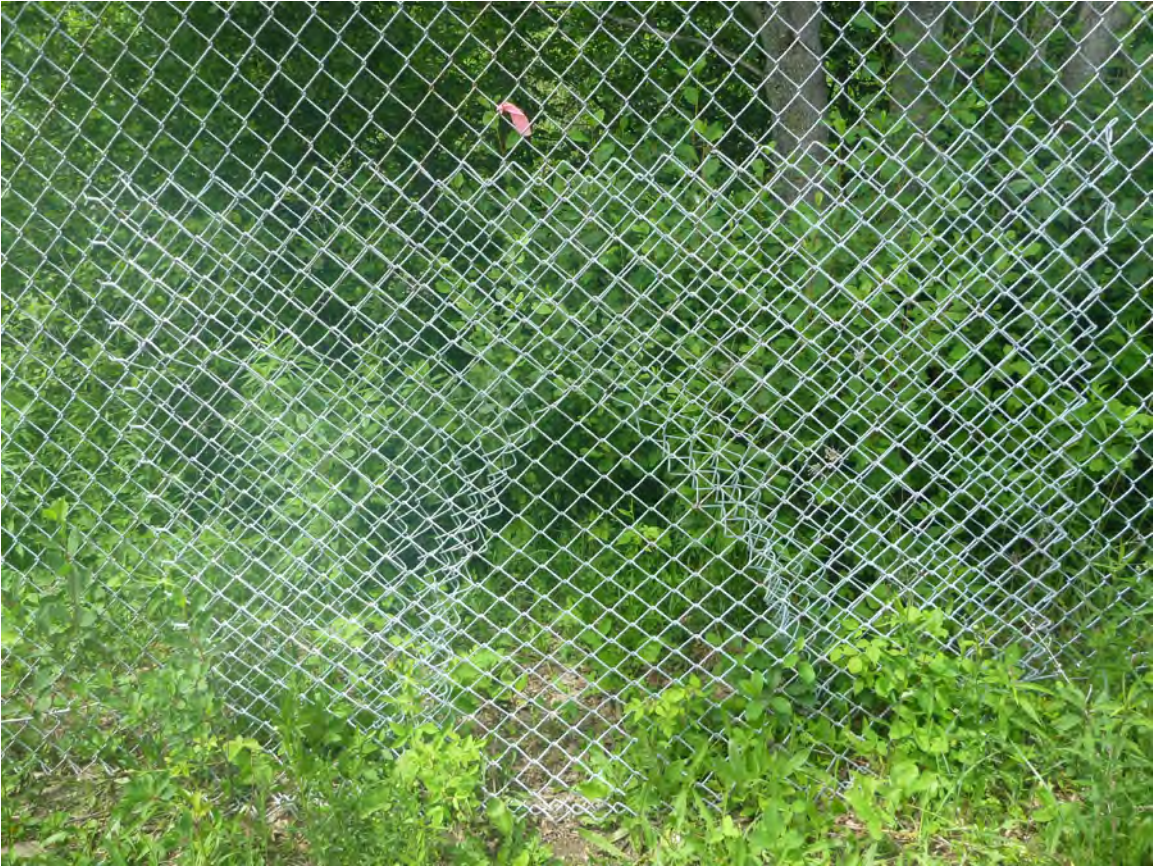
REPAIR PHOTO NW10A dated 06/02/2015

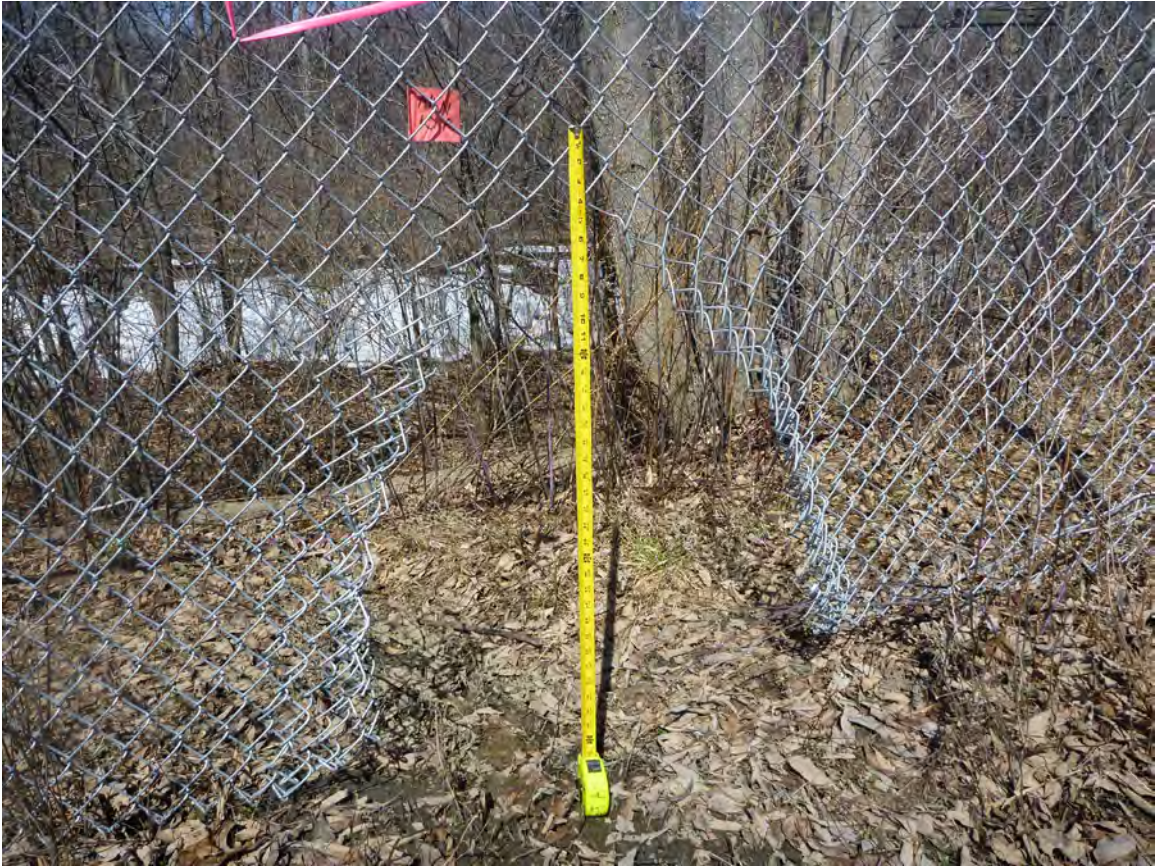
PHOTO NW10A discovered 03/18/2015

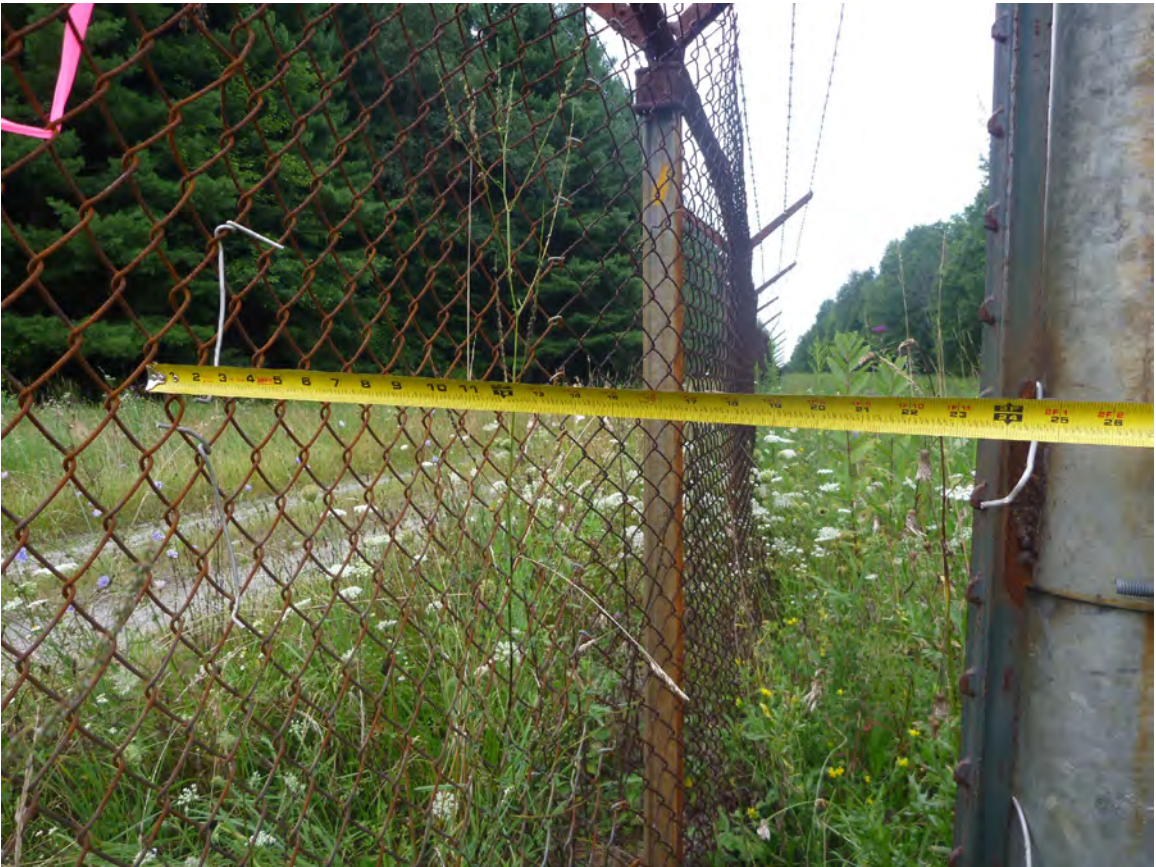
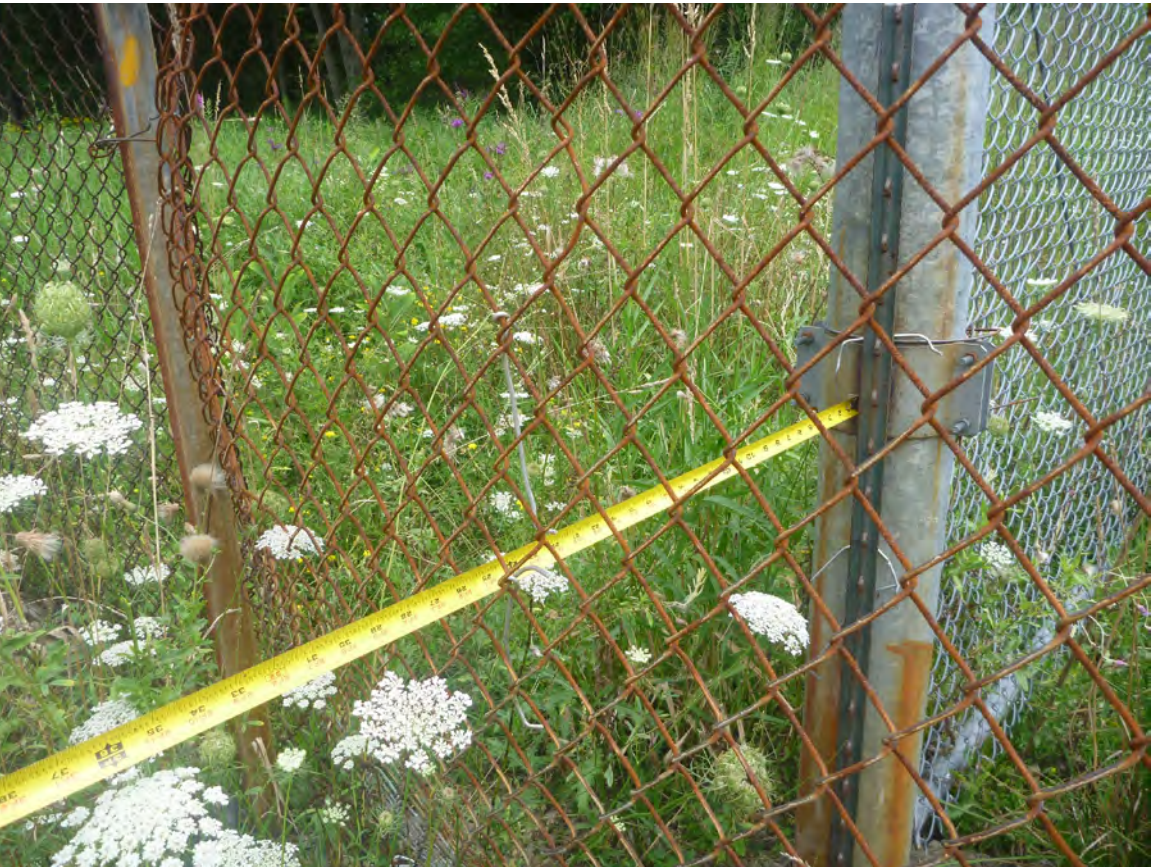
PHOTO NE10A discovered 08/06/2015

The Camp Ravenna perimeter fence has 4 missing sections/openings/holes in the fence fabric and areas that are in disrepair as documented in this report. These areas have been assigned the following call-out numbers: NE10A, NE32, NE38 and SE2A. See Attachment 1 – Figure 1 Index Map to Facility Perimeter Fence Inspection and attached Detail Sheets.

The Army was notified via e-mail on August 6, 10 and 11, 2015 of three new fence defects discovered during the 4th Quarter FY 2015 facility perimeter fence evaluation. These locations are NE38, NE10A, SE2A (See Attachment 1, Figure 1 Index Map and Summary Table, and associated detail sheets).

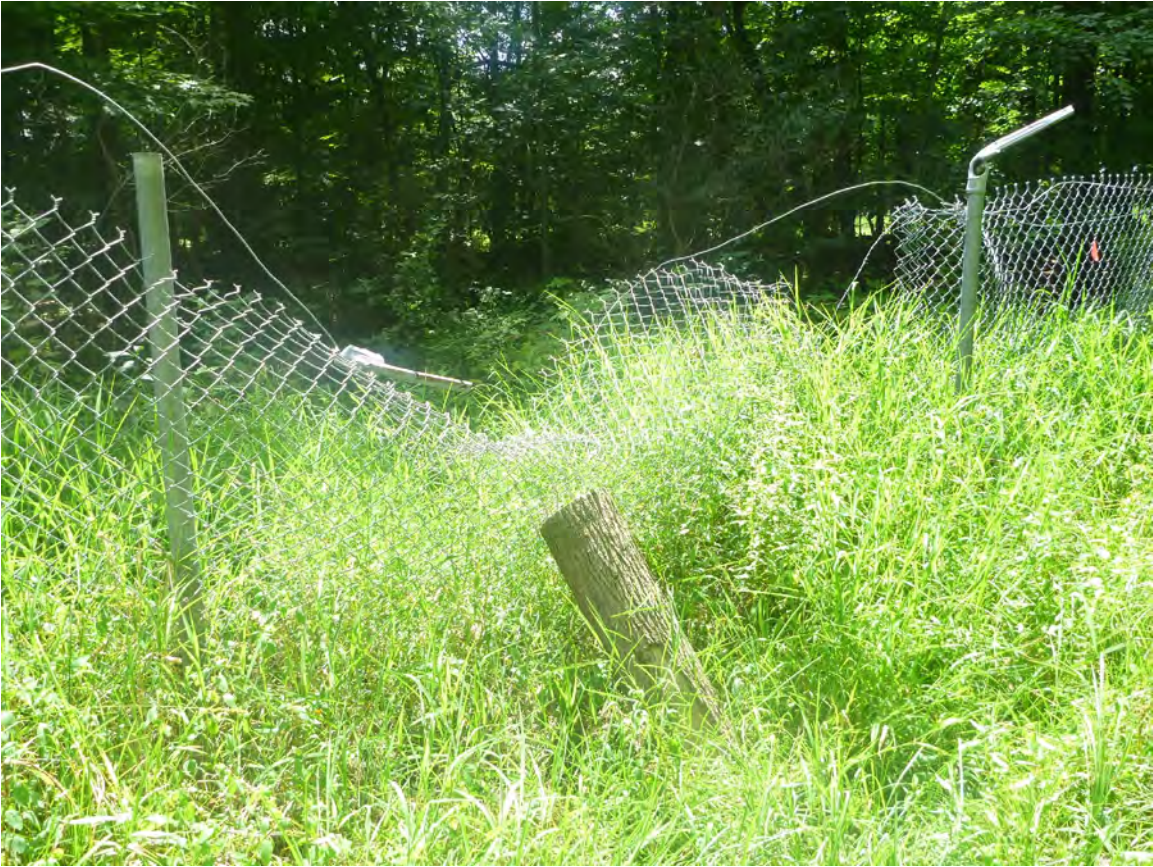
REPAIR PHOTO NE32 dated 08/05/2015 (In Progress)
