Final
2019 Annual Land Use Control Monitoring Report,
RVAAP-01 Ramsdell Quarry Landfill,
RVAAP-05 Winklepeck Burning Grounds,
RVAAP-08 through RVAAP-11 (Load Lines 1 through 4),
RVAAP-12 (Load Line 12) and RVAAP-51 (Dump Along Paris-Windham
Road)

Camp James A. Garfield Joint Military Training Center
Former Ravenna Army Ammunition Plant
Portage and Trumbull Counties, Ohio

Contract No. W912QR-18-C-0013

May 20, 2020

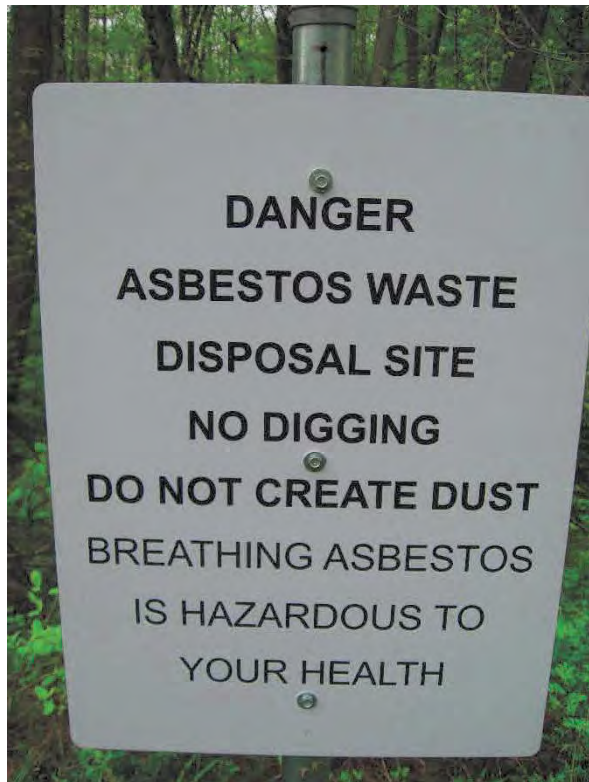
RVAAP-51, asbestos warning sign delineating Land Use Control area along Paris-Windham Road.
