**Time Critical Response Action for the
Rocket Ridge Area of Open Demolition Area #2
(RVAAP-004-R-01 Open Demolition Area #2 MRS)
Military Munitions Response Program
Ravenna Army Ammunition Plant
Ravenna, Ohio**

**OPERATIONS AND MAINTENANCE TRIP PREPORTS
and QUARTERLY EFFECTIVENESS EVALUATION REPORTS**

**TIME CRITICAL RESPONSE ACTION for the
ROCKET RIDGE AREA OF OPEN DEMOLITION AREA #2
(RVAAP-004-R-01 Open Demolition Area #2 MRS)**

**MILITARY MUNITIONS RESPONSE PROGRAM
RAVENNA ARMY AMMUNITION PLANT
RAVENNA, OHIO**

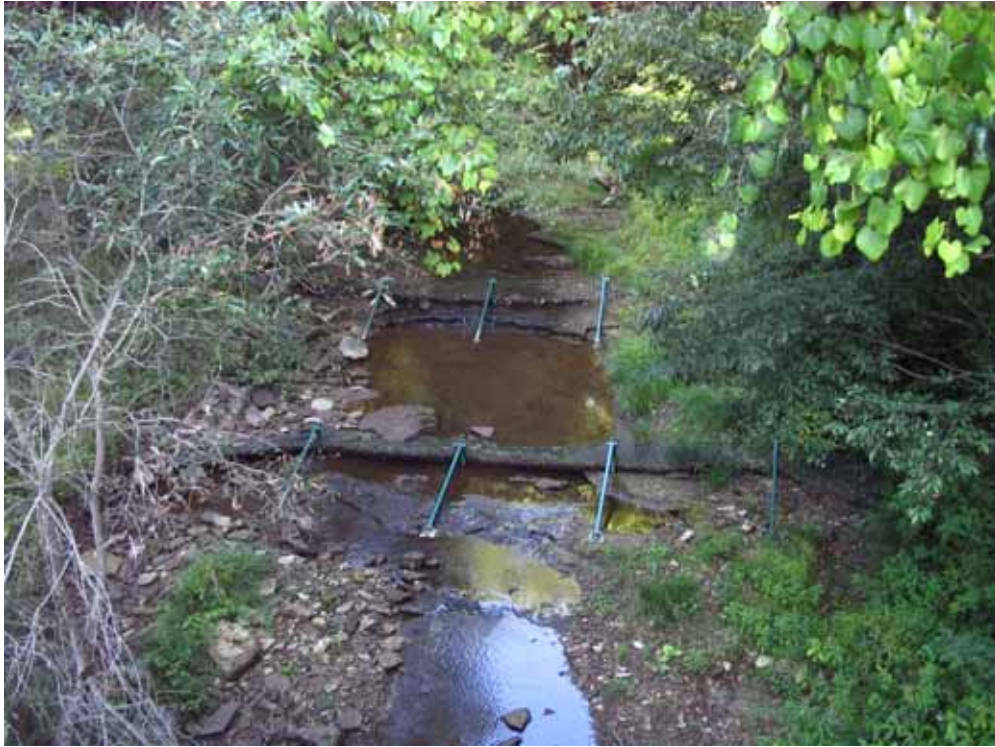
View of barriers upon arrival.

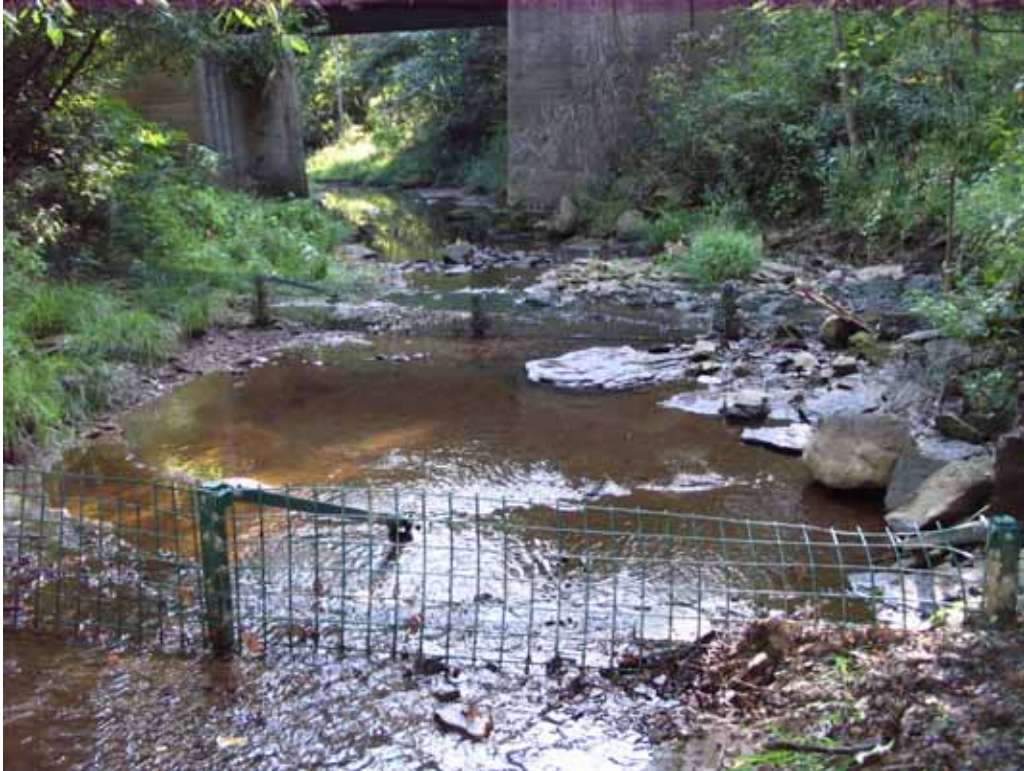
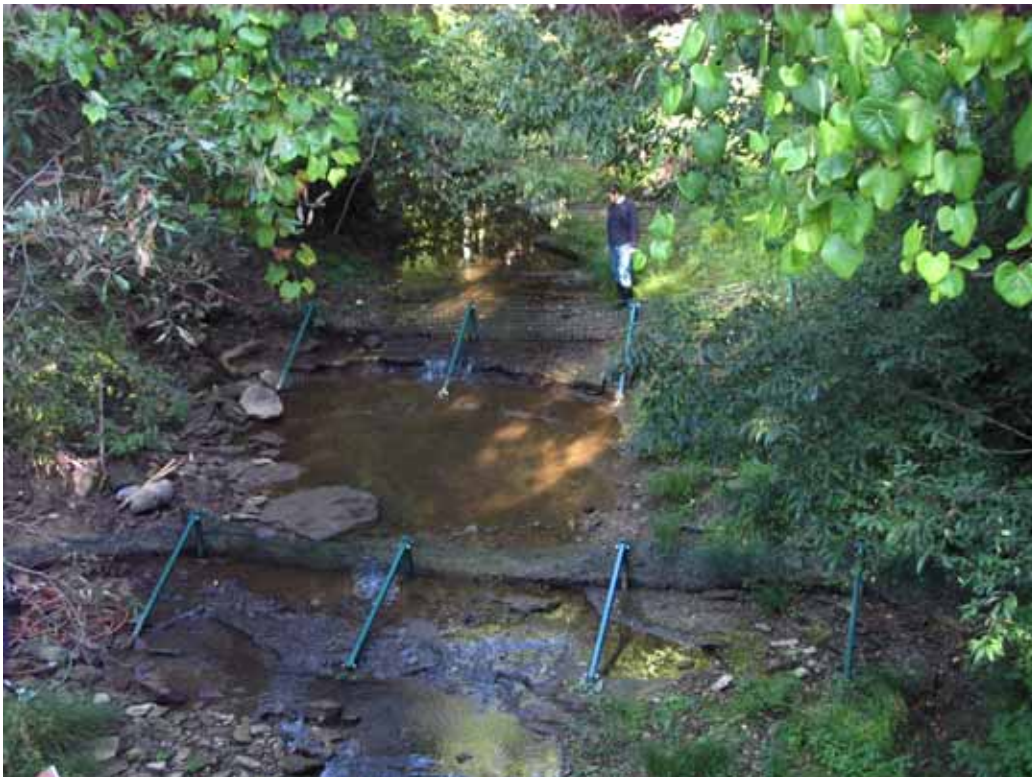
View of screens after cleaning and upon departure.

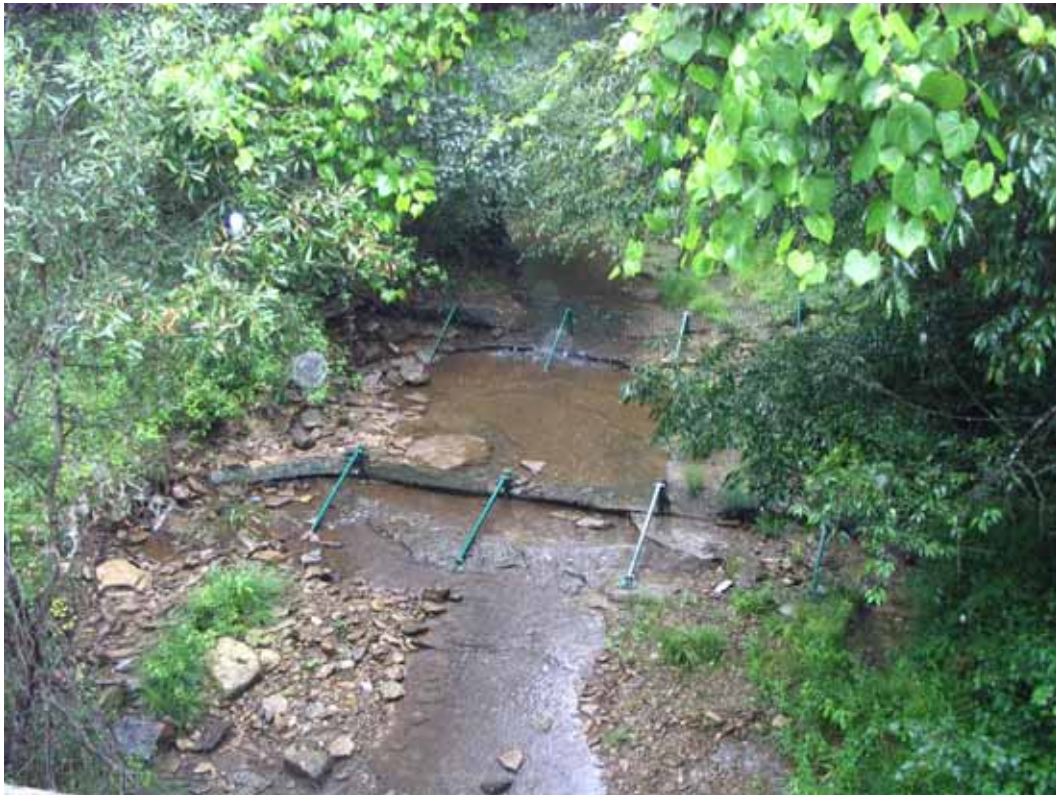
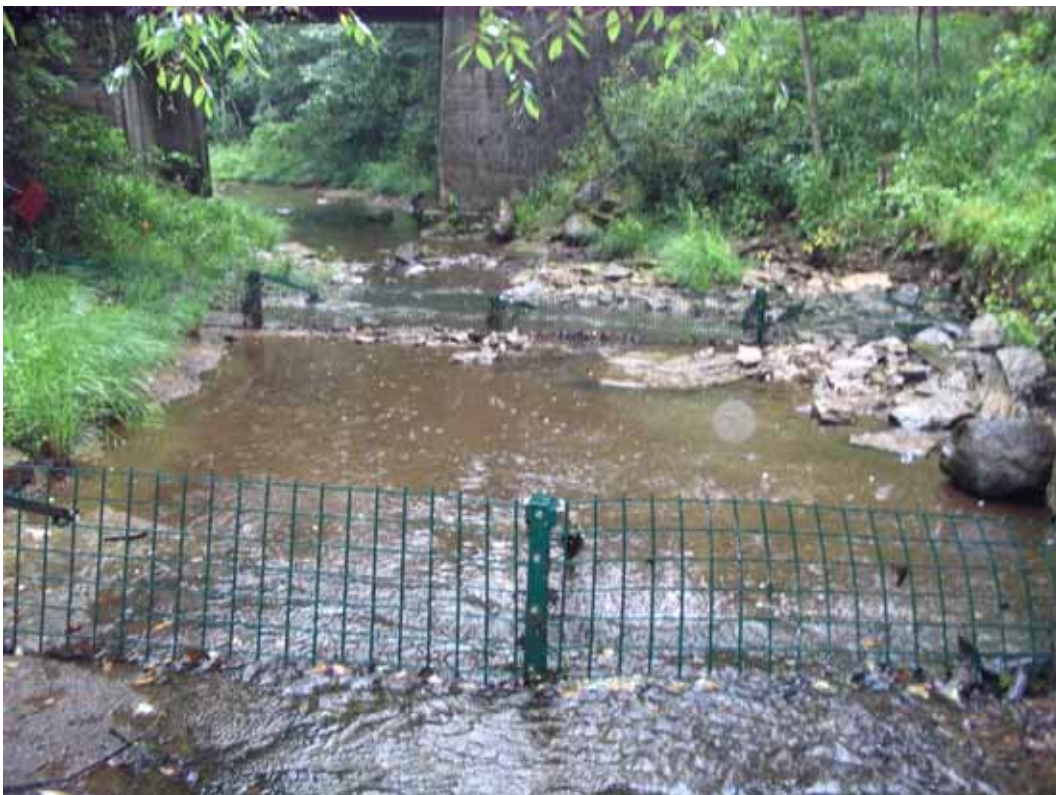
View of barriers upon arrival.

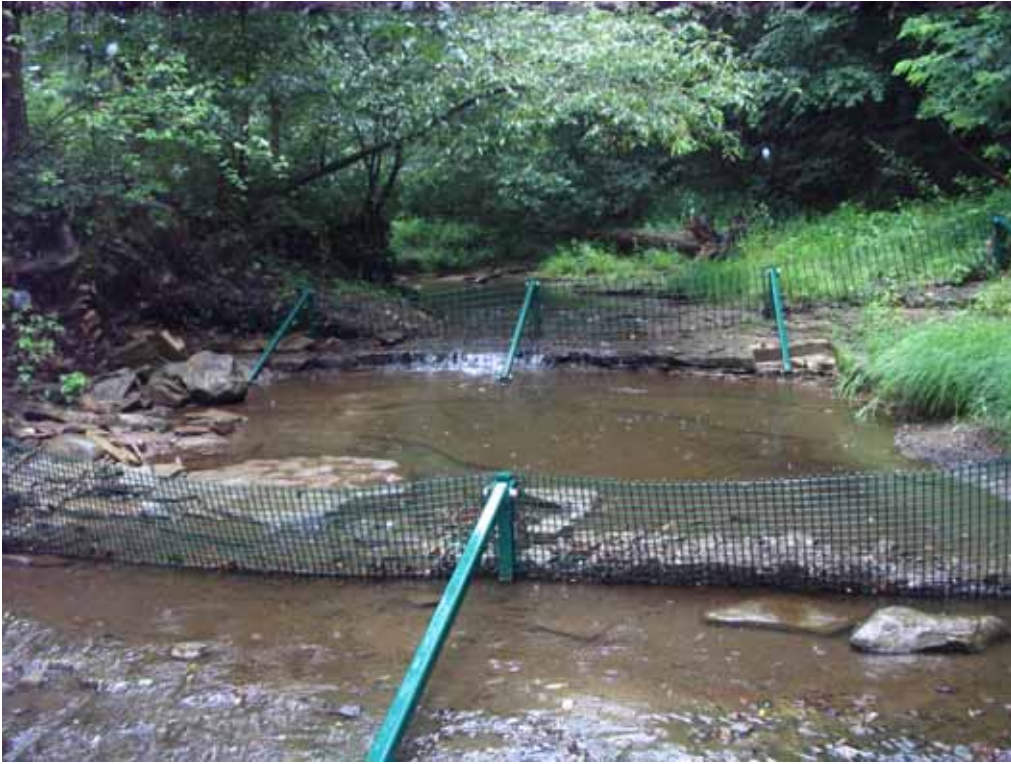
View of screens after cleaning and upon departure.

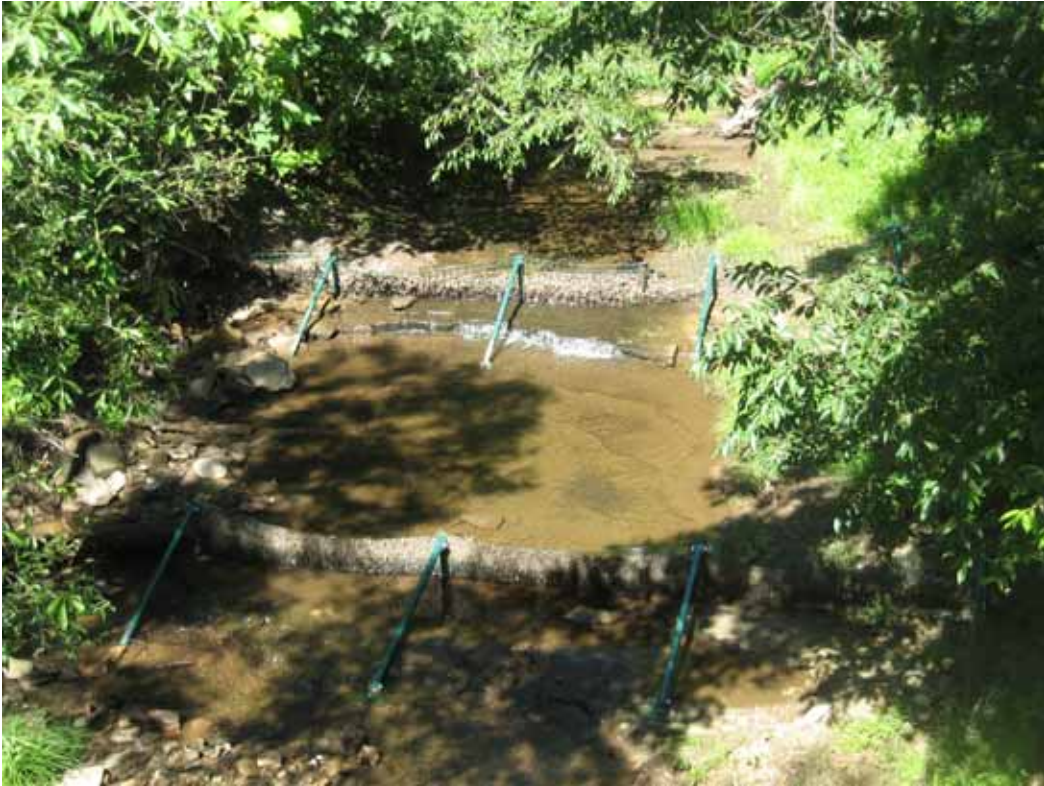
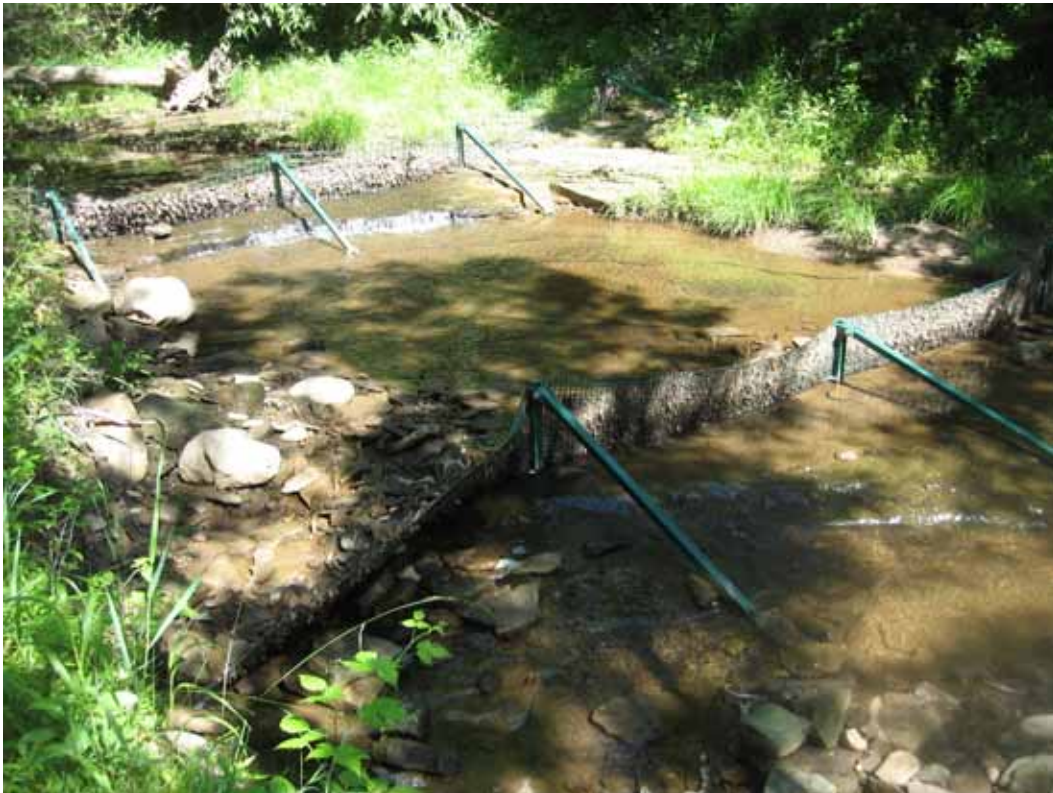
View of barriers upon arrival.

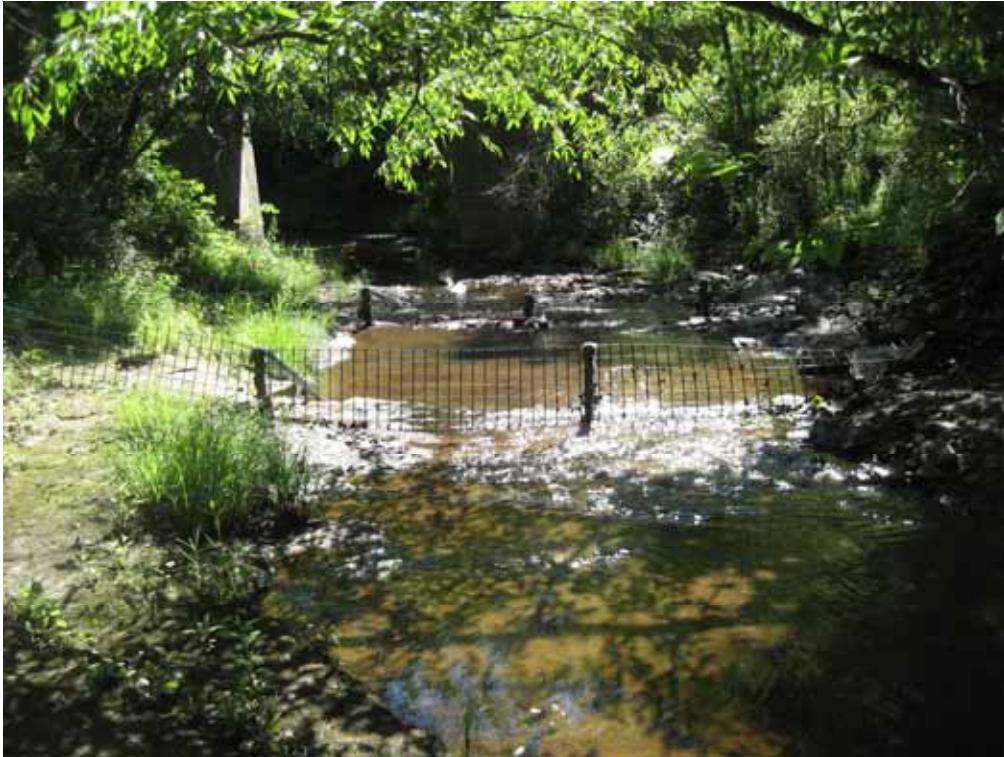
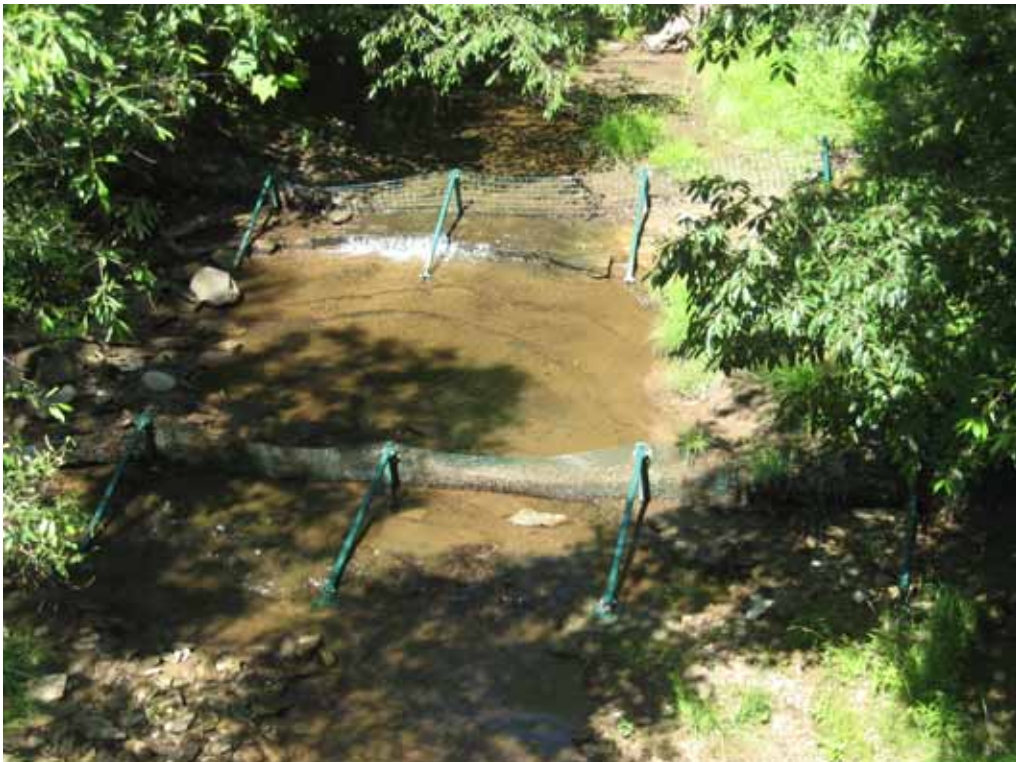
Screens after cleaning and upon departure.

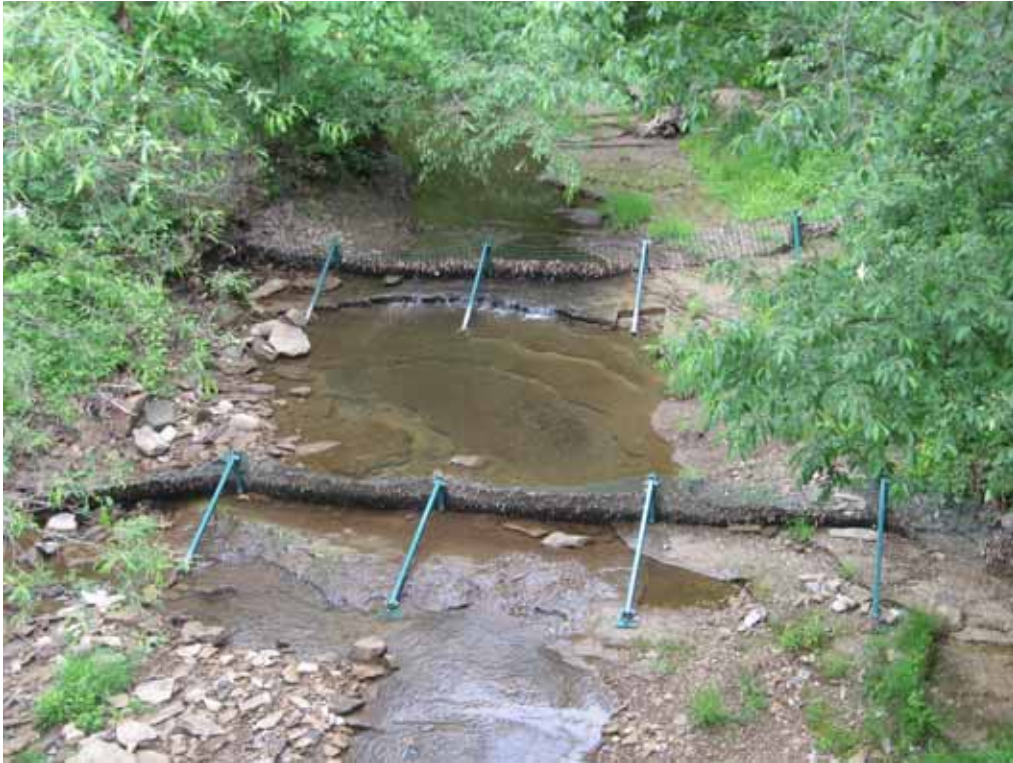
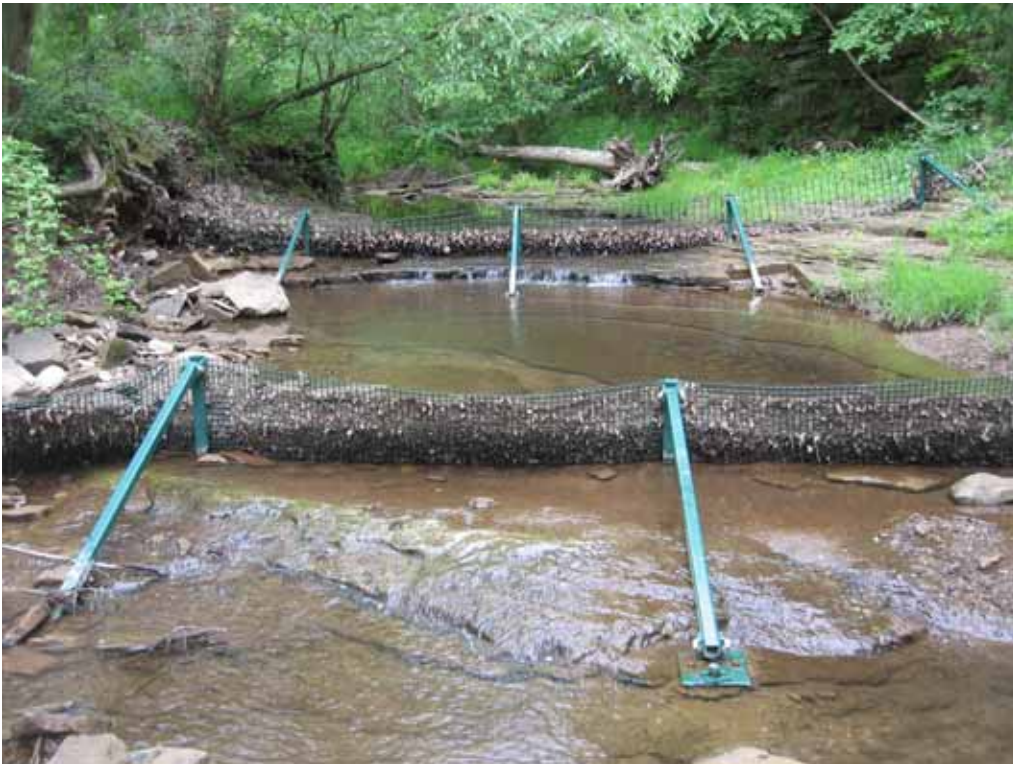
View of barriers upon arrival.

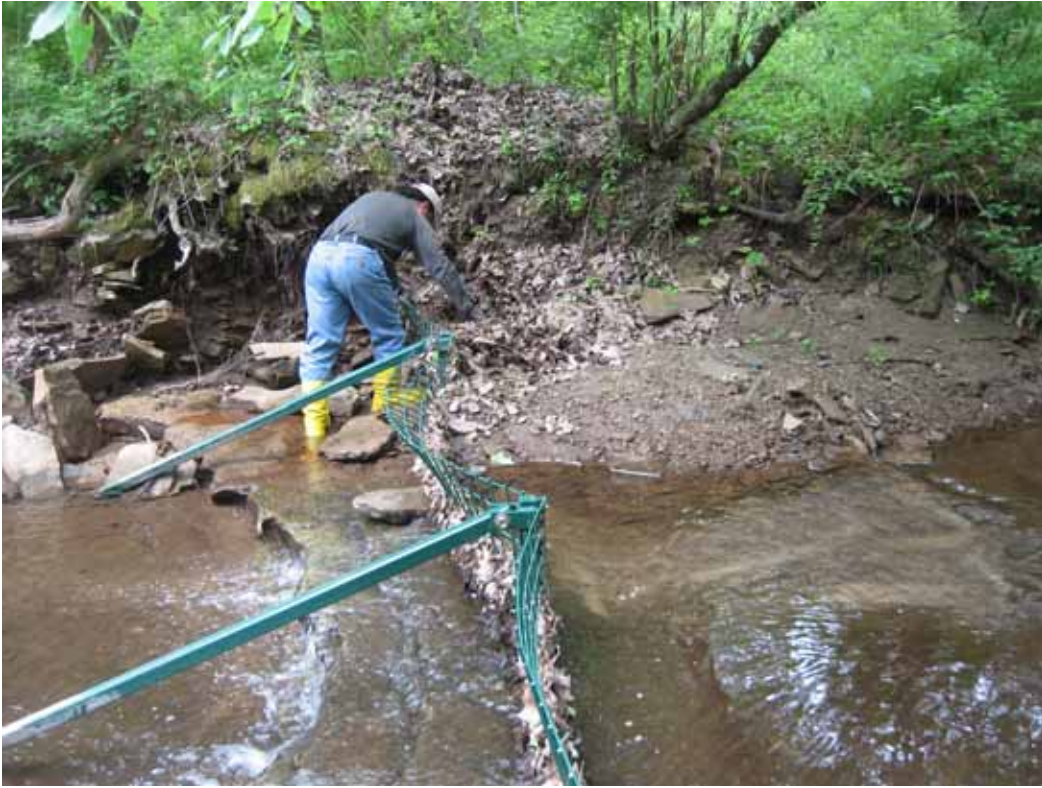
Picture showing cleaning of screen.

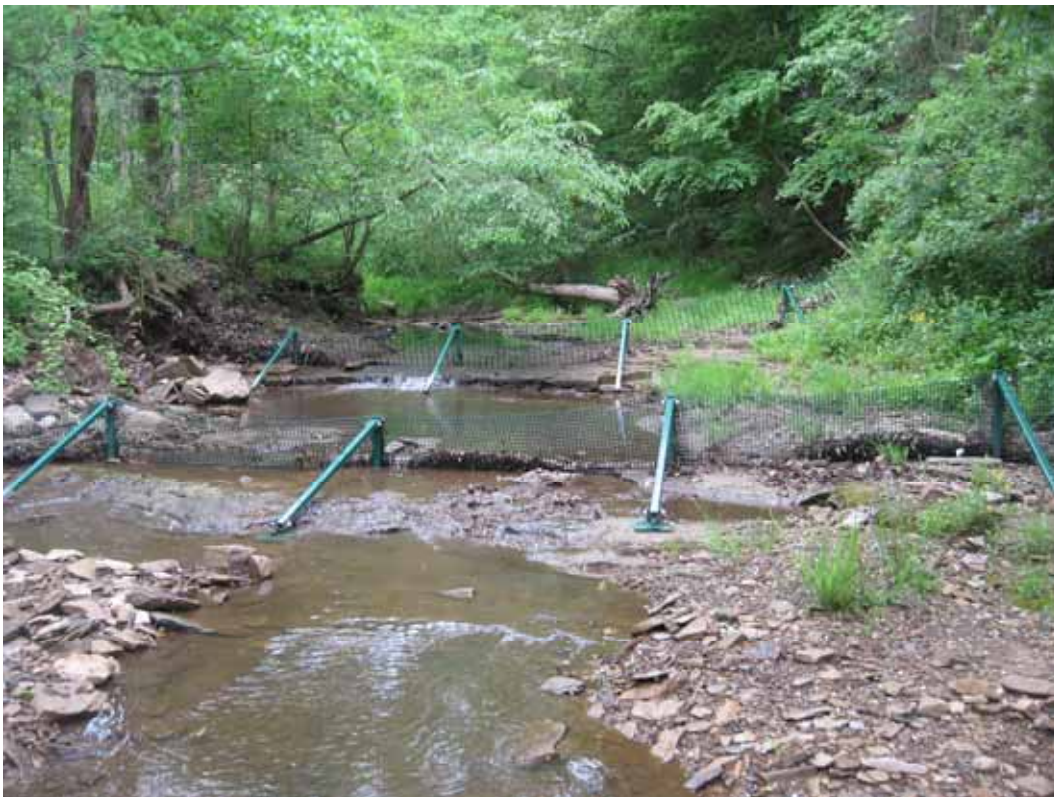
Screens after cleaning and upon departure.

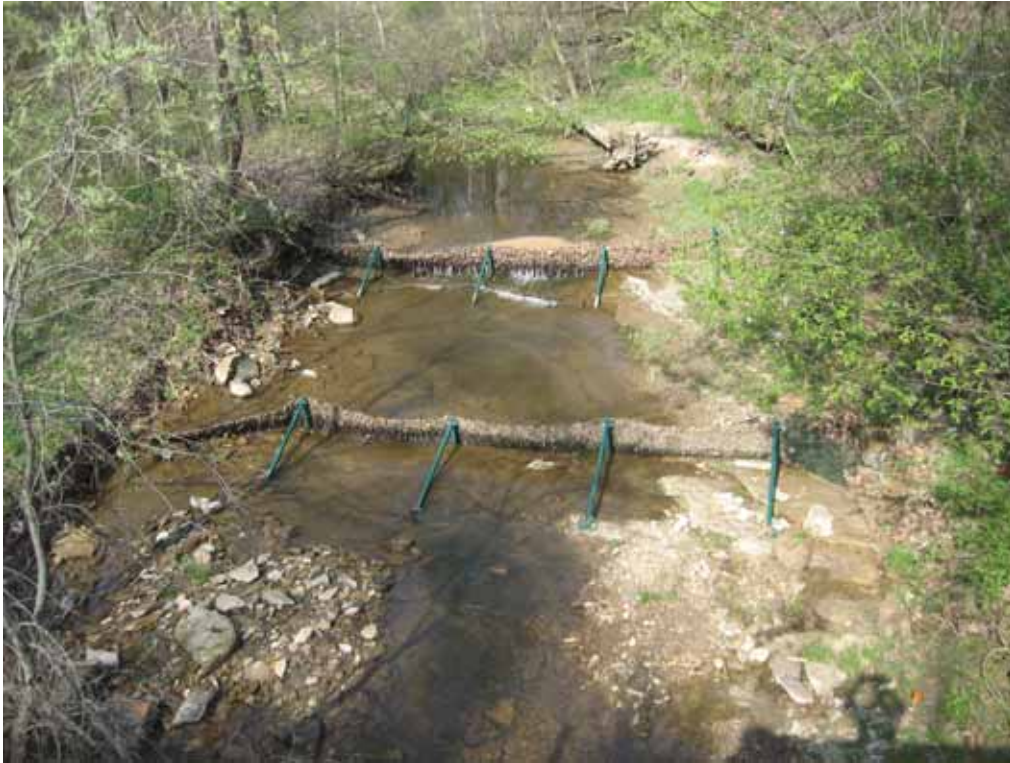
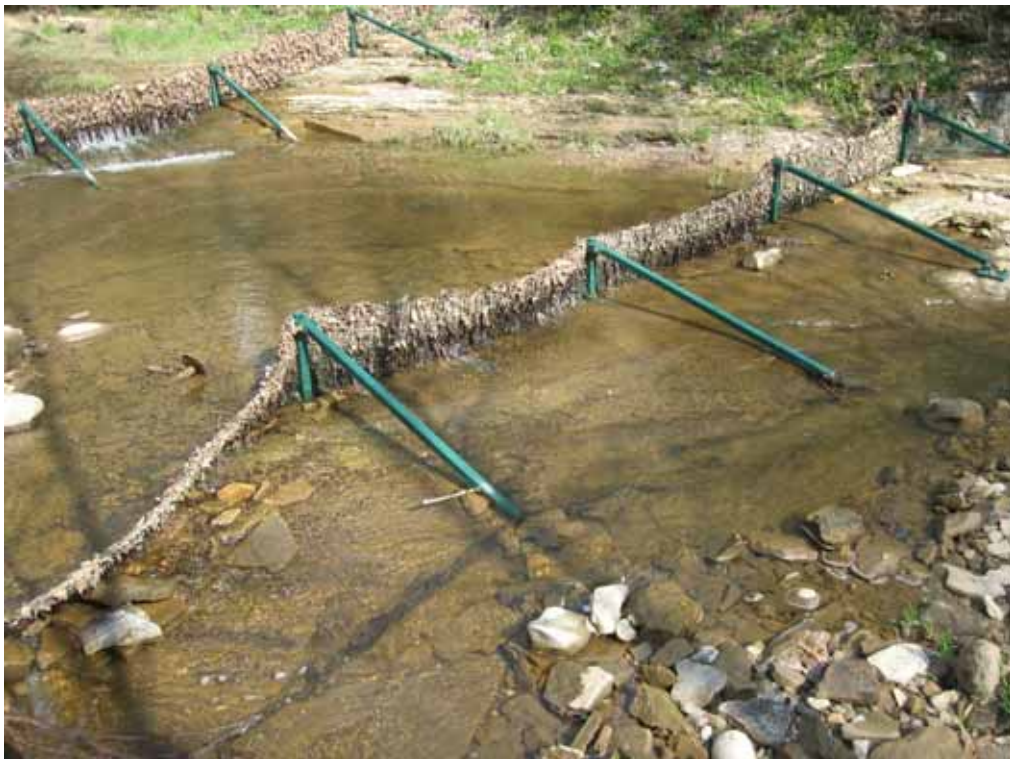
View of barriers upon arrival.

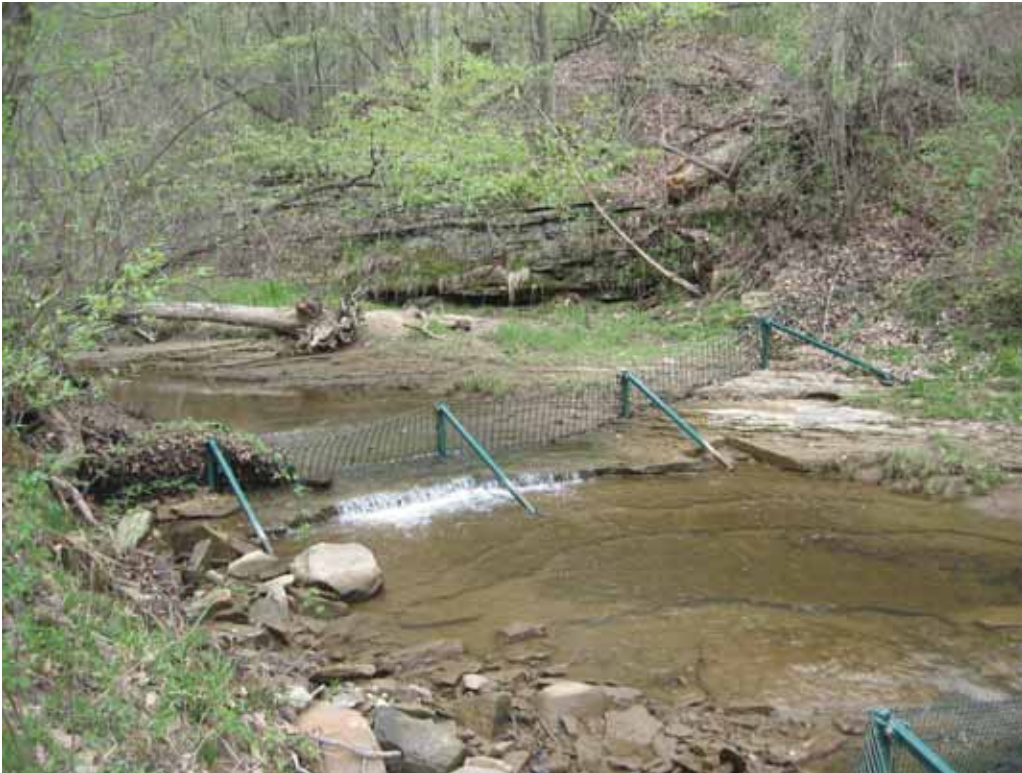
Close-up of top screen after cleaning.

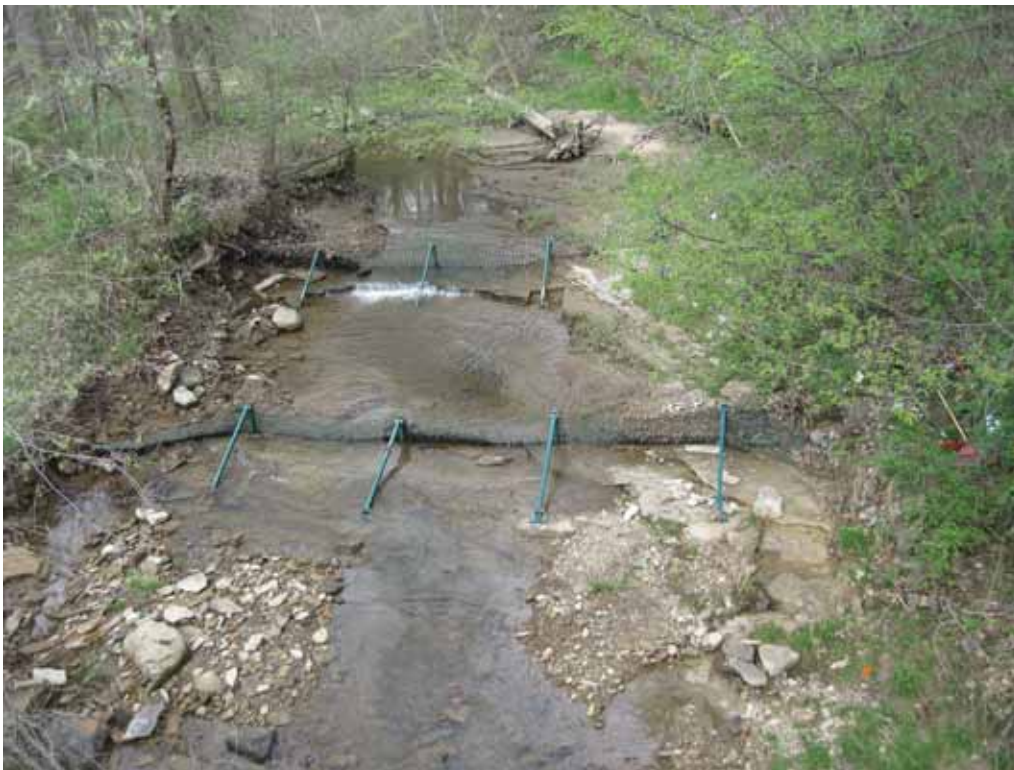
Picture showing both screens after cleaning.

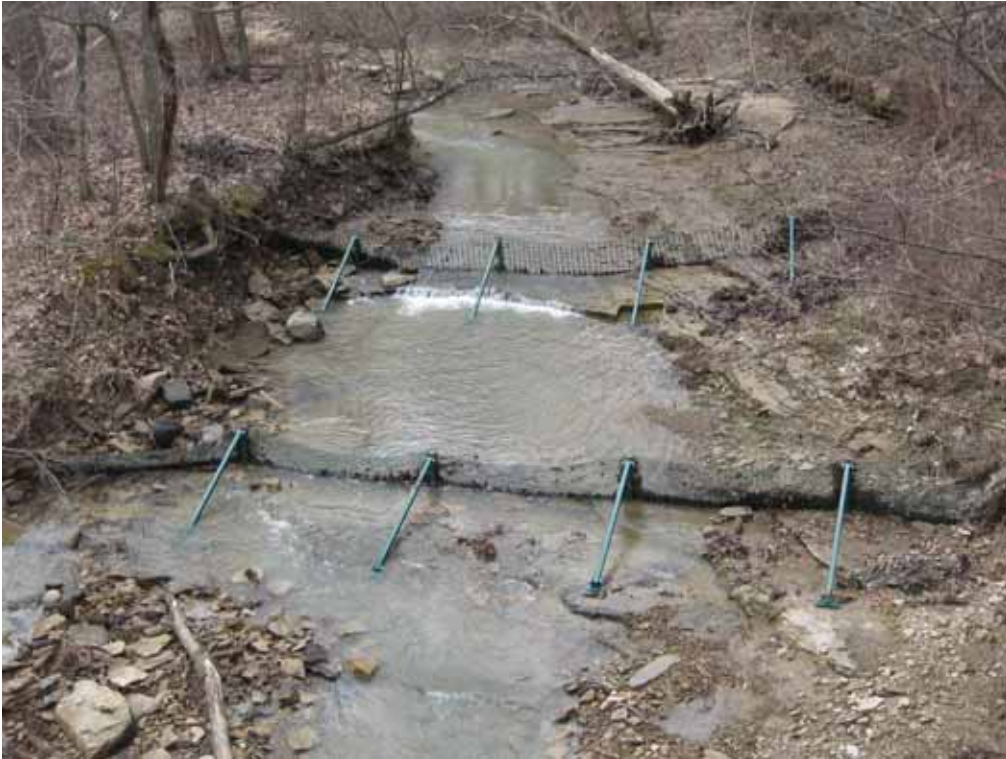
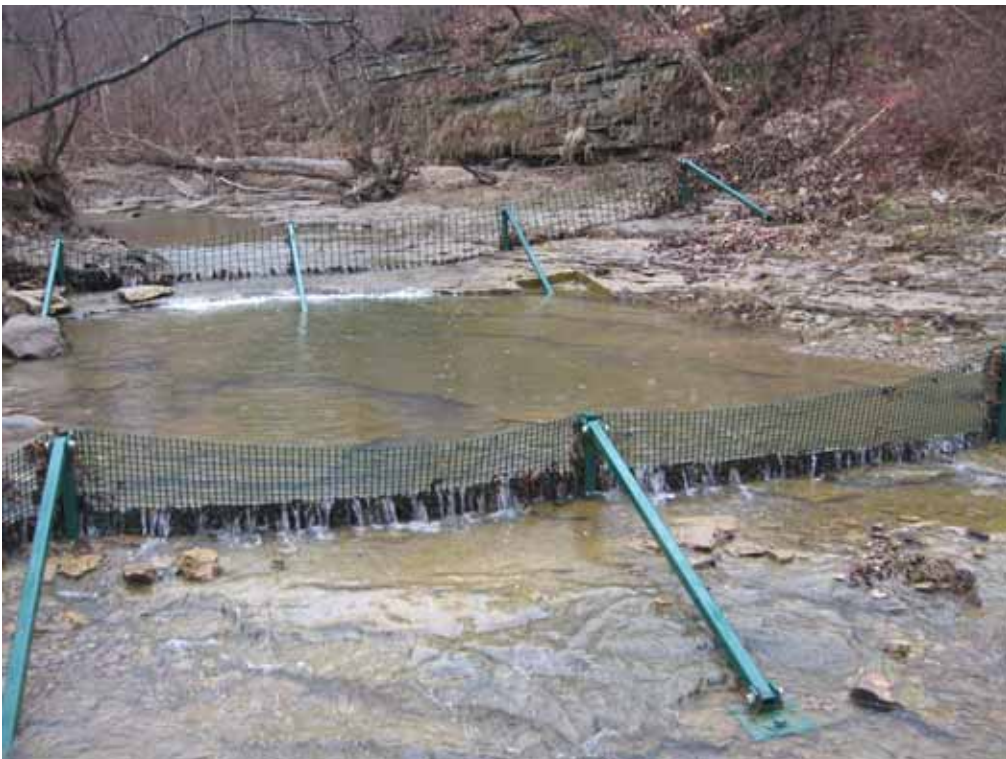
Barrier upon arrival.

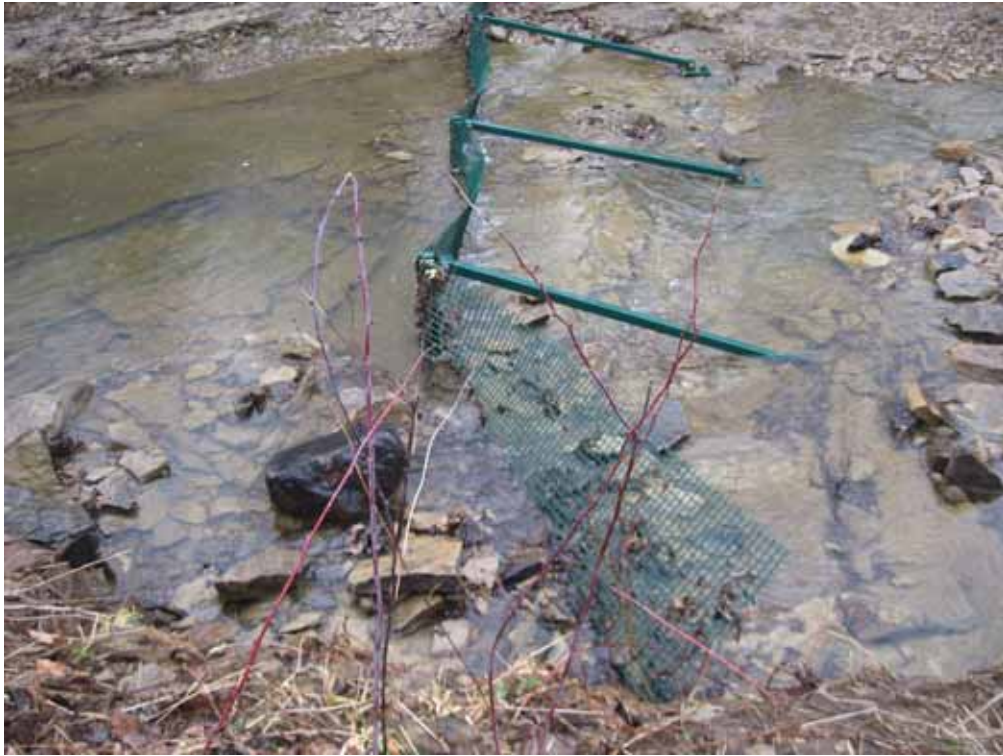
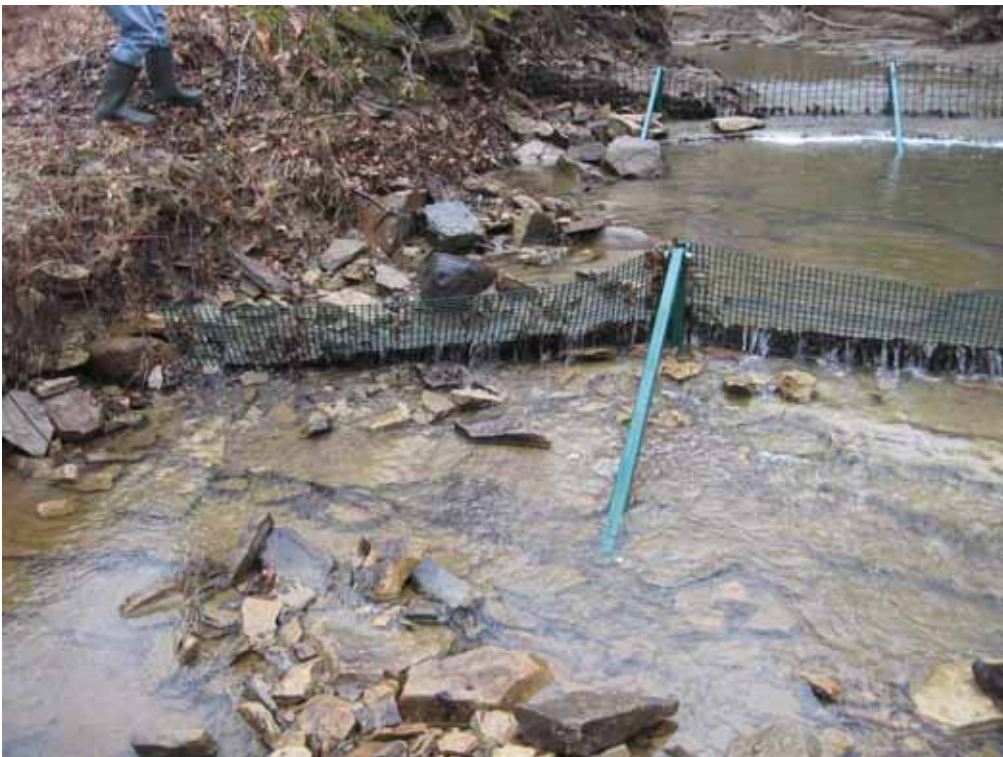
Pictures showing section of bottom screen detached from bank.

Prime Contract No:	E2M-S08-039		Report No.	7
PIKA JOB #:	08-53-134		Date:	03-25-09
Project:	Operation and Maintenance of the Sand Creek Barrier System			
Environmental Conditions:				
Weather Conditions (Bright Sun, Clear, Overcast, Rain, Snow):		Rain		
Temperature:		40°		
Wind (Still, Moderate, High):		Moderate		
Humidity (Dry, Moderate, Humid):		Moderate		
Project:	Operation and Maintenance of the Sand Creek Barrier System			
Field Activities:				
Description of debris inspection & removal activities: Removed small amount of leaves sticks and mud from barrier. No MEC/MD found.				
Barrier Integrity: The upstream screen panels are bowed but the barrier is operable. The downstream barrier needs repairs: the south panel has detached from the bank and the north panel is no longer keyed tightly into the bank.				
Assessment of any changes since previous visit: See above.				
Repairs made or need to be made: The gap between south screen panel and bank was filled with rocks to about 10-12 inches above creek bottom. PIKA will tighten the bolts on all posts. E2M will coordinate the repairs to the barrier system.

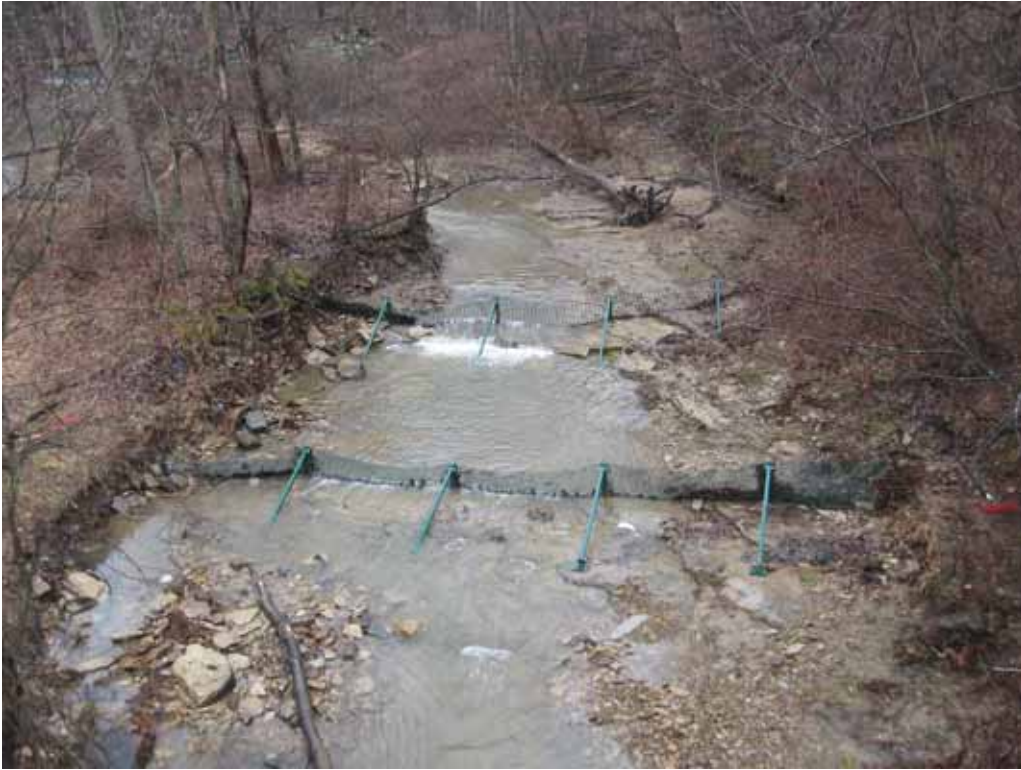
Barrier upon departure

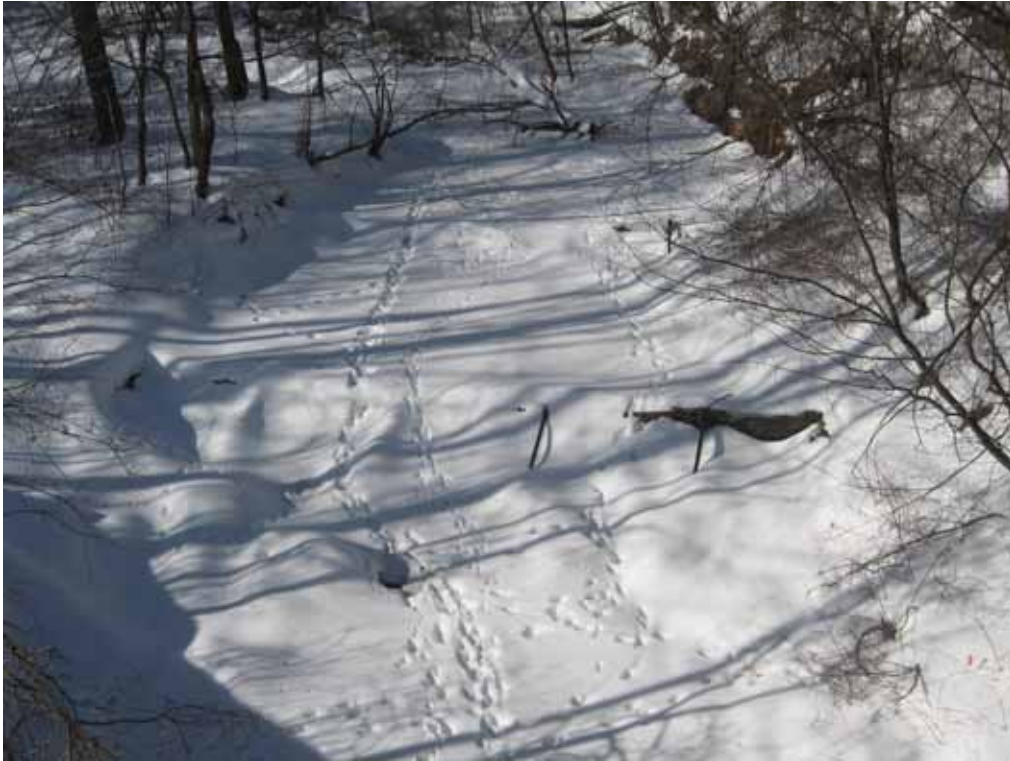
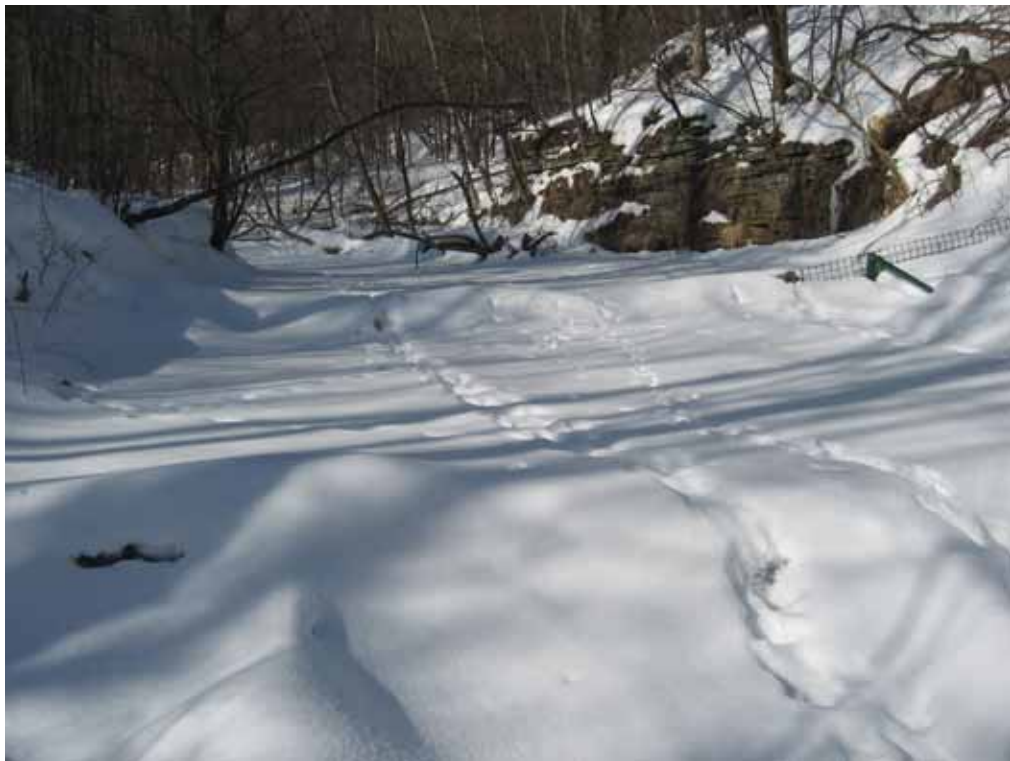
Barriers upon Arrival

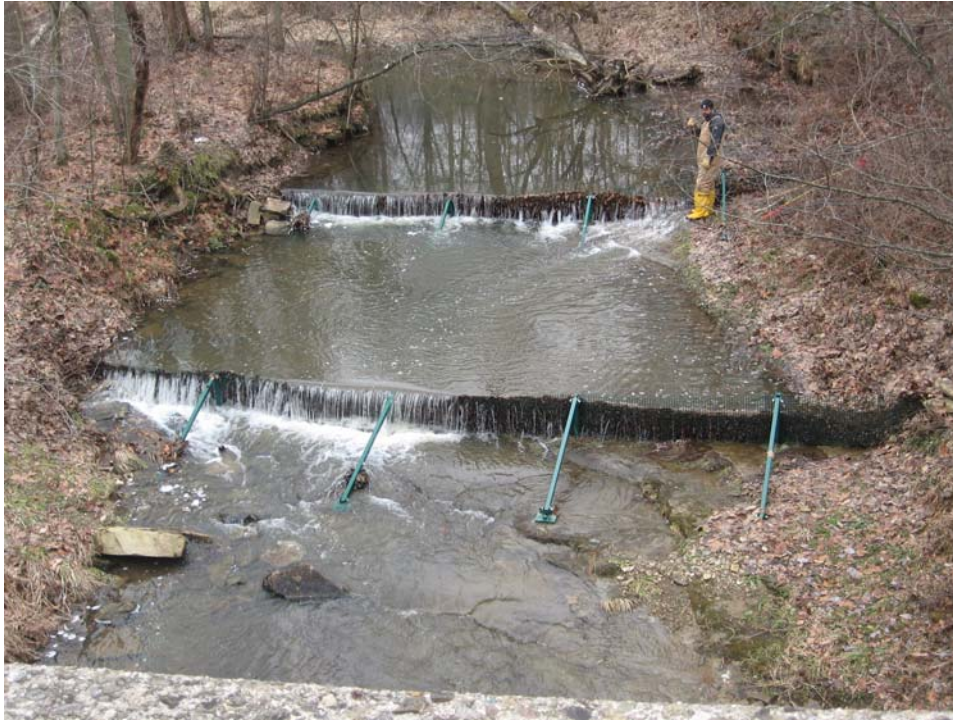
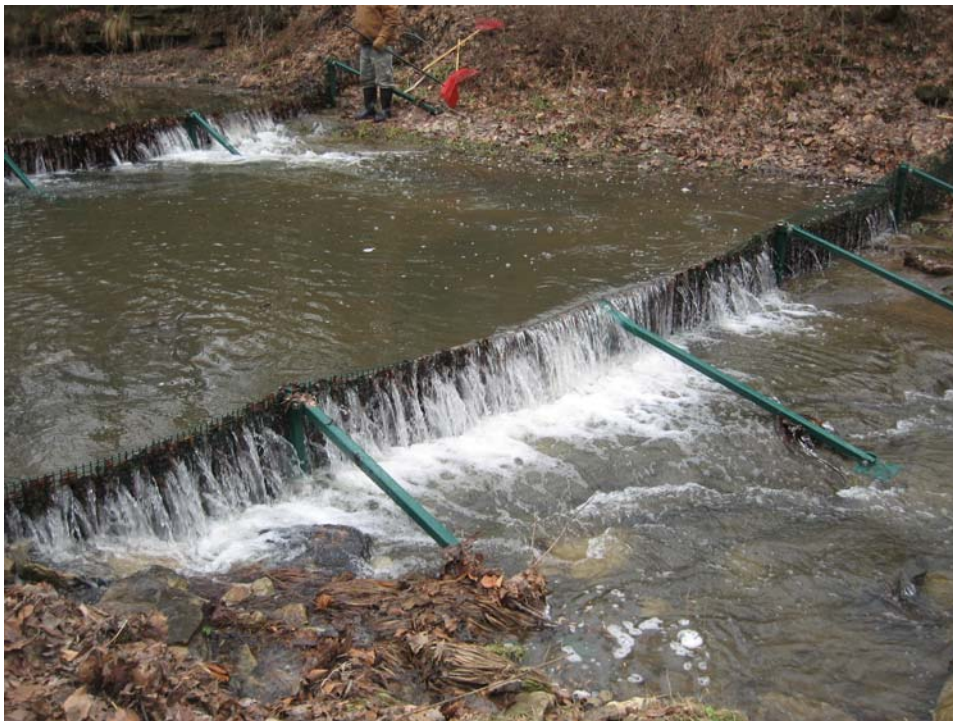
Overview of Screens upon arrival

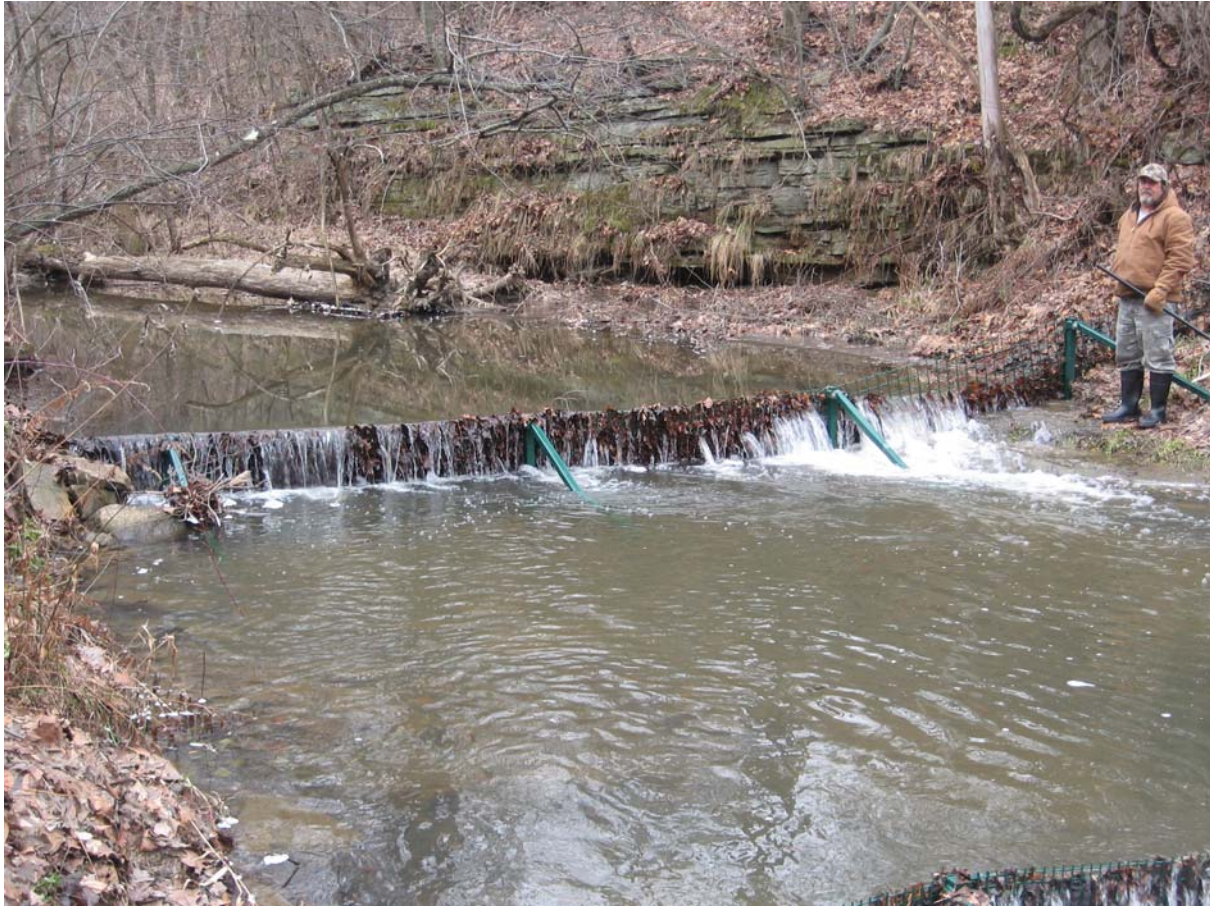
Overview of Screens upon arrival
