**Time Critical Response Action for the
Rocket Ridge Area of Open Demolition Area #2
(RVAAP-004-R-01 Open Demolition Area #2 MRS)
Military Munitions Response Program
Ravenna Army Ammunition Plant
Ravenna, Ohio**

**OPERATIONS AND MAINTENANCE TRIP PREPORTS
and QUARTERLY EFFECTIVENESS EVALUATION REPORTS**

**TIME CRITICAL RESPONSE ACTION for the
ROCKET RIDGE AREA OF OPEN DEMOLITION AREA #2
(RVAAP-004-R-01 Open Demolition Area #2 MRS)**

**MILITARY MUNITIONS RESPONSE PROGRAM
RAVENNA ARMY AMMUNITION PLANT
RAVENNA, OHIO**

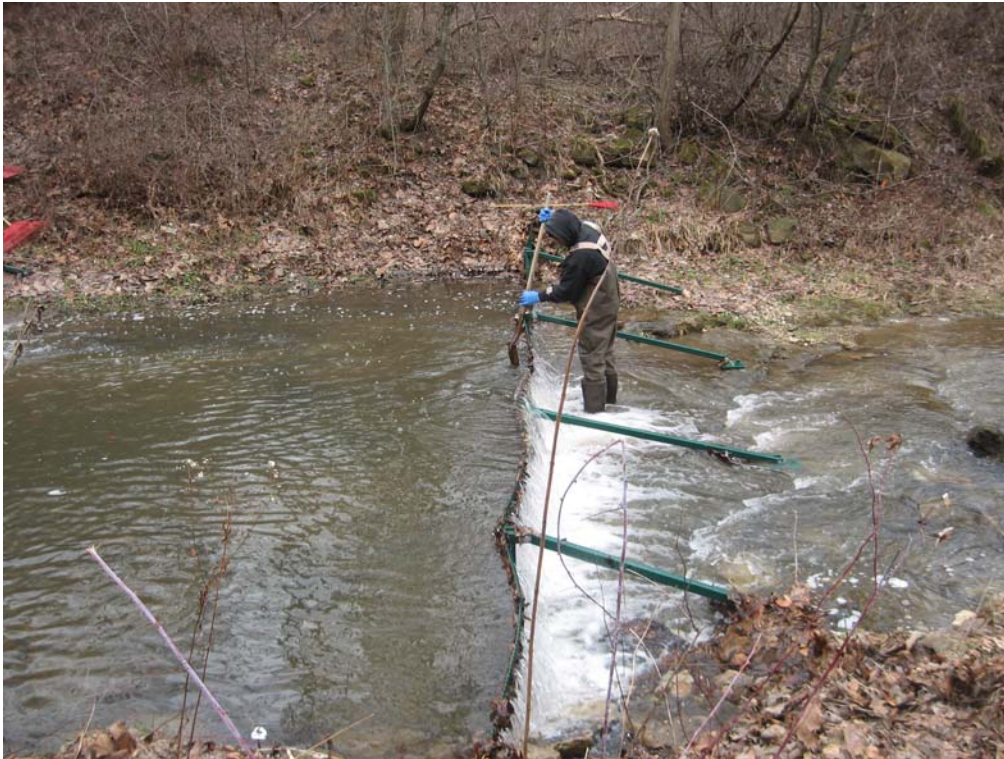
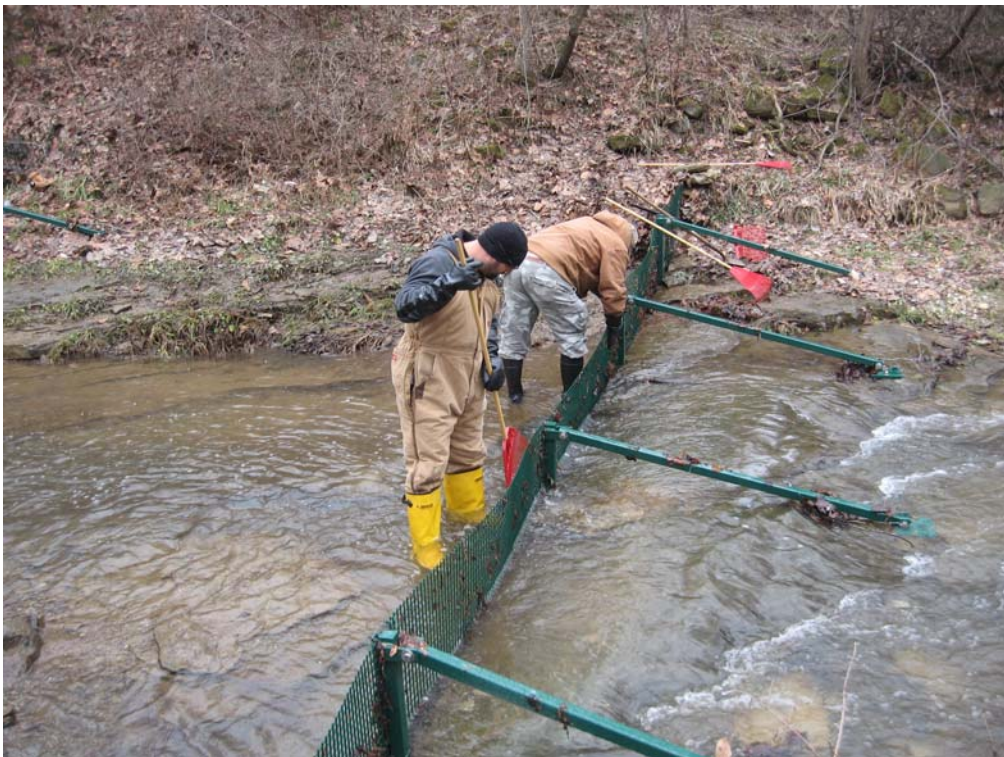
Cleaning Screens

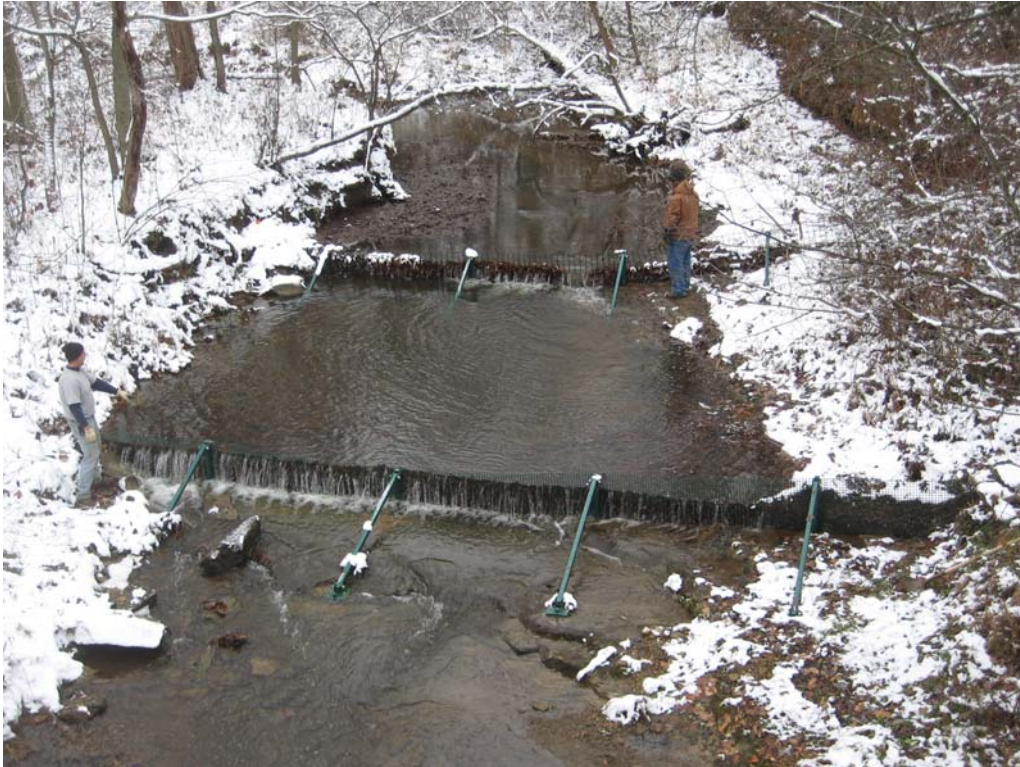
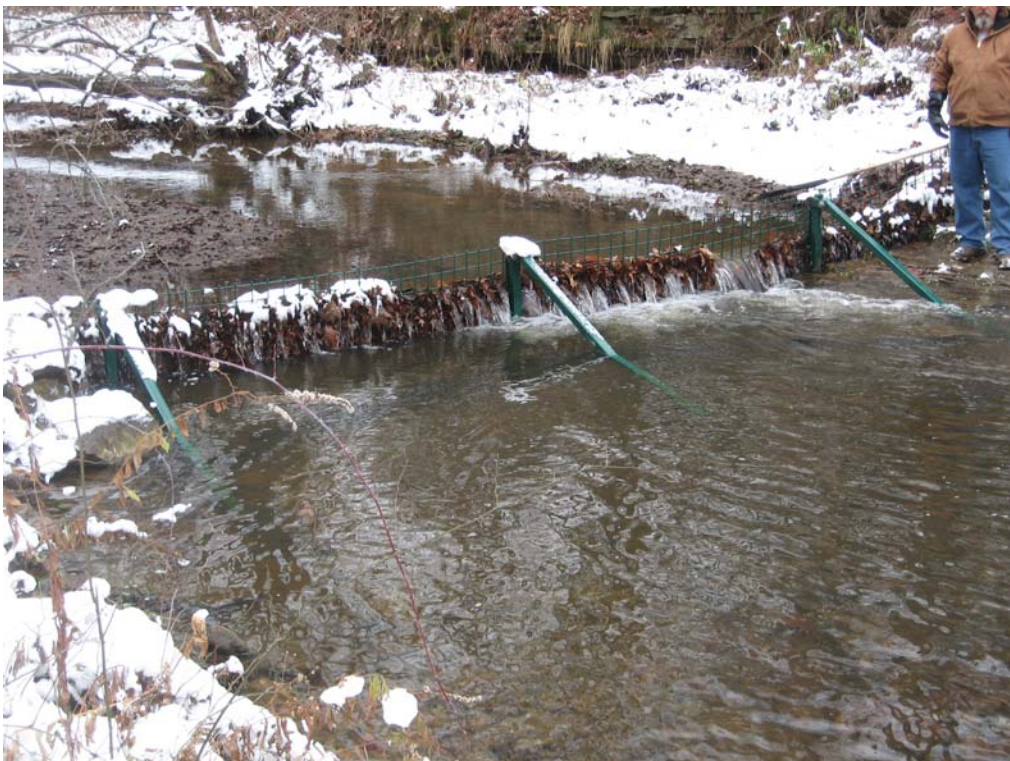
Overview of barrier upon arrival

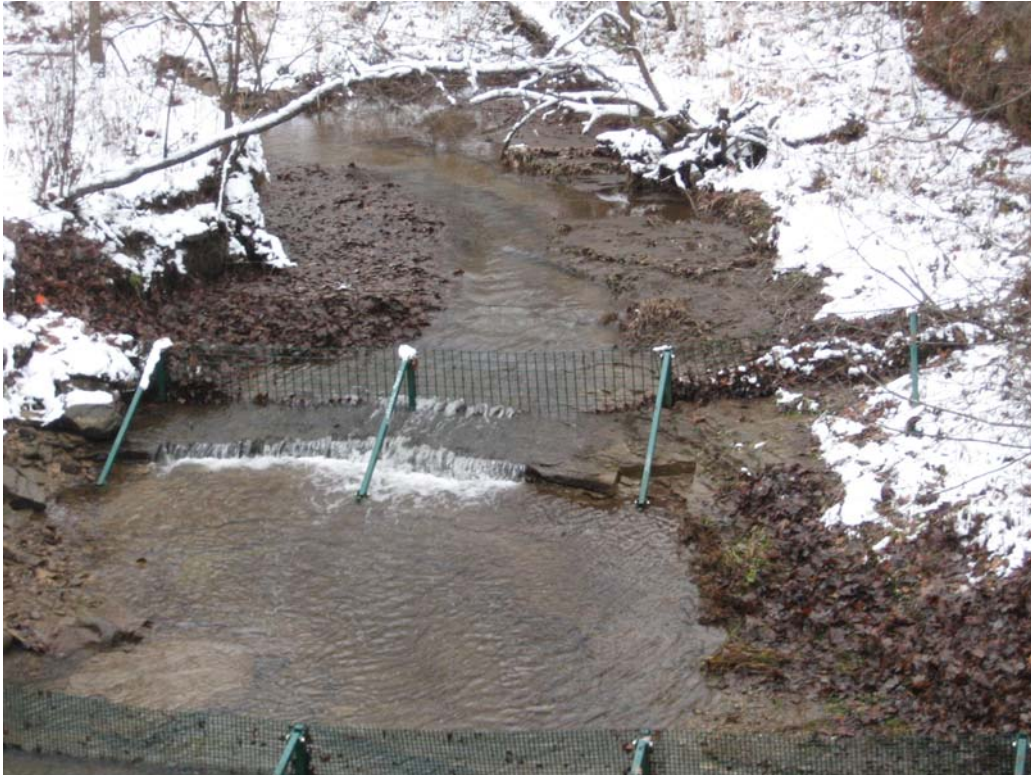
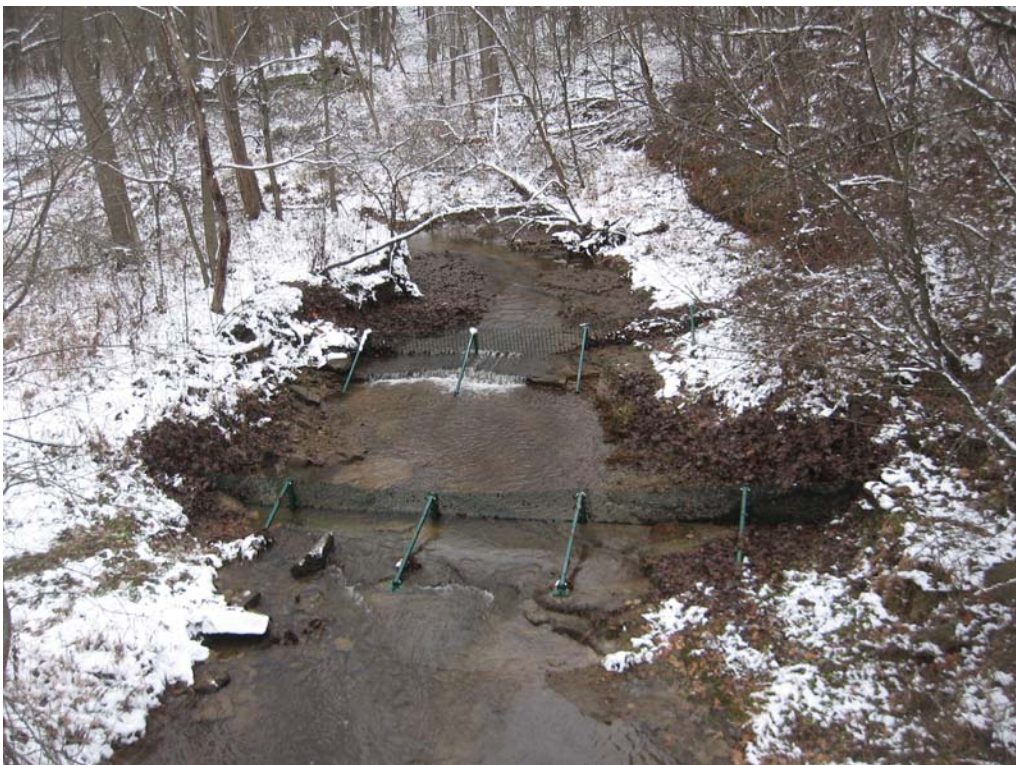
Overview of barriers before demobilization

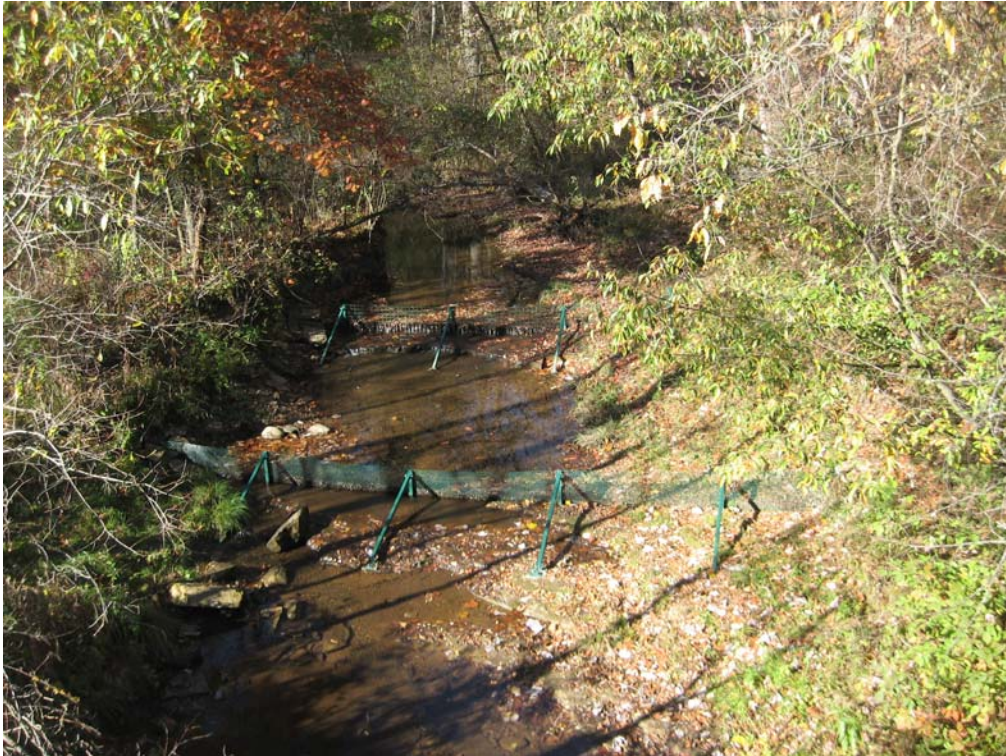
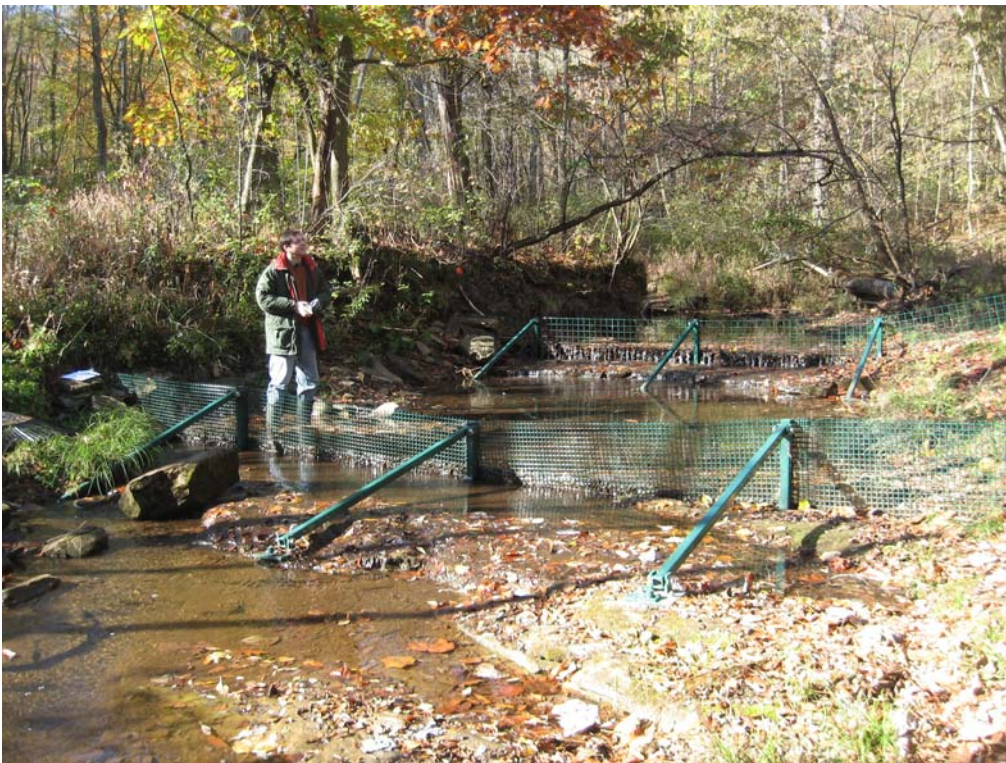
Overview of Screens upon arrival

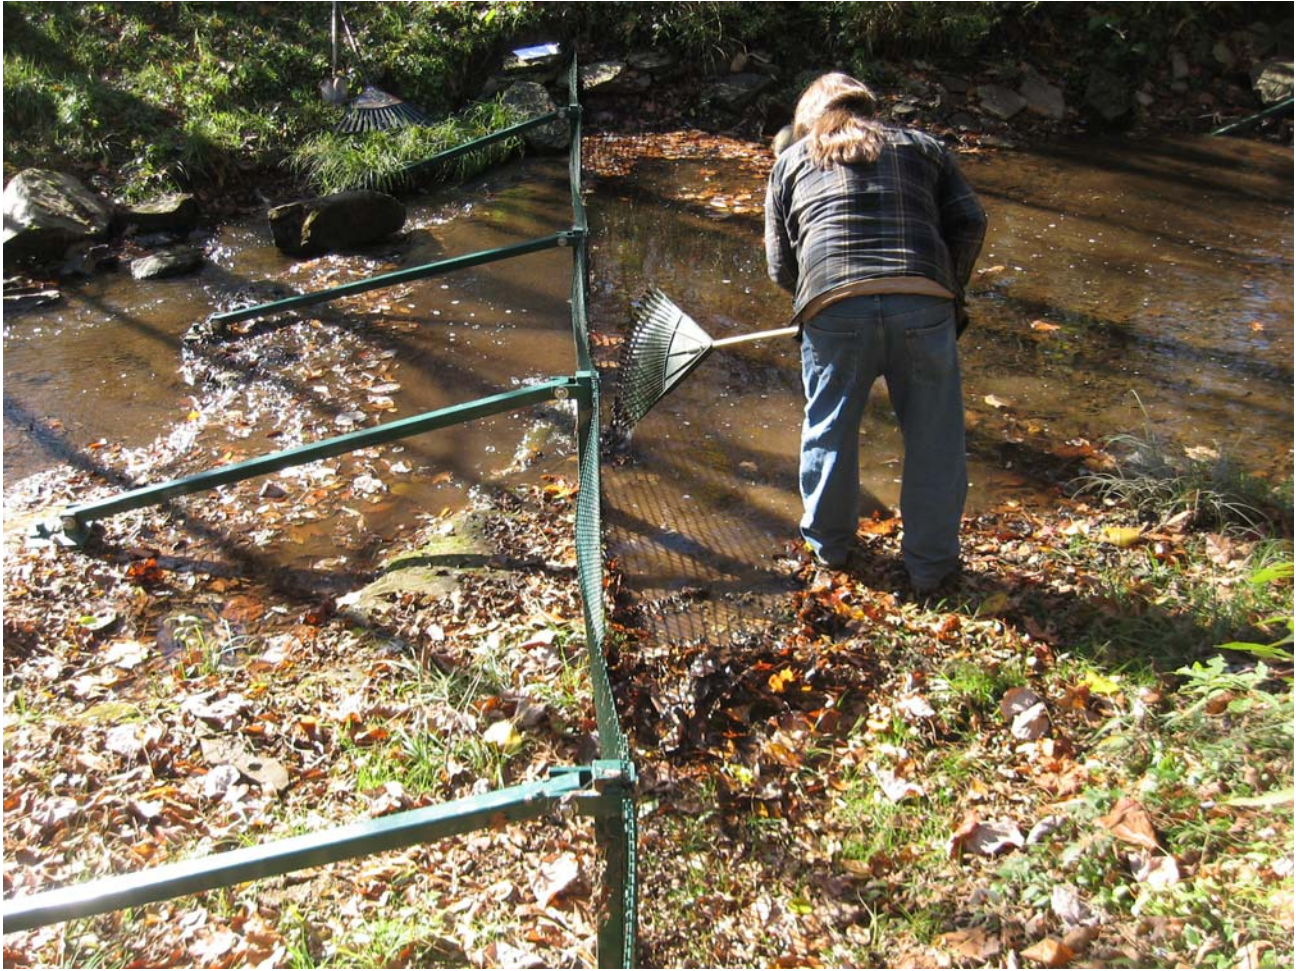
Cleaning Screen

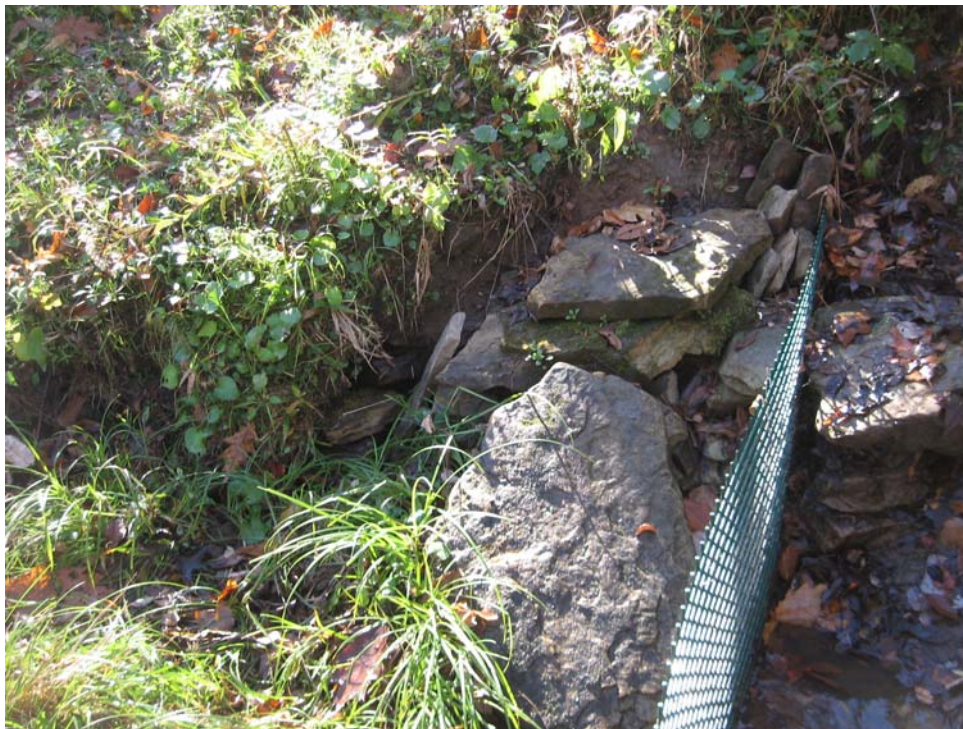
Washout area at barrier

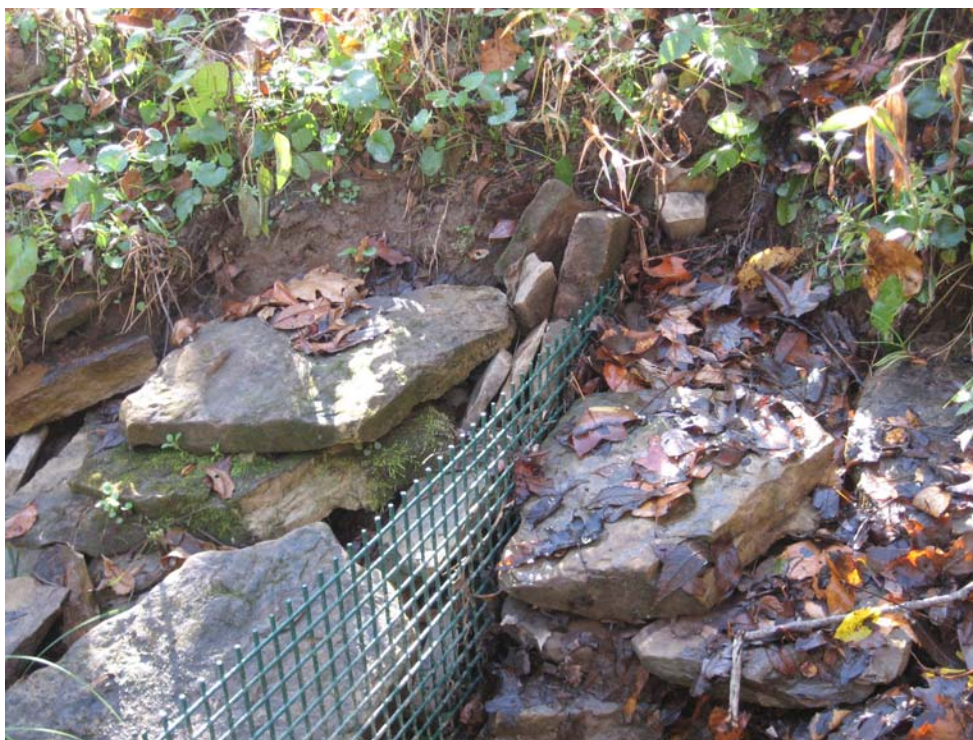
Washout area reinforced with rocks

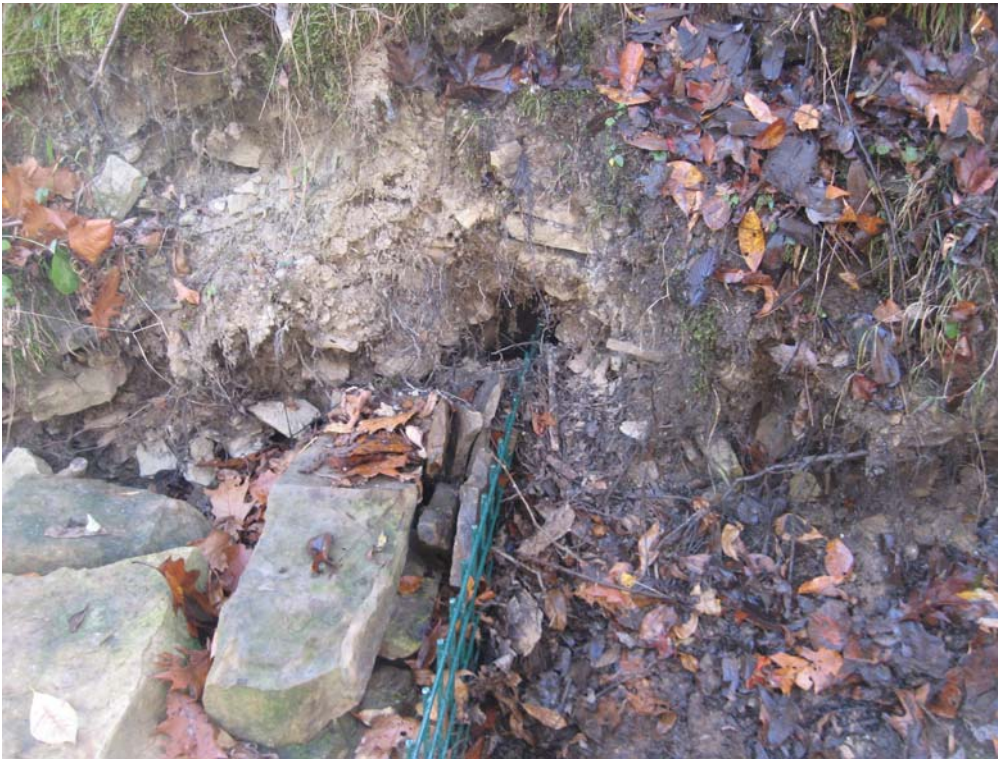
Washout area at barrier

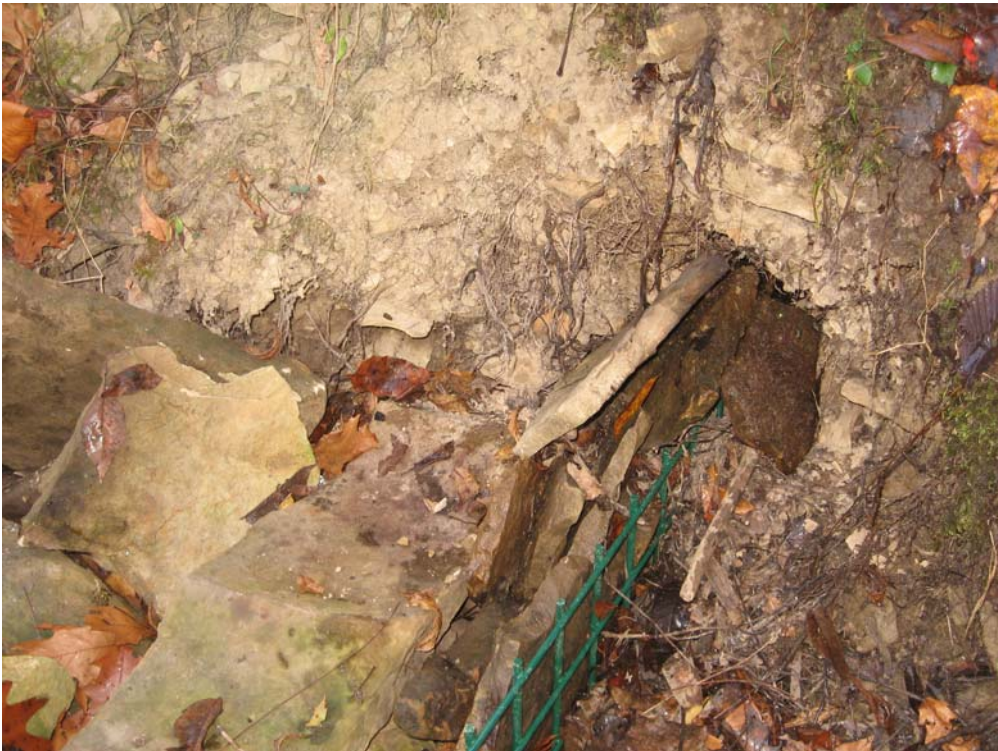
Washout area reinforced with rocks

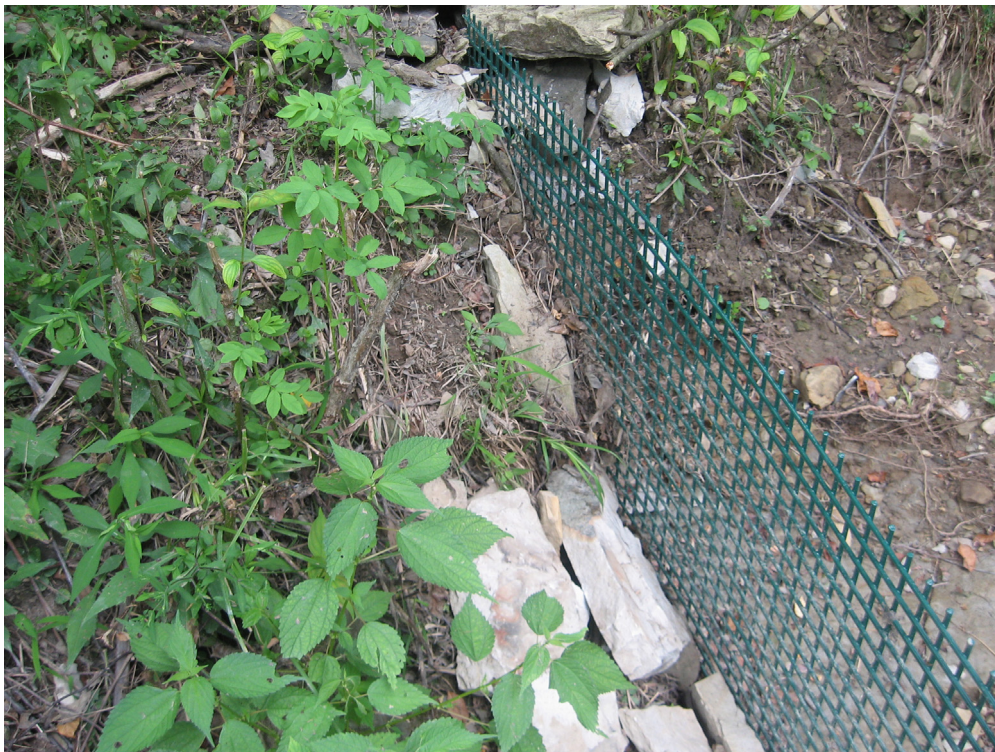
Washout area reinforced with rocks

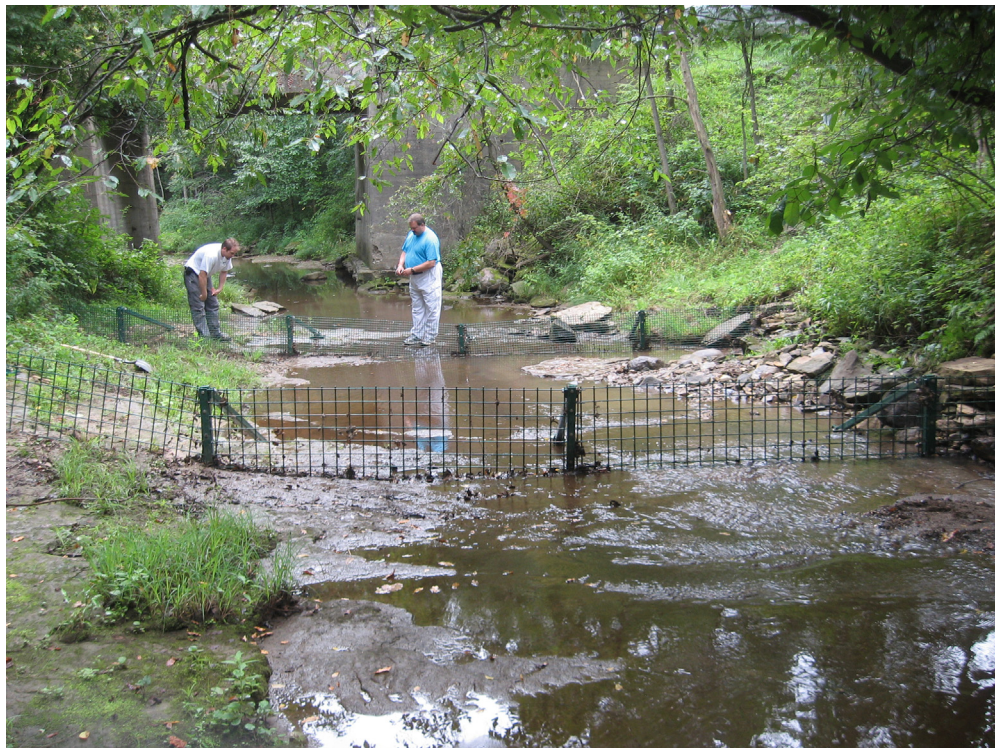
Ohio EPA inspection of Sand Creek Barrier

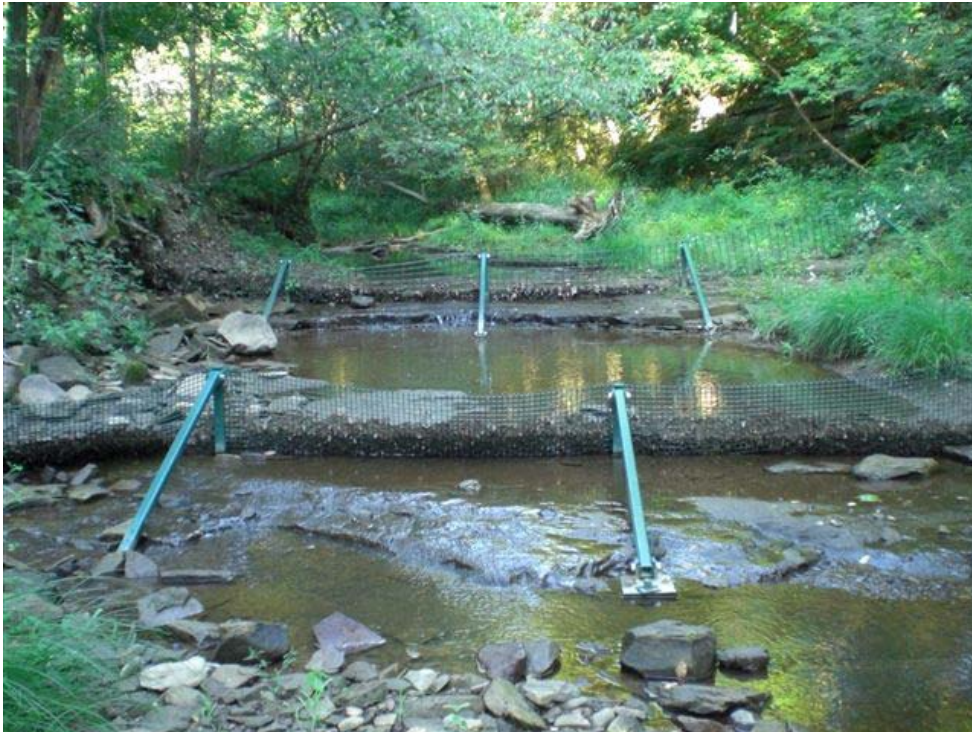
Materials found on the screens: Leaves, branches, sticks, sand and gravel. No munitions-related materials were found at the barrier (see Photo #1 in Attachment 1).

Photo 1: Sand Creek Barrier System (2 September 2009, before O&M)

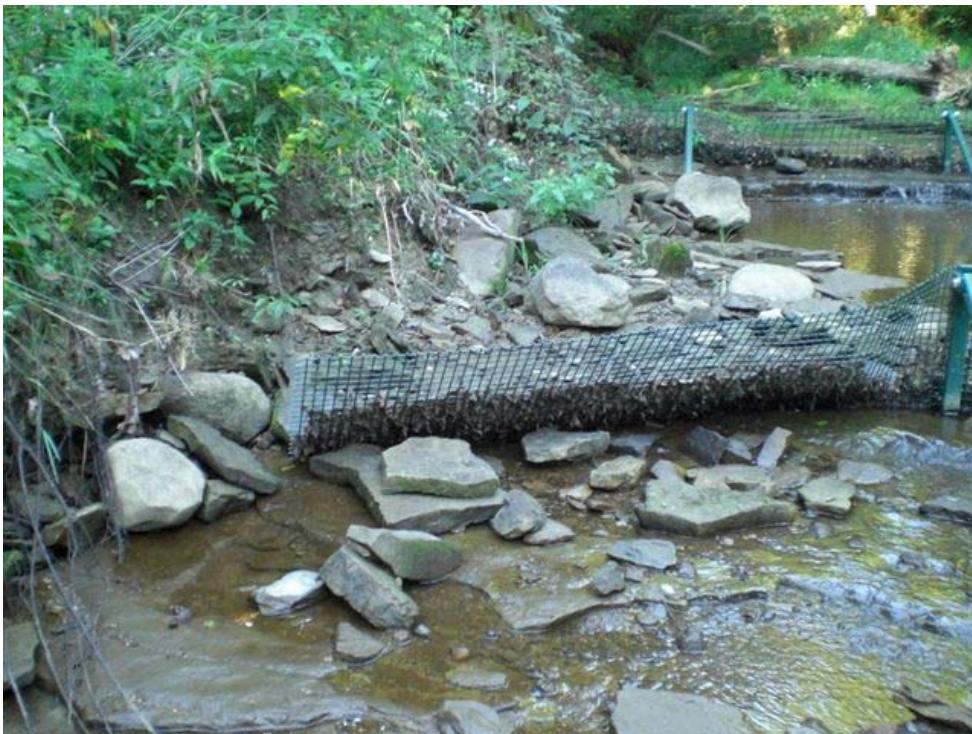
Downstream (1-inch grid) barrier: All posts and back braces were intact. The end panels had detached from the creek banks (see Photos #2 and #3). The tops of the panels were bowed in the direction of the water flow. Sand and gravel, approximately 2-3 inches deep, had accumulated in front of the third panel from the south.

Photo 2: Downstream barrier, south end panel (2 September 2009, before O&M)

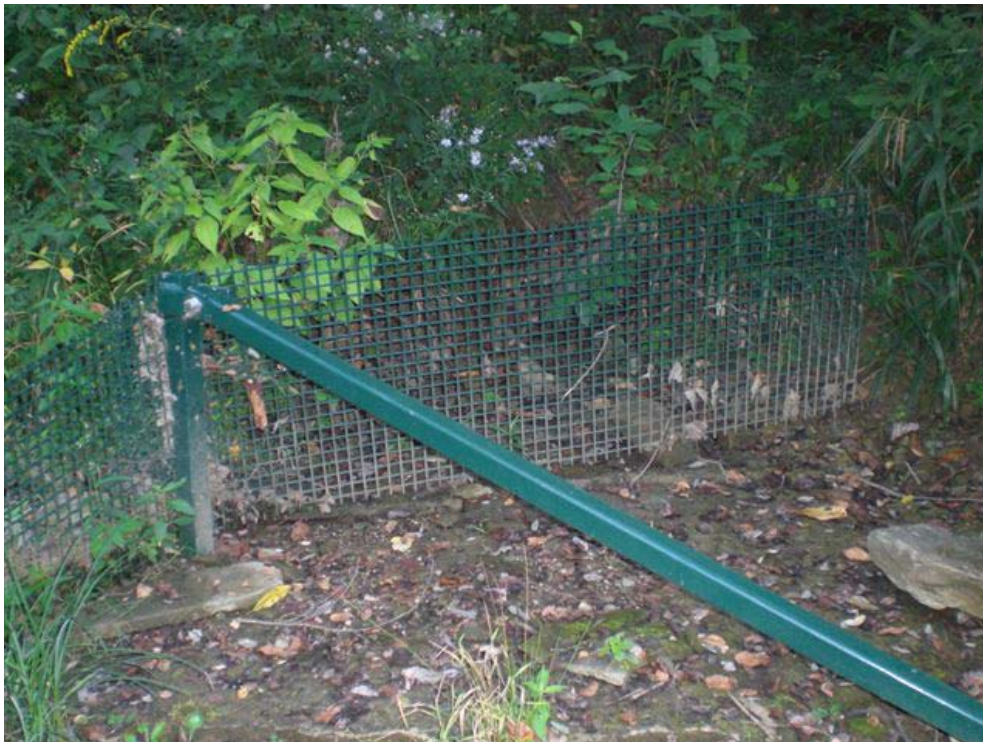
Photo 3: Downstream barrier, north end panel (2 September 2009, before O&M)

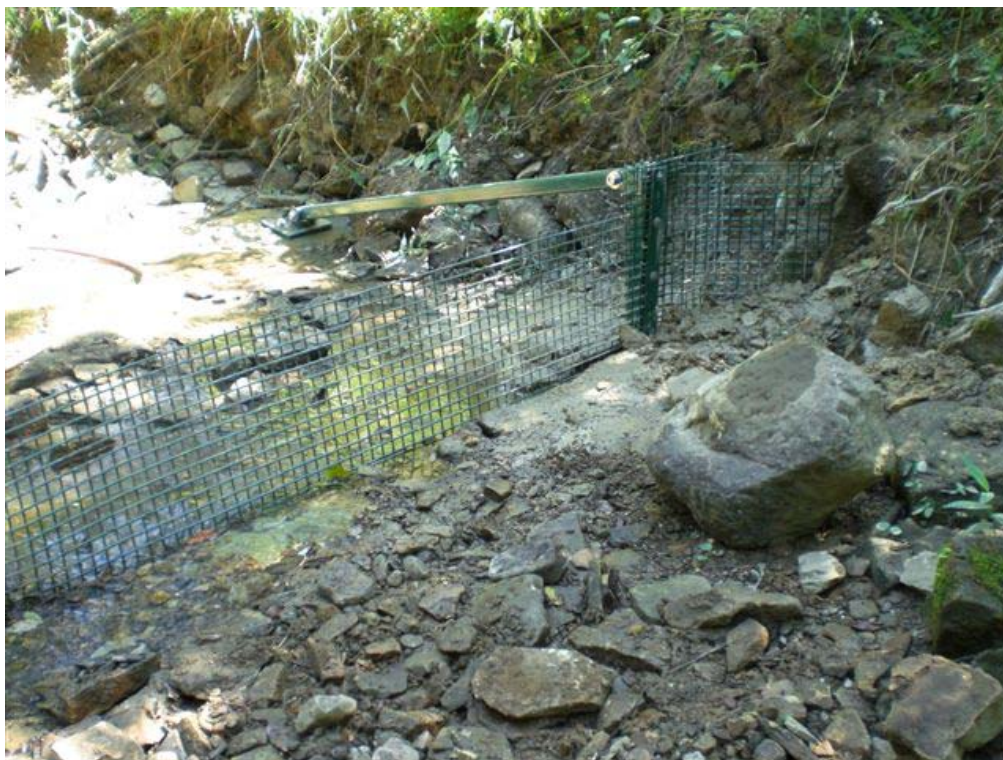
Photo 4: New post and panel at south end of downstream barrier (2 September 2009)

- One new post and back brace were installed at the south end of the downstream barrier. The new post is approximately 6.5 feet south of the next post. The screen panel that was detached from the creek bank was attached to the new post. A new panel was installed and keyed into the bank in front (upstream) and at 45 degrees to the barrier line (see Photo #4).

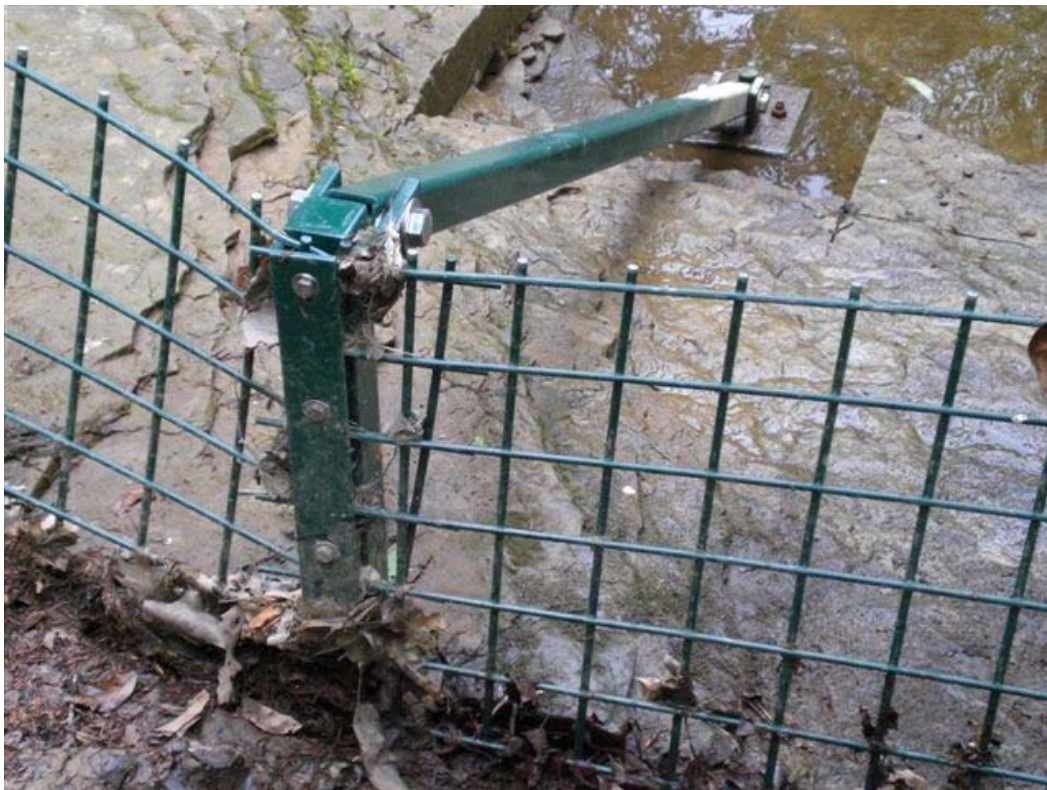
Upstream (3-inch grid) barrier: All posts and back braces are intact (see Photo #2). All barrier elements are in place and there are no gaps between the screen panels and creek bed and banks. The ends of the top two horizontal wires of the second panel from the south have detached from the post clamping system (see Photo #3). The tops of the panels are bowed in the direction of the water flow.

Photo 2: Upstream barrier, post and back brace (27 May 2009)

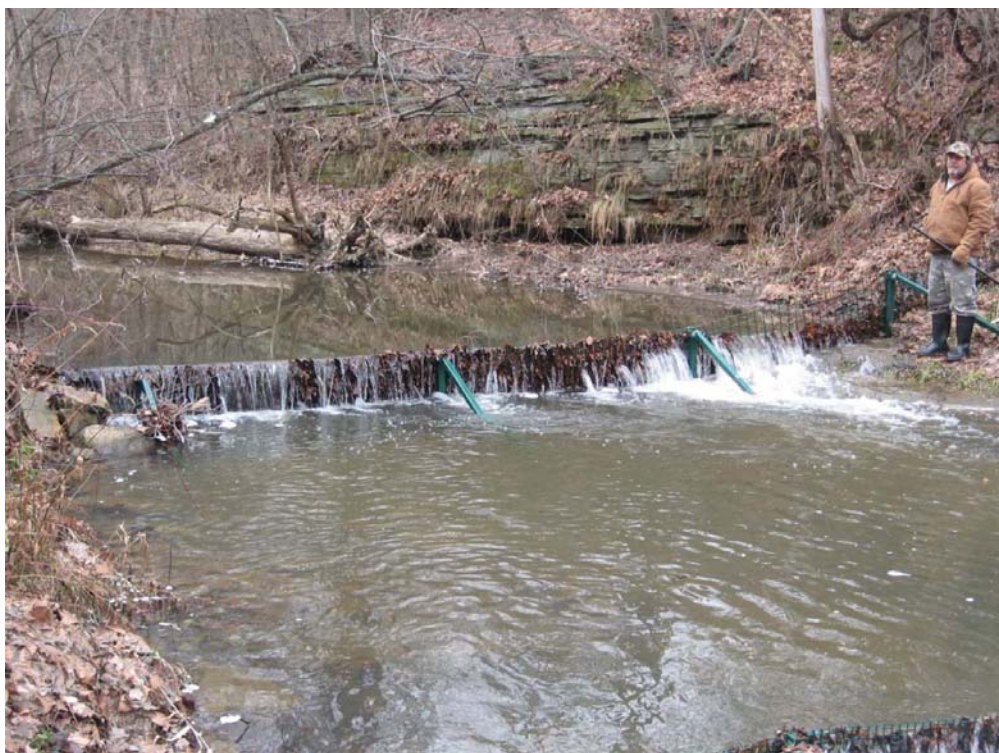
Photo 1: Upstream barrier loaded with leaves (12 December 2008)

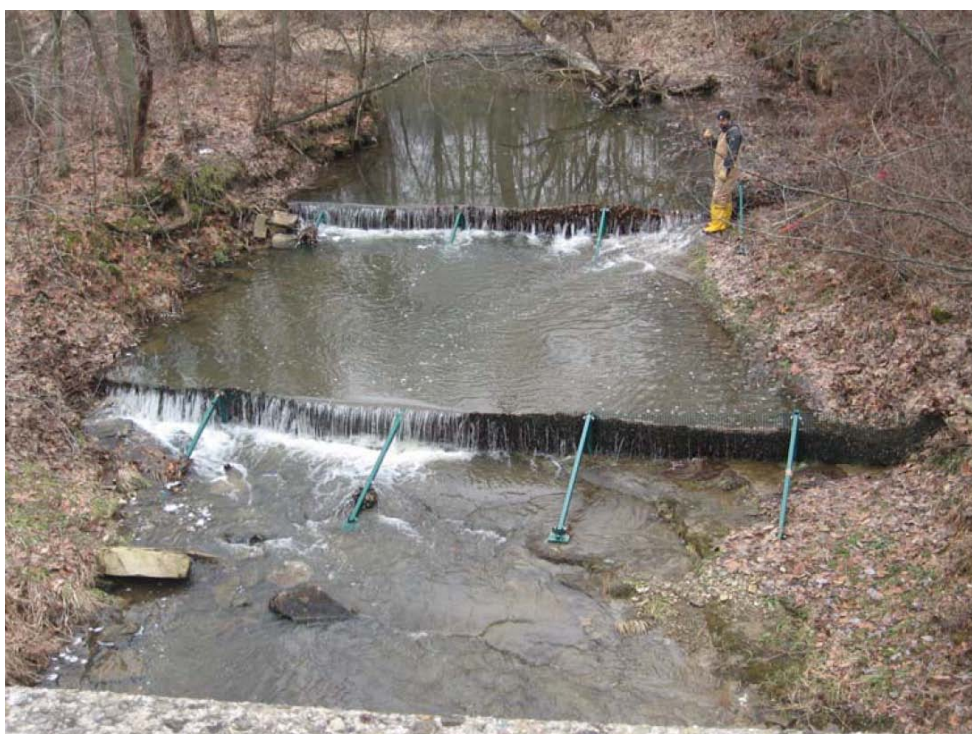
Photo 2: Water overflowing the barriers (12 December 2008)

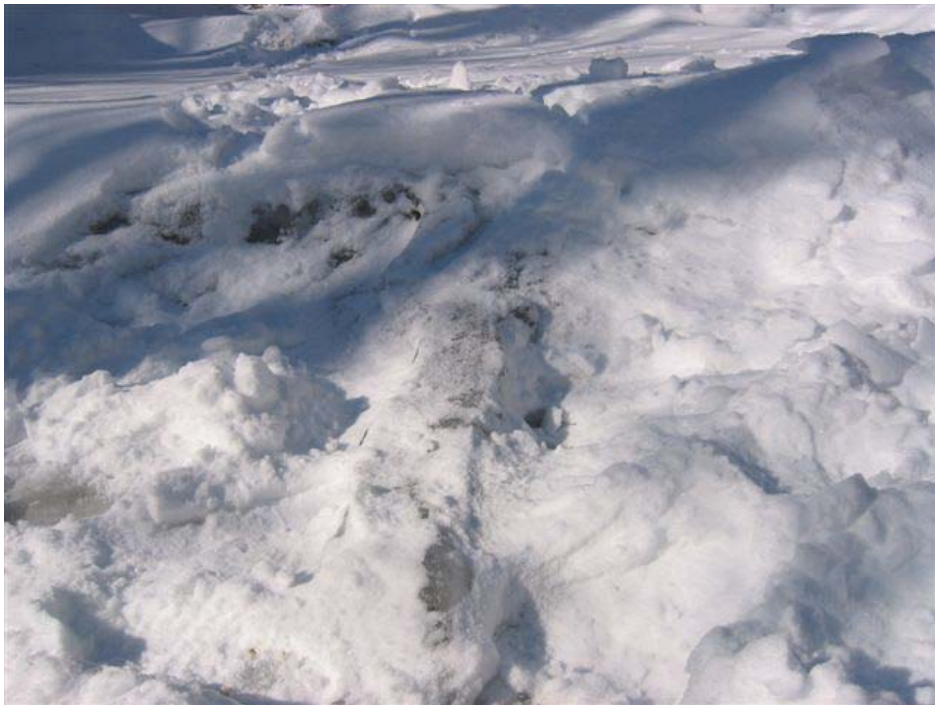
Photo 3: Screen and back brace encased in ice (5 February 2009)

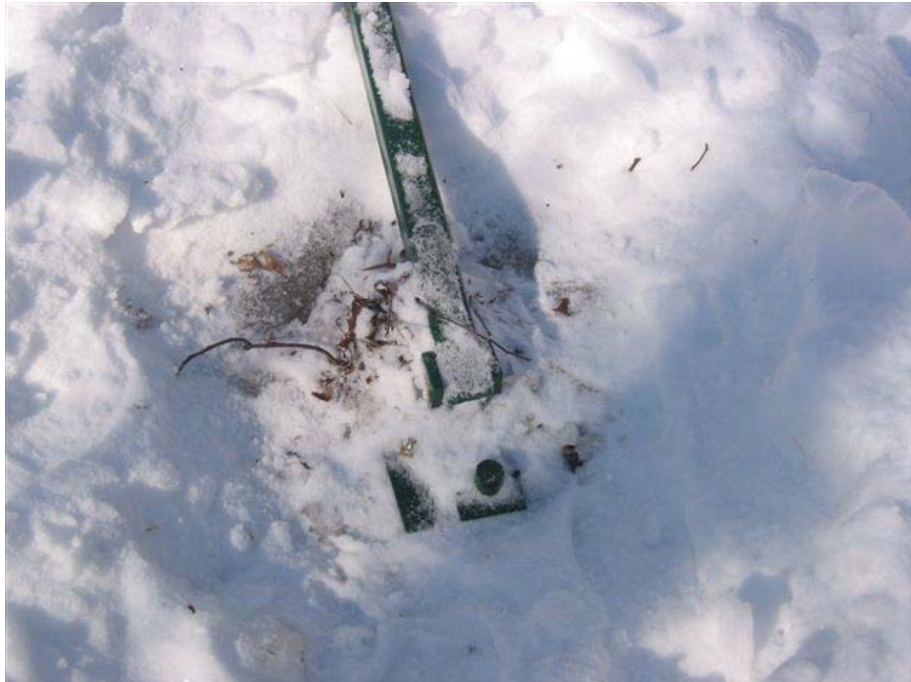
Photo 4: Base plate (12 December 2008)

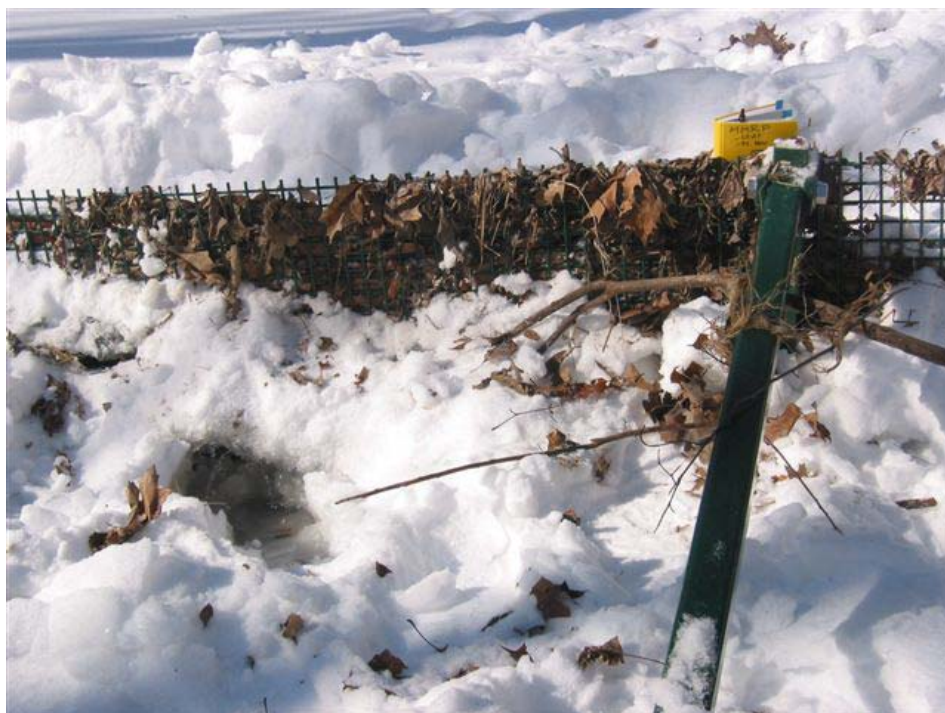
Photo 5: Post, back brace, and screen (12 December 2008)

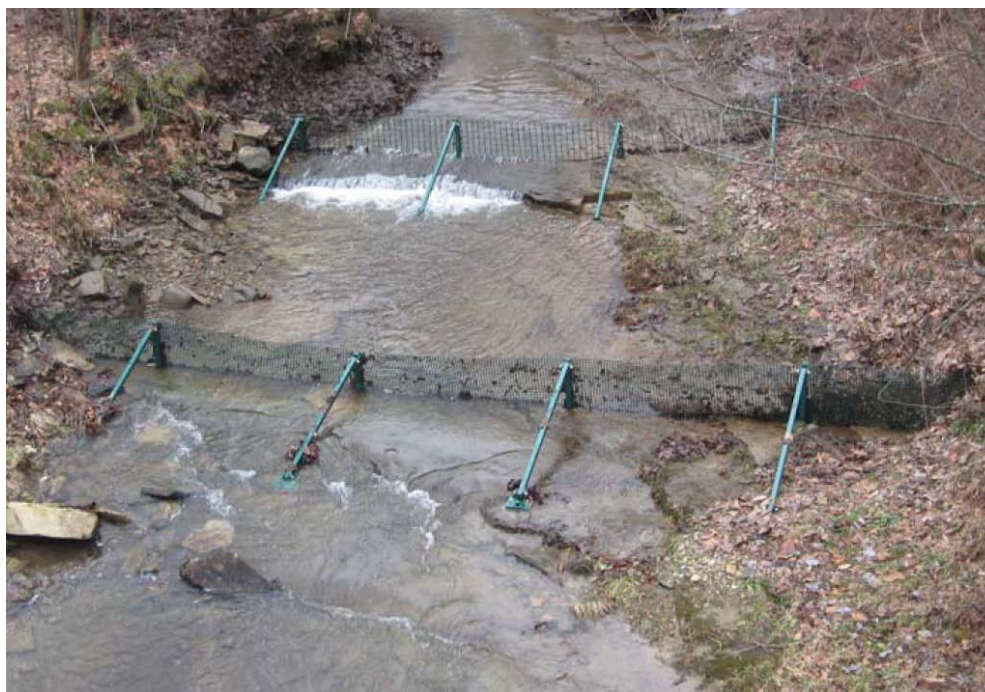
Photo 6: Barrier System after the 16 December 2008 O&M cleaning

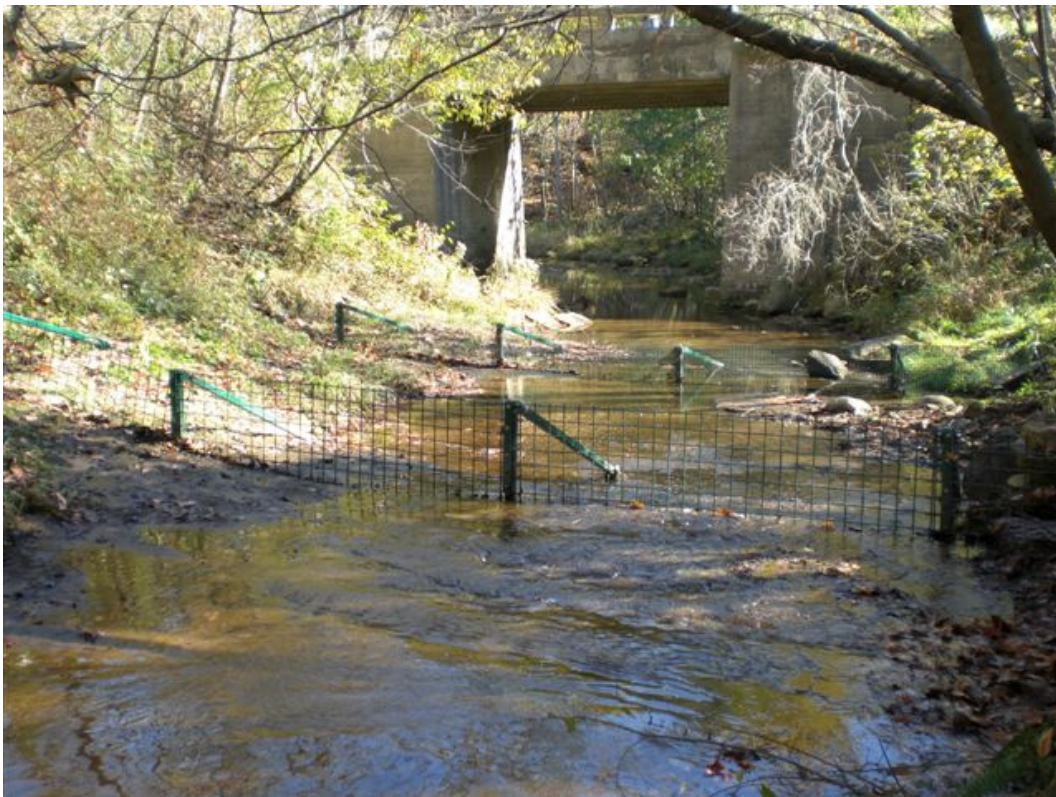
In the first three months of operation, the Barrier System has effectively performed as designed (Photos 6 and 7).

Photo 6: Barrier System, looking downstream

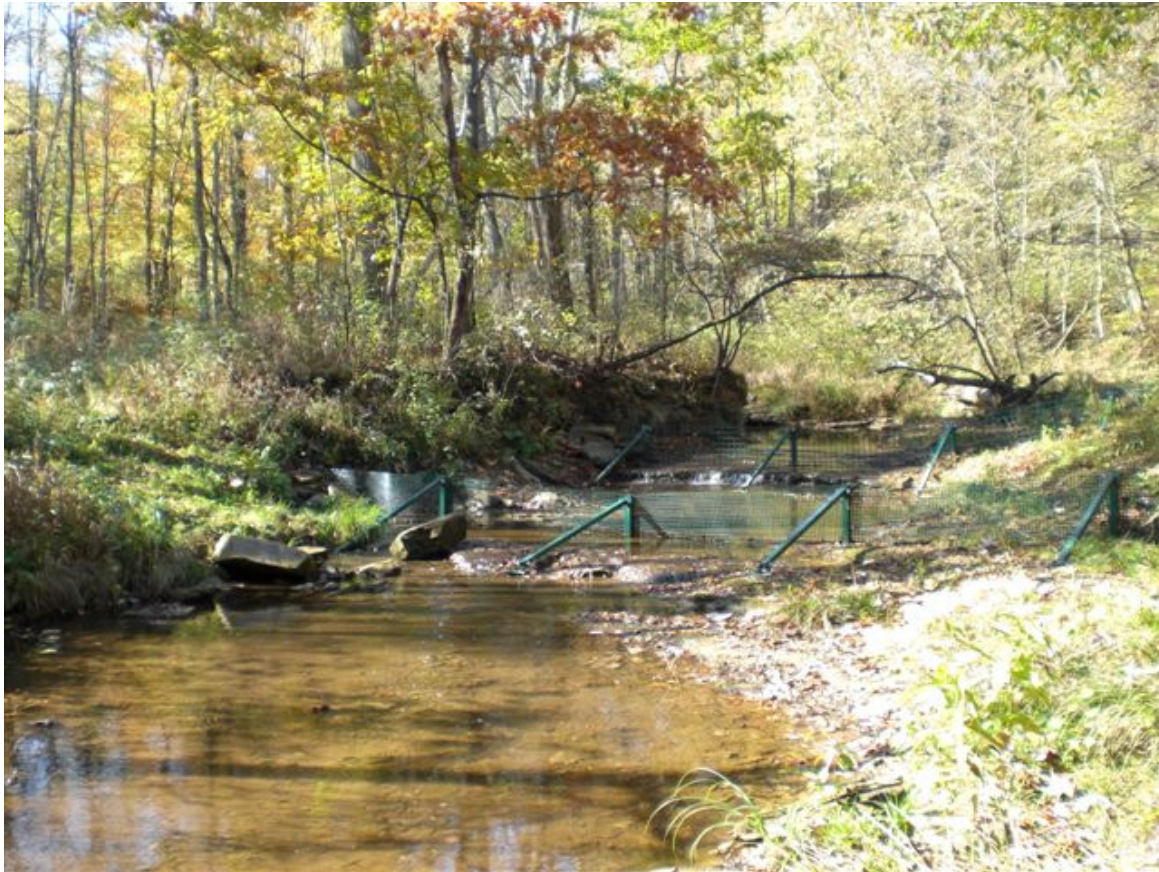
Photo 7: Barrier System, looking upstream
